# EPA Plans Urgent Cleanup Project at Abandoned Plant

## Baycote Metal Finishing Site

Mishawaka, Indiana

June 2012

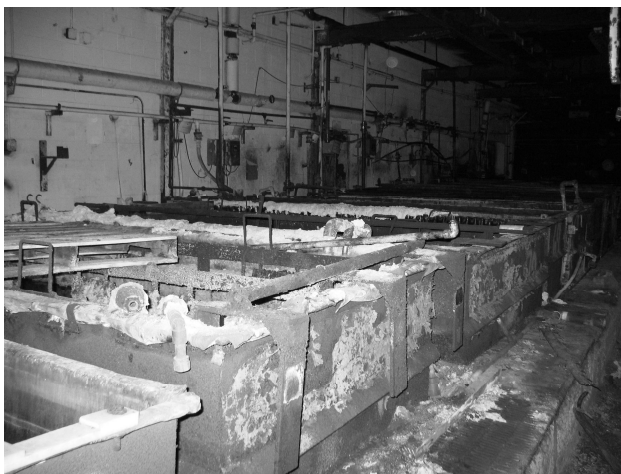
*Corroded, leaking vats like these are just a few of the dangerous problems discovered inside the former Baycote Metal facility in Mishawaka. EPA plans to start a six-month cleanup project at the end of May.*

- Develop and implement a site-specific health and safety plan for residents and workers, including an air monitoring plan and emergency contingency preparations.
- Inventory and categorize all substances in vats, pits, drums and other containers.
- Sample and analyze contents to determine disposal options.
- Consolidate and package material for transport and off-site disposal.
- Dismantle and decontaminate process equipment.
- Transport and dispose of all hazardous substances in an approved off-site disposal facility.

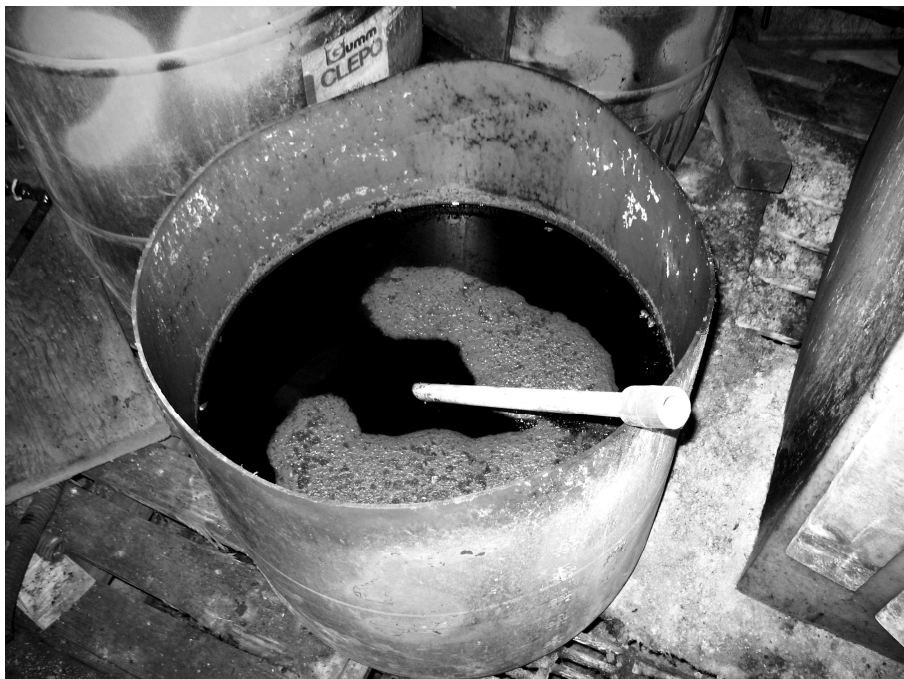
*This open barrel containing liquid waste was typical of the dozens of vats, drums and containers found abandoned in the former Baycote Metal building in Mishawaka, Indiana. EPA inspectors determined the site posed an imminent health threat to people in neighboring businesses and homes, and the Agency will conduct an emergency cleanup project starting this spring.*
