**REMOVAL PROGRAM  
AFTER ACTION REPORT  
FOR THE  
J & A FLORAL SITE  
BENTON, KENNEBEC COUNTY, MAINE  
11 OCTOBER THROUGH 21 DECEMBER 2011**

U.S. Environmental Protection Agency  
Region I  
Emergency Planning and Response Branch  
5 Post Office Square, Suite 100  
Boston, Massachusetts 02109-3912

Weston Solutions, Inc.  
Superfund Technical Assessment and Response Team III (START)  
3 Riverside Drive  
Andover, Massachusetts 01810

April 2012

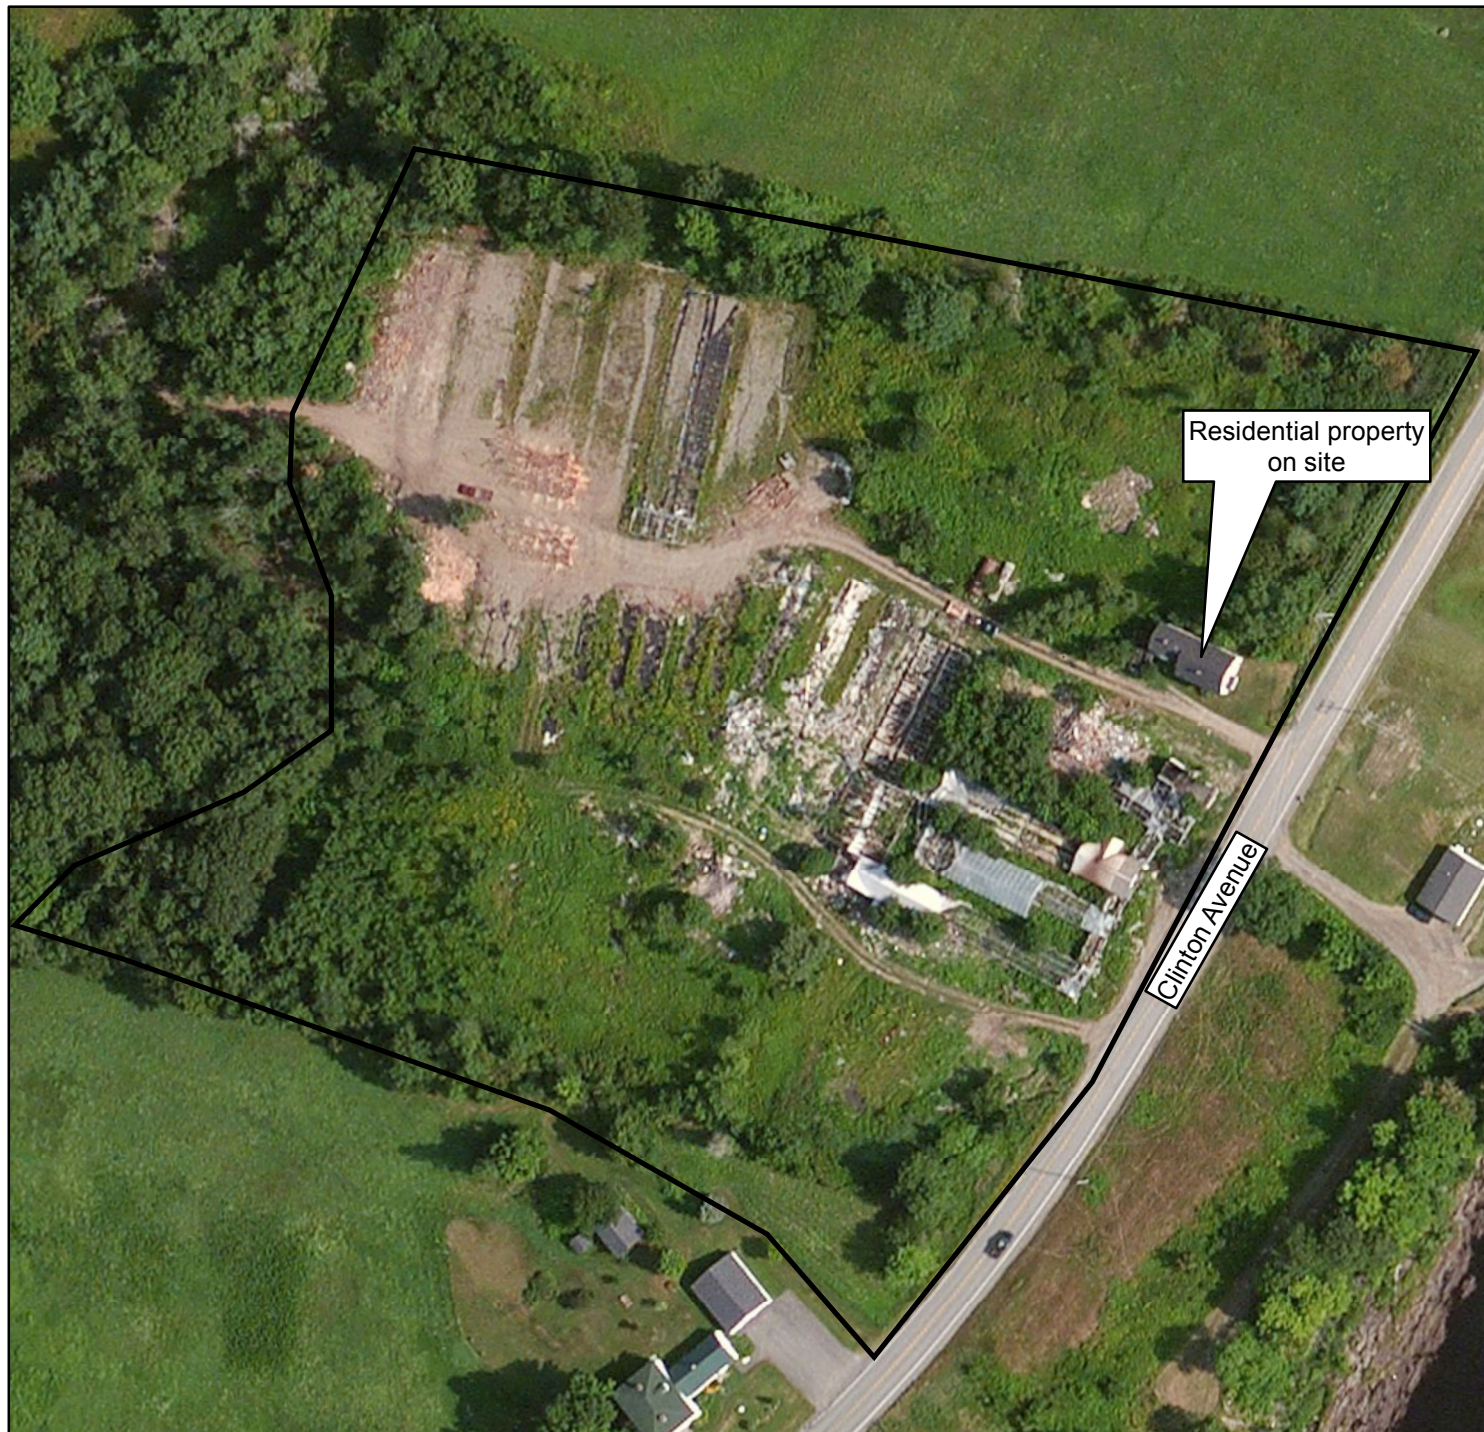
**Figure 2**

**Site Diagram**

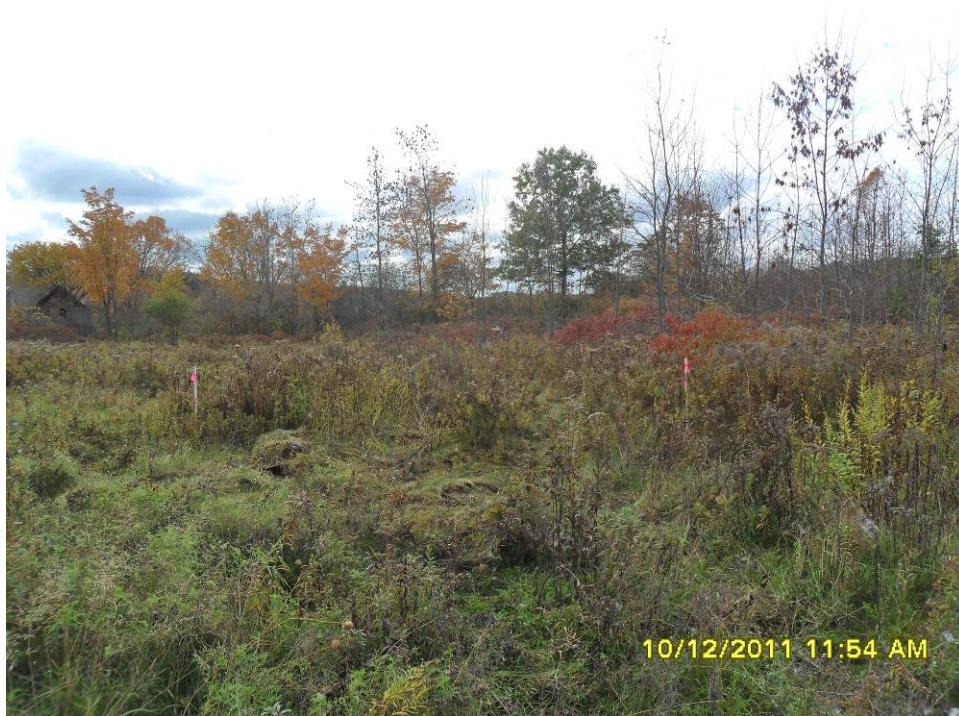
**SCENE:** View of Grid B, prior to vegetation clearing and excavation. Photograph taken facing south.

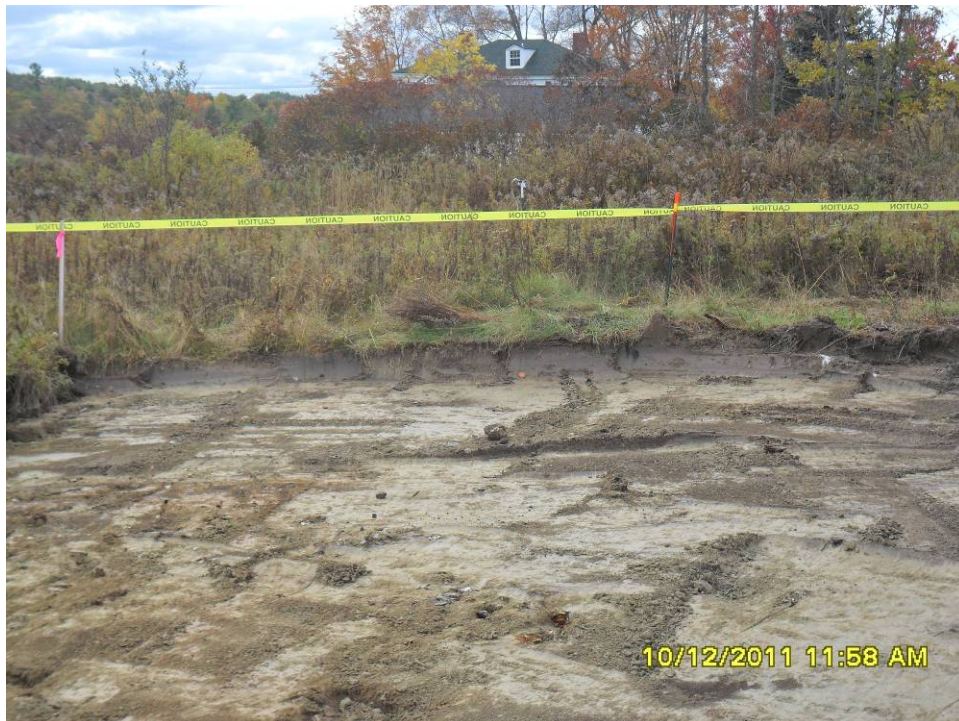
**SCENE:** View of the excavation of Grid A, and the air sampling pump located at the southern perimeter of the site. Photograph taken facing south.

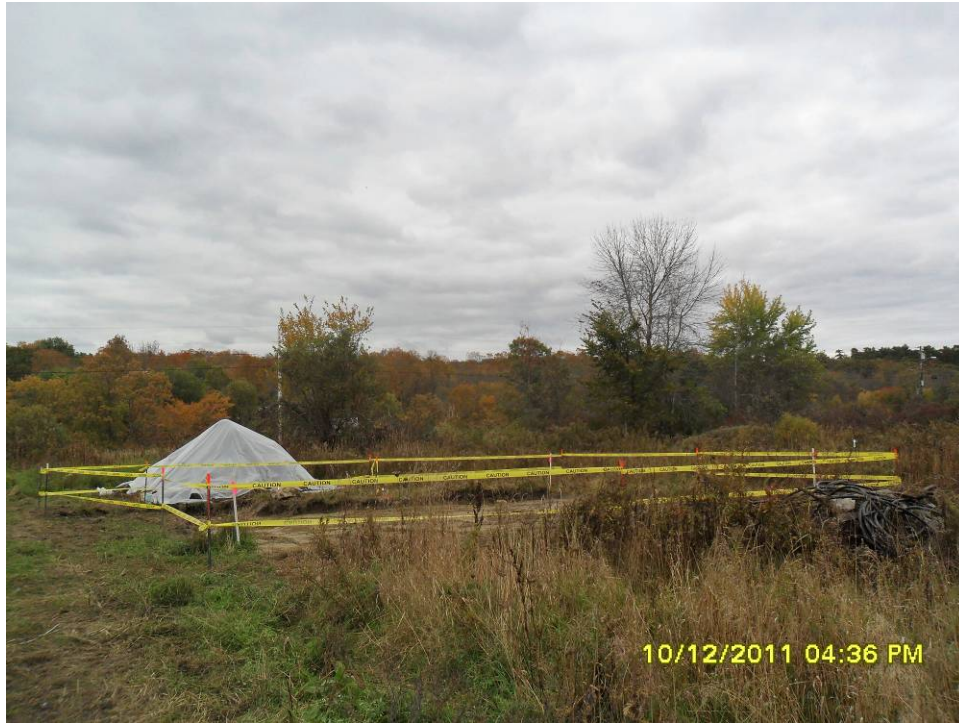
**SCENE:** View of Grid A, following soil excavation. Caution tape was installed around the excavation and the covered soil stockpile. Photograph taken facing southeast.

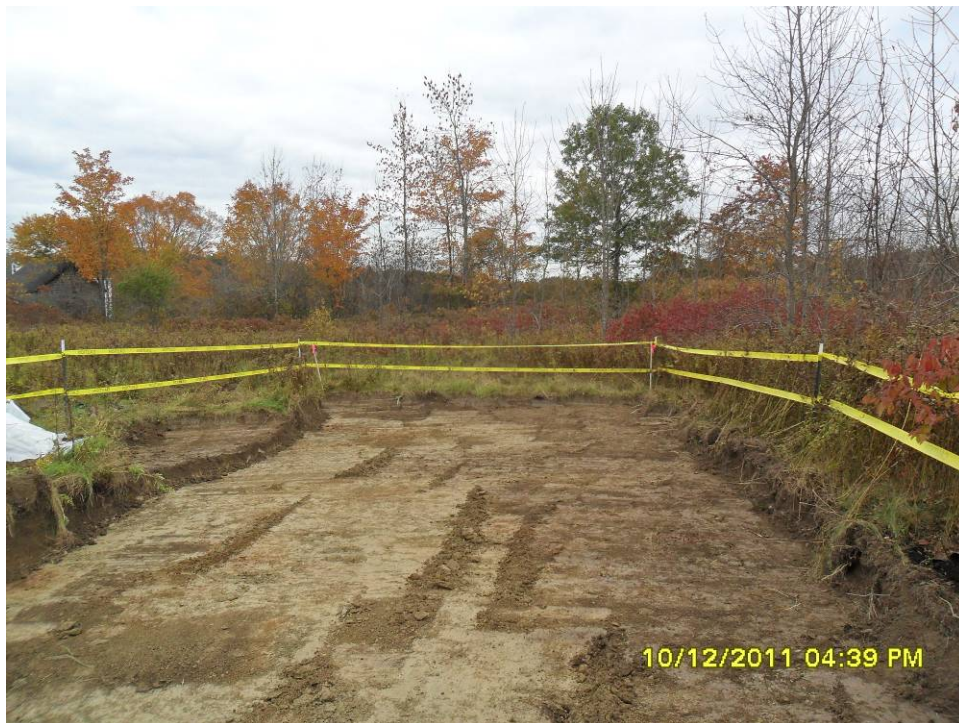
**SCENE:** View of Grid B, following soil excavation. Photograph taken facing south.

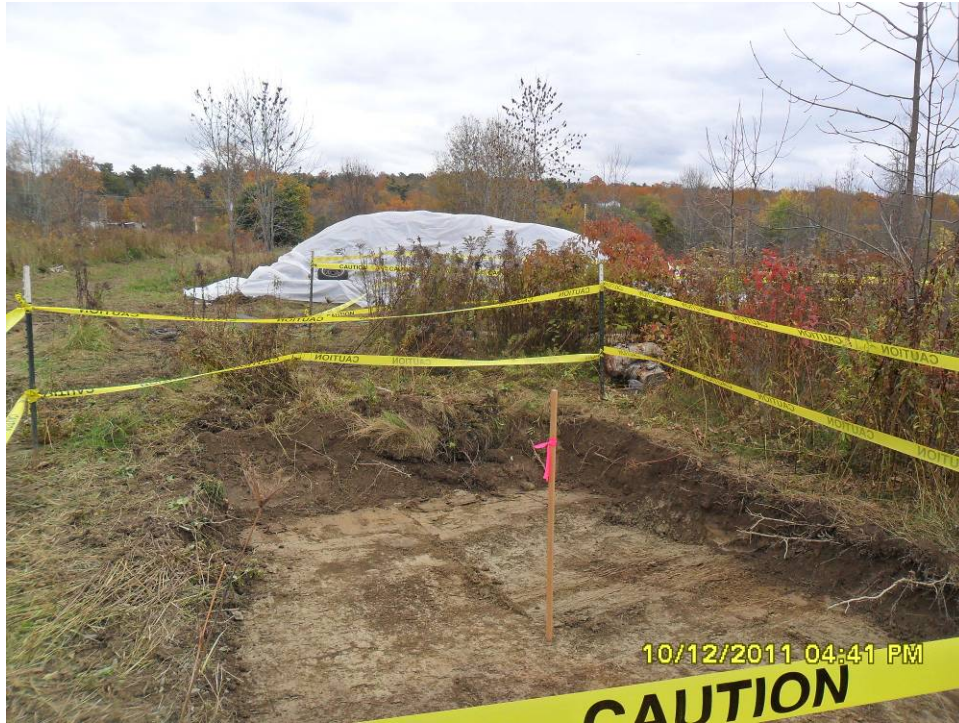
**SCENE:** View of Grid C, following soil excavation. Photograph taken facing east.

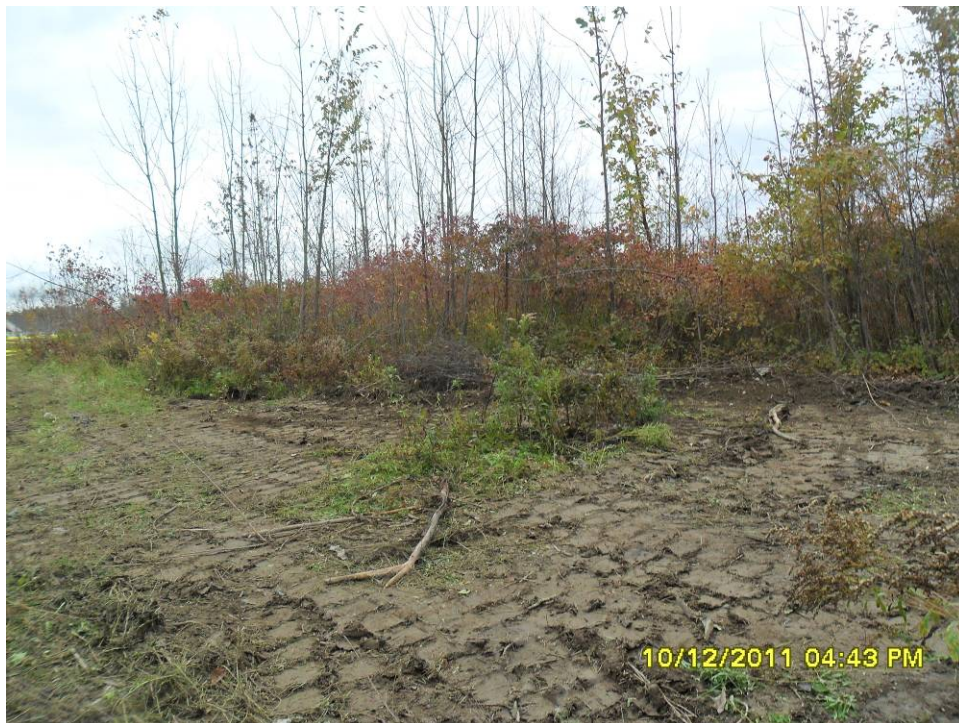
**SCENE:** View of the former location of the debris piles, following excavation. Photograph taken facing northeast.

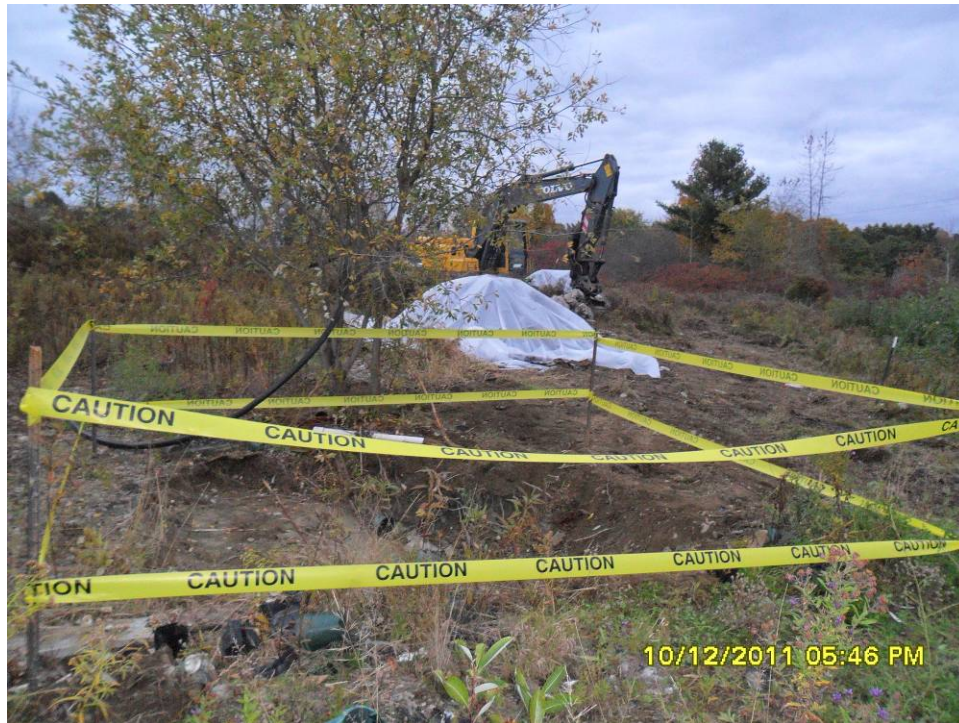
**SCENE:** View of Grid D, following soil excavation. Caution tape was installed around the excavation and the covered soil stockpile. Photograph taken facing west.

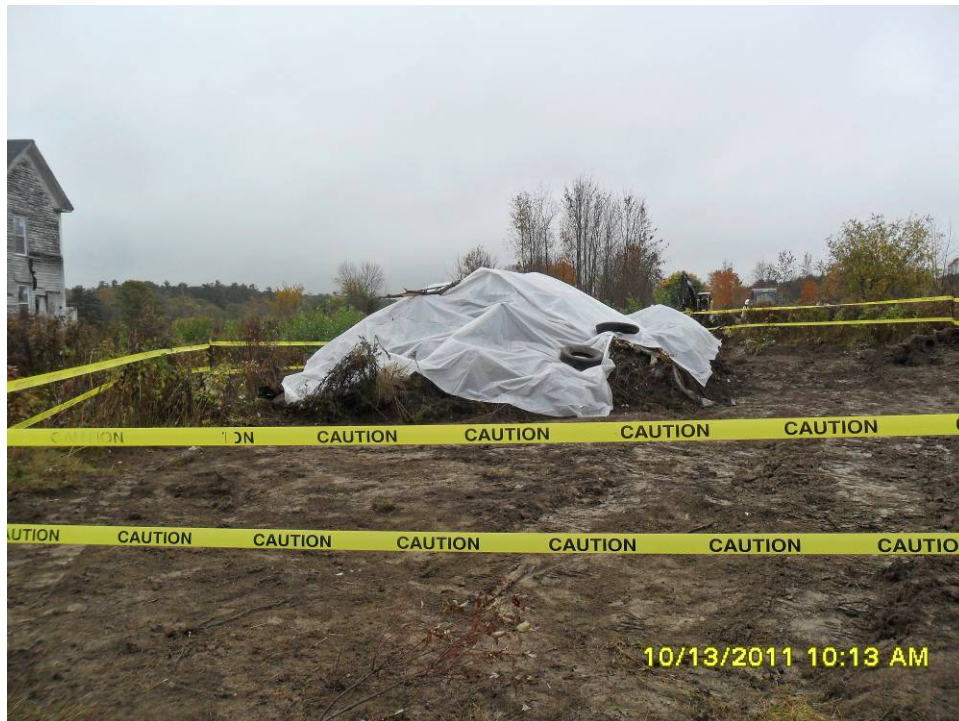
**SCENE:** View of Grid E, following soil excavation. Caution tape was installed around the excavation and the covered soil stockpile. Photograph taken facing south.

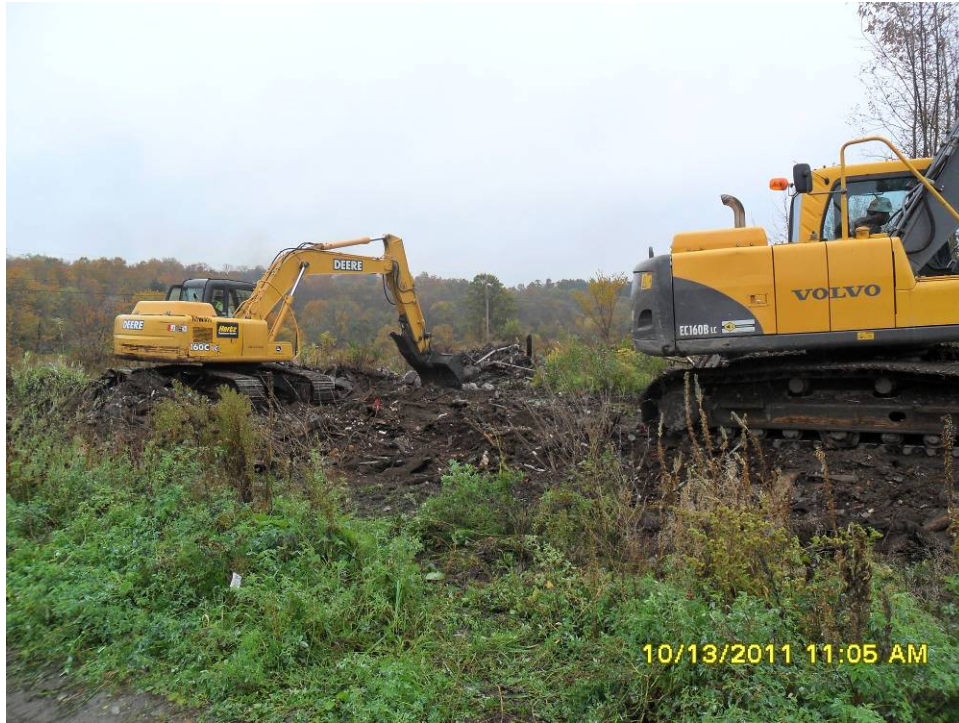
**SCENE:** View of debris removal from Grid F. Photograph taken facing south.

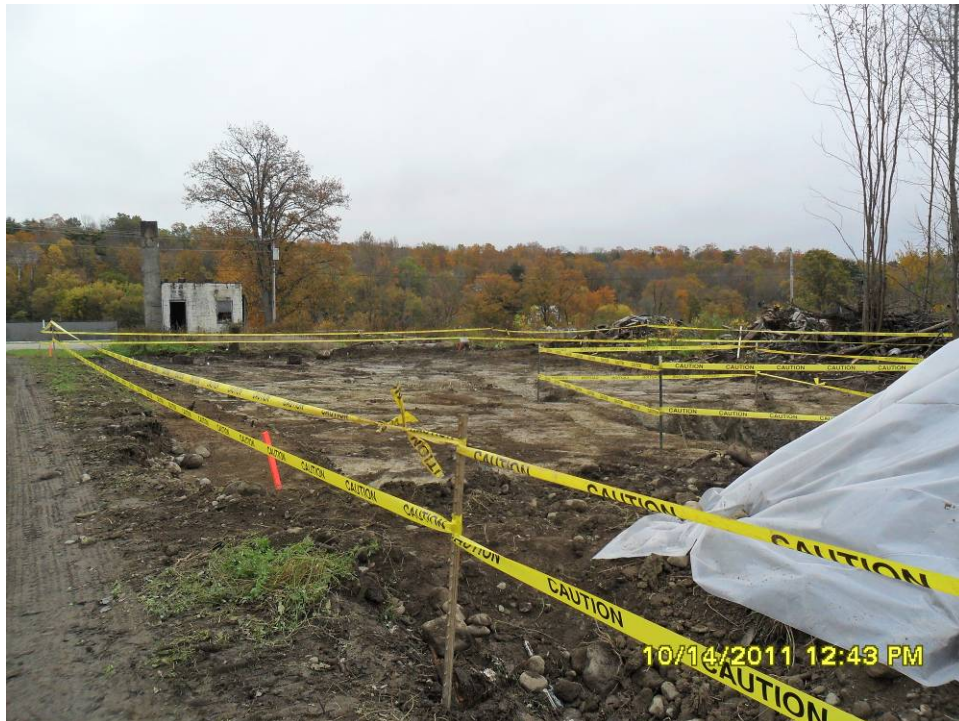
**SCENE:** View of Grid F, following soil excavation. Caution tape was installed around the excavation and the covered soil stockpile. Photograph taken facing east.

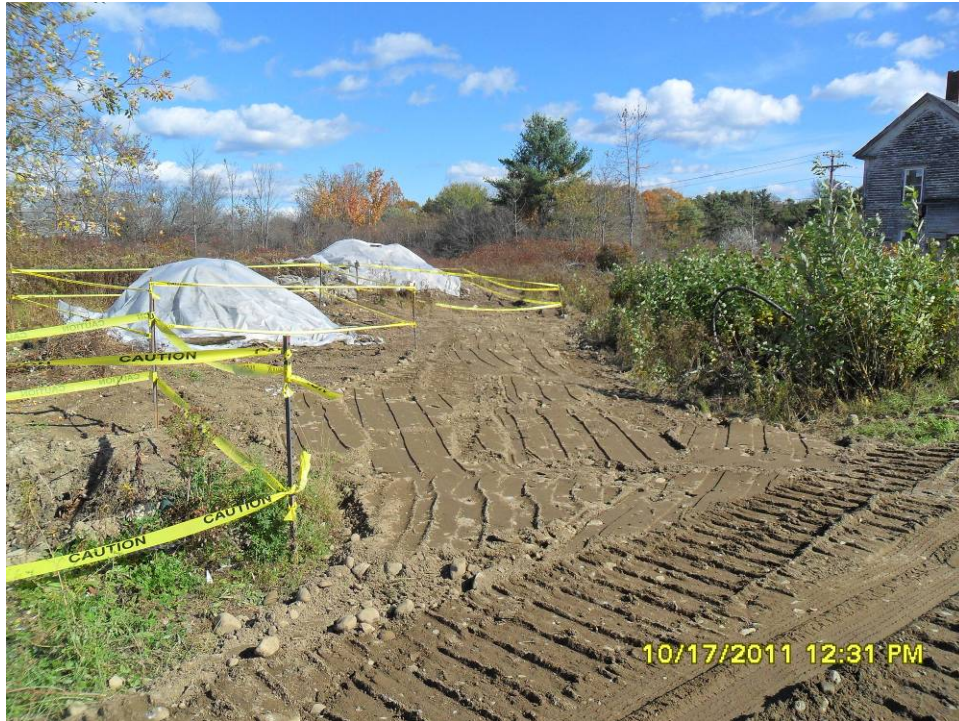
**SCENE:** View of the access road to Grids D and E. Photograph taken facing north.

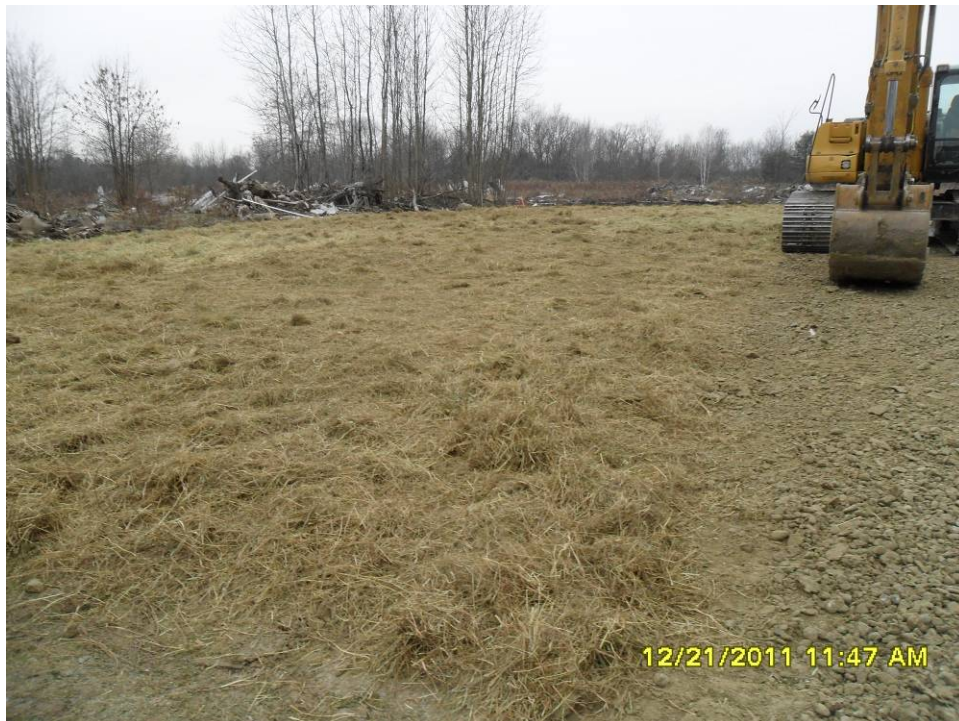
**SCENE:** View of Grid F, following backfill and restoration activities. Photograph taken facing northwest.

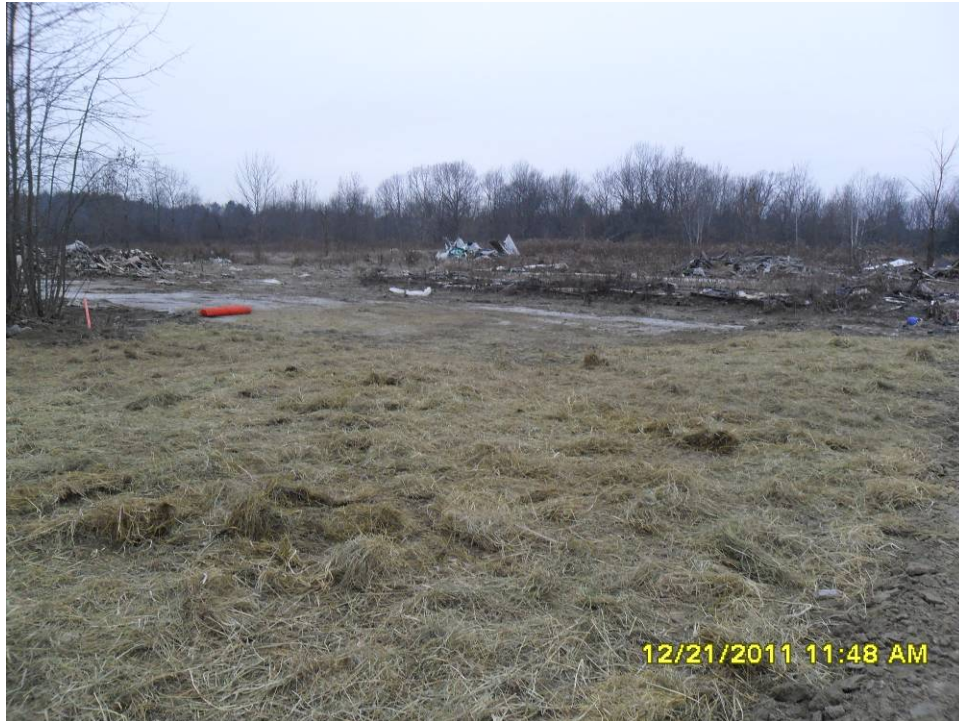
**SCENE:** View of the location of the Grid F stockpile area following load out and disposal. Photograph taken facing west.

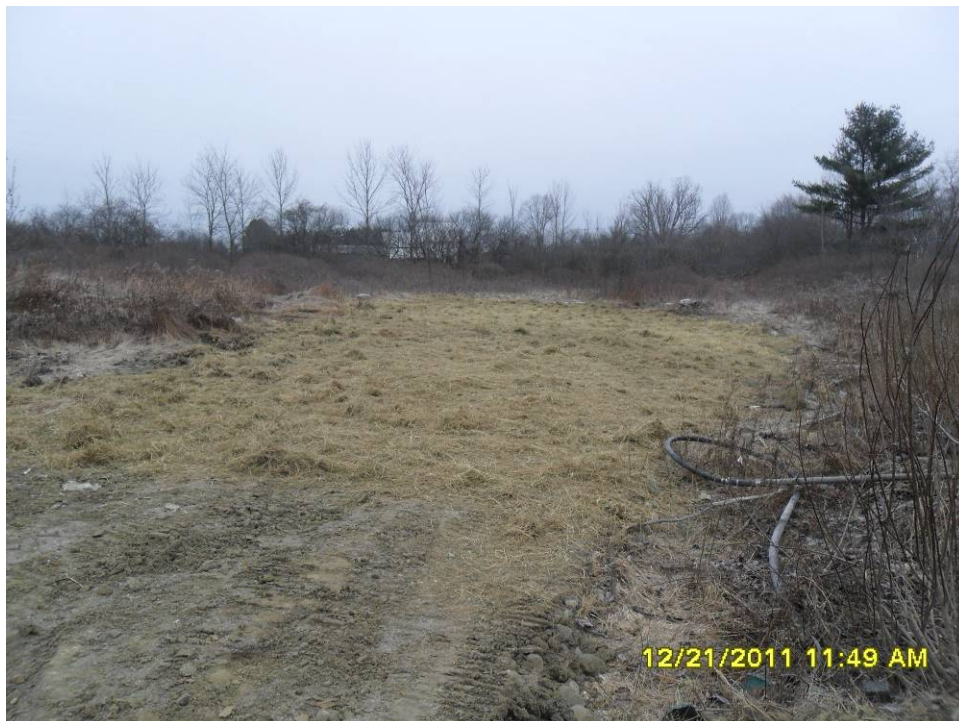
**SCENE:** View of Grid E, following backfill and restoration activities. Photograph taken facing northeast.

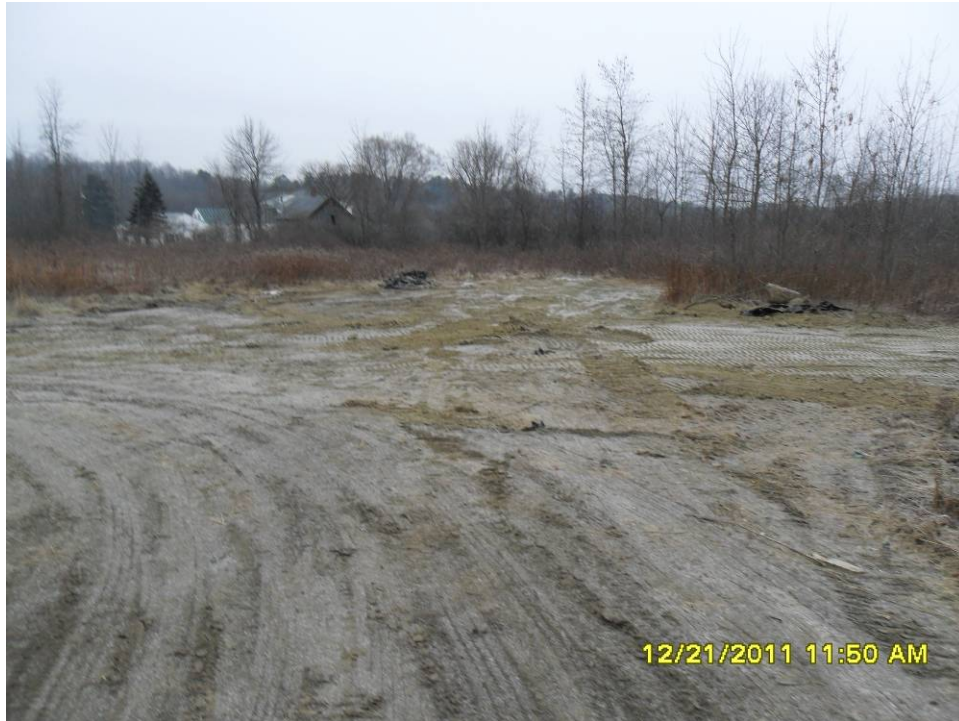
**SCENE:** View of Grids B and C, following backfill activities. Photograph taken facing south.

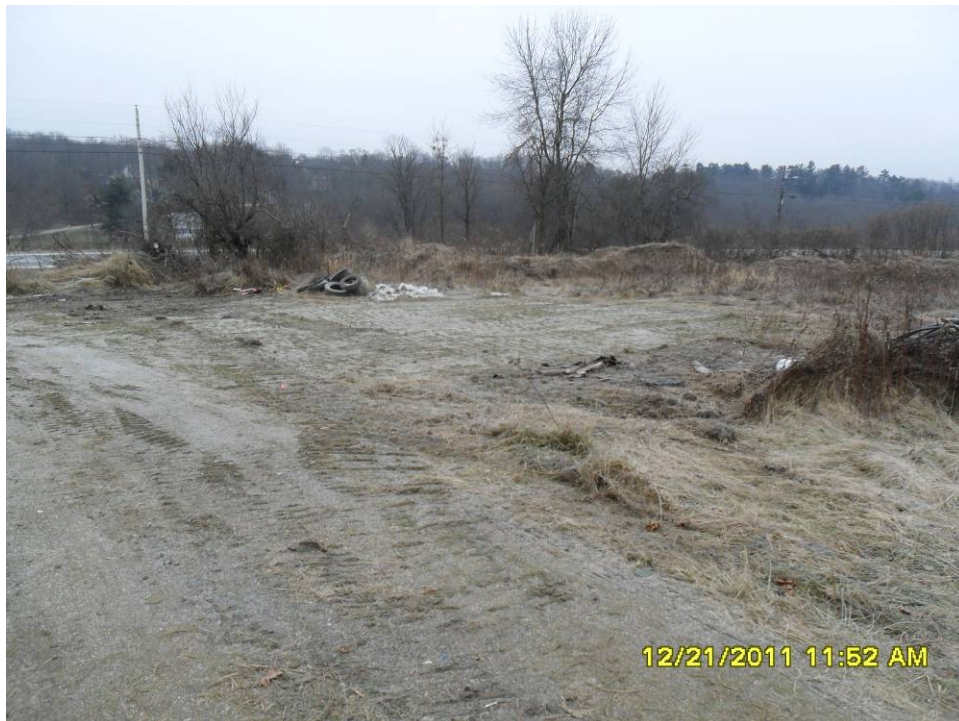
**SCENE:** View of Grid A, following backfill activities. Photograph taken facing south.
