**Subject: Final Time Critical Removal Action Report, Revision 0
Welch Group Environmental Palmetto
110 Palmetto Parkway
Belton, Anderson County, South Carolina
EPA Contract No. EP-W-05-053
Technical Direction Document (TDD) No. TNA-05-001-0129**

REMOVAL ACTION REPORT

**WELCH GROUP ENVIRONMENTAL PALMETTO
110 PALMETTO PARKWAY
BELTON, ANDERSON COUNTY, SOUTH CAROLINA**

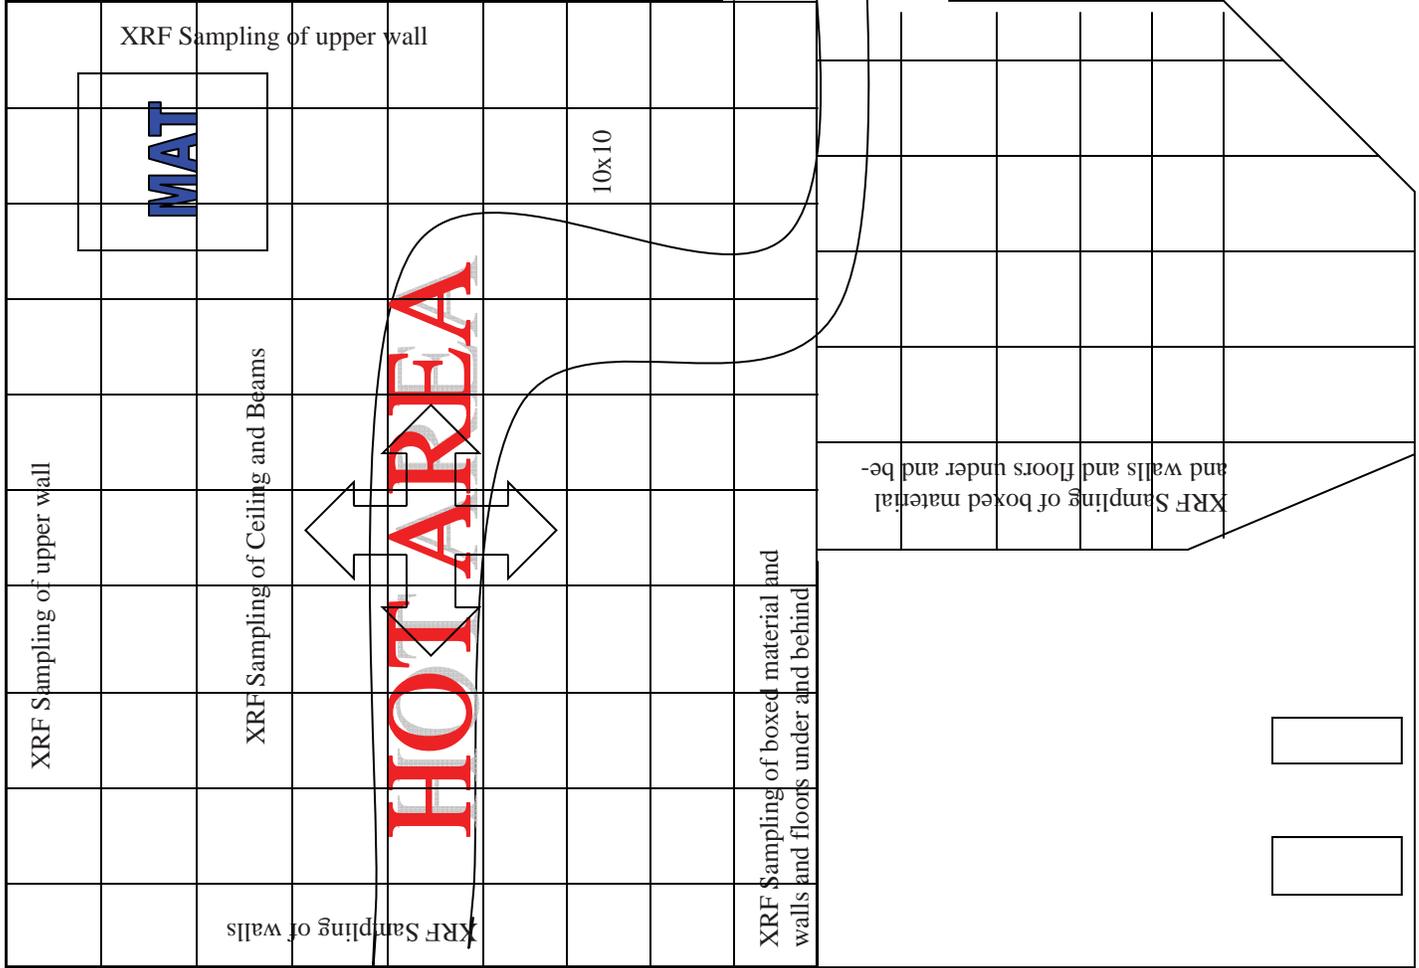
Traffic area with plastic path

HOT AREA

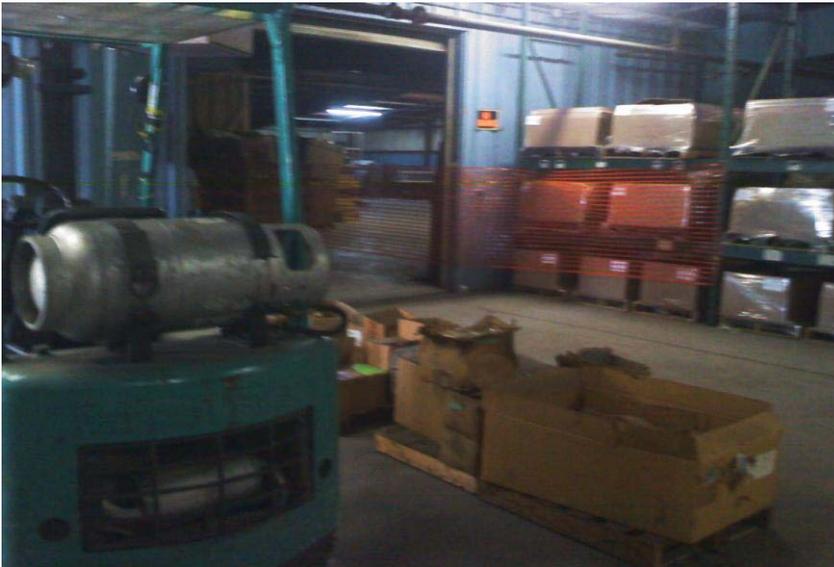
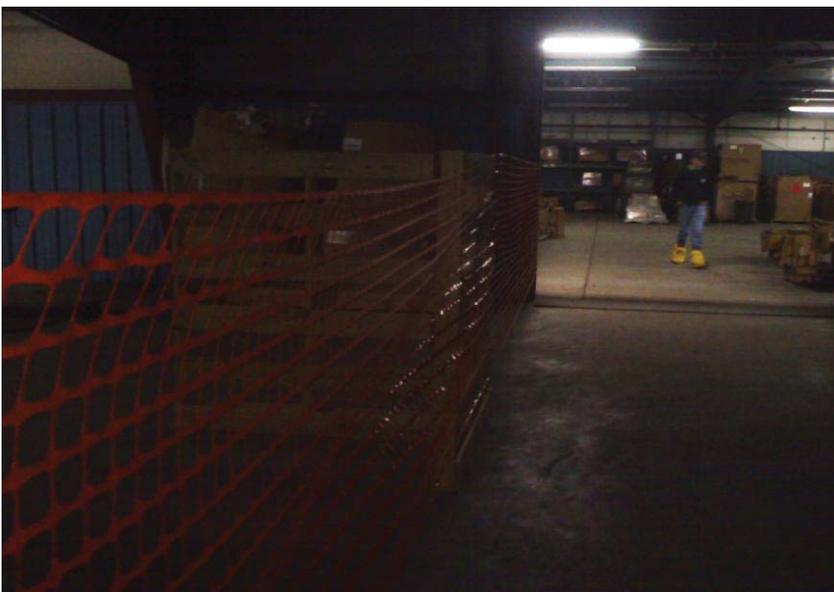
1. Barricade Fencing was put in place to control access to Exclusion Zones.

2. Paper Floor covering was placed in designated areas along barricade paths and secured with duct tape.
3. Keys to facility were turned over to Jerry, EPA contract to gain access for daily XRF readings.

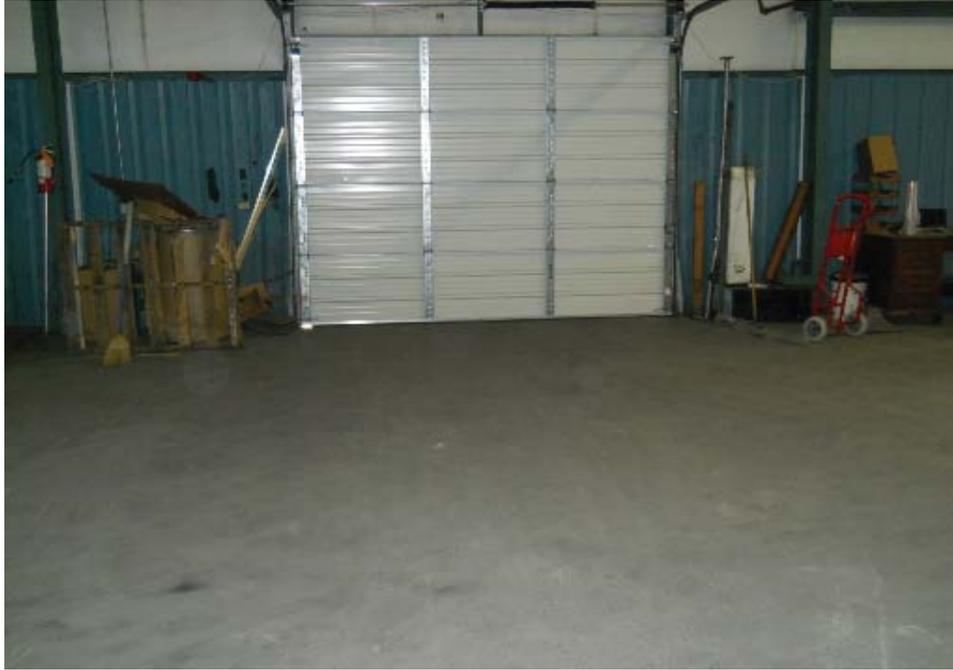
Official Photograph No. 3

Site Name: WGE Palmetto Facility **Date:** February 7, 2011
Location: Belton, Anderson County, South Carolina **TDD No:** TNA-05-001-0129
Photographer: Jerry Partap, START
Subject: View of the loading dock where range recovered material entered the warehouse.

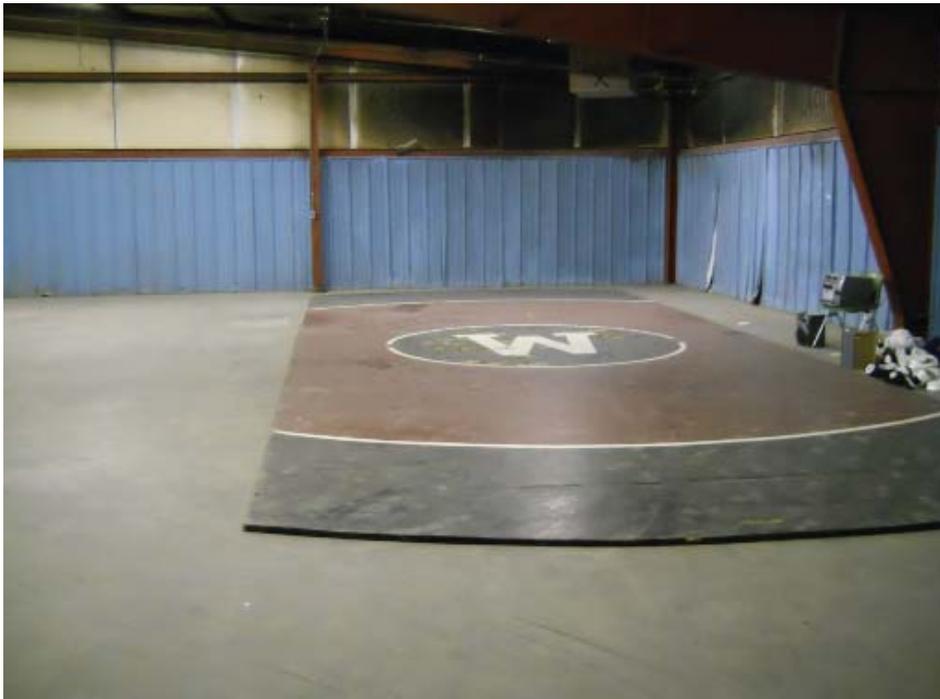
Official Photograph No. 4

Site Name: WGE Palmetto Facility **Date:** February 7, 2011
Location: Belton, Anderson County, South Carolina **TDD No:** TNA-05-001-0129
Photographer: Jerry Partap, START
Subject: View of the area where the range recovered material was stored.

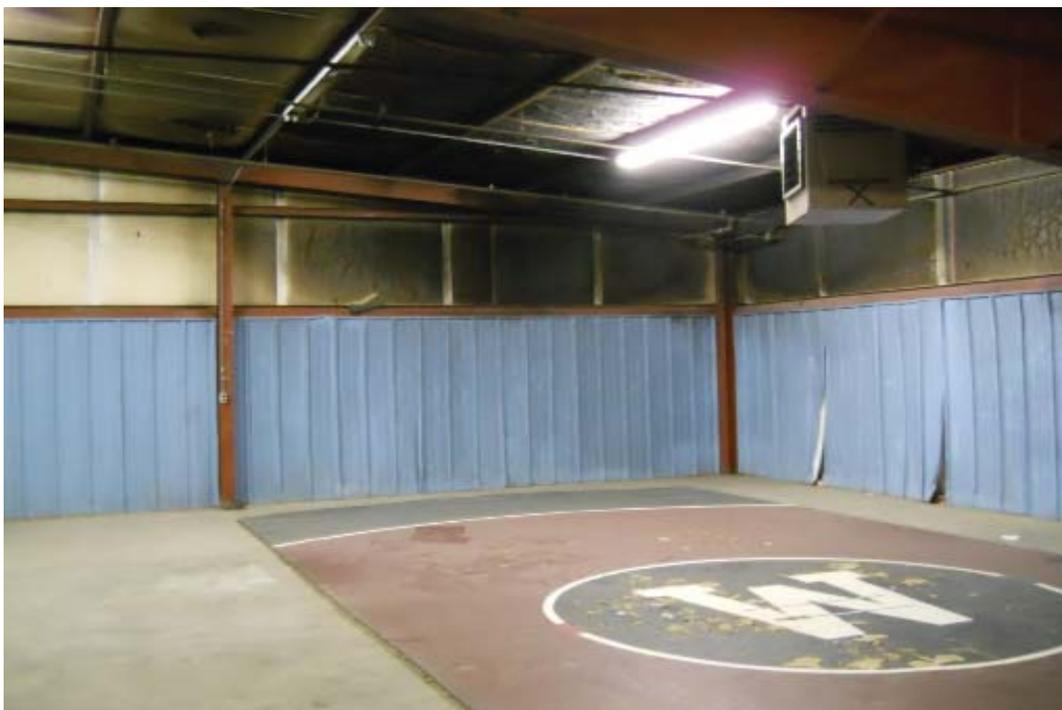
Official Photograph No. 5

Site Name: WGE Palmetto Facility **Date:** February 7, 2011
Location: Belton, Anderson County, South Carolina **TDD No:** TNA-05-001-0129
Photographer: Jerry Partap, START
Subject: Ceiling area where fire scorched interior of the building.

The fire that occurred in the warehouse was located in Area B and damage was confined to the warehouse insulation. WGE removed the ceiling insulation and secured it for disposal. WGE screened all items on the floor. WGE made an effort to decontaminate any items which screened above 400 ppm for lead. Items that could not be decontaminated were bagged and secured for disposal.

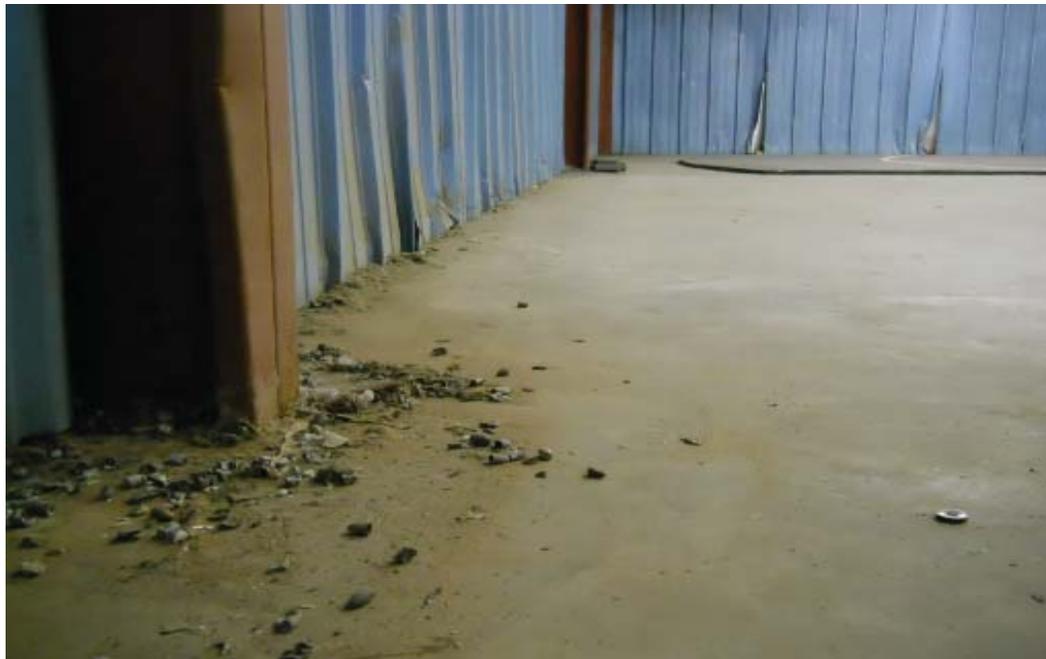
Official Photograph No. 6

Site Name: WGE Palmetto Facility **Date:** February 16, 2011
Location: Belton, Anderson County, South Carolina **TDD No:** TNA-05-001-0129
Photographer: Jerry Partap, START
Subject: View of spent casings and bullets on the warehouse floor.

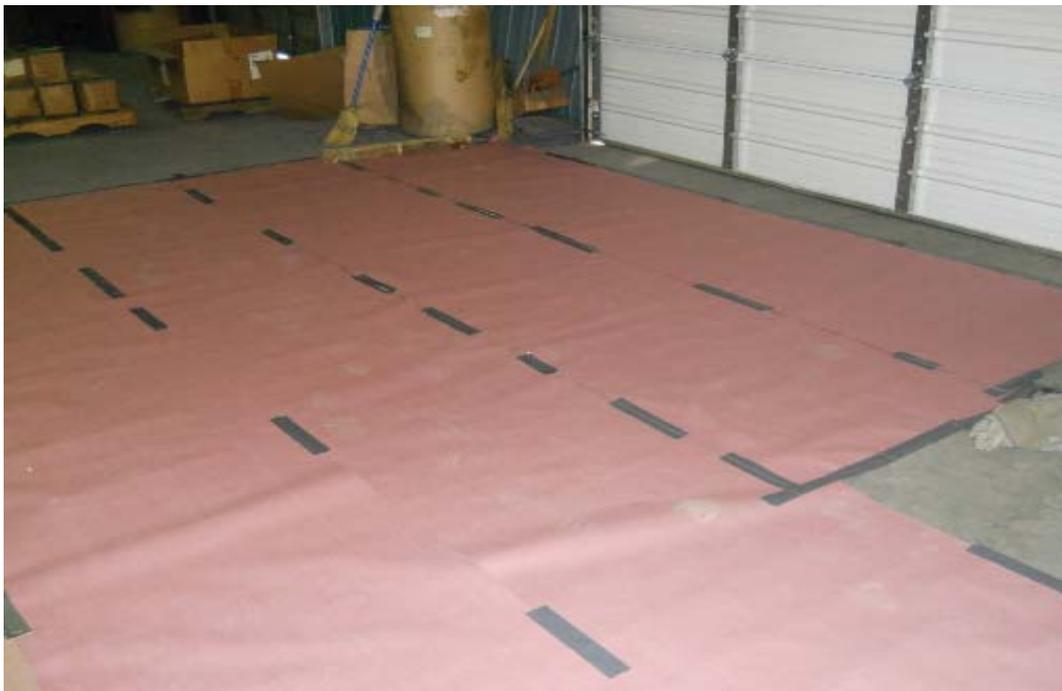
Official Photograph No. 9

Site Name: WGE Palmetto Facility **Date:** February 17, 2011
Location: Belton, Anderson County, South Carolina **TDD No:** TNA-05-001-0129
Photographer: Jerry Partap, START
Subject: View of secured warehouse flooring.

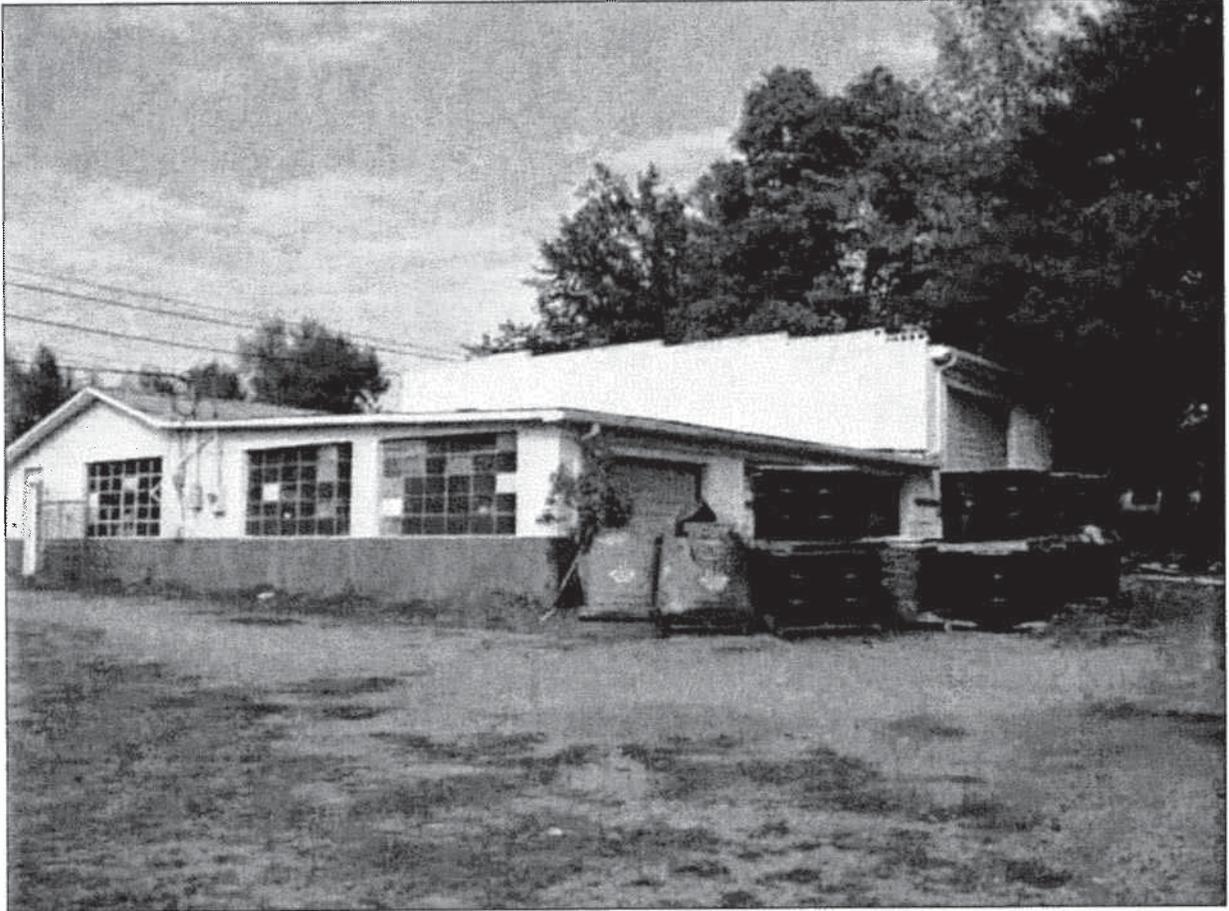
Estimated 350-400 drums located on backside of facility

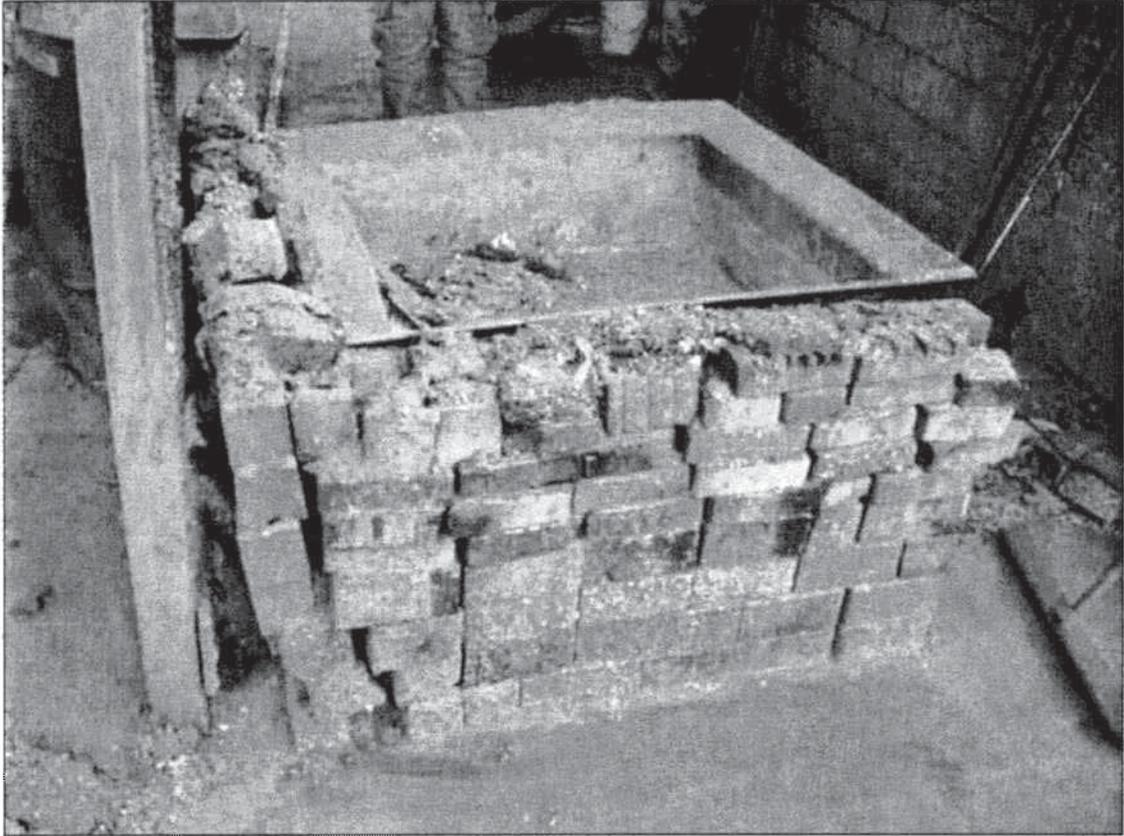
Melter and splattered lead on wall

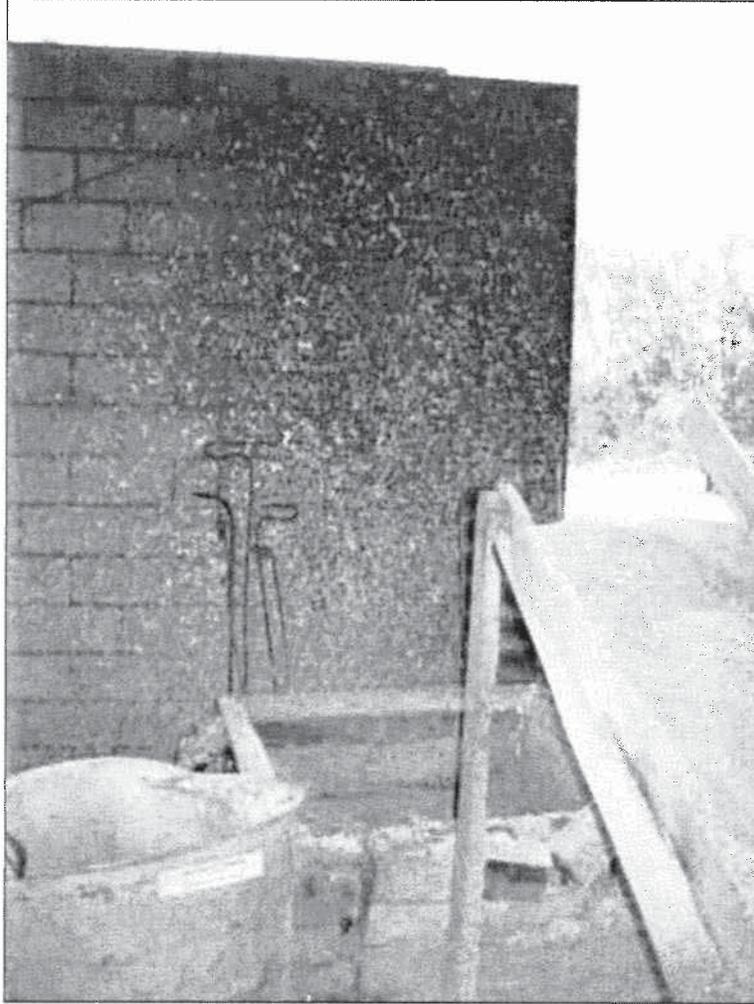
Processed material swept outside

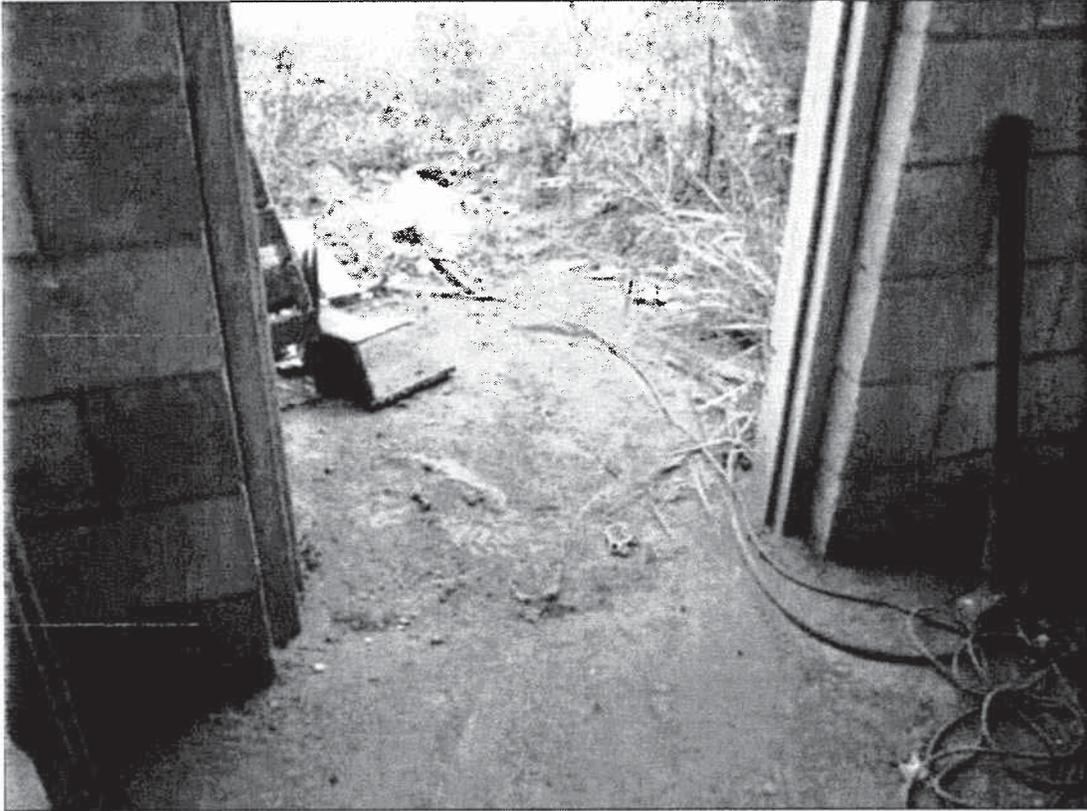
Processed material/slag inside facility

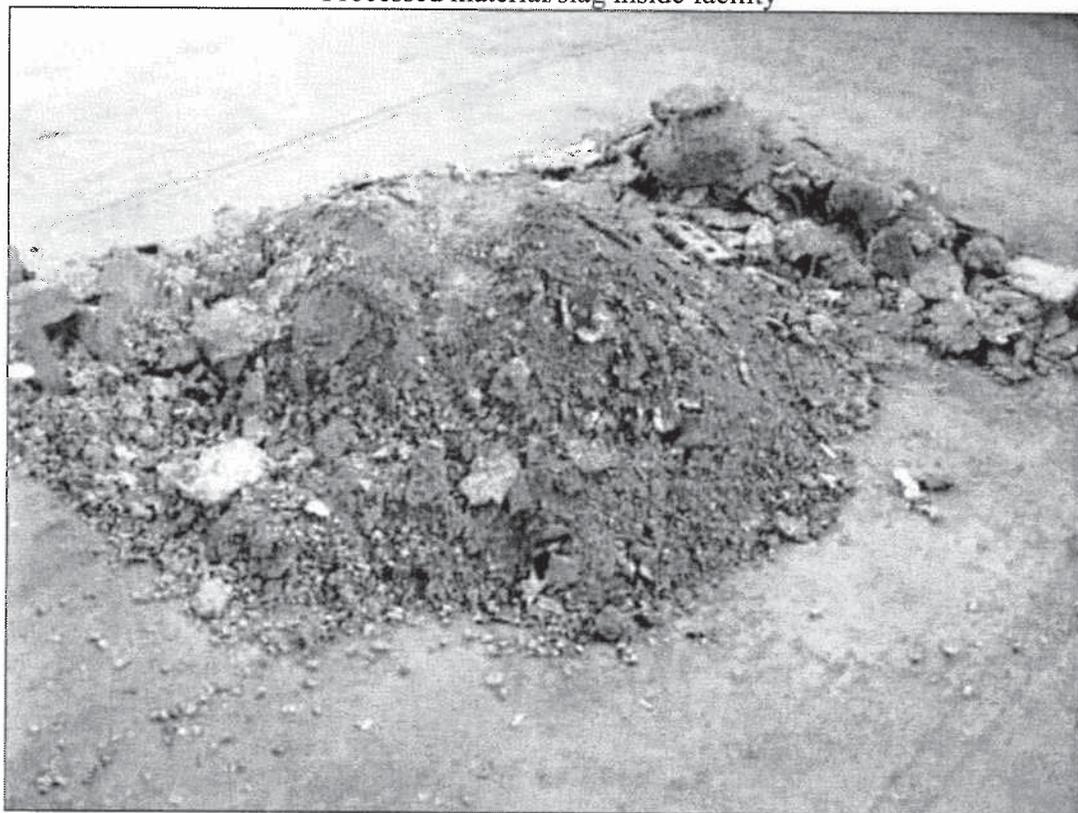
More processed material swept outside

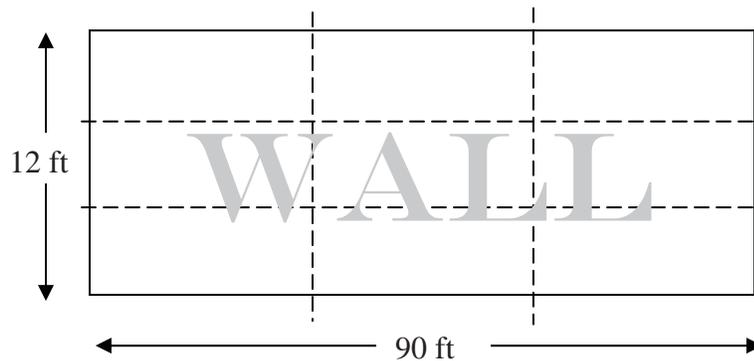
- Wall surface material and ancillary items attached to the wall (i.e., support beams: wood, steel, utility pipes, and door frames) will be treated as separate objects and sampled separately
- Separate the wall into nine equal sampling zones (example below)

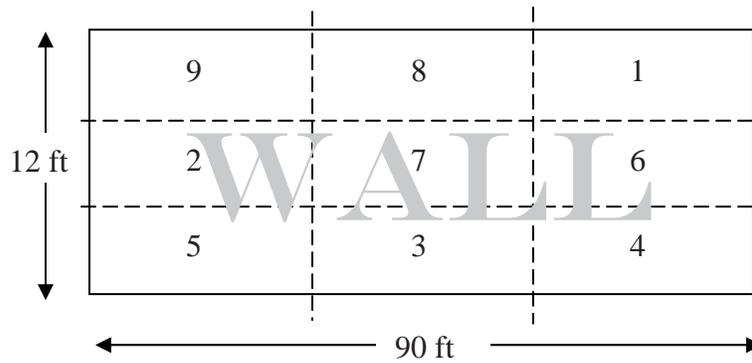
- Example: Sampling Area 1 random number diagram is applied to the previous diagram...

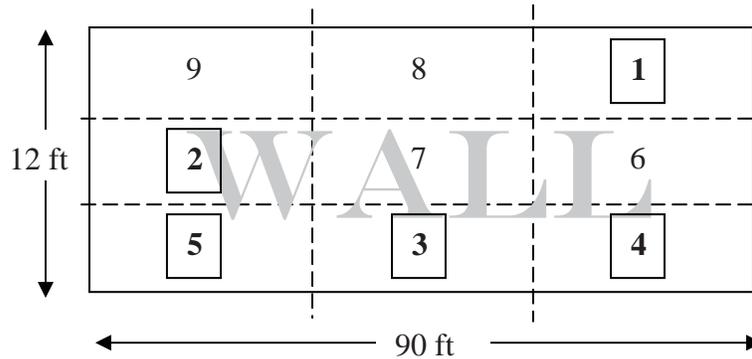
- The total wall square footage is 1080 square feet, thus a minimum of 5 samples need to be collected. (again, 9 is recommended)
- Sample locations are with grid locations 1 thru 5 will be collected.
