DRAFT – Asbestos and Lead-Based Paint Survey Report – Kuhlman Diecasting Site

Stanley, Kansas

Appendix B– Photographic Log

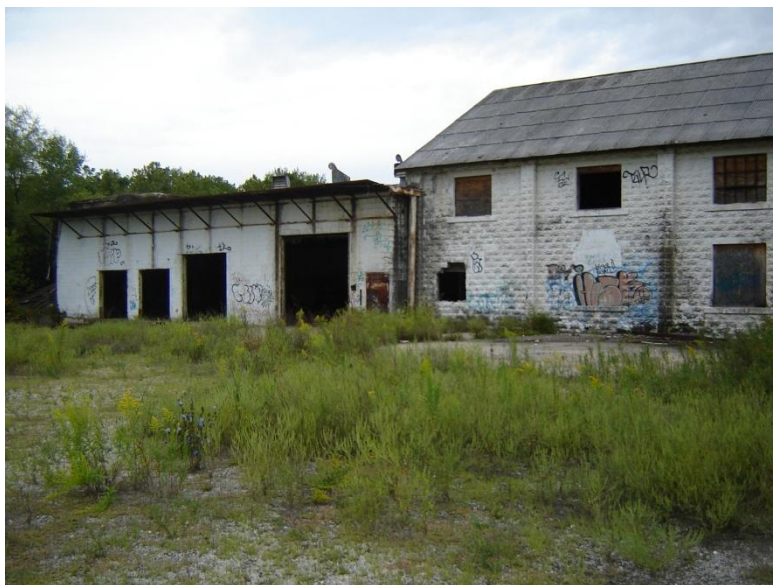
Targeted Brownfields Assessment Direction: Northwest	DESCRIPTION	This photograph shows the front of the Kuhlman Diecasting building. The building is inactive and in a dilapidated condition.	1
	CLIENT	Environmental Protection Agency Region 7	Date
	PHOTOGRAPHER	Jeff Pritchard	9-14-11

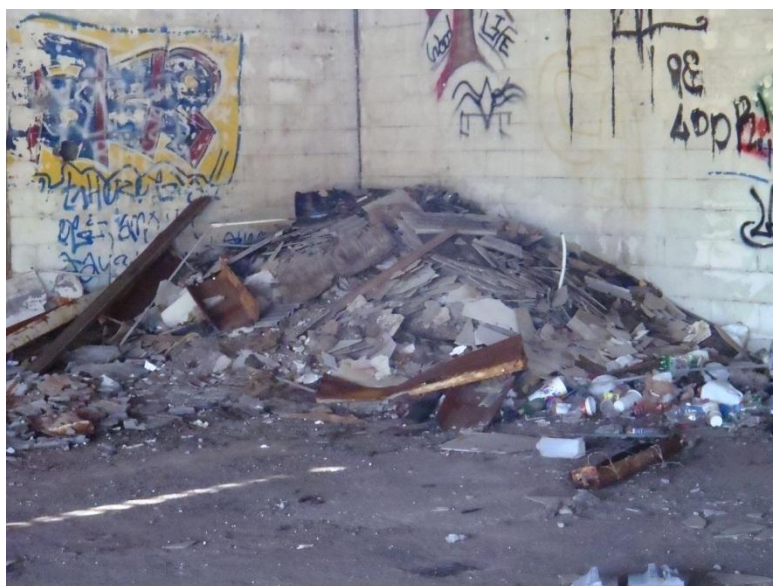
Targeted Brownfields Assessment Direction: Northwest	DESCRIPTION	This photograph shows a debris pile containing transite board located in the northwest corner of the loading dock.	2
	CLIENT	Environmental Protection Agency Region 7	Date
	PHOTOGRAPHER	Kirk Mammoliti	10-20-11

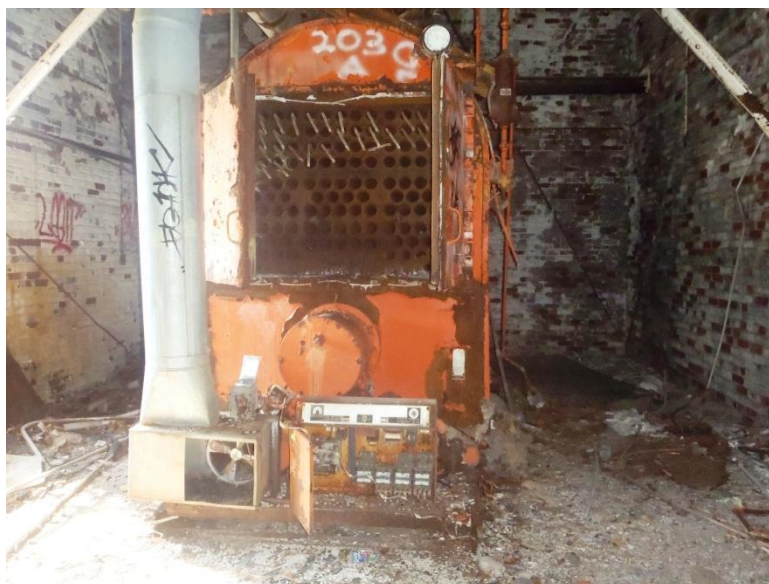
Targeted Brownfields Assessment Direction: West	DESCRIPTION	This photograph shows the boiler room located in the southwest corner of the building. The boiler contained orange lead-based paint.	3
	CLIENT	Environmental Protection Agency Region 7	Date
	PHOTOGRAPHER	Kirk Mammoliti	10-20-11

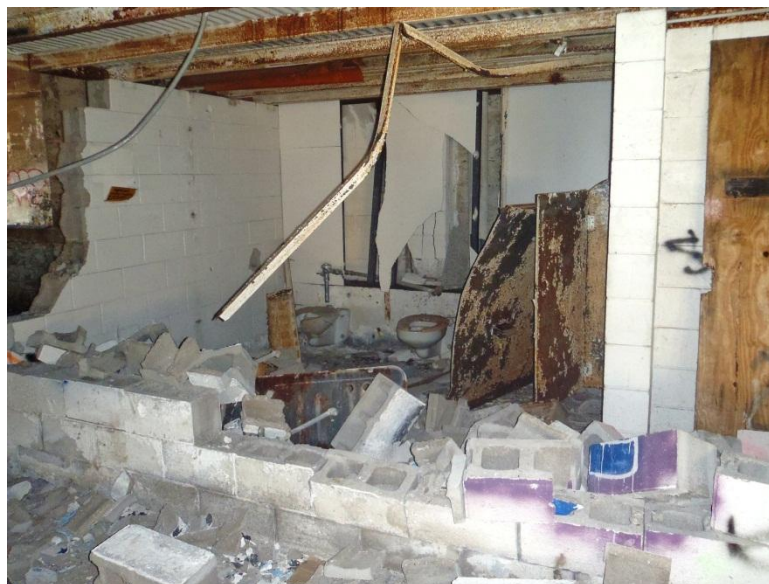
Targeted Brownfields Assessment Direction: Northwest	DESCRIPTION	This photograph shows a bathroom in the building that contained transite board and floor tile that were asbestos-containing.	4
	CLIENT	Environmental Protection Agency Region 7	Date
	PHOTOGRAPHER	Kirk Mammoliti	10-20-11

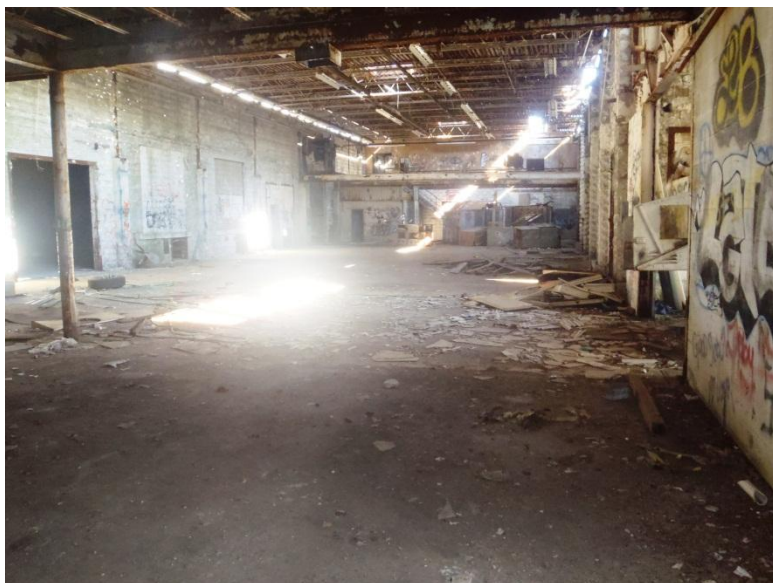
Targeted Brownfields Assessment Direction: East	DESCRIPTION	This photograph shows asbestos-containing transite board, roof tiles, and other debris scattered throughout the central portion of the building.	5
	CLIENT	Environmental Protection Agency Region 7	Date
	PHOTOGRAPHER	Kirk Mammoliti	10-20-11

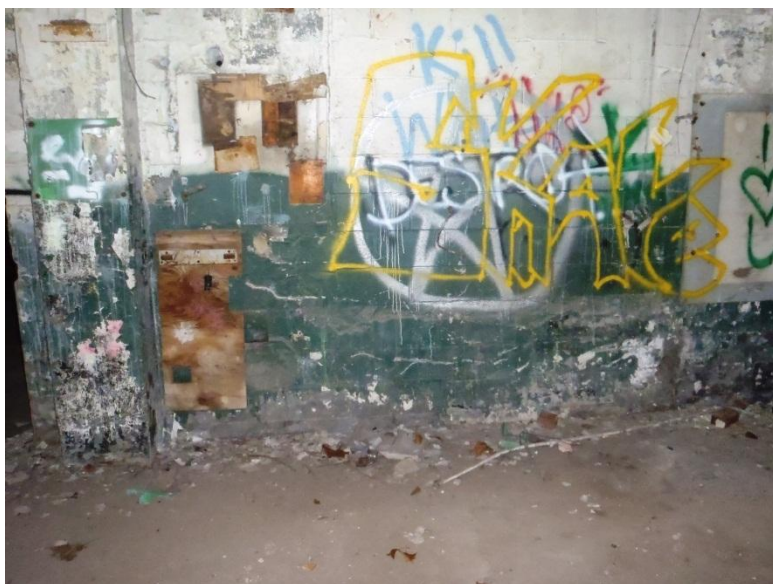
Targeted Brownfields Assessment Direction: North	DESCRIPTION	This photograph shows green lead-based paint located on the wall throughout the central room in the building.	6
	CLIENT	Environmental Protection Agency Region 7	Date
	PHOTOGRAPHER	Kirk Mammoliti	10-20-11

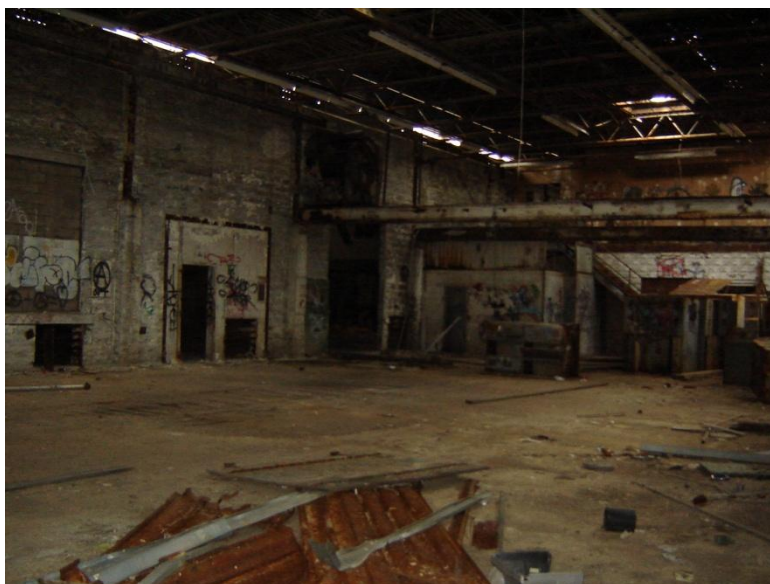
Targeted Brownfields Assessment Direction: Northeast	DESCRIPTION	This photograph shows the office located on the east side of the building. A bathroom in the office was determined to have asbestos-containing ceramic tile mastic.	7
	CLIENT	Environmental Protection Agency Region 7	Date
	PHOTOGRAPHER	Kirk Mammoliti	10-20-11

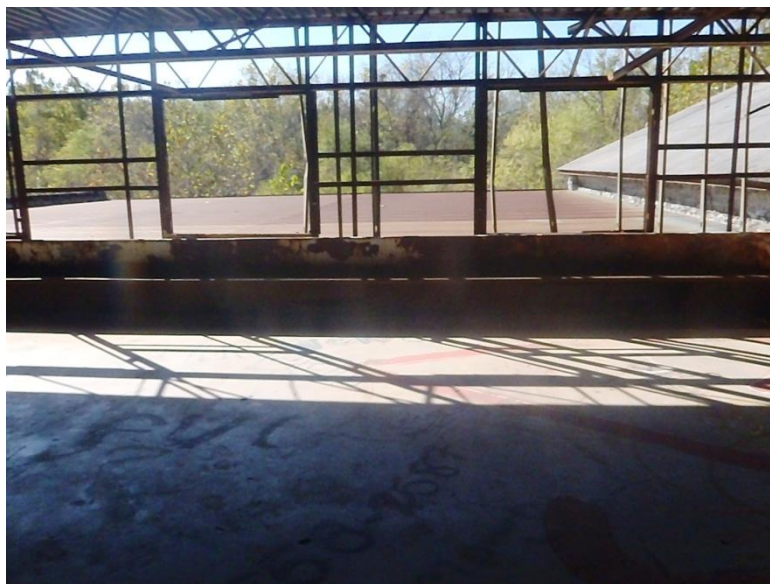
Targeted Brownfields Assessment Direction: West	DESCRIPTION	This photograph shows the pitched roof (in the distance) that was comprised of several asbestos-containing materials.	8
	CLIENT	Environmental Protection Agency Region 7	Date
	PHOTOGRAPHER	Kirk Mammoliti	10-20-11

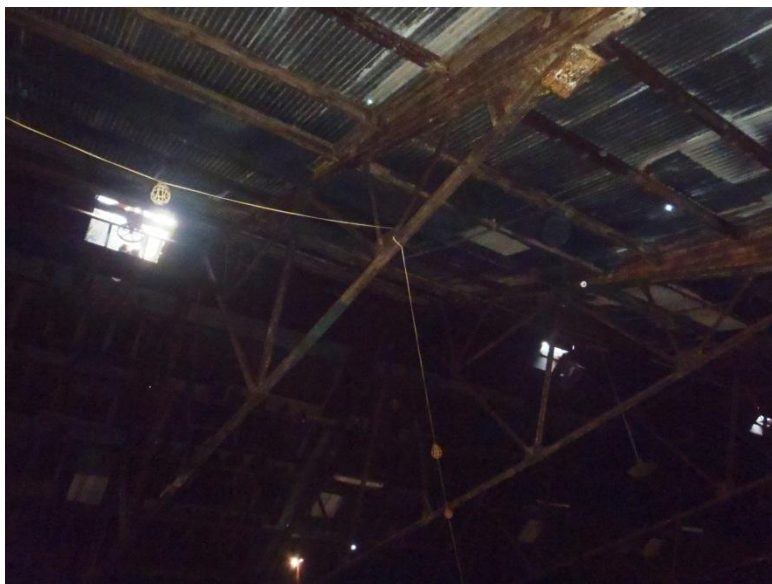
Targeted Brownfields Assessment Direction: NA	DESCRIPTION	This photograph shows the pitched roof composed of transite panels with an insulation under layer that were determined to be asbestos-containing materials.	9
	CLIENT	Environmental Protection Agency Region 7	Date
	PHOTOGRAPHER	Kirk Mammoliti	10-20-11

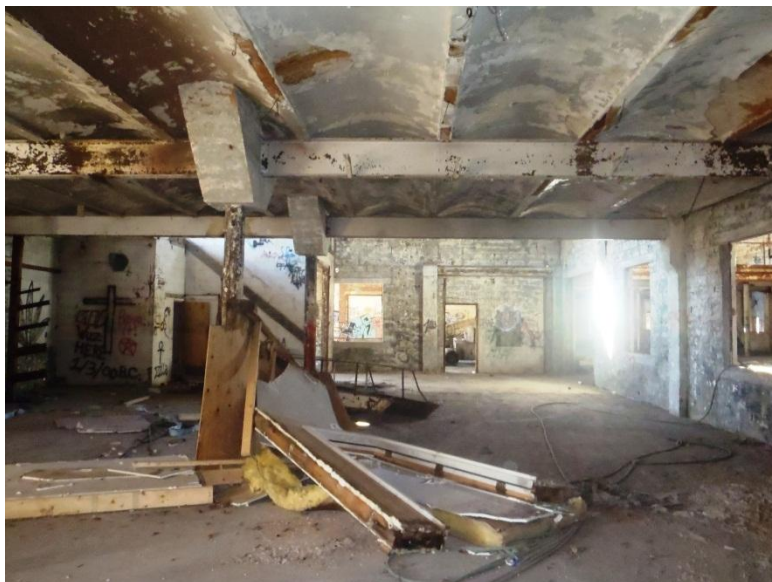
Targeted Brownfields Assessment Direction: West	DESCRIPTION	This photograph shows several pieces of asbestos-containing transite and debris located in the building.	10
	CLIENT	Environmental Protection Agency Region 7	Date
	PHOTOGRAPHER	Kirk Mammoliti	10-20-11
