MAINE DEPARTMENT OF ENVIRONMENTAL PROTECTION
OIL & HAZARDOUS MATERIALS REPORT

Spill Number: P-537-2011

Subject/Owner: GREAT FALLS PROPERTY LLC - -

Location Type Business - Industrial {ID}
Name COWAN MILL (FORMER)
Street Address MILL ST
MCD Town LEWISTON
Local Name LEWISTON
State/Province ME

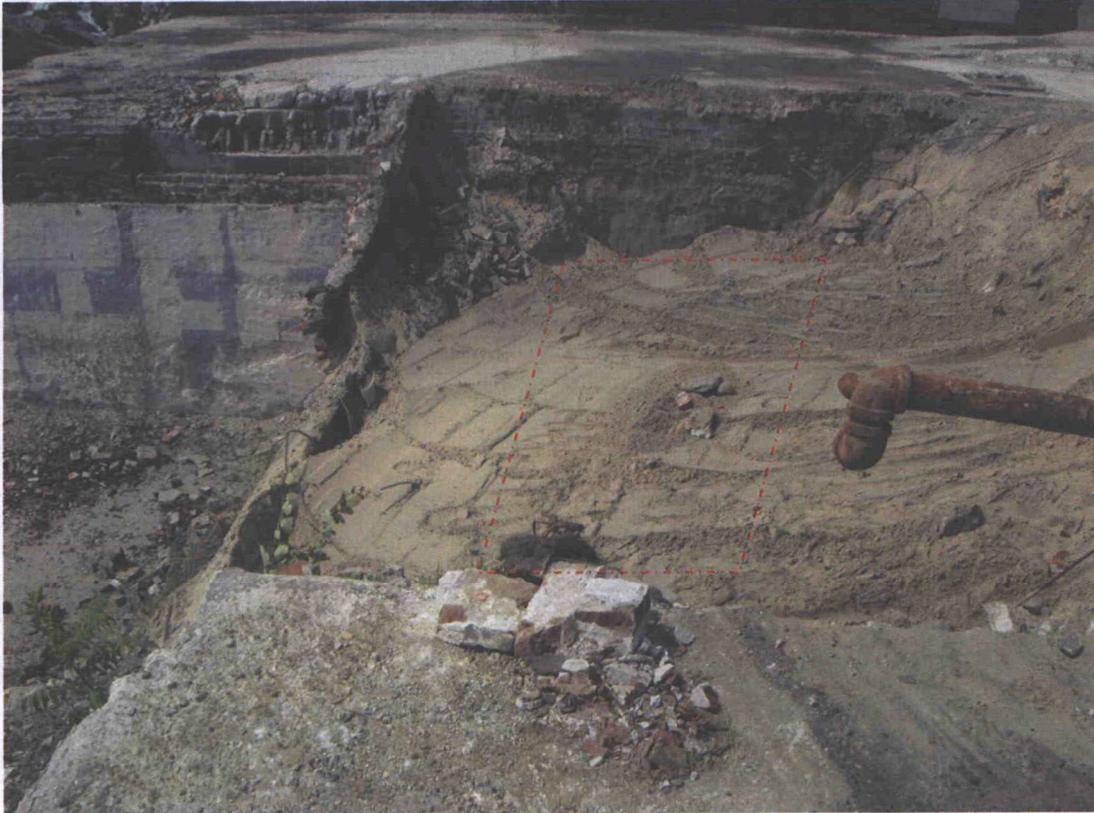
1. Tues. 7/12/11:
Looking north of the area of the removed UST. At center right is steel piping remaining from the removed UST that has yet to be properly abandoned. See also the earlier photos of the UST abandonment taken by Summit Environmental showing the fill before being filled in by K & K Construction.

1. As the tank appears to have been for #2 heating oil no Chapter 691 UST closure assessment was required.
2. I have advised Cressey of Summit Environmental that the remaining steel UST piping should have been removed during the UST abandonment but he wishes this to be delayed to be done later with future redevelopment work. See the records of MDEP Brownfields Unit for further information and site closure.
3. At this time no further Maine DEP Response Division actions are required. The area has already been subject to numerous soil borings and site assessments by Summit Environmental and by Sebago Technics. See the Maine DEP, BRWM Brownfields Unit and environmental site assessments for further information.

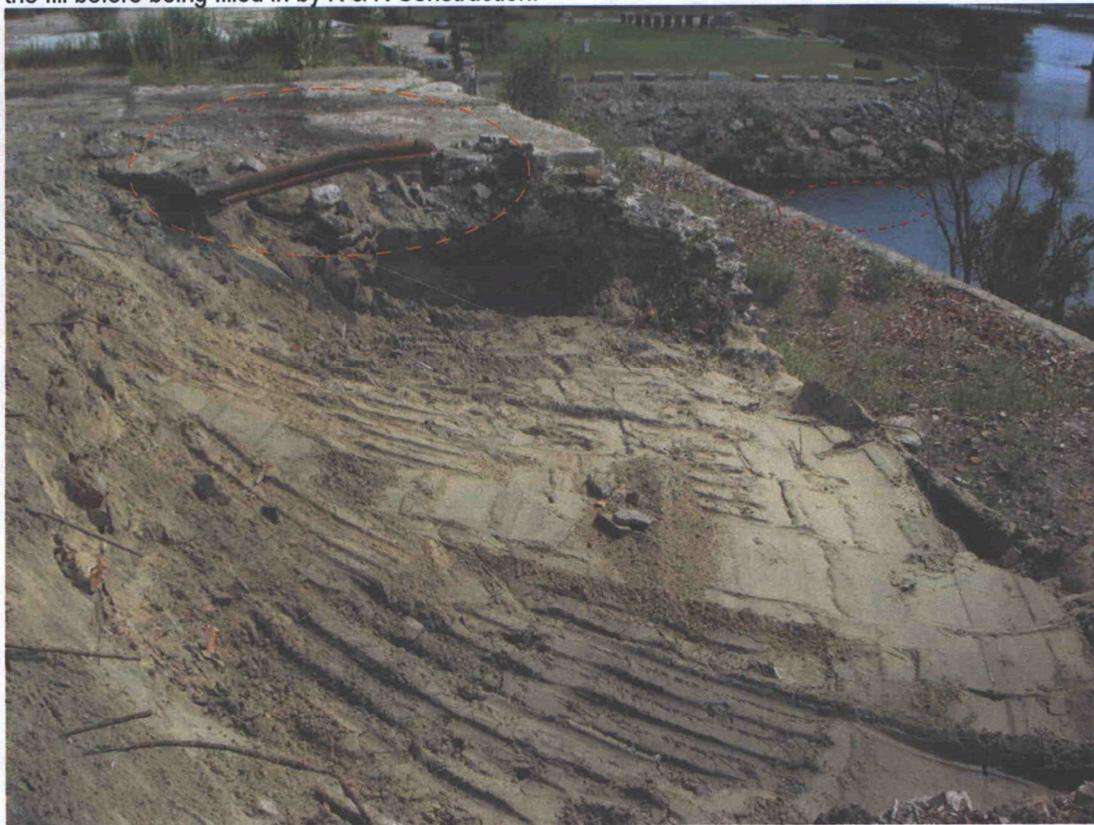
2. Tues. 7/12/11:
Looking south at the former UST location with new fill compacted by the excavator. At upper left are the 4" steel pipe (offset fillpipe?) and a 2" diameter pipe (product or vent pipe?). In the background is the city's Heritage Park and the location of the #6-oil discharge to the river.

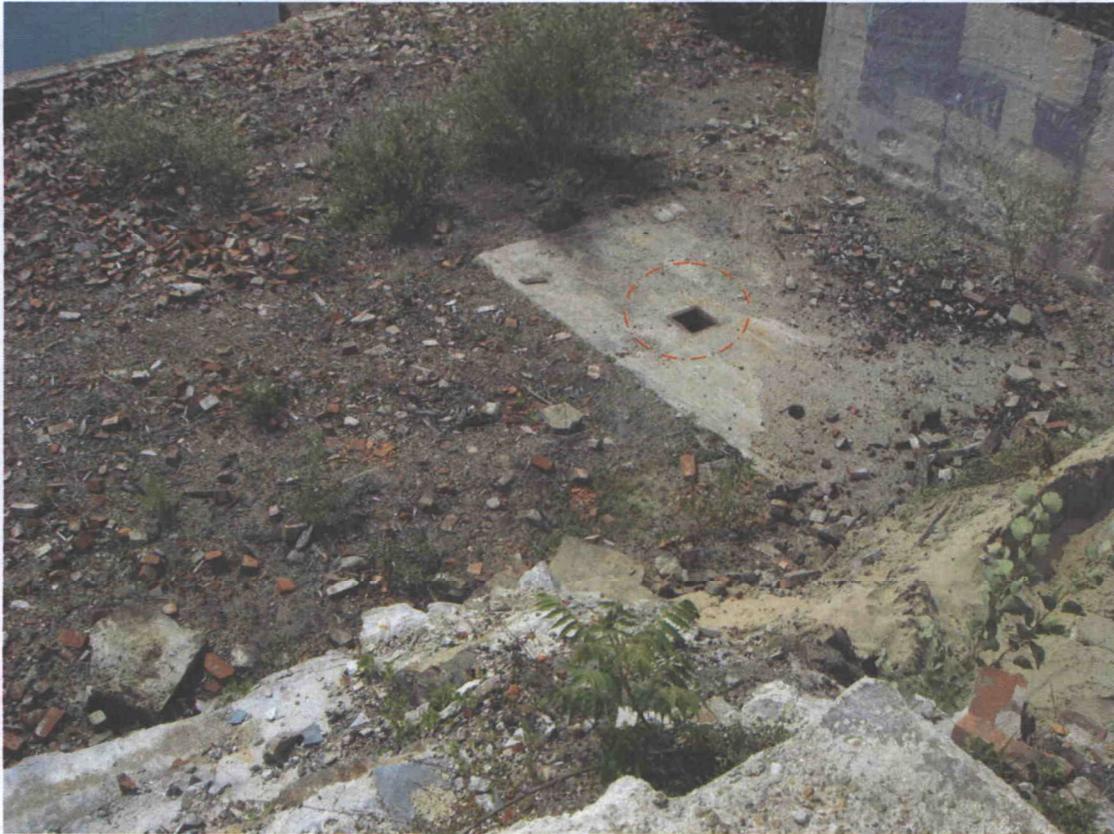
3. Tues. 7/12/11:
The area immediately below the UST location in what used to be the mill building before it burned; at upper right corner is the river. The square manway or drain opening has some horizontal piping below the concrete but no UST or riser pipes evident at the time.

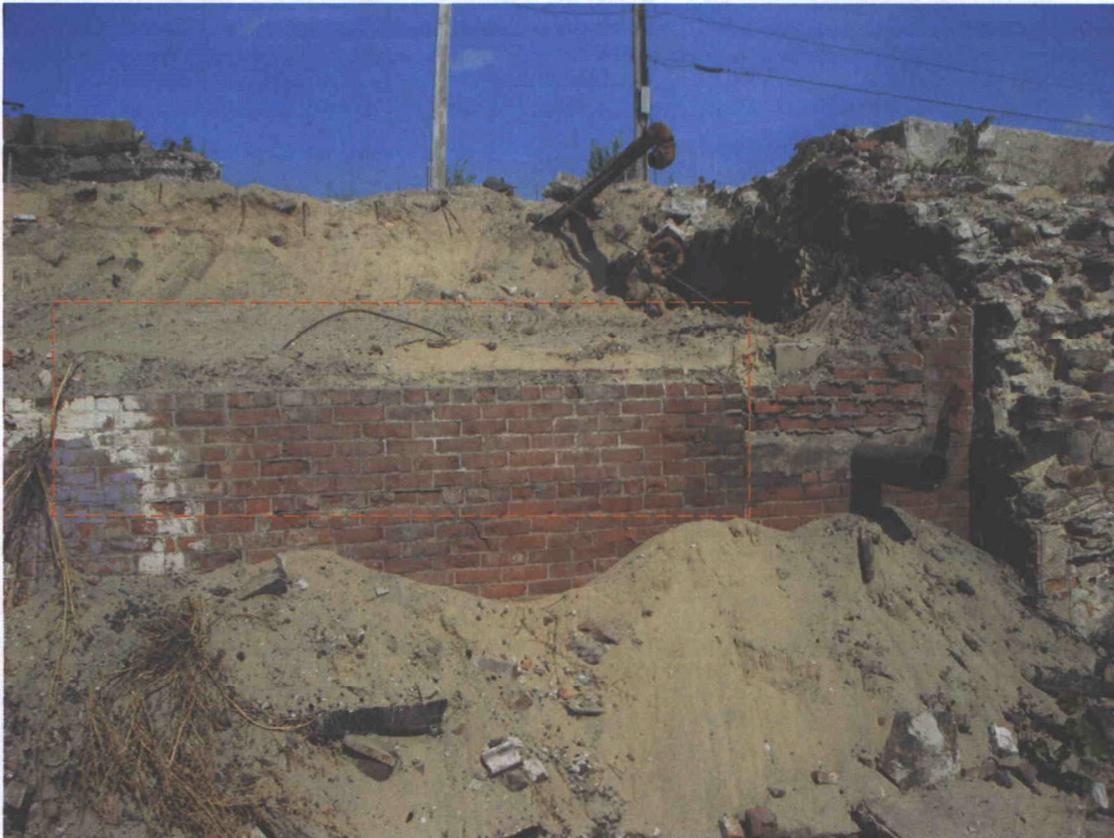
4. 7/19/11: Looking east at the brick wall forming the west containment of the UST area. At right is a steel drain pipe protruding thru the wall; above is the tank's vent and offset fill pipe. I noted no evidence of oil seeps through the wall or in the soil.

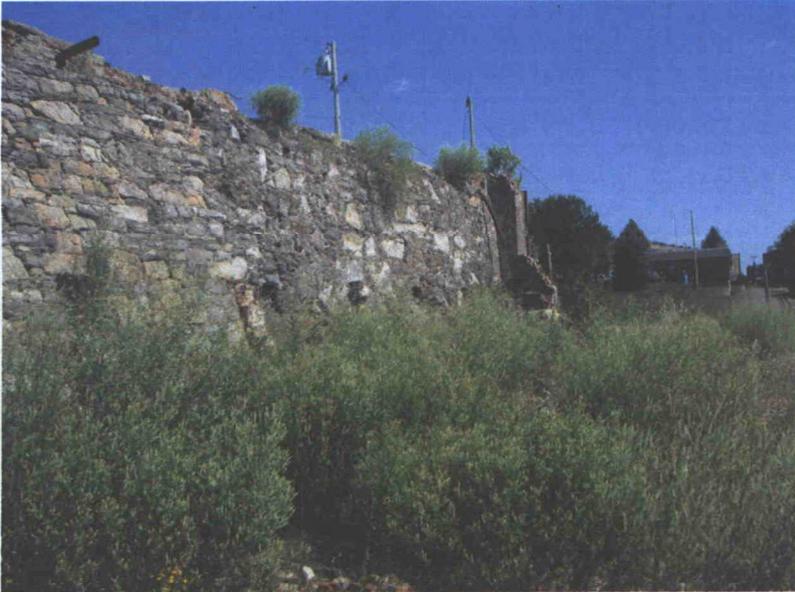
5. 7/19/11: Looking SE at the former building wall of the Cowan Mill with multiple pipes of varying sizes coming out of the wall.

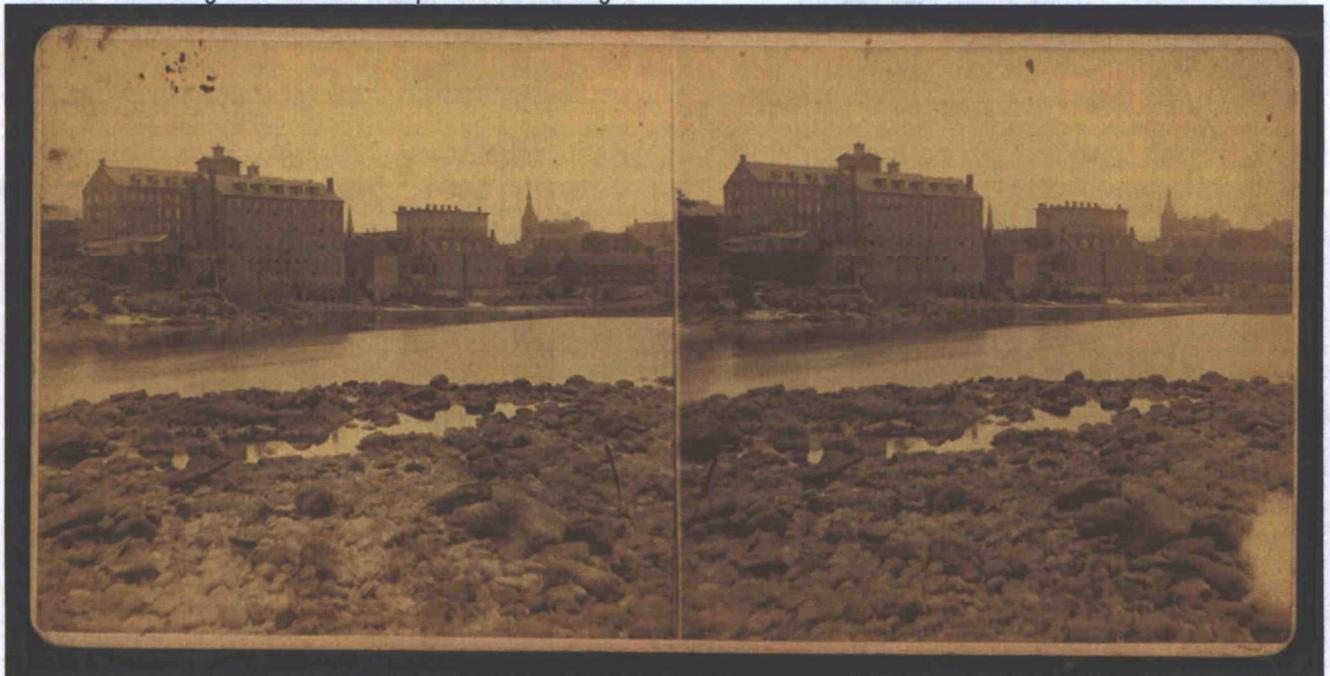
9.

Old stereoscopic photo of the Columbia Mill area at far right and the Cowan Mill Building left of center along the river. Close examination shows multiple old penstocks entering the river beneath the buildings.

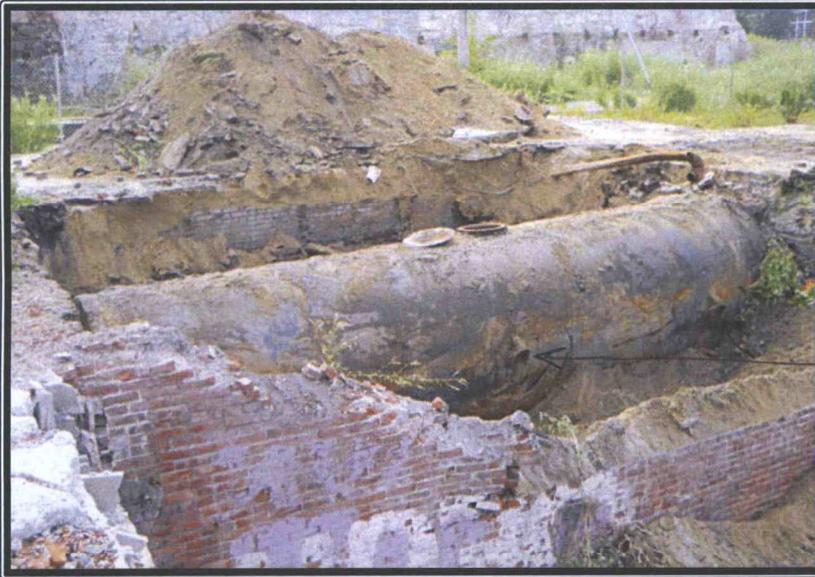
Photograph 1:

Photograph of exposed UST. The tank was located in a 16 foot by 25 foot vault filled with sand. Photographer standing on the foundation of the former smoke stack, looking towards Mill Street.

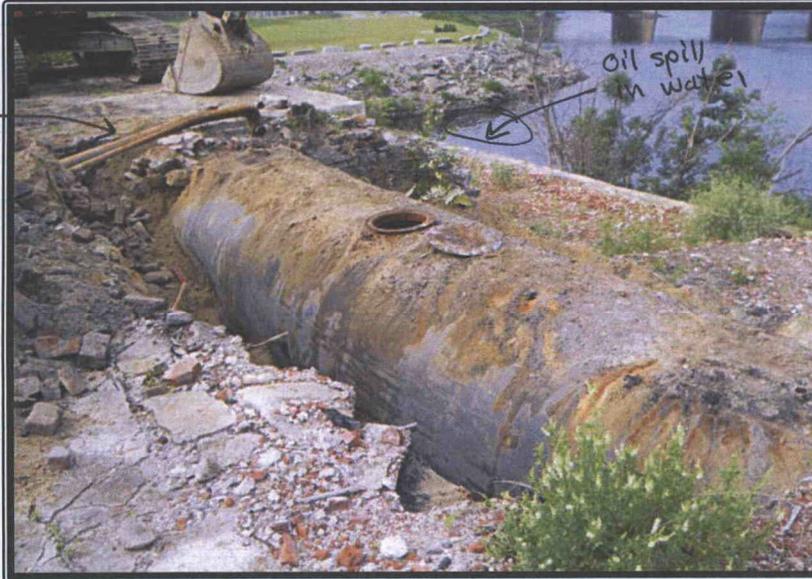
Photograph 2:

Photograph of exposed UST from a different angle.

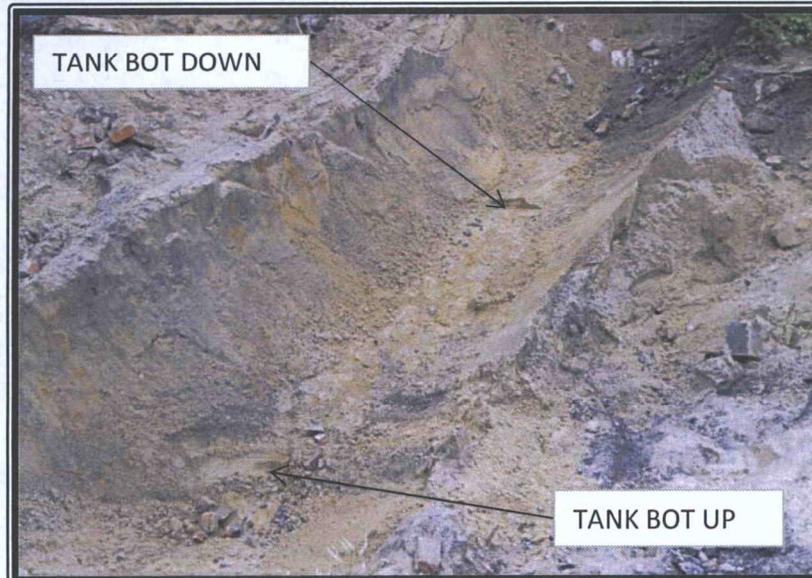
Photograph 3:

Sand below tank. Rusty areas were present, but there was no evidence of a release. Two samples of soil immediately below the UST were collected for analysis of extractable petroleum hydrocarbons (EPH). TANK BOT DOWN (down river side of UST), TANK BOT UP (up river side of UST).

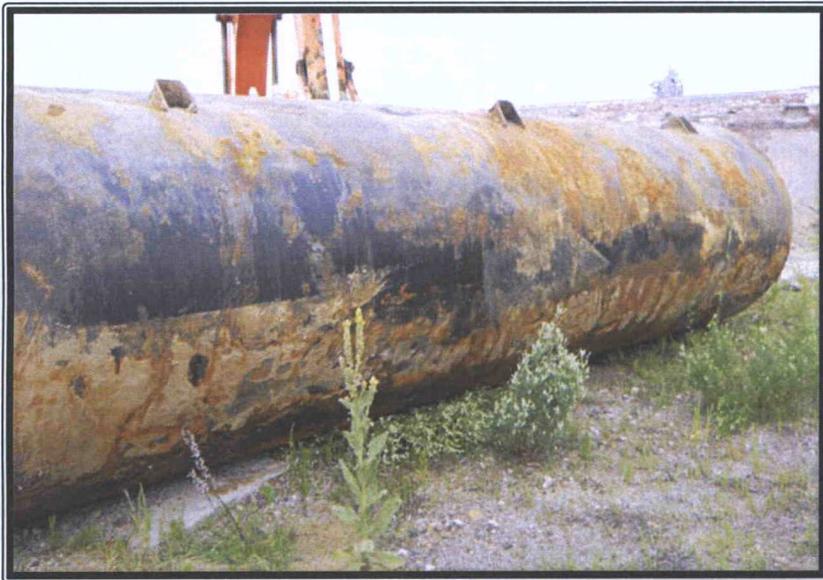
Photograph 4:

Bottom of the UST. All seams were welded and no evidence of broken seams or extensive rusting were observed.

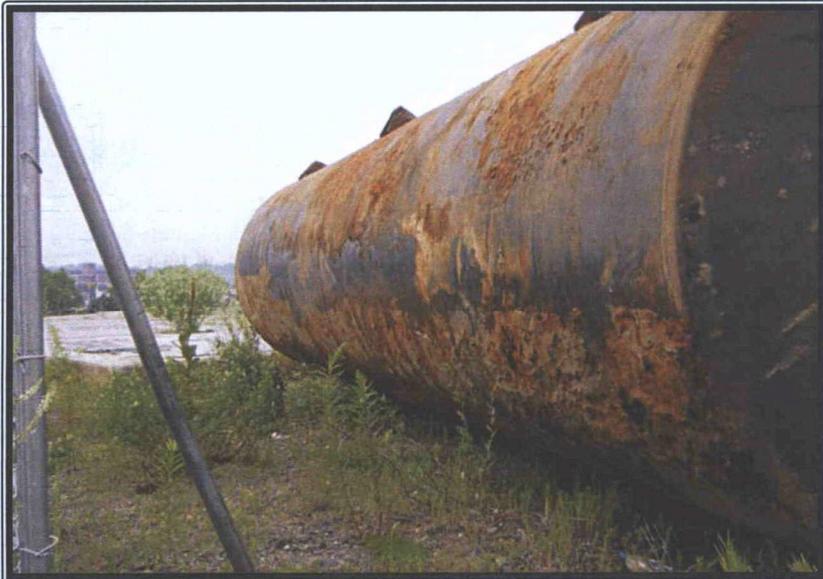
Photograph 5:

Bottom of the UST from a different angle.

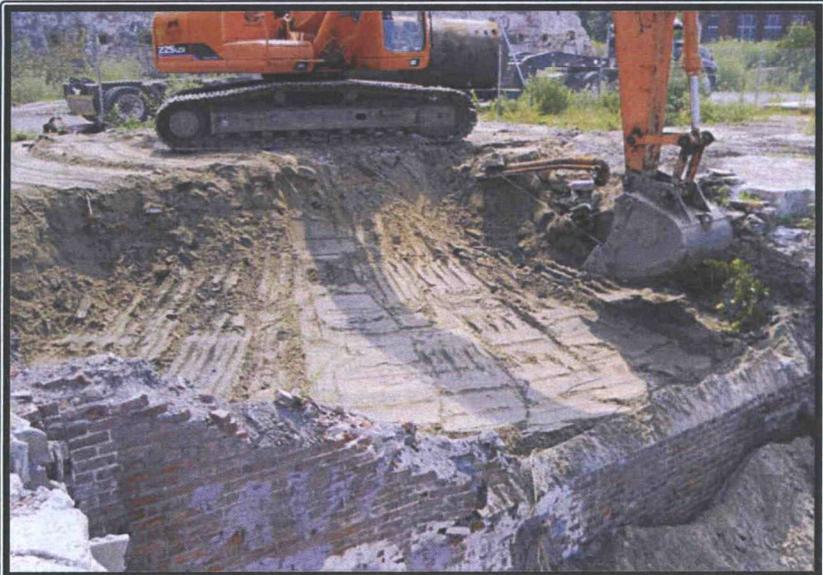
Photograph 6:

UST excavation after backfilling. Looking toward Mill Street.
