Letter Health Consultation

CHARLES BATCHELDER COMPANY SITE

NEWTOWN, CONNECTICUT

RE: Charles Batchelder Company Site
Newtown, CT
Health Consultation Letter Update 2012

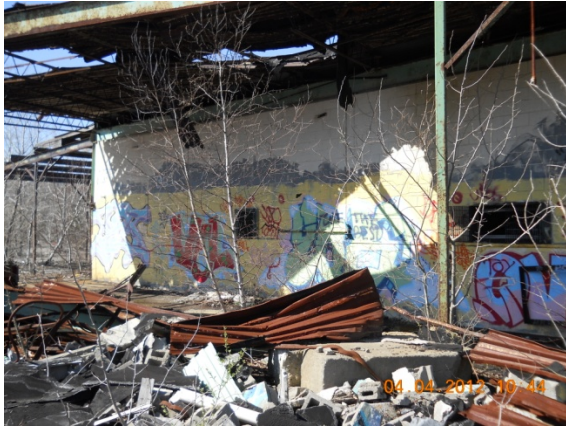
- The onsite buildings are in severe disrepair. The structural integrity of buildings appears compromised. Much of the roofing material has fallen into the interior of the buildings. A fire at the site several years ago involving the center building caused complete collapse of the structure and all that remains is a pile of rubble. Aside from the fire-caused collapsed building, these observations match what was observed in 1997.
- Numerous areas of debris (trash, building materials, broken glass, structural steel, old machinery, rusted drums, tires, vehicles) were observed across the entire site. This was also observed during the 1997 site visit.

- A large amount of graffiti was visible on the inside and outside of the buildings. Some of the graffiti had recent dates (within the last few years). Graffiti was also noted in 1997.

Collapsing Building, Debris Piles, Graffiti

- Eliminate safety hazards at the Site as quickly as is reasonably achievable.
- Eliminate exposure to the piles of baghouse fines and dross located throughout the site.

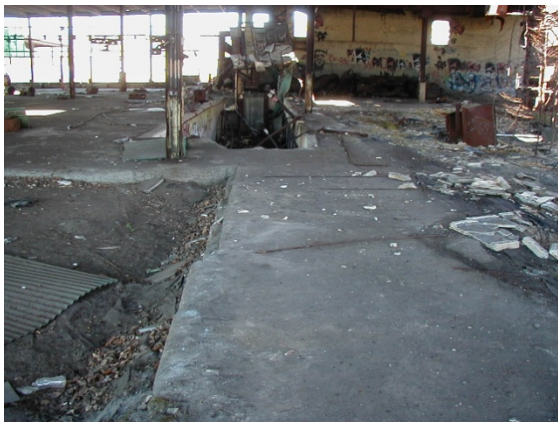
- Open pits are present inside several buildings. This was also observed in 1997.
- Two large tanks (with sections cut out on the ends) were observed. Oily water filled the bottom of both tanks. These tanks were observed in the same condition in 1997.

Open Pit

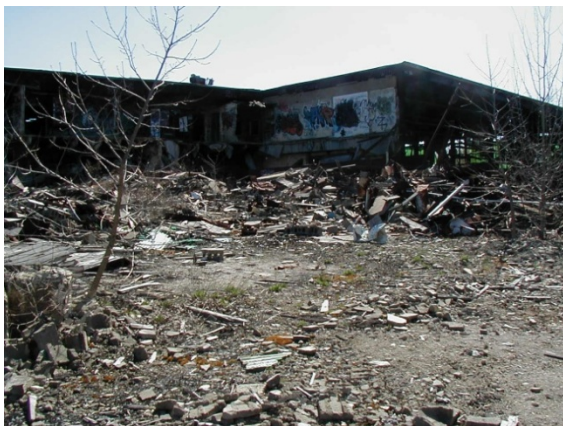
Building Collapsed After the Fire

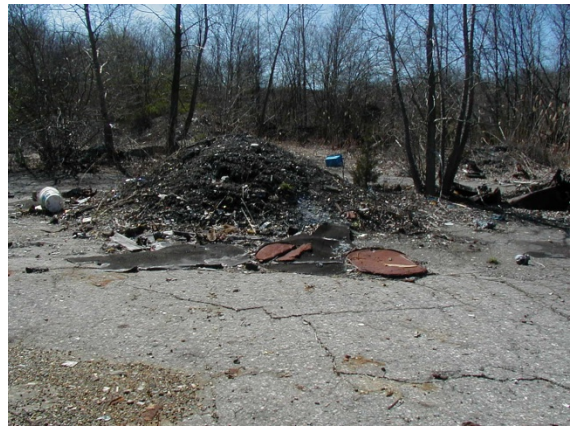
Debris Pile

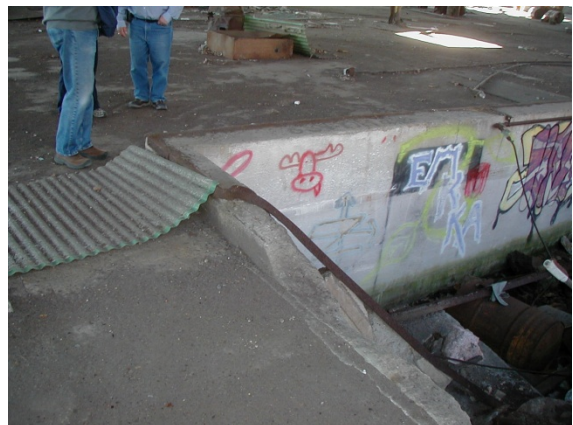
Open Pit

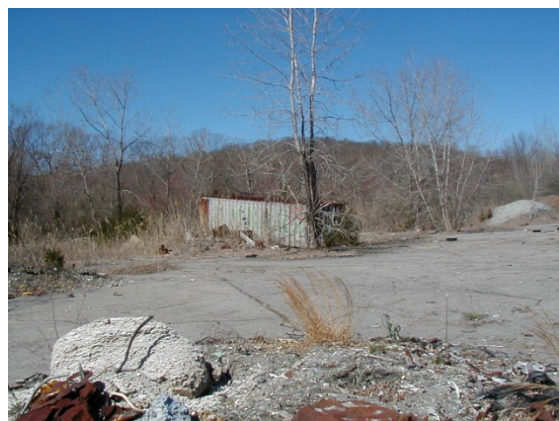
- Large piles of baghouse fines and dross (i.e. metal waste) are located throughout the site. One pile is located inside the large building on the eastern part of the property. The pile was partially covered with a geotextile membrane.

Debris (foreground), metal waste pile (background)

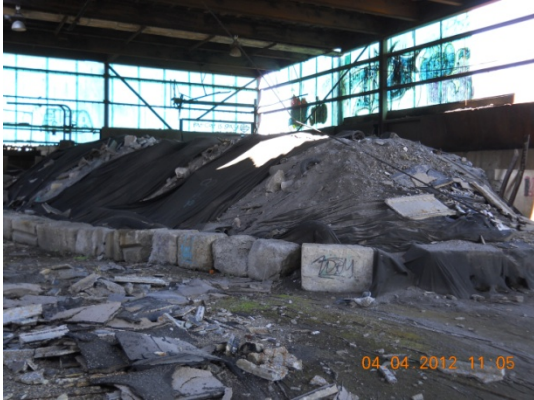
Metal waste pile partially covered with geotextile

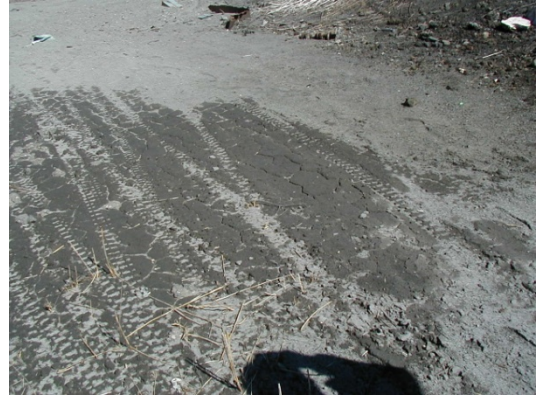
- Tire tracks (most likely from a dirt bike, motorcycle or all-terrain vehicle) were visible on the large piles of metal waste in the eastern portion of the site. Tire tracks were also visible inside the large building on the eastern part of the property. One of the town representatives on the site visit stated that as recently as two weeks prior to the site visit, he had witnessed trespassers at the site and had required them to vacate the property. In 1997, tire tracks were also observed on and around the metal waste piles.

Tire tracks

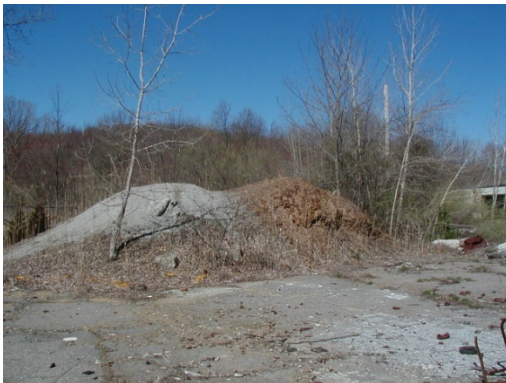
- The material in the metal waste piles was observed to be extremely fine-grained, almost the consistency of flour. On the day of the site visit, the weather was not windy, but tiny particles could be seen in the air around the metal waste piles.

Metal waste pile

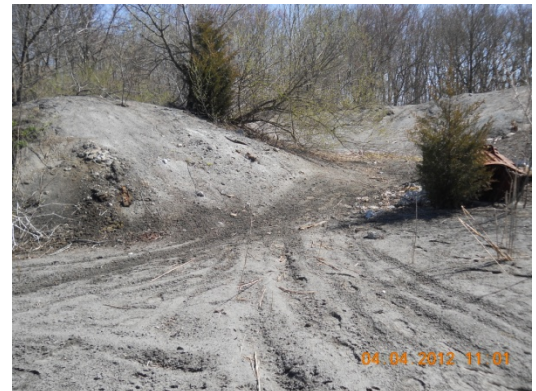
Tire tracks leading to/from pile

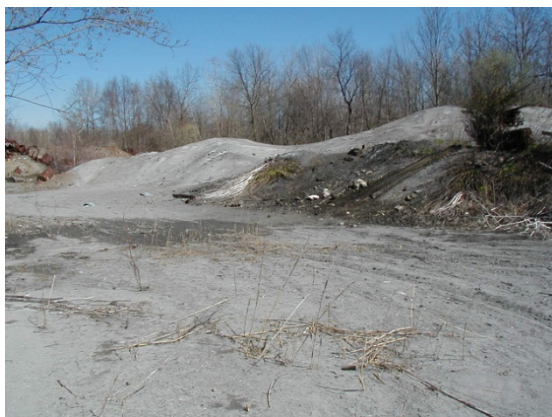
Largest metal waste pile, with tire tracks

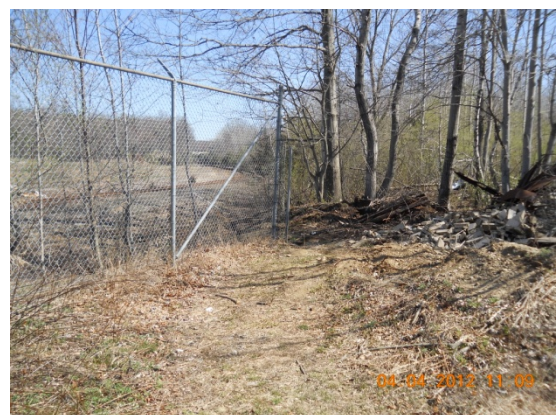
- A large section in the northeastern portion of the perimeter fence was cut away. Soon after the site visit, CTDPH was informed by the Town of Newtown that they had repaired the breach in the fence.

Missing portion of perimeter fence

- Place chemical and safety hazard warning signage on the perimeter fencing as soon as is practicable. Signage and perimeter fencing should be inspected periodically to ensure that the fencing has not been breached and the signage has not been removed.
