**Subject: Final Removal Assessment Letter Report
Villa Mobile Home Park Battery Dump
Kannapolis, Cabarrus County, North Carolina
EPA Contract No. EP-W-05-054
TDD No. TTEMI-05-003-0100**

VILLA MOBILE HOME PARK
 BATTERY DUMP
 KANNAPOLIS,
 CABARRUS COUNTY,
 NORTH CAROLINA
 TDD No. TTEMI-05-003-0100

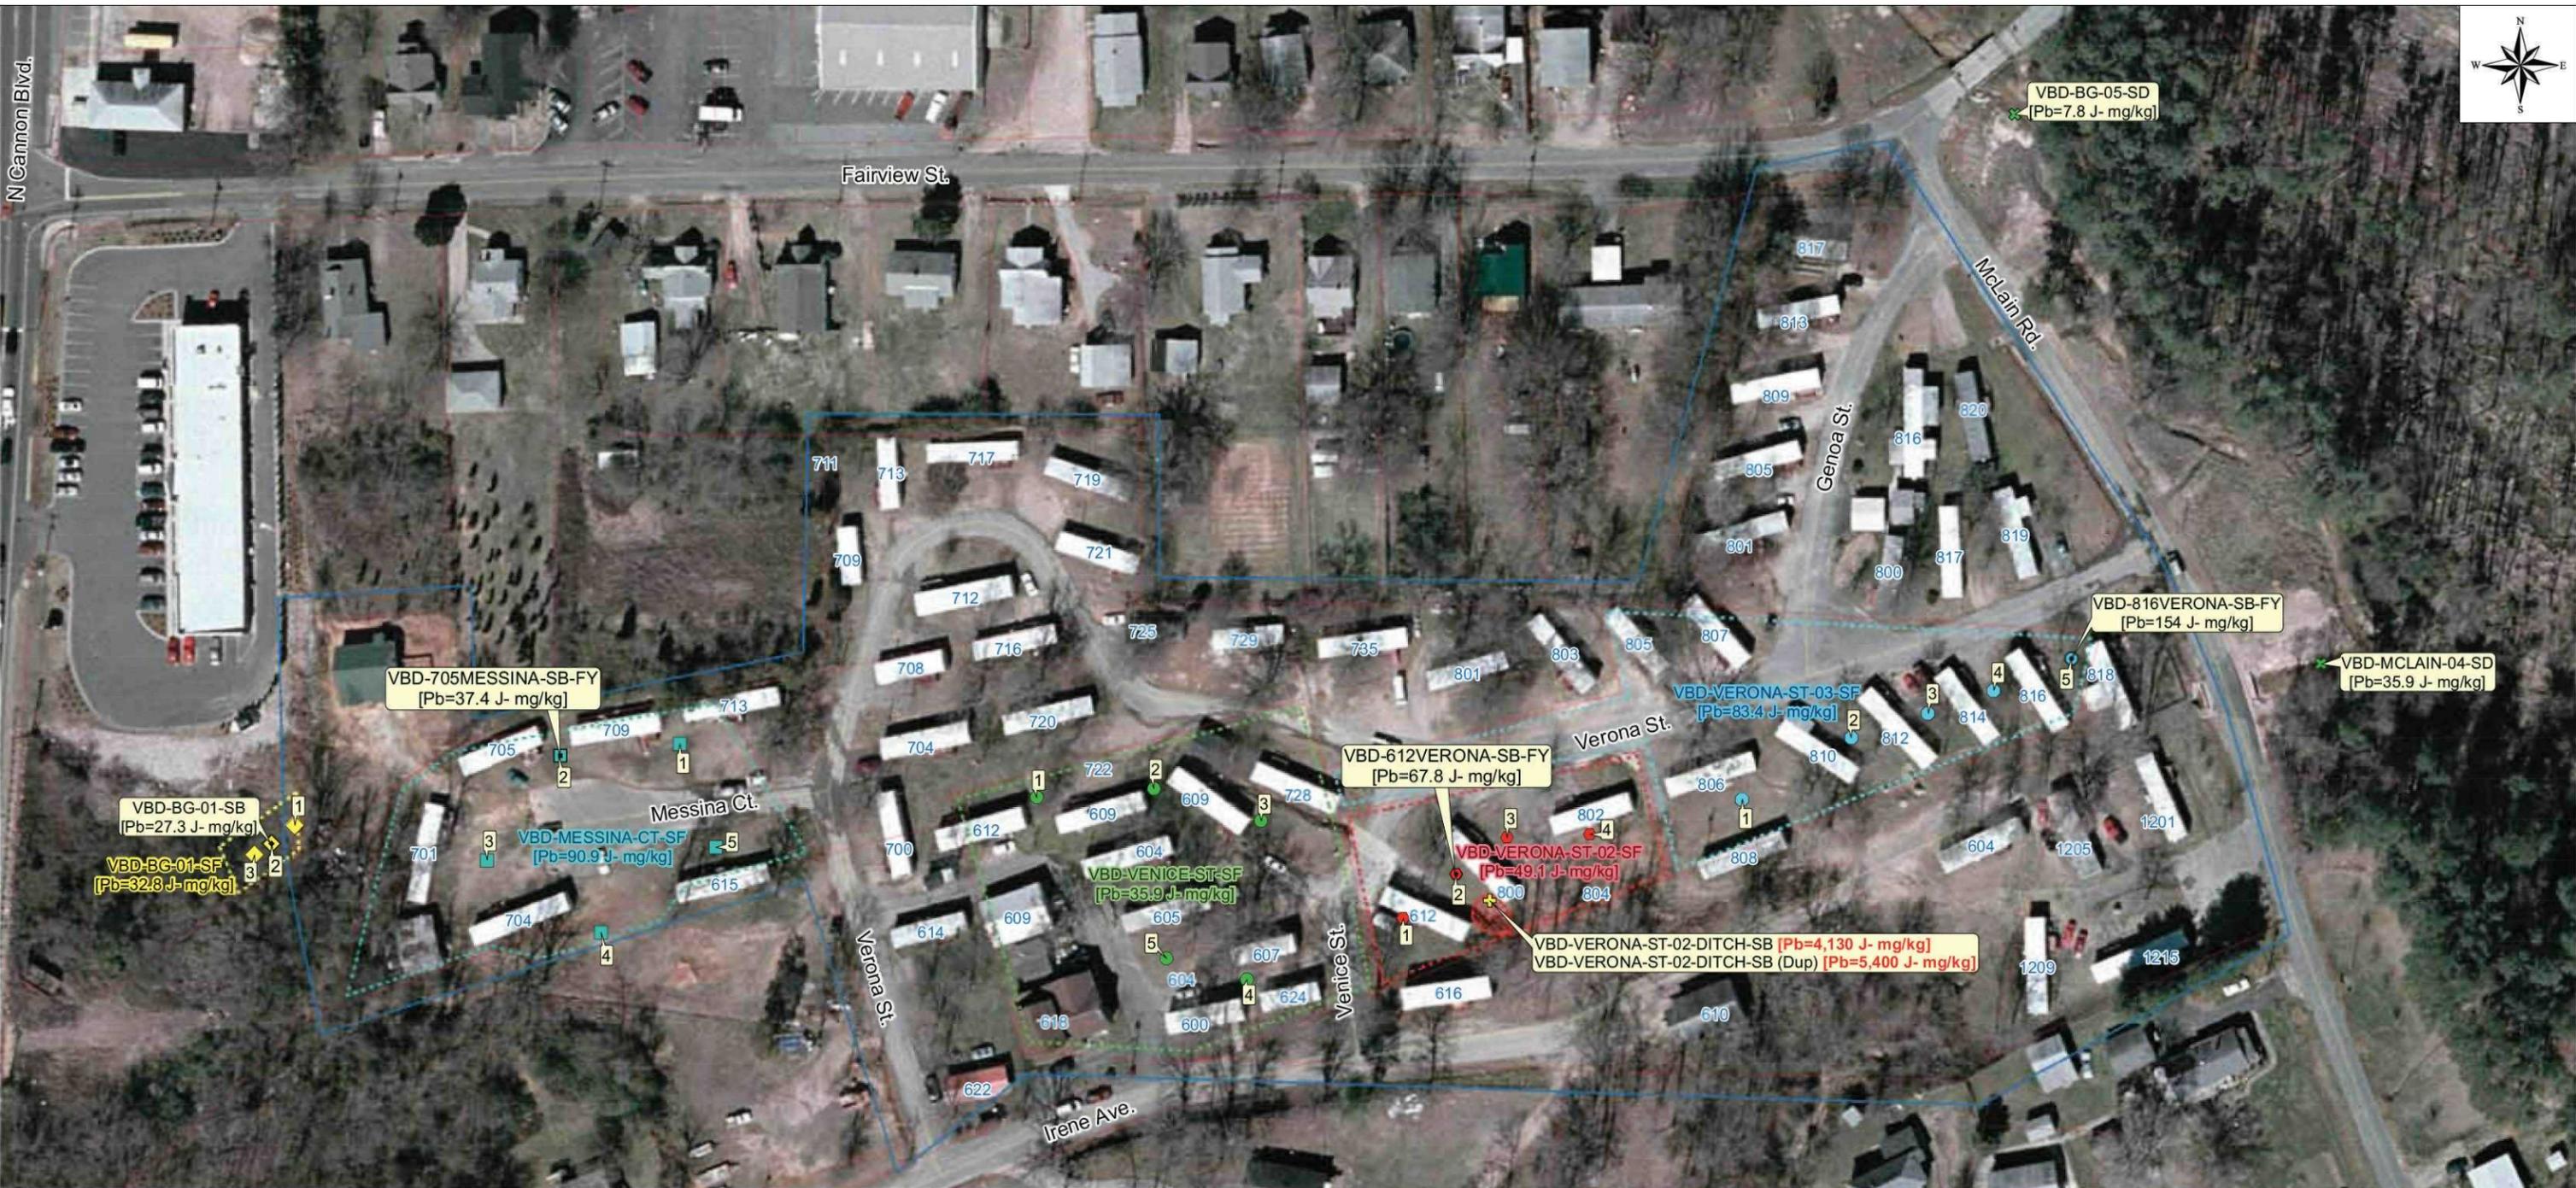
FIGURE 2
SITE LAYOUT
WITH LABORATORY RESULTS

Analytical results of lead in all other soil (surface and subsurface) and sediment samples were found to be below 154 mg/kg, which is well below the RSL of 400 mg/kg. Figure 2 in Appendix A presents analytical results in relation to their sampling locations. Attachment 1 contains the ENCO analytical data package. Table 1 in Appendix B provides the XRF screening results as well as the laboratory analytical results for each sample submitted for analysis. In most cases the XRF results reported a more conservative value (higher) than was confirmed by the contract laboratory.

Composite sampling areas are labeled with their composite sample ID. Lead concentrations (in mg/kg) appear in brackets below sample IDs. Lead concentrations at location VBD-VERONA-ST-02-DITCH are in red text because they exceed the RSL for lead (400 mg/kg).

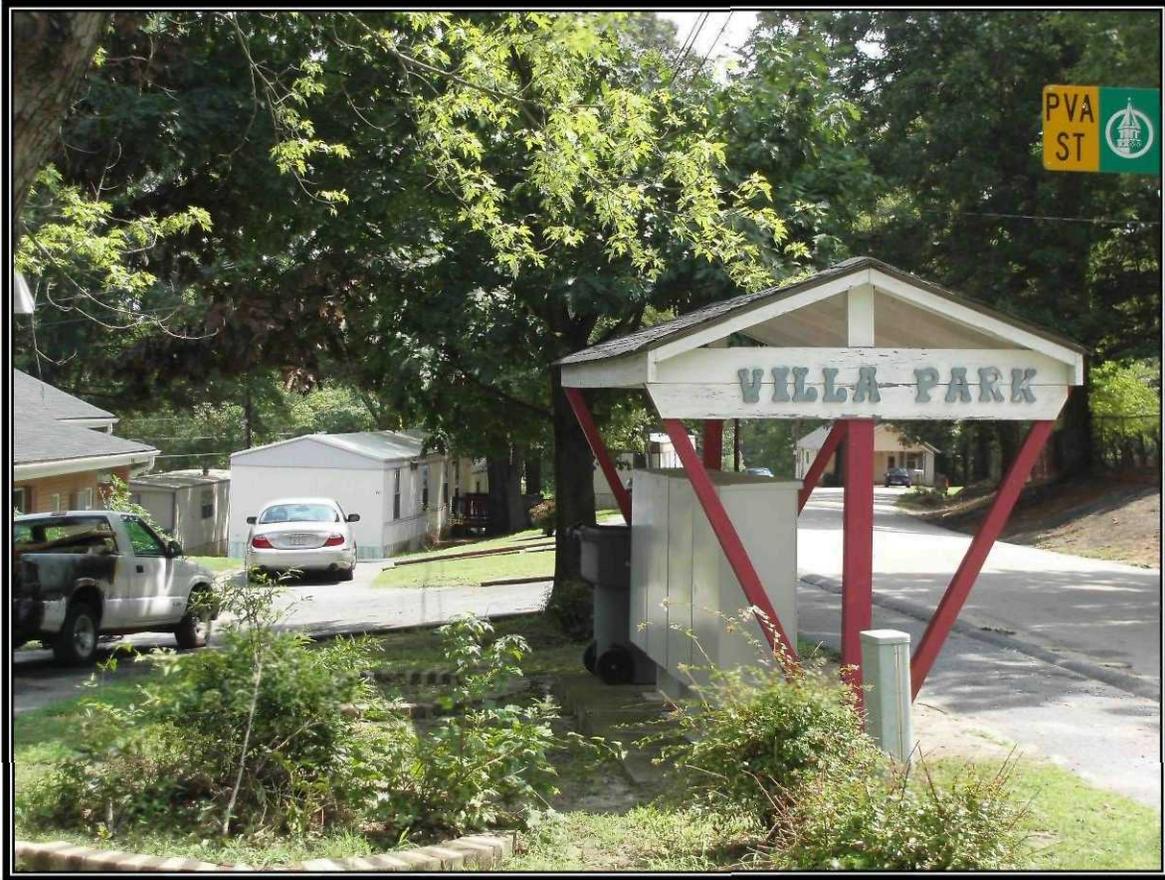
OFFICIAL PHOTOGRAPH NO. 1
U.S. ENVIRONMENTAL PROTECTION AGENCY

Subject: Tetra Tech met with North Carolina Department of Environment and Natural Resources (NCDENR) personnel on August 5, 20120, to conduct a soil removal assessment for total lead contamination at the Villa Mobile Home Park residential area.

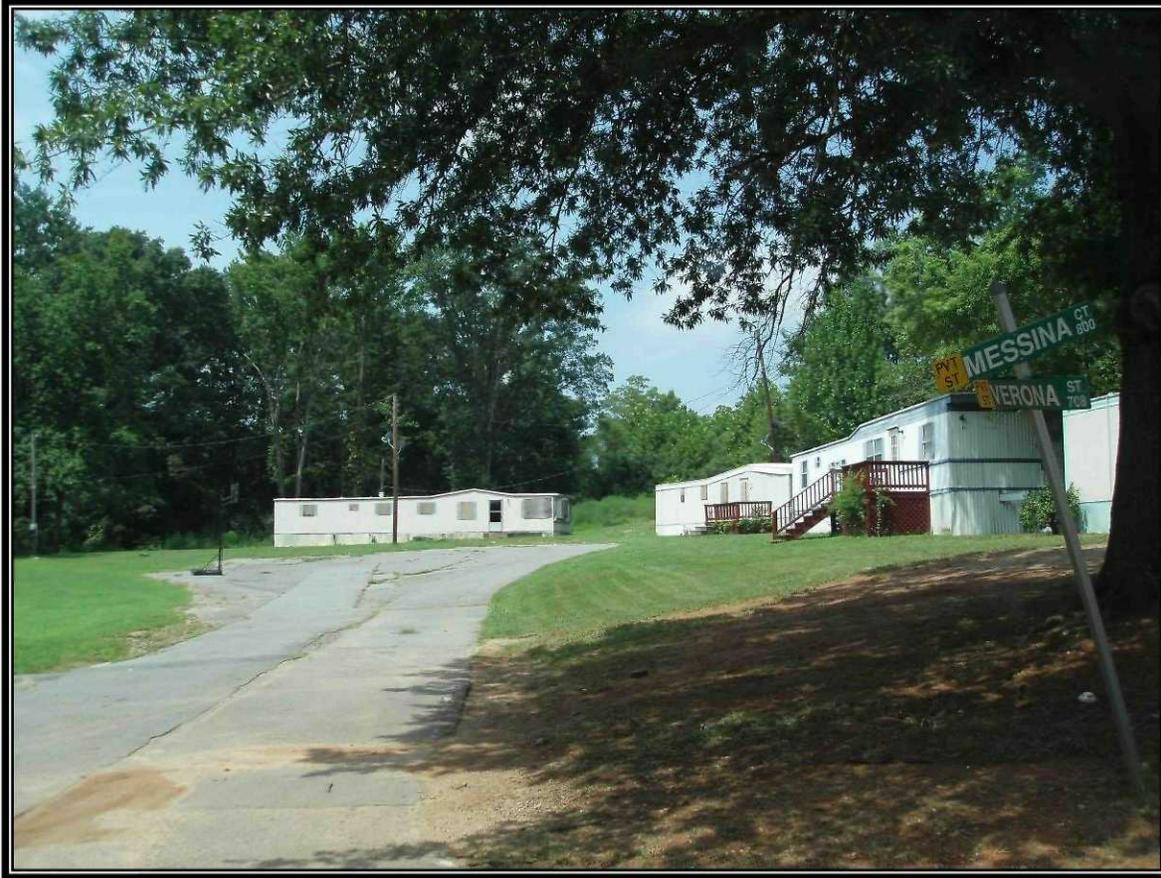
OFFICIAL PHOTOGRAPH NO. 2
U.S. ENVIRONMENTAL PROTECTION AGENCY

Subject: Sampling began at Messina Court on the western side of the site. A background soil samples was collected in the wooded area behind the last home. A composite surface soil and grab subsurface soil samples were collected in this area as well.

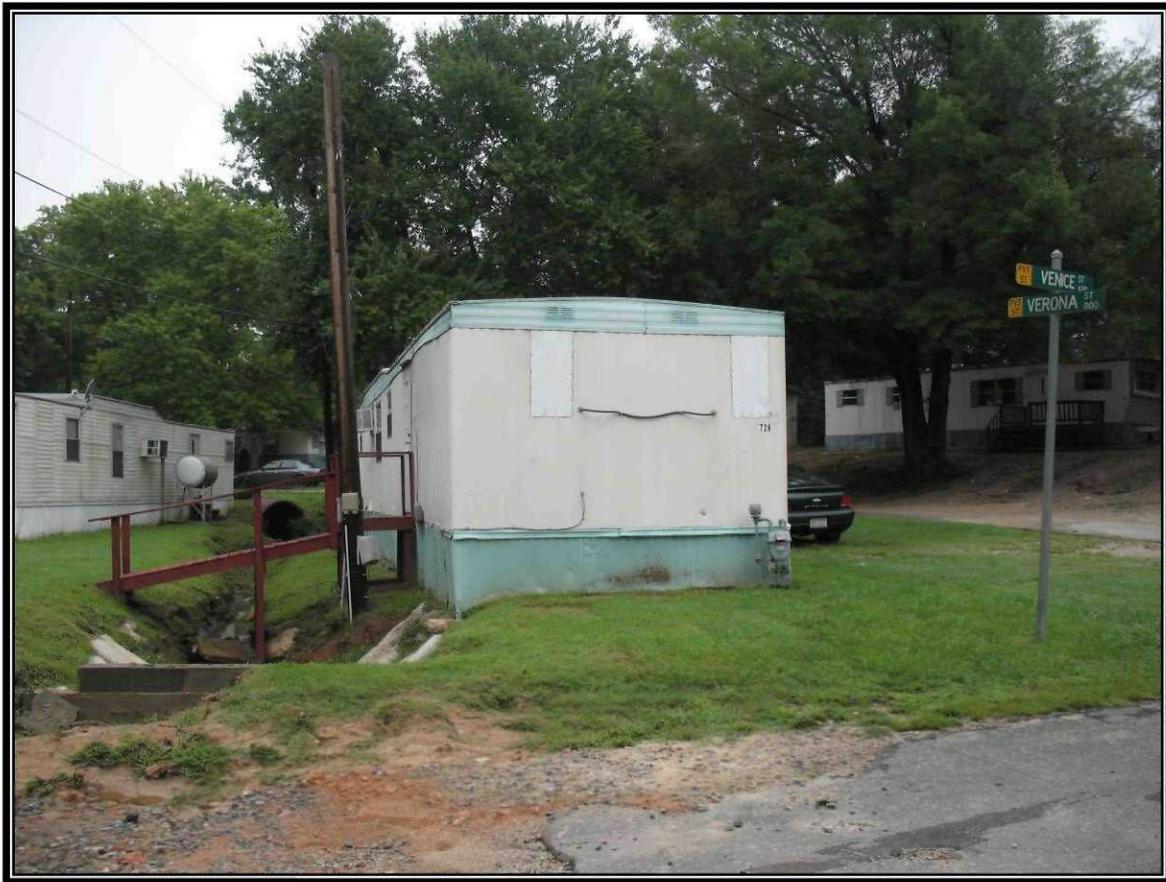
**OFFICIAL PHOTOGRAPH NO. 3
U.S. ENVIRONMENTAL PROTECTION AGENCY**

Subject: Surface water drainage ditch was located at the intersection of Venice Street and Verona Street at the center of the site. No battery chips were observed at this location.

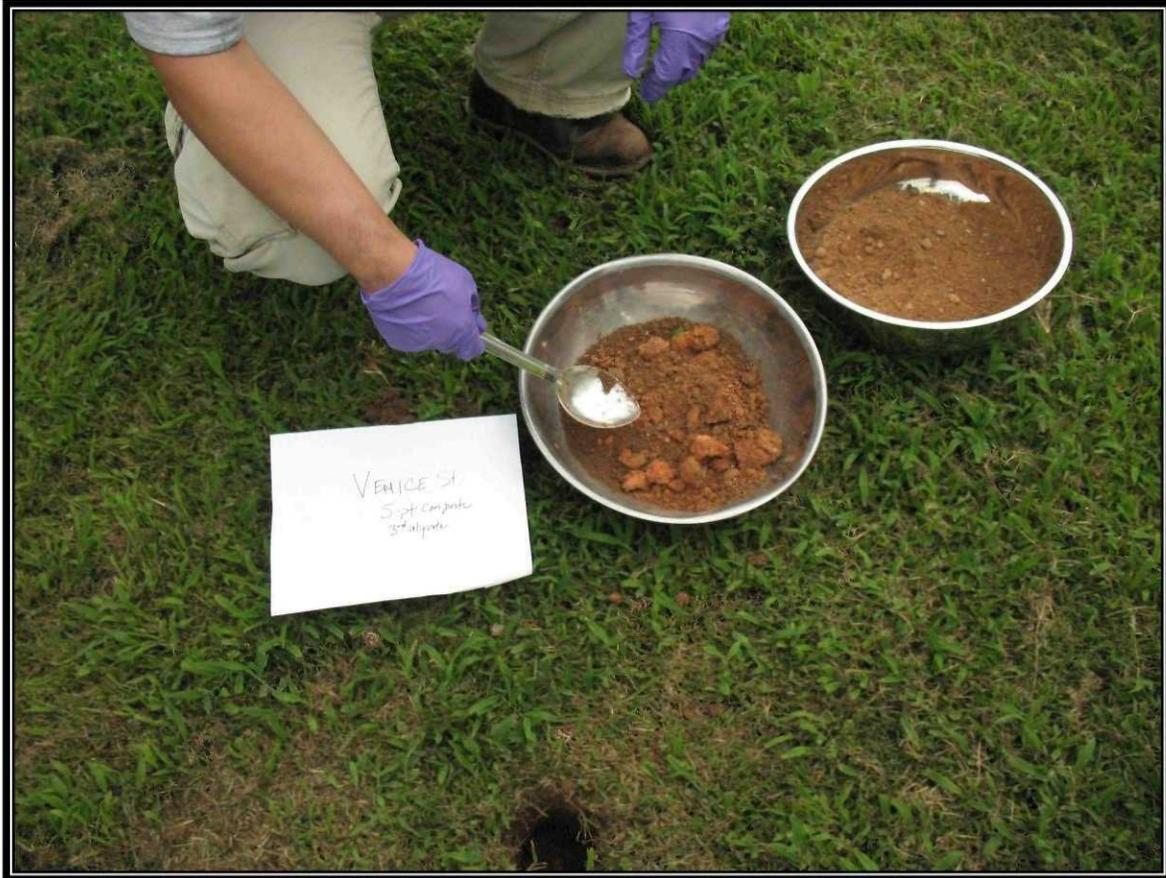
**OFFICIAL PHOTOGRAPH NO. 4
U.S. ENVIRONMENTAL PROTECTION AGENCY**

Subject: Aliquot #3 from the 5-point composite collected from surface soils on the western side of Venice Street at the center of the site. No battery chips were observed at this location.

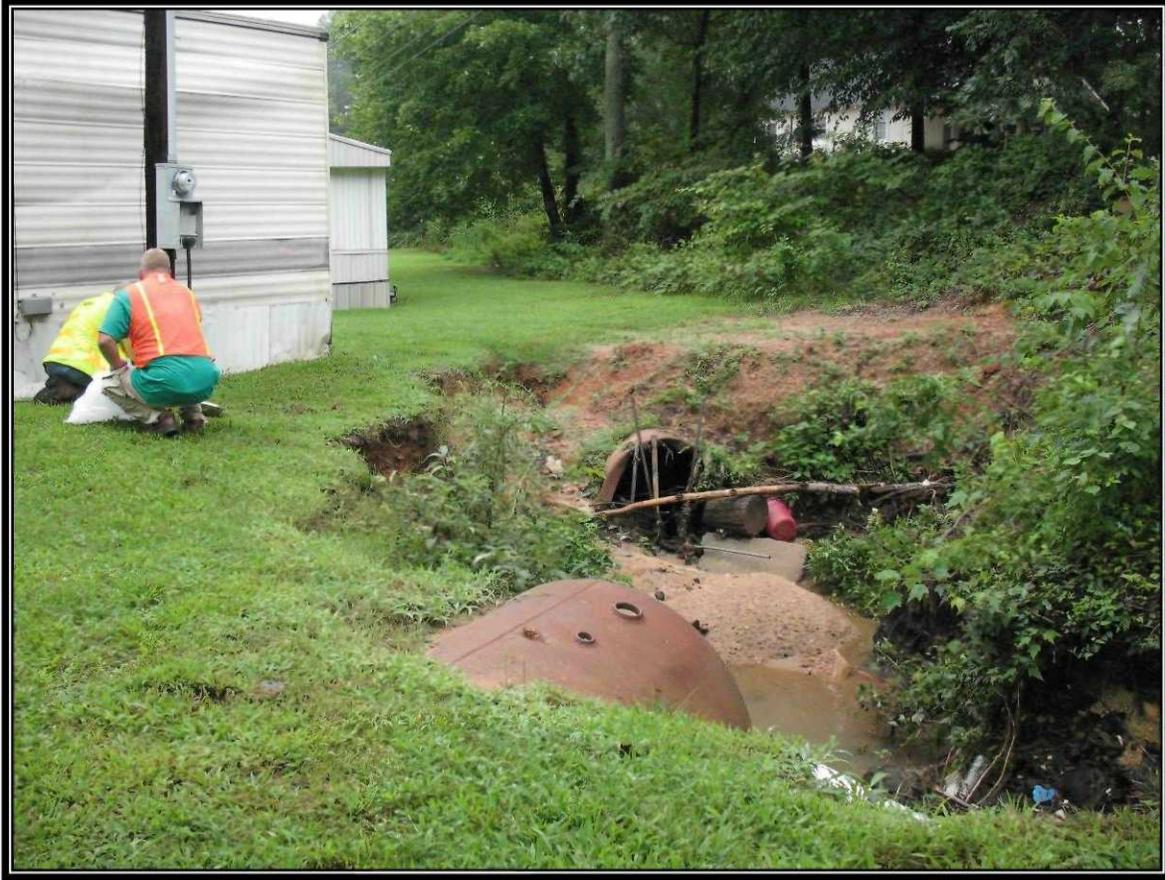
OFFICIAL PHOTOGRAPH NO. 5
U.S. ENVIRONMENTAL PROTECTION AGENCY

Subject: Ditch area between mobile home #612 and #800 on the eastern side of Venice Street at the center of the site. Debris and battery chips were observed in this area. Culverts appear to be storage tanks with both ends cut open. NCDENR collected in situ x-ray fluorescence (XRF) reading at the wash out area to determine the total lead concentrations.

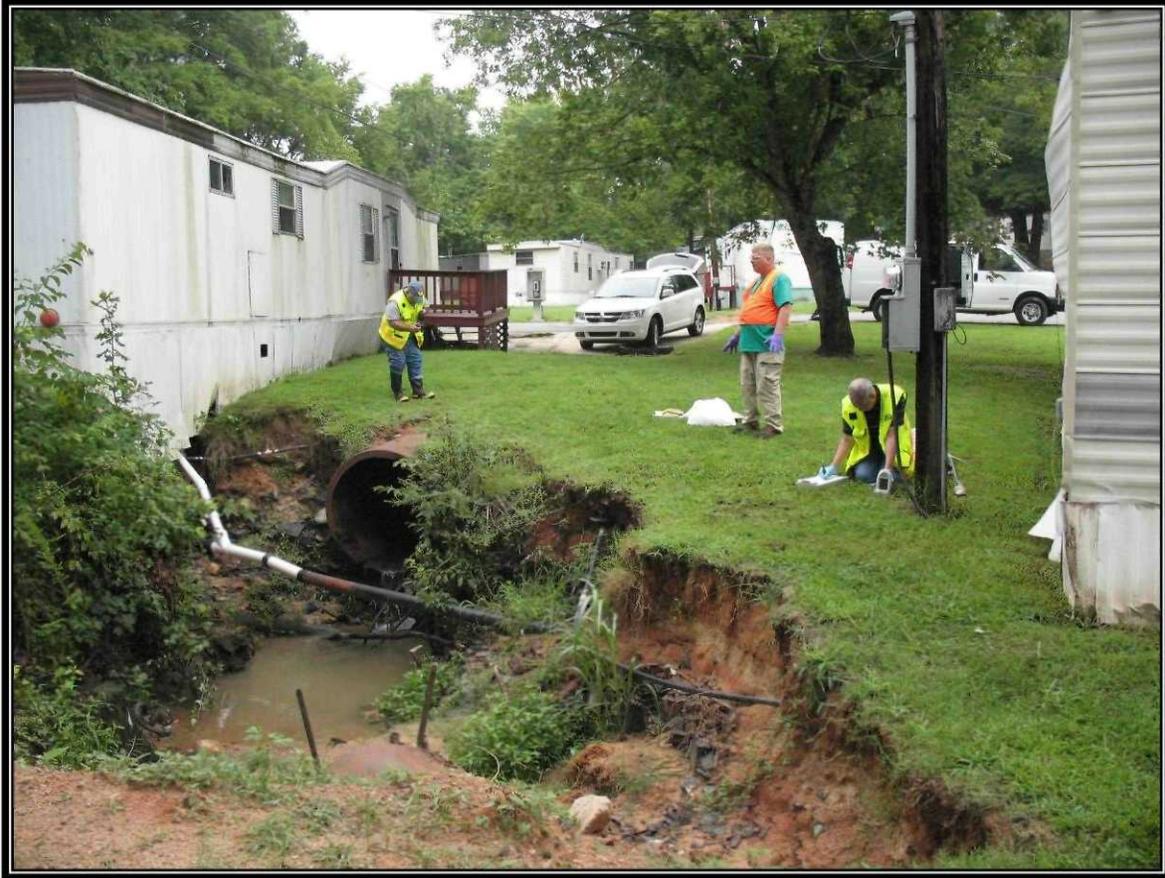
OFFICIAL PHOTOGRAPH NO. 6
U.S. ENVIRONMENTAL PROTECTION AGENCY

Subject: Ditch area between mobile home #612 and #800 on the eastern side of Venice Street.
Battery chips were observed at this location.

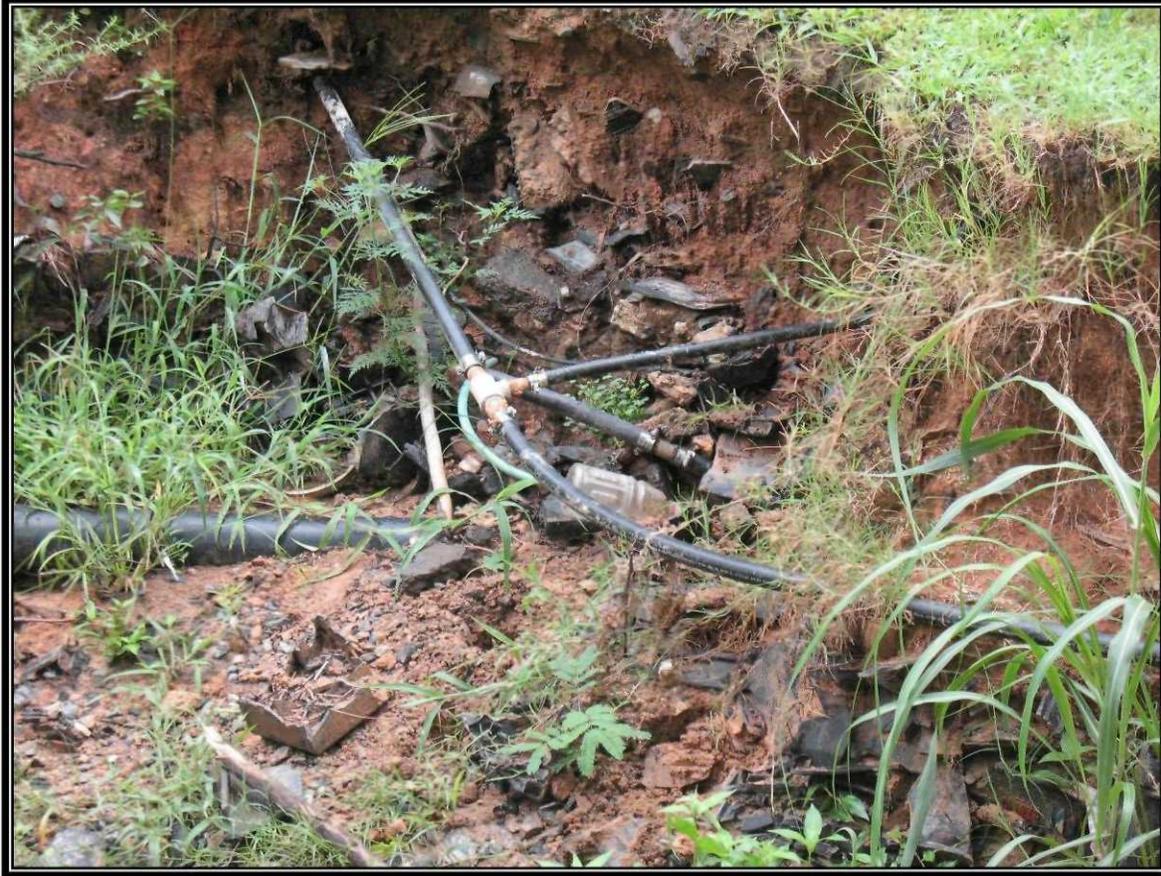
OFFICIAL PHOTOGRAPH NO. 7
U.S. ENVIRONMENTAL PROTECTION AGENCY

wall of the ditch area of concern where exposed battery chips were first observed. This area is behind the mobile home at 612 Venice Street. As a result, NCDENR personnel performed additional in situ screen around the ditch to delineate the area of contamination. NCDENR's report of the site visit provides more detail of their findings.

Subject: Ditch area between mobile home #612 and #800 on the eastern side of Venice Street. Battery chips and utility lines were observed in the exposed bank. Tetra Tech collected grab subsurface soil samples 0 to 6 inches into the ditch sidewall (3.5 to 4 feet below ground surface). Laboratory results of the subsurface soil samples showed lead concentrations from 4130 to 5400 milligrams per kilogram (mg/kg).

Based on the results of XRF screening and analytical results of samples collected for laboratory analysis, lead contamination is present above EPA RSL in the ditch area near 612 Venice Street of the VBD site. Future activities at the site to address lead contamination in the Verona Street ditch are at the discretion of EPA.

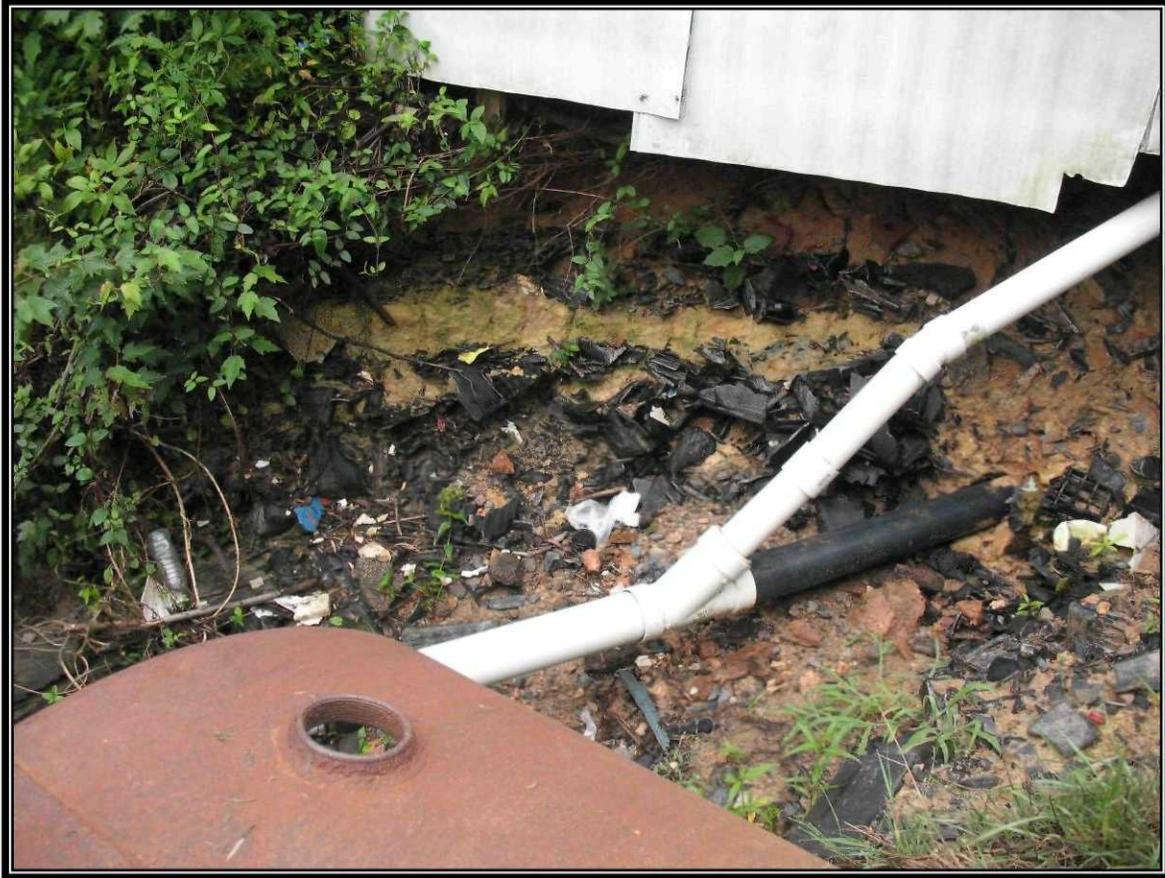
OFFICIAL PHOTOGRAPH NO. 8
U.S. ENVIRONMENTAL PROTECTION AGENCY

Subject: Ditch area between mobile home #612 and #800 on the eastern side of Venice Street.
Layers of battery chips were observed the exposed bank.

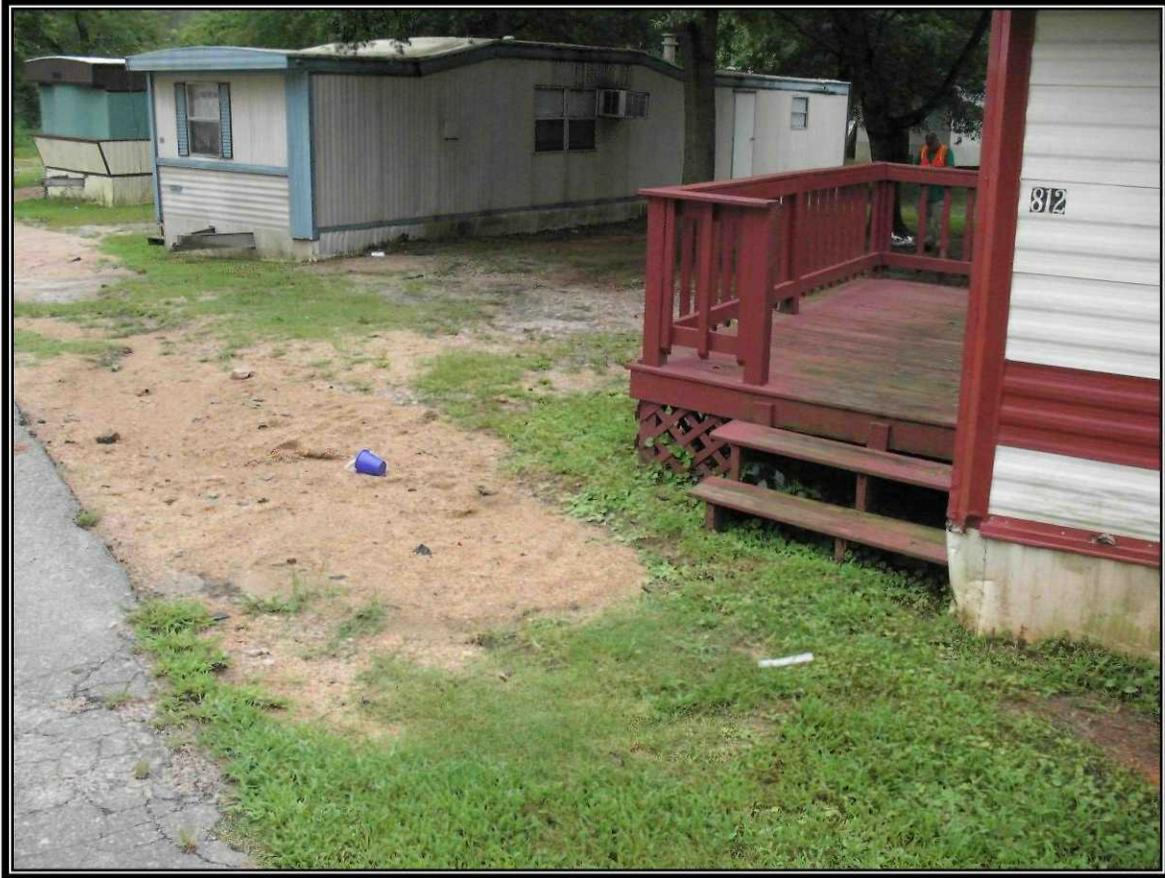
OFFICIAL PHOTOGRAPH NO. 9
U.S. ENVIRONMENTAL PROTECTION AGENCY

Subject: Battery chips were observed in a gravel area by mobile home #812 on Verona Street at the eastern side of the site. NCDENR personnel collected in situ XRF readings. Concentrations of lead were not detected above the EPA regional screening level of 400 mg/kg for lead in residential soil.

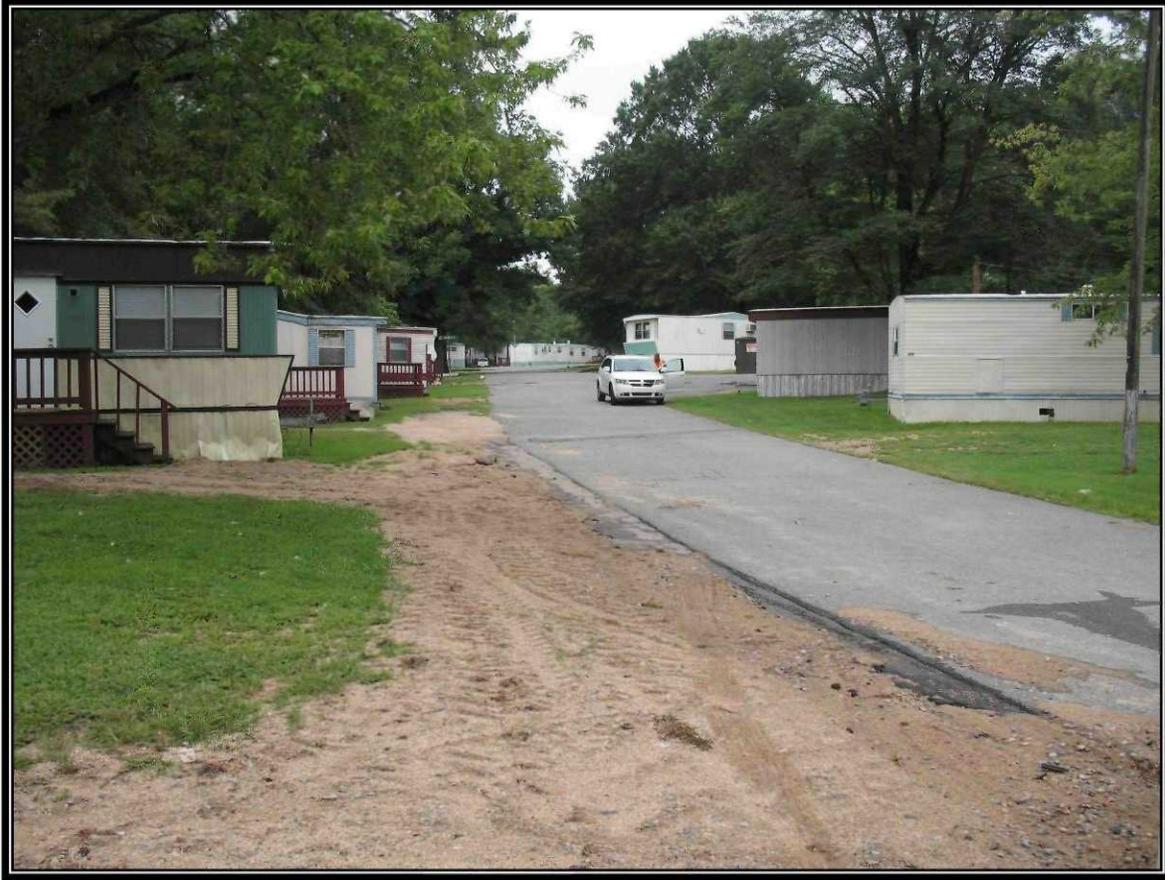
OFFICIAL PHOTOGRAPH NO. 10
U.S. ENVIRONMENTAL PROTECTION AGENCY

Subject: The final composite surface soil sample was collected in the area left of Verona Street on the eastern side of the site.

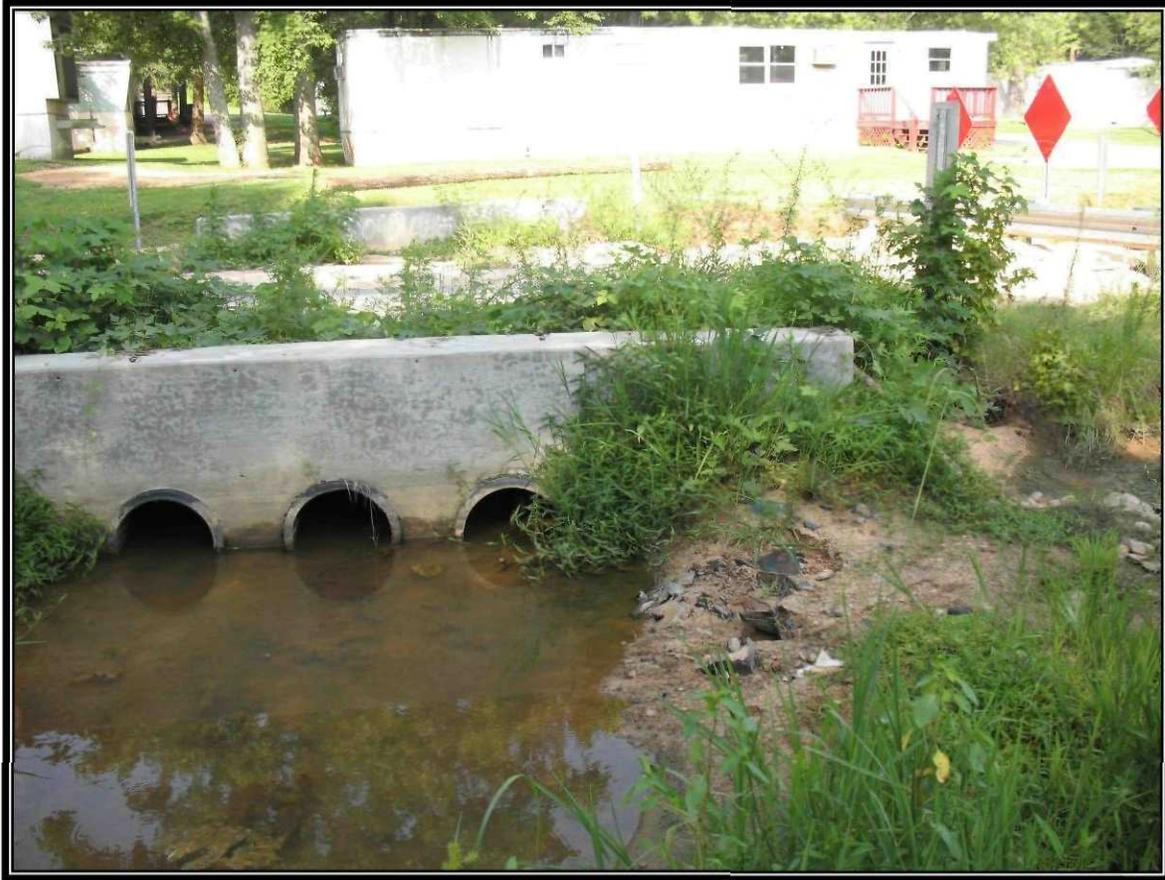
OFFICIAL PHOTOGRAPH NO. 11
U.S. ENVIRONMENTAL PROTECTION AGENCY

Subject: At the eastern side of the site at the McLain Road culvert; battery casings were observed in the surrounding gravel.

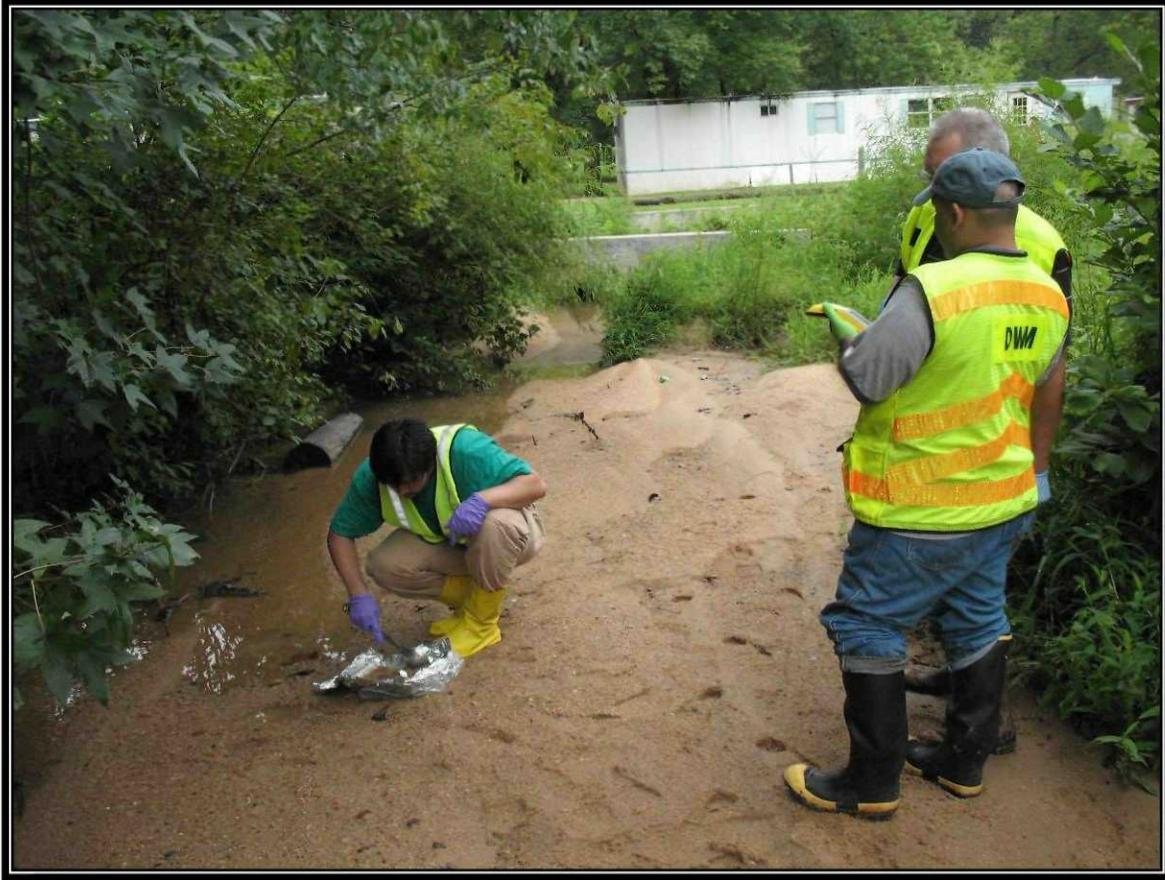
OFFICIAL PHOTOGRAPH NO. 12
U.S. ENVIRONMENTAL PROTECTION AGENCY

Subject: Tetra Tech collected a sediment sample just downstream of the McLain Road culvert area where batter chips were observed. NCDENR collected global positioning system (GPS) locations for each sample collected.

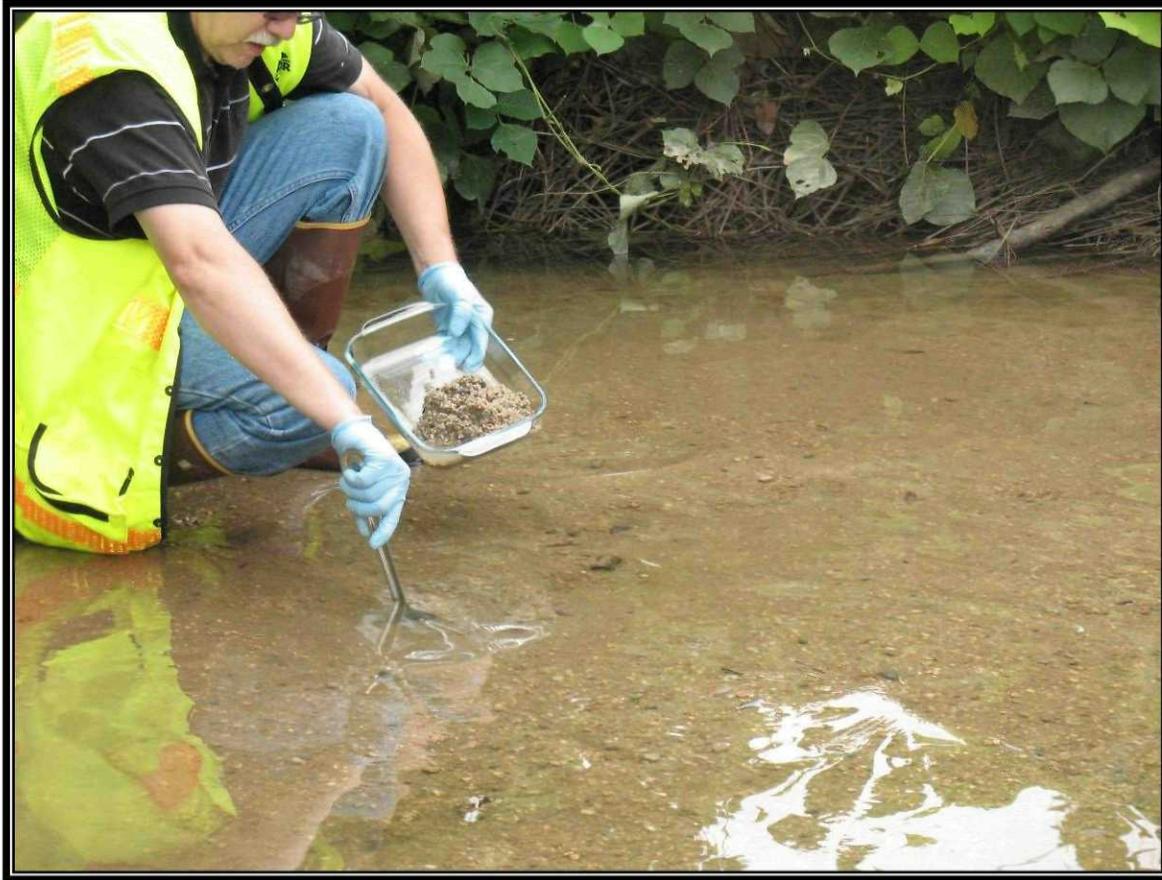
OFFICIAL PHOTOGRAPH NO. 13
U.S. ENVIRONMENTAL PROTECTION AGENCY

Subject: NCDENR collected the background sediment sample at the Fairview Street overpass near the intersection of McLain Road.
