**MITIGATION ACTION PLAN  
VILLA MOBILE HOME PARK  
BATTERY CASING DUMP SITE  
NCN000410583  
VENICE STREET AT VERONA STREET  
KANNAPOLIS, CABARRUS CO., NC  
S&ME PROJECT 1054-11-2025**

April 24, 2012

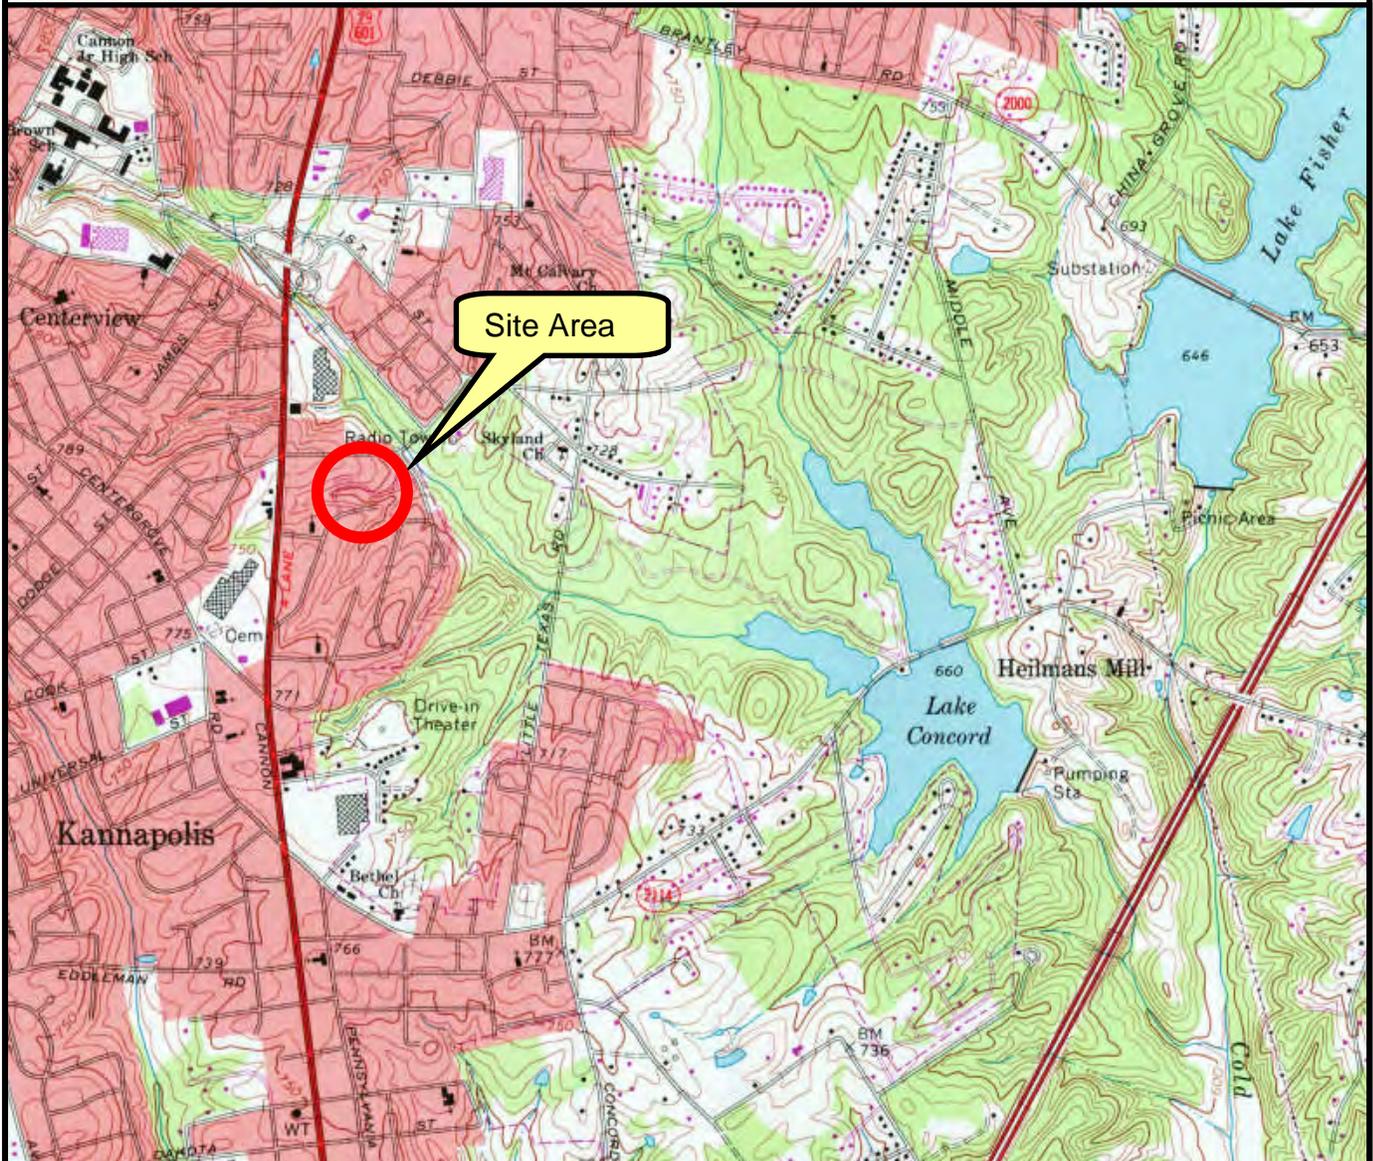
**1**

Base Map taken from 1969 Concord, NC USGS topographic map photorevised in 1987.

Based on the review and comparison of the various topographic maps, no areas of apparent filling were noted. A copy of the 1969 topographic maps is included as **Figure 1** and the historical topographic maps are included in **Appendix II**.

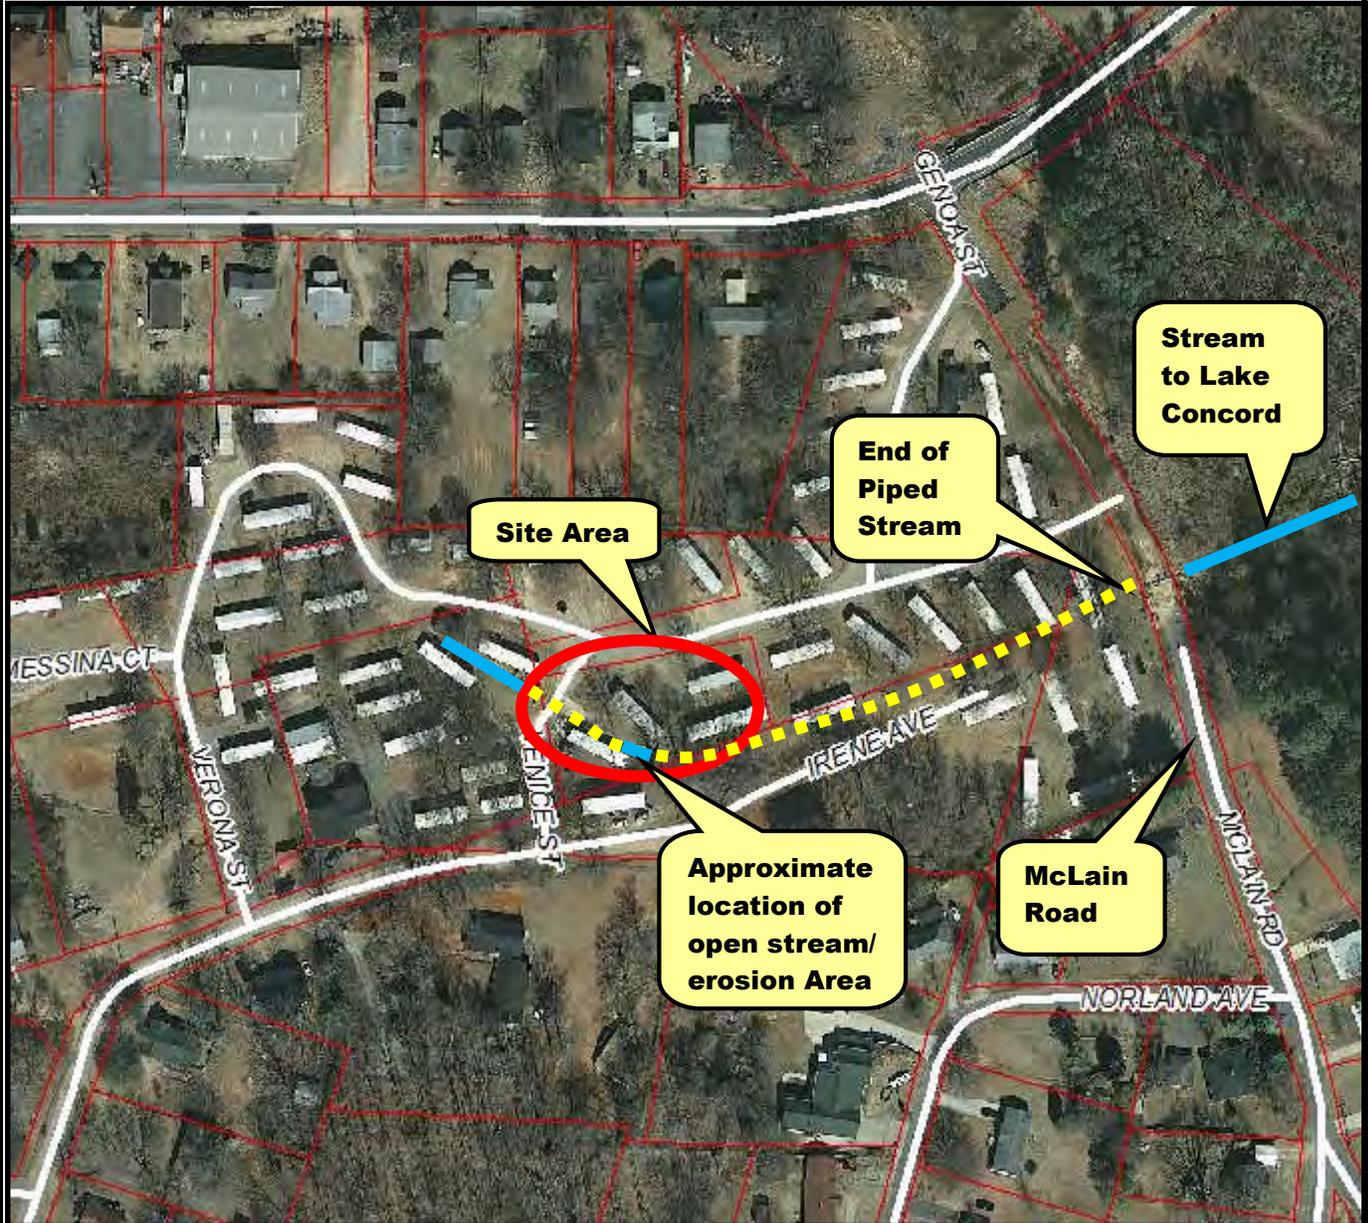
**2**

Approximate location of piped stream

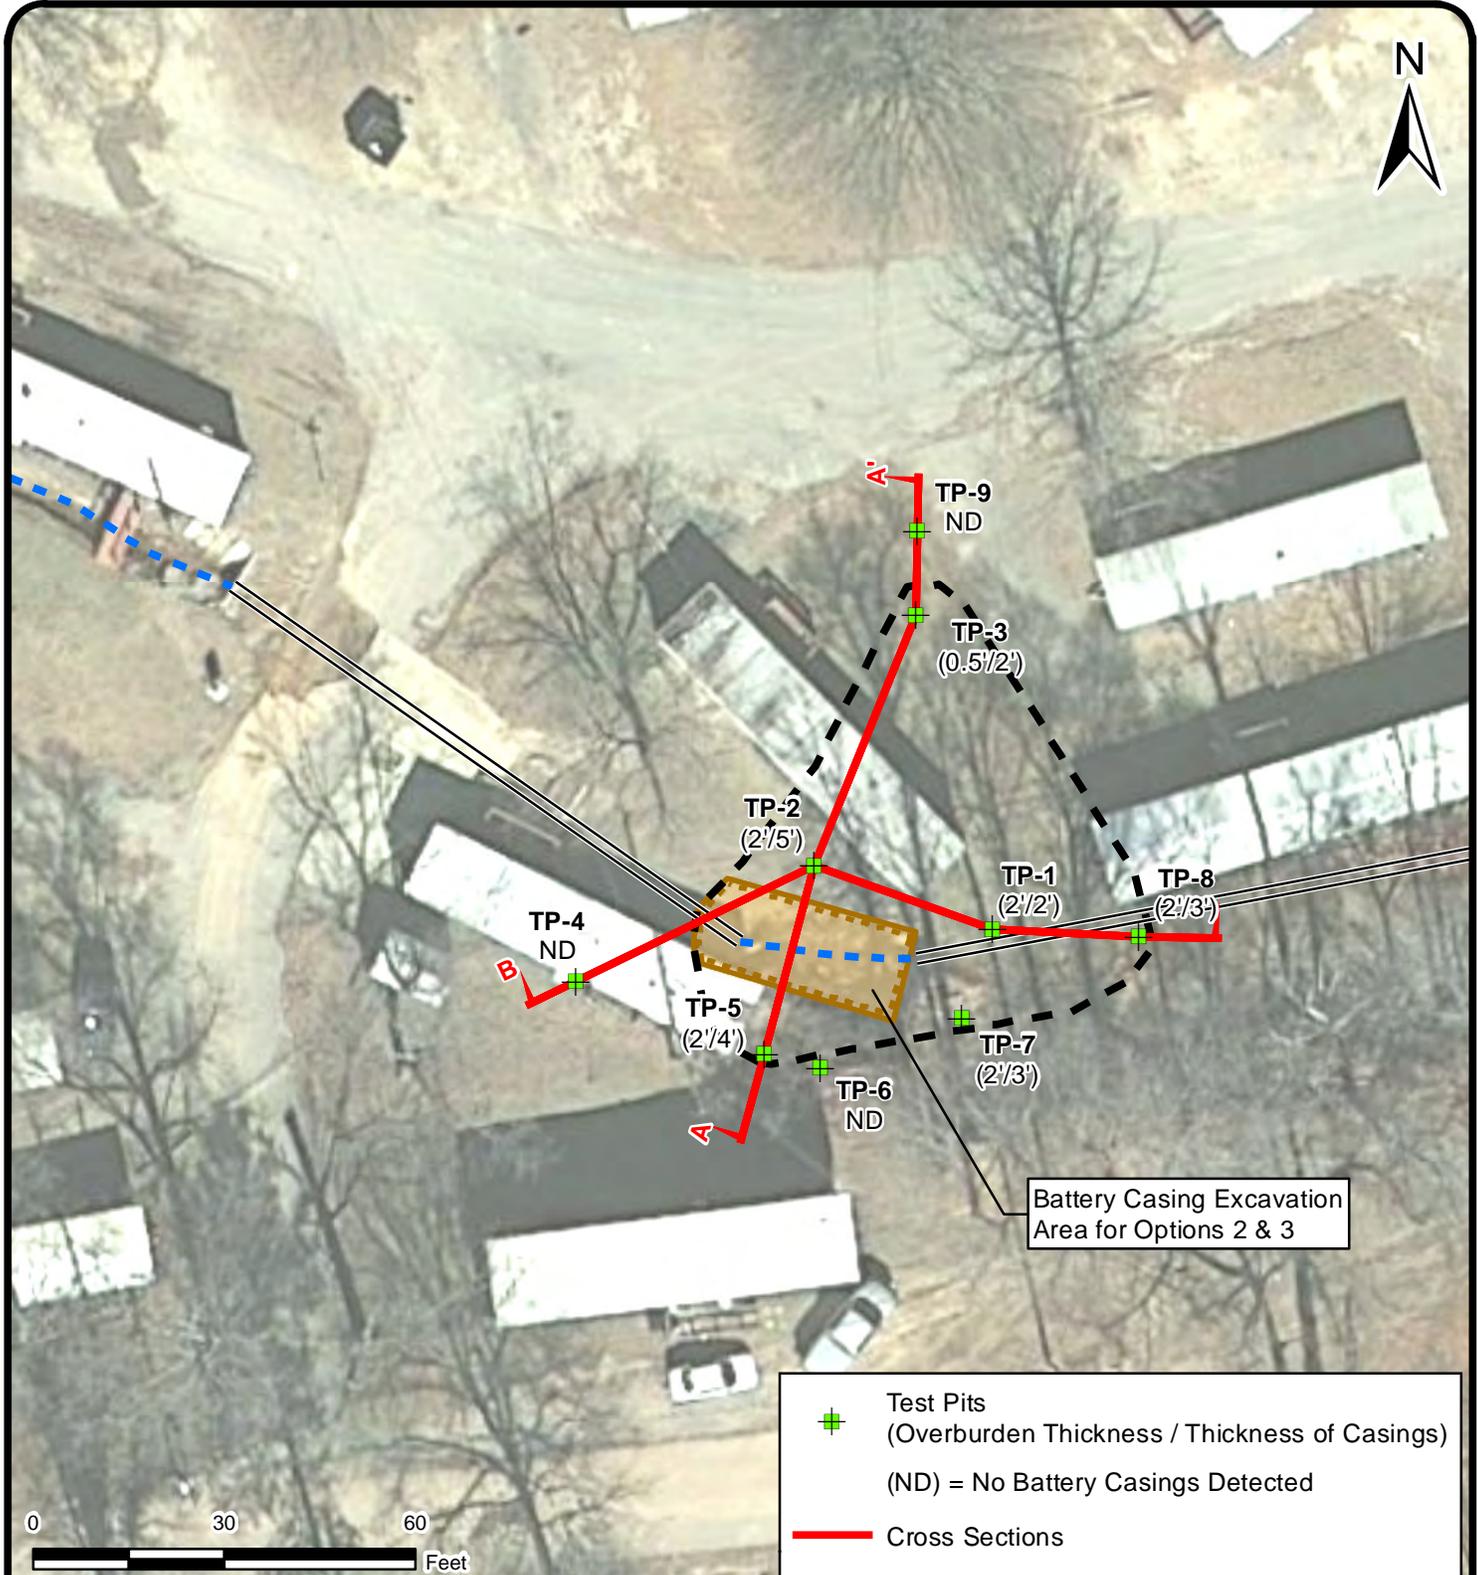
FIGURE NO.  
**3**

Battery Casing Excavation Area for Options 2 & 3

**SITE MAP WITH  
 EXTIMATED DUMP EXTENT**  
 VILLA MOBILE HOME PARK  
 VENICE STREET AT VERONA STREET  
 KANNAPOLIS, CABARRUS CO., NC

The Villa MHP site (State ID Number NCN000410583) is located near the intersection of Venice Street and Verona Street in Kannapolis, Cabarrus County, North Carolina (**Figure 1**). The site is a residential area containing several mobile homes (**Figure 2**). According to information provided to S&ME, in June 2010 a complaint was received from the City of Kannapolis citing pieces of automotive battery casings were observed within the banks of a stream channel that transects the mobile home park. The stream channel where the battery casings were observed is located south of the intersection of Venice and Verona Streets, immediately adjacent to, and below the southeastern corner of an abandoned mobile home (**Figure 3**).

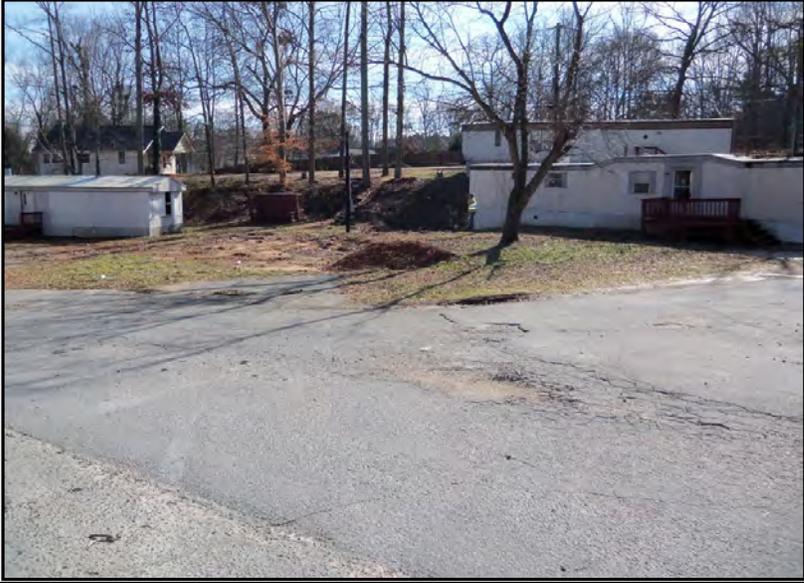
<b>Photo 1</b>

<b>Date:</b> 01/18/2012
		<b>Photographer:</b> Duane Bents
<b>Location</b>	Villa Mobile Home Park – Battery Casing Dump Site Venice Street & Verona Street, Kannapolis, NC	
<b>Remarks</b>	View of site area from corner of Venice Street & Verona Street, prior to removal of mobile home to right.

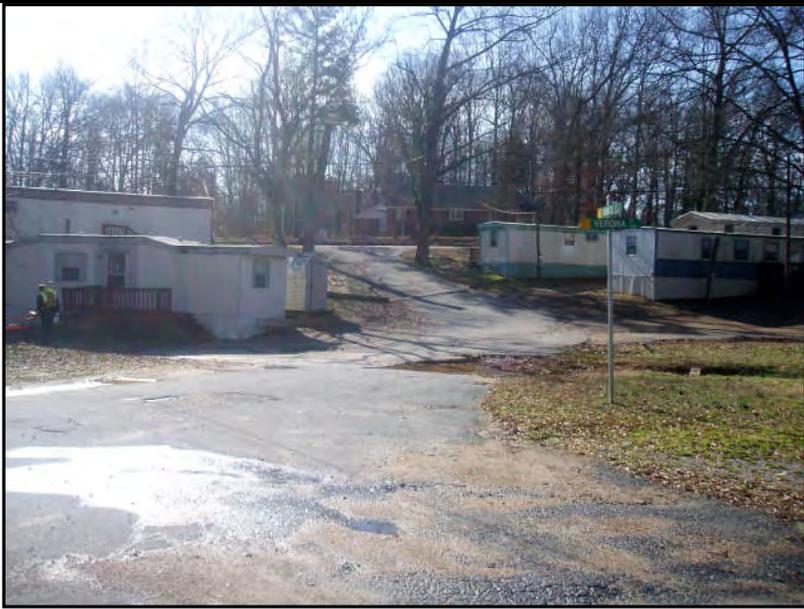
<b>Photo 2</b>

<b>Date:</b> 01/18/12
		<b>Photographer:</b> Roger Smith
<b>Location</b>	Villa Mobile Home Park – Battery Casing Dump Site Venice Street & Verona Street, Kannapolis, NC	
<b>Remarks</b>	View west and upstream of exposed/erosion area looking south on Venice Street.

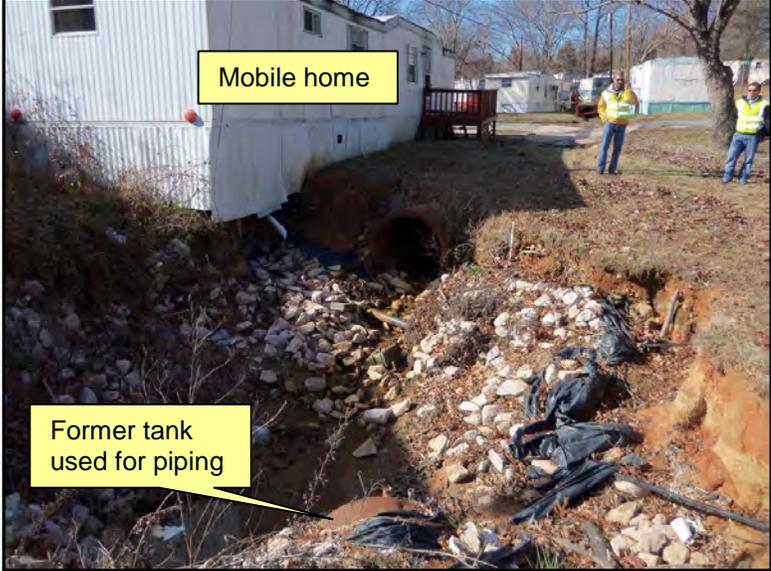
Photo 3

<p style="text-align: center;">Mobile home</p> <p style="text-align: center;">Former tank used for piping</p>	<p>Date: 01/18/2012</p> <p>Photographer: Duane Bents</p>
	<p><b>Location</b> Villa Mobile Home Park – Battery Casing Dump Site            Venice Street &amp; Verona Street, Kannapolis, NC</p> <p><b>Remarks</b> View of exposed erosion area containing battery casings and plastic and stone rip rap former repair attempt. Looking upstream.</p>

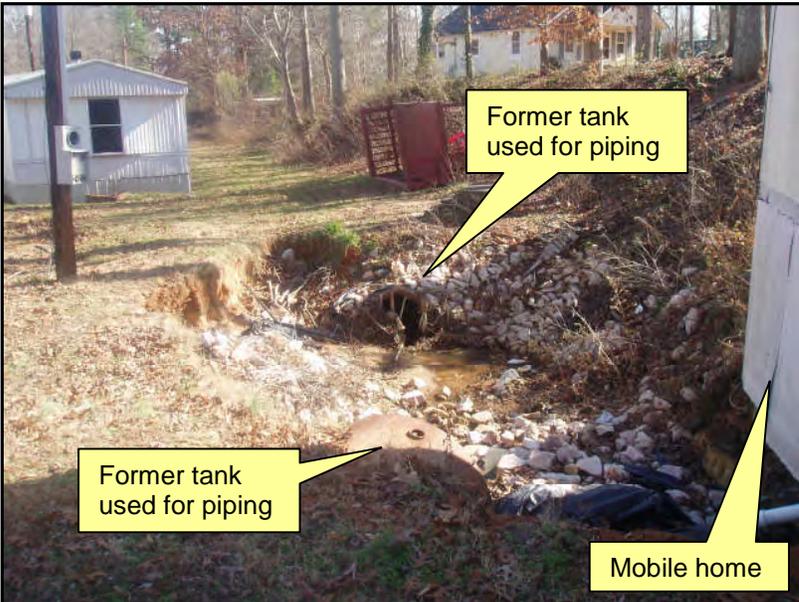
Photo 4

<p style="text-align: center;">Former tank used for piping</p> <p style="text-align: center;">Former tank used for piping</p> <p style="text-align: center;">Mobile home</p>	<p>Date: 01/18/2012</p> <p>Photographer: Roger Smith</p>
	<p><b>Location</b> Villa Mobile Home Park – Battery Casing Dump Site            Venice Street &amp; Verona Street, Kannapolis, NC</p> <p><b>Remarks</b> View of exposed erosion area containing battery casings and plastic and stone rip rap former repair attempt. Looking downstream with former mobile home to right.</p>

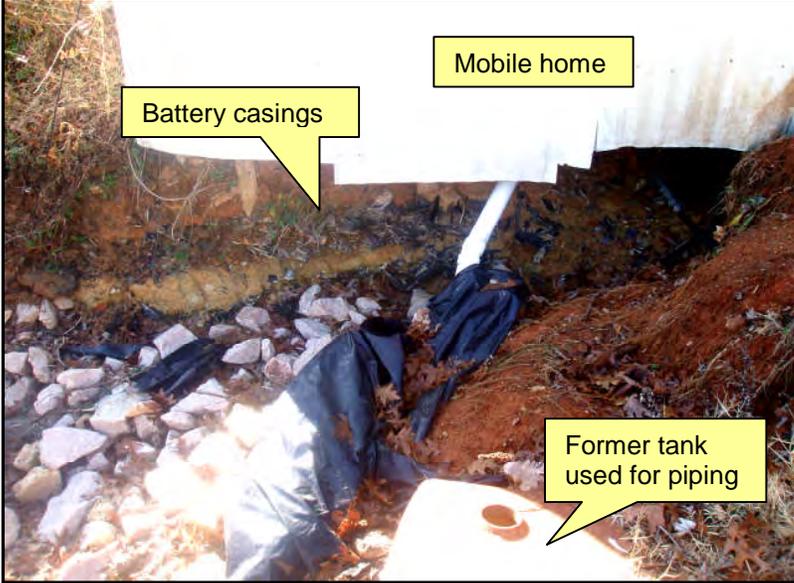
Photo 5

<b>Date:</b> 01/18/2012  <b>Photographer:</b> Roger Smith
<b>Location</b>	Villa Mobile Home Park – Battery Casing Dump Site Venice Street & Verona Street, Kannapolis, NC	
<b>Remarks</b>	View of battery casings in stream bank below mobile home.

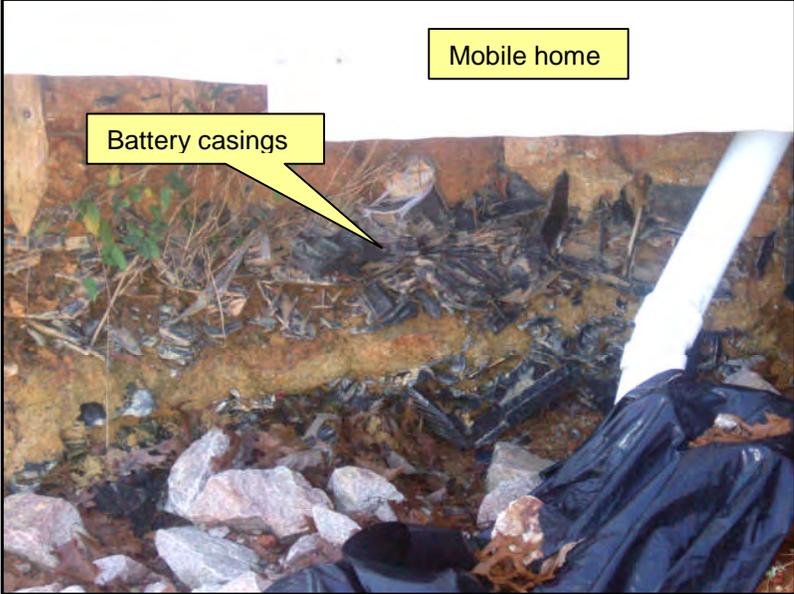
Photo 6

<b>Date:</b> 01/18/2012  <b>Photographer:</b> Roger Smith
<b>Location</b>	Villa Mobile Home Park – Battery Casing Dump Site Venice Street & Verona Street, Kannapolis, NC	
<b>Remarks</b>	Close up view of battery casings below mobile home.

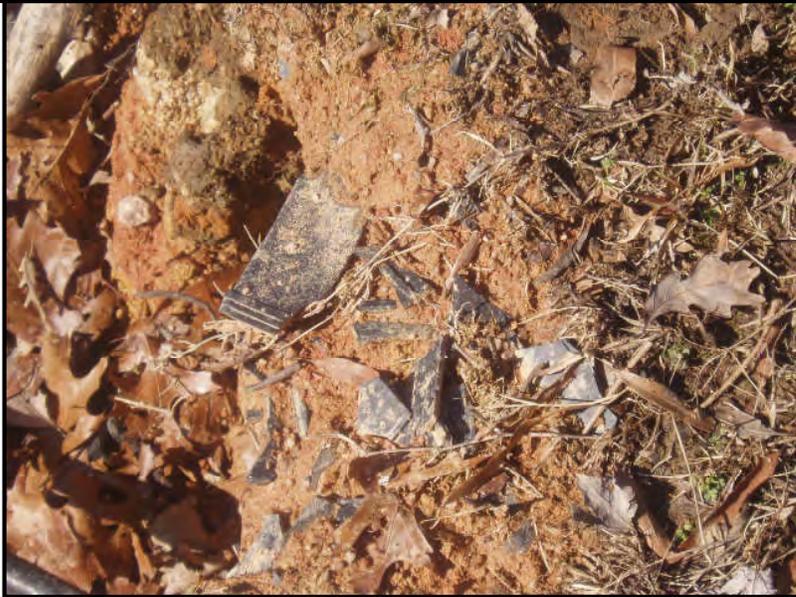
Photo 7

Date: 01/18/2012  Photographer: Roger Smith
<b>Location</b>	Villa Mobile Home Park – Battery Casing Dump Site Venice Street & Verona Street, Kannapolis, NC	
<b>Remarks</b>	Close up view of battery casings in side of stream channel, near ground surface.

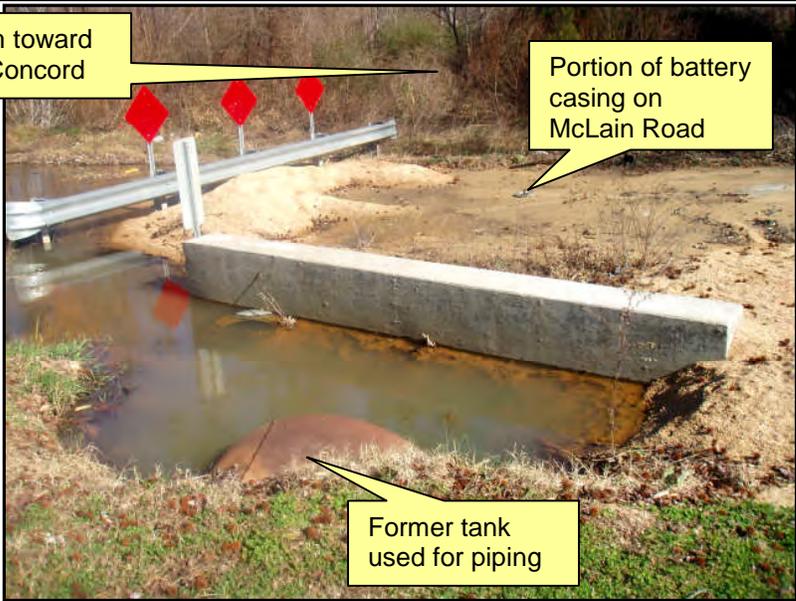
Photo 8

Date: 01/18/2012  Photographer: Roger Smith
<b>Location</b>	Villa Mobile Home Park – Battery Casing Dump Site Venice Street & Verona Street, Kannapolis, NC	
<b>Remarks</b>	View of piped stream discharge approximately 500 feet downstream for exposed area at McLain Road.

In order to remove the pieces of battery casings observed along the open section of the stream from McLain Road toward Lake Concord, a contractor will manually remove the observed battery casings by walking, wading, etc., the area. It is also recommended that the contractor use a rake to manually rake the sidewalls and stream bottom to also attempt to remove those pieces that lie just under the sediment surface. The removed battery casings should then be placed in a roll-off box and transported off-site for disposal as hazardous waste. It is estimated that there would be a maximum of 10 yds<sup>3</sup> (15 tons) or one roll-off box generated from along this stream section.

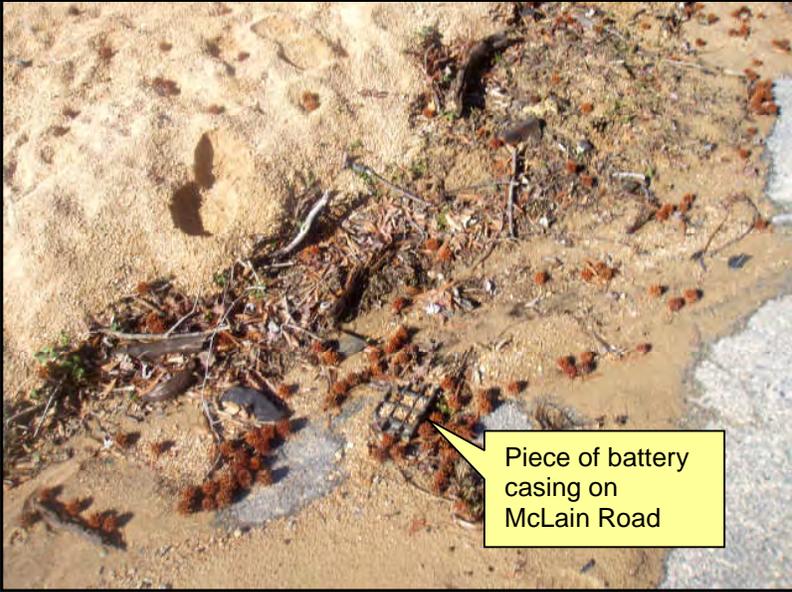
Photo 9

<p>Piece of battery casing on McLain Road</p>	<p>Date: 01/18/2012</p> <p>Photographer: Roger Smith</p>
<b>Location</b>	Villa Mobile Home Park – Battery Casing Dump Site Venice Street & Verona Street, Kannapolis, NC	
<b>Remarks</b>	Close up view of pieces of battery casings and sediment deposited on McLain Road, downstream of exposed area

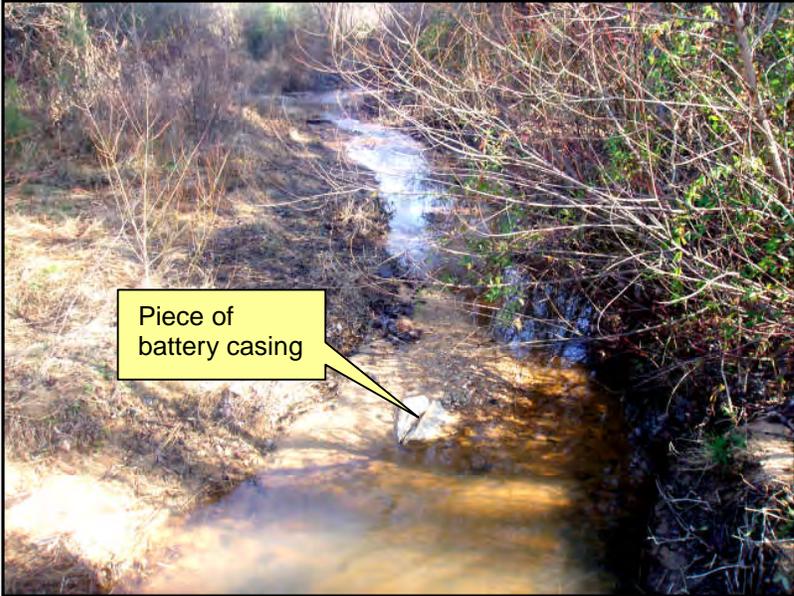
Photo 10

<p>Piece of battery casing</p>	<p>Date: 01/18/2012</p> <p>Photographer: Roger Smith</p>
<b>Location</b>	Villa Mobile Home Park – Battery Casing Dump Site Venice Street & Verona Street, Kannapolis, NC	
<b>Remarks</b>	View of stream below McLain Road with pieces of battery casings

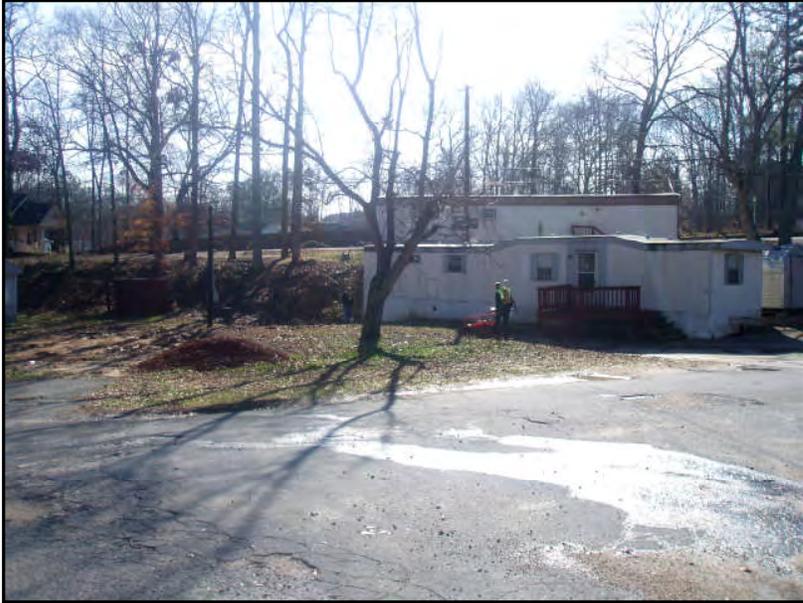
Photo 11

<b>Date:</b> 03/6/2012 <b>Photographer:</b> Curtis Helms, Jr.	
<b>Location</b>	Villa Mobile Home Park – Battery Casing Dump Site Venice Street & Verona Street, Kannapolis, NC
<b>Remarks</b>	View of site area while conducting geophysical survey

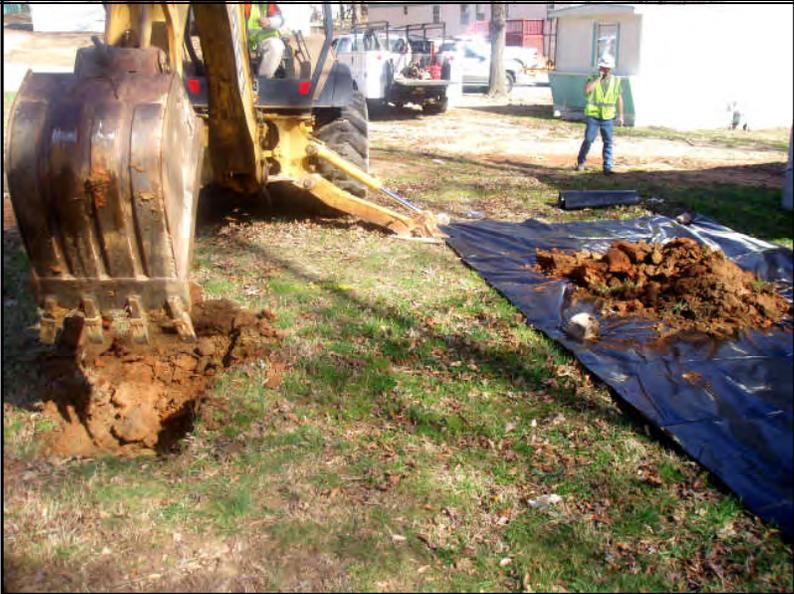
Photo 12

<b>Date:</b> 03/06/2012 <b>Photographer:</b> Curtis Helms, Jr.	
<b>Location</b>	Villa Mobile Home Park – Battery Casing Dump Site Venice Street & Verona Street, Kannapolis, NC
<b>Remarks</b>	Conducting test pit excavations

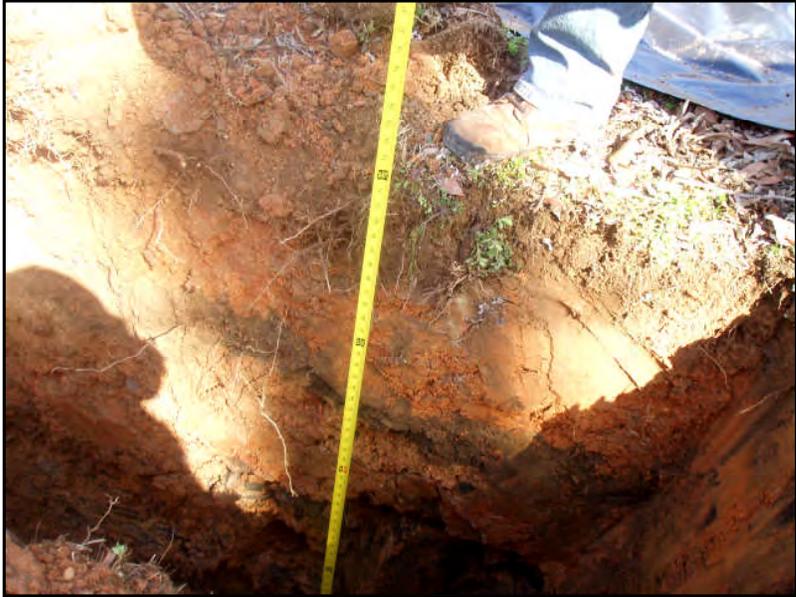
Photo 13

<b>Date:</b> 03/06/2012  <b>Photographer:</b> Curtis Helms, Jr.
<b>Location</b>	Villa Mobile Home Park – Battery Casing Dump Site Venice Street & Verona Street, Kannapolis, NC	
<b>Remarks</b>	View of sidewall of TP-2 with exposed battery casings approximately 2 feet below surface

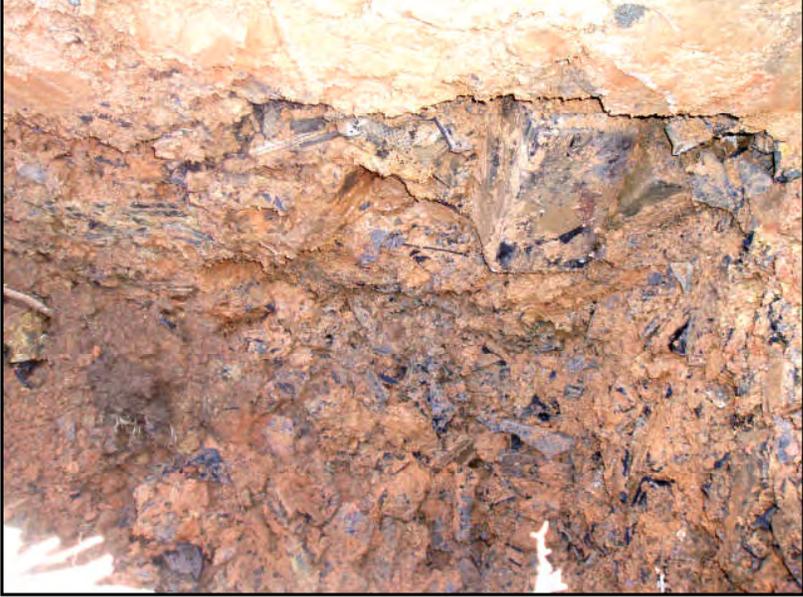
Photo 14

<b>Date:</b> 03/06/2012  <b>Photographer:</b> Curtis Helms, Jr.
<b>Location</b>	Villa Mobile Home Park – Battery Casing Dump Site Venice Street & Verona Street, Kannapolis, NC	
<b>Remarks</b>	Close up view of battery casings in sidewall of TP-2

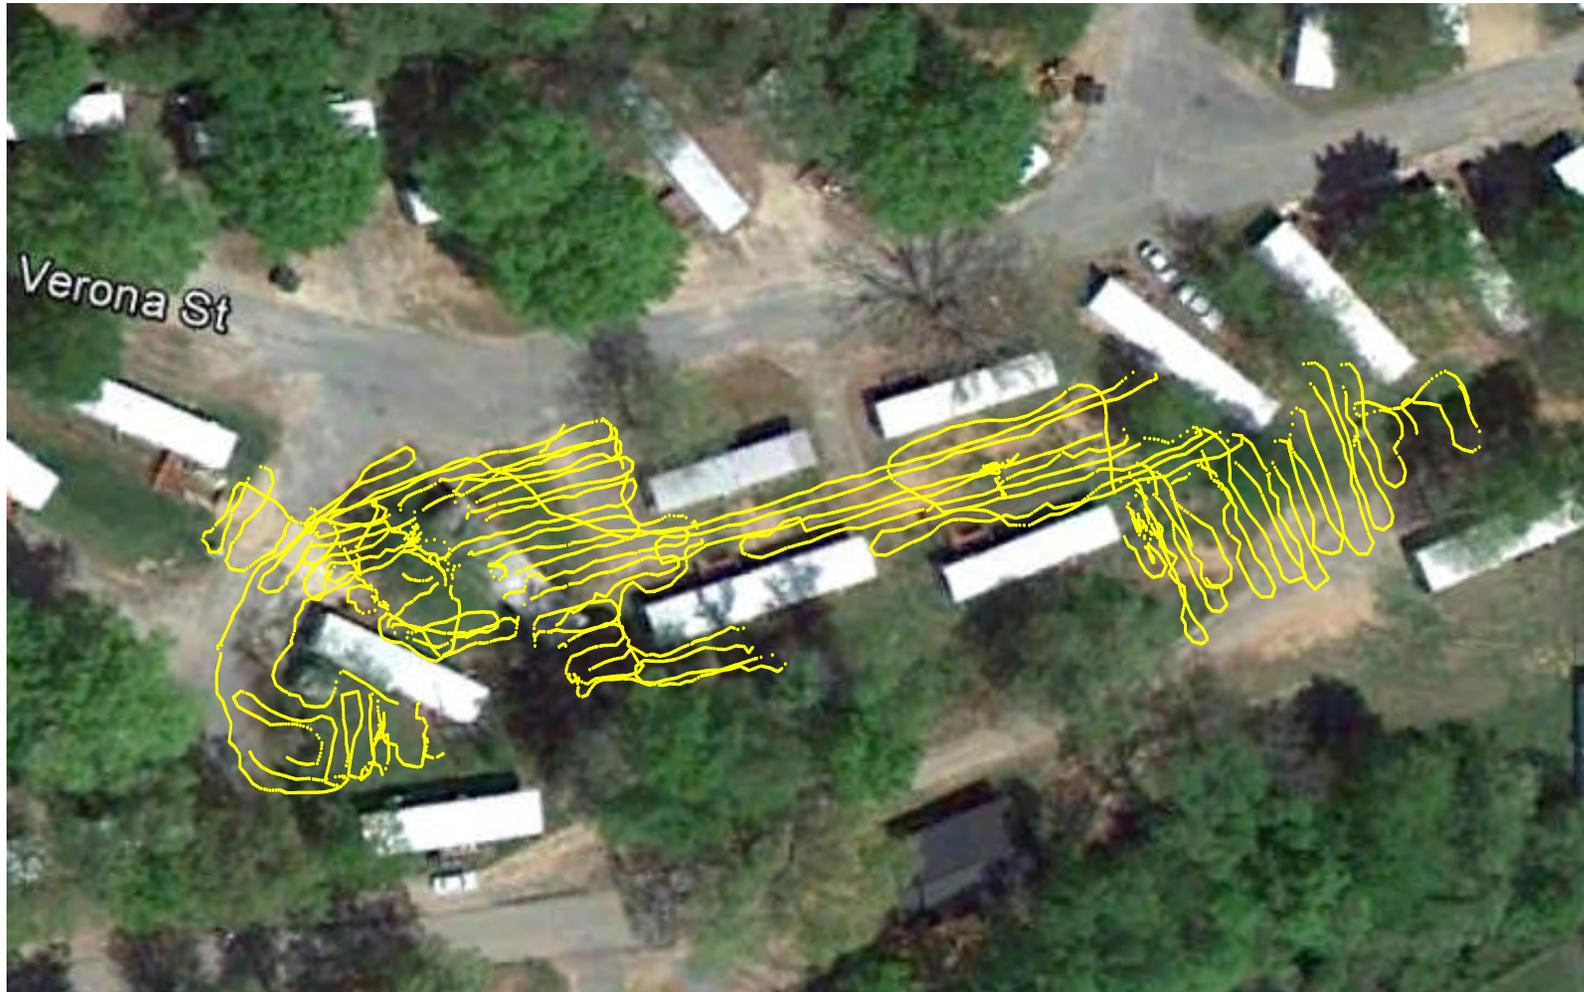
<b>TDEM TEST LOCATION PLAN</b> Villa Mobile Home Park – Battery Casing Venice Street at Verona Street, Kannapolis, North Carolina	FIGURE NO.	
DRAWN BY: KDH			1	
CHECKED BY: DDB			JOB NO.: 1054-11-2025	
DATE: 2-1-12

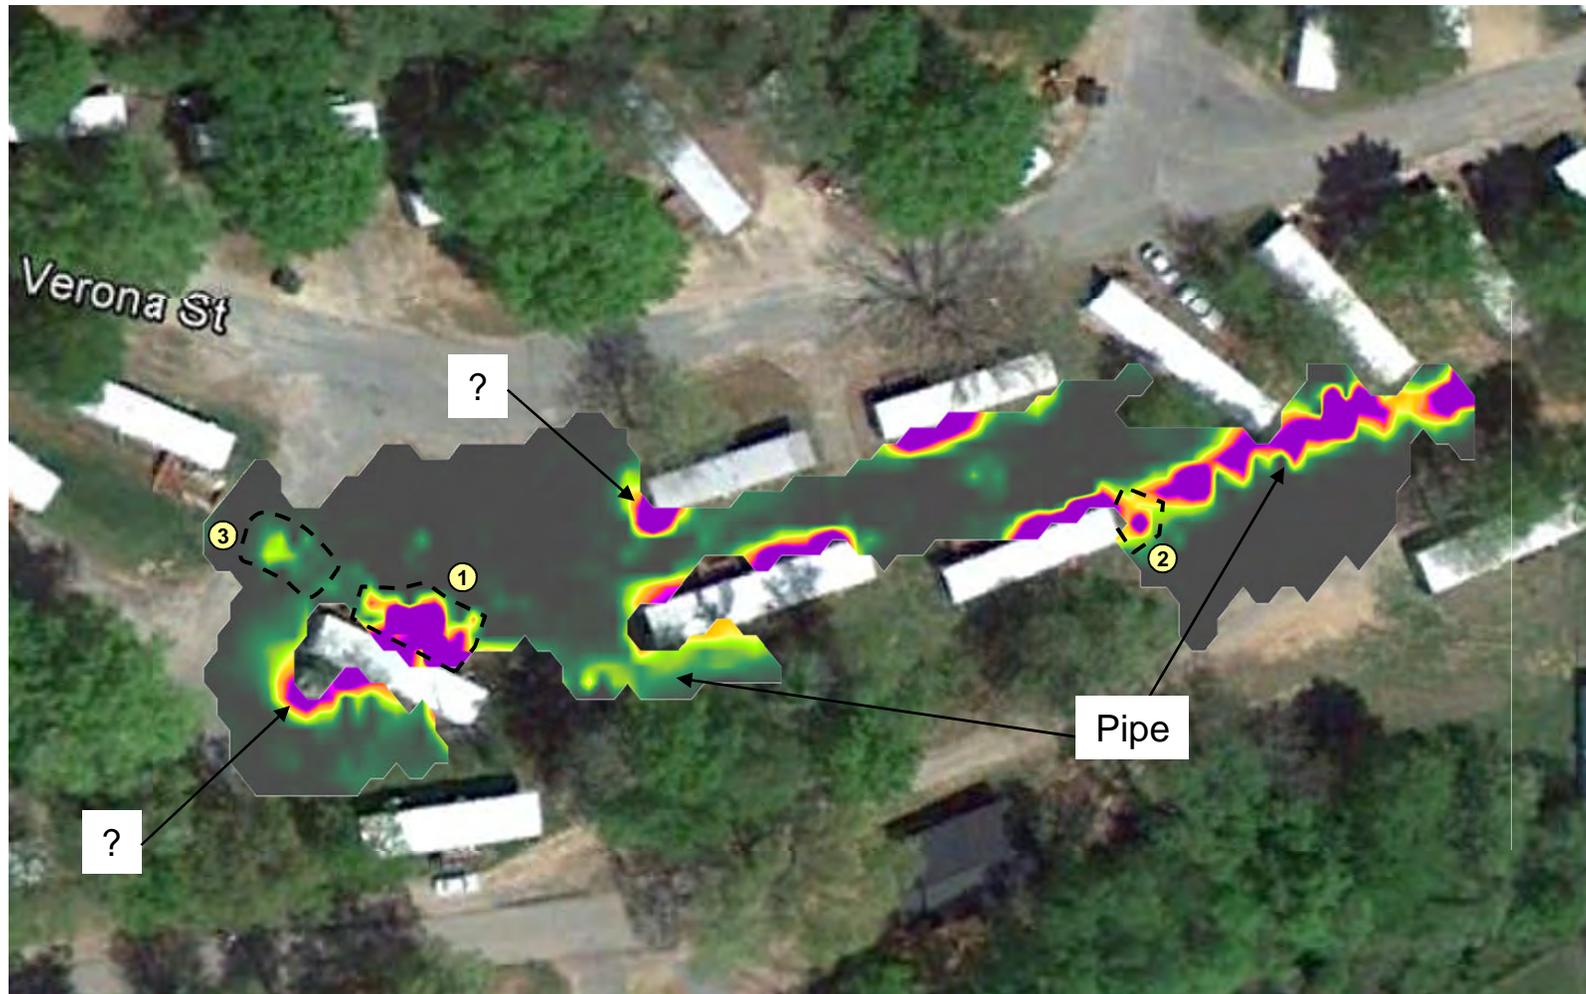
Conductivity (mV)

<p><b>TDEM DATA PLOT</b> <b>Villa Mobile Home Park – Battery Casing</b> Venice Street at Verona Street, Kannapolis, North Carolina</p>	FIGURE NO. <b>2</b>
JOB NO.: 1054-11-2025

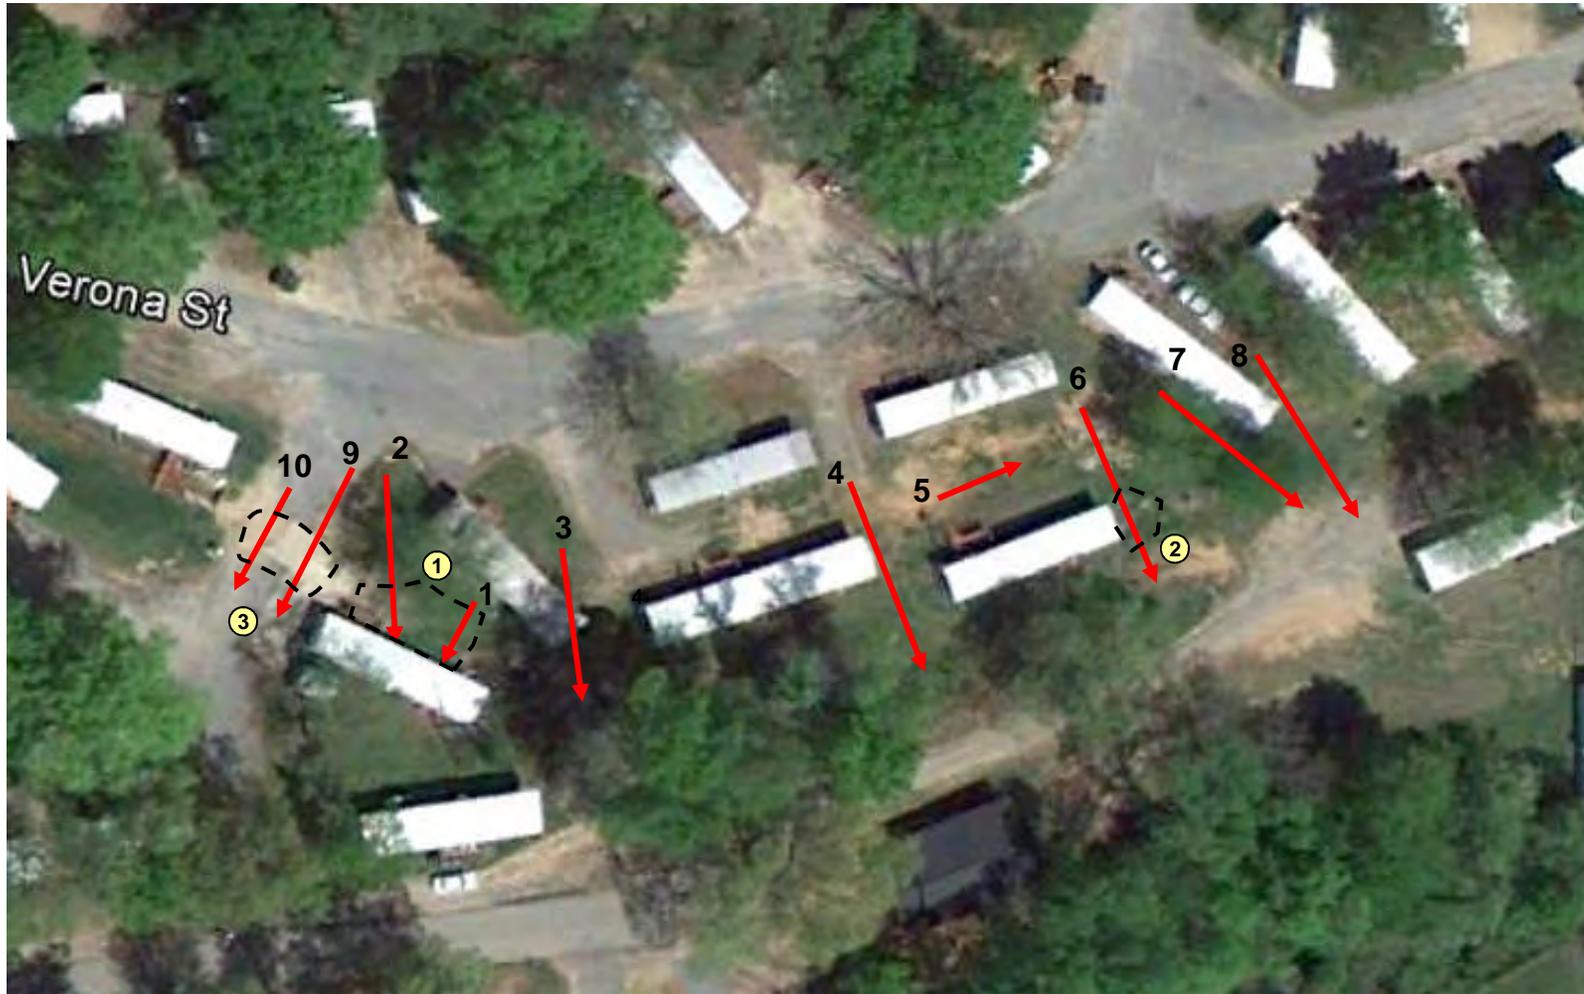
<p align="center"><b>GPR TEST LOCATION PLAN</b> Villa Mobile Home Park – Battery Casing Venice Street at Verona Street, Kannapolis, North Carolina</p>	FIGURE NO.  <b>3</b>
JOB NO.: 1054-11-2025
