**Subject: Comprehensive Environmental Response, Compensation, and Liability Act  
Site Assessment and Inspection Report  
Liberty Fibers Site  
Lowland, Hamblen County, Tennessee  
EPA Contract No. EP-W-05-054  
TDD No. TTEMI-05-003-0041**

The Tetra Tech EM Inc., Superfund Technical Assessment and Response Team (START) is submitting the site assessment and inspection report for the Liberty Fibers Site in Lowland, Hamblen County, Tennessee. This report summarizes field activities conducted at the site on 20 and 21 March 2008.

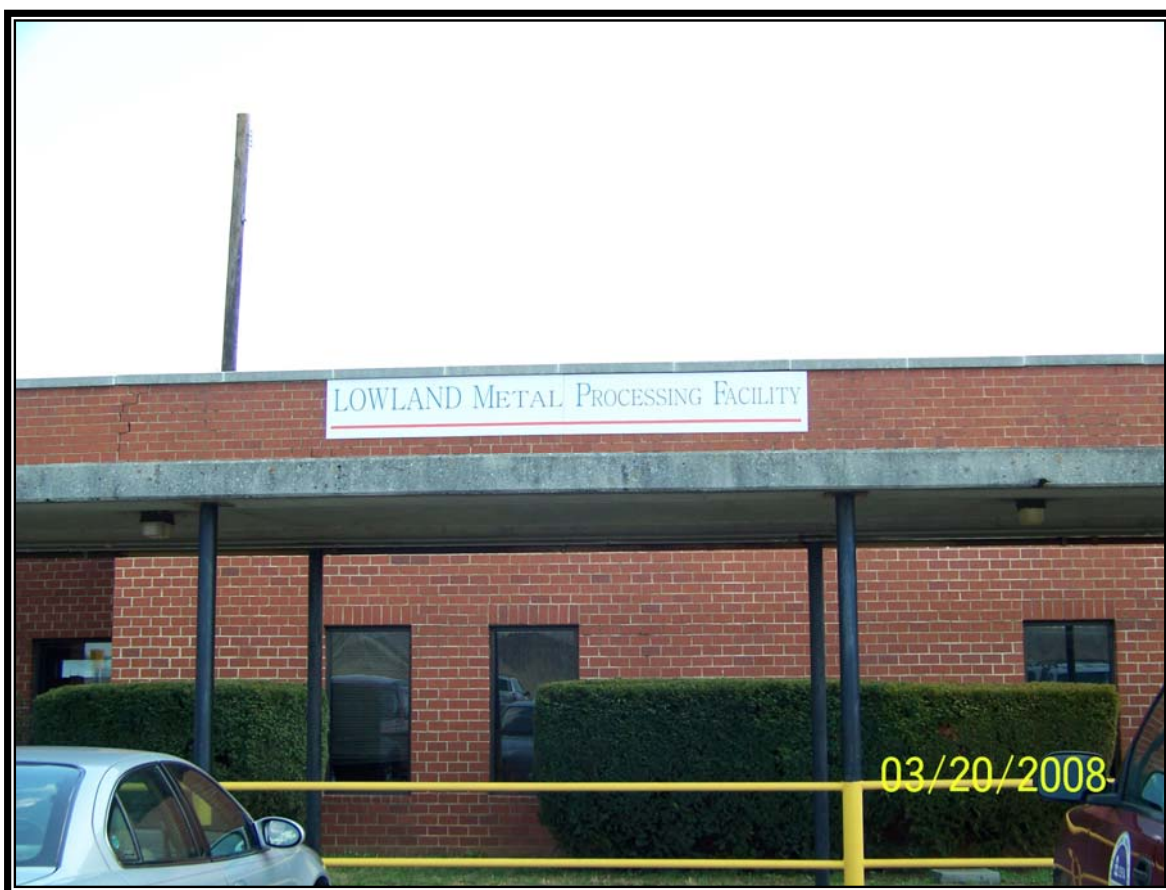
**OFFICIAL PHOTOGRAPH NO. 1**  
**U.S. ENVIRONMENTAL PROTECTION AGENCY**

<b>TDD Number:</b>	TTEMI-05-003-0041	<b>Location:</b>	Liberty Fibers Site
<b>Orientation:</b>	East	<b>Date:</b>	March 20, 2008
<b>Photographer:</b>	Chris Draper, Tetra Tech	<b>Witness:</b>	OSC Steve Spurlin, EPA
<b>Subject:</b>	Entrance to Lowland Metals Processing Facility, formerly Liberty Fibers (site).

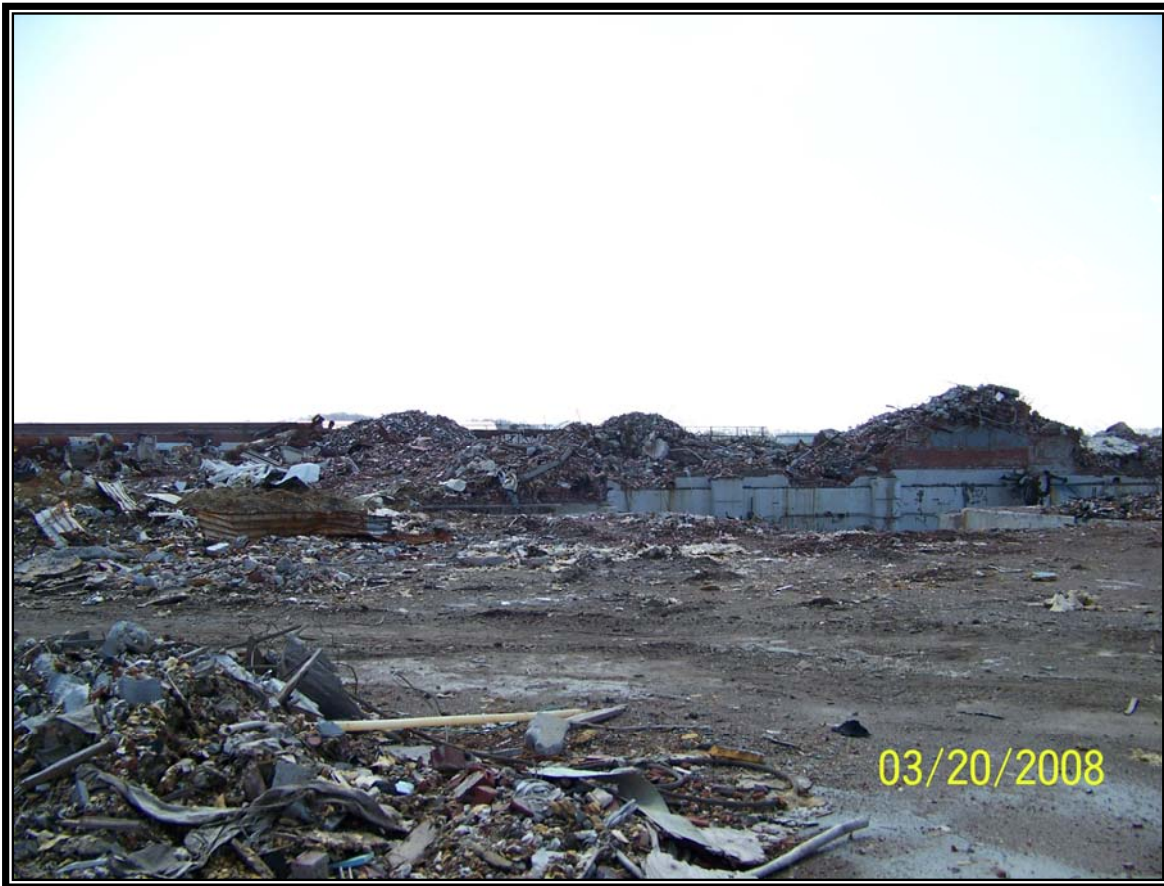
**OFFICIAL PHOTOGRAPH NO. 2**  
**U.S. ENVIRONMENTAL PROTECTION AGENCY**

<b>TDD Number:</b>	TTEMI-05-003-0041	<b>Location:</b>	Liberty Fibers Site
<b>Orientation:</b>	South	<b>Date:</b>	March 20, 2008
<b>Photographer:</b>	Chris Draper, Tetra Tech	<b>Witness:</b>	OSC Steve Spurlin, EPA
<b>Subject:</b>	Typical debris field present at the site due to demolition and metals reclamation.

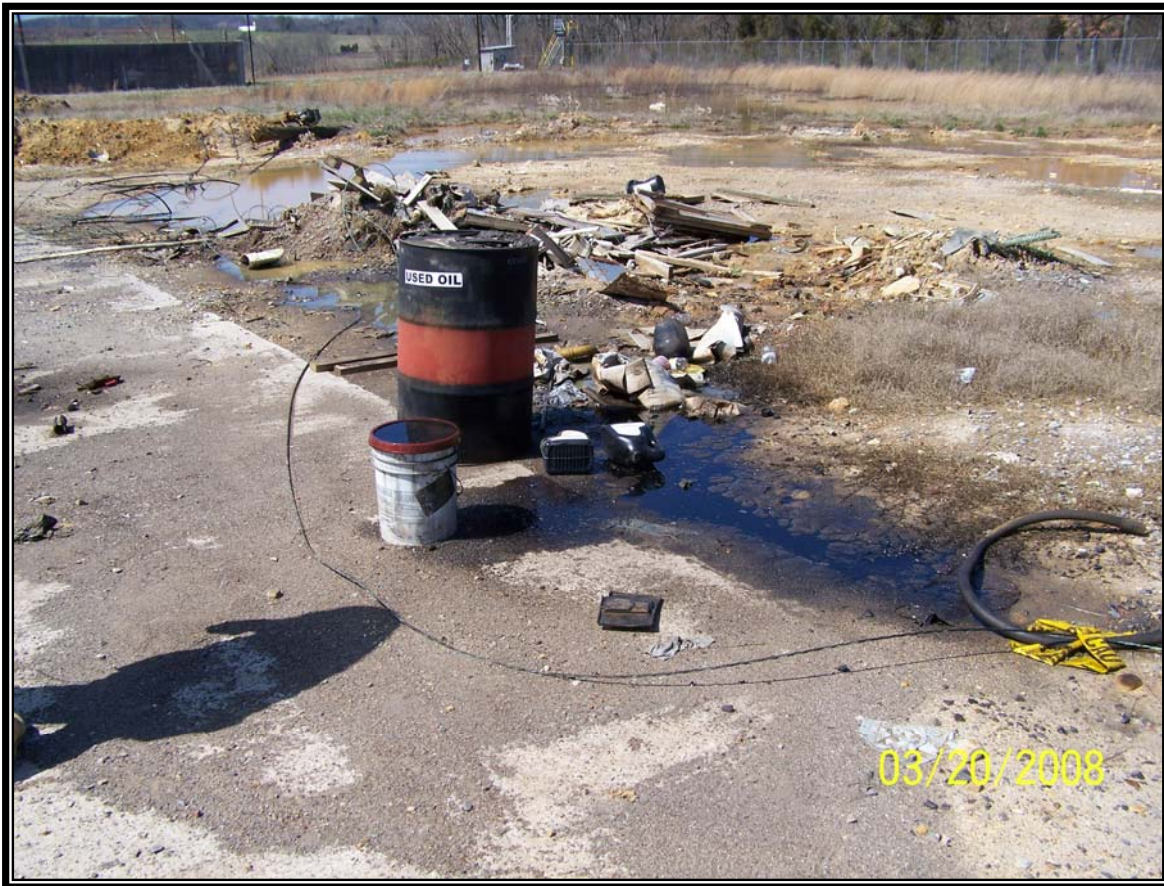
**OFFICIAL PHOTOGRAPH NO. 3**  
**U.S. ENVIRONMENTAL PROTECTION AGENCY**

<b>TDD Number:</b>	TTEMI-05-003-0041	<b>Location:</b>	Liberty Fibers Site
<b>Orientation:</b>	North	<b>Date:</b>	March 20, 2008
<b>Photographer:</b>	Chris Draper, Tetra Tech	<b>Witness:</b>	OSC Steve Spurlin, EPA
<b>Subject:</b>	Leaking drum of labeled "Used Oil" discovered along the road on the northern side of the site.

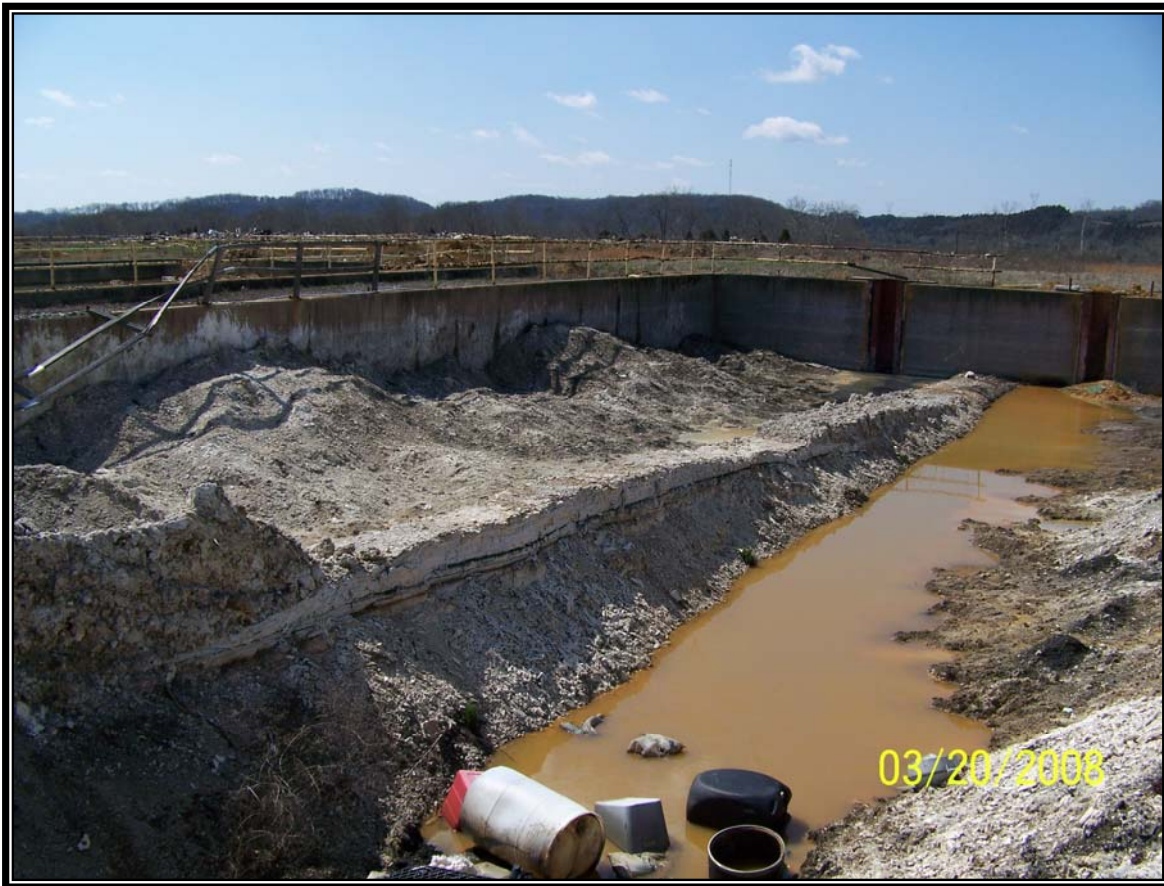
**OFFICIAL PHOTOGRAPH NO. 4**  
**U.S. ENVIRONMENTAL PROTECTION AGENCY**

<b>TDD Number:</b>	TTEMI-05-003-0041	<b>Location:</b>	Liberty Fibers Site
<b>Orientation:</b>	South	<b>Date:</b>	March 20, 2008
<b>Photographer:</b>	Chris Draper, Tetra Tech	<b>Witness:</b>	OSC Steve Spurlin, EPA
<b>Subject:</b>	Basin formerly used to neutralize caustic soda (calcium hydroxide) using sulfuric acid.

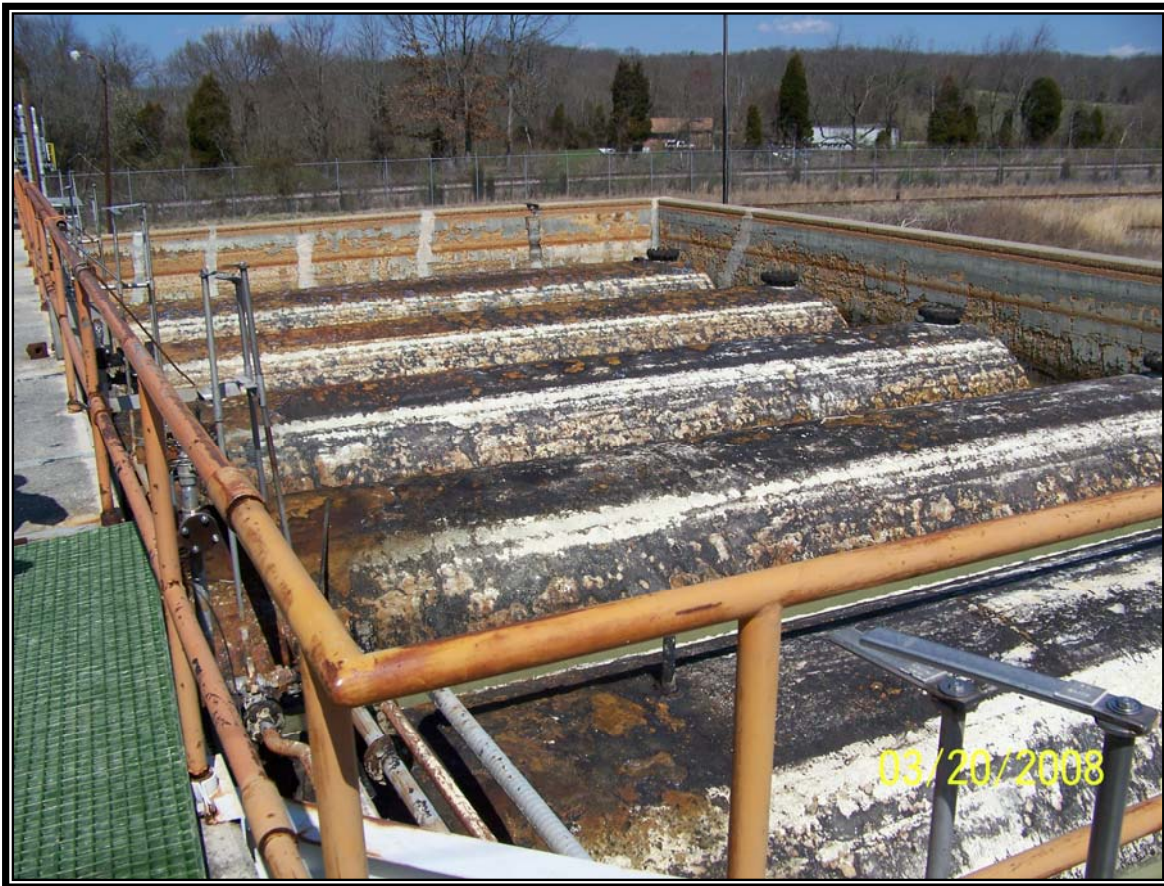
**OFFICIAL PHOTOGRAPH NO. 5**  
**U.S. ENVIRONMENTAL PROTECTION AGENCY**

Mr. Montgomery pointed-out and described the concrete vault that contains six tanks of approximately 10,000-gallons that were used to contain carbon disulfide, an extremely flammable chemical used in the manufacturing of rayon. The vault is typically filled with water to cover the tanks in order to reduce the possibility of fire and explosion. Mr. Montgomery identified a leak in the western wall of the vault that has resulted in the tanks being only one-half under water and possibly impacting the surrounding soil. OSC Spurlin indicated that a sample of the soil directly below the crack in the vault wall should be collected and analyzed for volatile organic compounds, specifically carbon disulfide. Table 2 summarizes all of the samples collected and the analytical results.

1431 CS<sub>2</sub> TANK VAULT W/ 6 EACH ~10000 GAL  
TANKS, MAY LEAK ON W. SIDE, POSSIBLY  
IMPACTING SOIL  
CS<sub>2</sub> IS POOR, ACUTELY HAZ. WASTE

<b>TDD Number:</b>	TTEMI-05-003-0041	<b>Location:</b>	Liberty Fibers Site
<b>Orientation:</b>	Northeast	<b>Date:</b>	March 20, 2008
<b>Photographer:</b>	Chris Draper, Tetra Tech	<b>Witness:</b>	OSC Steve Spurlin, EPA
<b>Subject:</b>	Vault containing six approximately 10,000-gallon tanks used to store carbon disulfide. The tanks are normally kept under water to preclude fire and explosion. The vault is leaking through a crack in the western wall, thus compromising the water blanket.

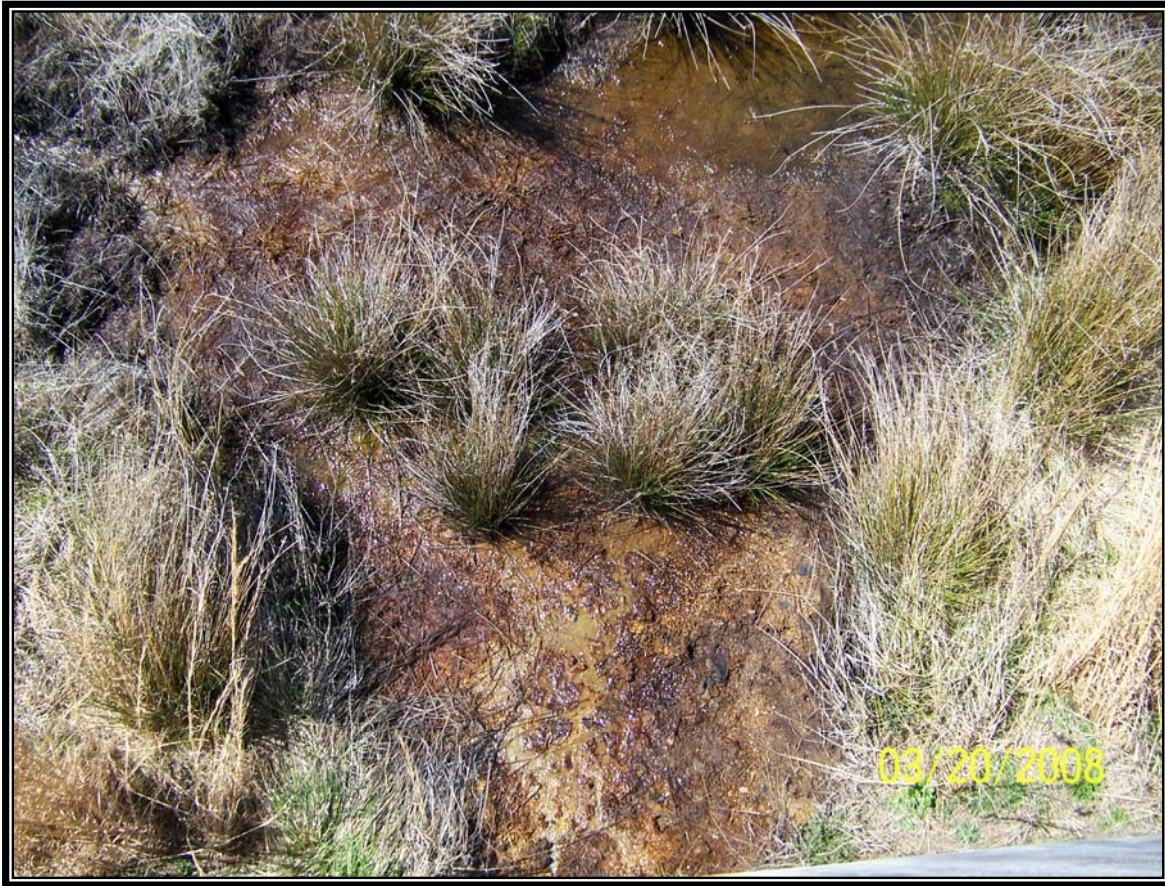
**OFFICIAL PHOTOGRAPH NO. 6**  
**U.S. ENVIRONMENTAL PROTECTION AGENCY**

<b>TDD Number:</b>	TTEMI-05-003-0041	<b>Location:</b>	Liberty Fibers Site
<b>Orientation:</b>	West	<b>Date:</b>	March 20, 2008
<b>Photographer:</b>	Chris Draper, Tetra Tech	<b>Witness:</b>	OSC Steve Spurlin, EPA
<b>Subject:</b>	Area immediately below the crack in the western wall of the carbon disulfide vault.

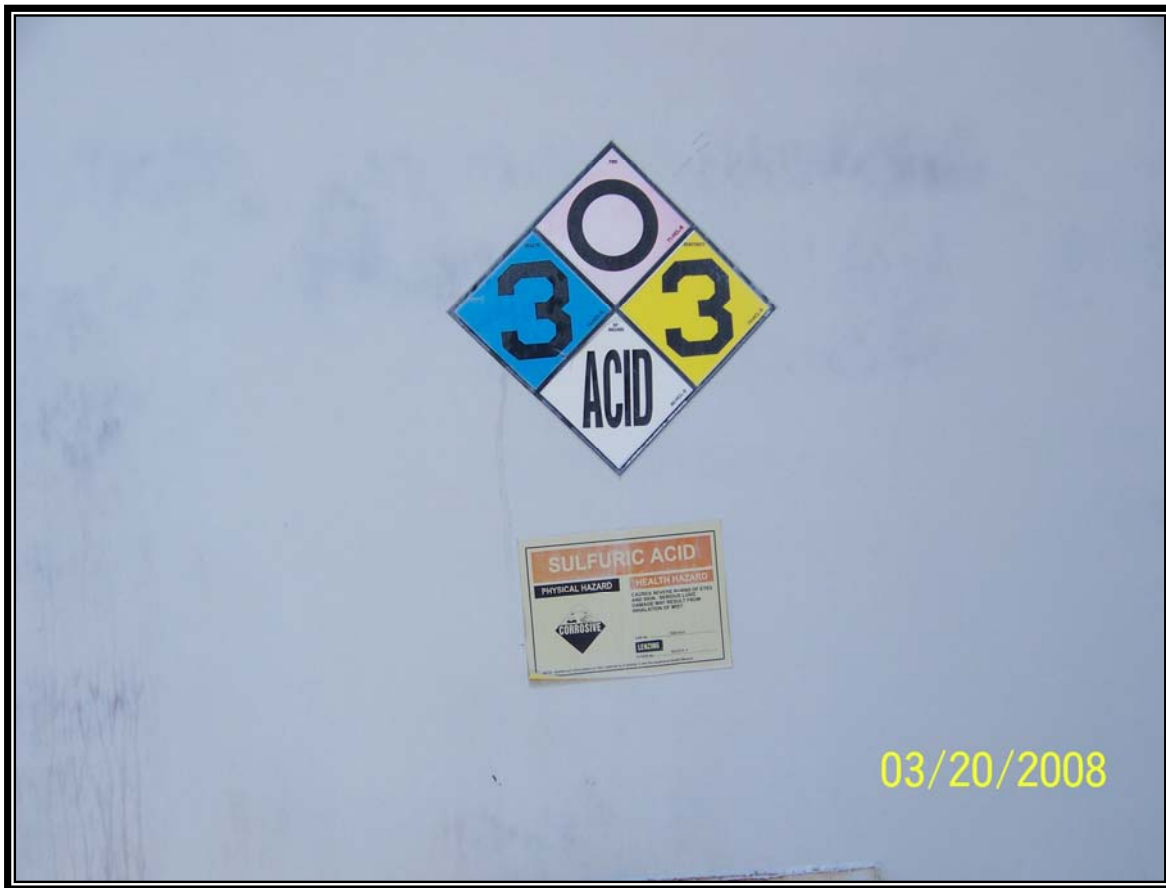
**OFFICIAL PHOTOGRAPH NO. 7**  
**U.S. ENVIRONMENTAL PROTECTION AGENCY**

<b>TDD Number:</b>	TTEMI-05-003-0041	<b>Location:</b>	Liberty Fibers Site
<b>Orientation:</b>	East	<b>Date:</b>	March 20, 2008
<b>Photographer:</b>	Chris Draper, Tetra Tech	<b>Witness:</b>	OSC Steve Spurlin, EPA
<b>Subject:</b>	Approximately 50,000-gallon sulfuric acid tank purported to still contain approximately 8-inches of product.

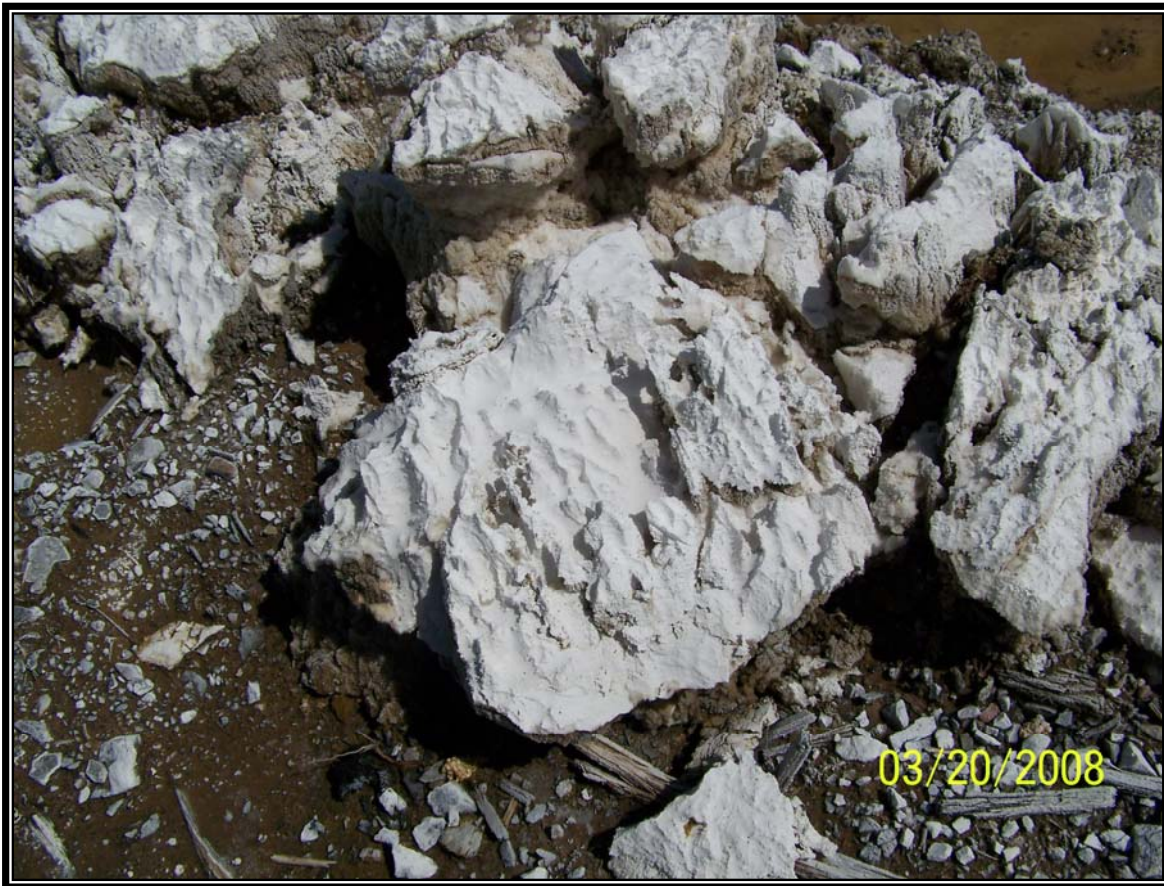
**OFFICIAL PHOTOGRAPH NO. 8**  
**U.S. ENVIRONMENTAL PROTECTION AGENCY**

<b>TDD Number:</b>	TTEMI-05-003-0041	<b>Location:</b>	Liberty Fibers Site
<b>Orientation:</b>	East	<b>Date:</b>	March 20, 2008
<b>Photographer:</b>	Chris Draper, Tetra Tech	<b>Witness:</b>	OSC Steve Spurlin, EPA
<b>Subject:</b>	Purported sodium sulfate on the ground east of the approximately 50,000-gallon sulfuric acid tank.

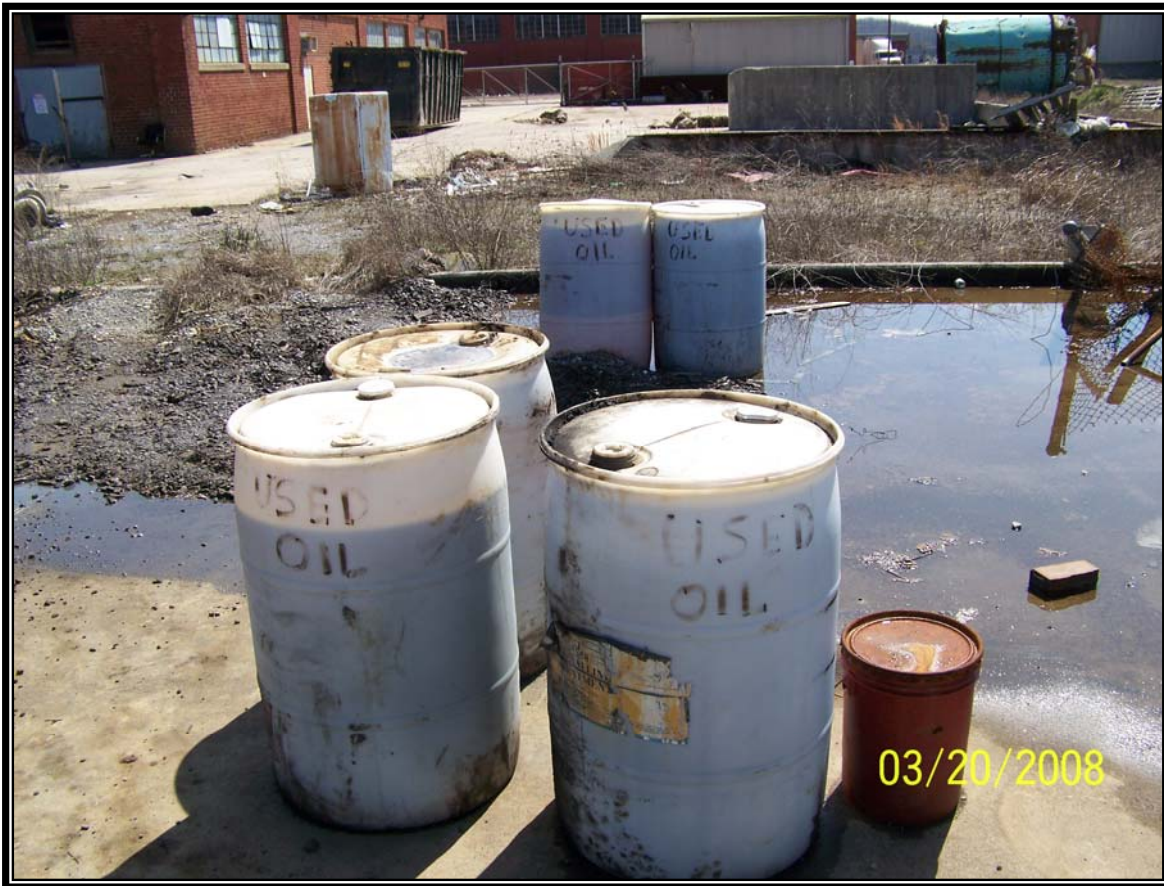
**OFFICIAL PHOTOGRAPH NO. 9**  
**U.S. ENVIRONMENTAL PROTECTION AGENCY**

<b>TDD Number:</b>	TTEMI-05-003-0041	<b>Location:</b>	Liberty Fibers Site
<b>Orientation:</b>	South	<b>Date:</b>	March 20, 2008
<b>Photographer:</b>	Chris Draper, Tetra Tech	<b>Witness:</b>	OSC Steve Spurlin, EPA
<b>Subject:</b>	Drums labeled as "Used Oil" within an oil-stained area of secondary containment holding a substantial amount of run on water.

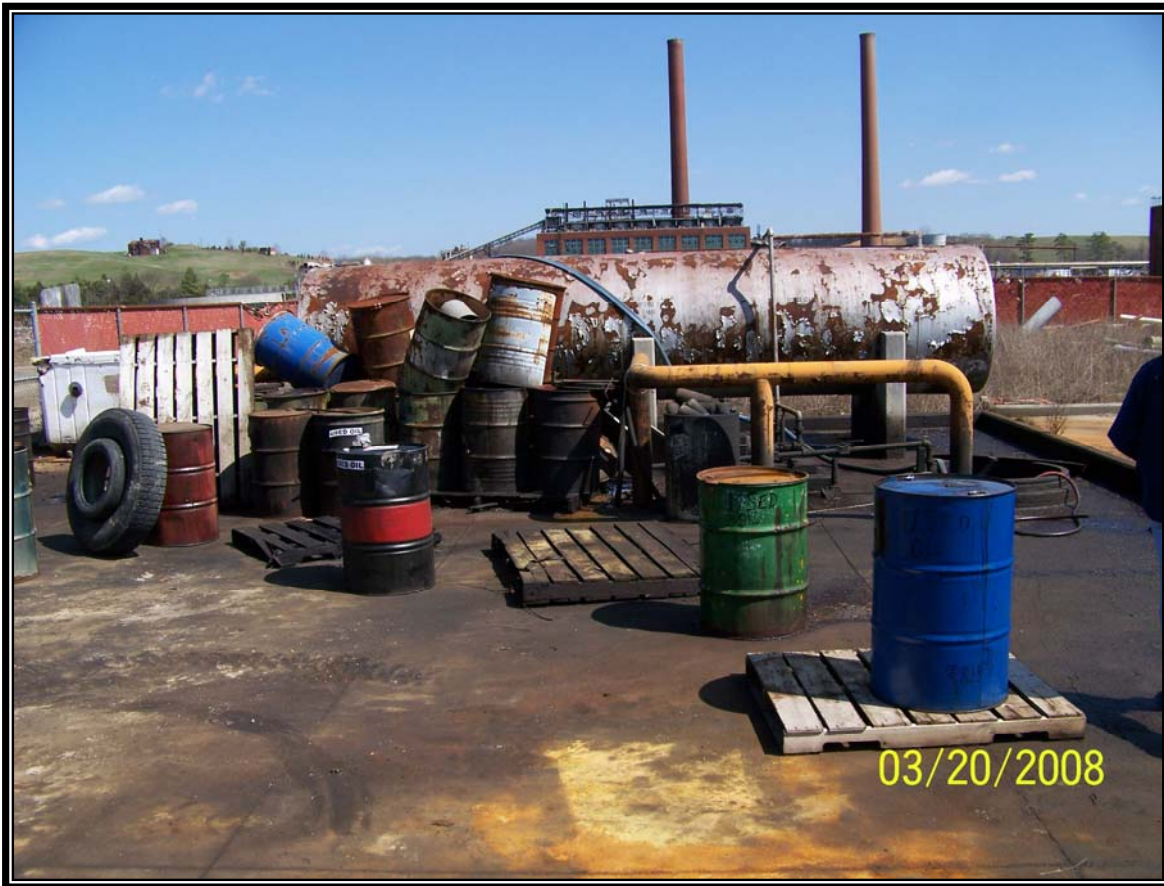
**OFFICIAL PHOTOGRAPH NO. 10**  
**U.S. ENVIRONMENTAL PROTECTION AGENCY**

<b>TDD Number:</b>	TTEMI-05-003-0041	<b>Location:</b>	Liberty Fibers Site
<b>Orientation:</b>	East	<b>Date:</b>	March 20, 2008
<b>Photographer:</b>	Chris Draper, Tetra Tech	<b>Witness:</b>	OSC Steve Spurlin, EPA
<b>Subject:</b>	Drums and an approximately 3,000-gallon tank labeled as "Used Oil" within an oil-stained area of secondary containment.

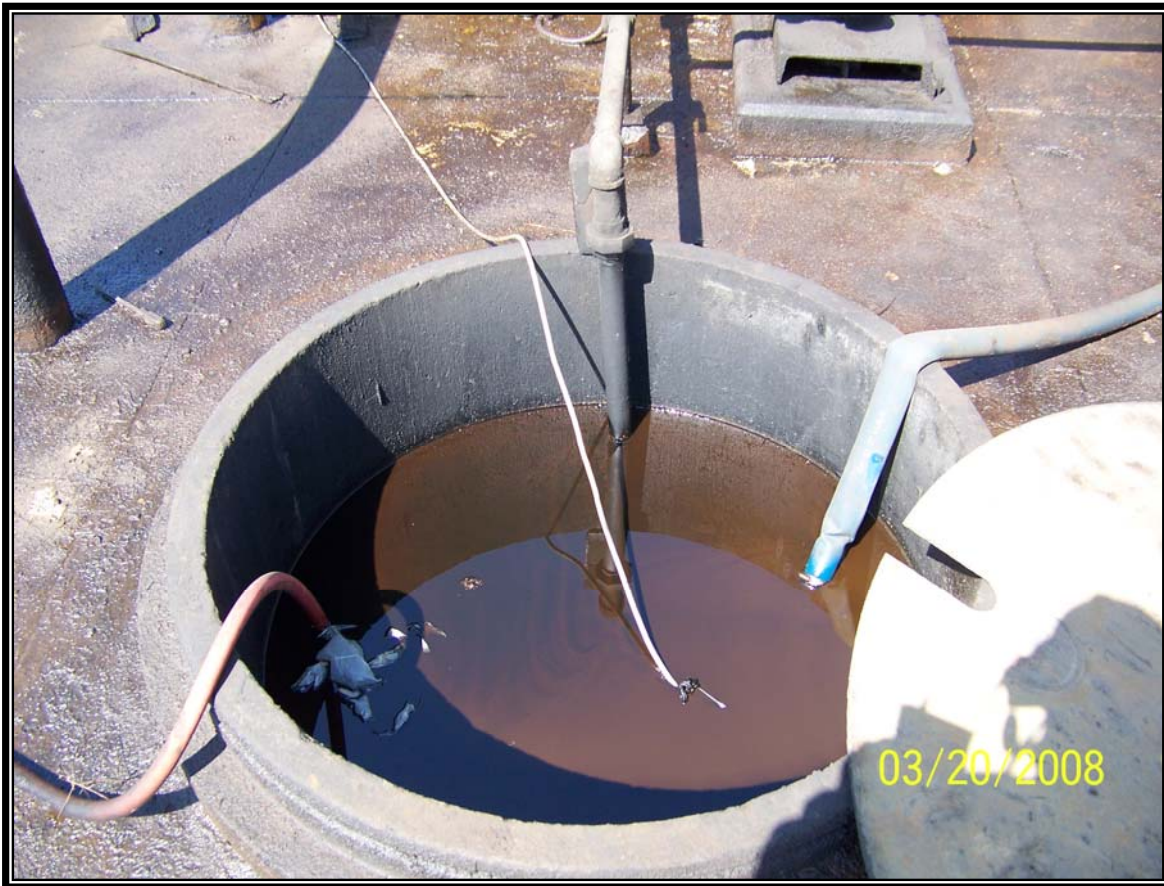
**OFFICIAL PHOTOGRAPH NO. 11**  
**U.S. ENVIRONMENTAL PROTECTION AGENCY**

<b>TDD Number:</b>	TTEMI-05-003-0041	<b>Location:</b>	Liberty Fibers Site
<b>Orientation:</b>	North	<b>Date:</b>	March 20, 2008
<b>Photographer:</b>	Chris Draper, Tetra Tech	<b>Witness:</b>	OSC Steve Spurlin, EPA
<b>Subject:</b>	Oil-water separator within an oil-stained area of secondary containment.

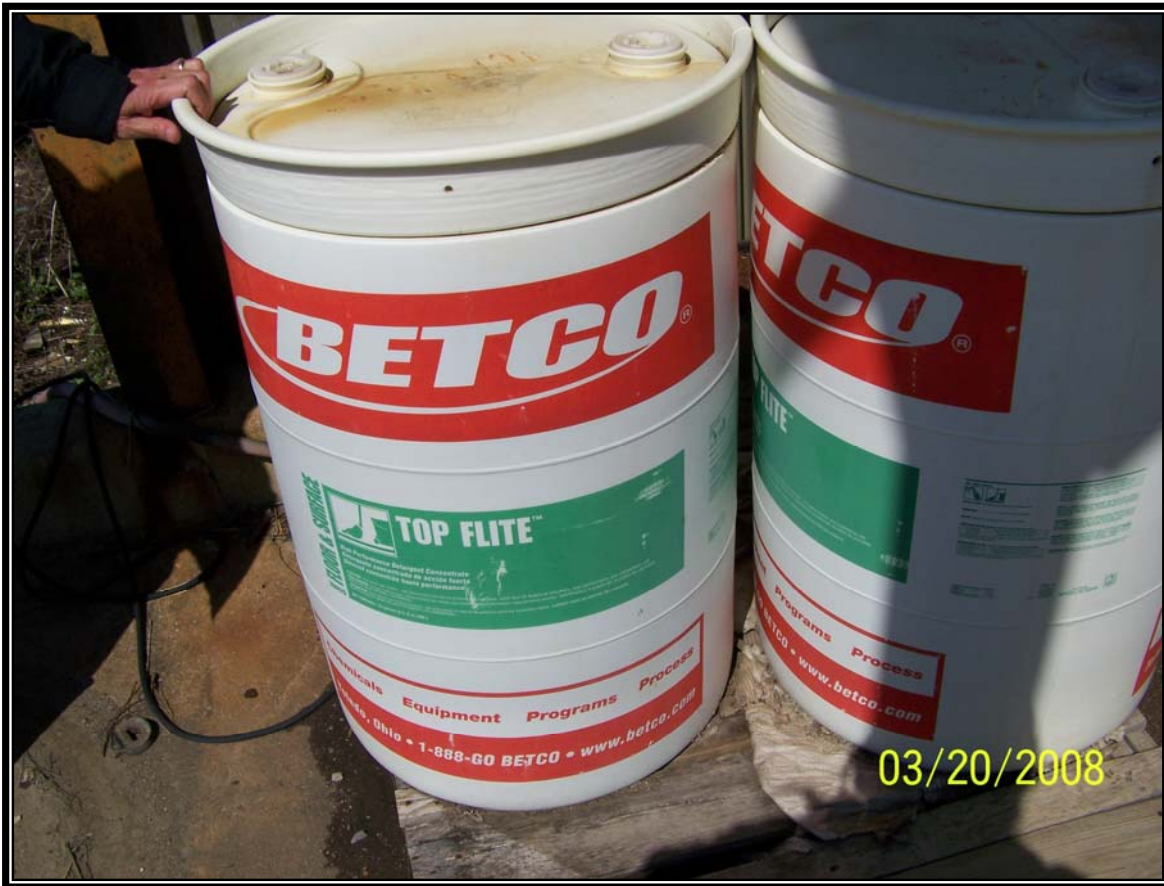
**OFFICIAL PHOTOGRAPH NO. 12**  
**U.S. ENVIRONMENTAL PROTECTION AGENCY**

<b>TDD Number:</b>	TTEMI-05-003-0041	<b>Location:</b>	Liberty Fibers Site
<b>Orientation:</b>	South	<b>Date:</b>	March 20, 2008
<b>Photographer:</b>	Chris Draper, Tetra Tech	<b>Witness:</b>	OSC Steve Spurlin, EPA
<b>Subject:</b>	Drum labeled as "BETCO Liquid Chisel" identifying sodium metasilicate as the primary ingredient.

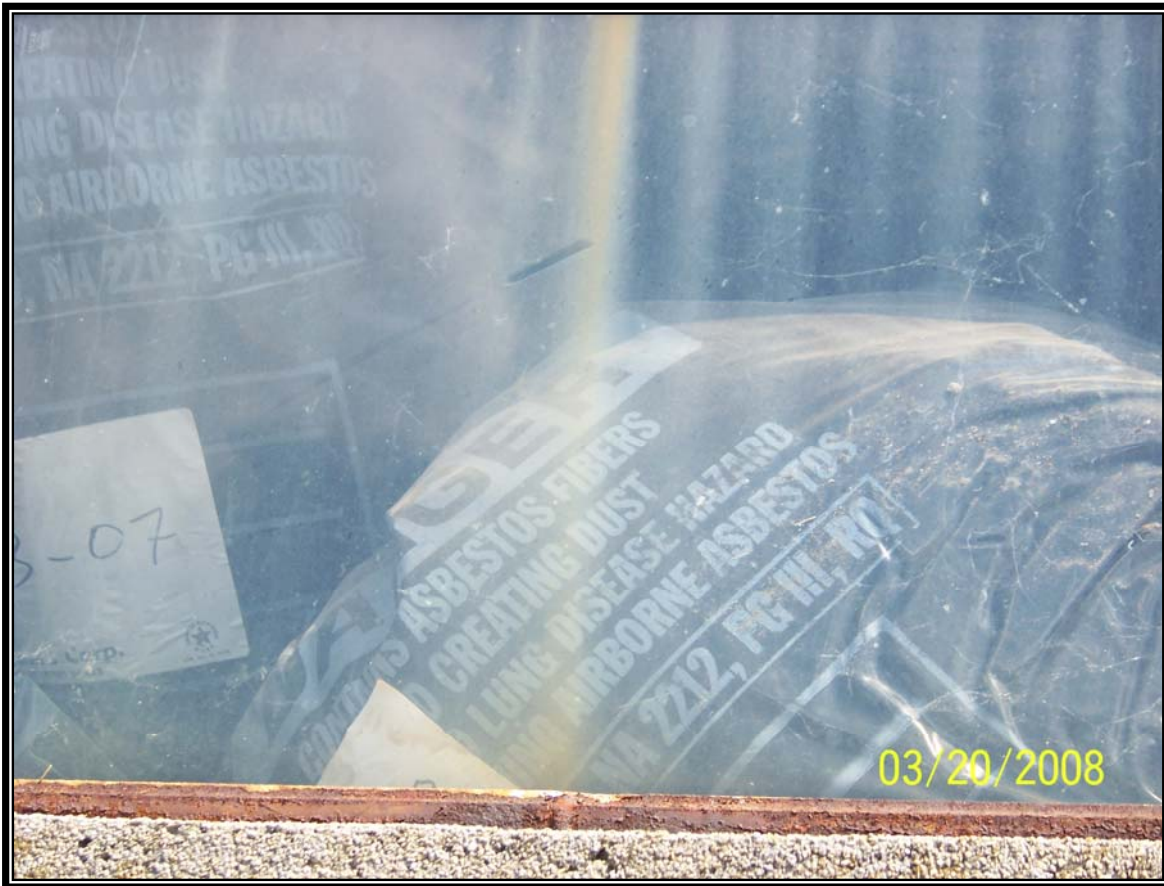
**OFFICIAL PHOTOGRAPH NO. 14**  
**U.S. ENVIRONMENTAL PROTECTION AGENCY**

<b>TDD Number:</b>	TTEMI-05-003-0041	<b>Location:</b>	Liberty Fibers Site
<b>Orientation:</b>	East	<b>Date:</b>	March 20, 2008
<b>Photographer:</b>	Chris Draper, Tetra Tech	<b>Witness:</b>	OSC Steve Spurlin, EPA
<b>Subject:</b>	View through window of building used to store asbestos containing materials removed from various locations throughout the site pending disposal.

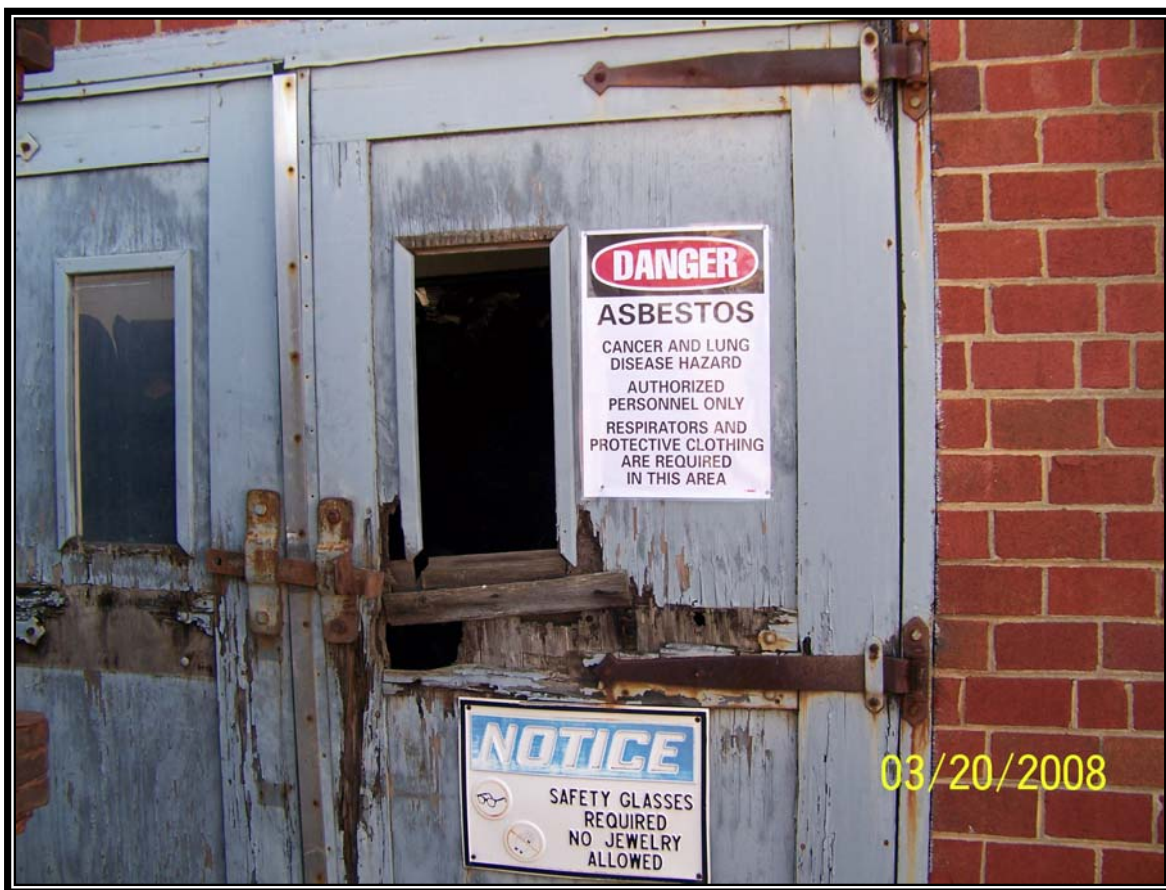
**OFFICIAL PHOTOGRAPH NO. 15**  
**U.S. ENVIRONMENTAL PROTECTION AGENCY**

<b>TDD Number:</b>	TTEMI-05-003-0041	<b>Location:</b>	Liberty Fibers Site
<b>Orientation:</b>	South	<b>Date:</b>	March 20, 2008
<b>Photographer:</b>	Chris Draper, Tetra Tech	<b>Witness:</b>	OSC Steve Spurlin, EPA
<b>Subject:</b>	Signage on door to building used to store asbestos containing materials removed from various locations throughout the site pending disposal.

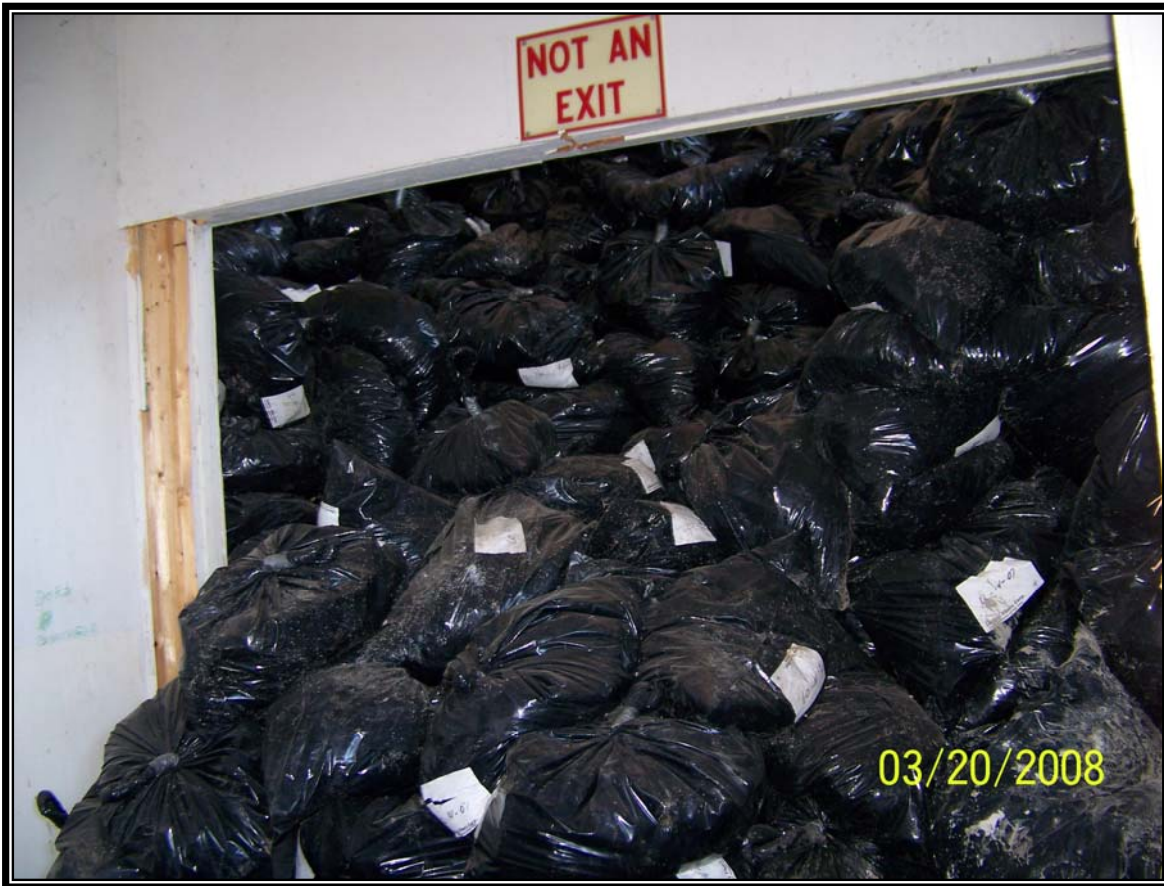
**OFFICIAL PHOTOGRAPH NO. 16  
U.S. ENVIRONMENTAL PROTECTION AGENCY**

<b>TDD Number:</b>	TTEMI-05-003-0041	<b>Location:</b>	Liberty Fibers Site
<b>Orientation:</b>	East	<b>Date:</b>	March 20, 2008
<b>Photographer:</b>	Chris Draper, Tetra Tech	<b>Witness:</b>	OSC Steve Spurlin, EPA
<b>Subject:</b>	View immediately right as you enter the door to building used to store asbestos containing materials removed from various locations throughout the site pending disposal.

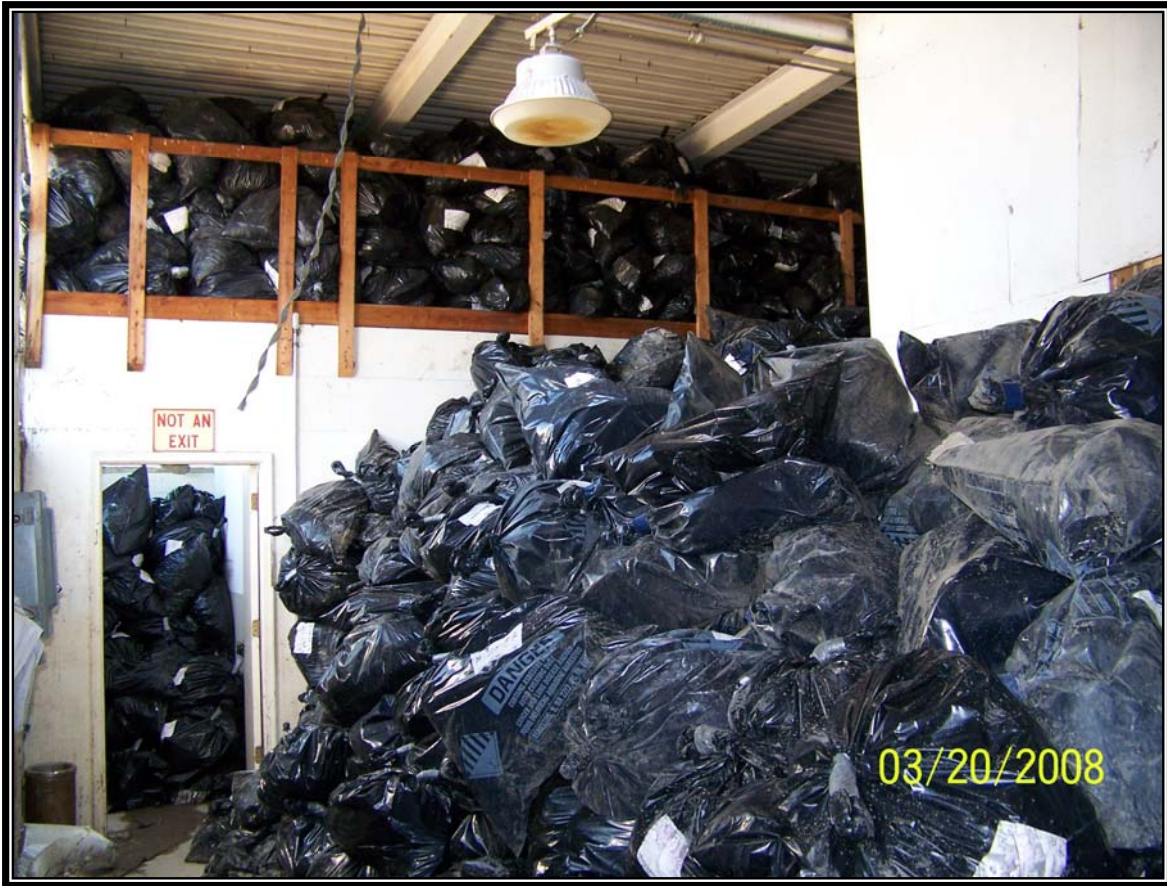
**OFFICIAL PHOTOGRAPH NO. 17  
U.S. ENVIRONMENTAL PROTECTION AGENCY**

<b>TDD Number:</b>	TTEMI-05-003-0041	<b>Location:</b>	Liberty Fibers Site
<b>Orientation:</b>	West	<b>Date:</b>	March 20, 2008
<b>Photographer:</b>	Chris Draper, Tetra Tech	<b>Witness:</b>	OSC Steve Spurlin, EPA
<b>Subject:</b>	View immediately left as you enter the door to building used to store asbestos containing materials removed from various locations throughout the site pending disposal.

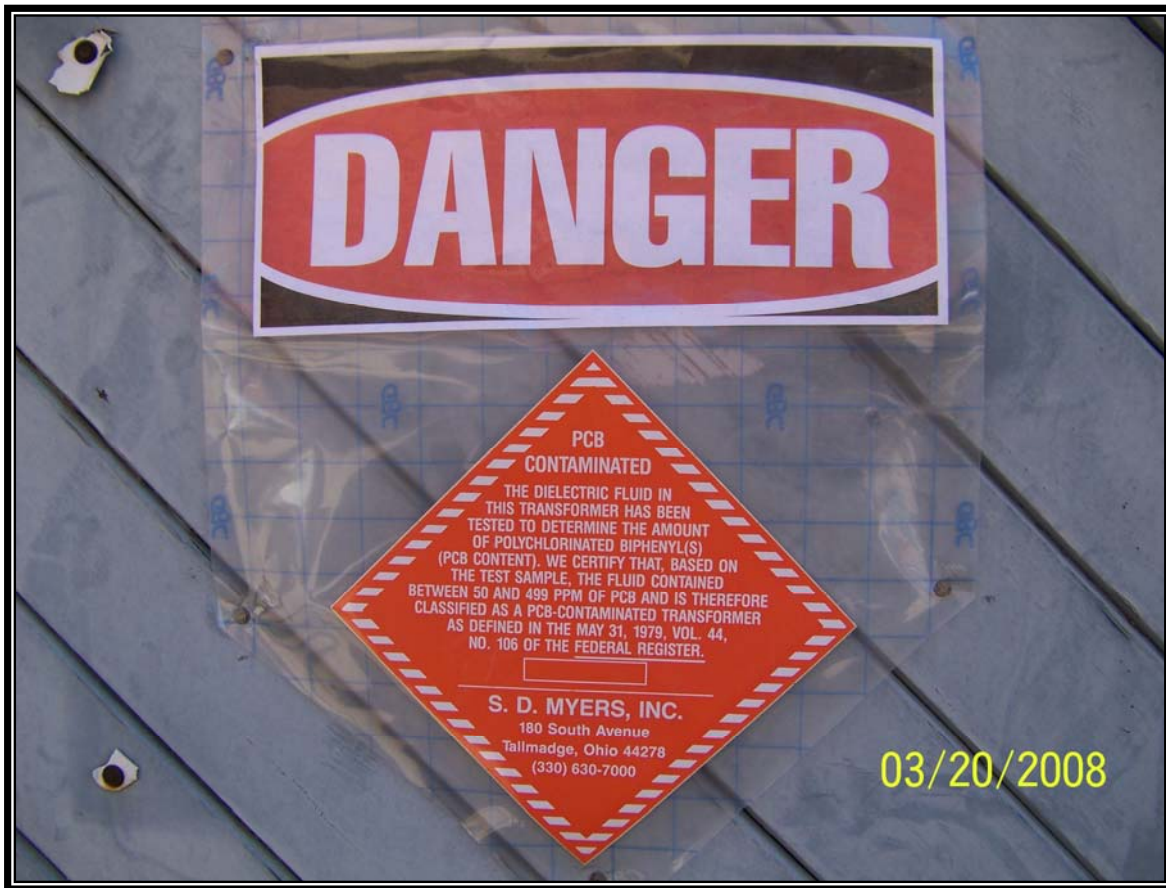
**OFFICIAL PHOTOGRAPH NO. 18  
U.S. ENVIRONMENTAL PROTECTION AGENCY**

**Subject:** Signage on door to non-permitted building used to store known and suspected polychlorinated biphenyl (PCB) containing materials and equipment removed from various locations throughout the site pending disposal.

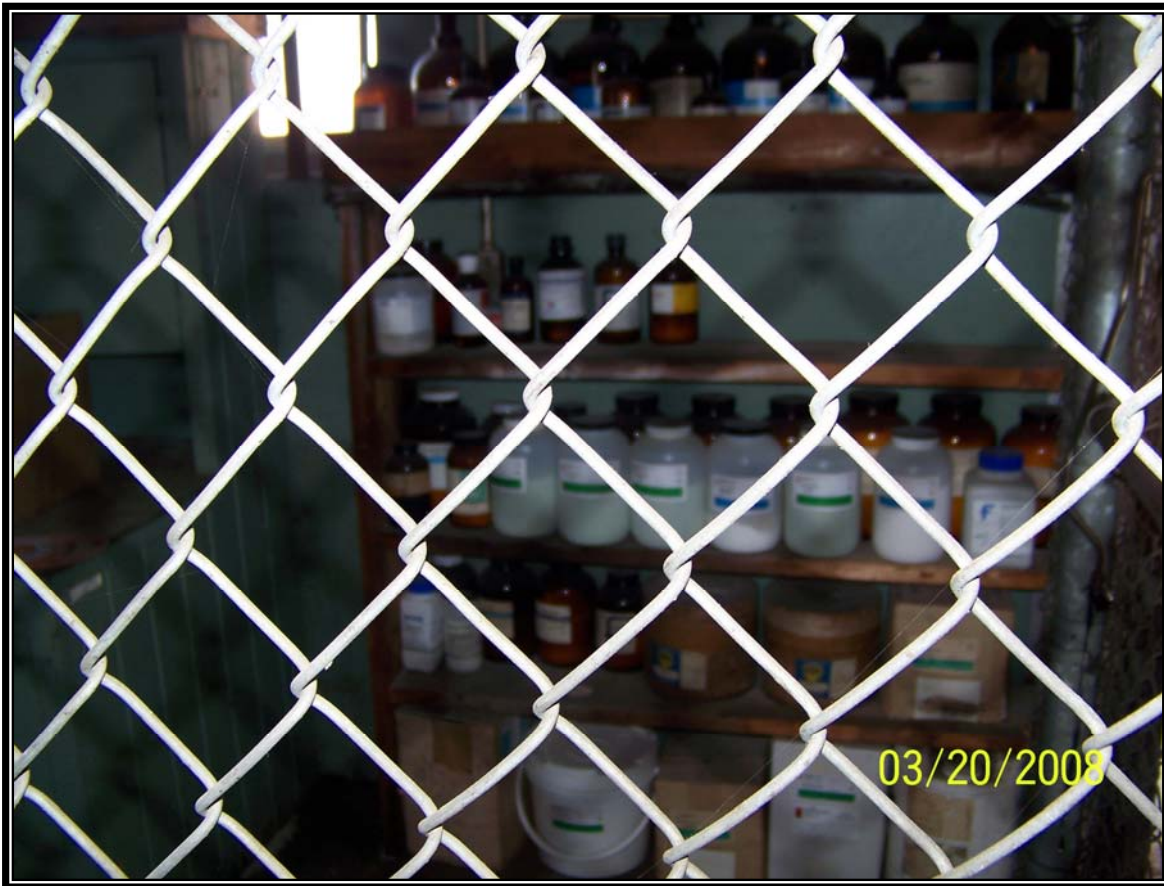
**OFFICIAL PHOTOGRAPH NO. 19**  
**U.S. ENVIRONMENTAL PROTECTION AGENCY**

**Subject:** Various laboratory quantity containers of chemicals that have been segregated pending disposal.

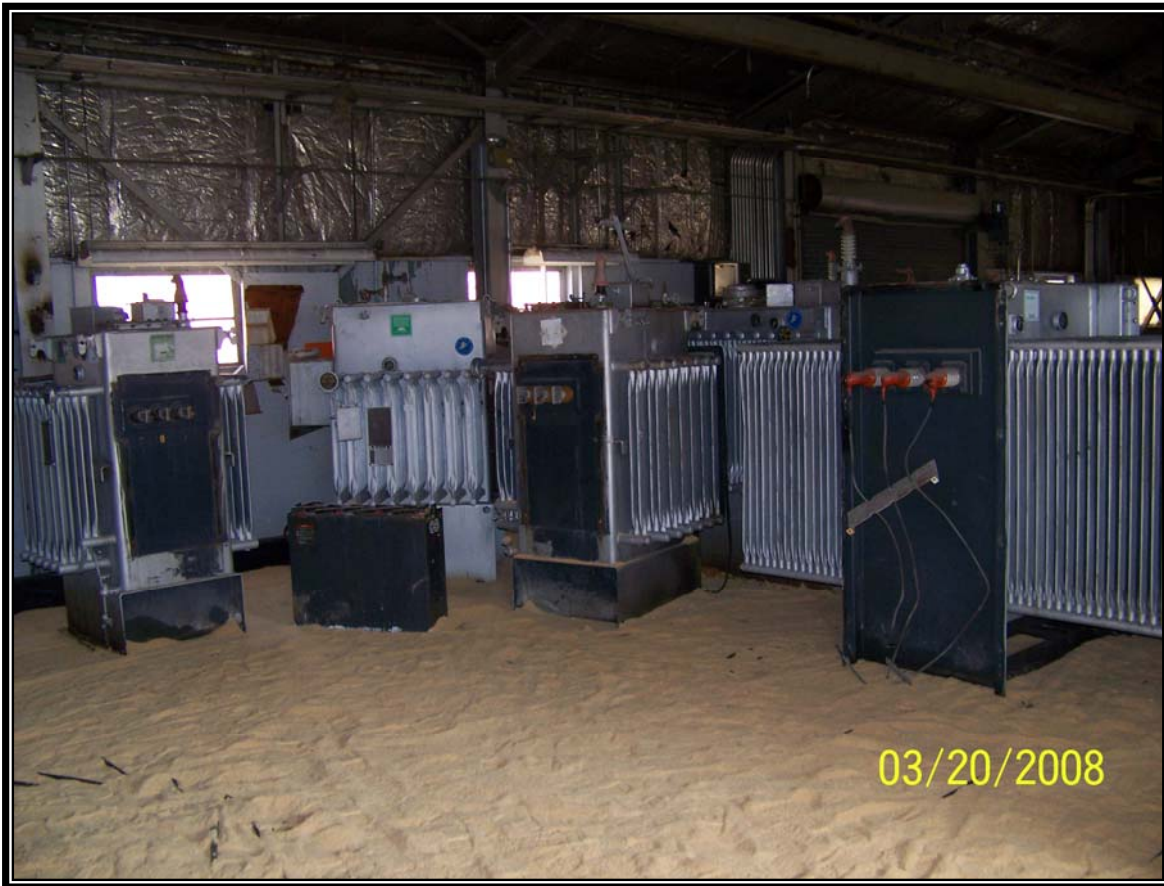
**OFFICIAL PHOTOGRAPH NO. 20**  
**U.S. ENVIRONMENTAL PROTECTION AGENCY**

**Subject:** Known and suspected PCB contaminated articles stored within a non-permitted area of secondary containment lined with plastic sheeting and sawdust.
