**Subject: Comprehensive Environmental Response, Compensation, and Liability Act  
Site Assessment and Inspection Report  
Liberty Fibers Site  
Lowland, Hamblen County, Tennessee  
EPA Contract No. EP-W-05-054  
TDD No. TTEMI-05-003-0041**

The Tetra Tech EM Inc., Superfund Technical Assessment and Response Team (START) is submitting the site assessment and inspection report for the Liberty Fibers Site in Lowland, Hamblen County, Tennessee. This report summarizes field activities conducted at the site on 20 and 21 March 2008.

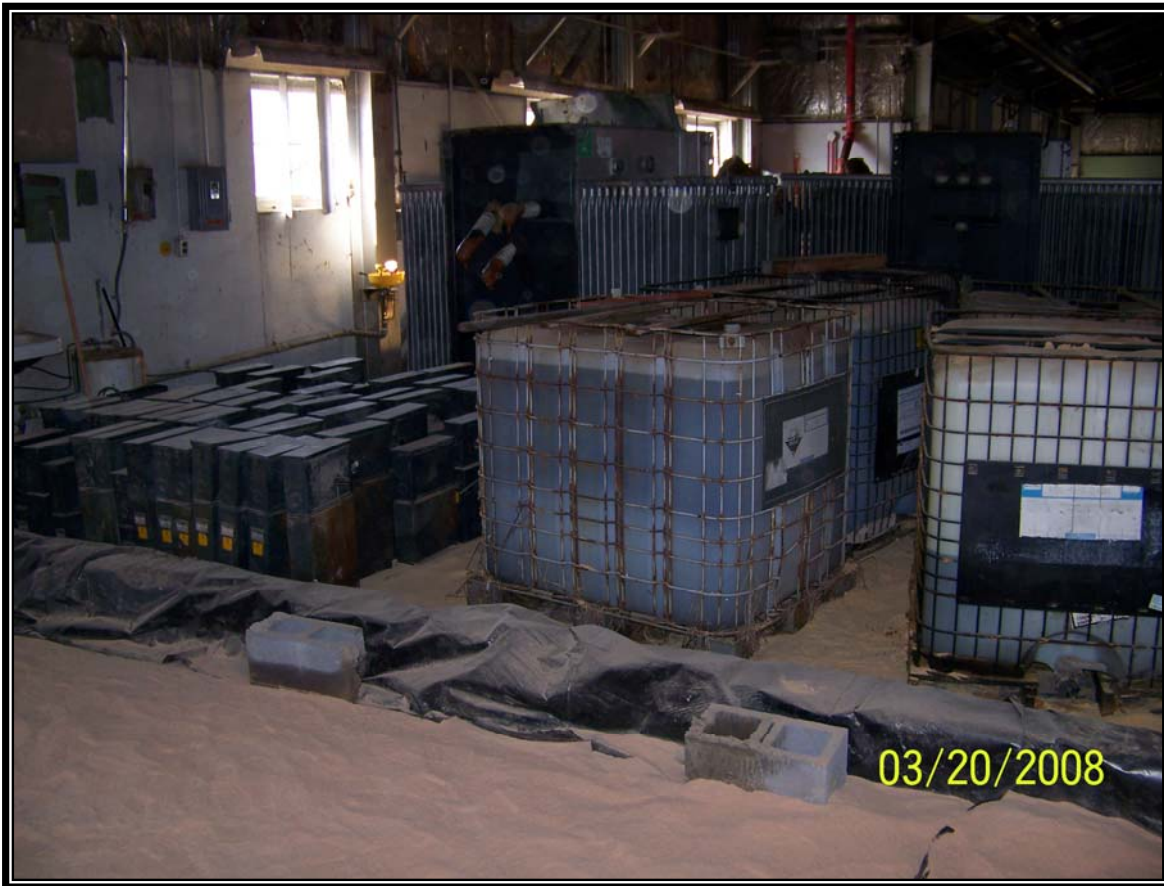
**OFFICIAL PHOTOGRAPH NO. 21**  
**U.S. ENVIRONMENTAL PROTECTION AGENCY**

<b>TDD Number:</b>	TTEMI-05-003-0041	<b>Location:</b>	Liberty Fibers Site
<b>Orientation:</b>	North	<b>Date:</b>	March 20, 2008
<b>Photographer:</b>	Chris Draper, Tetra Tech	<b>Witness:</b>	OSC Steve Spurlin, EPA
<b>Subject:</b>	Known and suspected PCB contaminated articles and oils stored within a non-permitted area of secondary containment lined with plastic sheeting and sawdust.

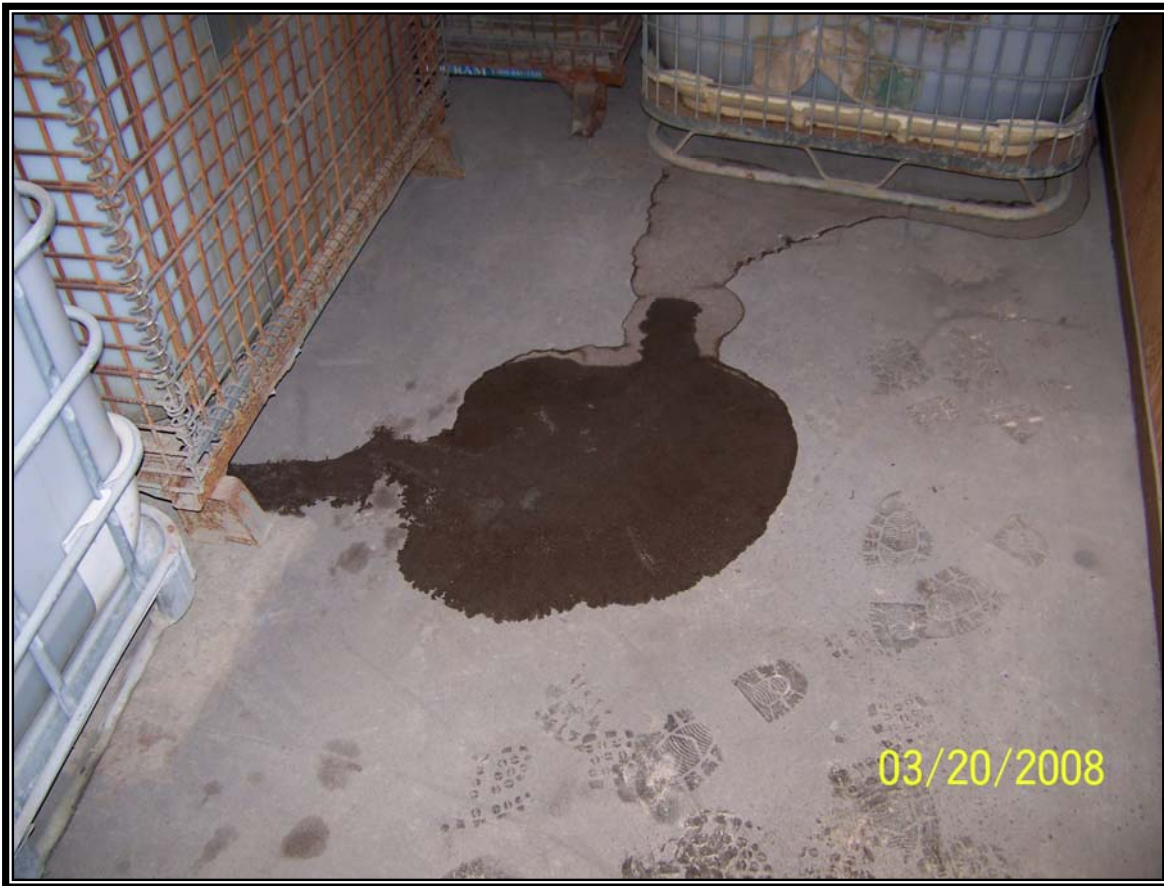
**OFFICIAL PHOTOGRAPH NO. 22**  
**U.S. ENVIRONMENTAL PROTECTION AGENCY**

<b>TDD Number:</b>	TTEMI-05-003-0041	<b>Location:</b>	Liberty Fibers Site
<b>Orientation:</b>	South	<b>Date:</b>	March 20, 2008
<b>Photographer:</b>	Chris Draper, Tetra Tech	<b>Witness:</b>	OSC Steve Spurlin, EPA
<b>Subject:</b>	Oil on floor outside of secondary containment and possibly leaking from a 250-gallon tote that purportedly contains non-PCB oil.

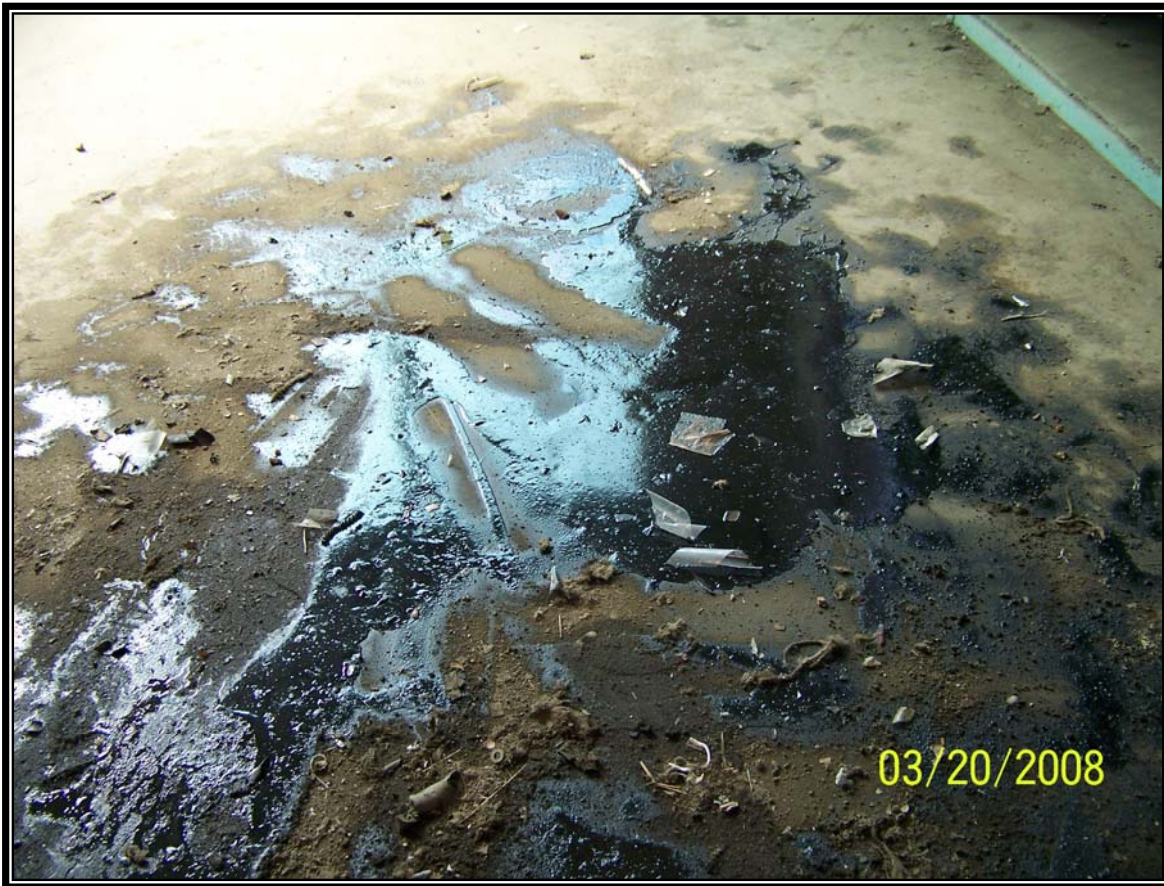
**OFFICIAL PHOTOGRAPH NO. 23**  
**U.S. ENVIRONMENTAL PROTECTION AGENCY**

**Subject:** Oil on floor in paint shop.

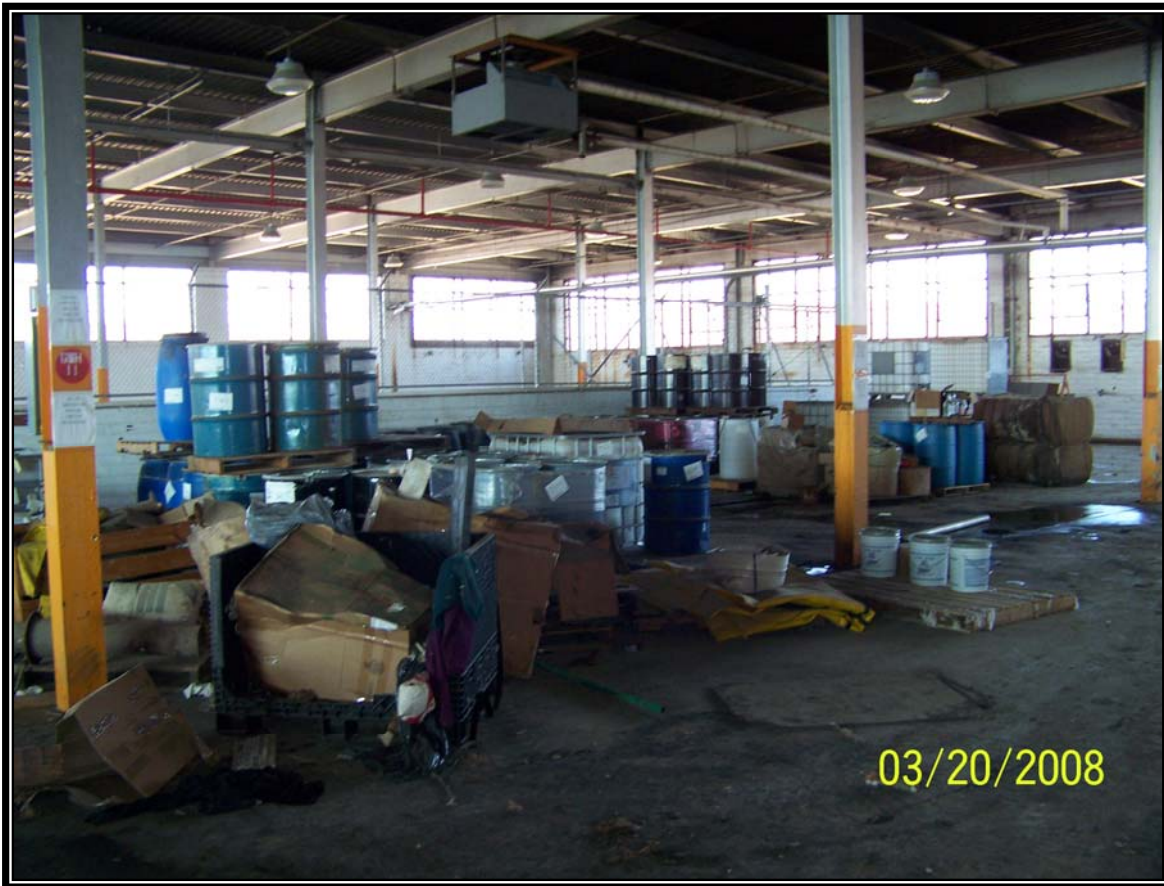
**OFFICIAL PHOTOGRAPH NO. 24**  
**U.S. ENVIRONMENTAL PROTECTION AGENCY**

1638 GENERAL STORAGE HAS SOME DRUMS  
AND SMALL CONTAINERS THAT APPEAR TO  
HAVE BEEN PLACED IN LOTS FOR SALE.  
1647 RIDE W/ MR. SAWYER : OSC SPURLIN  
TO SEE WHERE DOWNED, LEAKING  
TRANSFORMERS WERE FOUND

**Subject:** Drums and smaller containers of various hazardous and non-hazardous materials and substances discovered within a building used for general storage. The items appear to have been placed in lots in an attempt to sell them.

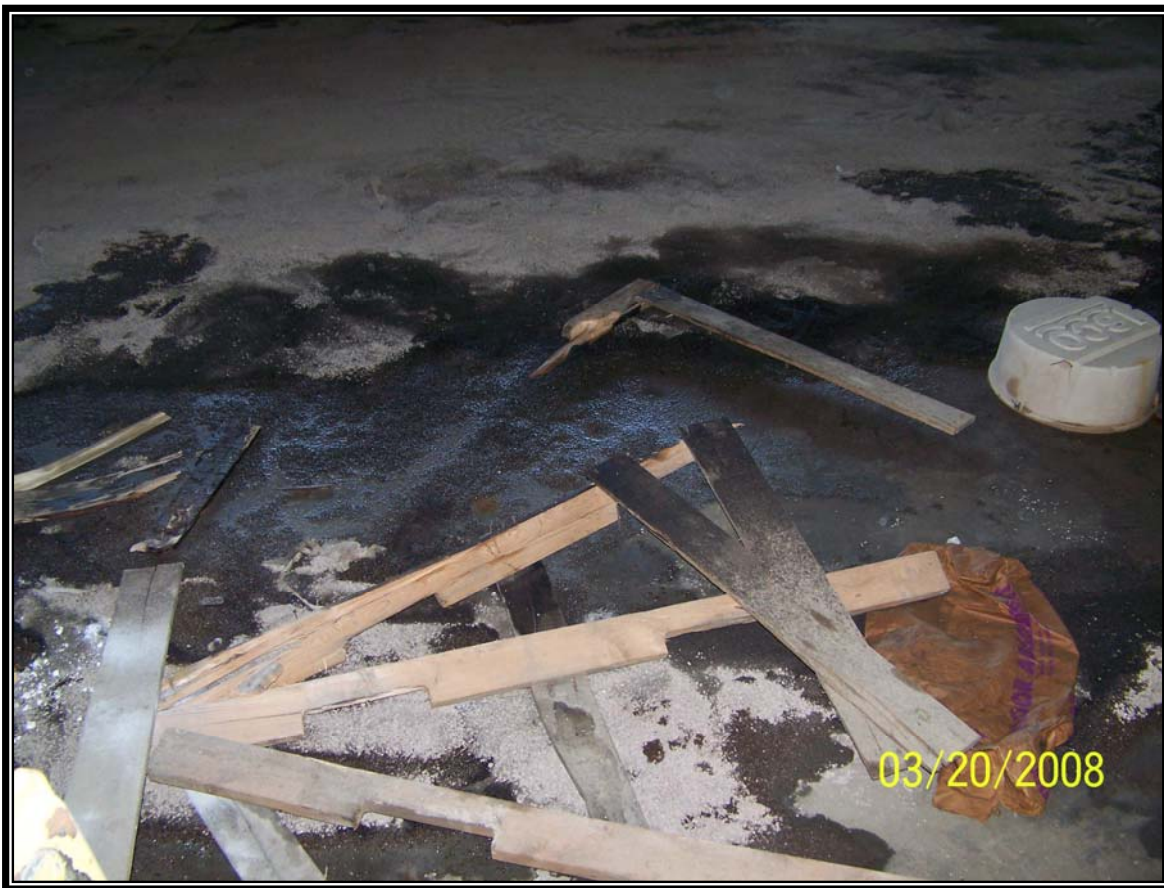
**OFFICIAL PHOTOGRAPH NO. 25**  
**U.S. ENVIRONMENTAL PROTECTION AGENCY**

**TDD Number:** TTEMI-05-003-0041      **Location:** Liberty Fibers Site  
**Orientation:** East      **Date:** March 20, 2008  
**Photographer:** Chris Draper, Tetra Tech      **Witness:** OSC Steve Spurlin, EPA  
**Subject:** Oil and absorbent on the floor within a building used for general storage.

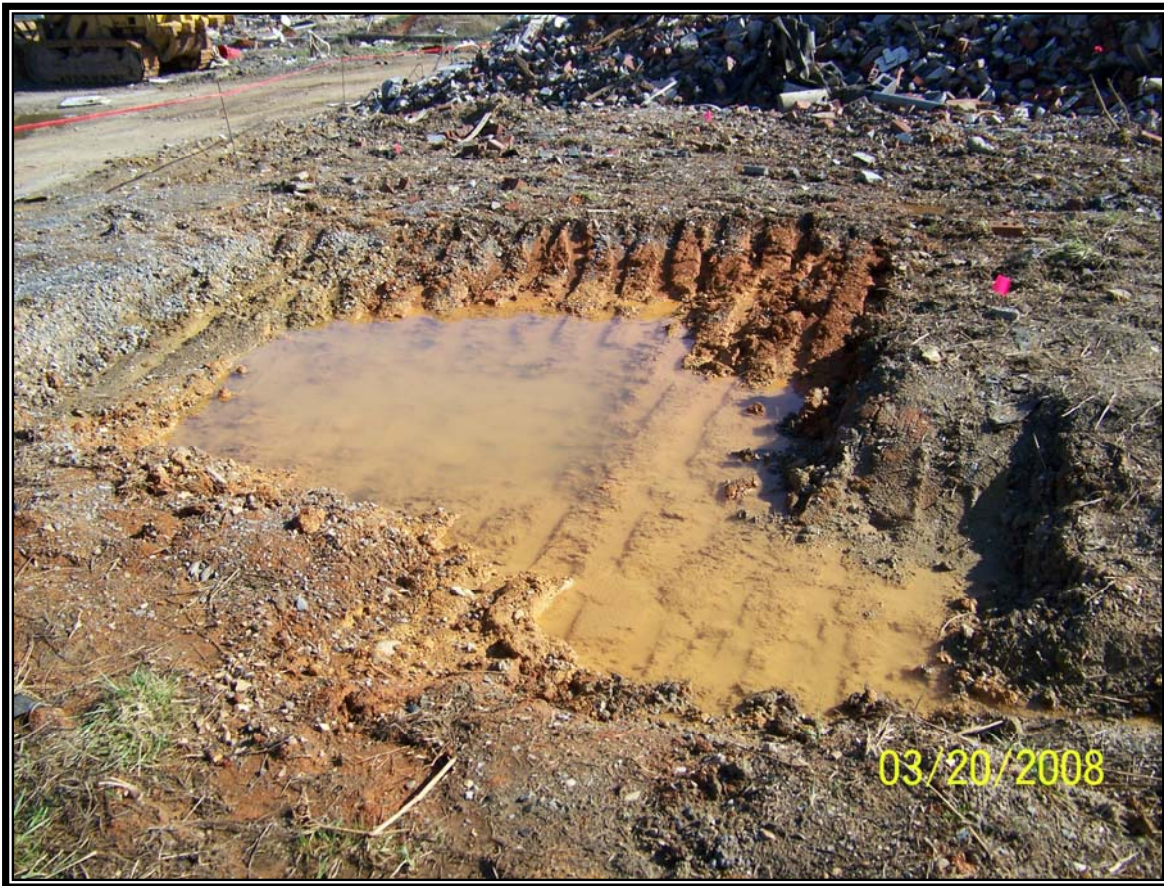
**OFFICIAL PHOTOGRAPH NO. 26**  
**U.S. ENVIRONMENTAL PROTECTION AGENCY**

**Subject:** Area where transformers were discovered on the ground by TDEC during a previous visit. The soil has been excavated and was stored onsite in a rolloff container at the time of this photograph.

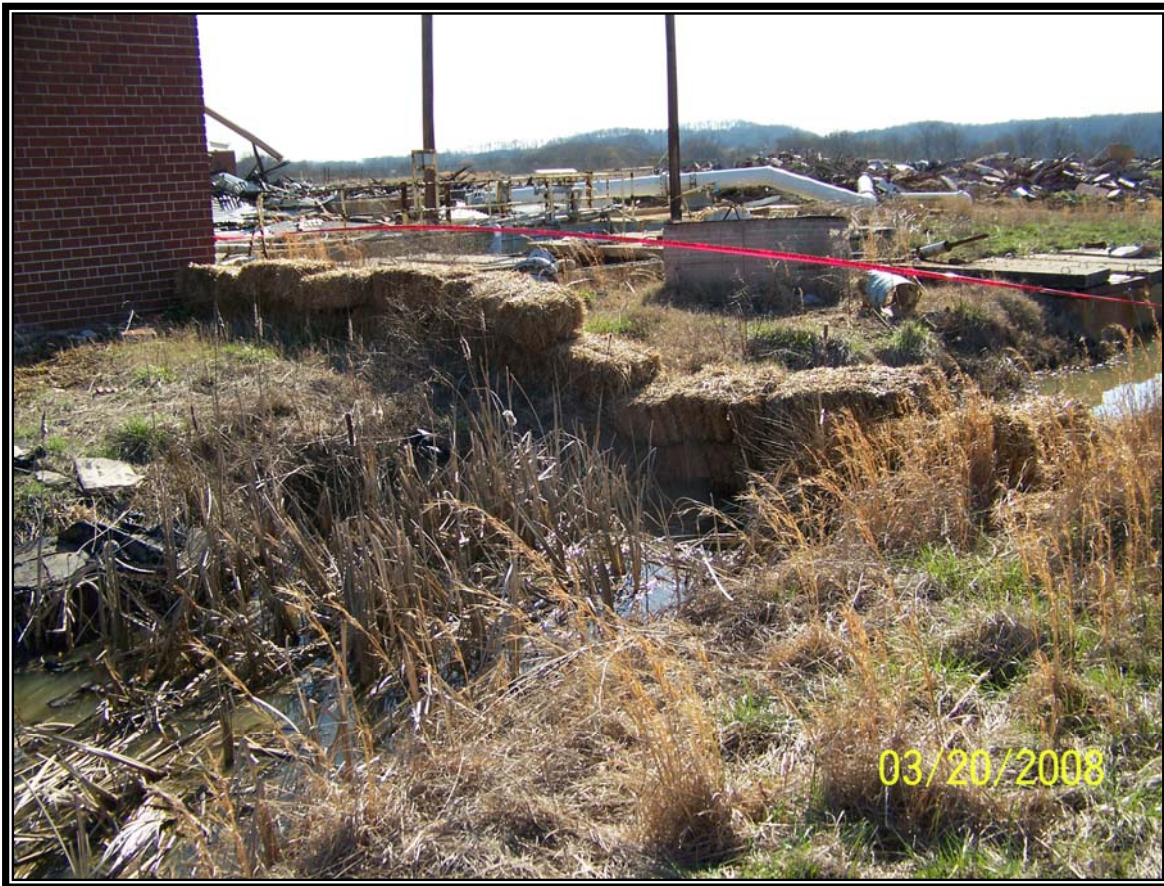
**OFFICIAL PHOTOGRAPH NO. 27**  
**U.S. ENVIRONMENTAL PROTECTION AGENCY**

<b>TDD Number:</b>	TTEMI-05-003-0041	<b>Location:</b>	Liberty Fibers Site
<b>Orientation:</b>	Southwest	<b>Date:</b>	March 20, 2008
<b>Photographer:</b>	Chris Draper, Tetra Tech	<b>Witness:</b>	OSC Steve Spurlin, EPA
<b>Subject:</b>	Straw bale dam in ditch immediately downgradient from area where transformers were discovered on the ground by TDEC officials during a previous visit.

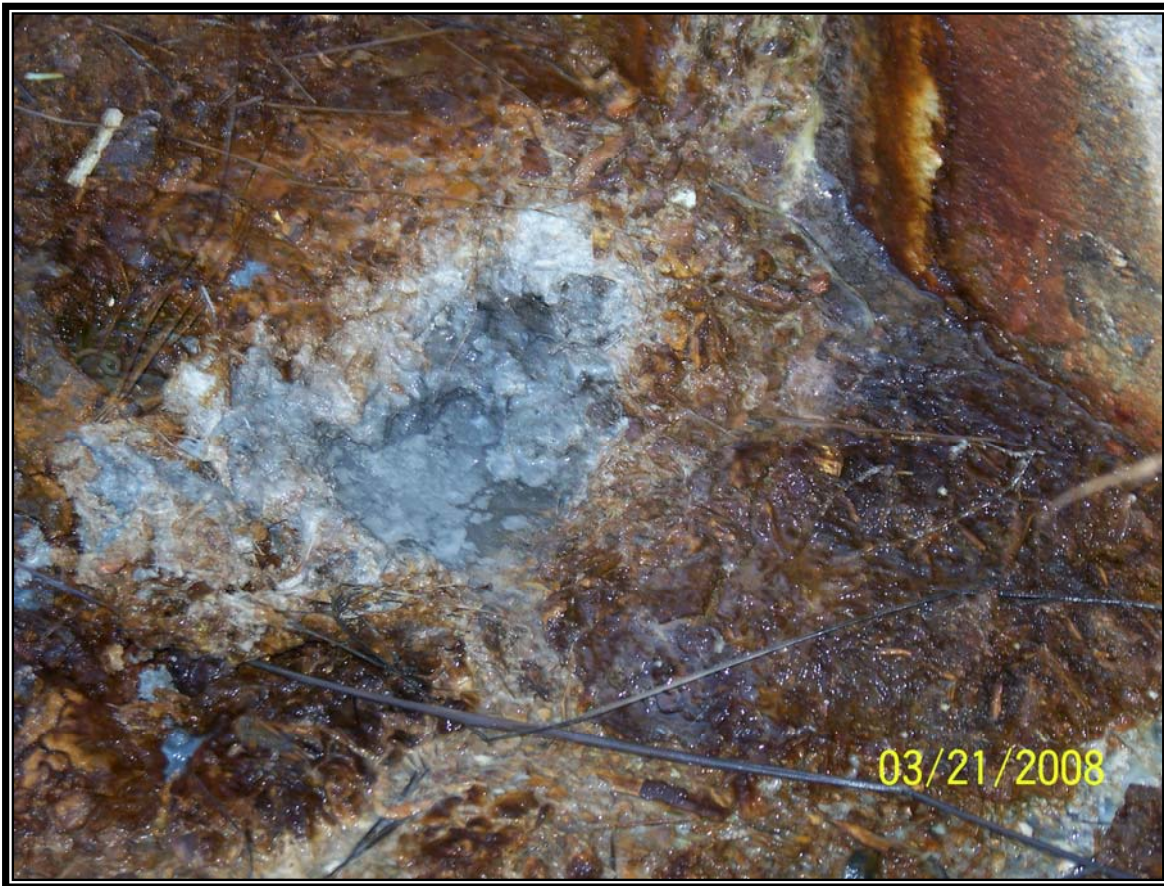
**OFFICIAL PHOTOGRAPH NO. 28**  
**U.S. ENVIRONMENTAL PROTECTION AGENCY**

0906 COLLECT LF-SS-01  
 2 EA 20Z JARS FOR VOAS  
 — SPECIFICALLY CS<sub>2</sub>  
 36.15756°N / -83.21056°W  
 LEAKING CRACK IN N<sup>th</sup> WEST WALL OF  
 CS<sub>2</sub> VAULT  
 DID NOT COLLECT SURFACE H<sub>2</sub>O SAMPLE  
 AT THIS LOCATION

<b>TDD Number:</b>	TTEMI-05-003-0041	<b>Location:</b>	Liberty Fibers Site
<b>Orientation:</b>	East	<b>Date:</b>	March 21, 2008
<b>Photographer:</b>	Chris Draper, Tetra Tech	<b>Witness:</b>	OSC Steve Spurlin, EPA
<b>Subject:</b>	Ground below the crack in western wall of the carbon disulfide vault where sample LF-SS-01 was collected.

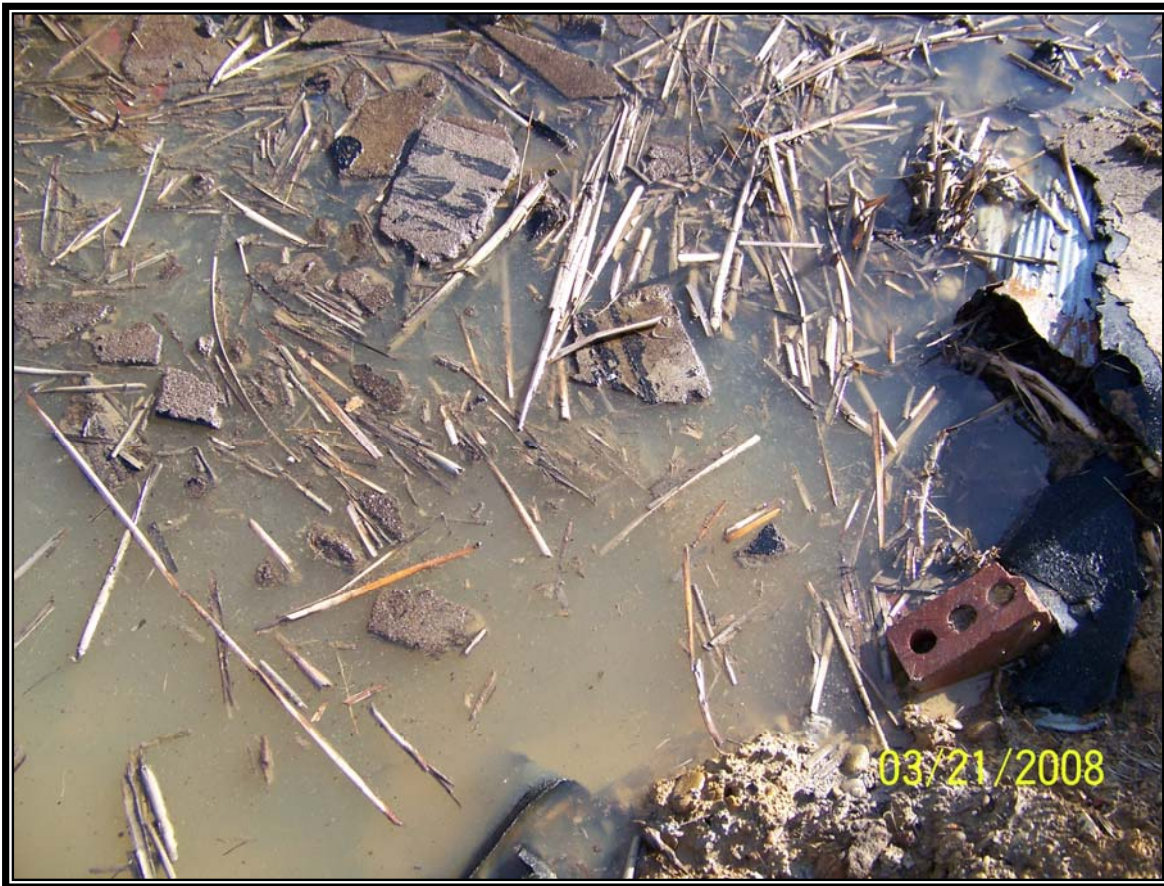
**OFFICIAL PHOTOGRAPH NO. 29**  
**U.S. ENVIRONMENTAL PROTECTION AGENCY**

<b>TDD Number:</b>	TTEMI-05-003-0041	<b>Location:</b>	Liberty Fibers Site
<b>Orientation:</b>	North	<b>Date:</b>	March 21, 2008
<b>Photographer:</b>	Chris Draper, Tetra Tech	<b>Witness:</b>	OSC Steve Spurlin, EPA
<b>Subject:</b>	Surface water with oil sheen in ditch immediately downgradient from the area where transformers were discovered on the ground by TDEC officials during a previous visit. Sample LF-SW-01 was collected from this location.

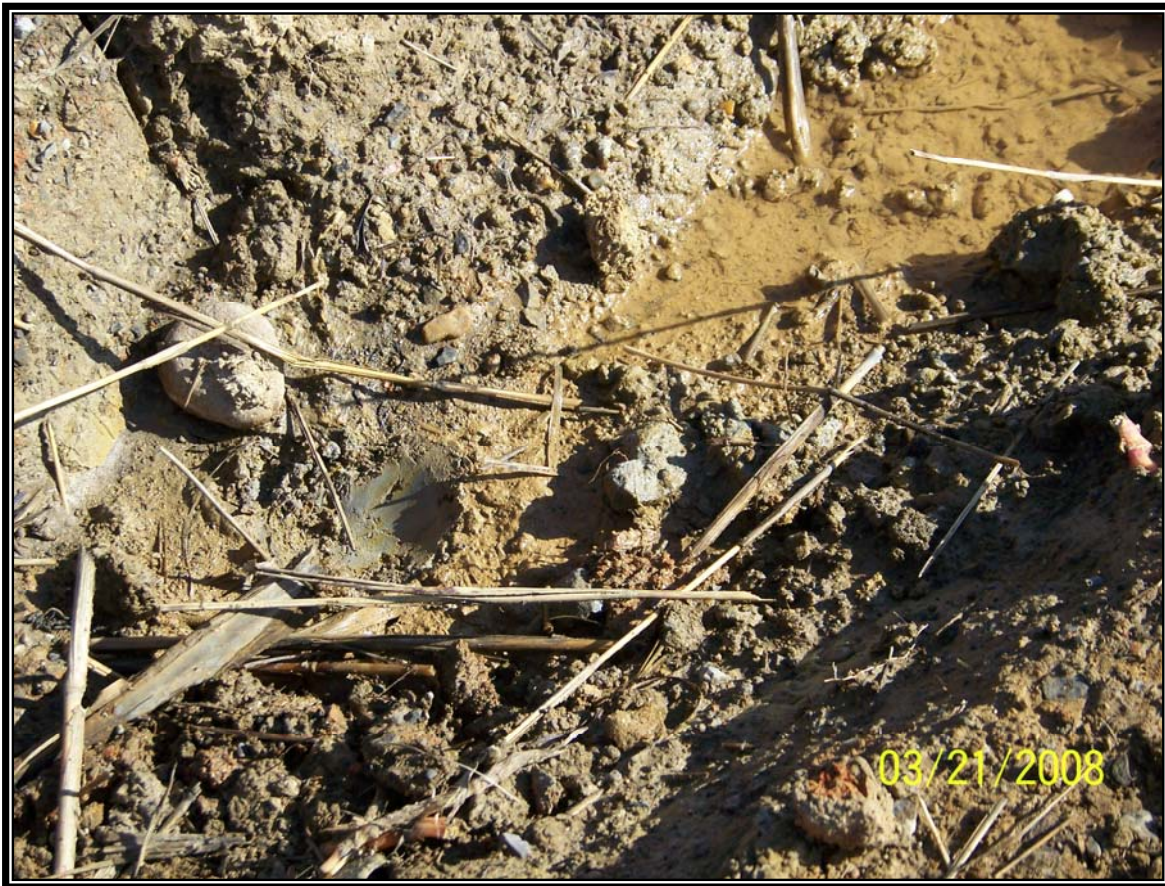
**OFFICIAL PHOTOGRAPH NO. 30**  
**U.S. ENVIRONMENTAL PROTECTION AGENCY**

<b>TDD Number:</b>	TTEMI-05-003-0041	<b>Location:</b>	Liberty Fibers Site
<b>Orientation:</b>	West	<b>Date:</b>	March 21, 2008
<b>Photographer:</b>	Chris Draper, Tetra Tech	<b>Witness:</b>	OSC Steve Spurlin, EPA
<b>Subject:</b>	Soil immediately downgradient from area where transformers were discovered on the ground by TDEC officials during a previous visit. Composite soil sample LF-SS-02 was collected from this location.

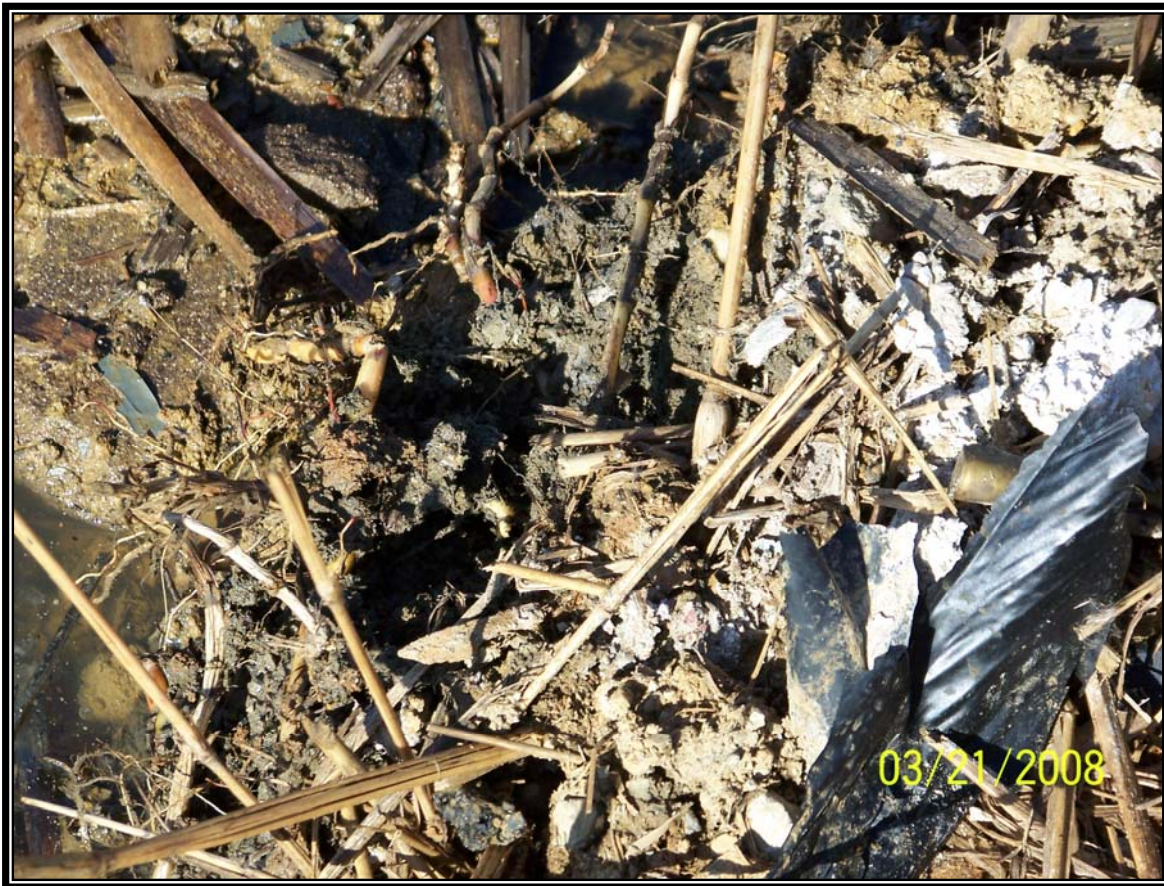
**OFFICIAL PHOTOGRAPH NO. 31**  
**U.S. ENVIRONMENTAL PROTECTION AGENCY**

**Subject:** Soil immediately downgradient from area where transformers were discovered on the ground by TDEC officials during a previous visit. Composite soil sample LF-SS-02 was collected from this location.

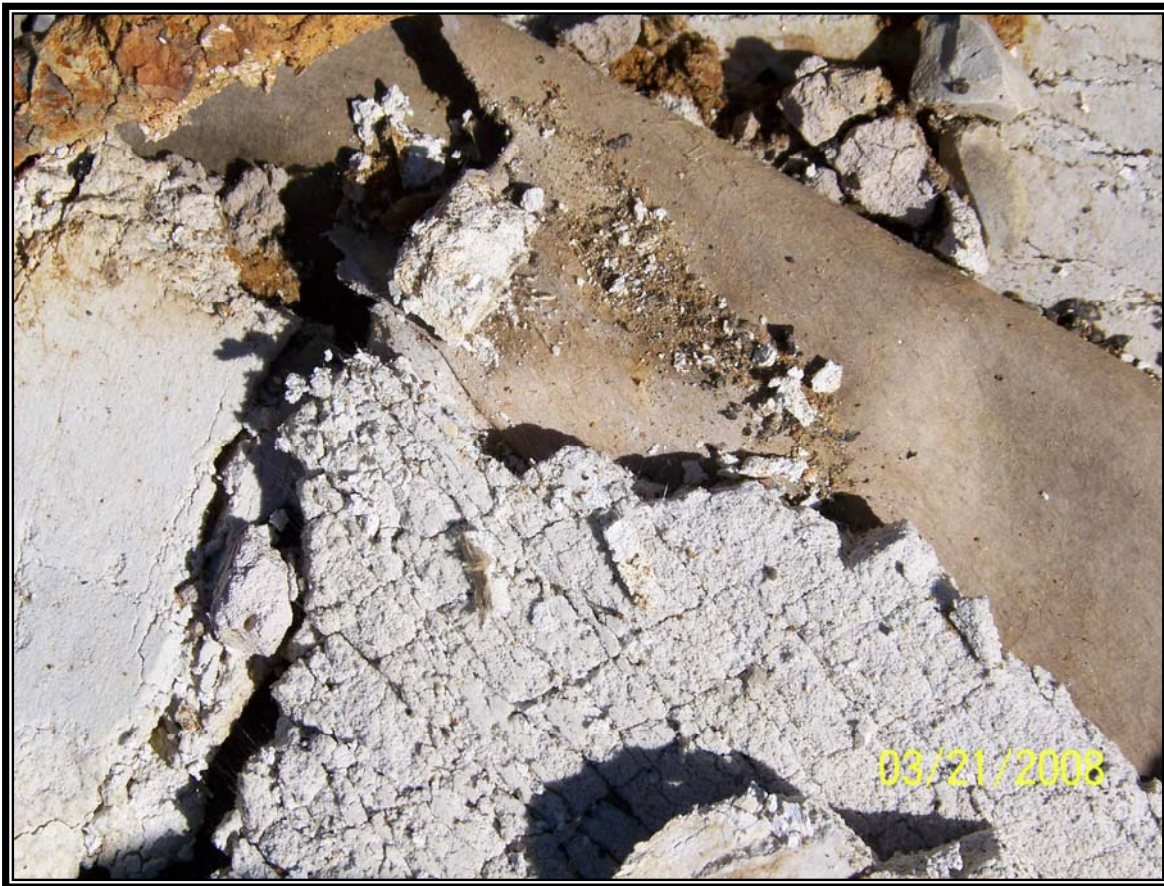
**OFFICIAL PHOTOGRAPH NO. 32**  
**U.S. ENVIRONMENTAL PROTECTION AGENCY**

<b>TDD Number:</b>	TTEMI-05-003-0041	<b>Location:</b>	Liberty Fibers Site
<b>Orientation:</b>	North	<b>Date:</b>	March 21, 2008
<b>Photographer:</b>	Chris Draper, Tetra Tech	<b>Witness:</b>	OSC Steve Spurlin, EPA
<b>Subject:</b>	Suspected asbestos-containing material comprising sample LF-ACM-01, which was collected near the road by the railroad tracks on the northern portion of the site.

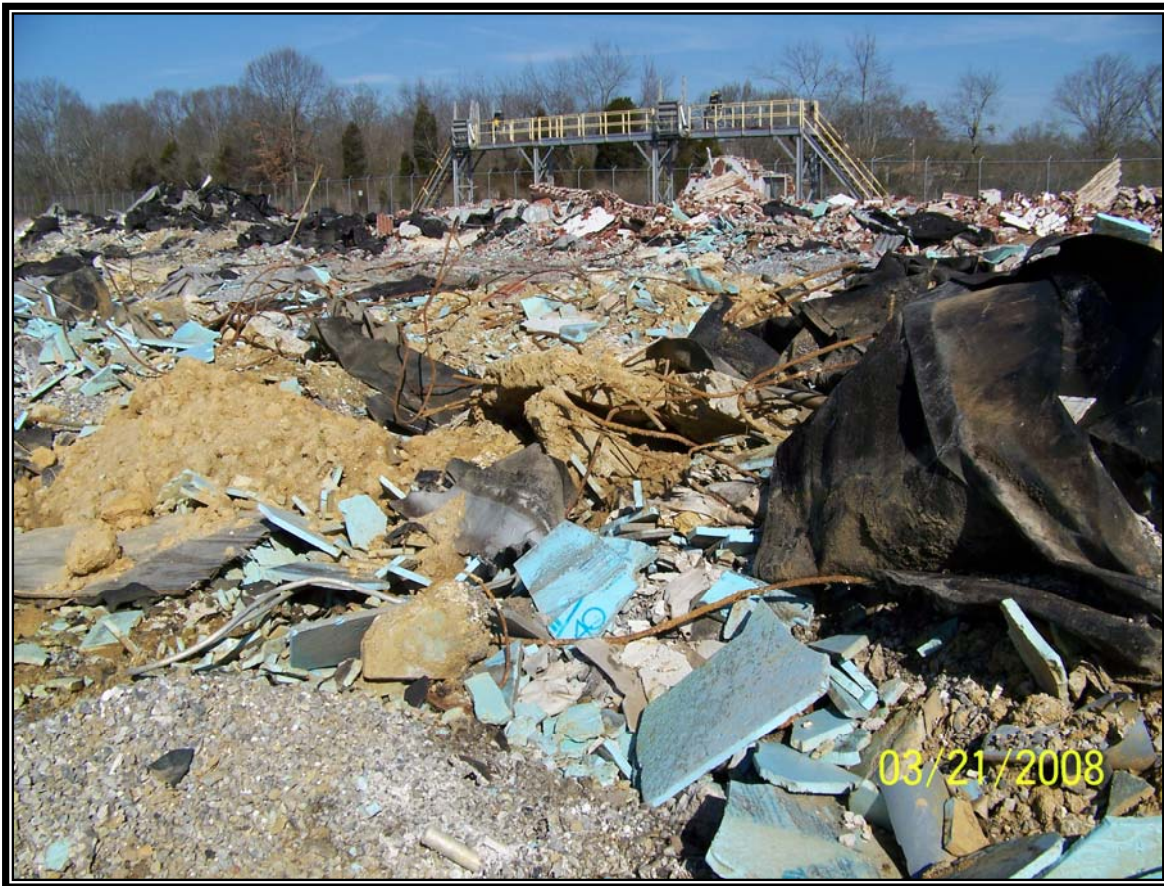
**OFFICIAL PHOTOGRAPH NO. 33**  
**U.S. ENVIRONMENTAL PROTECTION AGENCY**

**TDD Number:** TTEMI-05-003-0041      **Location:** Liberty Fibers Site  
**Orientation:** Northeast      **Date:** March 21, 2008  
**Photographer:** Chris Draper, Tetra Tech      **Witness:** OSC Steve Spurlin, EPA  
**Subject:** Prospective view of sample LF-ACM-01 collection site.

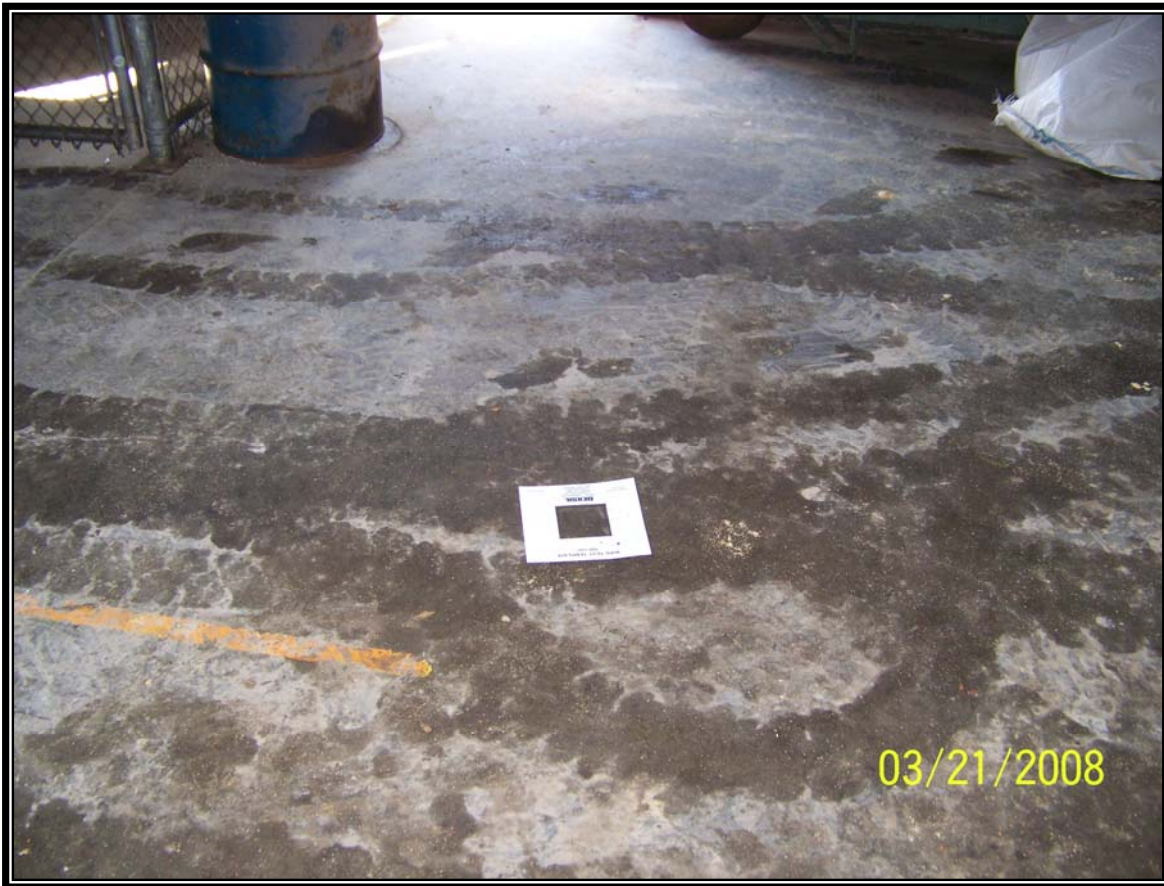
**OFFICIAL PHOTOGRAPH NO. 34**  
**U.S. ENVIRONMENTAL PROTECTION AGENCY**

**Subject:** Location where PCB wipe sample LF-PW-01 was collected from the floor immediately inside the door, outside of secondary containment within the non-permitted building used to store known and suspected PCB-containing materials and equipment removed from various locations throughout the site pending disposal.

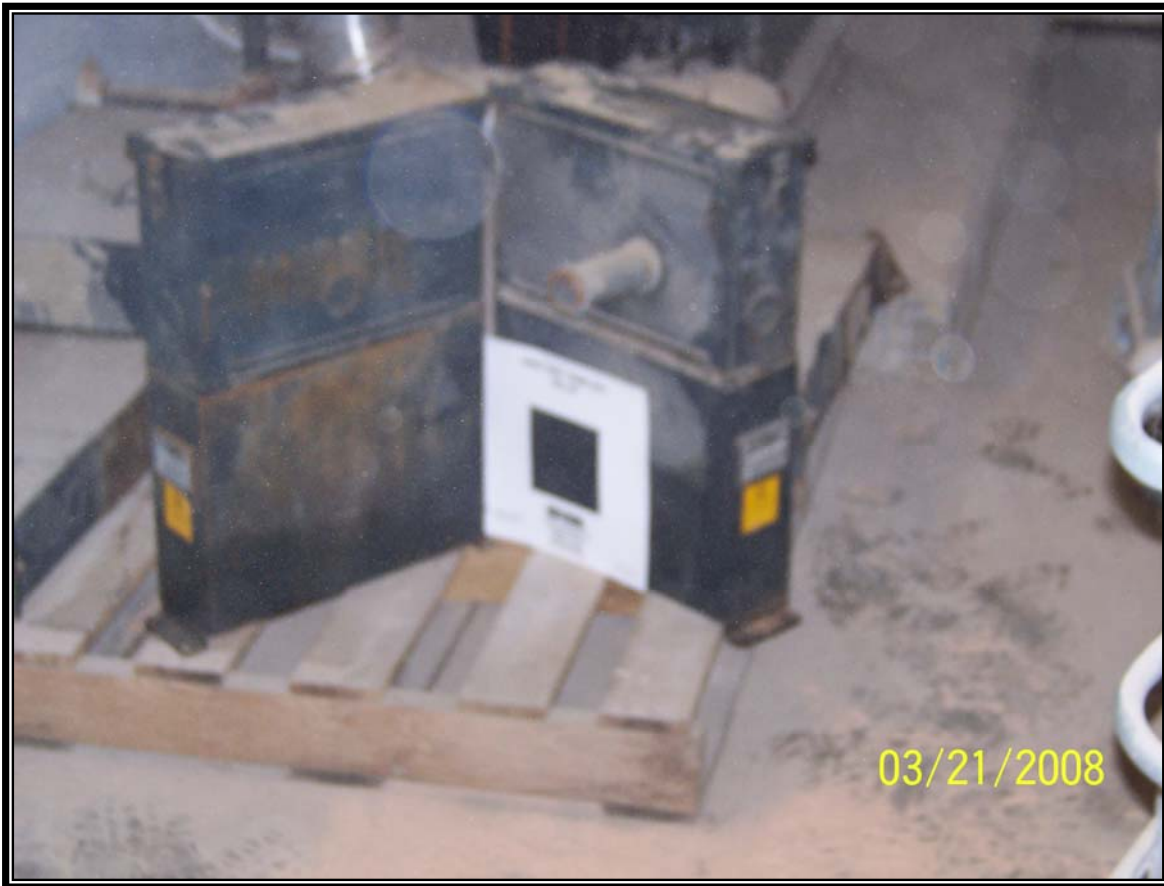
**OFFICIAL PHOTOGRAPH NO. 35**  
**U.S. ENVIRONMENTAL PROTECTION AGENCY**

1124 COLLECT LF-PW-02  
 FROM SIDE OF LEAKING CAPACITOR  
 OUTSIDE OF CONTAINMENT WITH  
 SANDUST AS ABSORBENT OF FLOOR

<b>TDD Number:</b>	TTEMI-05-003-0041	<b>Location:</b>	Liberty Fibers Site
<b>Orientation:</b>	South	<b>Date:</b>	March 21, 2008
<b>Photographer:</b>	Chris Draper, Tetra Tech	<b>Witness:</b>	OSC Steve Spurlin, EPA
<b>Subject:</b>	Location where PCB wipe sample LF-PW-02 was collected from oil staining on the side of a capacitor located outside of secondary containment.

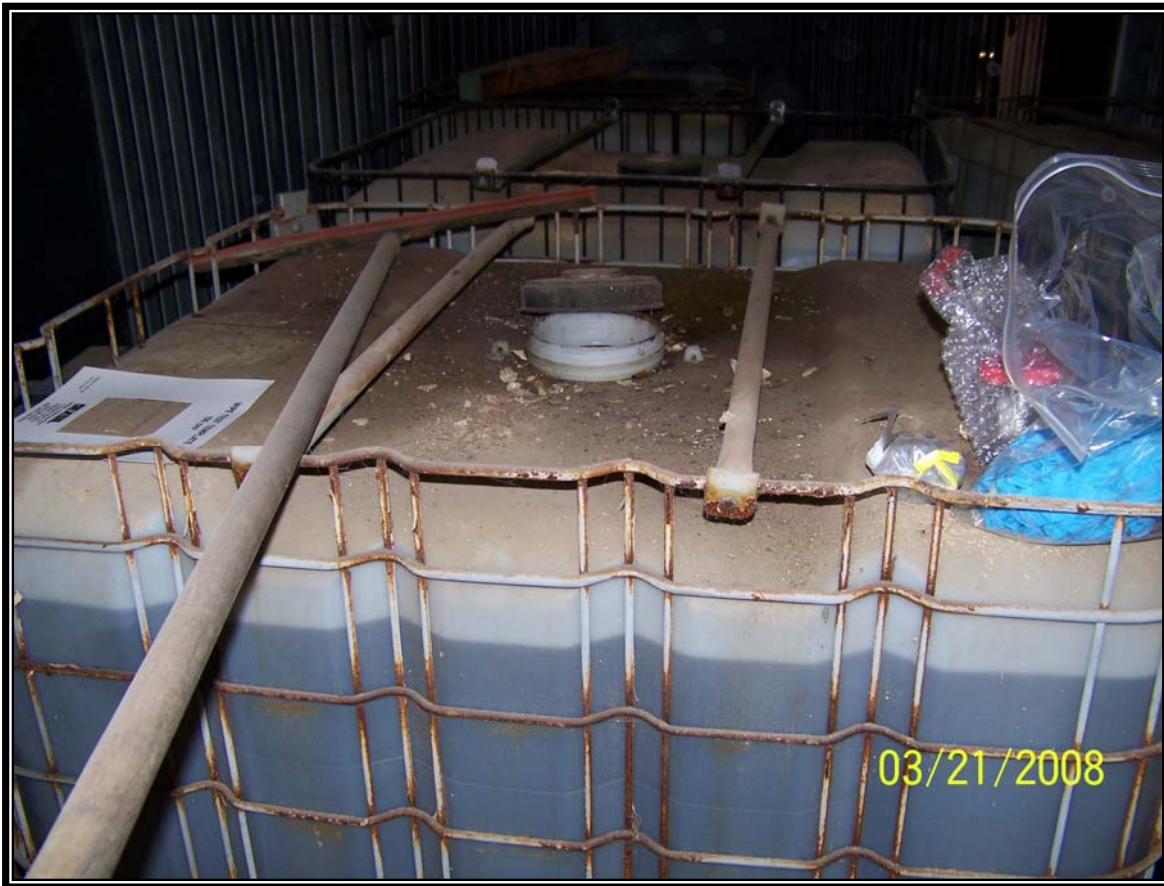
**OFFICIAL PHOTOGRAPH NO. 36**  
**U.S. ENVIRONMENTAL PROTECTION AGENCY**

<b>TDD Number:</b>	TTEMI-05-003-0041	<b>Location:</b>	Liberty Fibers Site
<b>Orientation:</b>	North	<b>Date:</b>	March 21, 2008
<b>Photographer:</b>	Chris Draper, Tetra Tech	<b>Witness:</b>	OSC Steve Spurlin, EPA
<b>Subject:</b>	Location where sample LF-PL-01 was collected from 250-gallon tote of oil within secondary containment.

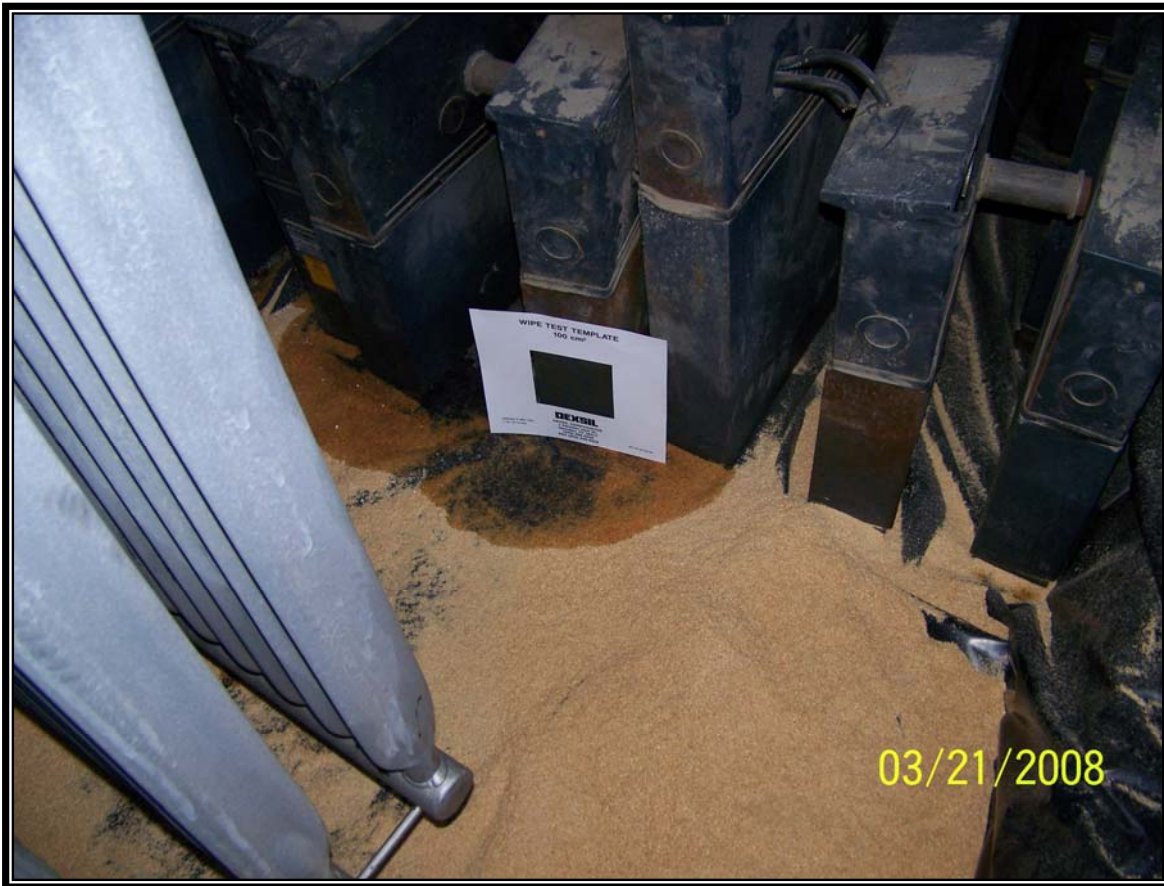
**OFFICIAL PHOTOGRAPH NO. 37**  
**U.S. ENVIRONMENTAL PROTECTION AGENCY**

1138 COLLECT LF-PW-03 FROM SIDE OF  
 LEAKING CAPACITOR WITHIN SECONDARY  
 CONTAINMENT

<b>TDD Number:</b>	TTEMI-05-003-0041	<b>Location:</b>	Liberty Fibers Site
<b>Orientation:</b>	South	<b>Date:</b>	March 21, 2008
<b>Photographer:</b>	Chris Draper, Tetra Tech	<b>Witness:</b>	OSC Steve Spurlin, EPA
<b>Subject:</b>	Location where PCB wipe sample LF-PW-03 was collected from oil staining on the side of a capacitor located within secondary containment.

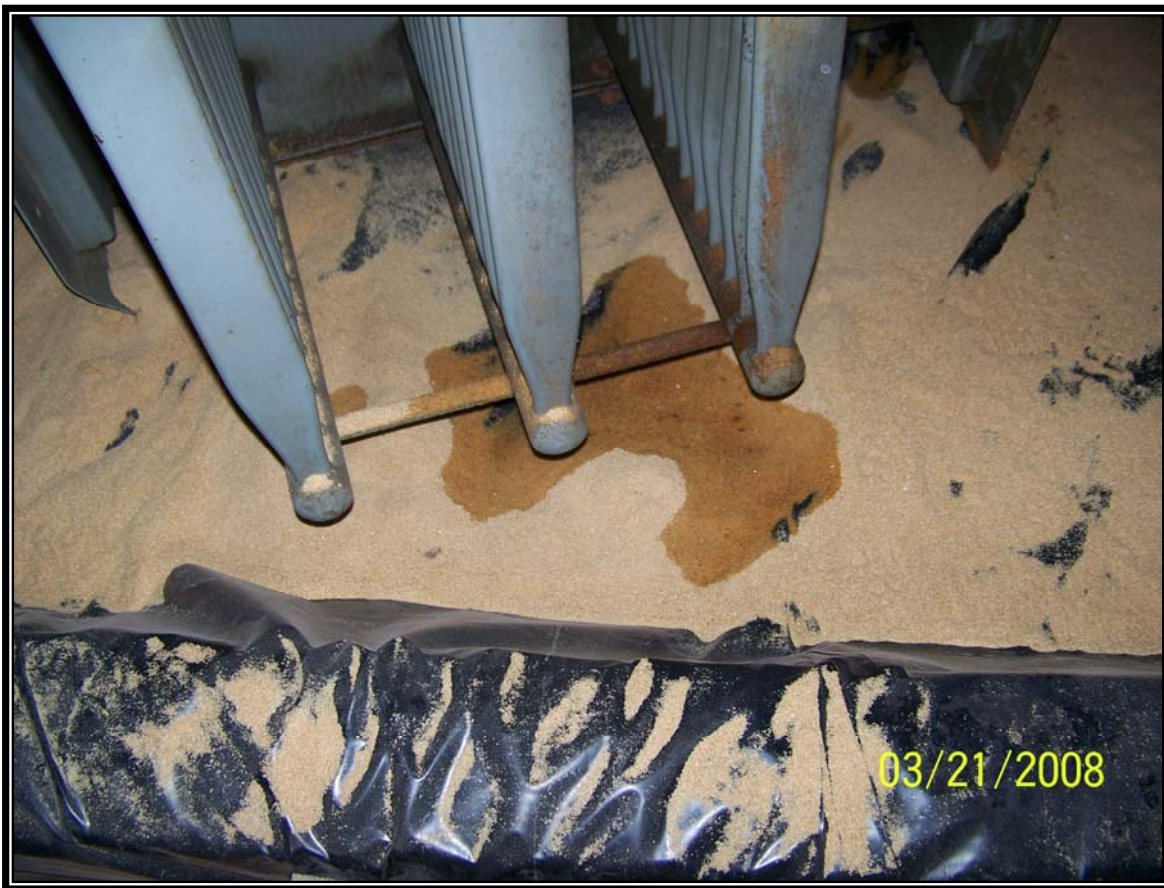
**OFFICIAL PHOTOGRAPH NO. 38**  
**U.S. ENVIRONMENTAL PROTECTION AGENCY**

LF-PW-03	Grab	Wipe	PCBs	Non-permitted PCB storage area; on side of leaking capacitor within secondary containment	ND
LF-PS-01	Grab	Solid	PCBs	Non-permitted PCB storage area; oil-soaked sawdust under transformer with serial number 7024835 within secondary containment	380 mg/kg (Arochlor 1260)

1153 COLLECT SOLID SANDUST SAMPLE  
 OF SUSPECTED PCB OIL LEAK UNDER  
 TRANSFORMER S/N: 7024835  
~~LF-SS-03~~ 1 EA 80Z JAR  
 LF-PS-01

<b>TDD Number:</b>	TTEMI-05-003-0041	<b>Location:</b>	Liberty Fibers Site
<b>Orientation:</b>	North	<b>Date:</b>	March 21, 2008
<b>Photographer:</b>	Chris Draper, Tetra Tech	<b>Witness:</b>	OSC Steve Spurlin, EPA
<b>Subject:</b>	Oil-stained sawdust within secondary containment and immediately below a transformer with serial number 7024835 where sample LF-PS-01 was collected.
