Re: Time-Critical Removal Action Report for the Stubblefield Salvage Yard Site, Walla  
Walla, Washington  
Contract Number EP-S7-06-02, Technical Direction Document Number 11-11-0003

# **TIME-CRITICAL REMOVAL ACTION REPORT**

**Stubblefield Salvage Yard Site  
Walla Walla, Washington  
TDD: 11-11-0003**

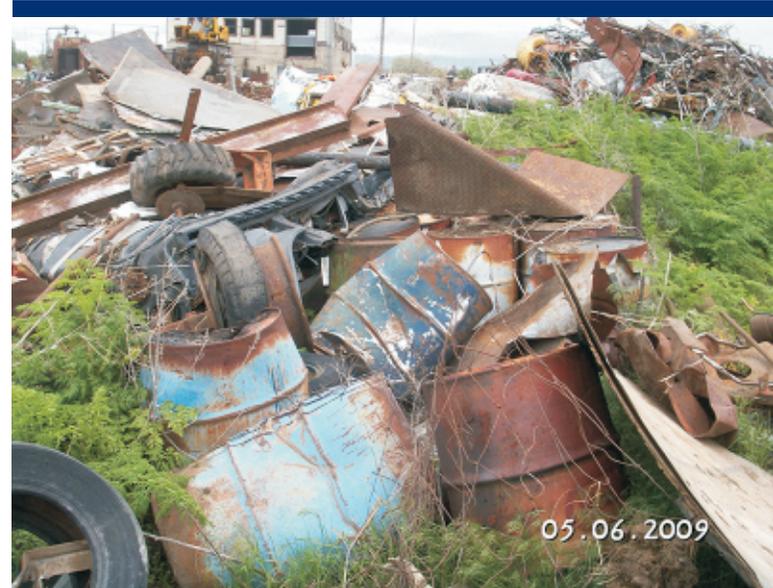
Photo 2 Unmanaged drums and scrap material with shop building in the background.

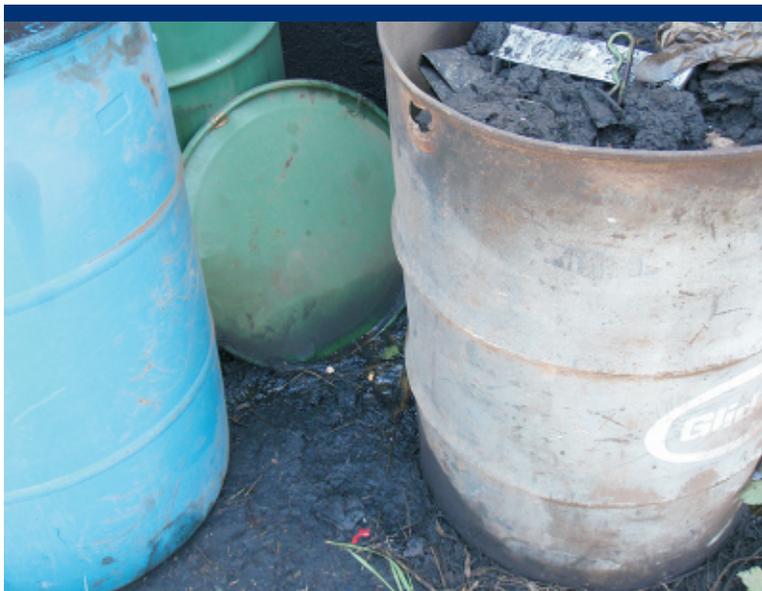
Photo 3 Leaking drums and stained soil in the drum field.

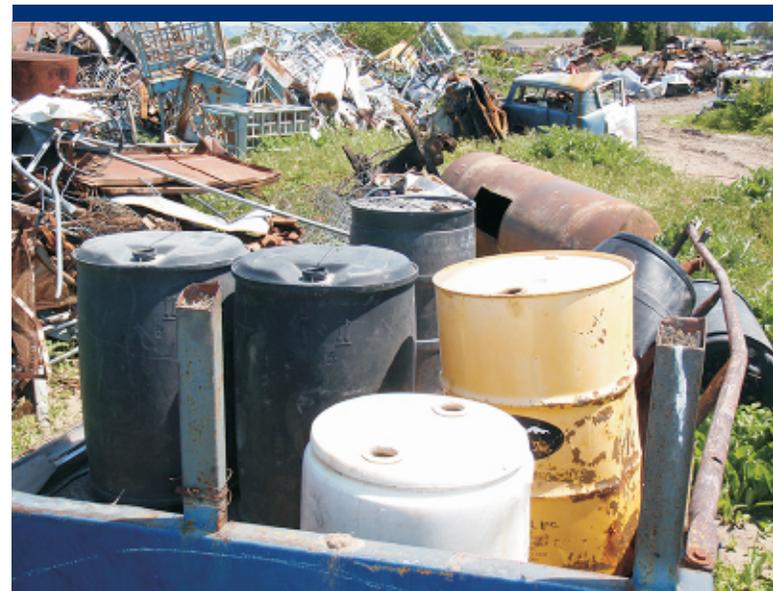
Photo 4 Drums without bungs in the drum field.

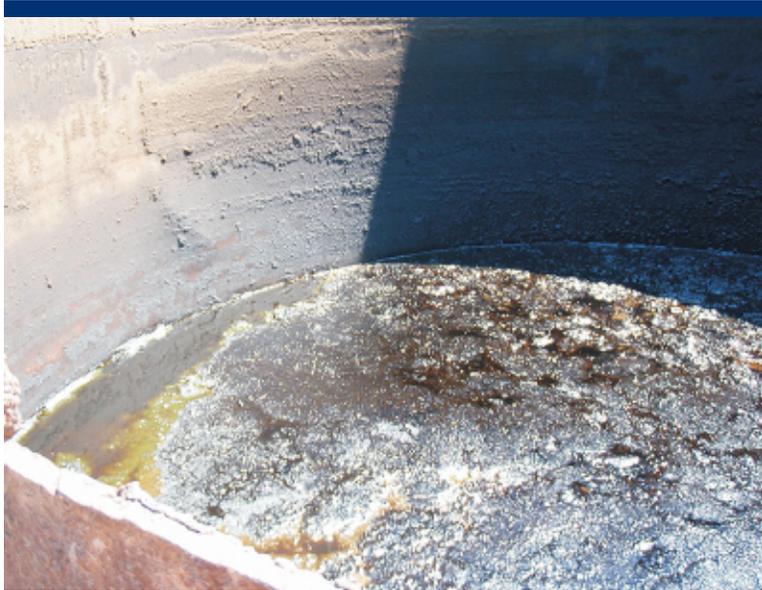
Photo 5 Open container of oily liquid in the drum field.

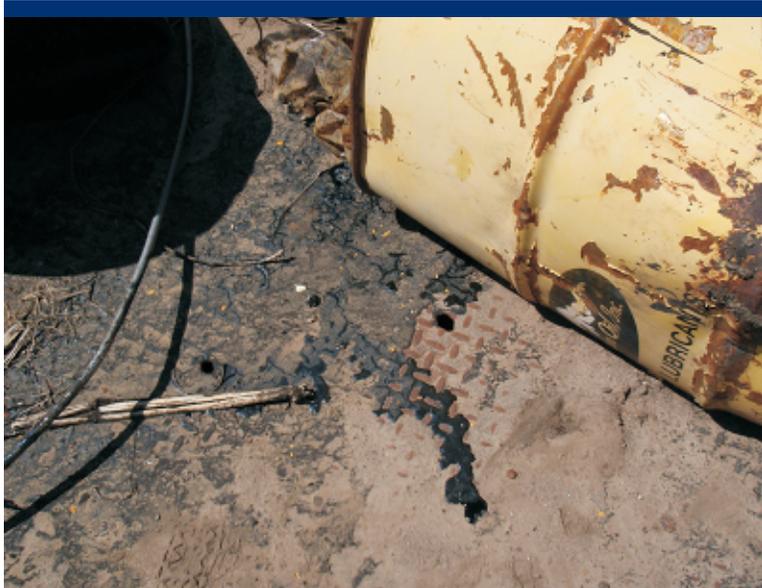
Photo 9 Leaking drum on its side.

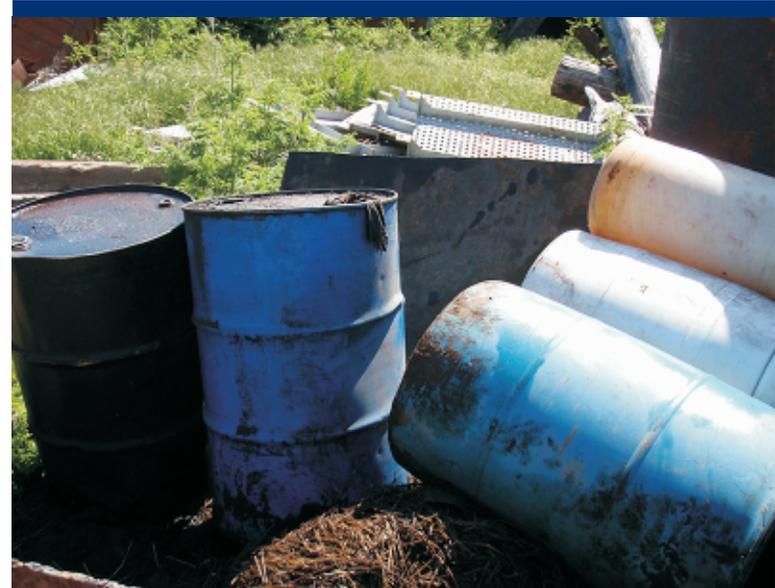
Photo 10 Oily drums in the drum field.

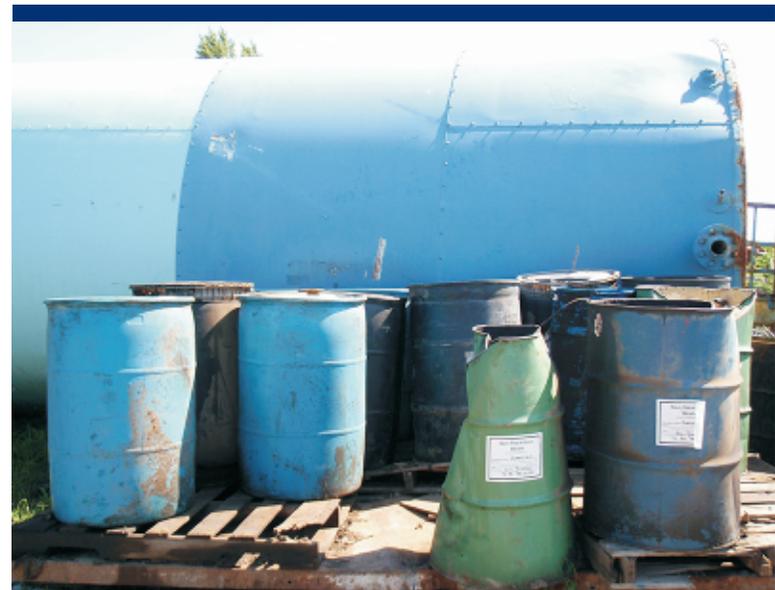
Photo 12 Uncovered and damaged drums in the drum field.

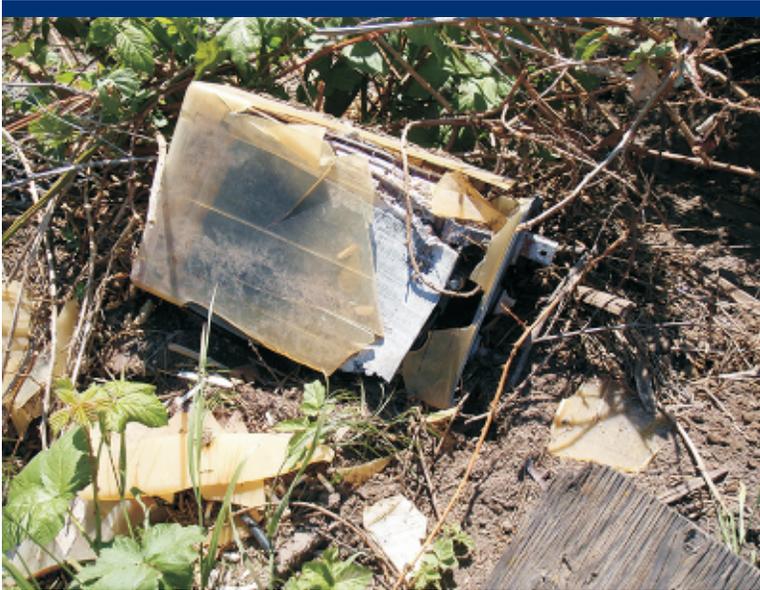
Photo 13 Crushed car battery.

ERRS also gathered additional hazardous materials from the site, including car batteries from a battery disposal area and various cylinders. Two of the cylinders were identified as containing anhydrous ammonia.

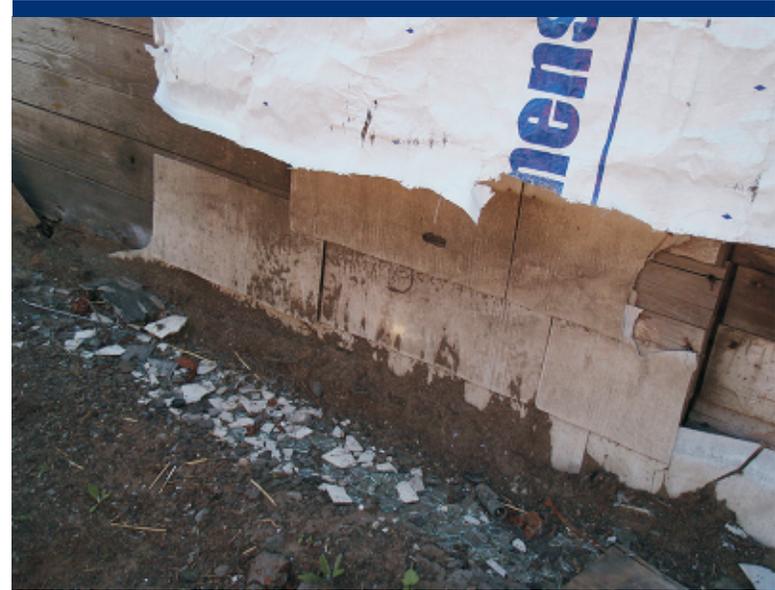
Photo 14 Friable ACM on the ground at the shop building.

On October 14, 2009, the asbestos abatement contractor began to remove damaged ACM siding from the shop building, and the remaining intact ACM siding was also removed to prevent future damage and release. The abatement work was completed on October 16. The abatement contractor also removed friable ACM that was present on the ground.

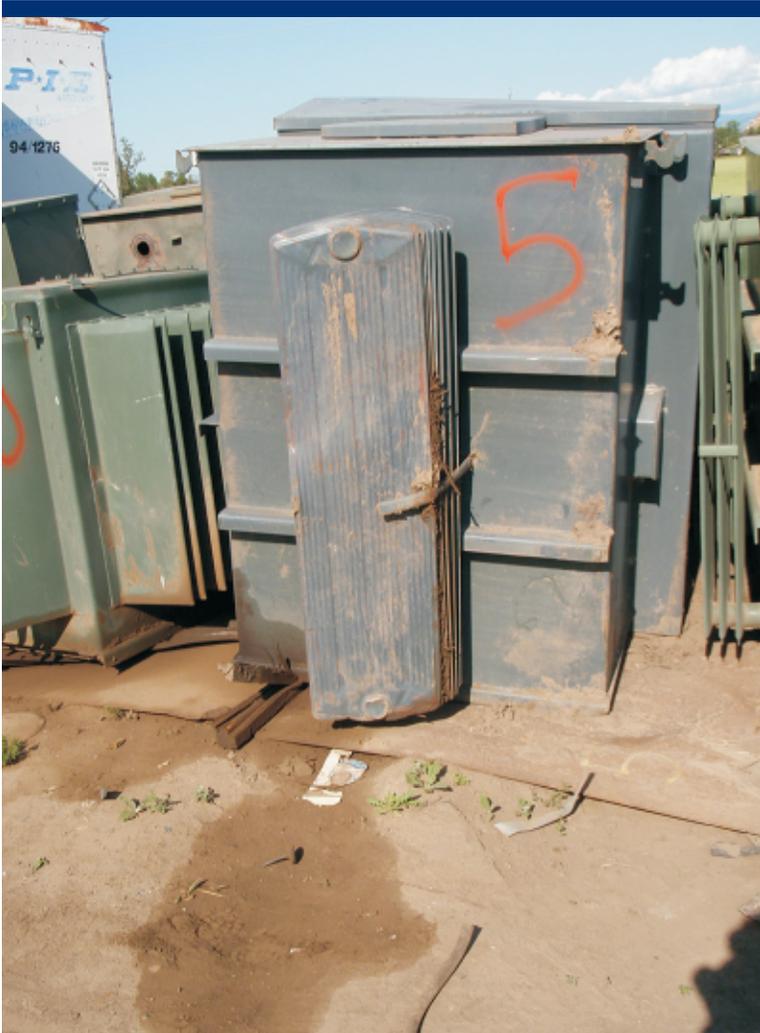
Photo 16 Leaking transformers.

In May 2009, EPA mobilized to the site and collected four product samples and five wipe samples from transformers at the site (E & E 2009d). The product and wipe samples were submitted for PCB analysis; results can be found in Appendix B. EPA also collected eight product samples from drums and submitted those samples for metals, PCBs, pesticides, TPH, SVOC, and VOC analyses, and in September 2009 EPA collected two additional product samples from the baler/shredder for PCB analysis (E & E 2009b). These results can be found in Appendix C. EPA determined that the drums, based on their contents and physical condition, presented a release and a threat of release of hazardous substances to the environment based on their contents and conditions.

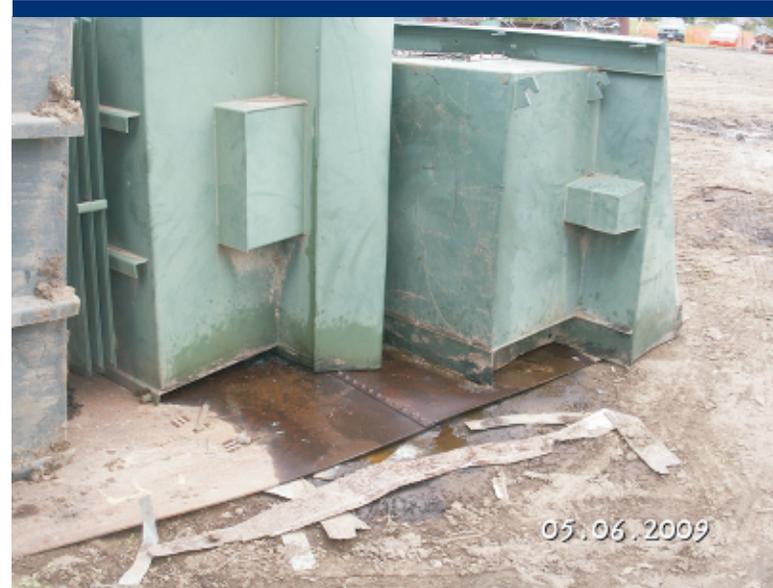
Photo 17 Leaking transformers.

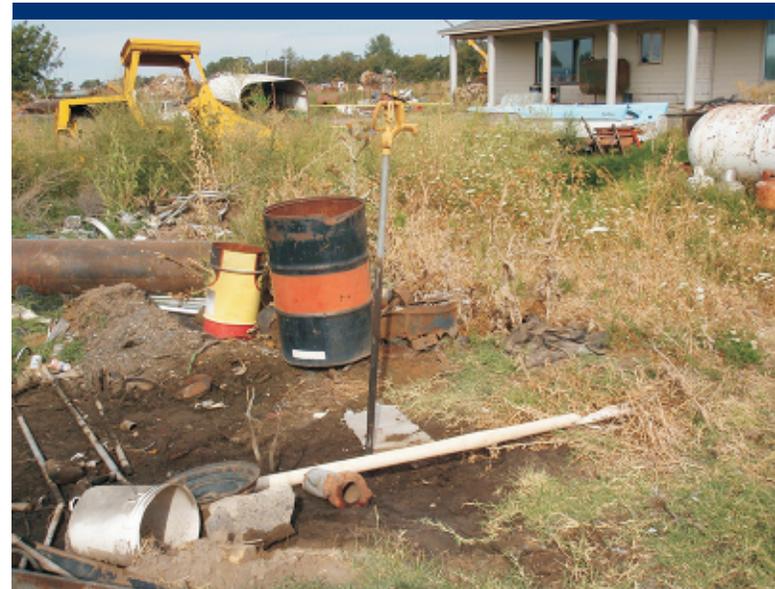
Photo 22 Stained soil near the drums with residence in the background.

The areas selected for excavation and off-site disposal were identified based on analytical results from the September 2009 sampling event along with visual observations (i.e., visibly stained soil) and field screening with a field-portable X-ray fluorescence (XRF) instrument. For the purpose of identifying and delineating contaminated soil areas for excavation, XRF results for lead were compared to the MTCRA cleanup level for industrial properties of 1,000 mg/kg. EPA identified three areas of surface soil contamination for excavation and off-site disposal, including one area of surface soil contamination associated with a broken battery storage area. The three areas were targeted in part because they were located away from the ongoing salvage operations and therefore presented safe working conditions for field personnel and were unlikely to be re-contaminated by salvage activities. In particular, EPA did not address contamination in the process area at this time because of the high likelihood of re-contamination from the baler/shredder equipment and other salvage yard operations.

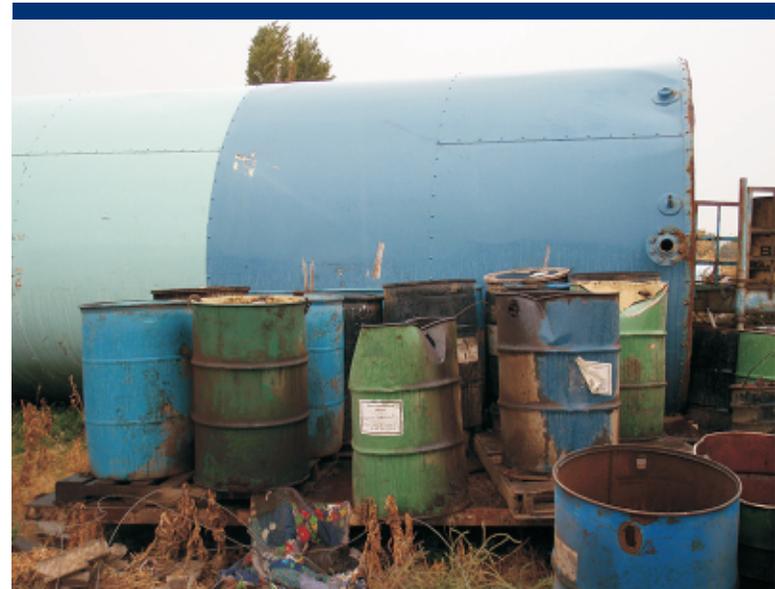
Photo 26 Drum DF06-03 with TSCA regulated PCBs.

In October 2009, ERRS gathered drums from around the site and staged them at the site staging area. ERRS recovered a total of 79 drums, with 60 containing liquid and 19 containing sludge. After the drums were staged, ERRS performed hazard categorization testing on their contents and then consolidated the drum wastes for disposal. In addition to the field hazard categorization testing, ERRS submitted 12 composite samples and three grab samples of product for PCB analysis; seven of the product samples had concentrations of PCBs with a maximum of 17 milligrams per kilogram (mg/kg). A copy of tabulated results can be found in Appendix D.

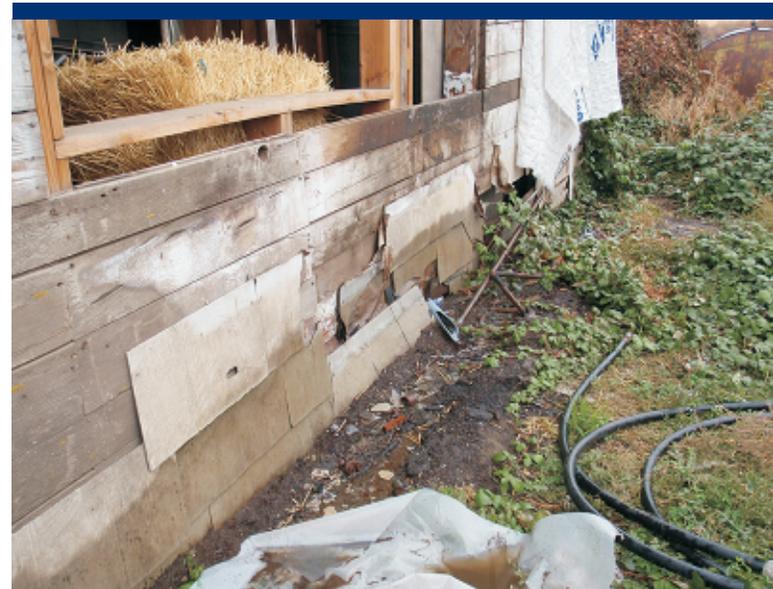
Photo 34 ACM siding on the shop building.

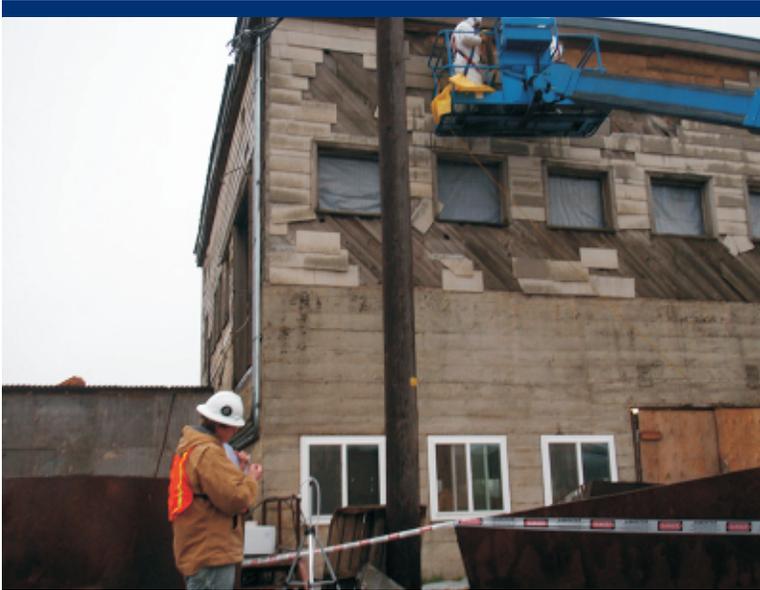
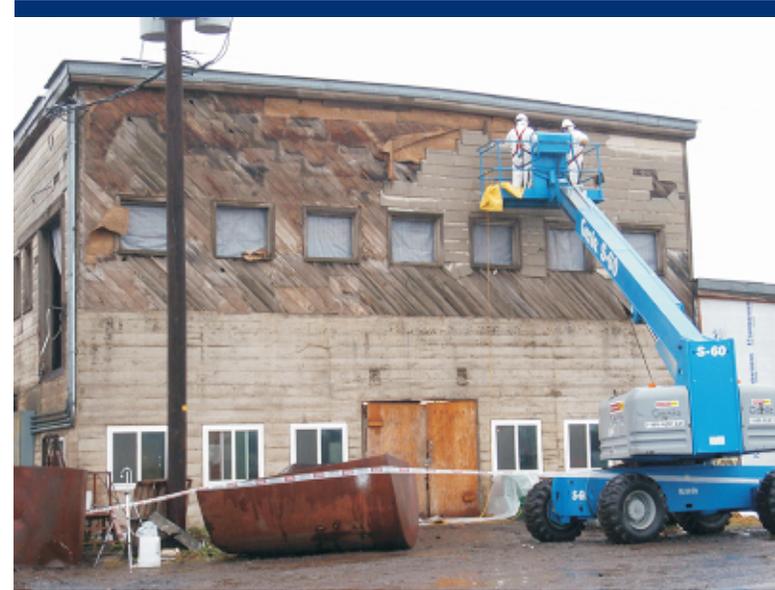
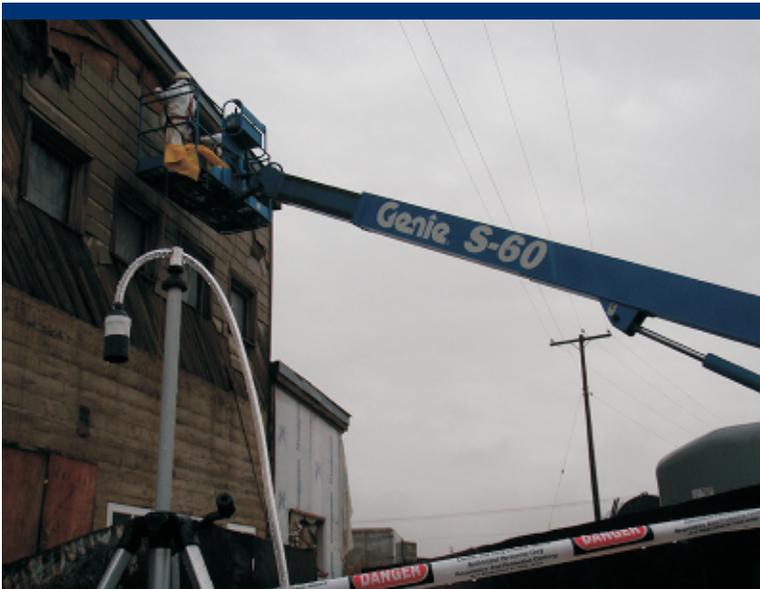
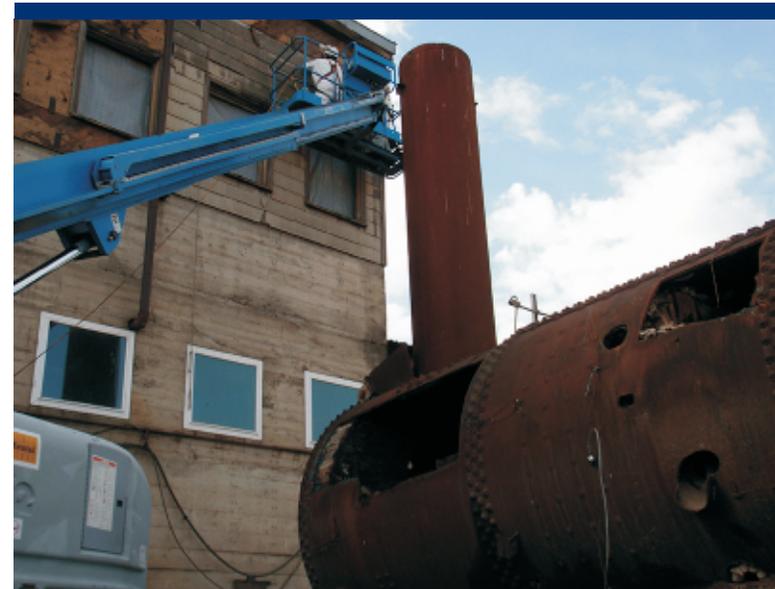
Photo 35 Asbestos abatement crew removing ACM siding from shop building.

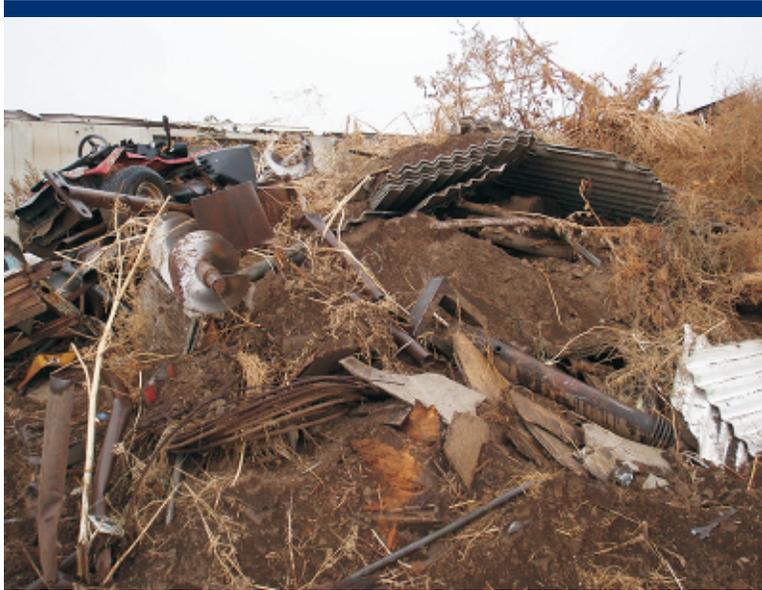
Photo 39 Soil and metal mixed with ACM panels in the northeast corner of the site.

On October 19, ERRS and the abatement contractor began to address a large pile of friable ACM at the northeast corner of the Site. The ACM was approximately 20 tons of 4-foot by 8-foot corrugated panels of asbestos containing cement that had been received at the site in the past. Since that time, the panels had become broken and intermingled with metal scrap and dirt that had been piled over the asbestos panels. With the assistance of the asbestos workers, ERRS used heavy equipment to segregate the scrap metal and non-contaminated material from the pile of ACM panels and asbestos-contaminated soil. The ACM waste was loaded into roll-off containers, and a total of 150 yd<sup>3</sup> of ACM waste was sent off site for disposal on October 22.

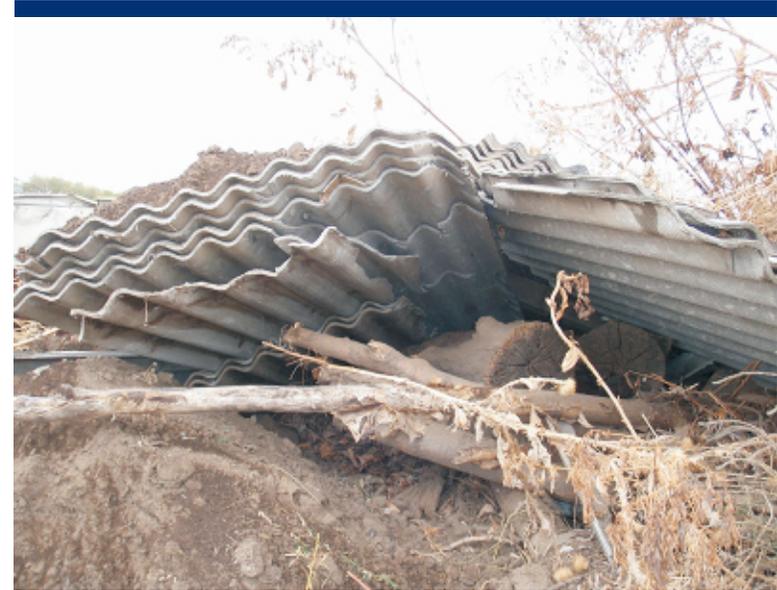
Photo 40 ACM panels in the northeast corner of the site.

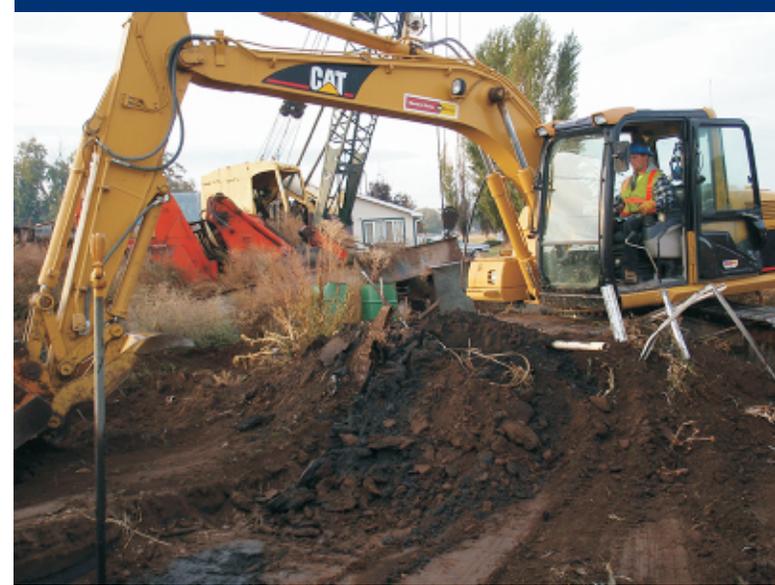
Photo 48 Excavating lead contaminated soil.

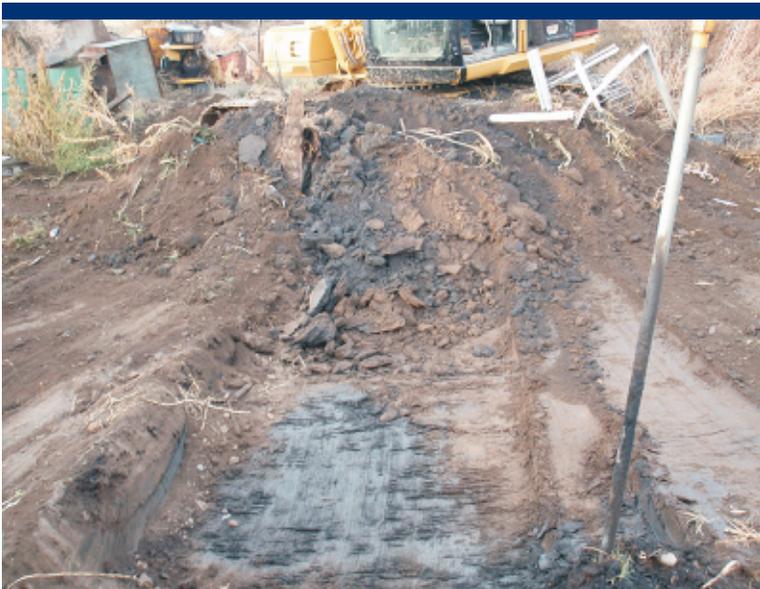
Photo 49 Stained soil in the drum field.

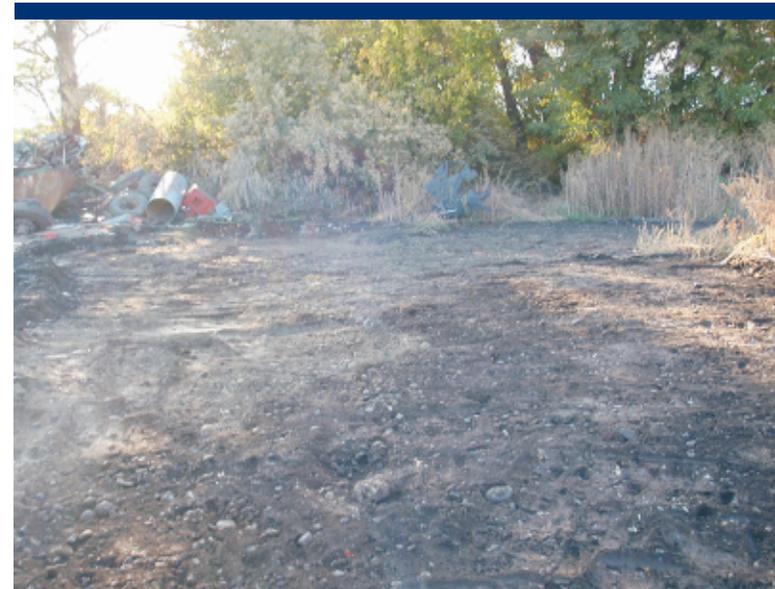
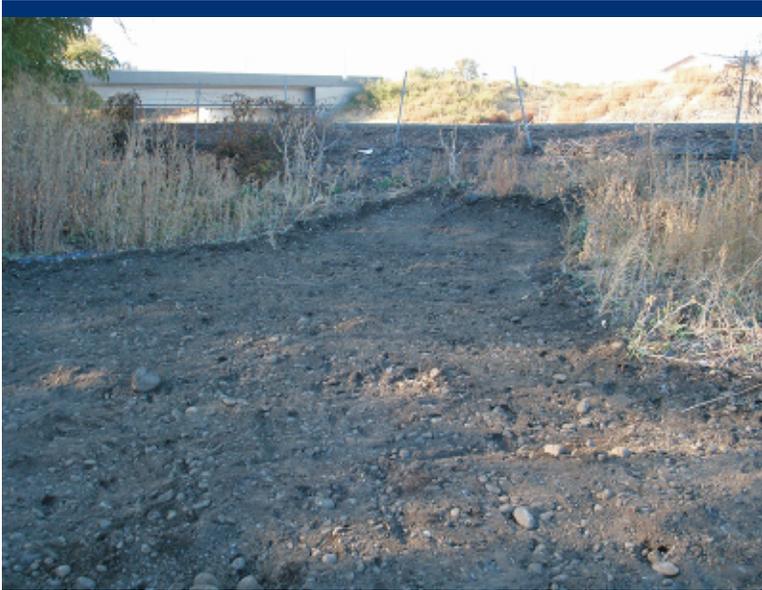
Photo 50 Excavation of surface soil at the swale.

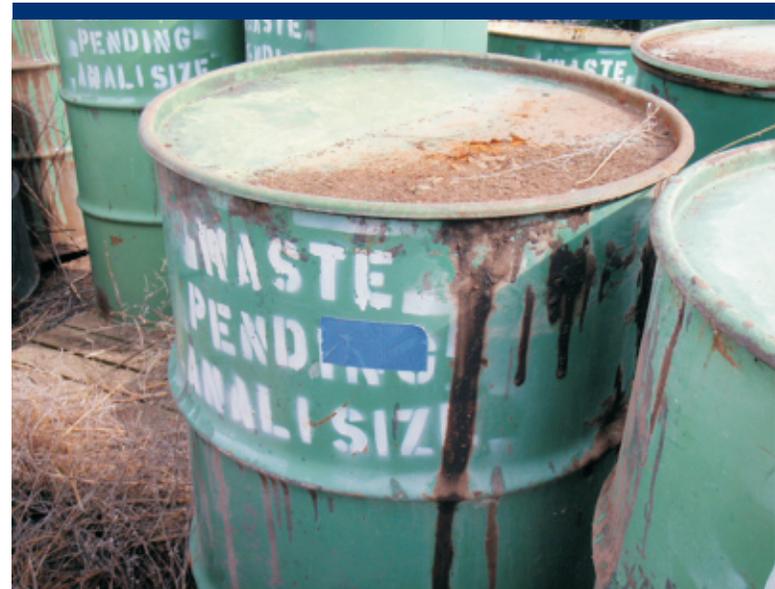
Photo 58 Drums with illegible writing on duct tape.

Many of the drums were previously labeled by a contractor retained by the operators of Stubblefield Salvage; however, the labels had faded or disintegrated due to age and exposure to the elements. Because most of the labels were illegible or missing, START sampled and performed modified hazard categorization analysis to assist ERRS in assigning waste categories to the contents of the drums (E & E 2012b). In addition to the field hazard categorization testing, ERRS submitted 16 composite samples and five grab samples of product for PCB analysis; results can be found in Appendix H.

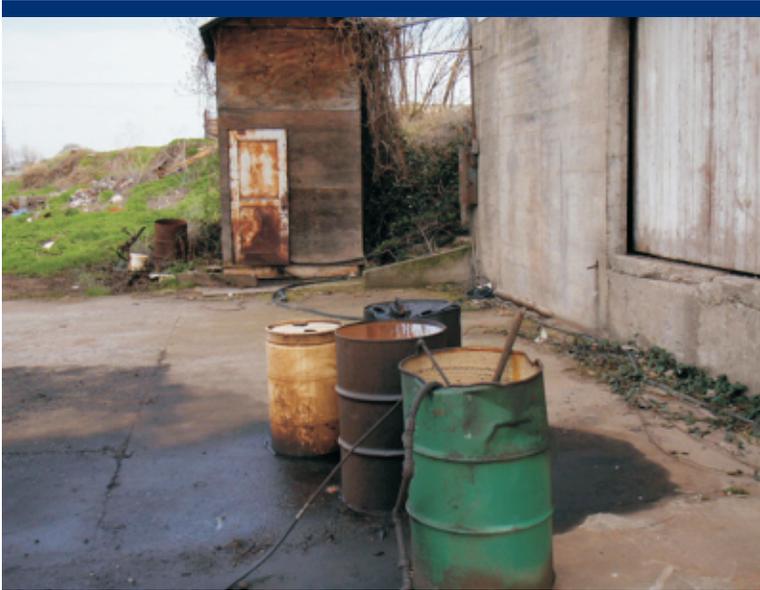
Photo 63 Abandoned and leaking drums at the north side of the shop building.  
*Direction: East* *April 2012 Sampling Event*

In April 2012, EPA mobilized to the site to remove additional drums that were staged at various locations throughout the site. Many of the drums were thought to have been generated and then abandoned during the shut-down of metal salvaging operations in 2010. The drums were unlabeled, in poor condition, and contained waste oil, other fuels, waste oil-contaminated debris, and other unknown contents. Additionally, evidence of leaking and/or spills had been observed in the adjacent surface soil near many of these drums.

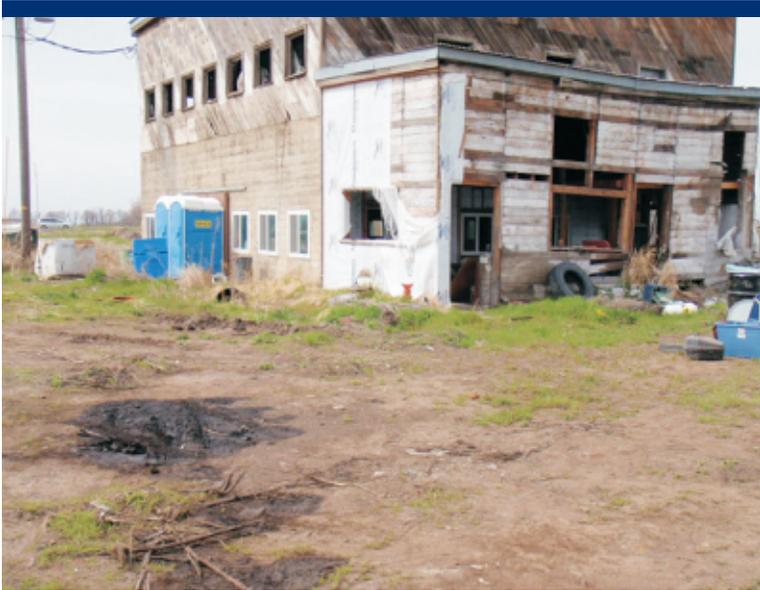
Photo 70 Stained soil near the southeast corner of the shop building.

Photo 71 Excavating stained soil near the shop building.
