**Subject: Phase I Targeted Brownfields Assessment
KCMO Municipal Farms
Animal Shelter Site at 4400 Raytown Road in Kansas City, Missouri
EPA Region 7, START 3, Contract No. EP-S7-06-01, Task Order No. 0002.015.022
Task Monitor: Todd Davis, Site Assessment Team Leader**

PHASE I TARGETED BROWNFIELDS ASSESSMENT

**ANIMAL SHELTER
4400 RAYTOWN ROAD, KANSAS CITY, MISSOURI**

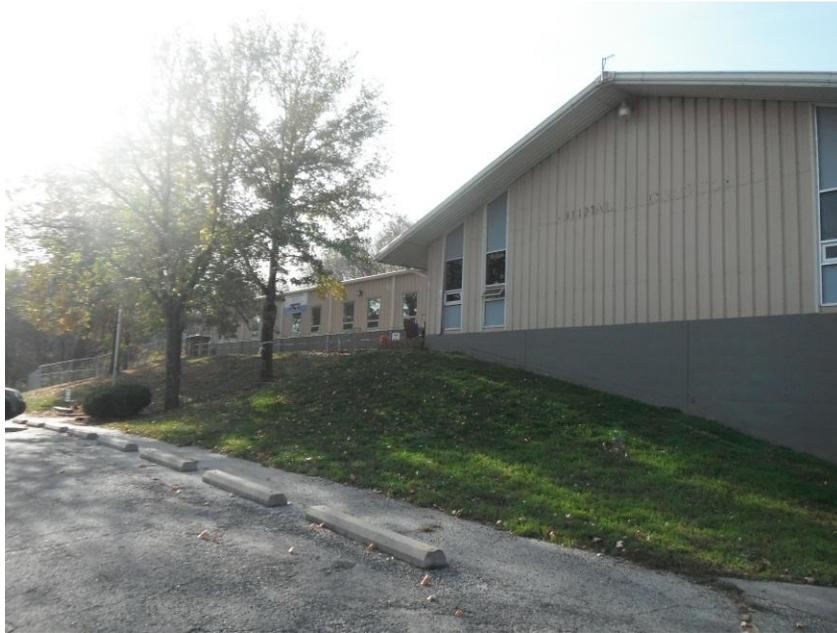
TETRA TECH PROJECT NO. X9004.06.0002.015.022 DIRECTION: South	DESCRIPTION	This photograph shows the northwestern side of the Animal Shelter, the subject property.	1
	CLIENT	Environmental Protection Agency - Region 7	DATE 11/2/12
	PHOTOGRAPHER	Kaitlyn Bahr

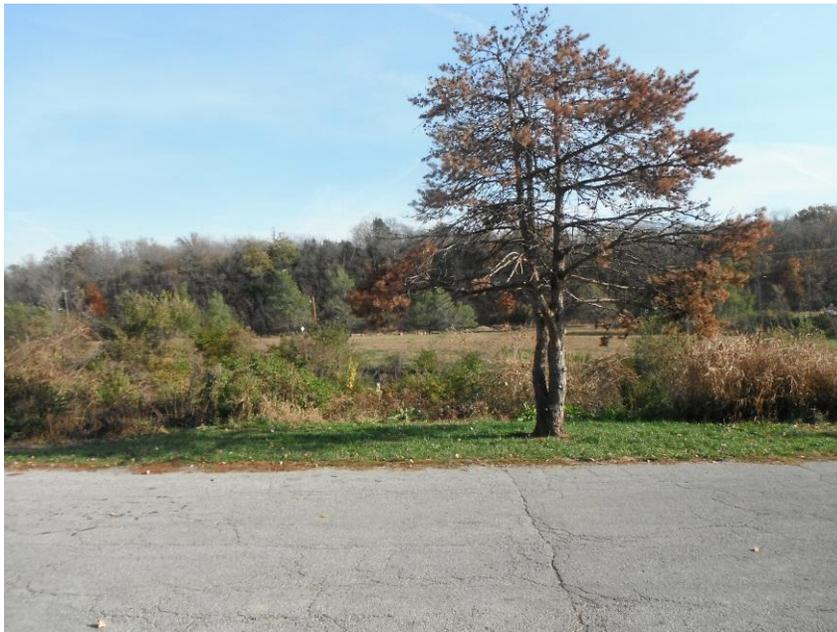
TETRA TECH PROJECT NO. X9004.06.0002.015.022 DIRECTION: North	DESCRIPTION	This photograph shows the open field with forestland beyond Raytown Road north of the subject property.	2
	CLIENT	Environmental Protection Agency - Region 7	DATE 11/2/12
	PHOTOGRAPHER	Kaitlyn Bahr

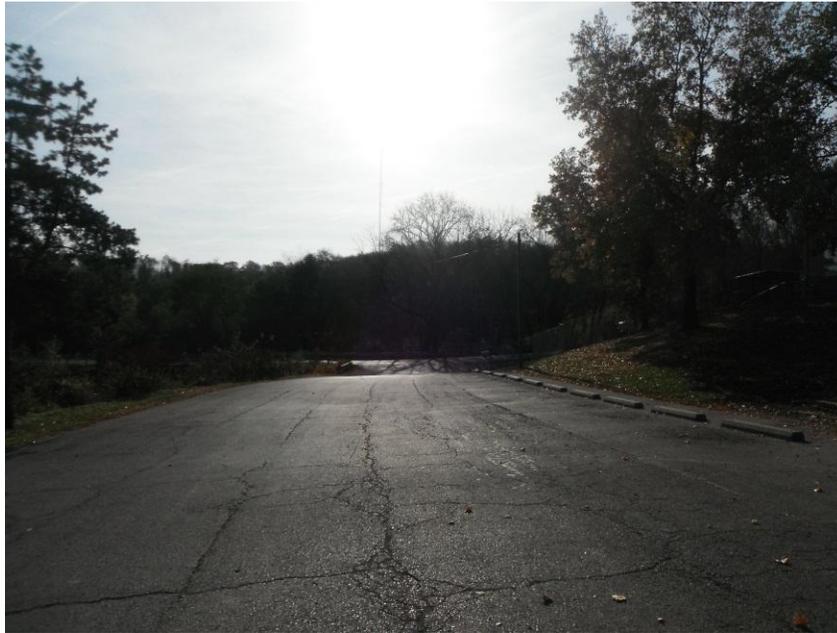
TETRA TECH PROJECT NO. X9004.06.0002.015.022 DIRECTION: Southeast	DESCRIPTION	This photograph shows the paved parking lot on the northern side of the subject property building with forestland beyond.	3
	CLIENT	Environmental Protection Agency - Region 7	DATE 11/2/12
	PHOTOGRAPHER	Kaitlyn Bahr

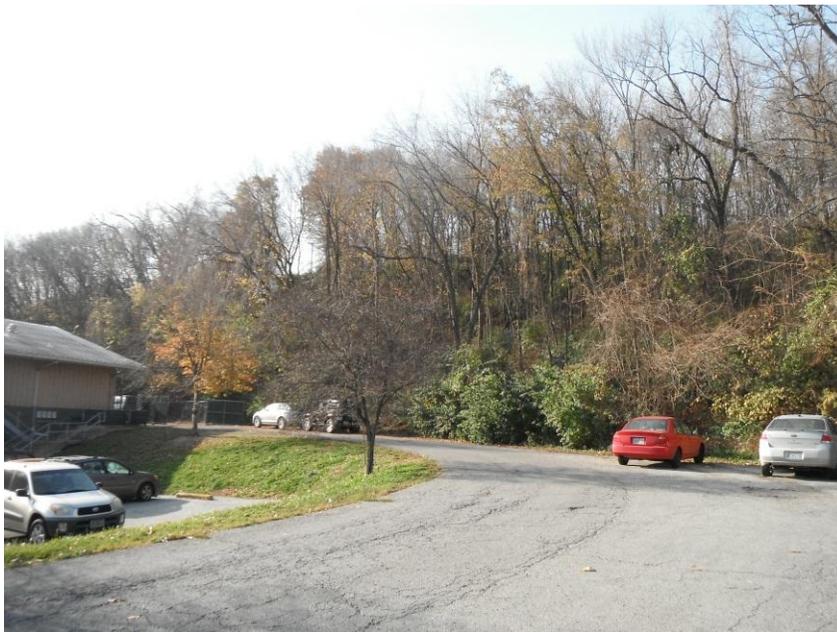
TETRA TECH PROJECT NO. X9004.06.0002.015.022 DIRECTION: South	DESCRIPTION	This photograph shows the west side of the subject property building and the paved driveway that surrounds the building with forestland beyond.	4
	CLIENT	Environmental Protection Agency - Region 7	DATE 11/2/12
	PHOTOGRAPHER	Kaitlyn Bahr

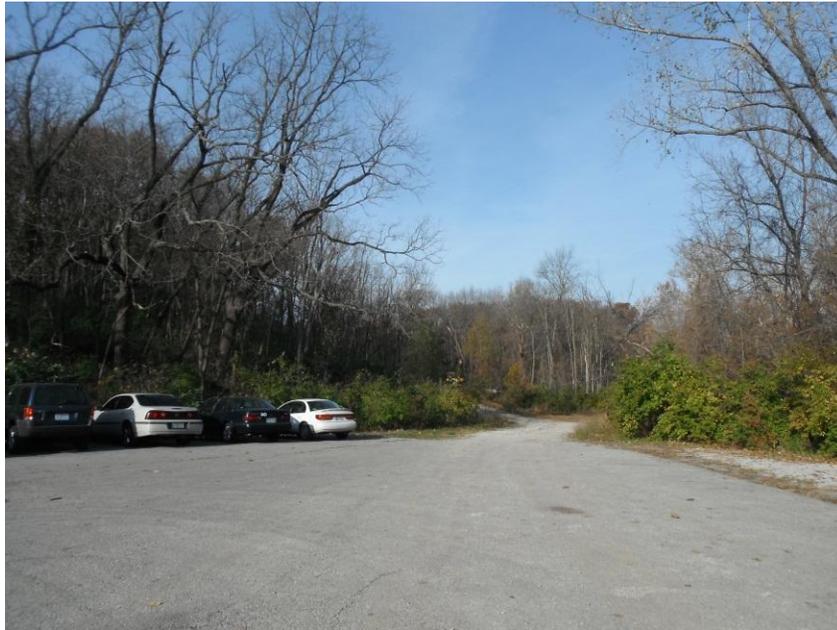
TETRA TECH PROJECT NO. X9004.06.0002.015.022 DIRECTION: North	DESCRIPTION	This photograph shows the paved parking lot and the gravel road on the western side of the subject property.	5
	CLIENT	Environmental Protection Agency - Region 7	DATE 11/2/12
	PHOTOGRAPHER	Kaitlyn Bahr

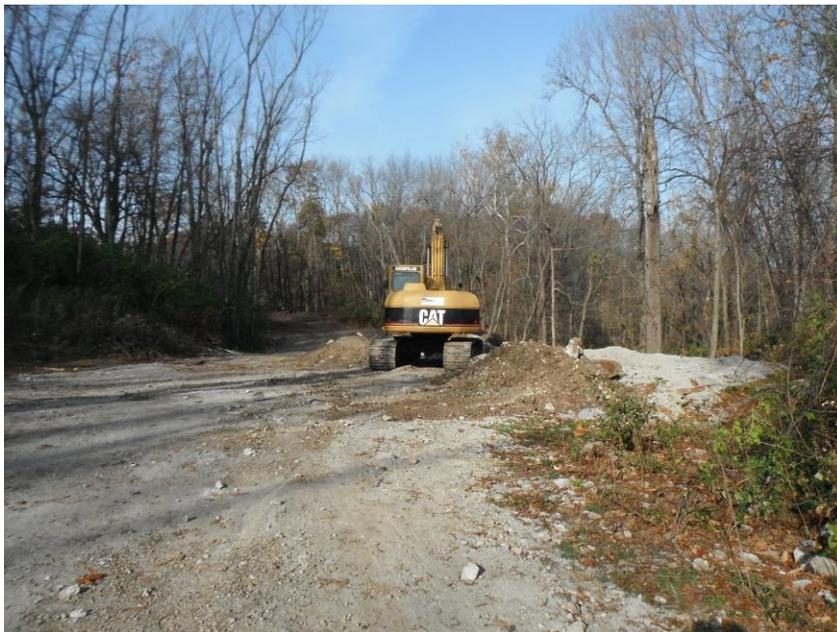
TETRA TECH PROJECT NO. X9004.06.0002.015.022 DIRECTION: West	DESCRIPTION	This photograph shows the construction equipment and disturbed dirt along the gravel road on the western portion of the subject property.	6
	CLIENT	Environmental Protection Agency - Region 7	DATE 11/2/12
	PHOTOGRAPHER	Kaitlyn Bahr

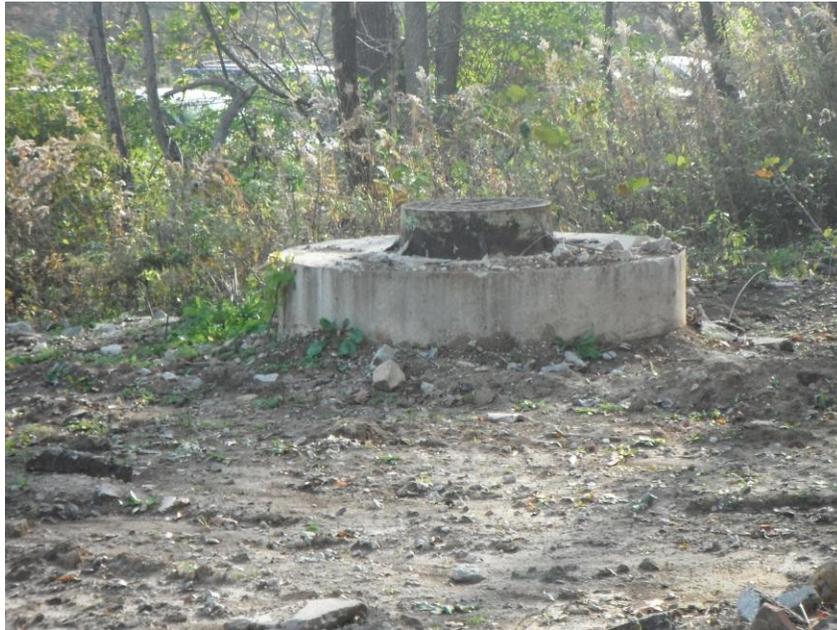
TETRA TECH PROJECT NO. X9004.06.0002.015.022 DIRECTION: East	DESCRIPTION	This photograph shows a manhole on the gravel road on the western portion of the subject property.	7
	CLIENT	Environmental Protection Agency - Region 7	DATE 11/2/12
	PHOTOGRAPHER	Kaitlyn Bahr

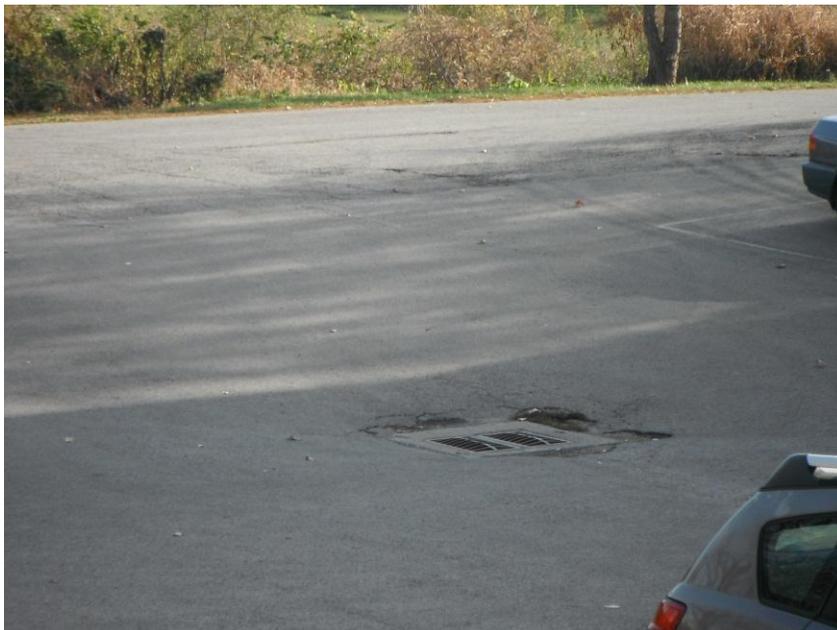
TETRA TECH PROJECT NO. X9004.06.0002.015.022 DIRECTION: North	DESCRIPTION	This photograph shows a storm drain in the parking lot on the west side of the subject property building.	8
	CLIENT	Environmental Protection Agency - Region 7	DATE 11/2/12
	PHOTOGRAPHER	Kaitlyn Bahr

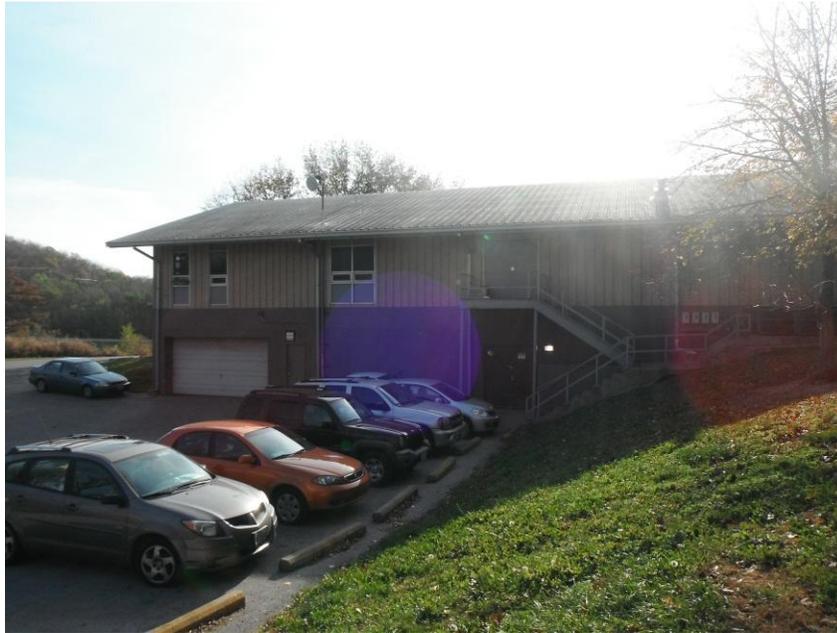
TETRA TECH PROJECT NO. X9004.06.0002.015.022 DIRECTION: East	DESCRIPTION	This photograph shows the west side of the subject property building.	9
	CLIENT	Environmental Protection Agency - Region 7	DATE 11/2/12
	PHOTOGRAPHER	Kaitlyn Bahr

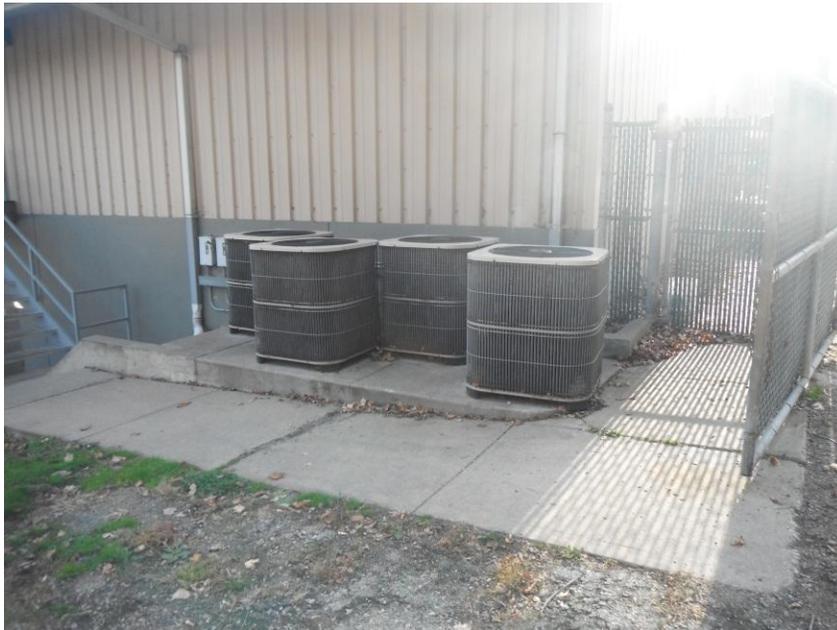
TETRA TECH PROJECT NO. X9004.06.0002.015.022 DIRECTION: East	DESCRIPTION	This photograph shows four air conditioning units on the west side of the subject property building.	10
	CLIENT	Environmental Protection Agency - Region 7	DATE 11/2/12
	PHOTOGRAPHER	Kaitlyn Bahr

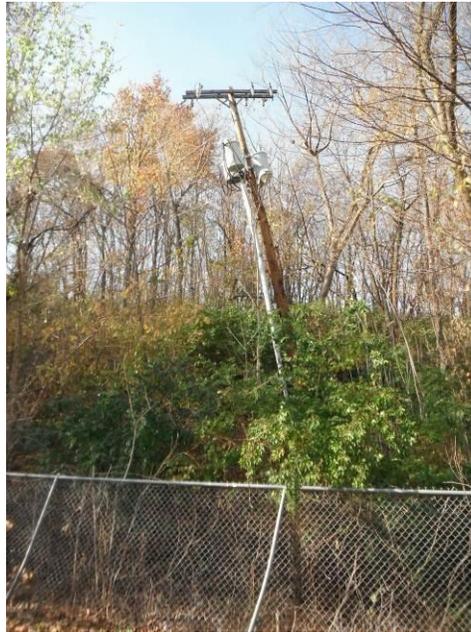
<p>TETRA TECH PROJECT NO. X9004.06.0002.015.022</p> <p>DIRECTION: South</p>	DESCRIPTION	This photograph shows a pole-mounted transformer labeled “no-polychlorinated biphenyls (PCB)” on the southern boundary of the subject property.	11
	CLIENT	Environmental Protection Agency - Region 7	DATE
	PHOTOGRAPHER	Kaitlyn Bahr	11/2/12

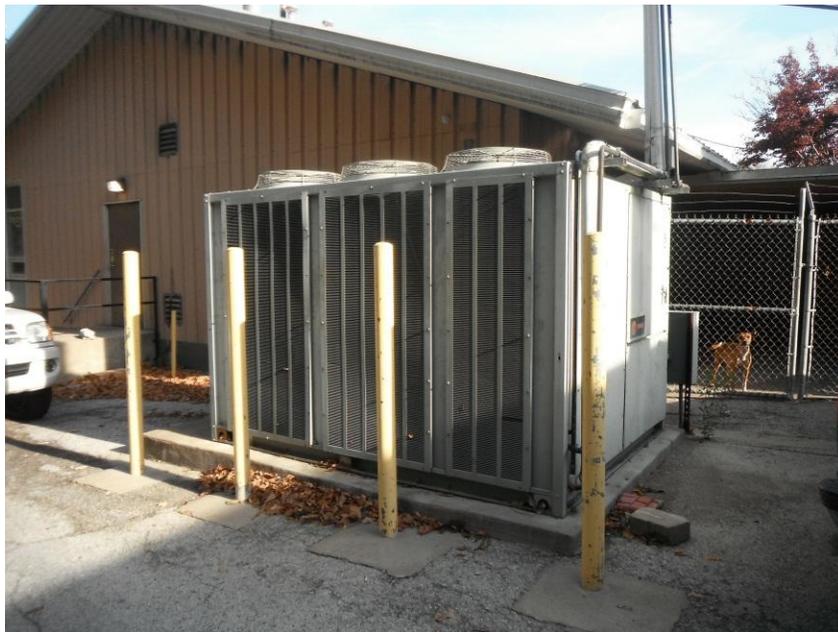
<p>TETRA TECH PROJECT NO. X9004.06.0002.015.022</p> <p>DIRECTION: North</p>	DESCRIPTION	This photograph shows a large cooling unit on the south side of the subject property building.	12
	CLIENT	Environmental Protection Agency - Region 7	DATE
	PHOTOGRAPHER	Kaitlyn Bahr	11/2/12

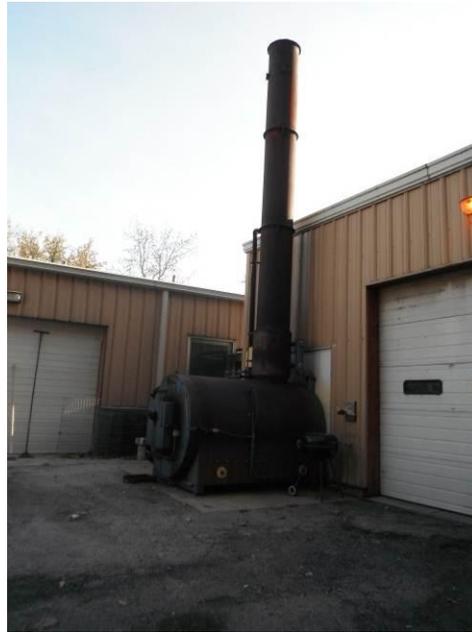
TETRA TECH PROJECT NO. X9004.06.0002.015.022 DIRECTION: North	DESCRIPTION	This photograph shows the incinerator smokestack on the south side of the subject property building.	13
	CLIENT	Environmental Protection Agency - Region 7	DATE 11/2/12
	PHOTOGRAPHER	Kaitlyn Bahr

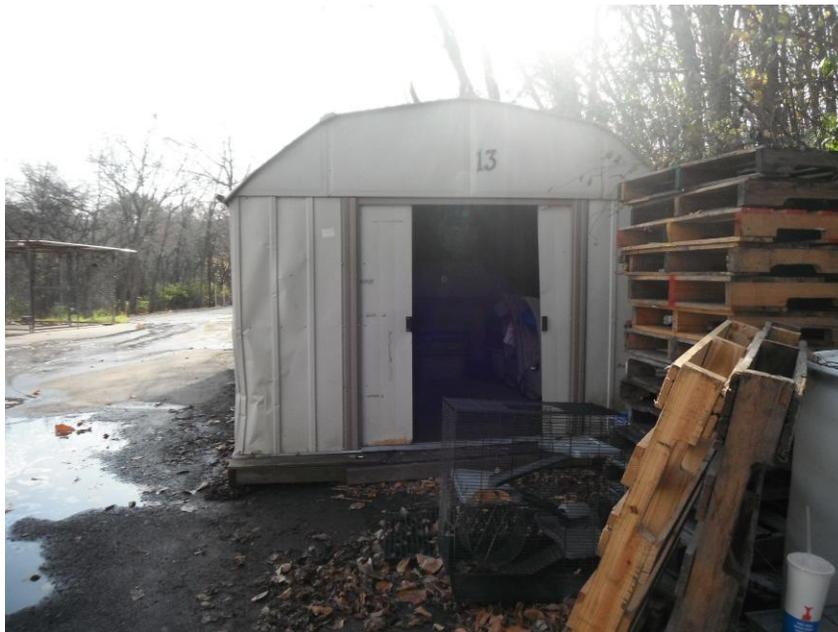
TETRA TECH PROJECT NO. X9004.06.0002.015.022 DIRECTION: North	DESCRIPTION	This photograph shows a storage shed and wooden pallets on the west side of the subject property building.	14
	CLIENT	Environmental Protection Agency - Region 7	DATE 11/2/12
	PHOTOGRAPHER	Kaitlyn Bahr

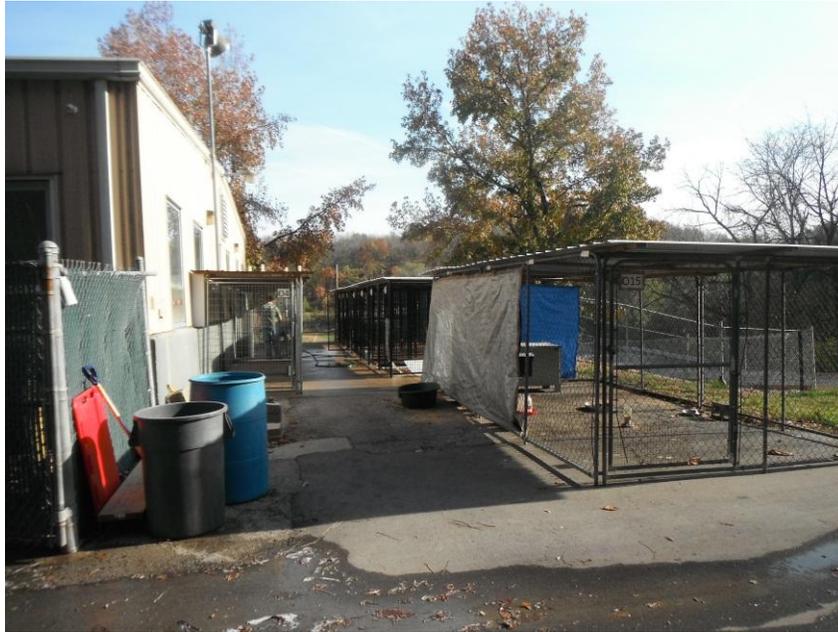
TETRA TECH PROJECT NO. X9004.06.0002.015.022 DIRECTION: North	DESCRIPTION	This photograph shows kennels on the eastern side of the subject property.	15
	CLIENT	Environmental Protection Agency - Region 7	DATE 11/2/12
	PHOTOGRAPHER	Kaitlyn Bahr

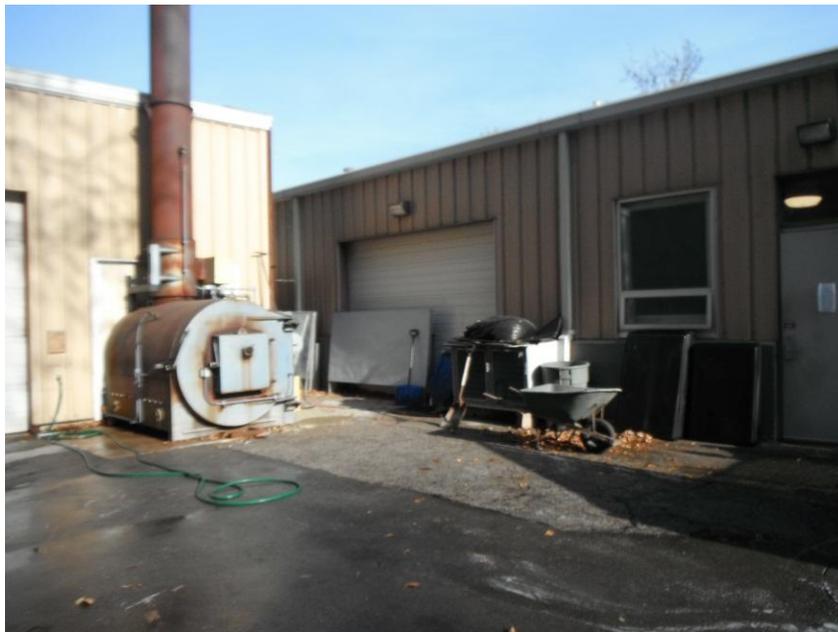
TETRA TECH PROJECT NO. X9004.06.0002.015.022 DIRECTION: Southwest	DESCRIPTION	This photograph shows the incinerator smoke stack on the east side of the subject property building.	16
	CLIENT	Environmental Protection Agency - Region 7	DATE 11/2/12
	PHOTOGRAPHER	Kaitlyn Bahr

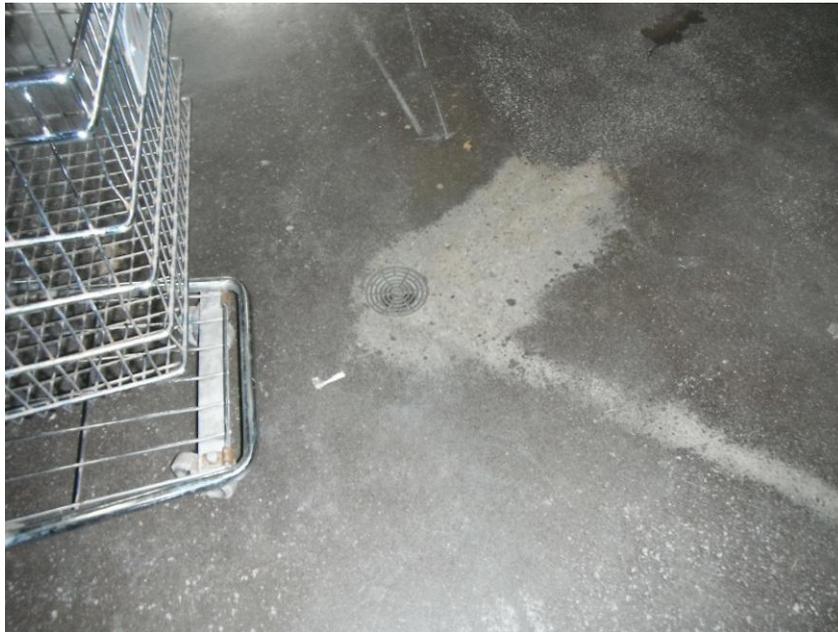
TETRA TECH PROJECT NO. X9004.06.0002.015.022 DIRECTION: East	DESCRIPTION	This photograph shows a floor drain in the garage on the east side of the subject property building.	17
	CLIENT	Environmental Protection Agency - Region 7	DATE 11/2/12
	PHOTOGRAPHER	Kaitlyn Bahr

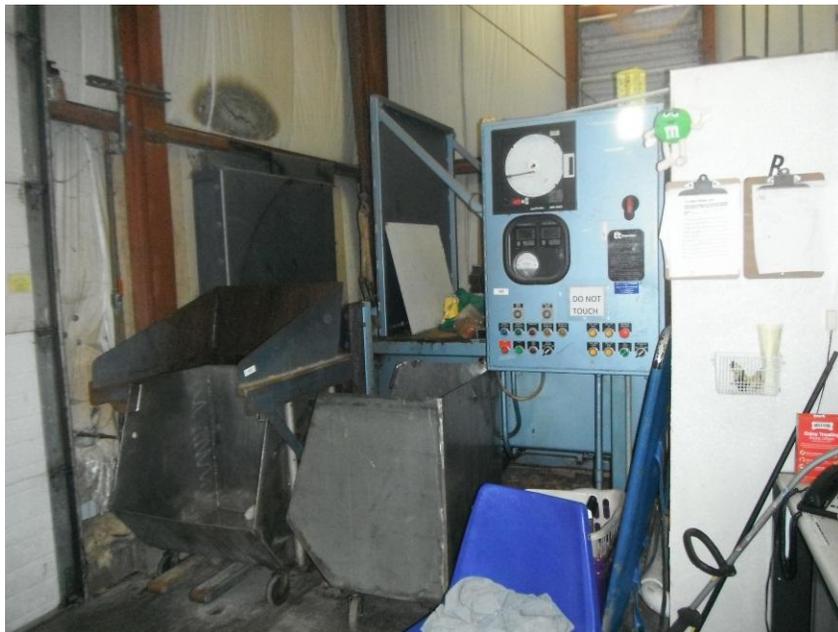
TETRA TECH PROJECT NO. X9004.06.0002.015.022 DIRECTION: Southwest	DESCRIPTION	This photograph shows the incinerator inside the garage on the east side of the subject property building.	18
	CLIENT	Environmental Protection Agency - Region 7	DATE 11/2/12
	PHOTOGRAPHER	Kaitlyn Bahr

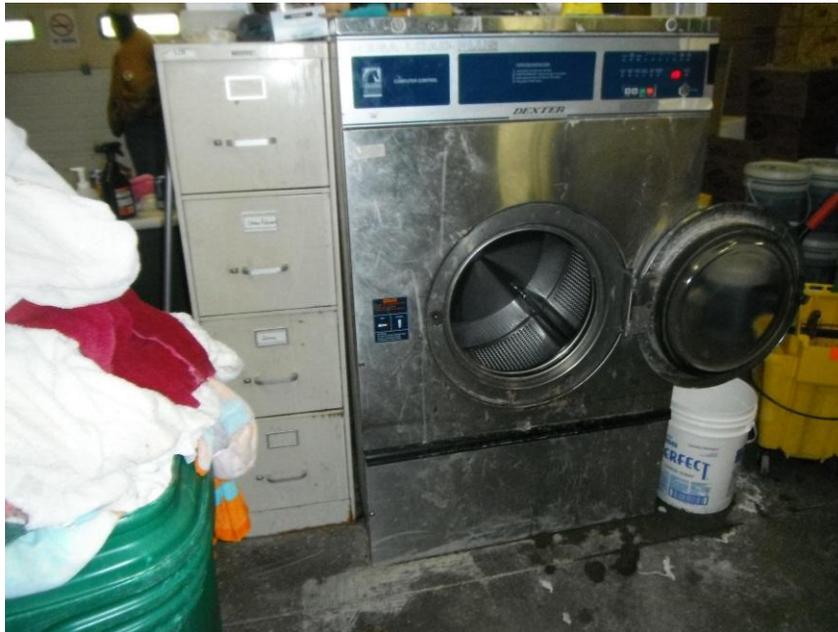
TETRA TECH PROJECT NO. X9004.06.0002.015.022 DIRECTION: North	DESCRIPTION	This photograph shows an industrial size washing machine in the garage on the east side of the subject property building.	19
	CLIENT	Environmental Protection Agency - Region 7	DATE 11/2/12
	PHOTOGRAPHER	Kaitlyn Bahr

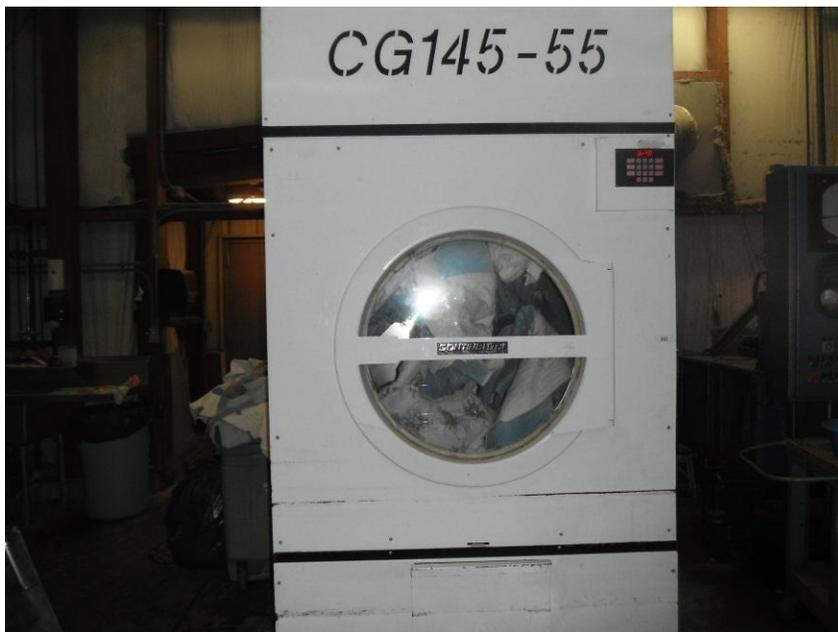
TETRA TECH PROJECT NO. X9004.06.0002.015.022 DIRECTION: North	DESCRIPTION	This photograph shows an industrial size dryer in the garage on the east side of the subject property building.	20
	CLIENT	Environmental Protection Agency - Region 7	DATE 11/2/12
	PHOTOGRAPHER	Kaitlyn Bahr

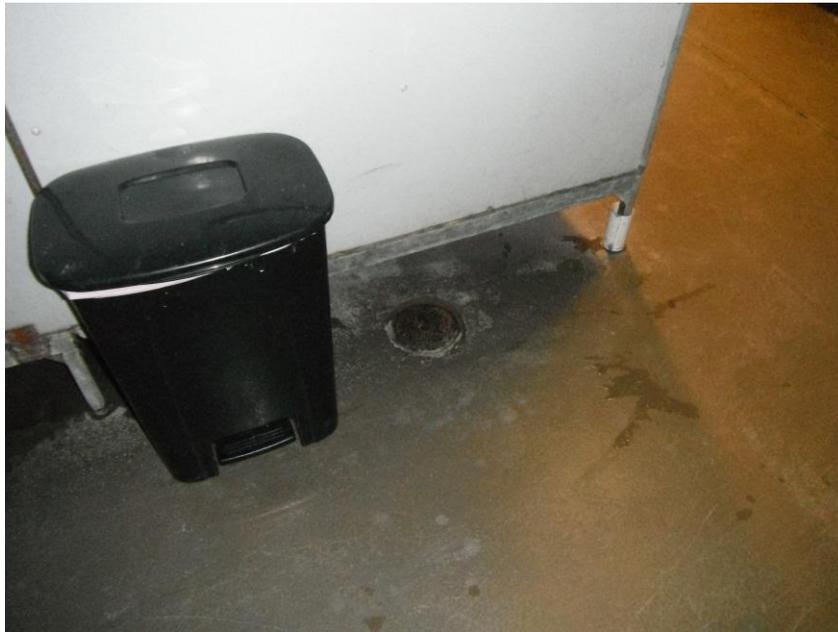
TETRA TECH PROJECT NO. X9004.06.0002.015.022 DIRECTION: North	DESCRIPTION	This photograph shows a floor drain in the dog kennel area of the subject property building.	21
	CLIENT	Environmental Protection Agency - Region 7	DATE 11/2/12
	PHOTOGRAPHER	Kaitlyn Bahr

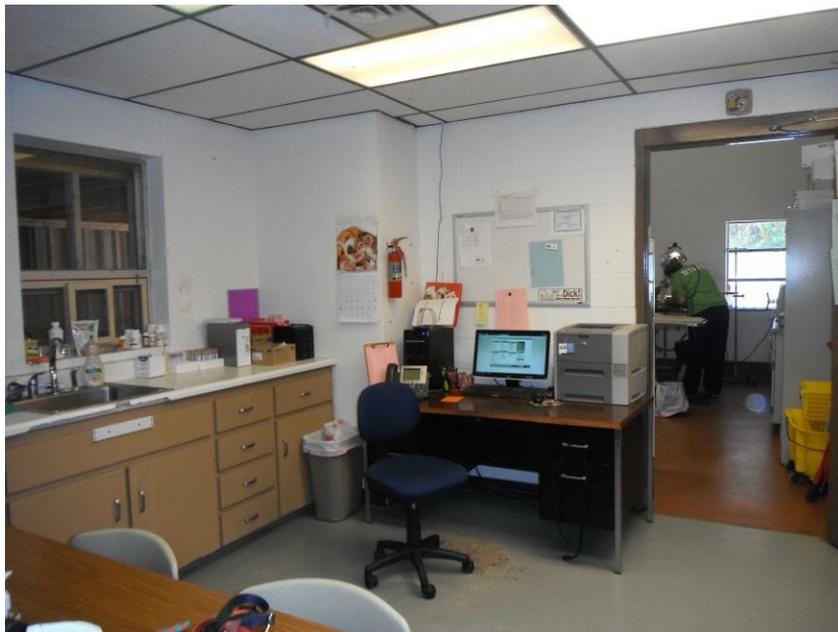
TETRA TECH PROJECT NO. X9004.06.0002.015.022 DIRECTION: South	DESCRIPTION	This photograph shows the office area with the surgery room beyond inside the subject property building.	22
	CLIENT	Environmental Protection Agency - Region 7	DATE 11/2/12
	PHOTOGRAPHER	Kaitlyn Bahr

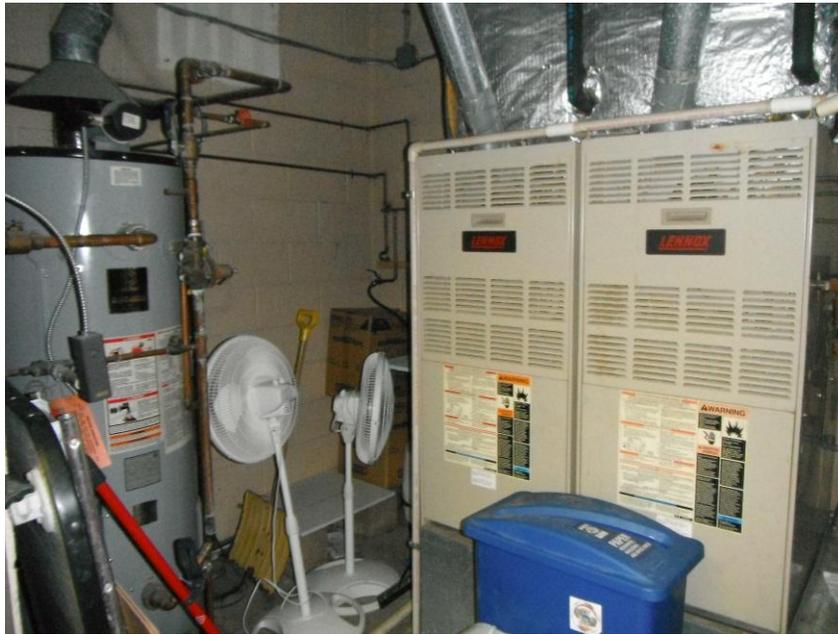
TETRA TECH PROJECT NO. X9004.06.0002.015.022 DIRECTION: North	DESCRIPTION	This photograph shows the furnace and water heater in a storage closet in the subject property building.	23
	CLIENT	Environmental Protection Agency - Region 7	DATE 11/2/12
	PHOTOGRAPHER	Kaitlyn Bahr

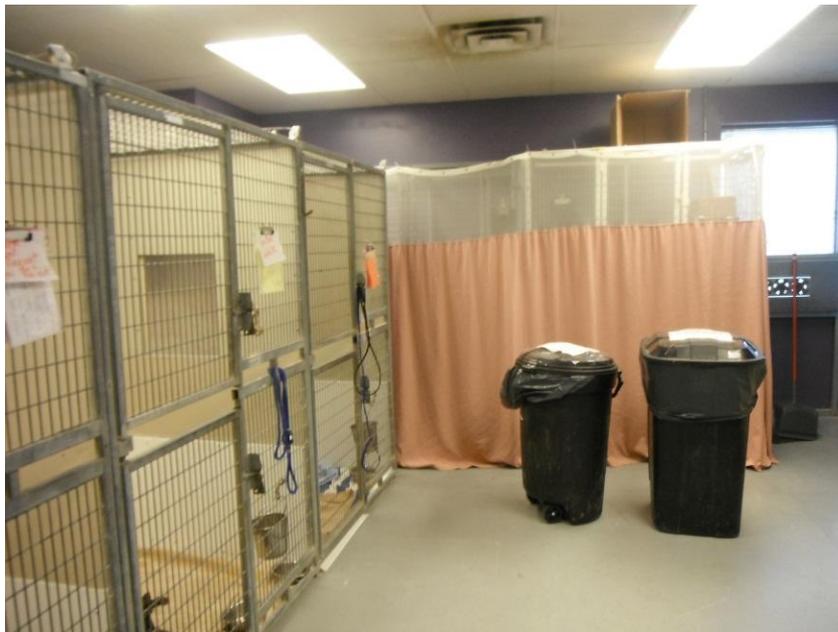
TETRA TECH PROJECT NO. X9004.06.0002.015.022 DIRECTION: South	DESCRIPTION	This photograph shows one of the dog kennel rooms in the subject property building.	24
	CLIENT	Environmental Protection Agency - Region 7	DATE 11/2/12
	PHOTOGRAPHER	Kaitlyn Bahr

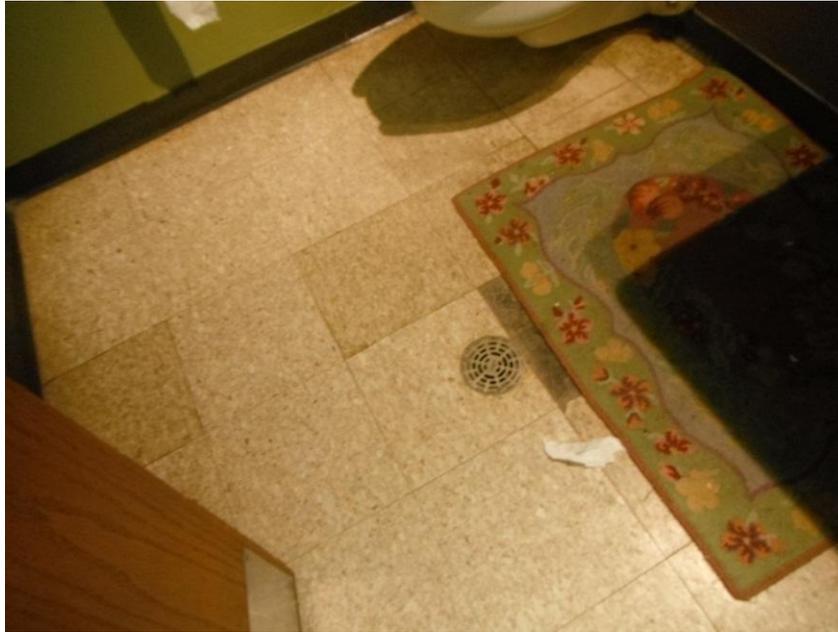
TETRA TECH PROJECT NO. X9004.06.0002.015.022 DIRECTION: South	DESCRIPTION	This photograph shows a floor drain in the women's bathroom in the subject property building.	25
	CLIENT	Environmental Protection Agency - Region 7	DATE 11/2/12
	PHOTOGRAPHER	Kaitlyn Bahr

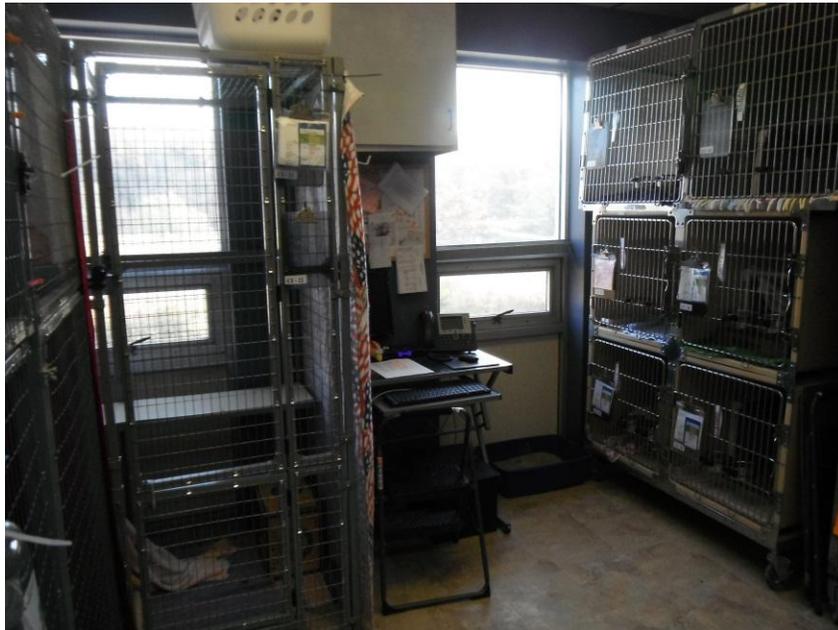
TETRA TECH PROJECT NO. X9004.06.0002.015.022 DIRECTION: South	DESCRIPTION	This photograph shows the cat kennel room in the subject property building.	26
	CLIENT	Environmental Protection Agency - Region 7	DATE 11/2/12
	PHOTOGRAPHER	Kaitlyn Bahr
