**OFFICIAL PHOTOGRAPH NO. 1  
U.S. ENVIRONMENTAL PROTECTION AGENCY (EPA)**

**TDD Number:** TTEMI-05-001-0186                      **Location:** Royster Guano Removal  
**Orientation:** West    **Date:** August 3, 2012  
**Photographer:** Brian Croft, Tetra Tech                      **Witness:** Didi Fung, Tetra Tech  
**Subject:** Tetra Tech conducted lead and arsenic screening at residential properties.

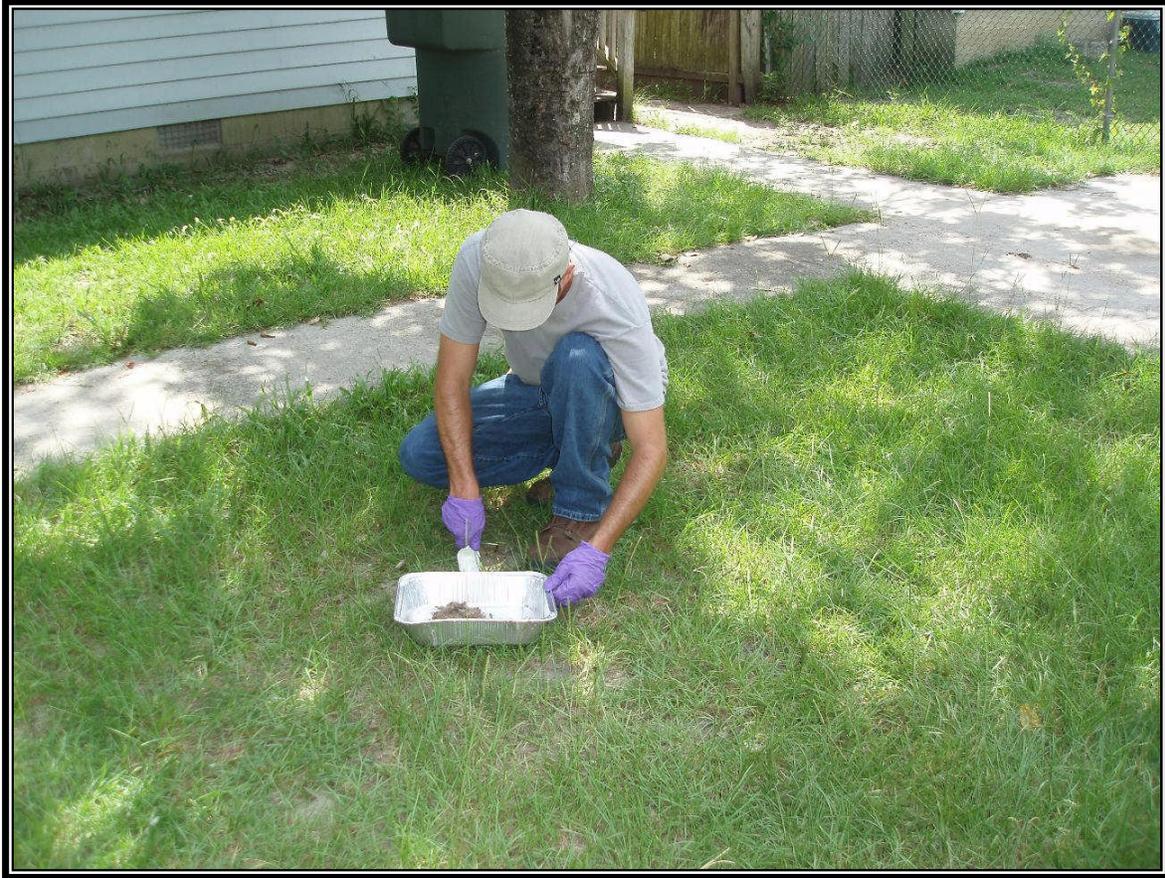
**OFFICIAL PHOTOGRAPH NO. 2**  
**U.S. ENVIRONMENTAL PROTECTION AGENCY**

**Subject:** Tetra Tech collected composite soil samples from residential properties for laboratory analysis.

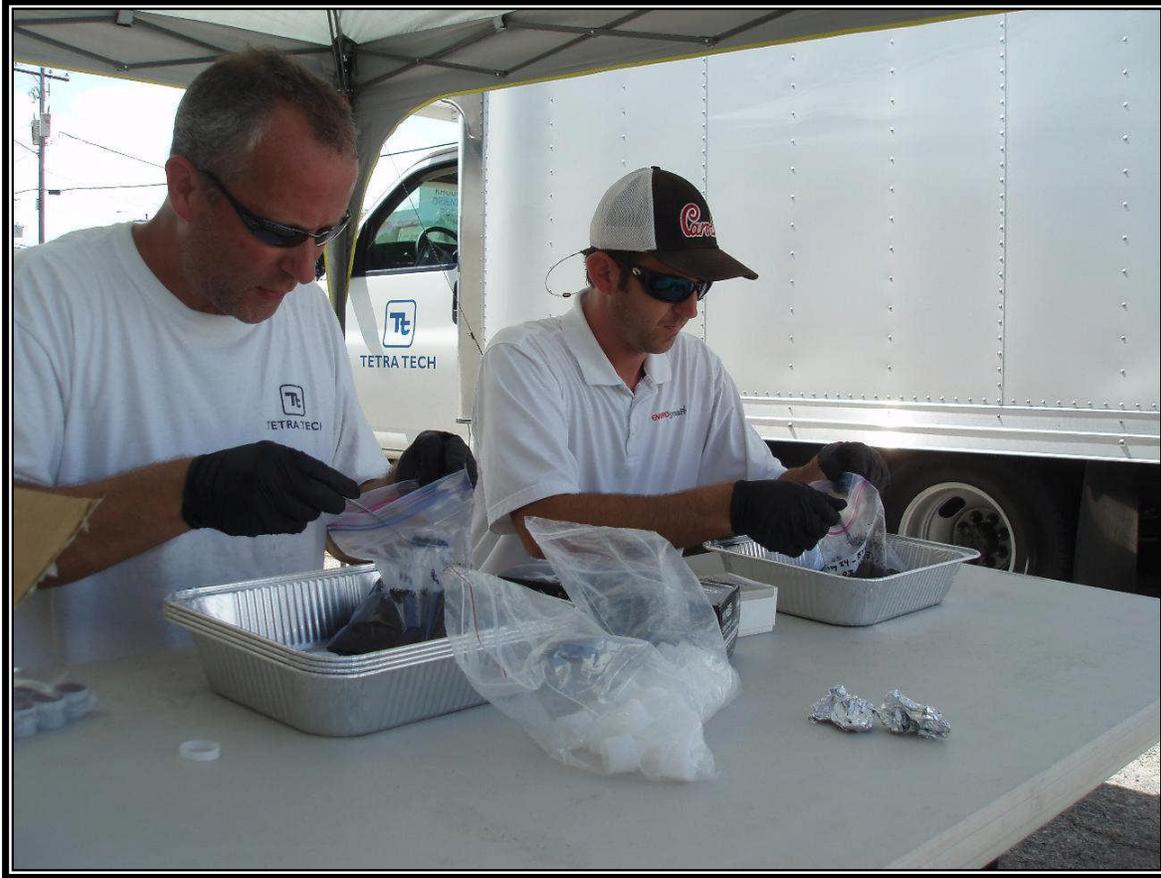
**OFFICIAL PHOTOGRAPH NO. 3**  
**U.S. ENVIRONMENTAL PROTECTION AGENCY**

**Subject:** Tetra Tech prepared soil sample containers for X-ray fluorescence (XRF) lead and arsenic screening.

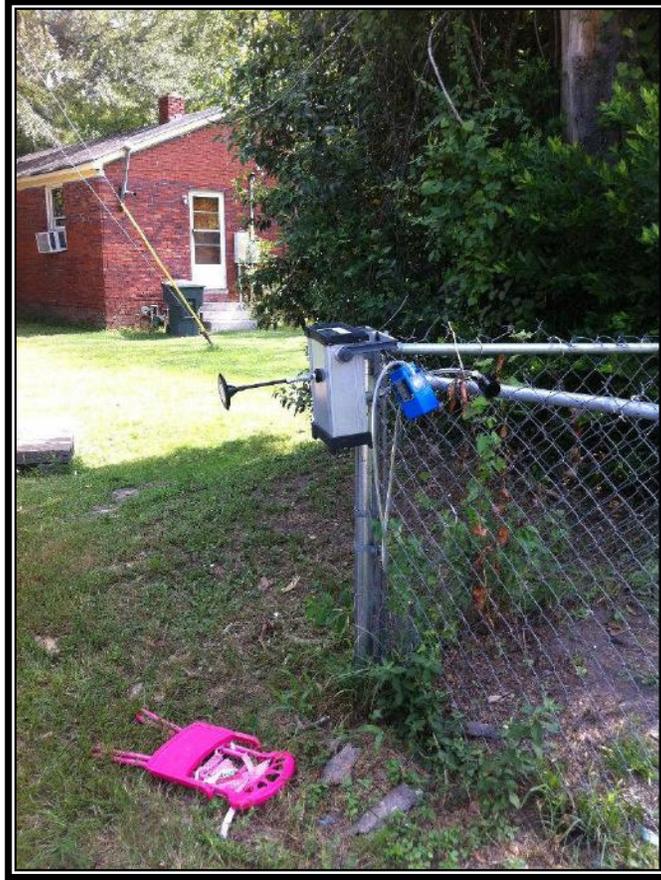
**OFFICIAL PHOTOGRAPH NO. 4**  
**U.S. ENVIRONMENTAL PROTECTION AGENCY**

**Subject:** Air sampling and particulate monitoring was conducted in the Edisto Court community during the removal investigation.

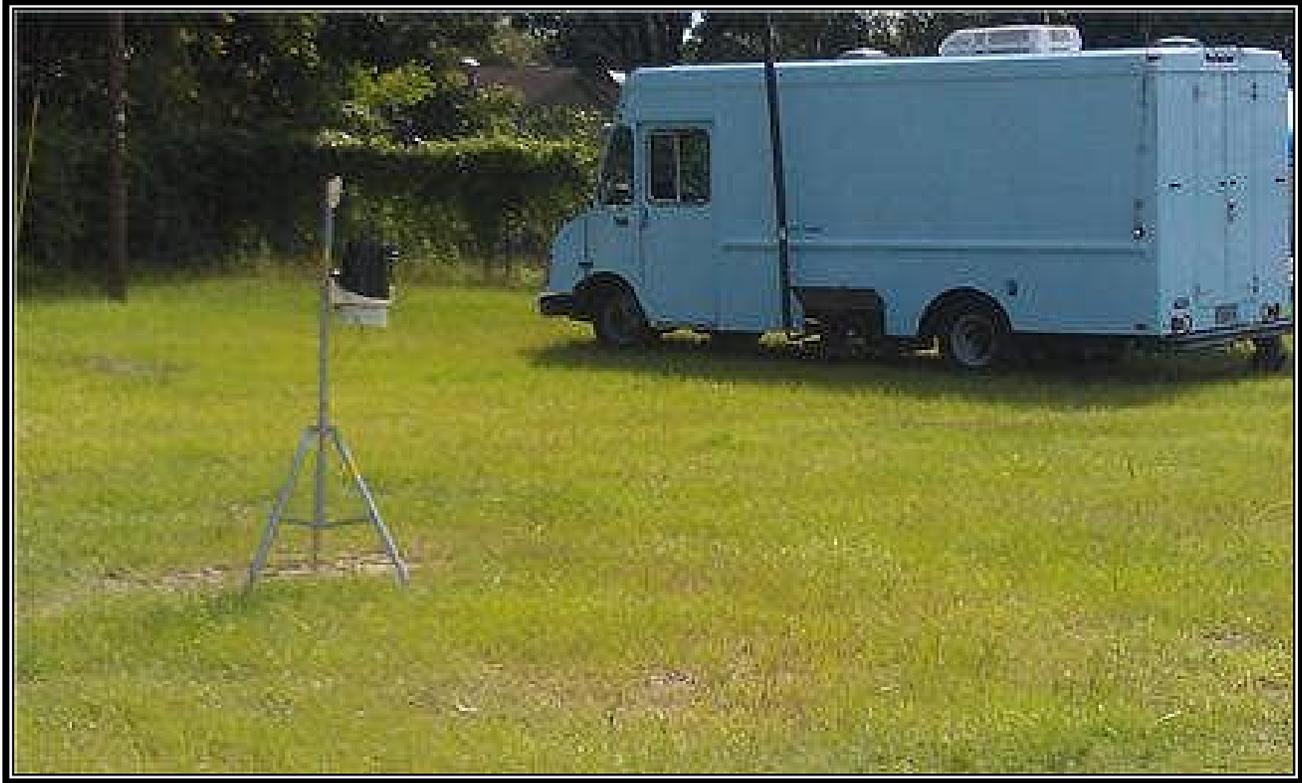
**OFFICIAL PHOTOGRAPH NO. 5  
U.S. ENVIRONMENTAL PROTECTION AGENCY**

**TDD Number:** TTEMI-05-001-0186                      **Location:** Royster Guano Removal  
**Orientation:** North West                                      **Date:** August 4, 2012  
**Photographer:** Didi Fung, Tetra Tech                      **Witness:** Brian Croft, Tetra Tech  
**Subject:** A meteorological station was deployed to document local wind direction.

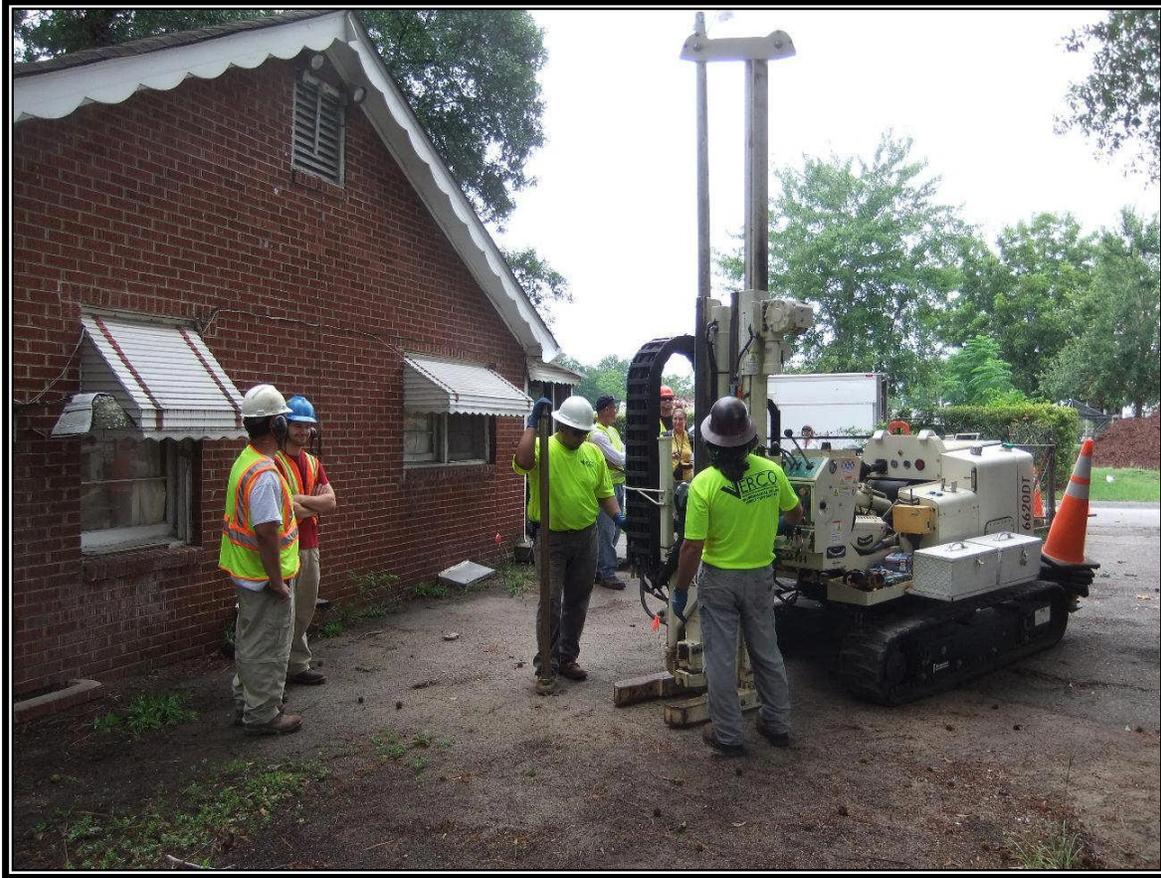
**OFFICIAL PHOTOGRAPH NO. 6**  
**U.S. ENVIRONMENTAL PROTECTION AGENCY**

**Subject:** A geoprobe was used to provide XRF ex situ screening access at soil depths of 3 inches below ground surface (bgs), 12 inches bgs, and 24 inches bgs at 27 residential properties.

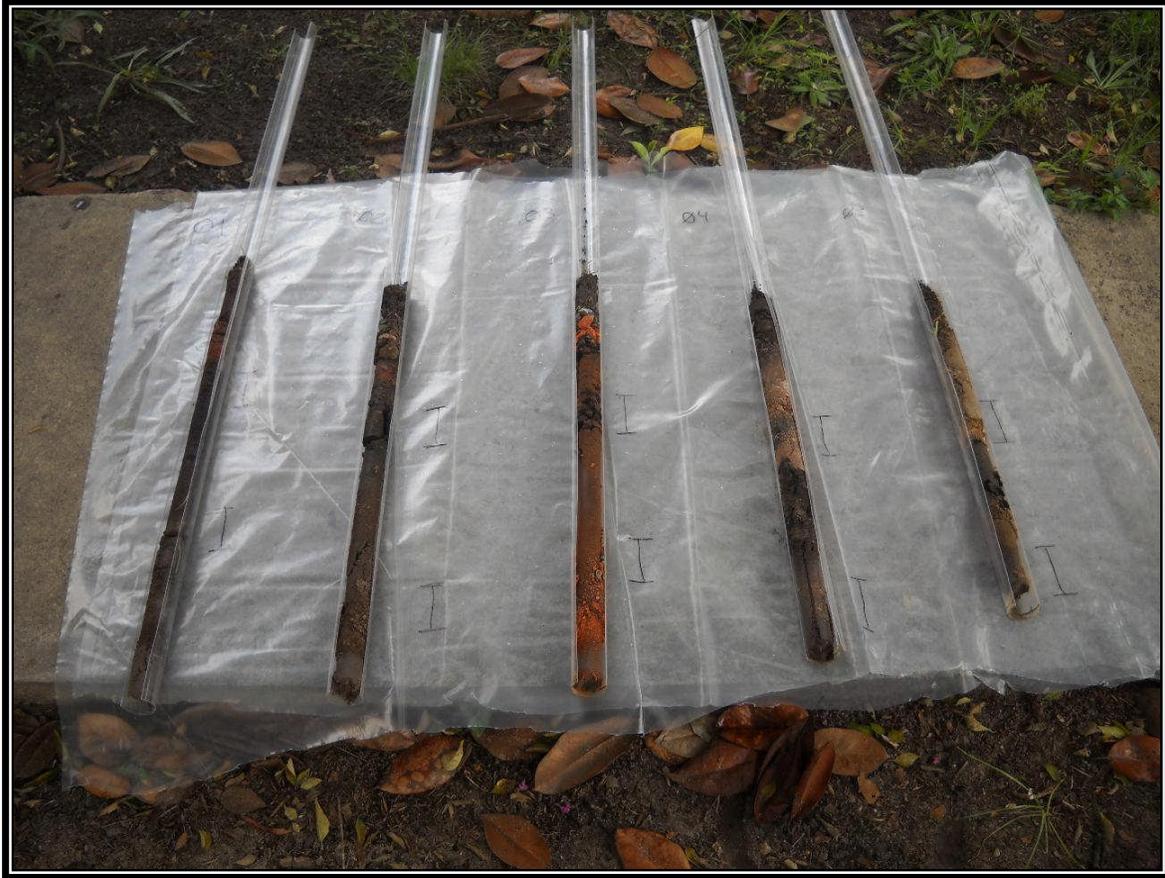
**OFFICIAL PHOTOGRAPH NO. 7  
U.S. ENVIRONMENTAL PROTECTION AGENCY**

**Subject:** Soil cores from the geoprobe were sampled at select intervals, as indicated.

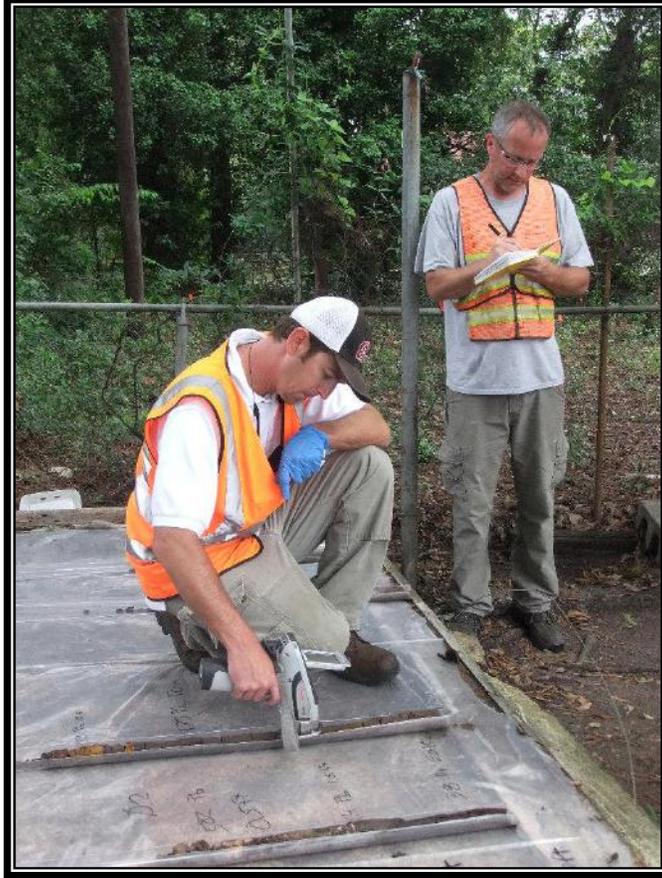
**OFFICIAL PHOTOGRAPH NO. 8**  
**U.S. ENVIRONMENTAL PROTECTION AGENCY**

**Subject:** Soil cores were screened for lead and arsenic using XRF in situ during assessment activities.

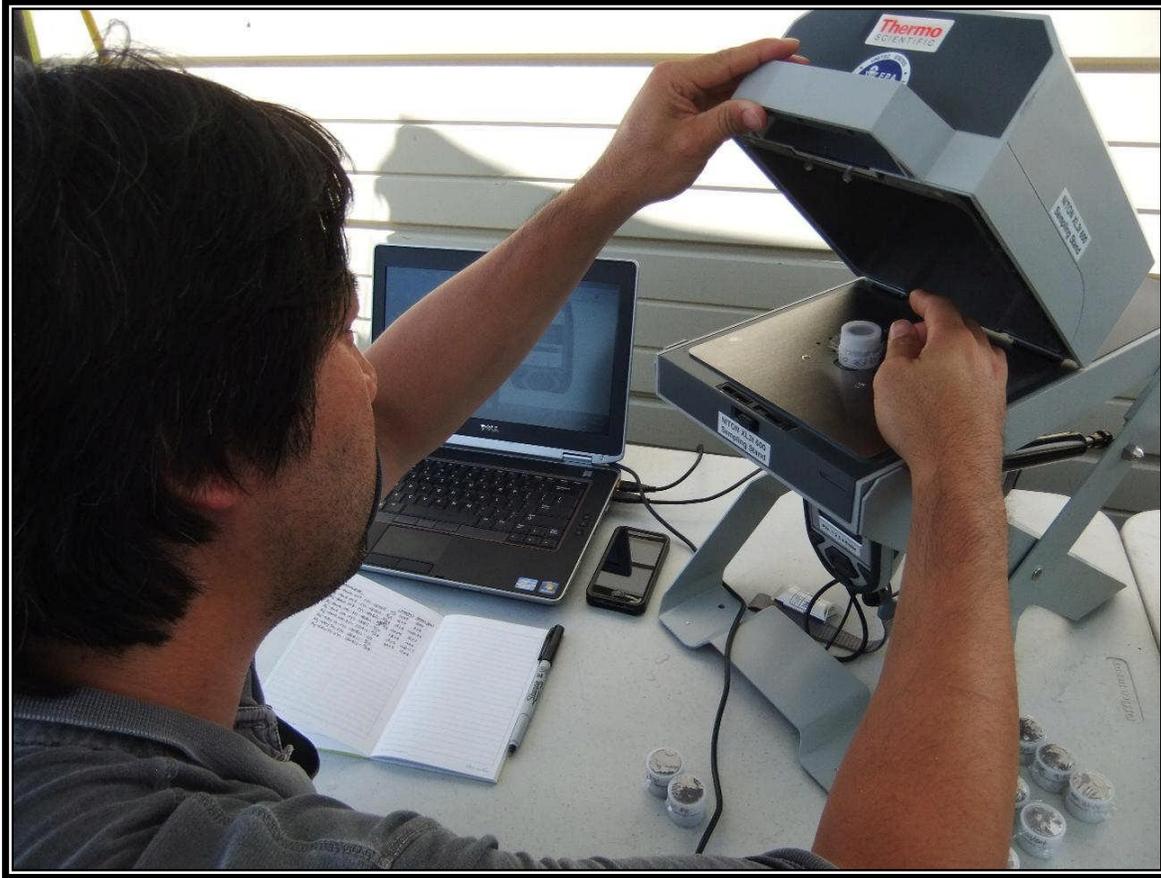
**OFFICIAL PHOTOGRAPH NO. 9  
U.S. ENVIRONMENTAL PROTECTION AGENCY**

**Subject:** Soil samples were also screened for lead and arsenic using XRF ex situ during assessment activities.

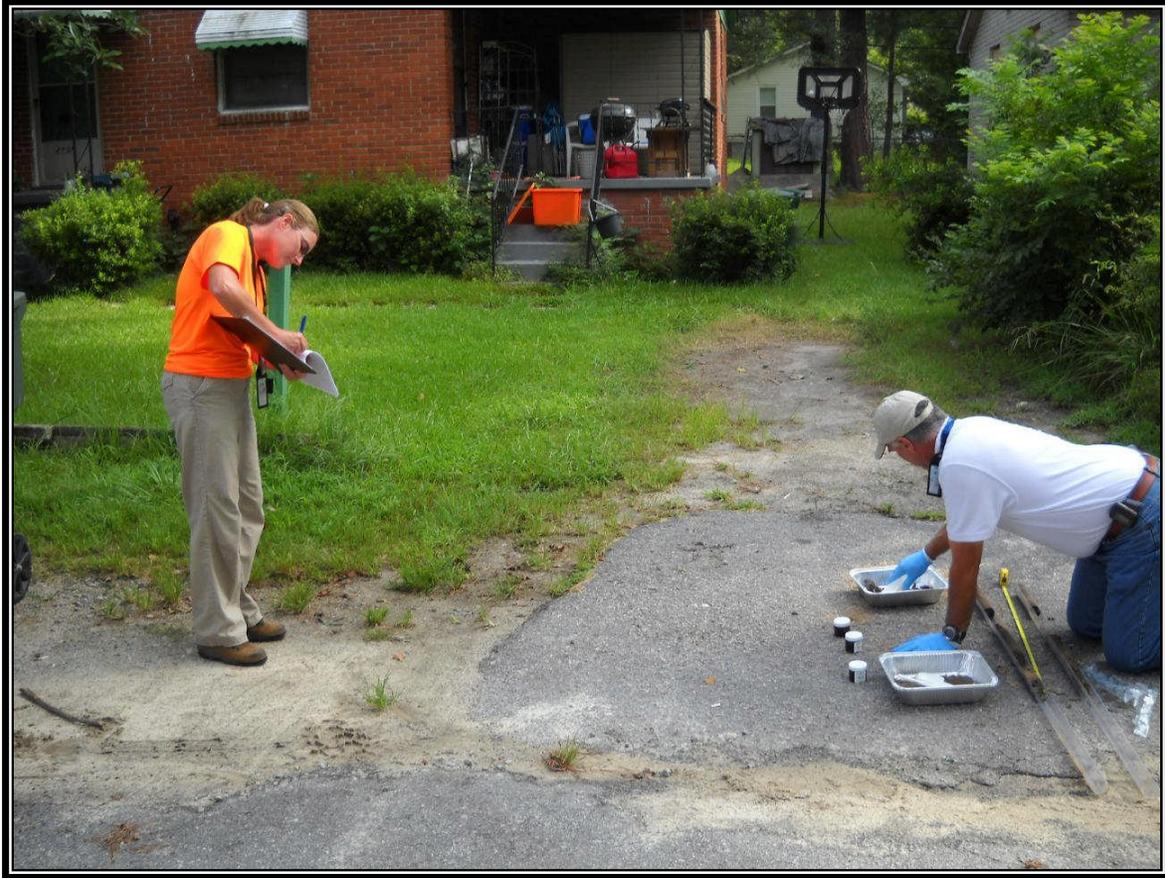
**OFFICIAL PHOTOGRAPH NO. 10  
U.S. ENVIRONMENTAL PROTECTION AGENCY**

**Subject:** The South Carolina Department of Health & Environmental Control (SCDHEC) collected and logged soil samples during assessment activities.

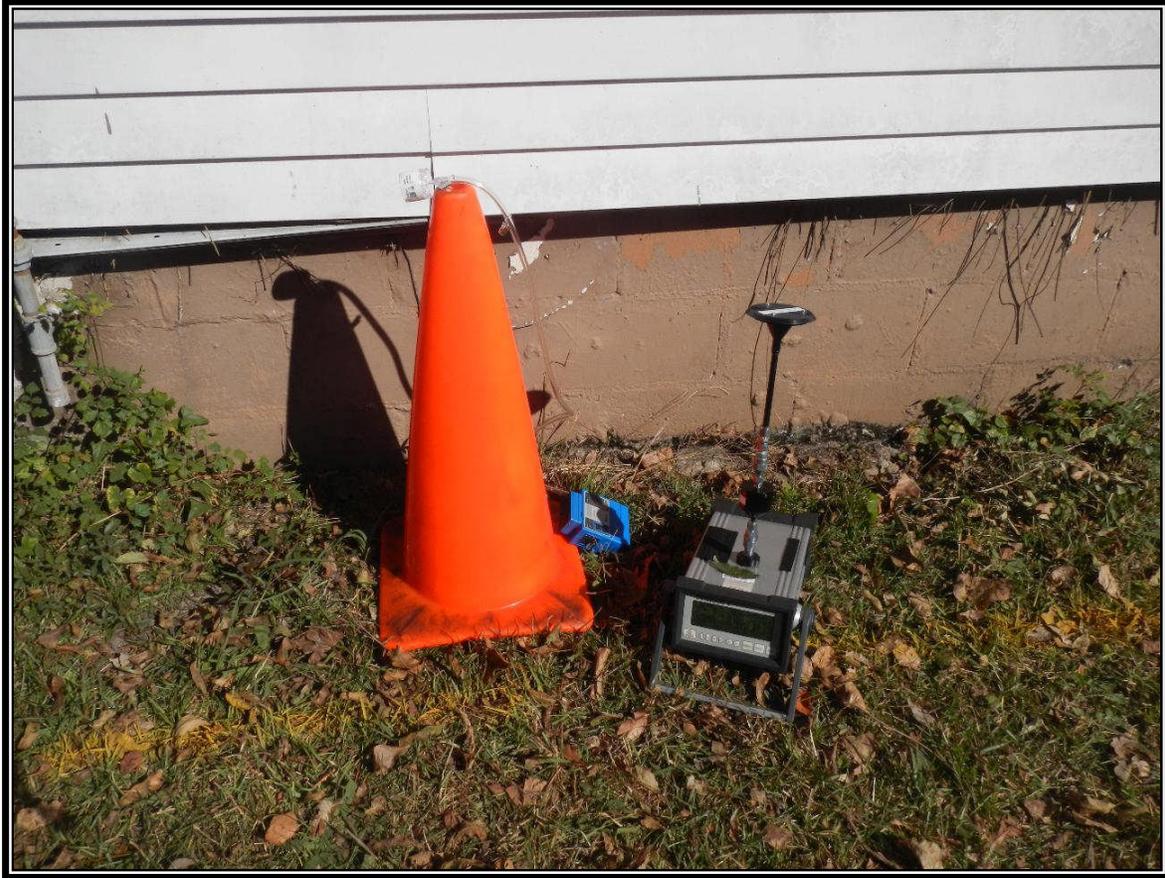
**OFFICIAL PHOTOGRAPH NO. 11  
U.S. ENVIRONMENTAL PROTECTION AGENCY**

**Subject:** A DataRAM particulate monitor was deployed and an air sample was collected upwind of the excavation at 1029 Howe St.

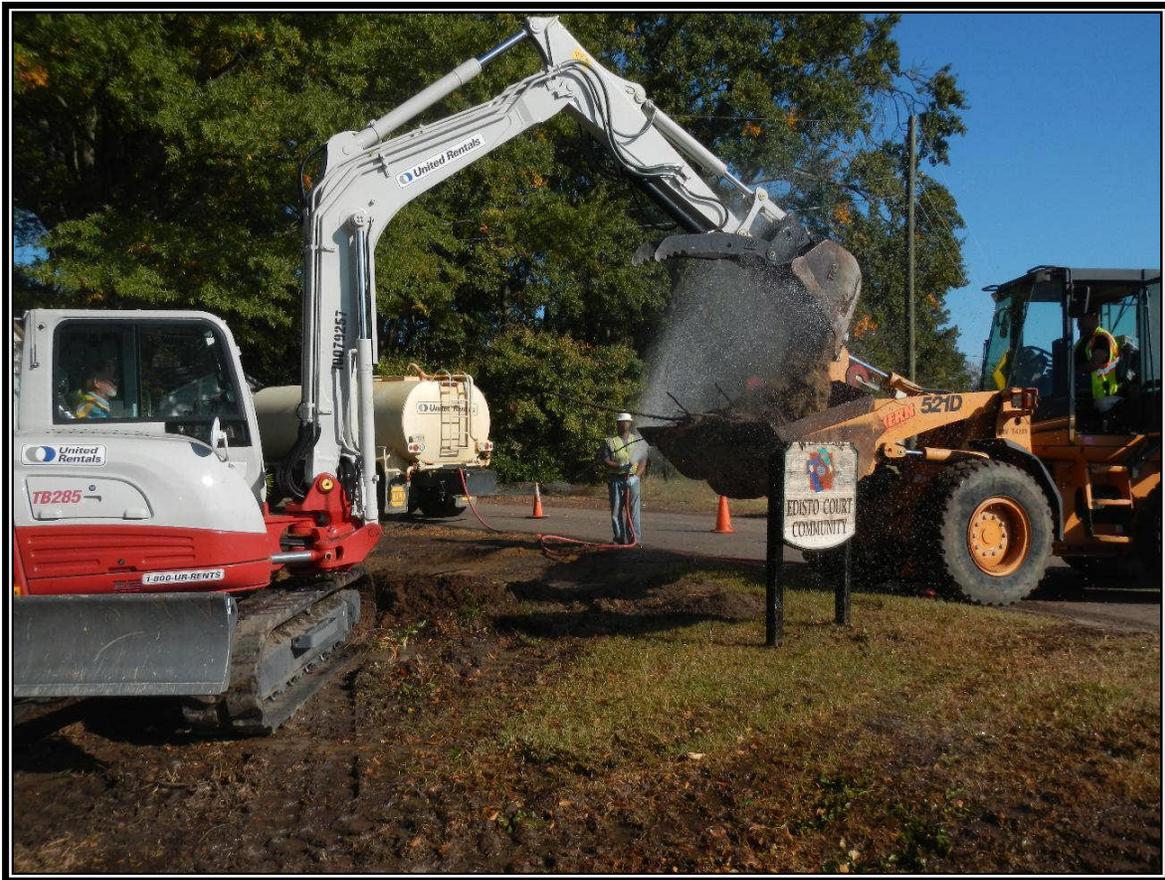
**OFFICIAL PHOTOGRAPH NO. 12  
U.S. ENVIRONMENTAL PROTECTION AGENCY**

**TDD Number:** TTEMI-05-001-0186                      **Location:** Royster Guano Removal  
**Orientation:** East    **Date:** November 5, 2012  
**Photographer:** Bryan Vasser, Tetra Tech              **Witness:** Scott Garpiel, WRS Compass  
**Subject:** Excavation and dust suppression activities were conducted at 1049 Howe Street.

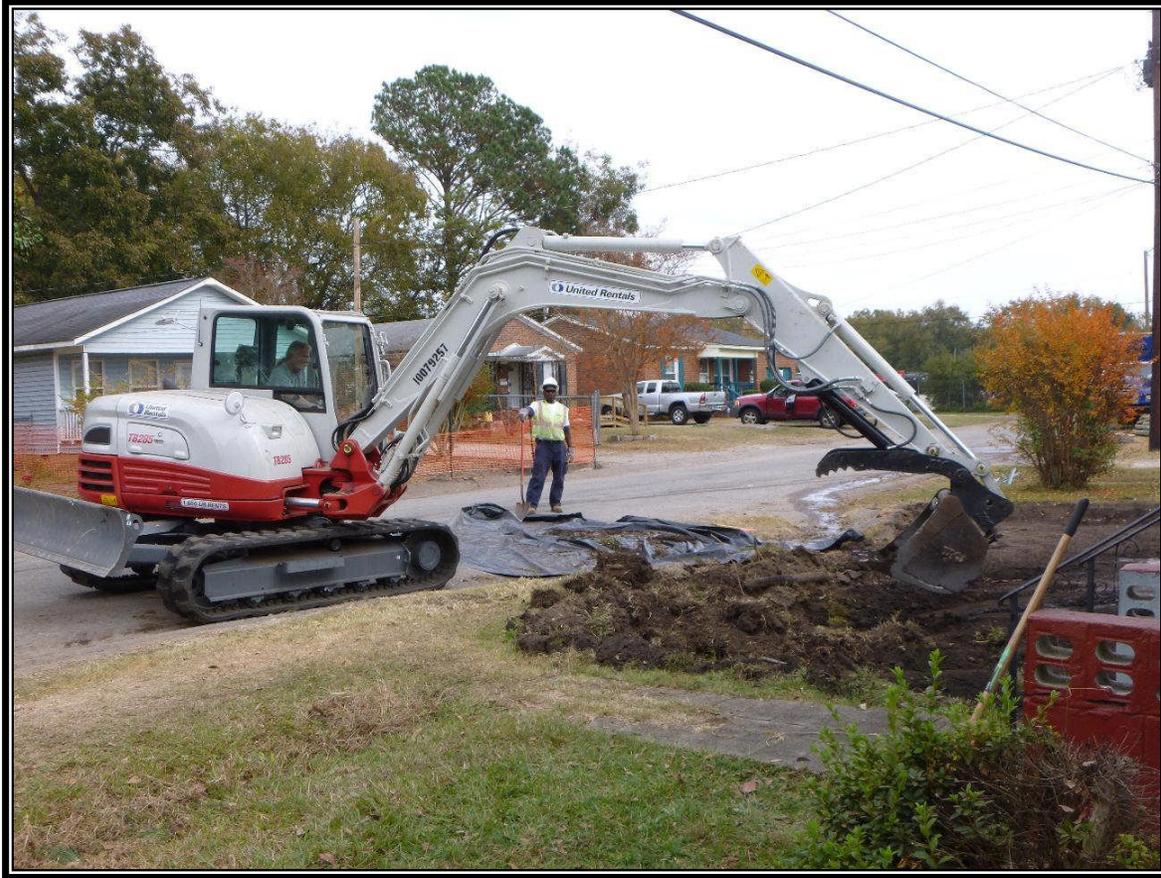
**OFFICIAL PHOTOGRAPH NO. 13  
U.S. ENVIRONMENTAL PROTECTION AGENCY**

**TDD Number:** TTEMI-05-001-0186                      **Location:** Royster Guano Removal  
**Orientation:** North East                                      **Date:** November 12, 2012  
**Photographer:** James Gooch, Tetra Tech                      **Witness:** Scott Garpiel, WRS Compass  
**Subject:** Excavation activities were conducted on Easy Street.

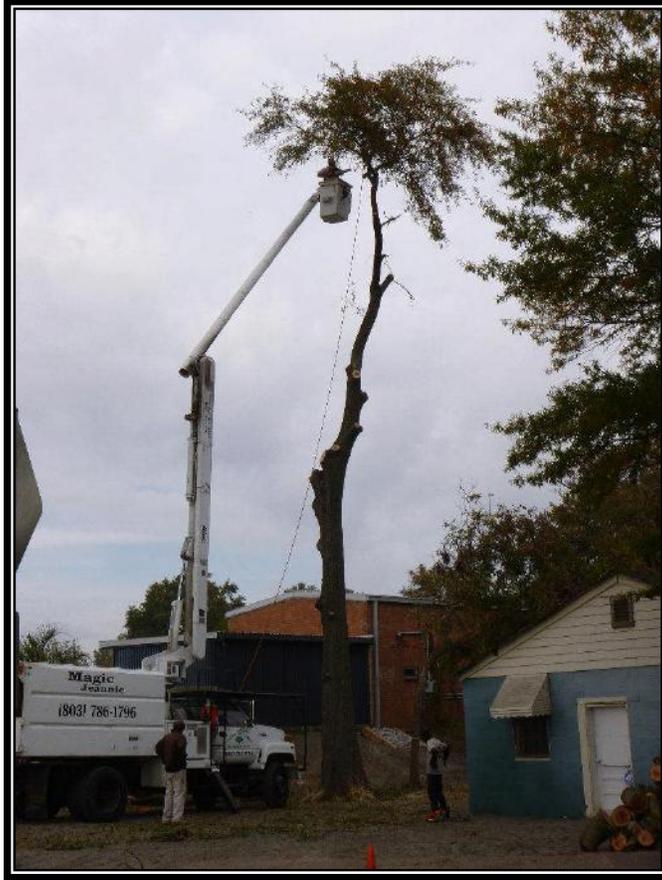
**OFFICIAL PHOTOGRAPH NO. 14  
U.S. ENVIRONMENTAL PROTECTION AGENCY**

**TDD Number:** TTEMI-05-001-0186                      **Location:** Royster Guano Removal  
**Orientation:** South    **Date:** November 12, 2012  
**Photographer:** James Gooch, Tetra Tech                      **Witness:** Scott Garpiel, WRS Compass  
**Subject:** Tree removal activities were conducted on Easy Street.

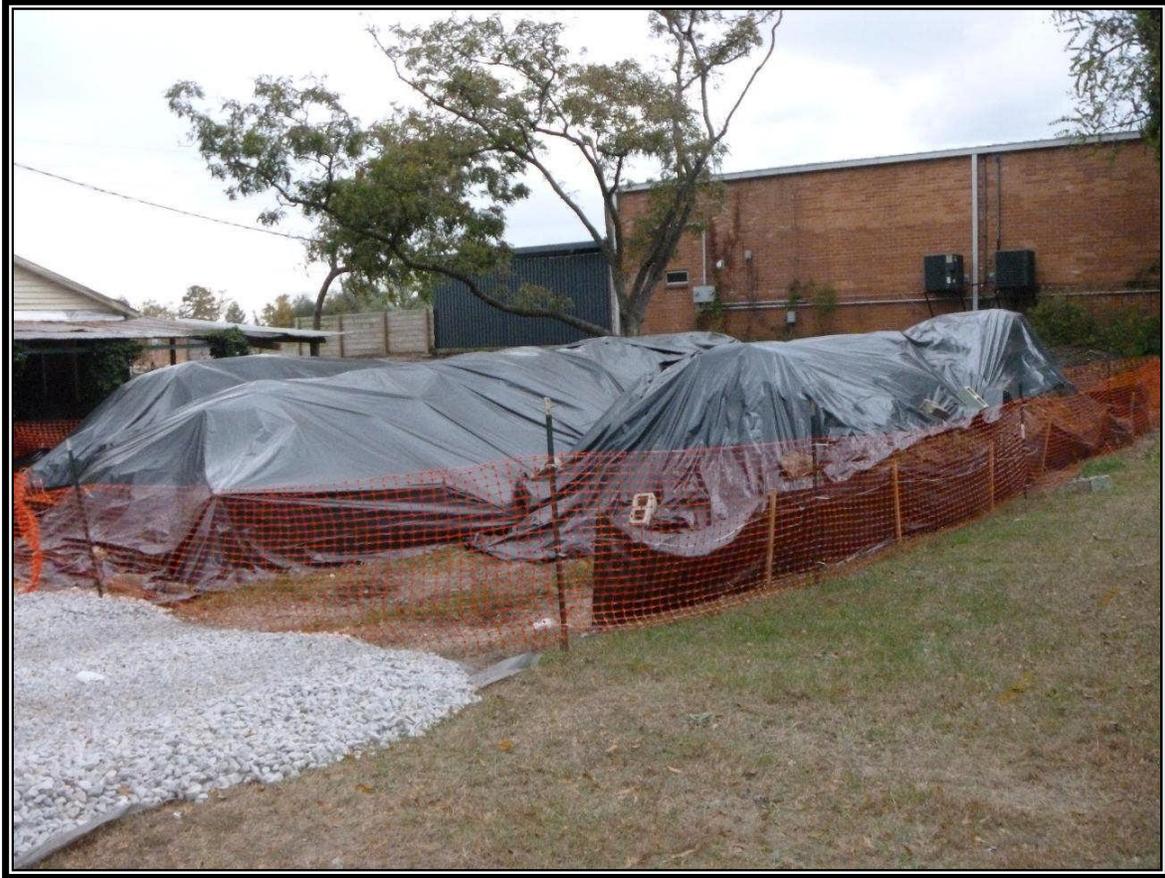
**OFFICIAL PHOTOGRAPH NO. 15**  
**U.S. ENVIRONMENTAL PROTECTION AGENCY**

**Subject:** A staging area for contaminated soil prior to offsite disposal was located at 1045 Howe Street.

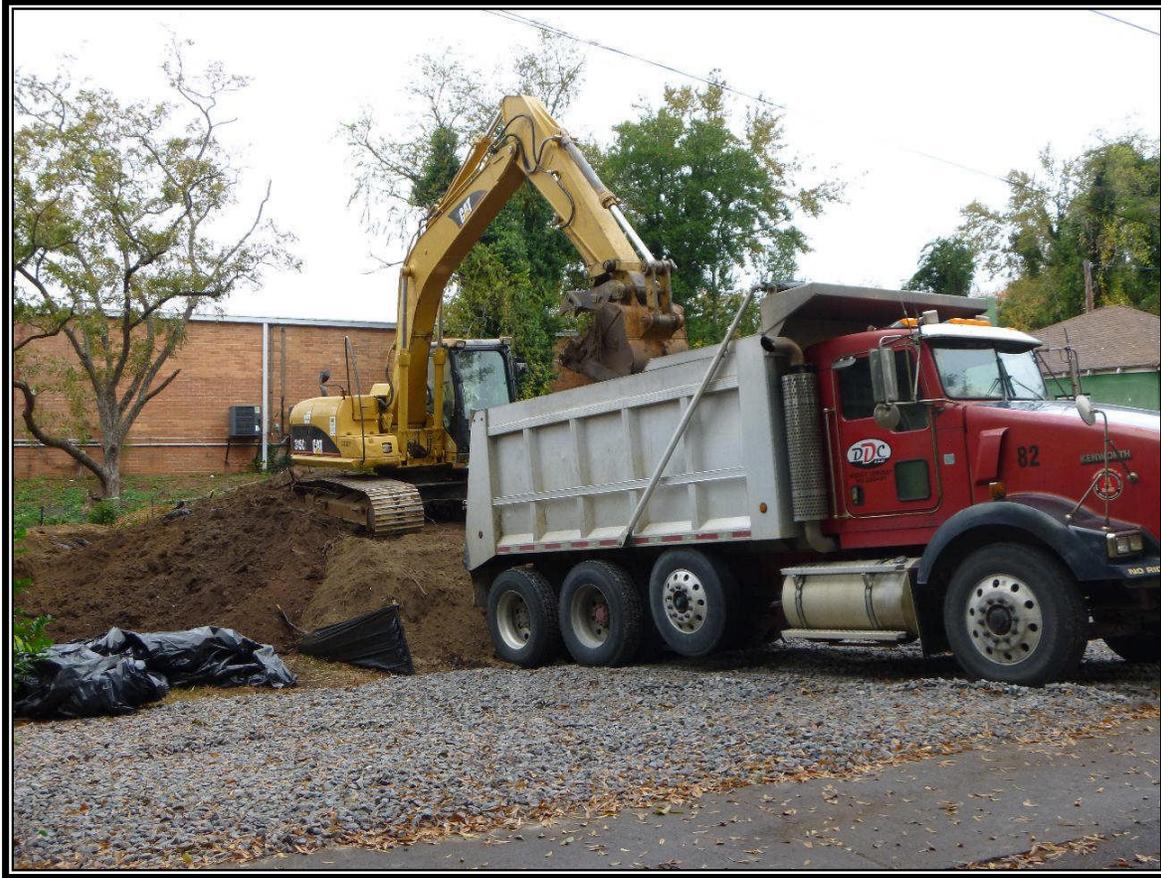
**OFFICIAL PHOTOGRAPH NO. 16  
U.S. ENVIRONMENTAL PROTECTION AGENCY**

**TDD Number:** TTEMI-05-001-0186                      **Location:** Royster Guano Removal  
**Orientation:** North West                                      **Date:** November 13, 2012  
**Photographer:** James Gooch, Tetra Tech                      **Witness:** Scott Garpiel, WRS Compass  
**Subject:** Contaminated soil from the staging area was loaded for offsite disposal.

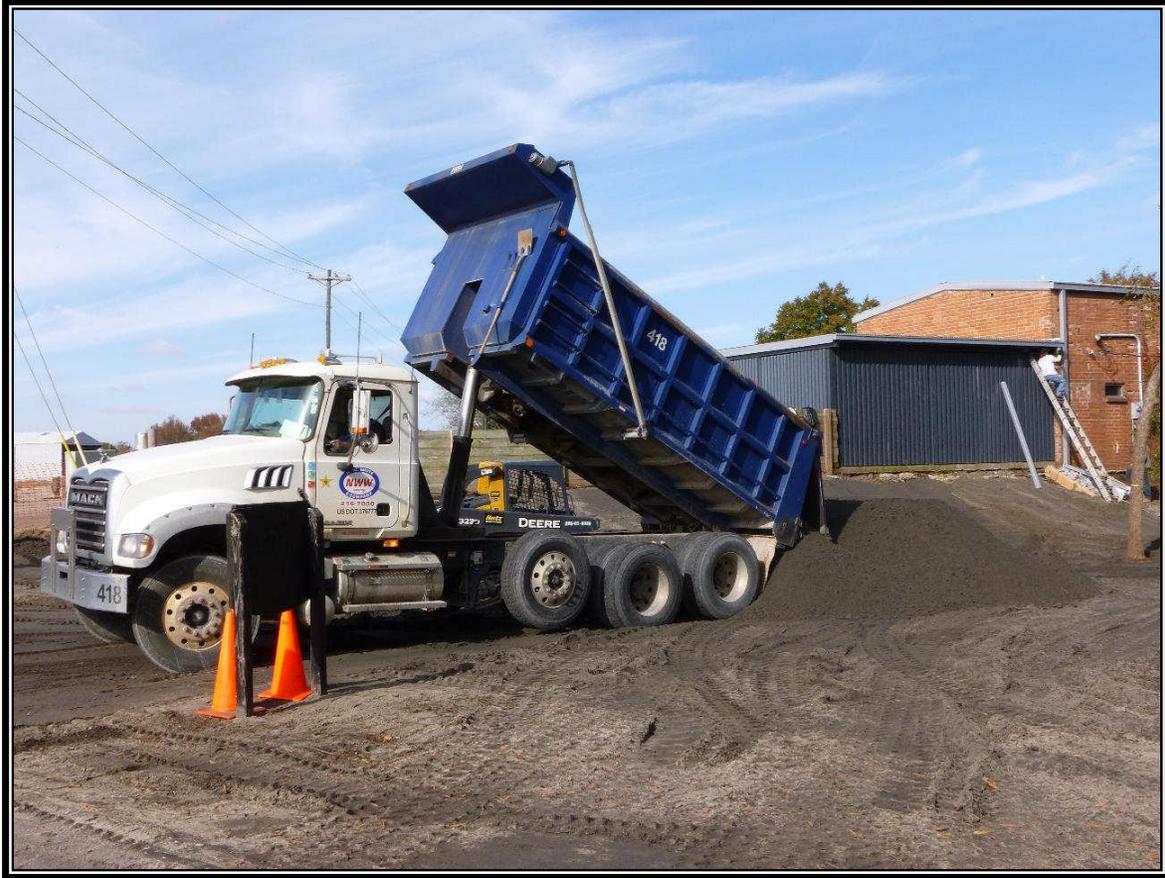
**OFFICIAL PHOTOGRAPH NO. 18**  
**U.S. ENVIRONMENTAL PROTECTION AGENCY**

**TDD Number:** TTEMI-05-001-0186                      **Location:** Royster Guano Removal  
**Orientation:** North West                                      **Date:** November 16, 2012  
**Photographer:** James Gooch, Tetra Tech                      **Witness:** Scott Garpiel, WRS Compass  
**Subject:** Clean topsoil was delivered for backfilling excavated yards.

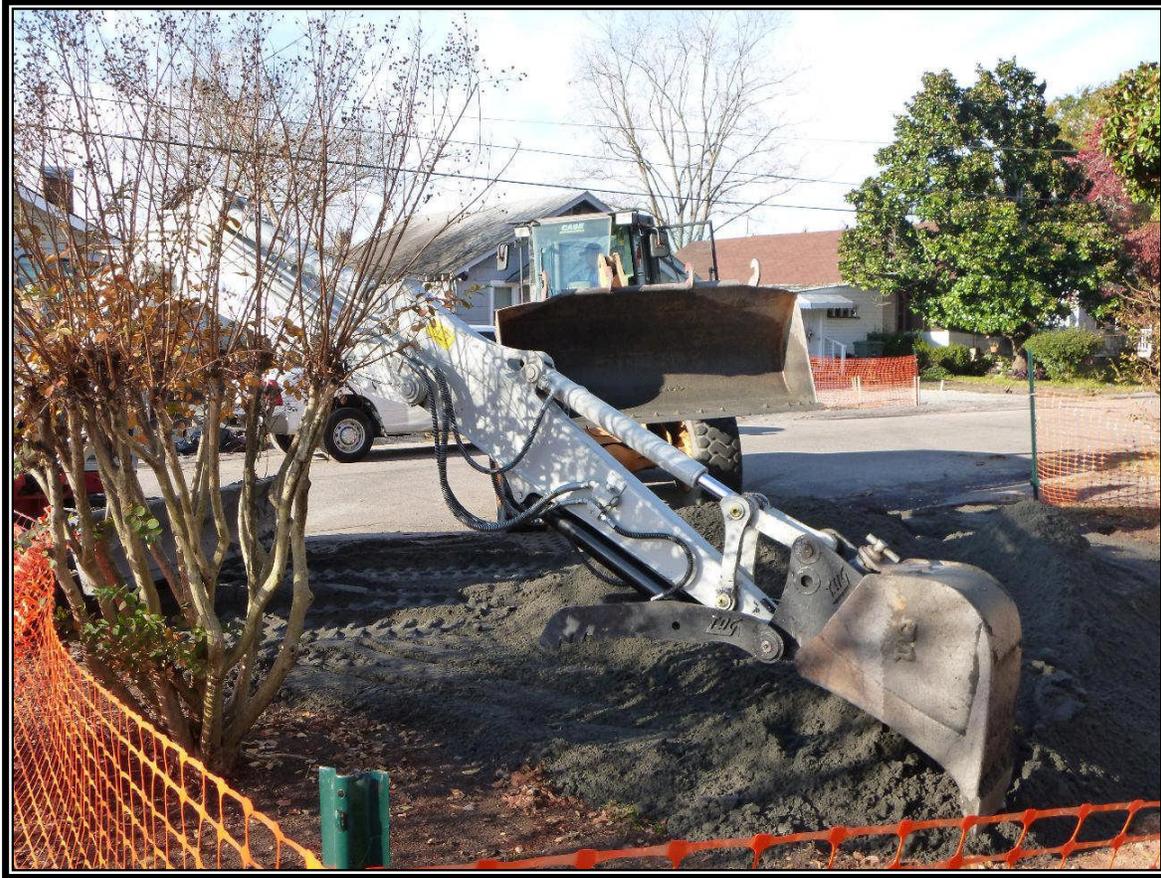
**OFFICIAL PHOTOGRAPH NO. 19**  
**U.S. ENVIRONMENTAL PROTECTION AGENCY**

**TDD Number:** TTEMI-05-001-0186      **Location:** Royster Guano Removal  
**Orientation:** South      **Date:** November 16, 2012  
**Photographer:** James Gooch, Tetra Tech      **Witness:** Scott Garpiel, WRS Compass  
**Subject:** Excavated yards were backfilled with clean topsoil.

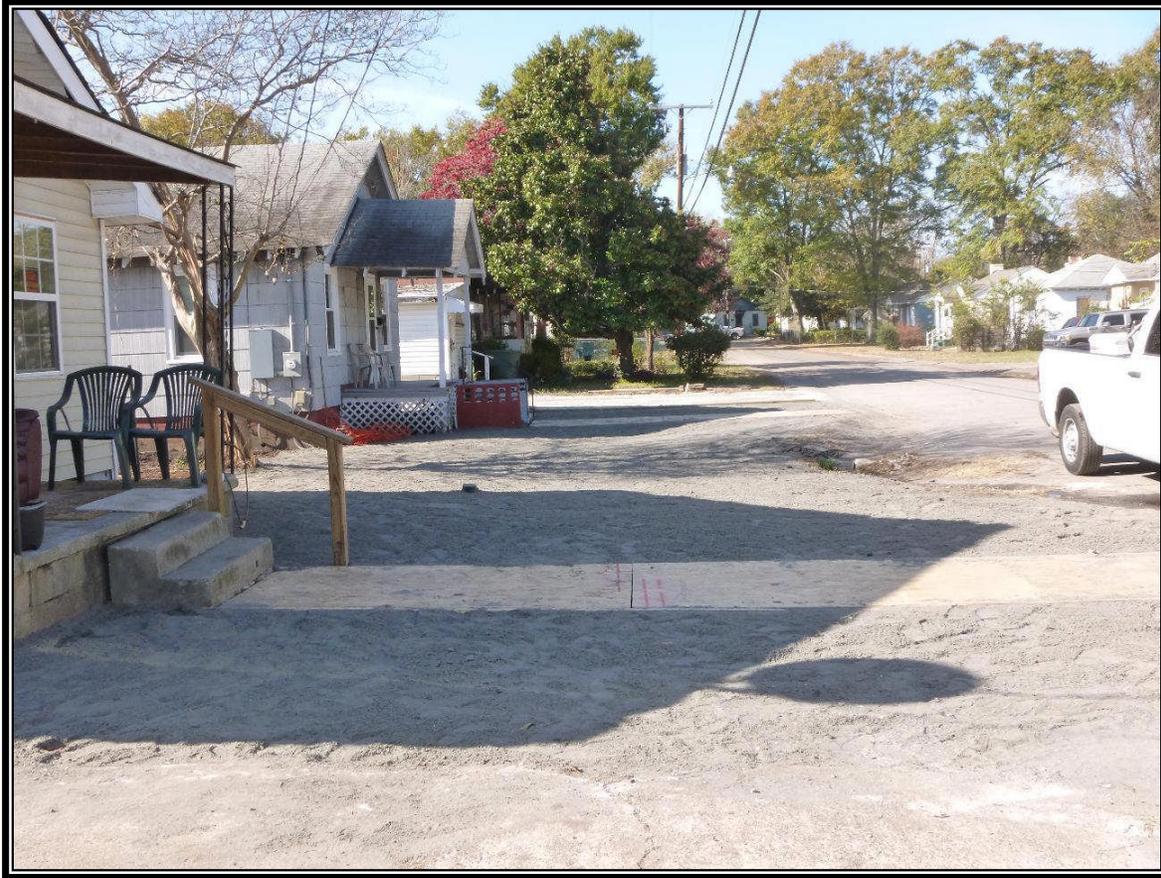
**OFFICIAL PHOTOGRAPH NO. 20**  
**U.S. ENVIRONMENTAL PROTECTION AGENCY**

**TDD Number:** TTEMI-05-001-0186                      **Location:** Royster Guano Removal  
**Orientation:** West    **Date:** November 19, 2012  
**Photographer:** James Gooch, Tetra Tech                      **Witness:** Scott Garpel, WRS Compass  
**Subject:** A view of the backfilled front yards on Easy Street.

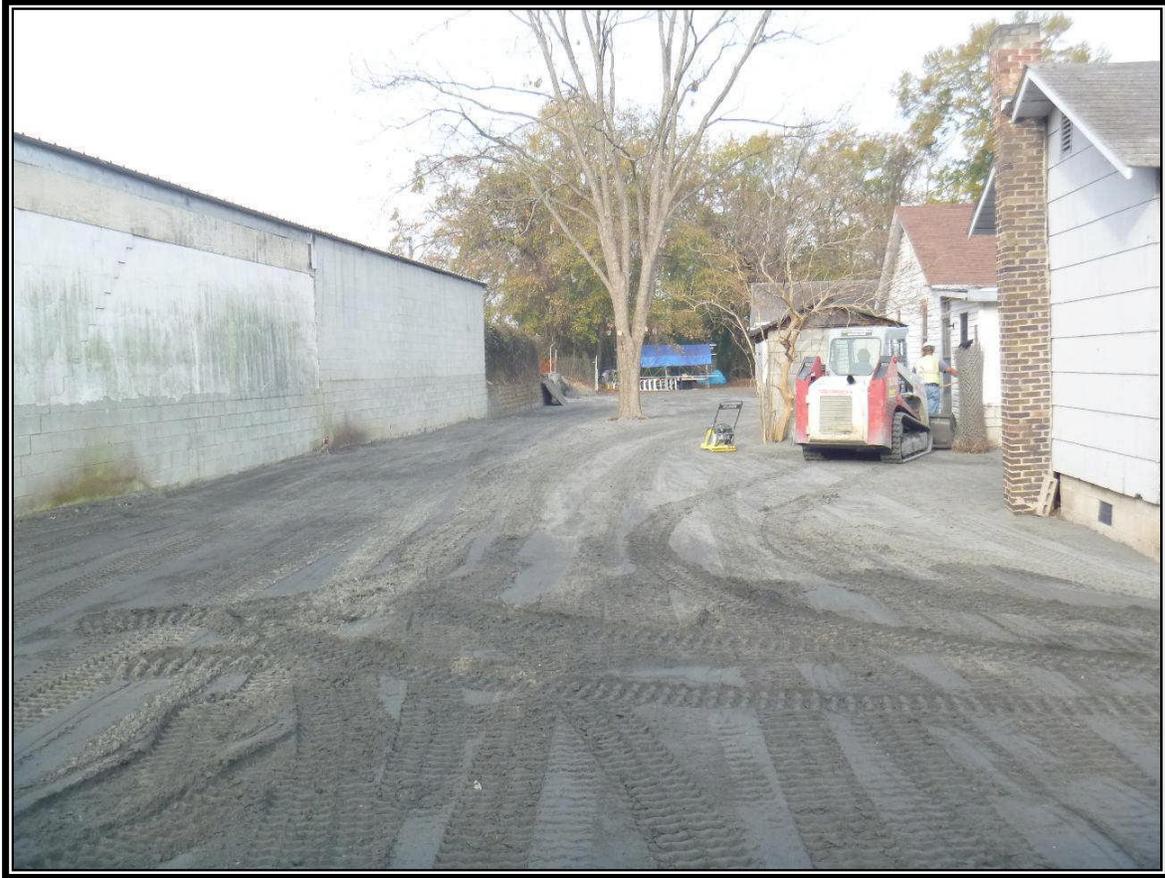
**OFFICIAL PHOTOGRAPH NO. 21  
U.S. ENVIRONMENTAL PROTECTION AGENCY**

**Subject:** A view of the backfilled back yards on Easy Street.

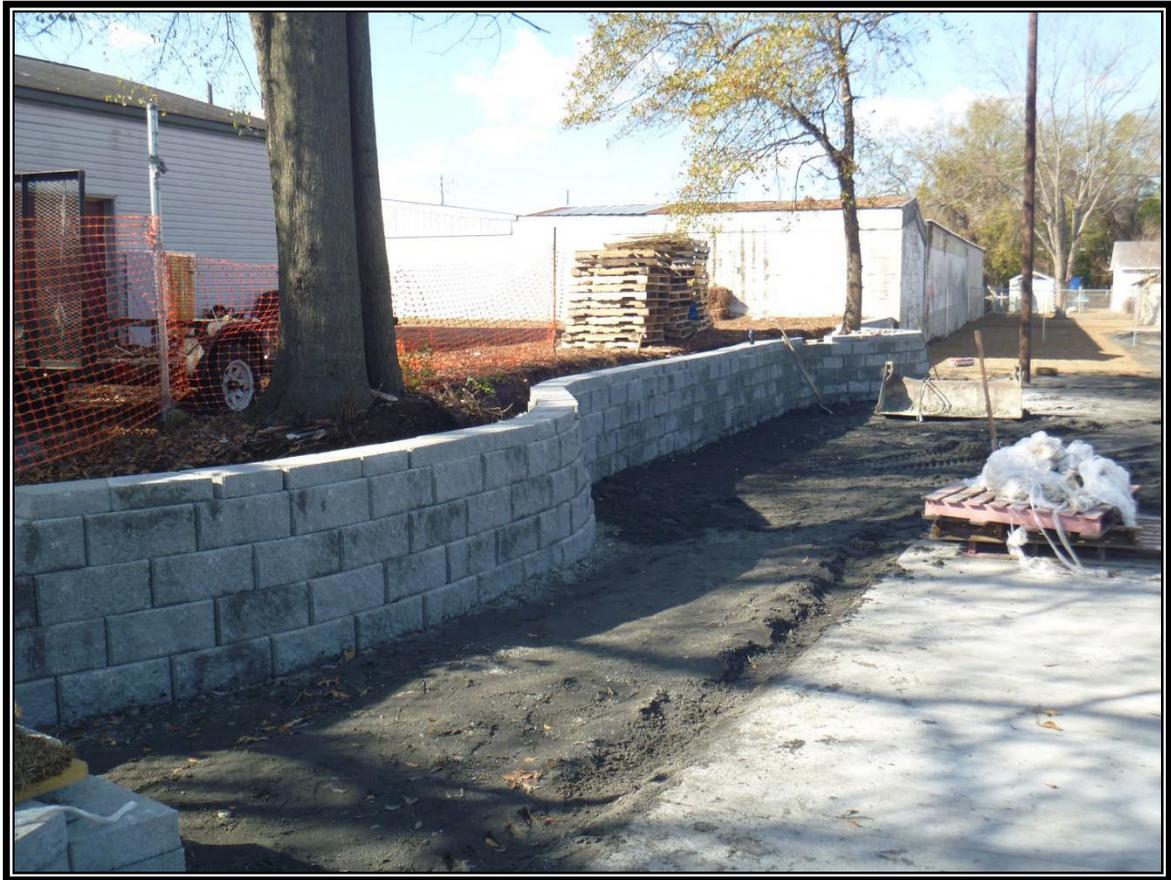
**OFFICIAL PHOTOGRAPH NO. 23**  
**U.S. ENVIRONMENTAL PROTECTION AGENCY**

**Subject:** A retaining wall and driveway were improved following excavation activities at 85 Easy Street.
