**Phase I
ENVIRONMENTAL SITE ASSESSMENT
OF
MYRA ROAD EXTENSION PROJECT
SALVAGE YARD
595 Offner Road
Walla Walla County Parcel Number 350724440023
WALLA WALLA, WASHINGTON**

August 2005

HDR Engineering, Inc.
2805 Saint Andrews Loop
Suite A
Pasco, Washington 99301

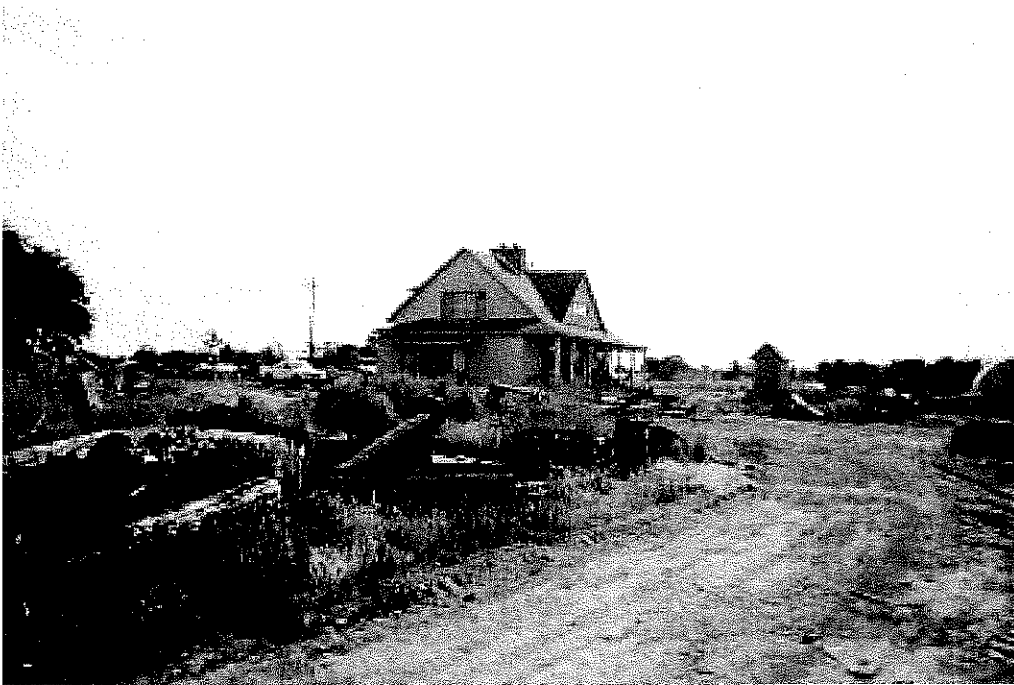
Photo 2. View toward northeast. Creosoted poles in foreground, residence in background.

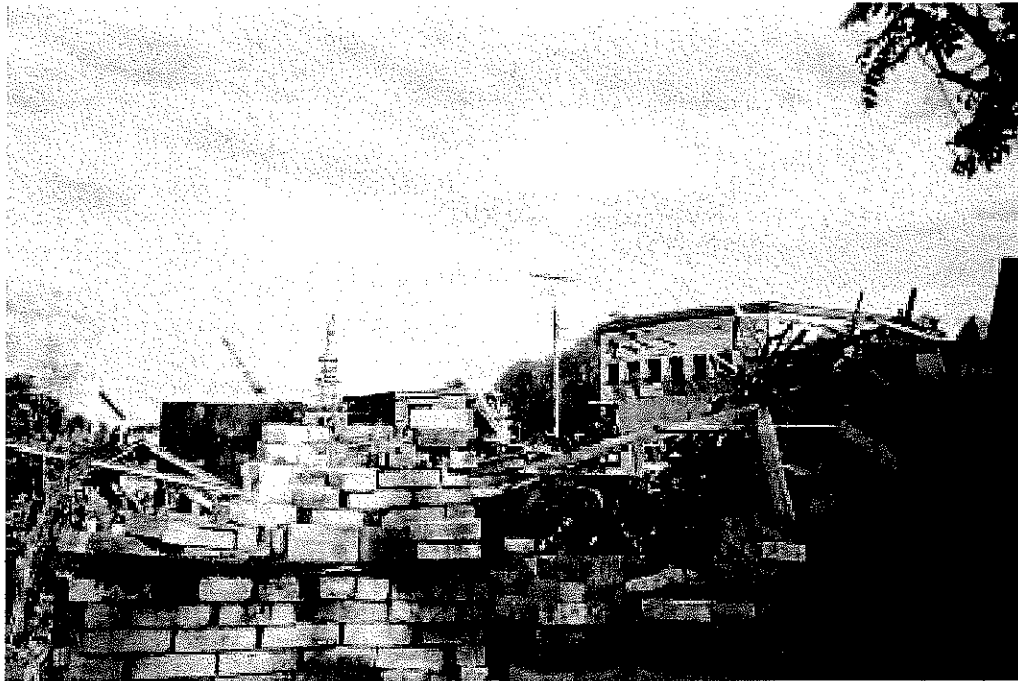
Photo 3. View toward northwest. Power pole with 3 non-PCB transformers in background.

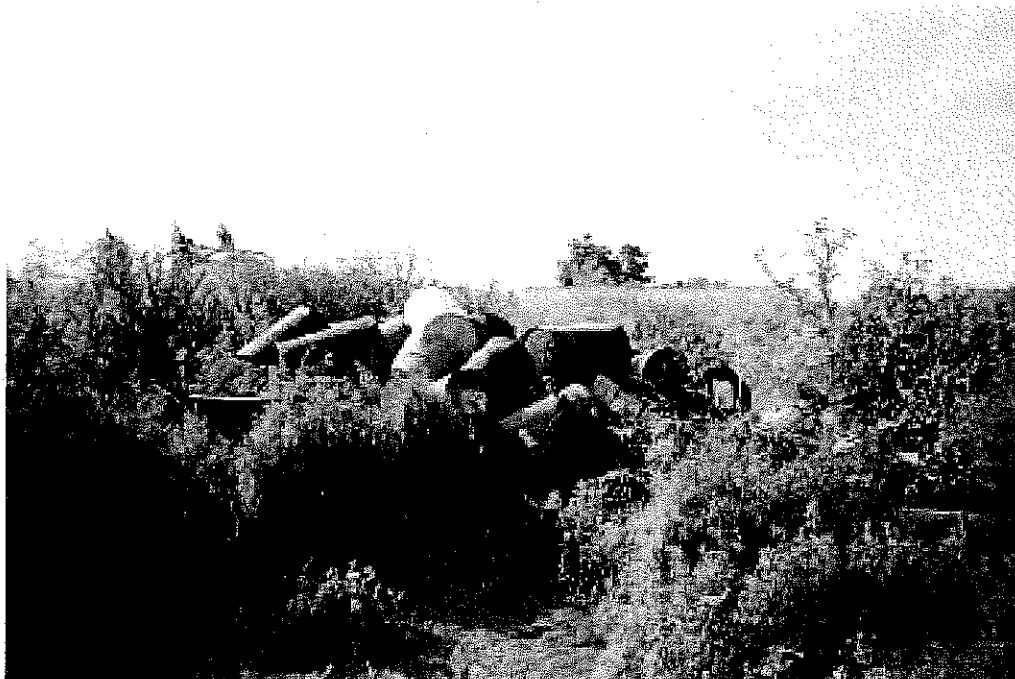
Photo 5. View to south. Pile of 55-gallon drums.

A myriad of drums were located on the subject property. In some areas, drums were stored together; in other areas isolated drums were noted. Both plastic and metal drums were observed. Labeling of the drums indicated substances varying from apple juice concentrate to petroleum based lubricants. Most of the drums that were checked appeared empty. Two drums near the compactor and shearer were found to contain hydraulic oil and petroleum based lubricant. Due to the number of drums present and the manner in which they were stacked, contents (former and/or current) were not obtainable for all drums.

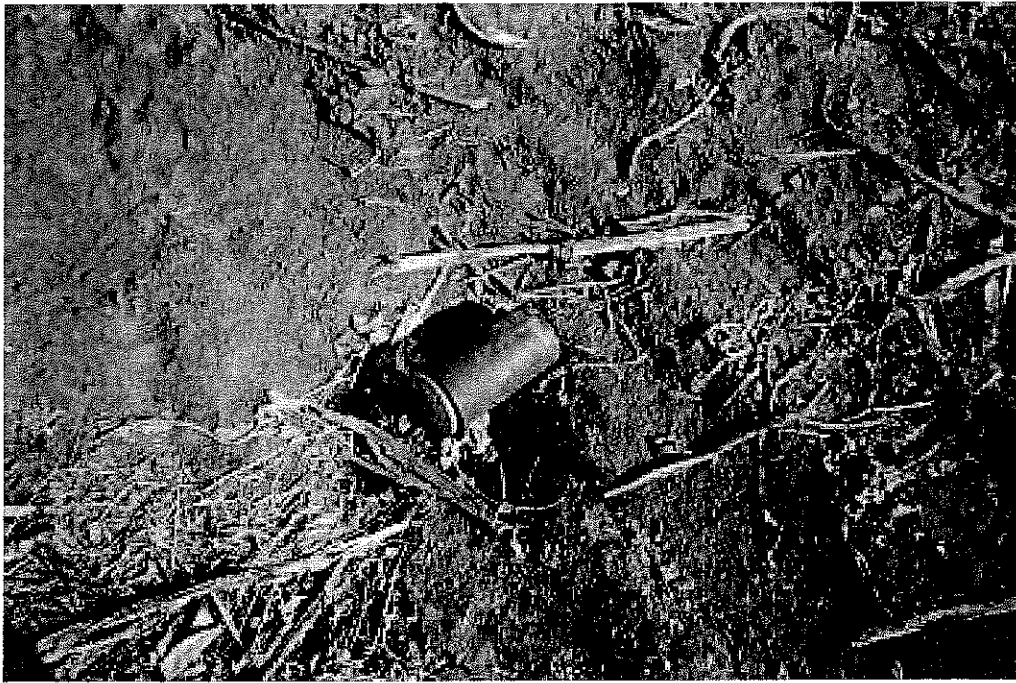
Photo 7. Example of isolated soil staining from single motor part.

Piles of engine parts and automotive batteries were observed throughout the subject property. Oily stains were observed around engine parts. Lead and acid may be leaking from batteries; piles were so great in size that surface visibility was impaired. Creosoted posts and poles were also observed lying directly on the ground surface.

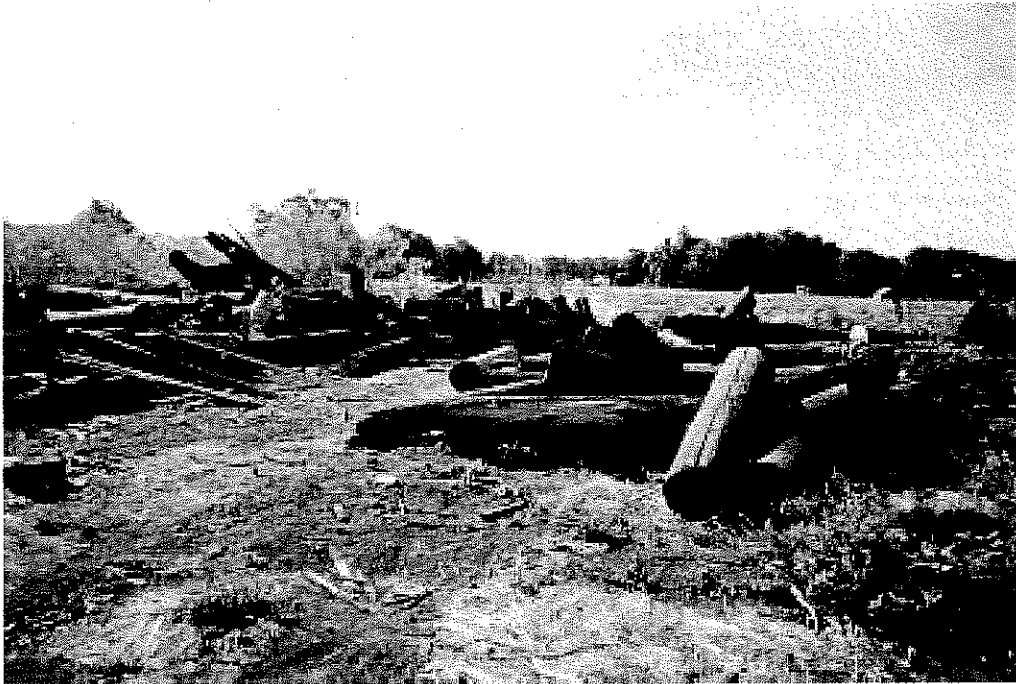
Photo 8. View to south. Pile of creosoted poles.

Other piles of salvage items of concern include a pile of car batteries and at least two piles of creosoted telephone poles. Piles of rubber and tires were also observed.

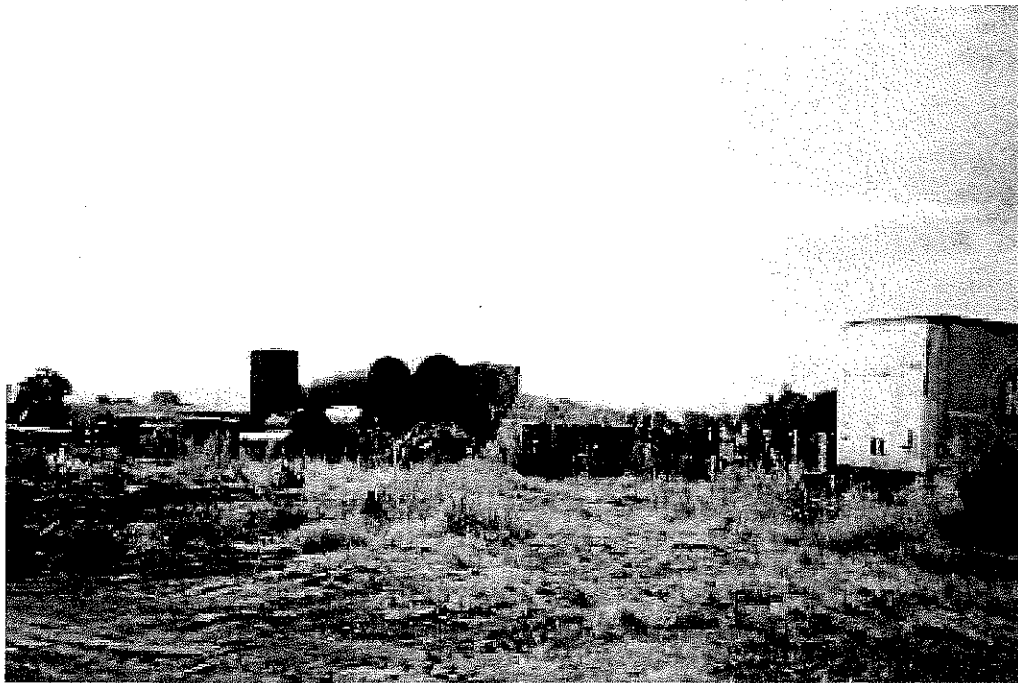
Photo 9. View to southwest. From left to right: large storage tanks, 55-gallon drums, trailer.

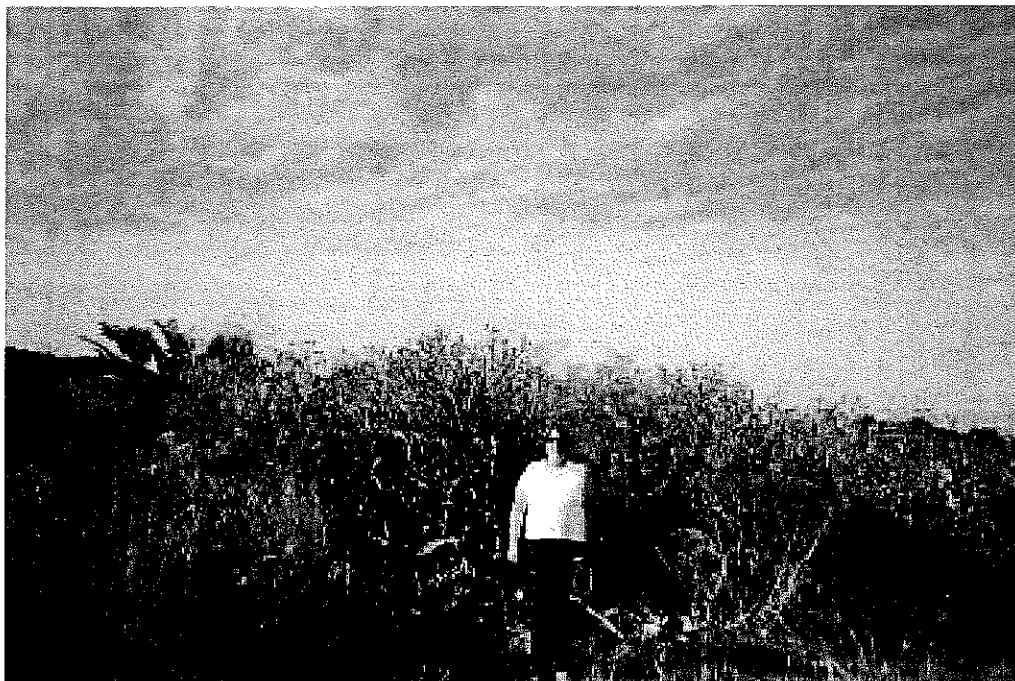
Photo 11. View to south. Photo shows height of weeds in area, inhibiting surface visibility.

At the time of the site visit, the parcel was dry and contained many areas covered with shoulder to head-high weedy vegetation, limiting surface visibility in many areas. Much of the high vegetation was dense, thorny or covered in briars which prohibited access to those areas. The majority of the site was observed from the series of dirt roads that wind

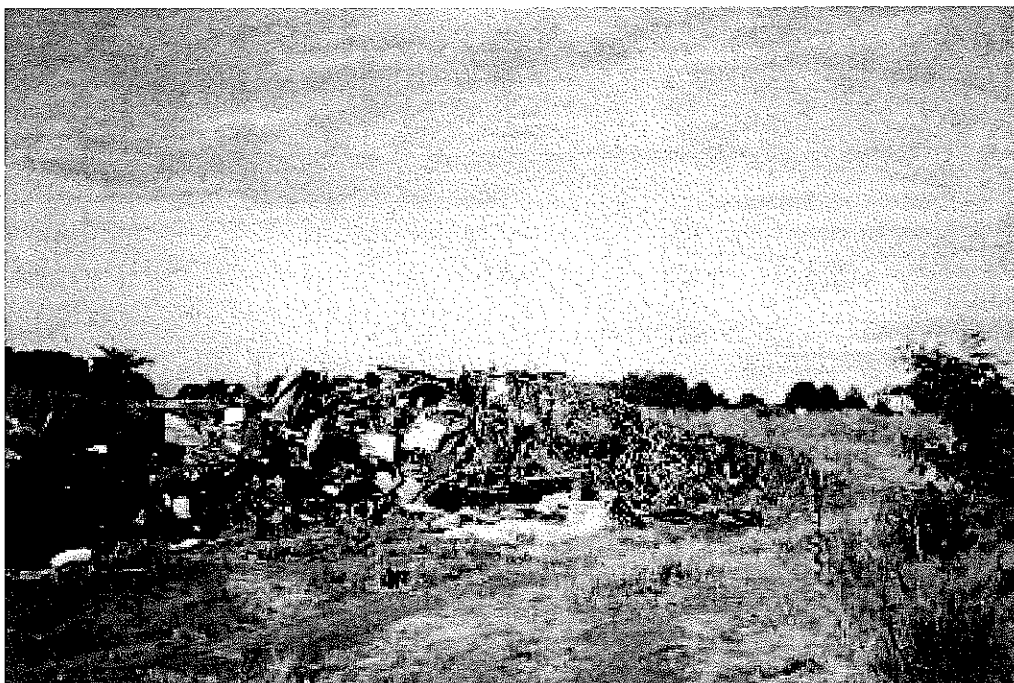
Photo 14. View to southwest. Pile of rubber.

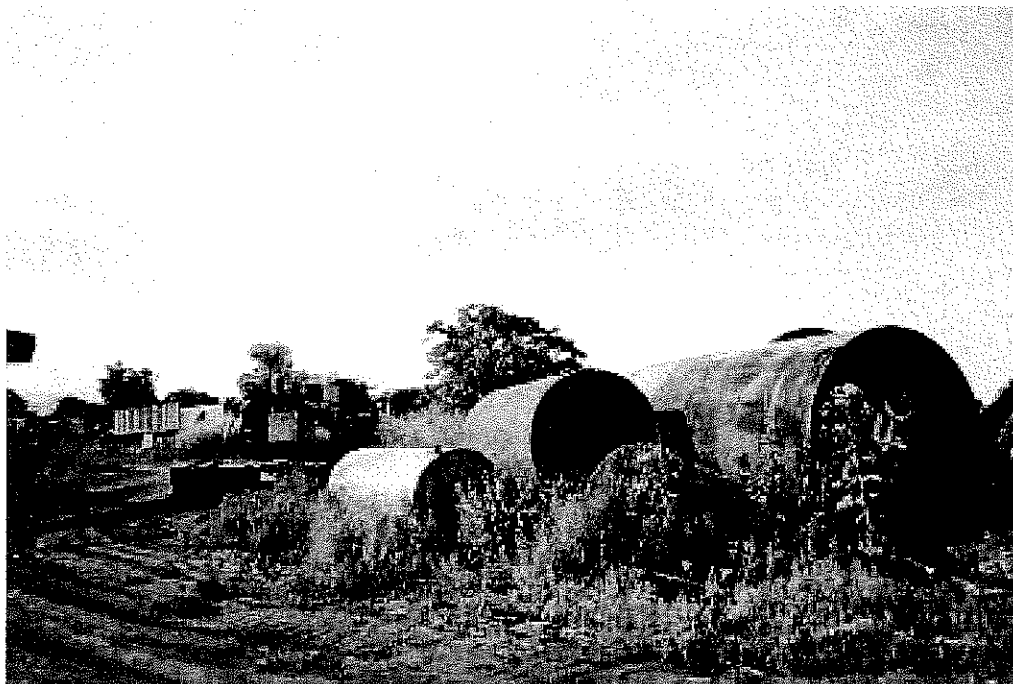
Photo 16. View to south. Large storage tanks.

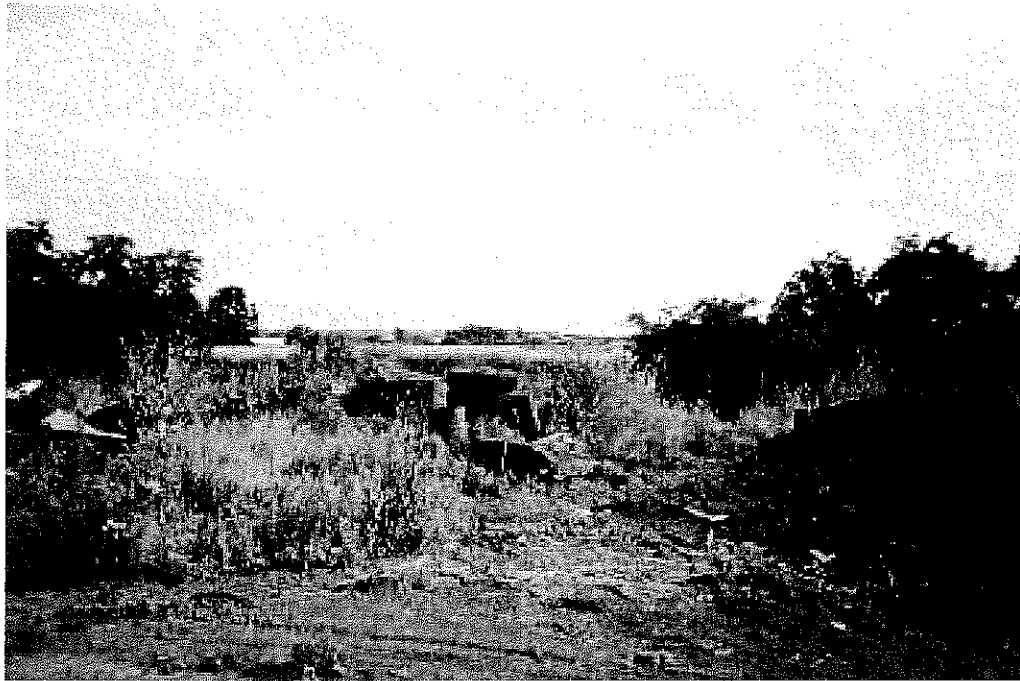
Photo 17. View to north. Pile of miscellaneous debris, including tires and drums.

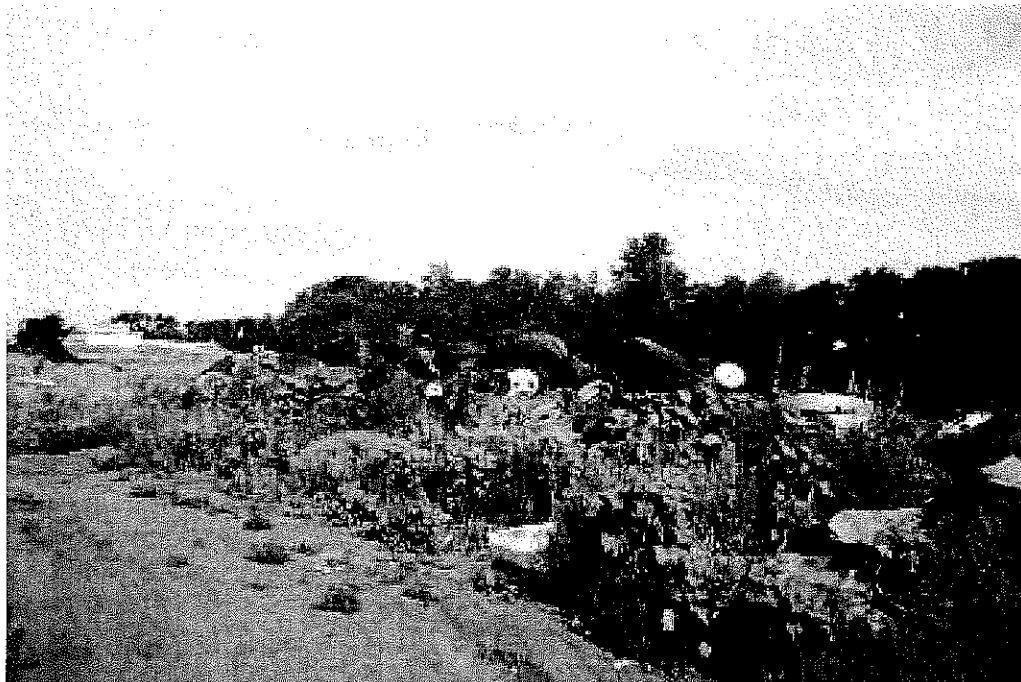
Photo 18. View to northwest. Pile of tires.

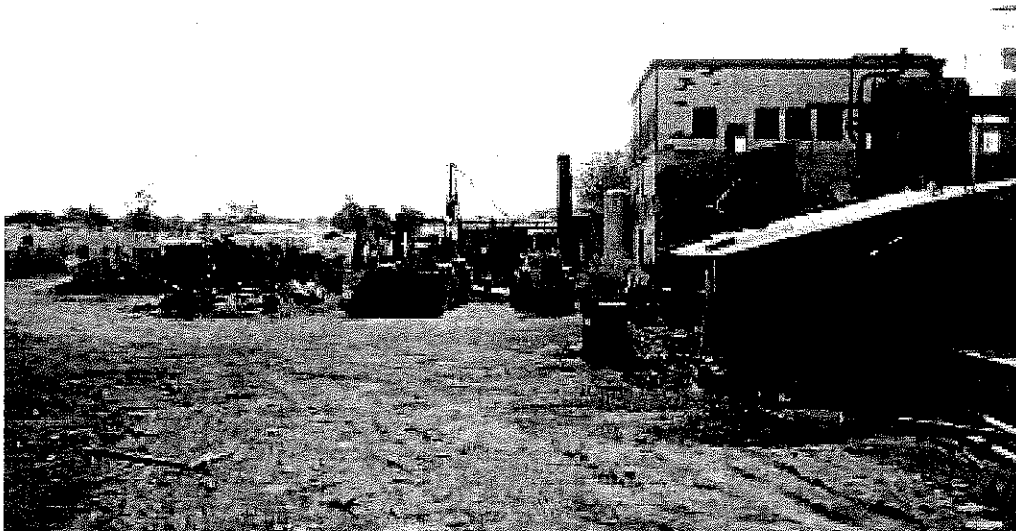
Photo 20. View to east. Shear and compactor to right, industrial building in background.
