**Subject: Opossum Creek Drum Site Assessment Report**  
**Moraine, Montgomery County, Ohio**  
**Technical Direction Document No.: S05-0001-1211-013**  
**WESTON START Contract No.: EP-S5-06-04**  
**Document Control No.: 2050-2A-BFPT**

**SITE ASSESSMENT REPORT  
FOR THE  
OPOSSUM CREEK DRUM SITE  
MORaine, MONTGOMERY COUNTY, OHIO  
SITE ID NO. C5Q1**

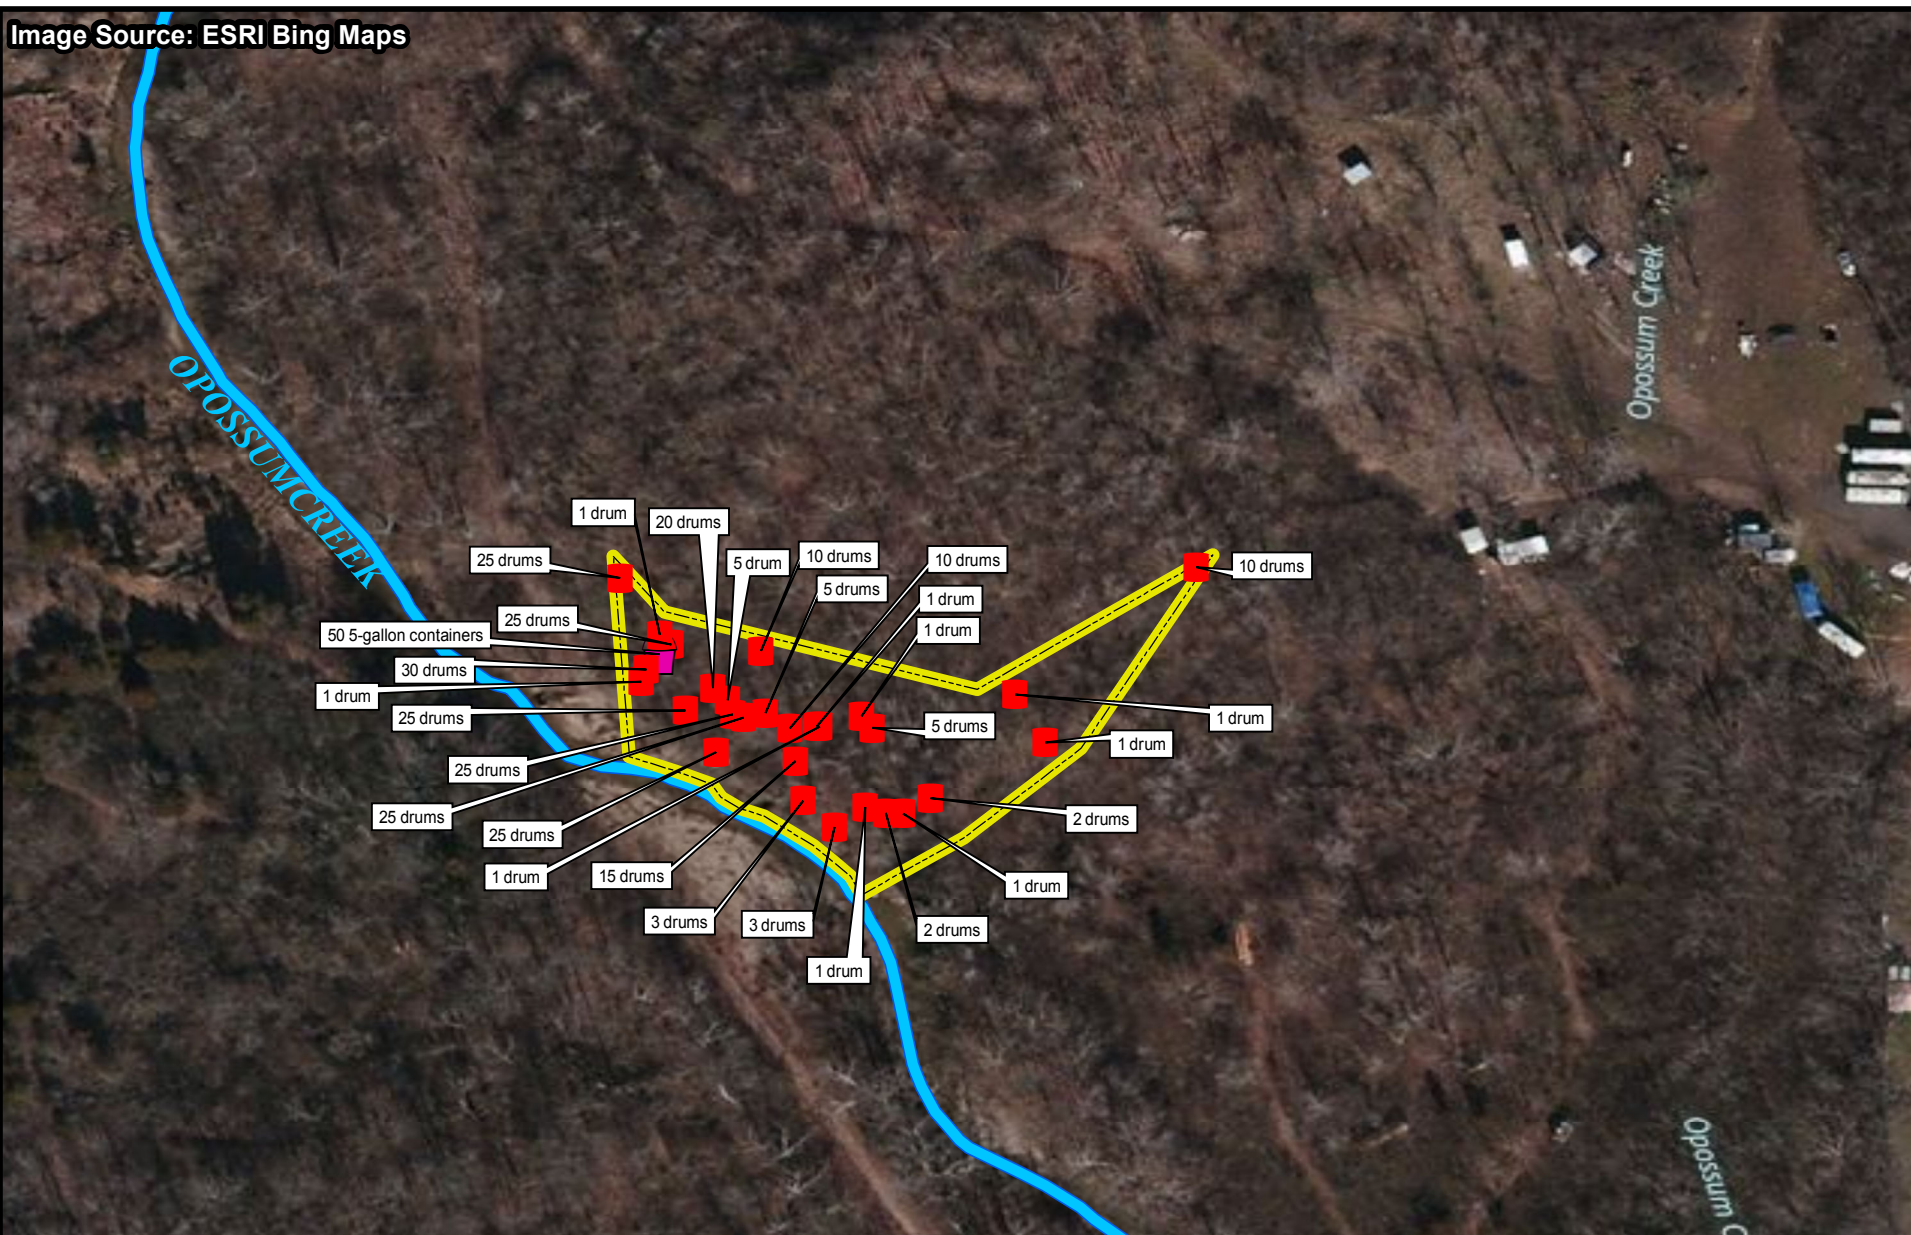
**Figure 3-1**  
 Drum Burial Map  
 Opossum Creek Drum Site  
 Moraine, Montgomery County, Ohio

WESTON START used a Trimble GeoXH unit to identify the border of the drum burial area and the coordinates of the visible partially buried drums. **Figure 3-1** shows the drum burial area.

During the site assessment, WESTON START observed and documented the presence of hundreds of buried and partially buried 55-gallon drums and about 50 5-gallon containers (**Figure 3-1**). Drums and containers were corroded, and some had released their contents onto the ground. WESTON START also observed visible ink waste from the buried drums next to and within the waters of Opossum Creek.

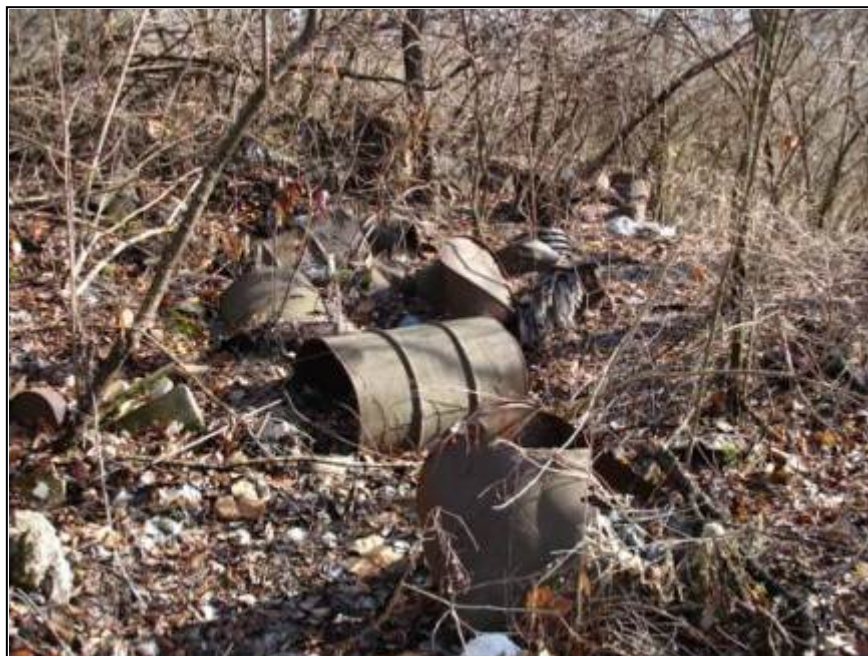
**Photograph No.:** 1

**Subject:** Partially buried 55-gallon drums and containers

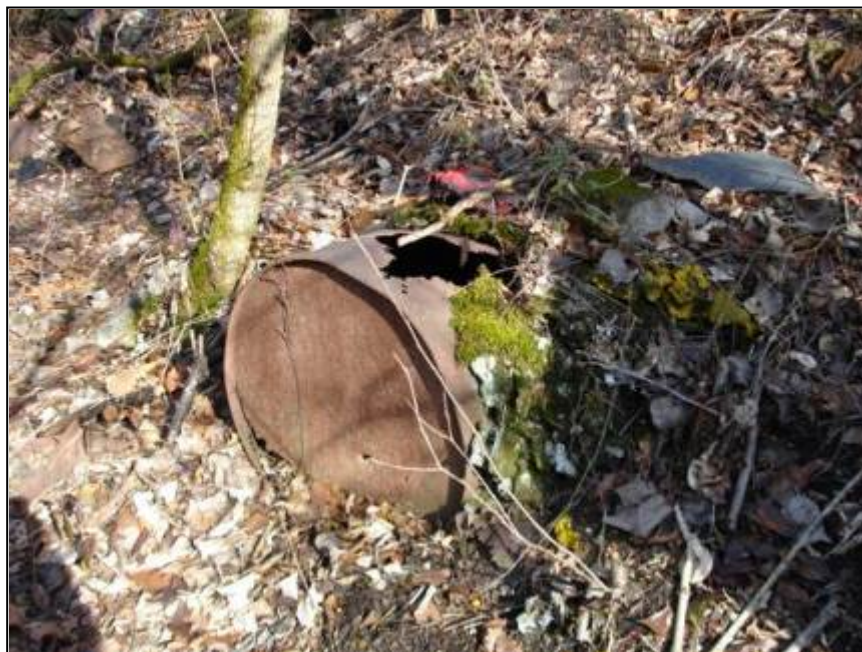
**Photograph No.:** 2

**Subject:** Severely corroded 55-gallon drum

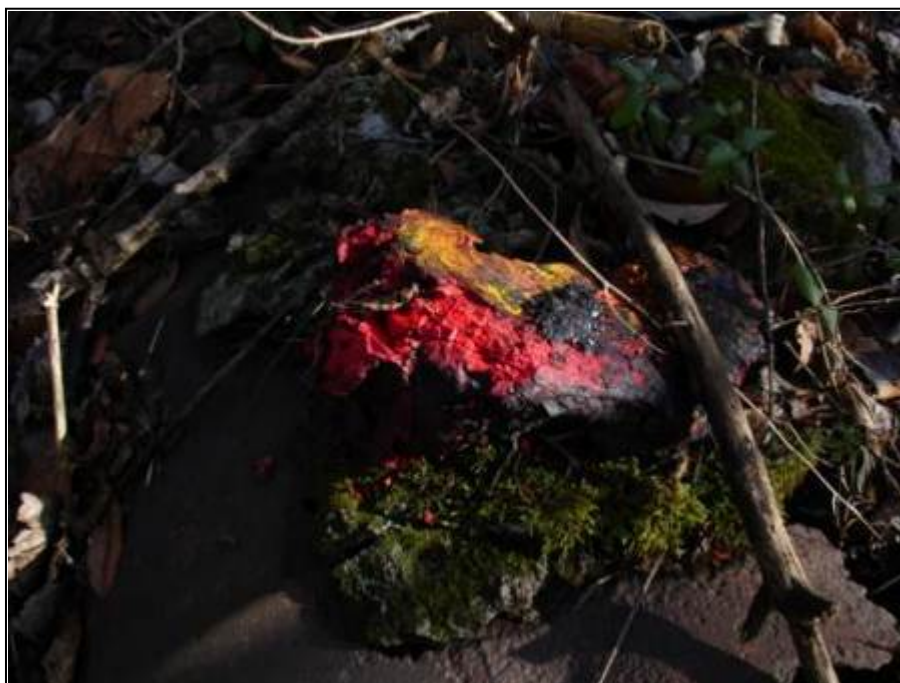
**Photograph No.:** 3

**Subject:** Dried, multi-colored ink waste within partially buried drum

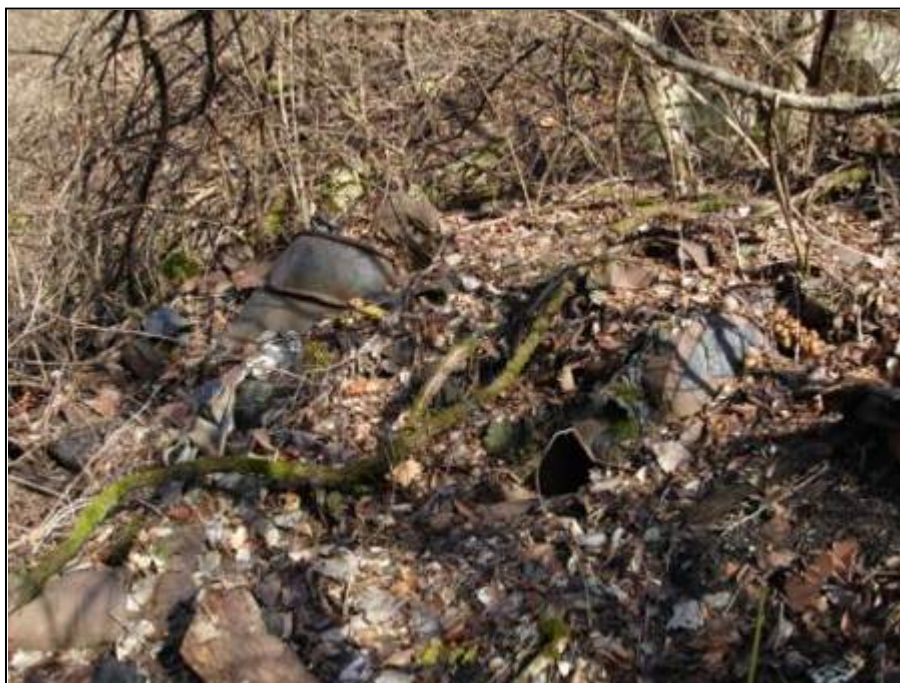
**Photograph No.:** 4

**Subject:** Buried and partially buried 55-gallon drums and containers

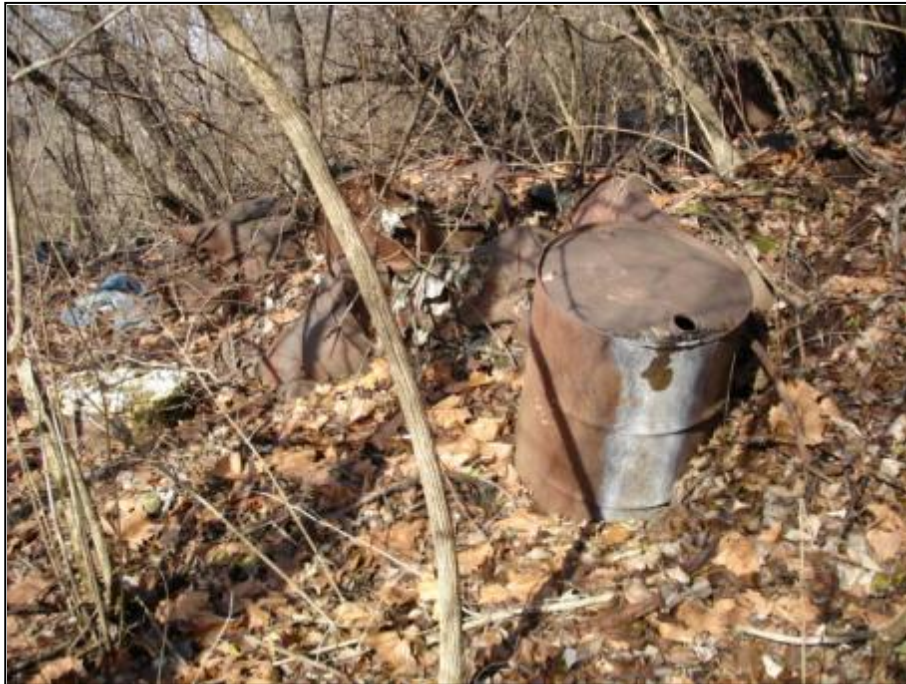
**Photograph No.:** 9

**Subject:** Abandoned drums protruding from ground in the drum burial area

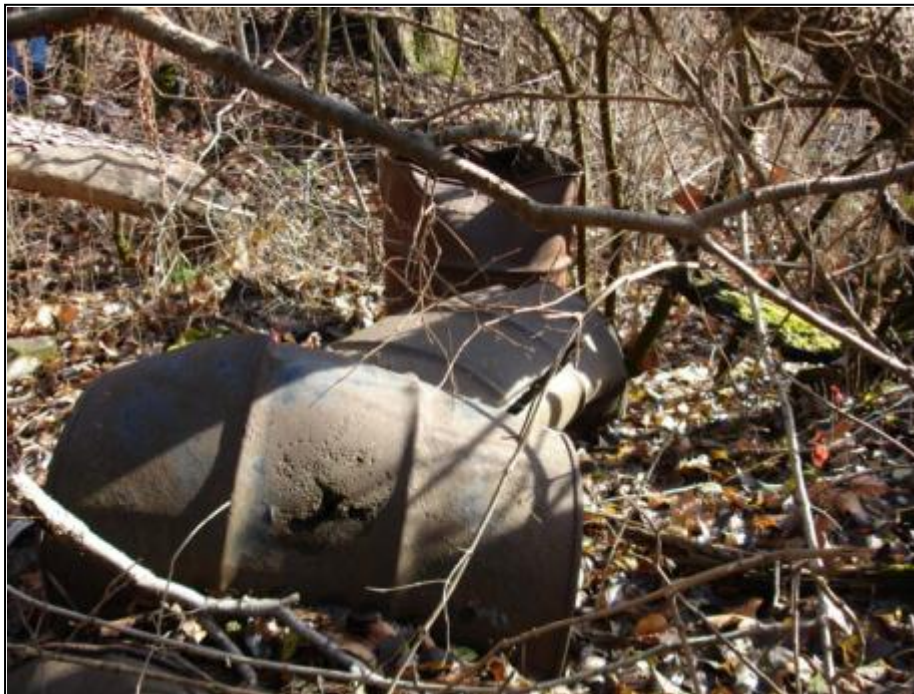
**Photograph No.:** 10

**Subject:** Severely corroded drum

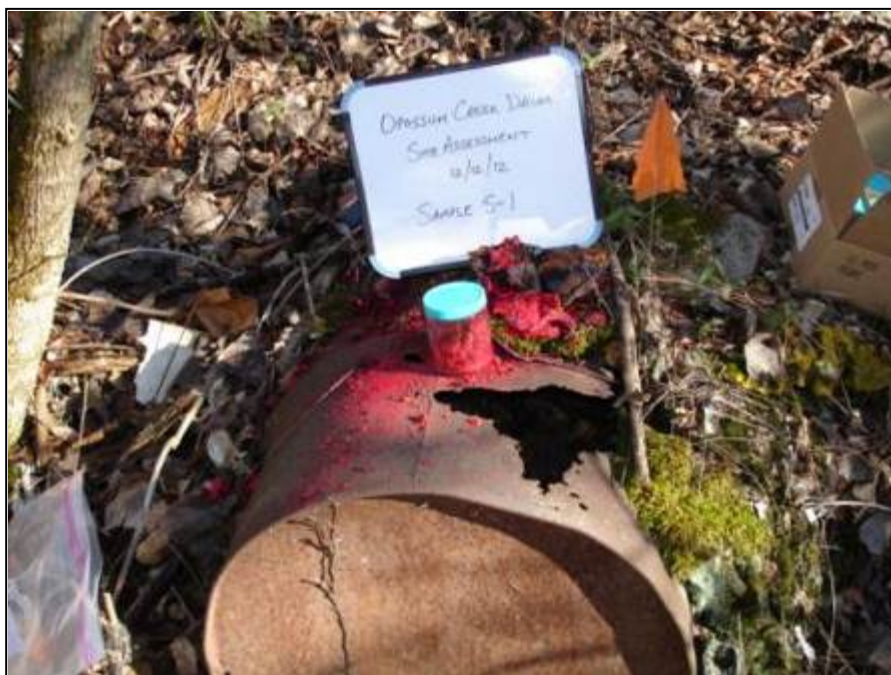
**Photograph No.:** 11

Sample S-1 was collected from a partially buried 55-gallon drum using a poly scoop. The sample consisted of a red ink solid, and XRF readings showed a total lead concentration of 93,356 ppm and a total arsenic concentration of 4,471 ppm.

**Subject:** Drum from which investigative waste solid sample S-1 was collected

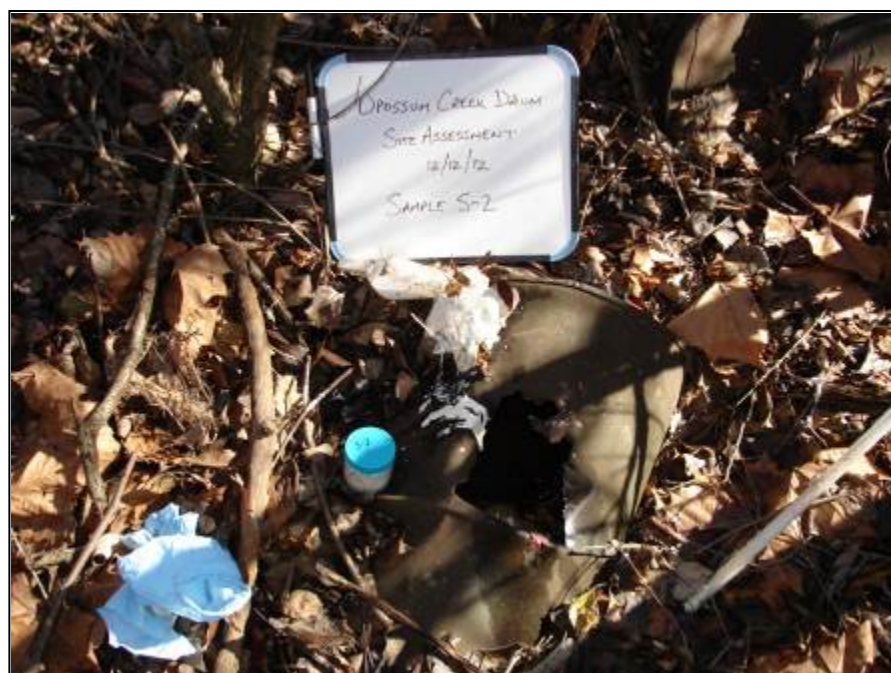
**Photograph No.:** 12

Sample S-2 was collected from the hole in the side of a partially buried, corroded drum using a plastic scoop. The sample consisted of clear liquid mixed with white sludge that had the appearance of white paint. The PID VOC reading for the drum's contents was 3,000 ppm.

**Subject:** Containers from which investigative liquid/sludge waste sample S-2 was collected

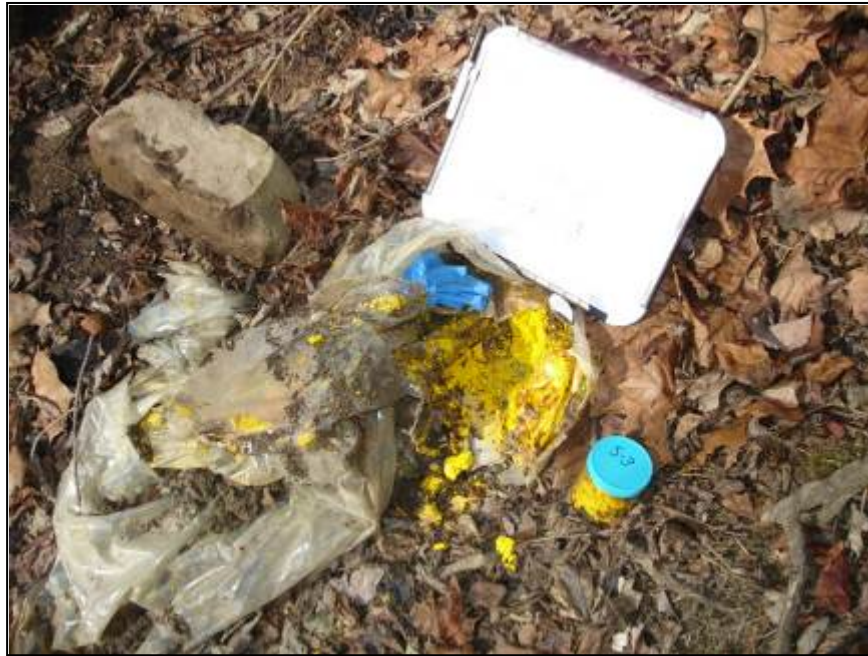
**Photograph No.:** 13

Sample S-3 was collected from surficial soil next to Opossum Creek using a poly scoop. The sample consisted of surficial soil mixed with yellow ink solids, and XRF readings showed a total lead concentration of 27,799 ppm.

**Subject:** Investigative soil and waste solid sample S-3

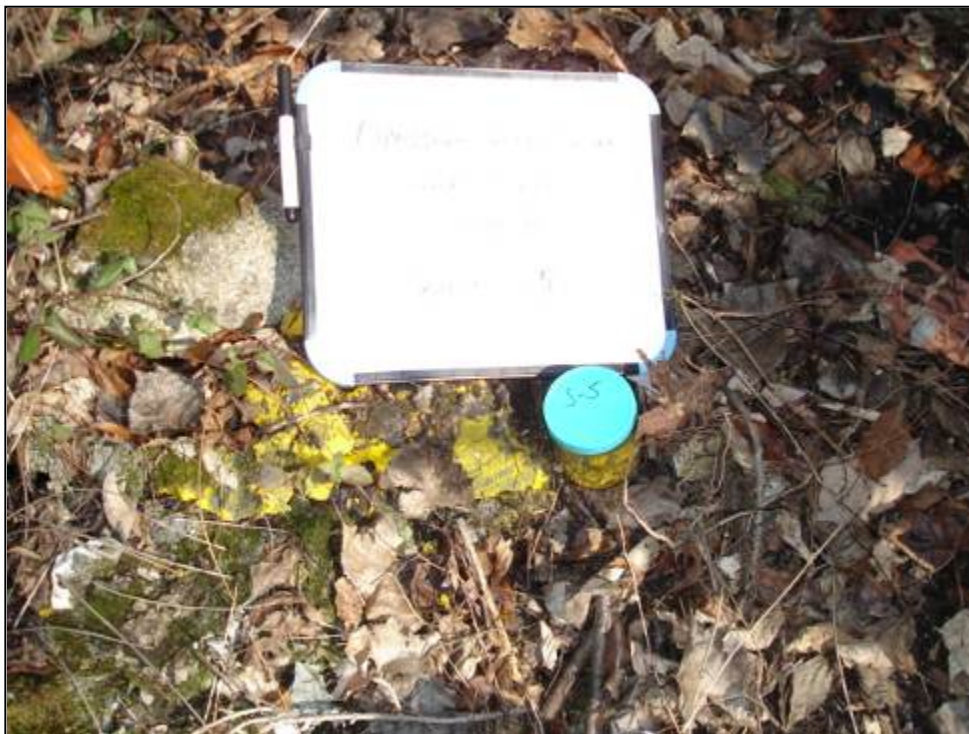
**Photograph No.:** 15

Sample S-5 was collected from the ground in the drum burial area using a poly scoop. The sample consisted of a mixture of surficial soil and yellow ink solids, and XRF readings showed a total lead concentration of 147,390 ppm.

**Subject:** Investigative soil and waste solid sample S-5

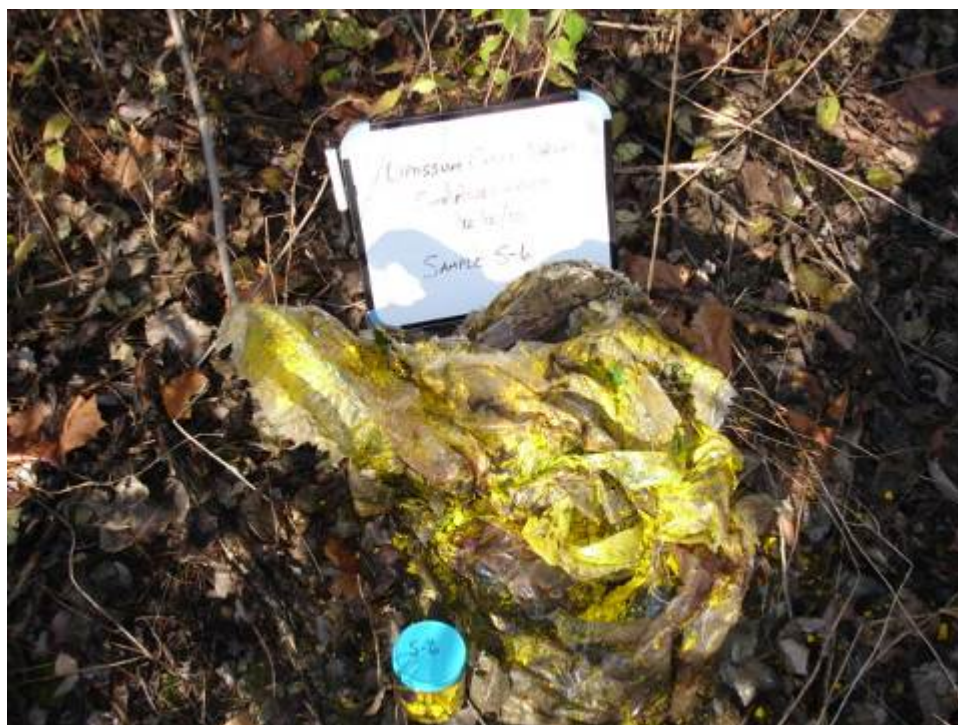
**Photograph No.:** 16

Sample S-6 was collected from the ground in the drum burial area using a poly scoop. The sample consisted of a mixture of surficial soil and yellow ink solids, and XRF readings showed a total lead concentration of 104,064 ppm.

**Subject:** Yellow ink solids on ground; investigative soil and waste solid sample S-6

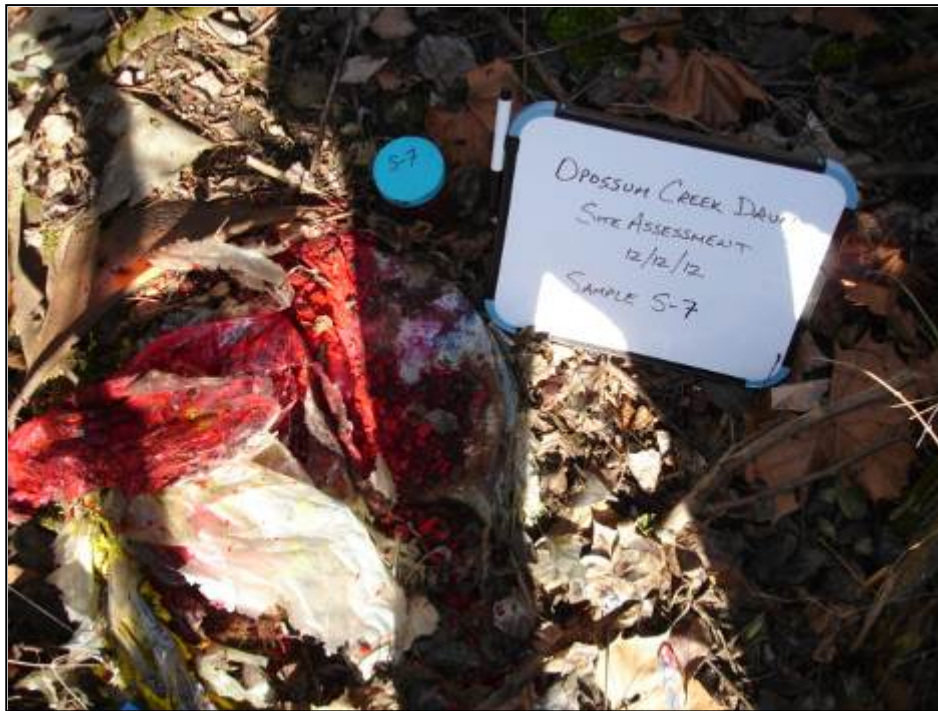
**Photograph No.:** 17

Sample S-7 was collected from a partially buried 55-gallon drum using a poly scoop. The sample consisted of a red ink solid, and XRF readings showed a total lead concentration of 60,502 ppm and a total arsenic concentration of 4,956 ppm.

**Subject:** Investigative waste solid sample S-7

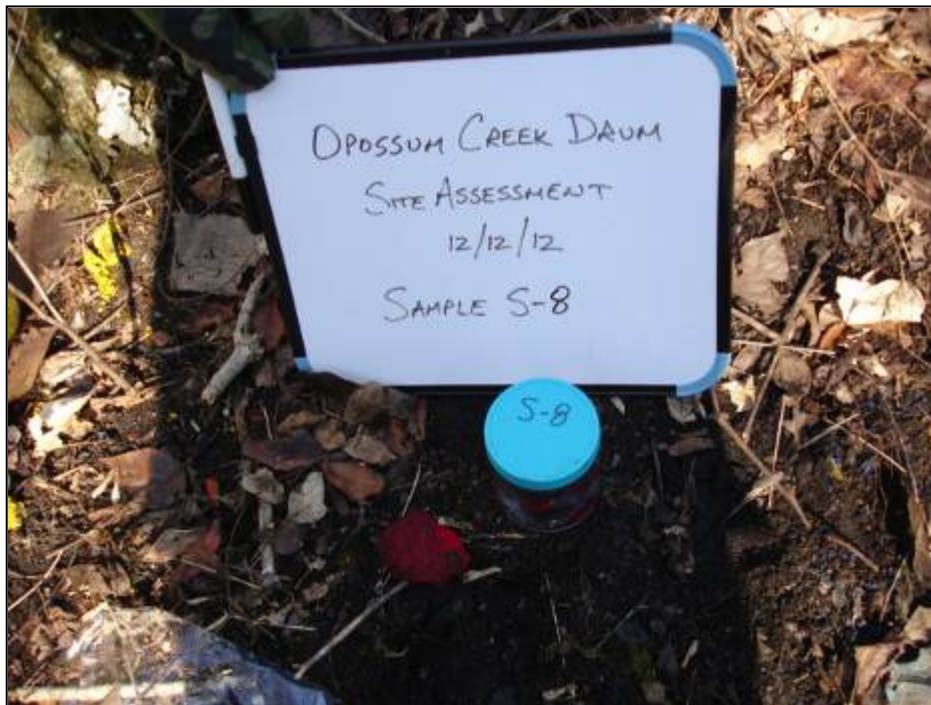
**Photograph No.:** 18

**Subject:** Red ink solids on ground; investigative soil and waste solid sample S-8

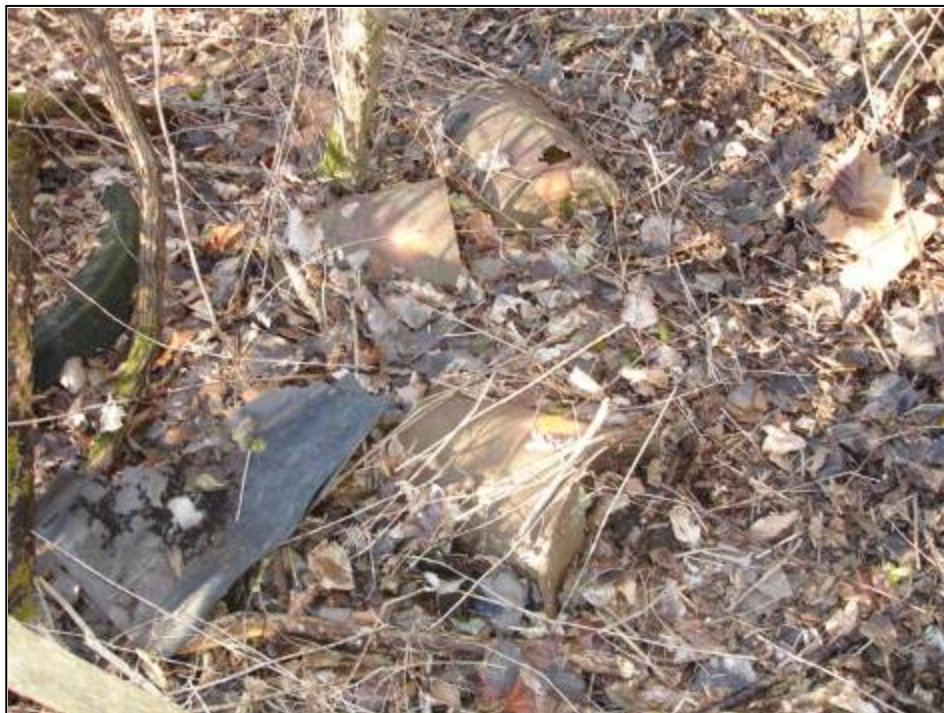
**Photograph No.:** 20

**Subject:** Partially buried and corroded drums next to Opossum Creek
