## **VI MITIGATION WORK PLAN**

**SOUTH DAYTON DUMP AND LANDFILL SITE  
MORaine, OHIO**

**Prepared by:  
Conestoga-Rovers  
& Associates**

**MAY 2013  
REF. NO. 038443 (18)**

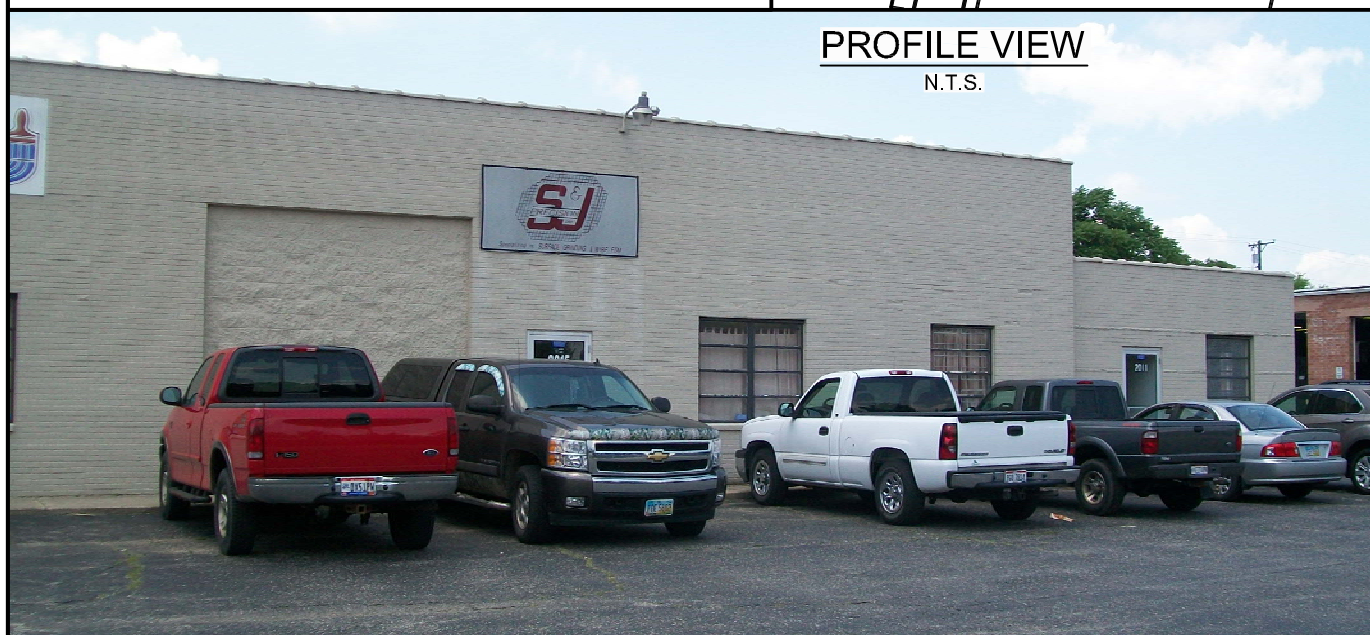
PARCEL 5172 - S&J PRECISION BUILDING 12  
2015 DRYDEN ROAD  
SOUTH DAYTON DUMP AND LANDFILL SITE  
*Moraine, Ohio*

Single story, industrial-use building, constructed in the 1950s. Divided into two equal sections, north and south sides. Total footprint is 11,600 sq. ft. Approximately 16 ft. high. Slab-on-grade, concrete block building with brick front. Exterior openings - windows, utility pipe penetrations, bay doors, personnel doors.

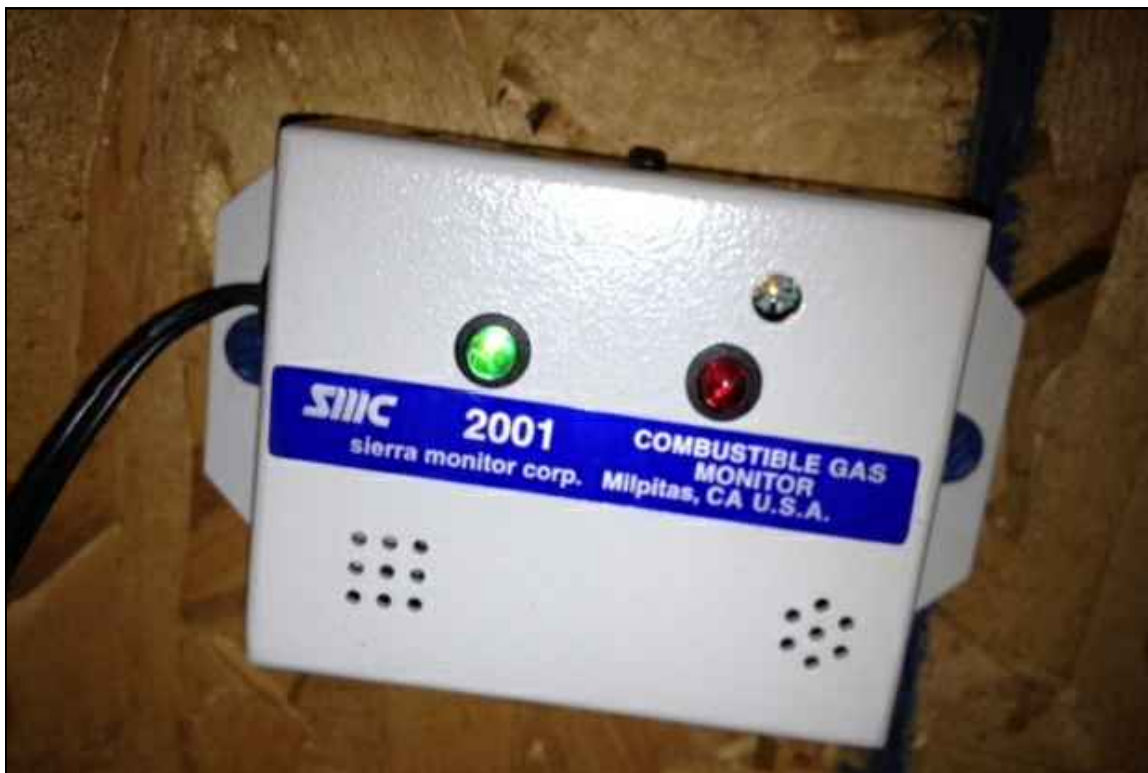
PHOTO 1: METHANE MONITOR CLOSE-UP IN SIM TRAINER, 2031 DRYDEN ROAD

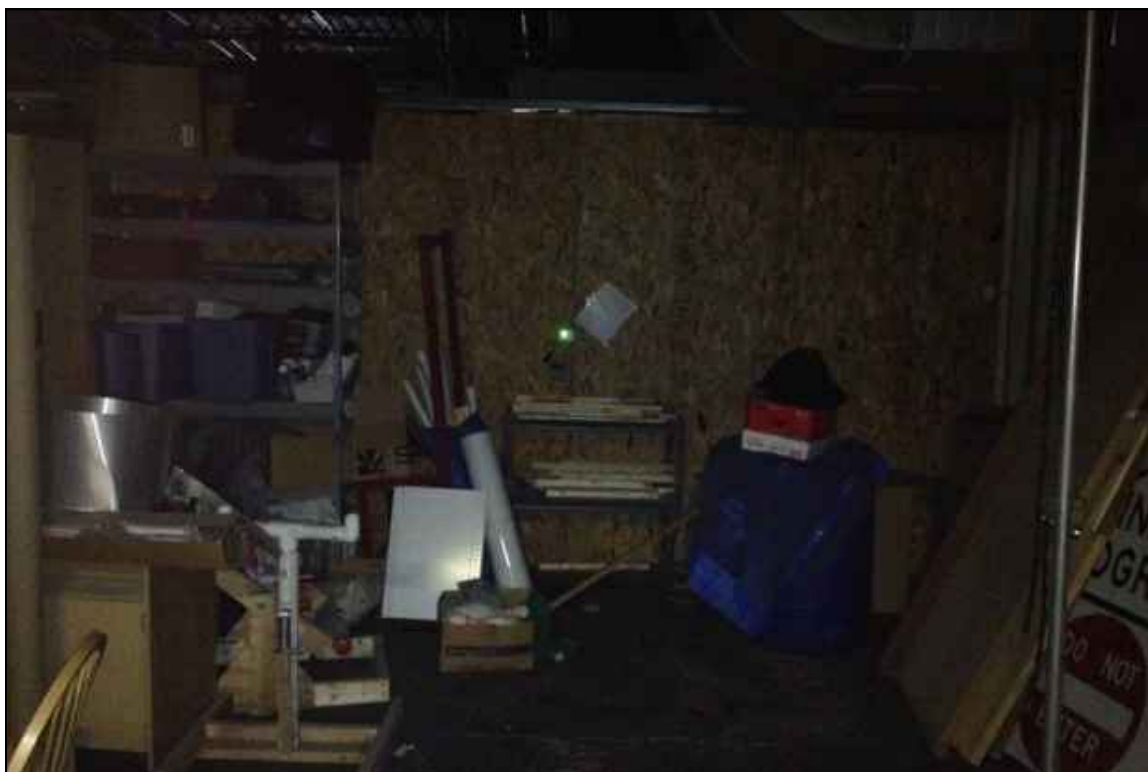
PHOTO 2: METHANE MONITOR STORAGE LOCATION IN SIM TRAINER, 2031 DRYDEN ROAD

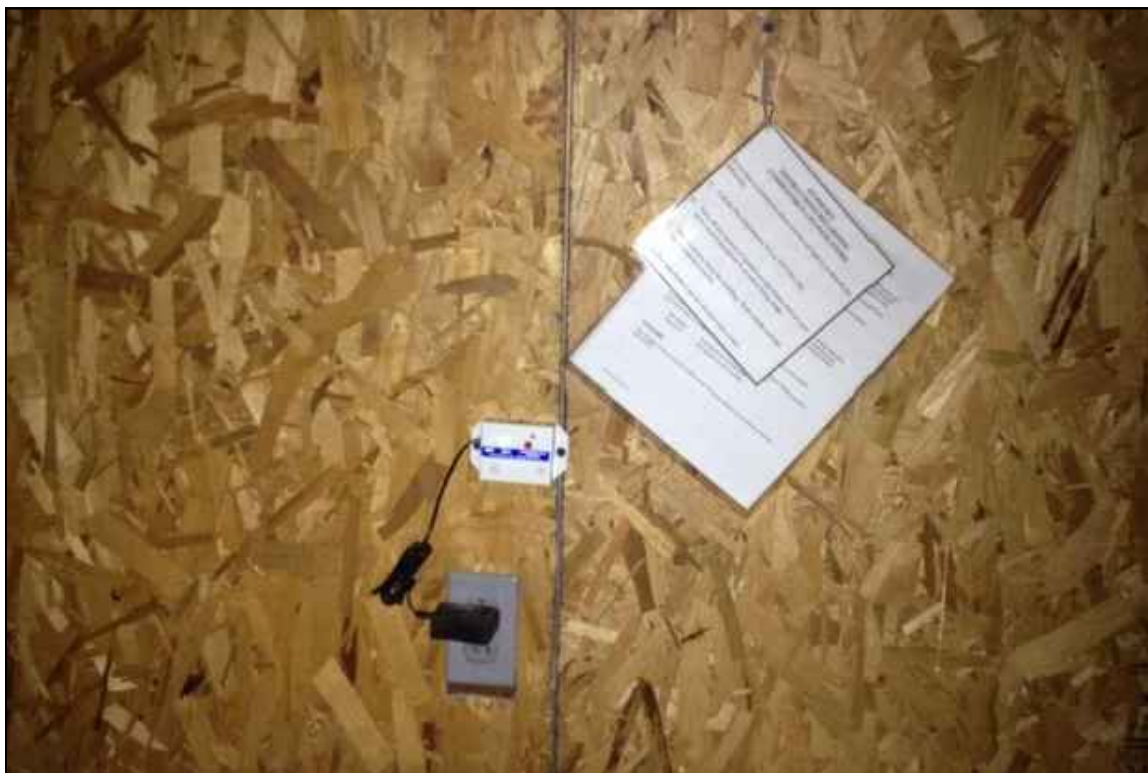
PHOTO 3: METHANE MONITOR SETUP IN SIM TRAINER, 2031 DRYDEN ROAD

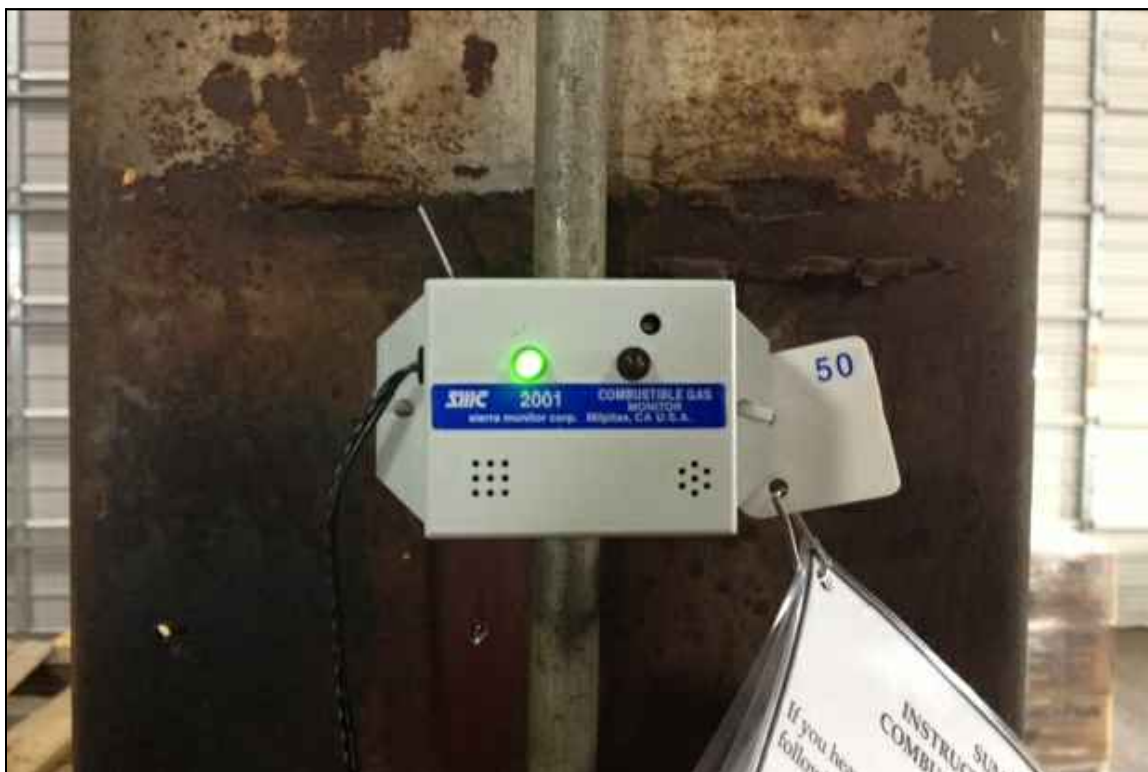
PHOTO 4: METHANE MONITOR SETUP IN VALLEY ASPHALT, 1903 DRYDEN ROAD

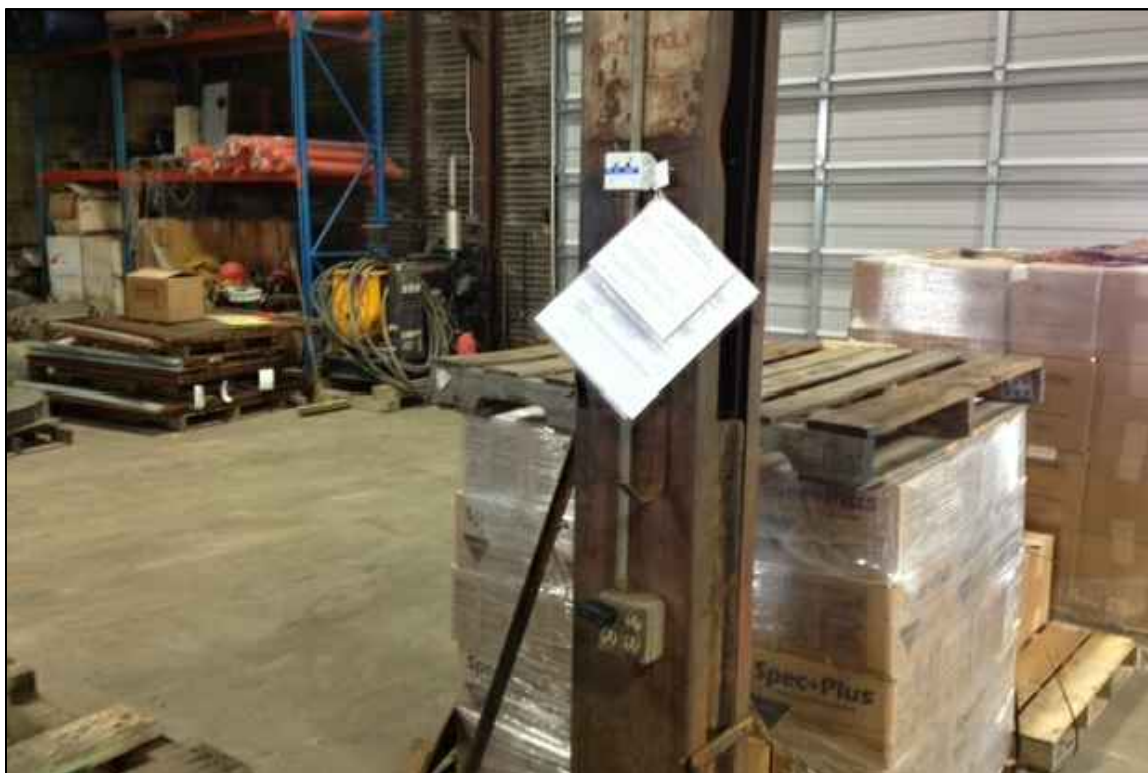
PHOTO 5: METHANE MONITOR WAREHOUSE LOCATION IN VALLEY ASPHALT, 1903 DRYDEN ROAD

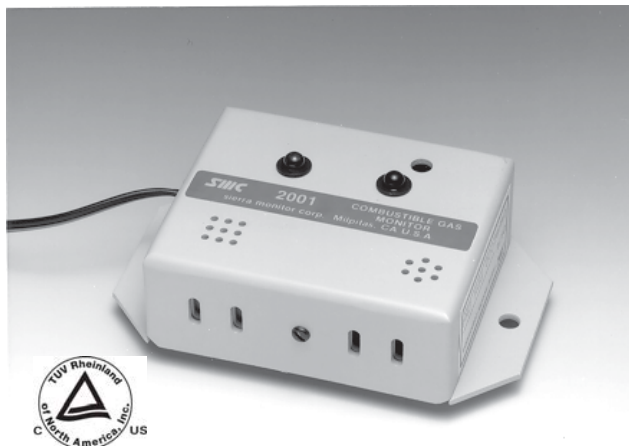
*The Model 200X Series are compact, solid-state, fixed-installation single alarm monitors designed for continuous area monitoring of Combustible Gas, Hydrogen Sulfide, or Carbon Monoxide.*

The Model 200X Series consists of three separate gas monitors, Model 2001 for Combustibles Model 2003 Hydrogen Sulfide and Model 2006 for Carbon Monoxide. A red LED (light-emitting diode) and audible alarm activate when the concentration of gas exceeds the factory-set (and user-adjustable) level. A green LED indicator on the monitor shows that power is connected and it is a safe condition.

The standard configuration has a buzzer and normally operating open relay, a fail-safe normally operating closed relay is field selectable.

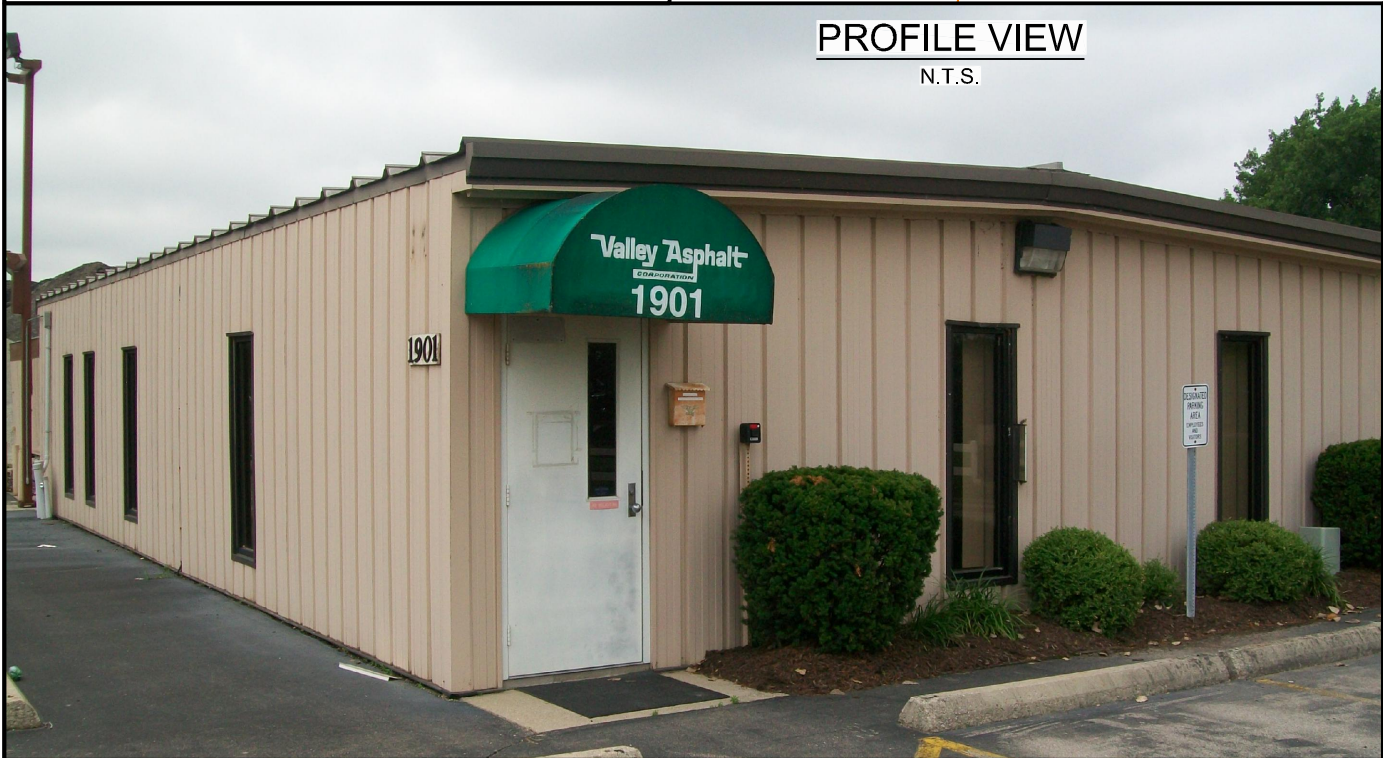
figure G.1

**Building Characteristics:**  
Single-story commercial-use building, constructed prior to 1993. Footprint is 1,500 sq. ft. Primarily office space (6 single offices) with bathrooms and kitchenette. 8 ft. drop ceilings. Brick building with steel cladding, windows are inoperable. Concrete slab-on-grade, covered with wall-to-wall carpeting. Average air tightness, weather seals in fair condition. Heating provided by forced air natural gas furnace, central A/C from exterior ground unit. Exterior openings - vents, utility pipe penetrations, 2 personnel doors. Building has been vacant for 4 to 5 years.

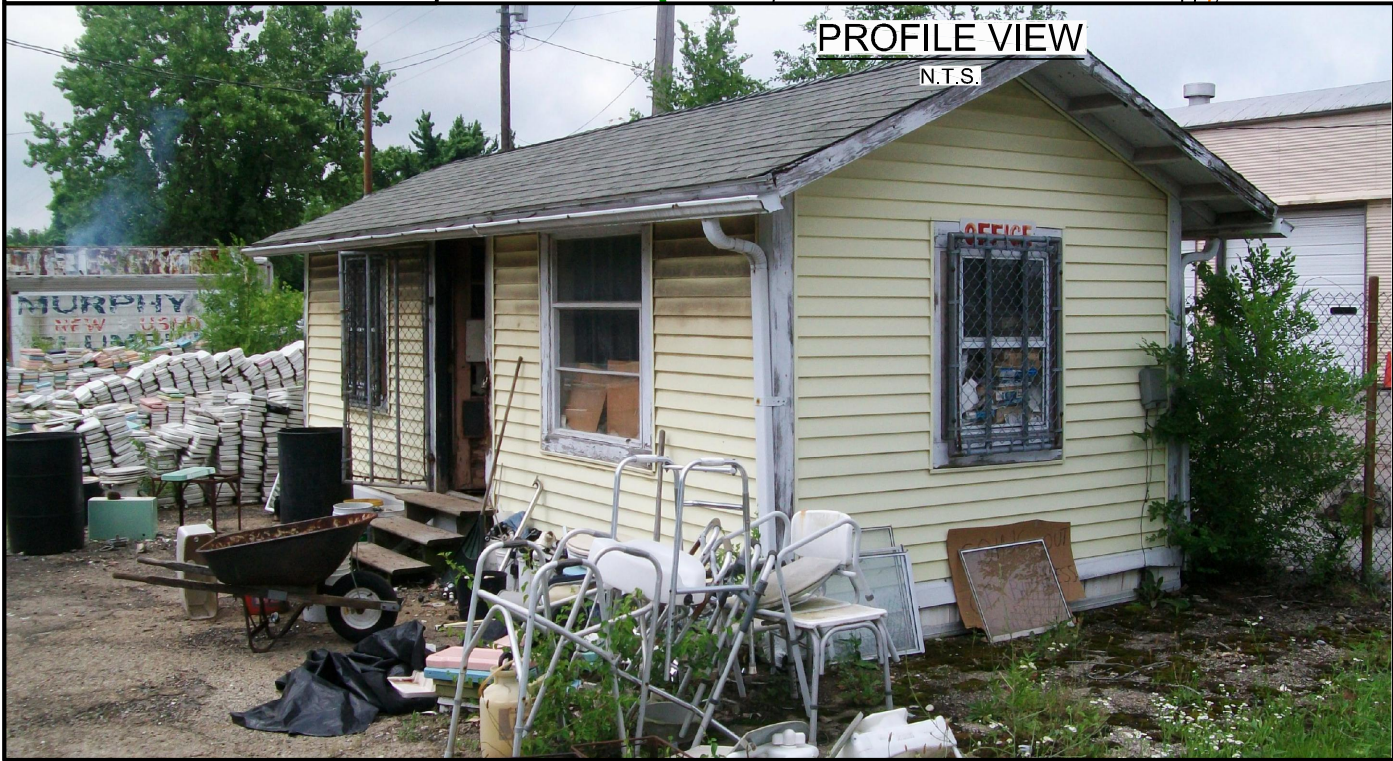
Building Characteristics:  
Single-story commercial-use building. 365 sq. ft building on raised foundation, with wood siding, constructed prior to 1950s. No weather seals present, not air tight. Exterior openings - windows, door. No HVAC systems present.  
Occupancy - vacant since July 1, 2011.

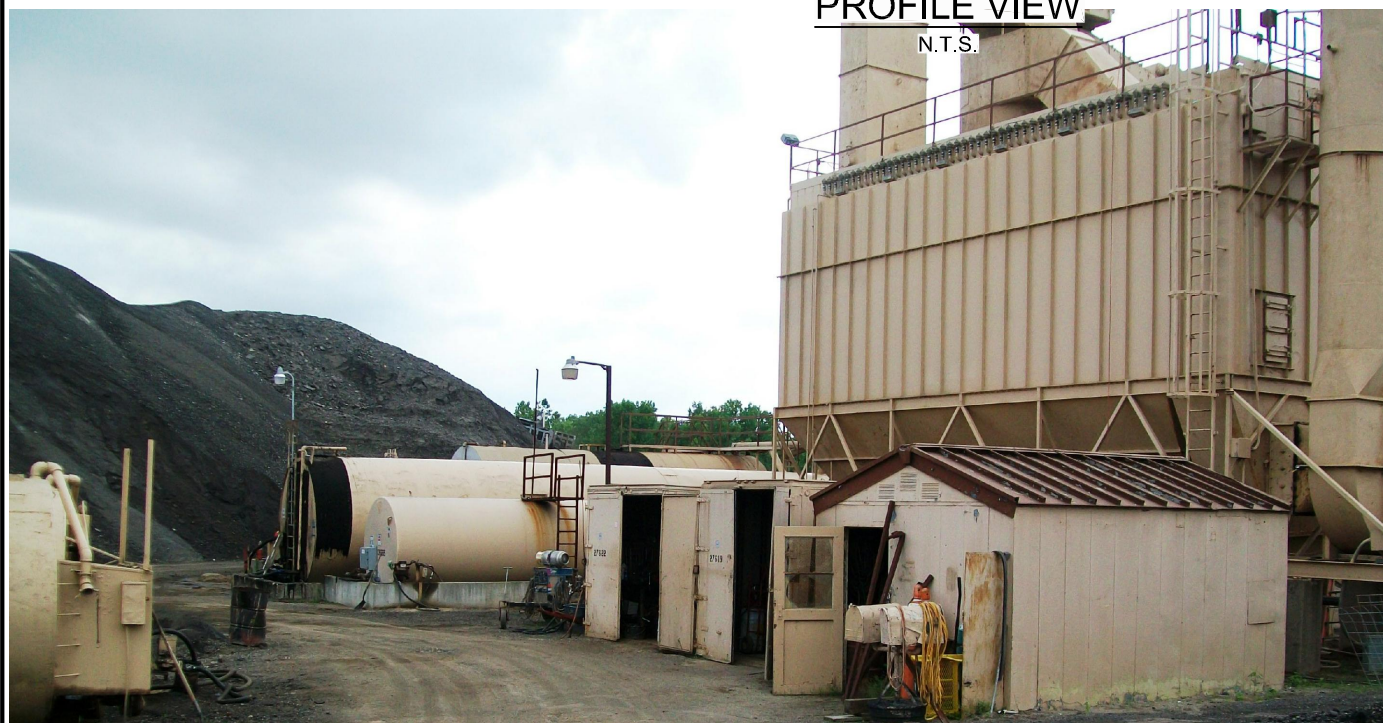
**Building Characteristics:**  
Single-story industrial-use building with steel panels. 218 sq. ft. steel-frame, steel-sided storage shed with earthen floor, constructed prior to 2005. No insulation, not air tight. No HVAC systems present. Exterior openings - vents and personnel door. Building used for chemical storage.  
No regular occupancy, storage only

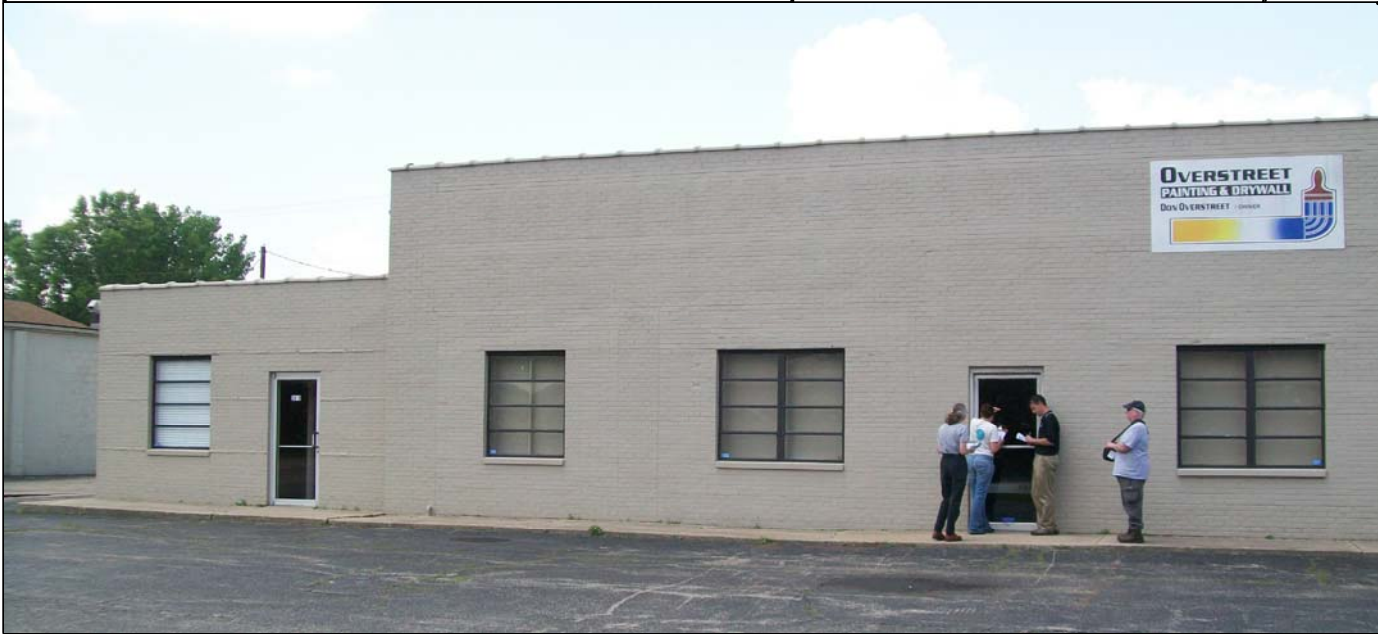
**Building Characteristics:**  
Single story, industrial-use building, constructed in the 1950s. Divided into two equal sections, north and south sides. Total footprint is 11,600 sq. ft. Approximately 16 ft high. Slab-on grade, concrete block building with brick front. Exterior openings - windows, utility pipe penetrations, bay doors, personnel doors. Not insulated, average air tightness, weather seals in fair condition. North side is the S&J Precision building. See figure G.11. South side is the Overstreet Painting building. Commercial-use storage building. Primarily paint and vehicle storage with vehicle detailing space. Bare concrete floor with cracks. Heating provided by forced air natural gas furnace ceiling unit. No A/C. No regular occupancy - storage only.

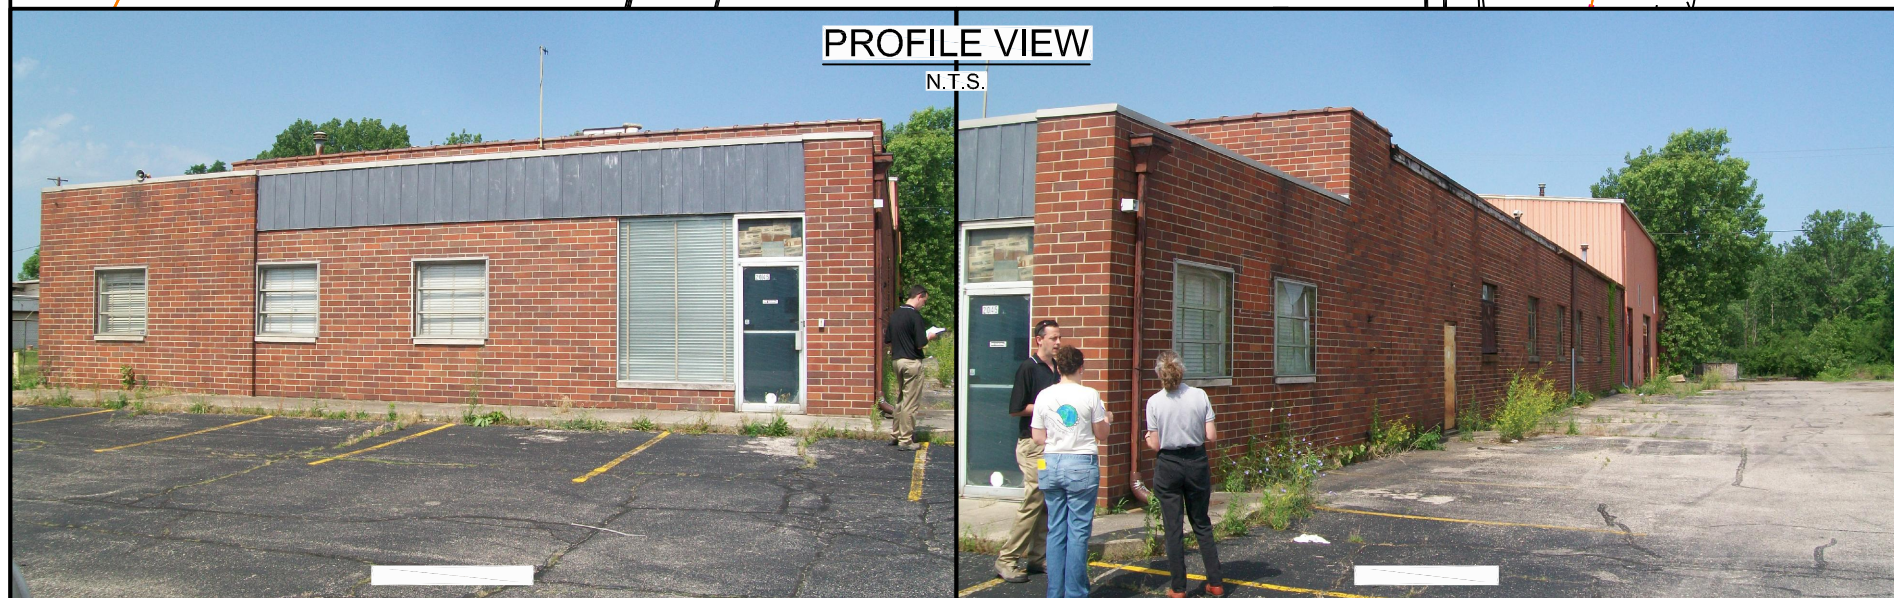
figure G.16  
PARCEL 5174 - COMMAND ROOFING BUILDING 16  
2045 DRYDEN ROAD  
SOUTH DAYTON DUMP AND LANDFILL SITE  
*Moraine, Ohio*

**Building Characteristics:**  
Single-story, commercial-use storage building, constructed prior to 1968. 12,500 sq. ft concrete slab-on-grade building. Areas A (approximately 12 ft high) and B (approximately 16 ft high) constructed with brick, with weather seals in poor condition. Spray-on insulation (possible asbestos) used in Area B. Areas C (approximately 24 ft high) to E constructed with steel beams and metal siding. No HVAC systems in use as of June 2011. Not air tight. Damp and moldy, with visible evidence of water staining in office area A. Floor slab in poor condition, with cracks and unsealed joints throughout the building, particularly cracked in Areas D and E. Heavy floor staining in areas B through E. Exterior openings - office windows, personnel doors, sliding and roll-up doors.  
Infrequent and variable occupancy by 2 adults.

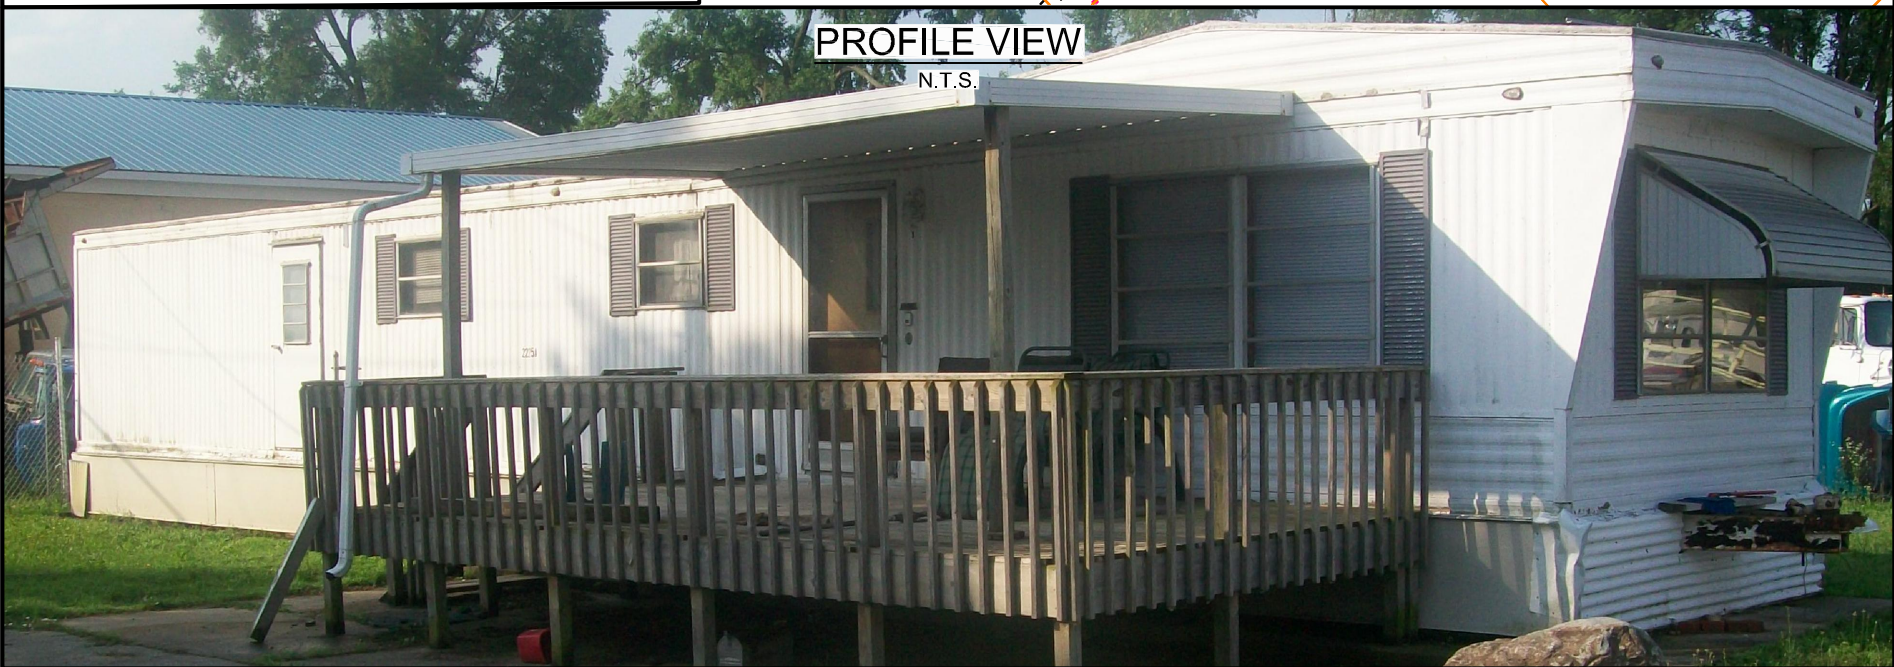
**Building Characteristics:**  
Single-story, residential trailer, constructed early 1990s. 685 sq. ft. trailer with crawl space enclosed by wood skirting in poor condition, over a concrete pad. Concrete and wood appear damp. Insulated trailer with average air tightness, weather seals in fair condition. Heating provided by forced air propane furnace. Central A/C present. Exterior openings - vents, utility pipe penetrations, windows, doors.

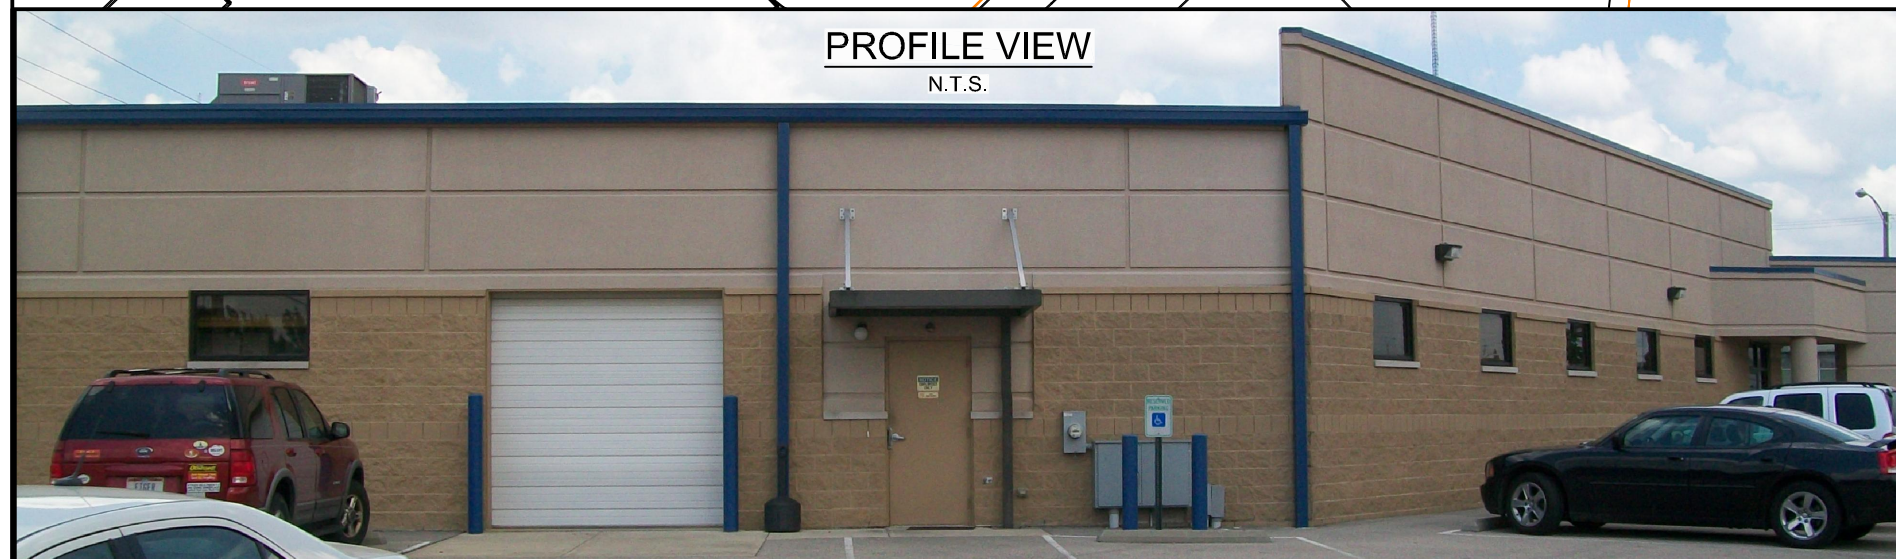
figure G.23  
PARCEL 3207 - GLOBE EQUIPMENT BUILDING 23  
2153 DRYDEN ROAD  
SOUTH DAYTON DUMP AND LANDFILL SITE  
*Moraine, Ohio*

**Building Characteristics:**  
Single-story commercial/industrial-use building. Primarily office space with some assembly/warehouse space. Constructed in 2004 over historic location of gas station and junk yard. Footprint is 9,954 sq. ft. Slab-on-grade concrete building, unsealed joints in assembly/warehouse room. Wall-to-wall carpeting in the office space. Insulated and air tight building, with weather seals in good condition. Heating provided by forced air natural gas roof-top units. Central A/C provided by roof-top units. Exterior openings - vents, utility pipe penetrations, inoperable windows, personnel doors, roll-up door. Occupied weekdays from 8 AM to 5 PM by approximately 15 adult workers.
