**Subject: Letter Report
Villa Mobile Home Park
Kannapolis, Cabarrus County, North Carolina
Technical Direction Document (TDD) No.: TNA-05-001-0176
Contract No.: EP-W-05-053**

**VILLA MOBILE HOME PARK
KANNAPOLIS,
CABARRUS COUNTY,
NORTH CAROLINA
TDD No. TNA-05-001-0176**

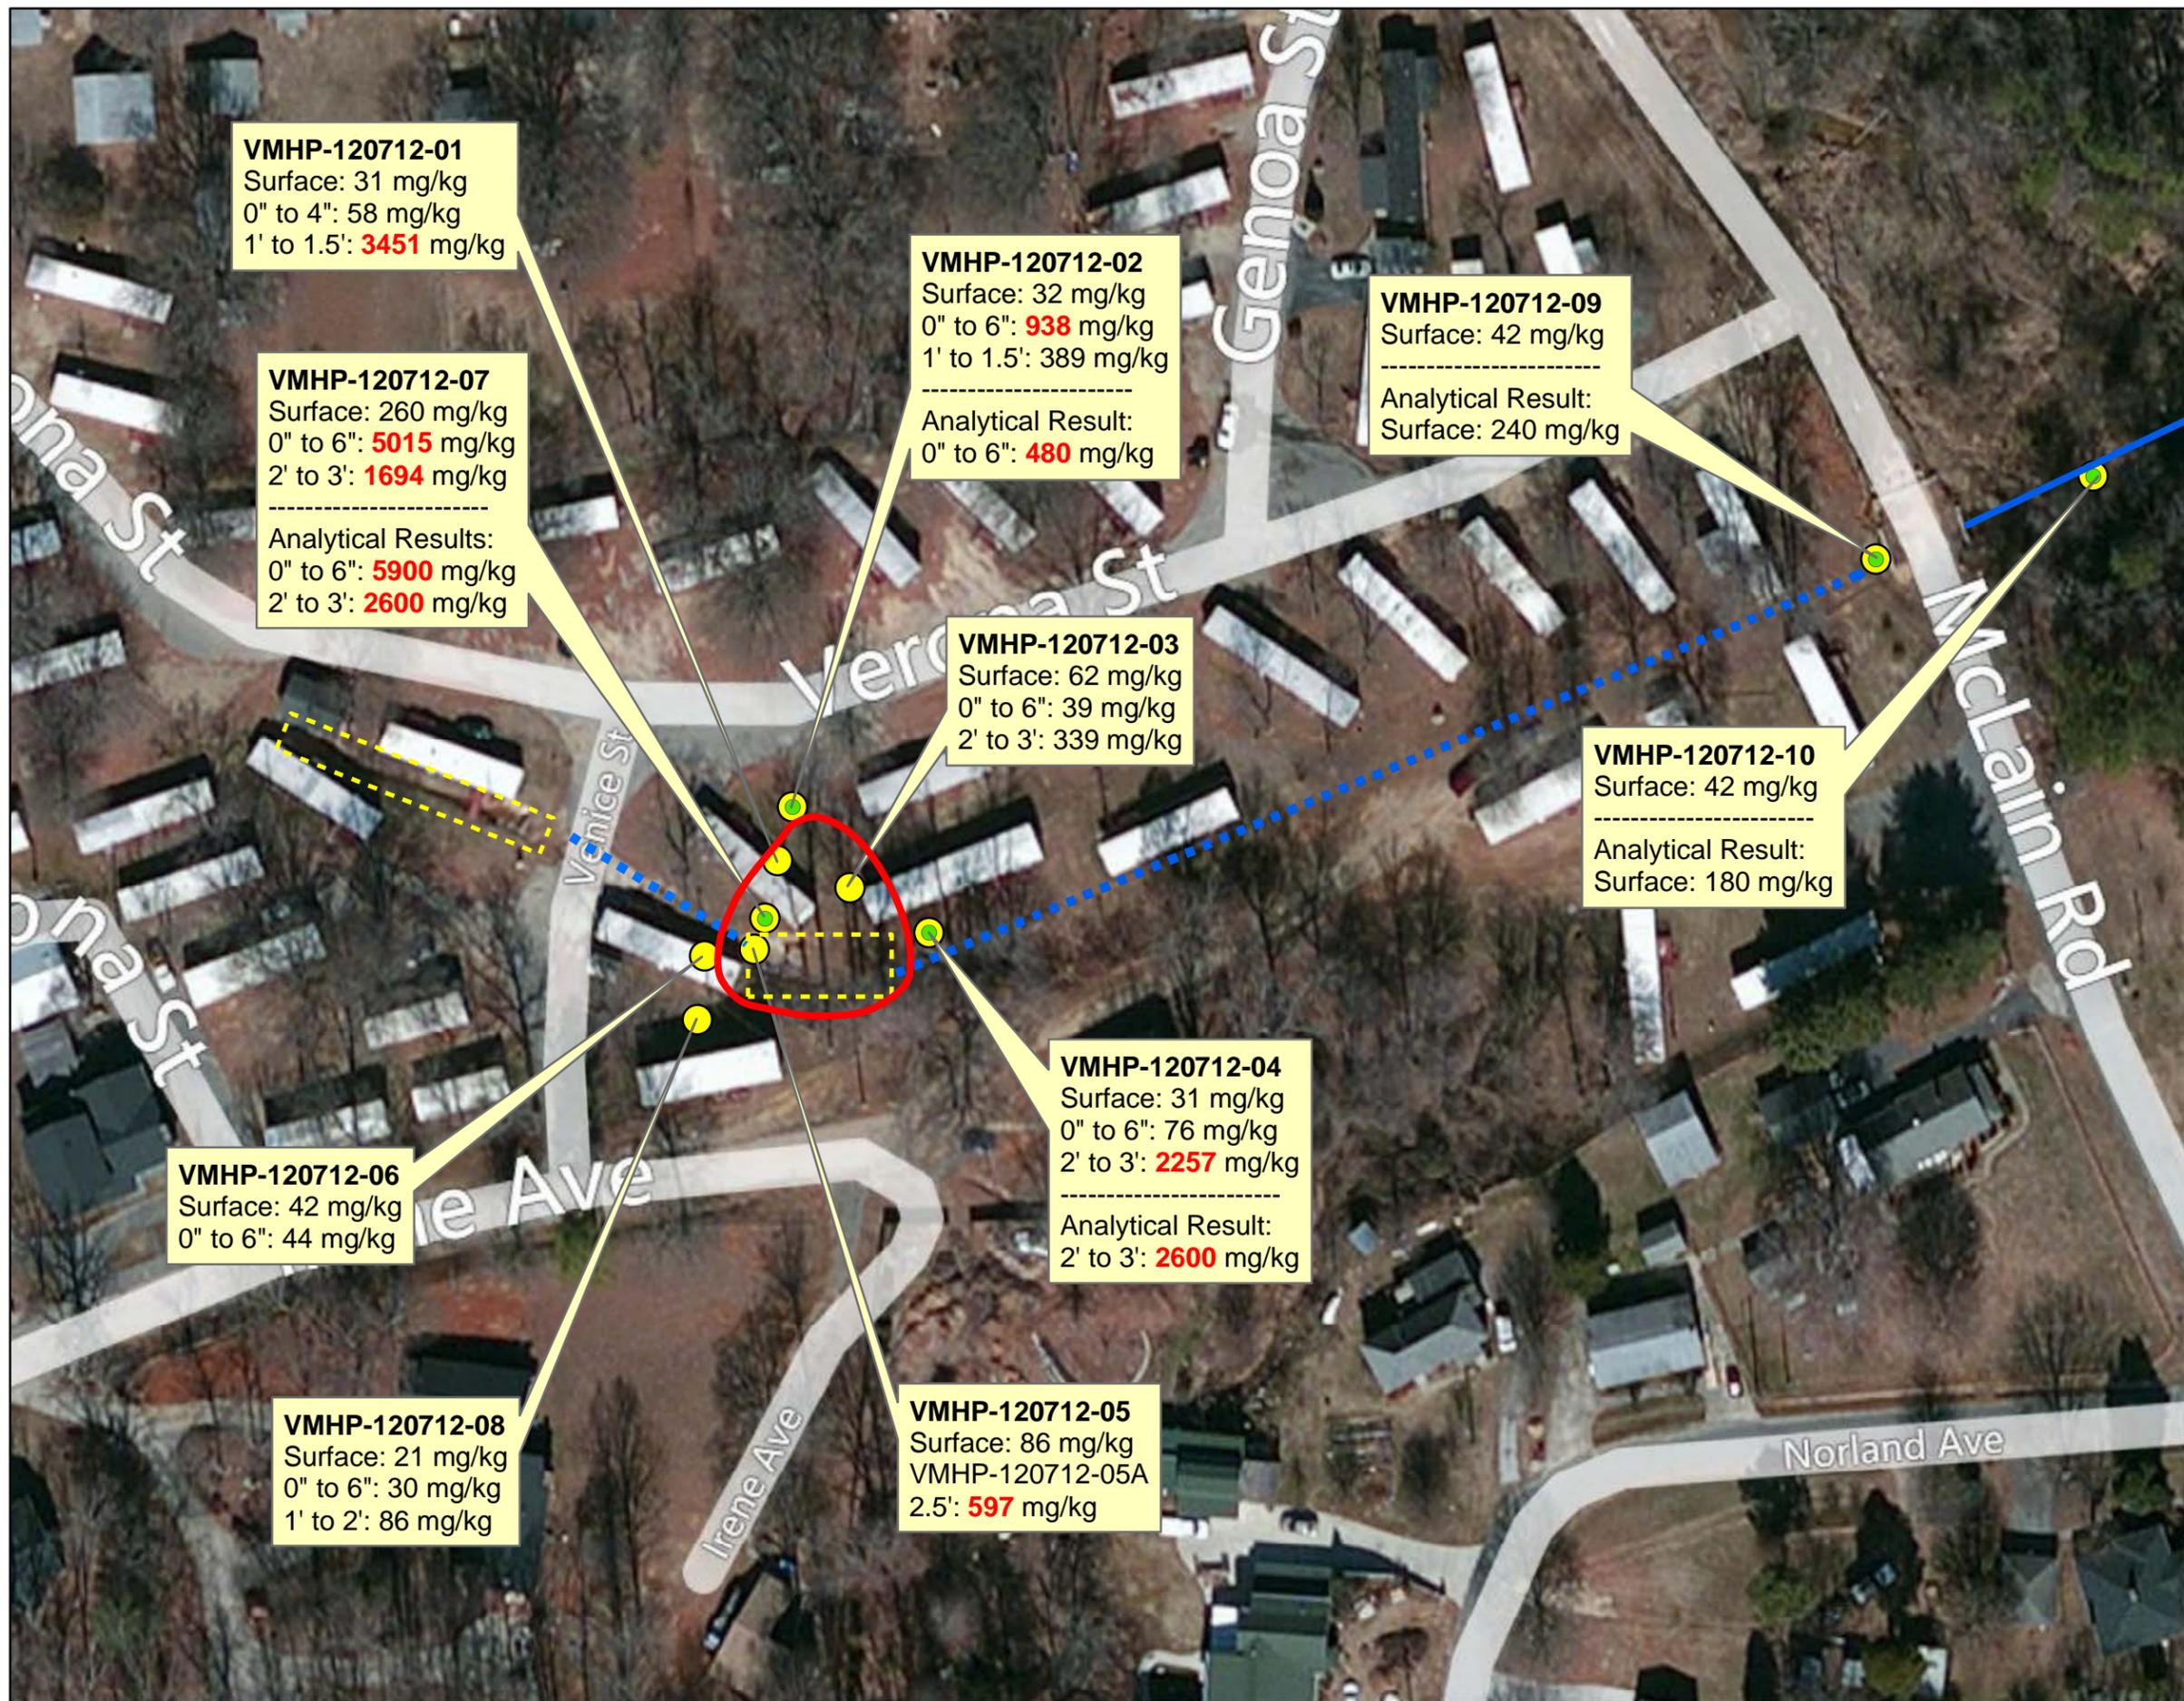
VMHP-120712-01
 Surface: 31 mg/kg
 0" to 4": 58 mg/kg
 1' to 1.5': **3451** mg/kg

VMHP-120712-07
 Surface: 260 mg/kg
 0" to 6": **5015** mg/kg
 2' to 3': **1694** mg/kg

In July 2012, EPA and OTIE START personnel conducted a limited site assessment of surface soils, subsurface soils, and sediments in the areas indicated by the S&ME report, *Mitigation Action Plan*, dated April 24, 2012. START performed soil screening with a portable XRF analyzer at eight different locations around the open pit drainage area at intervals of 0 inches (surface), 0 to 6 inches below ground surface (bgs), and 2 to 3 feet bgs where conditions allowed. Samples for XRF screening were extracted using a stainless steel hand auger and composited prior to screening. Seven samples were collected during this assessment including two sediment samples collected from the surface stream floor at the McLain Road crossing, and approximately 50 feet east of McLain Road, respectively. Results of sample analysis indicated lead levels in excess of the RML of 400 mg/kg in five of the seven samples (see Table 1 and Figure 3). All work described above was performed under TDD #TNA-05-003-0171.

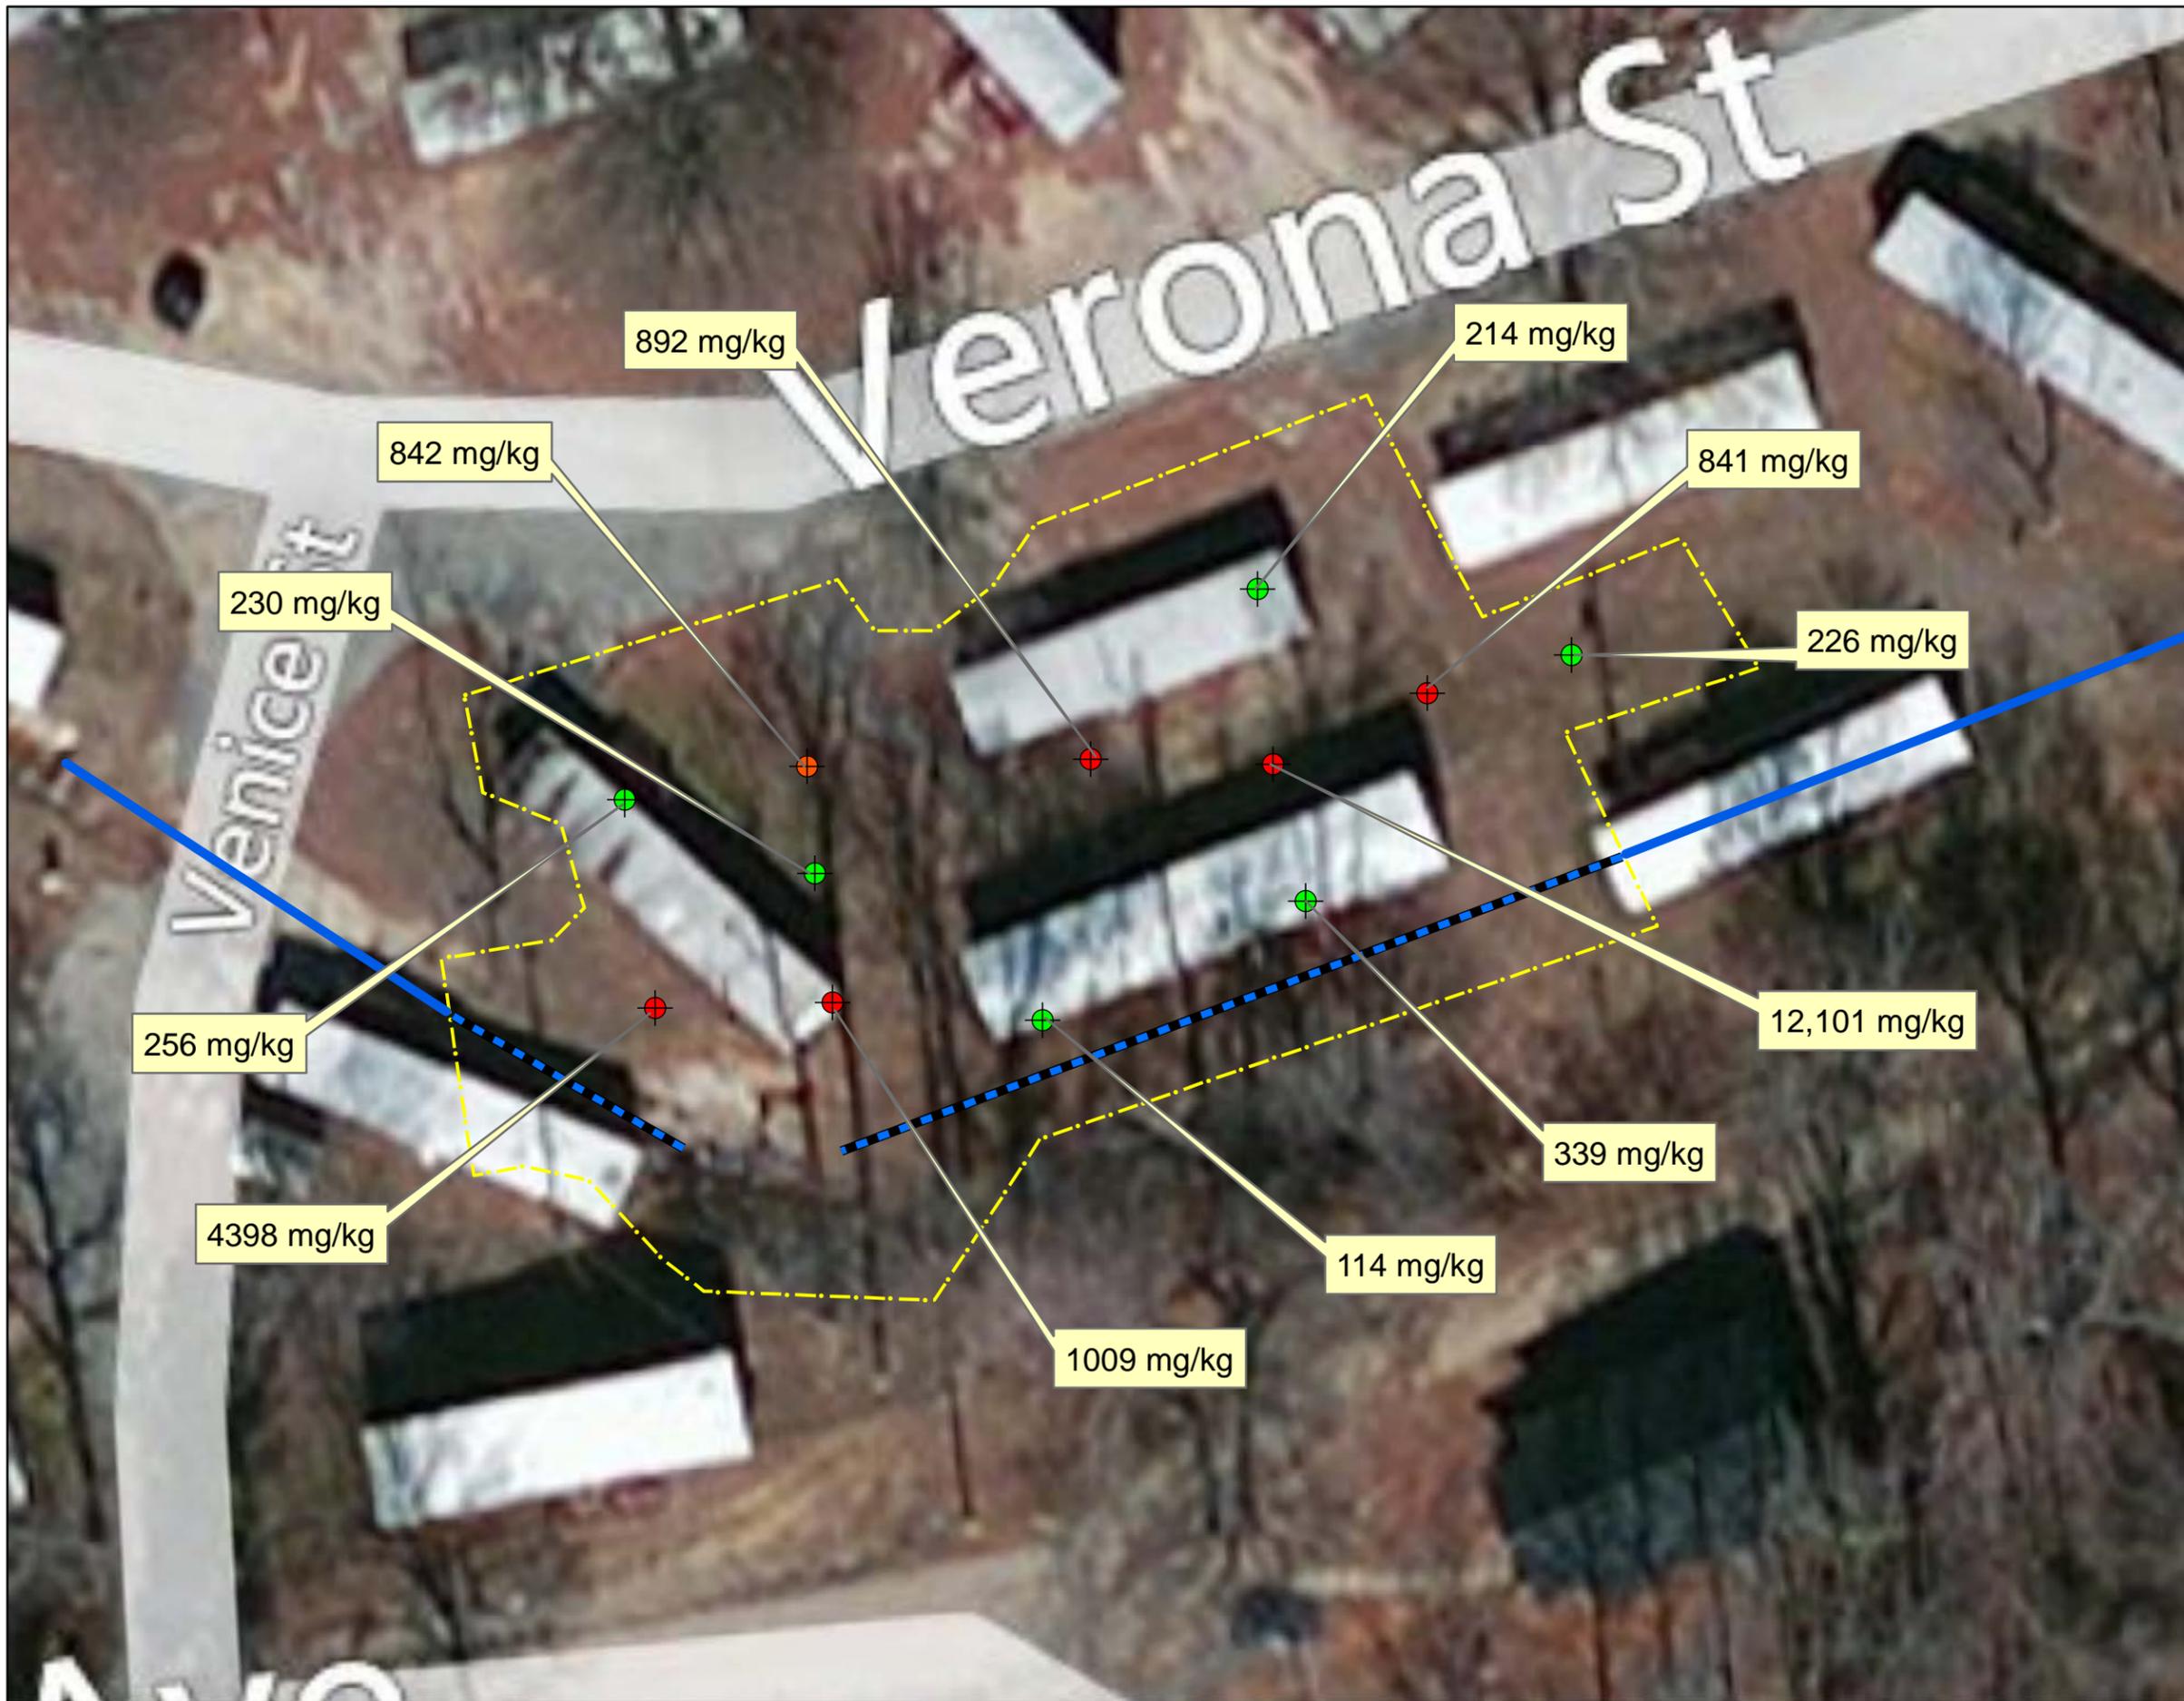
**FIGURE 3
 XRF AND ANALYTICAL RESULTS
 FOR LEAD - JULY 12, 2012**

- Extent of Excavation
 - Lead Concentration < RML
 - Lead Concentration > RML
 - Piped Stream
 - Conduit Removed
- Notes:
 - RML: Removal Management Level of 400 milligrams per kilogram (mg/kg)
 - XRF: X-Ray Fluorescence
- 0 25 50 Feet

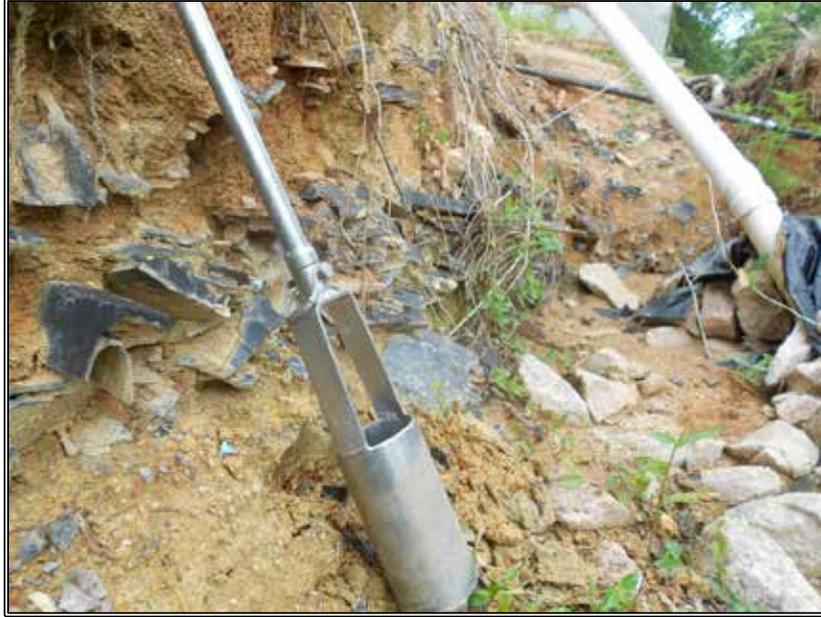
Official Photograph No. 1

Subject: Exposed battery casings in open pit drainage with dislodged plastic and rip rap rock.

In September 2010, the potentially responsible party (PRP) attempted a corrective action to stabilize and cover the battery casings in the open pit drainage area by placing a heavy-gauge plastic liner over the exposed soils and covering the plastic with large rip rap rock. Subsequent stormwater flow through the open pit drainage area dislodged the rip rap rock and damaged the plastic liner to the point that it was no longer effectively blocking the exposure risk to residents.

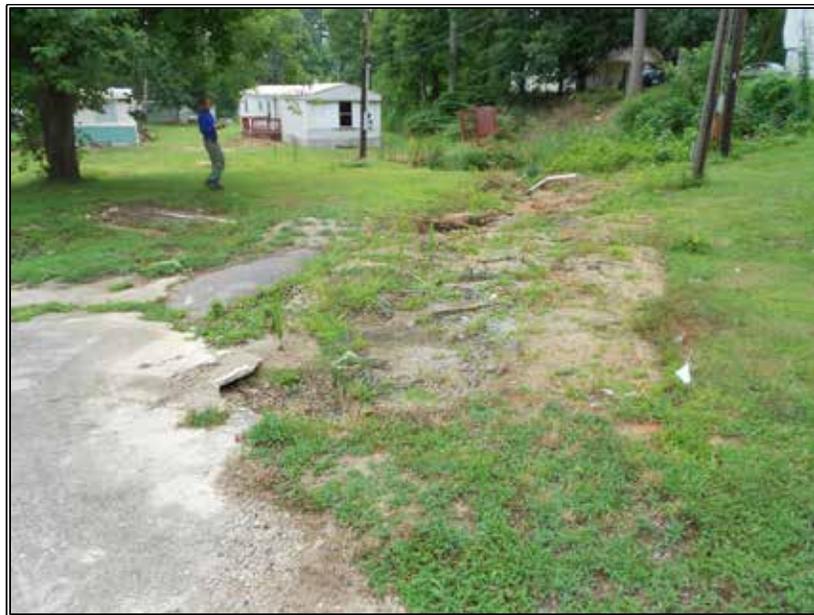
Official Photograph No. 2

Subject: Standing on Venice Street facing east where overland flow has scoured surface soils leading to open pit.

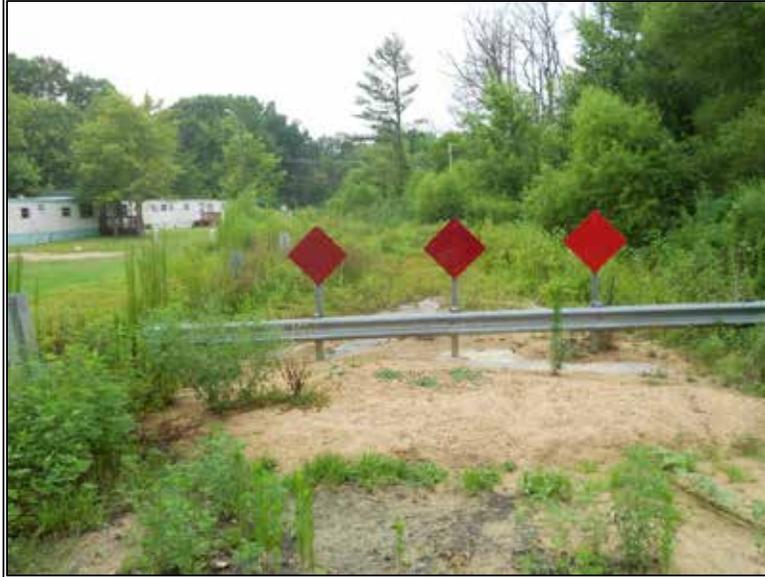
Official Photograph No. 3

Site Name: Villa Mobile Home Park Battery Dump Site **Date:** July 7, 2012
Location: Kannapolis, Cabarrus County, North Carolina **TDD No:** TNA-05-001-0176
Photographer: Eric Morris, OTIE - EPA Region 4 START Contractor
Subject: Facing north on closed segment of McLain Road where tributary is piped underneath roadway.

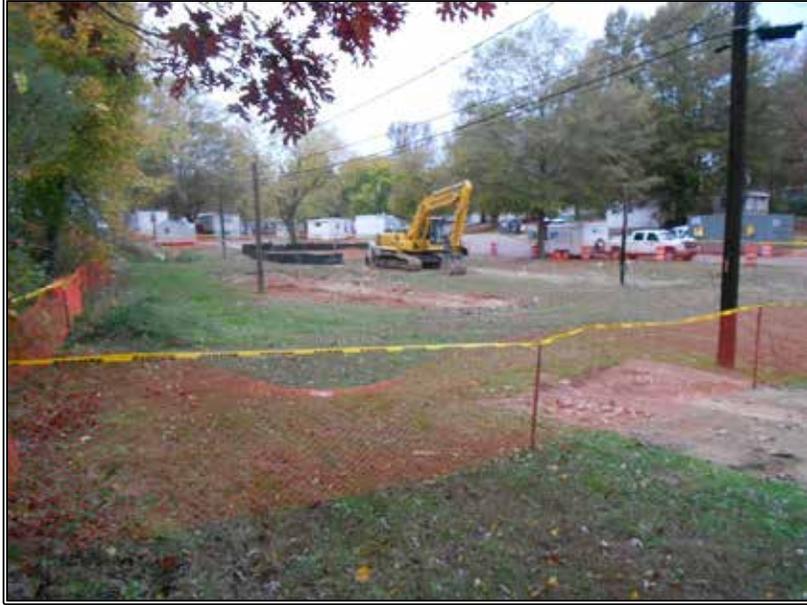
Official Photograph No. 5

Site Name: Villa Mobile Home Park Battery Dump Site **Date:** October 30, 2012
Location: Kannapolis, Cabarrus County, North Carolina **TDD No:** TNA-05-001-0176
Photographer: Eric Morris, OTIE - EPA Region 4 START Contractor
Subject: Condition of site prior to removal action – facing west from southeast corner of the site.

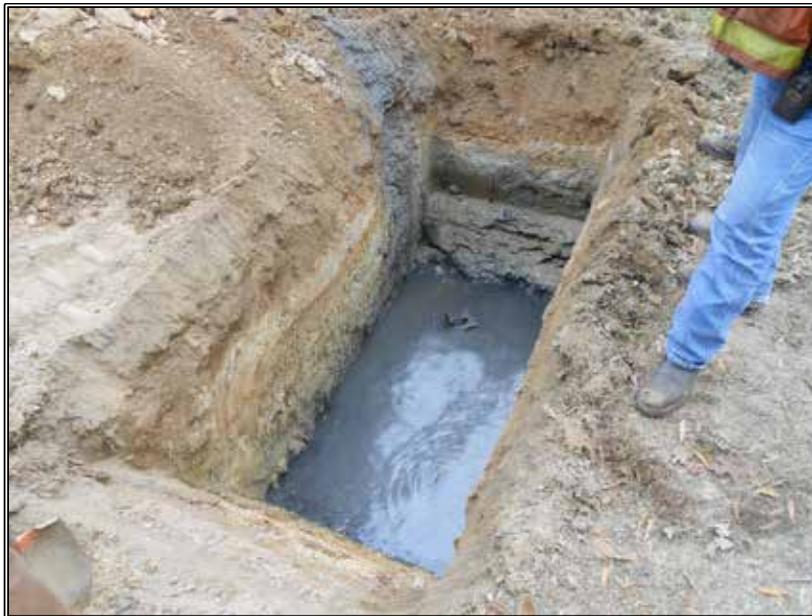
Official Photograph No. 6

Site Name: Villa Mobile Home Park Battery Dump Site **Date:** October 30, 2012
Location: Kannapolis, Cabarrus County, North Carolina **TDD No:** TNA-05-001-0176
Photographer: Eric Morris, OTIE - EPA Region 4 START Contractor
Subject: Water from casing layer flooding test pit.

During excavation on November 1, 2012, water began leaching from the upgradient sidewall of the trench and pooling in the excavation. The water appeared to be flowing out of the casing layer, and stopped after several hours. On-site observation suggested that the water had previously leaked out of the drainage pipe at the south side of the site and pooled in this low lying area. The pipe segments did not appear to be installed in a manner that would allow them to drain properly, and the sections of pipe adjacent to the excavation in this area created a “belly”, where water could pool. This created a sag in the contour of the drainage pipe that may have allowed water to back-up and infiltrate this loosely packed casing layer. The water was confined in a sump pit at a depth of approximately 10 feet bgs and sampled by START for metals analysis. Lead and arsenic were detected at 331,000 micrograms per liter ($\mu\text{g/L}$) and 99 $\mu\text{g/L}$, respectively (see Table 2). Most of the wastewater percolated into the walls and floor of the sump pit and the remainder was covered with clean backfill the following week.

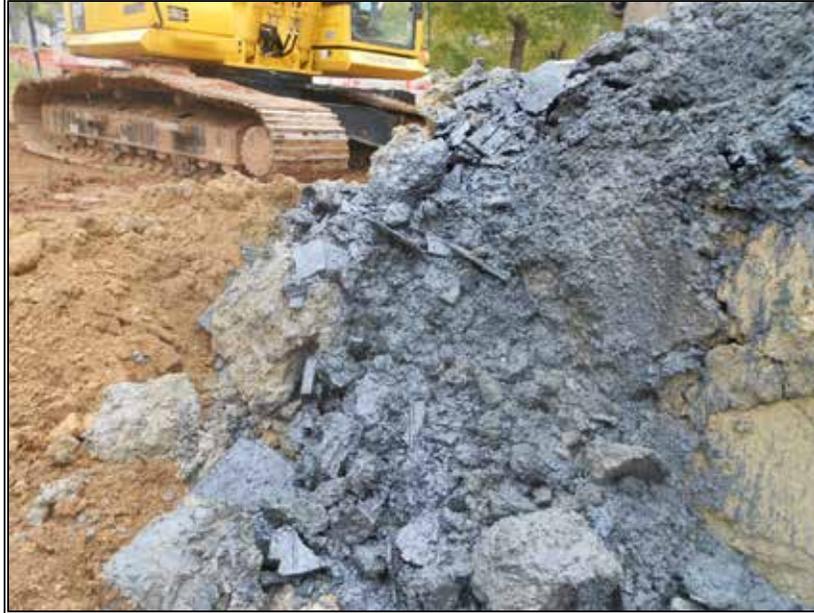
Official Photograph No. 7

Subject: Battery casings and saturated soil from test pit.

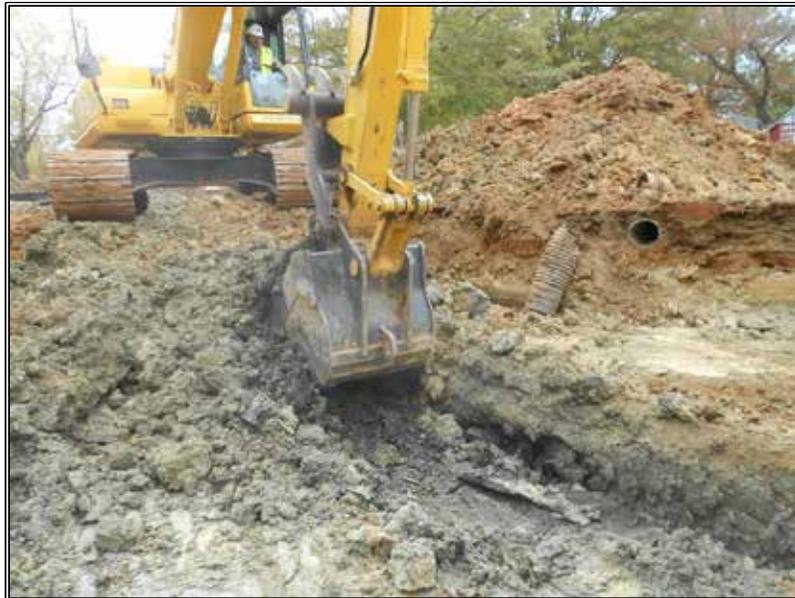
Official Photograph No. 8

Subject: Excavating battery casings and soil from approximately -6' to -8' below grade surface (bgs).

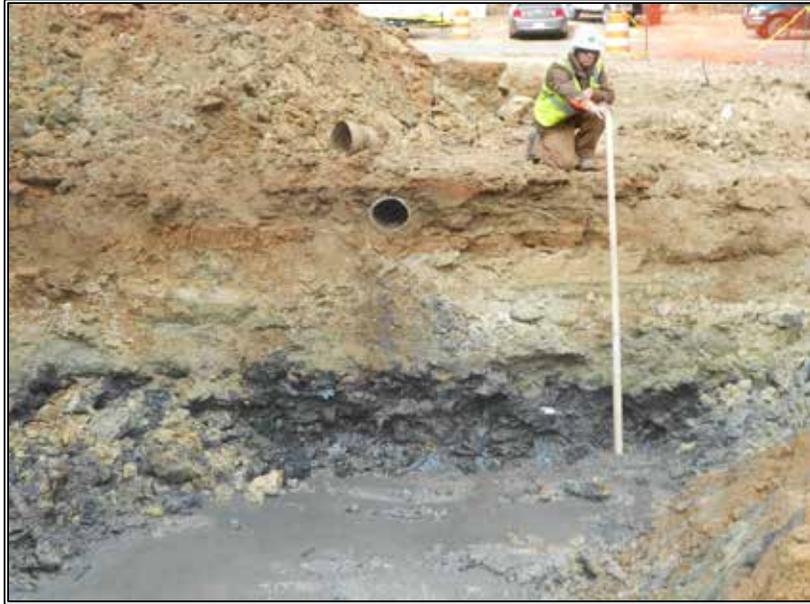
Official Photograph No. 9

Site Name: Villa Mobile Home Park Battery Dump Site **Date:** October 31, 2012
Location: Kannapolis, Cabarrus County, North Carolina **TDD No:** TNA-05-001-0176
Photographer: Eric Morris, OTIE - EPA Region 4 START Contractor
Subject: Battery casing layer extending from approximately -5' to -8' bgs.

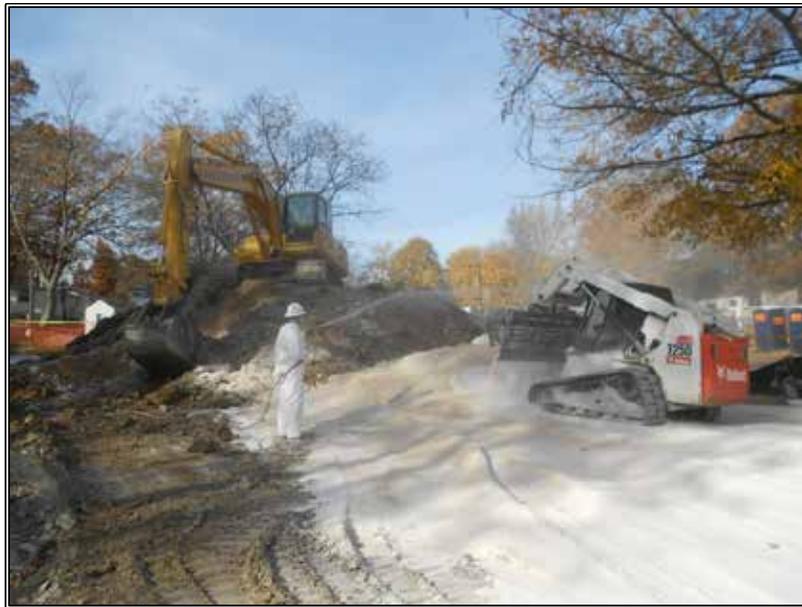
Official Photograph No. 10

Site Name: Villa Mobile Home Park Battery Dump Site **Date:** November 14, 2012
Location: Kannapolis, Cabarrus County, North Carolina **TDD No:** TNA-05-001-0176
Photographer: Eric Morris, OTIE - EPA Region 4 START Contractor
Subject: ERRS personnel mixing EnviroBlend into casing soils and spraying for dust control.

On November 2, 2012, START and ERRS collected a representative sample of stockpiled casing soils and shipped it to Premier Magnesia, LLC in West Conshohocken, Pennsylvania for a bench study. Premier Magnesia, LLC is the producer and distributor of EnviroBlend, a mixture of magnesium oxide and calcium phosphates that is often used to stabilize metals in soil so that it may be disposed of as non-hazardous waste. The bench study indicated that the product was well suited to treat the contaminant levels and soil type present on site. From November 2012 to January 2013, a total of 182.88 tons of EnviroBlend was delivered to the site from distribution points in Delaware and Alabama.

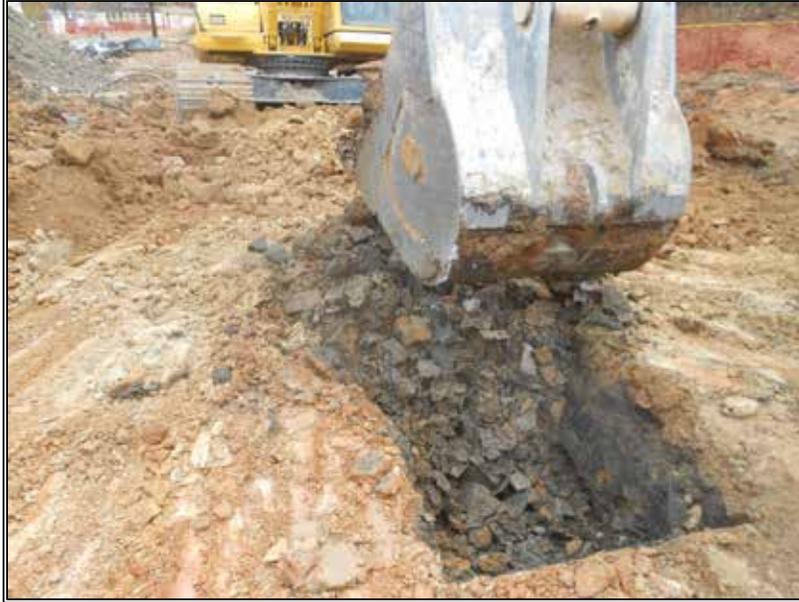
Official Photograph No. 11

Site Name: Villa Mobile Home Park Battery Dump Site **Date:** November 18, 2012
Location: Kannapolis, Cabarrus County, North Carolina **TDD No:** TNA-05-001-0176
Photographer: Eric Morris, OTIE - EPA Region 4 START Contractor
Subject: Test pit at far west end of the site.

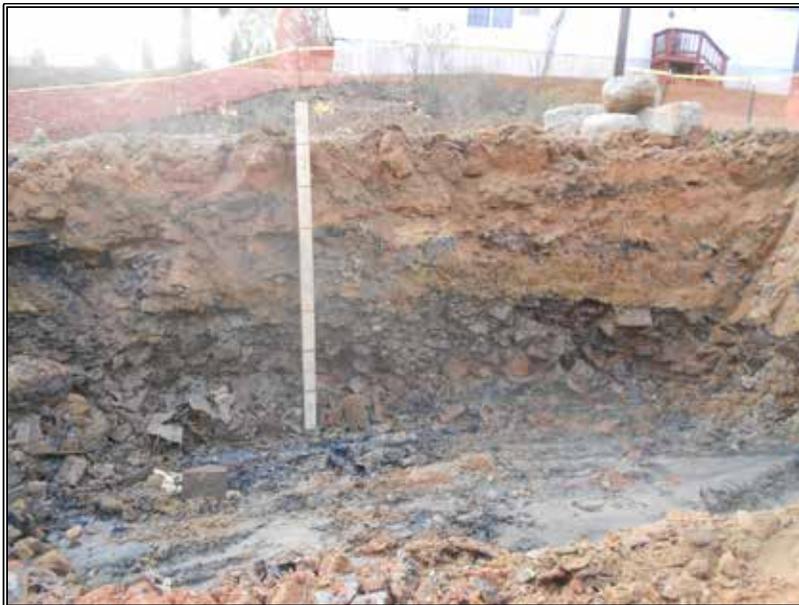
Official Photograph No. 12

Site Name: Villa Mobile Home Park Battery Dump Site **Date:** November 19, 2012
Location: Kannapolis, Cabarrus County, North Carolina **TDD No:** TNA-05-001-0176
Photographer: Eric Morris, OTIE - EPA Region 4 START Contractor
Subject: Side wall of excavation where a six-foot later of battery casings was buried. Area is immediately north of open pit where casings were first observed.

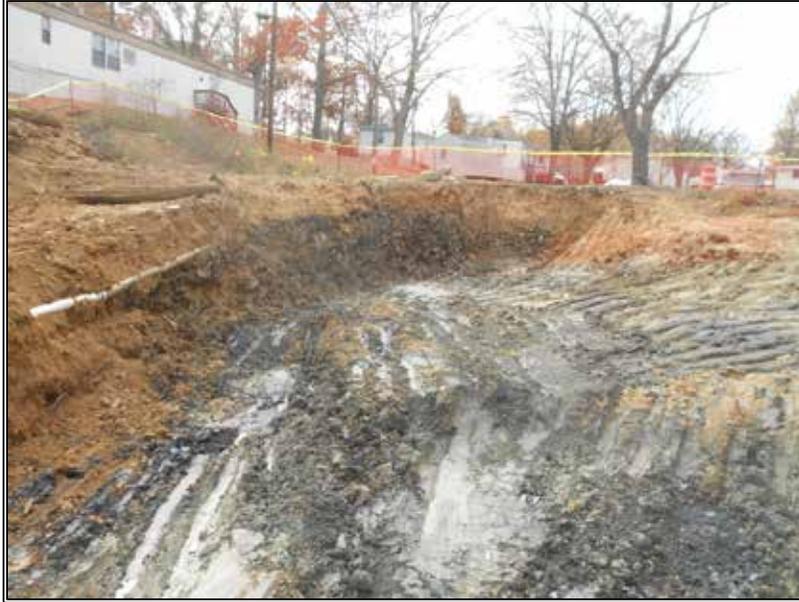
Official Photograph No. 13

Site Name: Villa Mobile Home Park Battery Dump Site **Date:** November 19, 2012
Location: Kannapolis, Cabarrus County, North Carolina **TDD No:** TNA-05-001-0176
Photographer: Eric Morris, OTIE - EPA Region 4 START Contractor
Subject: Facing west from floor of excavation near center of site. Repaired septic line visible in north-facing sidewall.

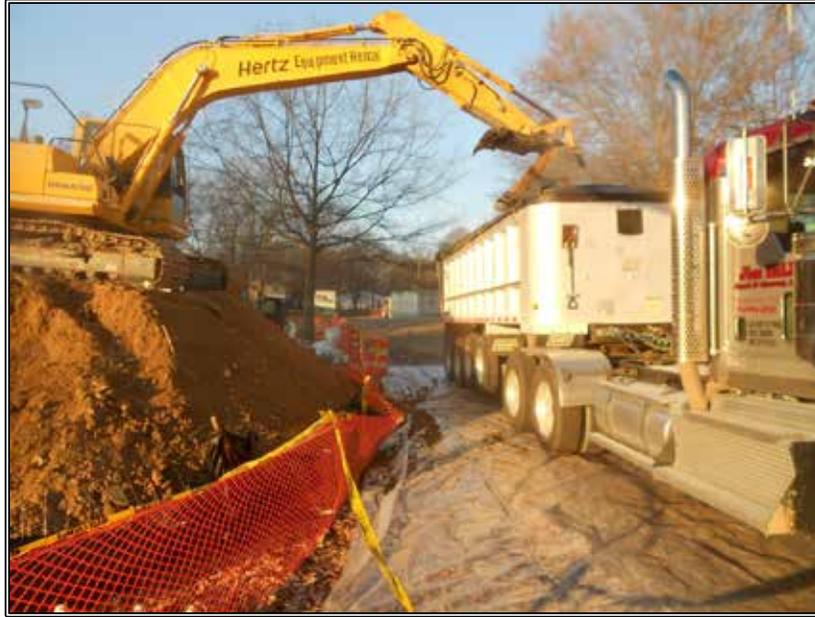
Official Photograph No. 15

Subject: Loading treated casing soils for shipment.

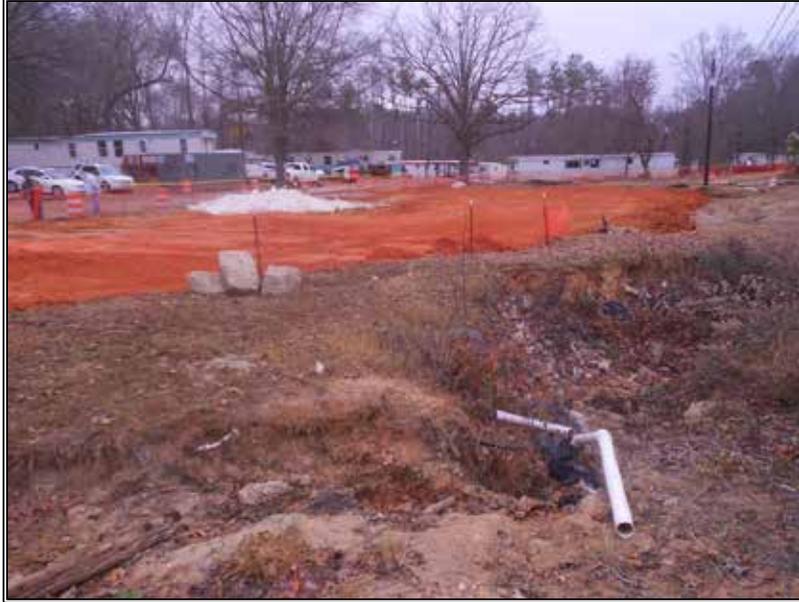
Official Photograph No. 17

Site Name: Villa Mobile Home Park Battery Dump Site **Date:** December 7, 2012
Location: Kannapolis, Cabarrus County, North Carolina **TDD No:** TNA-05-001-0176
Photographer: Eric Morris, OTIE - EPA Region 4 START Contractor
Subject: Open pit and surrounding soils, as well as ASTs buried along southern edge of site (right of photo) left in place over December demobilization.

It should be noted that, due to a delay in finalizing plans for the stream restoration project planned by NCDENR, ERRS was unable to excavate all of the soils containing battery casings during one work period and demobilized from December 7, 2012 until January 22, 2013. Soils in and around the open pit area at the northwest corner of the site, as well as the AST pipe segments and soils immediately surrounding these segments along the southern edge of the site were left in place to manage stormwater moving through the site until NCDENR's contractor, S&ME, completed the plans.

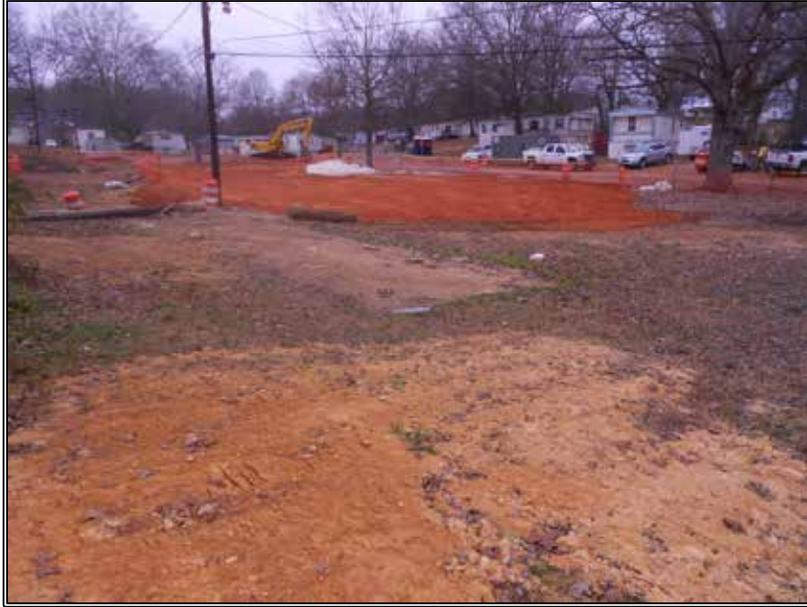
Official Photograph No. 18

Site Name: Villa Mobile Home Park Battery Dump Site **Date:** December 7, 2012
Location: Kannapolis, Cabarrus County, North Carolina **TDD No:** TNA-05-001-0176
Photographer: Eric Morris, OTIE - EPA Region 4 START Contractor
Subject: Condition of site upon December demobilization – facing east from northwest corner of the site at intersection of Venice Street and Verona Street.

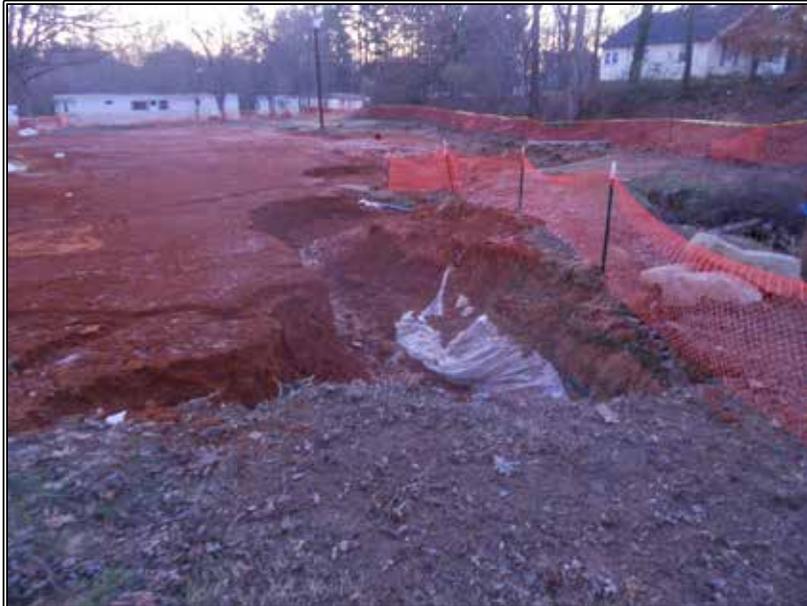
Official Photograph No. 20

Site Name: Villa Mobile Home Park Battery Dump Site **Date:** January 22, 2013
Location: Kannapolis, Cabarrus County, North Carolina **TDD No:** TNA-05-001-0176
Photographer: Eric Morris, OTIE - EPA Region 4 START Contractor
Subject: Erosion damage caused by overland flow of stormwater discovered upon remobilization to the site.

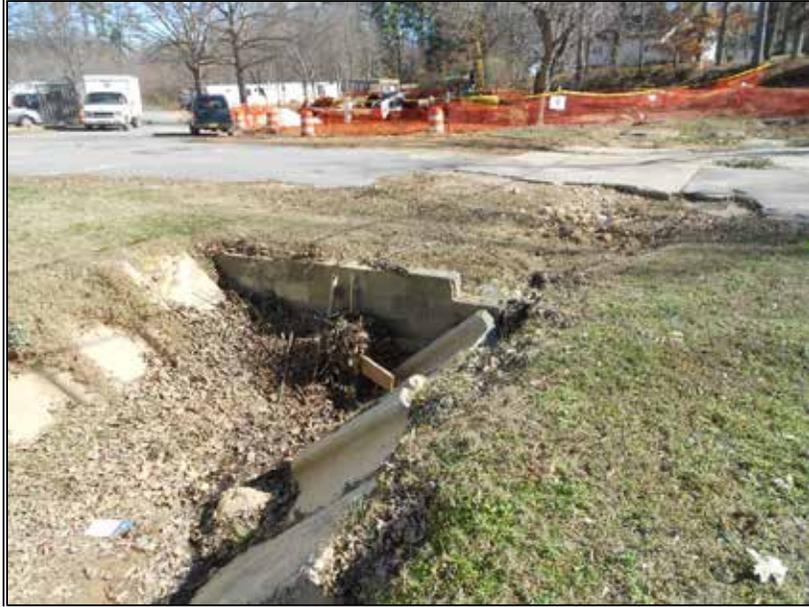
Official Photograph No. 21

Site Name: Villa Mobile Home Park Battery Dump Site **Date:** January 22, 2013
Location: Kannapolis, Cabarrus County, North Carolina **TDD No:** TNA-05-001-0176
Photographer: Eric Morris, OTIE - EPA Region 4 START Contractor
Subject: Upstream blockage of piped tributary on the west side of Venice Street that resulted in erosion of fill materials placed at the west end of the site.

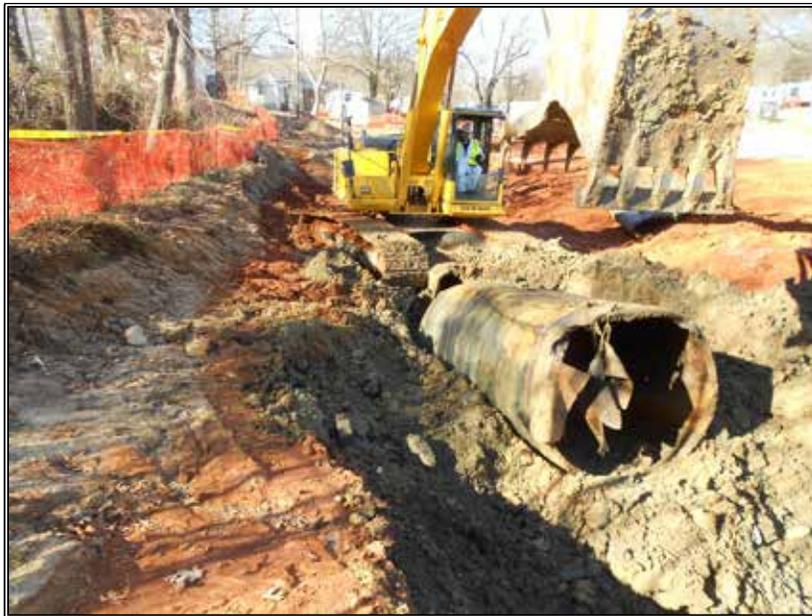
Official Photograph No. 22

Site Name: Villa Mobile Home Park Battery Dump Site **Date:** January 22, 2013
Location: Kannapolis, Cabarrus County, North Carolina **TDD No:** TNA-05-001-0176
Photographer: Eric Morris, OTIE - EPA Region 4 START Contractor
Subject: Removal of converted AST pipe segments.

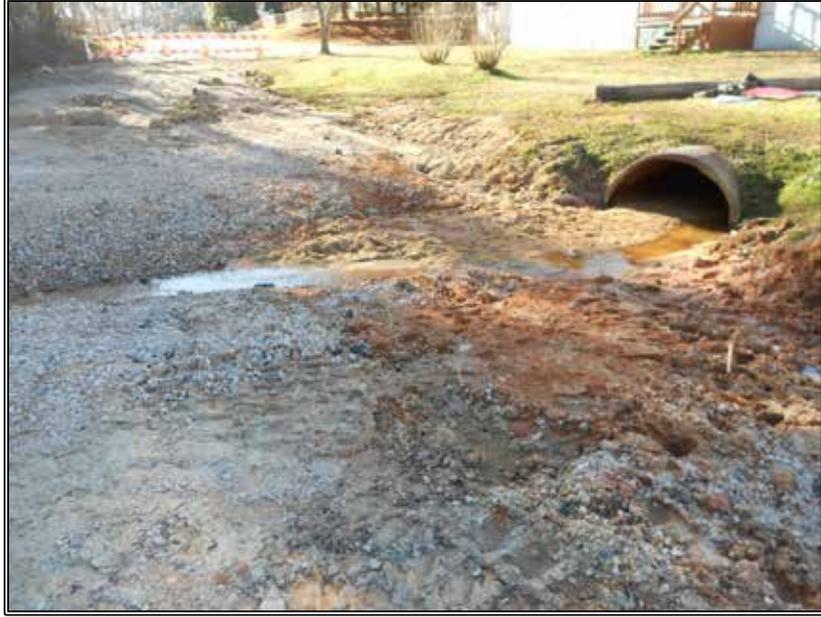
Official Photograph No. 23

Subject: Facing south on McLain Road following removal of asphalt, headwalls and conduit by City of Kannapolis personnel.

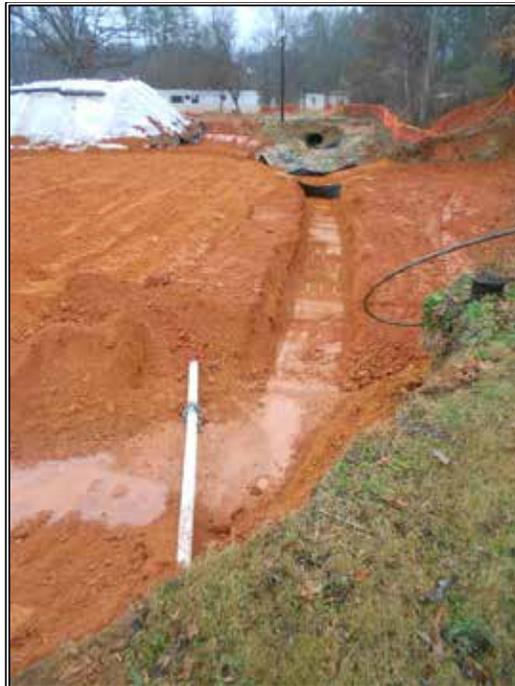
Official Photograph No. 26

Site Name: Villa Mobile Home Park Battery Dump Site **Date:** January 30, 2013
Location: Kannapolis, Cabarrus County, North Carolina **TDD No:** TNA-05-001-0176
Photographer: Eric Morris, OTIE - EPA Region 4 START Contractor
Subject: Measures taken to prepare for major overnight precipitation event.

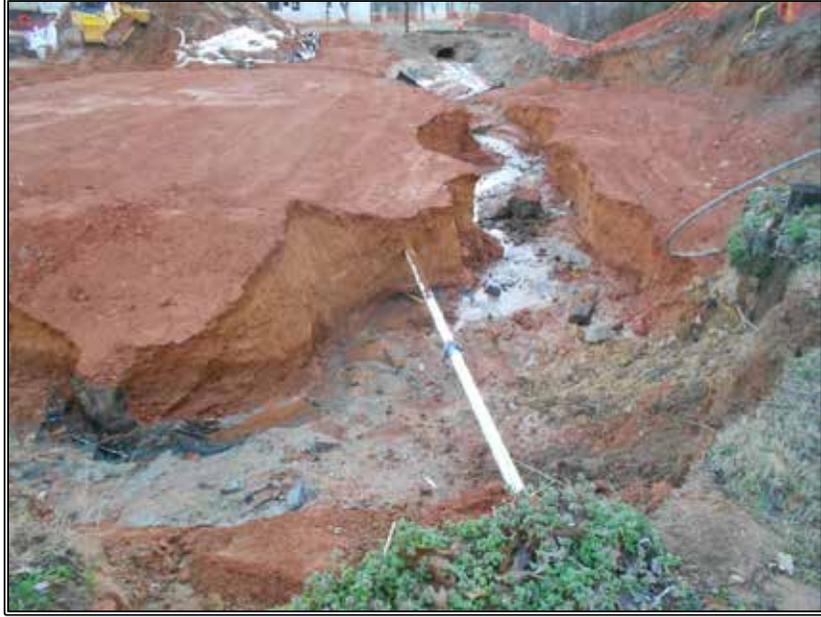
Official Photograph No. 27

Subject: Erosion damage caused by major overnight precipitation event.

sandbags. Although ERRS had previously cleaned out the clogged inlet at Venice Street, stormwater again overflowed the pipe and impacted the west end of the site. Erosion of placed fill material was significant and silt fencing placed the previous day by ERRS was washed out. A significant amount of sedimentation was observed at the outfall of the piped stream to the east of McLain Road after this rain event.

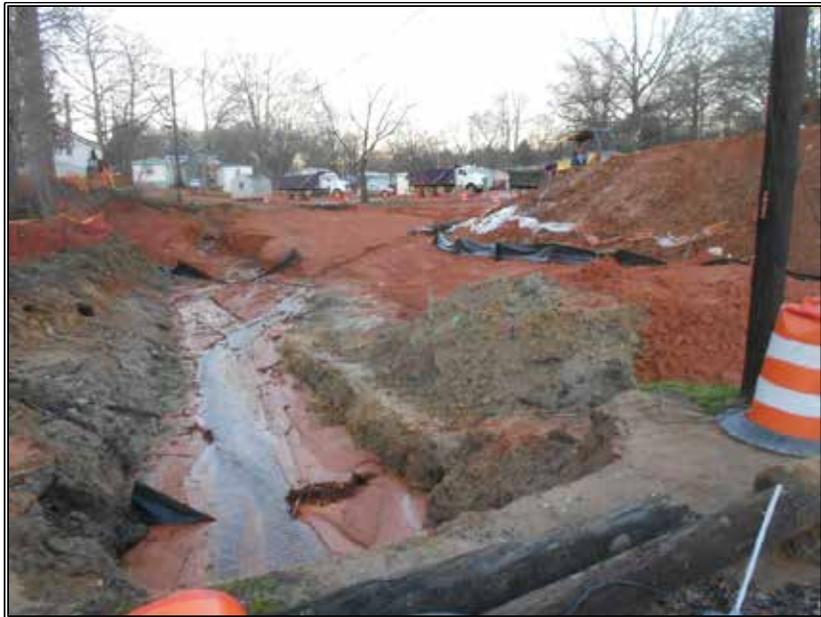
Official Photograph No. 28

Subject: Erosion damage caused by major overnight precipitation event.

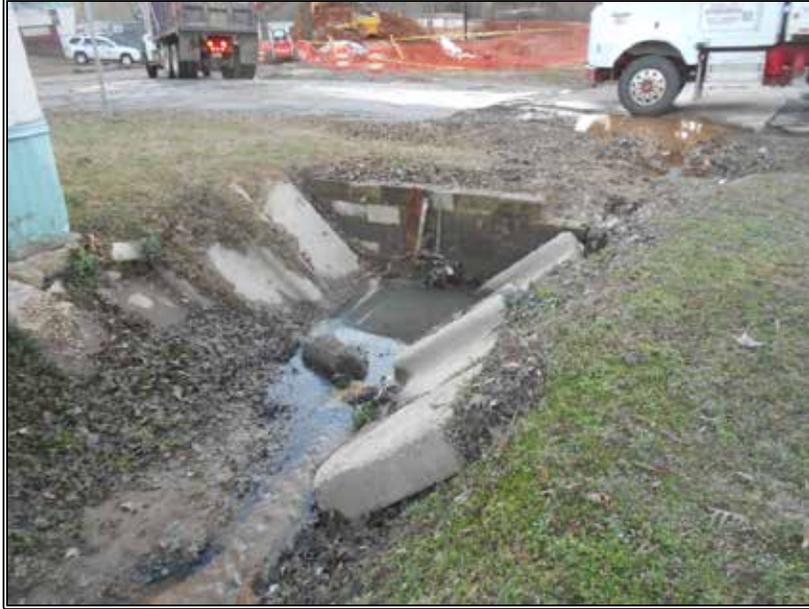
Official Photograph No. 29

Subject: Blockage of piped tributary on the west side of Venice Street that resulted in erosion. Debris from a previous obstruction had been removed by ERRS personnel prior to overnight precipitation event.

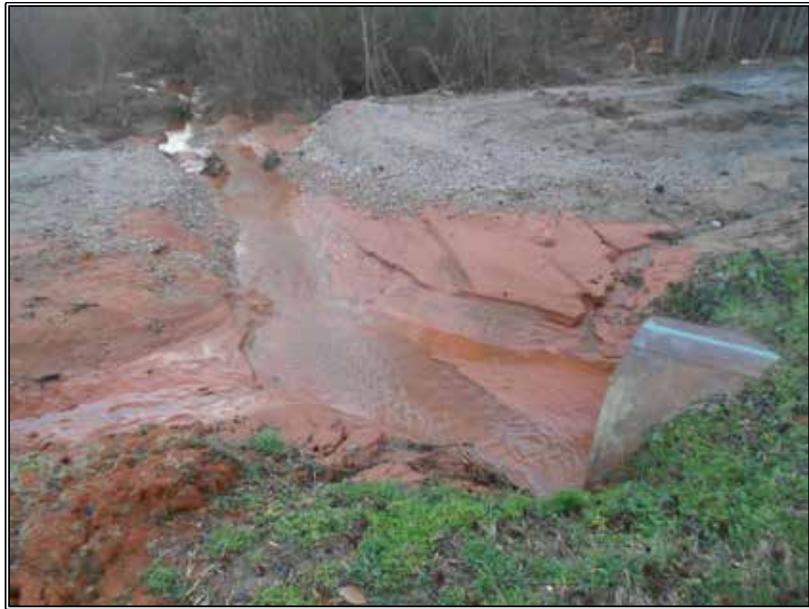
Official Photograph No. 30

Subject: Sedimentation of tributary at McLain Road resulting from erosion of placed fill material after overnight precipitation event.

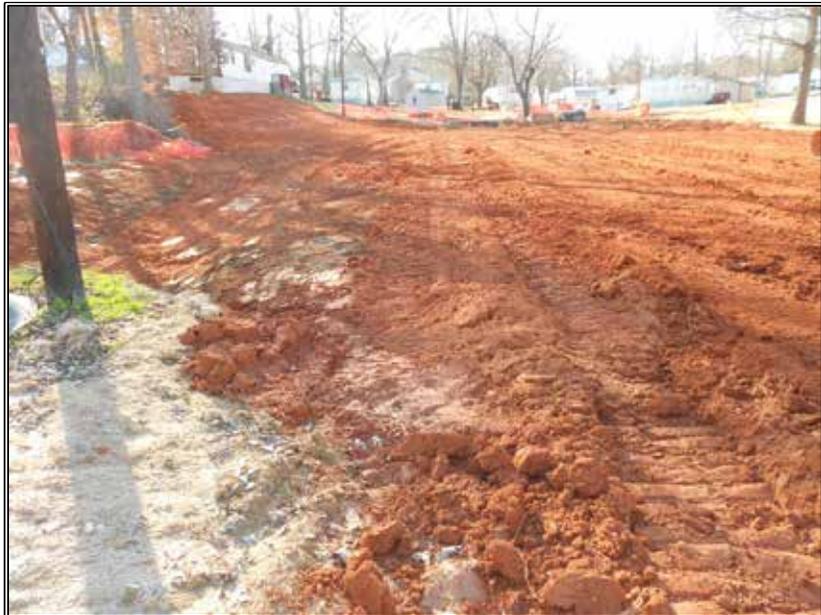
Official Photograph No. 31

Site Name: Villa Mobile Home Park Battery Dump Site **Date:** February 5, 2013
Location: Kannapolis, Cabarrus County, North Carolina **TDD No:** TNA-05-001-0176
Photographer: Eric Morris, OTIE - EPA Region 4 START Contractor
Subject: Condition of site upon transfer of oversight to NCDENR - facing east from northwest corner of the site at intersection of Venice Street and Verona Street.
