**Subject: Final CERCLA Removal Action Letter Report
Seven Out
Waycross, Ware County, Georgia
EPA Contract No. EP-W-05-054
TDD No. TTEMI-05-001-0076**

The Tetra Tech EM Inc. (Tetra Tech) Superfund Technical Assessment and Response Team (START) is submitting this final letter report summarizing removal action activities at the Seven Out site located in Waycross, Ware County, Georgia, from March 25 through July 28, 2009.

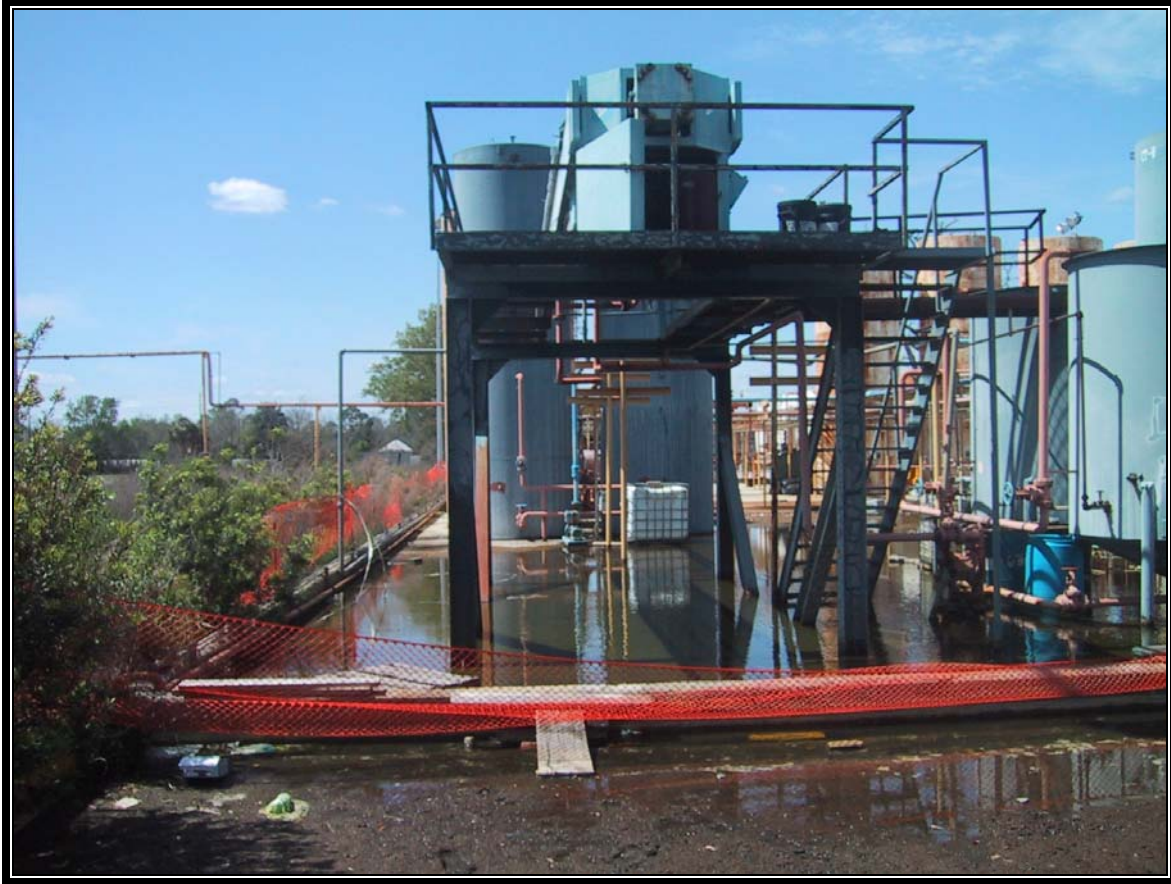
OFFICIAL PHOTOGRAPH NO. 1
U.S. ENVIRONMENTAL PROTECTION AGENCY

Subject: Standing water in the secondary containment area, located at 901 Francis Street, Waycross, Ware County, Georgia.

On March 25, 2009, Tetra Tech START and Winter arrived at the Seven Out property to initiate removal action activities. A significant amount of standing water from recent rain events was observed within the containment areas. Winter used a vacuum truck to pump rainwater from the containment areas into temporary storage tanks (also known as "frac" tanks). Winter also re-secured safety fencing previously installed around the tank farm. Tetra Tech demobilized from the site on March 27, 2009.

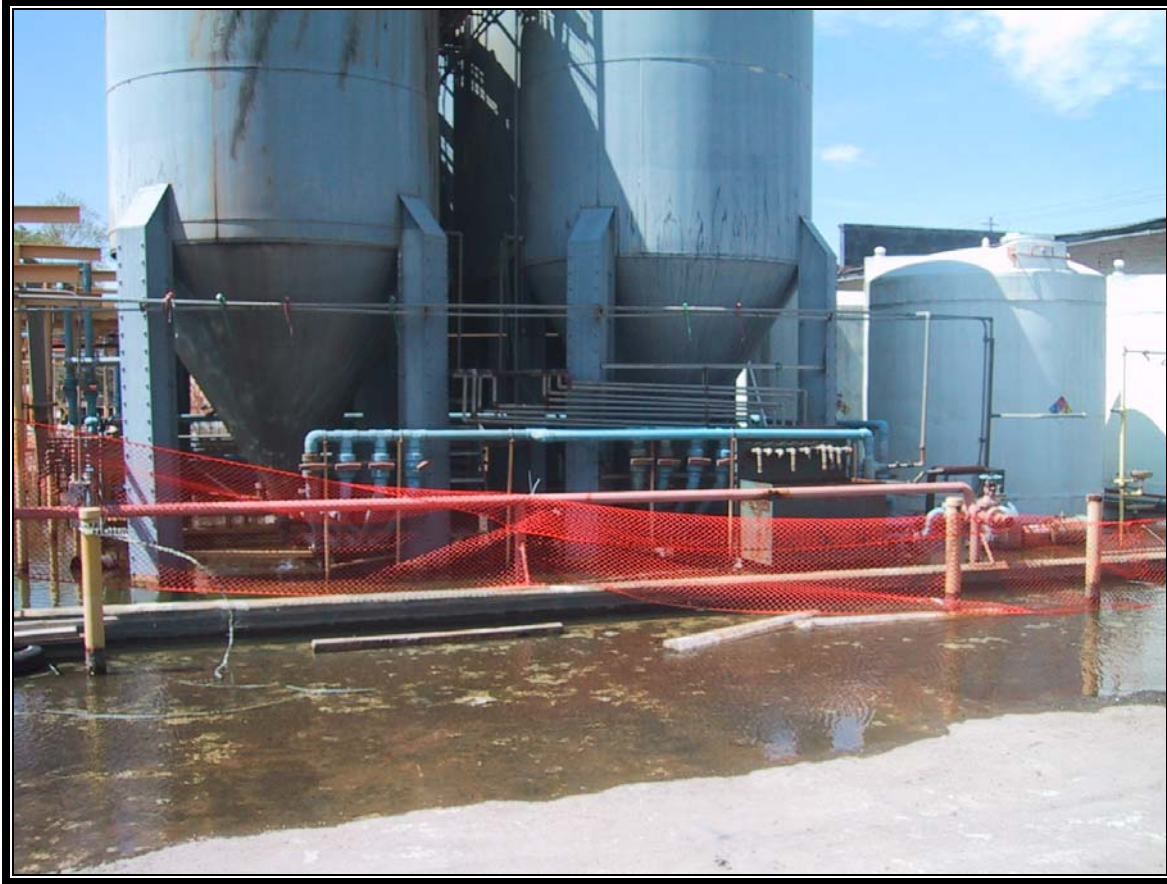
OFFICIAL PHOTOGRAPH NO. 2
U.S. ENVIRONMENTAL PROTECTION AGENCY

TDD Number:	TTEMI-05-001-0076	Location:	Seven Out Tank
Orientation:	West Northwest	Date:	March 25, 2009
Photographer:	Paul Prys, Tetra Tech	Witness:	J. Kooms, Winter Environmental
Subject:	Standing water inside and surrounding the secondary containment concrete knee wall.

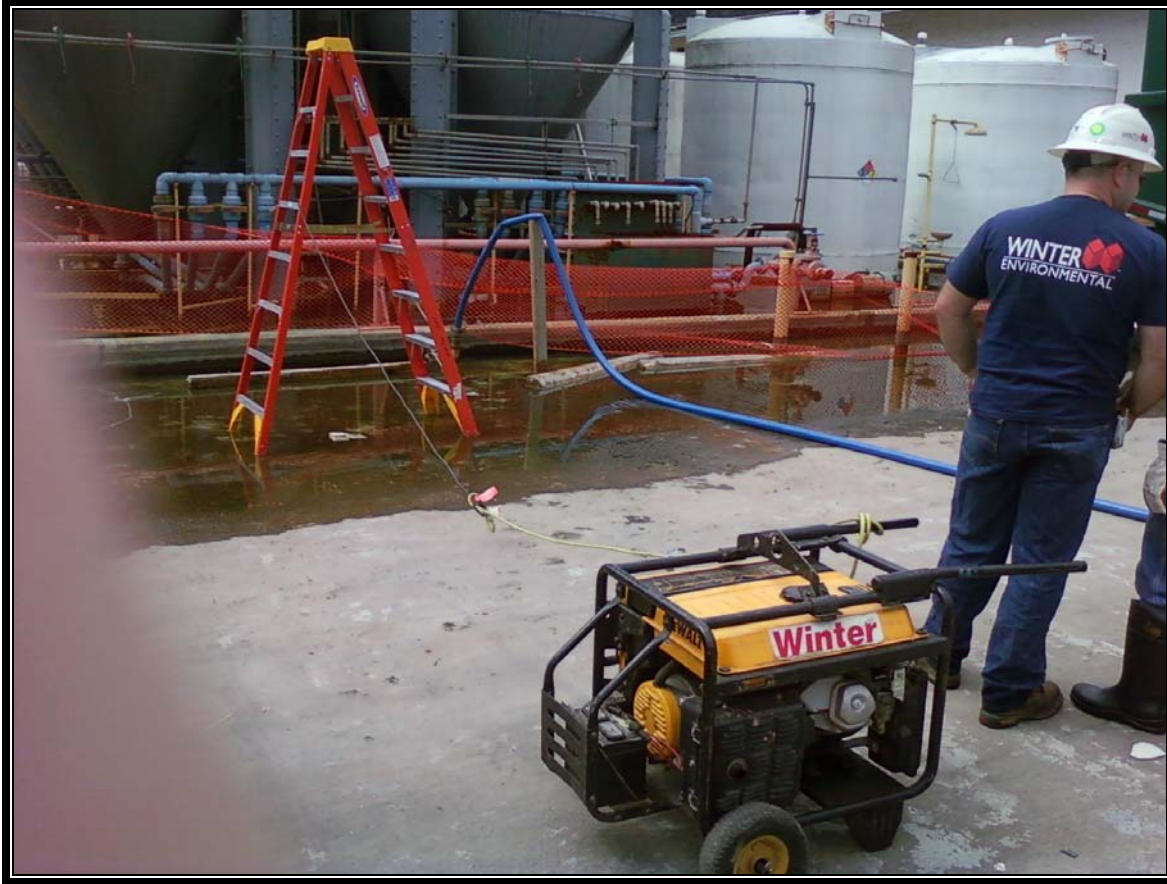
OFFICIAL PHOTOGRAPH NO. 3
U.S. ENVIRONMENTAL PROTECTION AGENCY

Subject: Winter Environmental Services (Winter) utilizes generator to power pumping apparatus to collect standing water.

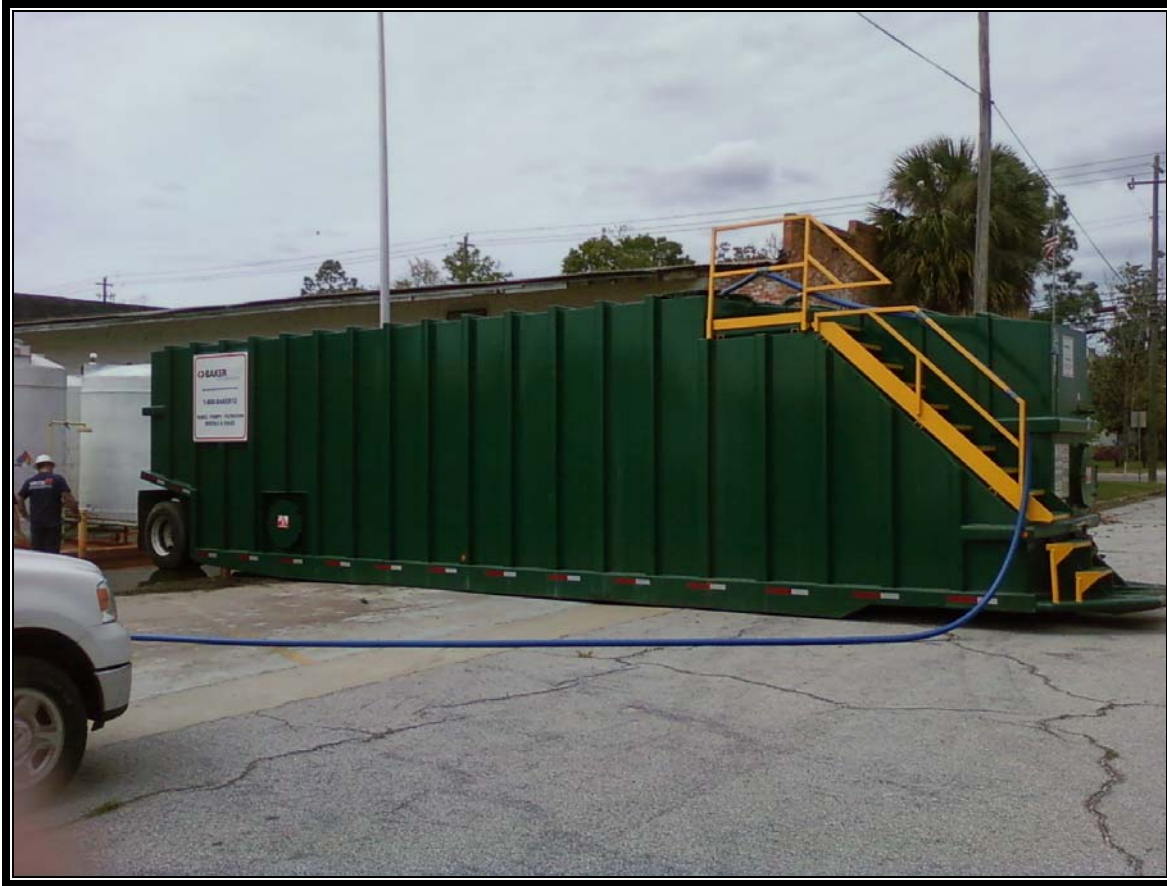
**OFFICIAL PHOTOGRAPH NO. 4
U.S. ENVIRONMENTAL PROTECTION AGENCY**

Subject: Winter stages tanker at the northeast corner of the containment area and pumps standing water from the secondary containment area into the frac tanker.

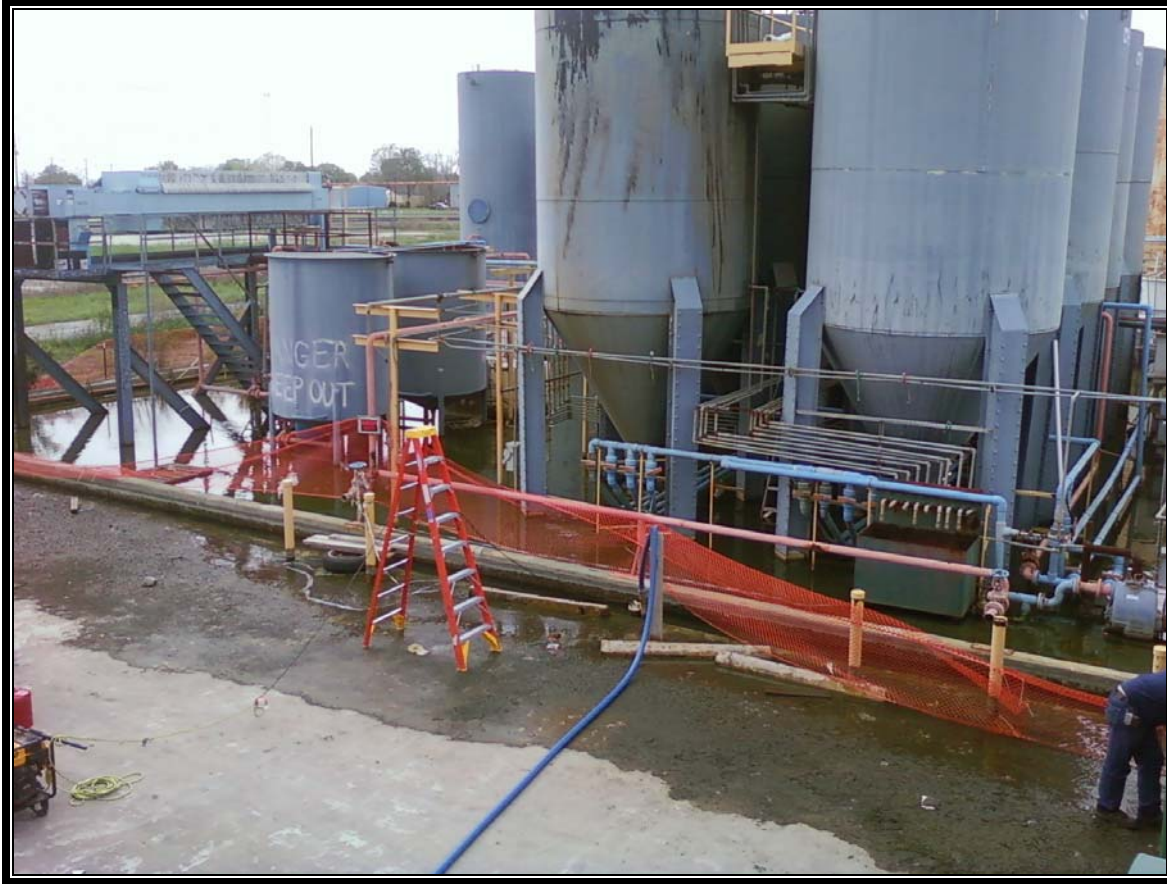
OFFICIAL PHOTOGRAPH NO. 5
U.S. ENVIRONMENTAL PROTECTION AGENCY

Subject: Winter continues to remove standing rain water from the secondary containment area.

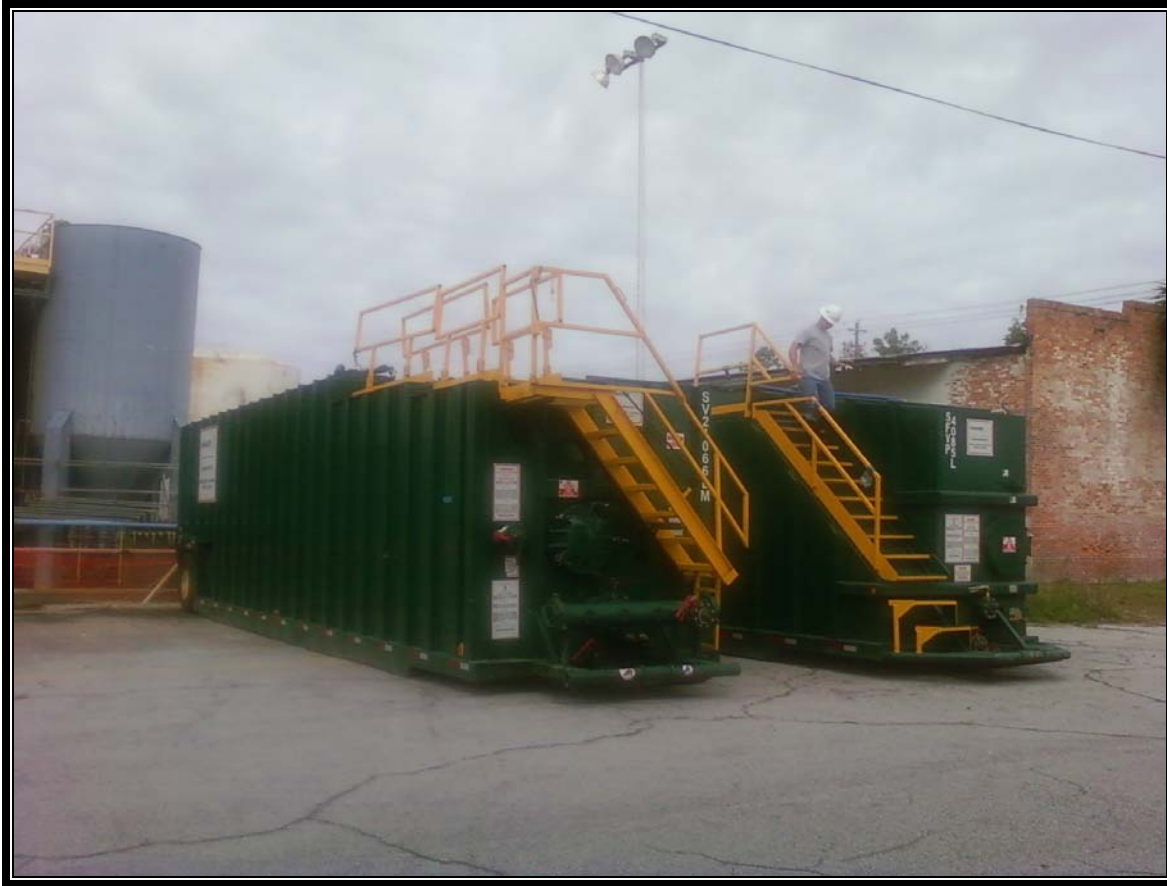
OFFICIAL PHOTOGRAPH NO. 6
U.S. ENVIRONMENTAL PROTECTION AGENCY

Subject: Winter stages a second frac tanker to collect the standing water.

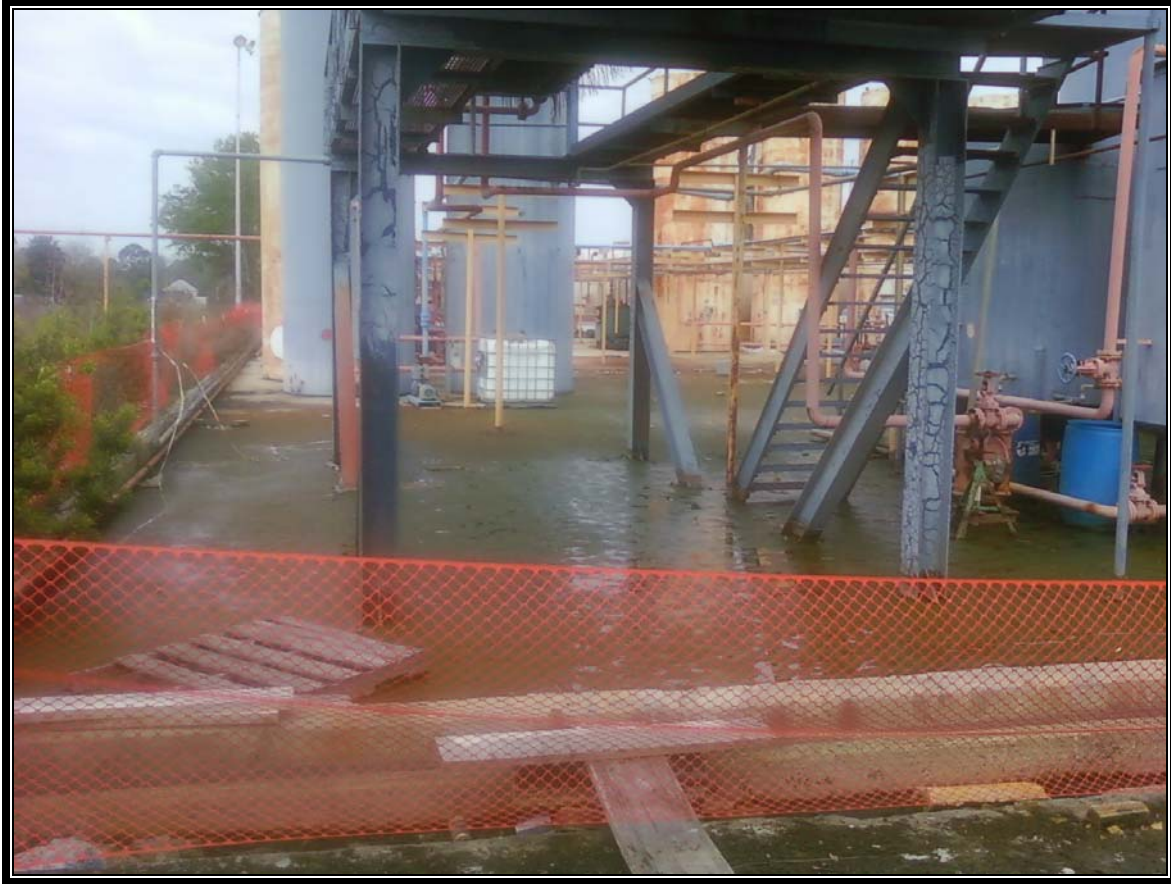
OFFICIAL PHOTOGRAPH NO. 7
U.S. ENVIRONMENTAL PROTECTION AGENCY

Subject: Standing water is receding from the southwest portion of the facility.

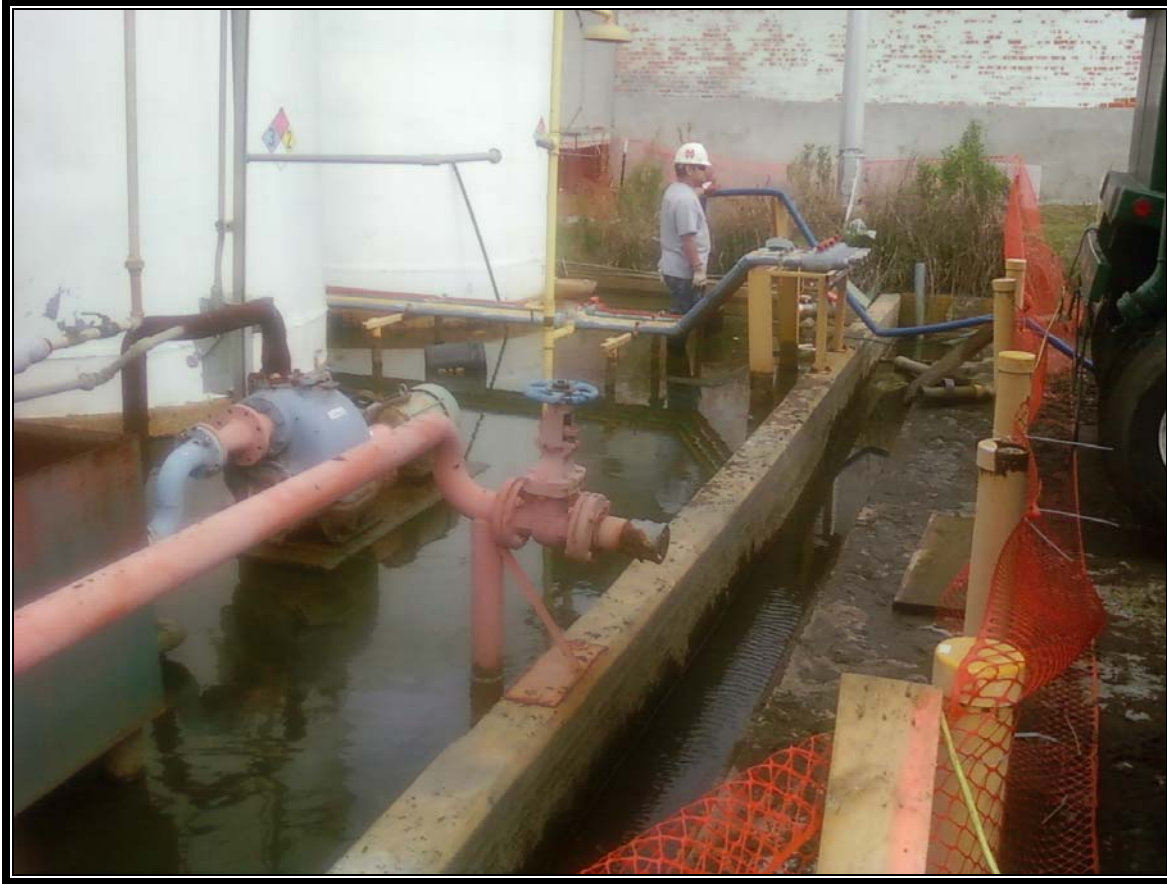
OFFICIAL PHOTOGRAPH NO. 8
U.S. ENVIRONMENTAL PROTECTION AGENCY

Subject: Winter collects rain water from the northeast section of the primary containment area.

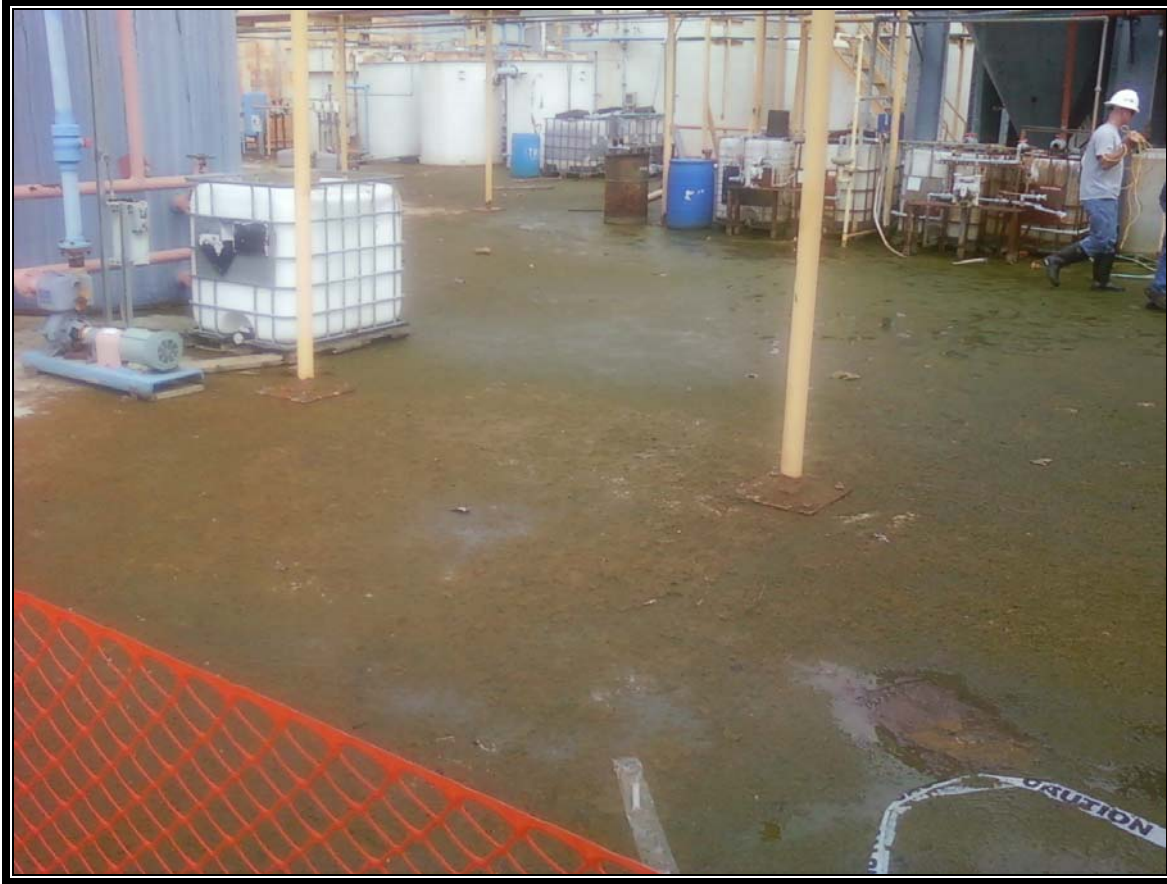
OFFICIAL PHOTOGRAPH NO. 9
U.S. ENVIRONMENTAL PROTECTION AGENCY

Subject: Winter completes rain water collection in the primary containment area.

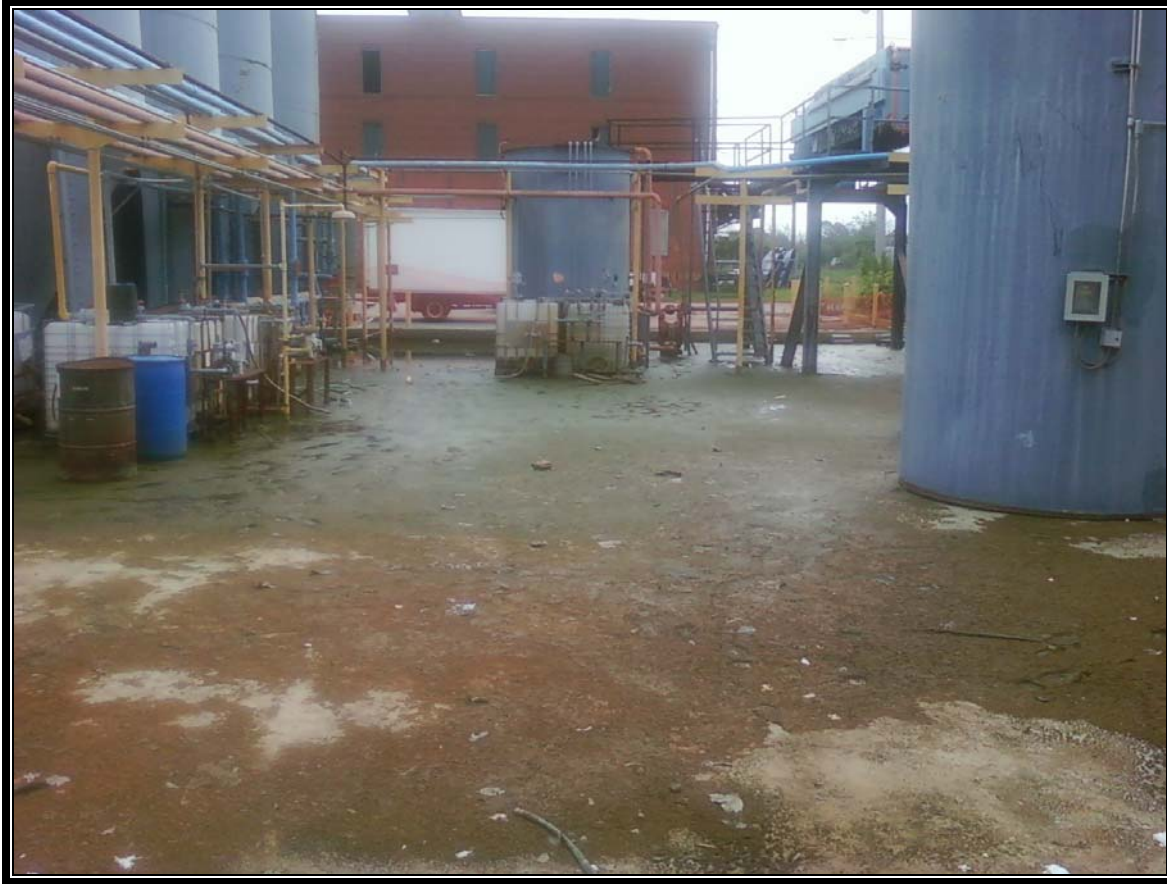
OFFICIAL PHOTOGRAPH NO. 10
U.S. ENVIRONMENTAL PROTECTION AGENCY

Subject: Winter completes removal of rain water from the primary containment area.

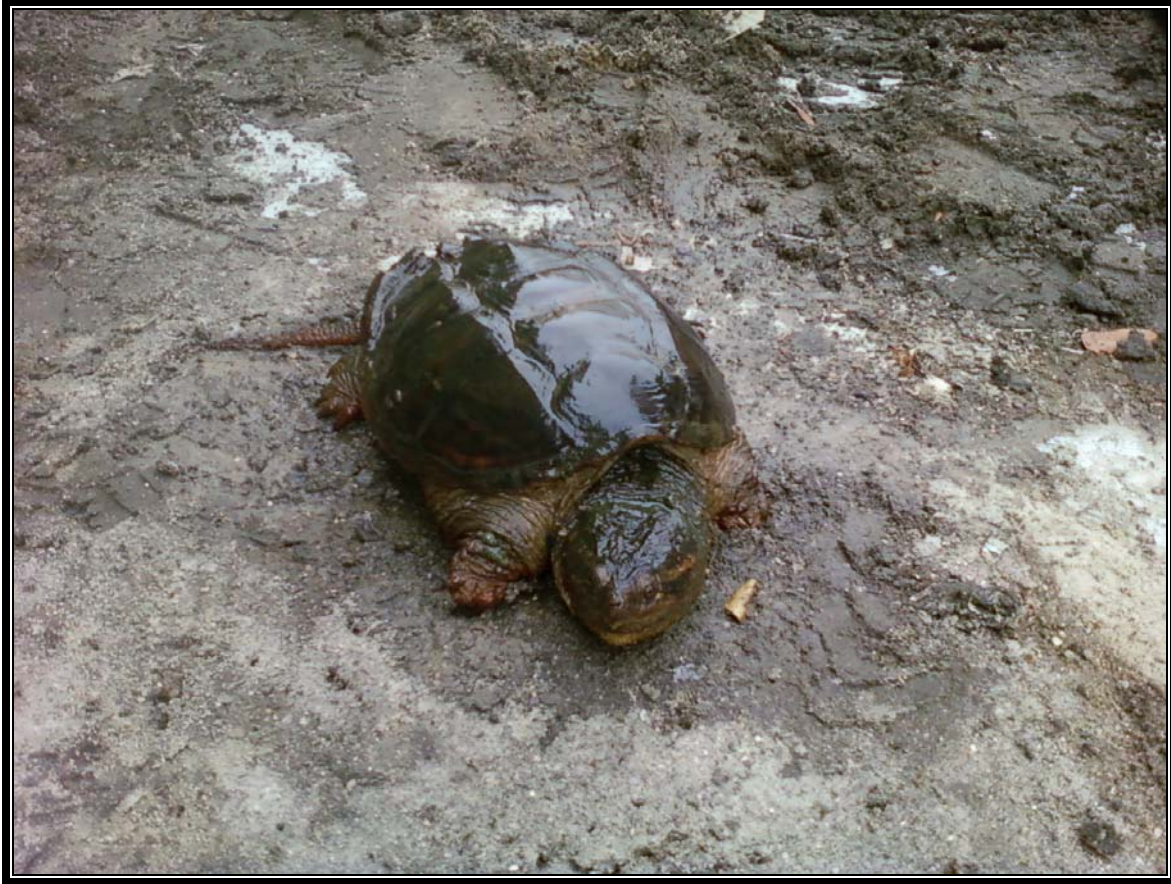
OFFICIAL PHOTOGRAPH NO. 11
U.S. ENVIRONMENTAL PROTECTION AGENCY

TDD Number:	TTEMI-05-001-0076	Location:	Seven Out Tank
Orientation:	N/A	Date:	March 26, 2009
Photographer:	Paul Prys, Tetra Tech	Witness:	J. Kooms, Winter Environmental
Subject:	A turtle survives the flooding but has a slight sheen of rain water and organic muck.

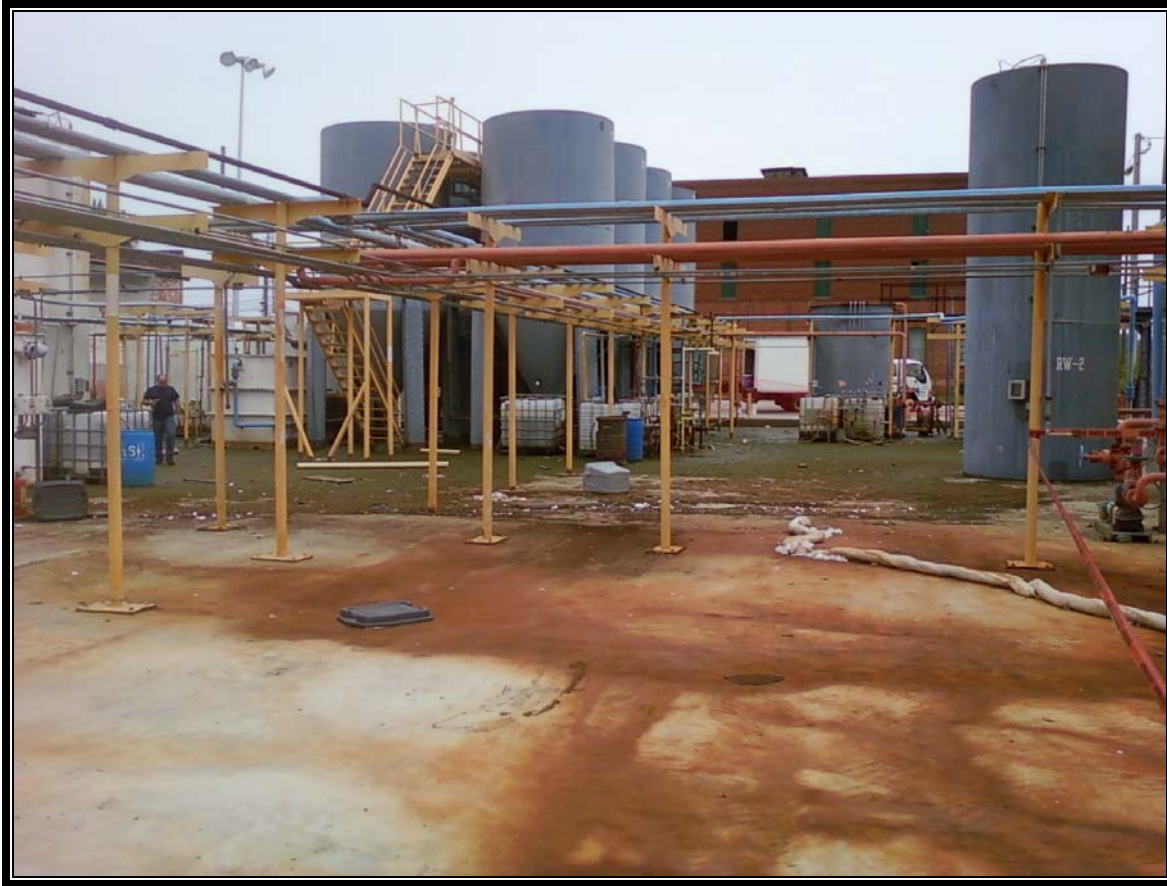
OFFICIAL PHOTOGRAPH NO. 12
U.S. ENVIRONMENTAL PROTECTION AGENCY

Subject: Winter stages totes along the southern perimeter of the primary containment area.

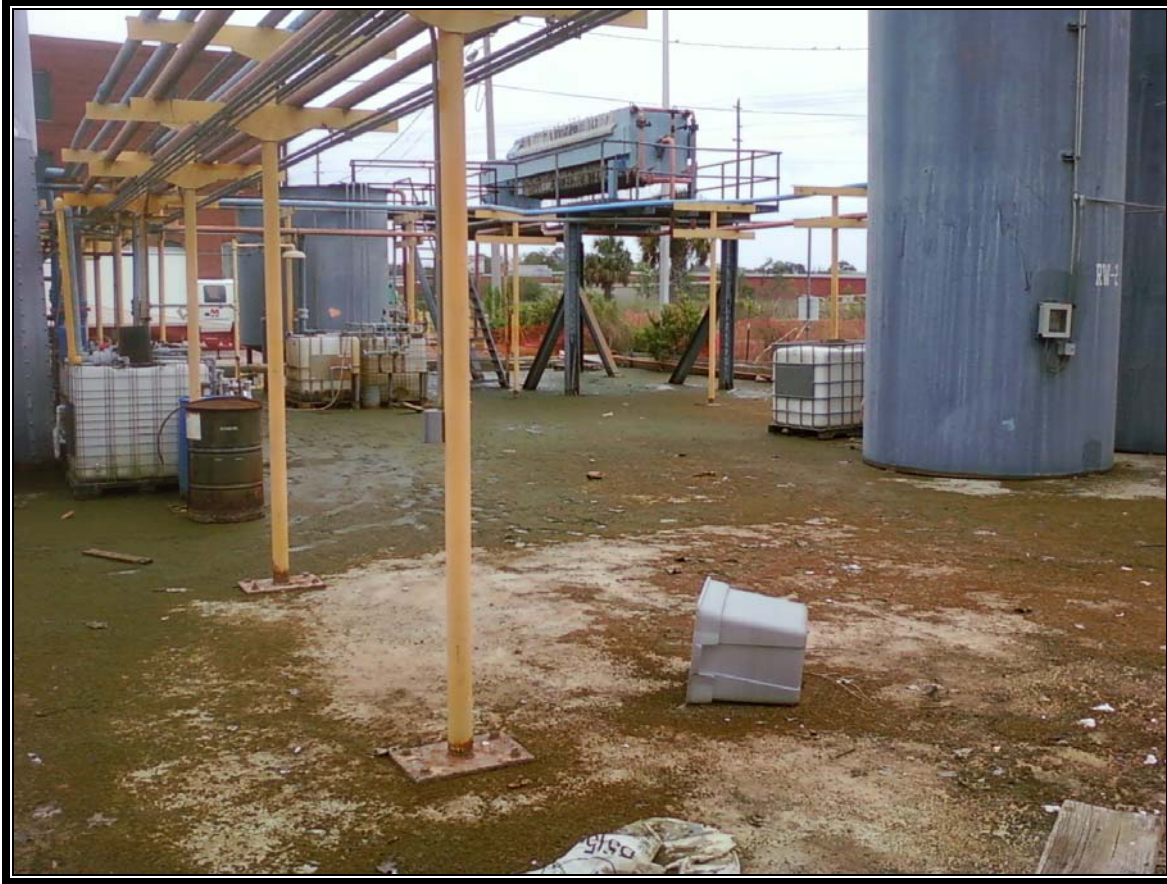
OFFICIAL PHOTOGRAPH NO. 13
U.S. ENVIRONMENTAL PROTECTION AGENCY

Subject: Winter completes removal of rain water located along the south to southwestern boundary of the primary containment area.

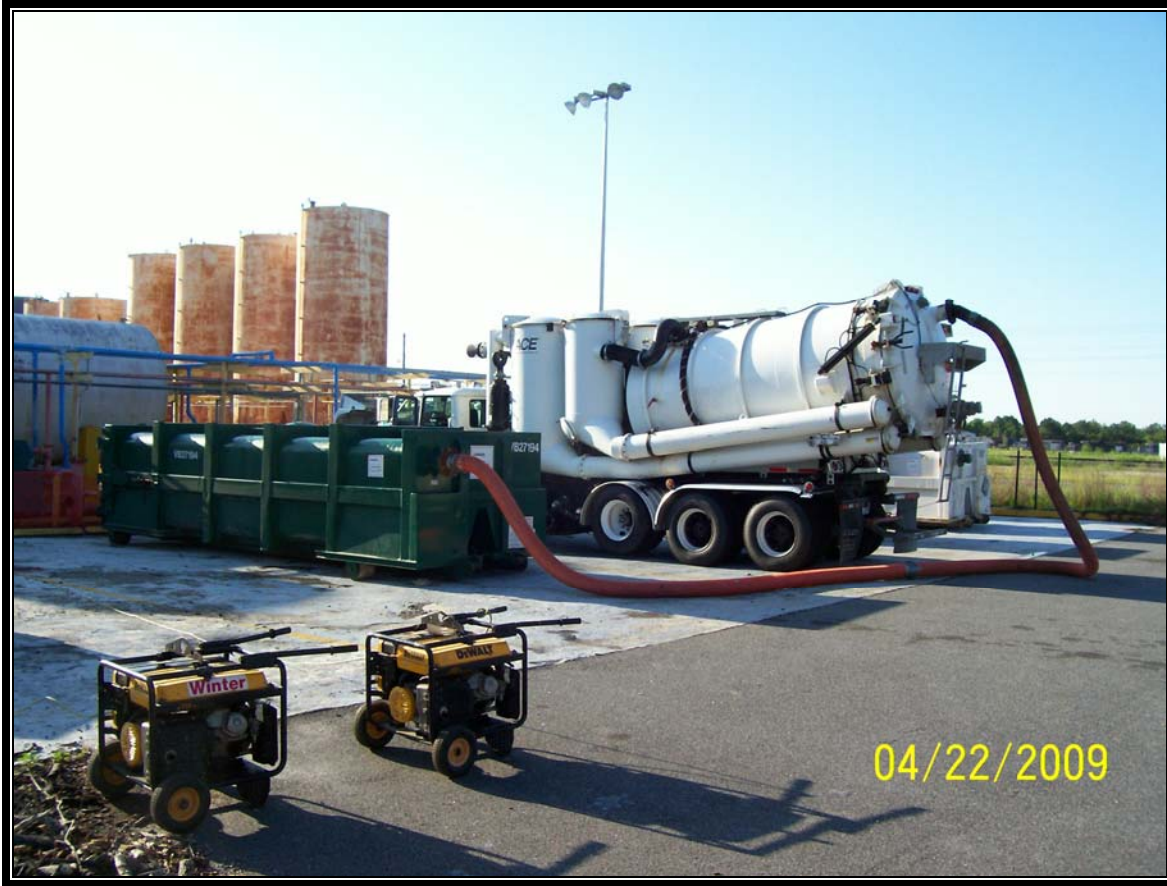
OFFICIAL PHOTOGRAPH NO. 14
U.S. ENVIRONMENTAL PROTECTION AGENCY

Subject: Winter utilizes vacuum truck to remove sludge from tank CD-3 into a containment box.

Tetra Tech START returned to the site from April 22-24, 2009, to observe removal activities. Tetra Tech observed Winter pumping and vacuuming materials from tanks CD-1, CD-3, and SS-2 into containment boxes. Winter reported to Tetra Tech that air monitoring was conducted as each tank was opened by either using the access hatch or cutting open the top of the tank. Winter utilized a non-sparking power saw to cut access holes as necessary. Based on air monitoring readings, Winter personnel conducted removal activities in Level C PPE. Winter used blowers to ventilate tanks as necessary prior to conducting removal activities. Tetra Tech observed Winter conducting air monitoring throughout ventilation and removal activities.

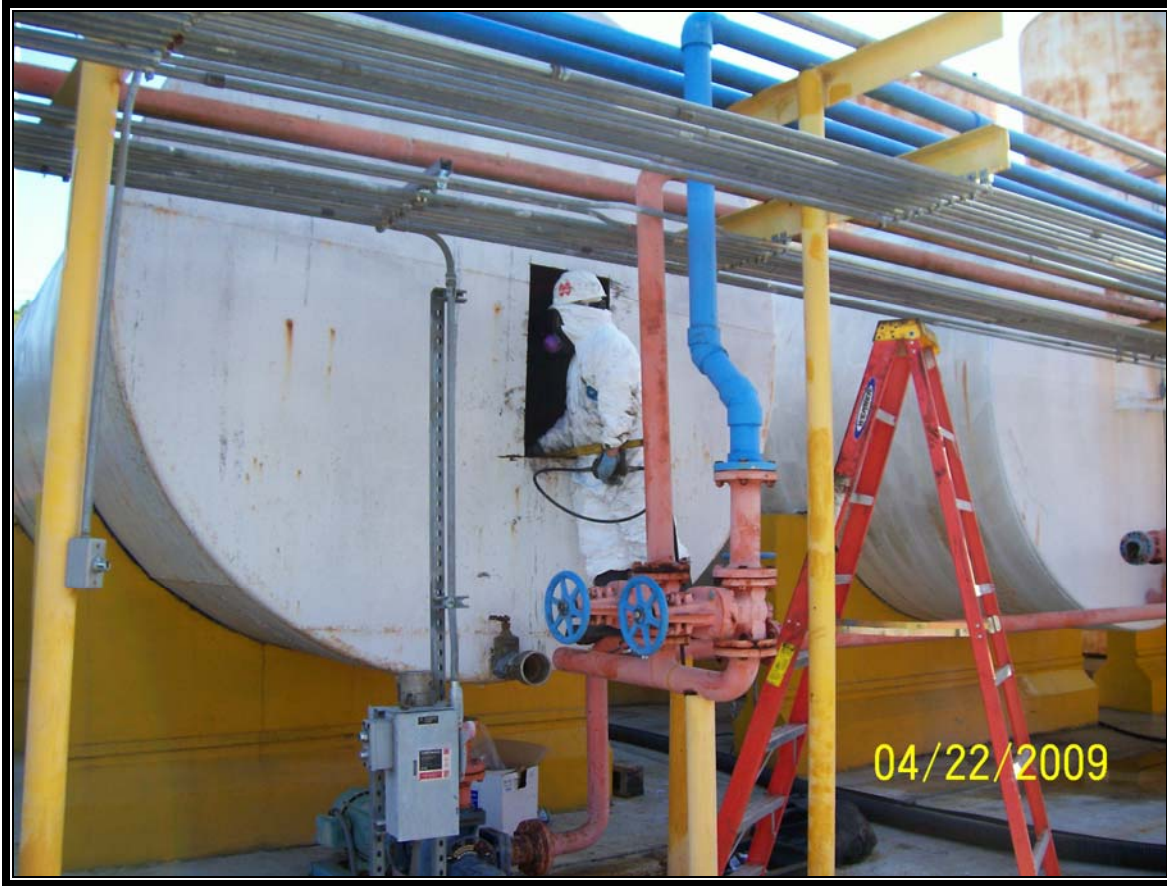
OFFICIAL PHOTOGRAPH NO. 15
U.S. ENVIRONMENTAL PROTECTION AGENCY

Subject: Winter pressure washes tank CD-3.

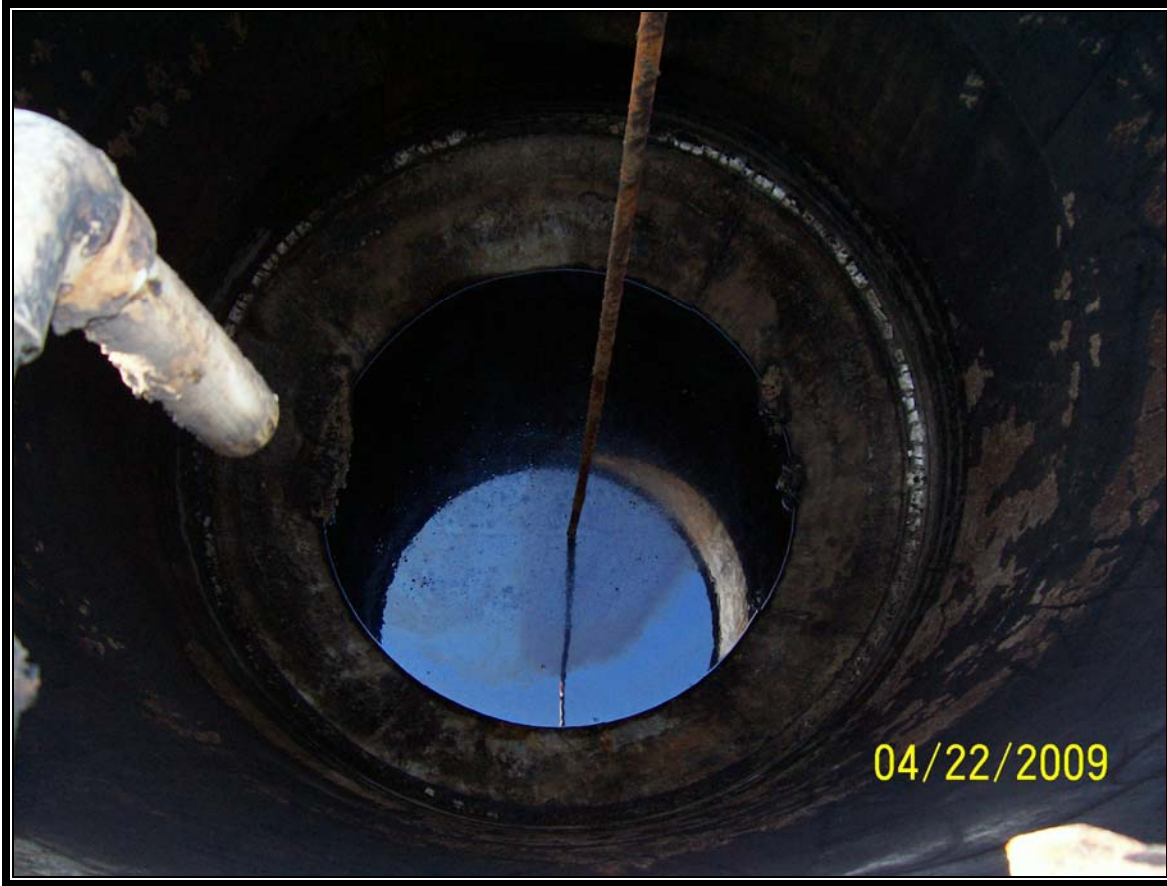
OFFICIAL PHOTOGRAPH NO. 16
U.S. ENVIRONMENTAL PROTECTION AGENCY

Subject: Winter pumps out tank CT-5.

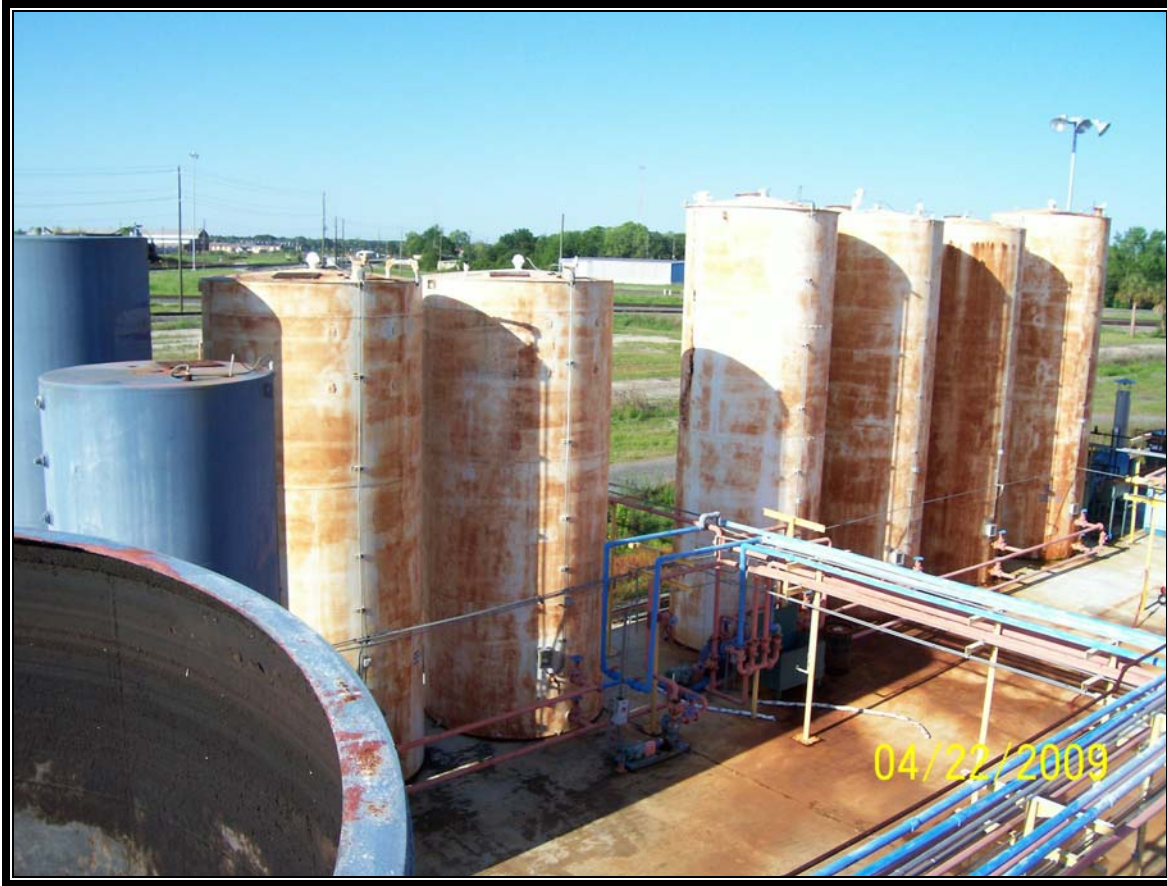
OFFICIAL PHOTOGRAPH NO. 17
U.S. ENVIRONMENTAL PROTECTION AGENCY

Subject: Seven Out tanks and concrete containment pad.

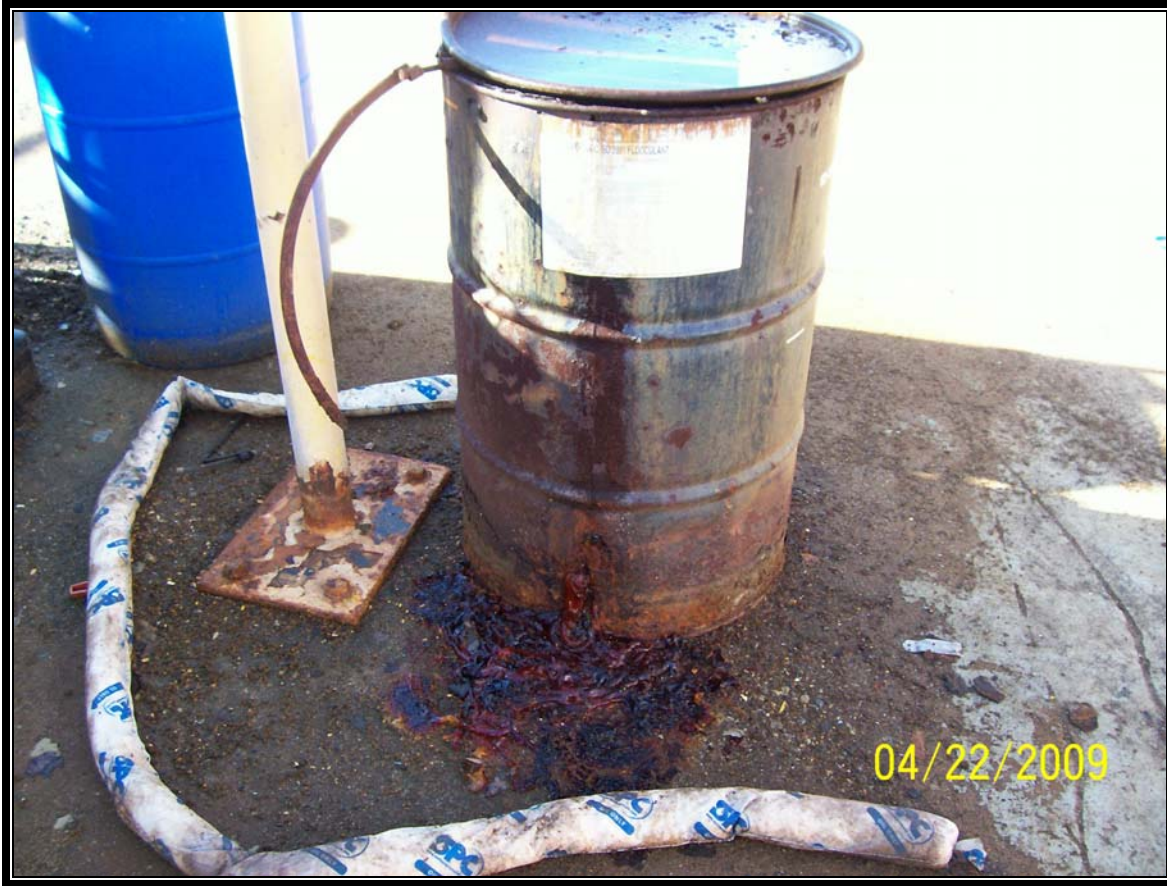
OFFICIAL PHOTOGRAPH NO. 18
U.S. ENVIRONMENTAL PROTECTION AGENCY

Subject: Absorbent boom is placed around a leaking drum of super-flocculant.

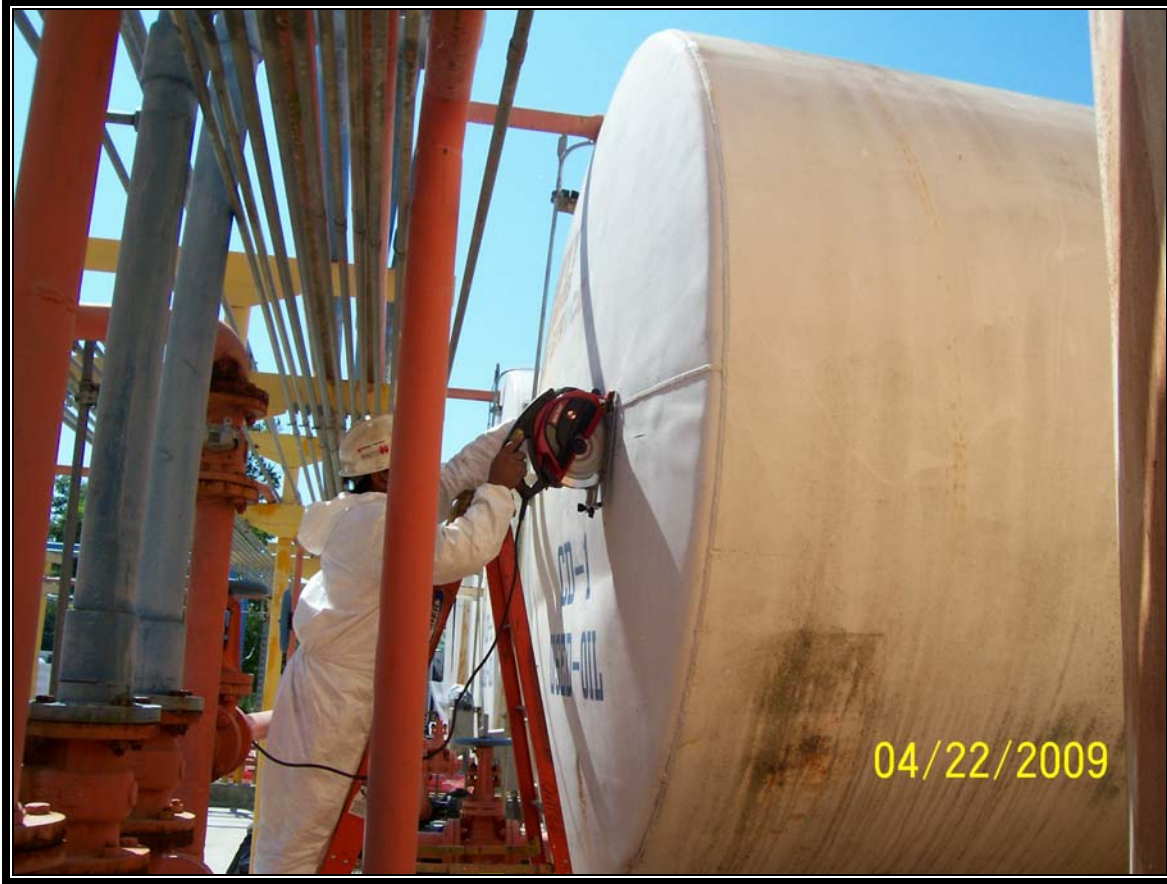
OFFICIAL PHOTOGRAPH NO. 19
U.S. ENVIRONMENTAL PROTECTION AGENCY

Subject: Winter utilizes saw to cut inlet into tank CD-1.

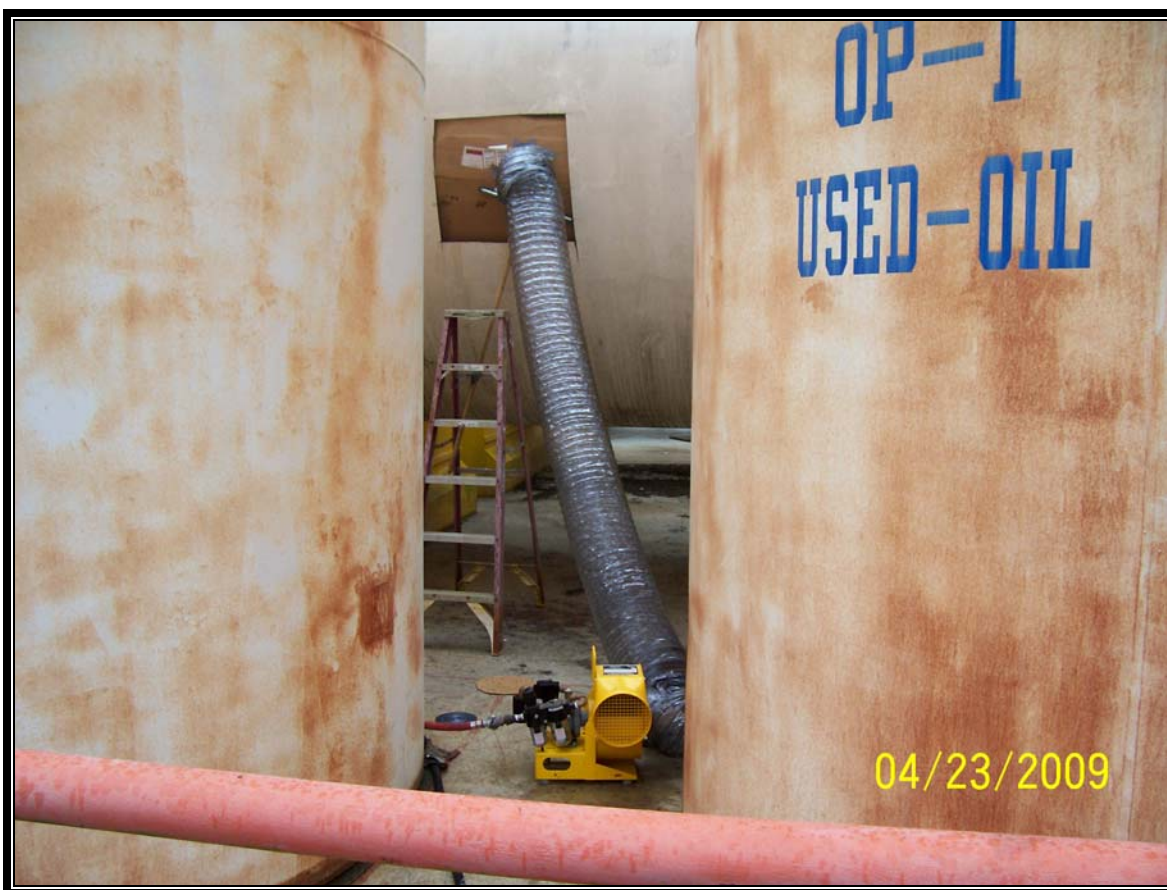
OFFICIAL PHOTOGRAPH NO. 20
U.S. ENVIRONMENTAL PROTECTION AGENCY

Subject: Winter utilizes engineering controls to remove standing vapor from tank CD-1 prior to removal efforts.

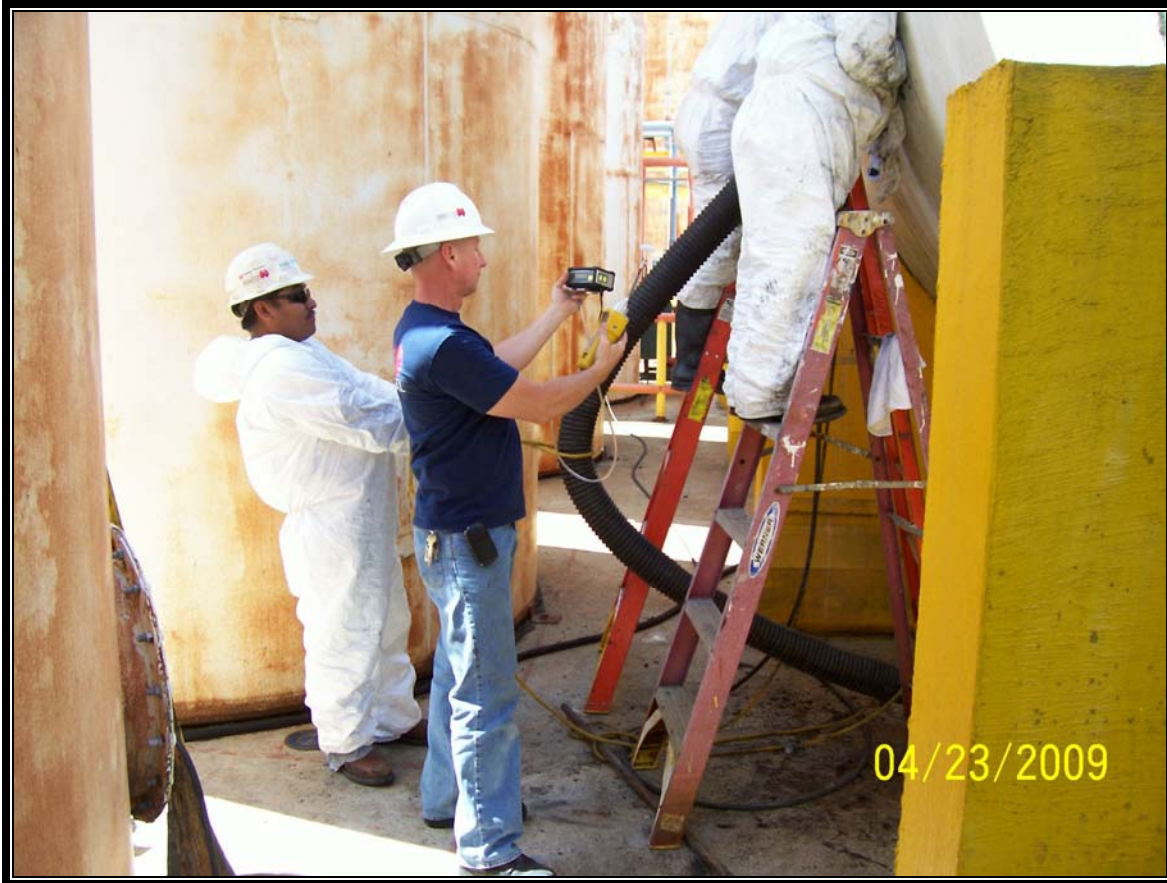
OFFICIAL PHOTOGRAPH NO. 21
U.S. ENVIRONMENTAL PROTECTION AGENCY

Subject: Winter conducts air monitoring of ambient conditions outside of tank CD-1.
