**Subject: Final CERCLA Removal Action Letter Report
Seven Out
Waycross, Ware County, Georgia
EPA Contract No. EP-W-05-054
TDD No. TTEMI-05-001-0076**

The Tetra Tech EM Inc. (Tetra Tech) Superfund Technical Assessment and Response Team (START) is submitting this final letter report summarizing removal action activities at the Seven Out site located in Waycross, Ware County, Georgia, from March 25 through July 28, 2009.

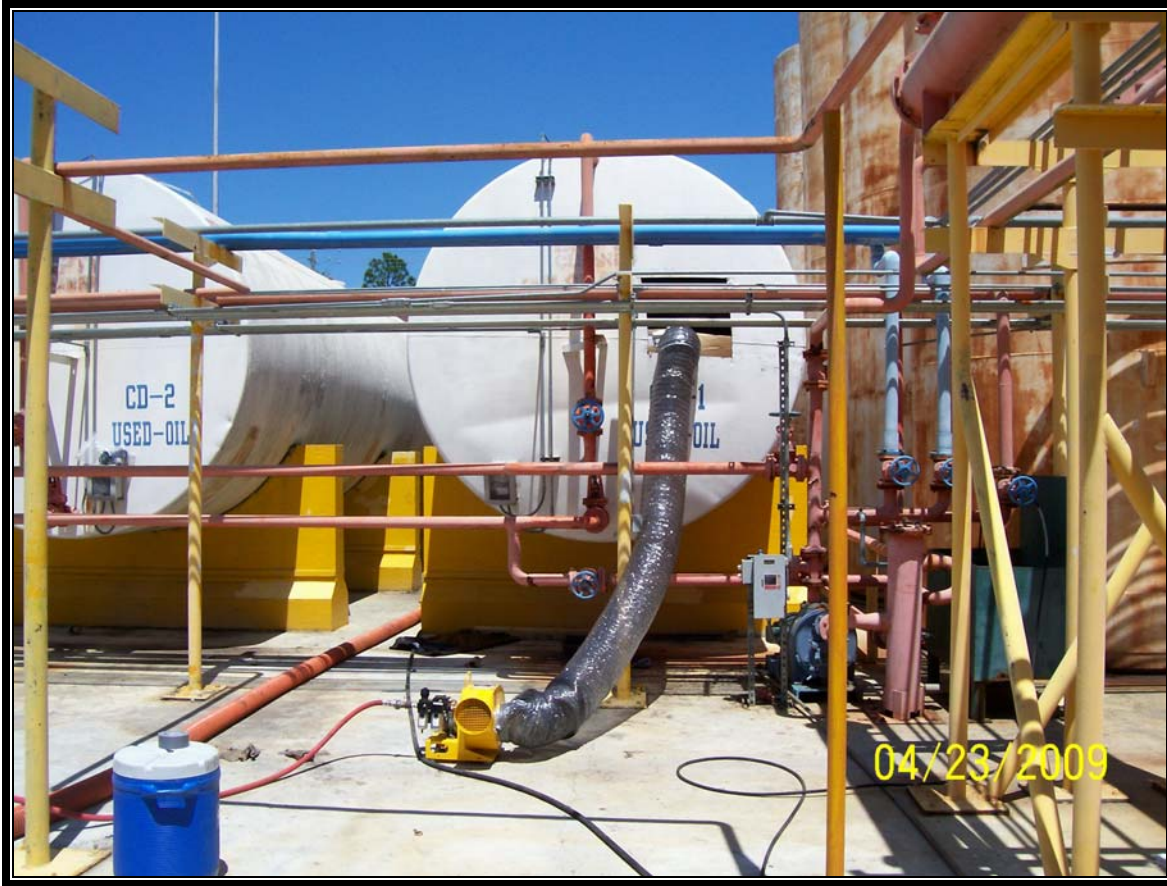
OFFICIAL PHOTOGRAPH NO. 22
U.S. ENVIRONMENTAL PROTECTION AGENCY

Subject: Winter continues to force vent tank CD-1 in an effort to remove additional harmful vapors prior to removal activities.

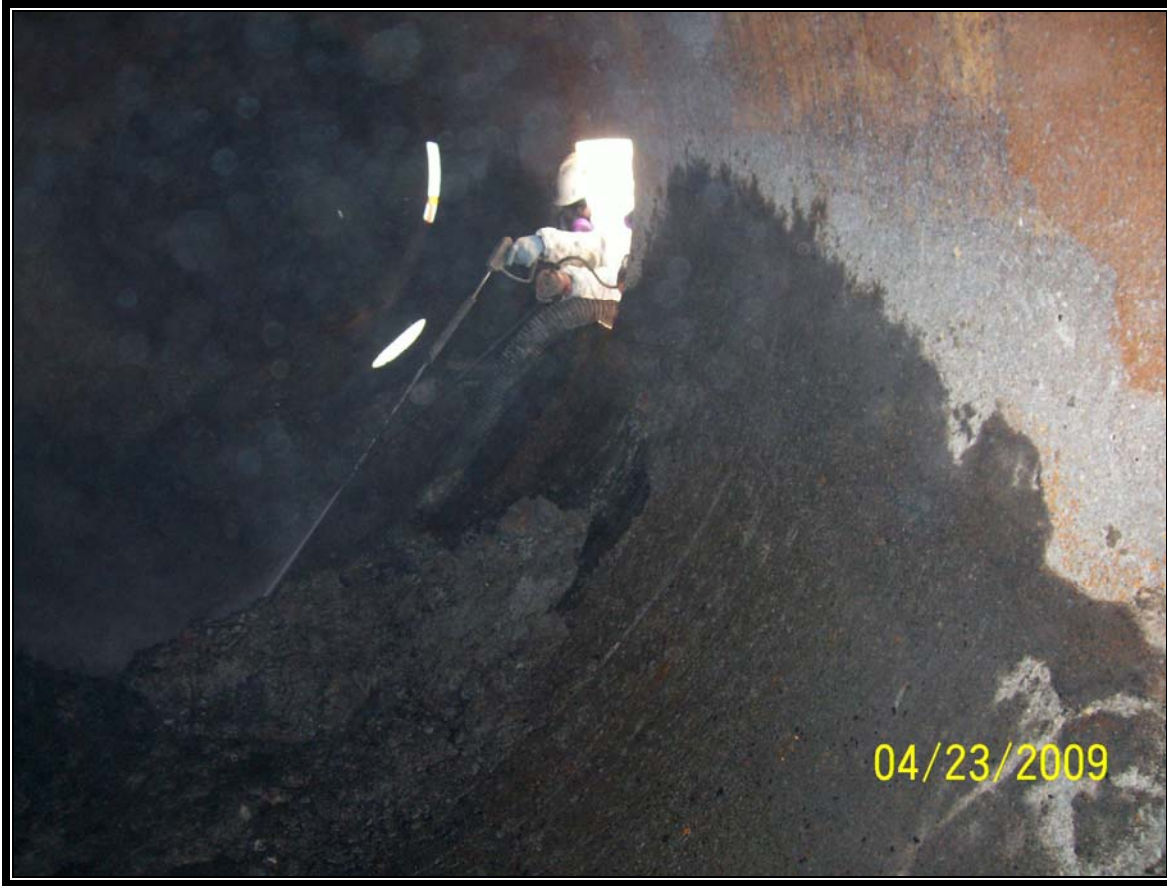
OFFICIAL PHOTOGRAPH NO. 23
U.S. ENVIRONMENTAL PROTECTION AGENCY

TDD Number:	TTEMI-05-001-0076	Location:	Seven Out Tank
Orientation:	North northeast	Date:	April 23, 2009
Photographer:	Paul Prys, Tetra Tech	Witness:	J. Kooms, Winter Environmental
Subject:	Winter utilizes a pressure washer to loosen sludge from the interior walls of the tank.

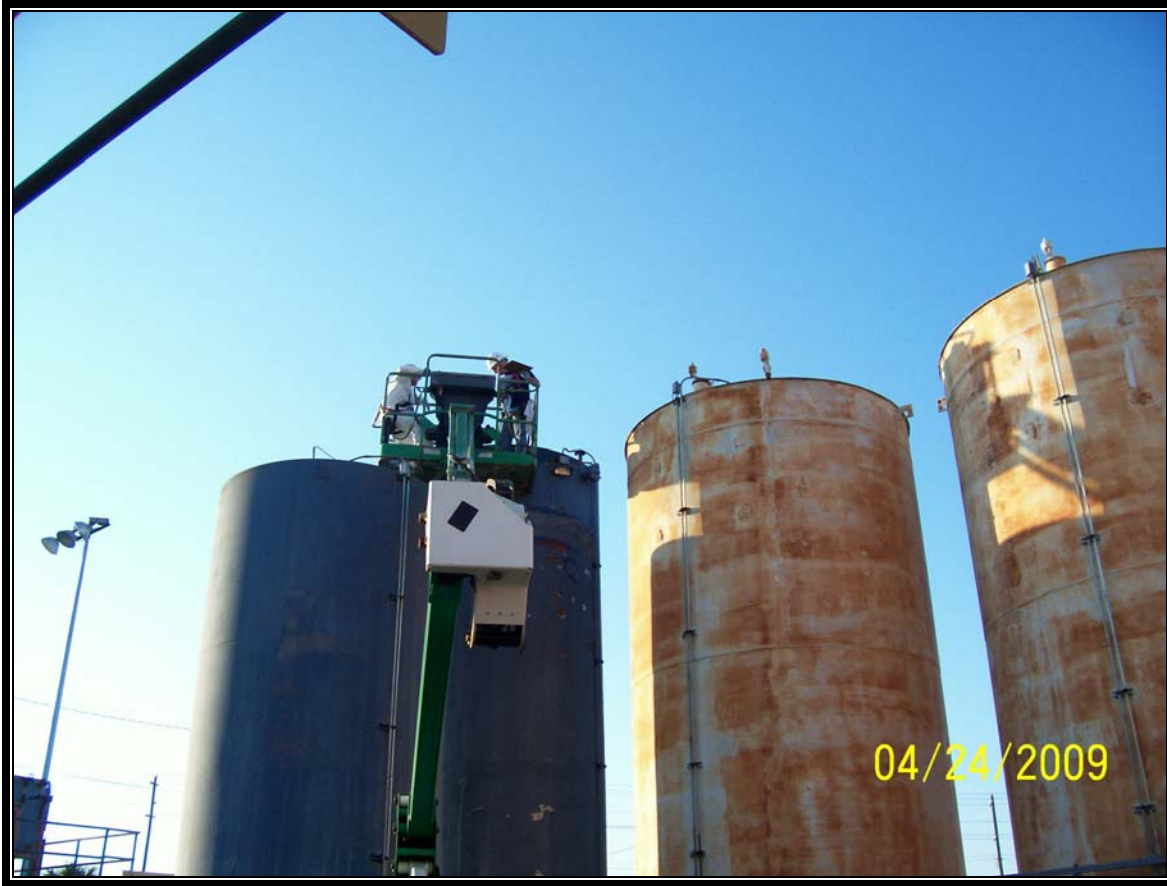
OFFICIAL PHOTOGRAPH NO. 24
U.S. ENVIRONMENTAL PROTECTION AGENCY

TDD Number:	TTEMI-05-001-0076	Location:	Seven Out Tank
Orientation:	Southeast	Date:	April 24, 2009
Photographer:	Paul Prys, Tetra Tech	Witness:	J. Kooms, Winter Environmental
Subject:	Winter utilizes a lift boom to gain access to tanks SS-2 and RW-1.

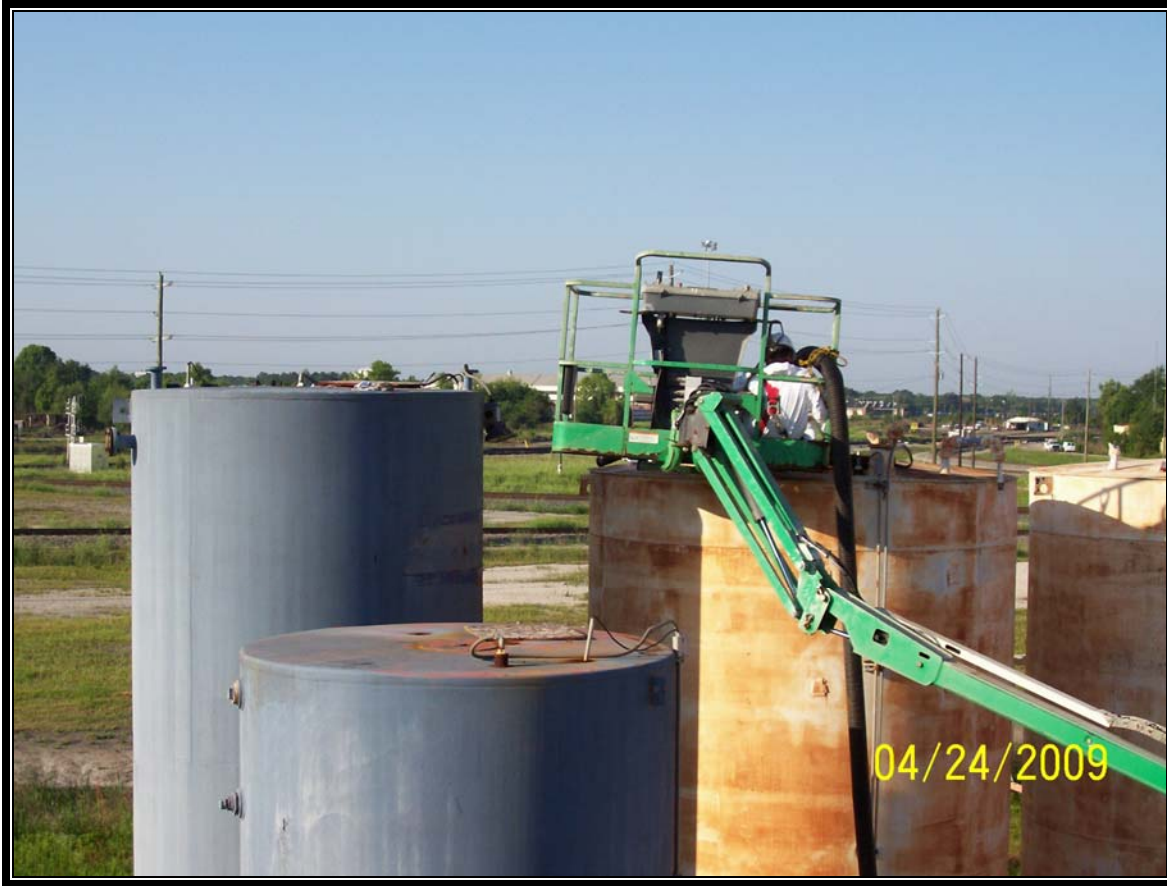
OFFICIAL PHOTOGRAPH NO. 25
U.S. ENVIRONMENTAL PROTECTION AGENCY

Subject: Winter utilizes pump to remove contents of tank SS-2.

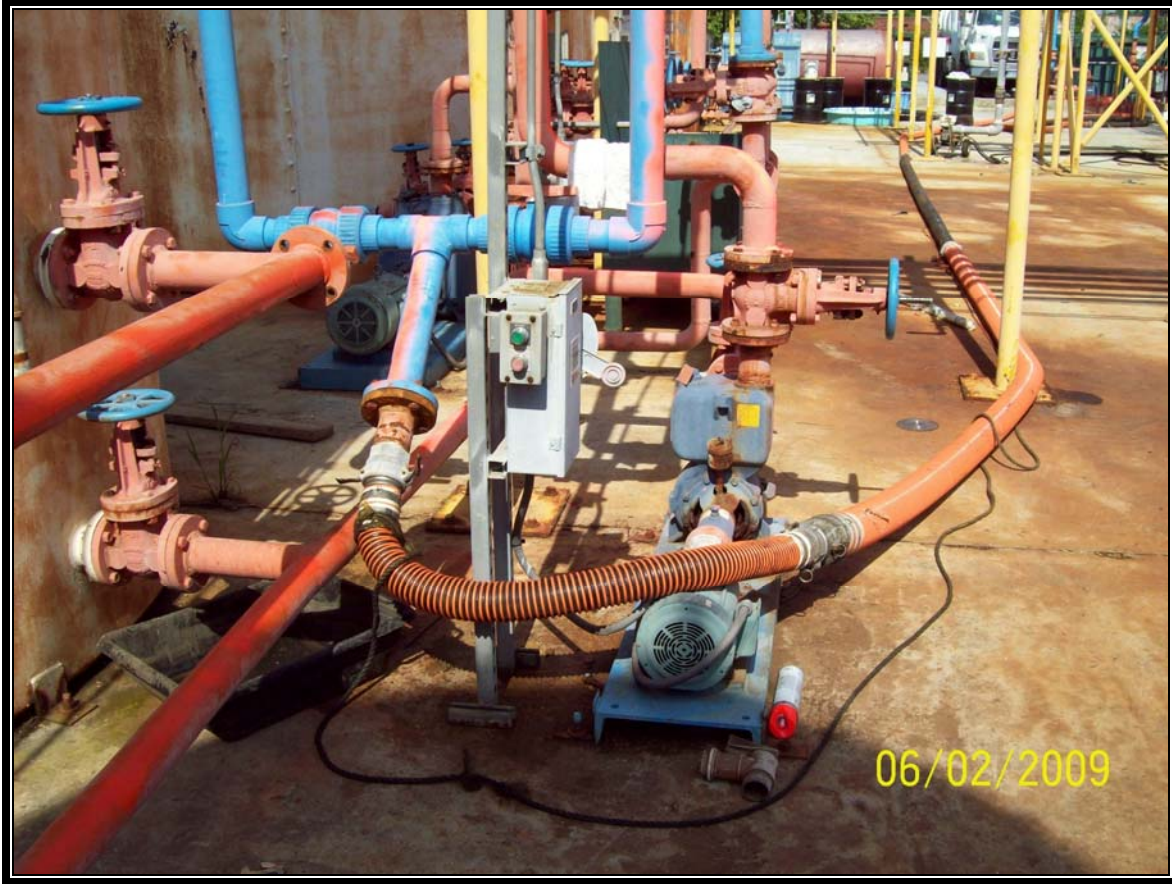
OFFICIAL PHOTOGRAPH NO. 26
U.S. ENVIRONMENTAL PROTECTION AGENCY

Subject: Winter removes waste from the pipe lines that transfer product to the tanks.

Tetra Tech returned to the Seven Out site on June 3, 2009, to observe ongoing removal activities. Because of operational issues with hose connections to the frac tanks, Winter was observed pumping stormwater directly from the containment to the sanitary sewer. Winter informed Tetra Tech that Winter had obtained verbal approval from the City prior to conducting this activity. At this time, Winter was observed conducting removal activities at tank CD-2. Tetra Tech demobilized at the end of the day on June 3, and Winter continued to remove waste from tanks SS-1, SH-4, OP-4, RW-1, and RW-2 from June 1 to July 17, 2009. Decontamination and closure of tanks CT-1, CT-8, ST-1, ST-2, DAF, DAF2, T-1, T-2, T-3, T-7, T-8, T-9, T-12, T-15, CD-1, CD-2, and CD-3 occurred from June 15-19, 2009. Decontamination of tanks SH-1, SH-2, SH-3, SH-4, OP-1, OP-2, OP-3, OP-4, SS-1, SS-2, DP-1, DP-2, RW-1, RW-2, T-4, T-5, T-6, and T-7B was performed from June 22 to July 17, 2009. On July 17, 2009, Winter reported that all pipes had been vacuumed out and disconnected from all tanks.

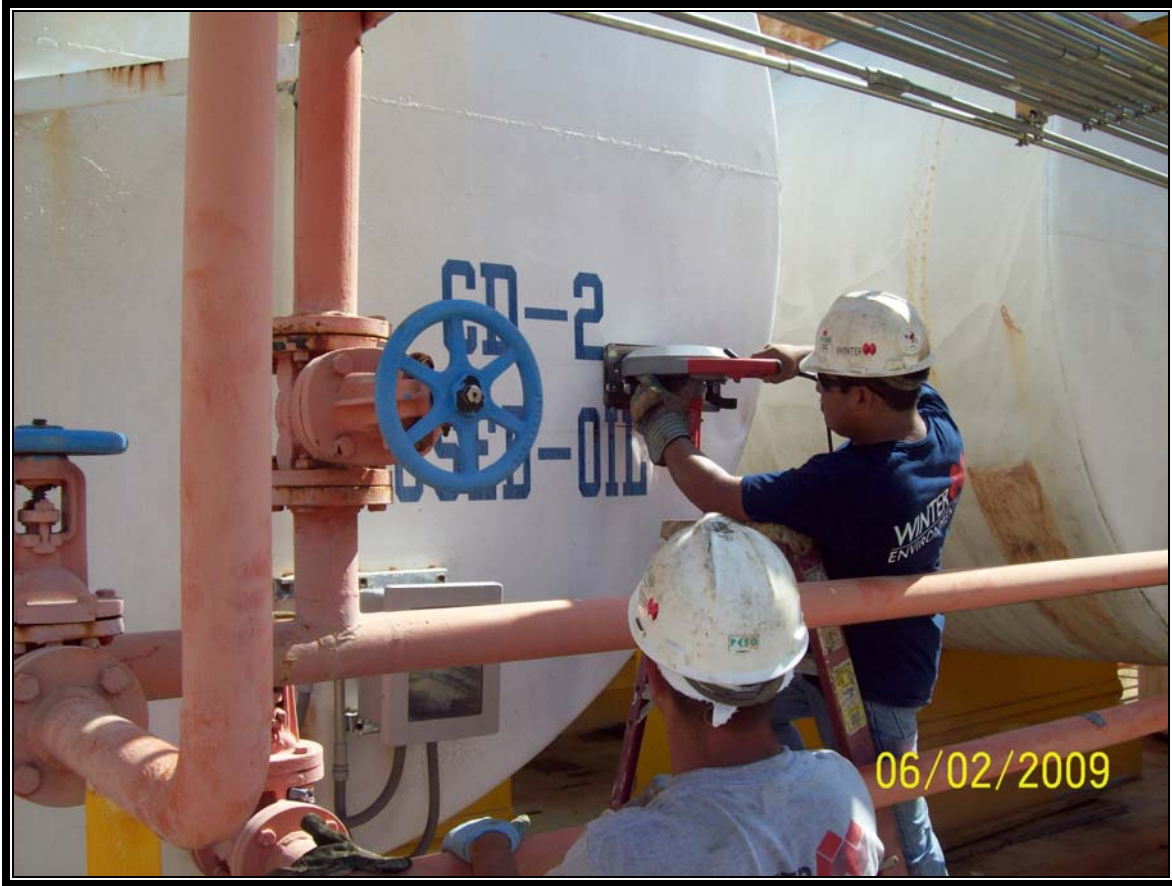
OFFICIAL PHOTOGRAPH NO. 27
U.S. ENVIRONMENTAL PROTECTION AGENCY

Subject: Winter utilizes saw to gain access to tank CD-2.

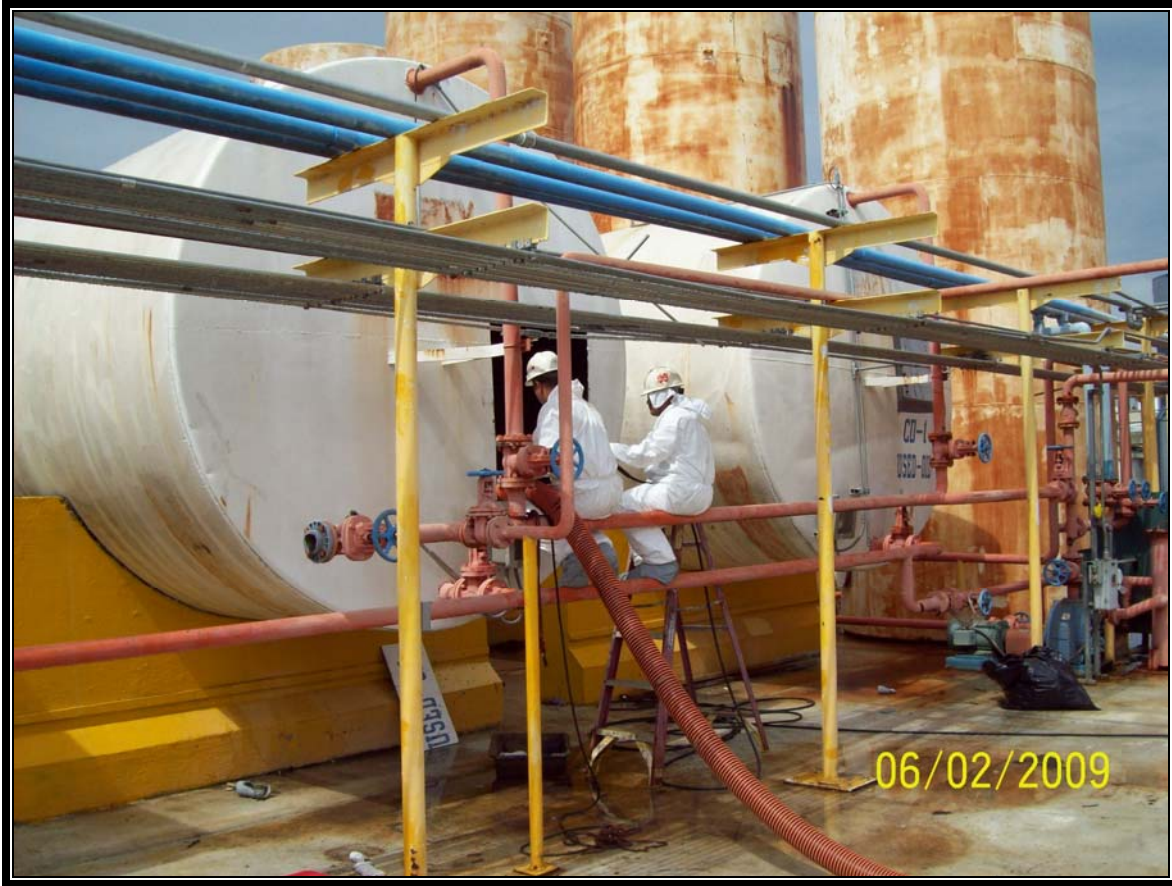
OFFICIAL PHOTOGRAPH NO. 28
U.S. ENVIRONMENTAL PROTECTION AGENCY

Subject: Winter pressure washes tank CD-2.

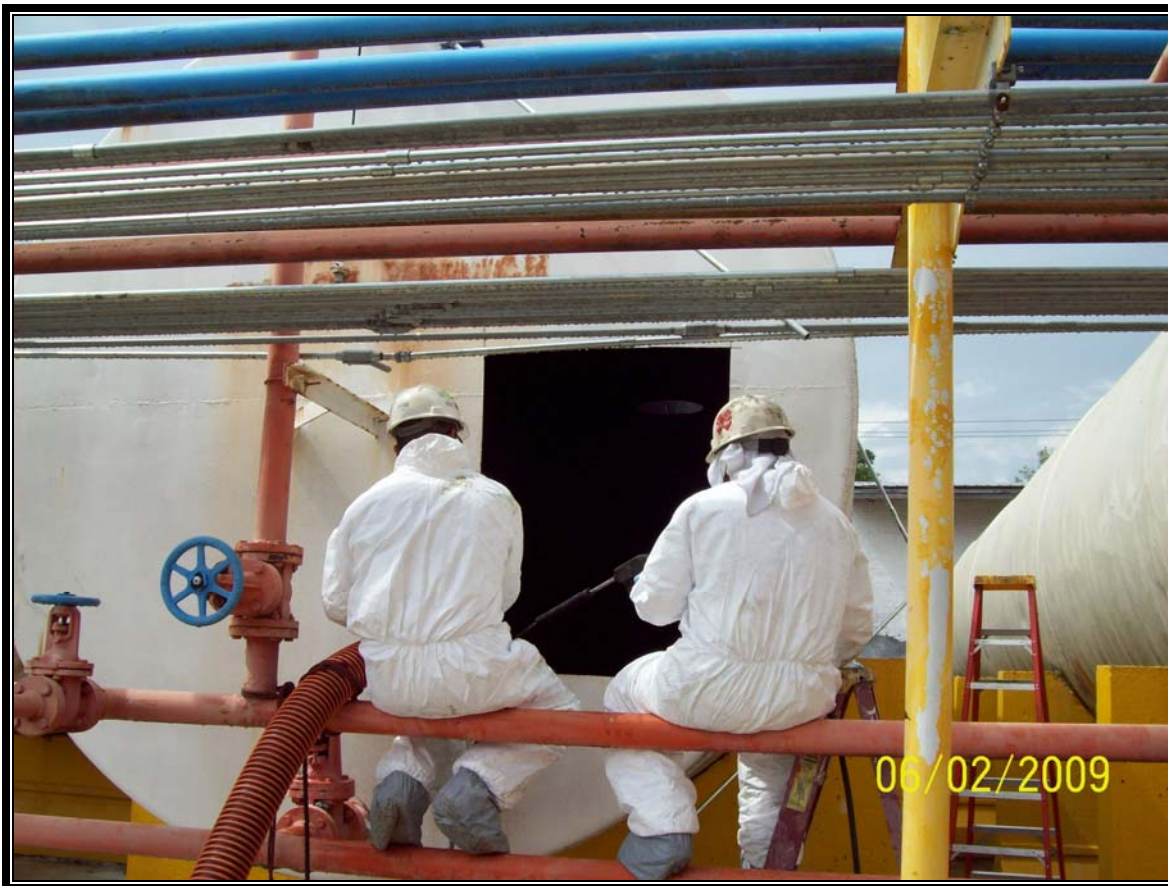
OFFICIAL PHOTOGRAPH NO. 29
U.S. ENVIRONMENTAL PROTECTION AGENCY

Subject: Winter pressure washes tank CD-2.

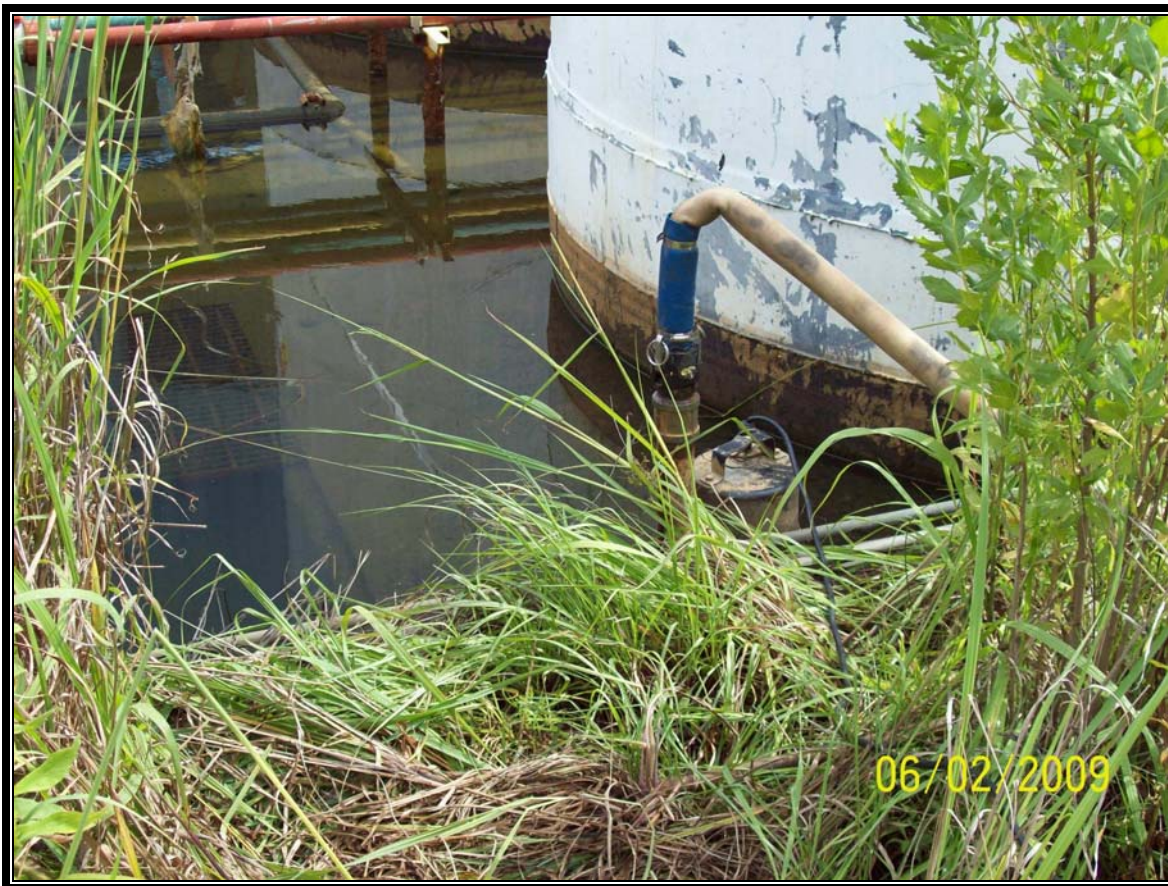
OFFICIAL PHOTOGRAPH NO. 30
U.S. ENVIRONMENTAL PROTECTION AGENCY

Subject: Winter removes rain water utilizing submersible pump.

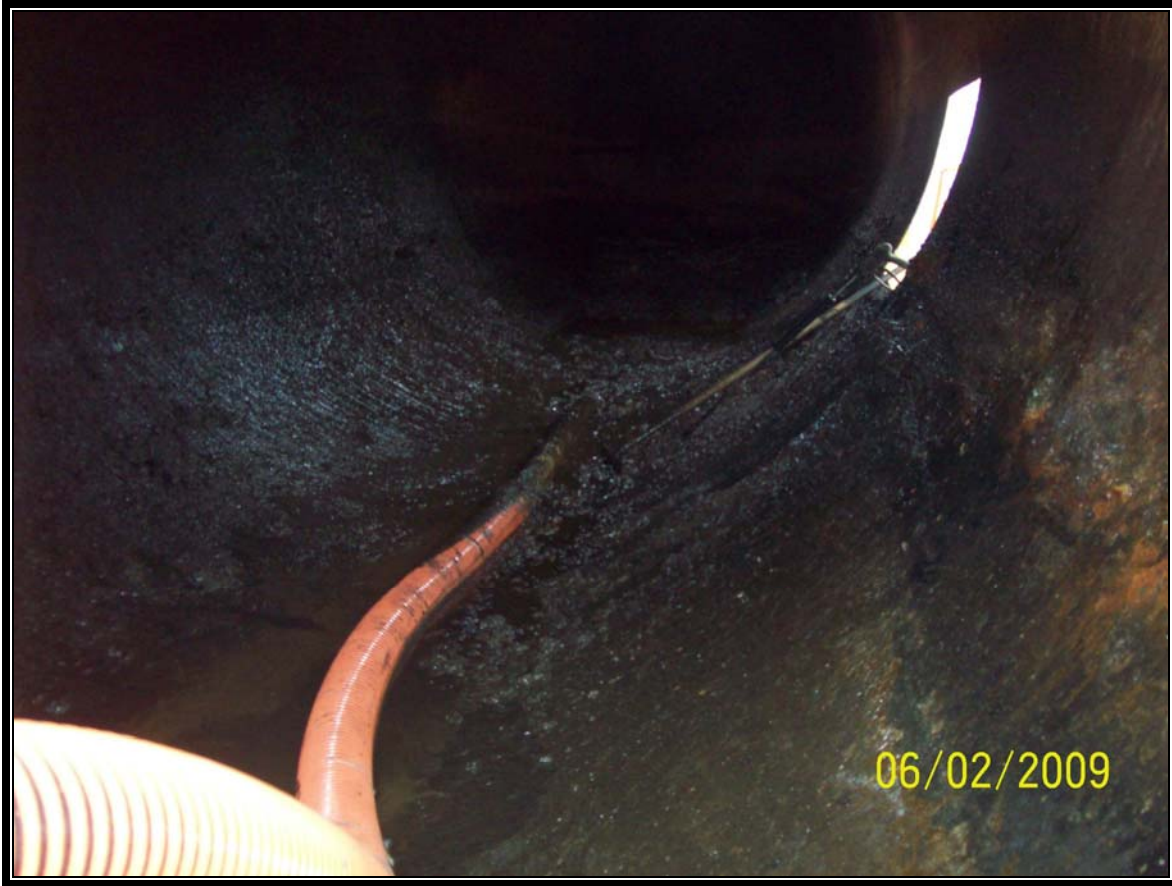
OFFICIAL PHOTOGRAPH NO. 31
U.S. ENVIRONMENTAL PROTECTION AGENCY

TDD Number:	TTEMI-05-001-0076	Location:	Seven Out Tank
Orientation:	North	Date:	June 02, 2009
Photographer:	Chuck Berry, Tetra Tech	Witness:	J. Kooms, Winter Environmental
Subject:	Winter collects sludge from tank CD-2.
