SITE ASSESSMENT REPORT
FOR
BUSH SITE
SPENCER TOWNSHIP, LUCAS COUNTY, OHIO
TDD # T05-9404-018
PAN # EOH1029SAA
DOCUMENT CONTROL # TAT-05-25-04092

SEPTEMBER 30, 1994

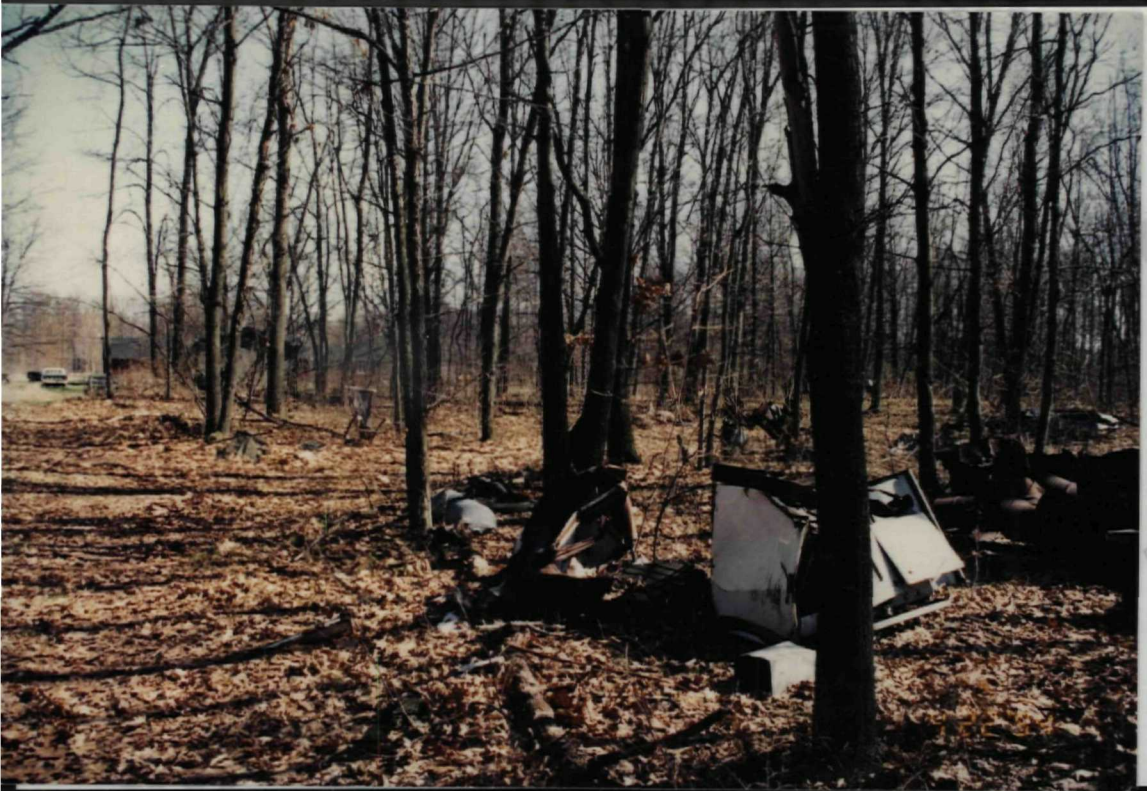
Site
1
North
Campus Infinity
er: Basham

Date: 4-22-94 Subject:
View along site roadway at Bush
Site. Note residence in
background.

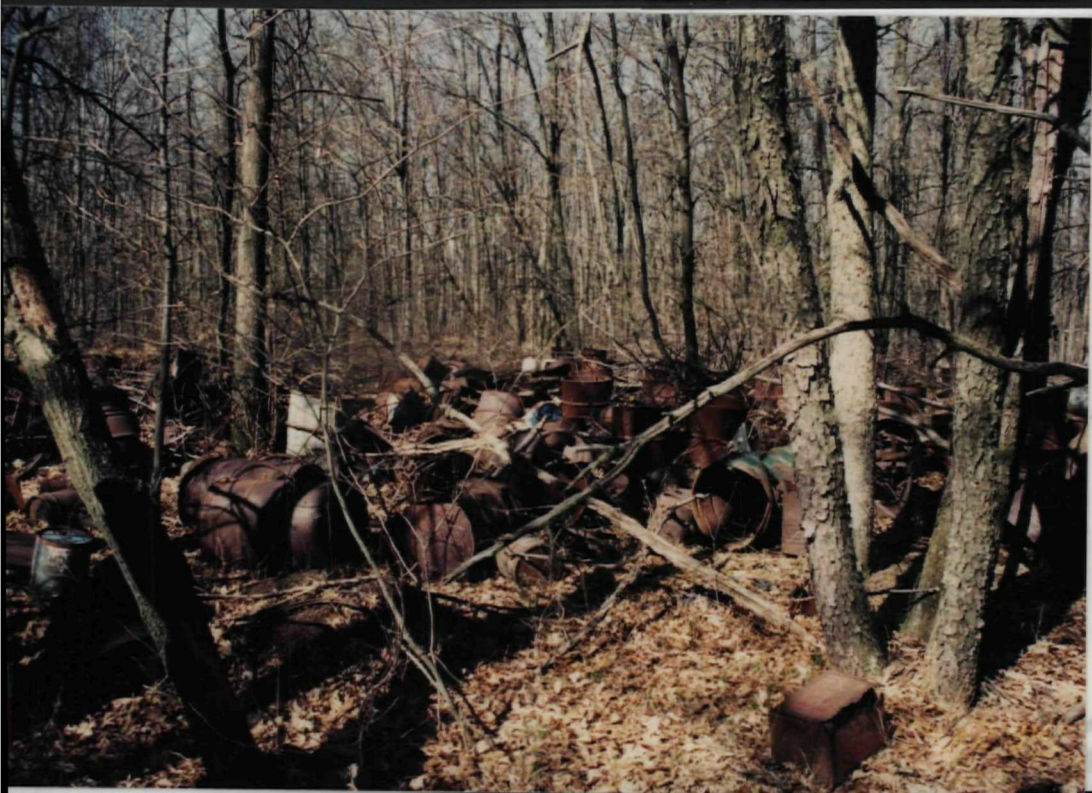
Site
2
West
Campus Infinity
er: Basham

Date: 4-22-94 Subject:
Typical surface debris at Bush
Site.

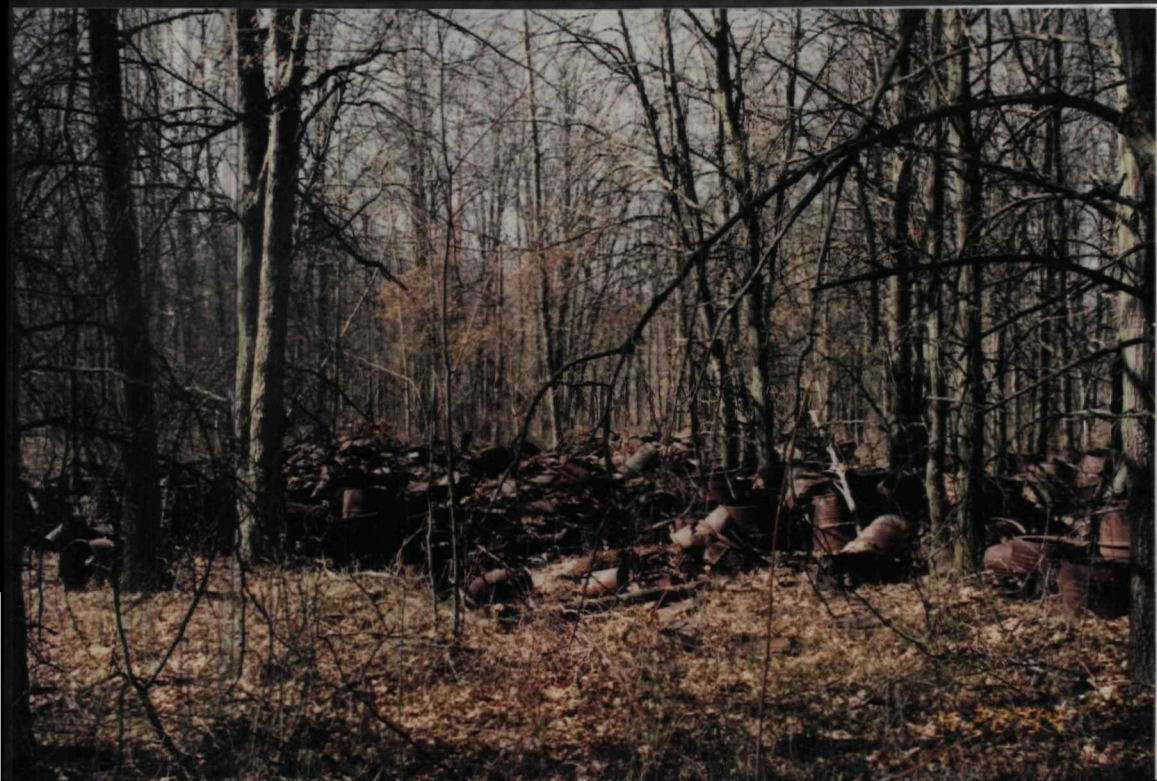
Site: Bush Site
 Photo No: 3
 Direction: West
 Camera: Olympus Infinity
 Photographer: Basham

Date: 4-22-94
 Typical surface
 scattered in woods
 Site.

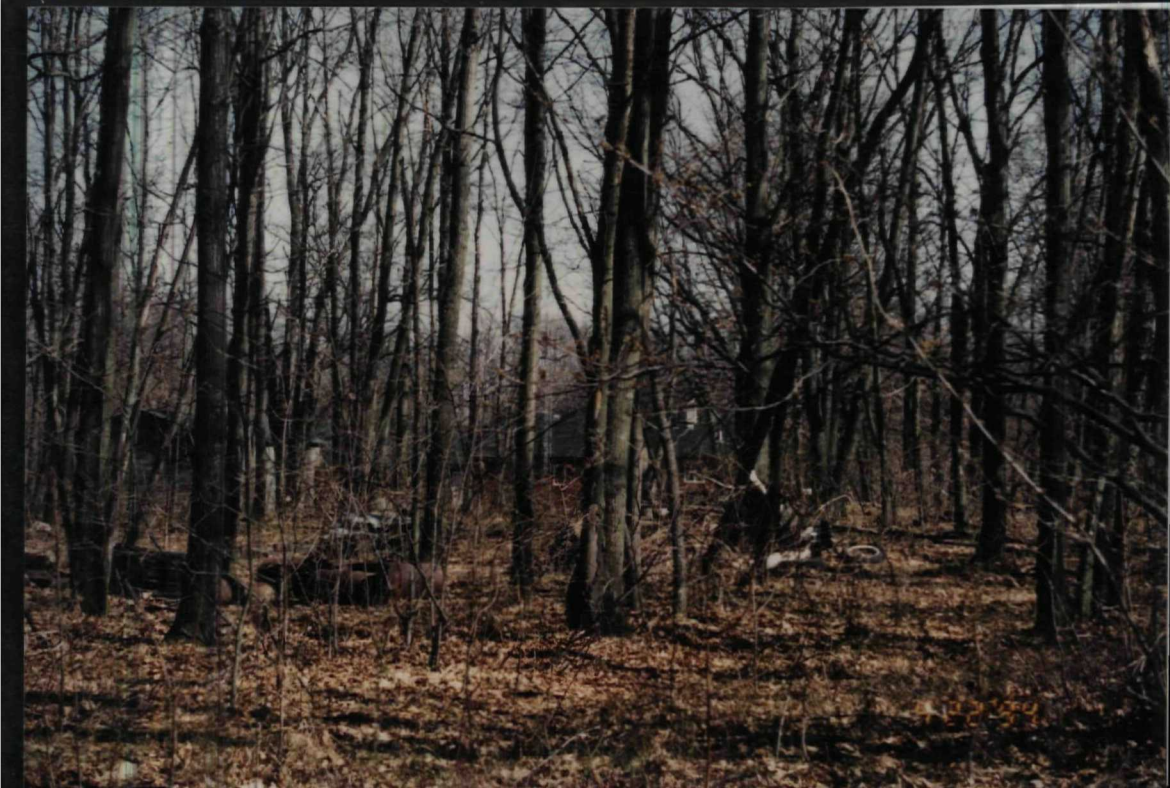
Site: Bush Site
 Photo No: 4
 Direction: North
 Camera: Olympus Infinity
 Photographer: Basham

Date: 4-22-94
 Bush family residence
 background with
 scattered on the site

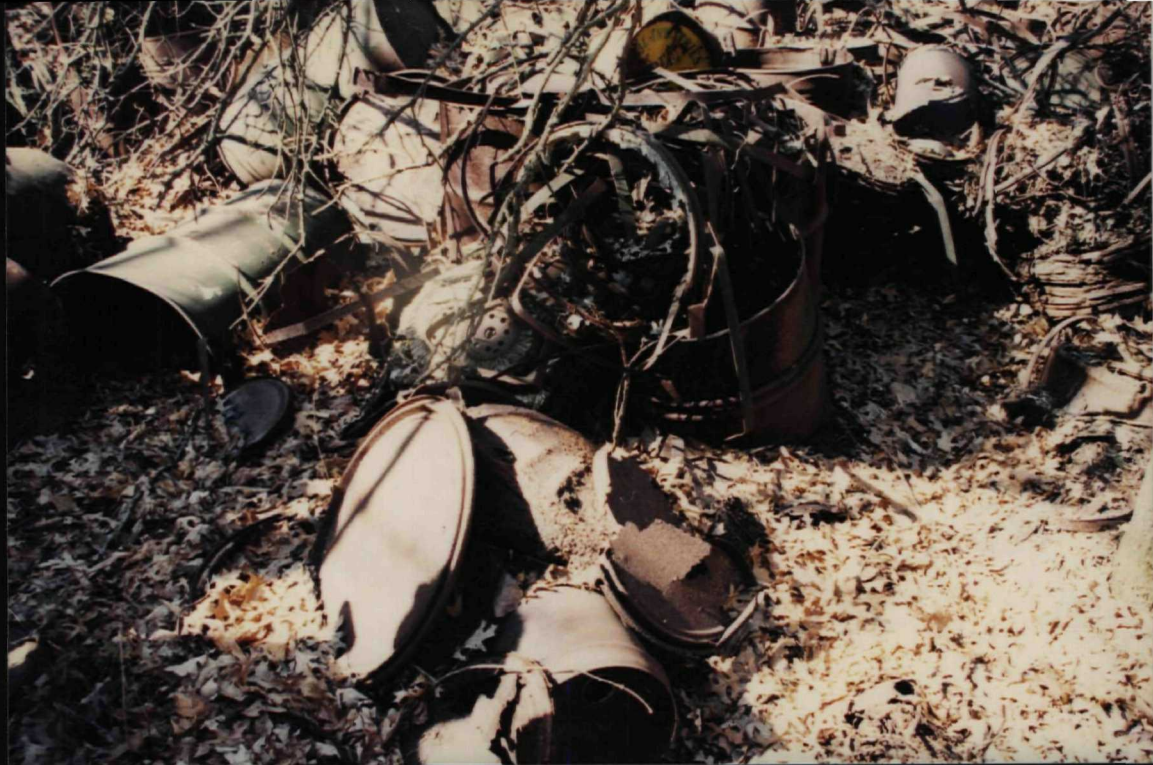
Site: Bush Site
 Photo No: 5
 Direction: Down
 Camera: Olympus Infinity
 Photographer: Basham

Date: 4-22-94 Subject:
 Typical surface debris at Bush
 Site.

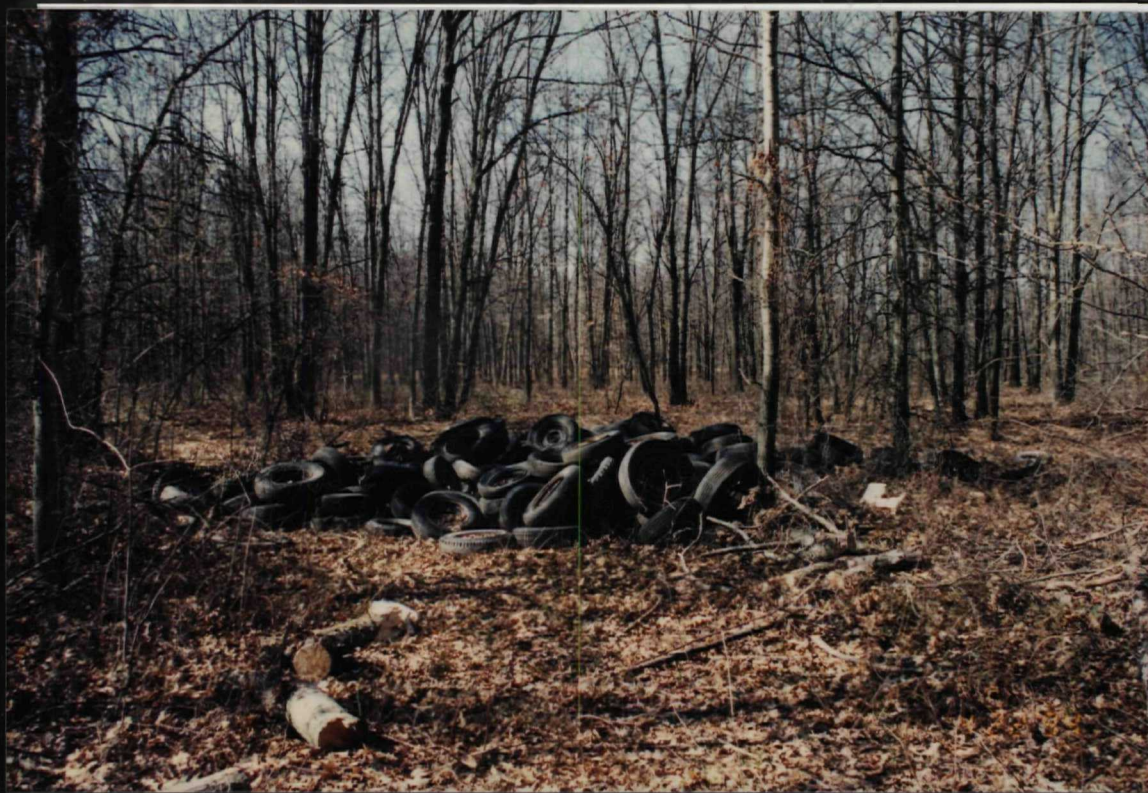
Site: Bush Site
 Photo No: 6
 Direction: Down
 Camera: Olympus Infinity
 Photographer: Basham

Date: 4-22-94 Subject:
 Pile of tires in woods at Bush
 Site.

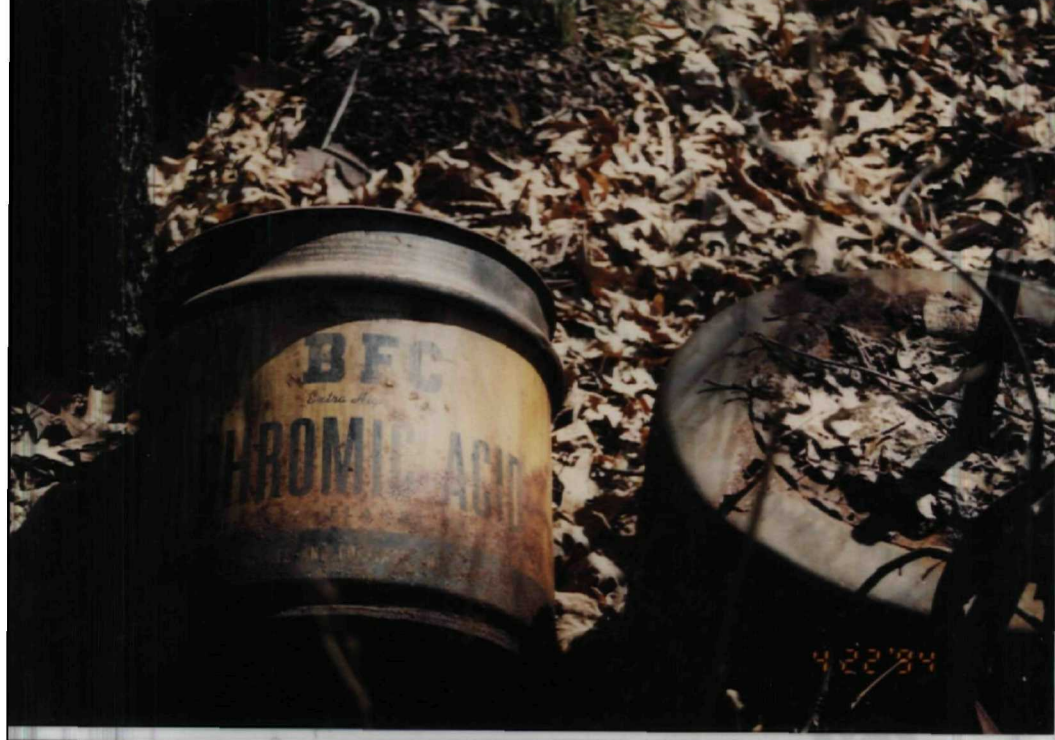
Site: Bush Site
 Photo No: 7
 Direction: Down
 Camera: Olympus Infinity
 Photographer: Basham

Date: 4-22-94
 Subject: Chromic Acid container at Bush Site.

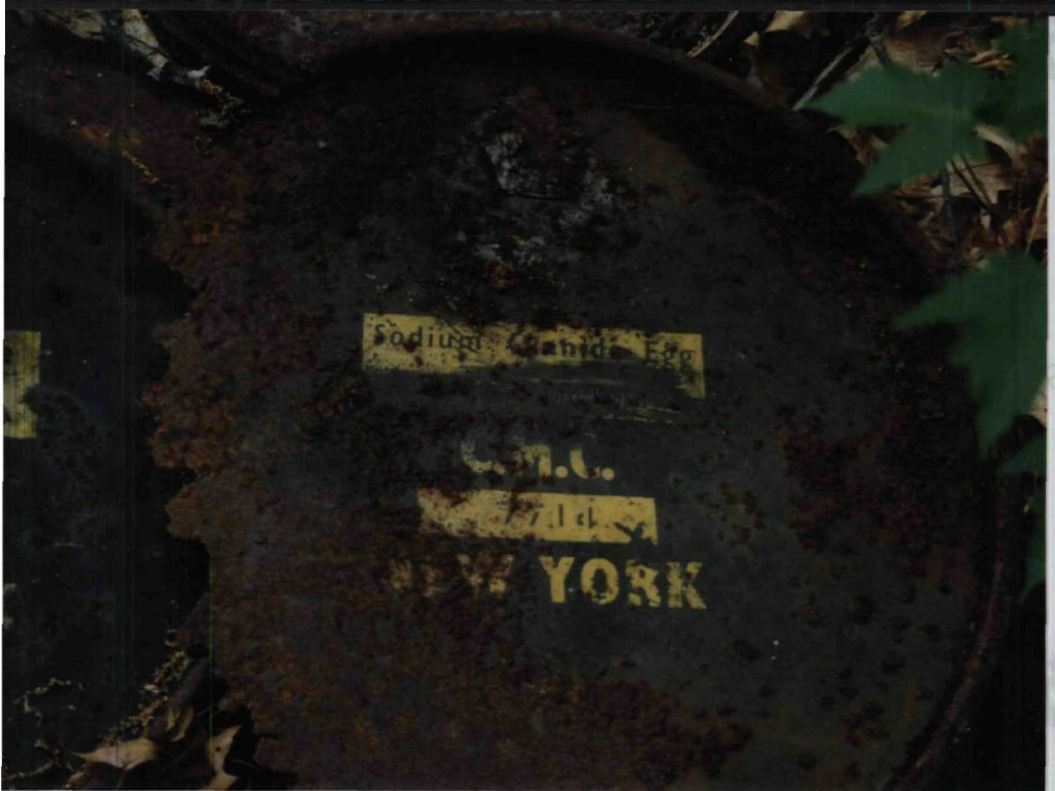
Site: Bush Site
 Photo No: 8
 Direction: Down
 Camera: Olympus Infinity
 Photographer: Caldwell

Date: 5-24-94
 Subject: Drum lid labeled "sodium cyanide egg" in pile of hundreds of lids and drums.

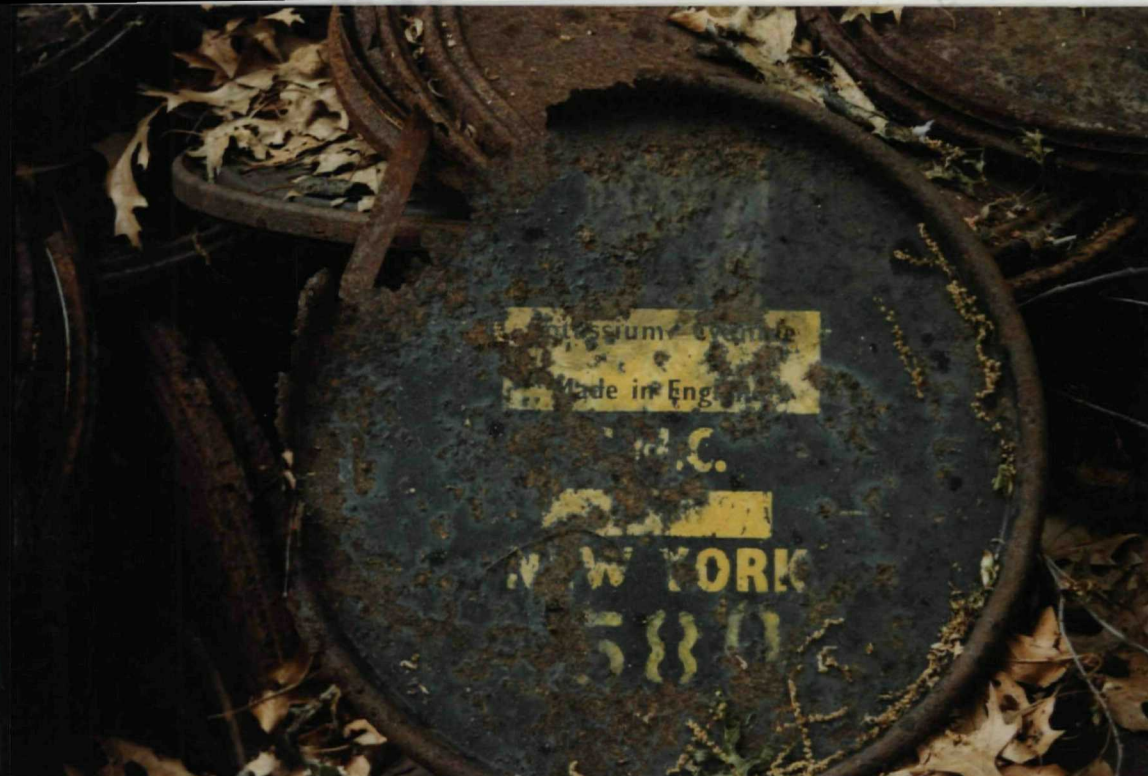
Site: Bush Site
 Photo No: 9
 Direction: Down
 Camera: Olympus Infinity
 Photographer: Caldwell

Date: 5-24-99 Subject:
 Drum lid labeled "potassium
 cyanide" in pile of hundreds of
 lids and drums.

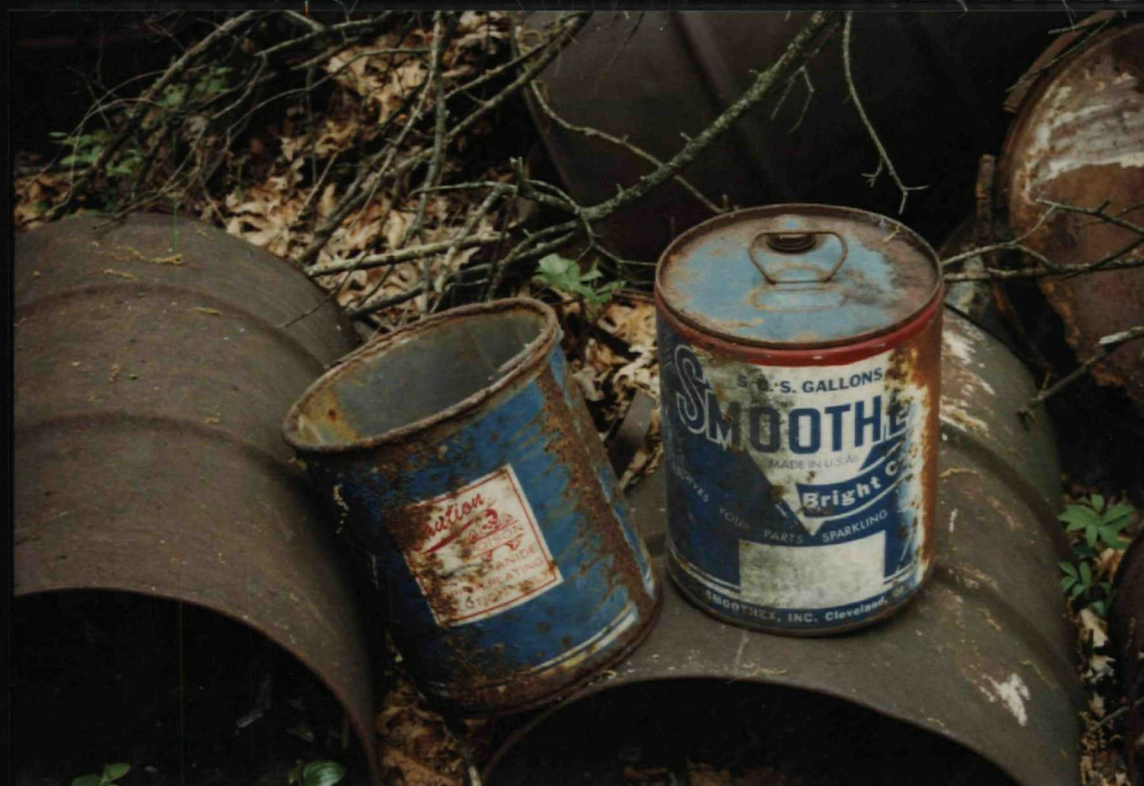
Site: Bush Site
 Photo No: 10
 Direction: Down
 Camera: Olympus Infinity
 Photographer: Caldwell

Date: 5-24-94 Subject:
 Two plating chemical containers
 at the Bush Site.

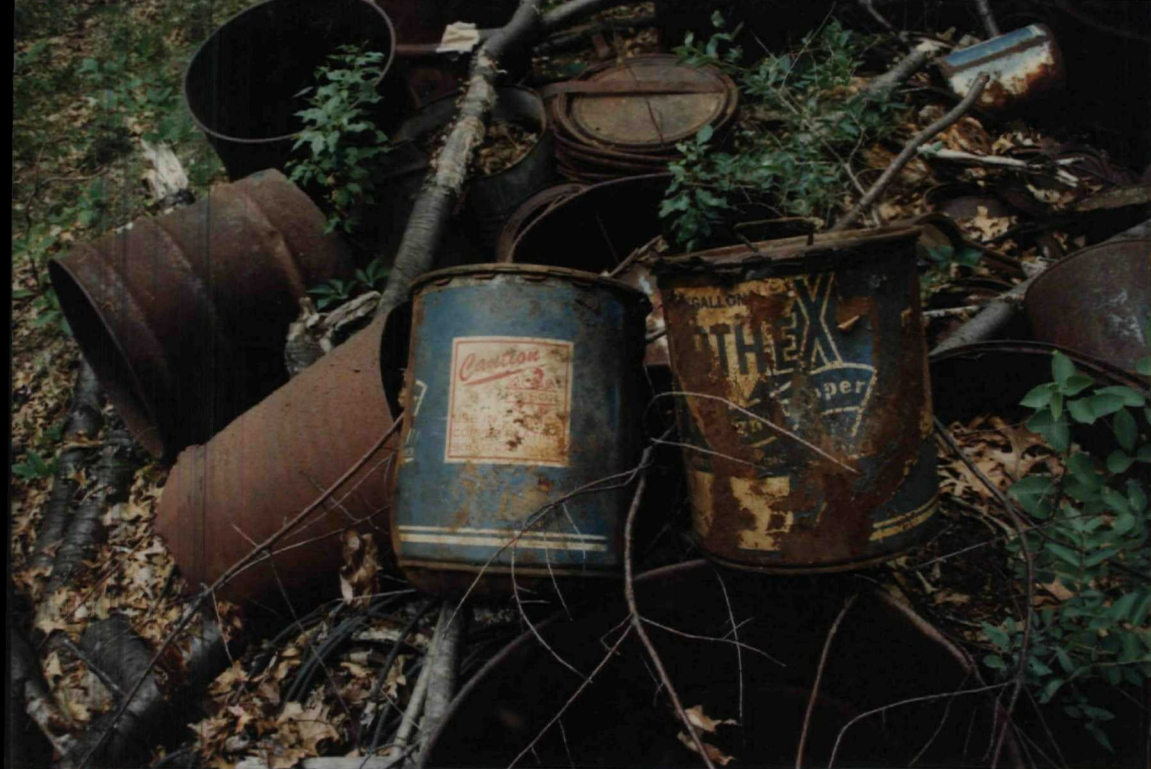
Site: Bush Site
Photo No: 11
Direction: West
Camera: Olympus Infinity
Photographer: Caldwell

Date: 5-24-94
Subject:
Additional small containers at
the Bush Site.

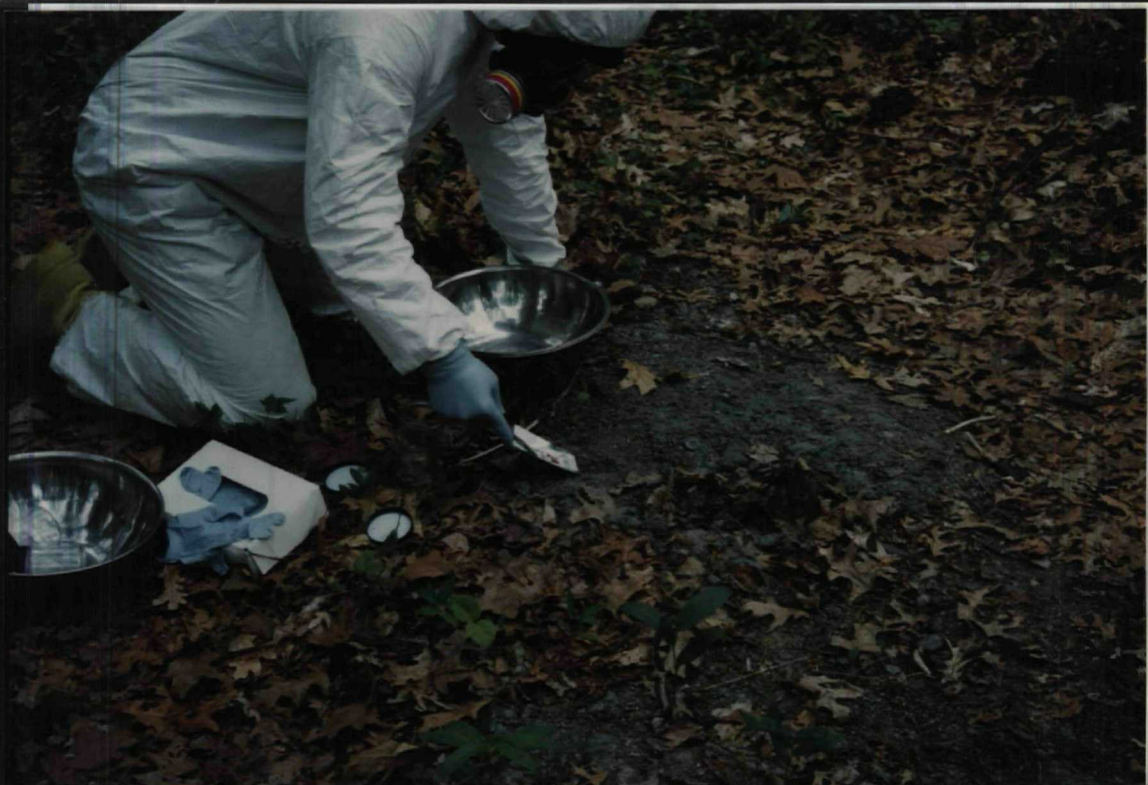
Site: Bush Site
Photo No: 12
Direction: West
Camera: Olympus Infinity
Photographer: Caldwell

Sample BUSH-01 was a grey solid collected from waste found on the surface of the site. The sample was analyzed for total Resource Conservation and Recovery Act (RCRA)-listed metals and total cyanide. The sample contained elevated concentrations of barium (260 parts per million (ppm)), chromium (630 ppm), lead (250 ppm), and total cyanide (180 ppm). The Toxicity Characteristic Leachate Procedure (TCLP) was performed on the sample and the leachate was analyzed for these metals. The concentrations of the target metals in the TCLP leachate were below regulatory limits. Reactive cyanide analysis was also performed on the sample and the sample concentrations did not exceed the regulatory limits.

Date: 5-24-94
Subject:
Sampling team collects Bush-01.
Sample described as gray opaque
solid.

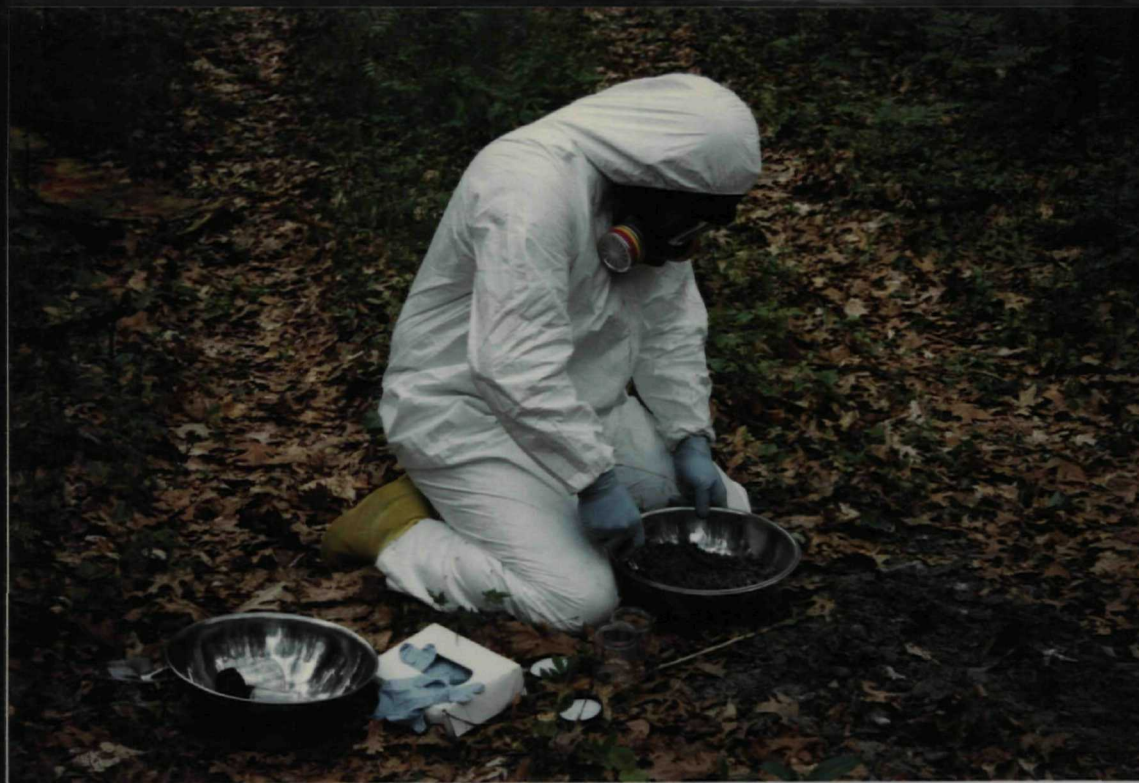
Site: Bush Site
Photo No: 13
Direction: North
Camera: Olympus Infinity
Photographer: Caldwell

Date: 5-24-94 Subject:
Sampling team homogenizing
sample labeled Bush-01.

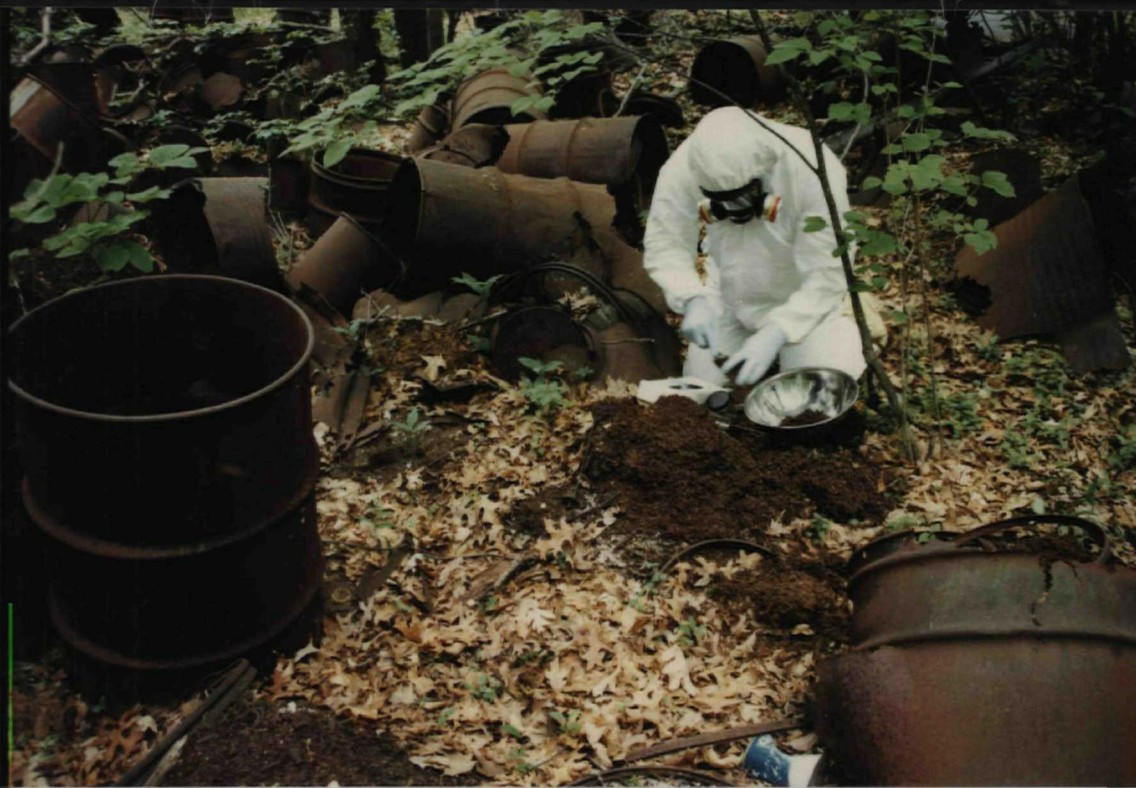
Site: Bush Site
Photo No: 14
Direction: Down
Camera: Olympus Infinity
Photographer: Caldwell

Sample BUSH-02 was a brown solid material containing metal turnings collected from waste found on the surface of the site. The sample was analyzed for total RCRA-listed metals, volatile organic compounds, and total cyanide. The sample contained elevated concentrations of arsenic (45 ppm), chromium (2,000 ppm), and lead (990 ppm). The sample also contained traces of acetone (280 ppb), methyl ethyl ketone (130 ppb), and toluene (11 ppb). The TCLP was performed on the sample and the leachate was analyzed for these metals. The concentrations of the target metals in the TCLP leachate were below regulatory limits.

Date: 5-24-94 Subject:
Sample team collects sample
Bush-02, described as brown
opaque solid with metal
turnings.

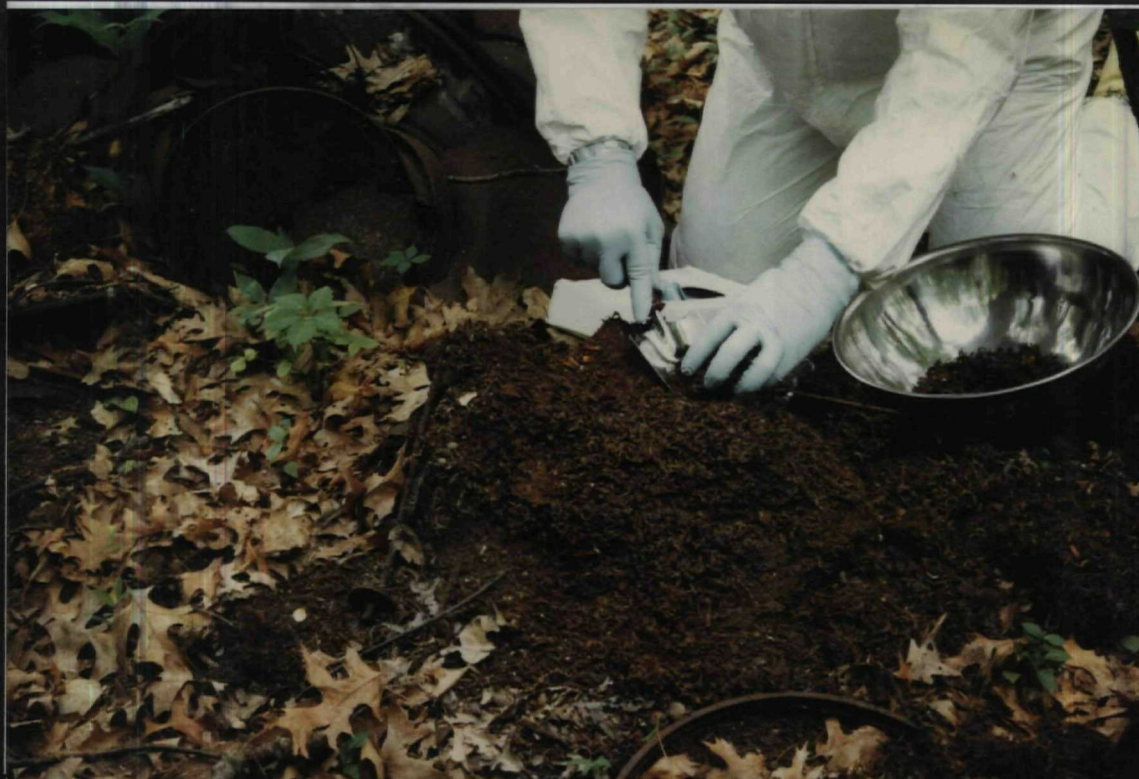
Site: Bush Site
 Photo No: 15
 Direction: Down
 Camera: Olympus Infinity
 Photographer: Caldwell

Date: 5-24-94
 Close-up of Bush-02 being collected.

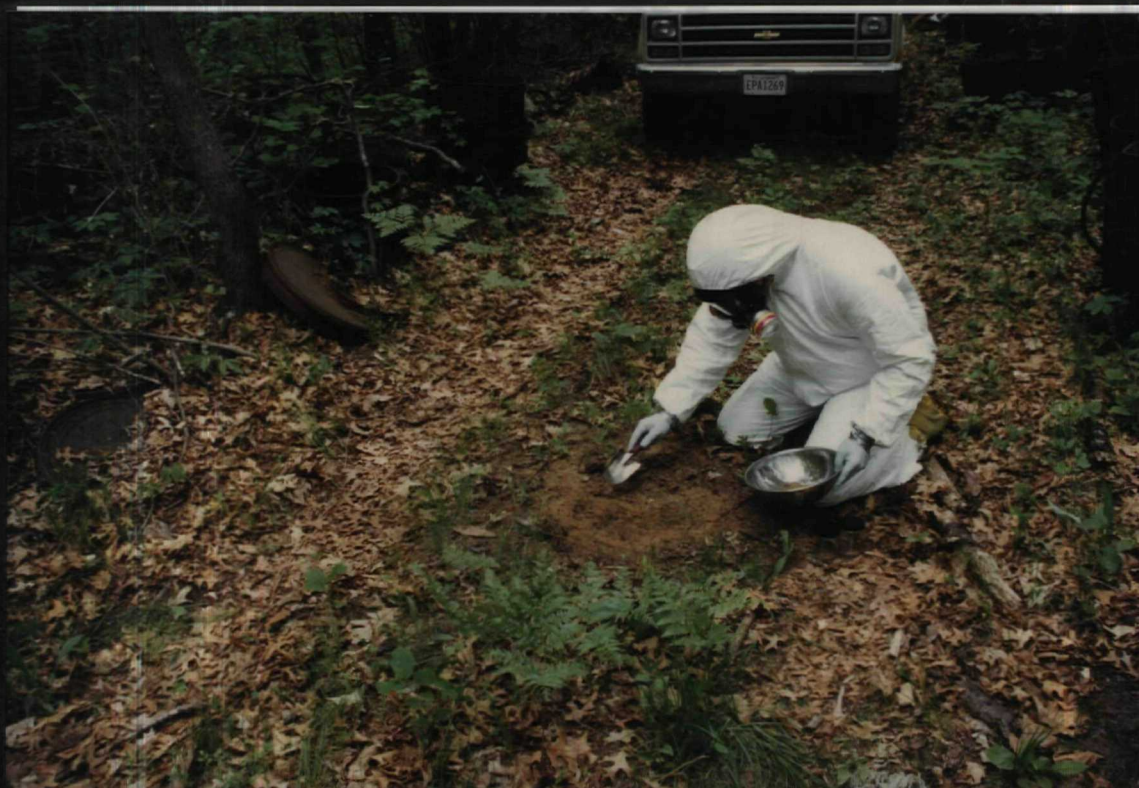
Site: Bush Site
 Photo No: 16
 Direction: Down
 Camera: Olympus Infinity
 Photographer: Caldwell

total RCRA-listed metals and total cyanide. The sample contained elevated concentrations of arsenic (11 ppm), barium (16 ppm), chromium (29 ppm), and selenium (16 ppm). The TCLP was performed on the sample and the leachate was analyzed for these metals. The concentrations of the target metals in the TCLP leachate were below regulatory limits.

Date: 5-24-94
 Sample team collects Bush-03.
 Sample described as brown opaque solid.
