Moon Hines Flowline Spill

Wayne County, Mississippi

Operations and Maintenance Report February 11, 2014

Prepared by: FC&E Engineering, LLC

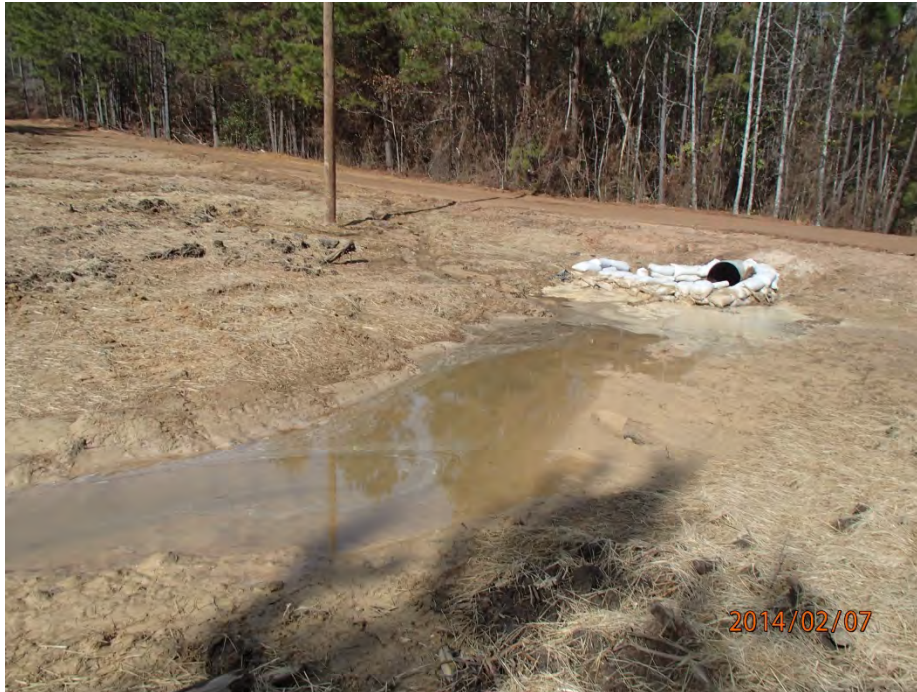
Underflow Dam – 2/7/14

- The excavation area and underflow dam showed no signs of oil upon inspection.
- Zone A exhibited to very small areas with very low amounts of oil leaching from the ground.

Overview of underflow dam and excavation area.

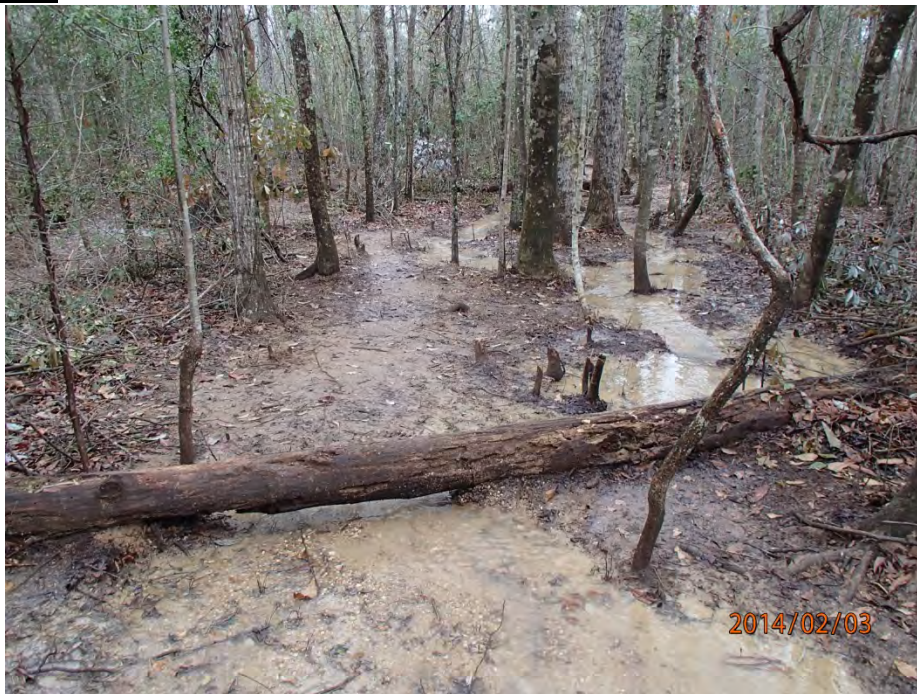
Zone A – 2/3/14

Overview of area in Zone A

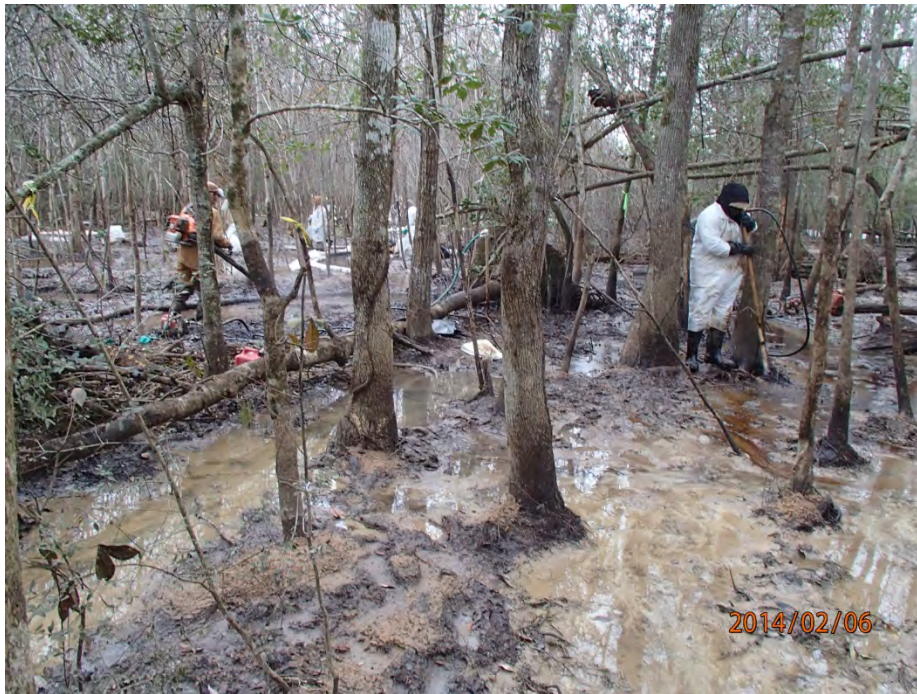
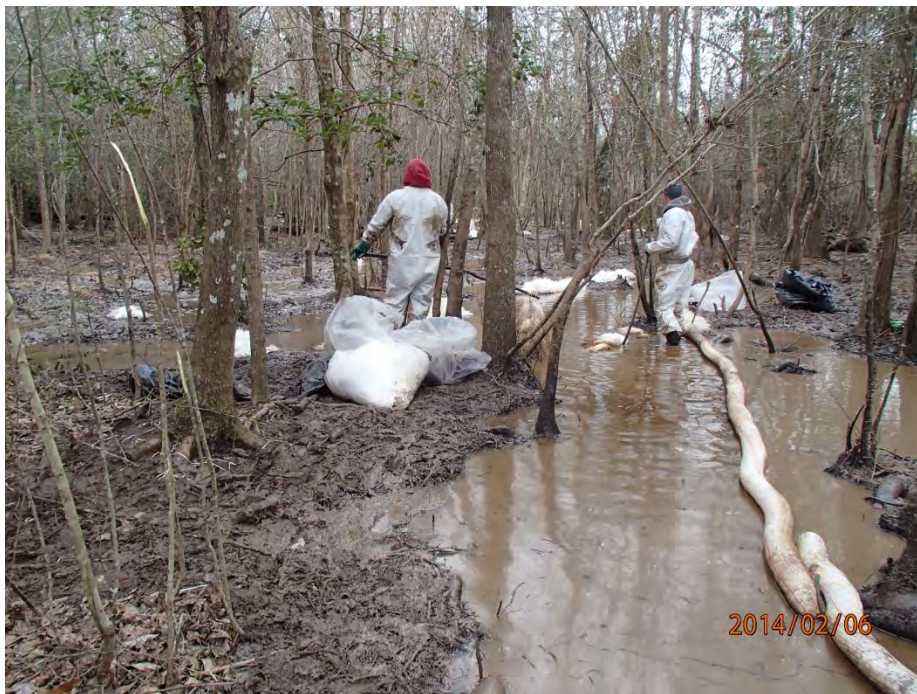
Zone B – 2/6/14

- Zone B had a few areas with medium amounts of oil leaching from the ground and root systems. These areas were targeted with 1" inch water pumps and flushed. Oil was collected downstream using oil absorbent pads, snares, and sock booms. Oil Gator was applied and tilled into the soil following the targeted activities. Stations B1 and B2 showed low to medium levels of recoverable oil during the targeted flushing.

Targeted stinging and cleanup in Zone B

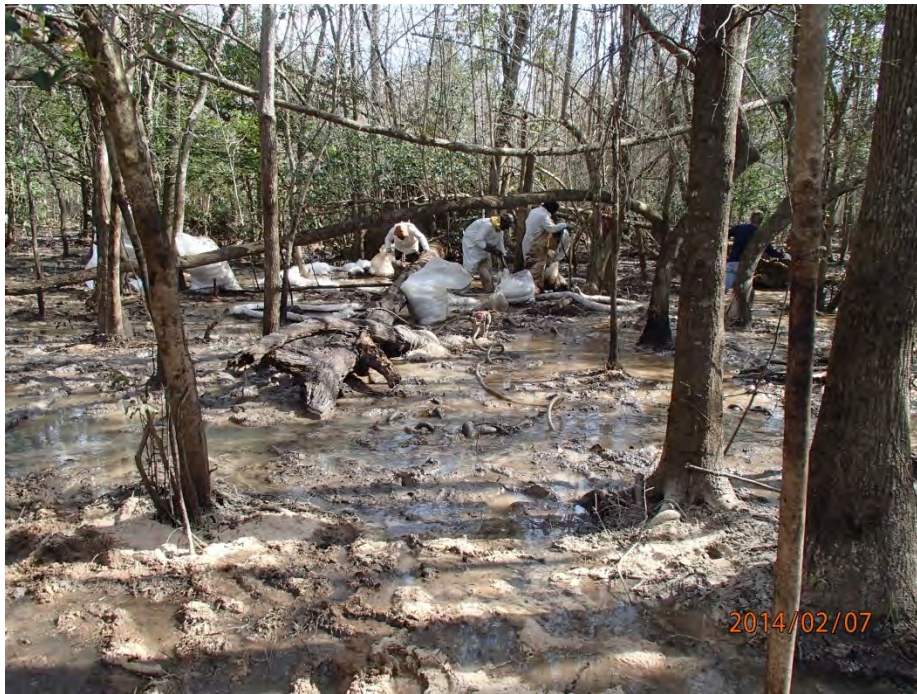
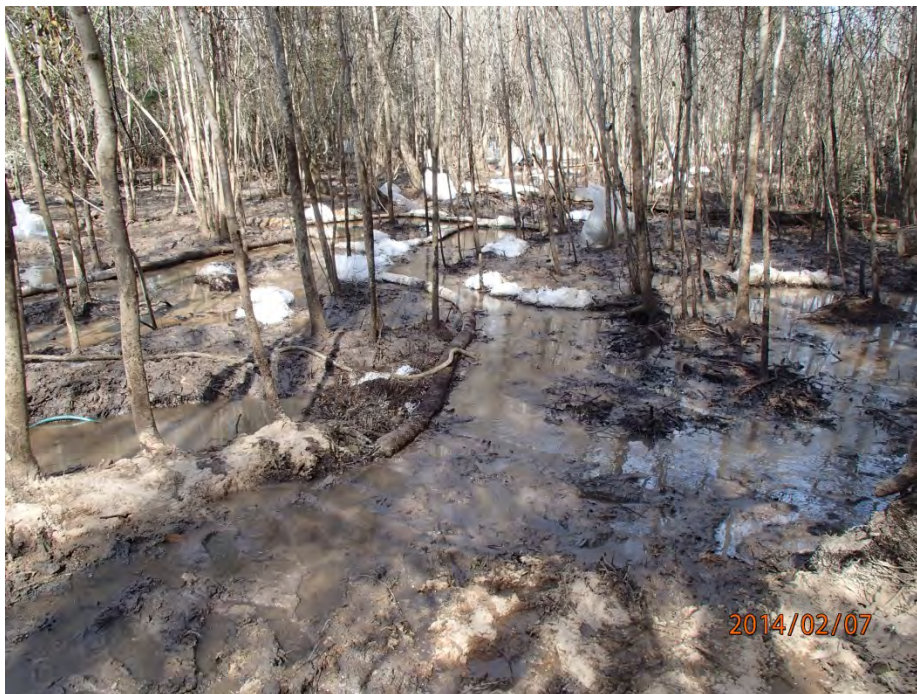
Zone B – 2/7/14

Targeted stinging and cleanup in Zone B

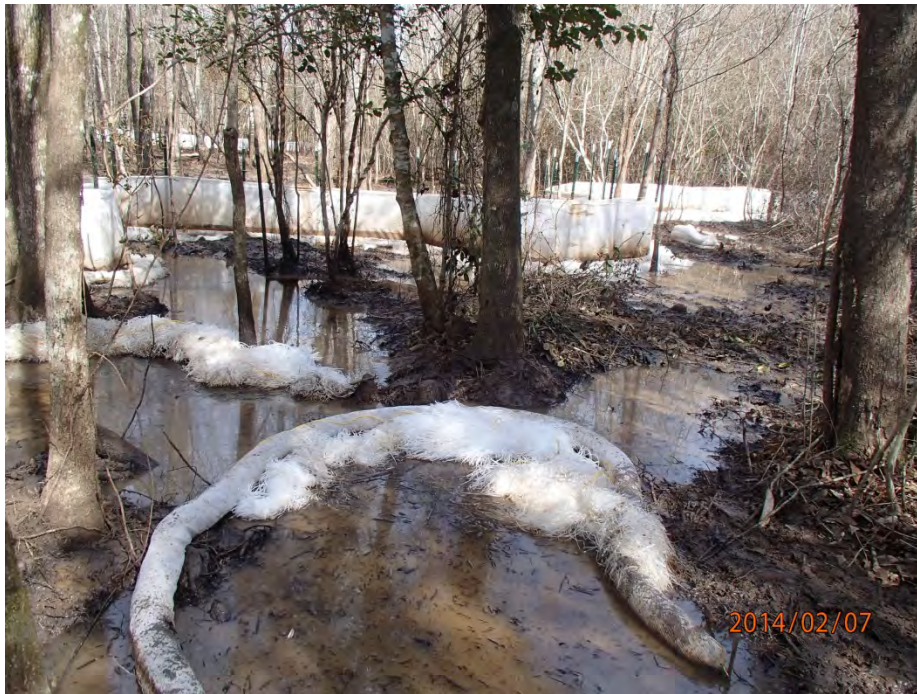
O&M Station B1 – with new sock boom and snare.

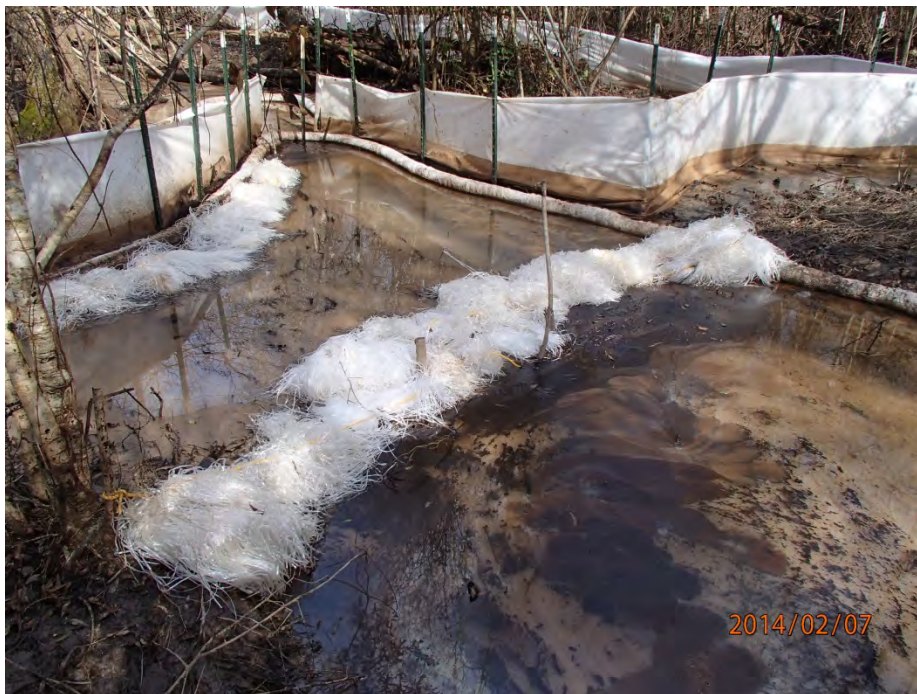
O&M Station B2 – with new sock boom and snare.

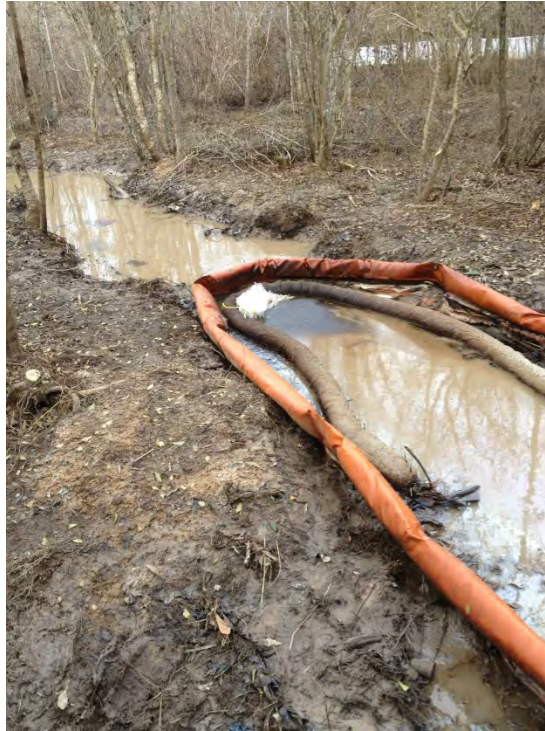
- Zone C had a few areas with low amounts of oil leaching from the ground and root systems. No targeted flushing occurred in Zone C. Stations C1, C2, C3, C4 and C5 showed low amounts of recoverable oil. Stations C6 and C7 showed very low signs of recoverable oil. Most of the oil present was degraded beyond the point of recovery with pads and snares.

O&M Station C3 – Before replacement of sock boom.

O&M Station C3 – After replacement of sock boom.

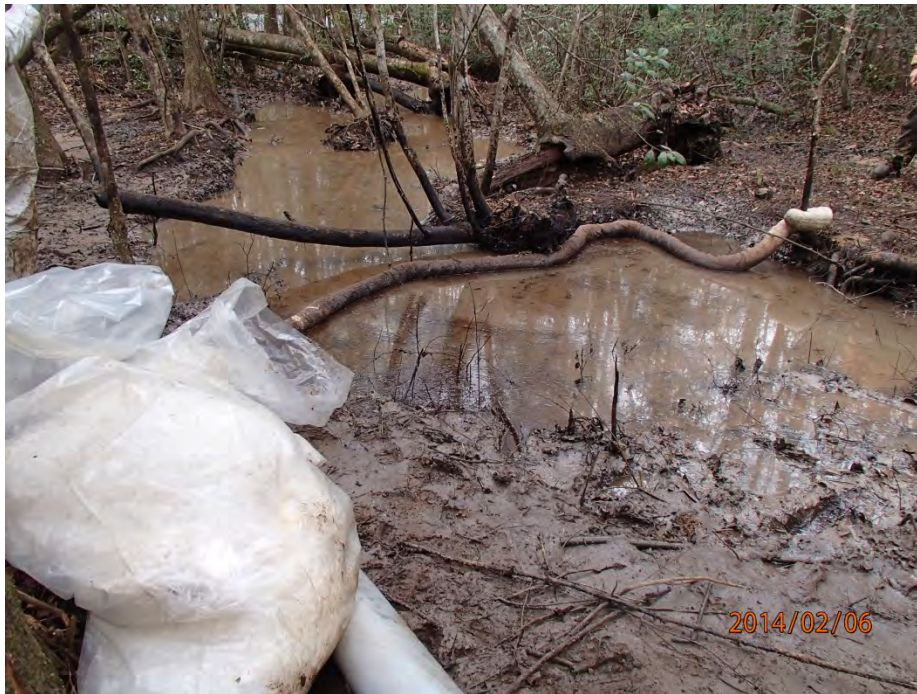
O&M Station C6 – Before replacement of sock book.

O&M Station C6 – After replacement of sock book.

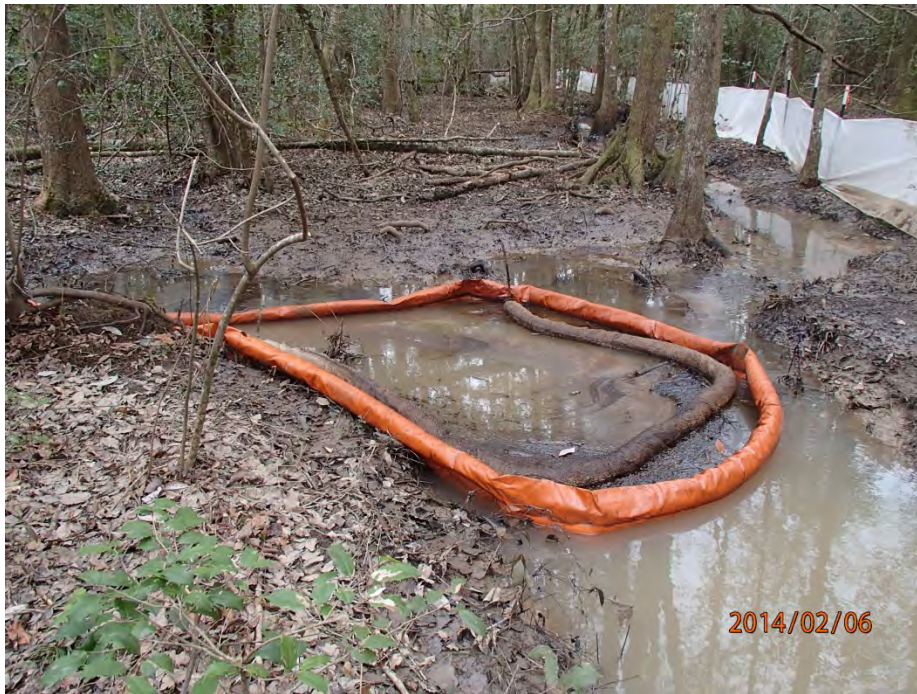
O&M Station C7 – Before replacement of sock book and snares.

O&M Station C7 – After replacement of sock book and snares.

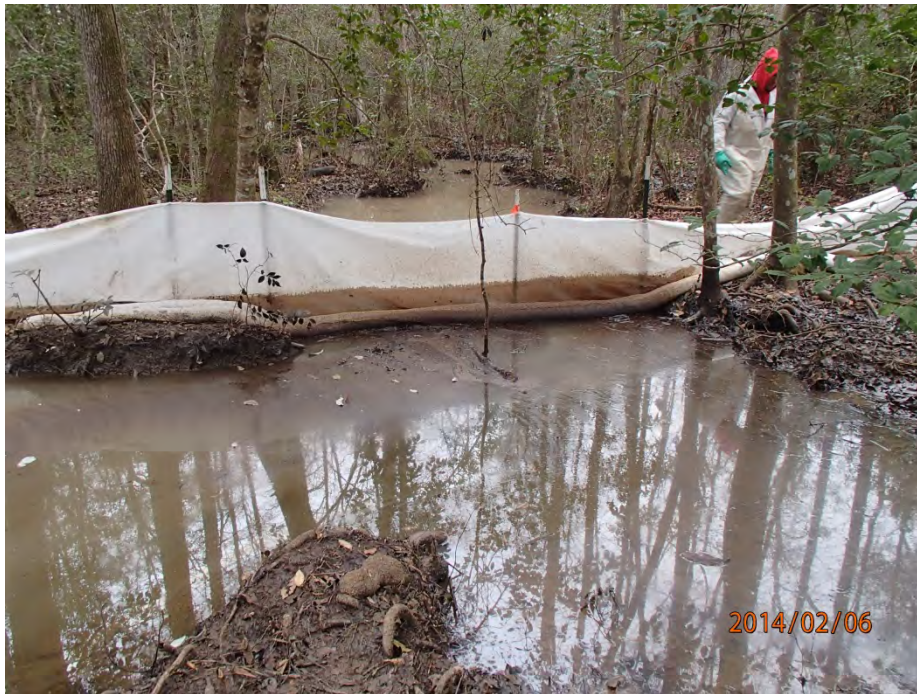
- Zone D had no signs of oil leaching. Stations D1 and D2 showed no signs of recoverable oil. Most of the oil present was degraded beyond the point of recovery with pads and snares.

O&M Station D1 – Before replacement of sock boom.

O&M Station D1 – After replacement of sock boom.

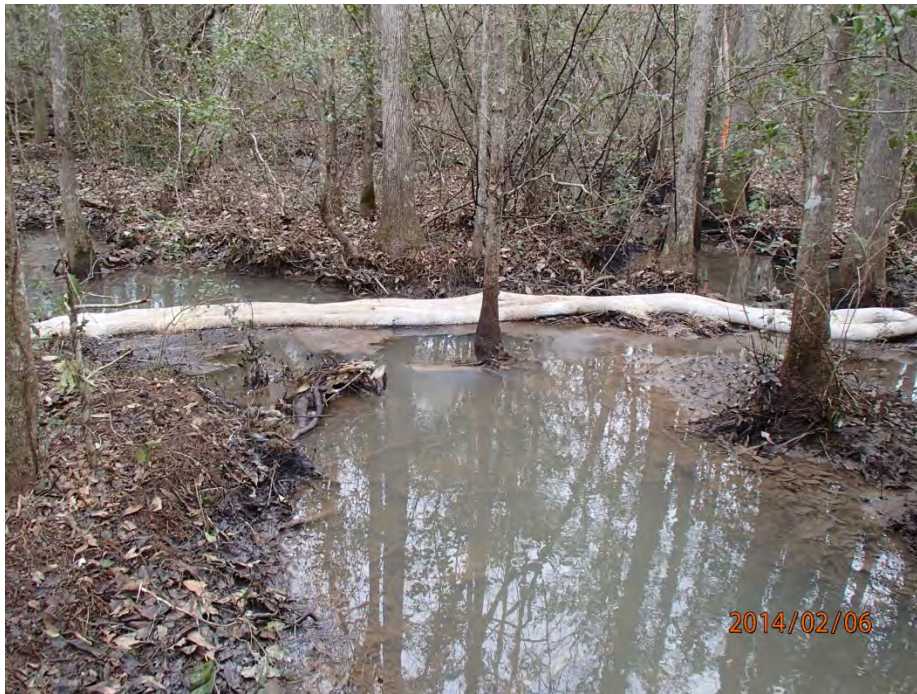
O&M Station D2 – Three sock booms and one snare line before replacement.

O&M Station D2 – One sock boom and one snare line after replacement.

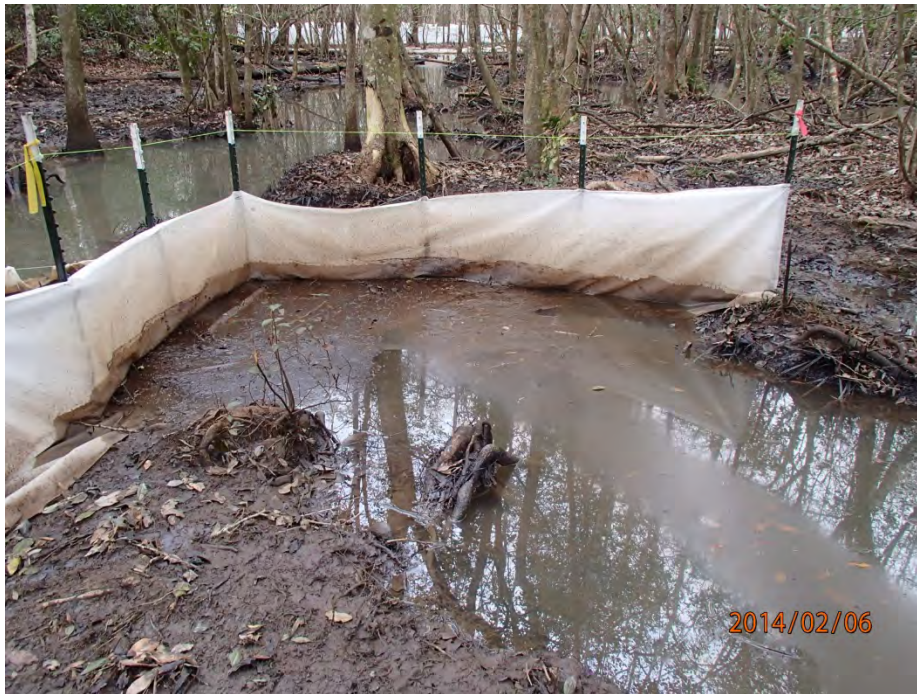
- Zone E had no signs of oil leaching. Stations E1, E2, E3 and E4 showed no signs of recoverable. The minimal amount of oil present was degraded beyond the point of recovery with pads and snares.

O&M Station E1 – Before placement of snare and sock boom.

O&M Station E1 – After placement of snare and sock boom.

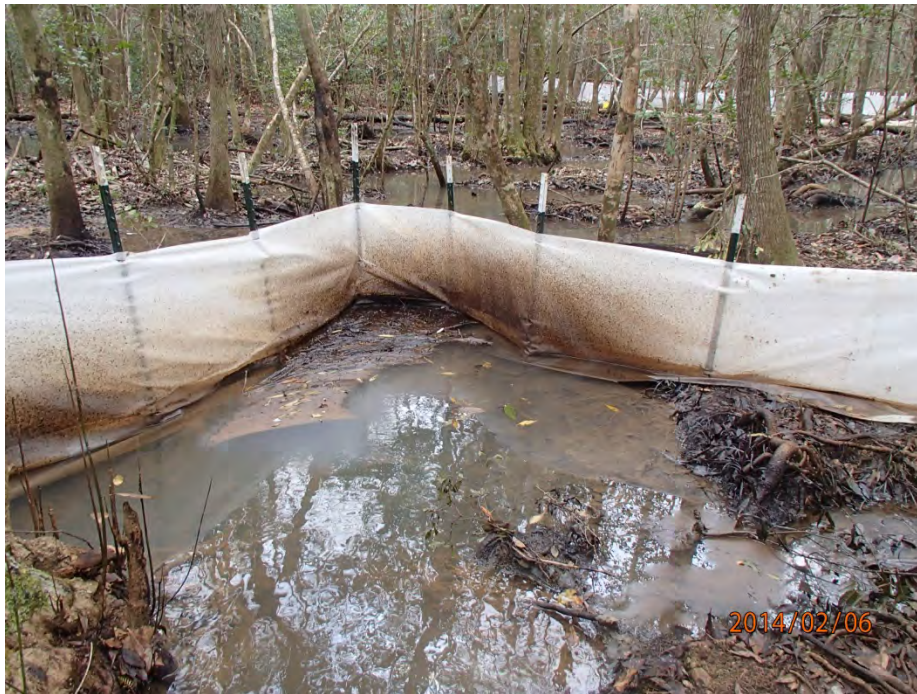
O&M Station E2 – Before placement of sock boom.

O&M Station E2 – After placement of sock boom.

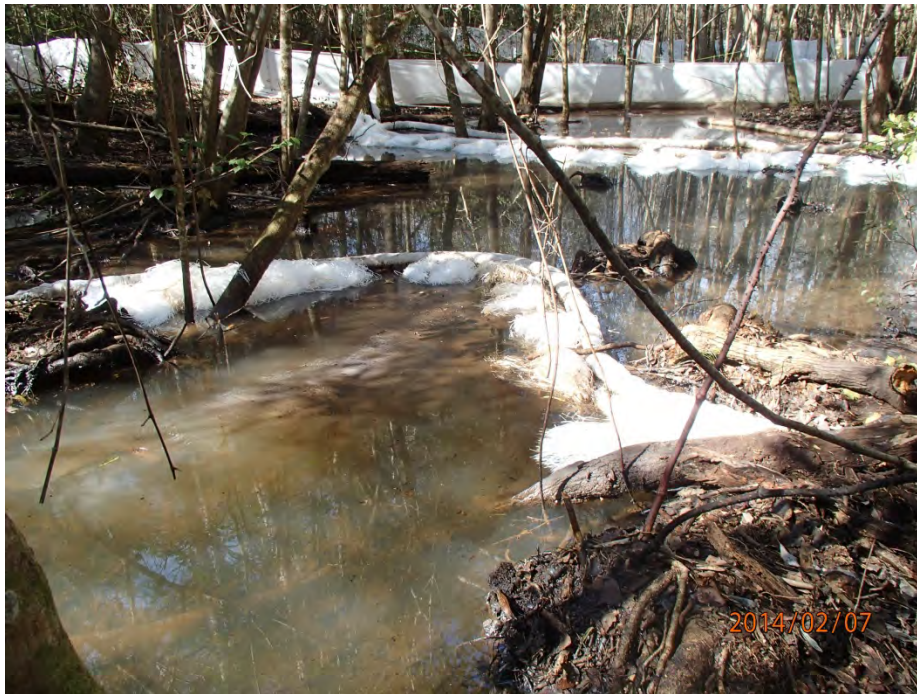
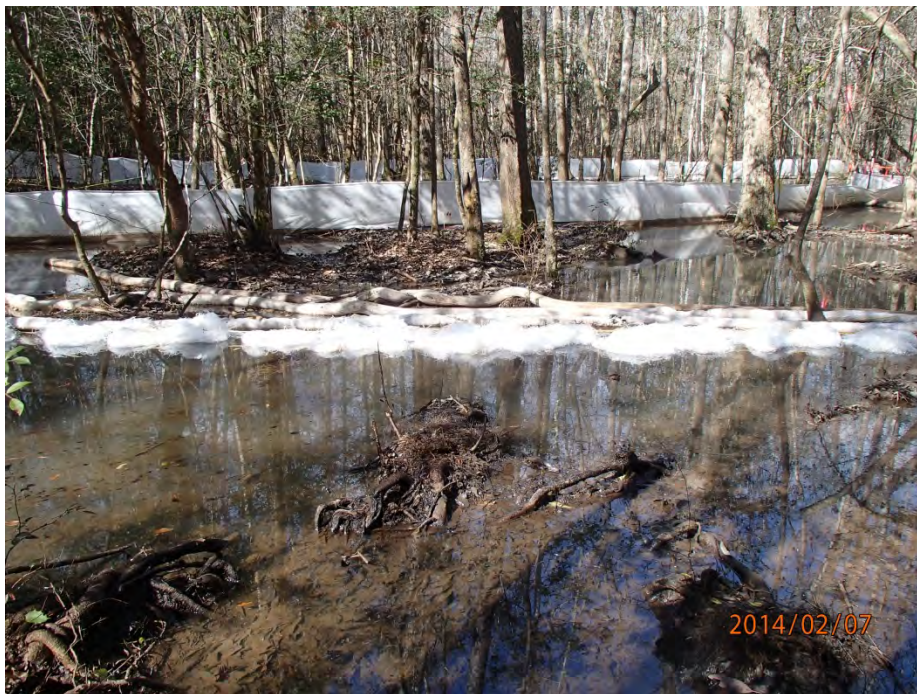
Zone E – 2/7/14

Additional replacement of sock boom and snare in Zone E.
