**Subject: Final Letter Report  
Ironwood Manufactured Gas Plant (MGP) Site - Removal Action  
Ironwood, Gogebic County, Michigan  
Technical Direction Document No. S05-0001-1207-020  
Document Control No. 1917-2A-BITO  
Contract No. EP-S5-06-04**

Ironwood MGP Site  
January 22, 2014

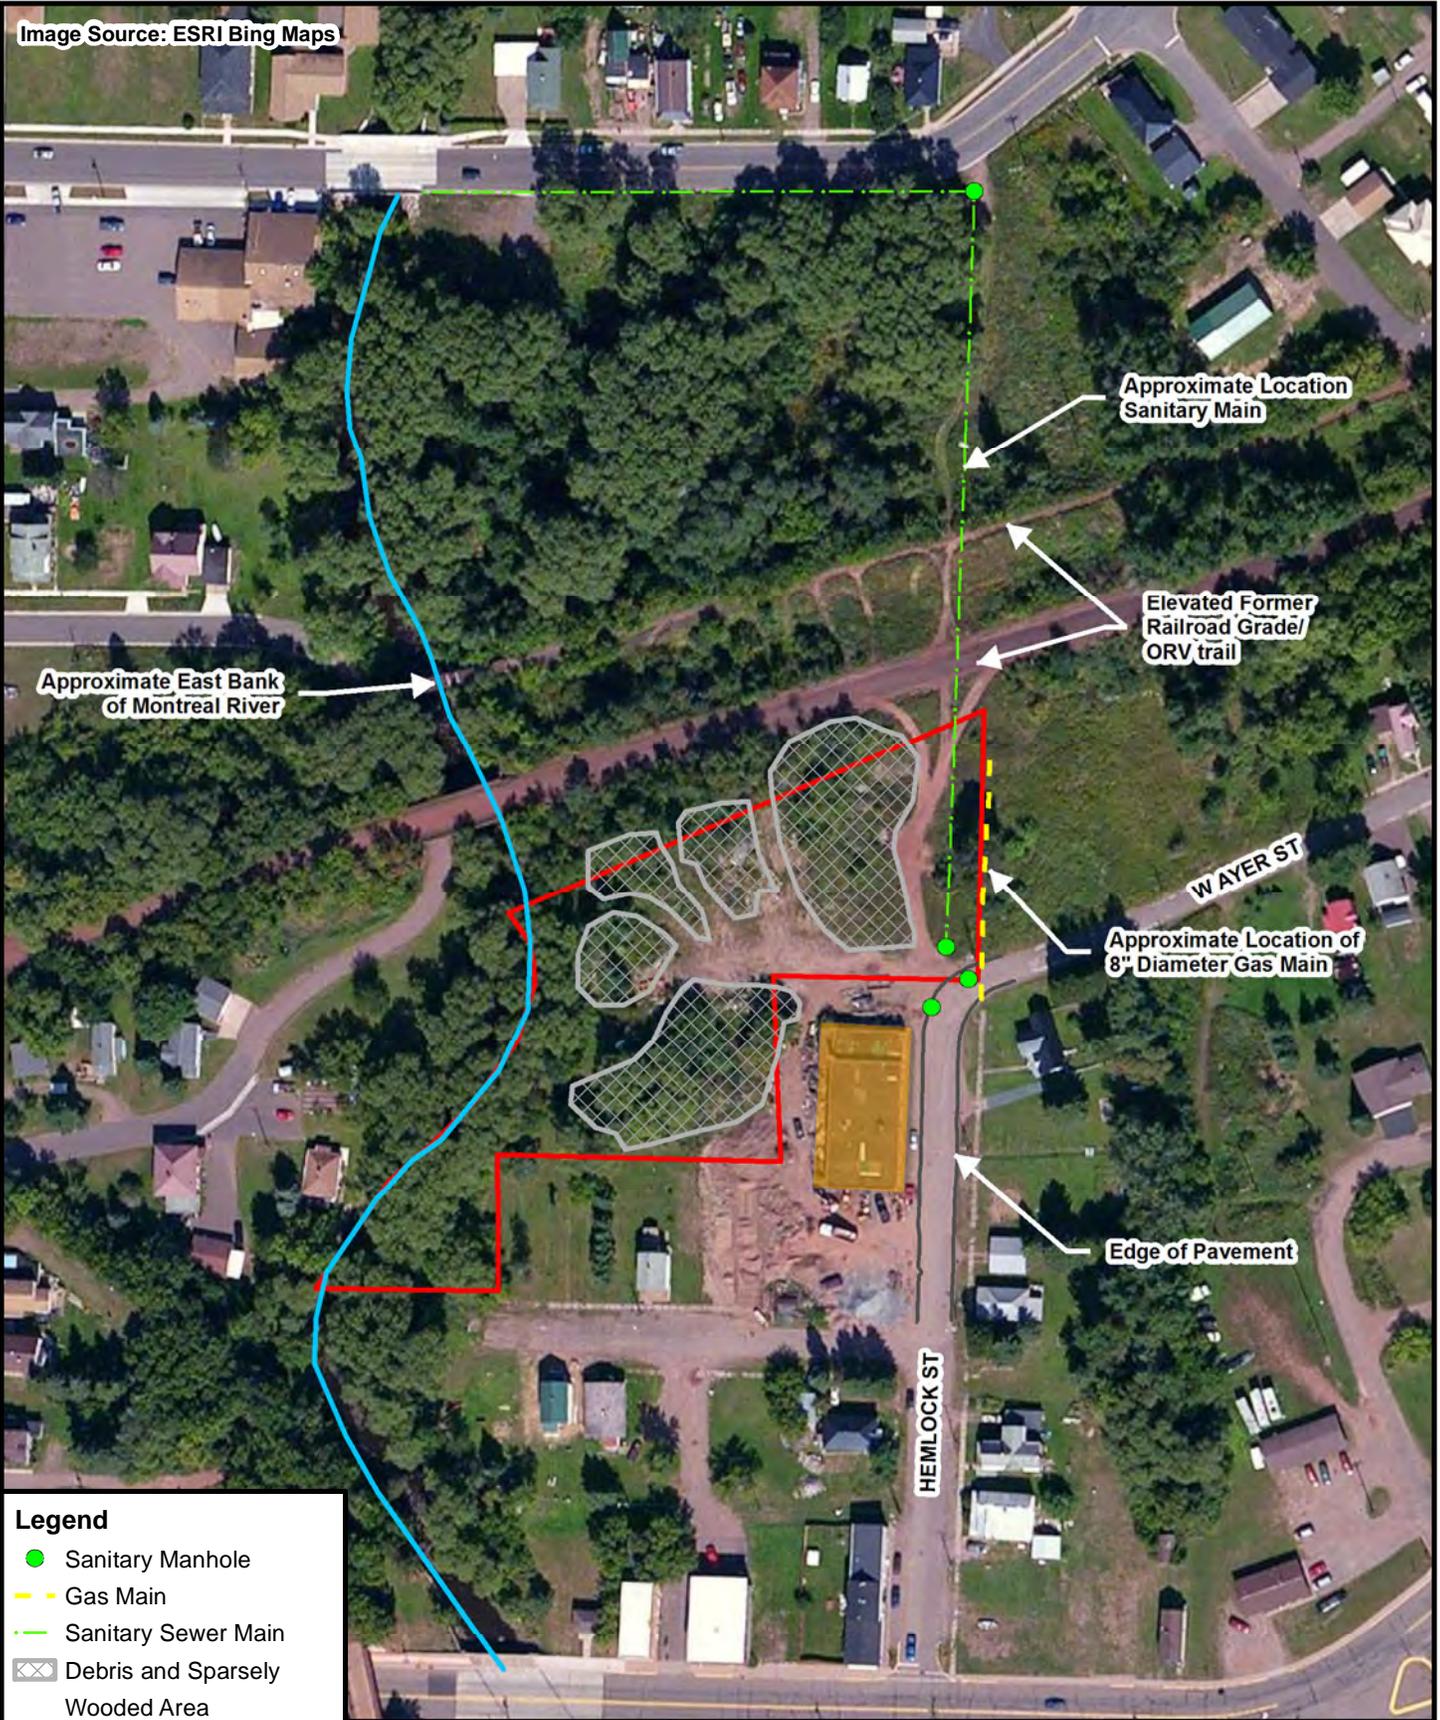
**Figure 2**  
Pre-Removal Site Layout Map  
Ironwood MGP Site  
Ironwood, Gogebic County, Michigan

- Sanitary Manhole
- Gas Main
- Sanitary Sewer Main
- Debris and Sparsely Wooded Area
- Fahrner Excavating
- Site Boundary

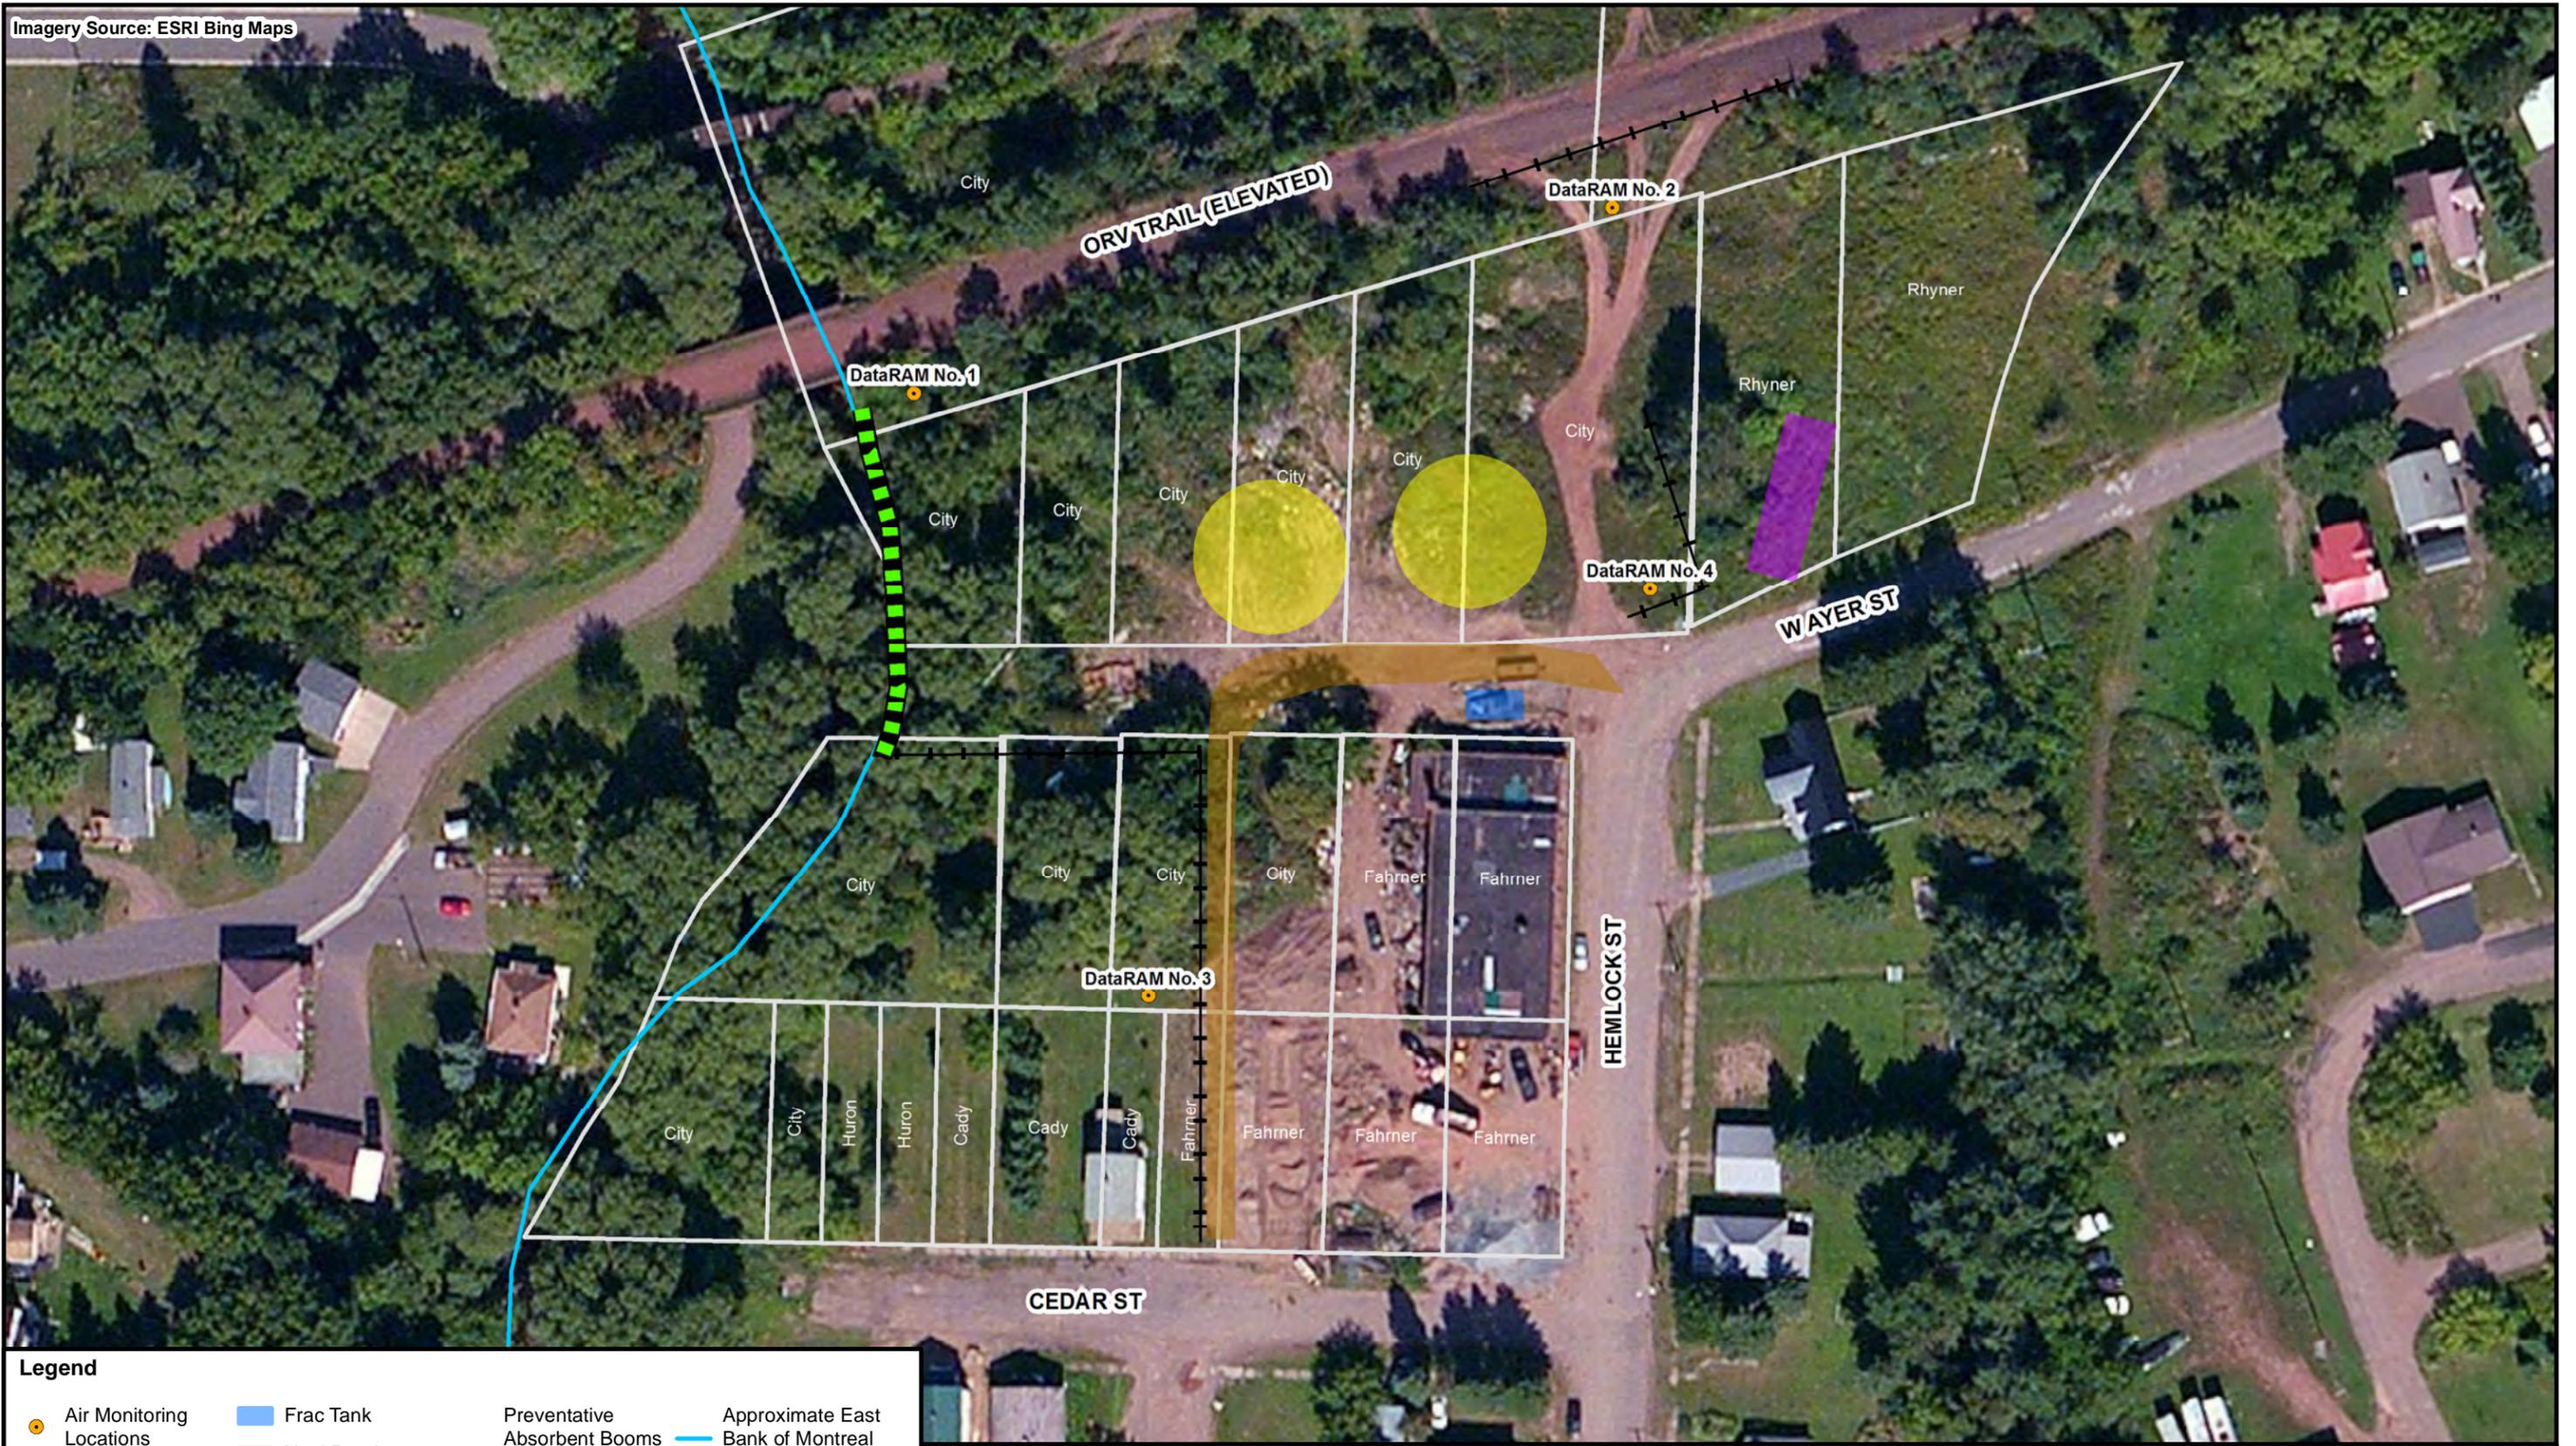
**Figure 3**  
 Site Layout and Temporary Facilities  
 Ironwood MGP Site  
 Ironwood, Gogebic County, Michigan

The most notable structures remaining at the Site are the round, 40- to 50-foot-diameter, concrete foundations for the former aboveground gasometer tanks (see **Figure 3** in **Attachment A**). The gasometer tanks stored manufactured gas before discharge to the distribution system. Condensation of the stored gas could result in the formation of tar and residuals within the tanks. The large concrete structures generally were clean, but some staining was present over the surface of the structures. Ultimately, the excavation and disposal of the gasometer tank foundations was found to be cost-prohibitive, and encapsulation was determined to be the most cost-effective means of mitigating potential exposure risks at the Site. The abovegrade portions of the structures were scraped using heavy equipment and power-washed to remove staining. Several coats of opaque sealant then were applied to the surface of the structures.

Groundwater infiltrating the excavation was collected and disposed of using hoses, pumps, and similar equipment. In addition, on August 31, 2012, a fractionation (frac) tank was delivered to the Site to allow for the storage and characterization of collected groundwater (see **Figure 3** in **Attachment A**).

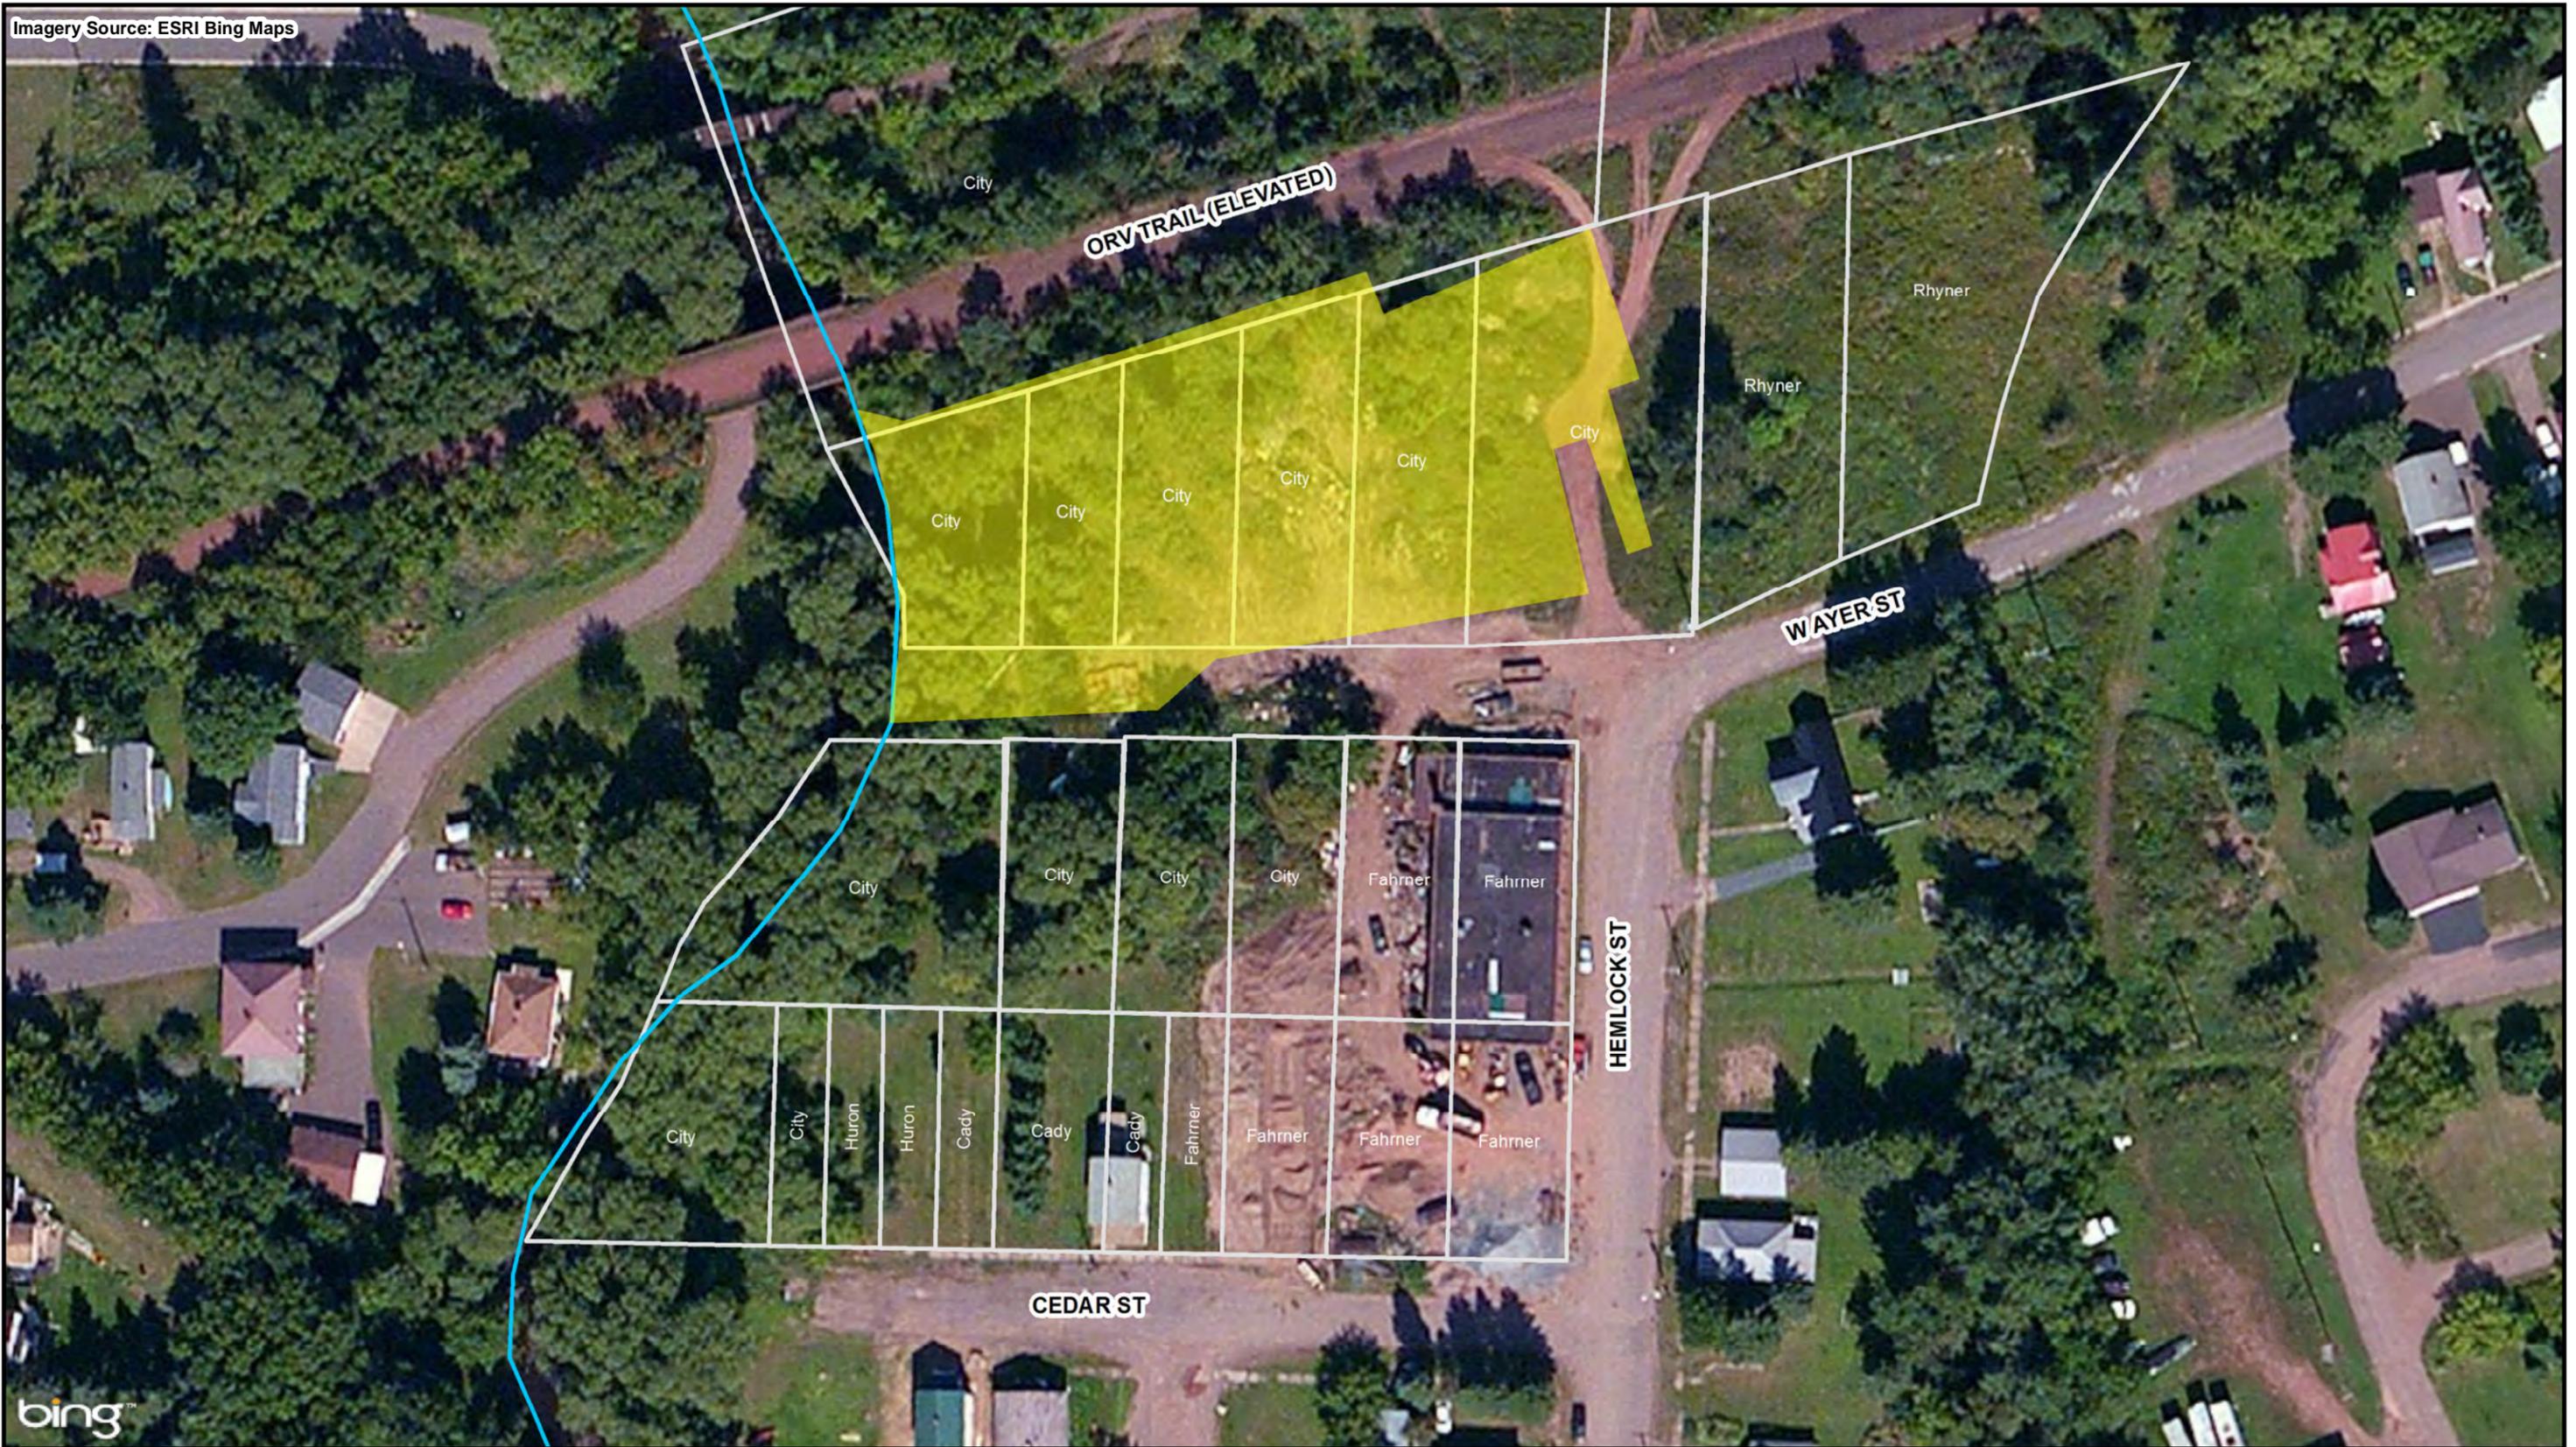
The ERRS contractor completed initial activities at the Site that included the installation of temporary fencing around the Site perimeter to limit access to authorized personnel. **Figure 3 in Attachment A** shows the Site layout and temporary facilities installed during the removal action. The work area was bordered to the east by an access road to the ORV trail that borders the Site to the north. Boulders 2 to 3 feet in diameter at the Site were relocated to the southern boundary of the ORV trail to prevent ORV traffic from using the access road.

Construction traffic, including haul trucks and vendors, accessed the Site from a primary access point established in the southeast corner of the active work area. A temporary haul road was established at the Site (see **Figure 3 in Attachment A**) using gravel to provide stable access for haul trucks. The temporary haul road created a one-way loop, allowing trucks to enter at the primary access point, get loaded, and then exit southbound along the western boundary of the Fahrner Excavating property. The temporary haul road was altered during the course of construction to accommodate changes in the extent of excavation as well as off-site construction activities near the Site.

EPA conducted real-time perimeter air monitoring during the removal action to document particulate concentrations at the Site perimeter. The air monitoring was conducted using four DataRAM 4TM Model DR-4000 (DR4) units (see **Figure 3** in **Attachment A**). The DR4 units were linked using a wireless, network-based communication system called VIPER, which allowed real-time transmission of data from field sensors to a local computer, remote computer, and/or enterprise server for data management, analysis, and visualization. One DR4 unit was deployed around the northwest, northeast, southwest, and southeast sides of the Site near sensitive receptors. Real-time data from the DR4 units was transmitted to the Site command post, where it was monitored continuously.

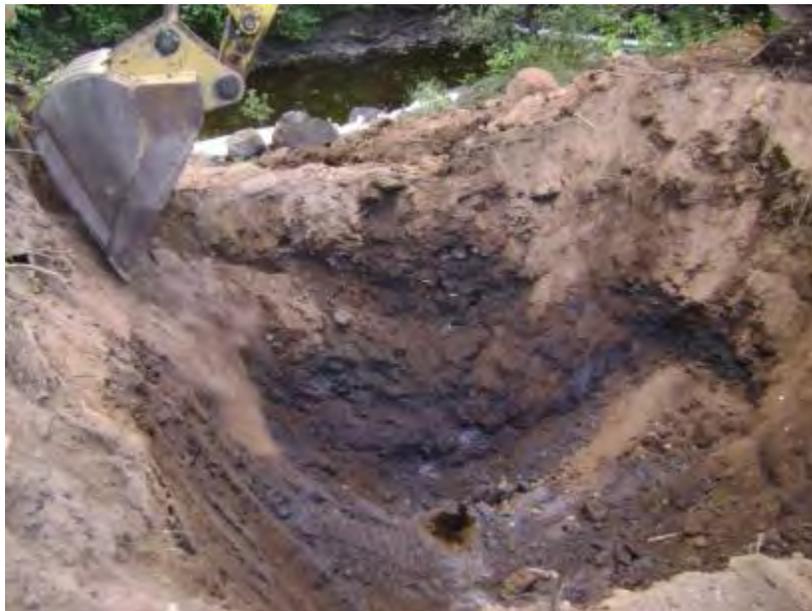
**Photograph No.:** 14

**Subject:** Free product appearing as oily puddle and staining in excavation near Montreal River

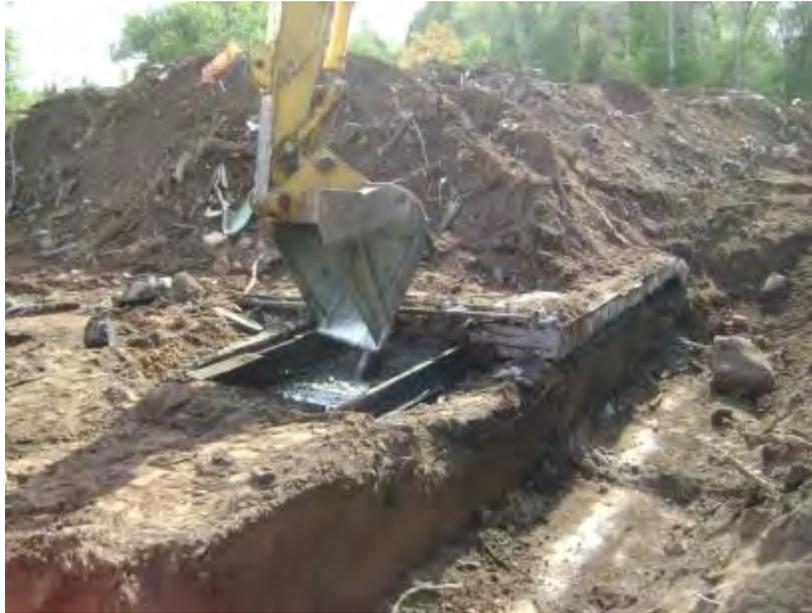
**Photograph No.:** 17

**Subject:** One of three vats of coal tar and process waste unearthed during excavation of building foundations in eastern portion of Site

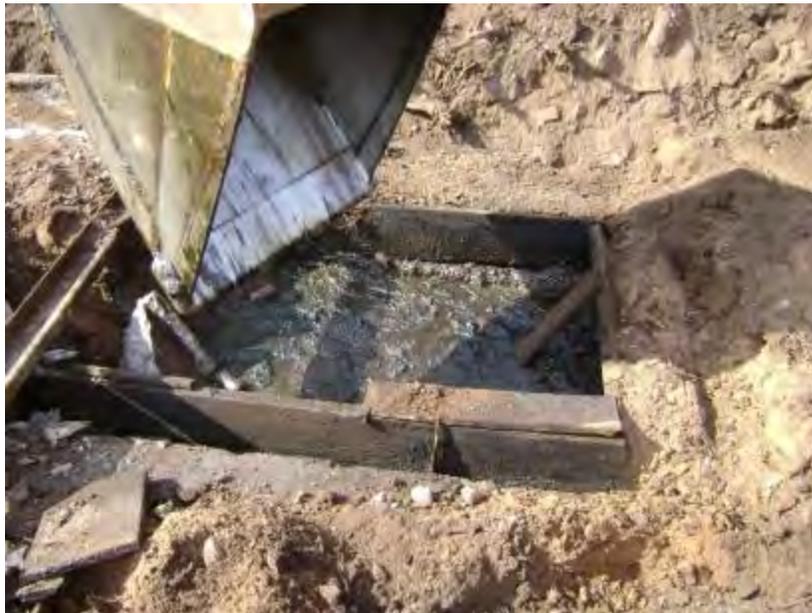
**Photograph No.:** 18

**Subject:** Vat of coal tar and process residuals unearthed during excavation of building foundations in eastern portion of Site

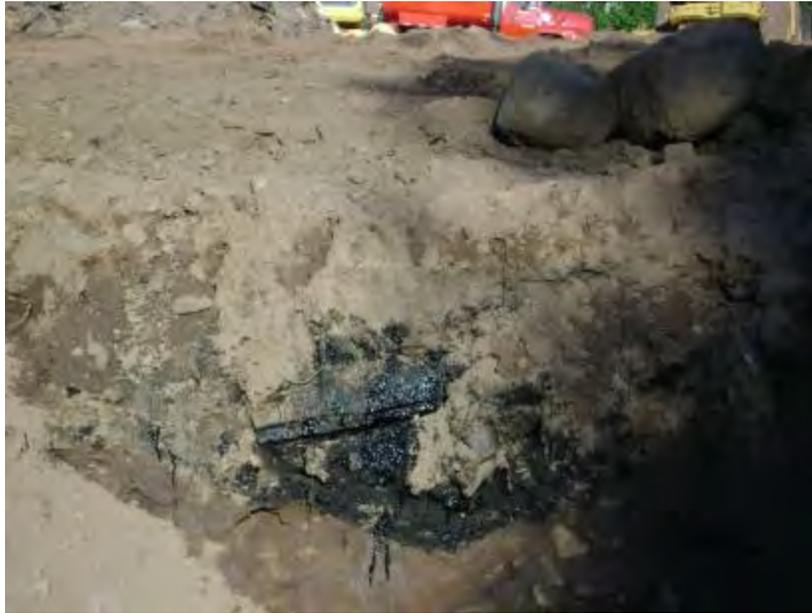
**Photograph No.:** 21

**Subject:** Coal tar and stained soil in excavation sidewall

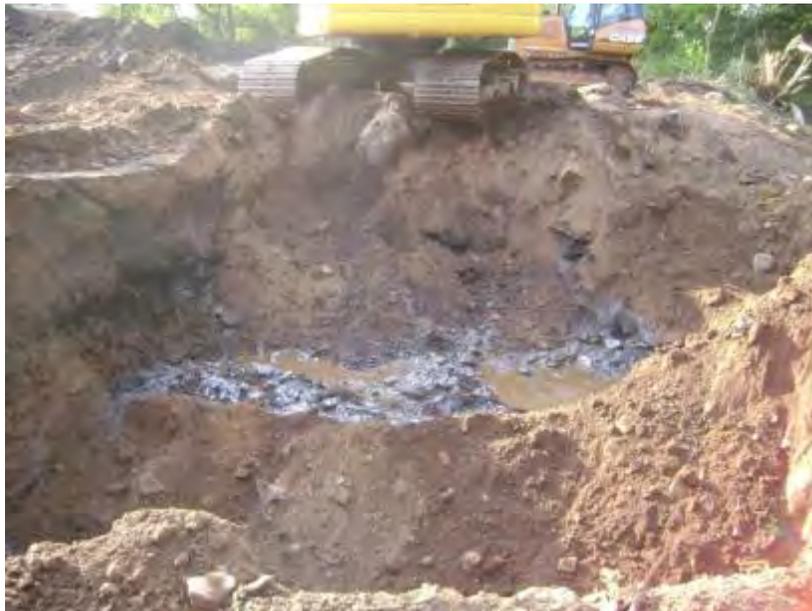
**Photograph No.:** 22

**Subject:** MGP residuals and stained soil in excavation; liquids encountered in excavation solidified with dry contaminated soil; very little groundwater encountered during excavation

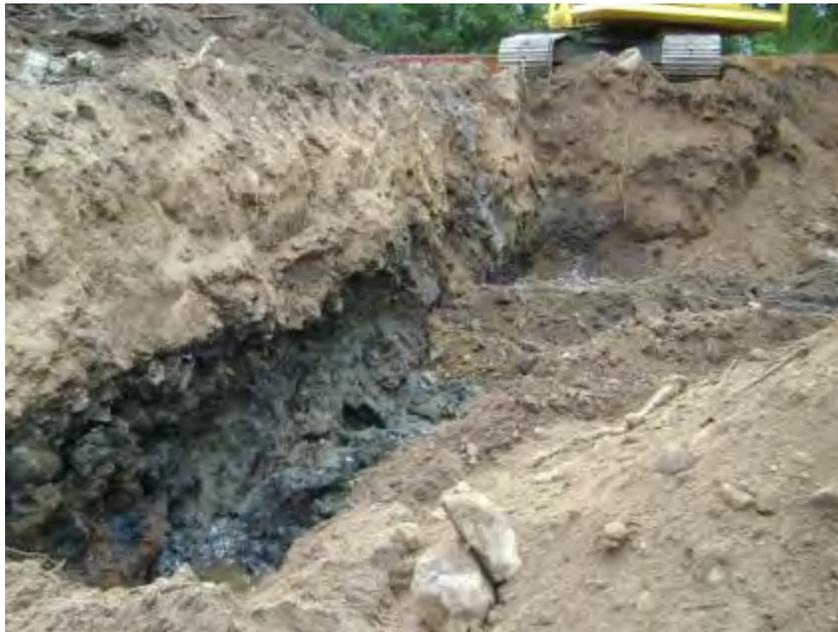
**Photograph No.:** 24

**Subject:** Buried MGP residuals and stained soil in excavation sidewall

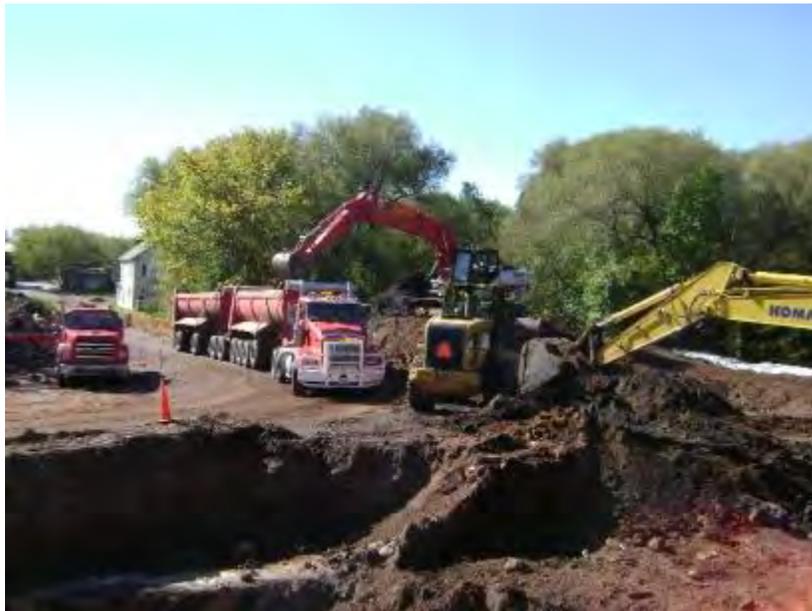
**Photograph No.:** 28

**Subject:** Excavation along western-most gasometer well foundation; soil stockpile and truck loading operations visible in background

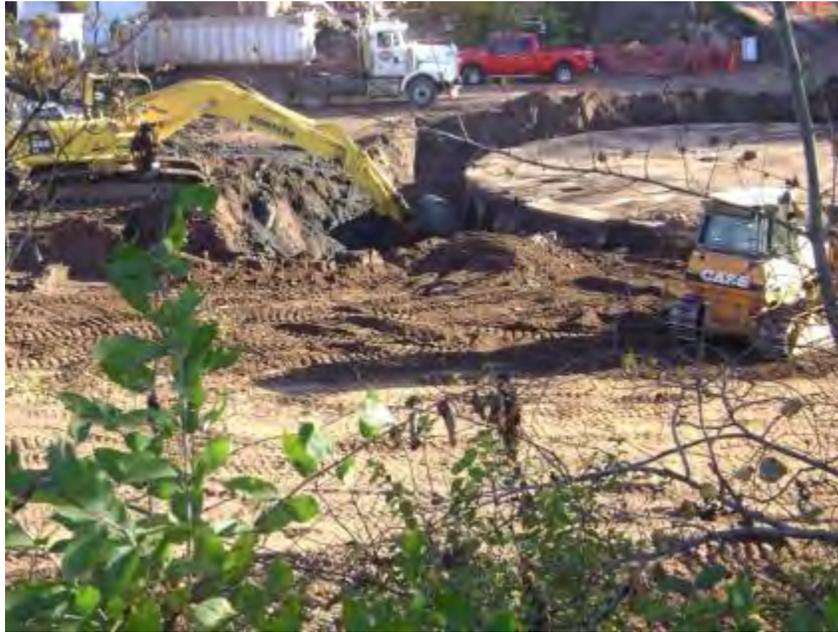
**Photograph No.:** 29

**Subject:** Excavation around western gasometer tank foundation

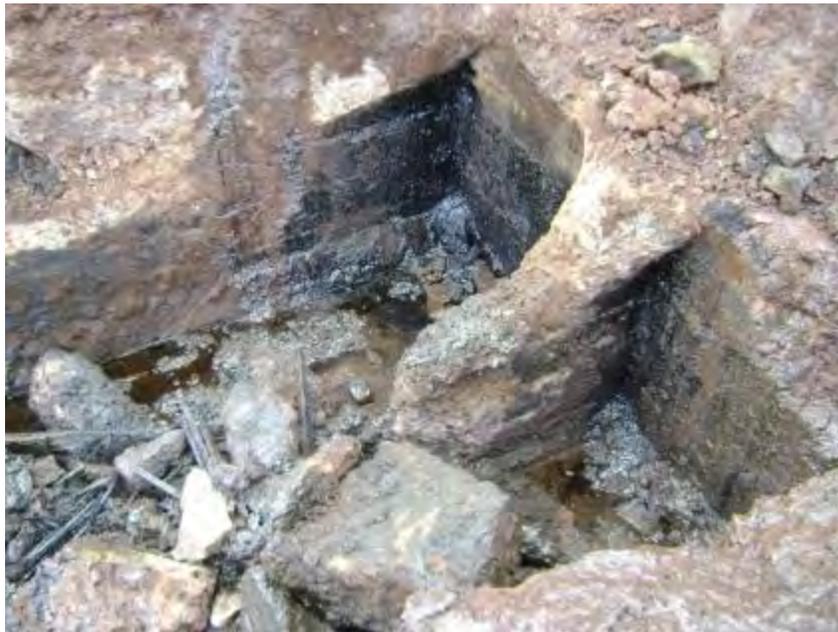
**Photograph No.:** 30

**Subject:** Voids in western gasometer well foundation after removal of MGP residuals

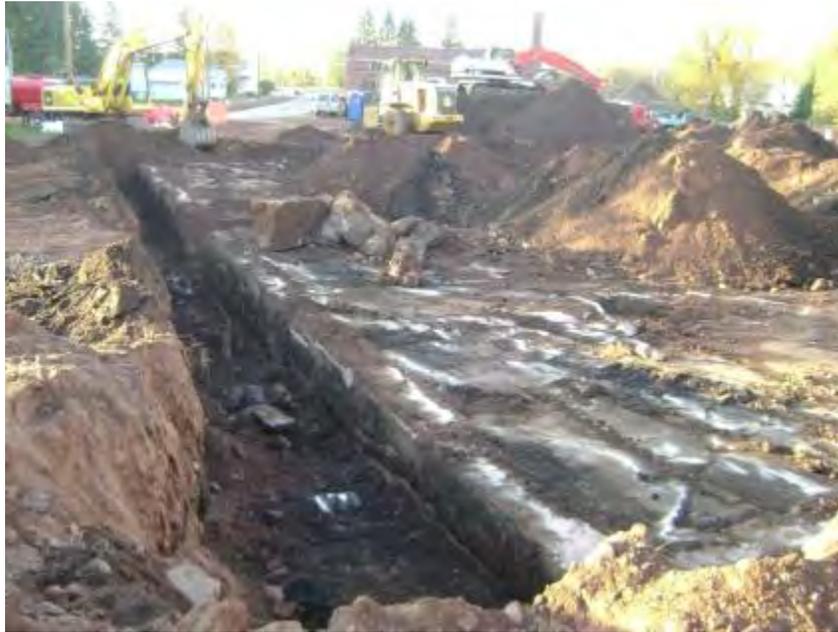
**Photograph No.:** 31

**Subject:** Excavation along eastern building foundation in former Site operating area

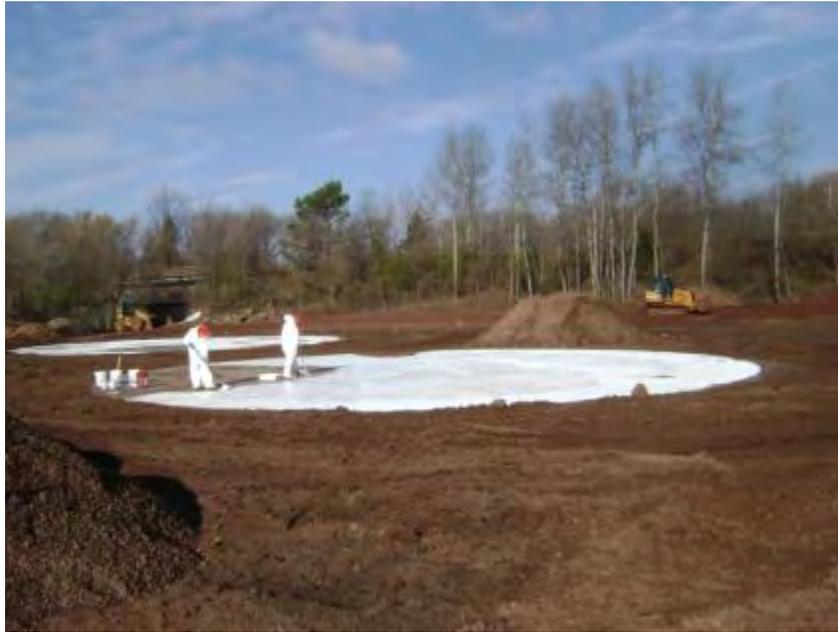
**Photograph No.:** 35

**Subject:** Application of sealant on eastern gasometer well foundation surface

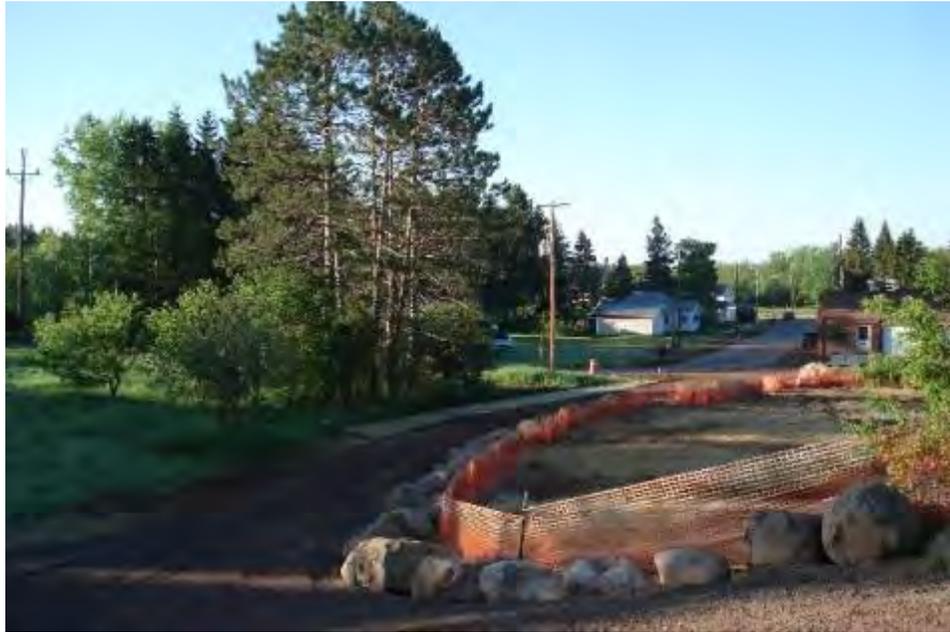
**Site:** Ironwood MGP Site  
**Photograph No.:** 45  
**Direction:** South  
**Subject:** Eastern limits of Site after restoration activities

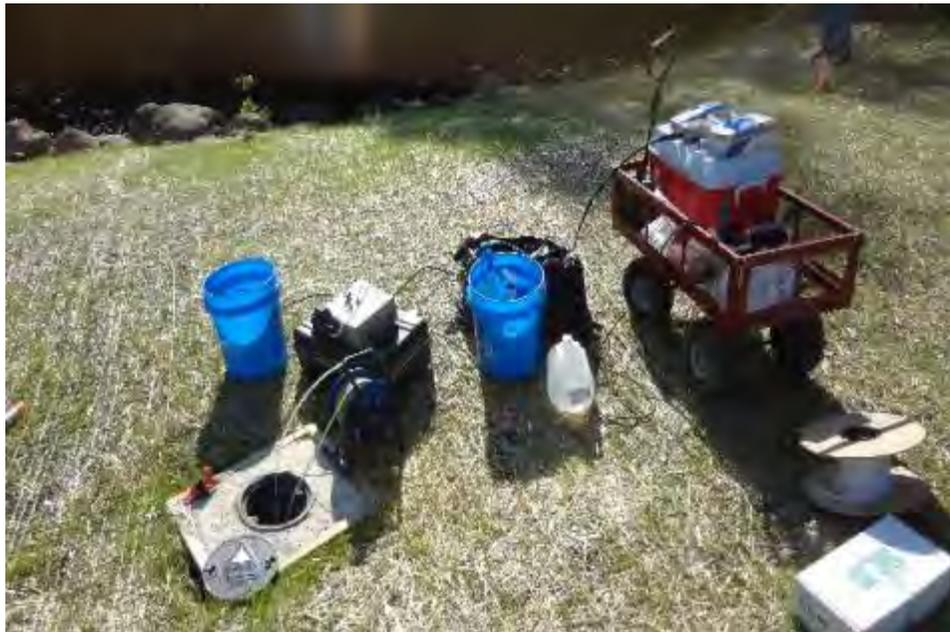
**Site:** Ironwood MGP Site  
**Photograph No.:** 46  
**Direction:** West  
**Subject:** Low-flow groundwater sampling at Monitoring Well 4

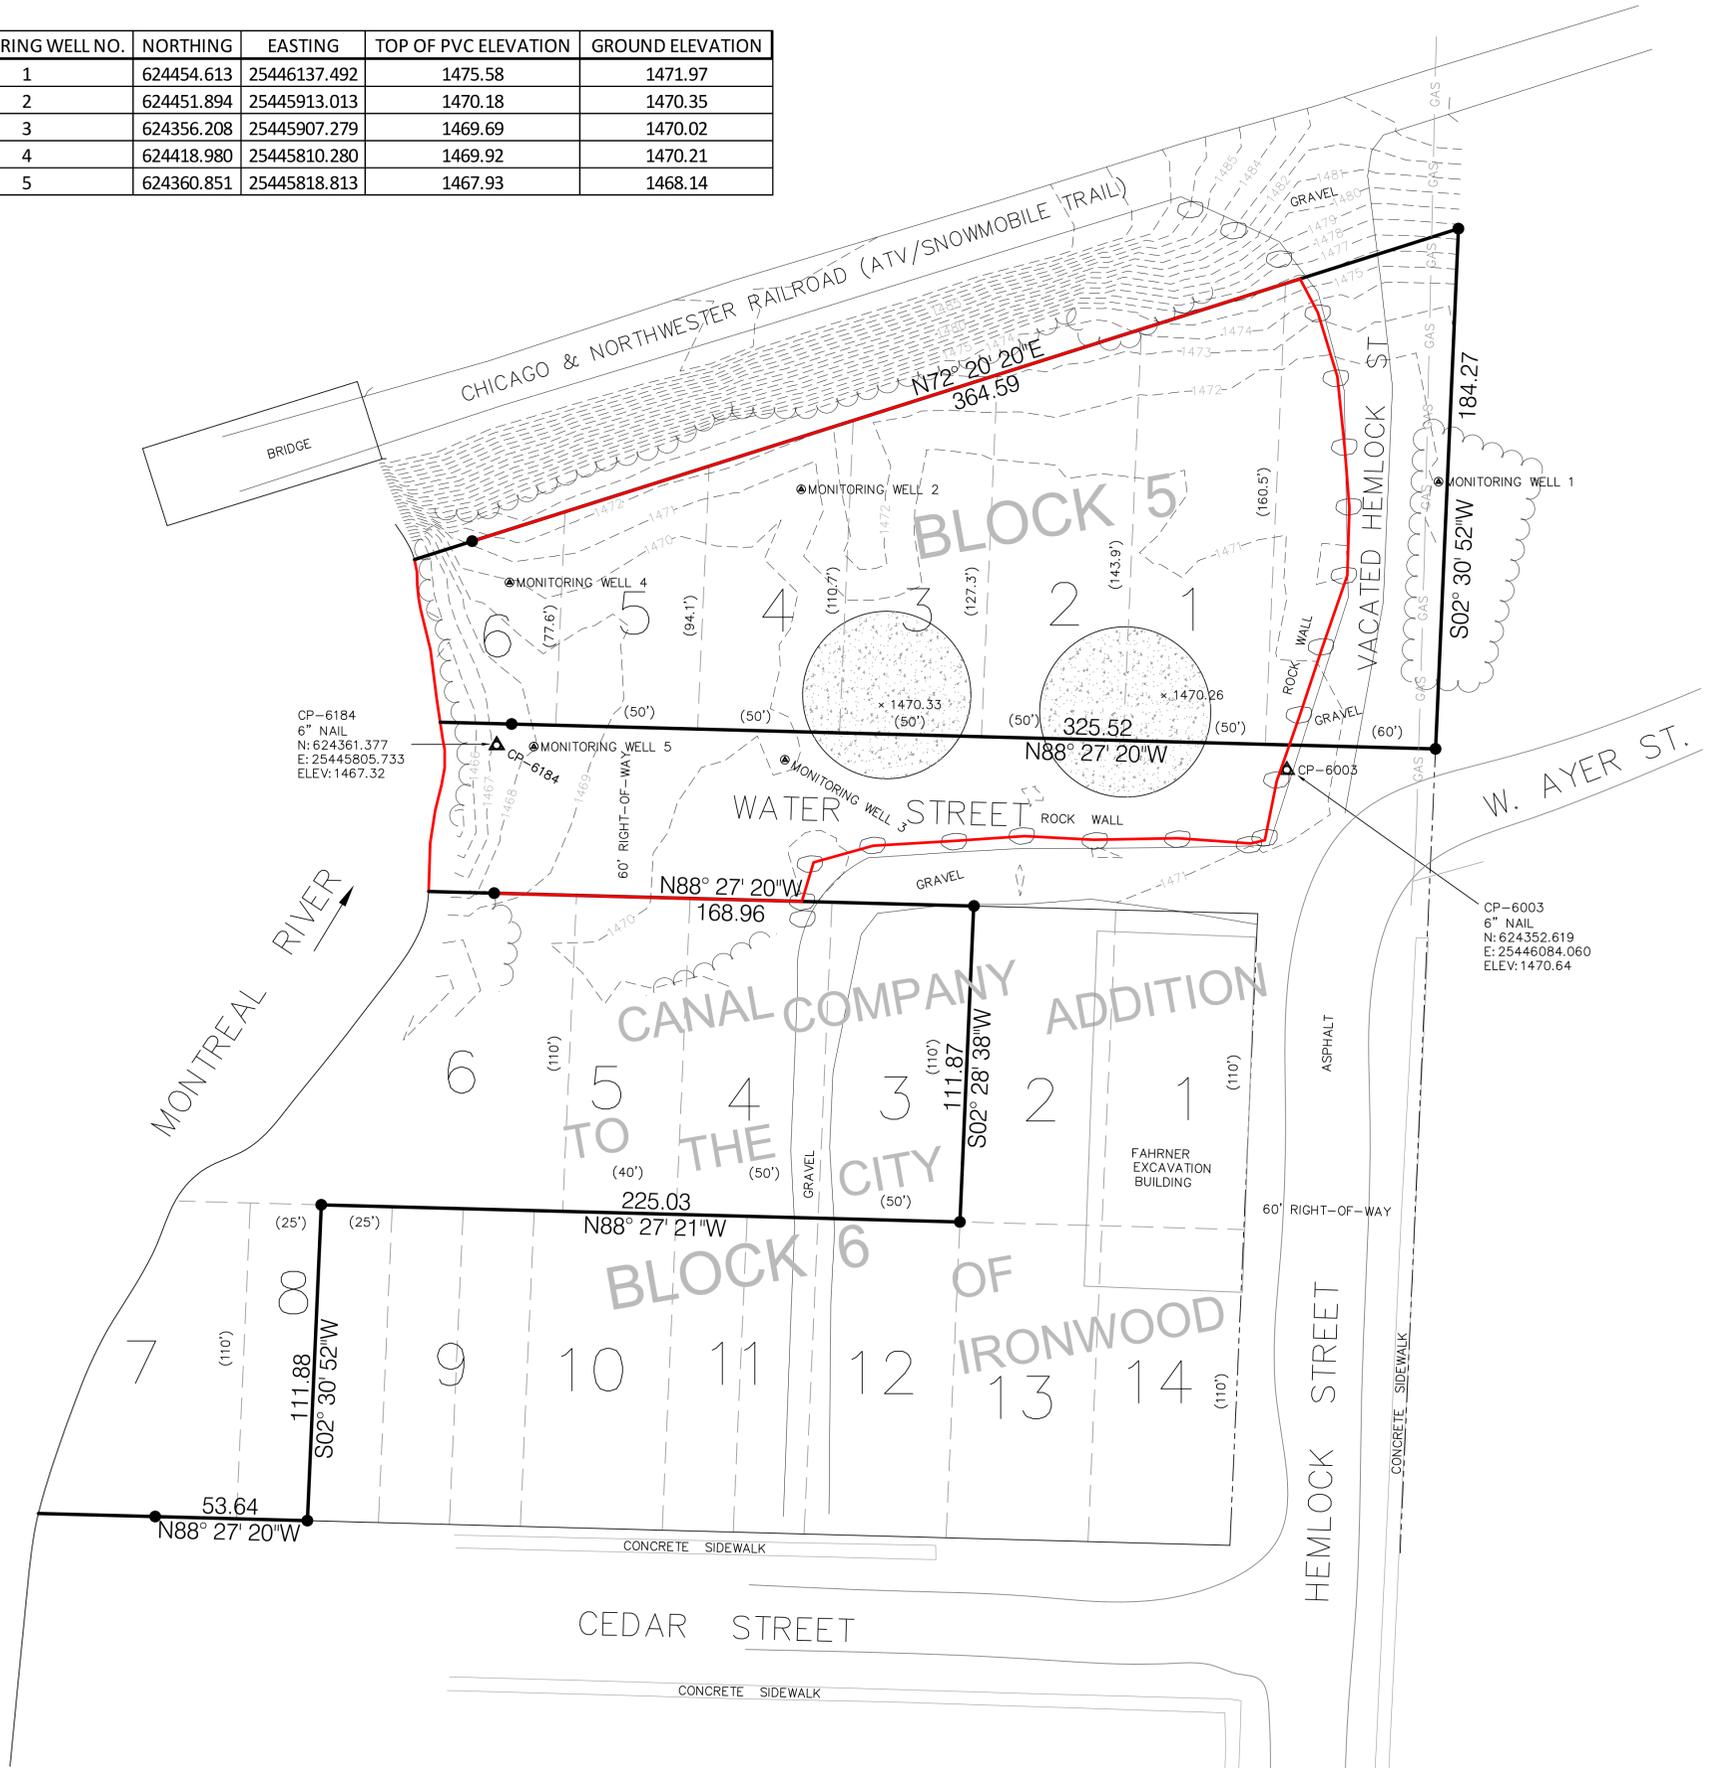
MONITORING WELL NO.	NORTHING	EASTING	TOP OF PVC ELEVATION	GROUND ELEVATION
1	624454.613	25446137.492	1475.58	1471.97
2	624451.894	25445913.013	1470.18	1470.35
3	624356.208	25445907.279	1469.69	1470.02
4	624418.980	25445810.280	1469.92	1470.21
5	624360.851	25445818.813	1467.93	1468.14

On June 11 and 12, 2013, four borings were advanced using hollow-stem auger drilling techniques and replacement monitoring wells were constructed in each boring. The survey map in **Attachment F** shows the replacement monitoring wells as Monitoring Wells 2 through 5. Coleman constructed the replacement monitoring wells using Schedule 40 polyvinyl chloride (PVC) riser material and a 5-foot-long, Schedule 40 PVC slotted screen. Coleman developed the replacement monitoring wells the next day using disposable bailers, alternately surging and purging the wells until the extracted groundwater appeared sediment-free. Monitoring well 1 installed by the MDEQ in 2010 was not disturbed by the removal action activities.

- The excavation, removal, damage, or other interference with the existing on-site monitoring wells (Monitoring Wells 1 through 5 in **Attachment F**) is prohibited.
