## Appendix D

# Daily Progress Reports

**Southwest Vermiculite (Phase II) – Removal Action  
Daily Progress Report  
November 5, 2013**

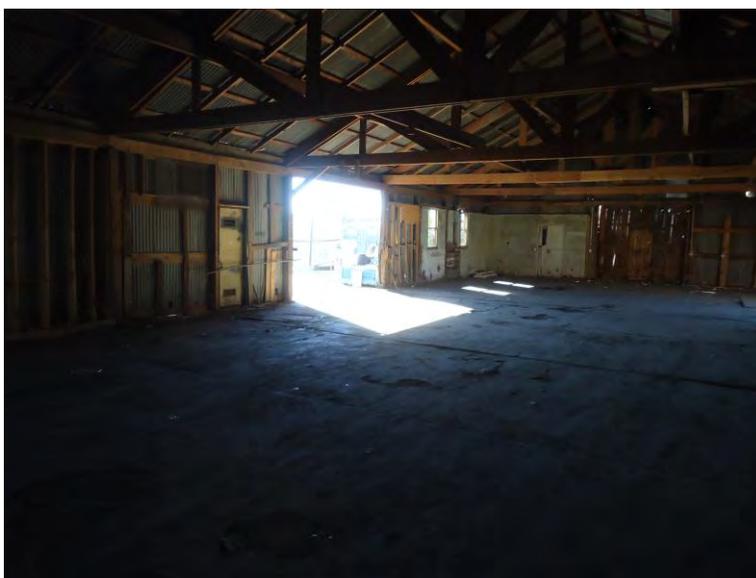
Photograph DSC00551: Expanded View of interior of Exfoliation building in advance of abatement.

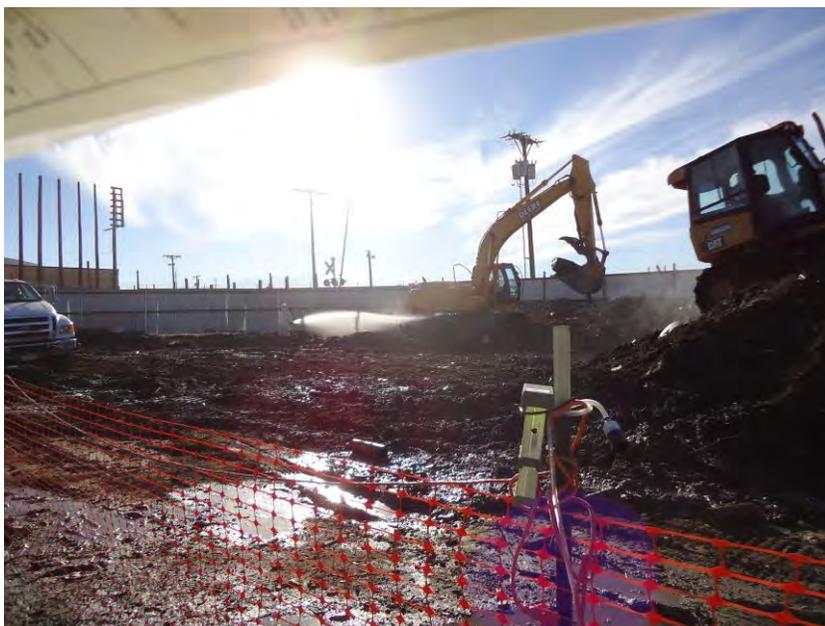
Photograph DSC00567; View facing west at excavation and stockpiling activities. Note apparent adequate wetting.

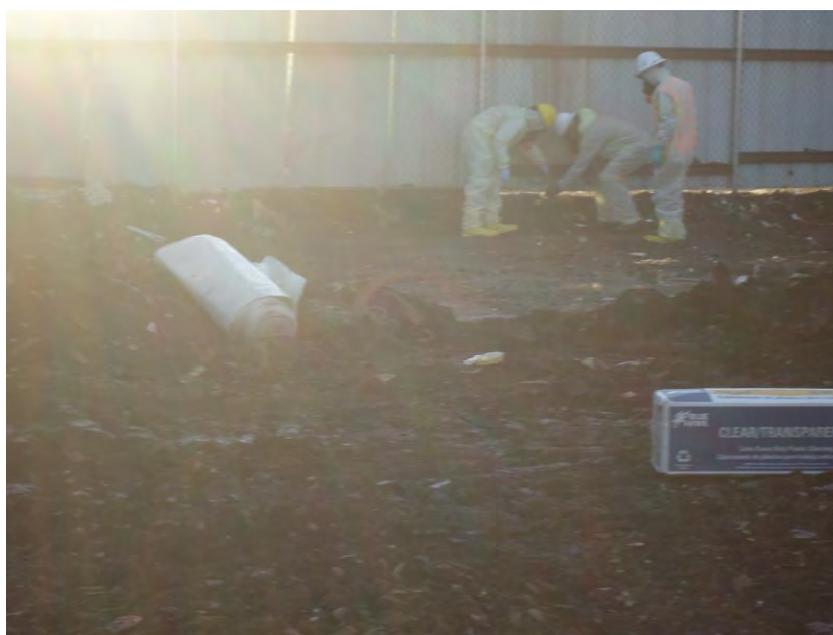
Photograph DSC00571: View of ERRS and START personnel assessing depth of excavation area.

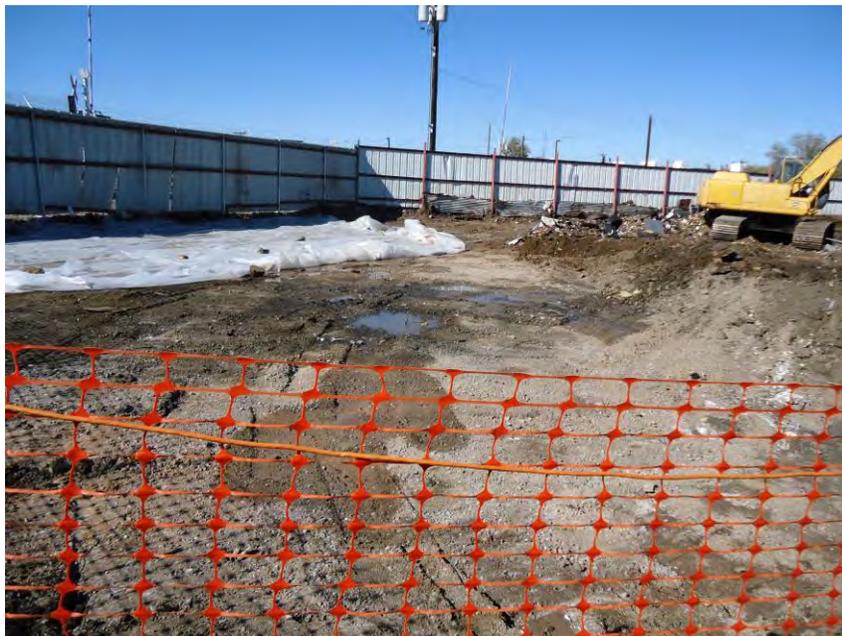
Photograph DSC0573; View facing west at excavated area along SW portion of W. Silver property (Grid AB North).

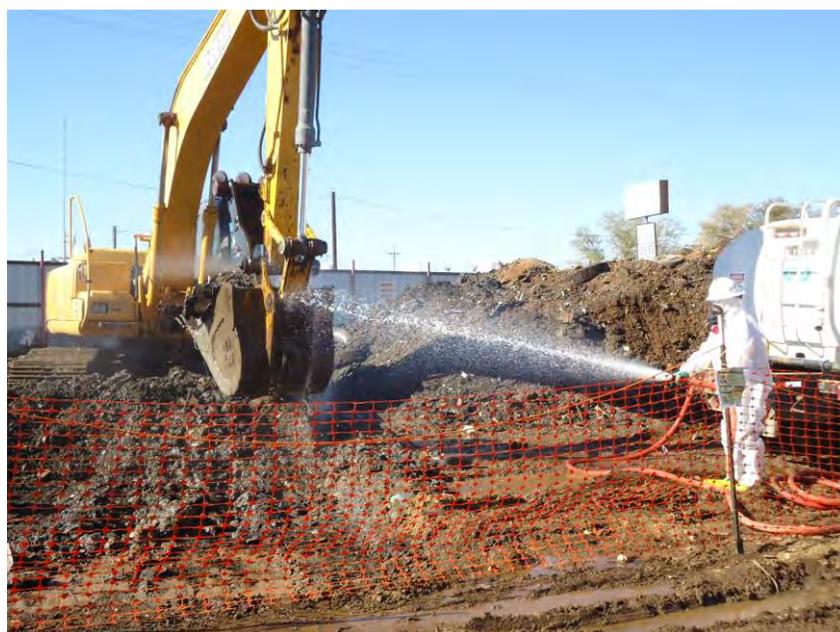
Photograph DSC00575: View of excavation activities along eastern portion of Grid AB. Note wetting activities.

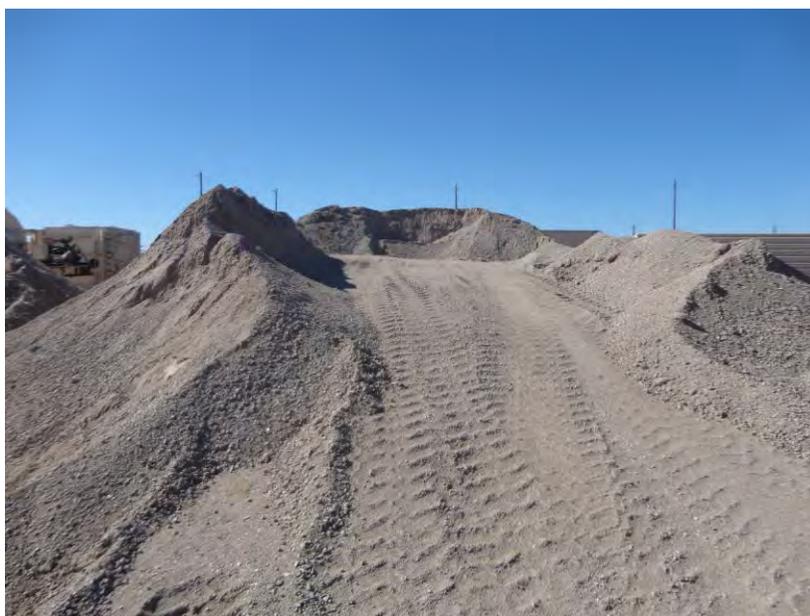
Photograph DSC04190: View of pile of potential cover materials (crushed concrete), at material storage yard south of downtown Albuquerque, NM.

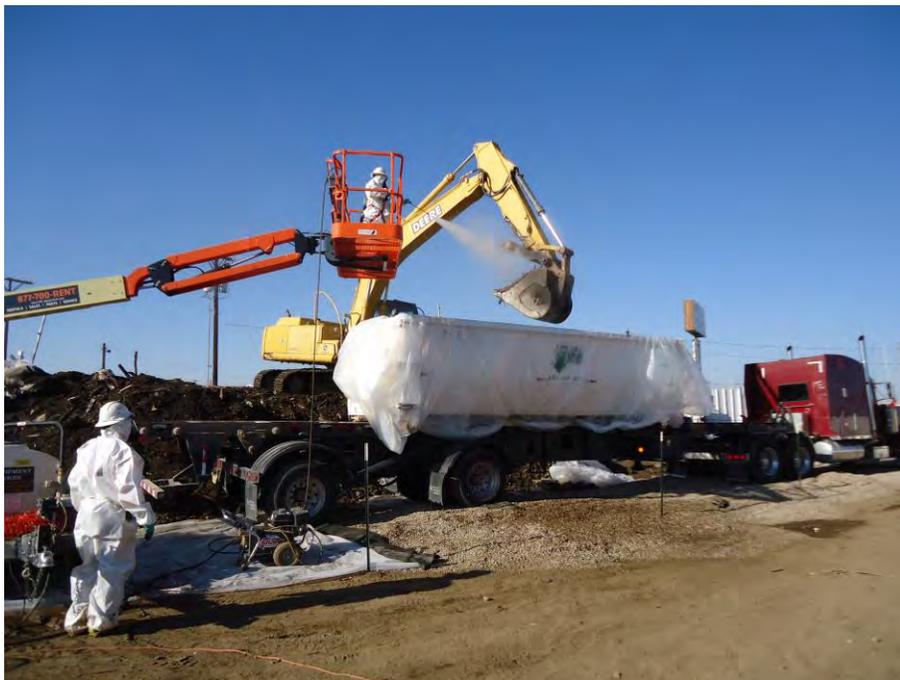
Photograph DSC00591; Expanded view southwest at loading operations. Note wetting (pressure washer) operations.

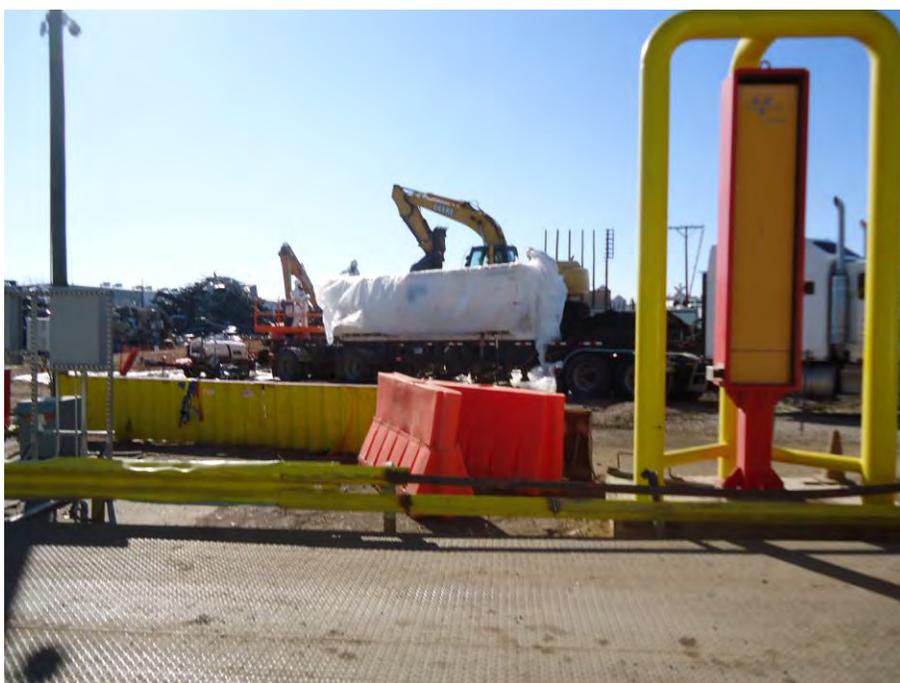
Photograph DSC00592: Expanded view of loading operations along the northern portion of the Grid A area.

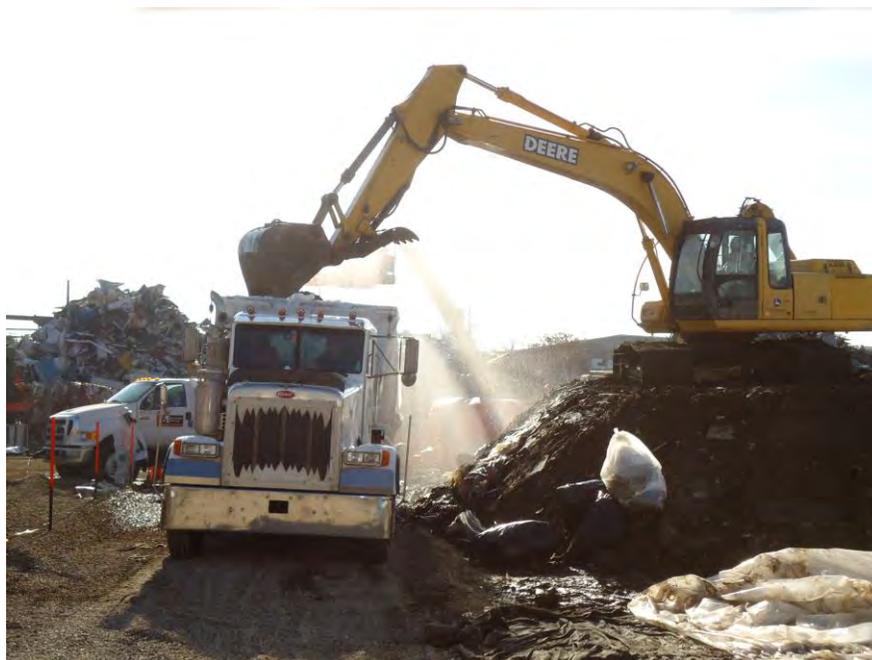
Photograph DSC0594; View east-southeast of loading operations. Note ongoing wetting.

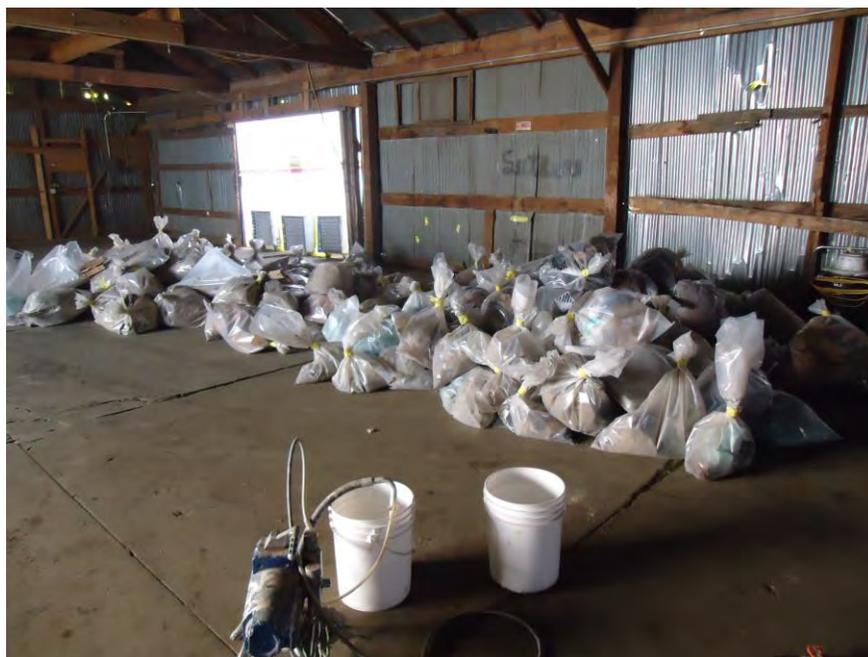
Photograph DSC00602: Interior view of exfoliation building and bagged asbestos resulting from the abatement of the building.

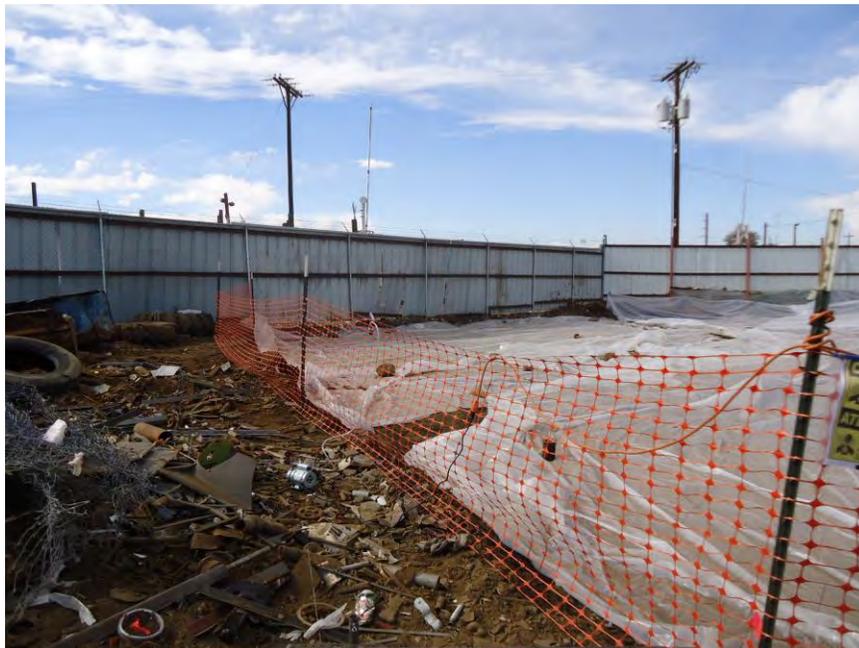
Photograph DSC00610; View southeast of excavated and covered grid on W. Silver site. Note air sampling location on barricade fencing.

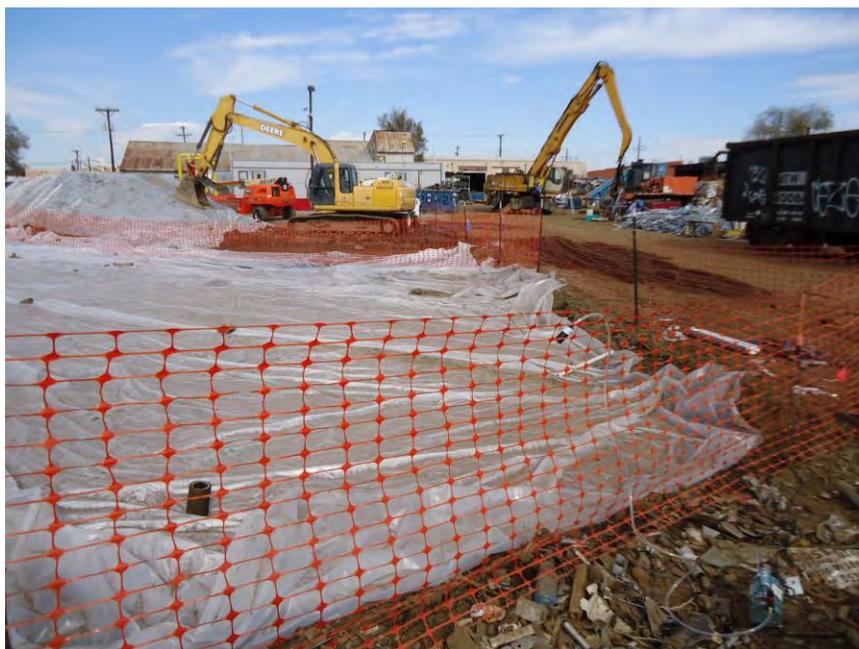
Photograph DSC00611: Expanded view north of excavated grid and active operations on W. Silver site.

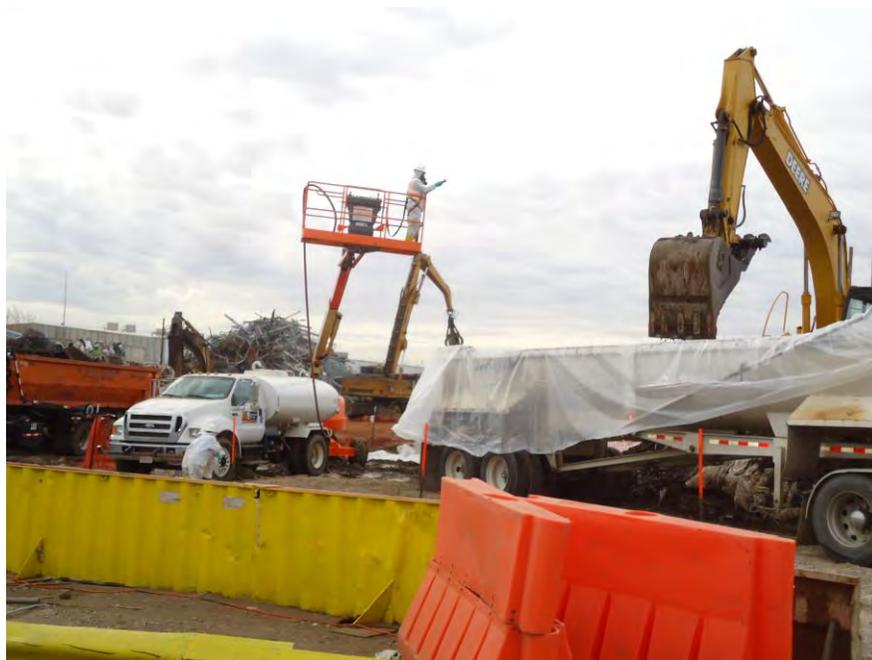
Photograph DSC0616; View southeast of loading operations. Note ongoing wetting/dust suppression activities.

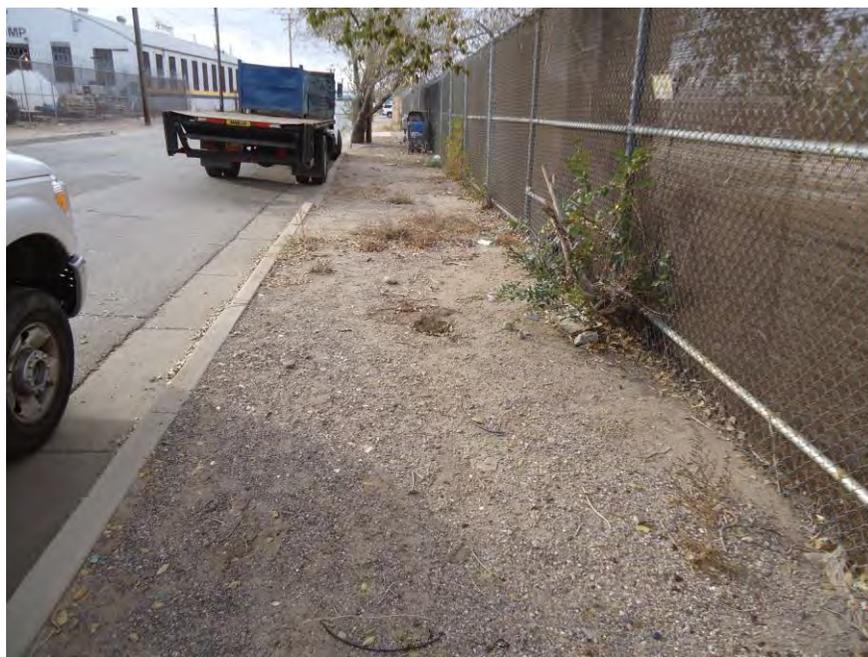
Photograph DSC00620: View of City ROW area along Haines Avenue NW prior to excavation.

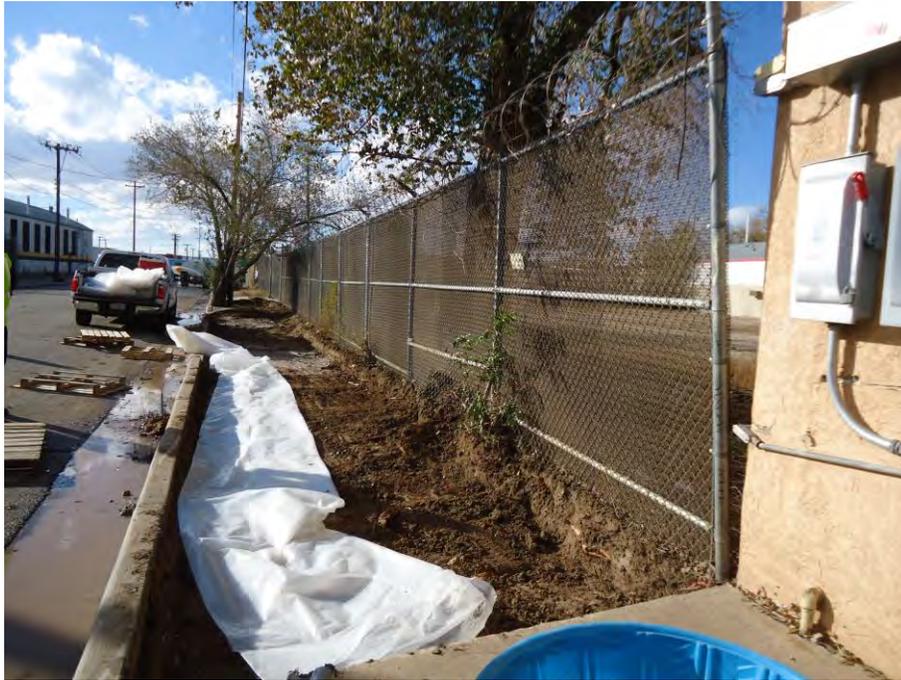
Photograph DSC0629; View west of the initial excavation area along Haines Avenue NW.

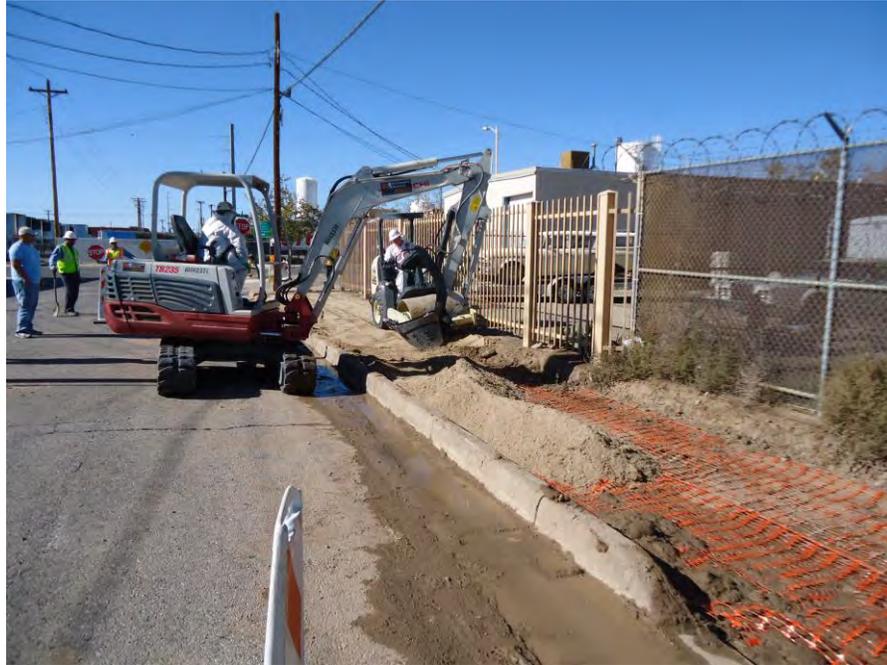
Photograph DSC0632; View west of the excavation activities in the City ROW areas along the north side of Haines Avenue NW, in between 1<sup>st</sup> and 2<sup>nd</sup> Street NW.

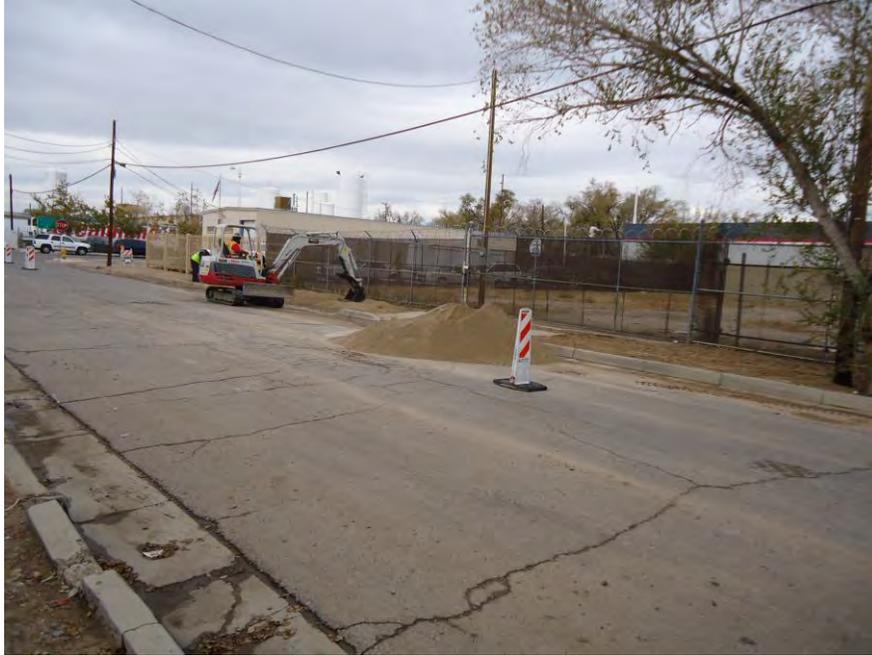
Photograph DSC00633: Final grading of “crusher fines” in the City ROW, Area E, Grids 010 and 011.

- a. Site Progress Made: ERRS loaded 8 end dumps/roll offs for disposal at the Keer's facility outside of Mountainair. ERRS placed a final cover of Crusher Fines on the backfilled area along the North side of Haines Avenue in the City ROW. ERRS managed the activities of Southwest Hazard Control (SHC); the ERRS asbestos abatement contractor.
- b. Problems Encountered: None

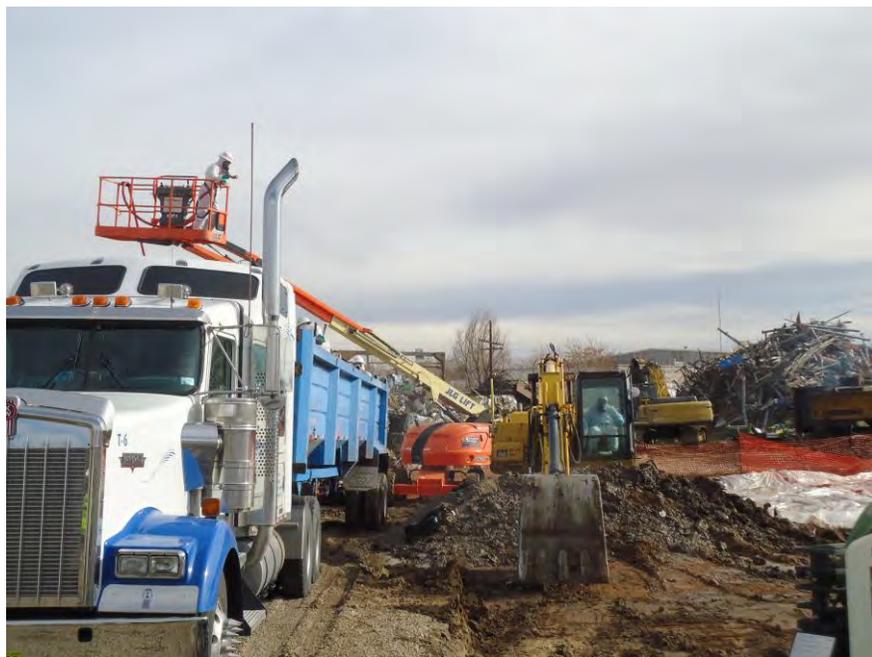
Photograph DSC0635; View southwest of the loading operations on the W. Silver facility.

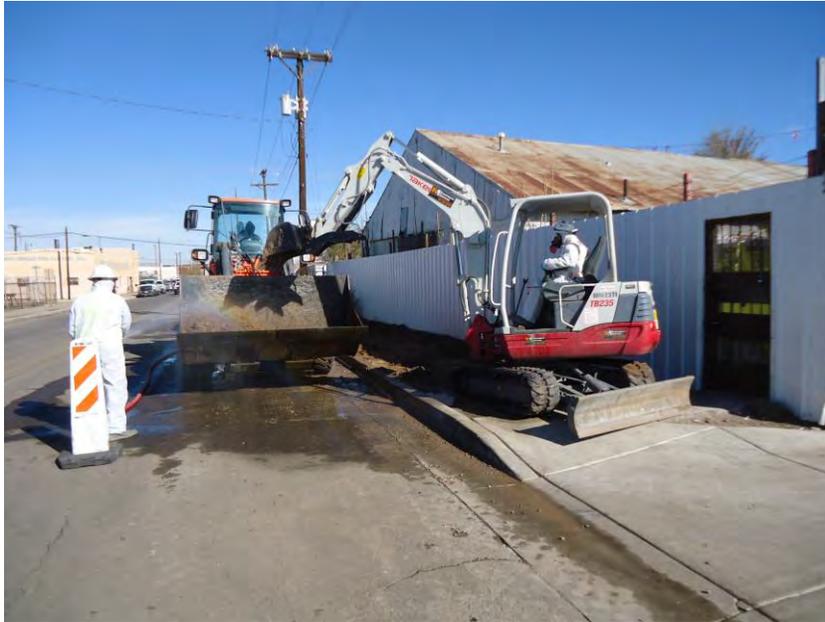
Photograph DSC00637: View of excavation activity in City ROW, Area E, Grid 001.

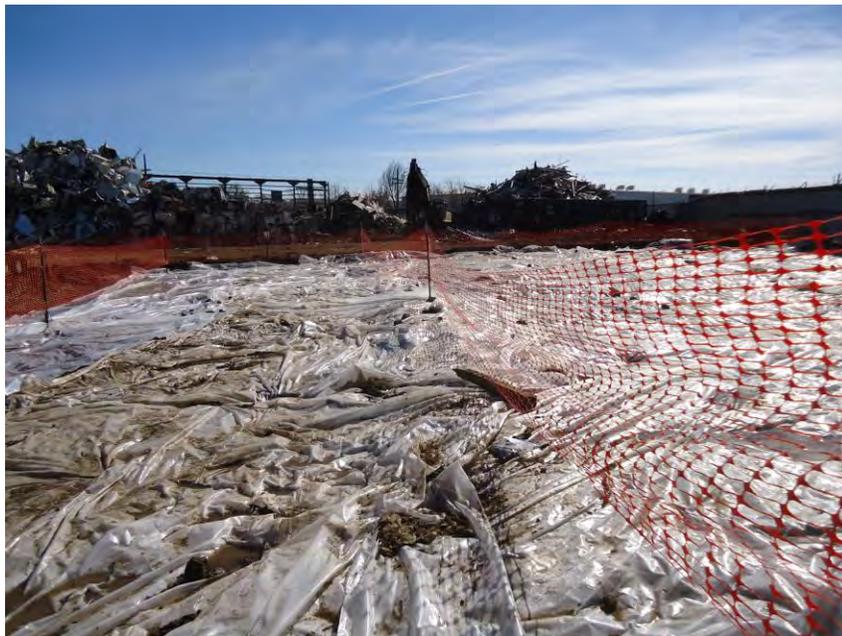
Photograph DSC00639: View of excavated area of Confirmation Sample "ASC" on W. Silver site.

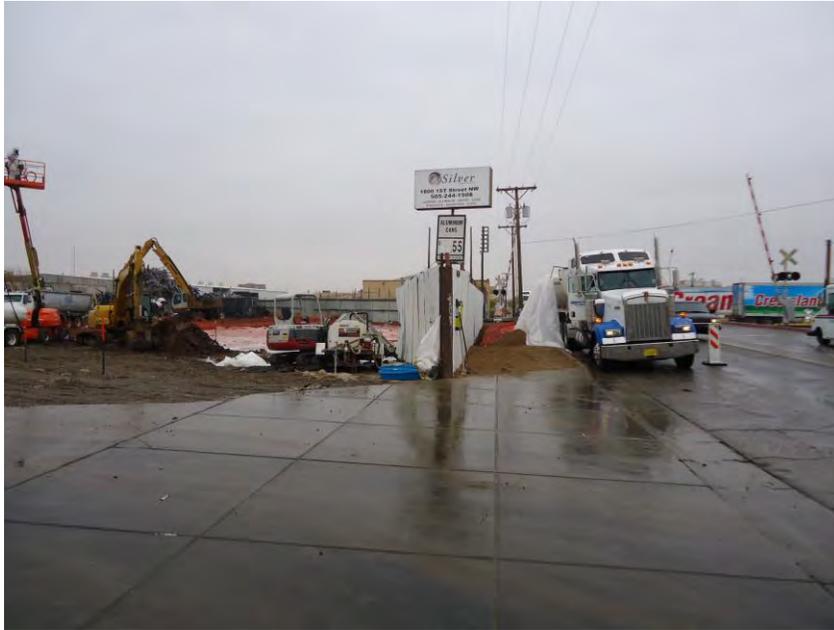
Photograph DSC00644: View of stockpile area and loading operations along 1<sup>st</sup> Street NW.

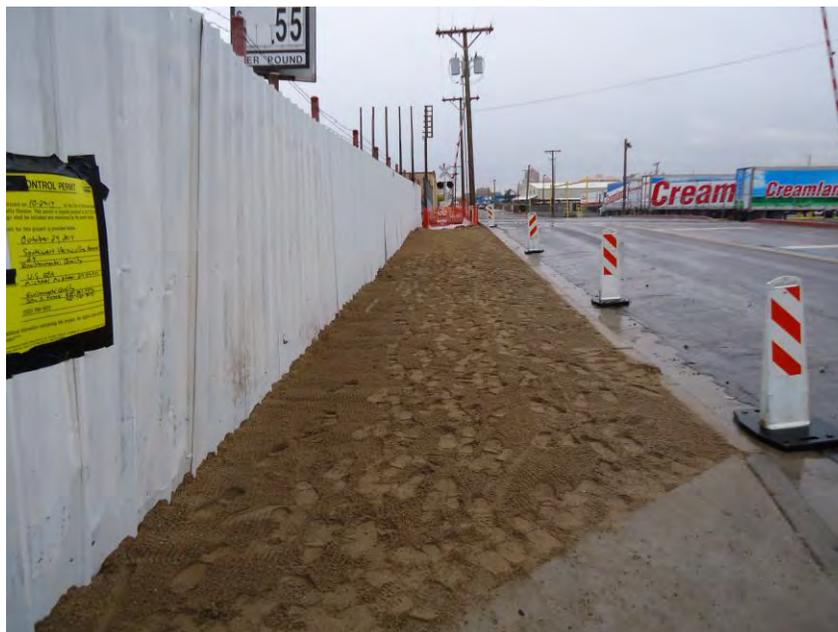
Photograph DSC00645: View of Area E, Grid 002 following excavation and backfilling.

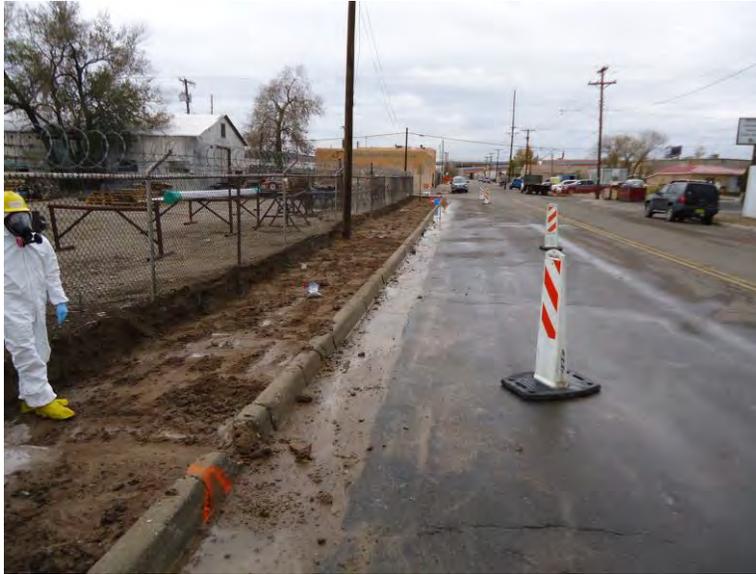
Photograph DSC00647: Expanded view of Area E, Grid 006 after conformation sample collection and prior to backfilling.

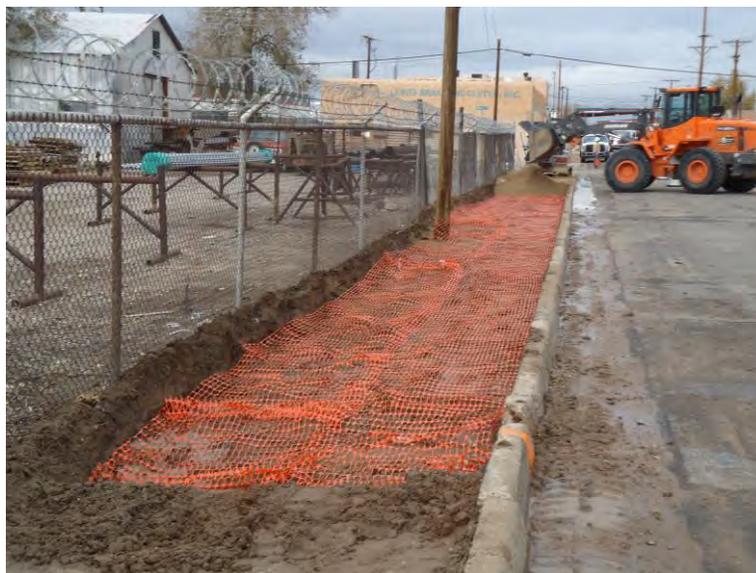
Photograph DSC00649: View of Area E, Grid 006 with barricade fencing in the excavation prior to backfilling.

- a. Site Progress Made: ERRS excavated Grid 006 of the City ROW. Following collection of a confirmation sample by START3, ERRS placed orange barricade fencing in the excavated area prior to backfilling. ERRS placed "crusher fines" on top of the backfill in the City ROW, Grids 001, 002 and 006. ERRS managed the activities of Southwest Hazard Control (SHC); the ERRS asbestos abatement contractor.
- b. Problems Encountered: None

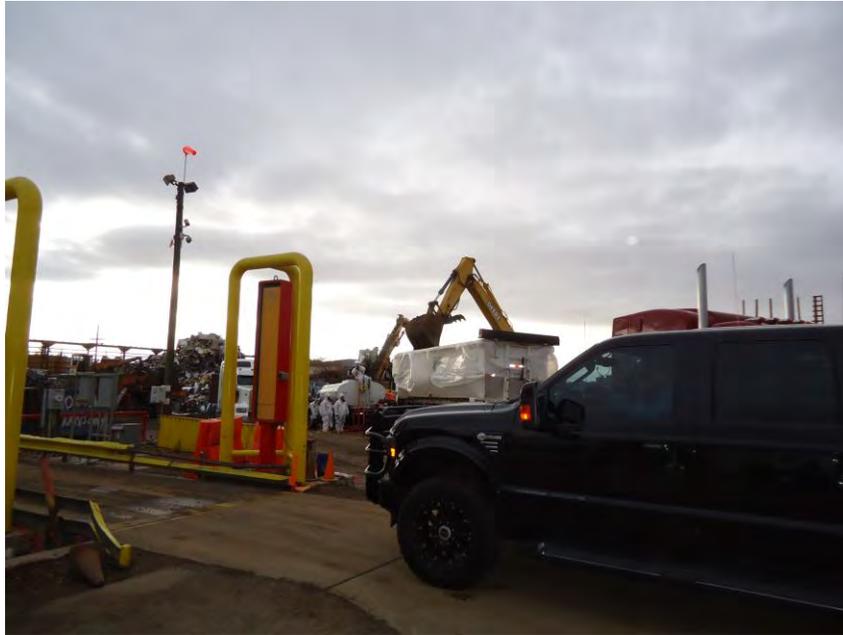
Photograph DSC00650: View of loading activity from stockpile on W. Silver site.

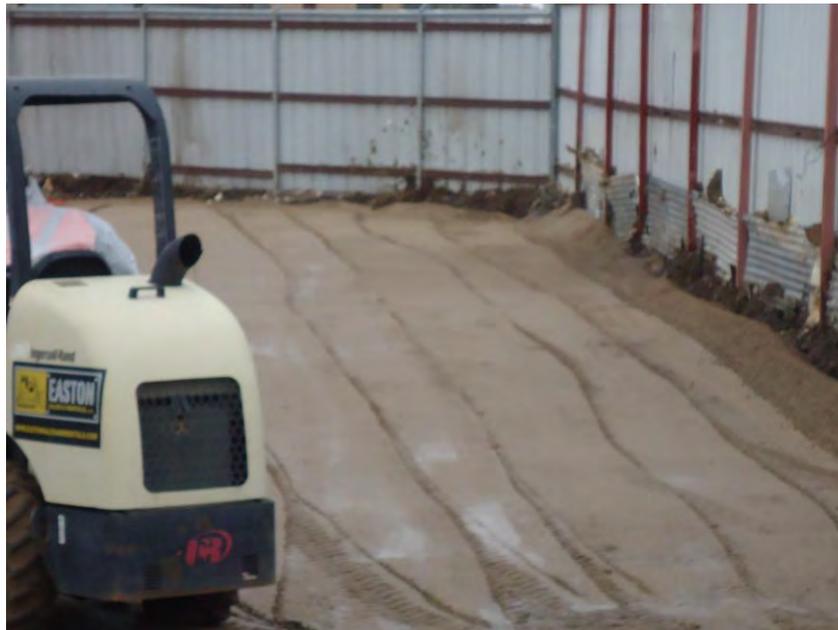
Photograph DSC00652: View of placement and compaction of "Cover Material" (Type A1A Product) within the excavated and cleared areas (B North, A South) on W. Silver site.

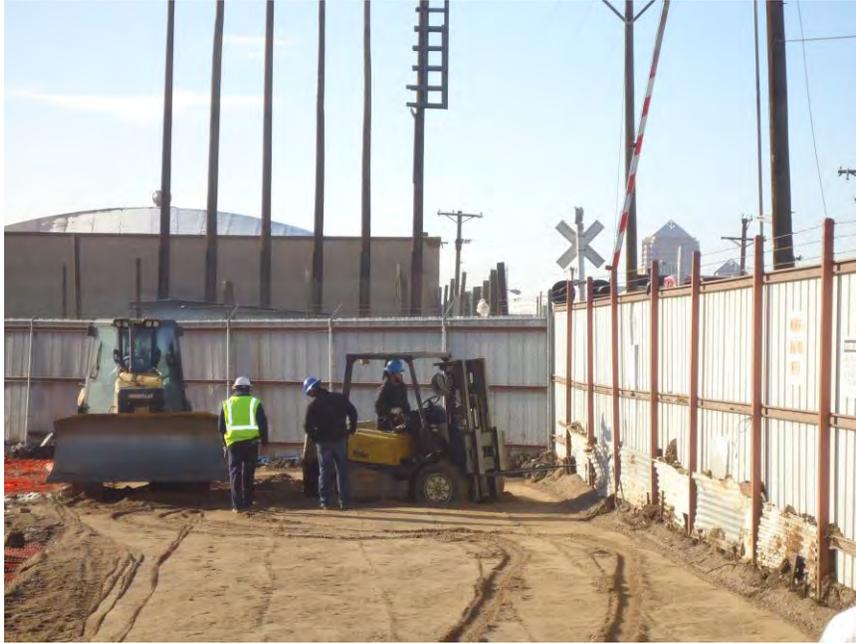
Photograph DSC00654: Photo south of forklift stuck on test track of compacted Cover Material.

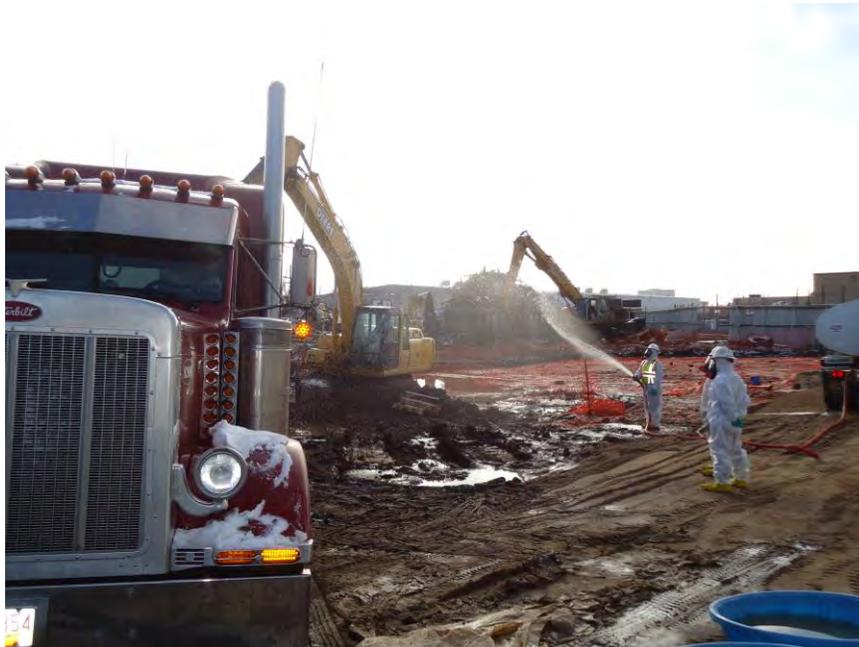
Photograph DSC00656: Photo southeast of loading operations on the W. Silver site.

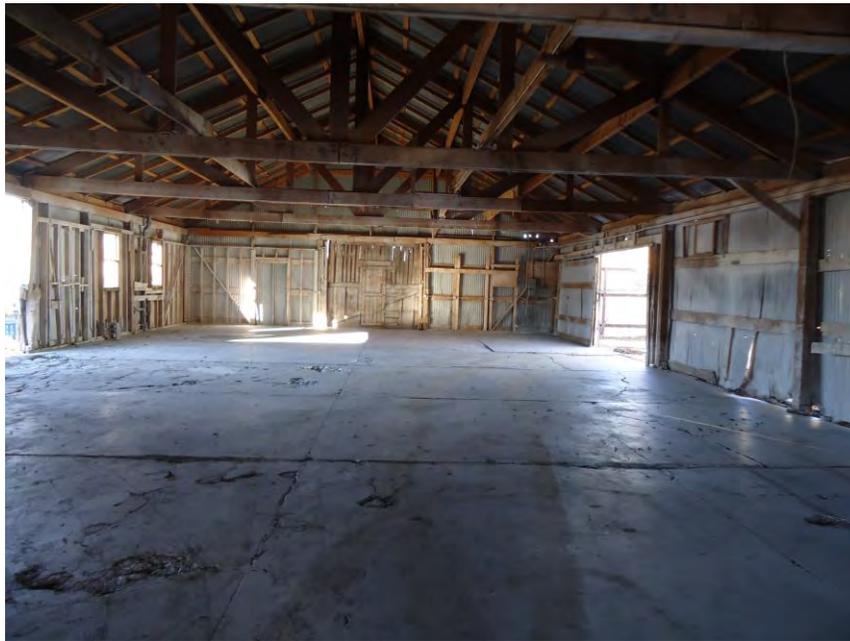
Photograph DSC00661: Expanded view looking west at interior of former exfoliation building, following completion of abatement activities.

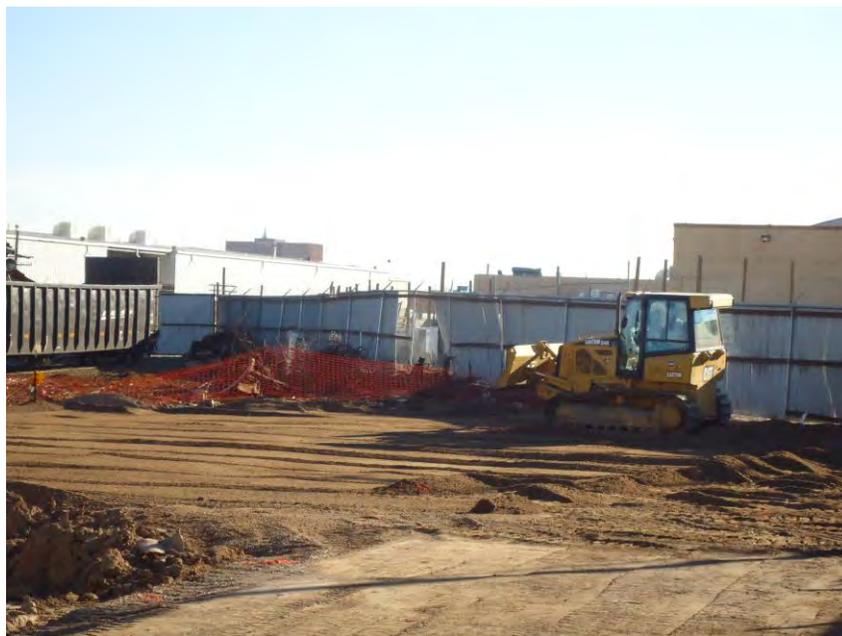
Photograph DSC00669: Close view looking south at grading and compaction of cover material in Area A, Grids A/B on the W. Silver site

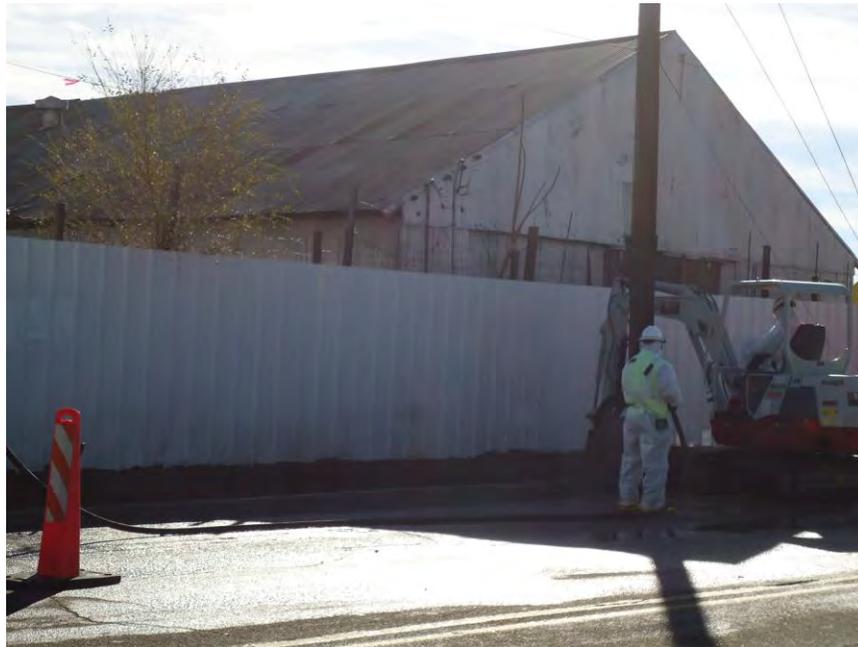
Photograph DSC00671: View looking southeast at excavation activities in Grid 001 of the City ROW. Dust suppression in progress.

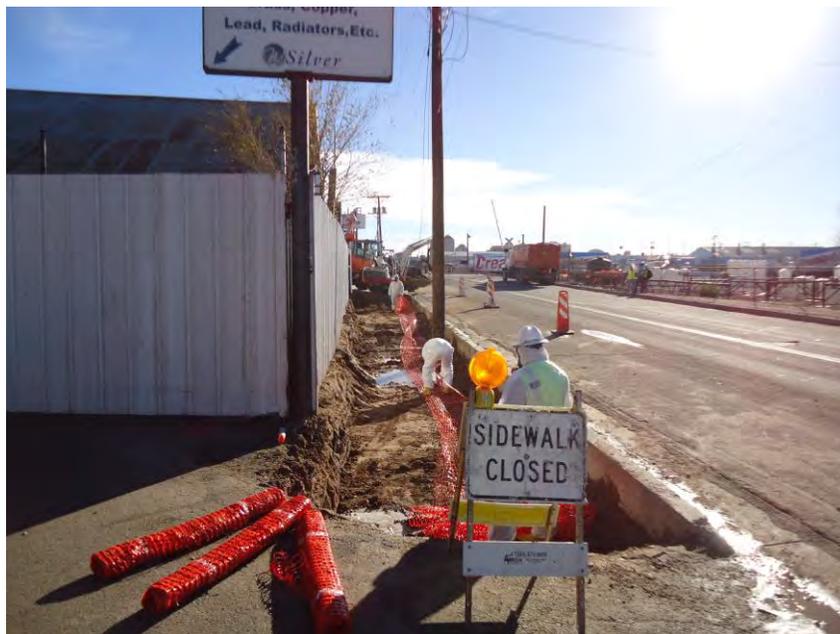
Photograph DSC00673: Expanded view looking south at final excavation depth and ongoing confirmation sampling and placement of barricade fencing in Grid 001 of the City ROW prior to backfilling

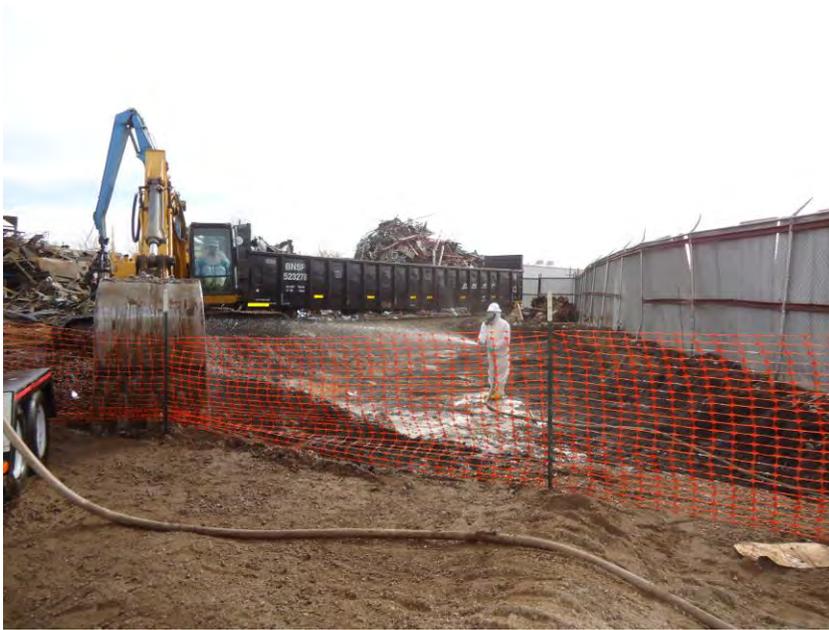
Photograph DSC00677: View looking southeast at excavation activities in the southern portion of Grid B on the W. Silver site. Dust suppression in progress.

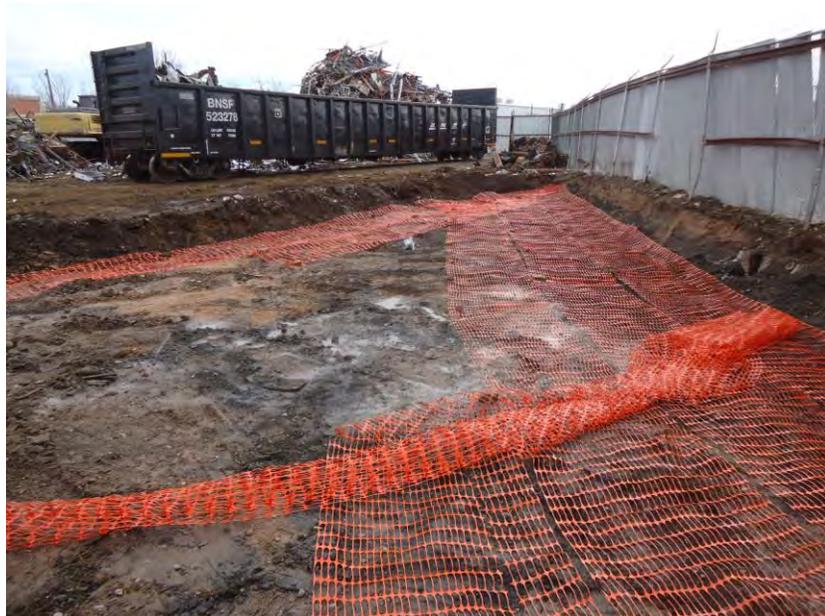
Photograph DSC00680: Close view looking southeast at final excavation depth and placement of barricade fencing in the southern portion of Grid B on the W. Silver site.

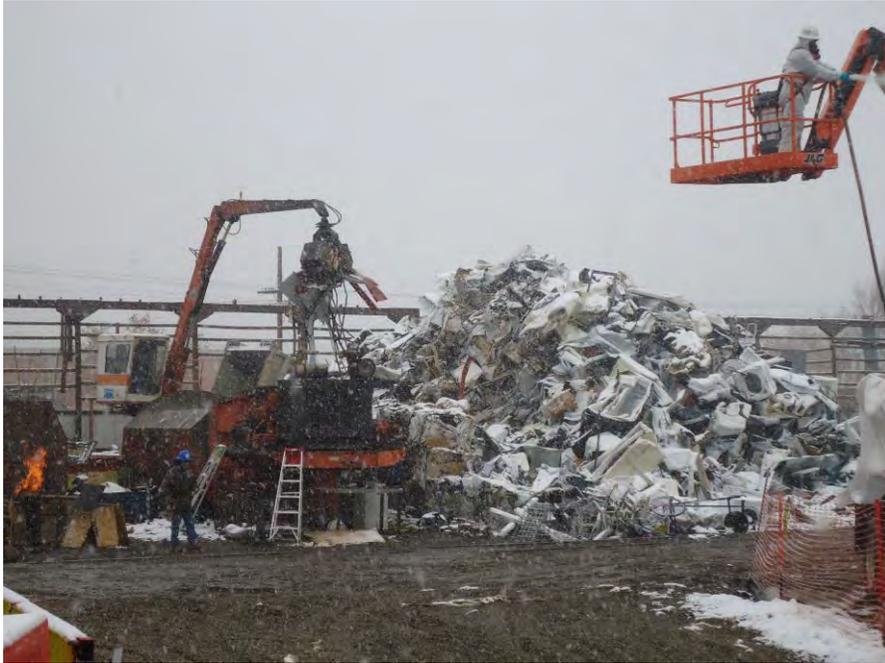
Photograph DSC00682: View looking southeast at dust suppression activities related to end dump/roll off loading. Note, W. Silver personnel operating in background.

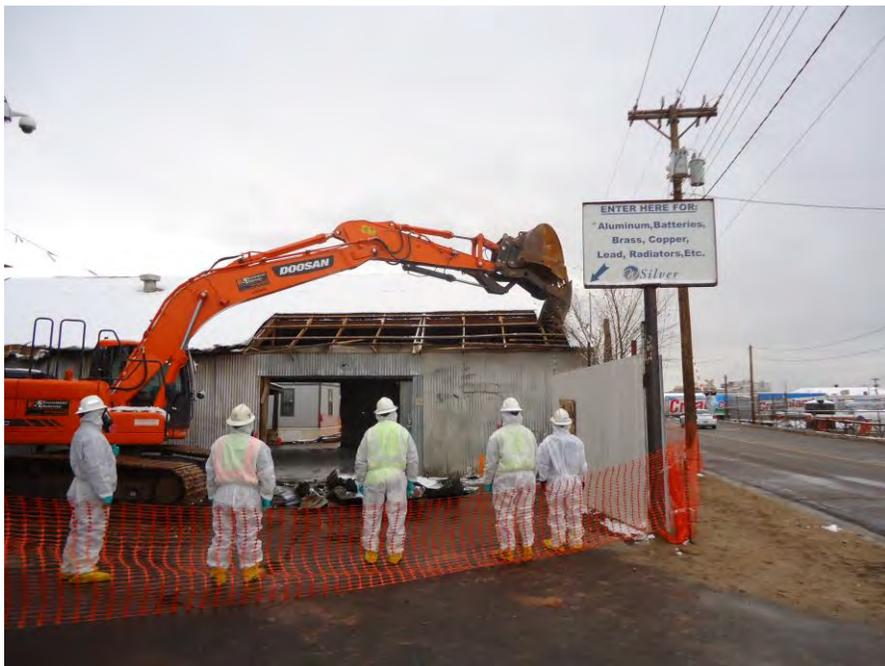
Photograph DSC00686: View looking south at initial demolition activities of the former exfoliation building, starting with removal of the sheet metal roofing,

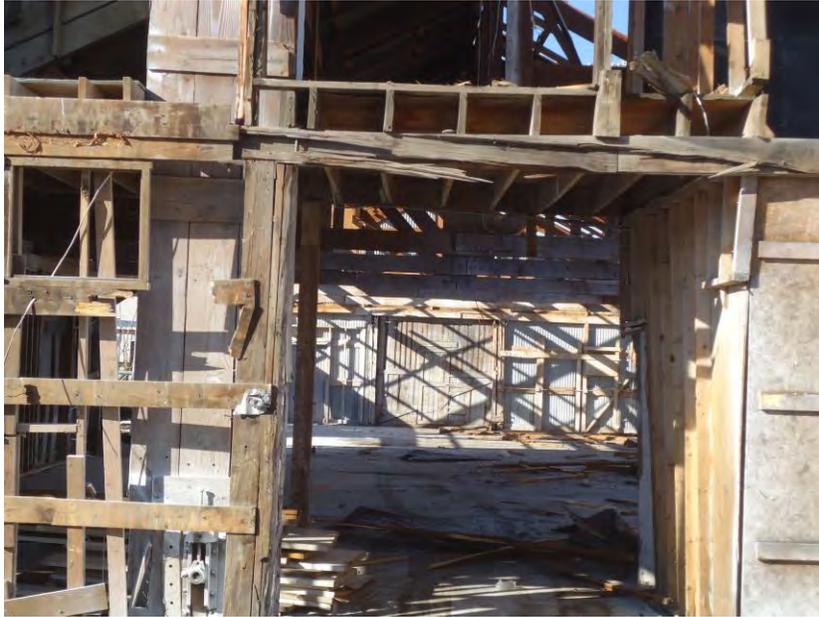
Photograph DSC00690: View looking west into the structure of the former exfoliation building during demolition activities.

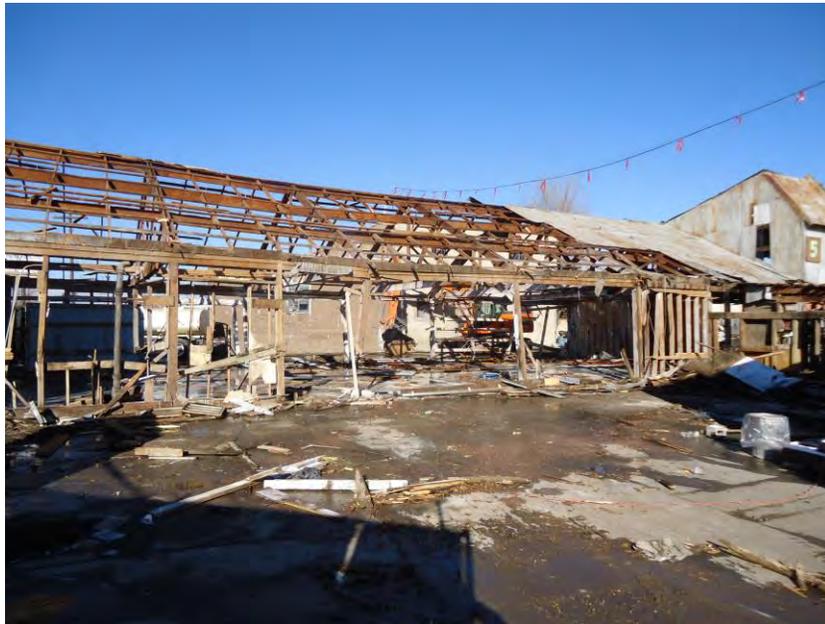
Photograph DSC00692: View looking northeast at former exfoliation building following removal of the sheet metal siding and roofing.

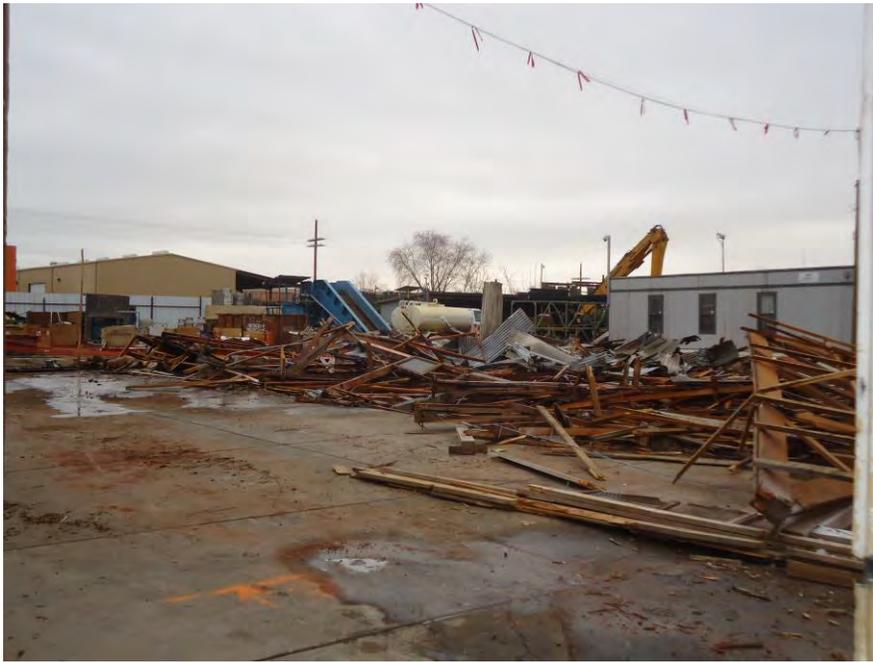
Photograph DSC00696: View looking southeast at debris from demolition of the former exfoliation building.
