## Appendix D

# Daily Progress Reports

**Southwest Vermiculite (Phase II) – Removal Action  
Daily Progress Report  
November 5, 2013**

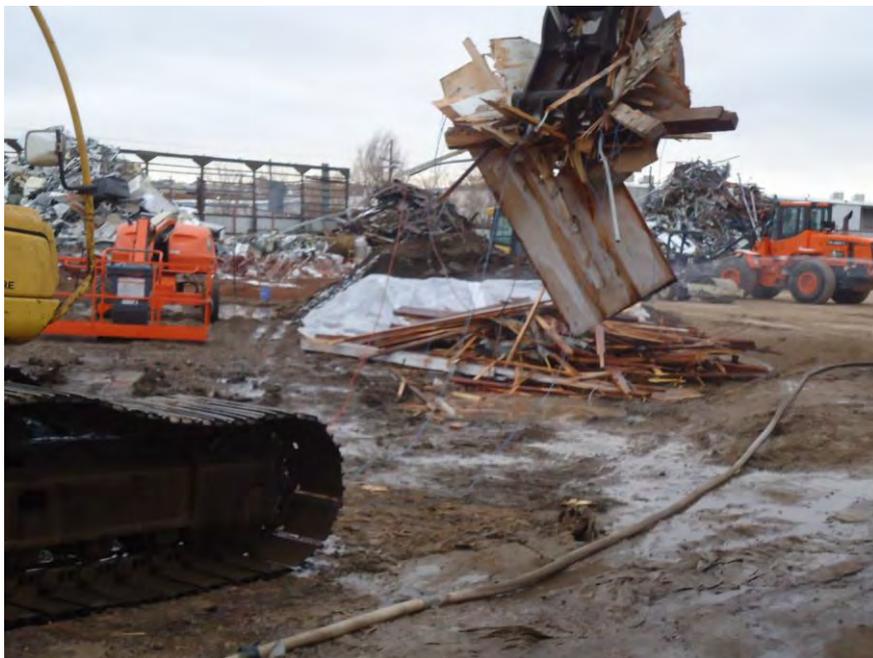
Photograph DSC00698: View looking southeast at stockpile area on the W. Silver site with debris from the former exfoliation building placed for disposal at Keer's landfill at Mountainair.

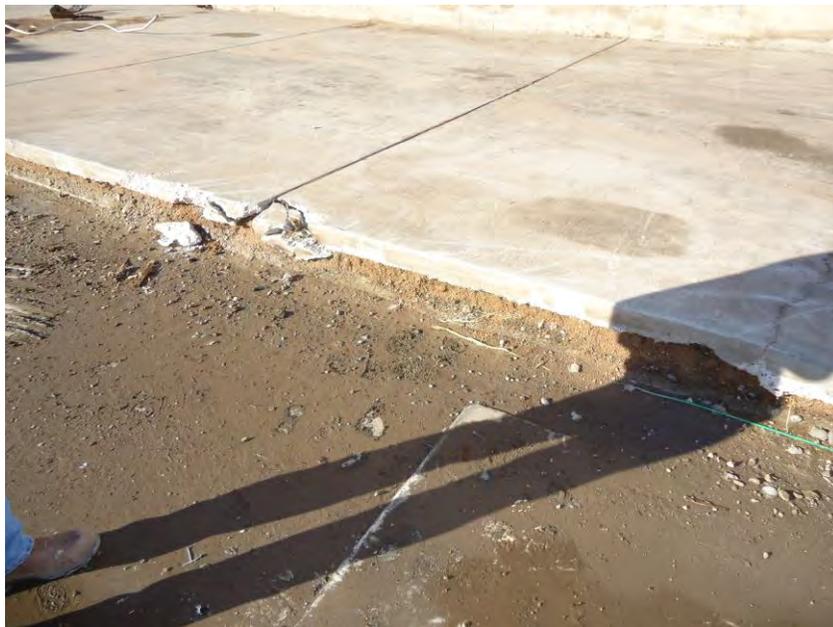
Photograph DSC00718: View looking northwest at exposed soil area where a visible vermiculite layer was observed under the concrete adjacent to the former exfoliation building concrete pad.

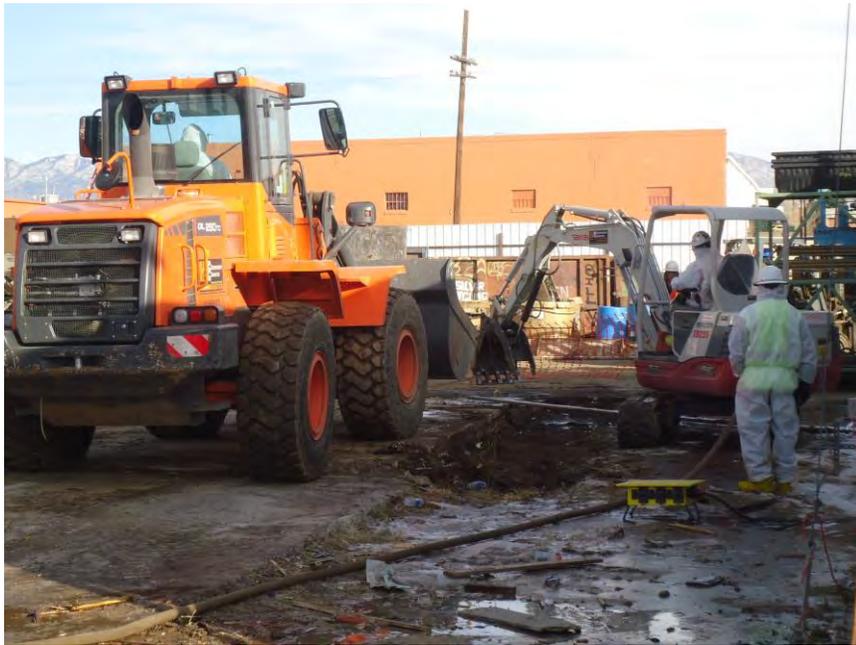
Photograph DSC00724: View looking east at excavation activities in a dirt strip (Grid 002) along the southern portion of the concrete pad adjacent to the former exfoliation building.

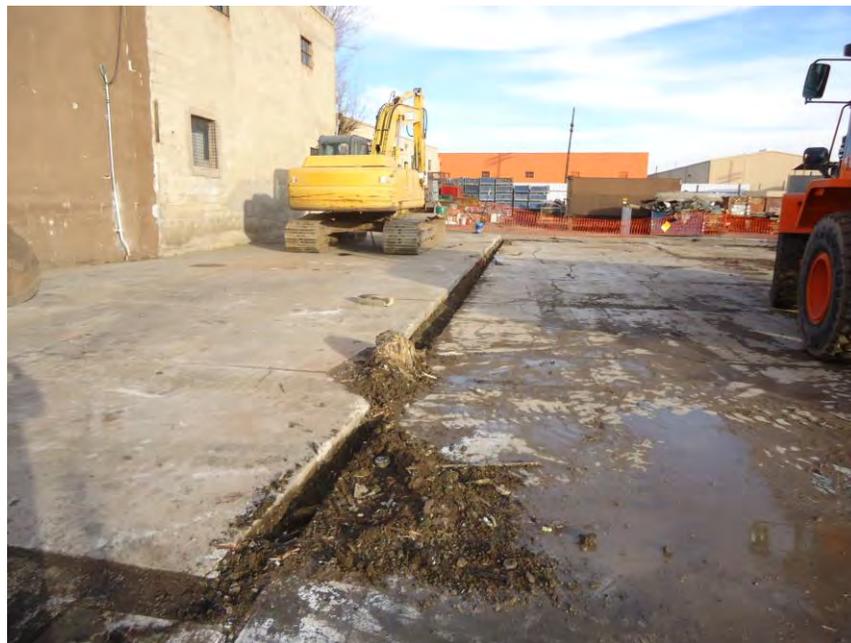
Photograph DSC00725: View looking east at excavation activities in a dirt strip (Grid 001) along the northern portion of the concrete pad adjacent to the former exfoliation building. A layer of visible vermiculite was observed in the soil under the concrete pad.

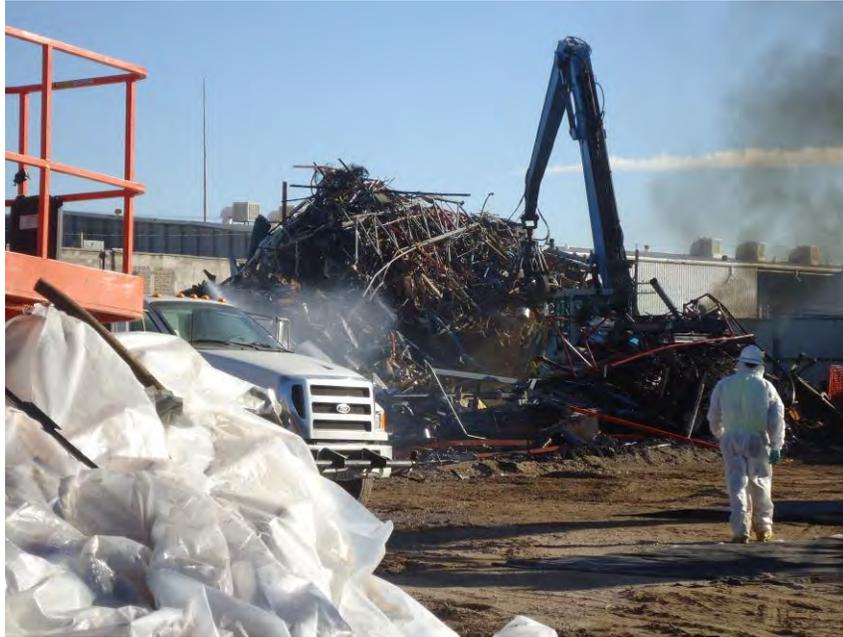
Photograph DSC00730: View looking southeast at activities related to moving scrap metal onto the cleaned Area A, Grids A/B from Grid E on the W. Silver site.

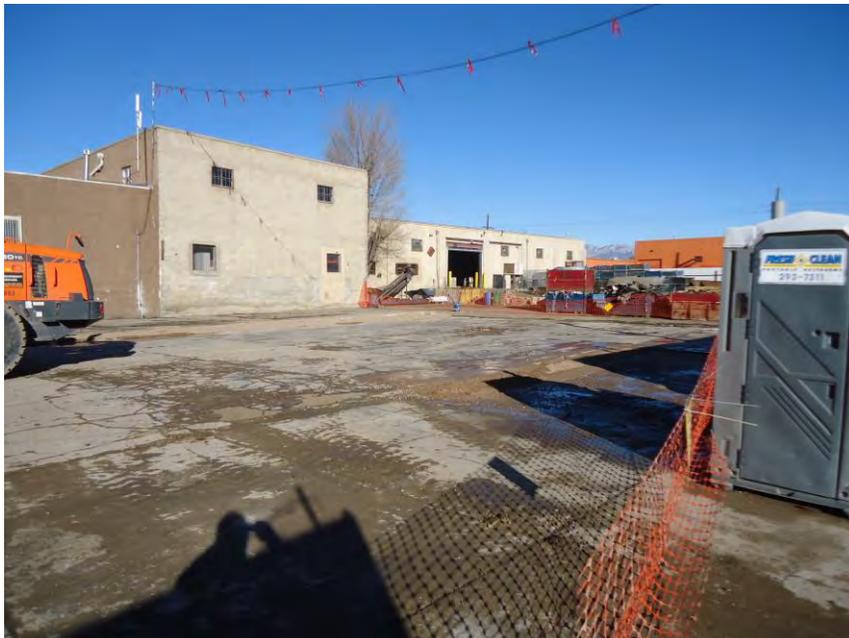
Photograph DSC00732: View looking northeast at cleaned concrete pad of the former exfoliation building.

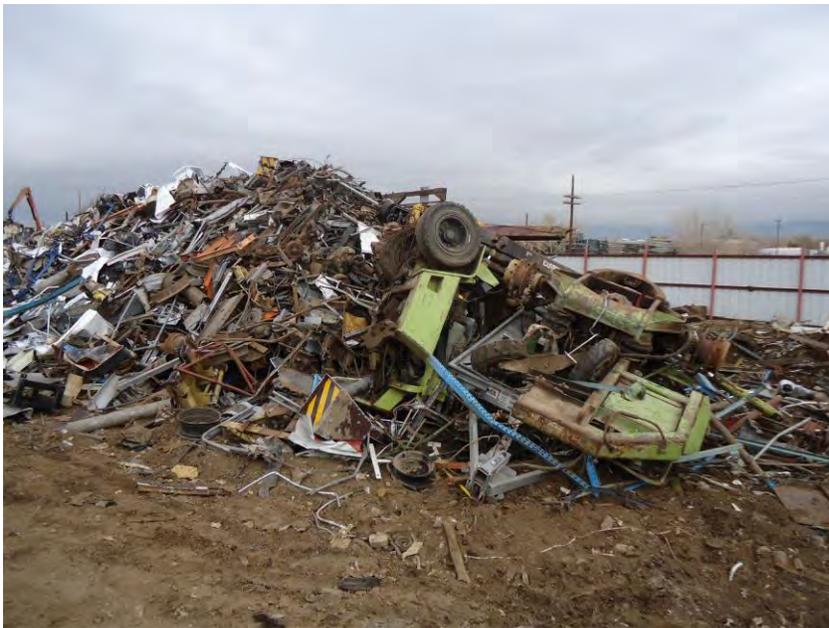
Photograph DSC00737: View looking east/northeast at scrap metal pile located on Grid A/B after relocation from Grid E.

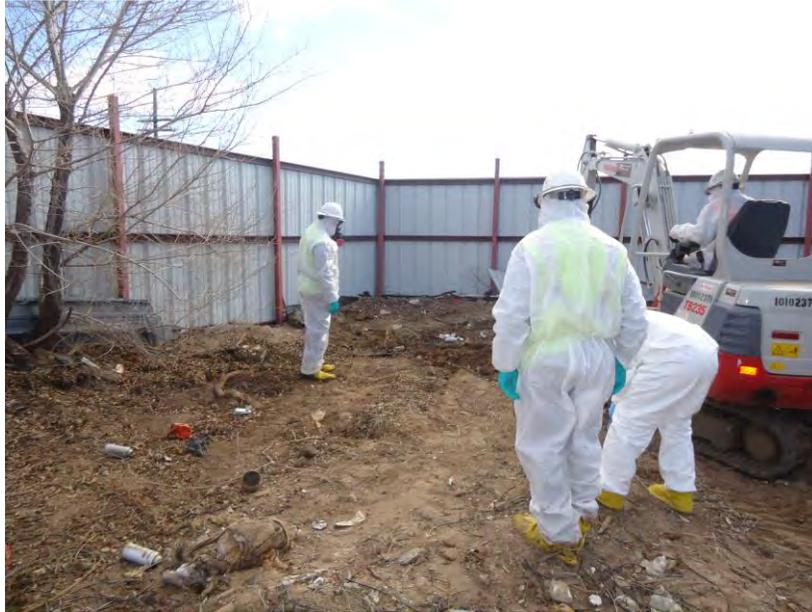
Photograph DSC00738: View looking south at initial sampling activities at location EW06 in Grid E on the W. Silver site.

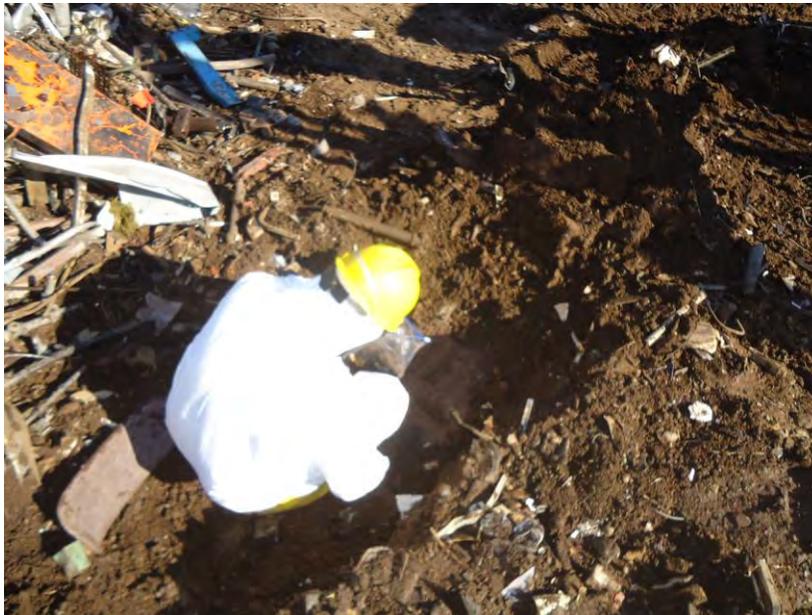
Photograph DSC00748: View looking north and down as sample collected from 12-18" bgs at location EW02 in Grid E on the W. Silver site.

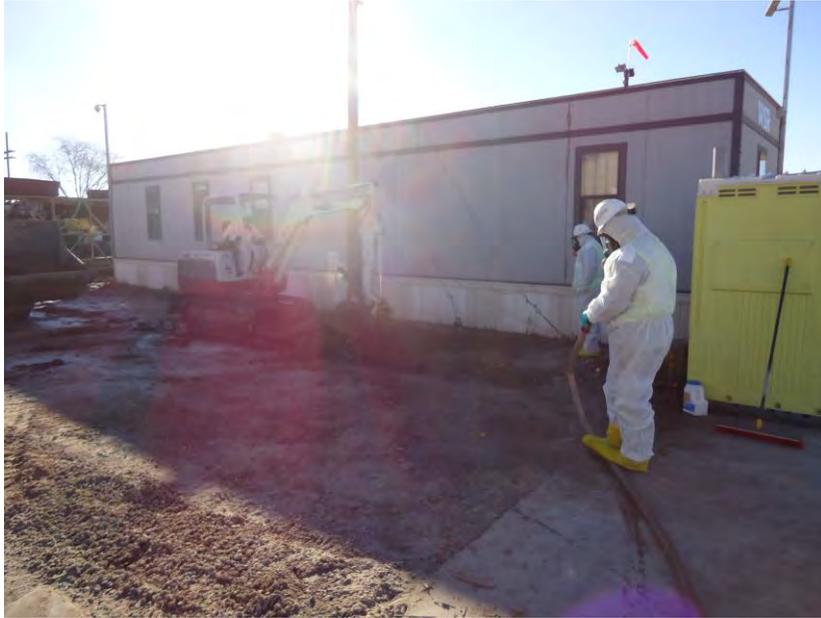
Photograph DSC00750: View looking southeast at excavation activities in Grid 002 of Area A on the W. Silver site. Dust suppression in progress.

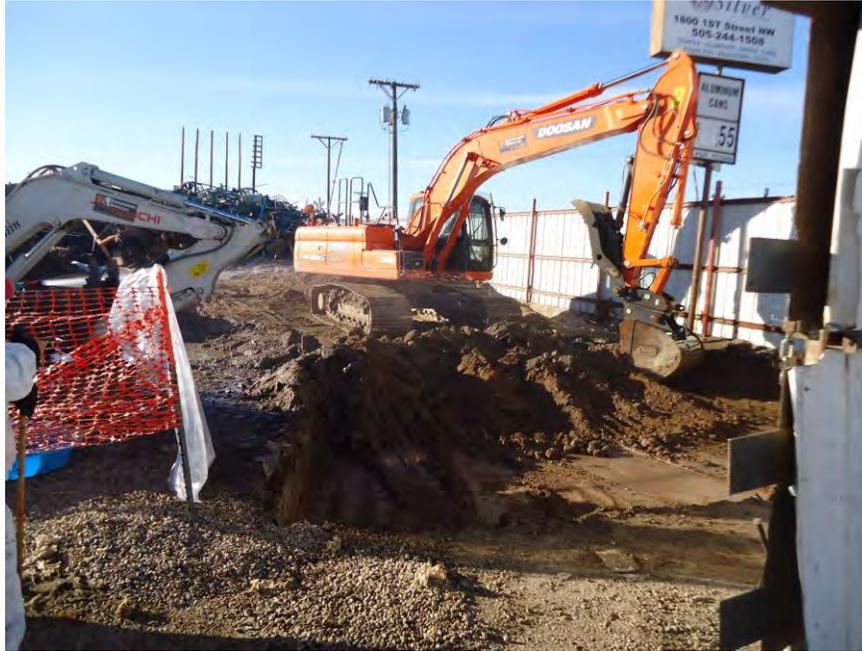
Photograph DSC00753: View looking south at excavation activities in the northwestern portion of Grid A on the W. Silver site. Dust suppression in progress.

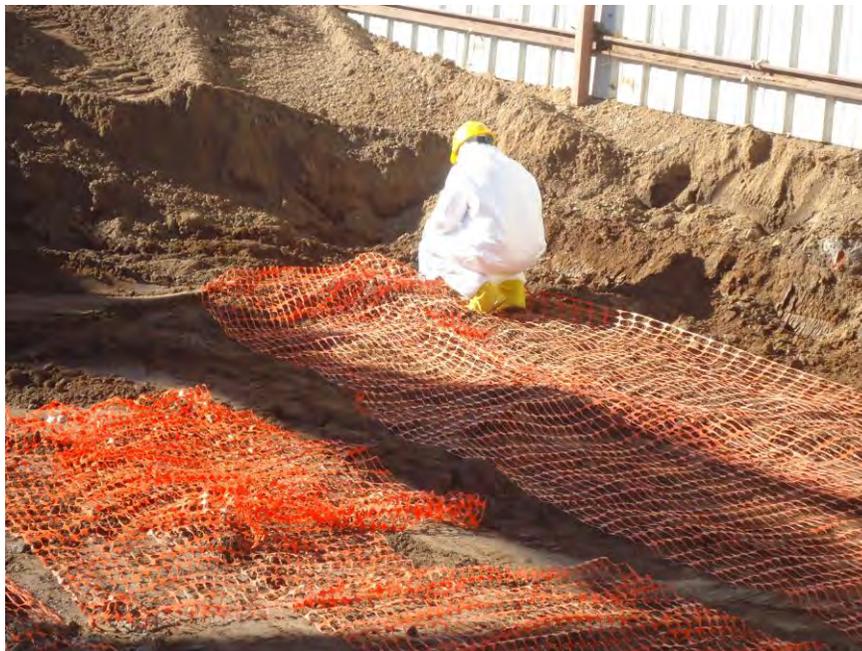
Photograph DSC00754: View looking southwest and down as sample aliquots are collected from the northwestern portion of Grid A on the W. Silver site.

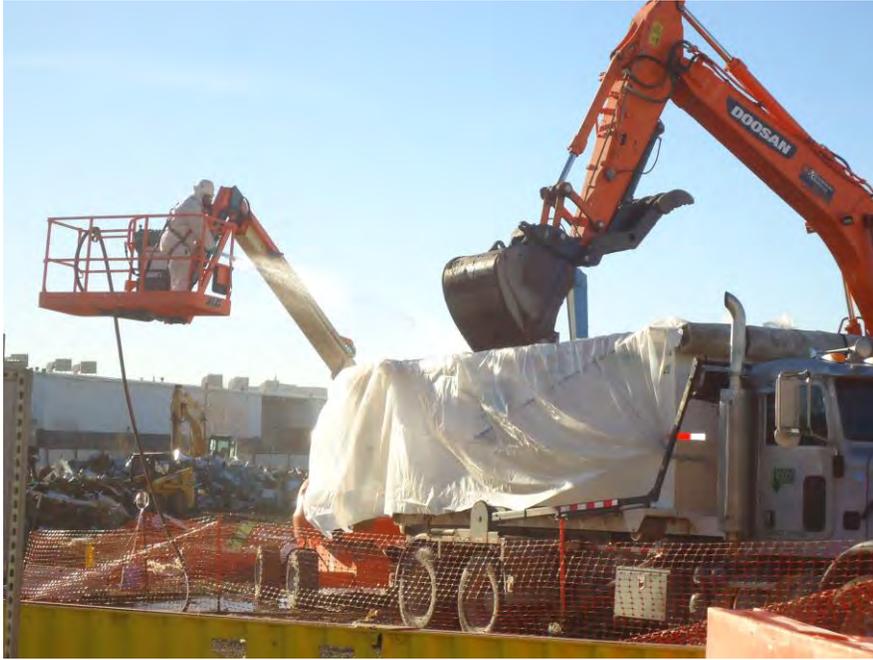
Photograph DSC00757: View looking southeast at loading from the soil stockpile in Grid A on the W. Silver site. Dust suppression in progress.

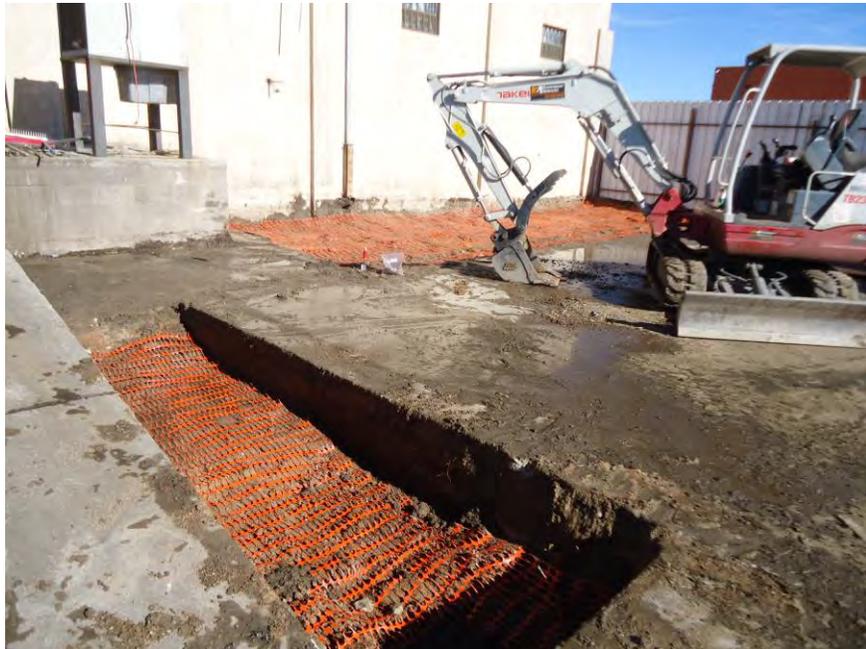
Photograph DSC00759: View looking northeast at the excavated area (Grid 019) south of the main warehouse.

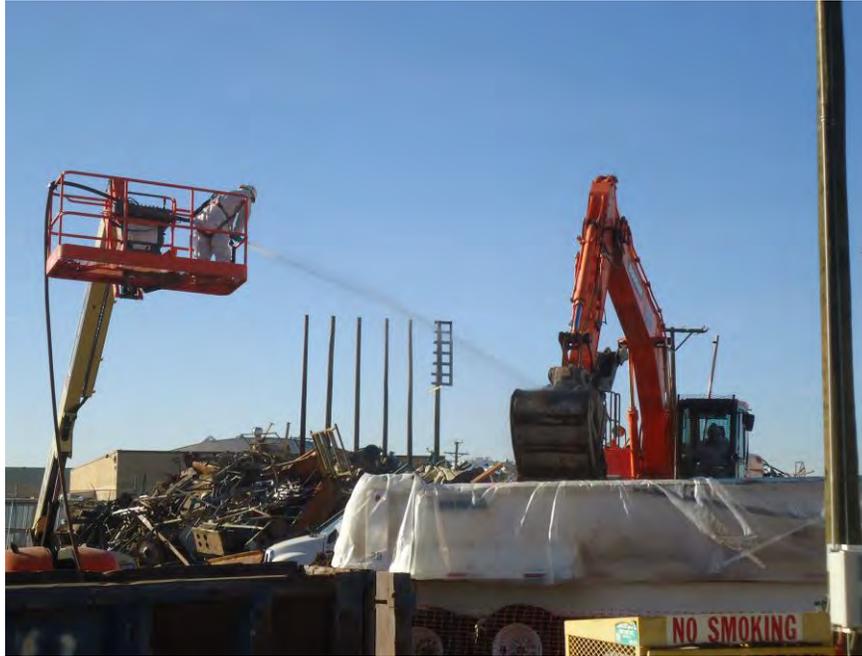
Photograph DSC00762: View looking southwest at loading from the soil stockpile in Grid A on the W. Silver site. Dust suppression in progress.

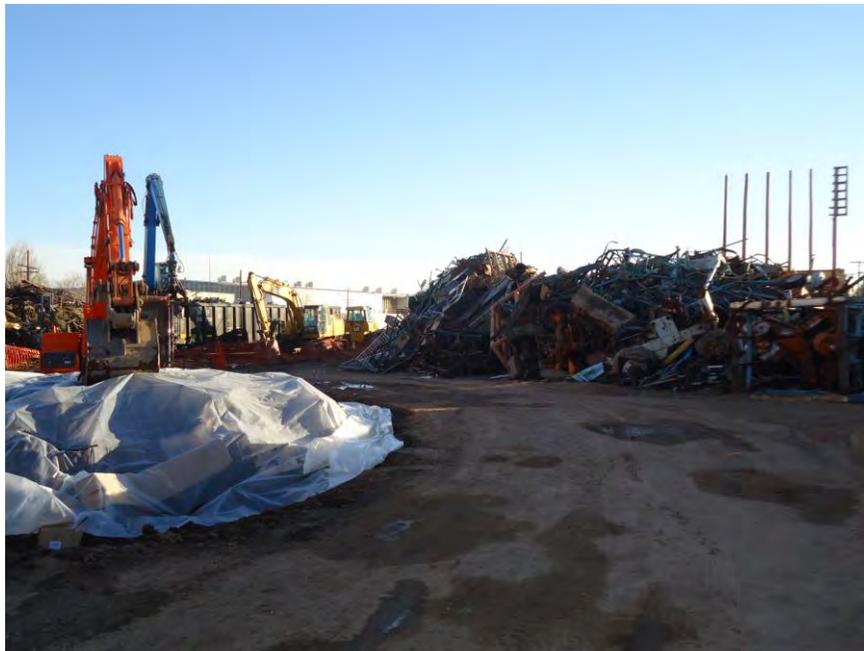
Photograph DSC00763: View looking southeast at Grids A/B with covered soil stockpile in foreground and bulk scrap metal in background. Also note W. Silver Grappler in background loading rail car.

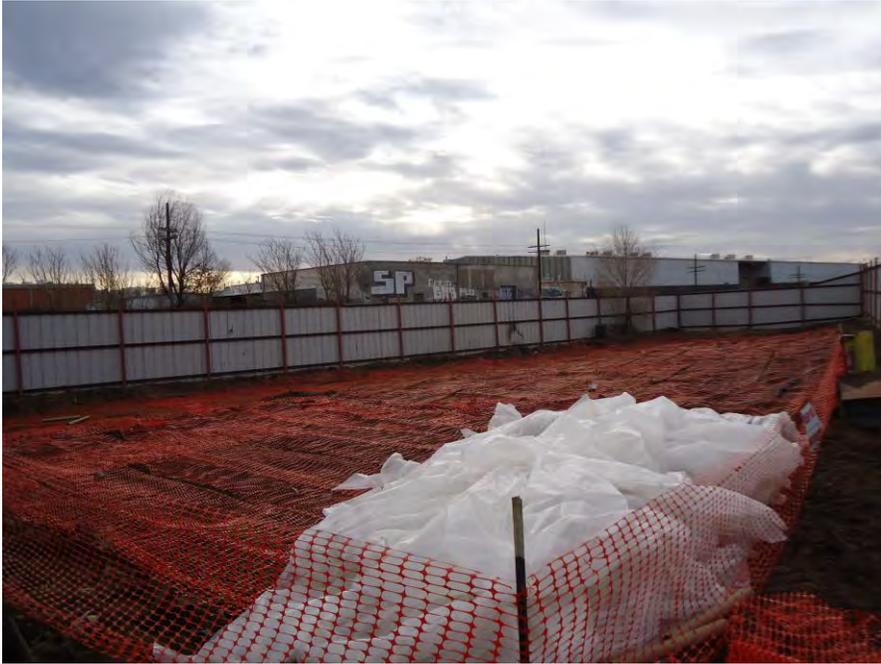
Photograph DSC00766: View looking southeast at Area A, Grid E after excavation was completed, and prior to placement of cover material.

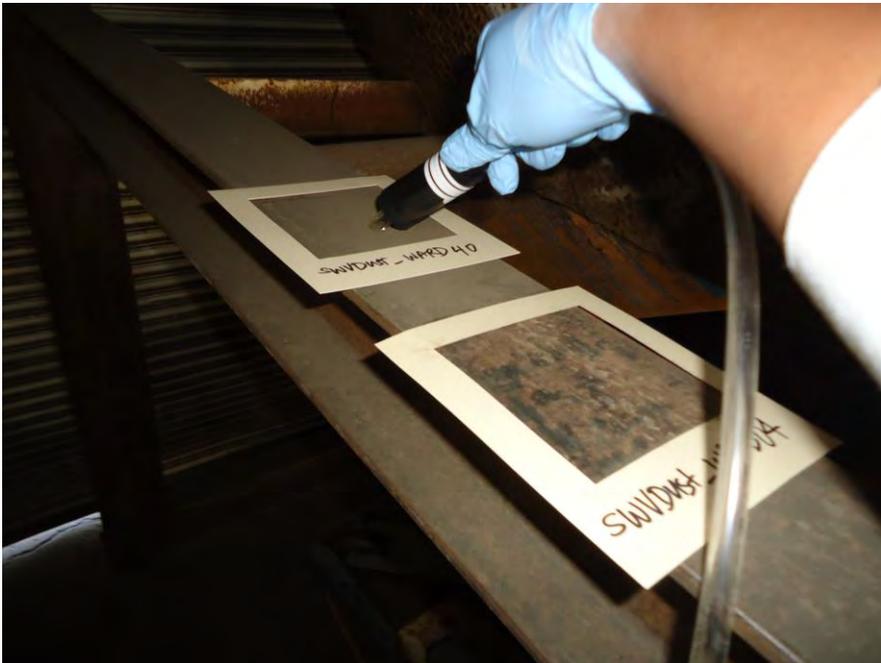
Photograph DSC00776: View looking northeast at "Dust Sampling" of Locations WARD04 and WARD40 (Duplicate), located on a steel cross beam of a Hopper in the north central portion of the main warehouse.

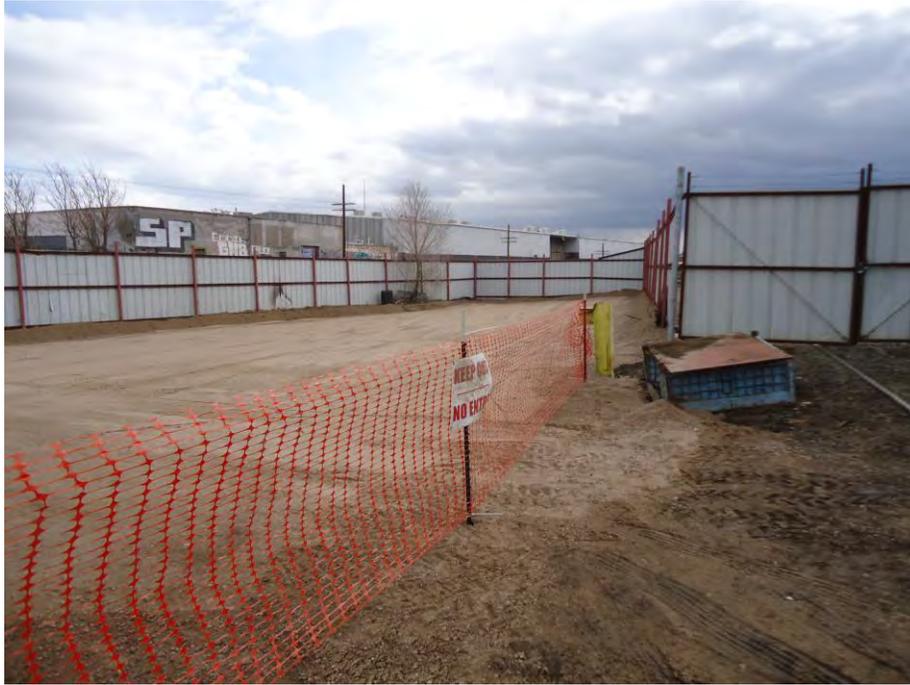
Photograph DSC00788: View looking southeast at Area A, Grid E after cover material was placed, compacted and graded immediately prior to departure for Holiday break.

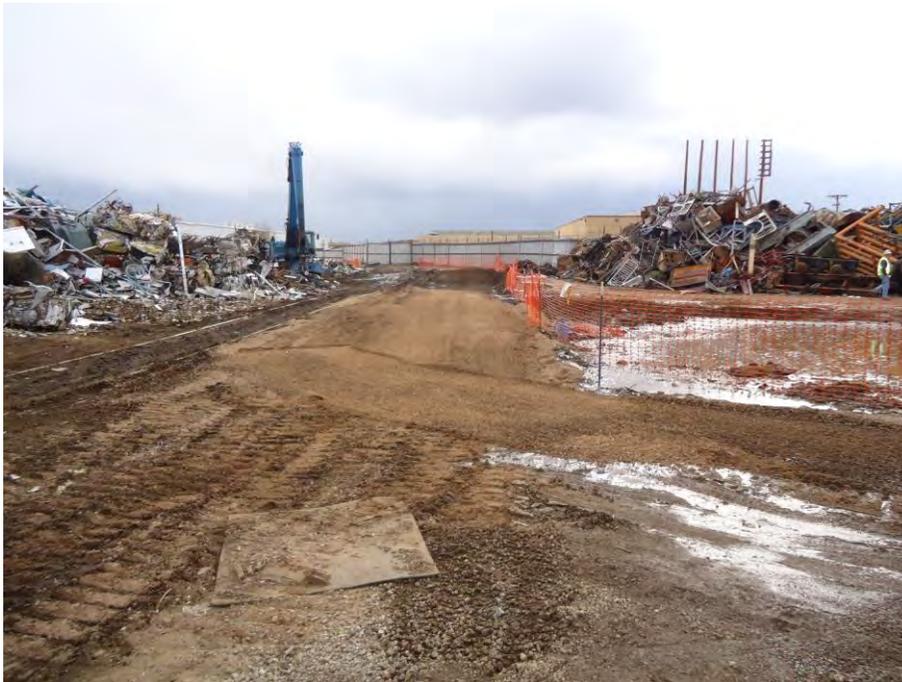
Photograph DSC00791: View looking south at cover material placed and graded along western side of rail spur on W. Silver site. Material placed to displace standing water resulting from recent rain and water used for decontamination.

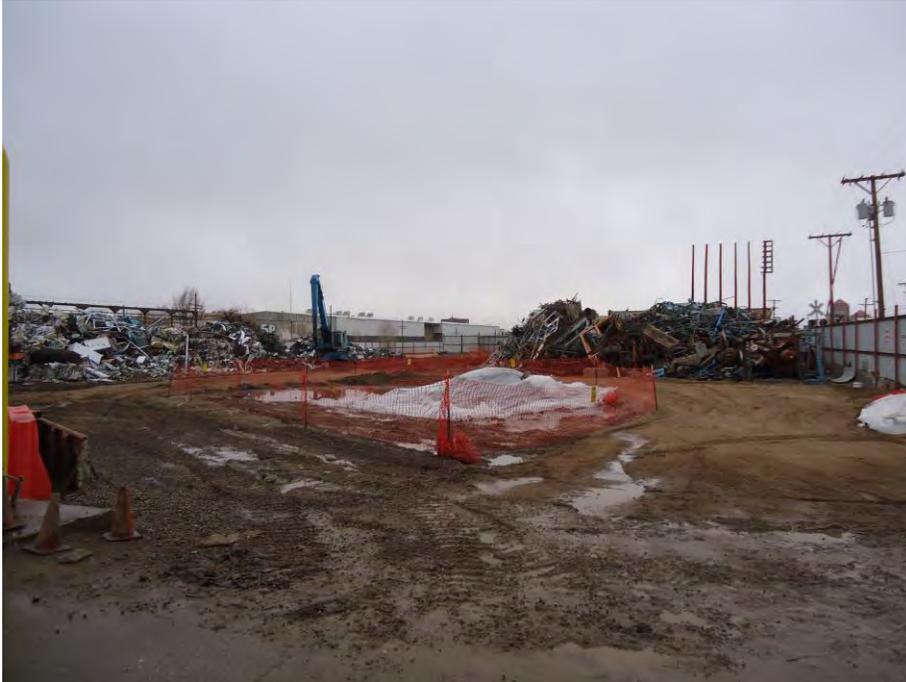
Photograph DSC00801: Expanded view looking southeast at W. Silver site prior to departure for the Holiday break. Note fencing and signage around stockpile area in Grid A.

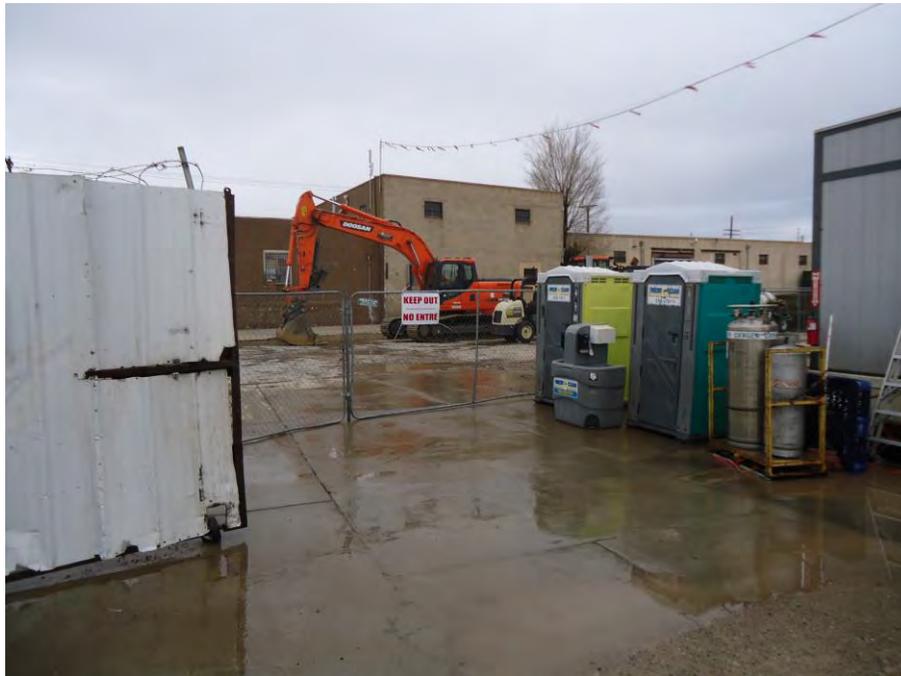
Photograph DSC00803: View looking northeast at fencing and signage around concrete pad for the Former Exfoliation Building prior to departing site for the Holiday break.

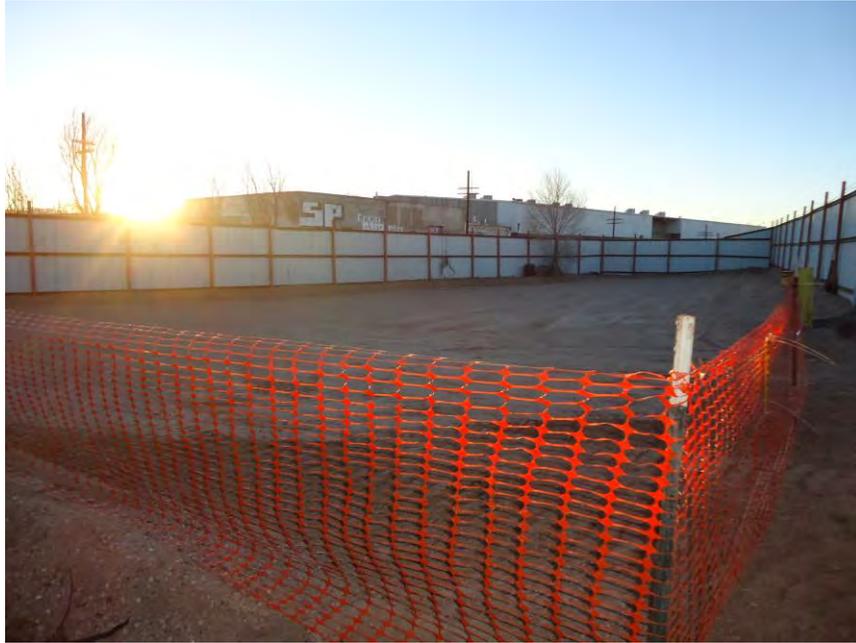
Photograph DSC00805: View looking southeast at Area A, Grid E after return from the Holiday break.

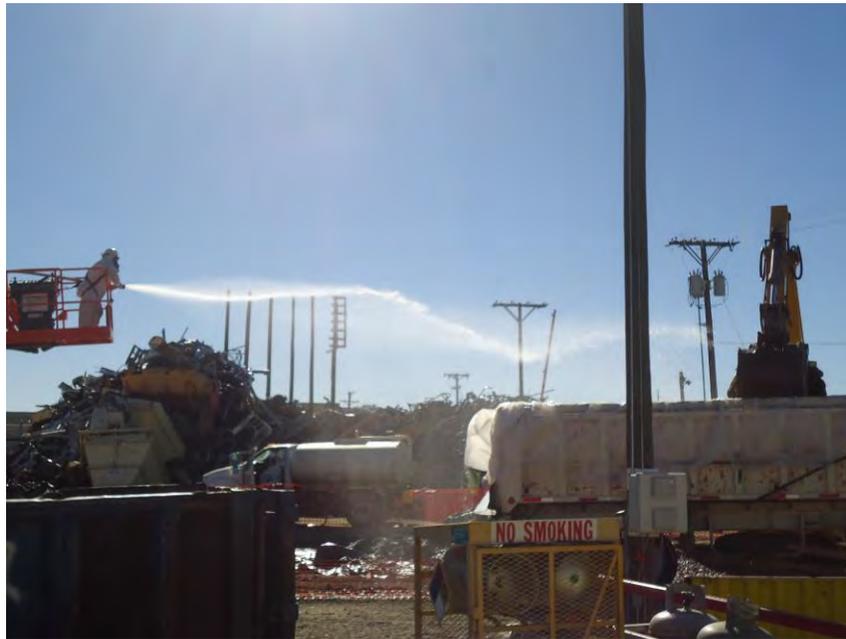
Photograph DSC00807: View looking south at loading activities on the W. Silver site. Dust suppression in progress.

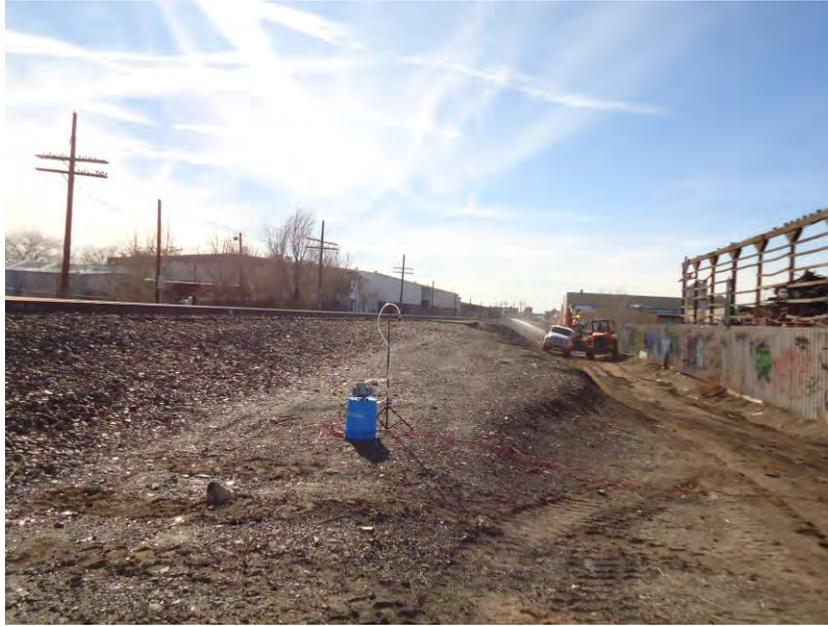
Photograph DSC00813: View looking south at southern portion of Area B (the NMDOT Railroad ROW) as excavation is initiated.

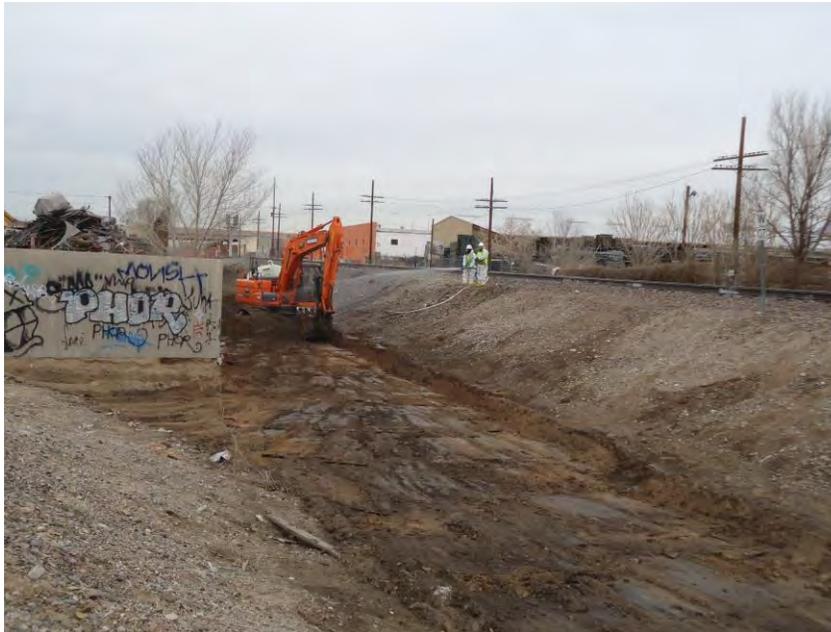
Photograph DSC00816: View looking north at excavation activity in the southern portion of Area B. Dust suppression in progress.

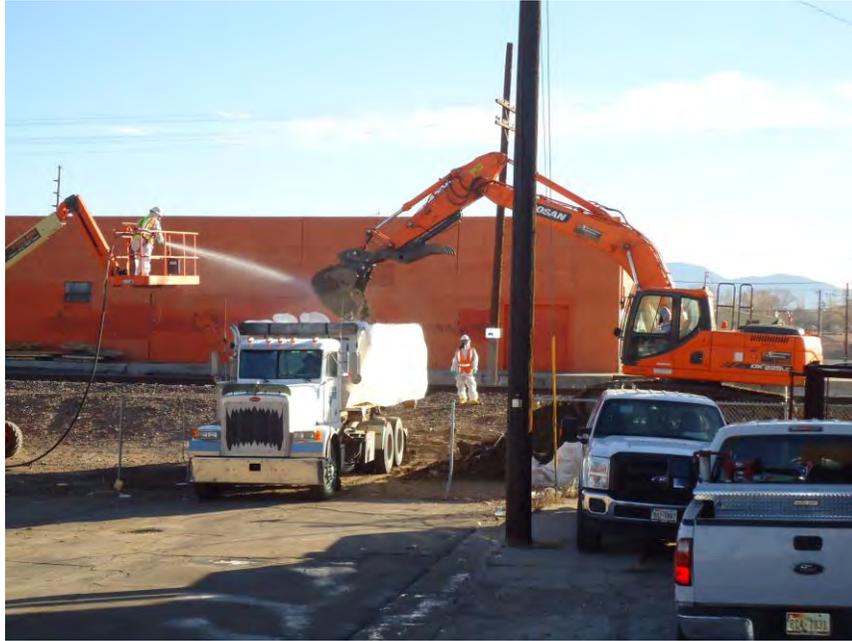
Photograph DSC00827: View looking east at truck loading activities along Haines Street and the NMDOT Railroad Right of Way. Dust suppression in progress.

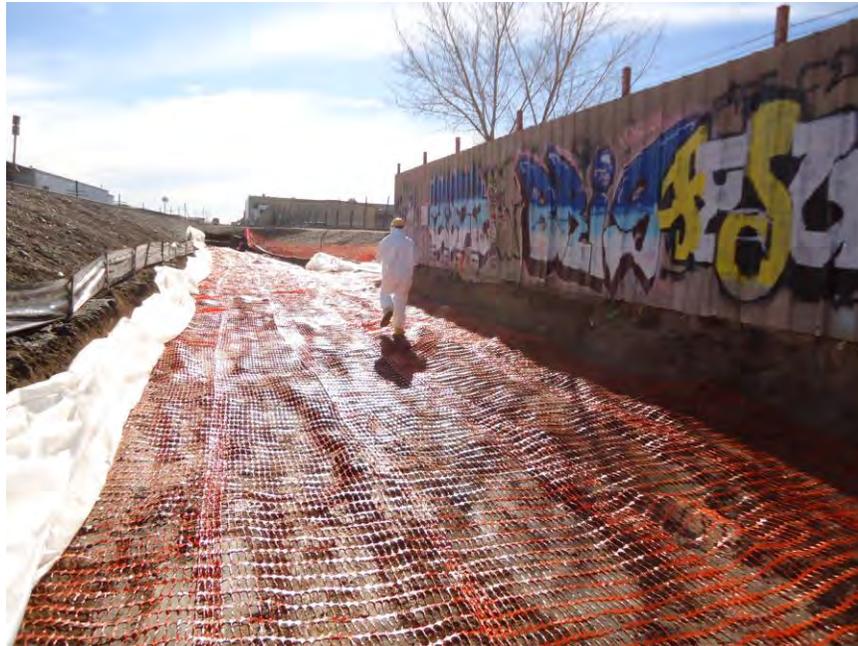
Photograph DSC00833: View looking south at confirmation sampling within excavated area the southern portion of the NMDOT Railroad ROW (Area B).

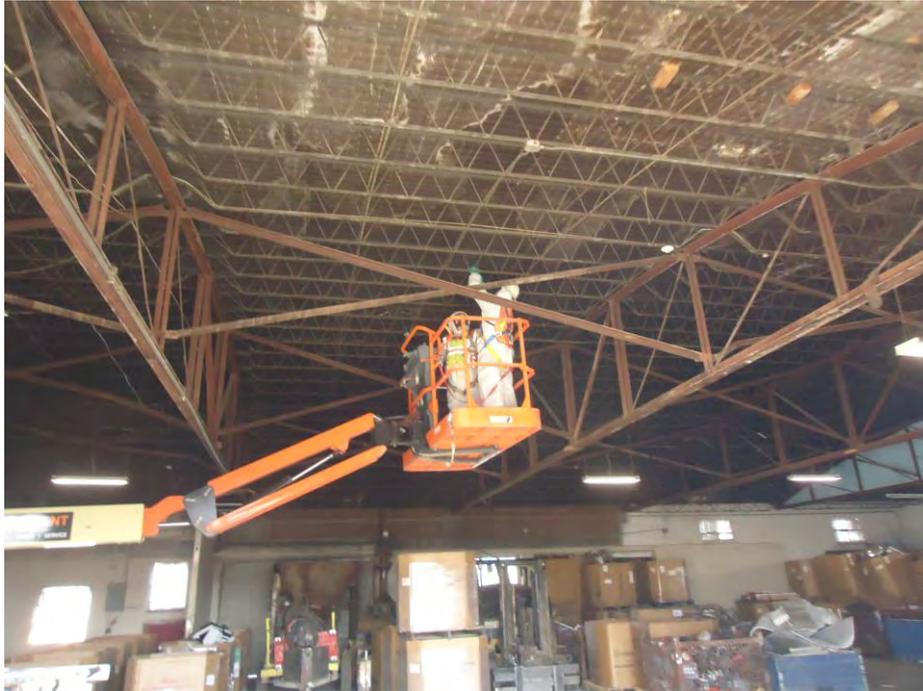
Photograph DSC00848: View of the collection of ceiling tiles/insulation samples from the W. Silver main warehouse, facing north.

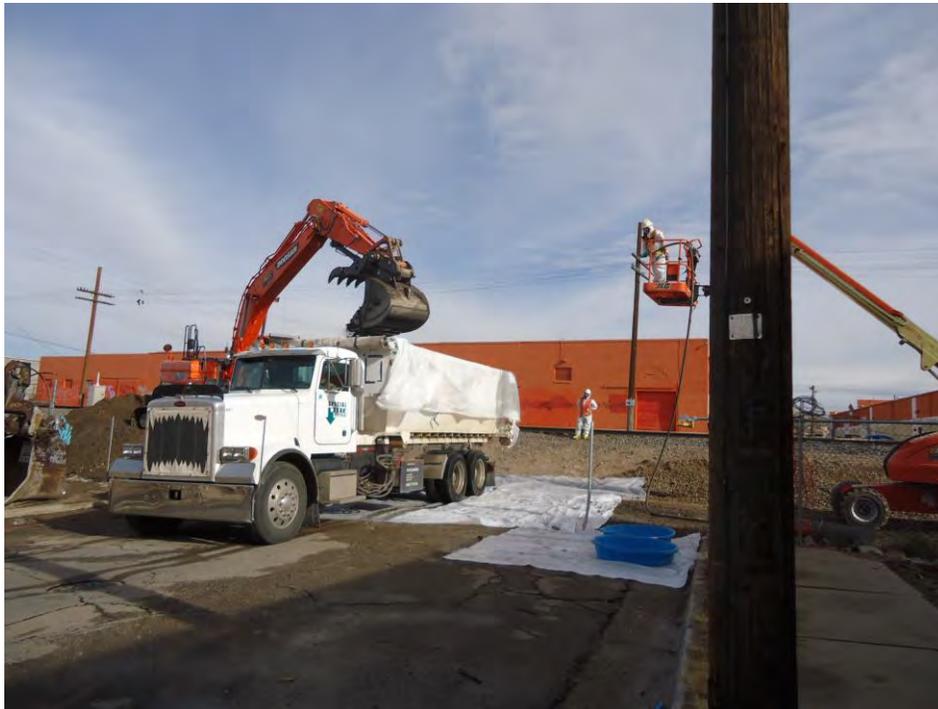
Photograph DSC00854: View looking northeast at truck loading activities along Haines Avenue NW and the NMDOT Railroad Right of Way. Dust suppression in progress.

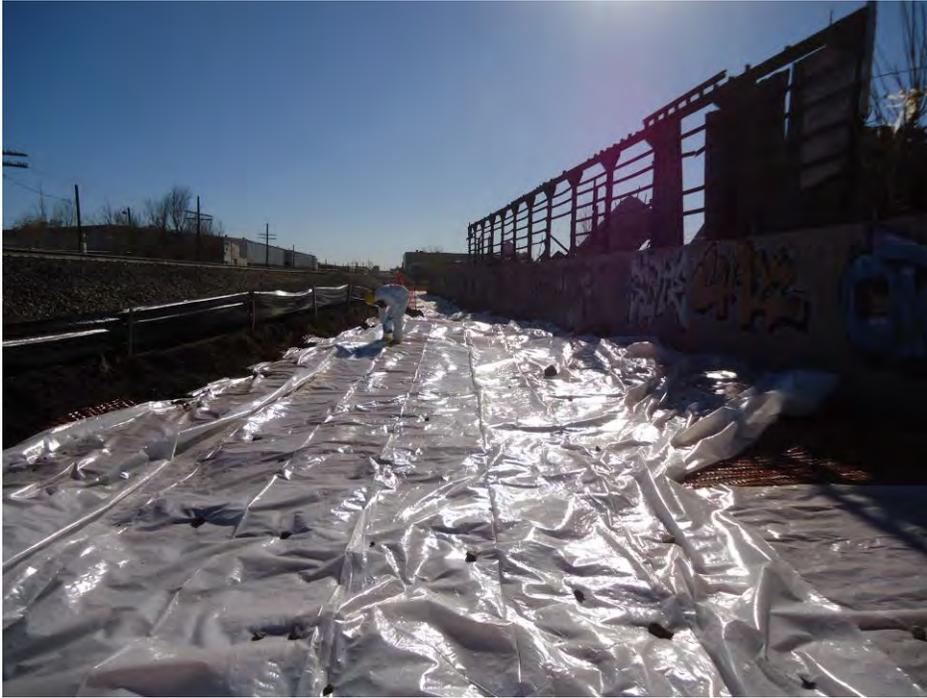
Photograph DSC00859: View looking south at the excavated areas of Area B, shown from Grid 012.

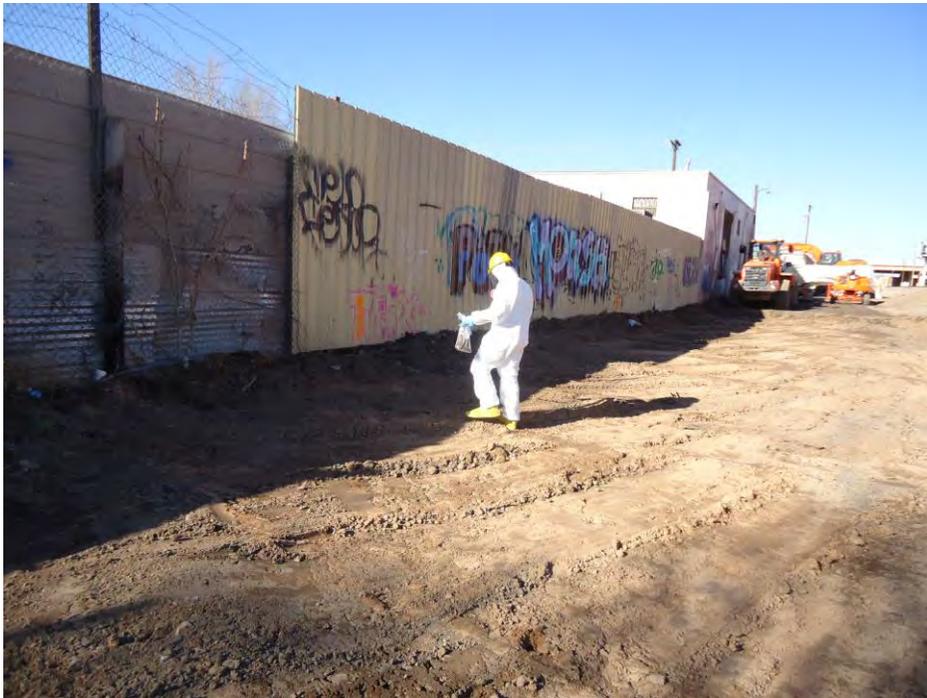
Photograph DSC00863: View looking north/northwest excavated areas of Area B, shown from Grid 10. Note loading operations of stockpiled soil in background.

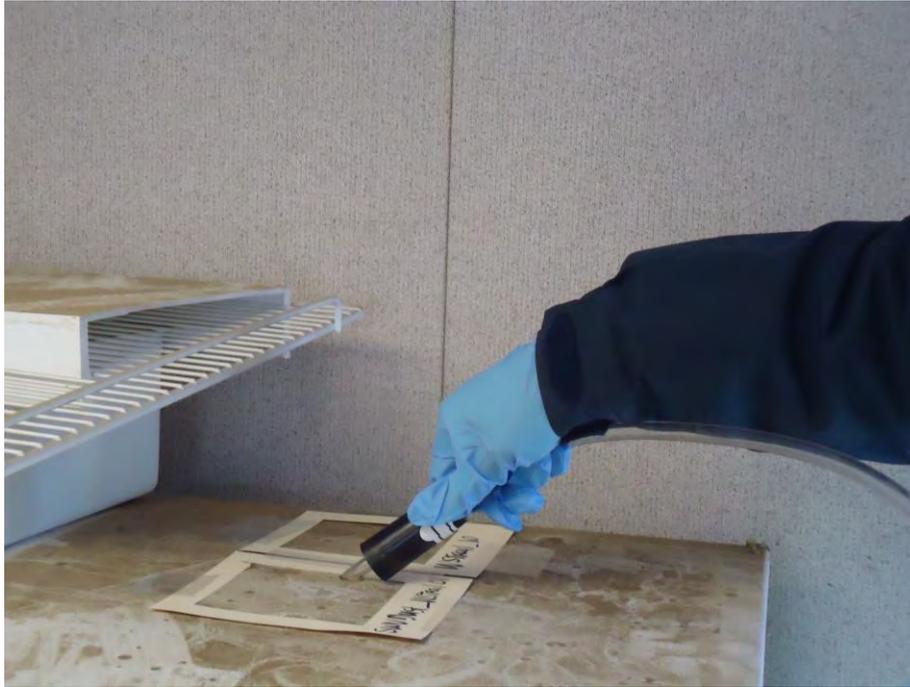
Photograph DSC00869: View looking south within the W. Silver Scale Trailer at Dust Sampling being conducted on top of the break room refrigerator.

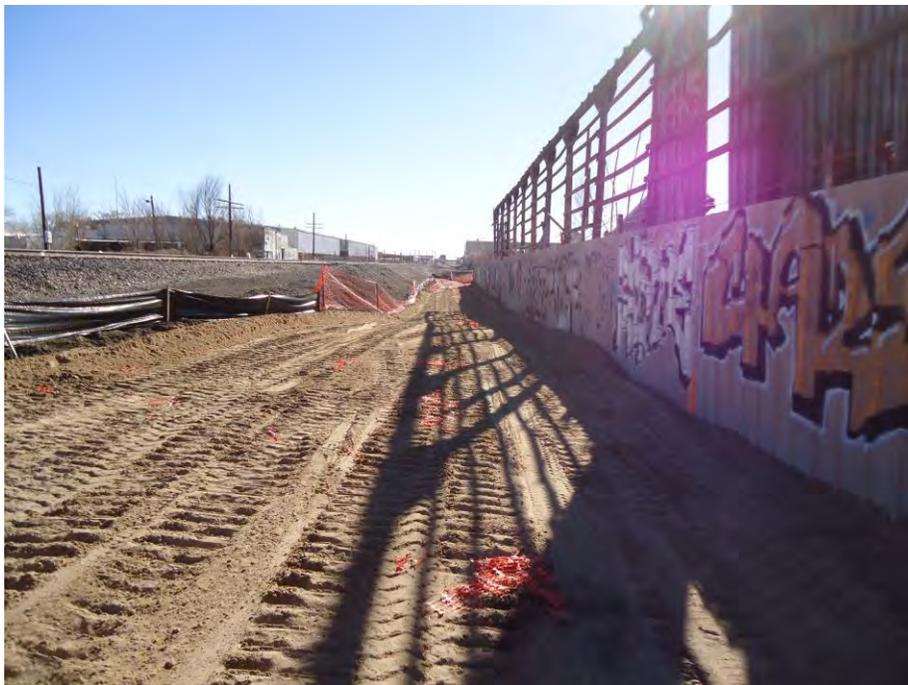
Photograph DSC00884: View looking south at initial layer of cover material placed in the southern portion of Area B. Additional cover material, compacting and grading still required.

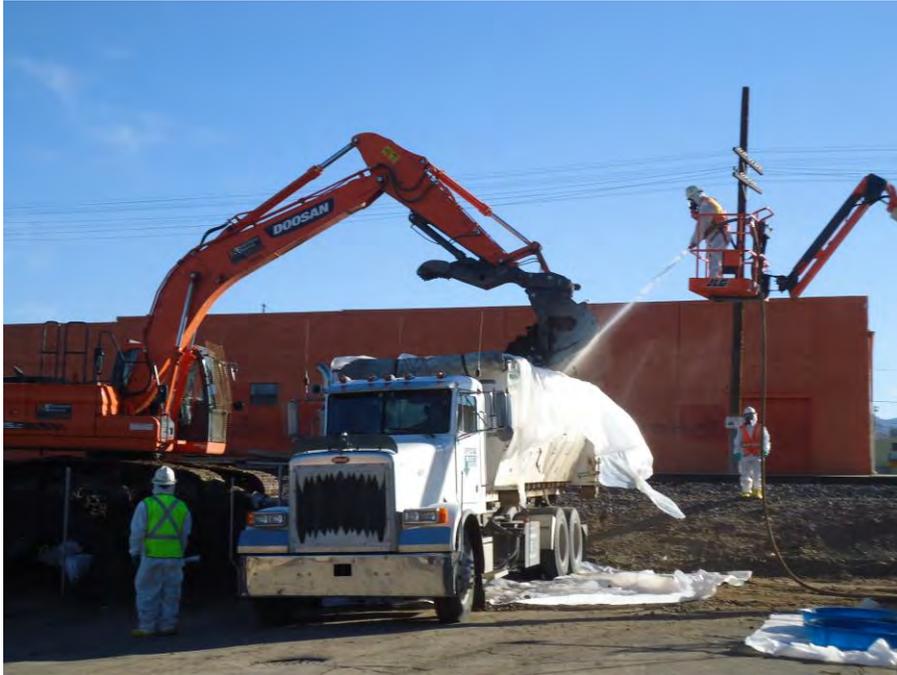
Photograph DSC00885: View looking east at truck loading in Area B. Dust suppression in progress.

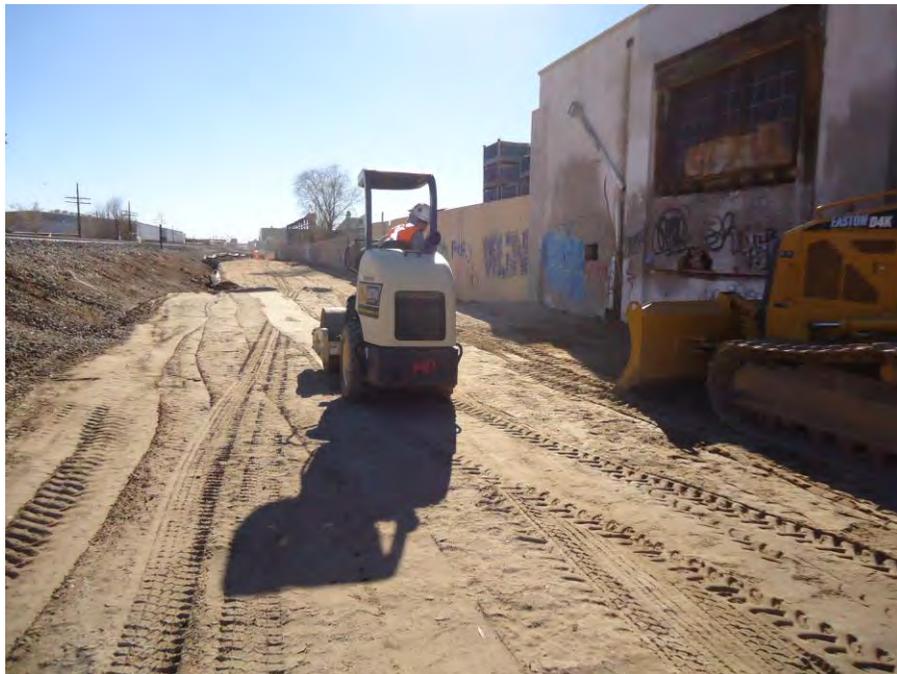
Photograph DSC00888: View looking south at compacting and grading of cover material placed in the northern portion of Area B.
