## Appendix D

# Daily Progress Reports

**Southwest Vermiculite (Phase II) – Removal Action  
Daily Progress Report  
November 5, 2013**

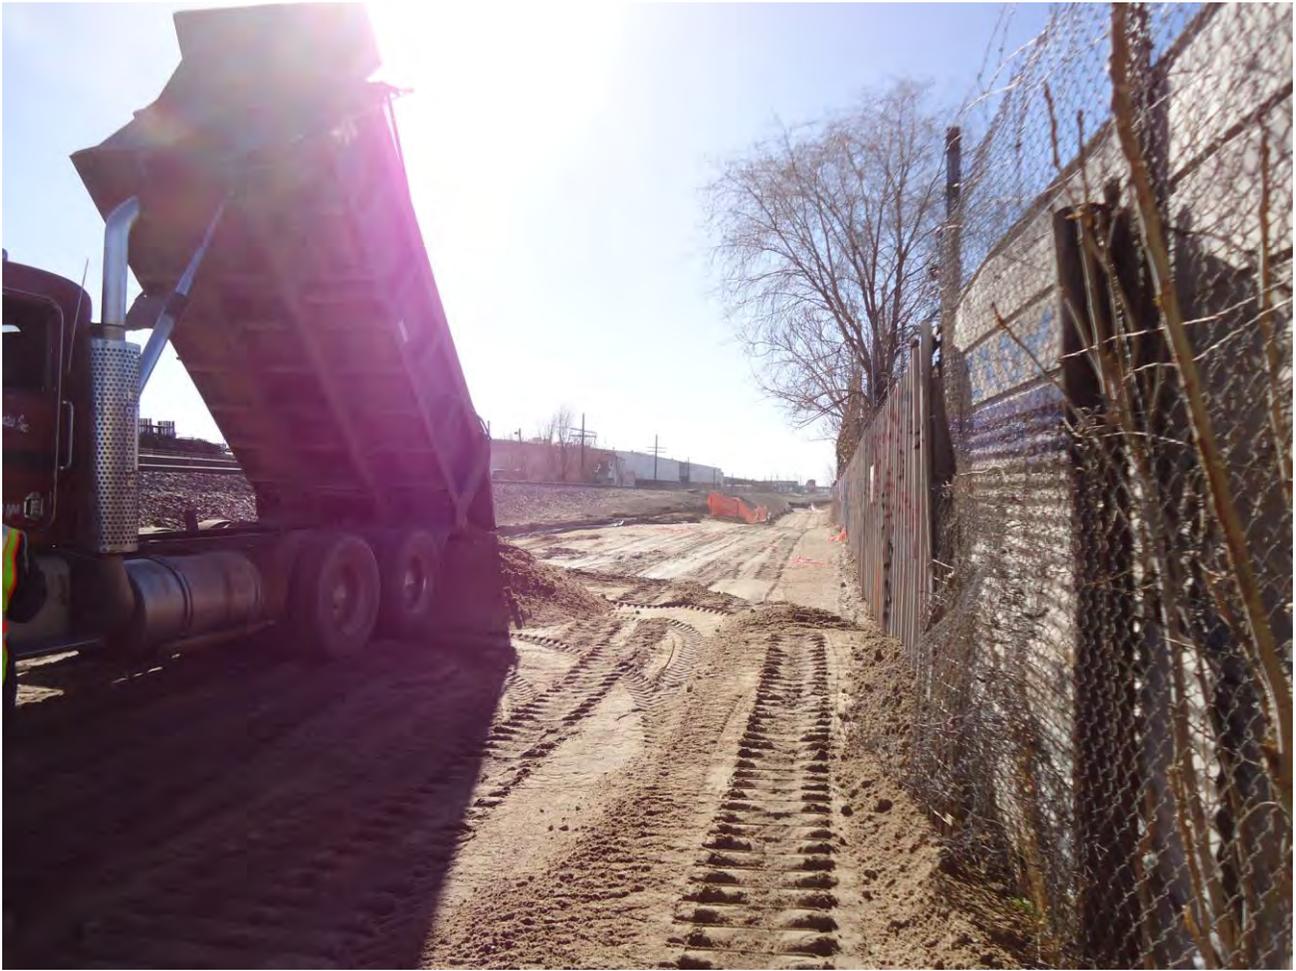
Photograph DSC00889: View looking south at truck dumping cover material in Area B.

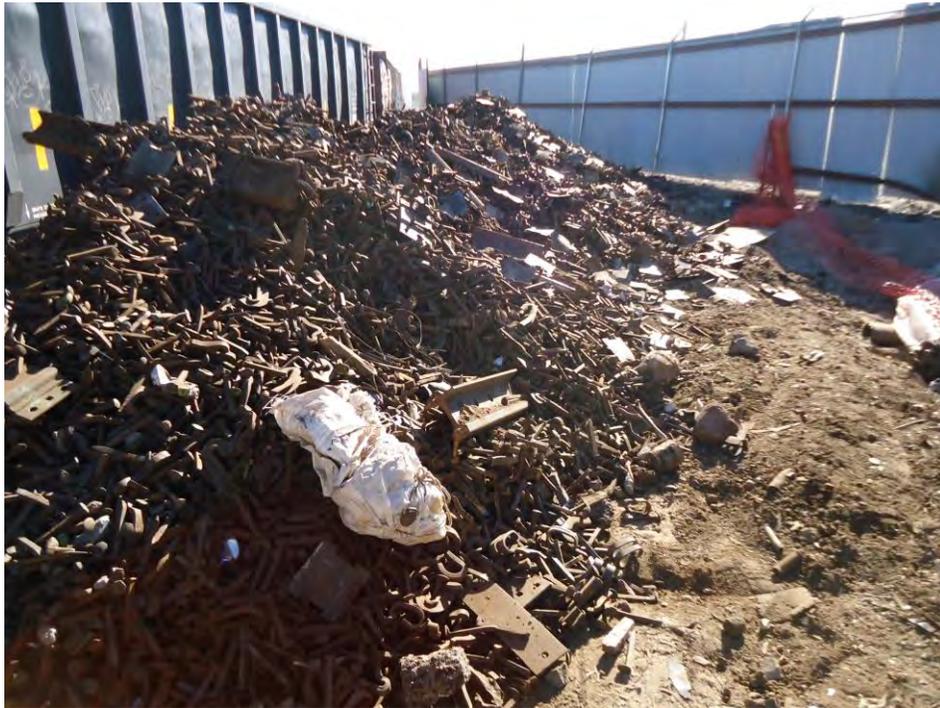
Photograph DSC00890: View looking south at scrap metal recently dumped onto the southwestern portion of Area A, Grid D.

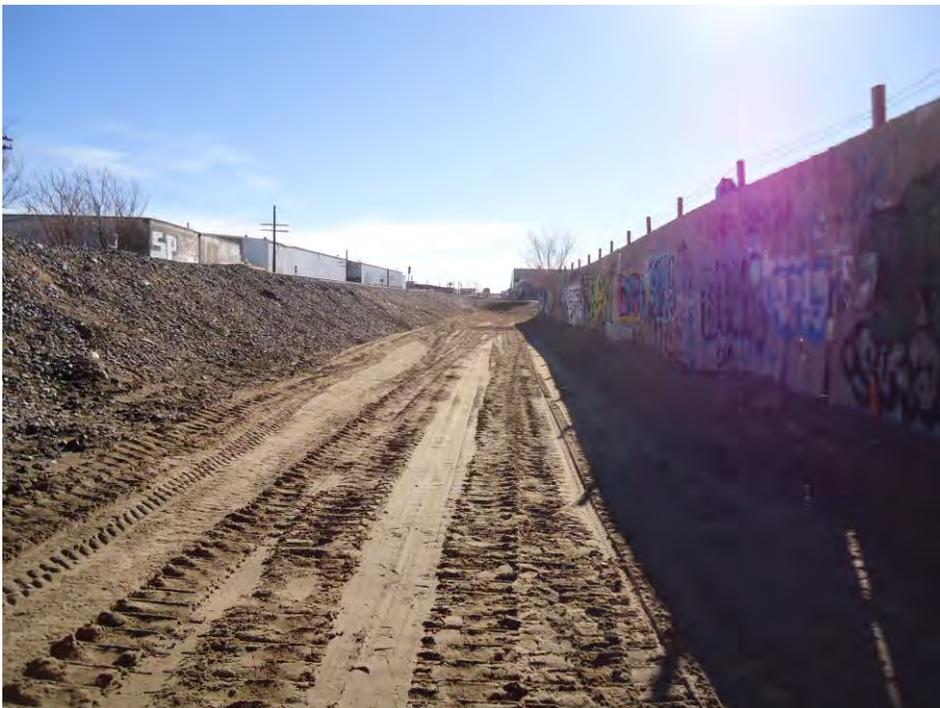
Photograph DSC00892: View looking south at Area B after cover material placed and graded.

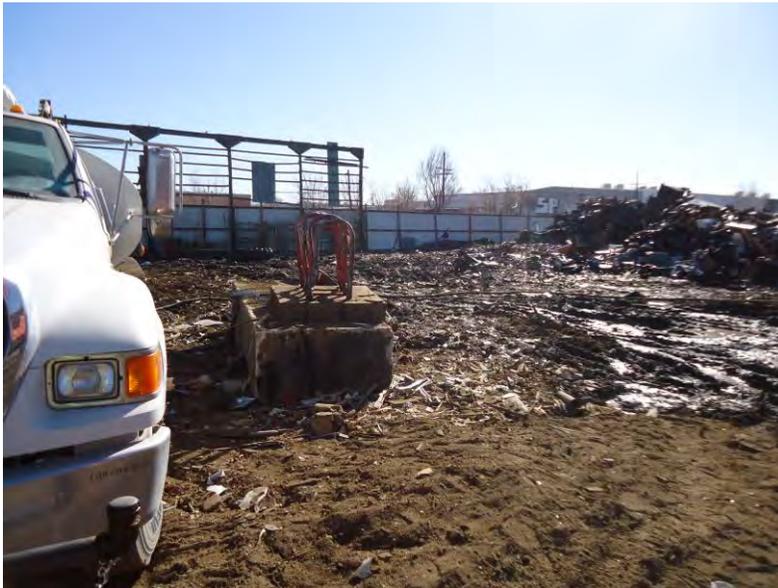
Photograph DSC00895: View looking southeast at Area A, Grid D east of the rail spur.

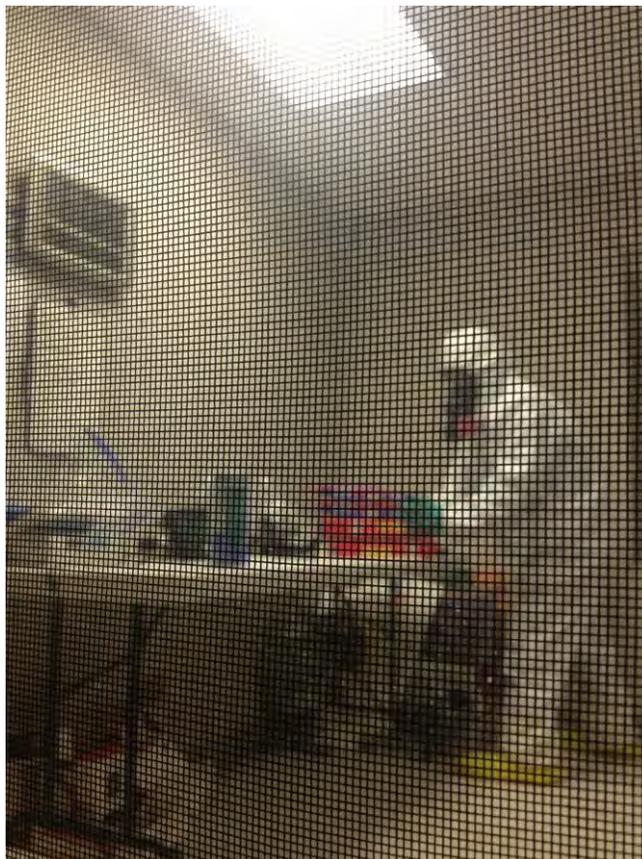
Photograph NB0004: View looking east into EPA Field Office Trailer as Decontamination is conducted.

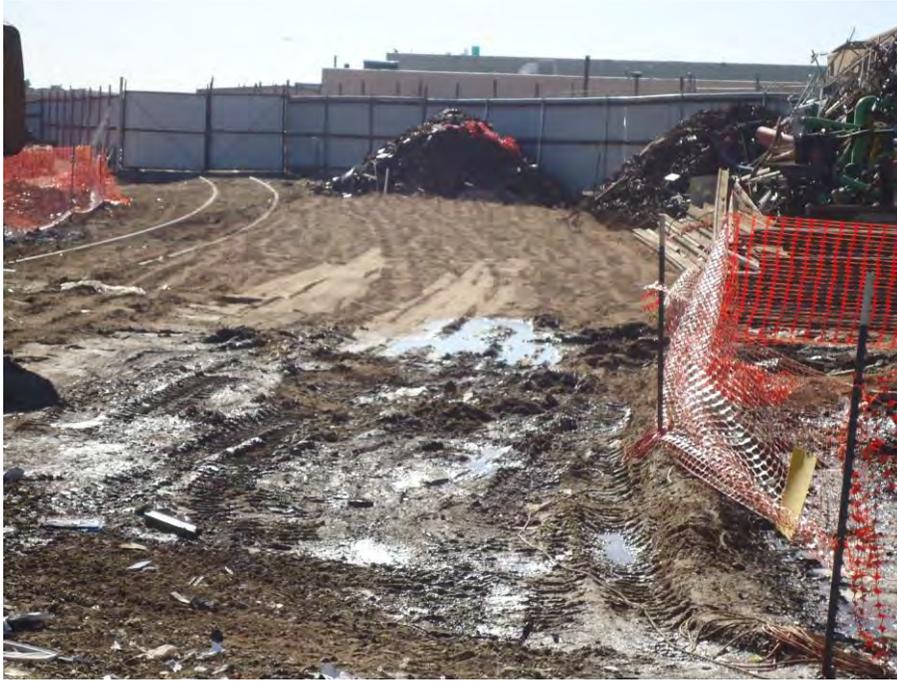
Photograph DSC00904: View looking south at Area A, Grid D west of the rail spur after excavation and placement of cover material.

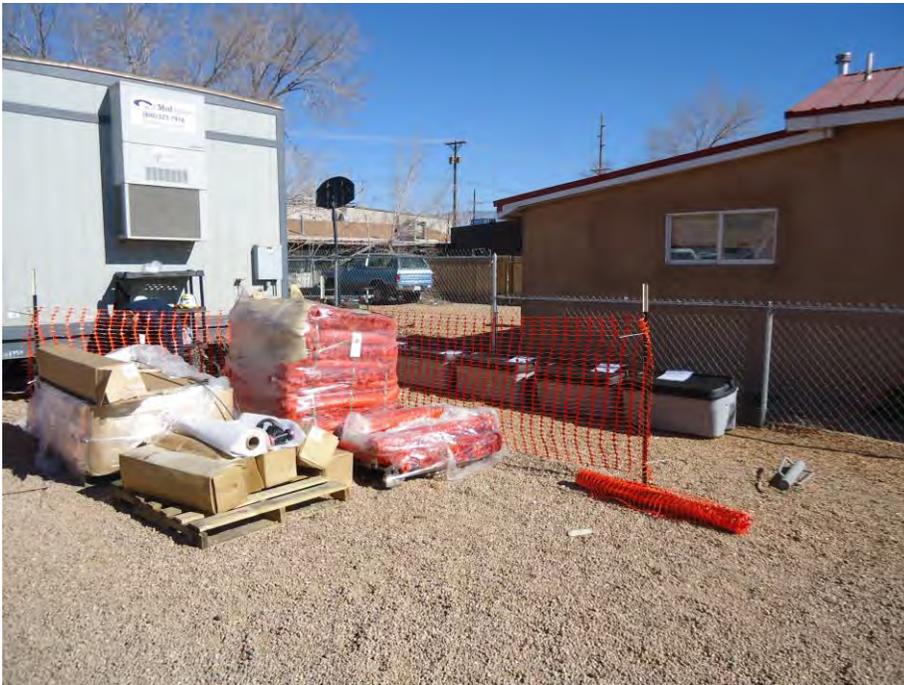
Photograph DSC00905: View looking northeast at decontamination and PPE staging area for the EPA Field Office Trailer.

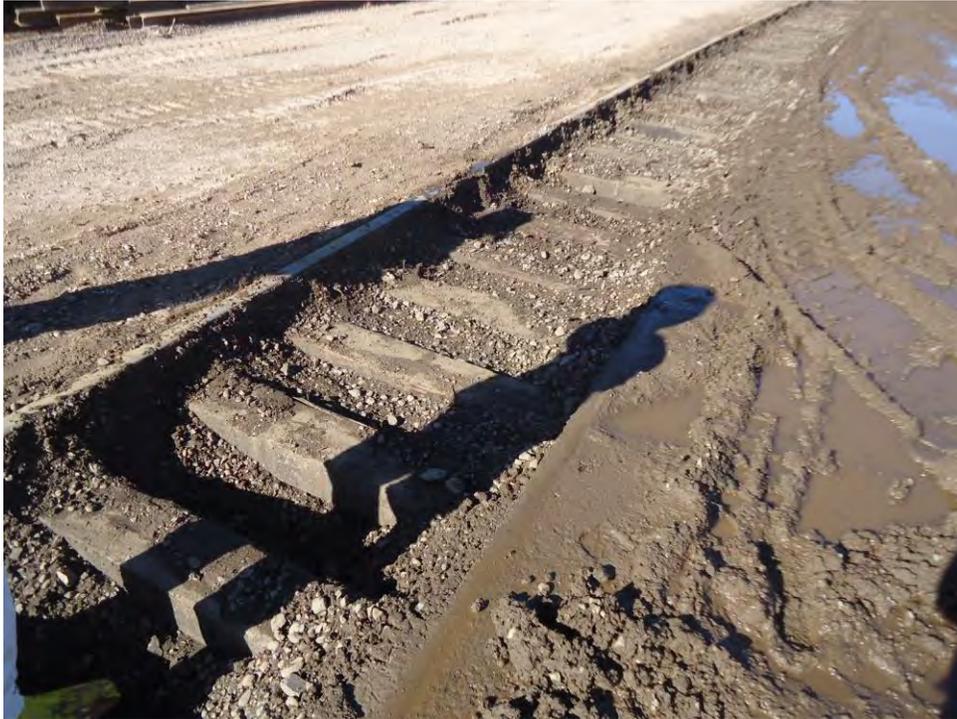
Photograph DSC00916: View looking north at excavated areas of W. Silver rail spur.

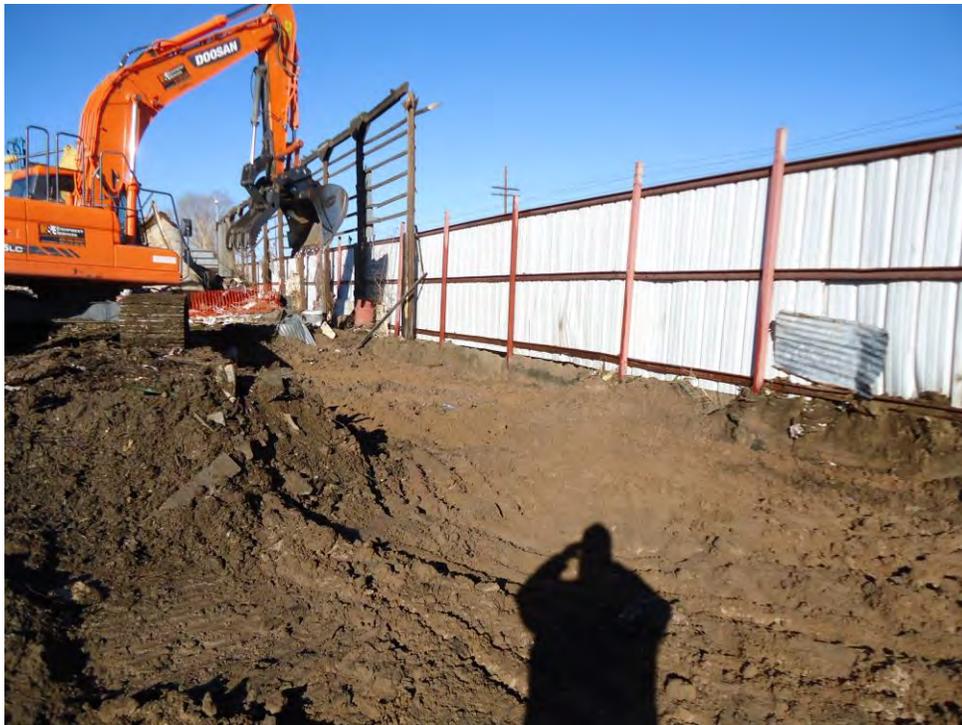
Photograph DSC00926: View looking northeast at excavation activities along Area A, Grid D fence line.  
Note saturated soil and removal of portions of historical (tall) wind fence.

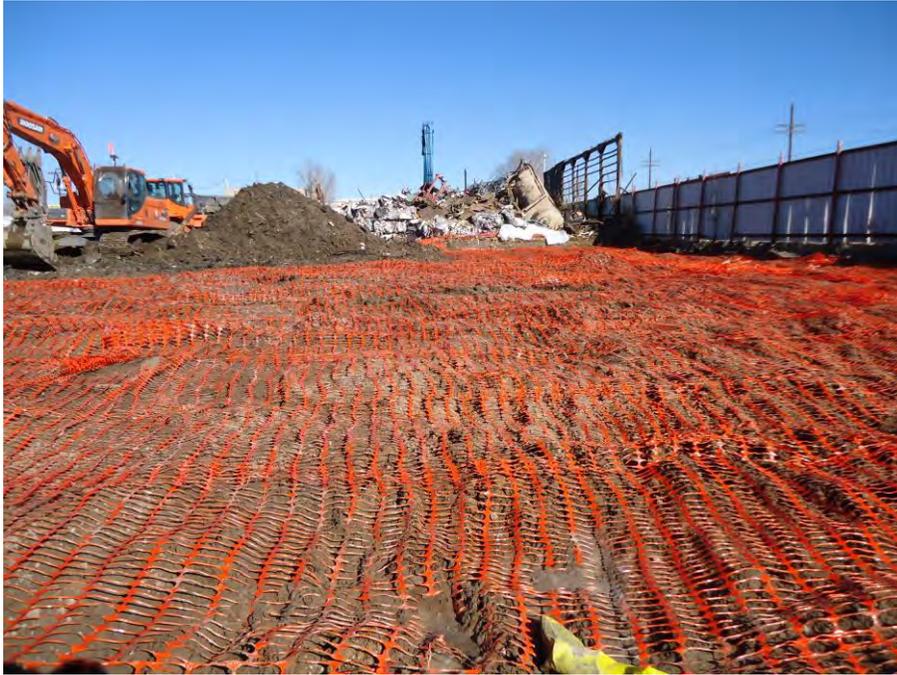
Photograph DSC00931: View looking north at excavated areas of W. Silver Area A, Grid D with barricade fencing in excavation base prior to placement of cover material.

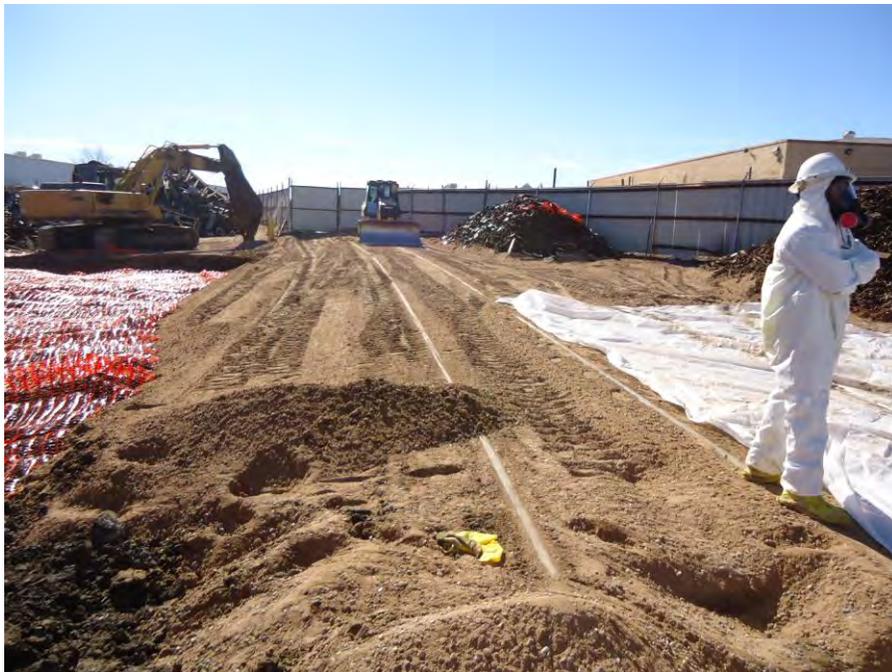
Photograph DSC00933: View looking south at Area A, Grids D and E along rail spur after initial placement and compaction of cover material.

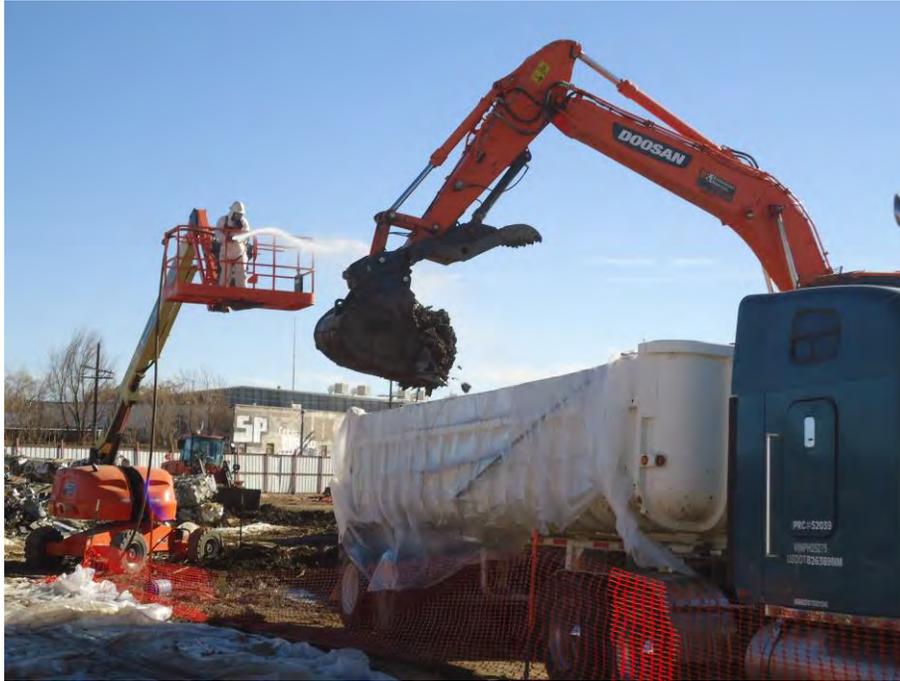
Photograph DSC00936: View looking southeast at loading operations from the stockpile on the W. Silver site.

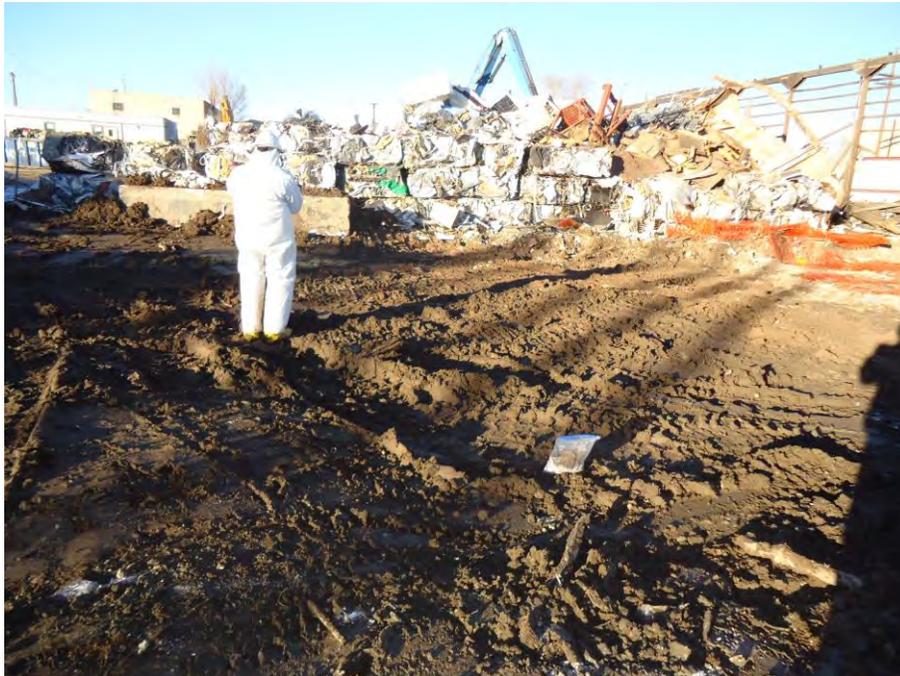
Photograph DSC00939: View looking north at sample within excavated area in northwest portion of Area A, Grids D.

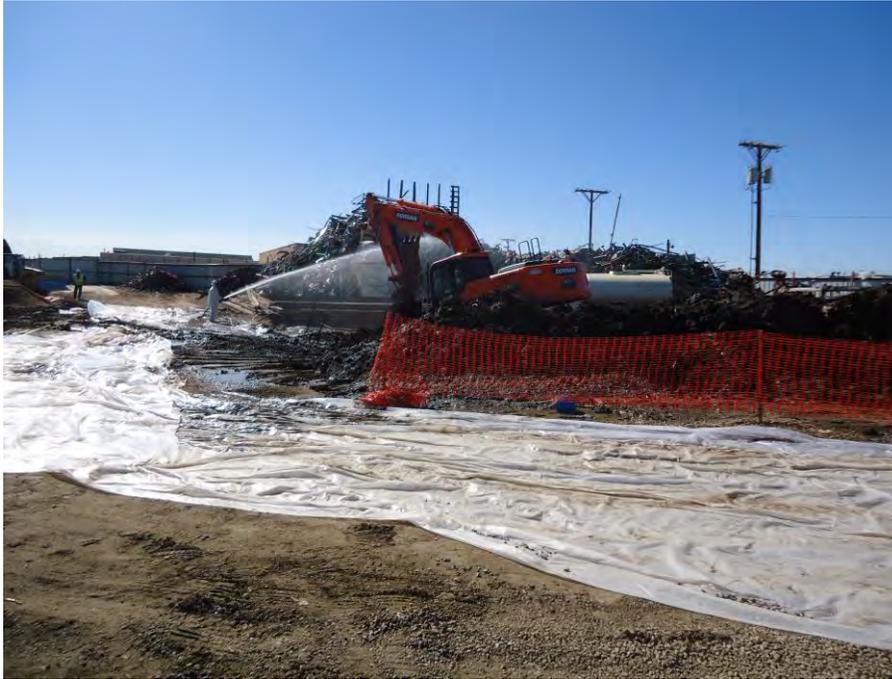
Photograph DSC00940: View looking south at loading operations from the stockpile on the W. Silver site. Poly layer is placed to allow truck with cover material to traverse to the Grid D area to dump.

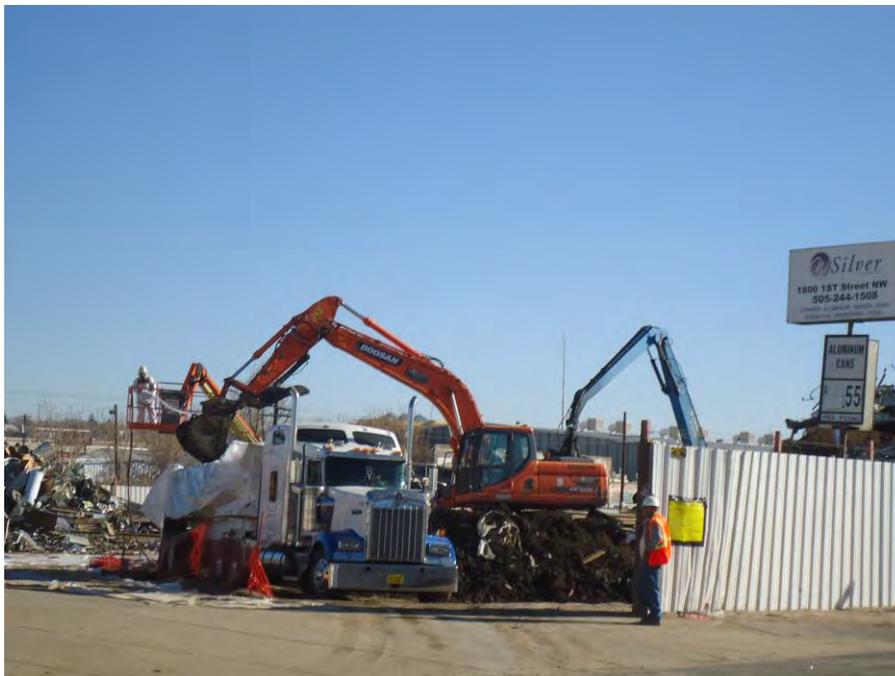
Photograph DSC00942: View looking southeast at loading operations from the W. Silver stockpile. Dust suppression in progress.

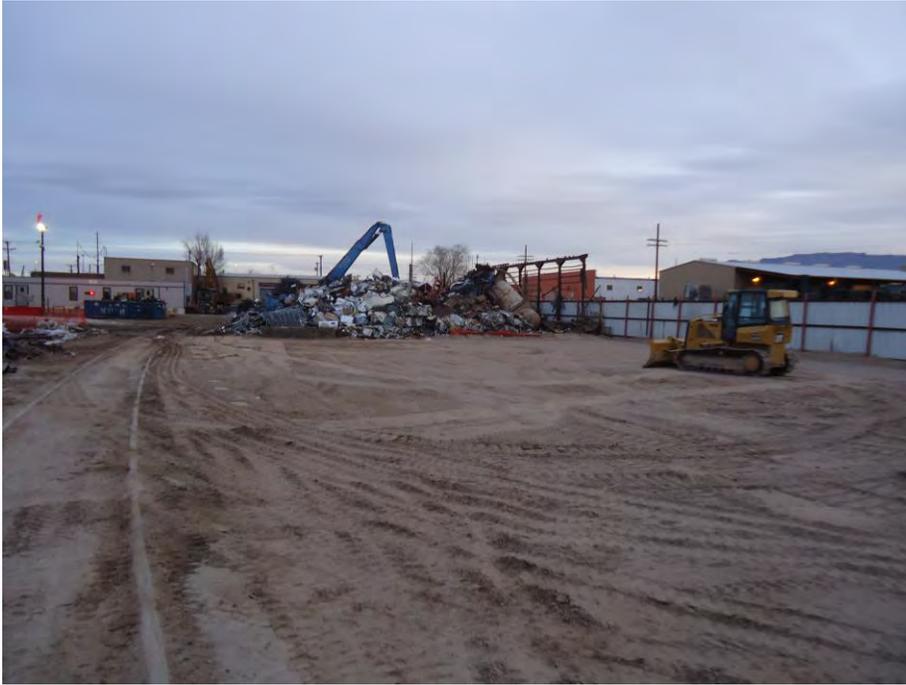
Photograph DSC00946: View looking north at completed Area A, Grid D.

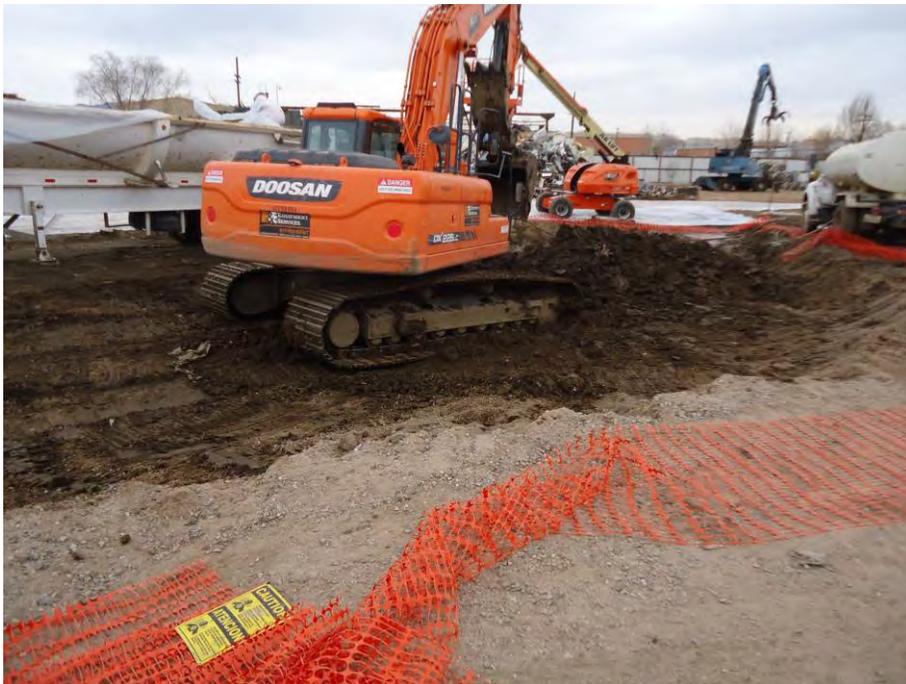
Photograph DSC00950: View looking east at loading operations and stockpile management at the W. Silver stockpile. Note current depth of approximately 30" bgs.

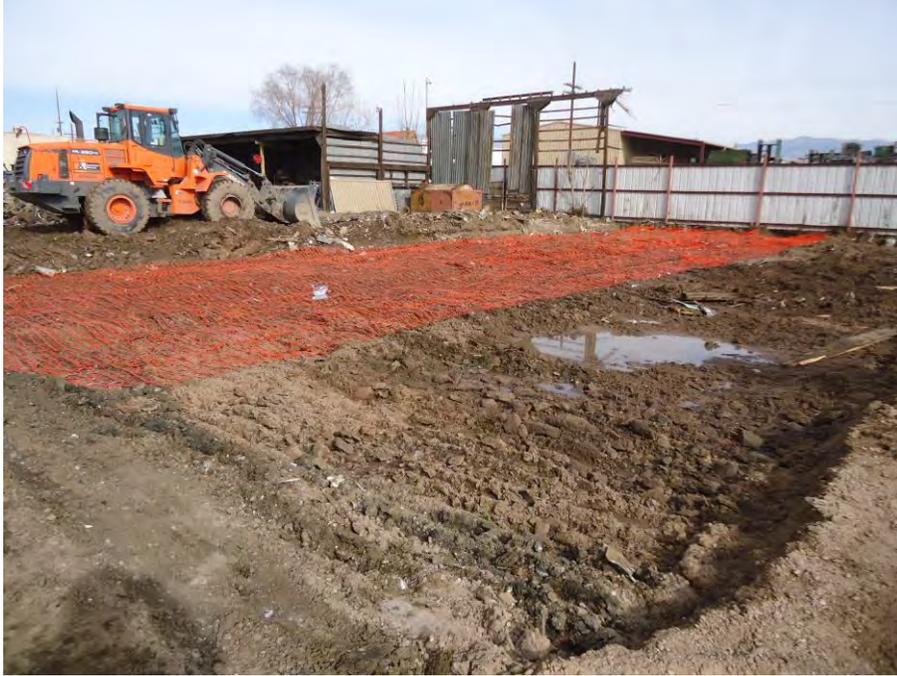
Photograph DSC00971: View looking northeast at confirmation sample in the excavated area of the southern portion of Area A, Grid C.

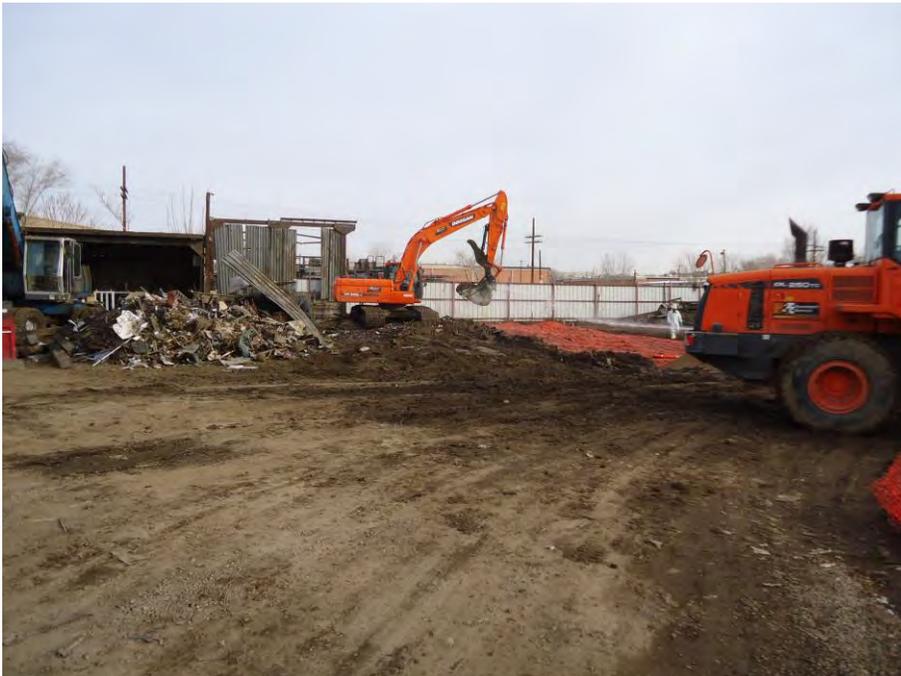
Photograph DSC00973: View looking southeast at excavation activities within the northern portion of Area A, Grid C. Dust suppression in progress.

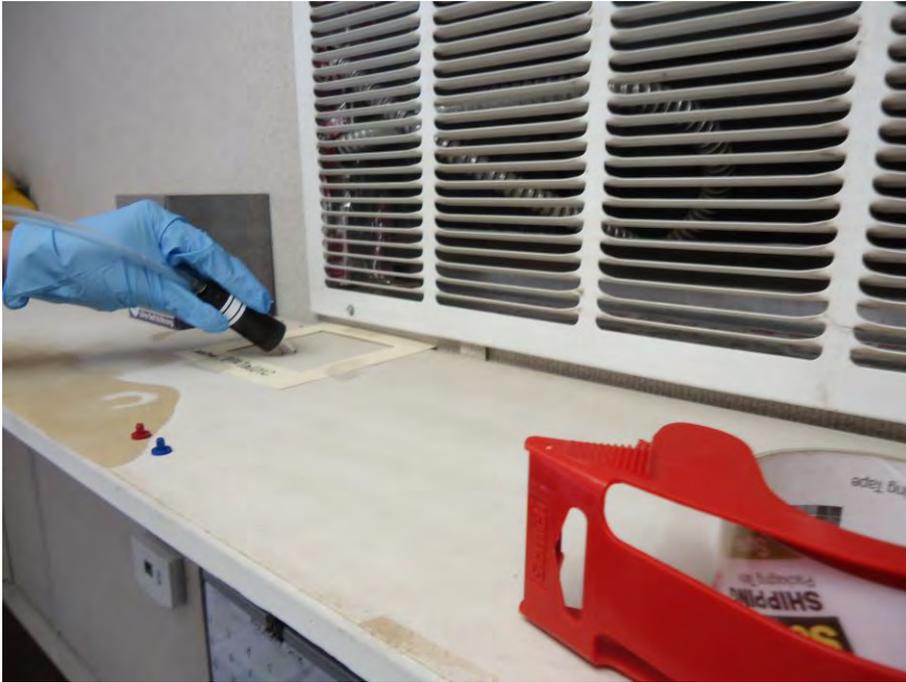
Photograph DSC00951: View looking southeast within the EPA Office Trailer at Dust sampling being collected to assess/confirm the trailer decontamination activities conducted the prior week.

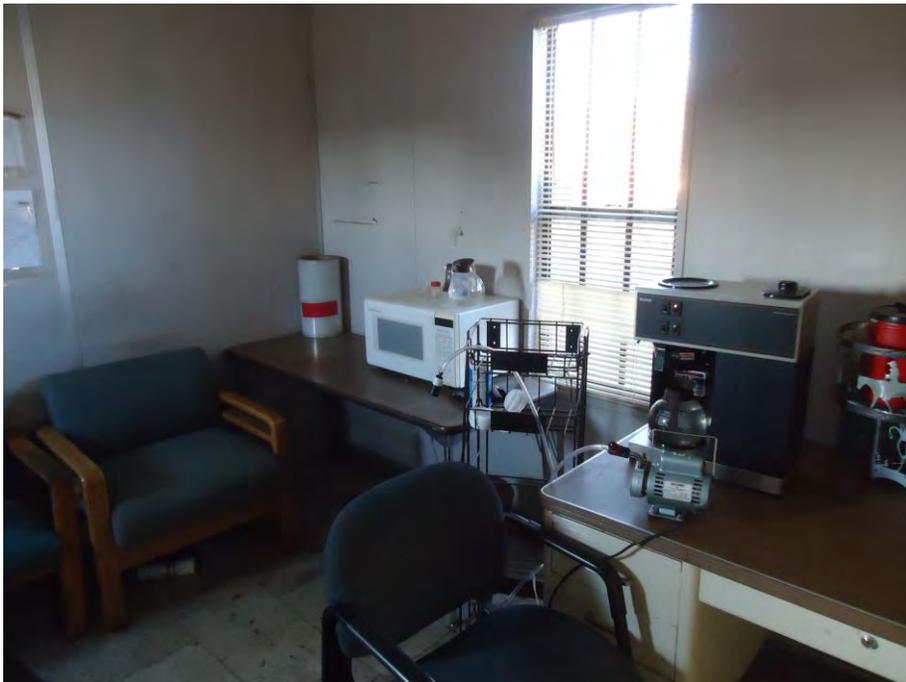
Photograph DSC00963: View looking northwest within the W. Silver Scale House trailer at the Air Sample being collected near the location of recent dust samples with elevated levels of Libby Amphibole.

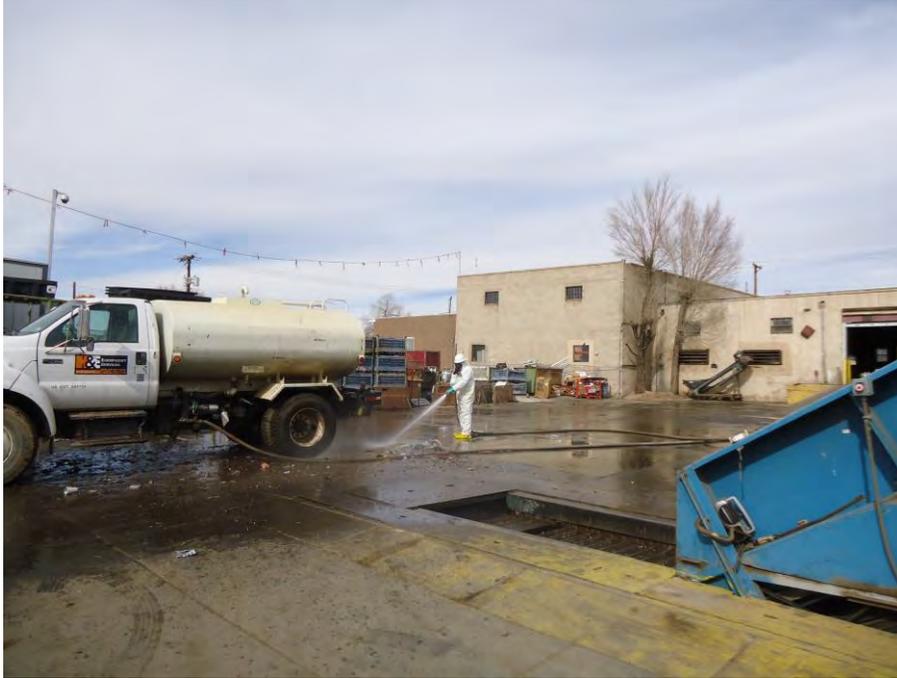
Photograph DSC00978: View looking northwest at ERRS power washing concrete pad between the W. Silver warehouse and the scrap yard area.

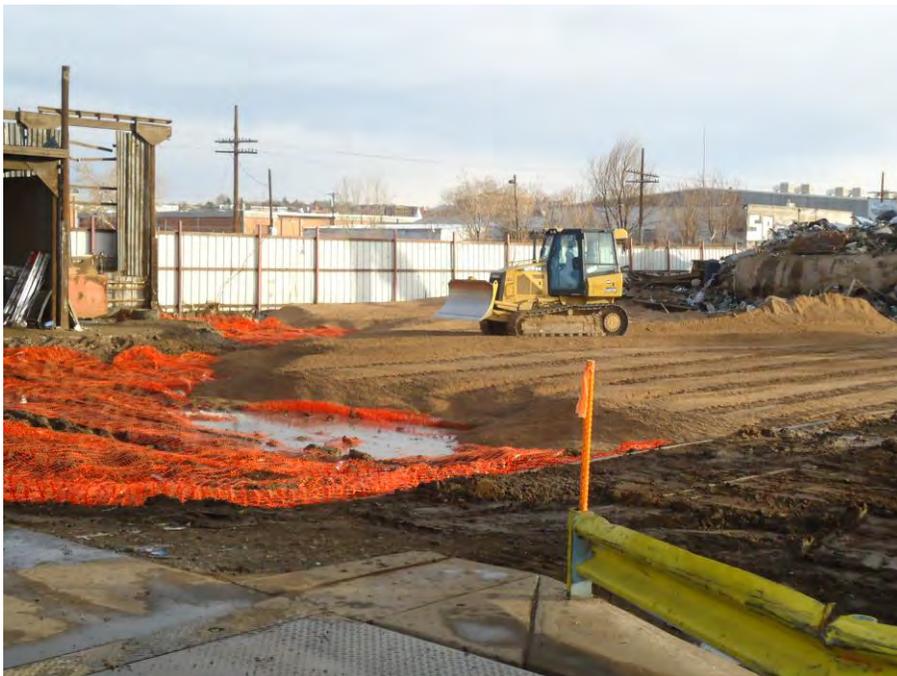
Photograph DSC00983: View looking southeast at grading activities within the northern portion of Area A, Grid C.

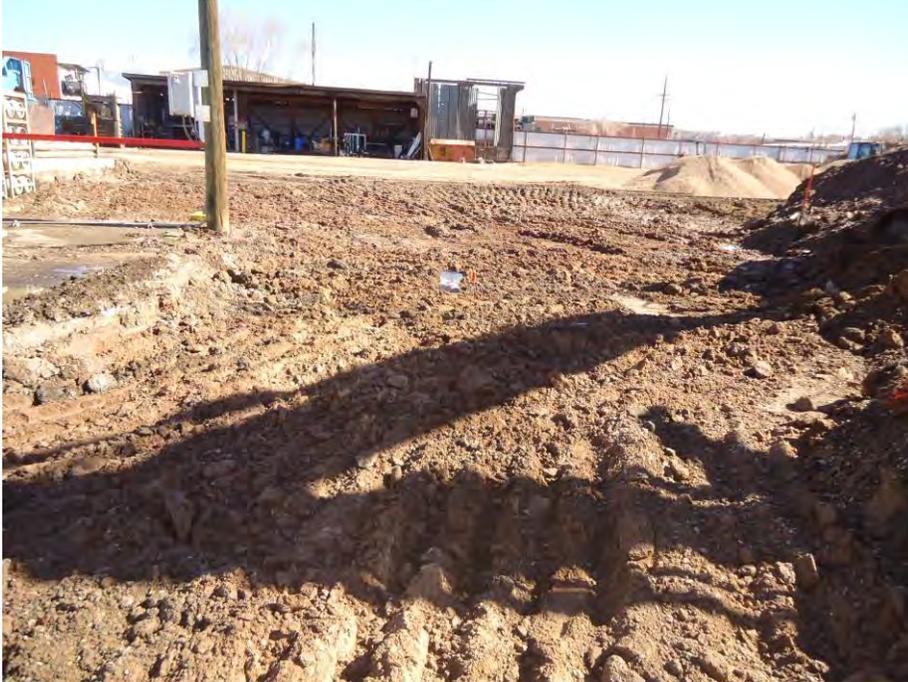
Photograph DSC00992: View looking southeast at excavated area in the northern portion of Area A, Grid A prior to placement of orange barricade fencing in base of excavation and placement of cover material.

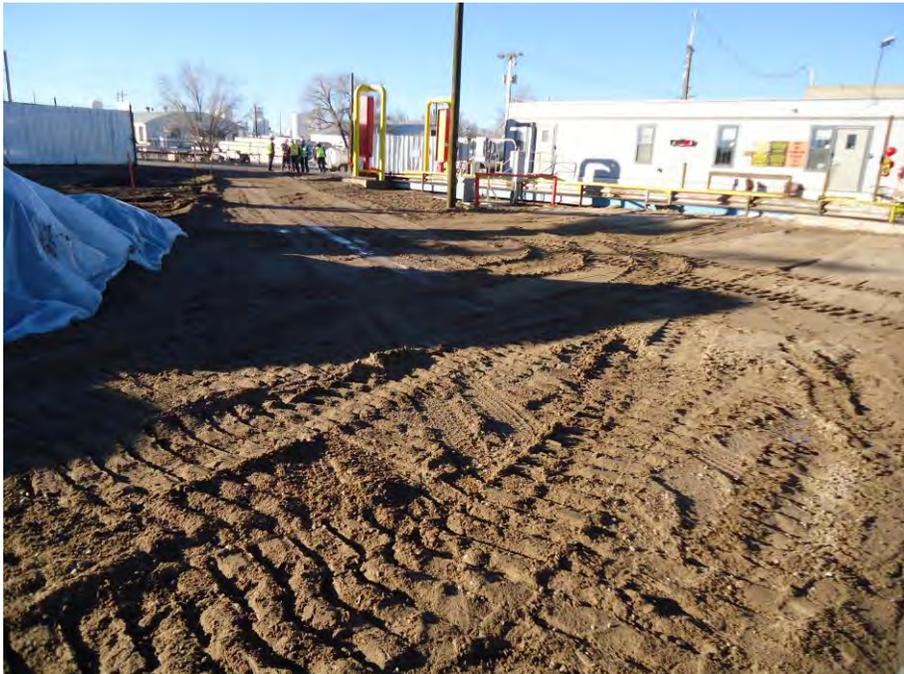
Photograph DSC01001: View looking northwest northern portion of Area A, Grid A after (partial) placement, compaction and grading of cover material.

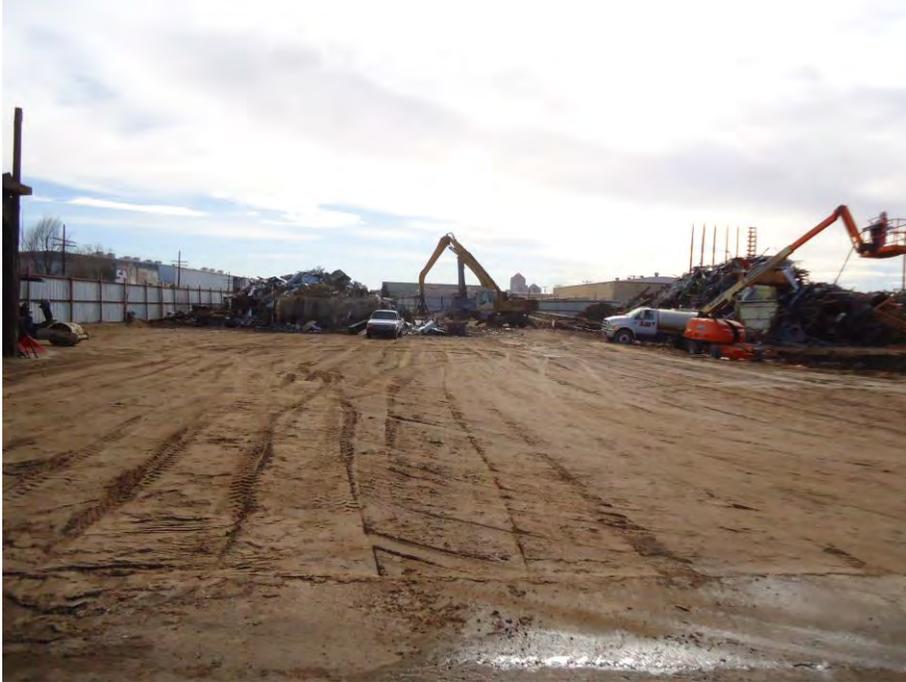
Photograph DSC01005: View looking south at Area A, Grid C following placement of cover material. Grading and compaction ongoing.

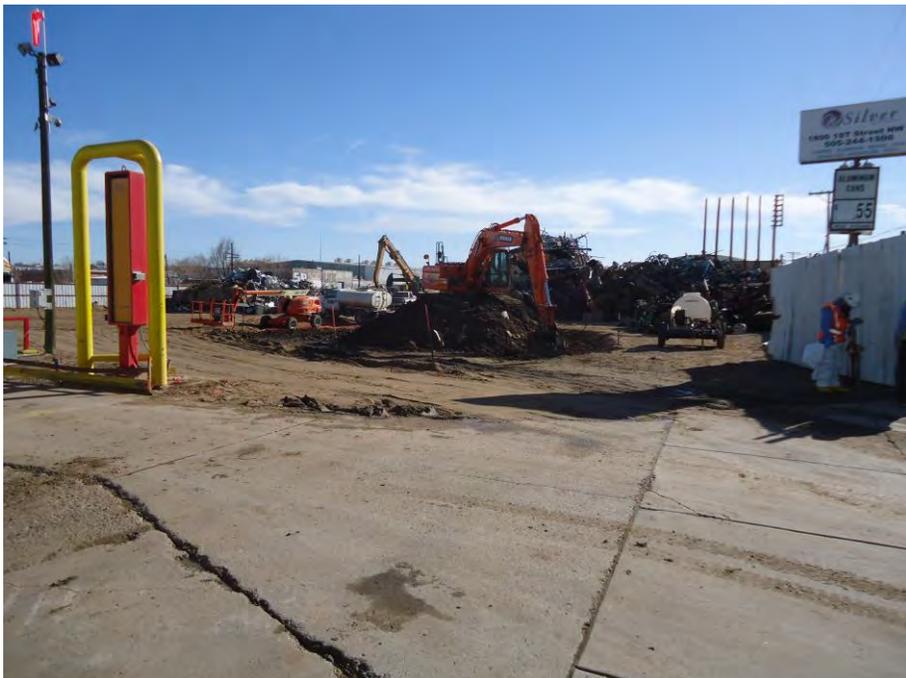
Photograph DSC01008: View looking southeast at remaining soil stockpile in middle/central portion of Area A, Grid A.

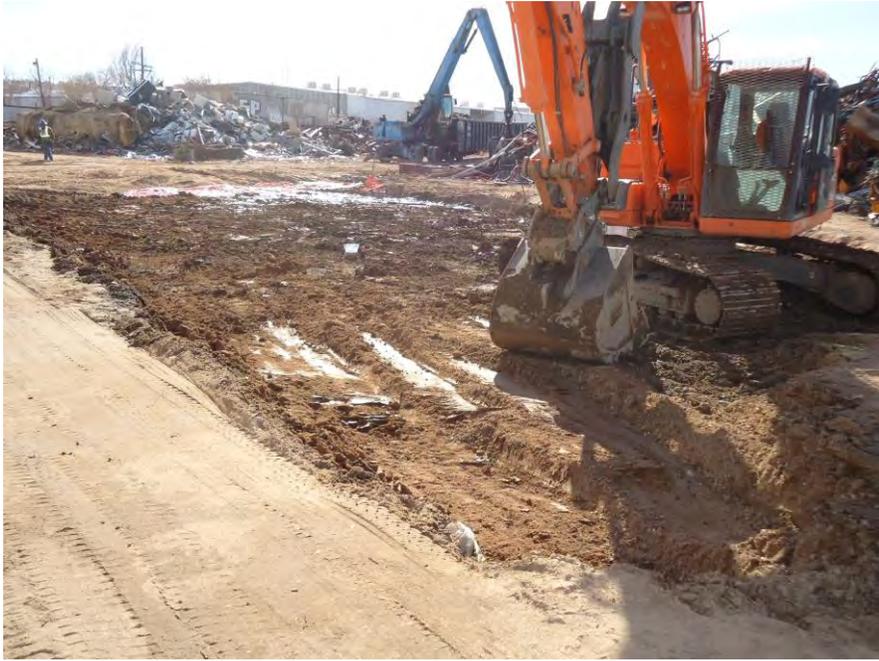
Photograph DSC01015: View looking southeast at excavated area in the central portion of Area A, Grid A following collection of the soil confirmation sample.

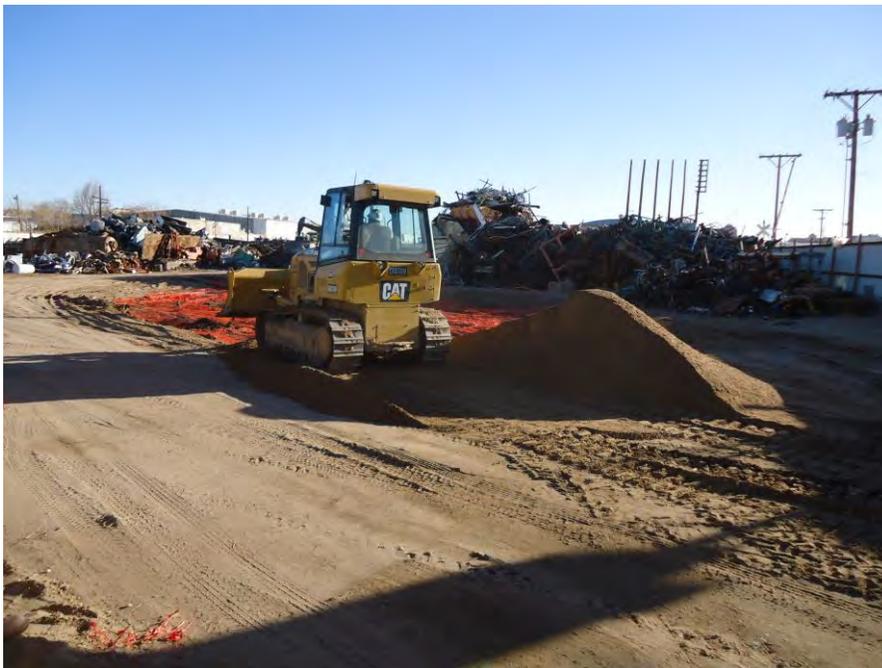
Photograph DSC01018: View looking southeast at remaining placement, compaction and grading of cover material in the area of the (former) soil stockpile in Area A, Grid A.

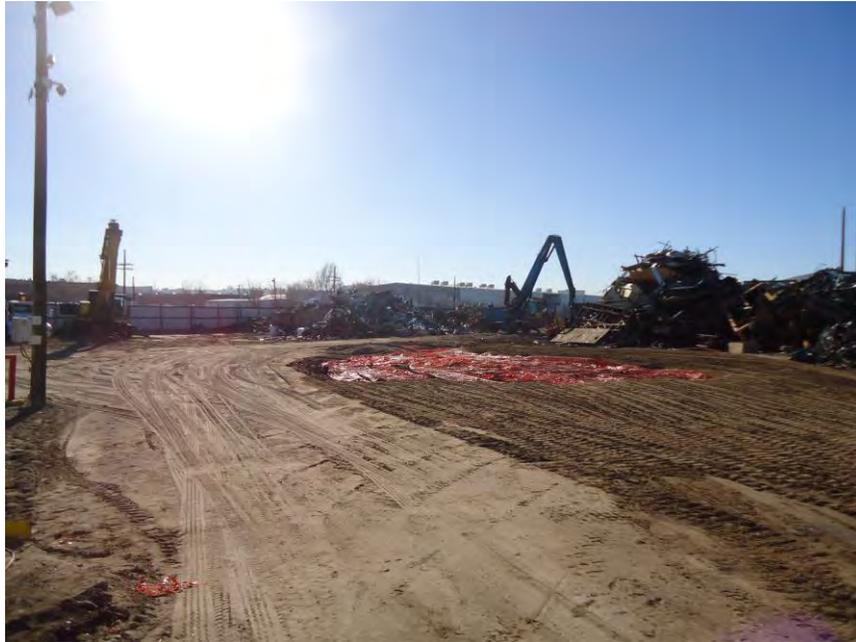
Photograph DSC01021: View looking southeast at main scrap yard area and ongoing placement of cover material in Area A, Grid A.

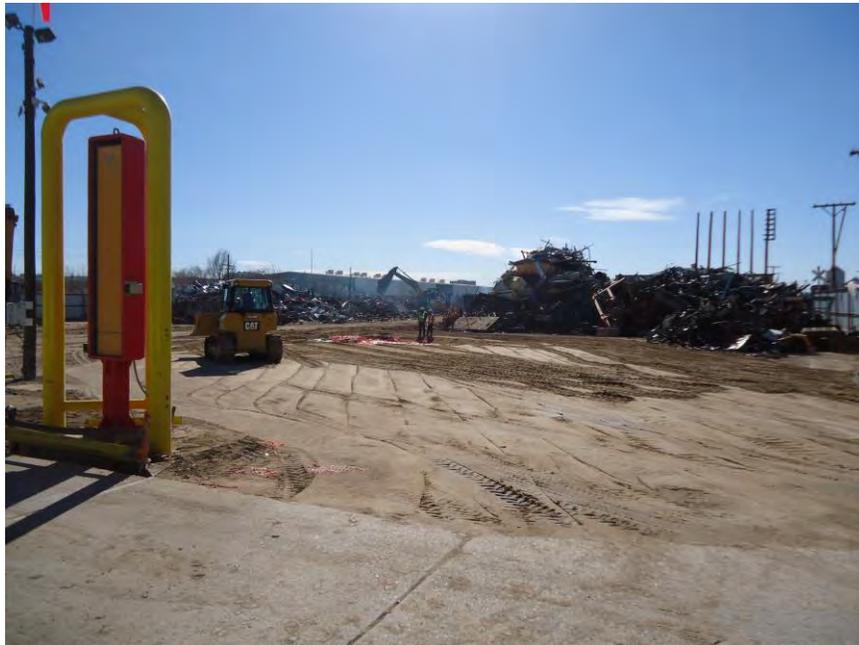
Photograph DSC01022: View looking south at final remaining placement, compaction and grading of cover material in the area of the (former) soil stockpile in Area A, Grid A.

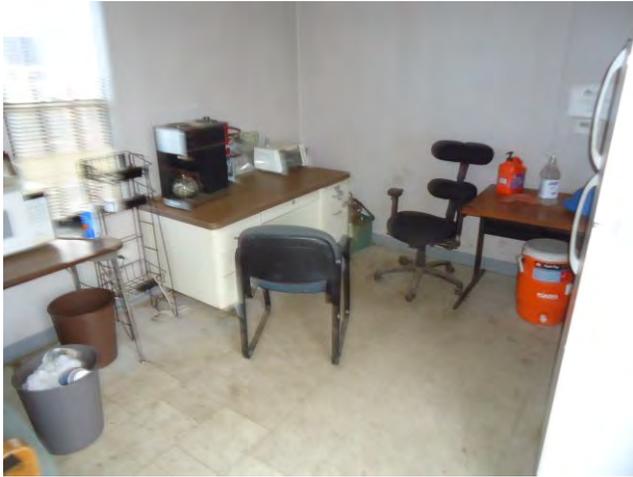
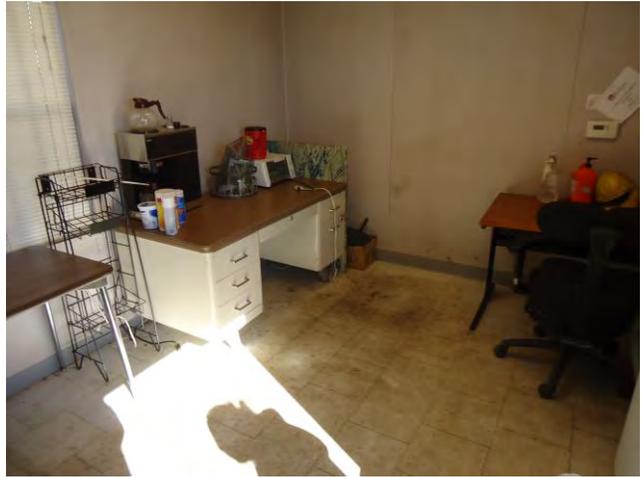
Photographs DSC01033 (Before) and DSC01058 (After): Scale trailer break room.

- a. Site Progress Made: ERRS coordinated the activities of Southwest Hazard Control (SHC) during the Decontamination and Abatement activities in the W. Silver Scale trailer. ERRS coordinated placement, compaction and grading of additional cover material in the southeast portion Area A, Grid A due to excess water and lack of stability with heavy loads resulting in rutting during unloading operations. ERRS received approval from the City of Albuquerque Air Department to waive of the 10-day advance notification period for conducting asbestos Abatement work.

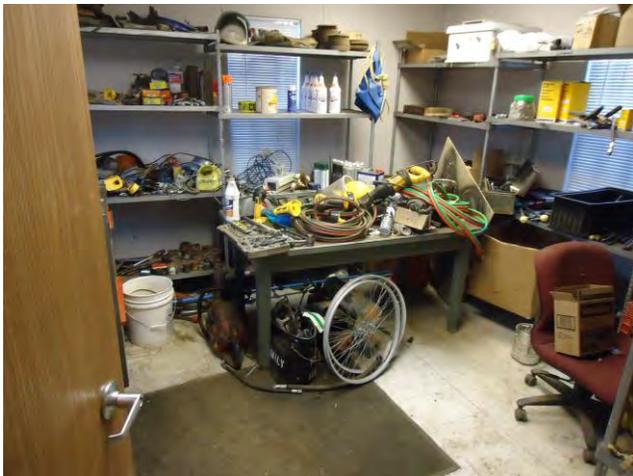
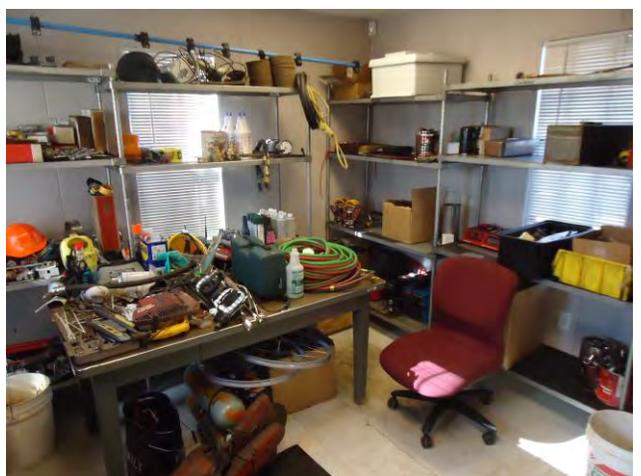
Photographs DSC01036 (Before) and DSC01061 (After): Scale trailer tool room.

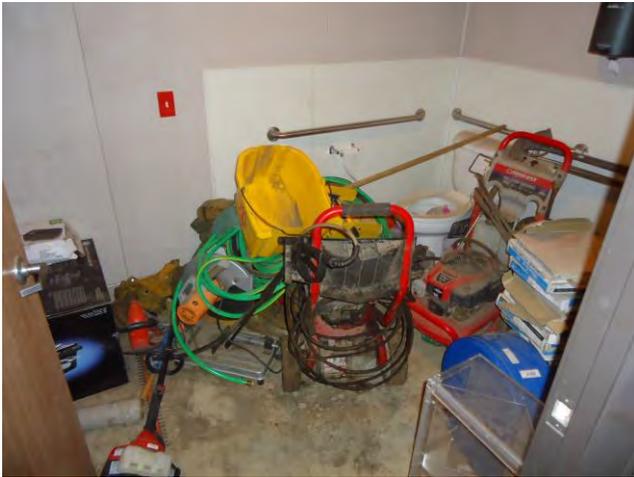
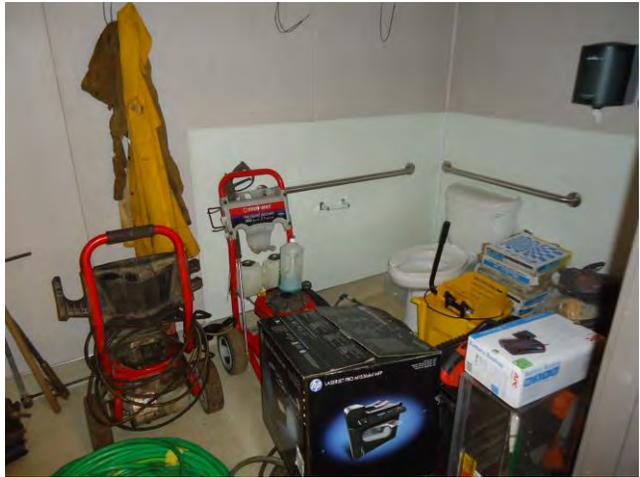
Photographs DSC01037 (Before) and DSC01060 (After): Scale trailer bath/storage room.

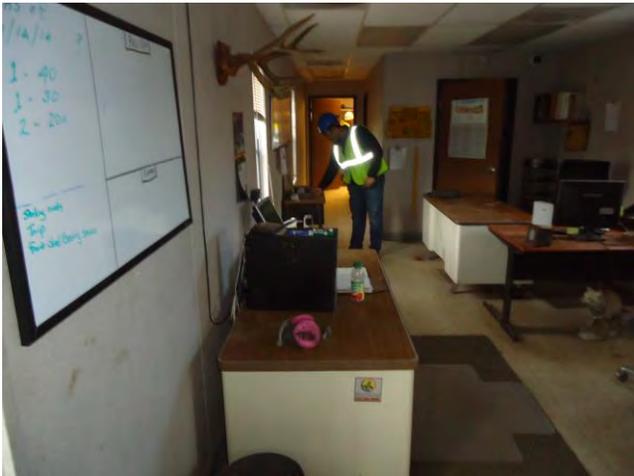
Photographs DSC01035 (Before) and DSC01056 (After): Scale trailer main room.
