## Appendix D

# Daily Progress Reports

**Southwest Vermiculite (Phase II) – Removal Action  
Daily Progress Report  
November 5, 2013**

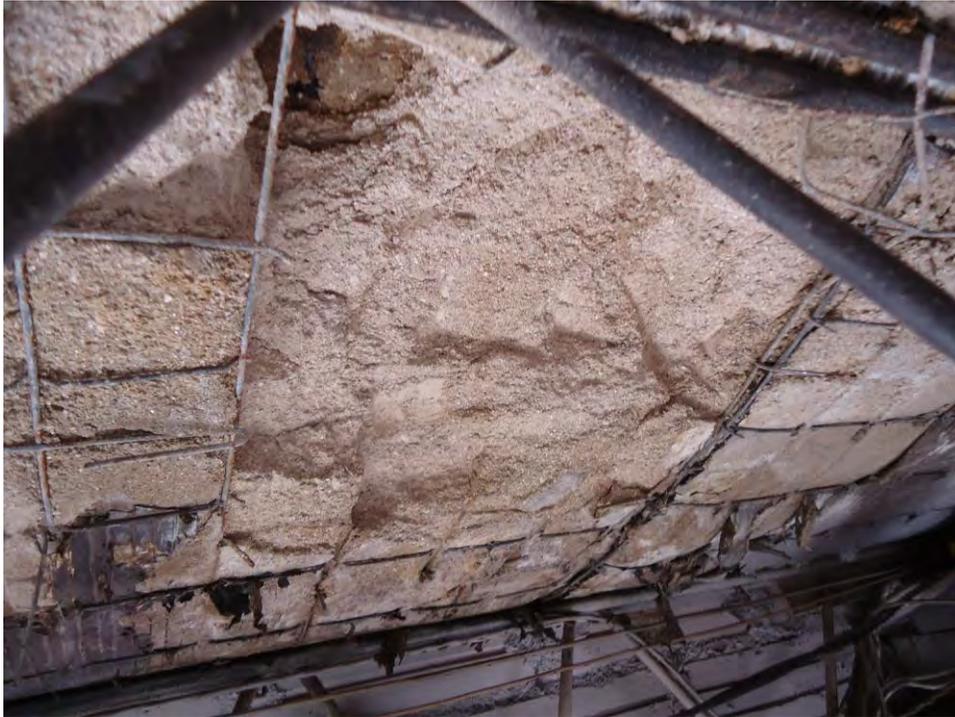
Photograph DSC01108: Close view of degraded ceiling insulation/tiles in the Main W. Silver Warehouse. Degraded areas prepped to assure adequate bonding with (Asbestos-Safe) Encasement material.

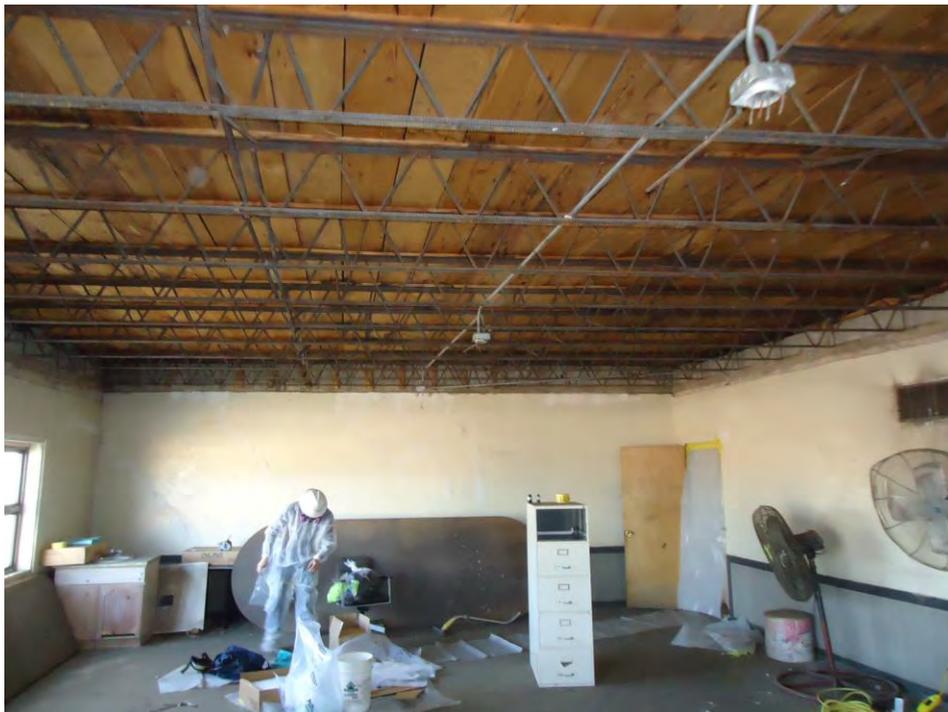
Photograph DSC01114: View of main portion of loft area above W. Silver's Main Offices in advance of Abatement/Decontamination activities.

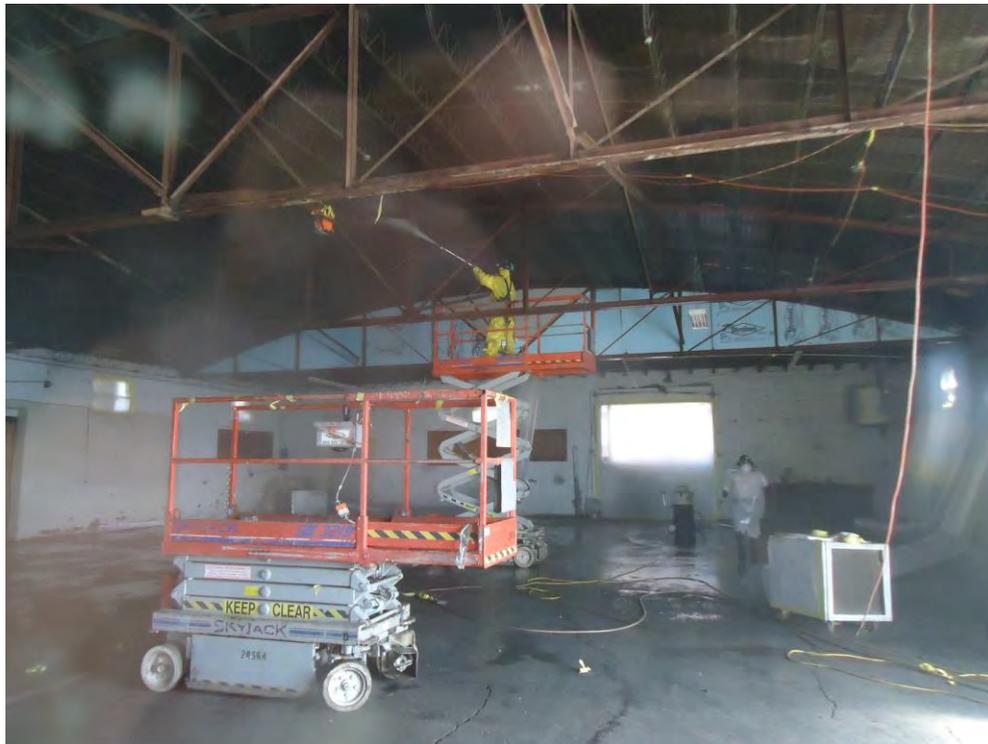
Photograph DSC01124: View (from view port) of Decontamination/Abatement activities in the eastern portion of the Main W. Silver Warehouse.

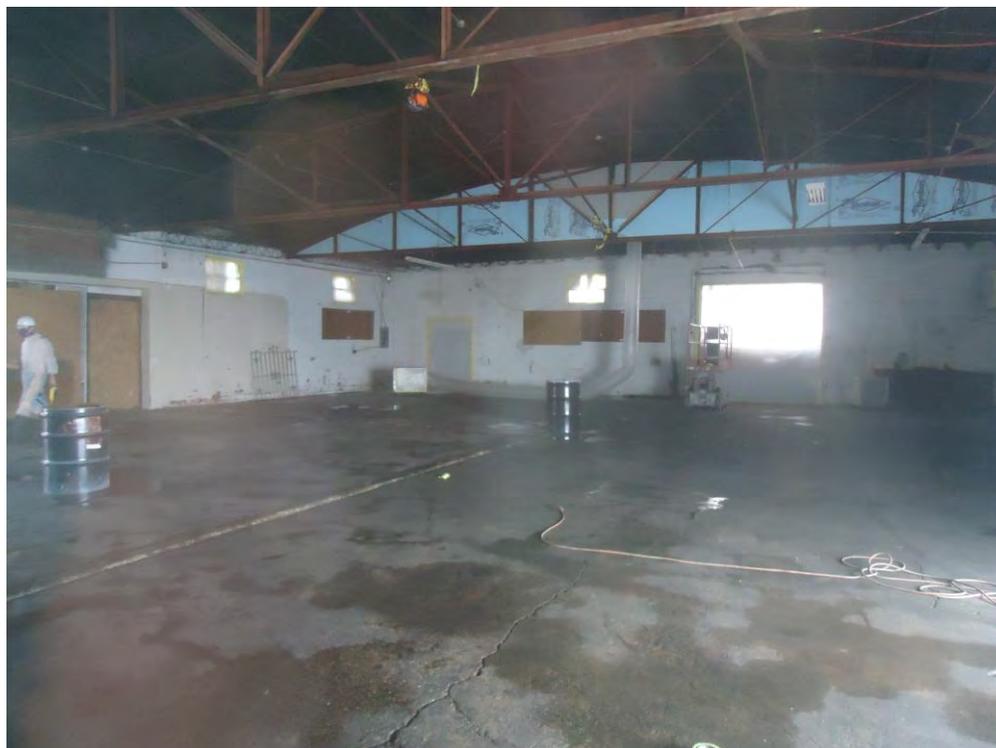
Photograph DSC01126: View of eastern portion of Main W. Silver Warehouse following Decontamination/Abatement activities.

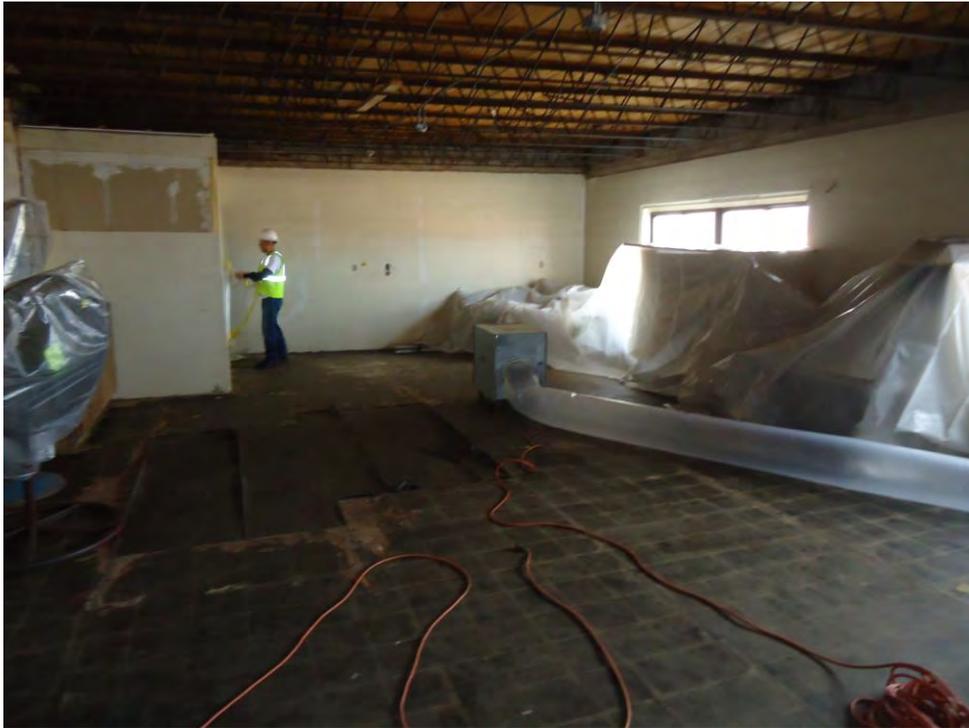
Photograph DSC01128: View of W. Silver loft area after Decontamination/Abatement completed and “clearance” received.

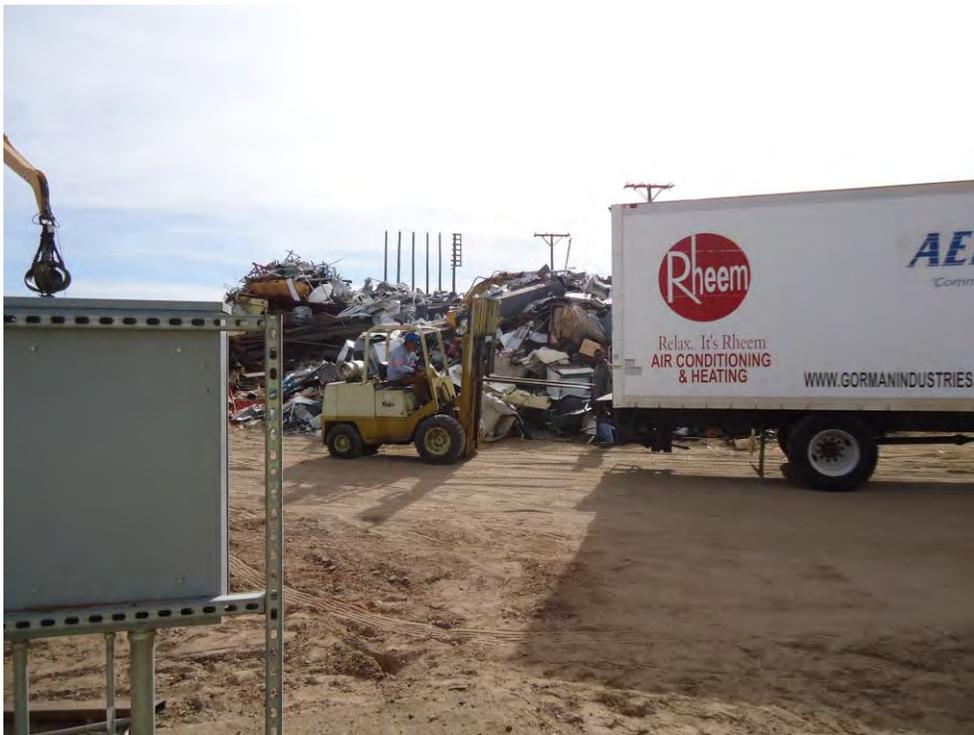
Photograph DSC01141: South view of forklift operating ON the soil in Area A, Grid A of the W. Silver scrap yard.
