Subject: Assessment Letter Report, Revision 1
Francis Street Site
Waycross, Ware County, Georgia
EPA Contract No. EP-W-05-054
TDD No. TTEMI-05-003-0168

The Tetra Tech Superfund Technical Assessment and Response Team (START) is submitting this letter report summarizing assessment activities conducted on December 19, 2013 at the Francis Street Site in Waycross, Ware County, Georgia. This report incorporates revisions based on comments made on the letter report submitted April 3, 2014. This report contains six enclosures. Enclosure 1 contains figures depicting the Site and sampling locations. Enclosure 2 contains tables presenting the analytical results for soil and sediment samples collected during field activities. Enclosure 3 contains the photographic log. Enclosure 4 provides the Tetra Tech START field logbook notes. Enclosure 5 provides the analytical data package. Enclosure 6 provides the Tetra Tech data validation report.

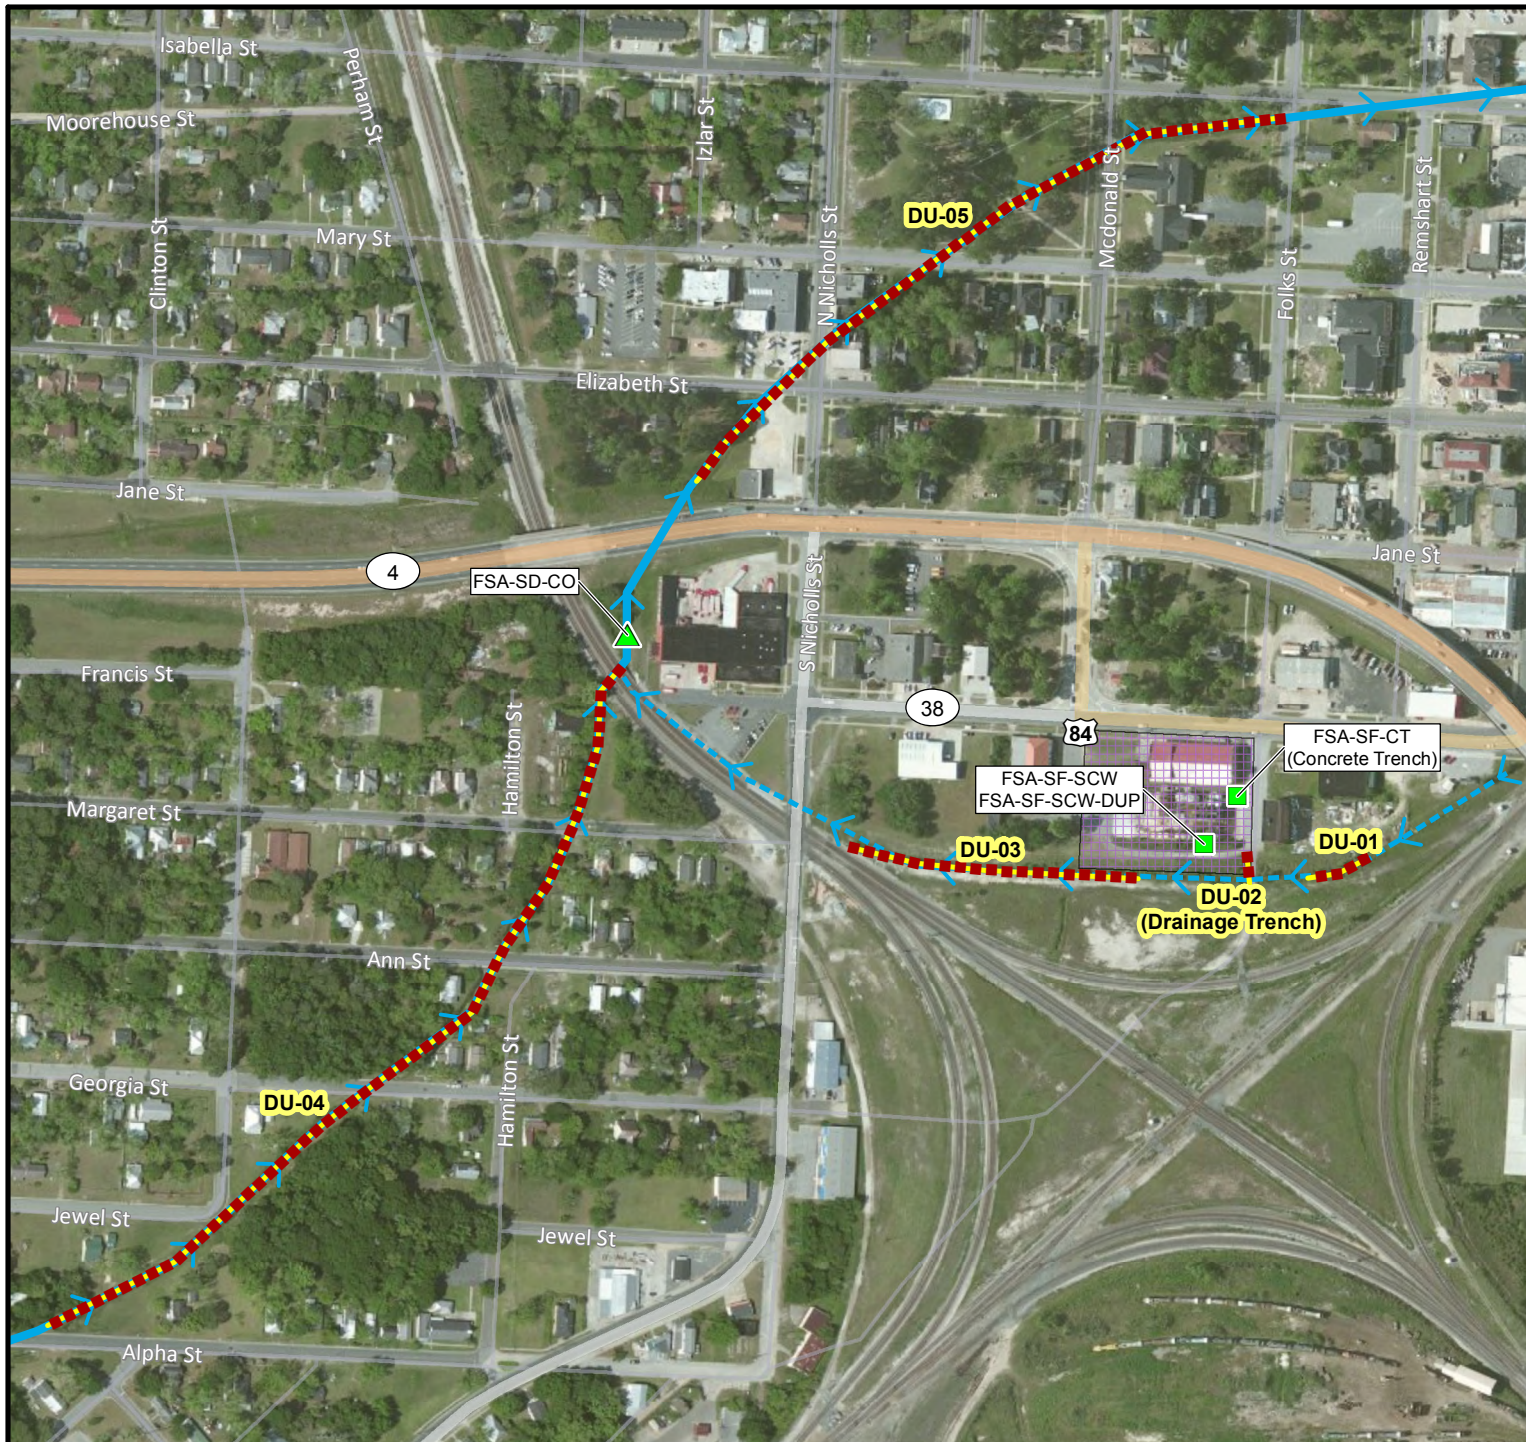
FIGURE 2

The former Seven Out facility was a wastewater treatment facility located on about 2.36 acres at 901 Francis Street, Waycross, Ware County, Georgia (see Figure 1 in Enclosure 1). The Site consists of a small service building and a tank farm containing dozens of vertical and horizontal tanks, with associated piping and valve works, although most structures were removed in November 2013. The Site is bounded by Francis Street to the north, Folks Street to the east, and property owned by CSX railroad to the south and west. Site stormwater discharges into a small drainage trench at the southeast corner of the Site and flows into a drainage ditch along the southern boundary. The drainage ditch flows west for about 1,100 feet before it discharges into a drainage canal (see Figure 2 in Enclosure 1).

Site Layout
 and Sampling Locations

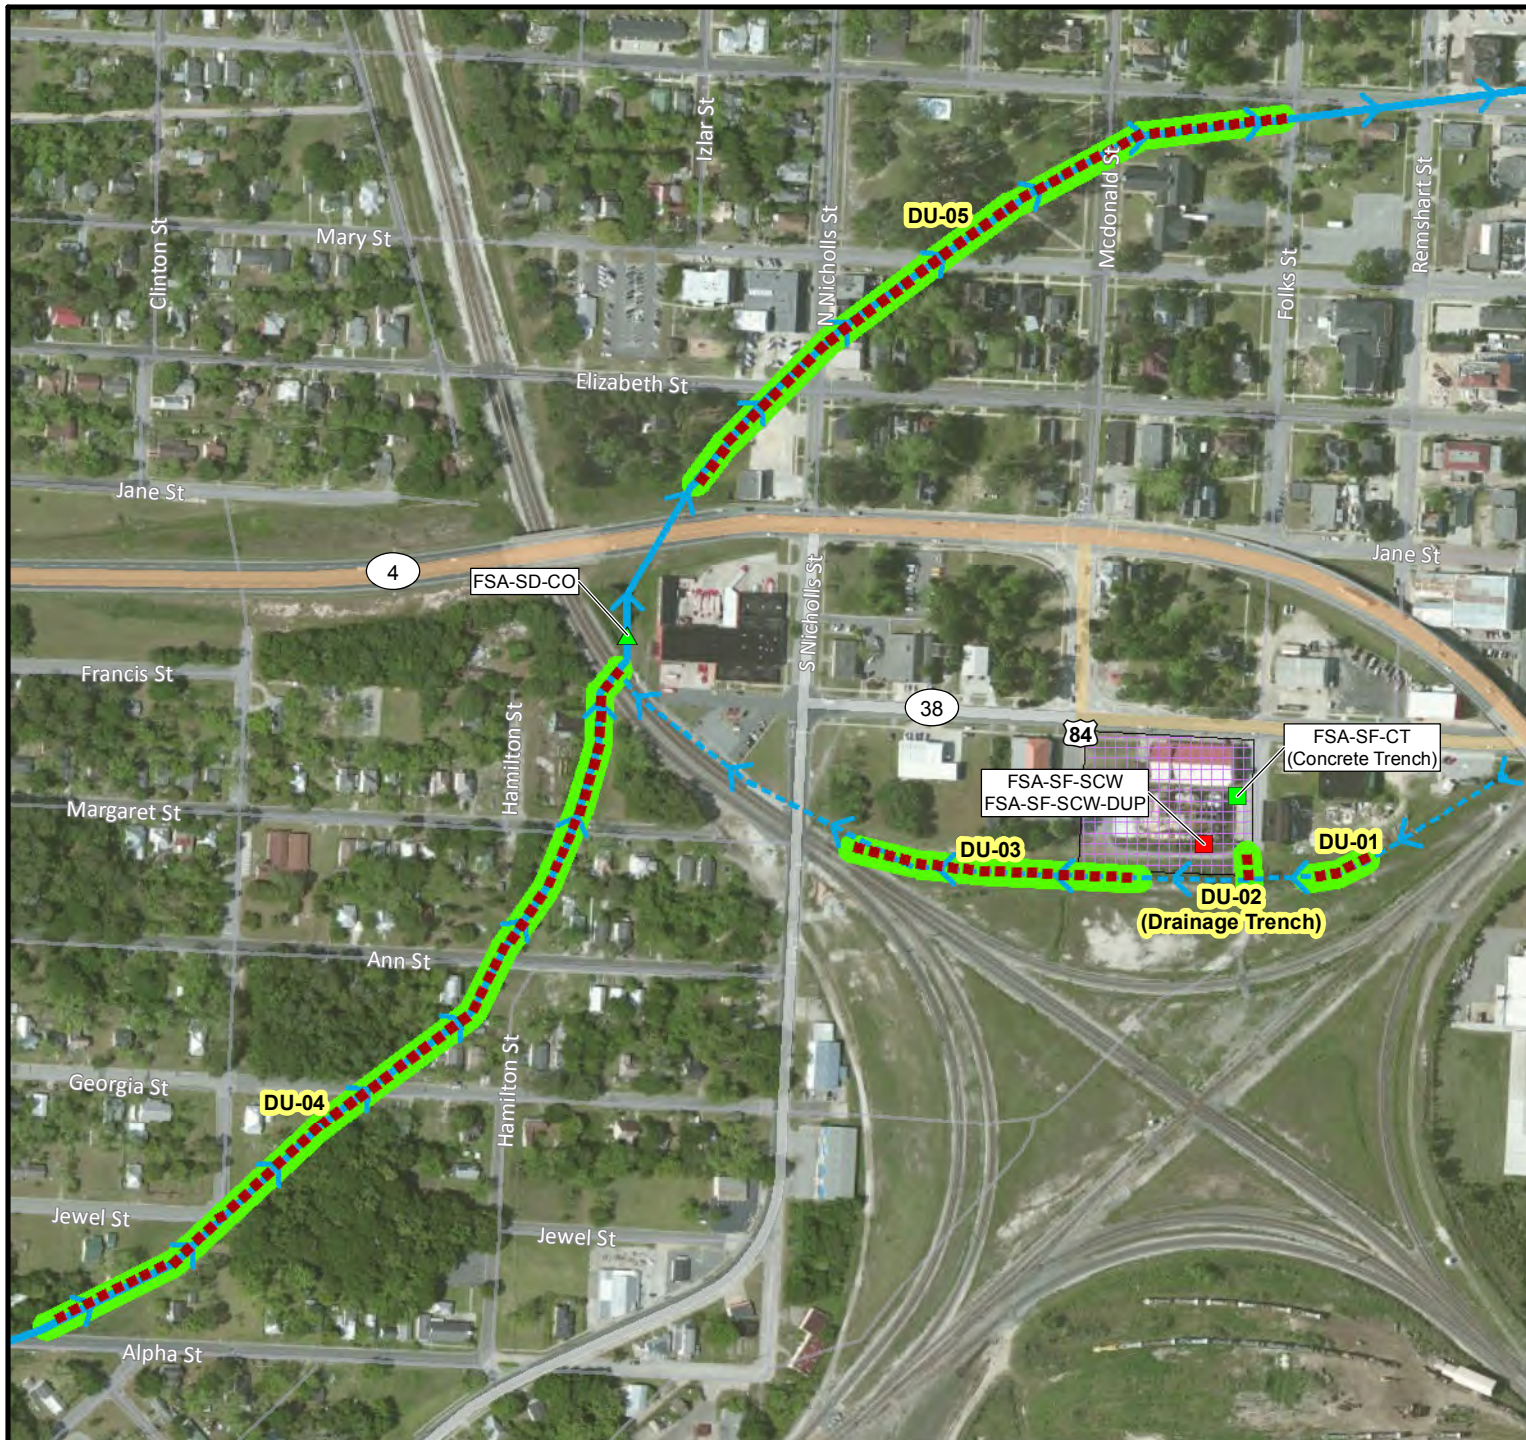
FIGURE 3

Sampling Results
 Compared to GaEPD RSSs

The soil samples collected outside of the southern containment wall contained benzo(a)pyrene at concentrations exceeding the GaEPD Type 1 soil RRS. Benzo(a)pyrene was detected at 1,800 µg/kg in soil sample FSA-SF-SCW and 2,100 µg/kg in soil sample FSA-SF-SCW-DUP; these concentrations exceed the GaEPD Type 1 soil RRS of 1,640 µg/kg. No other analytes were detected at concentrations exceeding GaEPD Type 1 soil RRS at the southern containment wall location.

No analytes were detected above GaEPD Type 1 soil RRS in the soil sample collected from the concrete trench at the northeast corner of the Site.

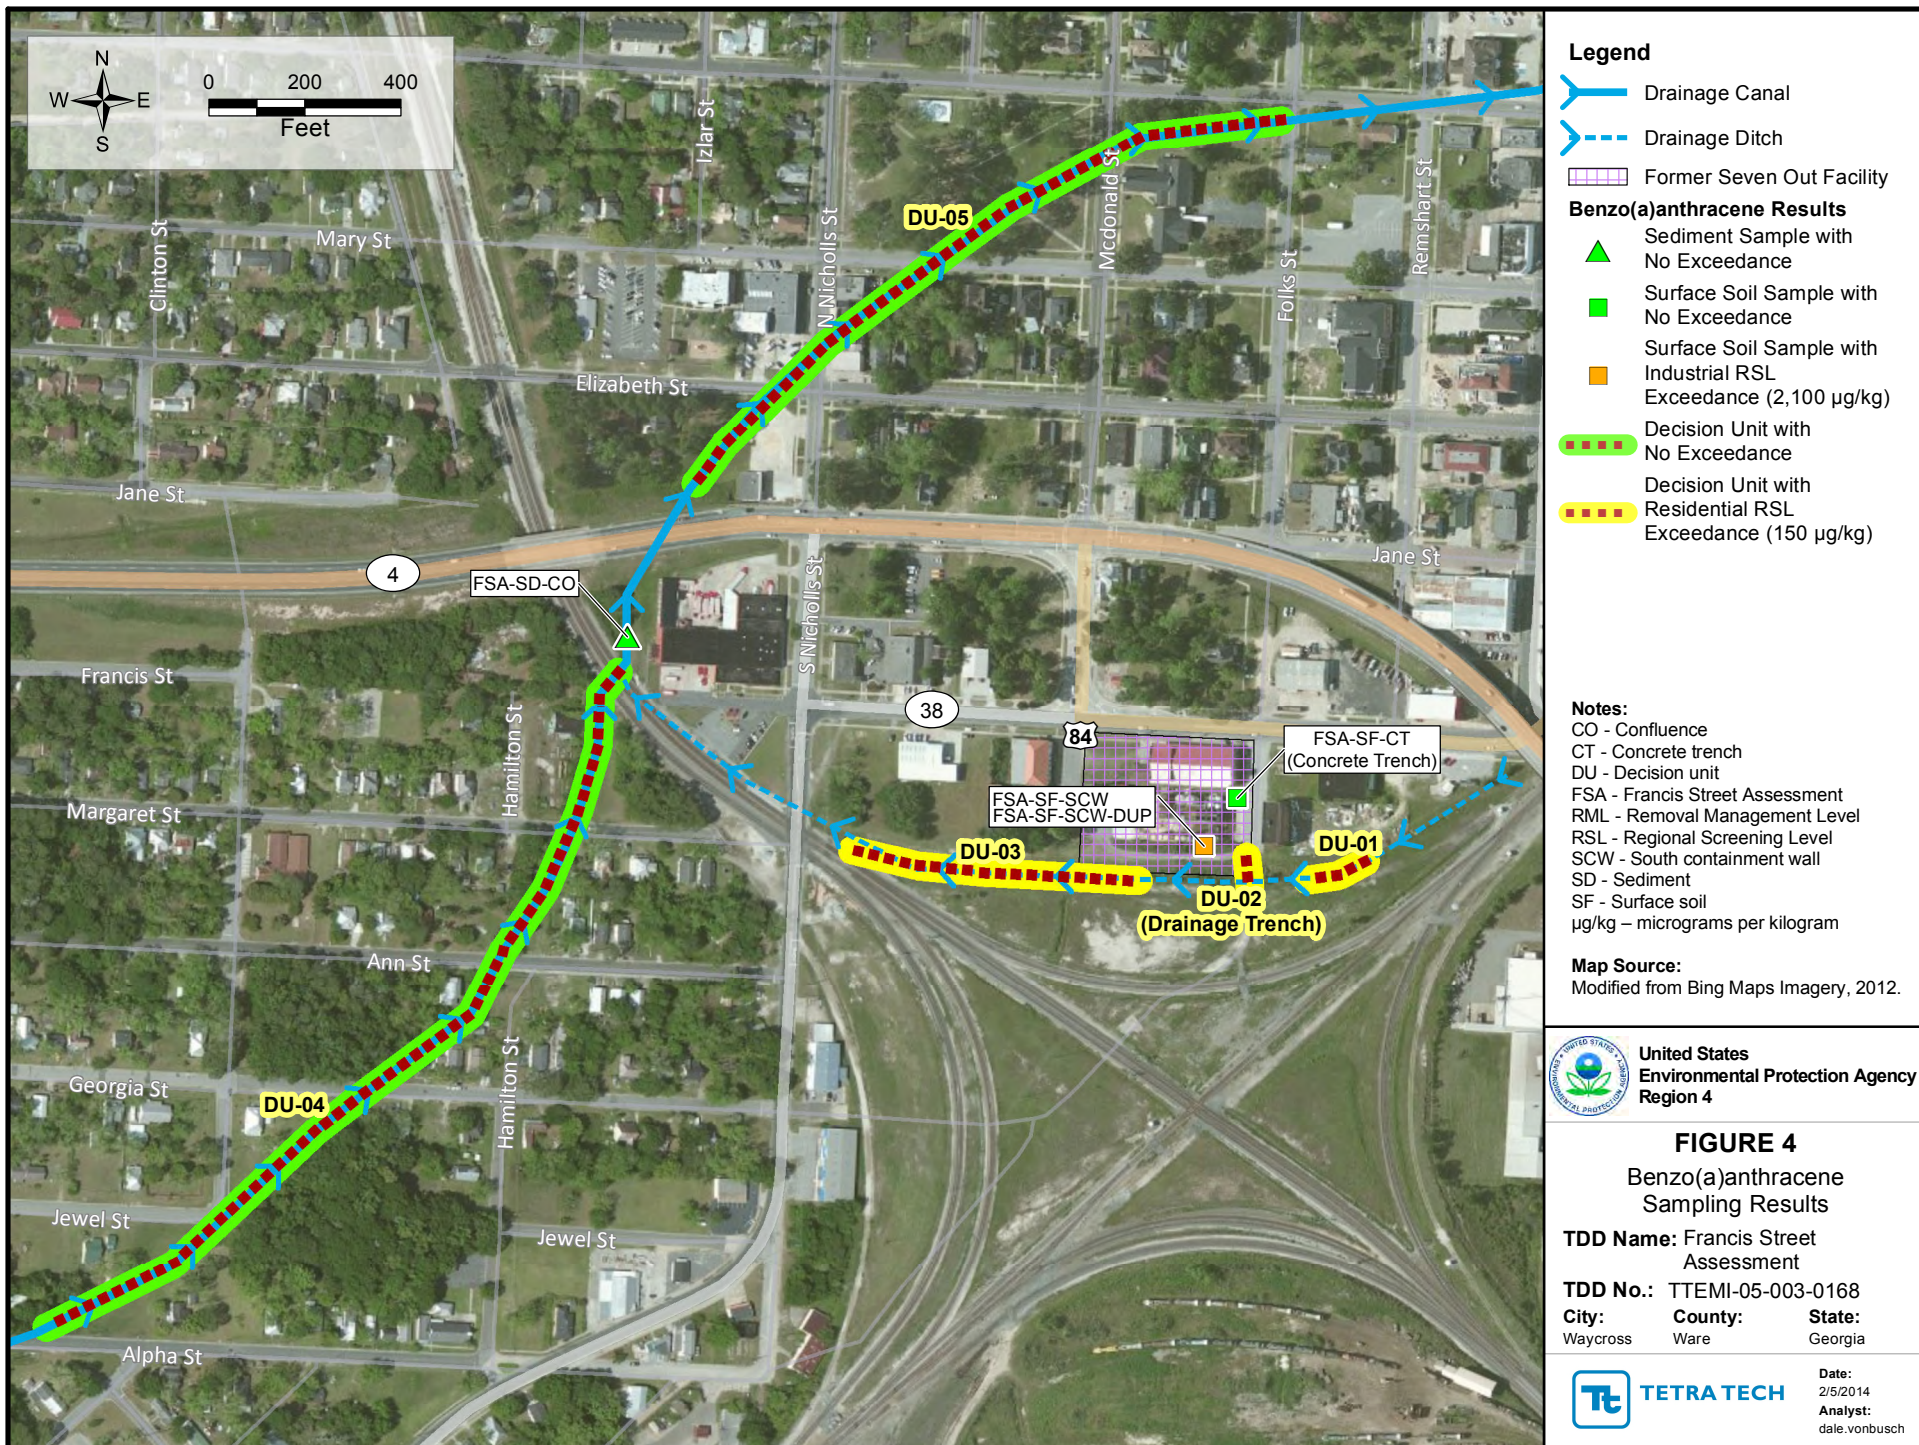
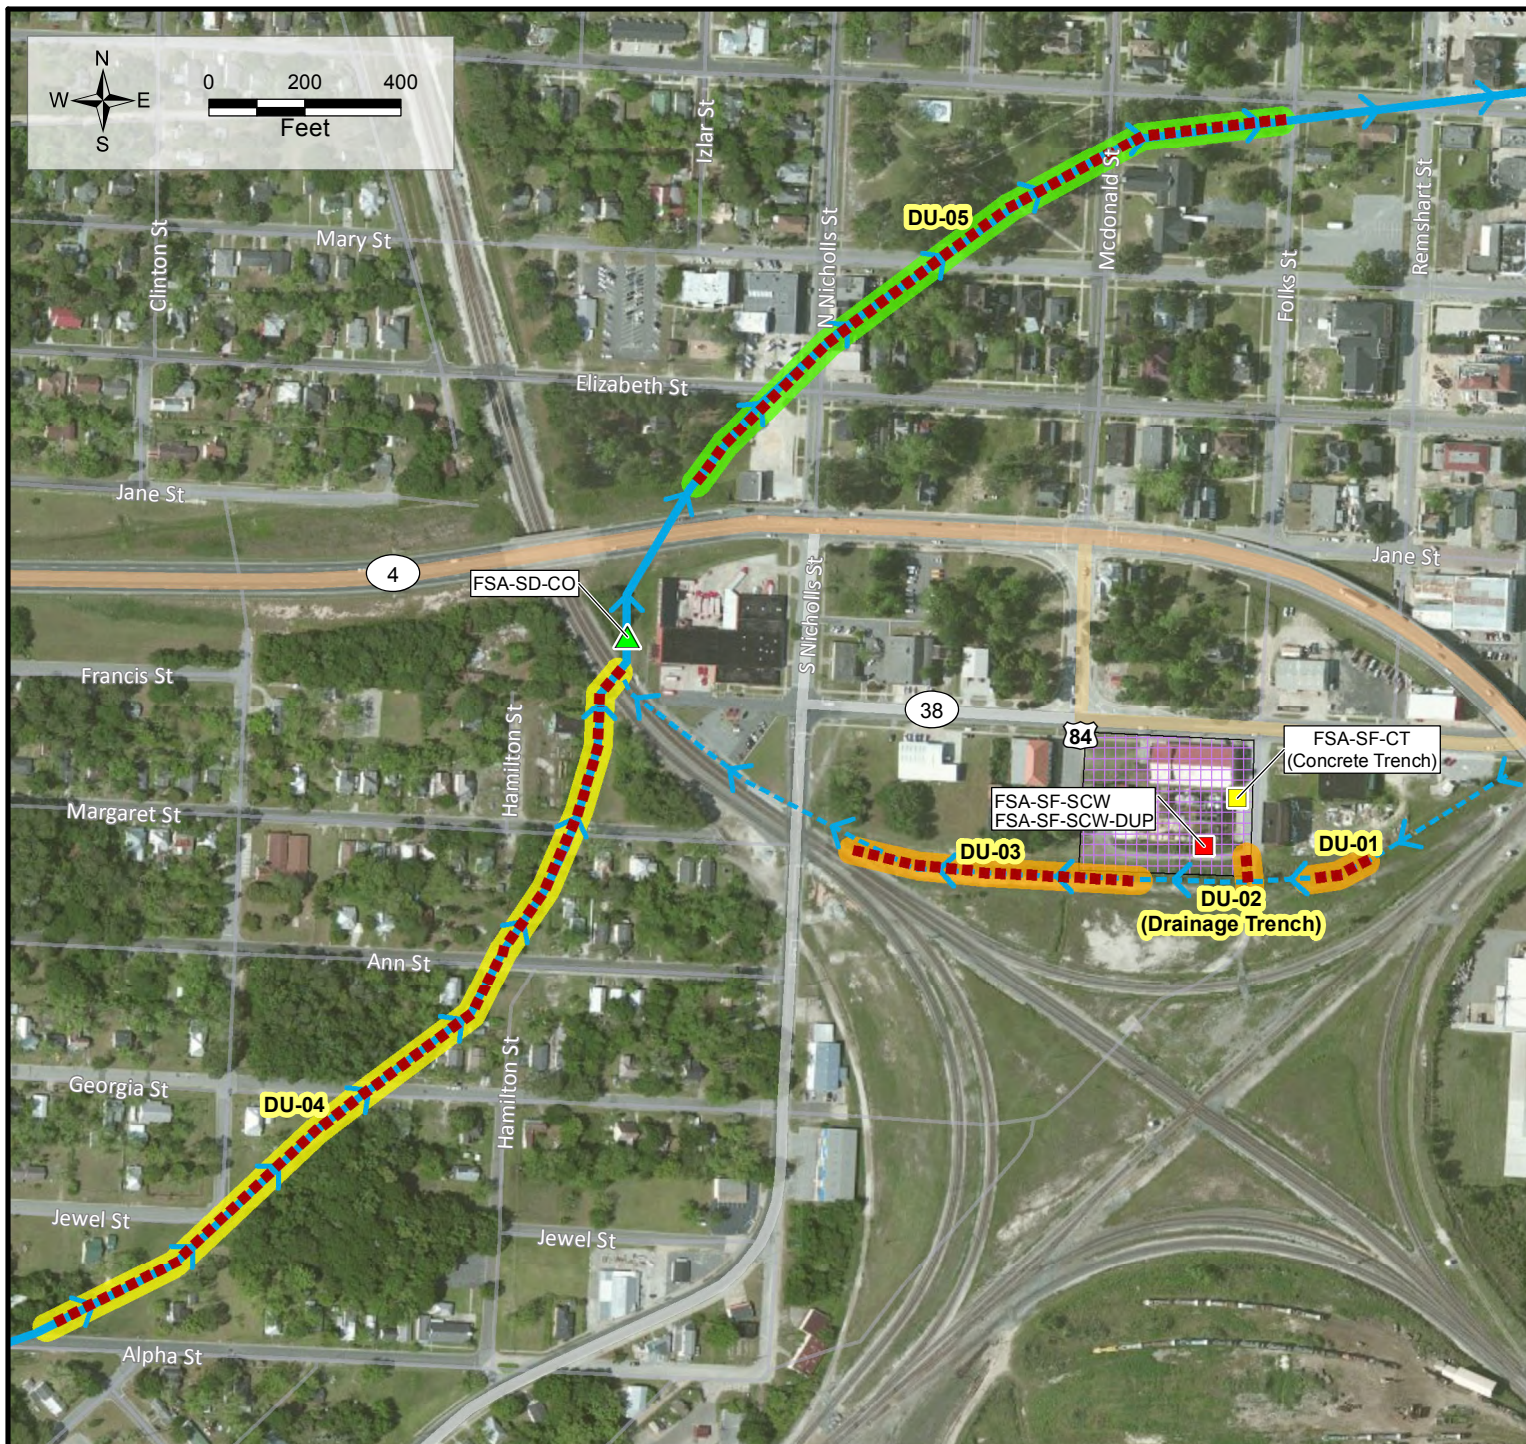
FIGURE 5

Benzo(a)pyrene
 Sampling Results

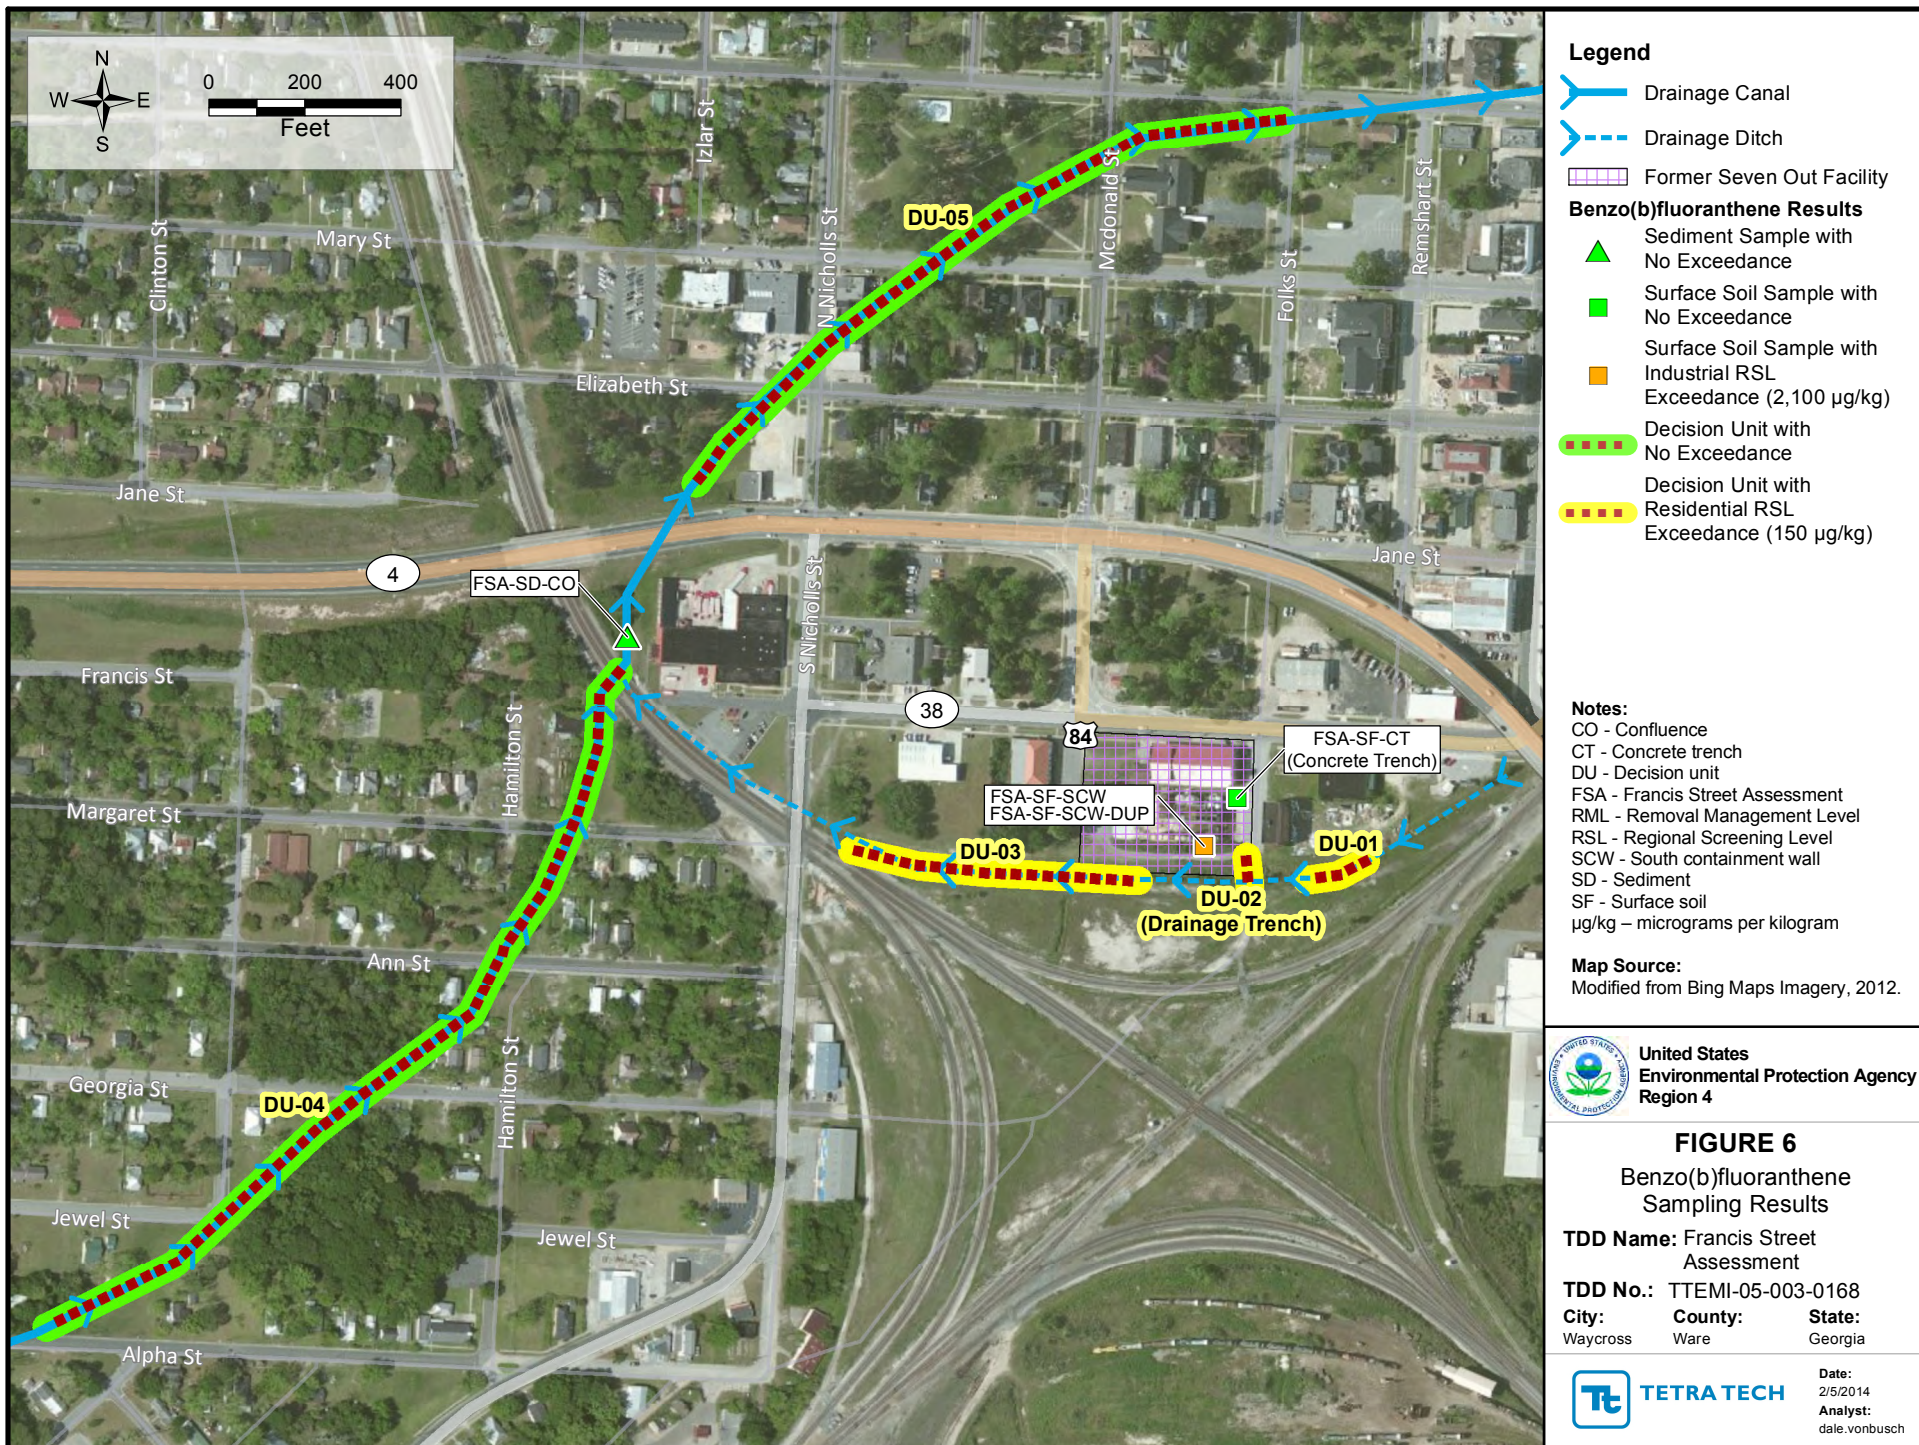
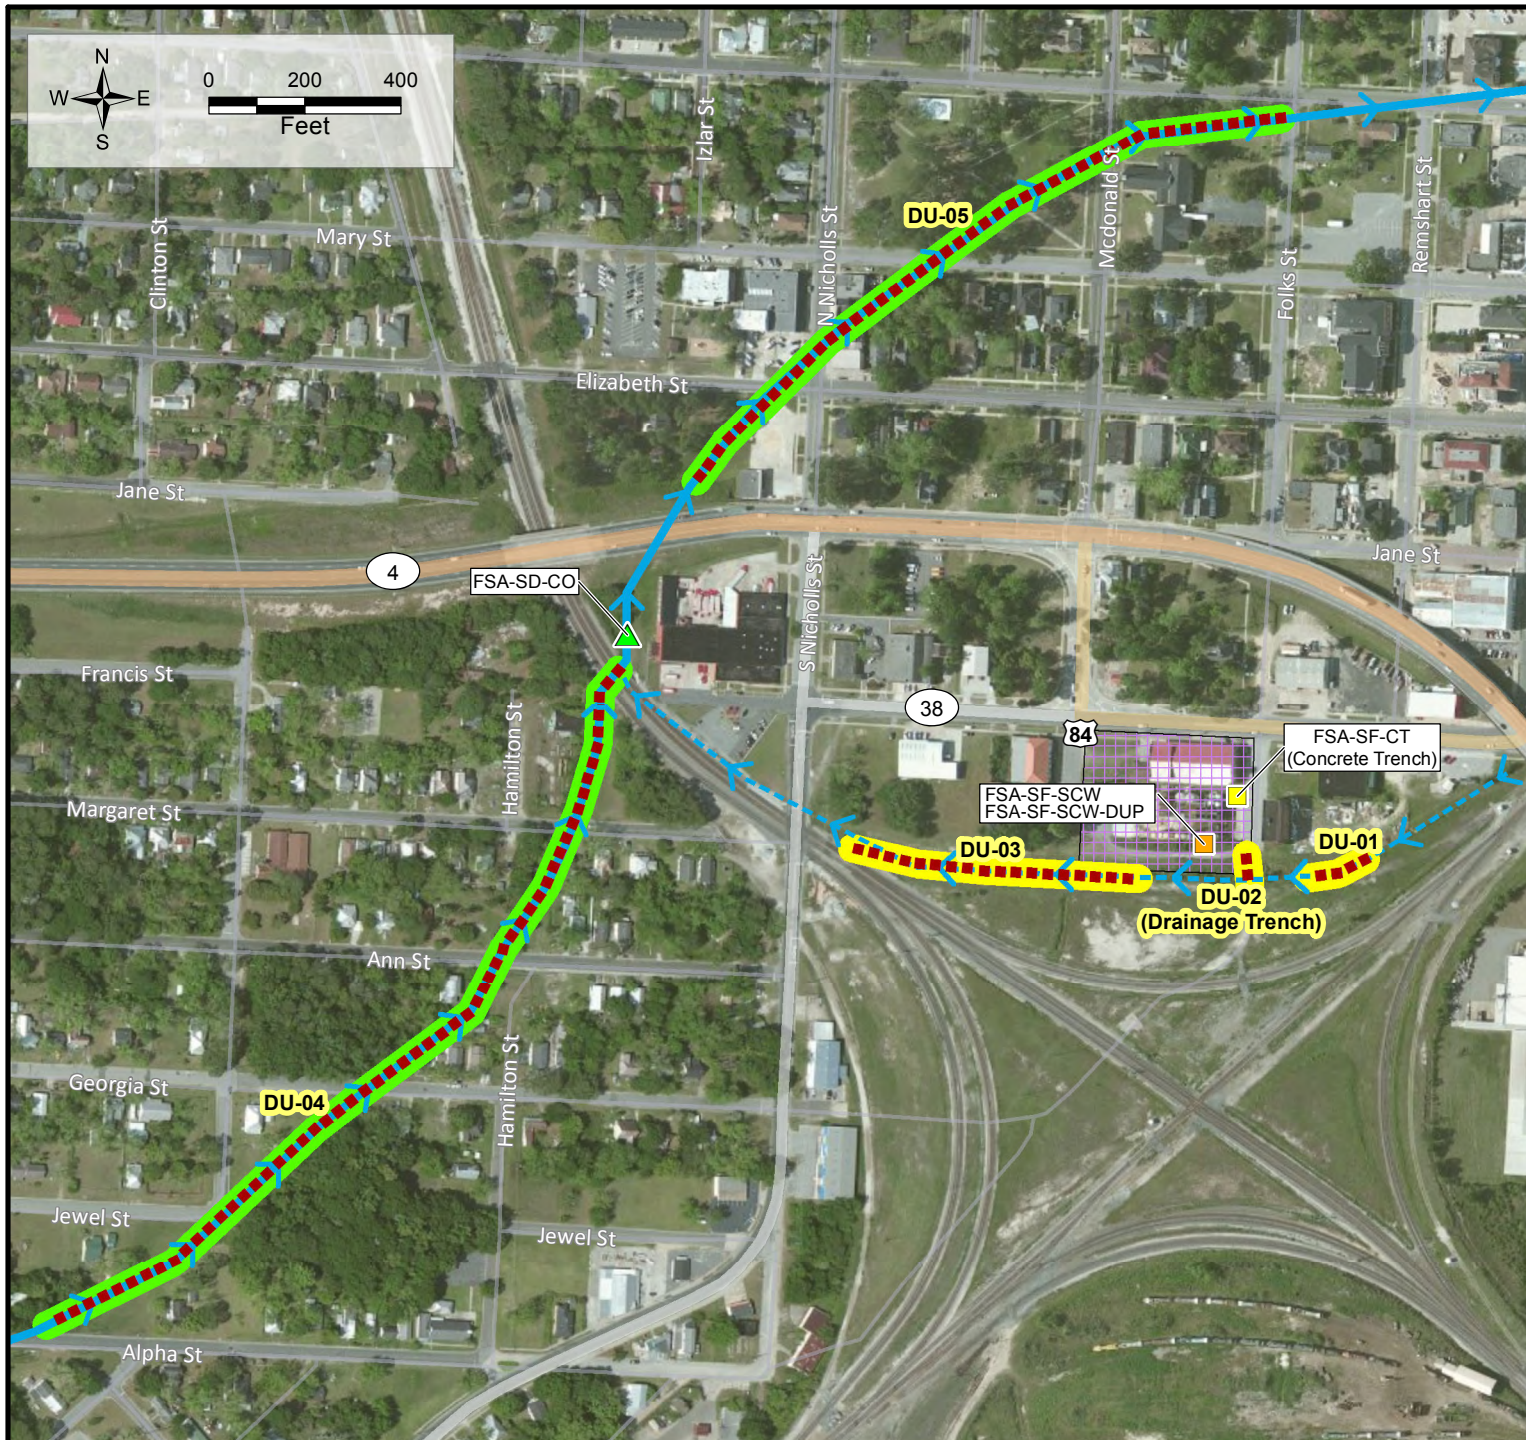
FIGURE 7

Dibenz(a,h)anthracene
 Sampling Results

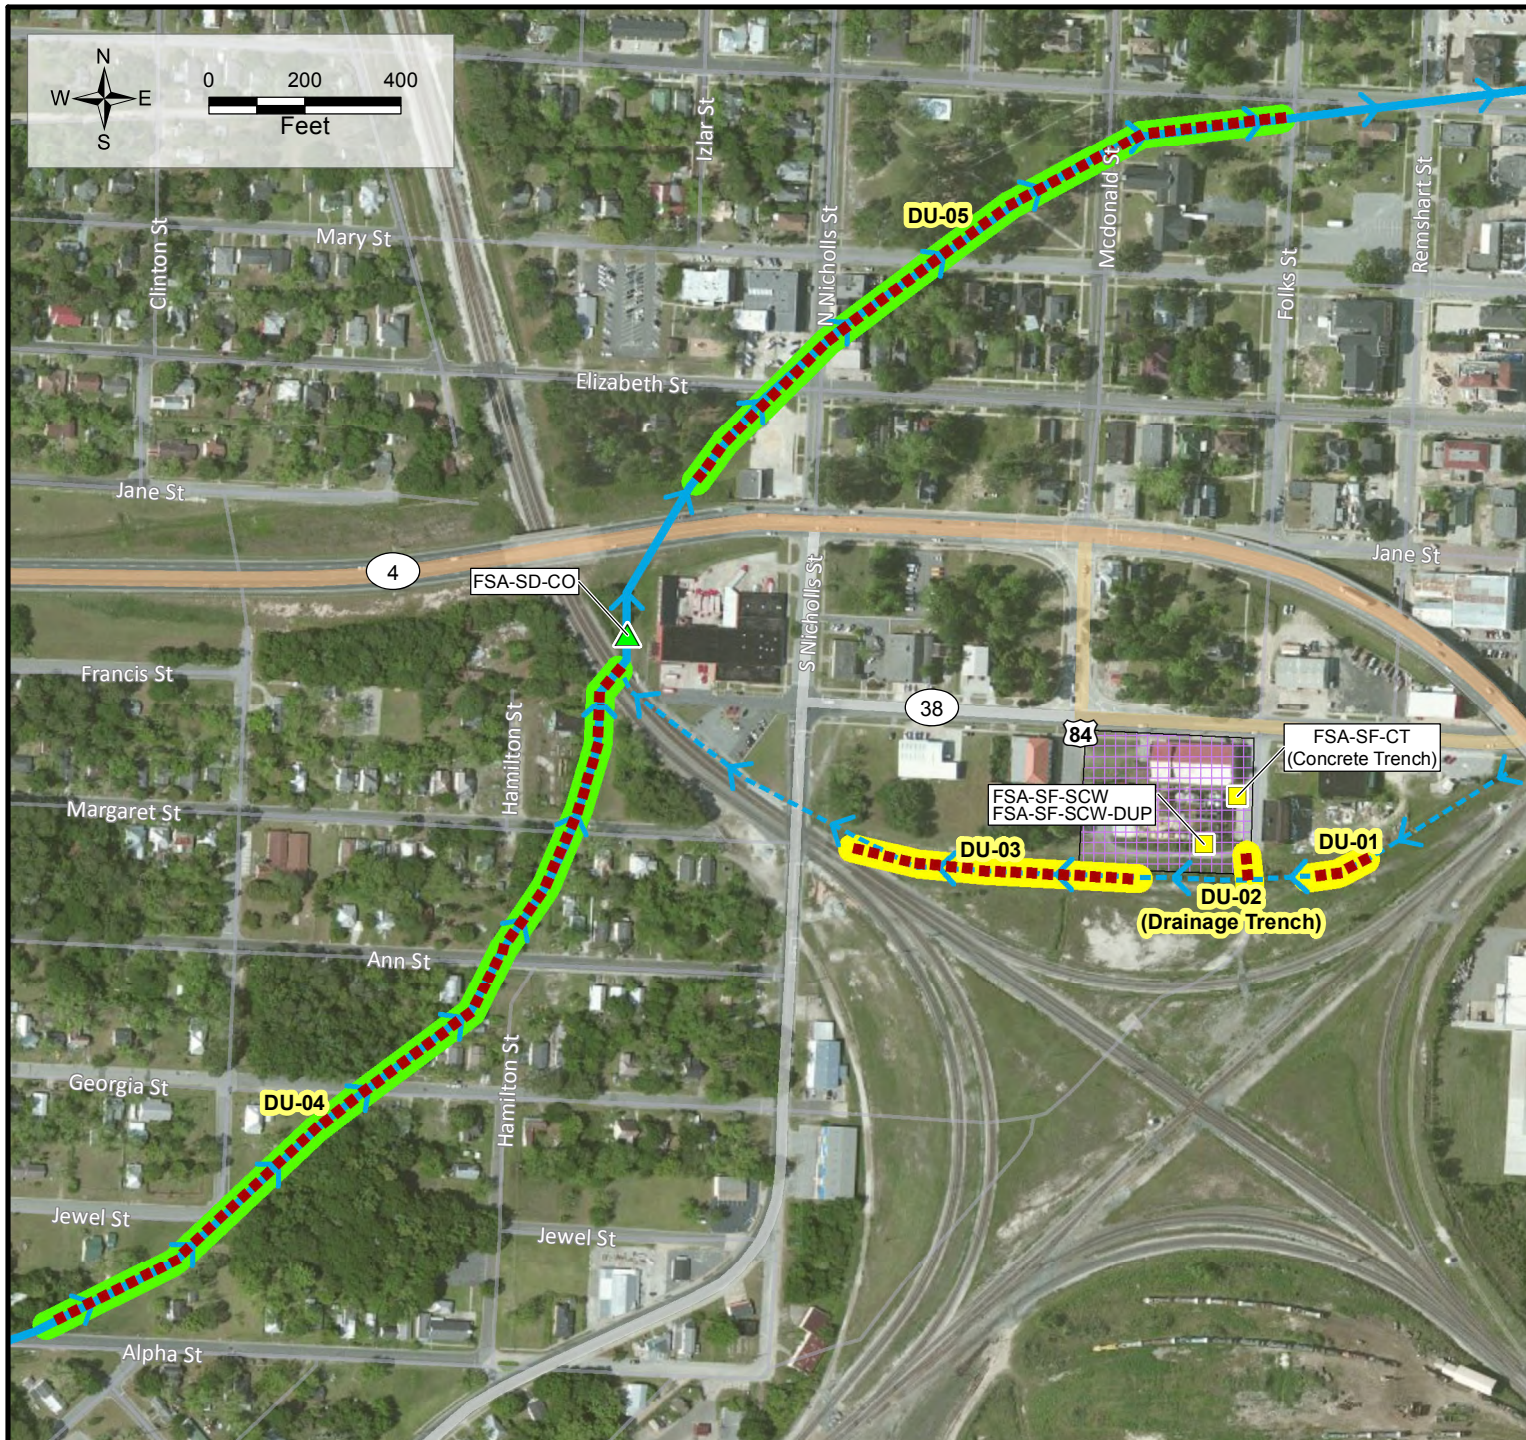
FIGURE 8

Indeno(1,2,3-cd)pyrene
 Sampling Results

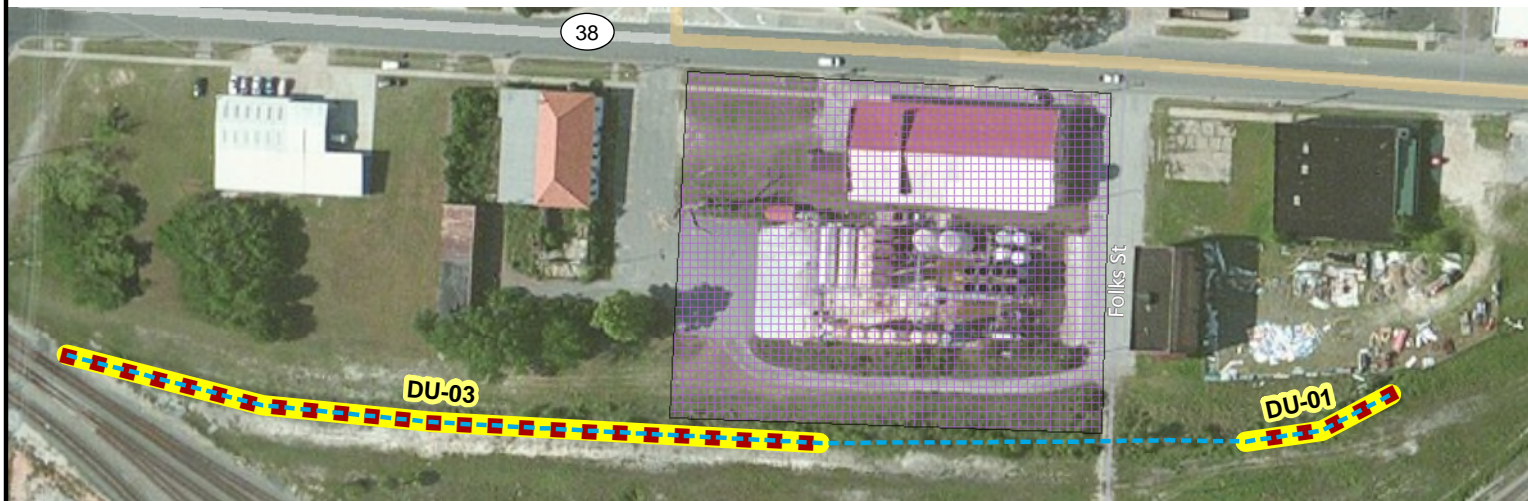
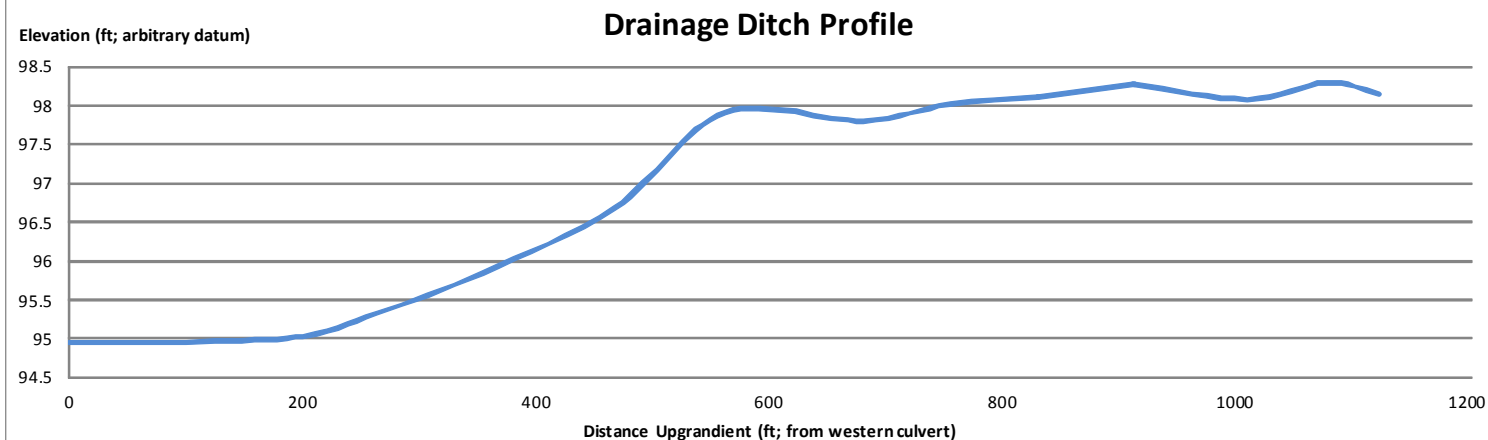
FIGURE 9

On February 28, 2014, the EPA OSC and Tetra Tech site manager returned to the Site to survey the drainage ditch from the east end of DU01 to the west end of DU03. The survey was conducted with a theodolite and surveyor's rod. The ditch was found to have an overall slope of 0.00285 (3.19 feet of fall over the 1,120 feet length) west, towards the drainage canal. The elevation profile is depicted on Figure 9 in Enclosure 2.

Drainage Ditch
Elevation Profile

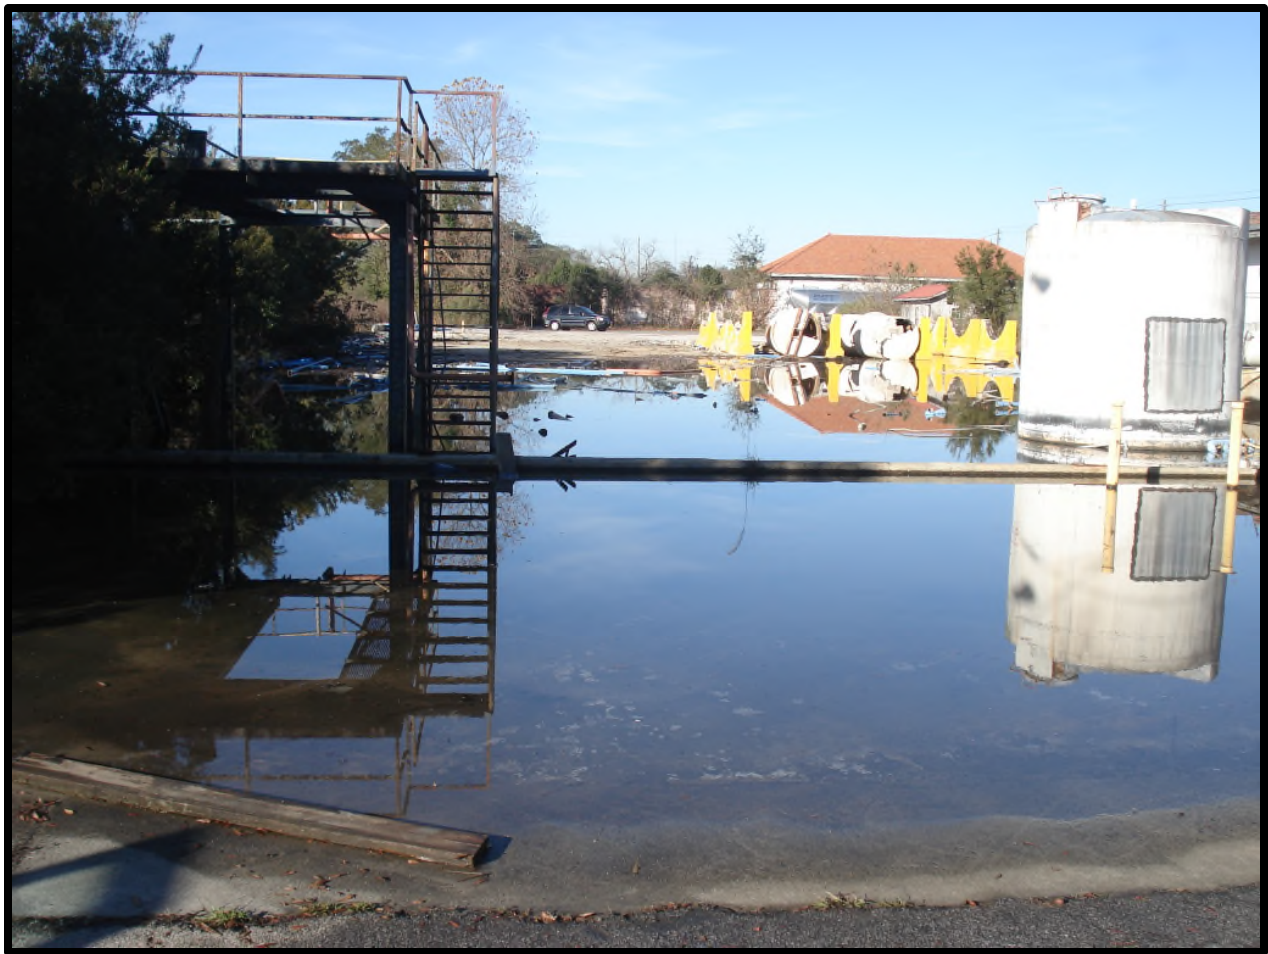
OFFICIAL PHOTOGRAPH NO. 1
U.S. ENVIRONMENTAL PROTECTION AGENCY

Subject: The former Seven Out wastewater treatment facility (located at 901 Francis Street, Waycross, Ware County, Georgia) as well as surrounding stormwater drainage pathways, was the focus of the Francis Street Assessment. The former facility has been decommissioned, and most of the structures and equipment associated with former operations have been demolished and removed. Soil samples FSA-SF-SCW and FSA-SF-SCW-DUP were collected south (out of frame) of the former filter press platform visible on the left of the frame.

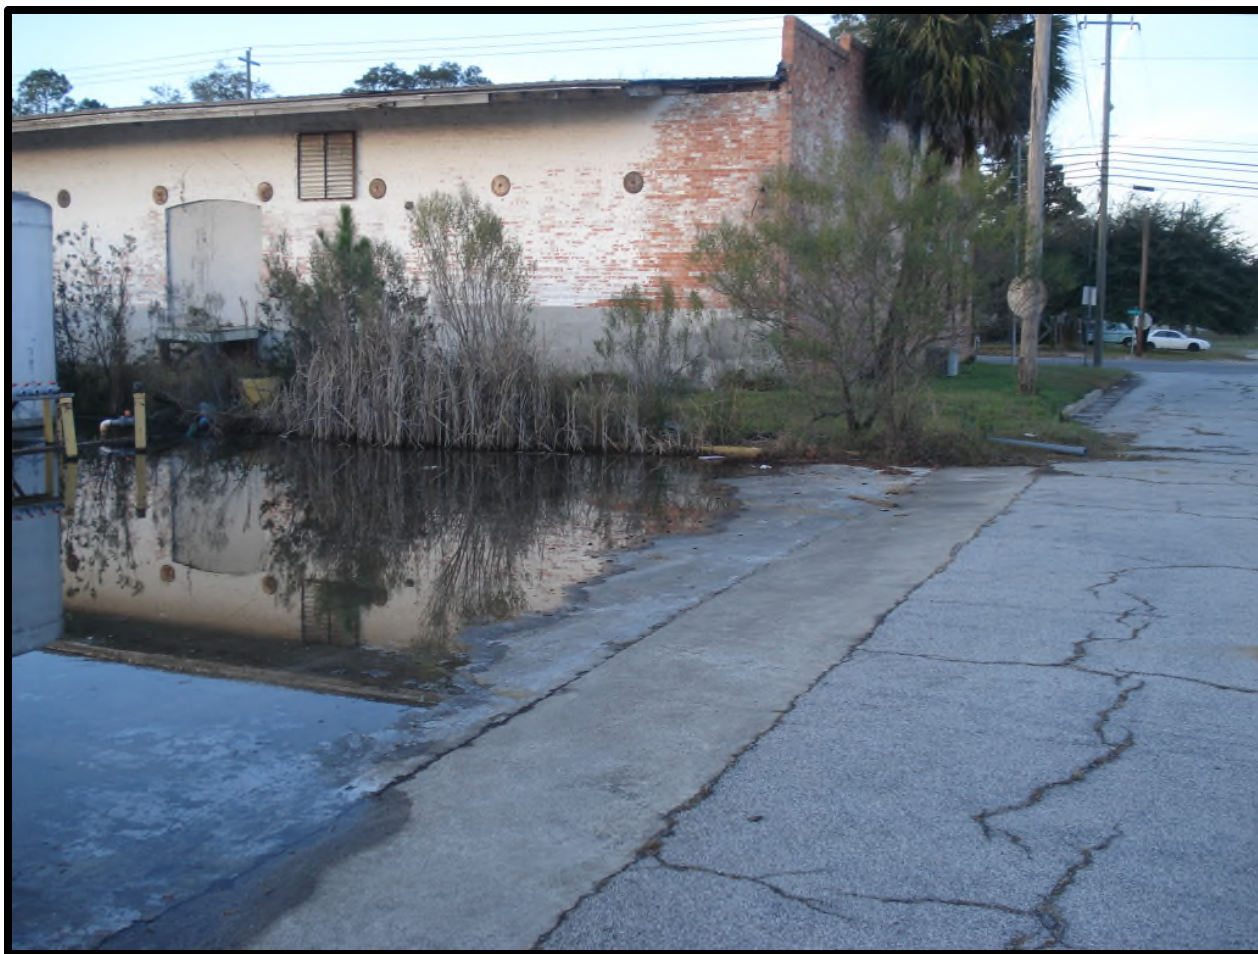
OFFICIAL PHOTOGRAPH NO. 2
U.S. ENVIRONMENTAL PROTECTION AGENCY

Subject: Soil sample FSA-SF-CT was collected from a small concrete trench at the northeast corner of the former Seven Out Site.

Composite soil sample FSA-SF-CT was collected from a small concrete trench along the eastern side of the former Seven Out property. The sample was collected with a hand auger from 0 to 6 inches below ground surface (bgs). Although the trench does not appear to be the main drainage pathway for the majority of the Site, it does appear to capture some runoff from the northeastern portion of the Site.

Soil samples collected from the former Seven Out site contained PAHs at levels exceeding comparison levels. Soil sample FSA-SF-CT, collected from the concrete trench at the northeast corner of the site, contained benzo(a)pyrene at 77 J+ micrograms per kilogram ($\mu\text{g/kg}$) and dibenz(a,h)anthracene at 16 $\mu\text{g/kg}$, which exceeds the EPA RSL of 15 $\mu\text{g/kg}$ for residential soil.

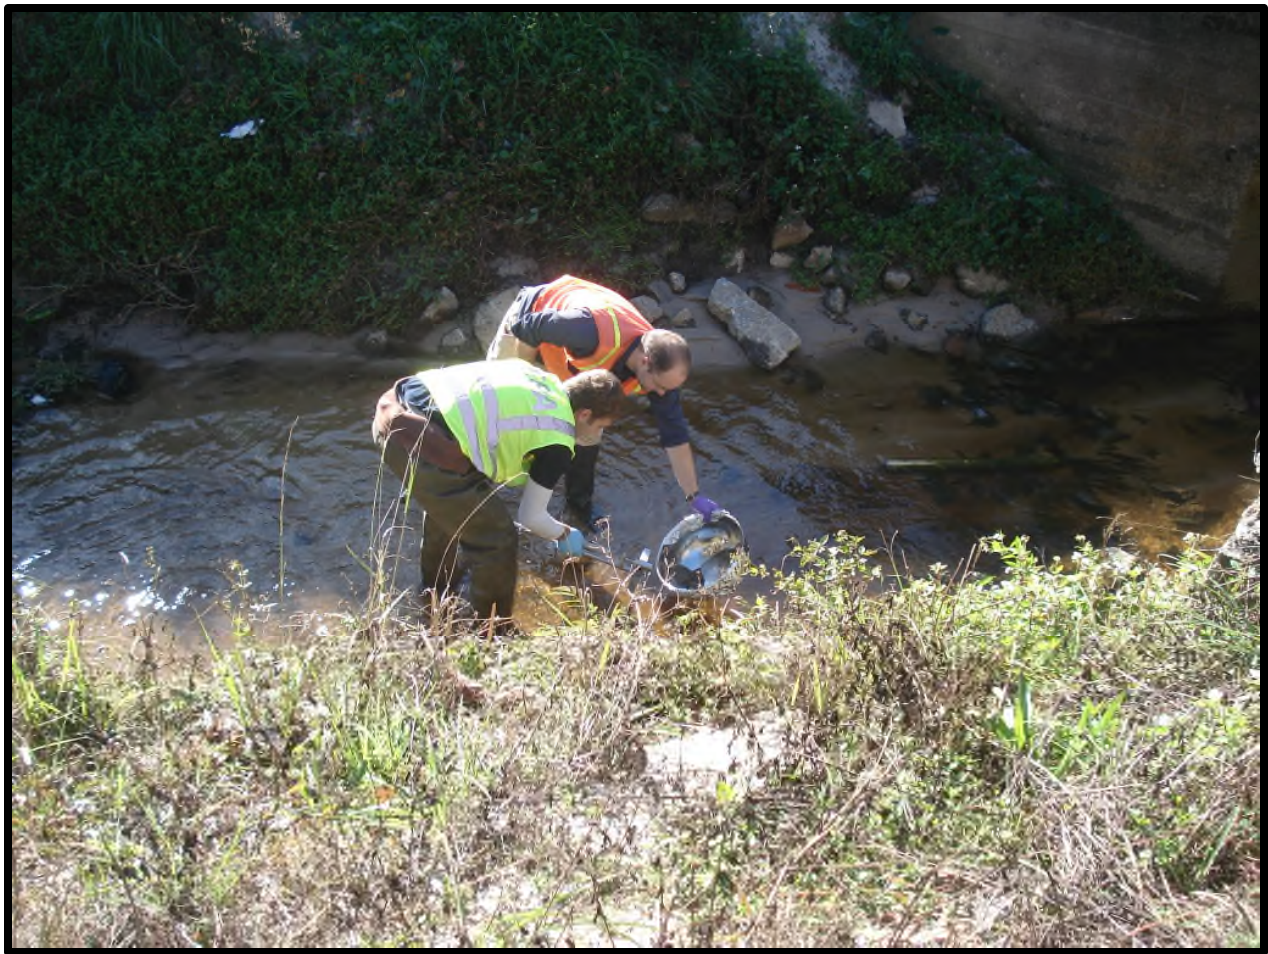
OFFICIAL PHOTOGRAPH NO. 3
U.S. ENVIRONMENTAL PROTECTION AGENCY

Subject: Tetra Tech field team members, U.S. Environmental Protection Agency (EPA) personnel, Ware County Health Department personnel, and Georgia Department of Public Health personnel participated in the sampling event. Sediment samples from five decision units (DU) were collected using incremental sampling methodology (ISM). ISM sampling was conducted using a specialized ISM sampler and stainless steel bowls and spoons.
