Subject: Assessment Letter Report, Revision 1
Francis Street Site
Waycross, Ware County, Georgia
EPA Contract No. EP-W-05-054
TDD No. TTEMI-05-003-0168

The Tetra Tech Superfund Technical Assessment and Response Team (START) is submitting this letter report summarizing assessment activities conducted on December 19, 2013 at the Francis Street Site in Waycross, Ware County, Georgia. This report incorporates revisions based on comments made on the letter report submitted April 3, 2014. This report contains six enclosures. Enclosure 1 contains figures depicting the Site and sampling locations. Enclosure 2 contains tables presenting the analytical results for soil and sediment samples collected during field activities. Enclosure 3 contains the photographic log. Enclosure 4 provides the Tetra Tech START field logbook notes. Enclosure 5 provides the analytical data package. Enclosure 6 provides the Tetra Tech data validation report.

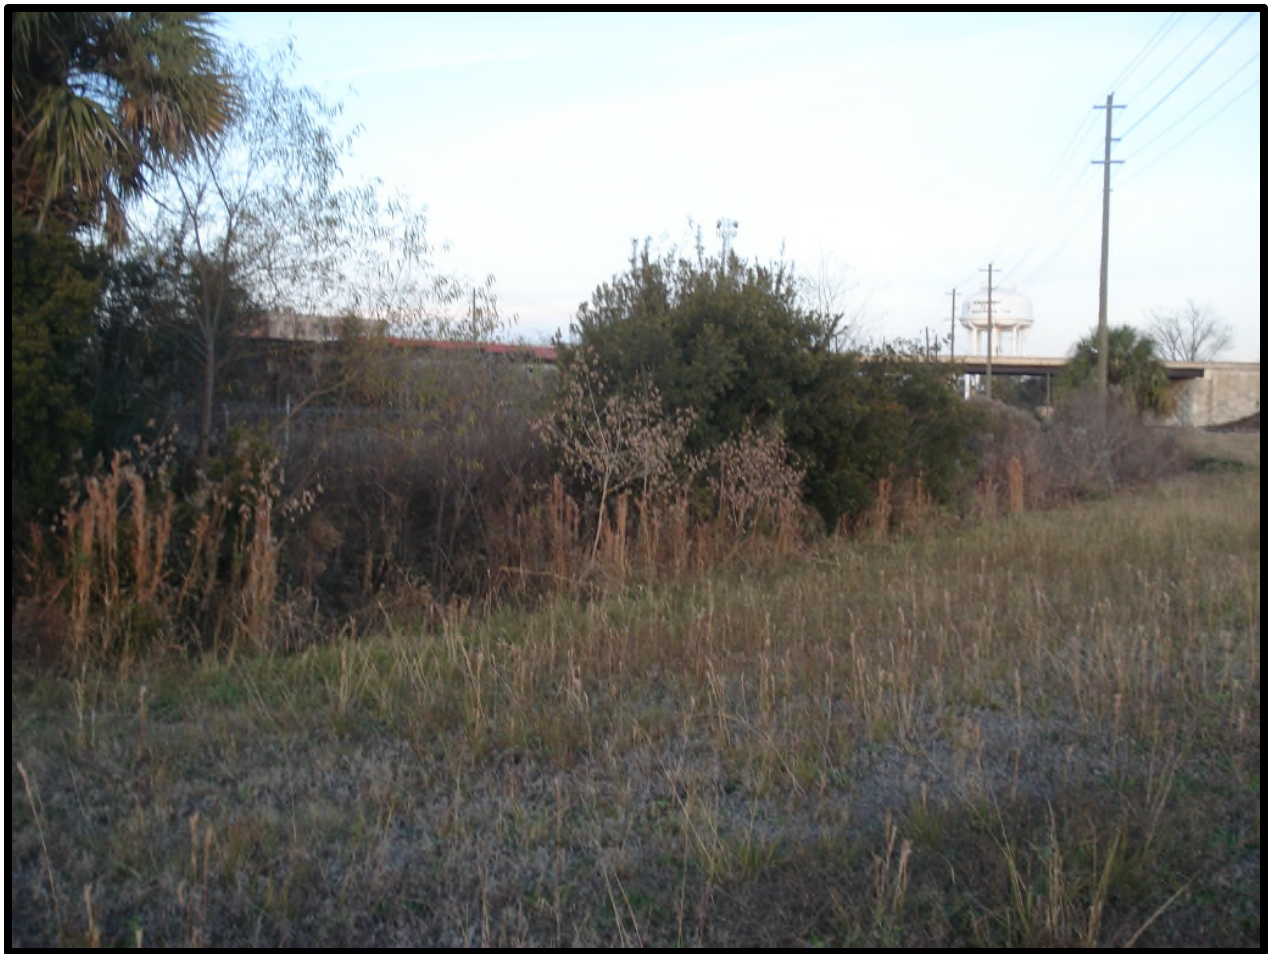
OFFICIAL PHOTOGRAPH NO. 4
U.S. ENVIRONMENTAL PROTECTION AGENCY

TDD Number:	TTEMI-05-003-0168	Location:	Francis Street Assessment
Orientation:	East	Date:	December 19, 2013
Photographer:	John Snyder, Tetra Tech	Witness:	Amber Skiles, Tetra Tech
Subject:	The portion of the drainage ditch east of the former Seven Out Site was designated DU-01 and served as the background sediment sample location.

Sediment sample FSA-SD-DU01 was collected from DU 01, the drainage ditch upgradient of the former Seven Out Site. The sample was a 30-increment ISM sample, with increments collected from 0 to 3 inches below sediment grade (bsg). The sediment sample was collected as a drainage ditch background sample to assess contamination levels upgradient of the former Seven Out facility.

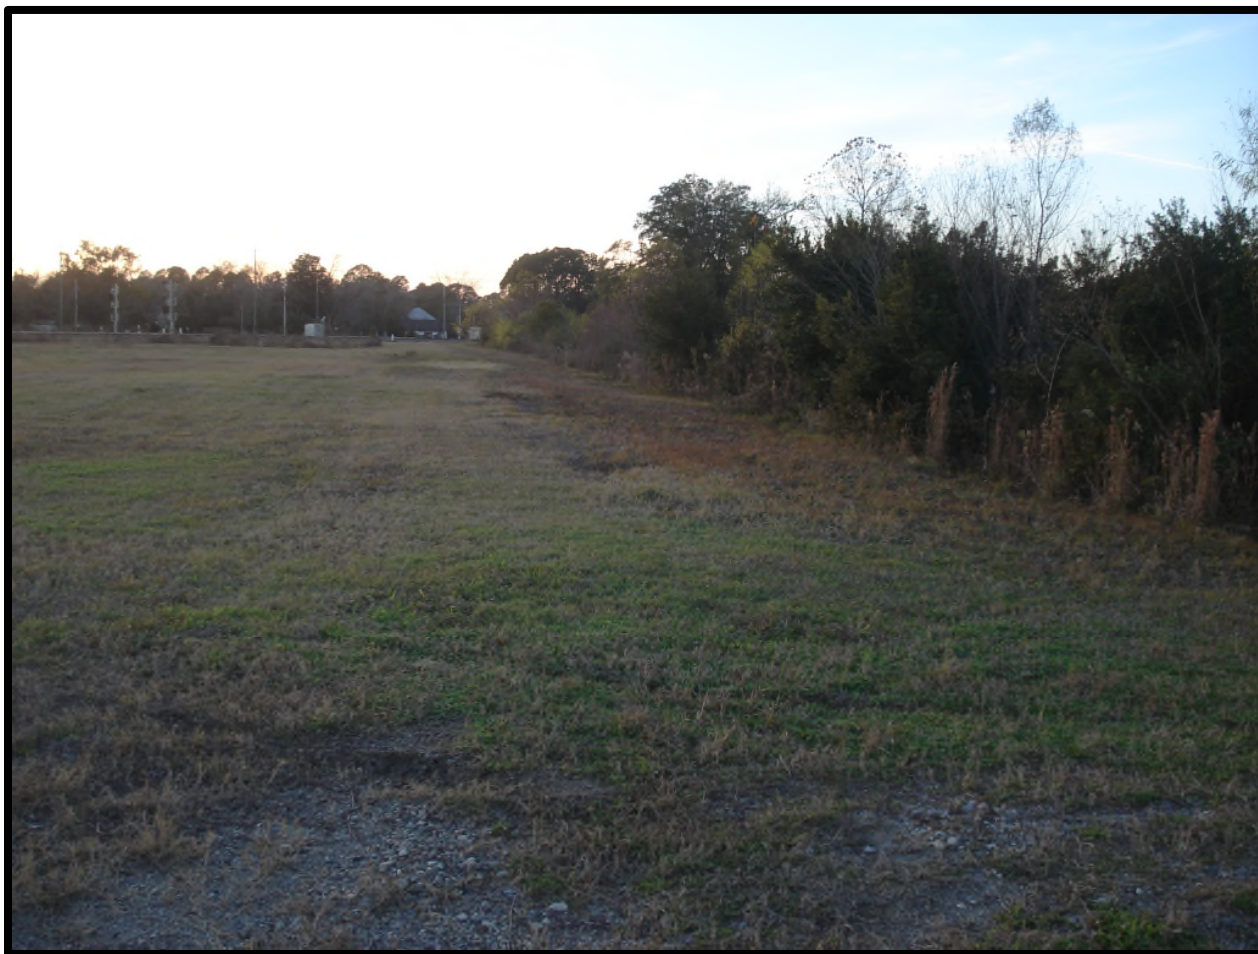
OFFICIAL PHOTOGRAPH NO. 5
U.S. ENVIRONMENTAL PROTECTION AGENCY

Subject: The portion of the drainage ditch running between the former Seven Out Site and the railroad tracks west of the Site was designated DU-03.

Three sediment samples (FSA-SD-DU03-A, FSA-SD-DU03-B, and FSA-SD-DU03-C) were collected from DU 03, the section of the drainage ditch running from downgradient of the drainage trench to the railroad tracks west of the Site. Three sediment samples (“triplicate sampling”) were collected to allow calculation of a total relative standard deviation (RSD) value to assess contaminant homogeneity within the DU. Additionally, one sample (FSA-SD-DU03-A) was selected for laboratory triplicate analysis to

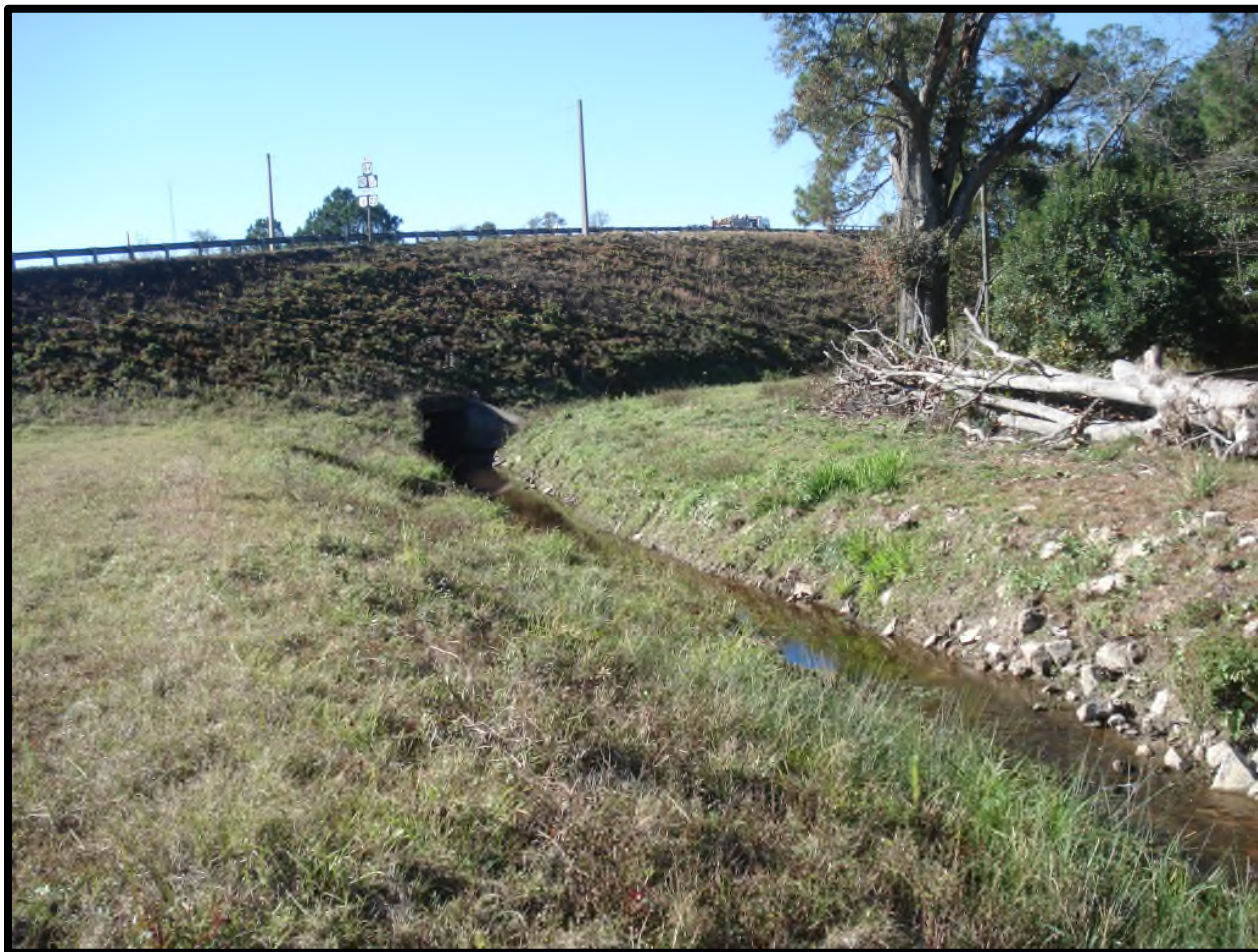
OFFICIAL PHOTOGRAPH NO. 6
U.S. ENVIRONMENTAL PROTECTION AGENCY

TDD Number:	TTEMI-05-003-0168	Location:	Francis Street Assessment
Orientation:	South	Date:	December 19, 2013
Photographer:	John Snyder, Tetra Tech	Witness:	Amber Skiles, Tetra Tech
Subject:	The portion of the drainage canal running between the Highway 82 overpass (background of frame) and Folk Street was designated DU-05.

Sediment sample FSA-SD-DU05 was a 30-increment composite sediment sample collected from the drainage canal, between the Highway 82 overpass and Folks Street. The sample was a 30-increment ISM sediment sample collected from 0 to 3 inches bsg. This sample was intended to assess possible contamination in the drainage canal downgradient of the confluence with the drainage ditch.
