**SITE ASSESSMENT REPORT
CARTER COLOR COAT SITE
DETROIT, WAYNE COUNTY, MICHIGAN**

TDD No.:	S05-0709-001
Date Prepared:	January 23, 2008
Contract No.:	EP-S5-0603
Prepared by:	STN Environmental JV
START Project Manager:	Stephen Wolfe
Telephone No.:	(216) 214-8824
U.S. EPA On-Scene Coordinator:	Jeffrey Kimble
Telephone No.:	(734) 692-7688

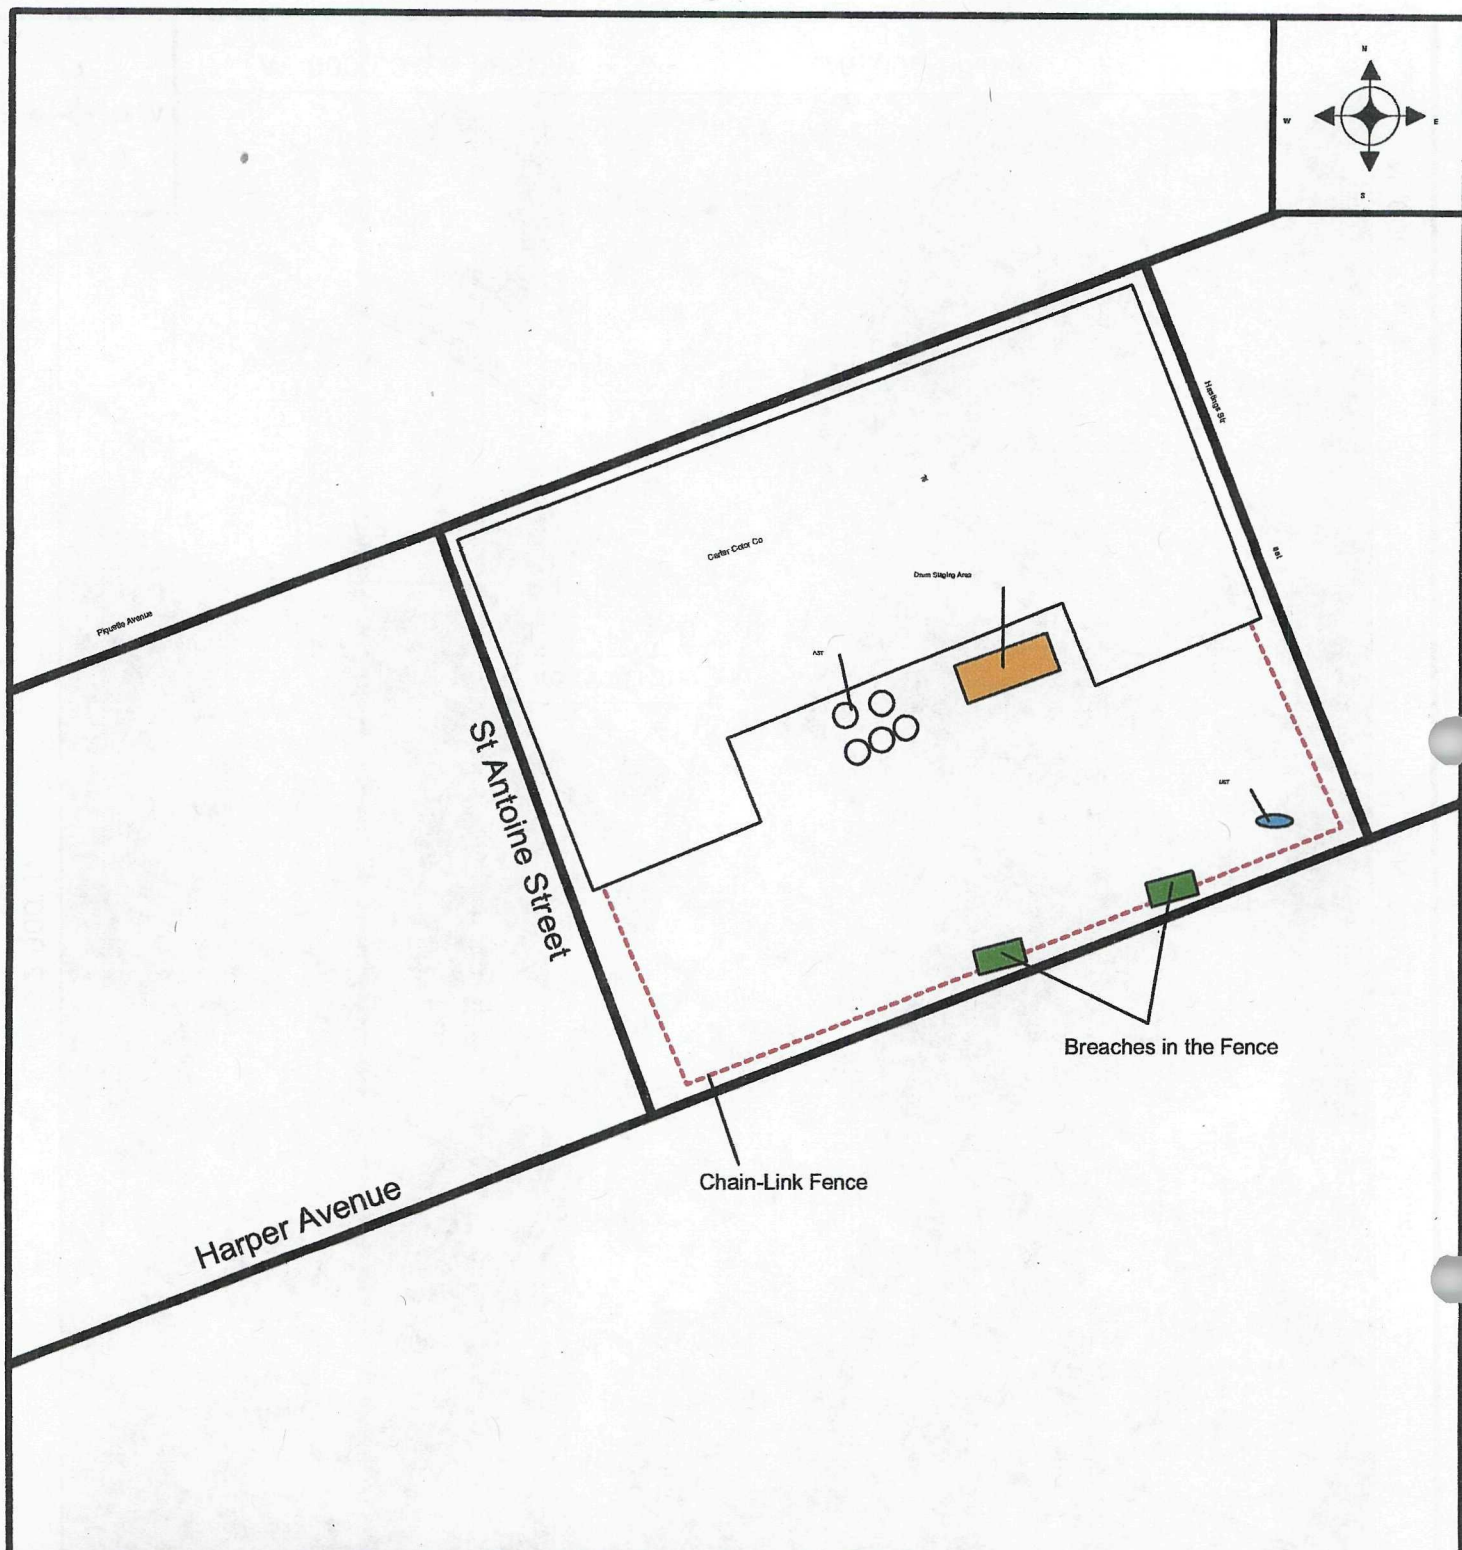
Figure 2
Site Features

The Carter Color Coat site is located at 6051 Hastings Street in Detroit, Michigan at 42° 22.184' north latitude and 83° 03.598' west longitude (Figure 1). A large six-storey concrete and steel frame building covers approximately one-half of the property. The other half of the property was primarily used for parking. The property is fenced, but not secure. The site is located in a mixed residential and industrial neighborhood with residential properties located approximately one-half mile to the southwest of the site. The site is bordered by Hastings Street to the northeast, Harper Street to the southeast, St. Antoine Street to the southwest, and Piquette Street to the northwest. Other industrial properties surround the site on all 4 sides (Figure 2).

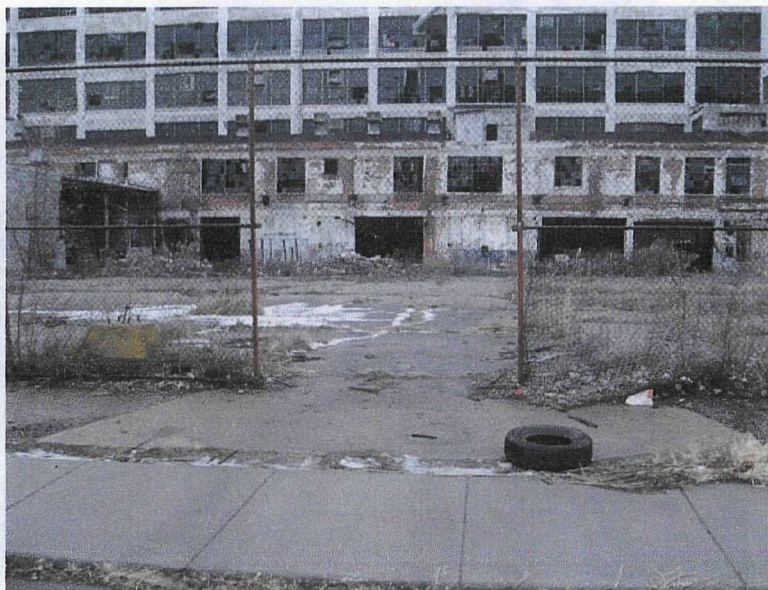
Site:	Carter Color Coat		
Date:	December 11, 2007		
Photographer:	Stephen Wolfe		
Photo Number:	1	Direction:	Northwest
Comment	A view of a missing segment of the chainlink fence along Harper Avenue..

START performed a perimeter walk prior to all parties arriving on to the site and discovered several breaches in the chain link fence and that the board covering one of the entrances had been removed. Evidence of vagrants in the area was also documented by START.

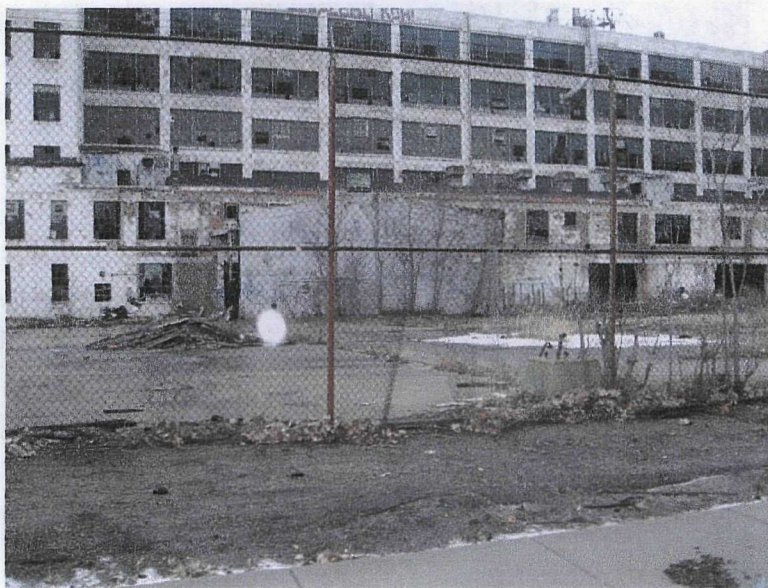
Site:	Carter Color Coat		
Date:	December 11, 2007		
Photographer:	Stephen Wolfe		
Photo Number:	2	Direction:	Northwest
Comment	A view of a missing segment of the chainlink fence along Harper Avenue..

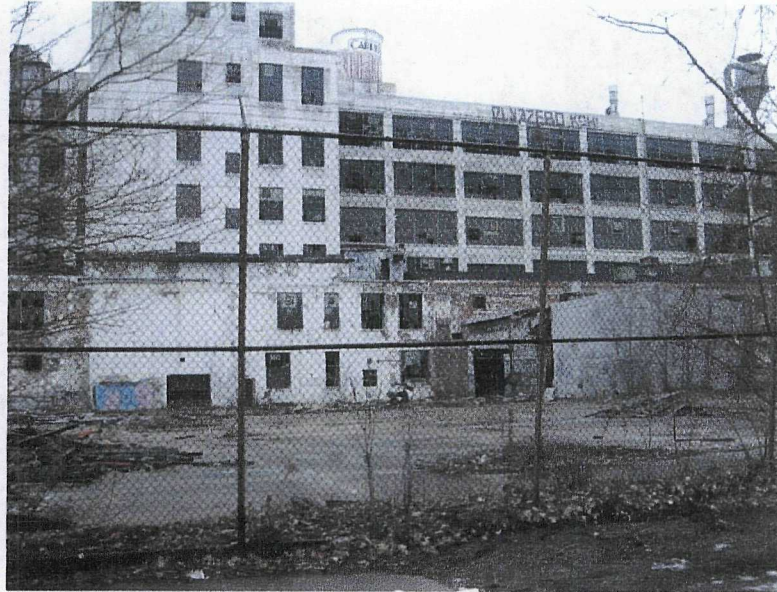
Site:	Carter Color Coat		
Date:	December 11, 2007		
Photographer:	Stephen Wolfe		
Photo Number:	3	Direction:	Northwest
Comment	A view of graffiti and broken windows on the Carter Color Coat building.

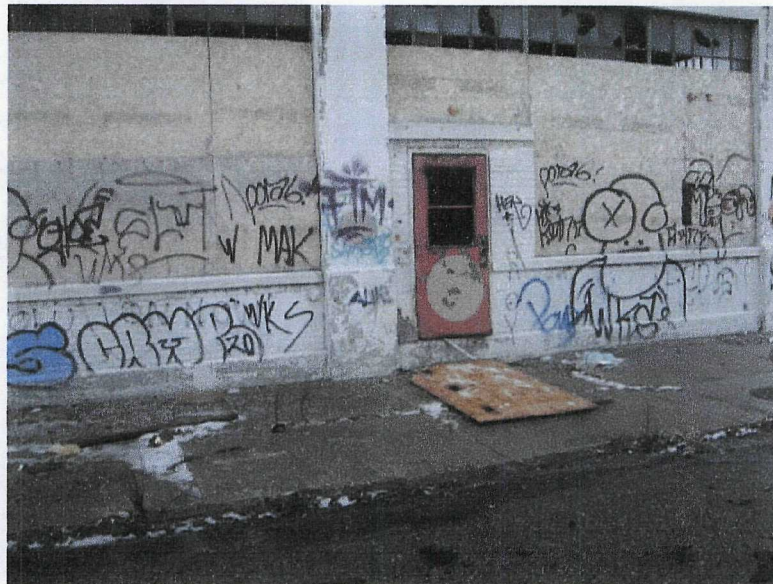
Site:	Carter Color Coat		
Date:	December 11, 2007		
Photographer:	Stephen Wolfe		
Photo Number:	4	Direction:	Southwest
Comment	A view of graffiti and a removed board on the Hastings Street side of the property.

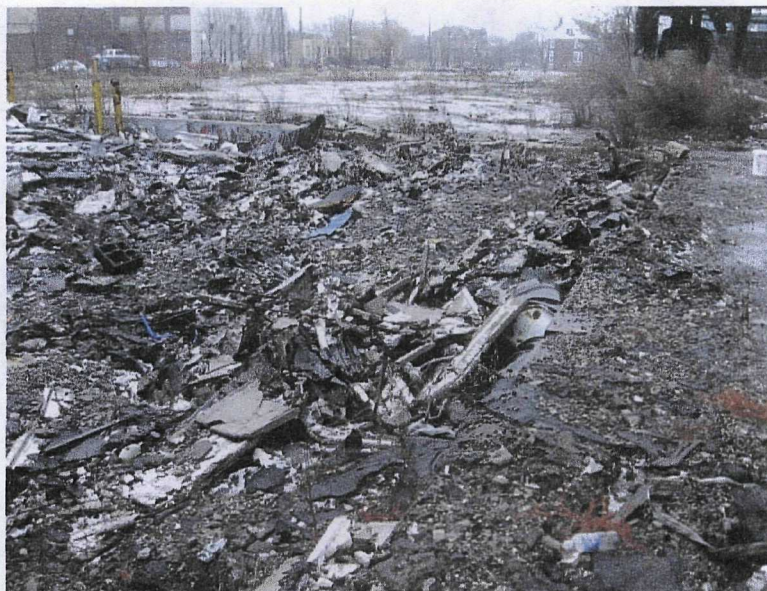
Site:	Carter Color Coat		
Date:	December 11, 2007		
Photographer:	Stephen Wolfe		
Photo Number:	5	Direction:	Southeast
Comment	A view of the area where drums were staged by MDEQ. Partially buried drums are visible.

The MDEQ personnel guided the OSC and START to the past sampling locations. All the drums that were staged on-site were now buried under debris (concrete, shingles, etc.). Samples from these drums could not be collected by START because they were buried under the debris.

Currently, the drums that were staged by MDEQ are buried under general construction debris and are unable to be sampled until they are unburied. Some of the drums reportedly contain hazardous substance such as flammable liquids and solids or corrosive liquids. In addition, the material in an outside tank and outside pits were frozen solid and a sample was not able to be collected to verify the toxicity threat of the material. The sumps are open to the environment and the material inside the pits could be released to the environment during periods of heavy rains.

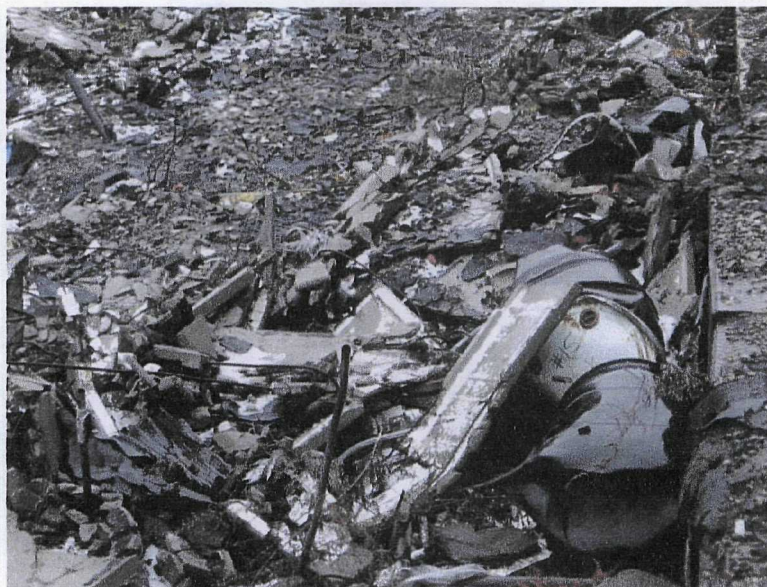
Site:	Carter Color Coat		
Date:	December 11, 2007		
Photographer:	Stephen Wolfe		
Photo Number:	6	Direction:	Down
Comment	A view of the area where drums were staged by MDEQ. Partially buried drums are visible.

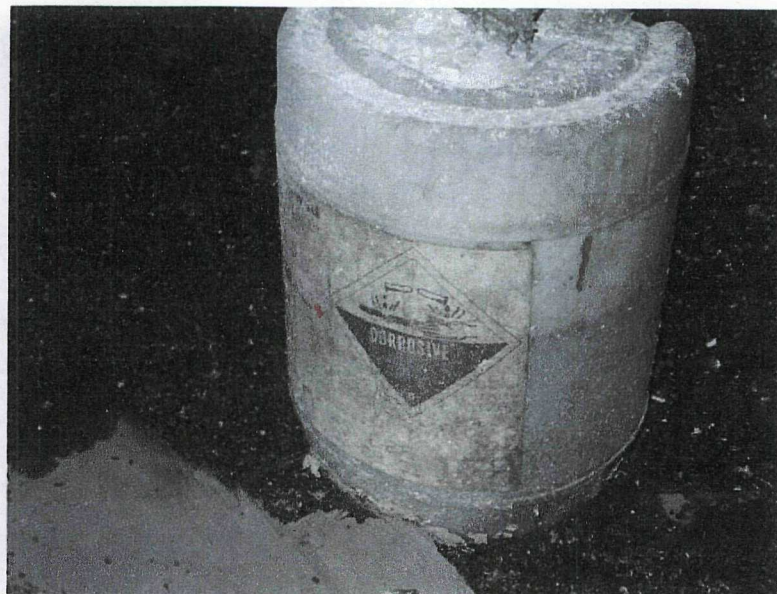
Site:	Carter Color Coat		
Date:	December 11, 2007		
Photographer:	Stephen Wolfe		
Photo Number:	7	Direction:	Down
Comment	A view of a 5-gallon tote with a corrosive label that was found inside the building.

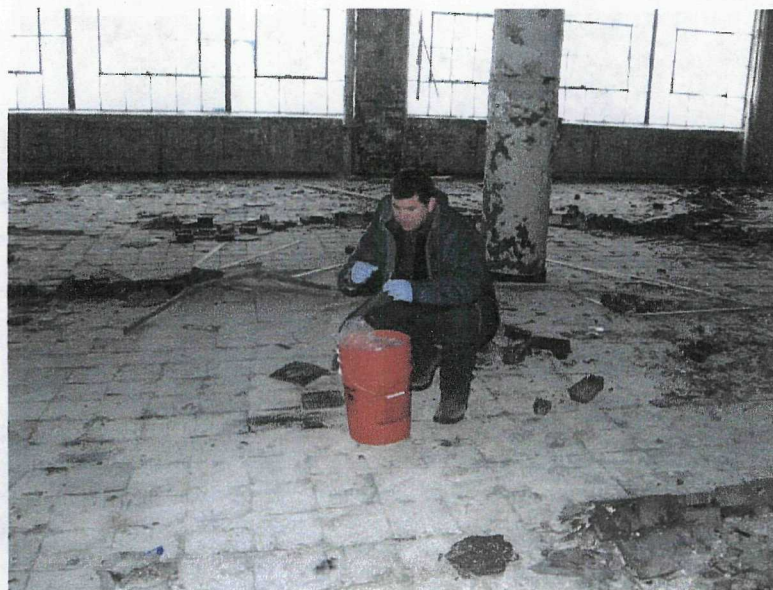
Site:	Carter Color Coat		
Date:	December 11, 2007		
Photographer:	Jeffrey Kimble		
Photo Number:	8	Direction:	Southeast
Comment	START collecting a PCB wipe sample.

Five wipe samples were collected from random areas of the wood block flooring and analyzed for PCBs. Aroclor-1260 was detected in CCC-Wipe 4th Floor at 260 micrograms/wipe ($\mu\text{g/wipe}$), Aroclor-1254 was detected in samples CCC-Wipe 3rd Floor (1.1 $\mu\text{g/wipe}$), CCC-Wipe 2nd Floor (1.7 $\mu\text{g/wipe}$), and CCC-Wipe Ground Floor (17 $\mu\text{g/wipe}$). All other Aroclors of PCBs were non-detect in the samples (Table 3).
