**SITE ASSESSMENT REPORT
FOR
JOSEPH STREET ASBESTOS SITE
MARION, MARION COUNTY, OHIO**

Date Prepared:	July 31, 2013
Technical Direction Document No.:	S05-0001-1303-009
Document Control No.	2113-2A-BDOF
Contract No.:	EP-S5-06-04
WESTON START Project Manager:	TJ McFarland
Telephone No.:	(440) 202-2802
U.S. EPA On-Scene Coordinator:	Stephen Wolfe

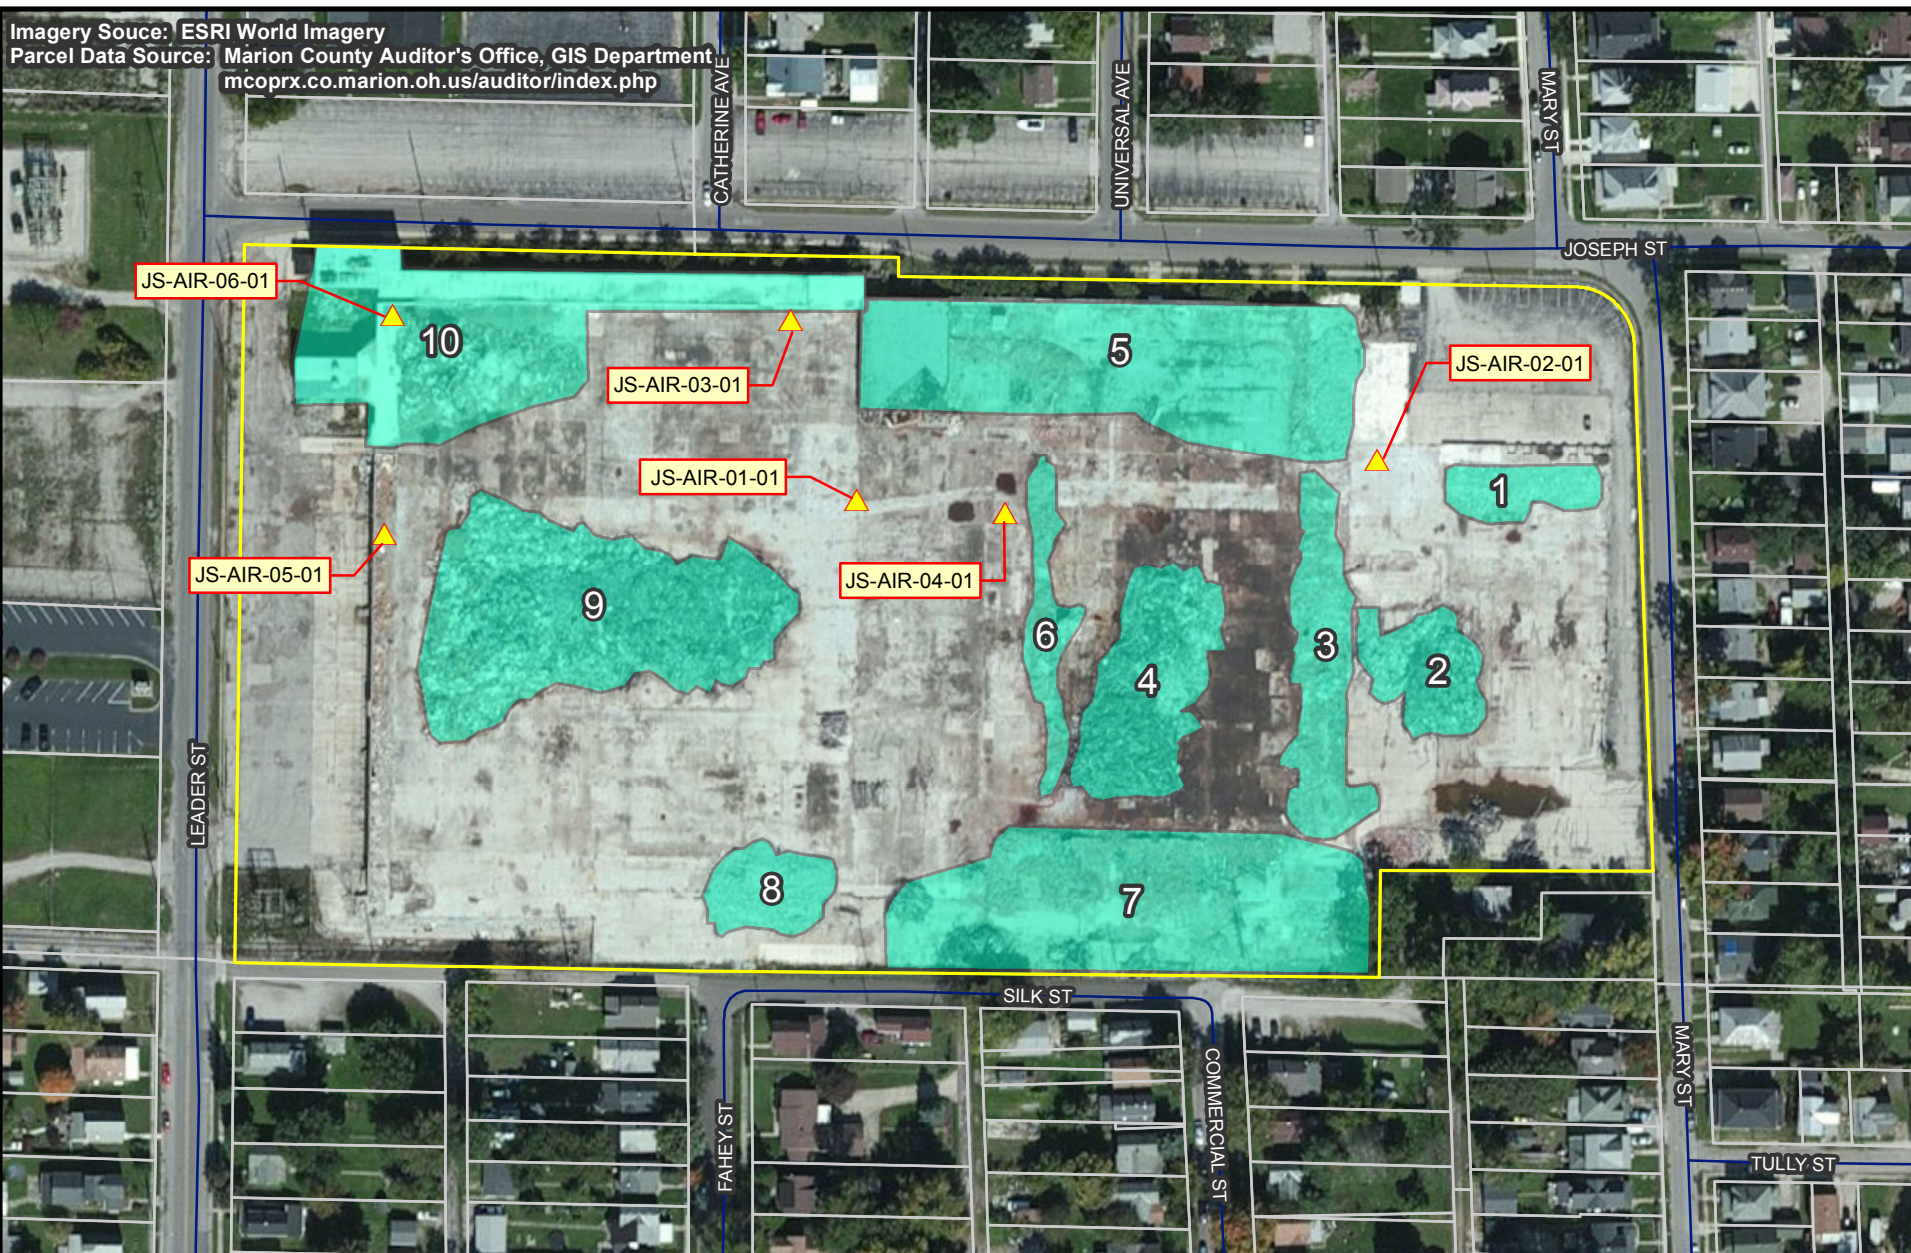
The Site is located at 333 Joseph Street in Marion, Marion County, Ohio (**Figure 1**). The Site's coordinates are 40°35'43.74" North latitude and 83°08'07.01" West longitude. The Site encompasses approximately 13.68 acres in a mixed residential, commercial, and light industrial area and once contained a commercial/warehouse building measuring approximately 440,000 square feet with a concrete floor. The former building was demolished with ACMs intact, and the Site now contains 10 piles of asbestos-contaminated demolition debris. Portions of the building in the northwest area of the Site still are partially intact. **Figure 2** shows the Site layout and demolition debris pile locations.

On April 16 and 17 and May 1, 2013, WESTON START collected representative ACM bulk samples from demolished and damaged building materials. A total of 26 homogeneous materials were identified during the site assessment, and a total of 52 investigative ACM bulk samples were collected for laboratory analysis. **Table 1** summarizes the ACM bulk samples collected. **Figure 2** shows the demolition debris pile locations.

laboratory data for the detection of airborne fibers and airborne asbestos fibers related to quiescent Site conditions at stationary locations downwind of the suspected ACM debris piles. **Figure 2** shows the stationary air sampling locations. Perimeter air sampling for asbestos was performed in accordance with National Institute for Occupational Safety and Health (NIOSH) Method 7400 (phase contrast microscopy [PCM]) and NIOSH Method 7402 (transmission electron microscopy [TEM]). Stationary air samples were collected using Sensidyne Air Con II high-volume sample pumps. The filter consisted of a 0.8-micron, 25-millimeter mixed cellulose ester (MCE) filter. The flow rate was set at approximately 10 liters per minute to collect samples. On April 13, 2013, WESTON START collected samples JS-AIR-01-01 and JS-AIR-02-01 from stationary air sampling locations. On May 1, 2013, WESTON START collected samples JS-AIR-03-01 through JS-AIR-06-01 from stationary air sampling locations.

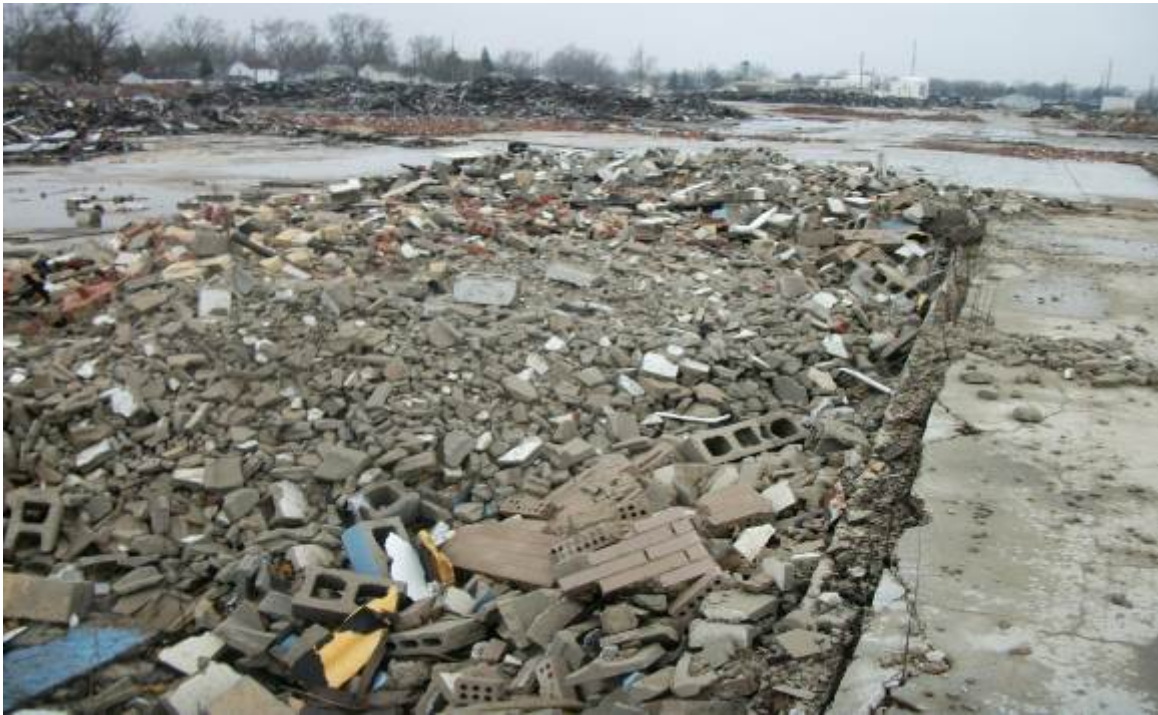
Debris Pile 1 is located near the northeast portion of the Site and primarily contains cinder blocks. The debris pile measures approximately 120 by 20 by 4 feet, or 356 cubic yards. During the site assessment, suspected ACM observed within this debris pile included floor tile, floor tile mastic, cellulose wallboard, asphaltic roofing, light-green styrofoam, and black tar on yellow brick. Historical investigations identified no suspect ACM in this pile, and no bulk samples were collected.

Site: Joseph Street Asbestos Site
Photograph No.: 1
Direction: West
Subject: Debris Pile 1

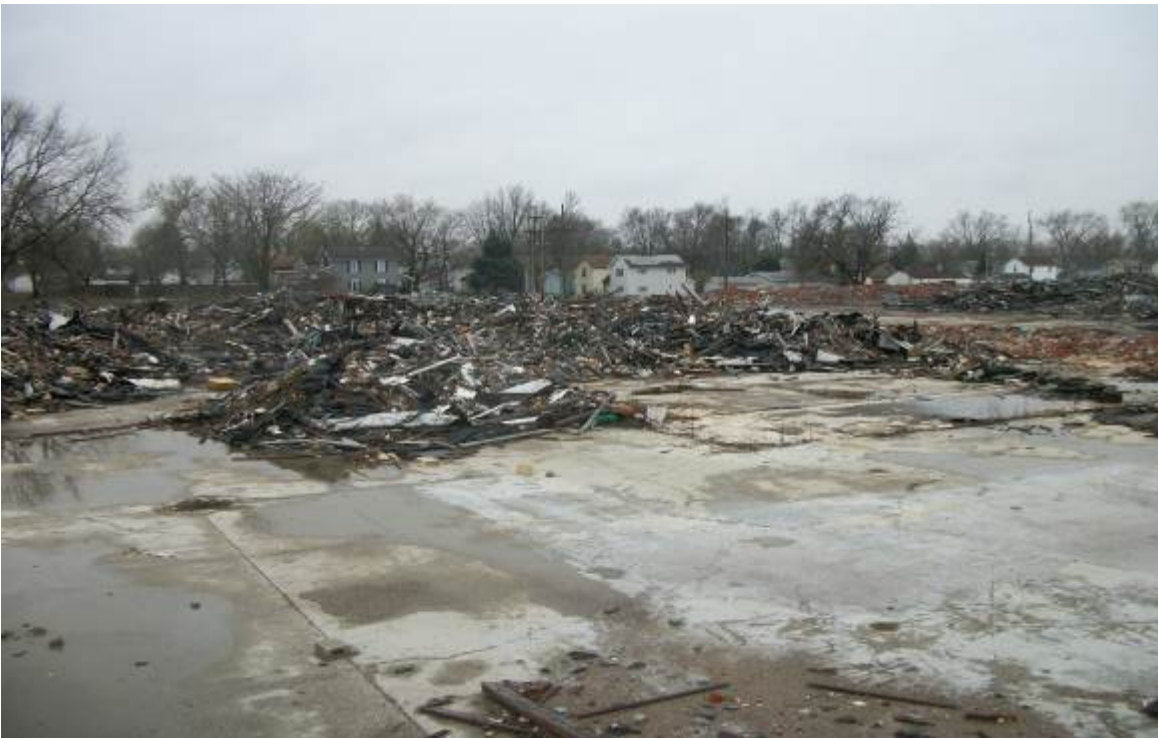
Debris Pile 2 is located near the eastern portion of the Site and primarily contains wood and roofing material. The debris pile measures approximately 90 by 80 by 8 feet, or 2,133 cubic

yards. During the site assessment, suspected ACM observed within this debris pile included transite fragments, cellulose wallboard, and asphaltic roofing. Historical investigations identified transite fragments throughout this pile; however, no bulk samples were collected.

Site: Joseph Street Asbestos Site
Photograph No.: 2
Direction: South
Subject: East and central portions of Debris Pile 2

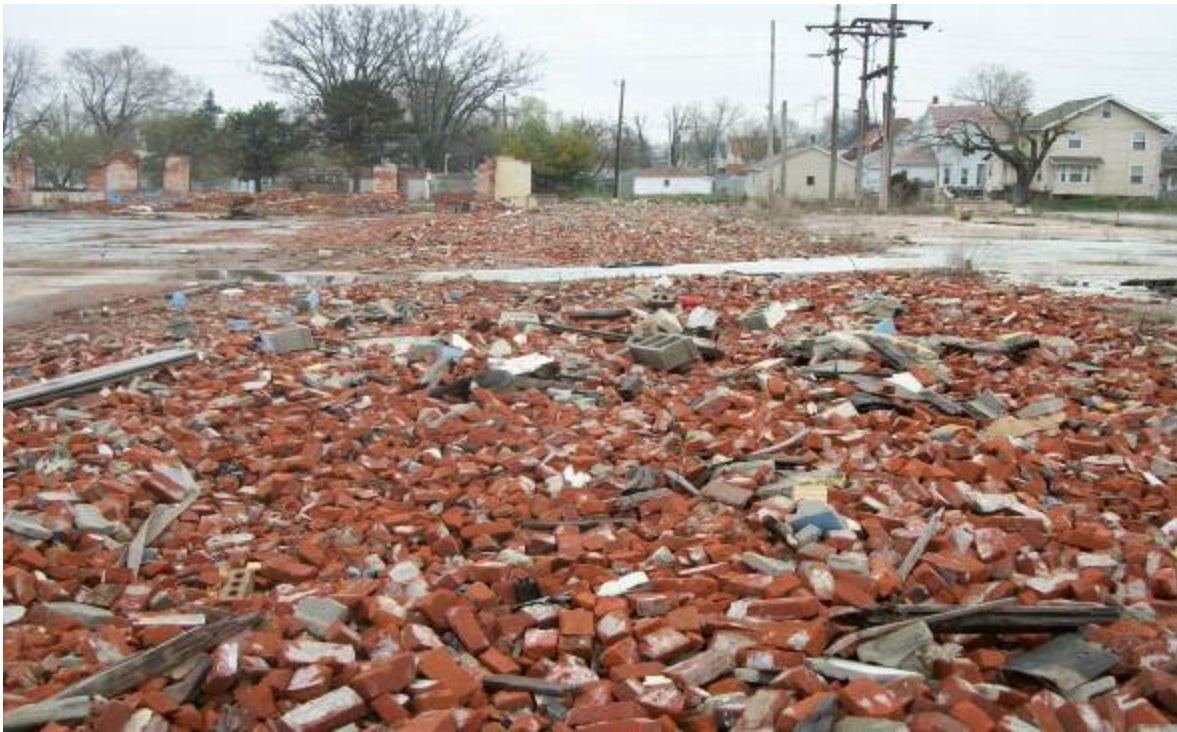
Debris Pile 3 is an elongated pile oriented north to south near the eastern portion of the Site and primarily contains red brick. The debris pile measures approximately 245 by 35 by 2 feet, or 635 cubic yards. During the site assessment, suspected ACM was observed within this debris pile and included transite fragments and asphaltic roofing. Historical investigations identified no suspect ACM in this pile, and no bulk samples were collected.

Site: Joseph Street Asbestos Site
Photograph No.: 3
Direction: North
Subject: North portion of Debris Pile 3

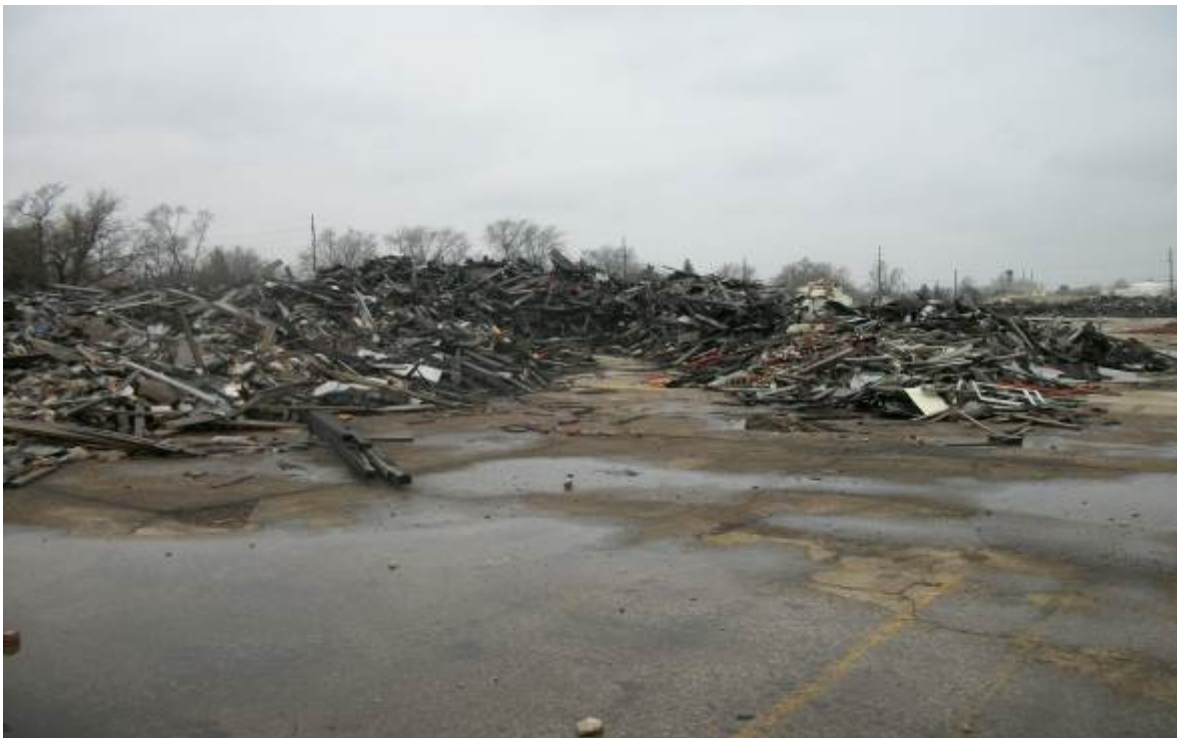
Debris Pile 4 is located near the central portion of the Site and primarily contains wood and roofing materials. The debris pile measures approximately 150 by 90 by 8 feet, or 4,000 cubic yards. During the site assessment, suspected ACM observed within this debris pile included transite, asphaltic roofing, cellulose wallboard, transite fragments, floor tile, floor tile mastic, and electrical panel fragments. Historical ACM sampling results indicate that asphaltic roofing from this pile did not contain asbestos at detectable concentrations.

Site: Joseph Street Asbestos Site
Photograph No.: 4
Direction: Southwest
Subject: Central portion of Debris Pile 4

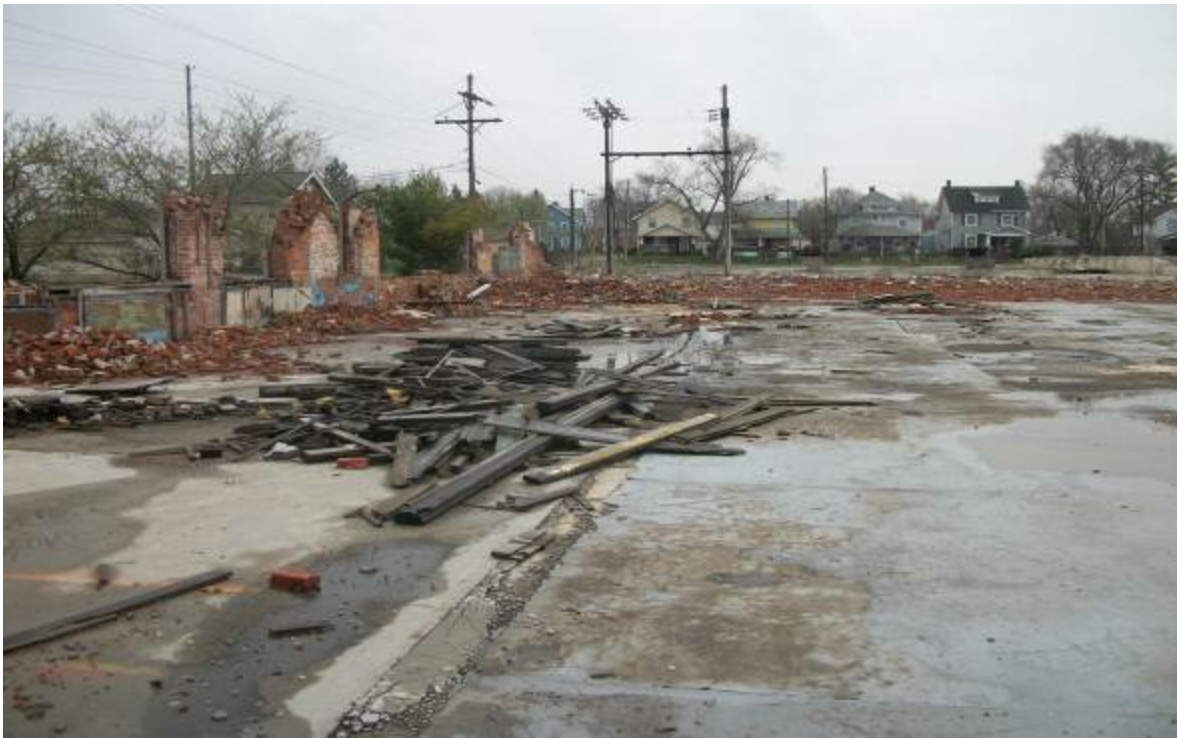
Debris Pile 5 is located in the northeastern portion of the Site and primarily contains brick and cinder block. The debris pile measures approximately 110 by 35 by 1 foot and 250 by 20 by 2 feet, or 513 cubic yards. During the site assessment, suspected ACM observed within this debris pile included floor leveling compound, linoleum, asphaltic roofing, floor tile, and floor tile mastic. Historical ACM sampling results indicate that floor leveling compound from this pile did not contain asbestos at detectable concentrations. In addition, historical investigations indicated that transite fragments were observed on the frontage of the Site along Joseph Street. However, during the site assessment, no transite fragments were observed in this area.

Site: Joseph Street Asbestos Site
Photograph No.: 5
Direction: East
Subject: Debris Pile 5

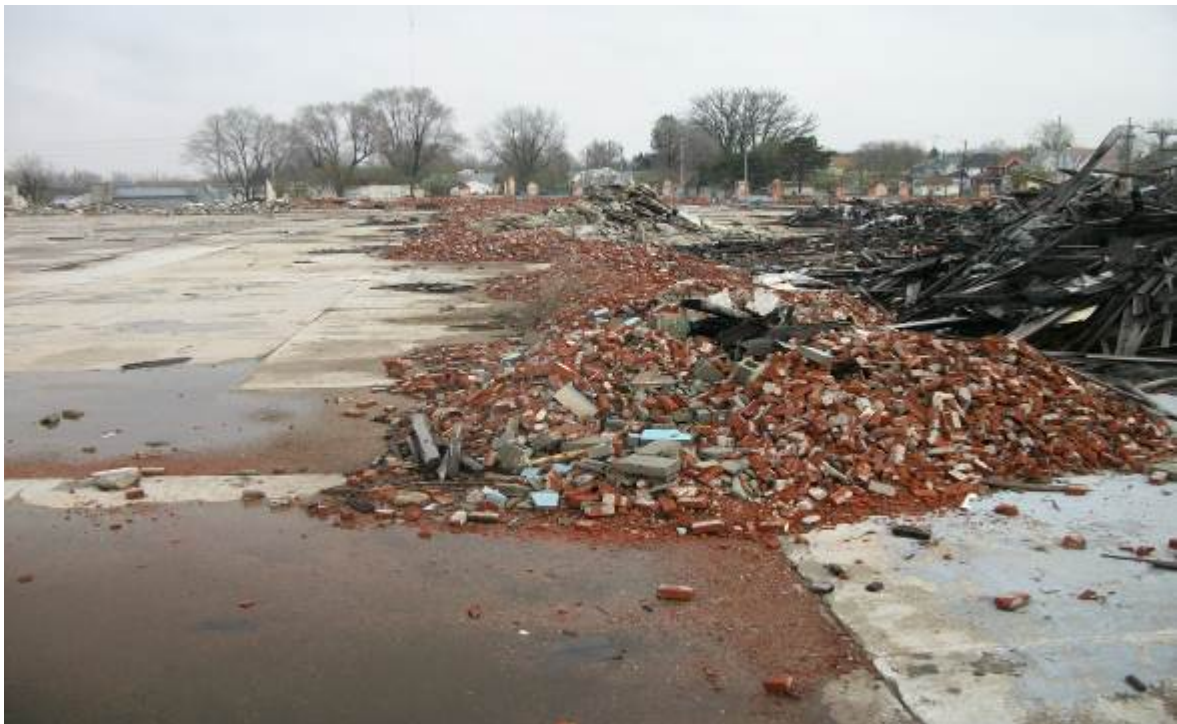
Debris Pile 6 is an elongated pile oriented north to south near the center of the Site and primarily contains brick and concrete. The debris pile measures approximately 230 by 20 by 3 feet, or 511 cubic yards. During the site assessment, suspected ACM observed within this debris pile included asphaltic roofing and transite fragments. Historical investigations identified no suspect ACM in this pile, and no bulk samples were collected. Although suspected ACM was identified within the debris piles, during the site assessment, no bulk samples were collected for laboratory analysis.

Site: Joseph Street Asbestos Site
Photograph No.: 6
Direction: North
Subject: Debris Pile 6

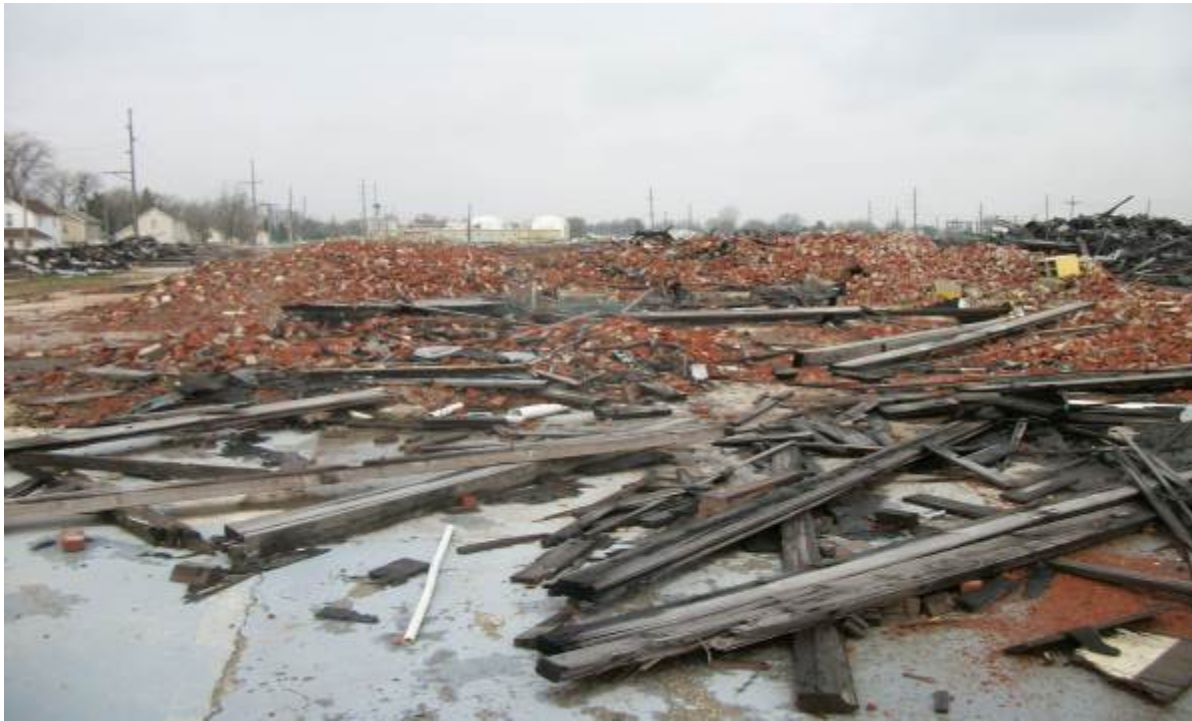
Debris Pile 7 is an elongated pile oriented east to west in the southeast corner of the Site and primarily contains brick and cinder block. The debris pile measures approximately 15 by 35 by 4 feet and 200 by 35 by 4 feet, or 1,115 cubic yards. During the site assessment, suspected ACM observed within this debris pile included slate roof material, asphaltic roofing, brick, and tar on precast concrete. Historical ACM sampling results from other investigations indicate that the asphaltic roofing tested positive for asbestos.

Site: Joseph Street Asbestos Site
Photograph No.: 7
Direction: West
Subject: Debris Pile 7

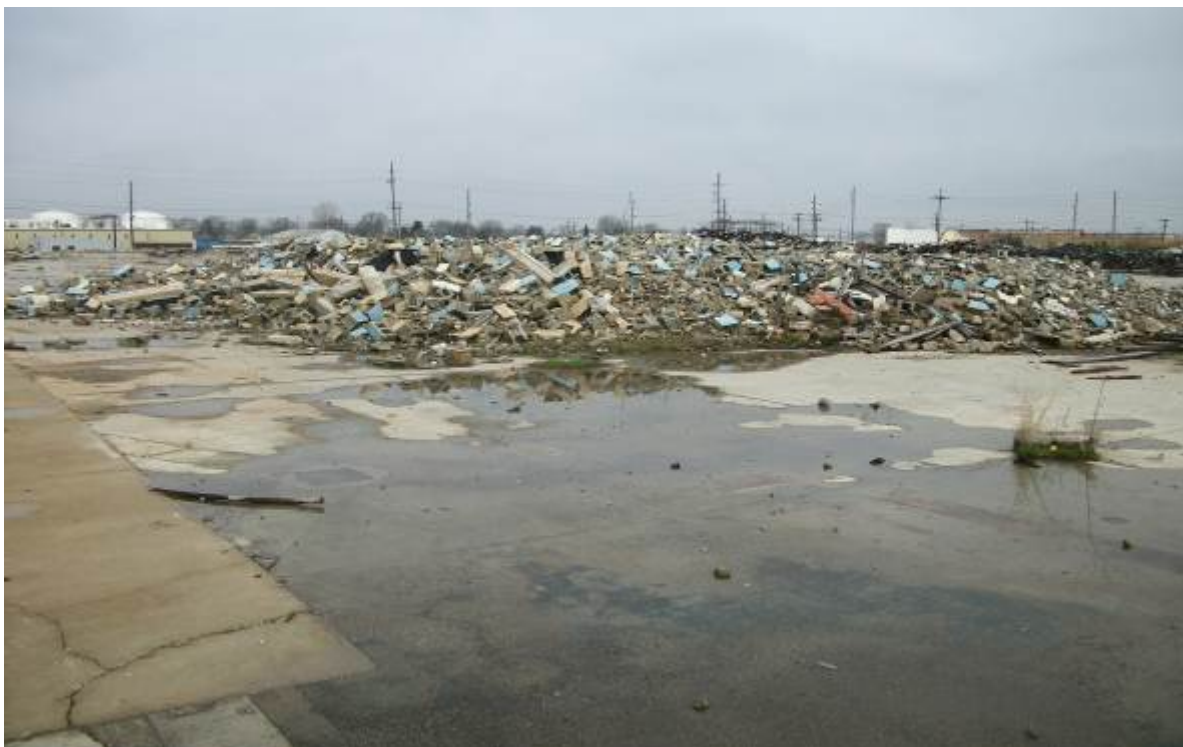
Debris Pile 8 is located in the south-central portion of the Site and primarily contains cinder block. The debris pile measures approximately 75 by 45 by 5 feet, or 625 cubic yards. During the site assessment, suspected ACM observed within this debris pile included white granular cement and asphaltic roofing. Historical ACM sampling results indicate that asphaltic roofing from this pile tested positive for asbestos.

Site: Joseph Street Asbestos Site
Photograph No.: 8
Direction: Northwest
Subject: Debris Pile 8

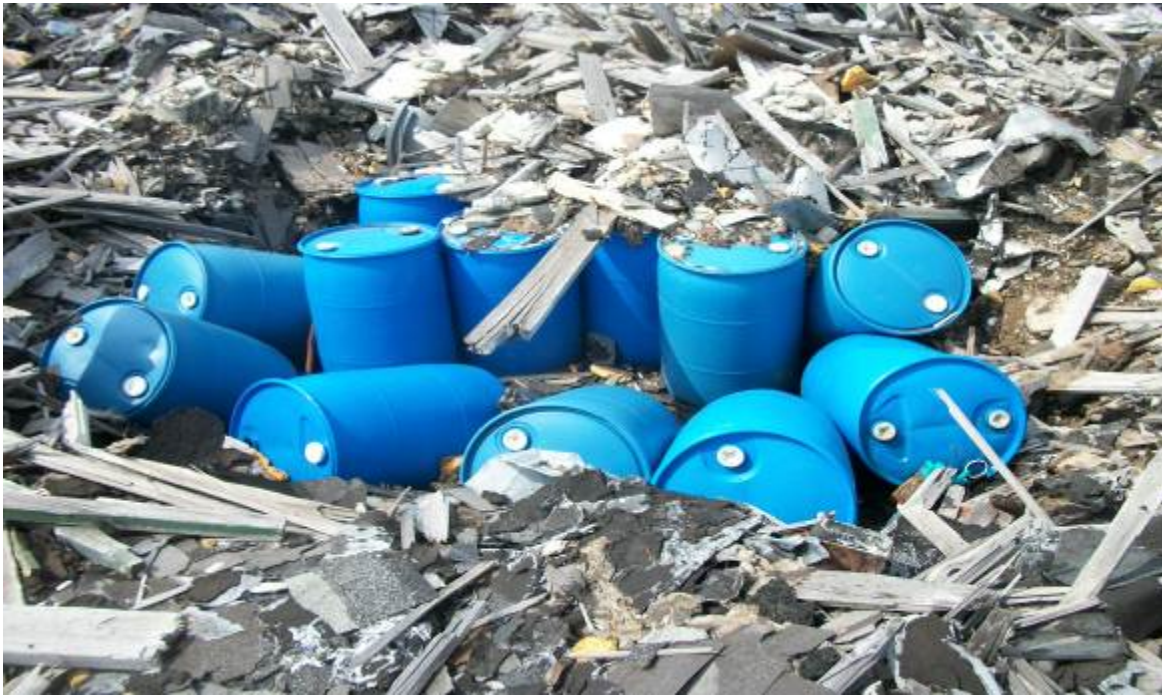
During the site assessment, WESTON START observed 12 55-gallon plastic drums in Debris Pile 9. The bungs on two of the drums were open. The bungs on the rest of the drums were closed and sealed. All the drums appeared to be intact. A small, damaged label on one drum

indicated that it contained vinegar. An emblem on the bung seals of the other drums matched the emblem on the one label that was found. . The pH of the liquid contents of one drum was 5 standard units (SU).

Site: Joseph Street Asbestos Site
Photograph No.: 11
Direction: North
Subject: Drums in Debris Pile 9

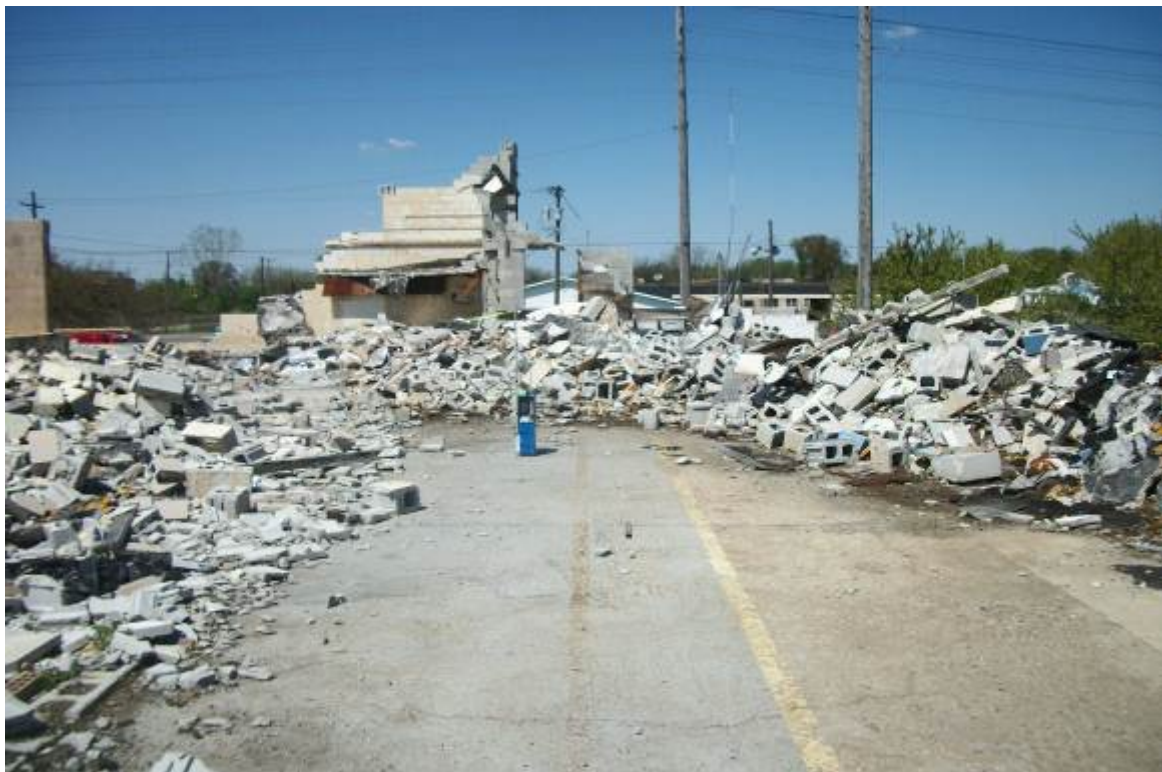
Site: Joseph Street Asbestos Site
Photograph No.: 12
Direction: West
Subject: Stationary air sampling unit
