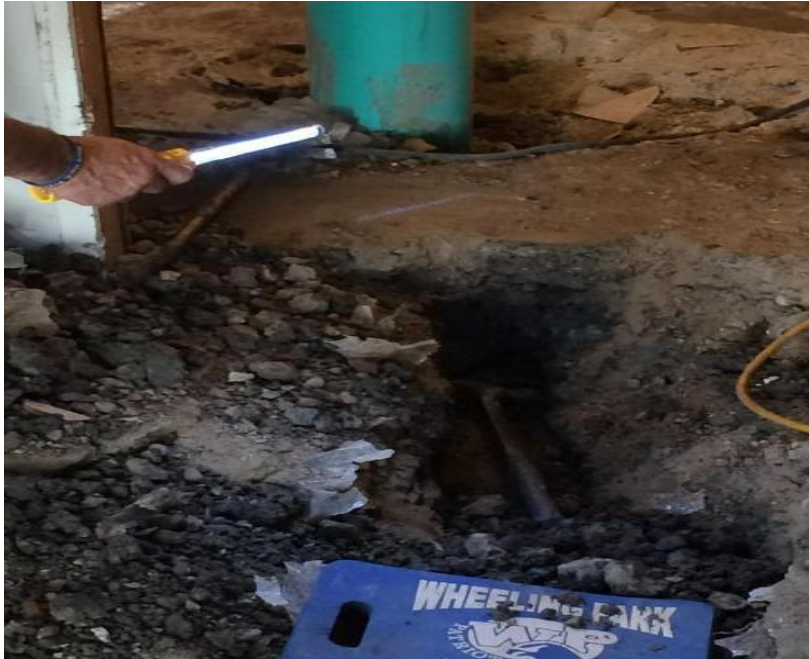
This Picture shows the pipe originating from the location of the abandoned oil under the floor of the apartment building. The blue pipe is the plastic pipe inserted into the well casing to act to ventilate the gas from the building. The steel pipe (under the floor) ends near some vertically oriented wooden pieces believed to be the original wooden conductor and then travels to the culvert.

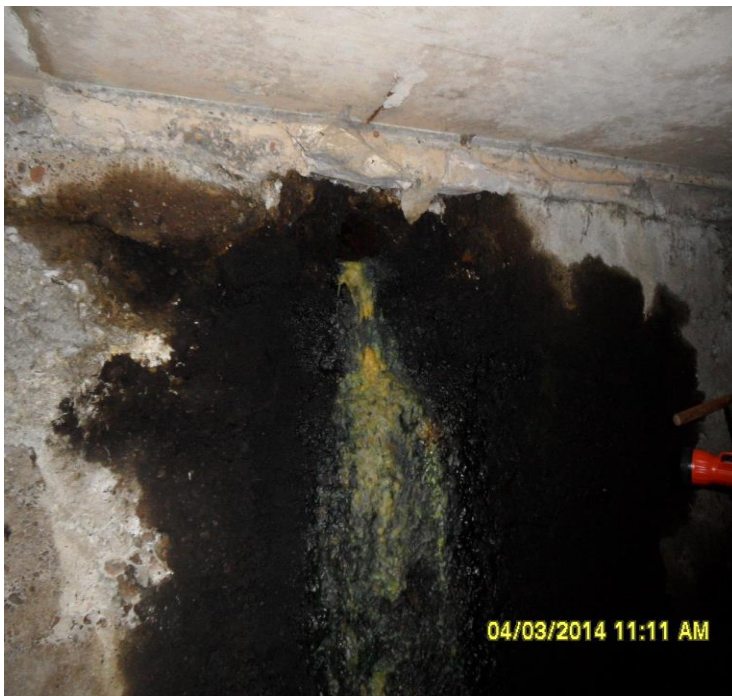
This picture shows the end of the pipe passing through the walls of the box culvert which is constructed around / over Stackyard Run. The pipe is positioned about 6 feet from the floor of the culvert and less than 12 inches from the ceiling. Note the yellow paraffin and the dark-colored oil stained wall.

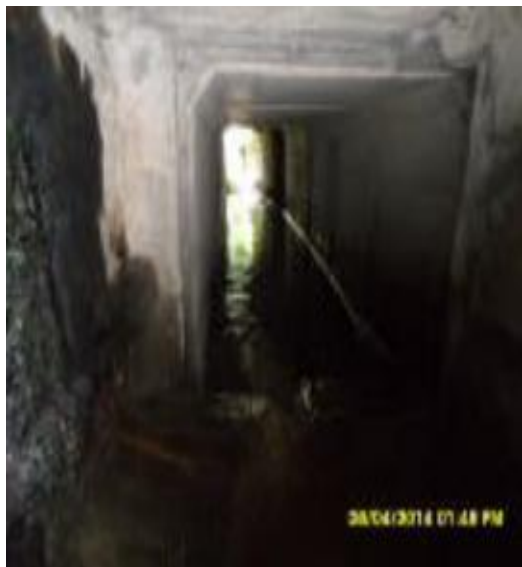
This picture shows the culvert wall (left) through which the pipe passes and its position relative to the flowing water of Stackyard Run. The picture is oriented such that the water flows away from the “front” of the picture and towards the “rear”.

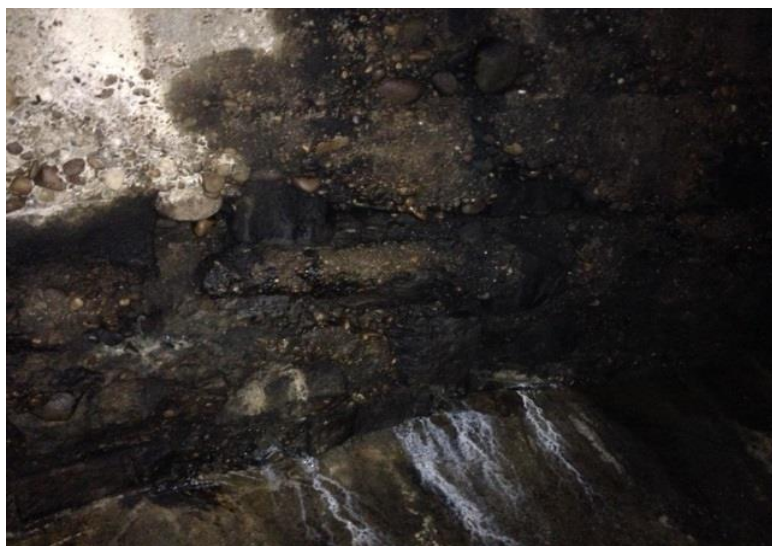
This is a closeup of the base of culvert wall at its connection with the concrete floor of the culvert. The wall is constructed of stone with a concrete/cement coating in some areas. Oil also seeps from the base of the wall which is about 18” from the flowing water of Stackyard Run. The OSC has observed oil globules and gas bubbles at this point.

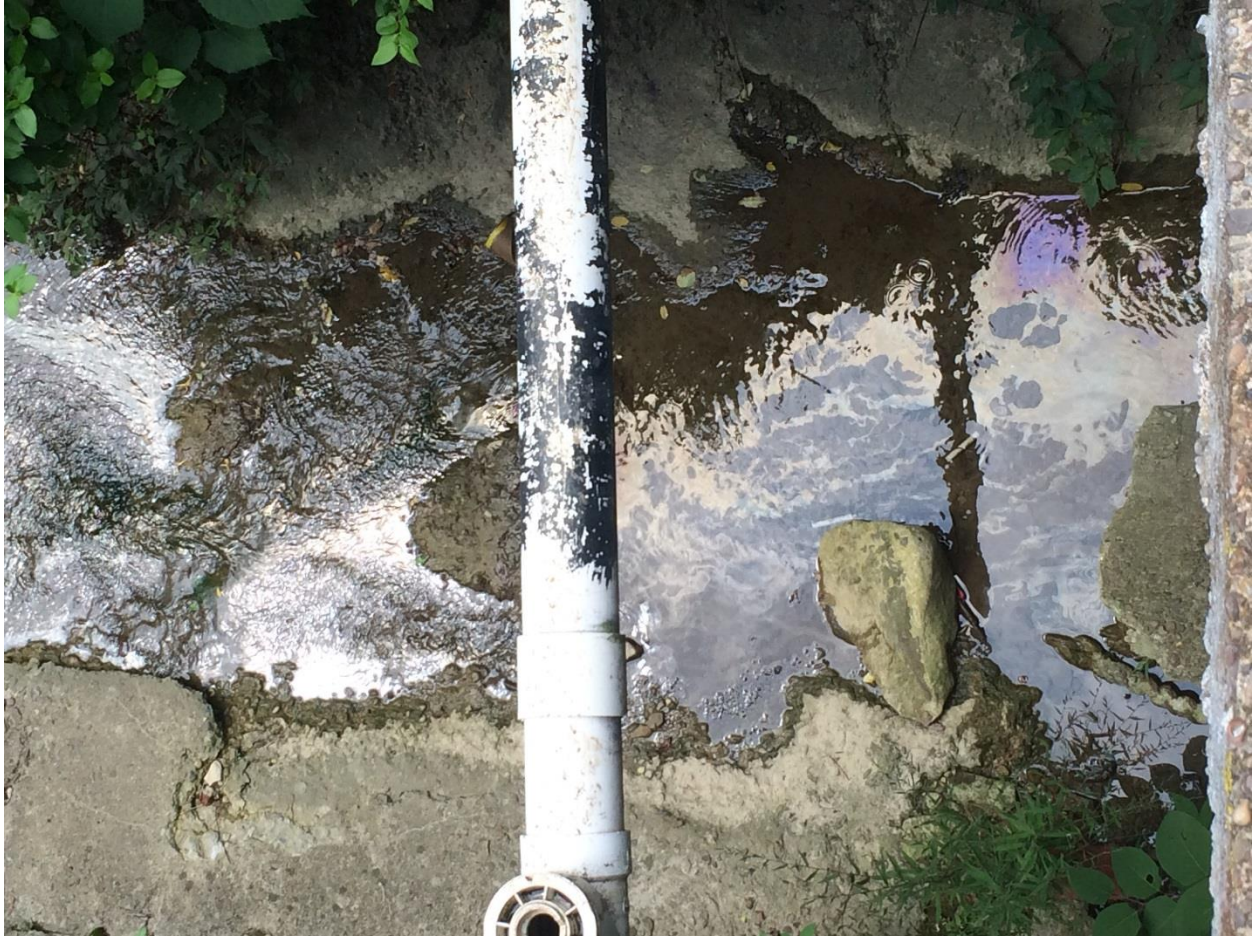
This is a picture of Stackyard Run as it flows from the culvert towards Wheeling Creek. The flow direction is from right to left in this picture.
