**Subject: Phase I Targeted Brownfields Assessment
Kansas City Missouri Public Works East Garage Site
Kansas City, Jackson County, Missouri
EPA Region 7, START 4, Contract No. EP-S7-13-06, Task Order No. 0002.019.001
Task Monitor: Todd Davis, Site Assessment Manager**

PHASE I TARGETED BROWNFIELDS ASSESSMENT
KANSAS CITY MISSOURI PUBLIC WORKS EAST GARAGE SITE
KANSAS CITY, JACKSON COUNTY, MISSOURI

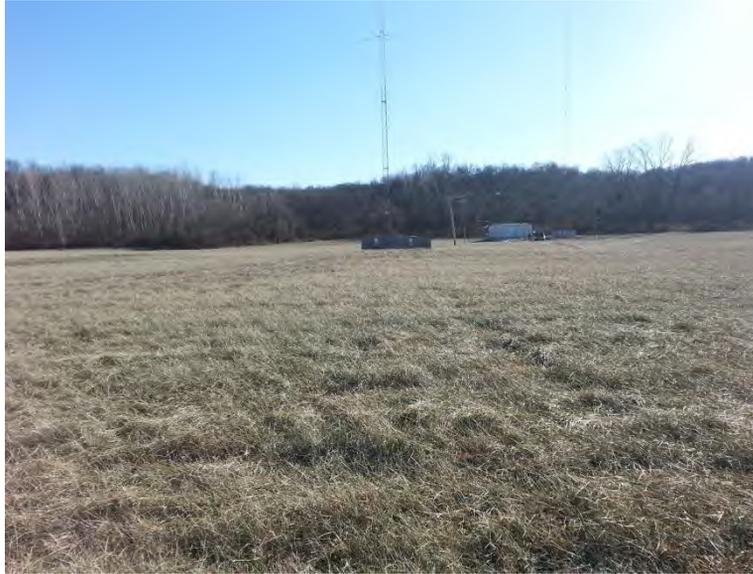
TETRA TECH PROJECT NO. X9025.14.0002.019.001 Direction: South	DESCRIPTION	This photograph shows a view of the subject property from the north.	1
	CLIENT	US Environmental Protection Agency	DATE
	PHOTOGRAPHER	Kumud Pyakuryal	12/12/2013

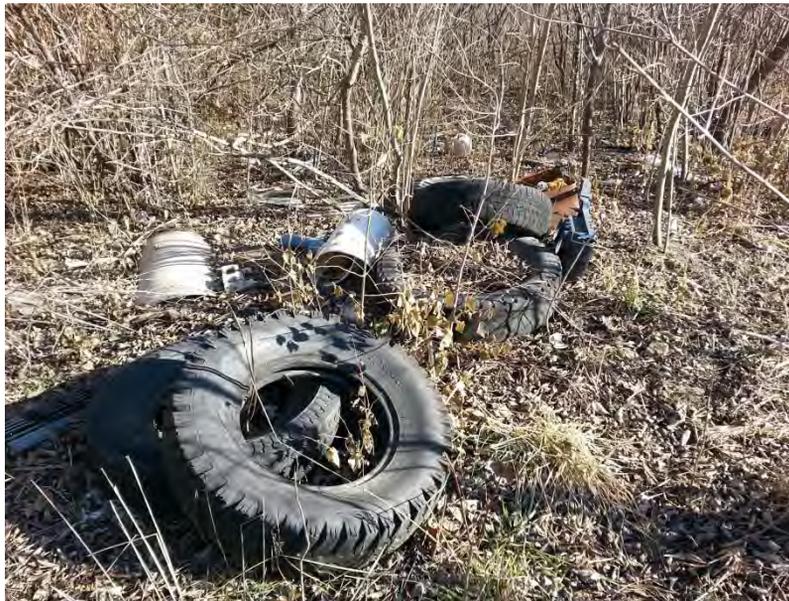
TETRA TECH PROJECT NO. X9025.14.0002.019.001 Direction: East	DESCRIPTION	This photograph shows the debris east of the access road on the subject property. The debris includes tires, electronics, construction materials, and general solid waste items.	2
	CLIENT	US Environmental Protection Agency	DATE
	PHOTOGRAPHER	Kumud Pyakuryal	12/12/2013

- Removal from the subject property and proper disposal of empty 1-quart and 5-gallon containers. START also recommends removal of solid waste observed at multiple locations at the subject property.

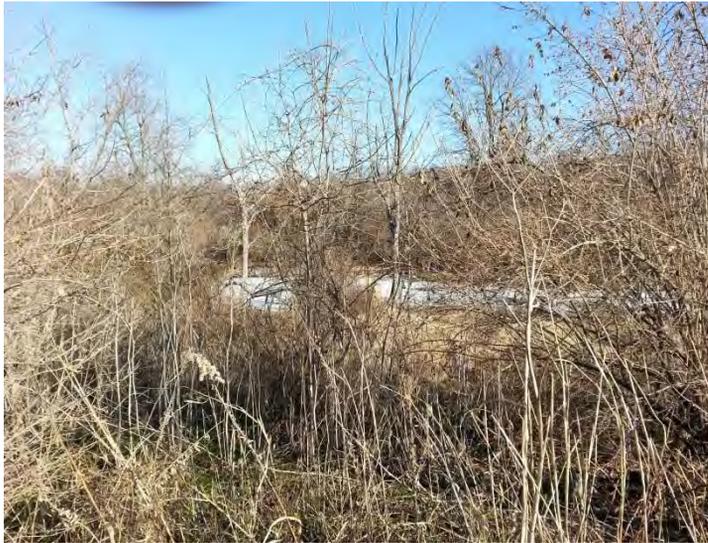
<p>TETRA TECH PROJECT NO. X9025.14.0002.019.001</p> <p>Direction: Southeast</p>	DESCRIPTION	This photograph shows the lagoon on the eastern portion of the subject property.	3
	CLIENT	US Environmental Protection Agency	DATE 12/12/2013
	PHOTOGRAPHER	Kumud Pyakuryal

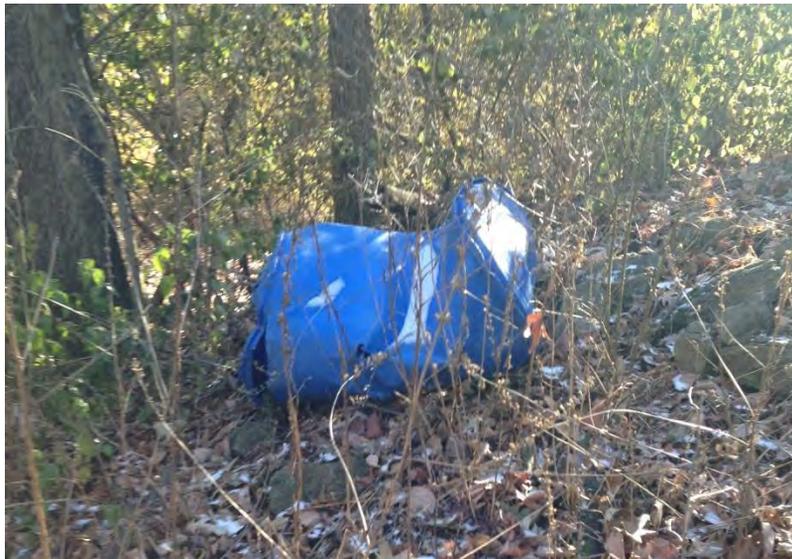
<p>TETRA TECH PROJECT NO. X9025.14.0002.019.001</p> <p>Direction: East</p>	DESCRIPTION	This photograph shows an empty 55-gallon drum east of the access road, in the forested area of the subject property.	4
	CLIENT	US Environmental Protection Agency	DATE 12/12/2013
	PHOTOGRAPHER	Kumud Pyakuryal

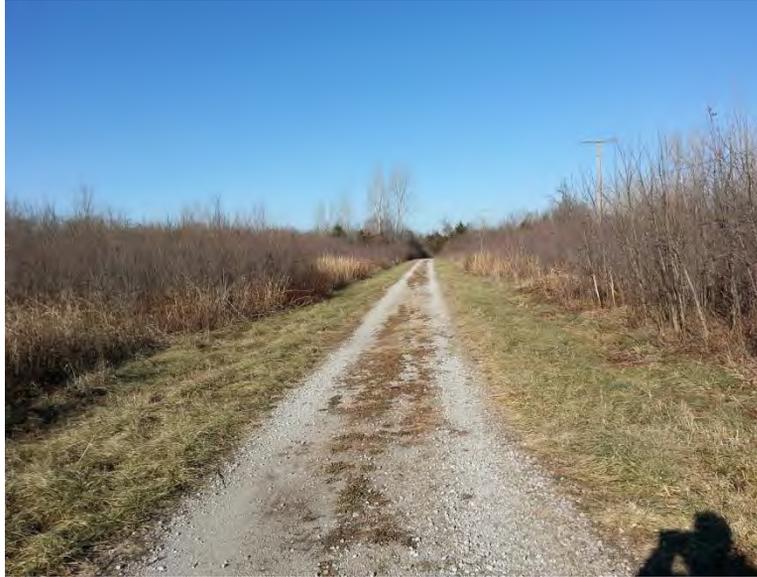
TETRA TECH PROJECT NO. X9025.14.0002.019.001 Direction: North	DESCRIPTION	This photograph shows the gravel (unpaved) access road.	5
	CLIENT	US Environmental Protection Agency	DATE 12/12/2013
	PHOTOGRAPHER	Kumud Pyakuryal

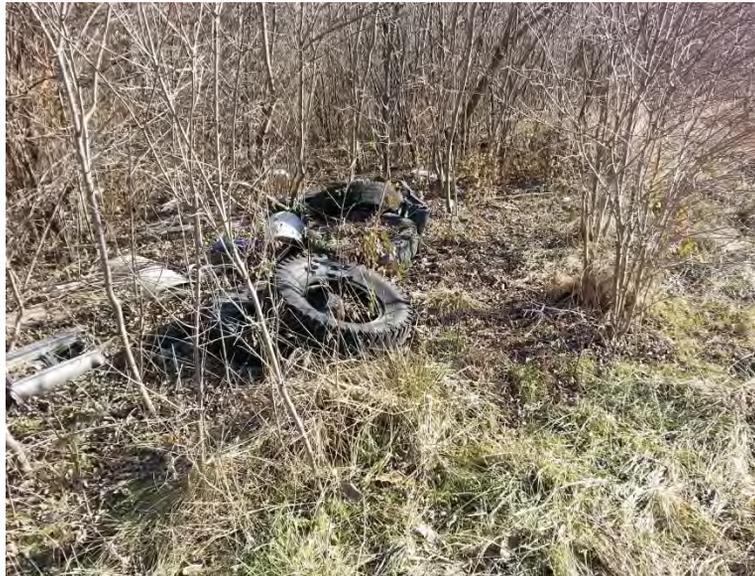
TETRA TECH PROJECT NO. X9025.14.0002.019.001 Direction: East	DESCRIPTION	This photograph shows a second pile of debris east of the access road on the subject property. The debris includes tires, electronics, construction materials, and general solid waste items.	6
	CLIENT	US Environmental Protection Agency	DATE 12/12/2013
	PHOTOGRAPHER	Kumud Pyakuryal

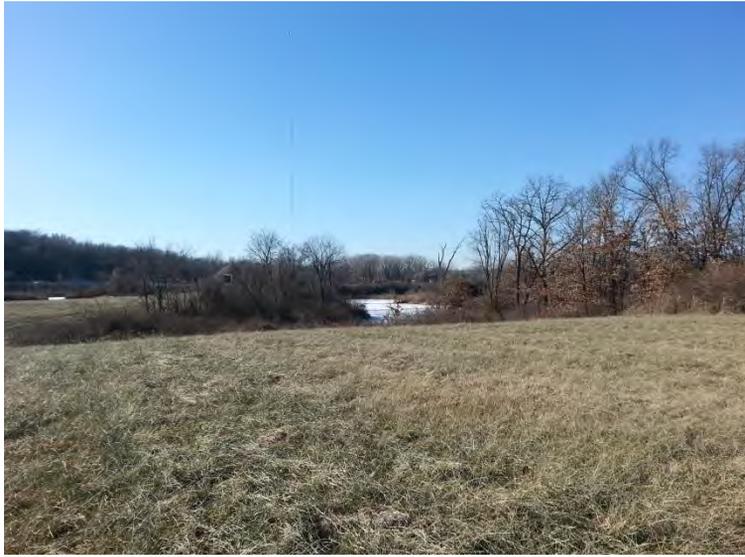
TETRA TECH PROJECT NO. X9025.14.0002.019.001 Direction: West	DESCRIPTION	This photograph shows the pond west of the subject property.	7
	CLIENT	US Environmental Protection Agency	DATE
	PHOTOGRAPHER	Kumud Pyakuryal	12/12/2013

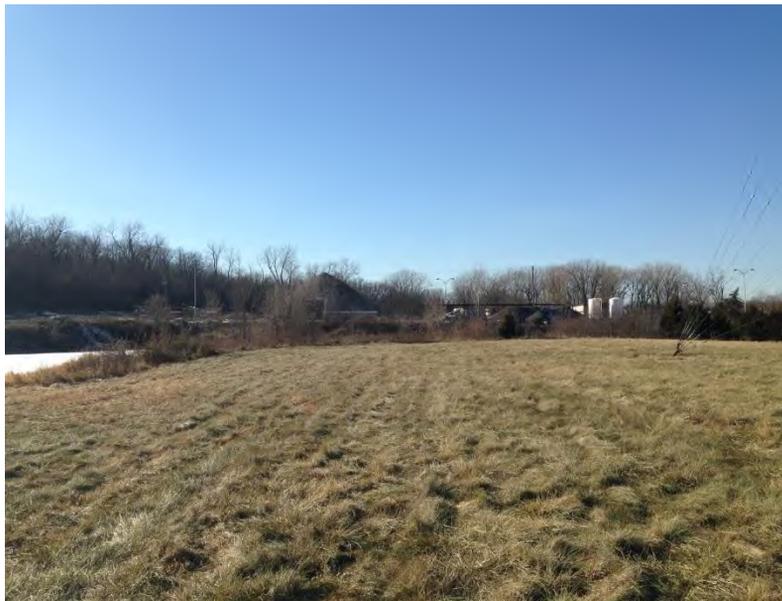
TETRA TECH PROJECT NO. X9025.14.0002.019.001 Direction: West/northwest	DESCRIPTION	This photograph shows the aboveground storage tanks within the adjacent property to the east.	8
	CLIENT	US Environmental Protection Agency	DATE
	PHOTOGRAPHER	Kumud Pyakuryal	12/12/2013

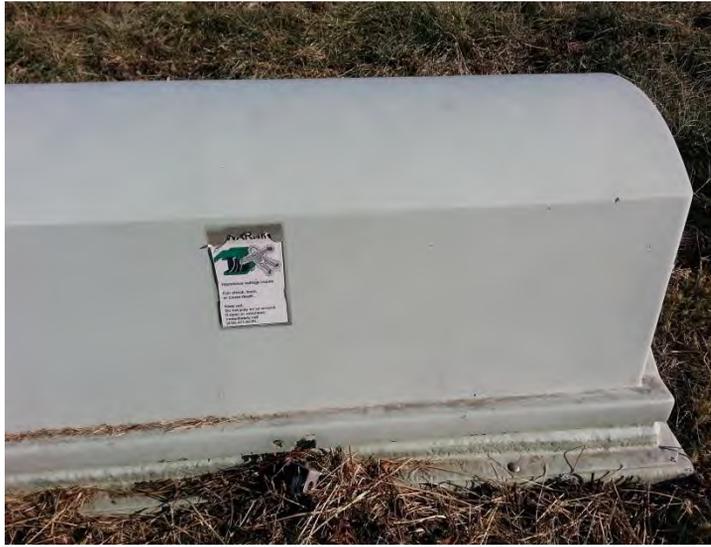
TETRA TECH PROJECT NO. X9025.14.0002.019.001 Direction: East	DESCRIPTION	This photograph shows a transformer or relay box on the subject property.	9
	CLIENT	US Environmental Protection Agency	DATE
	PHOTOGRAPHER	Kumud Pyakuryal	12/12/2013
