REMOVAL ACTION REPORT

**VCC COLUMBIA PHOSPHATE
COLUMBIA, RICHLAND COUNTY, SOUTH CAROLINA
TDD No.: TNA-05-001-0085
Contract No.: EP-W-05-053**

Revision 0

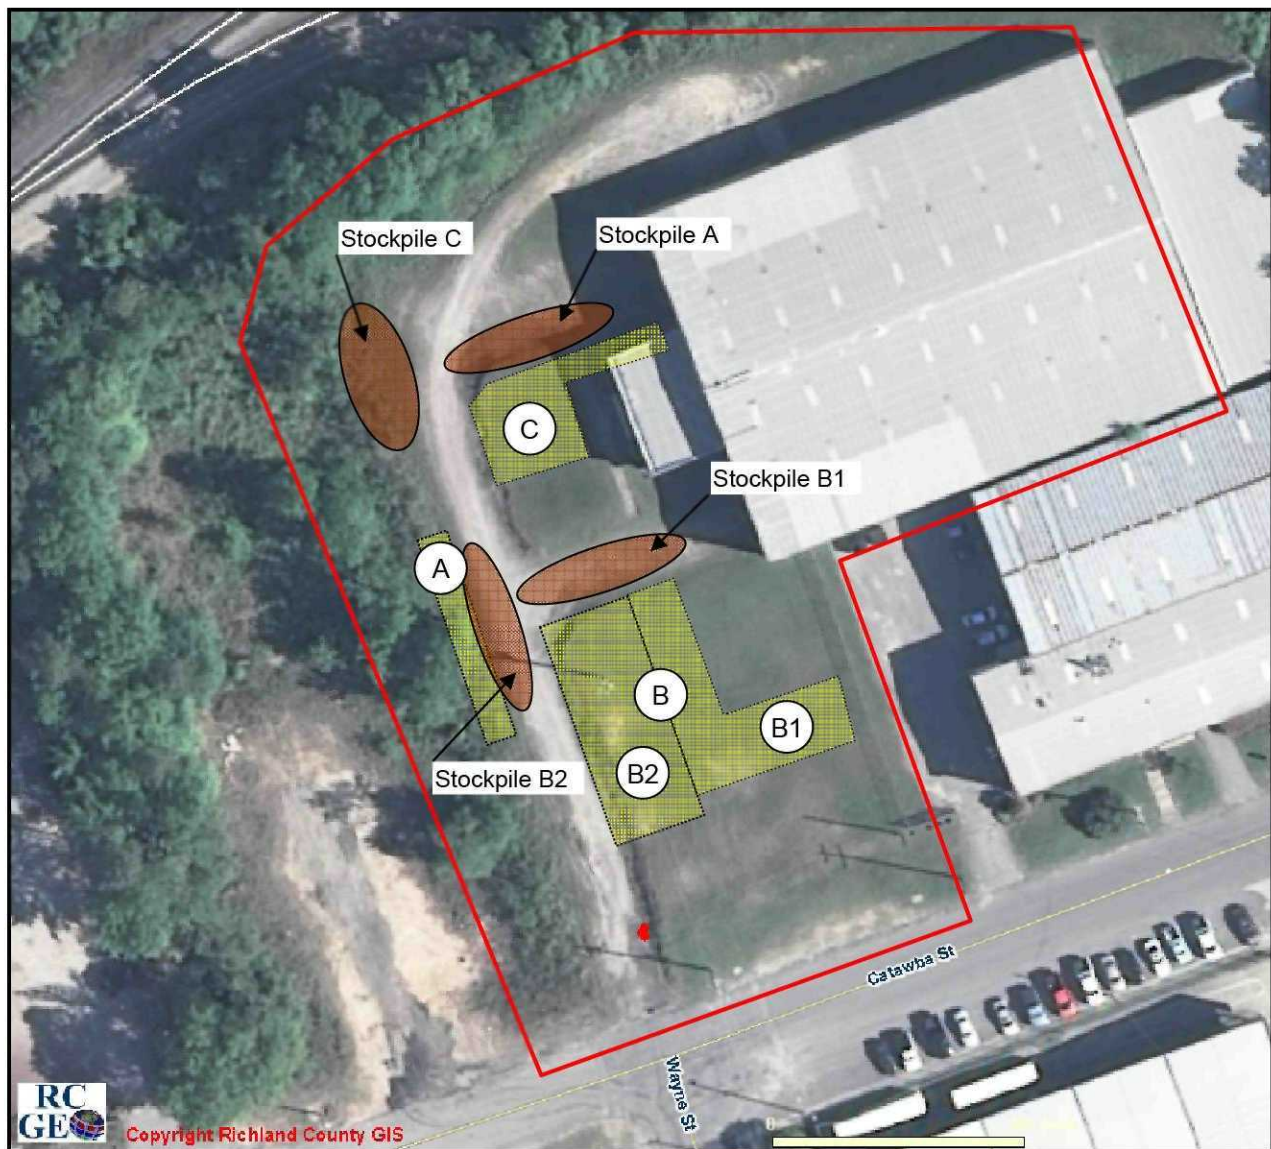
Scale: 1 inch = approximately 92 feet

Note: Excavation areas and stockpiles are shown in approximate size.

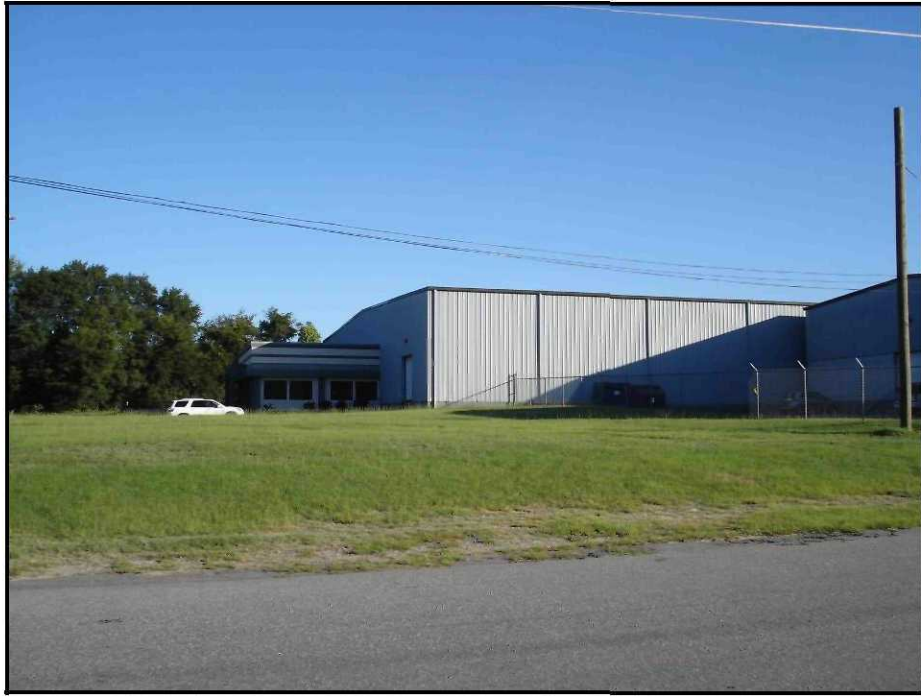
Official Photograph No. 1

Site Name:	VCC Columbia Phosphate	Date:	September 29, 2009
Location:	Columbia, Richland County, SC	TDD No:	TNA-05-001-0085
Photographer:	Ryan Stubbs, START		
Subject:	View of the site prior to Removal Action.

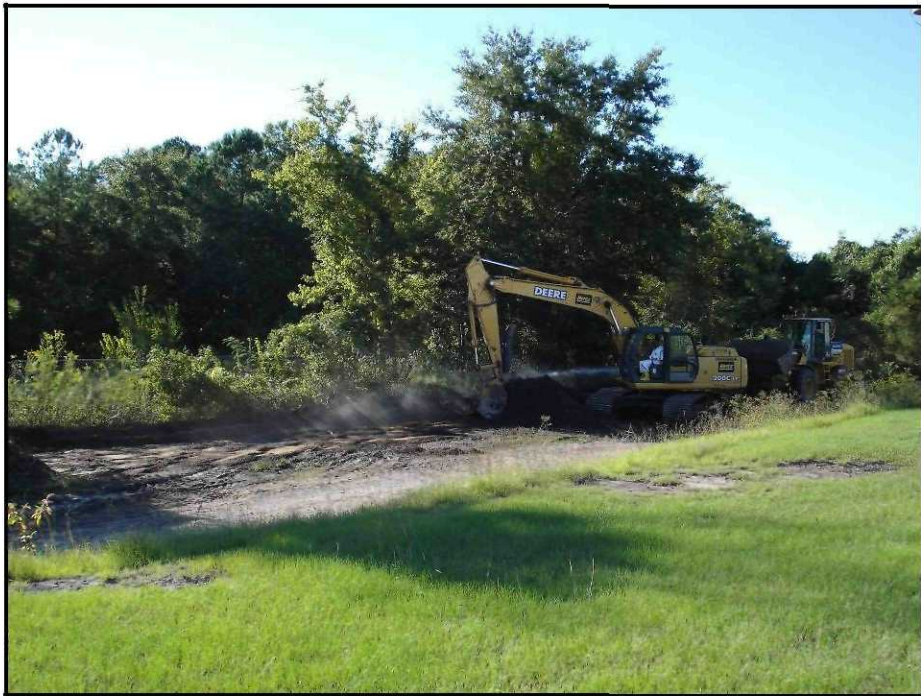
Official Photograph No. 2

Site Name:	VCC Columbia Phosphate	Date:	September 29, 2009
Location:	Columbia, Richland County, SC	TDD No:	TNA-05-001-0085
Photographer:	Ryan Stubbs, START		
Subject:	View of ERRS excavating the berm (Area A).

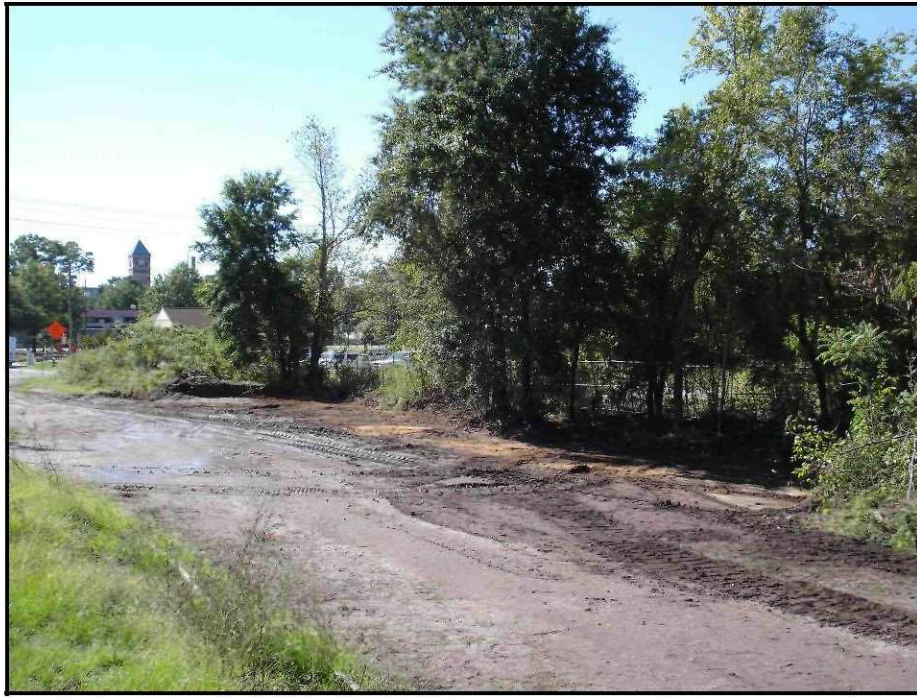
Official Photograph No. 3

Site Name:	VCC Columbia Phosphate	Date:	September 29, 2009
Location:	Columbia, Richland County, SC	TDD No:	TNA-05-001-0085
Photographer:	Ryan Stubbs, START		
Subject:	View of completed berm excavation (Area A).

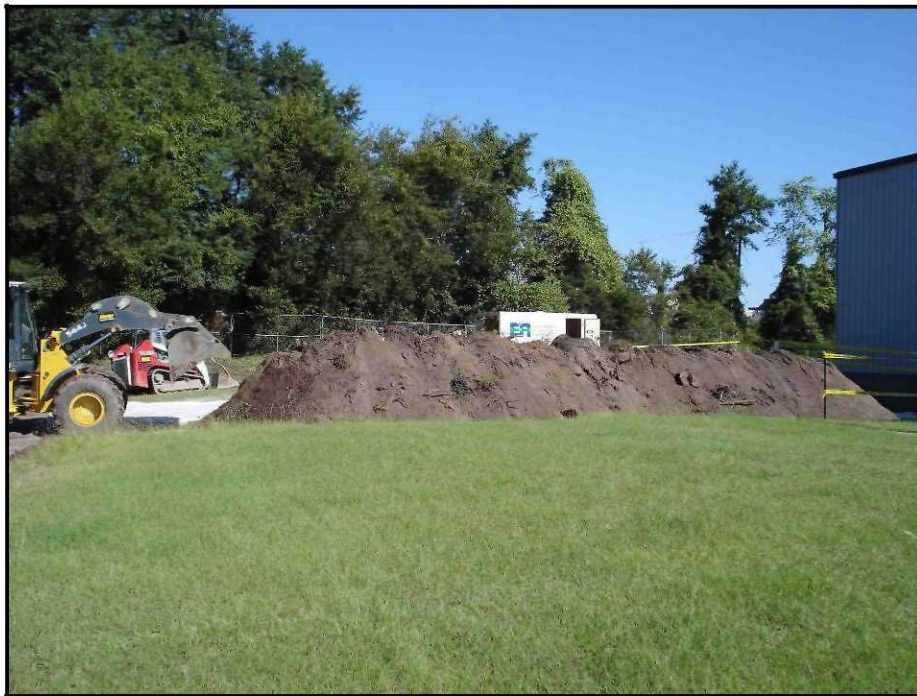
Official Photograph No. 4

Site Name:	VCC Columbia Phosphate	Date:	September 30, 2009
Location:	Columbia, Richland County, SC	TDD No:	TNA-05-001-0085
Photographer:	Ryan Stubbs, START		
Subject:	View of Stockpile A.

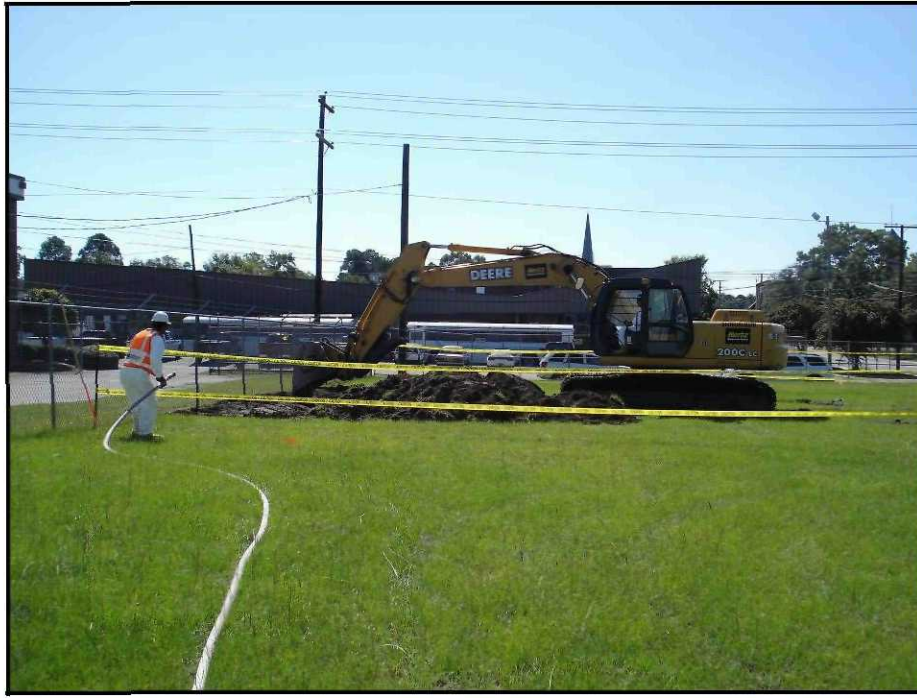
Official Photograph No. 5

Site Name:	VCC Columbia Phosphate	Date:	September 30, 2009
Location:	Columbia, Richland County, SC	TDD No:	TNA-05-001-0085
Photographer:	Ryan Stubbs, START		
Subject:	View of ERRS beginning excavating Area B1.

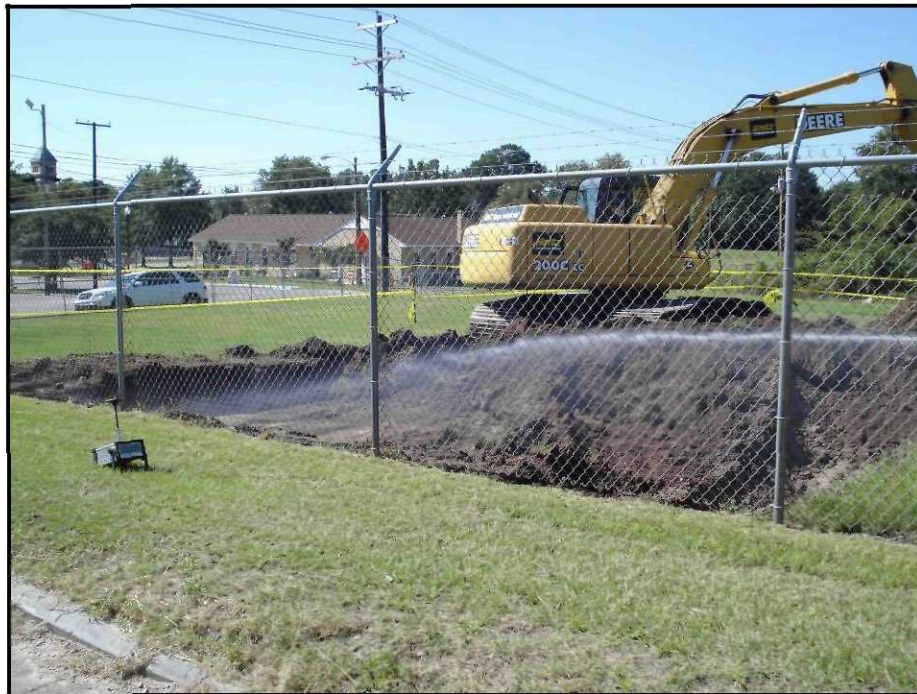
Official Photograph No. 6

Site Name:	VCC Columbia Phosphate	Date:	September 30, 2009
Location:	Columbia, Richland County, SC	TDD No:	TNA-05-001-0085
Photographer:	Ryan Stubbs, START		
Subject:	View of ERRS excavating Area B1.

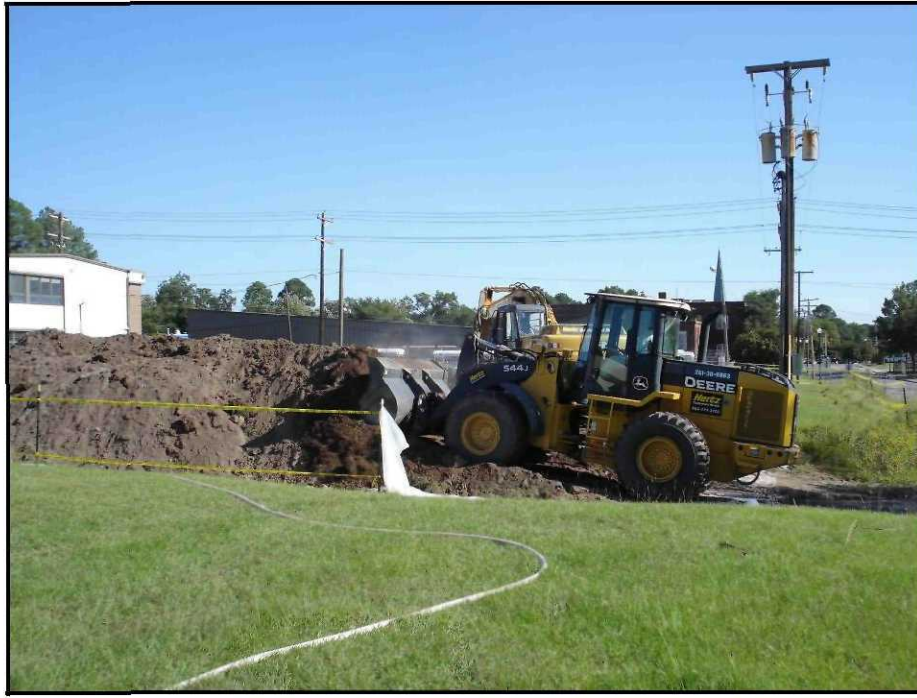
Official Photograph No. 7

Site Name: VCC Columbia Phosphate
Location: Columbia, Richland County, SC
Photographer: Ryan Stubbs, START
Subject: View of Stockpile B1.

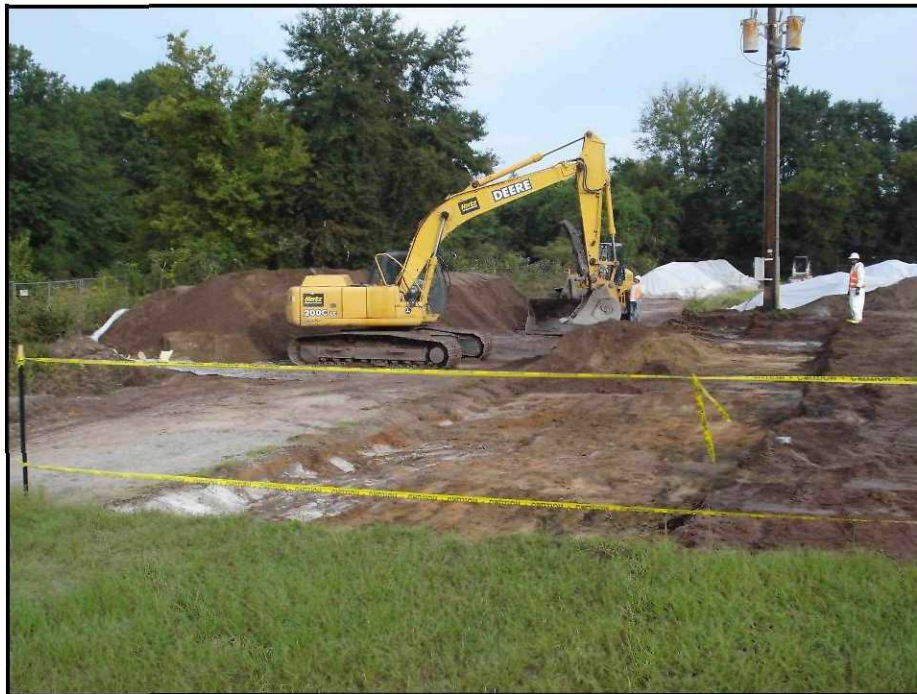
Official Photograph No. 8

Site Name: VCC Columbia Phosphate
Location: Columbia, Richland County, SC
Photographer: Ryan Stubbs, START
Subject: View of ERRS excavating Area B2.

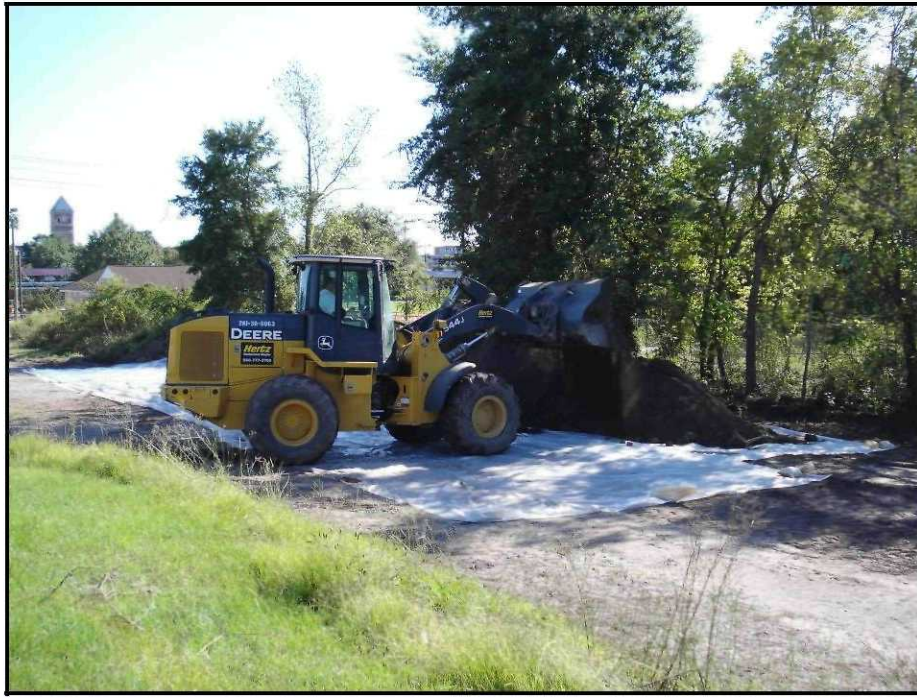
Official Photograph No. 9

Site Name: VCC Columbia Phosphate
Location: Columbia, Richland County, SC
Photographer: Ryan Stubbs, START
Subject: View of Stockpile B2.

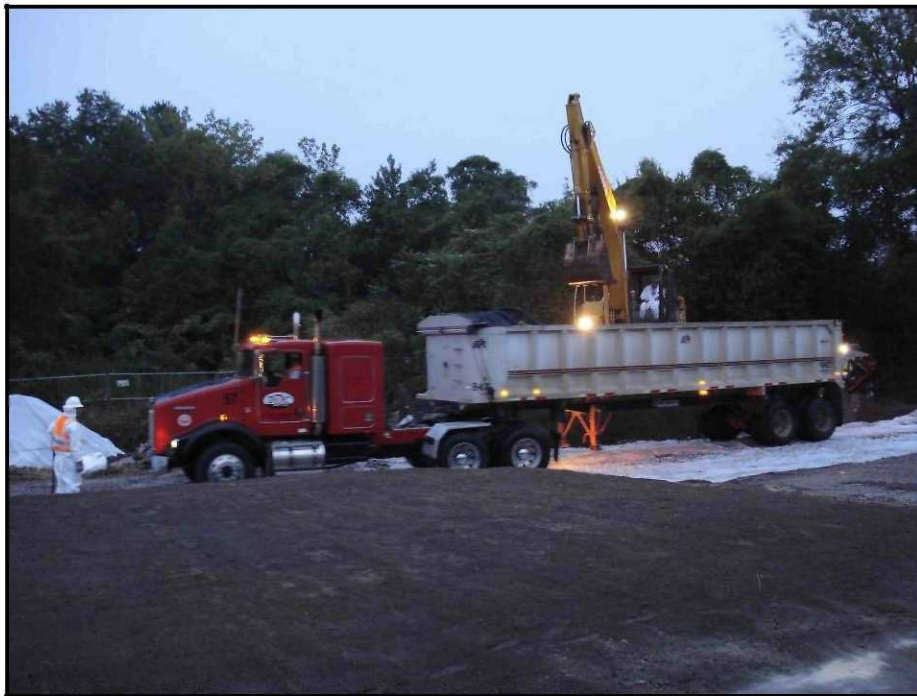
Official Photograph No. 10

Site Name: VCC Columbia Phosphate
Location: Columbia, Richland County, SC
Photographer: Ryan Stubbs, START
Subject: View of disposal truck being loaded from Stockpile C.

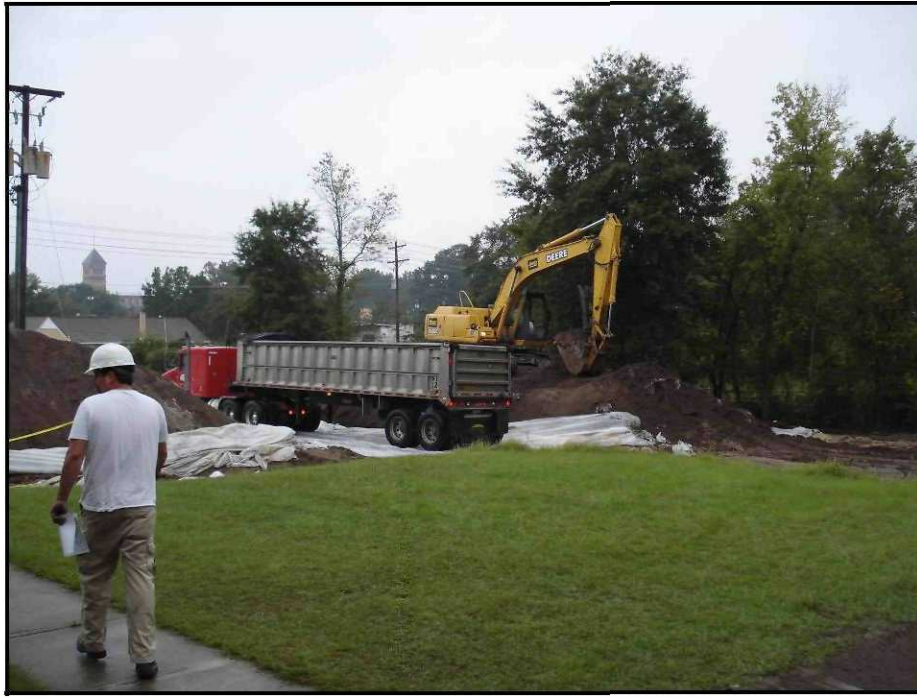
Official Photograph No. 11

Site Name:	VCC Columbia Phosphate	Date:	October 14, 2009
Location:	Columbia, Richland County, SC	TDD No:	TNA-05-001-0085
Photographer:	Ryan Stubbs, START		
Subject:	View of disposal truck being loaded from Stockpile B2.

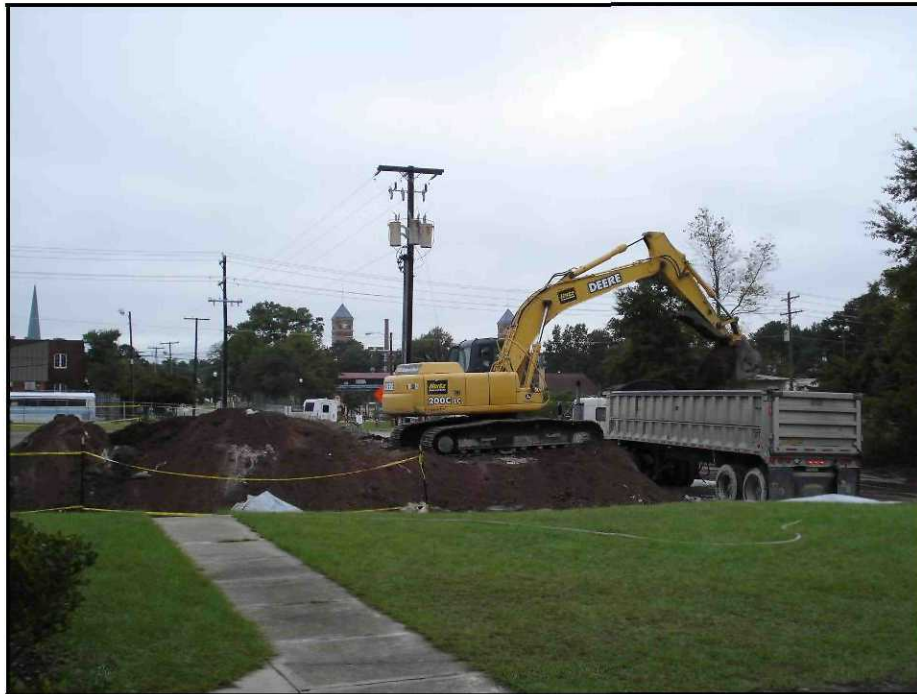
Official Photograph No. 12

Site Name:	VCC Columbia Phosphate	Date:	October 15, 2009
Location:	Columbia, Richland County, SC	TDD No:	TNA-05-001-0085
Photographer:	Ryan Stubbs, START		
Subject:	View of disposal truck being loaded from Stockpile B1.

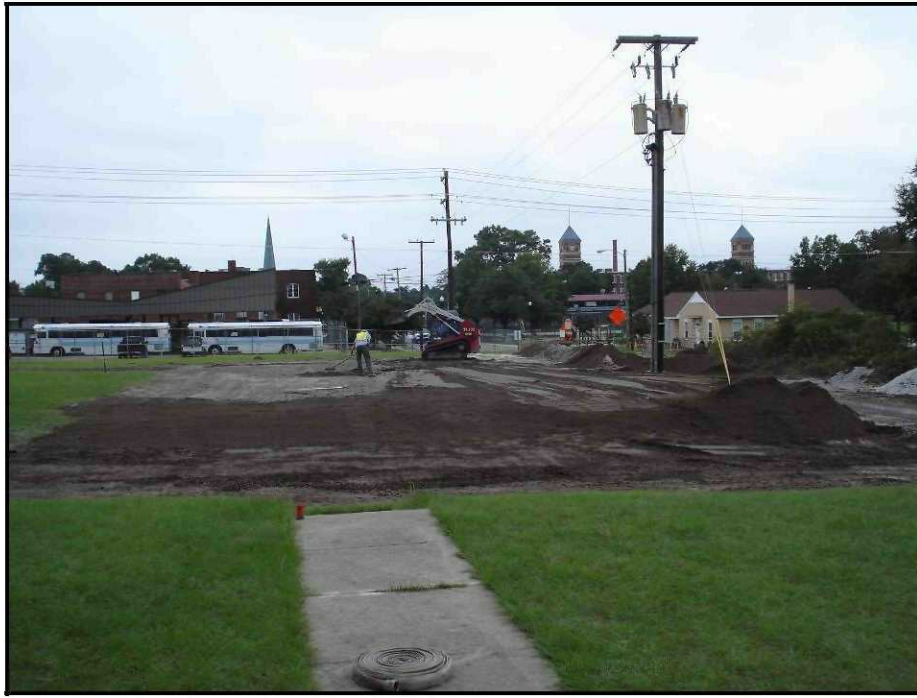
Official Photograph No. 13

Site Name:	VCC Columbia Phosphate	Date:	October 15, 2009
Location:	Columbia, Richland County, SC	TDD No:	TNA-05-001-0085
Photographer:	Ryan Stubbs, START		
Subject:	View of ERRS spreading and grading topsoil following backfill of Excavation Areas B1 and B2.

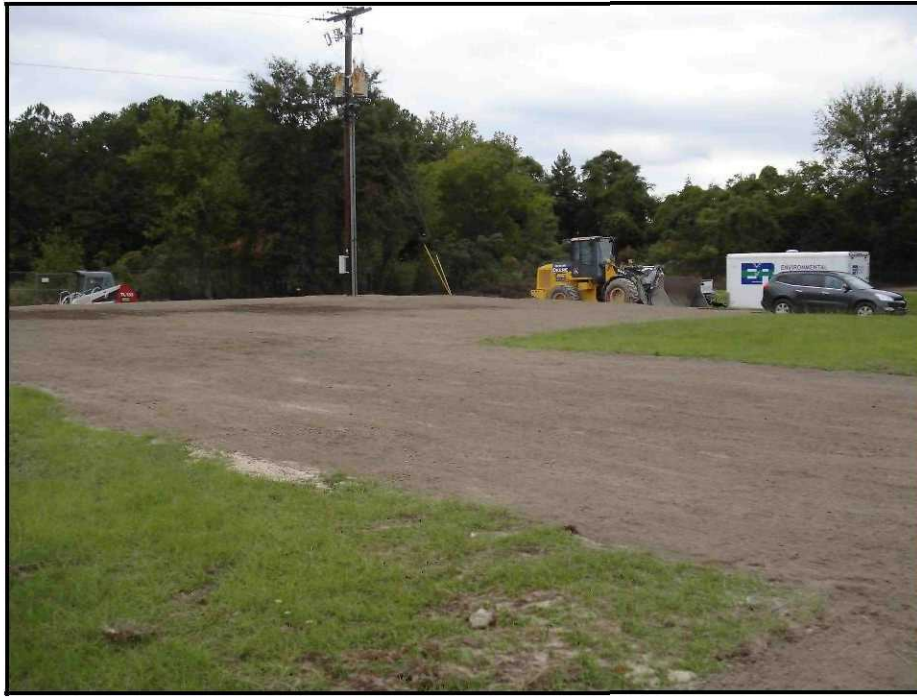
Official Photograph No. 15

Site Name:	VCC Columbia Phosphate	Date:	October 16, 2009
Location:	Columbia, Richland County, SC	TDD No:	TNA-05-001-0085
Photographer:	Ryan Stubbs, START		
Subject:	View of Excavation Areas B1 and B2 after completion of Removal Action.

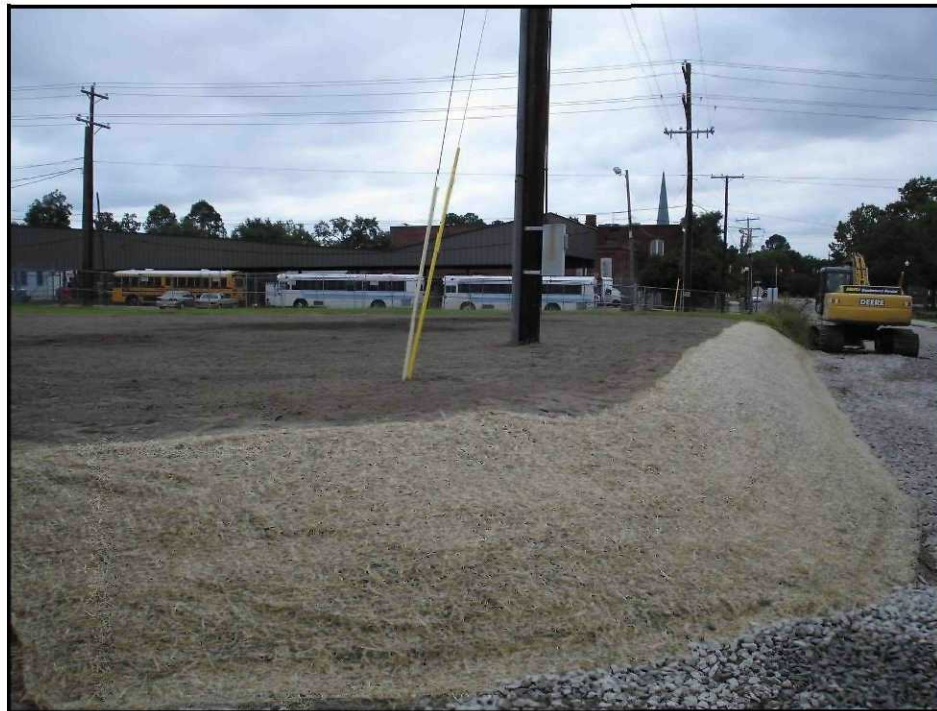
Official Photograph No. 16

Site Name:	VCC Columbia Phosphate	Date:	October 16, 2009
Location:	Columbia, Richland County, SC	TDD No:	TNA-05-001-0085
Photographer:	Ryan Stubbs, START		
Subject:	View of erosion control installed on the slope of Excavation Areas B1 and B2 after completion of Removal Action.
