Subject: Removal Investigation Report, Revision 0
American Electric
EPA Contract No. EP-W-05-053
Technical Direction Document (TDD) No. TNA-05-003-0095

REMOVAL INVESTIGATION REPORT

**AMERICAN ELECTRIC
JACKSONVILLE, DUVAL COUNTY, FLORIDA
CERCLIS ID: FLD061899449**

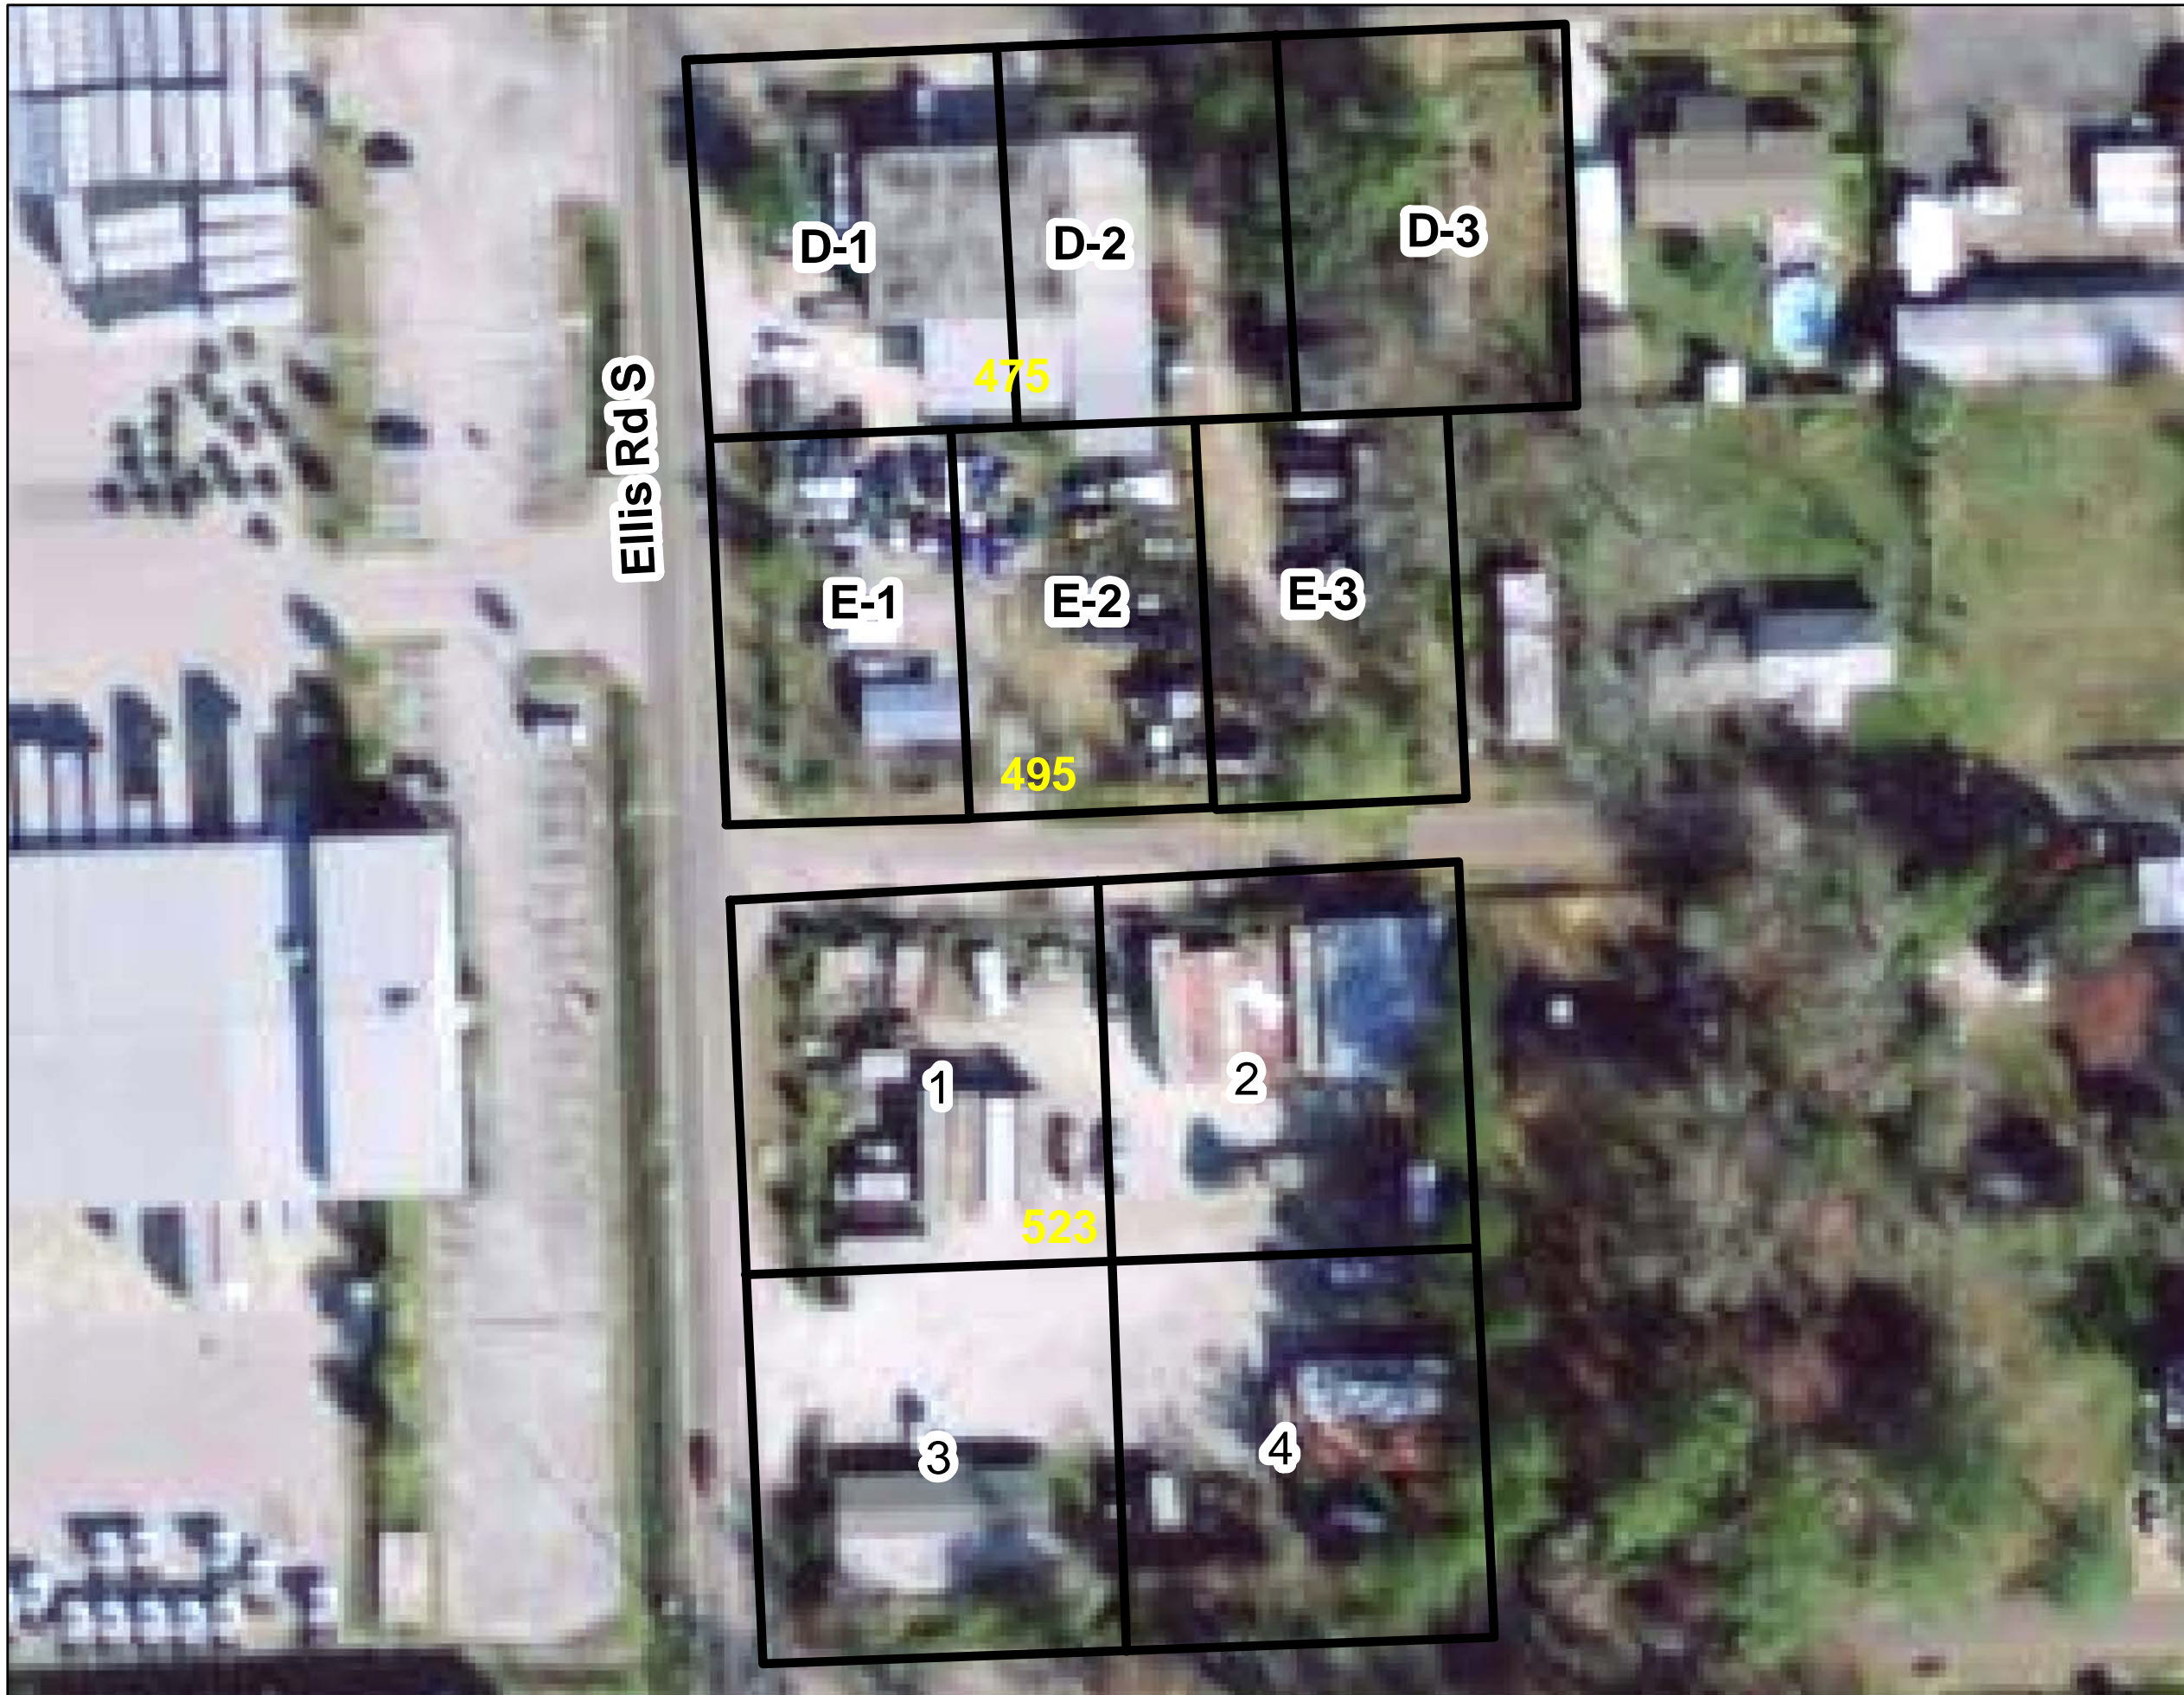
**FIGURE 2
INDUSTRIAL AREA
GRID MAP**

Geographic positioning information was collected for all sampling locations. Portions of the industrial area grid found in Figure 2 and the parcel map found in Figure 3 were geographically referenced using ArcView and uploaded to a hand-held Trimble® GPS system. Field sampling personnel collected coordinates from each of the four corners of the grid or parcel as well as the center point in order to collect the sampling location coordinates. Table 1 provided in Appendix B presents the GPS coordinates for each sample location.

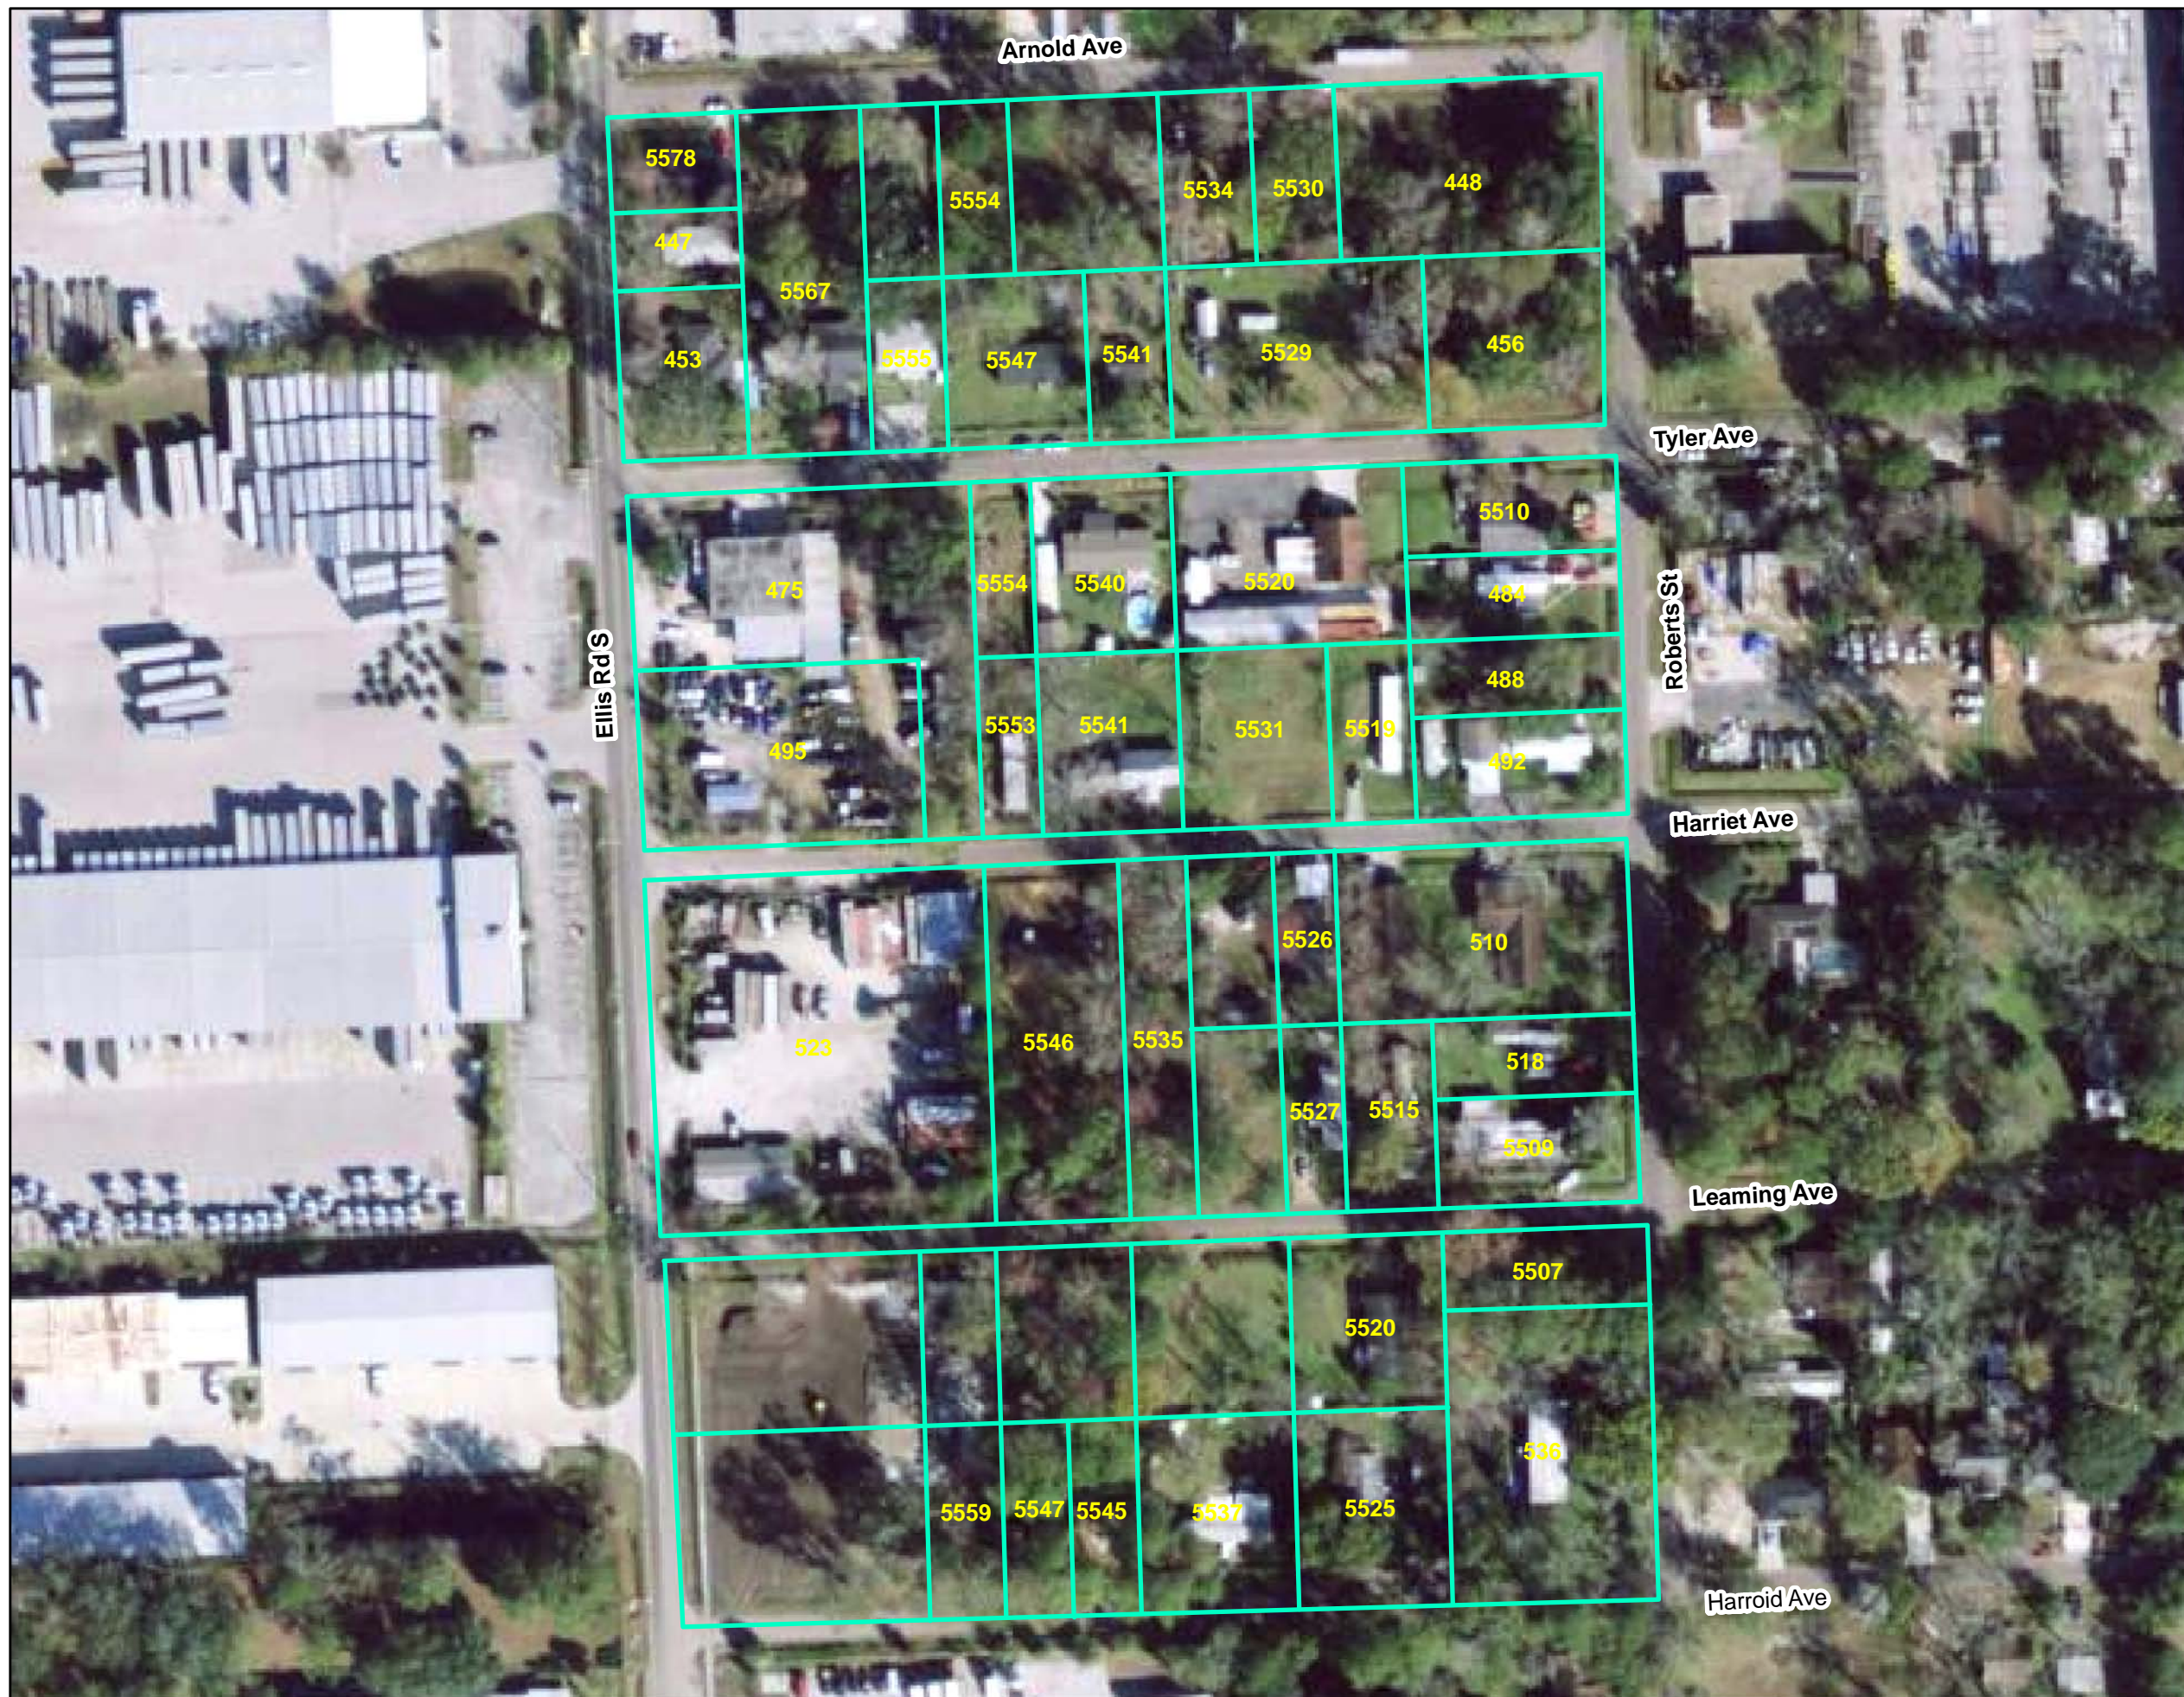
**FIGURE 3
PARCEL MAP**

START performed a field investigation that included soil and sediment sampling and analysis activities to identify the nature and extent of PCBs, Resource Conservation and Recovery Act (RCRA) metals, and dioxins in on-site soils as well as surrounding residential soils. Target analyte list (TAL) metals were sampled during previous investigations and based on those results, RCRA metals were chosen to be analyzed during this removal investigation instead of TAL metals. The locations to be sampled, which encompass a 4-block area, were originally subdivided into 56 grids, each measuring 100 feet by 100 feet; however, at the discretion of the EPA On-Scene Coordinator (OSC), the industrial properties (current property locations 475, 495, and 523 S. Ellis Road) were scheduled to be sampled using a modified grid system (Figure 2 in Appendix A). Because American Electric comprised the three industrial properties mentioned above, the locations were suspected to be “hot”. Therefore, the EPA OSC further divided the largest grid, 523 S. Ellis Road, into four 100 x 100 grids. The 475 S. Ellis Road location was divided into three smaller grids: D1, D2, and D3, while the 495 S. Ellis Road location was also divided into three smaller grids: E1, E2, and E3. In addition to the industrial properties to be sampled, residential properties to be sampled were divided by residential parcel location (Figure 3 in Appendix A).

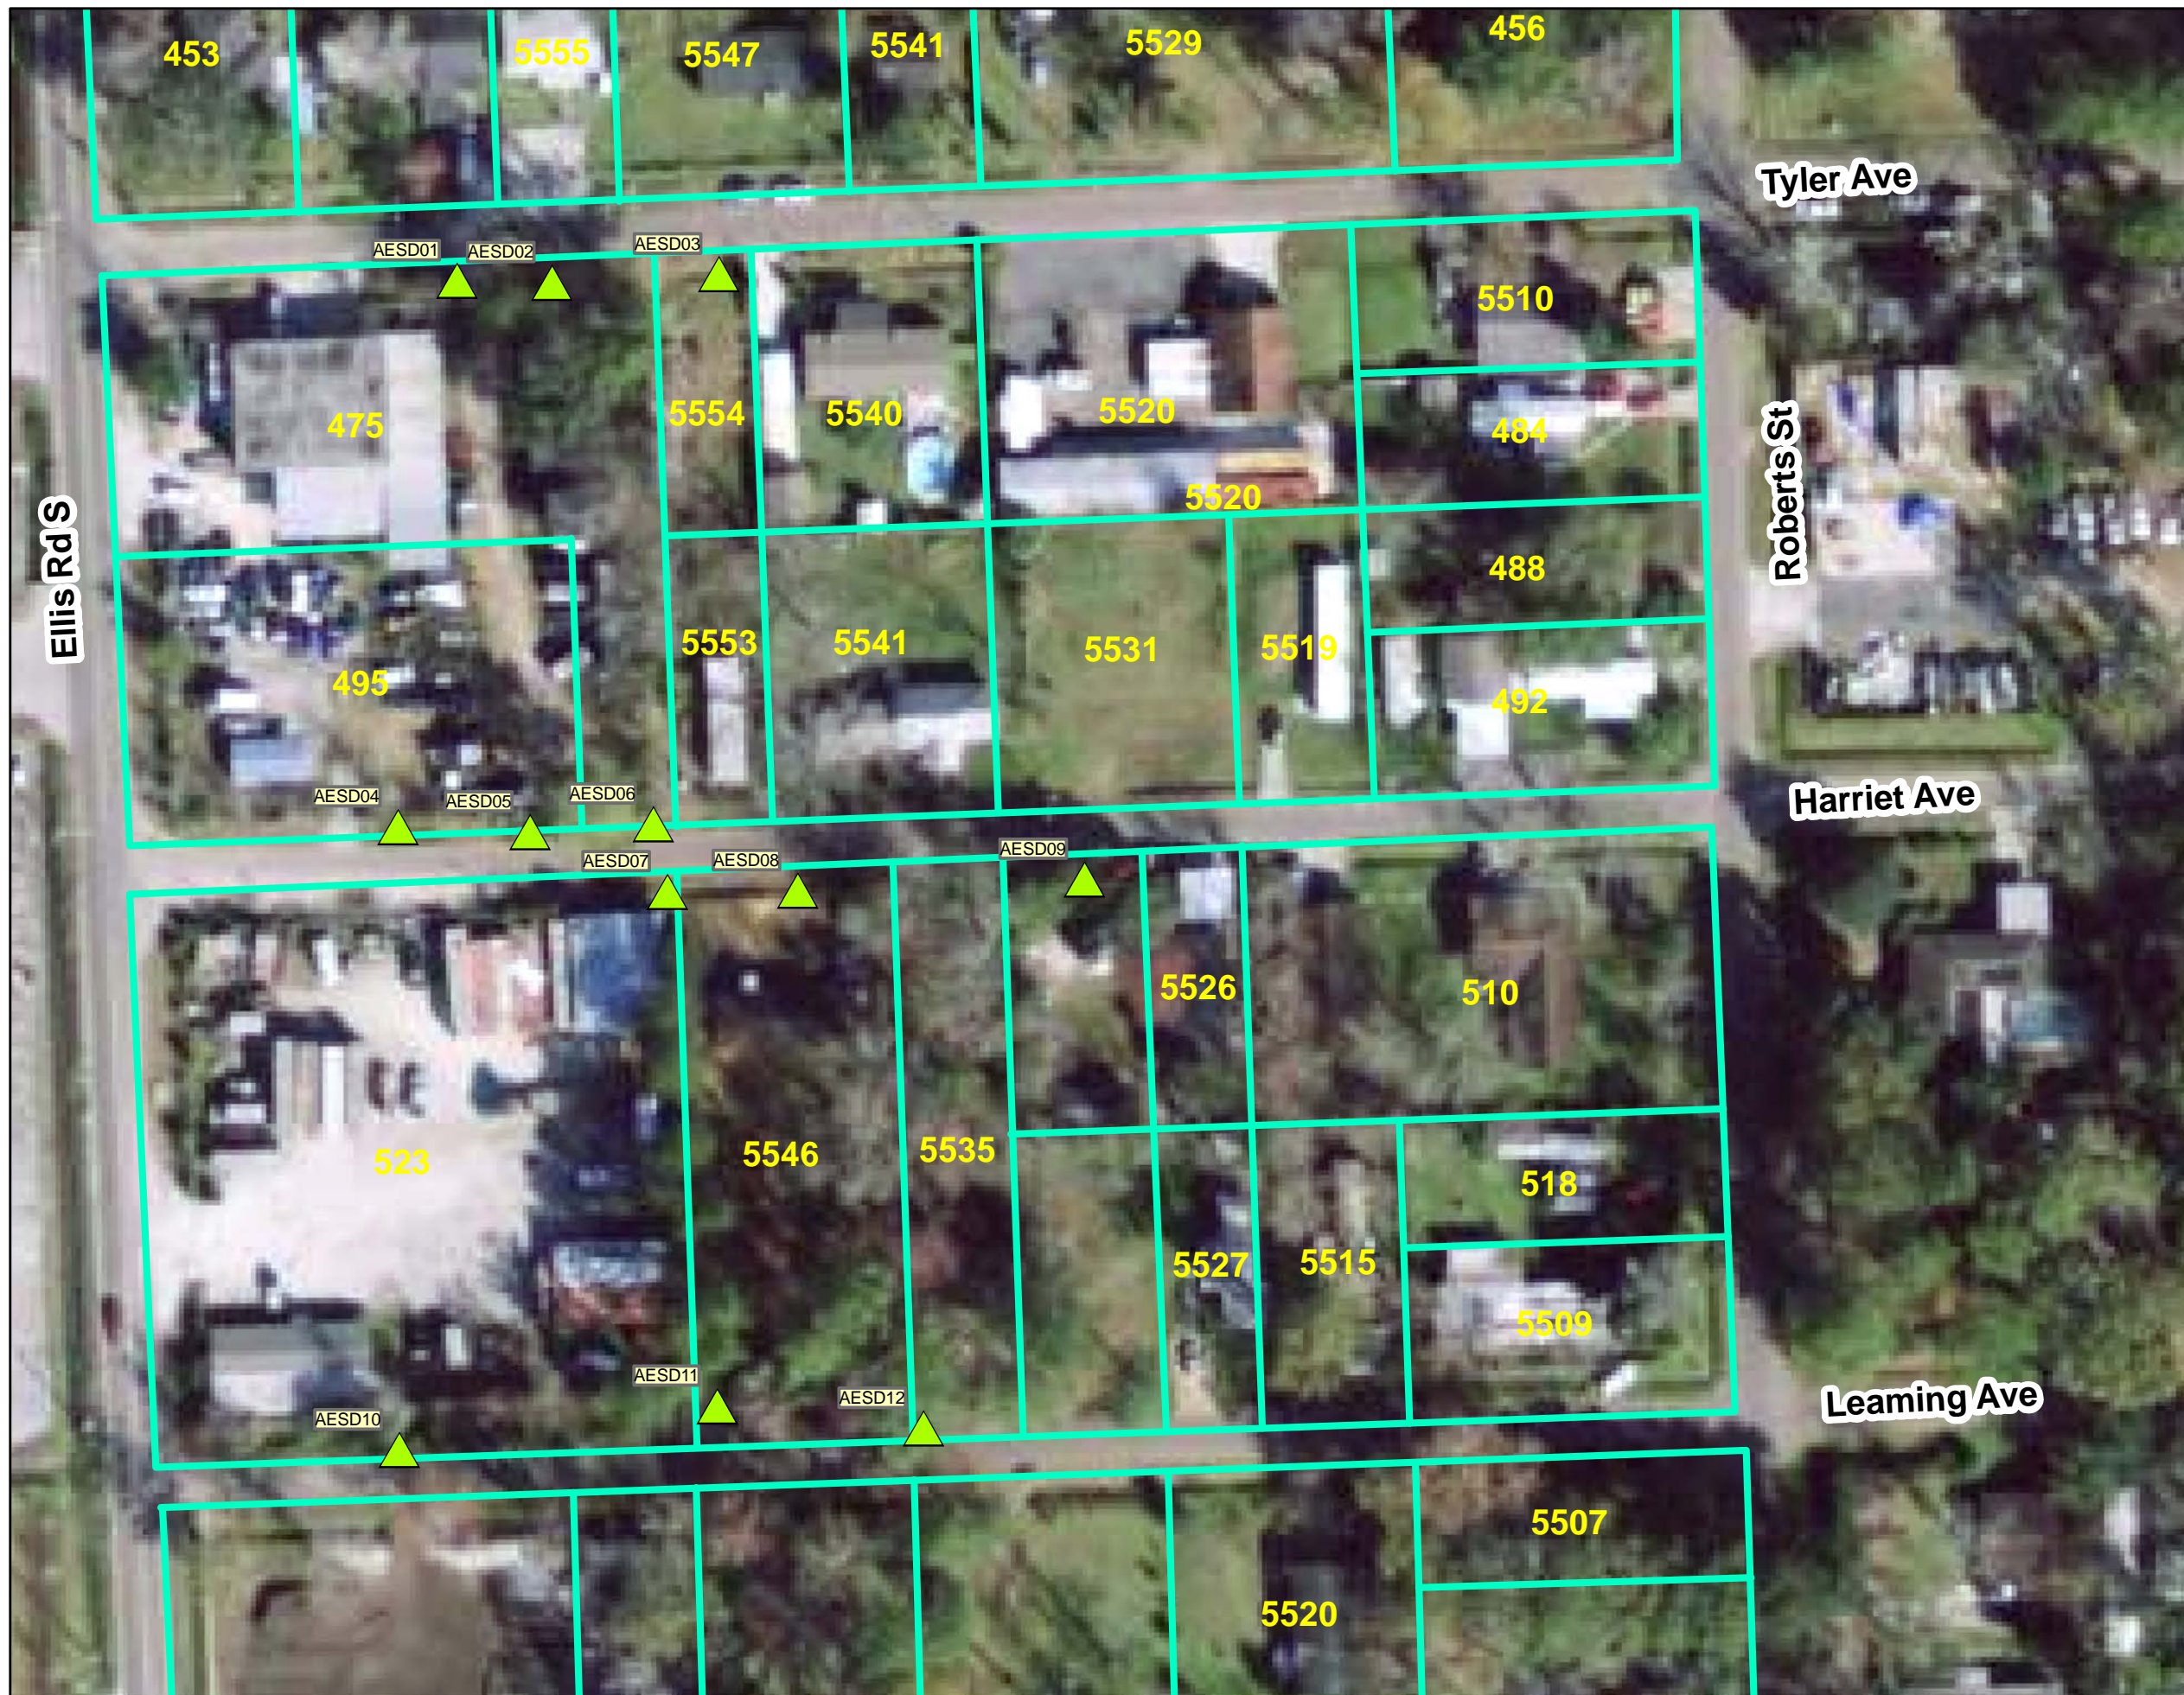
**FIGURE 4
SEDIMENT SAMPLES
LOCATION MAP**

- Parcel Boundary
- ▲ Sediment Samples

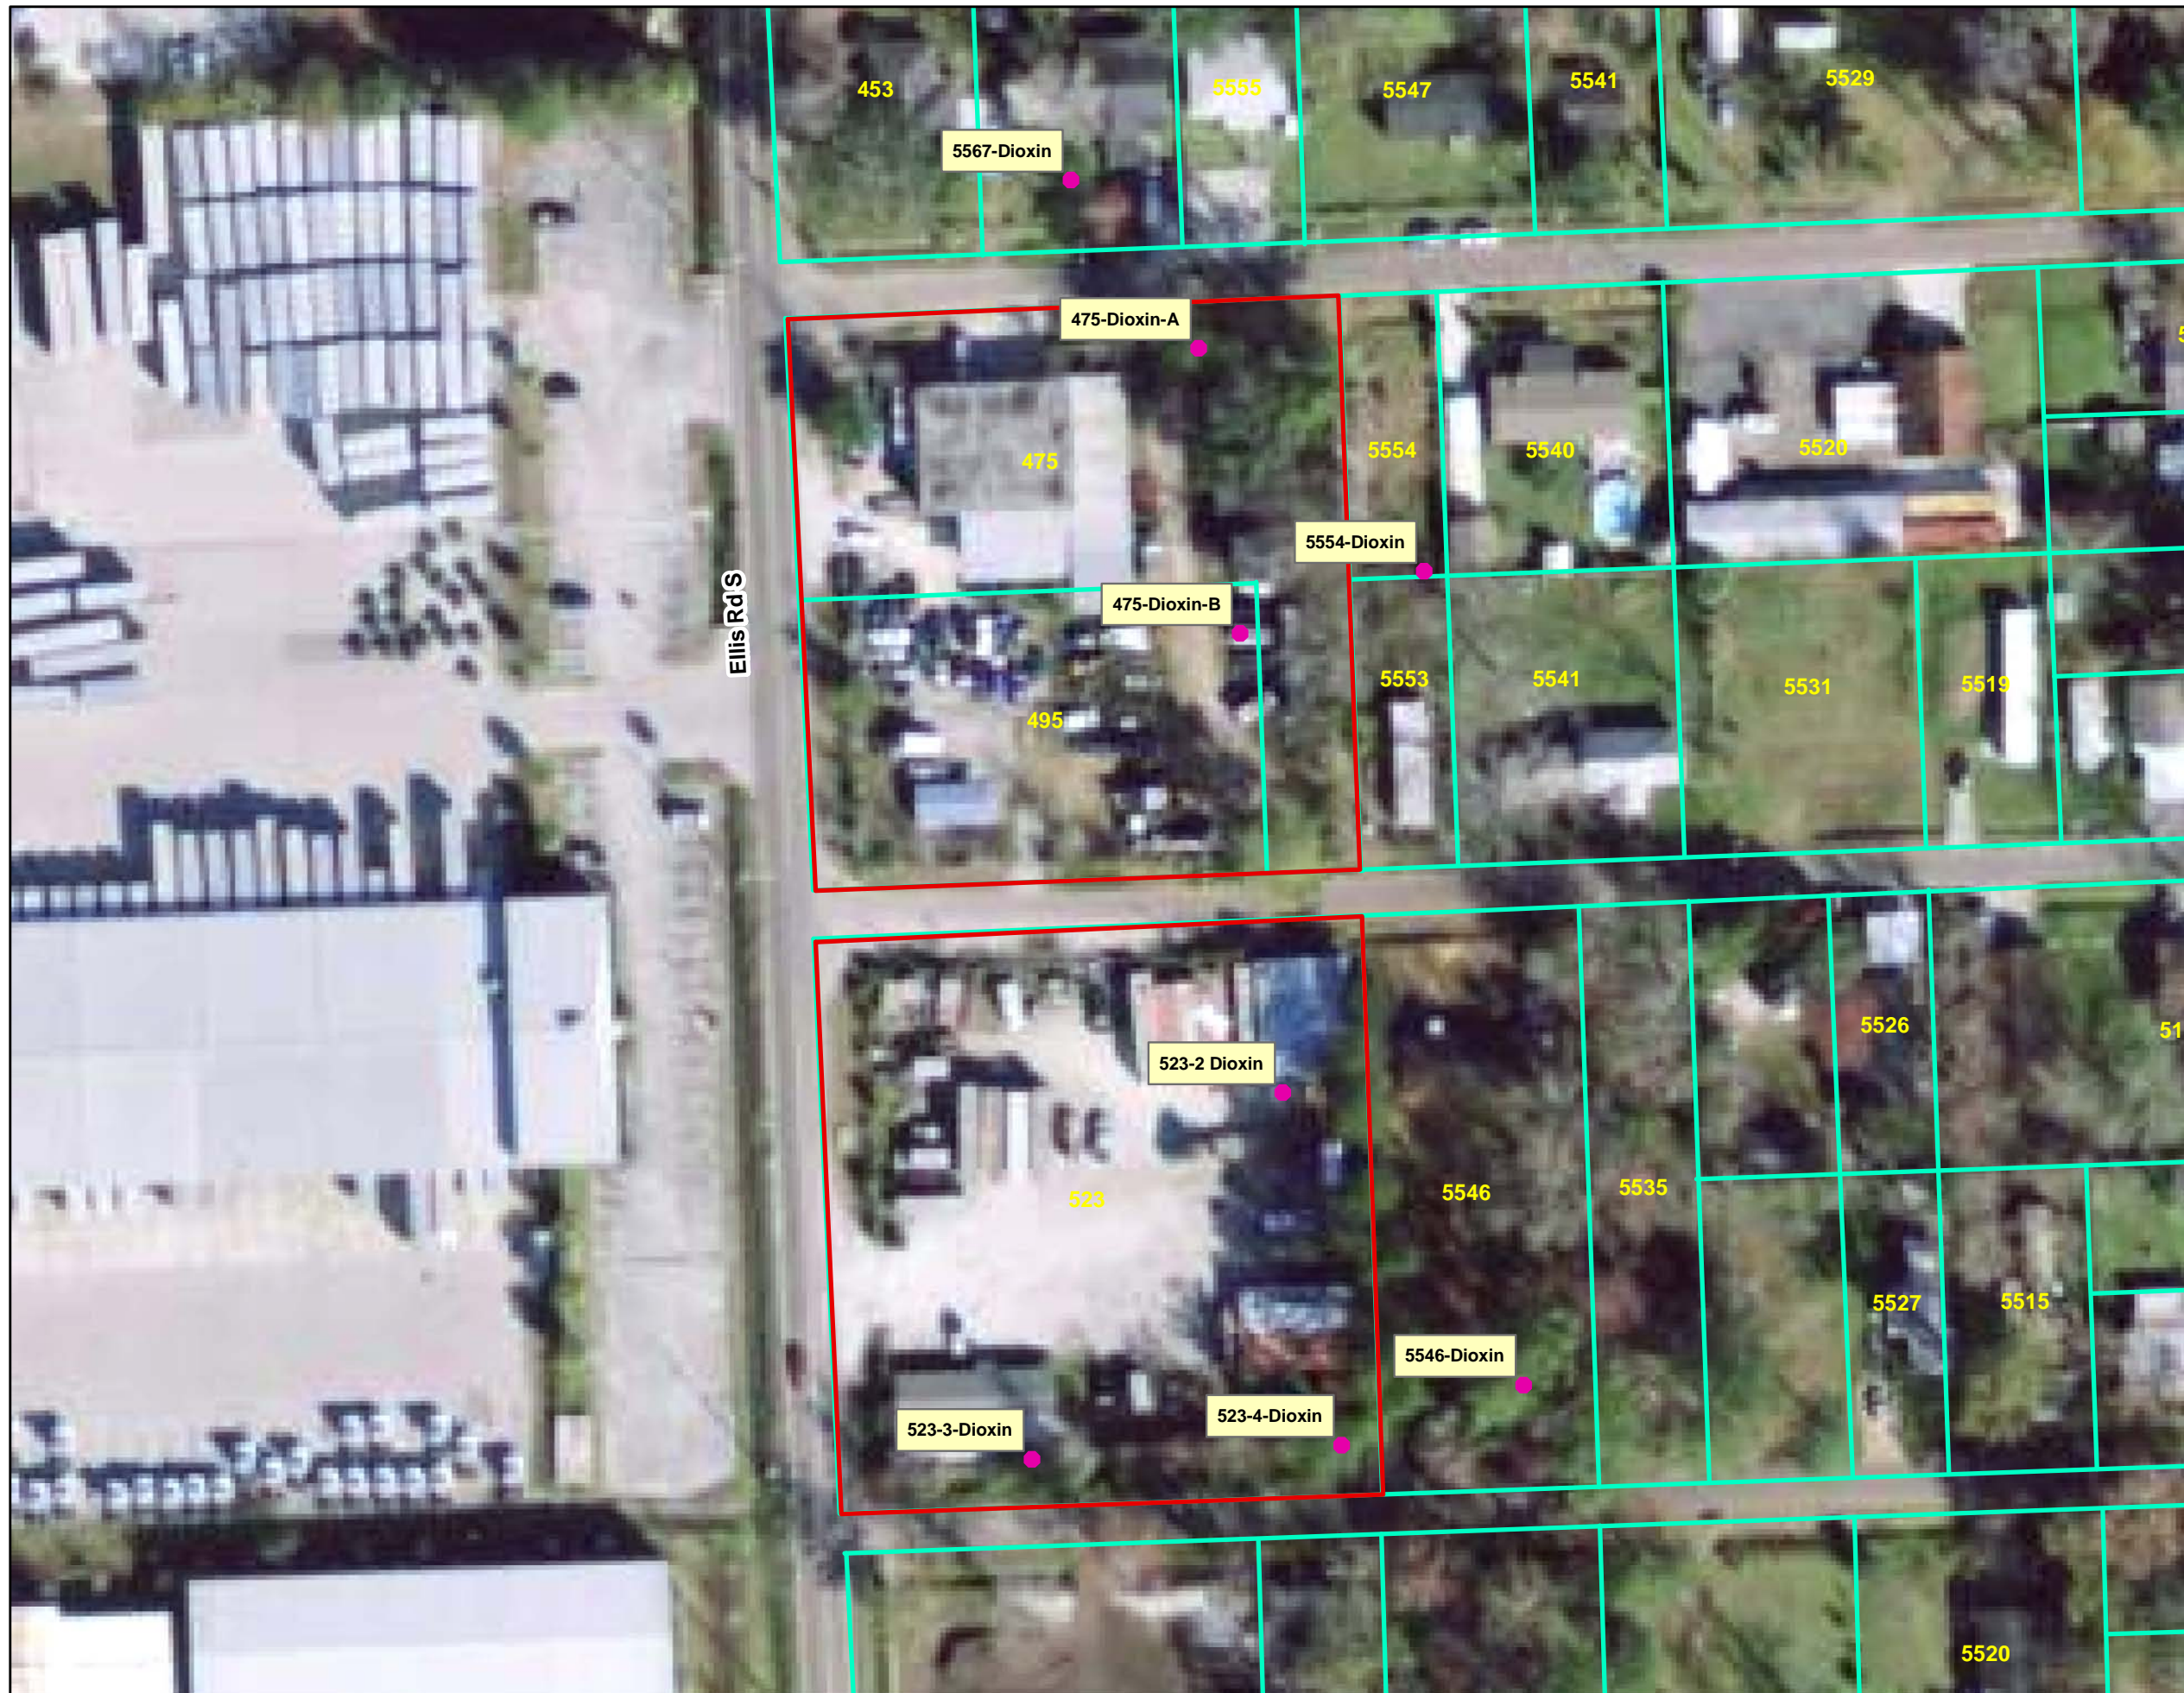
**FIGURE 5
DIOXIN SAMPLE
LOCATION MAP**

- Site boundary
- Parcel Boundary
- Dioxin Sample Location

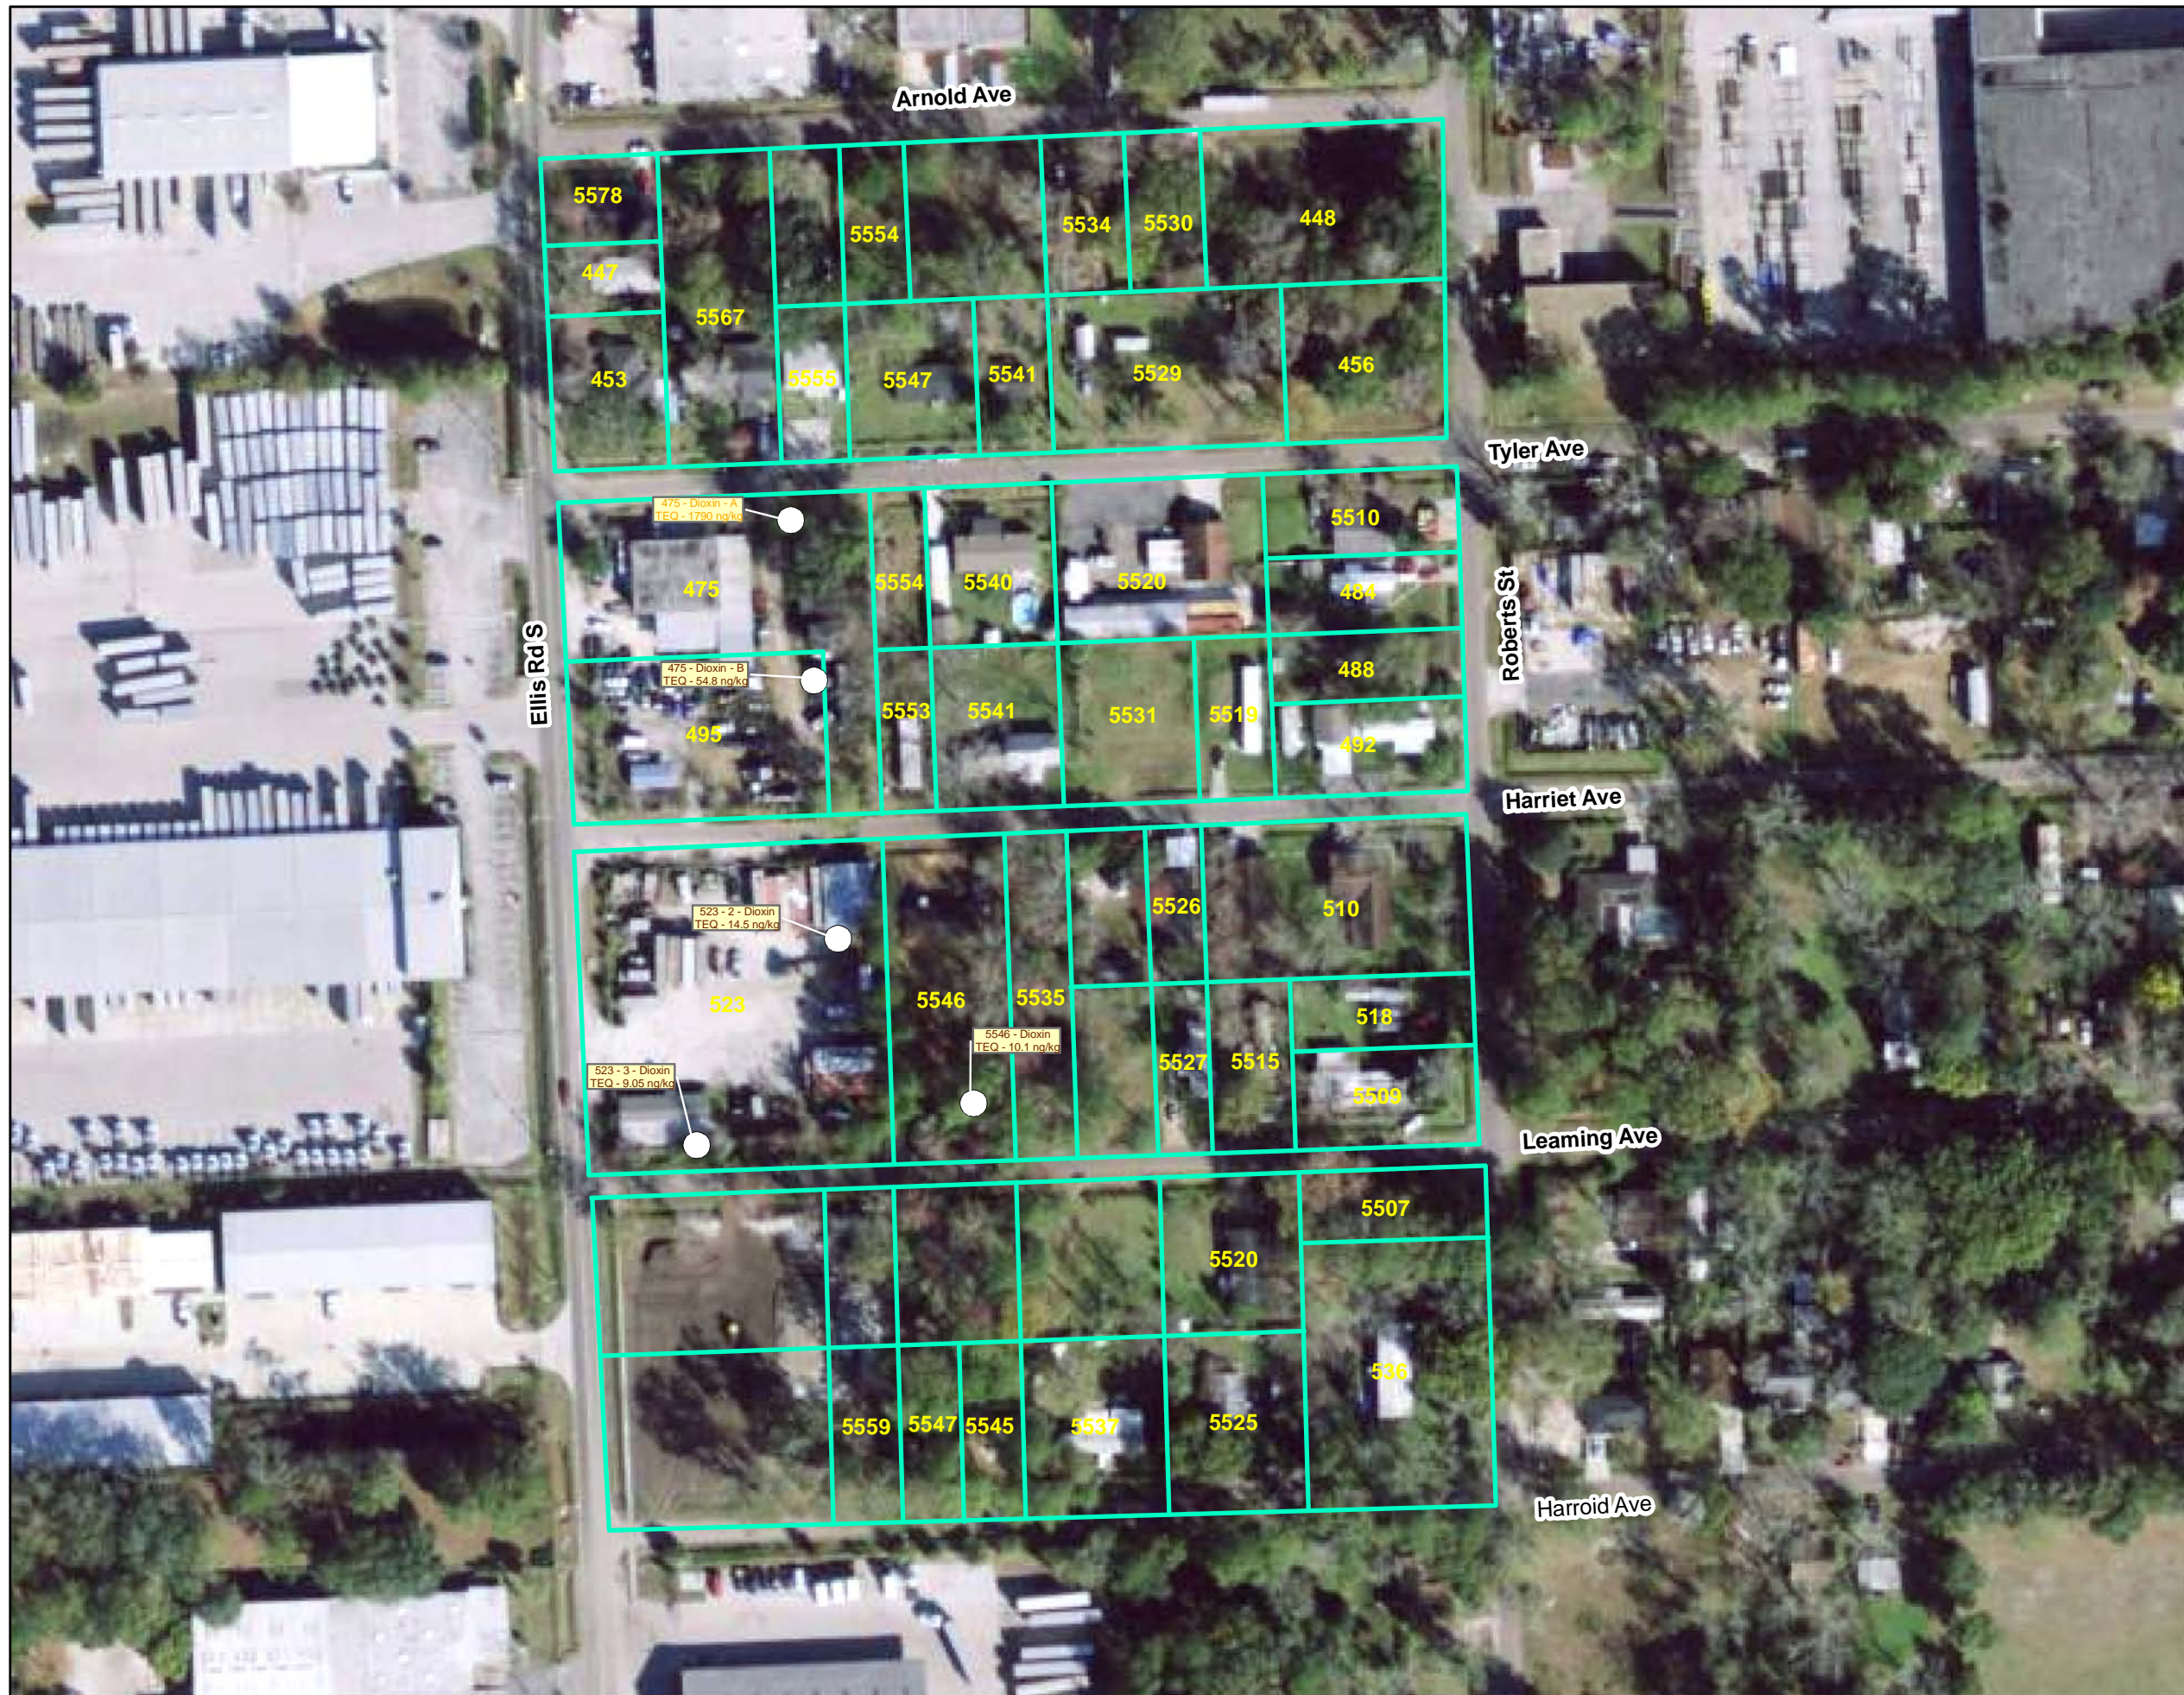
**FIGURE 7
DIOXIN
EXCEEDANCES**

Laboratory results for the soil grab samples indicated that four samples were above the residential FDEP SCTL of 7 nanograms per kilogram (ng/kg) for the Toxicity Equivalence Quotient (TEQ), with concentrations ranging from 9.05 ng/kg to 54.8 ng/kg, and one sample was above both the residential FDEP SCTL (7 ng/kg) and the EPA PRG of 1,000 ng/kg for the TEQ, with a value of 1,790 ng/kg. Sample results for dioxins above their respective limits are found in Appendix A, Figure 7.

Value exceeds two or more regulatory limits (SCTL, RAL, PRG)

Value exceeds either the SCTL, RAL, or the PRG

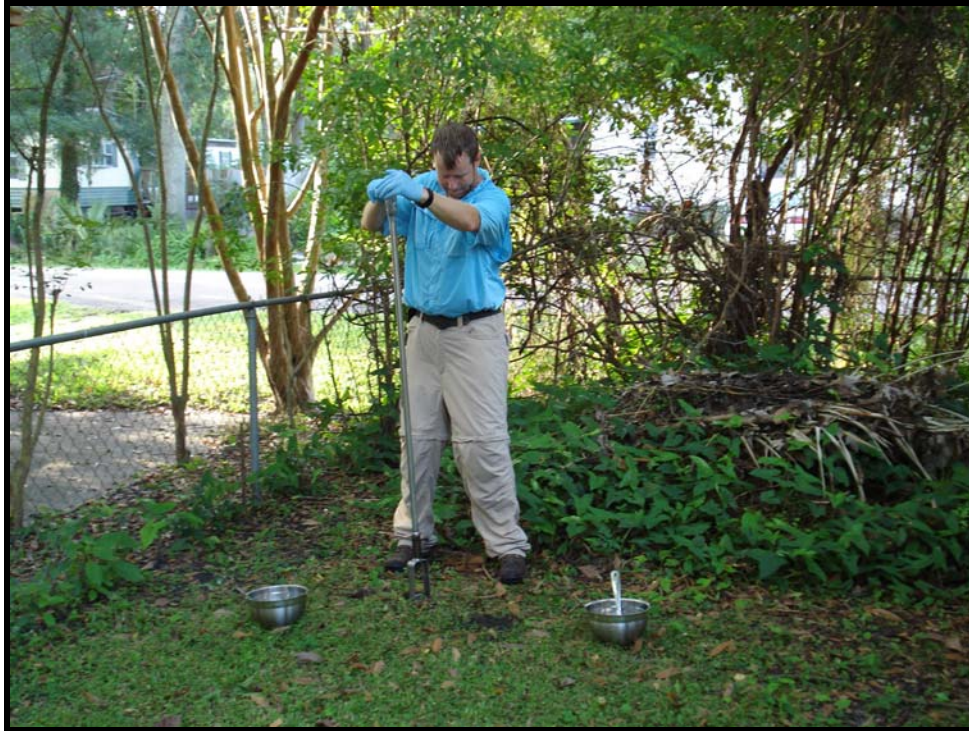
Official Photograph No. 1

Site Name:	American Electric	Date:	October 8, 2009
Location:	Jacksonville, Duval County, Florida	TDD No:	TNA-05-003-0095
Subject:	Augering location of a 5 point composite	Photographer:	A. Miolen

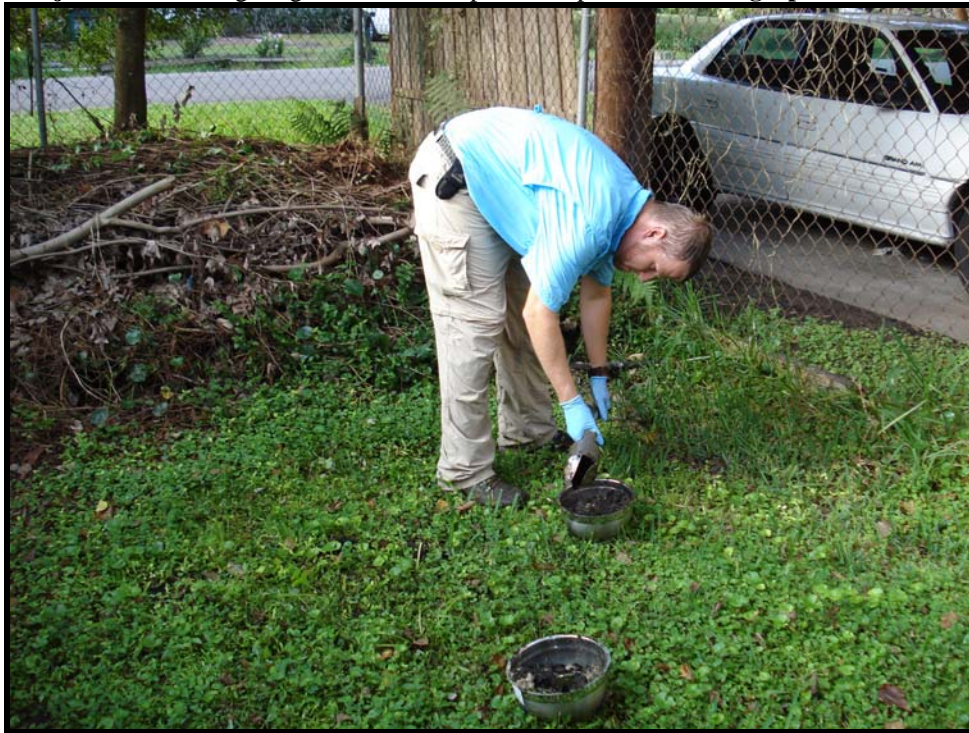
Official Photograph No. 2

Site Name:	American Electric	Date:	October 8, 2009
Location:	Jacksonville, Duval County, Florida	TDD No:	TNA-05-003-0095
Subject:	Collecting aliquot for 5 point composite	Photographer:	A. Miolen

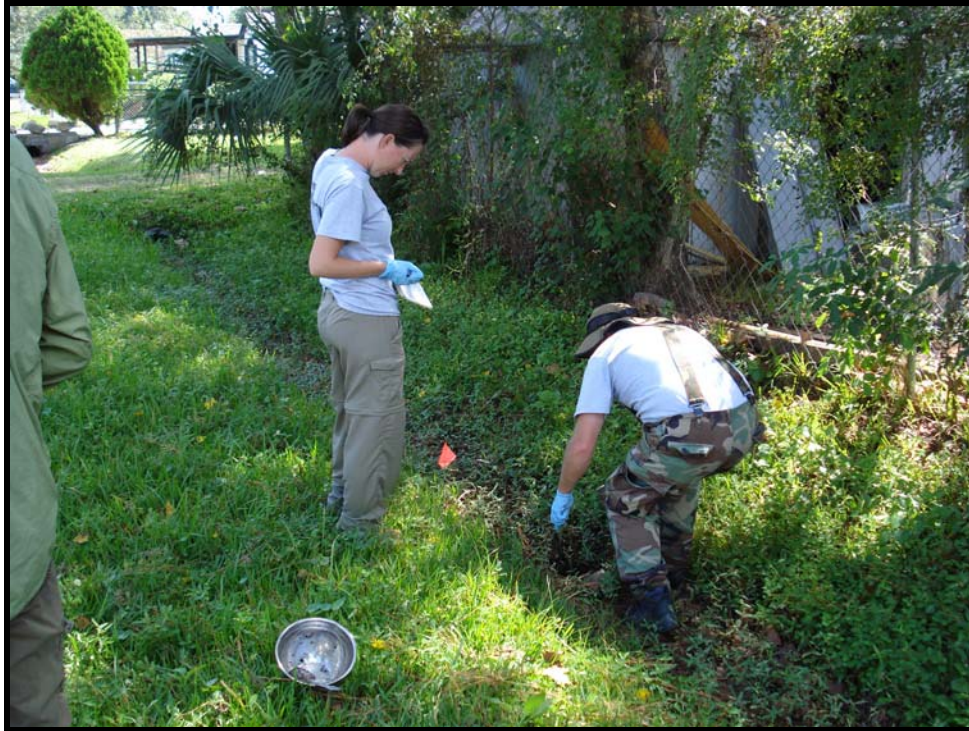
Official Photograph No. 3

Site Name:	American Electric	Date:	October 8, 2009
Location:	Jacksonville, Duval County, Florida	TDD No:	TNA-05-003-0095
Subject:	Collecting a sediment sample	Photographer:	R. Stubbs

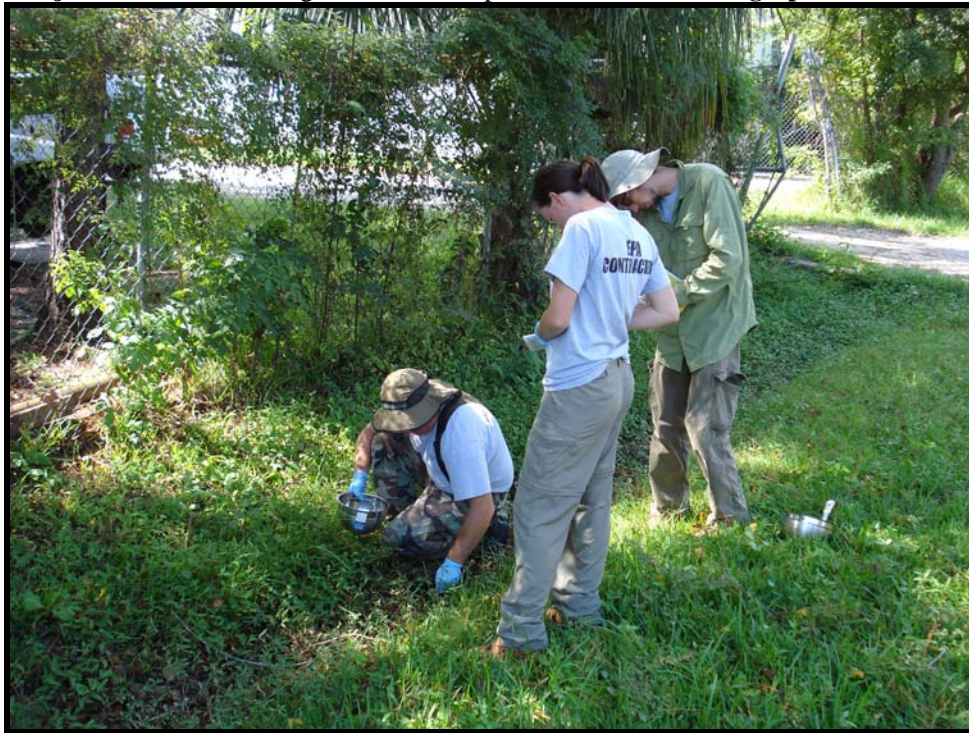
Official Photograph No. 4

Site Name:	American Electric	Date:	October 8, 2009
Location:	Jacksonville, Duval County, Florida	TDD No:	TNA-05-003-0095
Subject:	Collecting a sediment sample	Photographer:	R. Stubbs
