Draft Technical Memorandum

Orofino Asbestos Site

Vegetative Cover Performance Evaluation

April 14, 2014

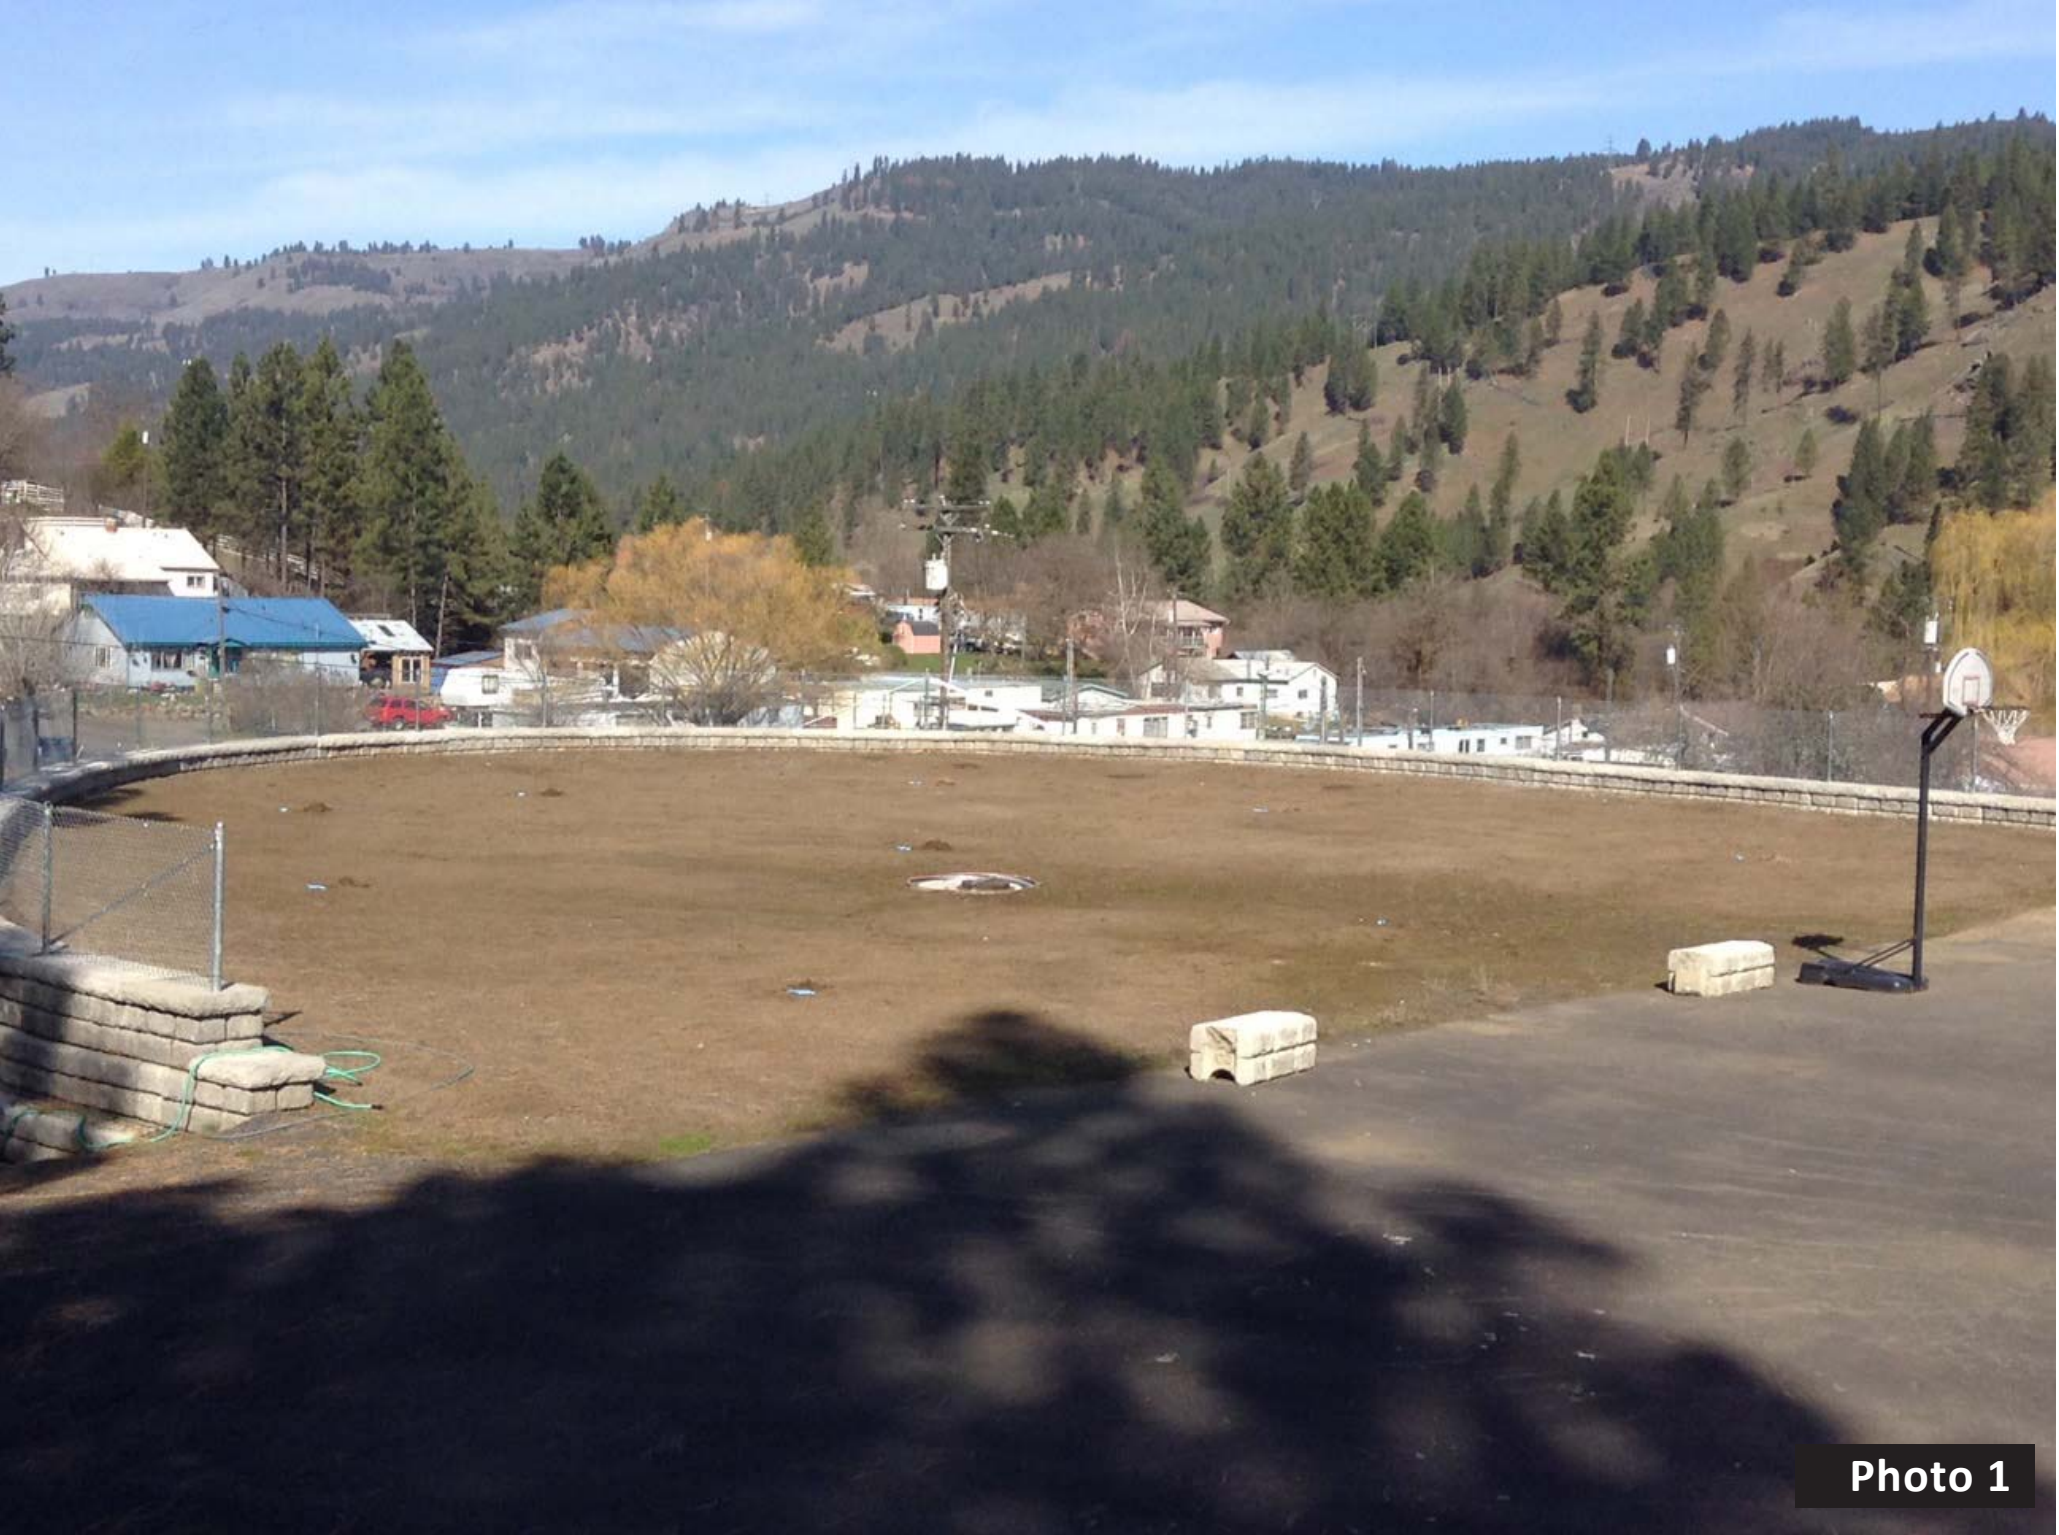
Photo 1

During the March 21, 2014 site visit, after making initial visual observations, we established a 9-point grid (3 x 3) across the area of the soil cover. At each grid point we dug a small test hole with a spoon or trowel to assess soil depth and characteristics at each grid point. The location of each grid points is visible as a small pile of soil with a blue sampling glove in Photo 1. Grid points are depicted schematically in Figure 1.

- During the March 21 site visit, there was no standing water on the soil cover area (see Photo 1), although the soil was found to be saturated at the surface and at depth locally. On March 21, soil moisture content varied by location, with slightly more than half of the area having saturated conditions below the immediate surface.

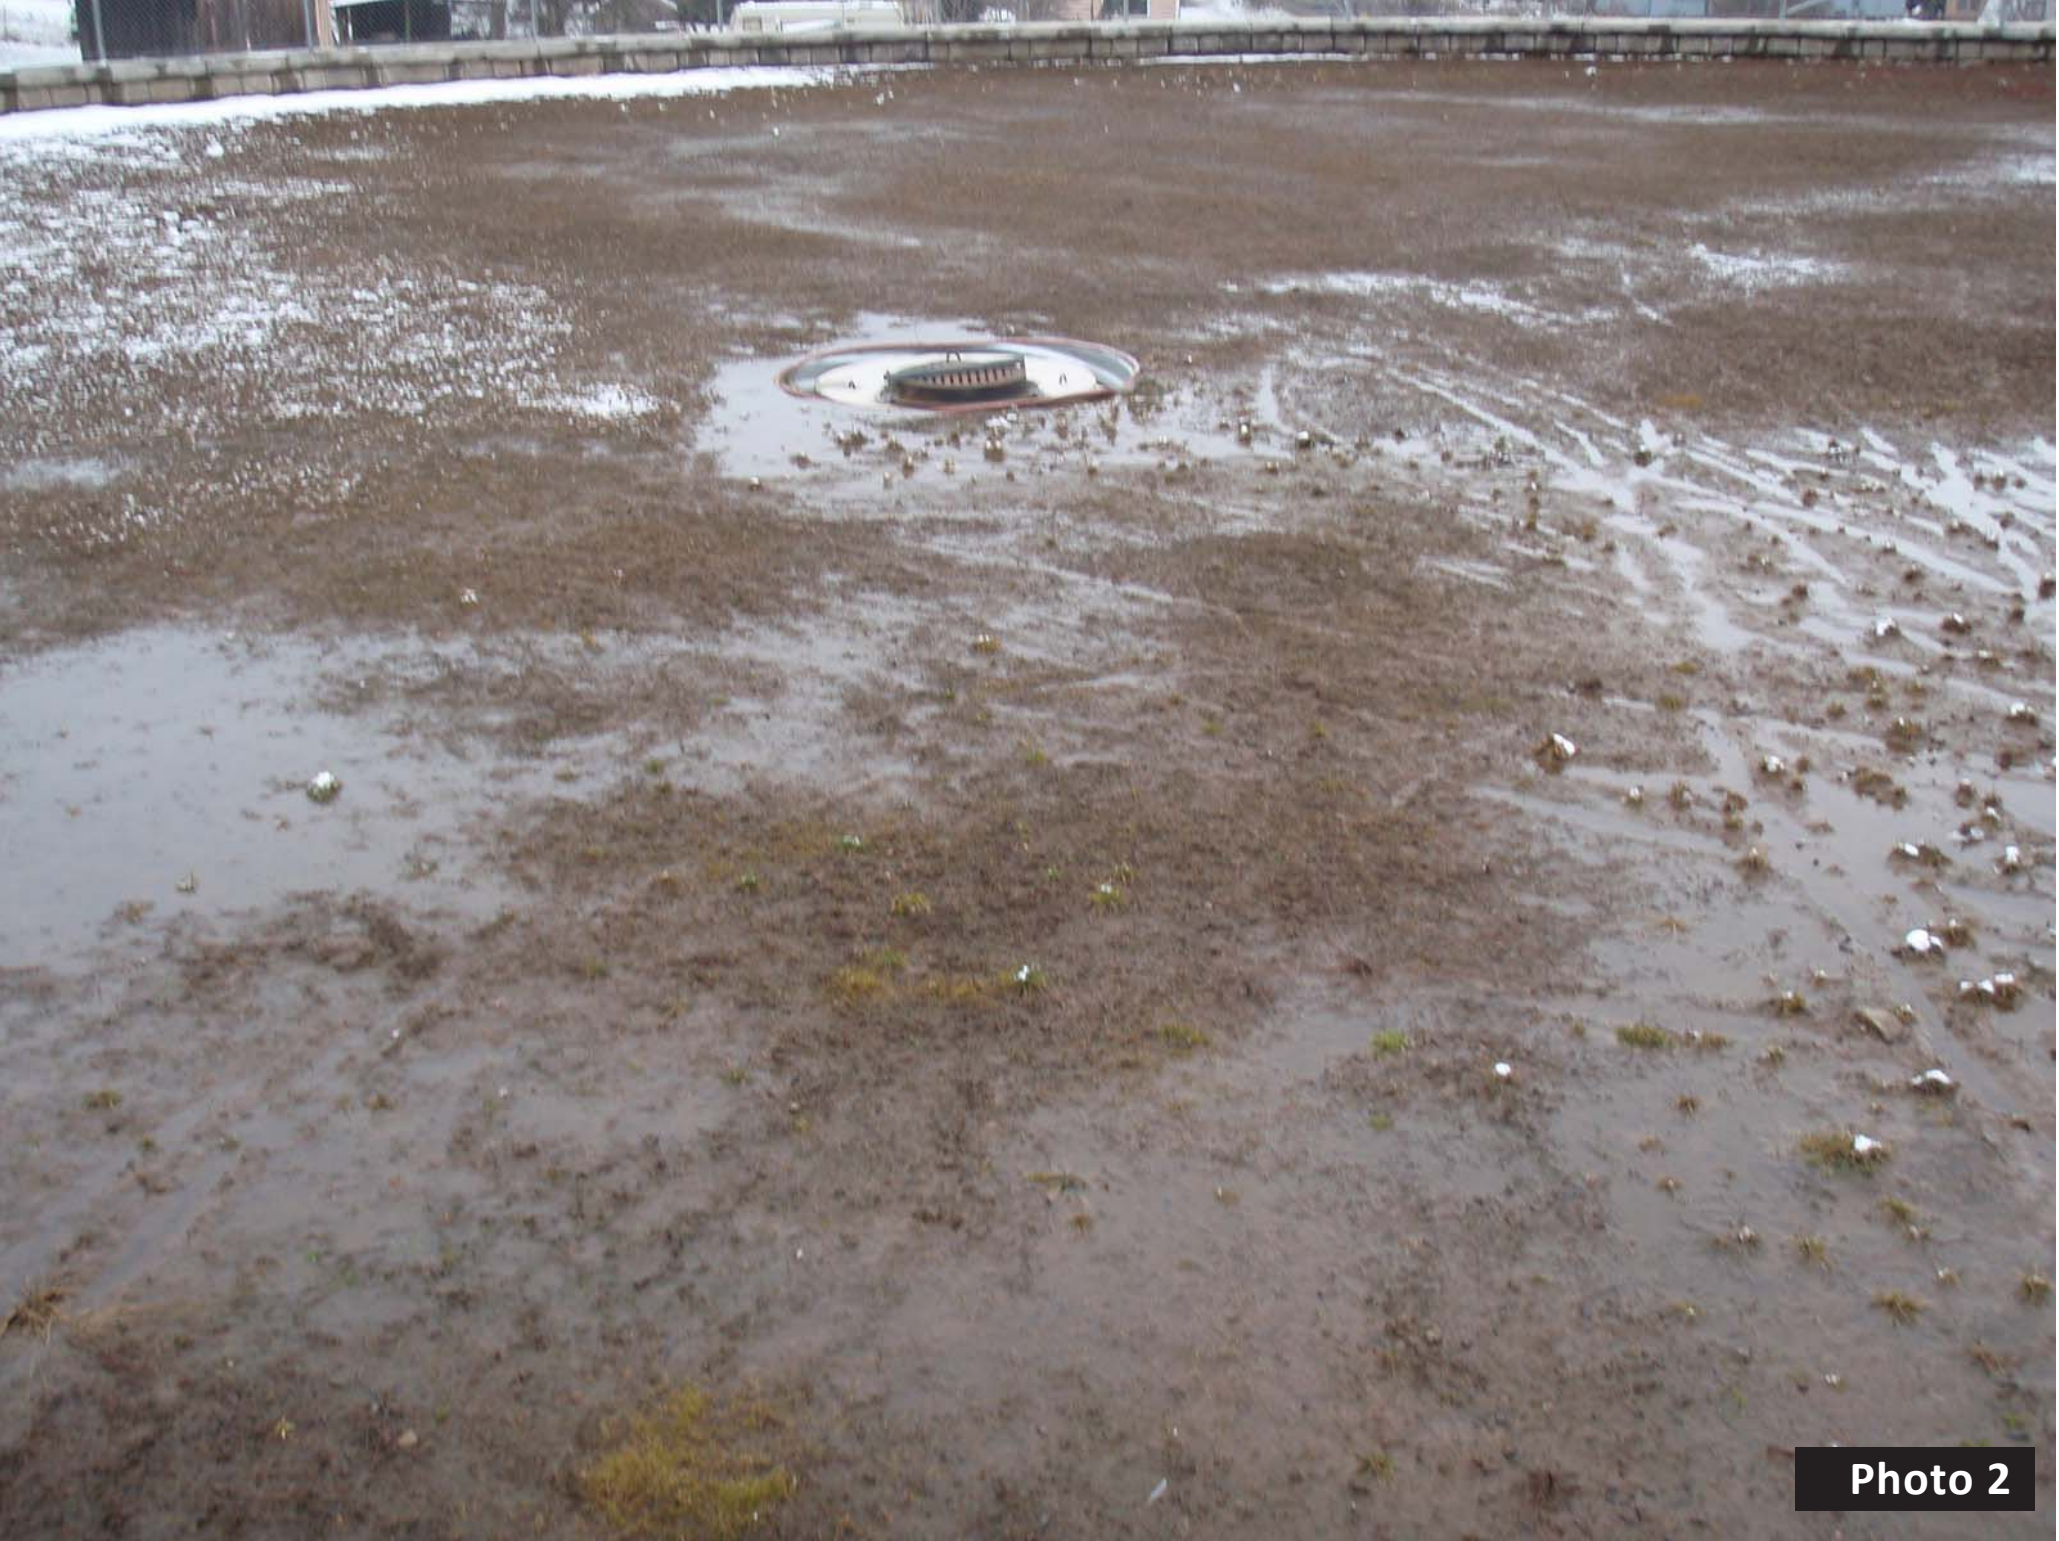
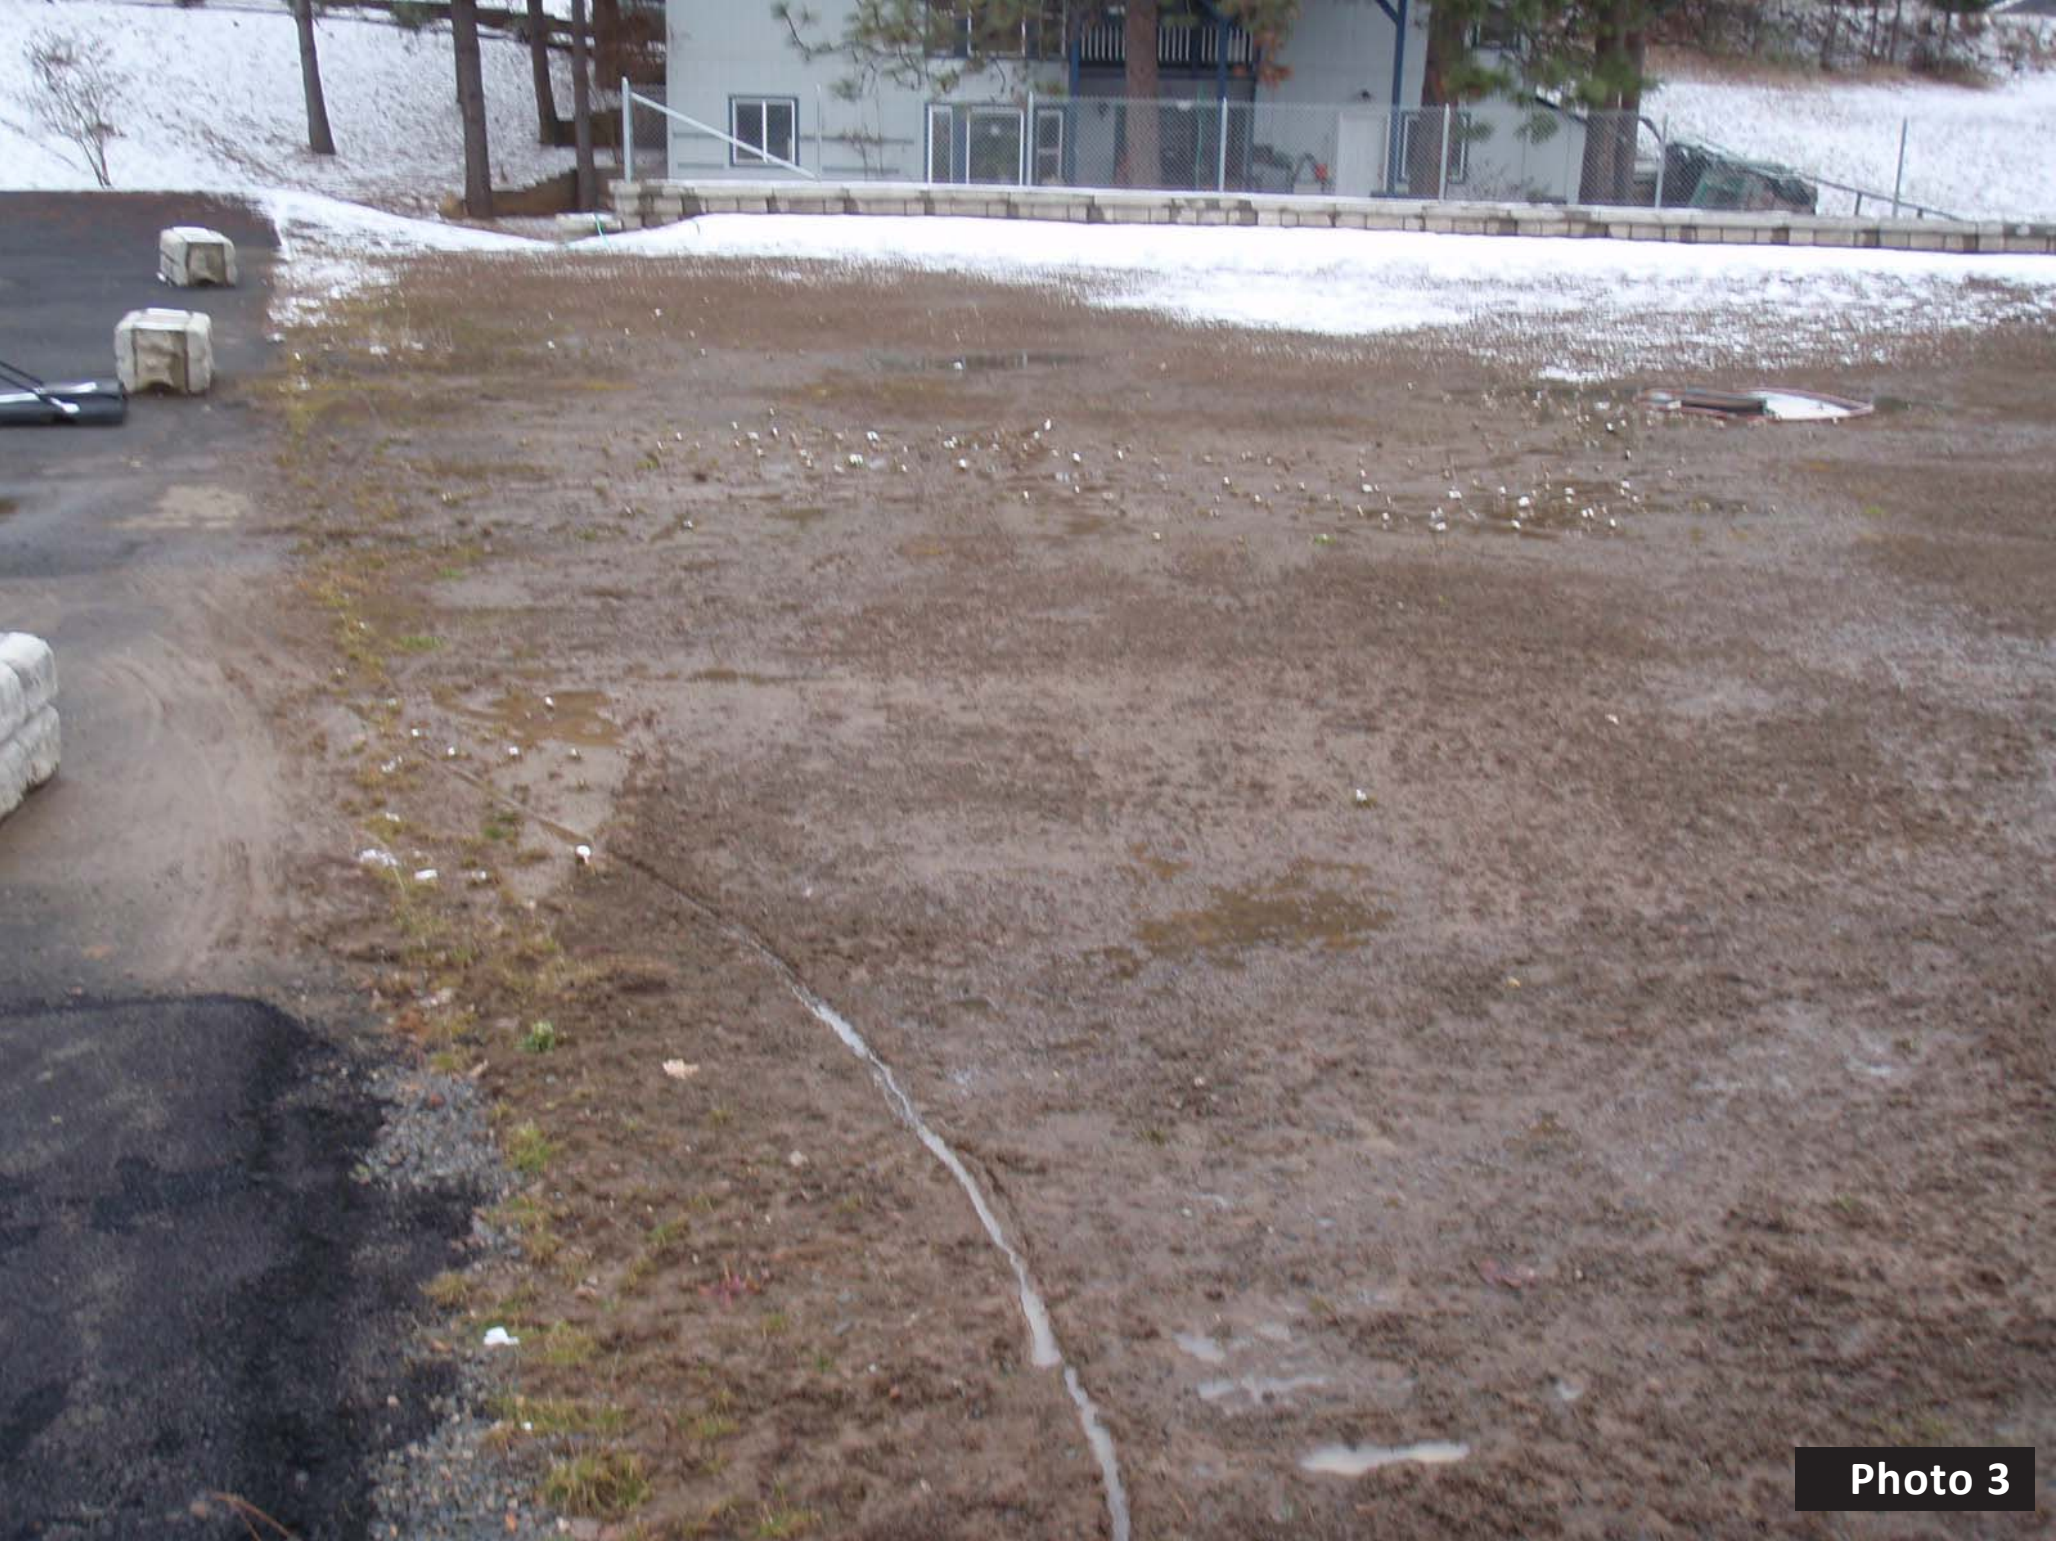
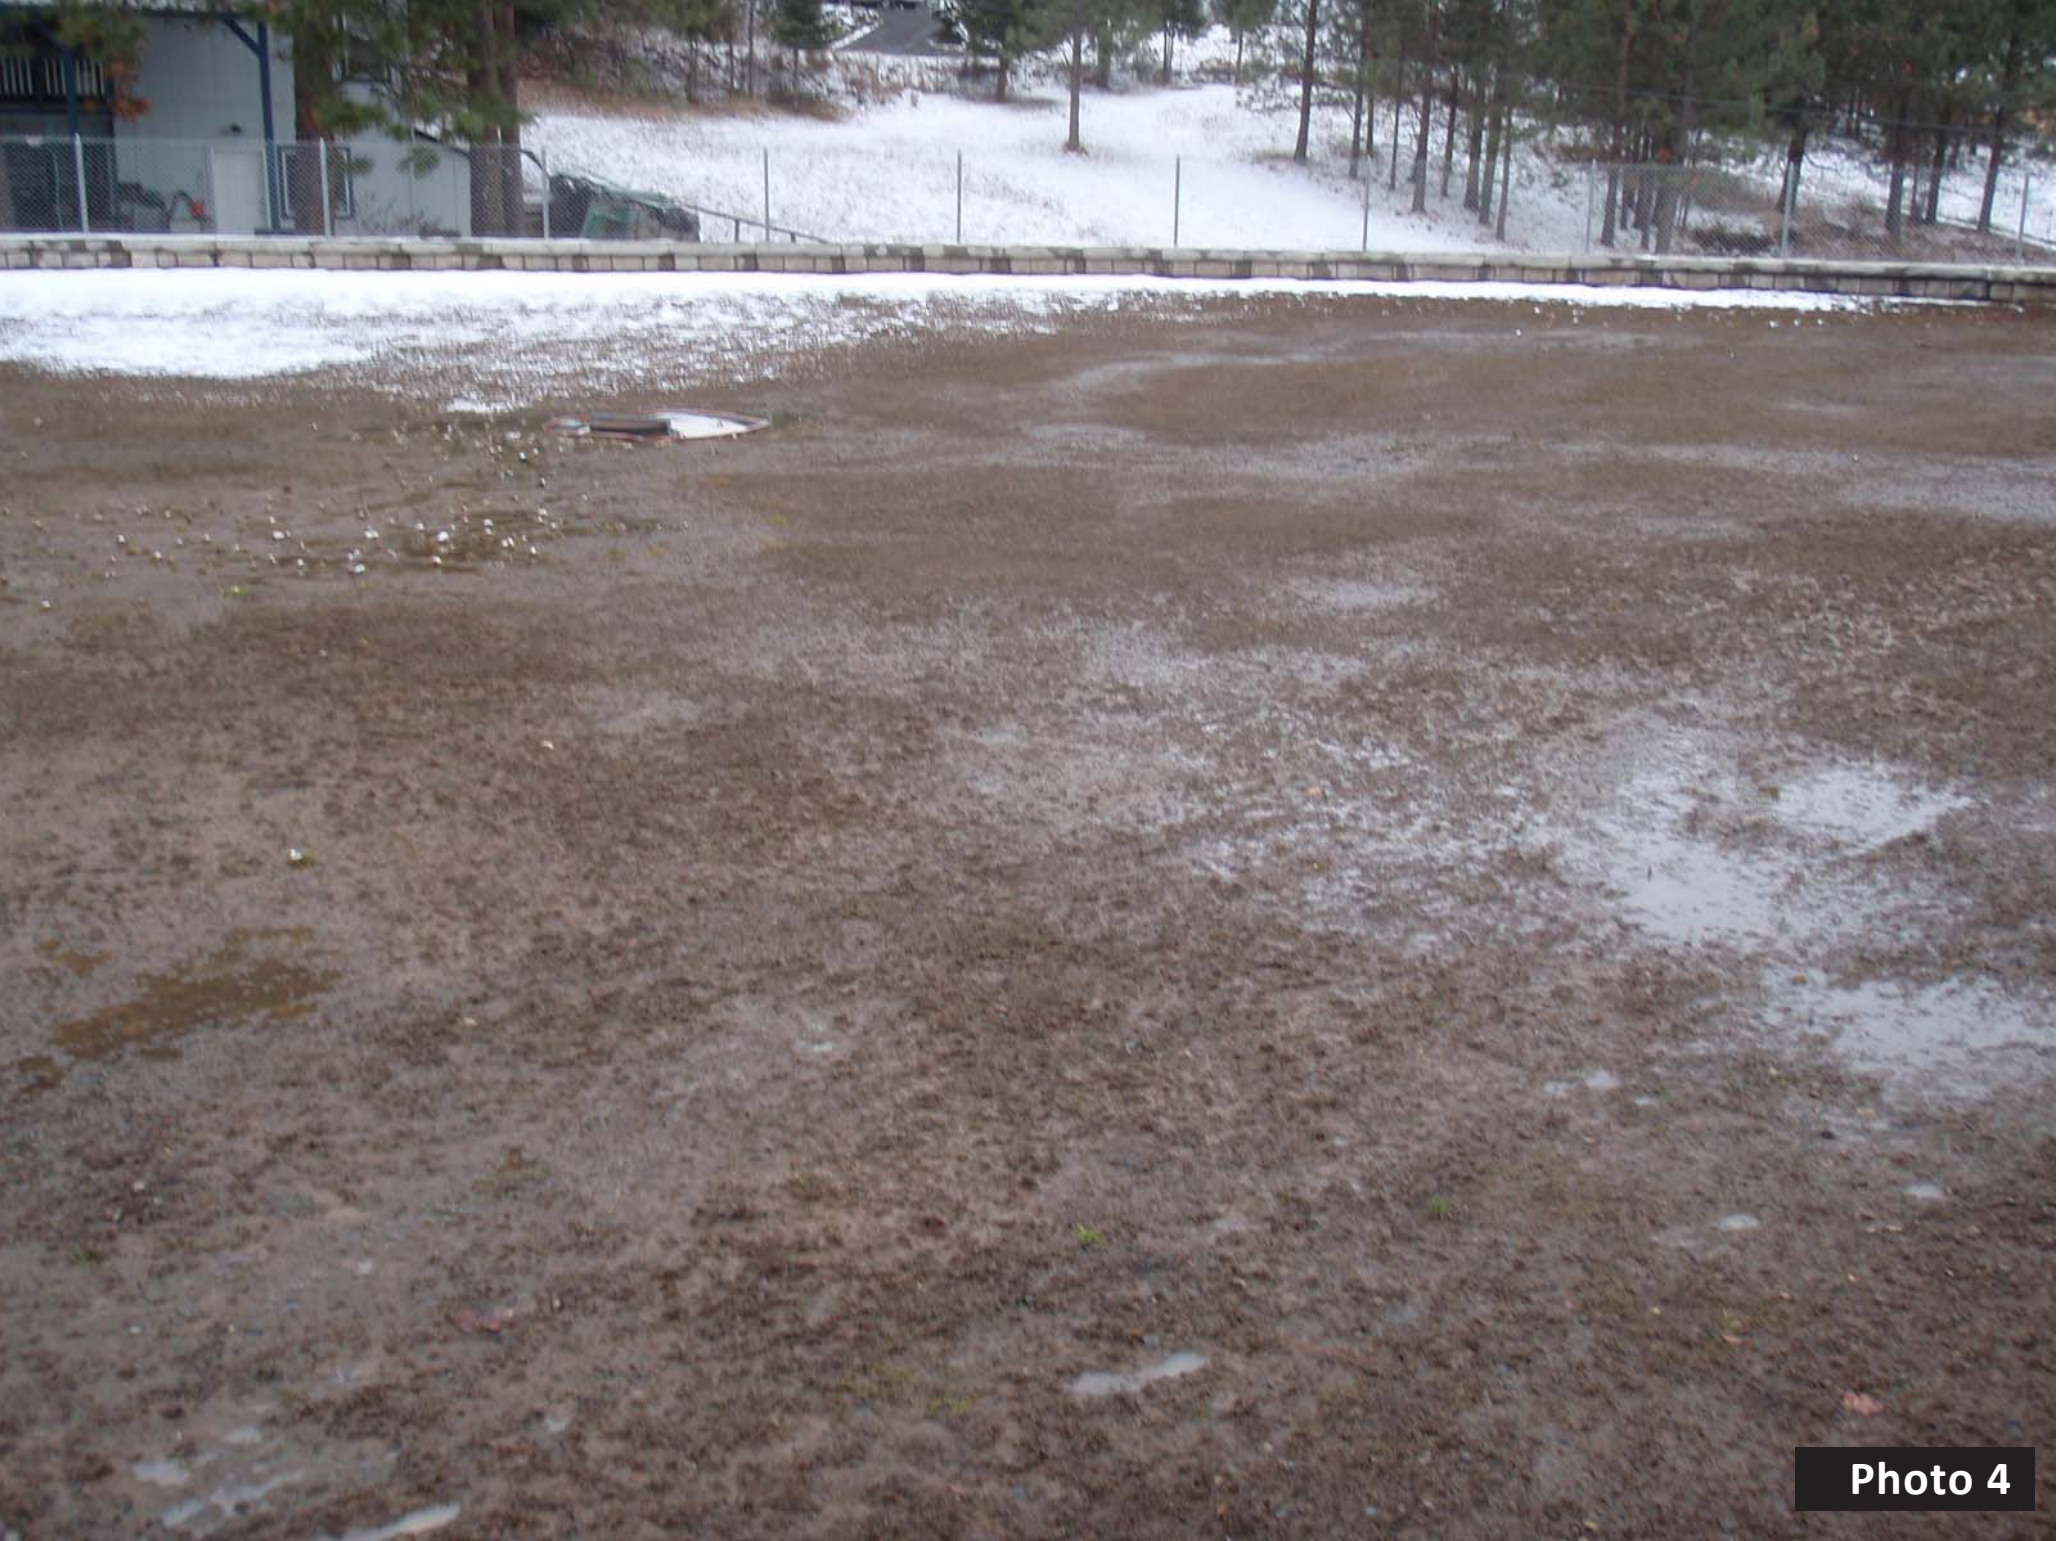
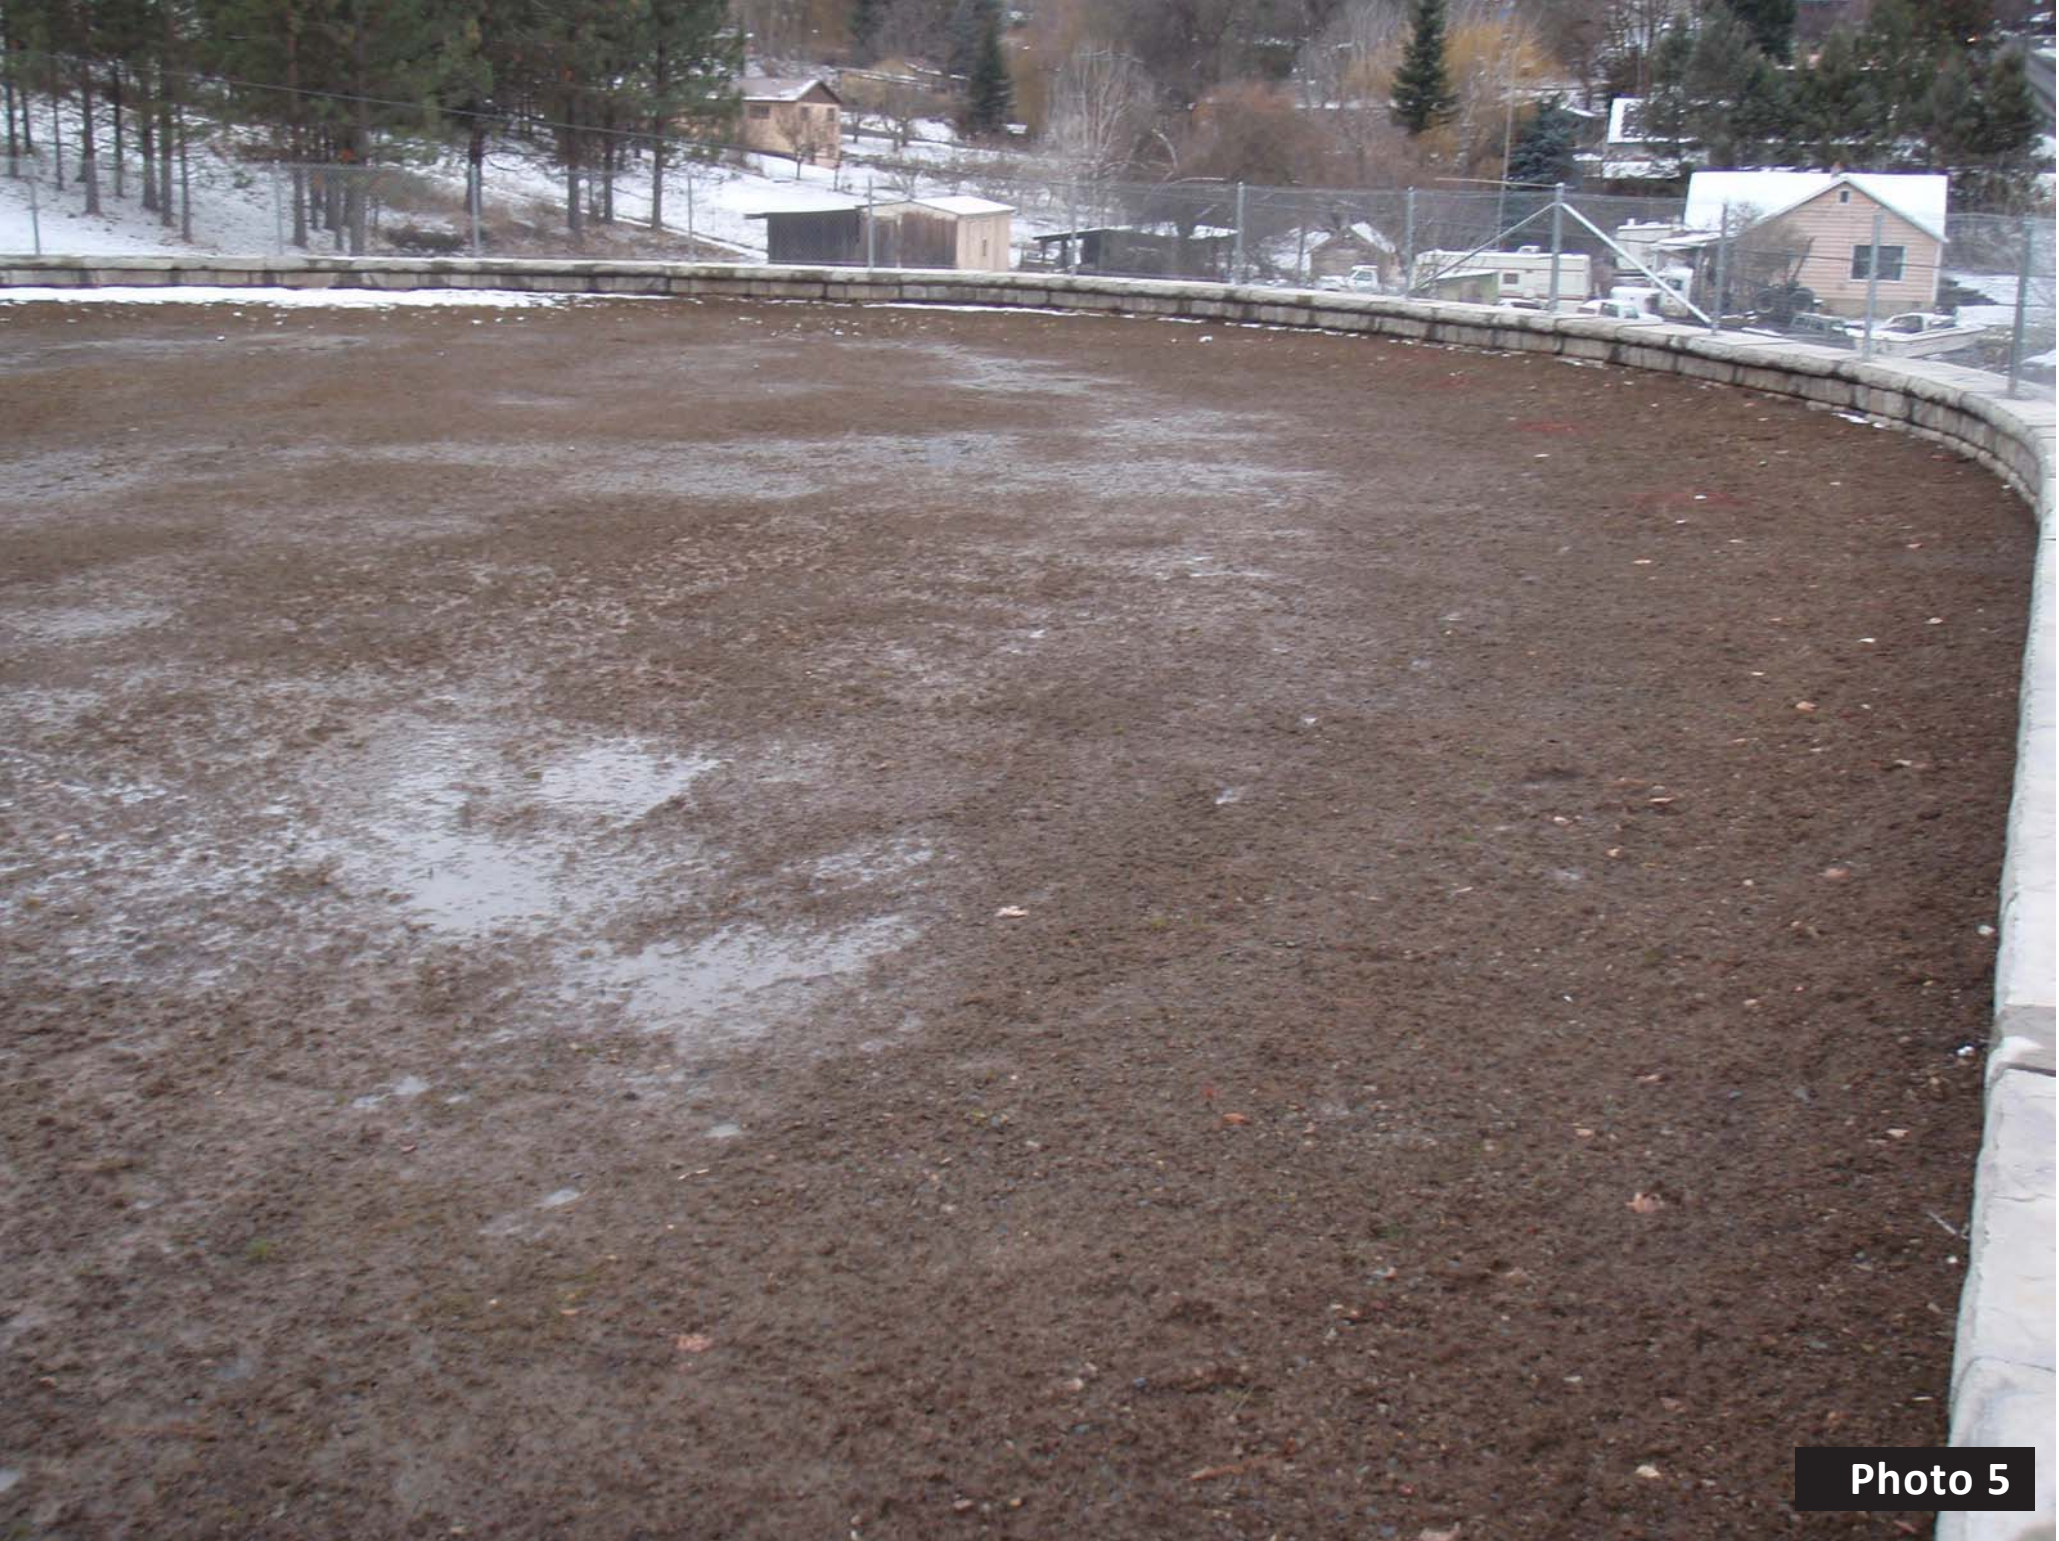
Photo 2

- During the site reconnaissance performed by Steve Hall and Mark Longtine on March 1, 2014, saturated conditions appeared to exist over the entire soil cover area, with shallow ponding over much of the area (see Photos 2, 3, 4, and 5).

The soil present over about half of the soil cover area (including grid points 1, 5, 6, 7, 8) contains abundant gravel and fines. The gradation of sand grain size is not known. The overall grain size distribution of the soil in this area is generally well-graded, with particle size ranging from gravel to clay. In general, well-graded soils have less porosity and lower permeability than poorly-graded soils. A given quantity of water will saturate a larger volume of low-porosity soil than high-porosity soil. A well-graded soil will tend to drain more slowly than a poorly-graded soil. Soil porosity and permeability are particularly important in cases where there is a barrier preventing migration of water, such as the plastic membrane preventing downward migration of water at the Orofino soil cover. Complete saturation of available porosity is evidenced by ponding across the cover area observed on March 1, 2014, and full-thickness saturation observed in test holes over about half the cover on March 21, 2014.

Saturated conditions may limit plant growth. It is possible that the saturated conditions that exist at the soil cover for part of the year are at least partially responsible for lack of vegetation. Lack of plant growth in turn limits transpiration, which, if plants were present, would reduce the soil water content. It is possible that, if vegetation were to become established on the soil cap during a period of favorable conditions, that the plants would subsequently support evapotranspiration at rates adequate to limit saturated conditions in the future.

- 1) Perform hydroseeding again this spring. Assure follow-up watering to support growth. Prior to application, work the soil to reduce the amount of gravel at the surface.
- 2) In addition to monitoring vegetative growth, monitor soil moisture conditions for saturation.
- 3) If hydroseeding is not successful, consider amending the existing soil with organic matter and/or nutrients.
- 4) If amending the existing soil with organic matter and/or nutrients is not successful, and excessive soil saturation persists, particularly in the southern portion of the soil cover, consider adding new soil or replacing existing soil to provide improved water-holding capacity and drainage.

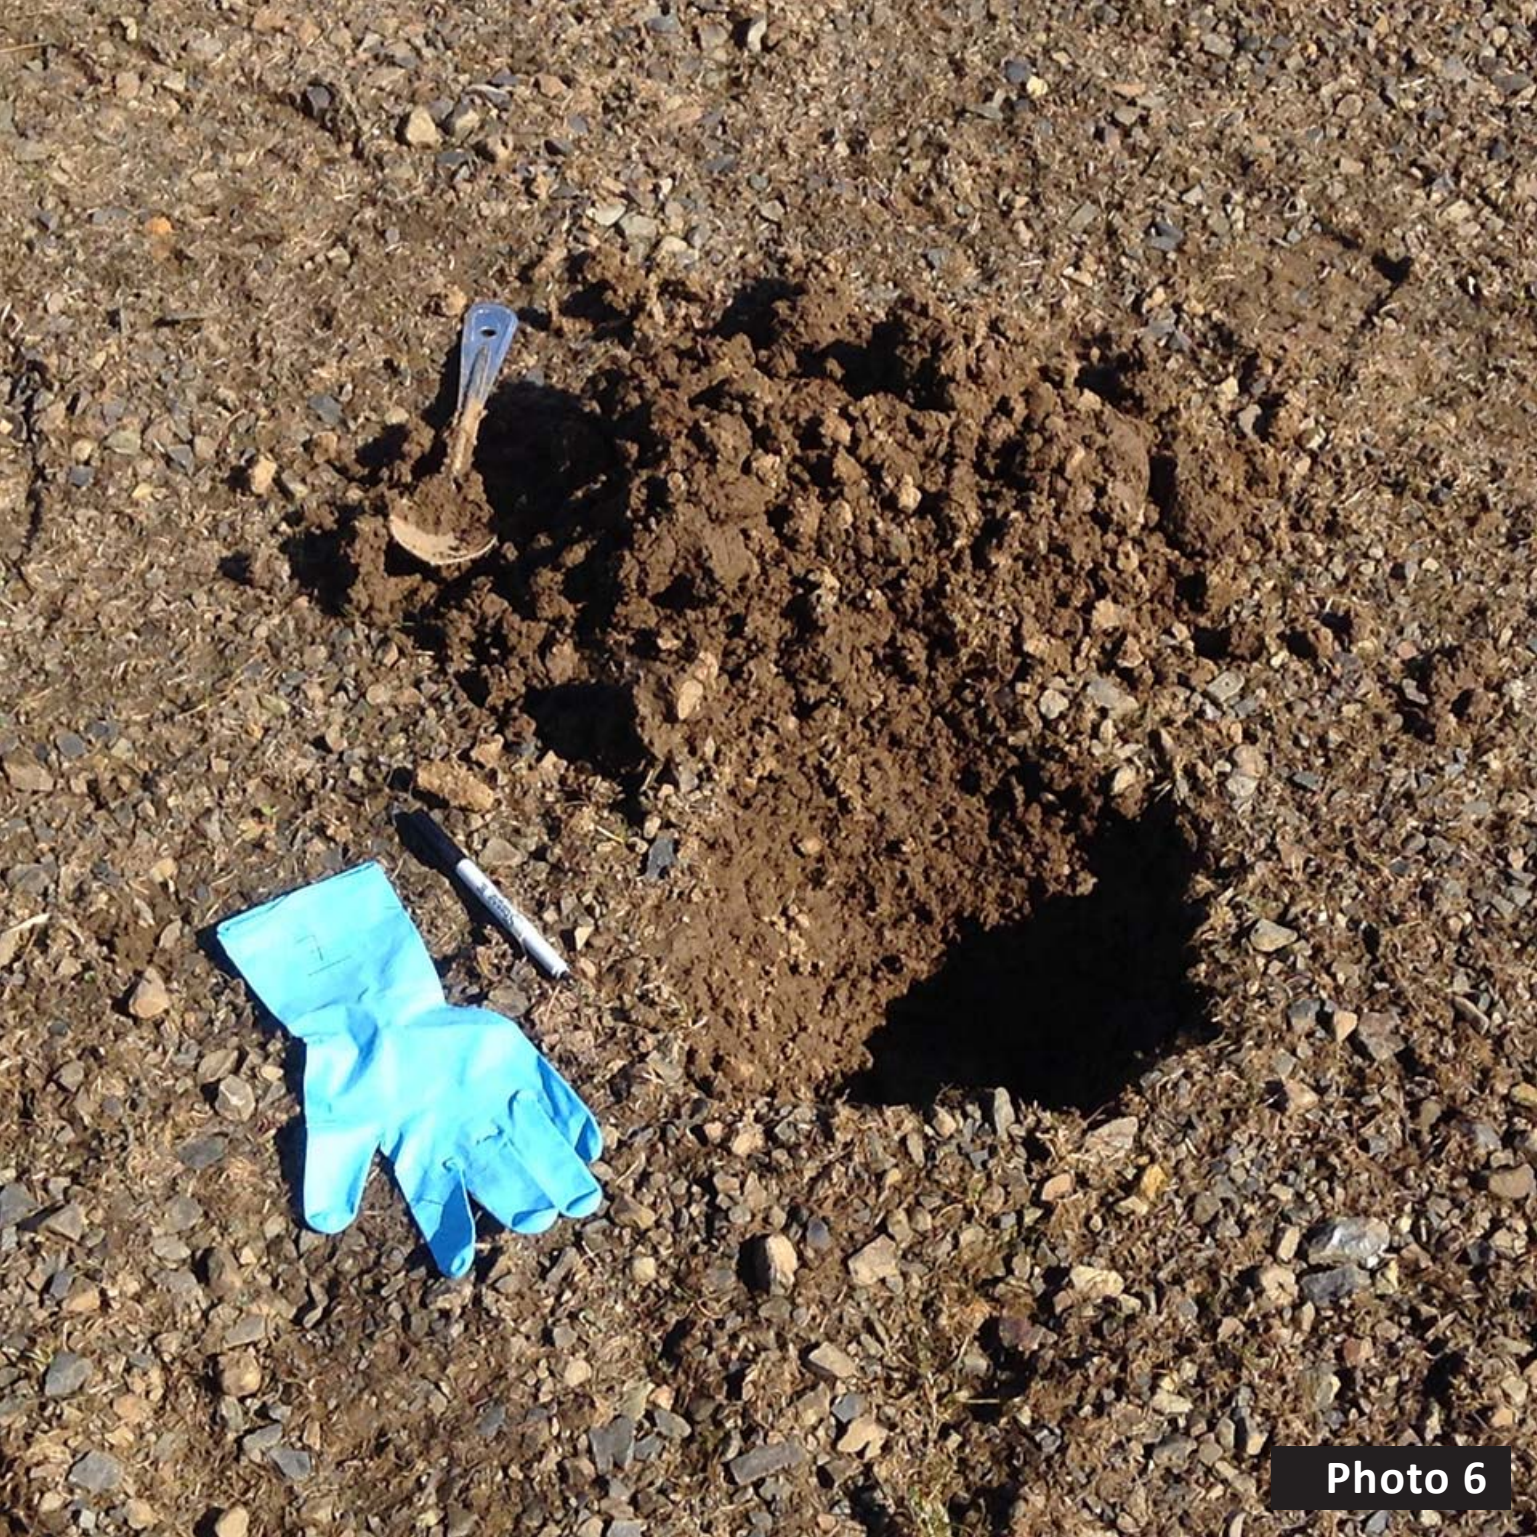
Photo 6

- Measured soil thickness was fairly consistent throughout the soil cap area, ranging from 8 to 10 inches.
- Across most of the soil cover area, the surface was covered by some amount of gravel up to 1.5 inches across. The amount of gravel on the surface was greater in the southern portion of the soil cover area. In places, up to approximately 60 percent or more of the surface area was

covered with gravel (see Photo 6). The presence of this clean gravel at the surface indicates that soil had been eroded (by runoff and/or wind), leaving the gravel lag behind.

Gravel presently covers much of the soil cover surface, particularly in the southern portion. Soil has been washed away from the gravel surfaces. The gravel acts to prevent contact of any new seed with soil and soil moisture.
