Draft Technical Memorandum

Orofino Asbestos Site

Vegetative Cover Performance Evaluation

April 14, 2014

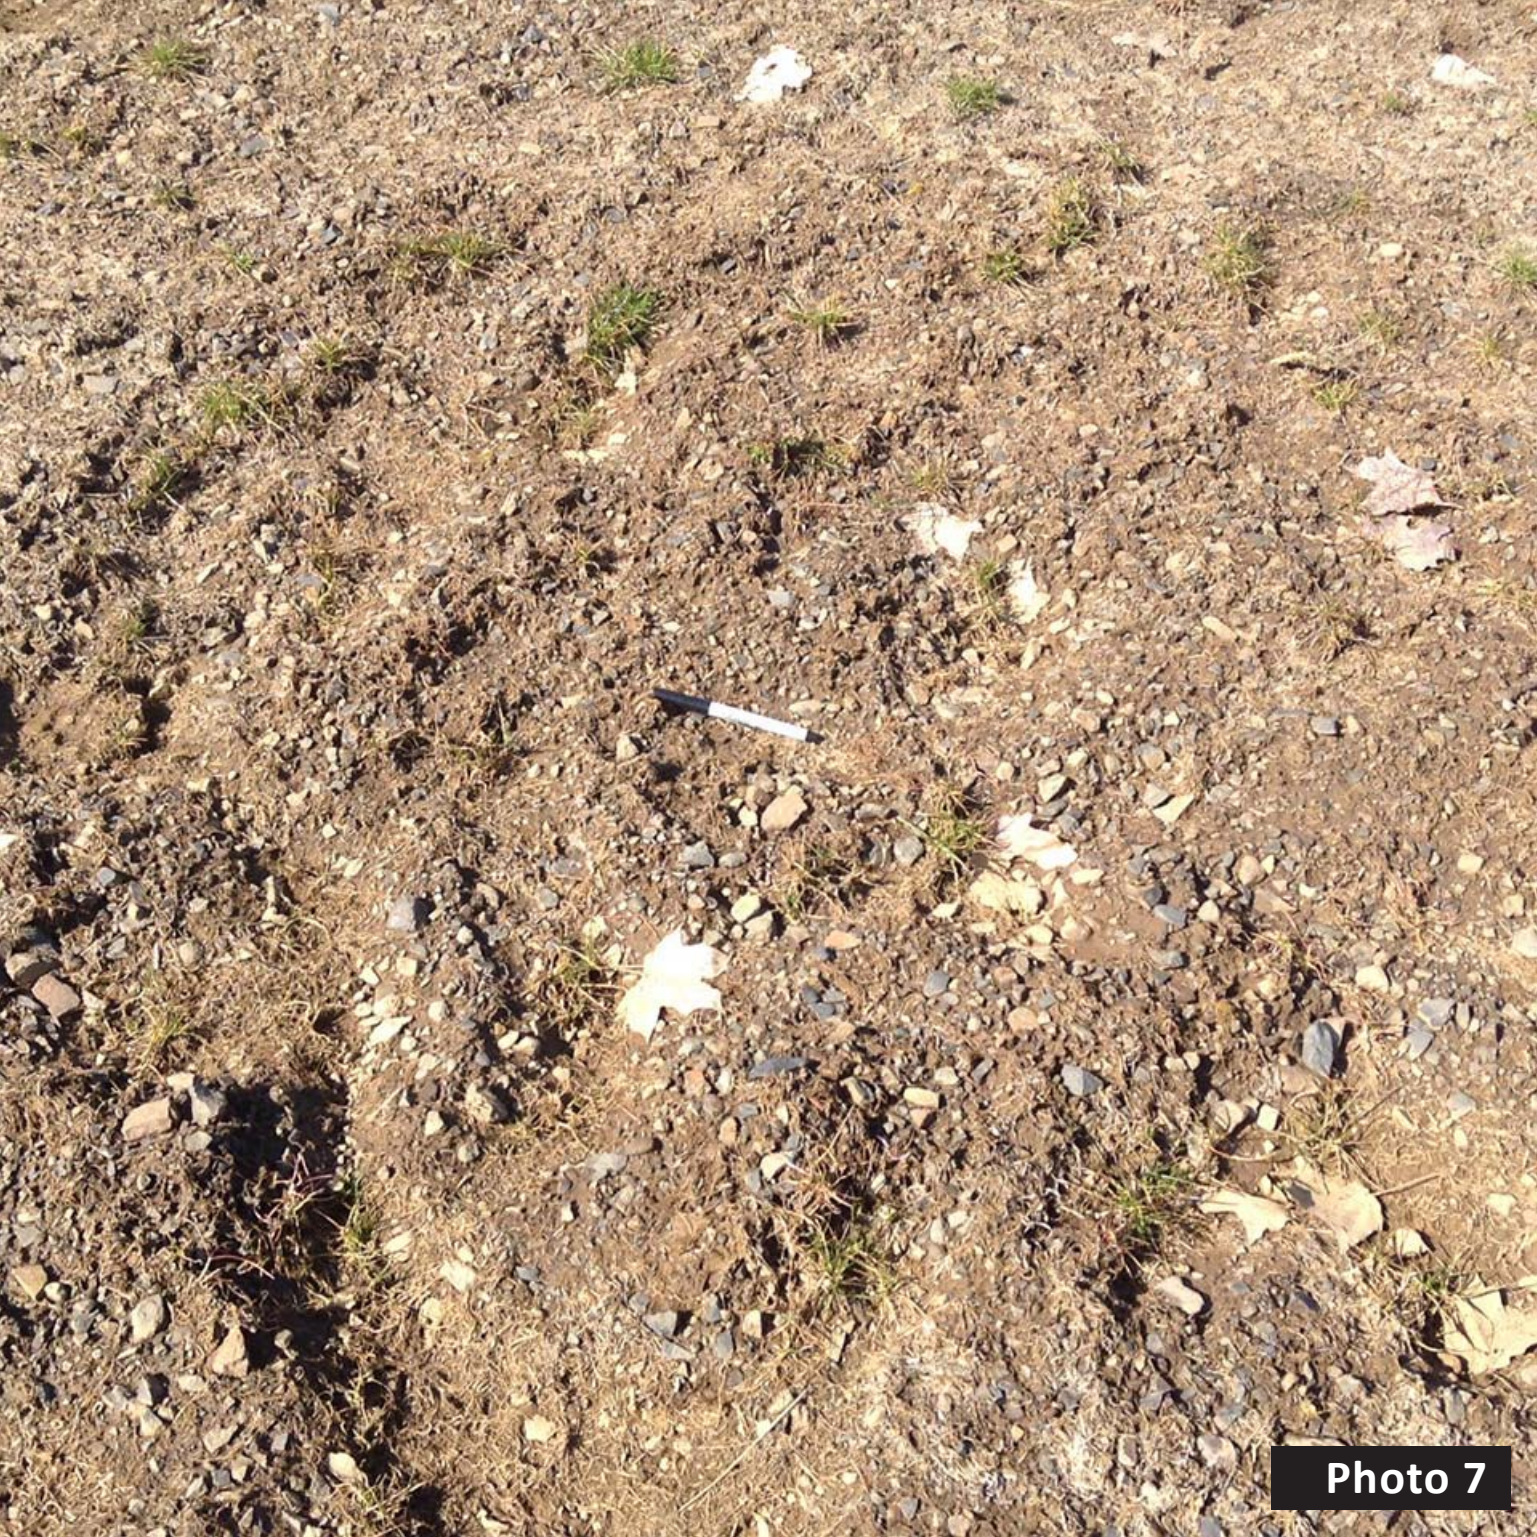
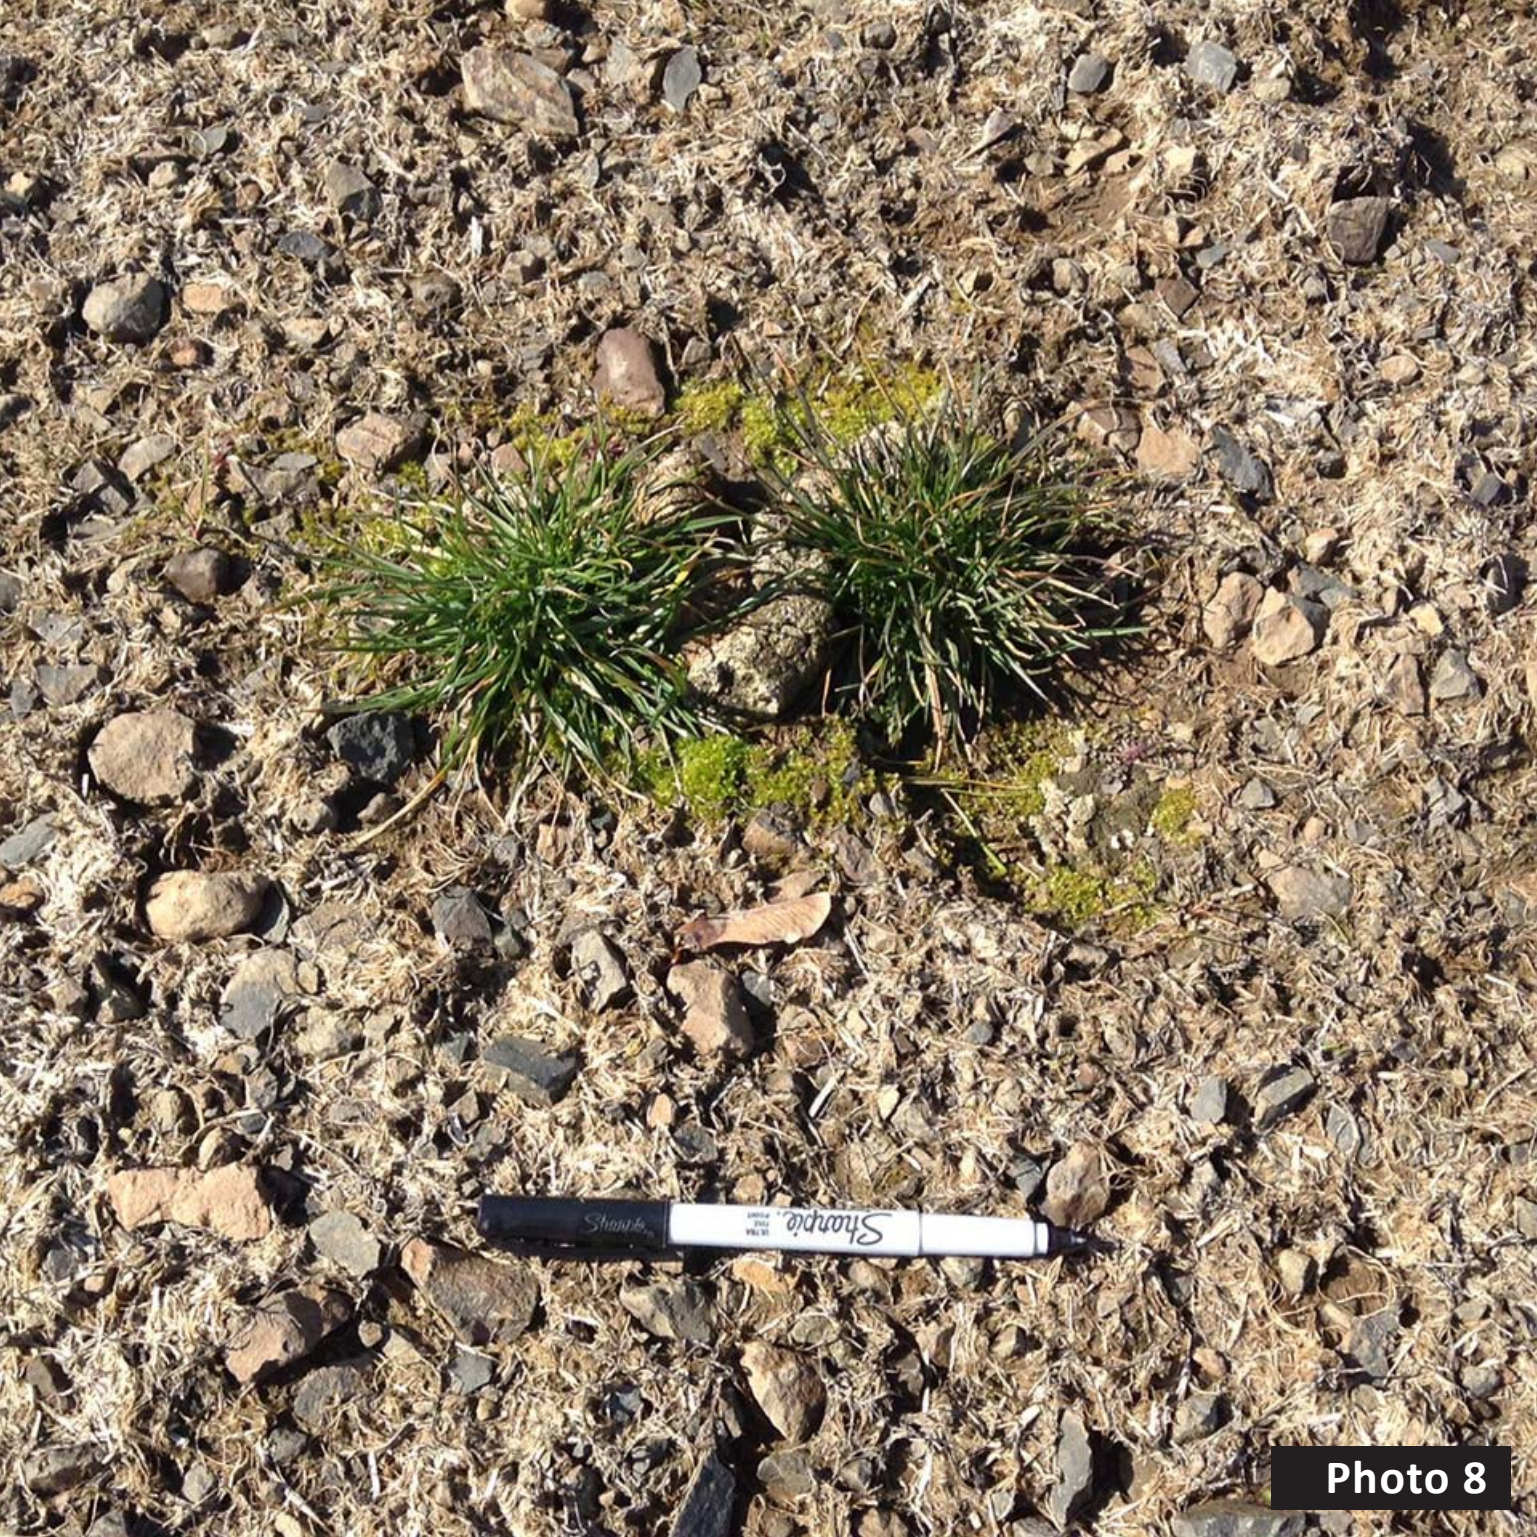
Photo 7

- There was some vegetation on the soil surface locally, including small sprouts of grass, moss, and thick patches of clover-like plants up to several feet across (see Photos 7, 8, 9, and 10).
- Other than the concentration of gravel at the surface, the grain size distribution and soil color were generally consistent from the top to the bottom of each test hole. Grain size distribution is discussed further below.

Although some vegetation, including grass, is beginning to grow locally on the soil cover, the coverage is sparse. There appear to be multiple factors that are partially responsible for the lack of vegetation, discussed below.

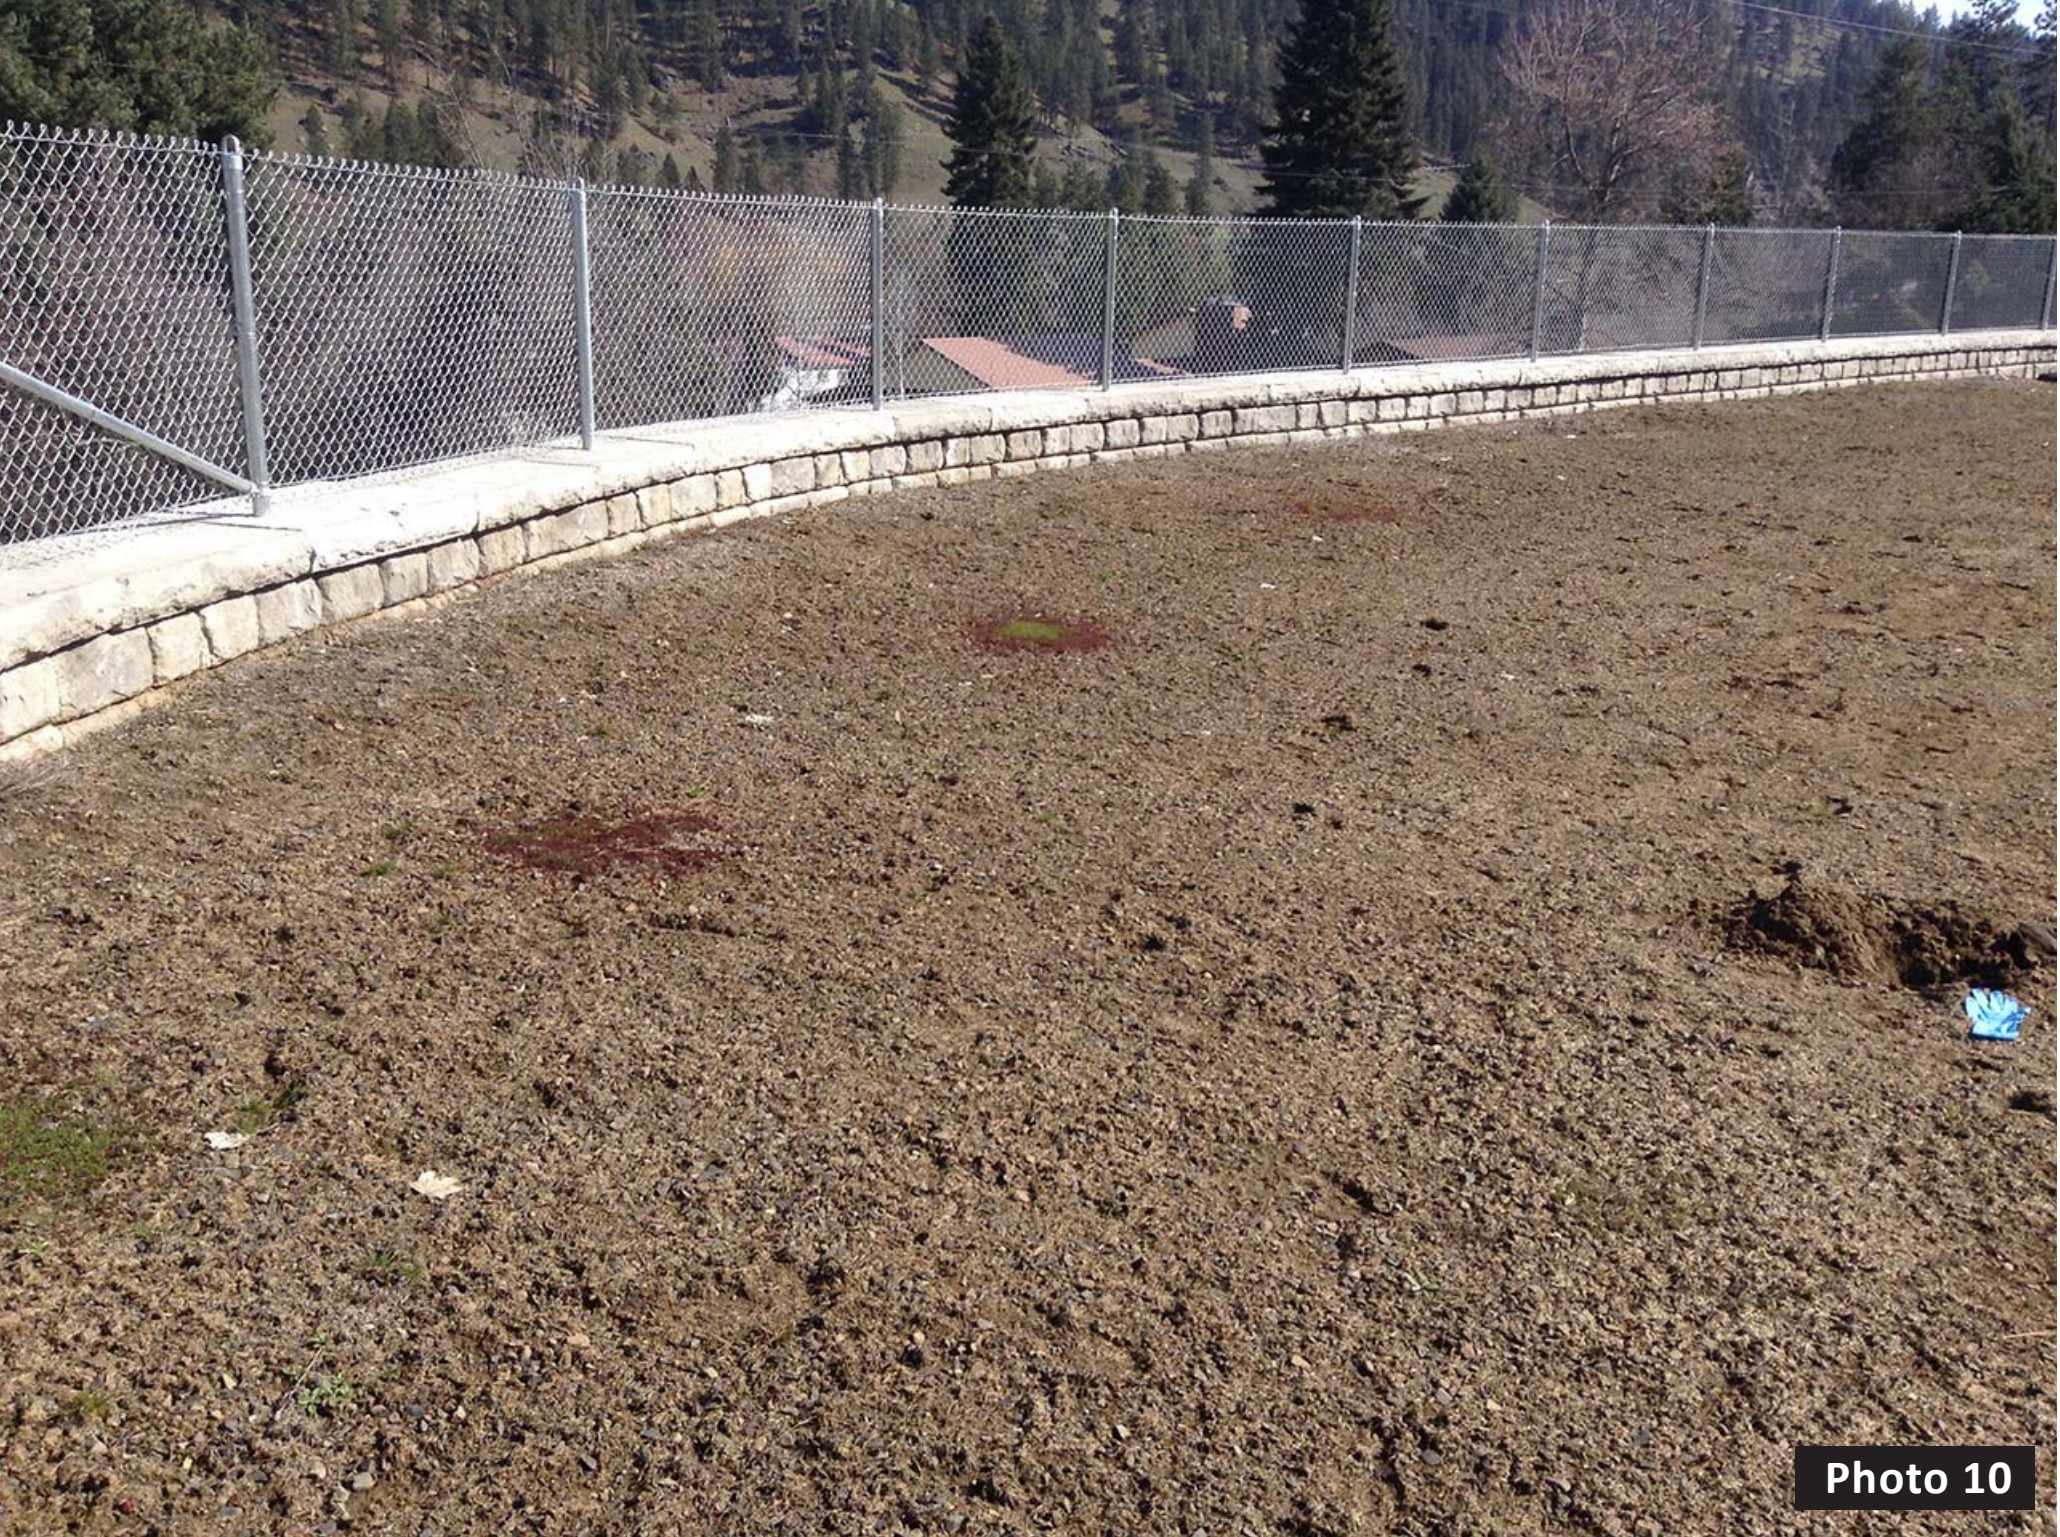
Photo 10

Pastor Hale Anderson informed Mark Longtine during the March 21, 2014 site visit that last summer he seeded the area between the drywell and the asphalt pavement because that area is typically wet and children often ride their bikes through the mud. He reportedly applied about ten pounds of seed. Some grass is growing in small patches in this area presently (see Photo 10).

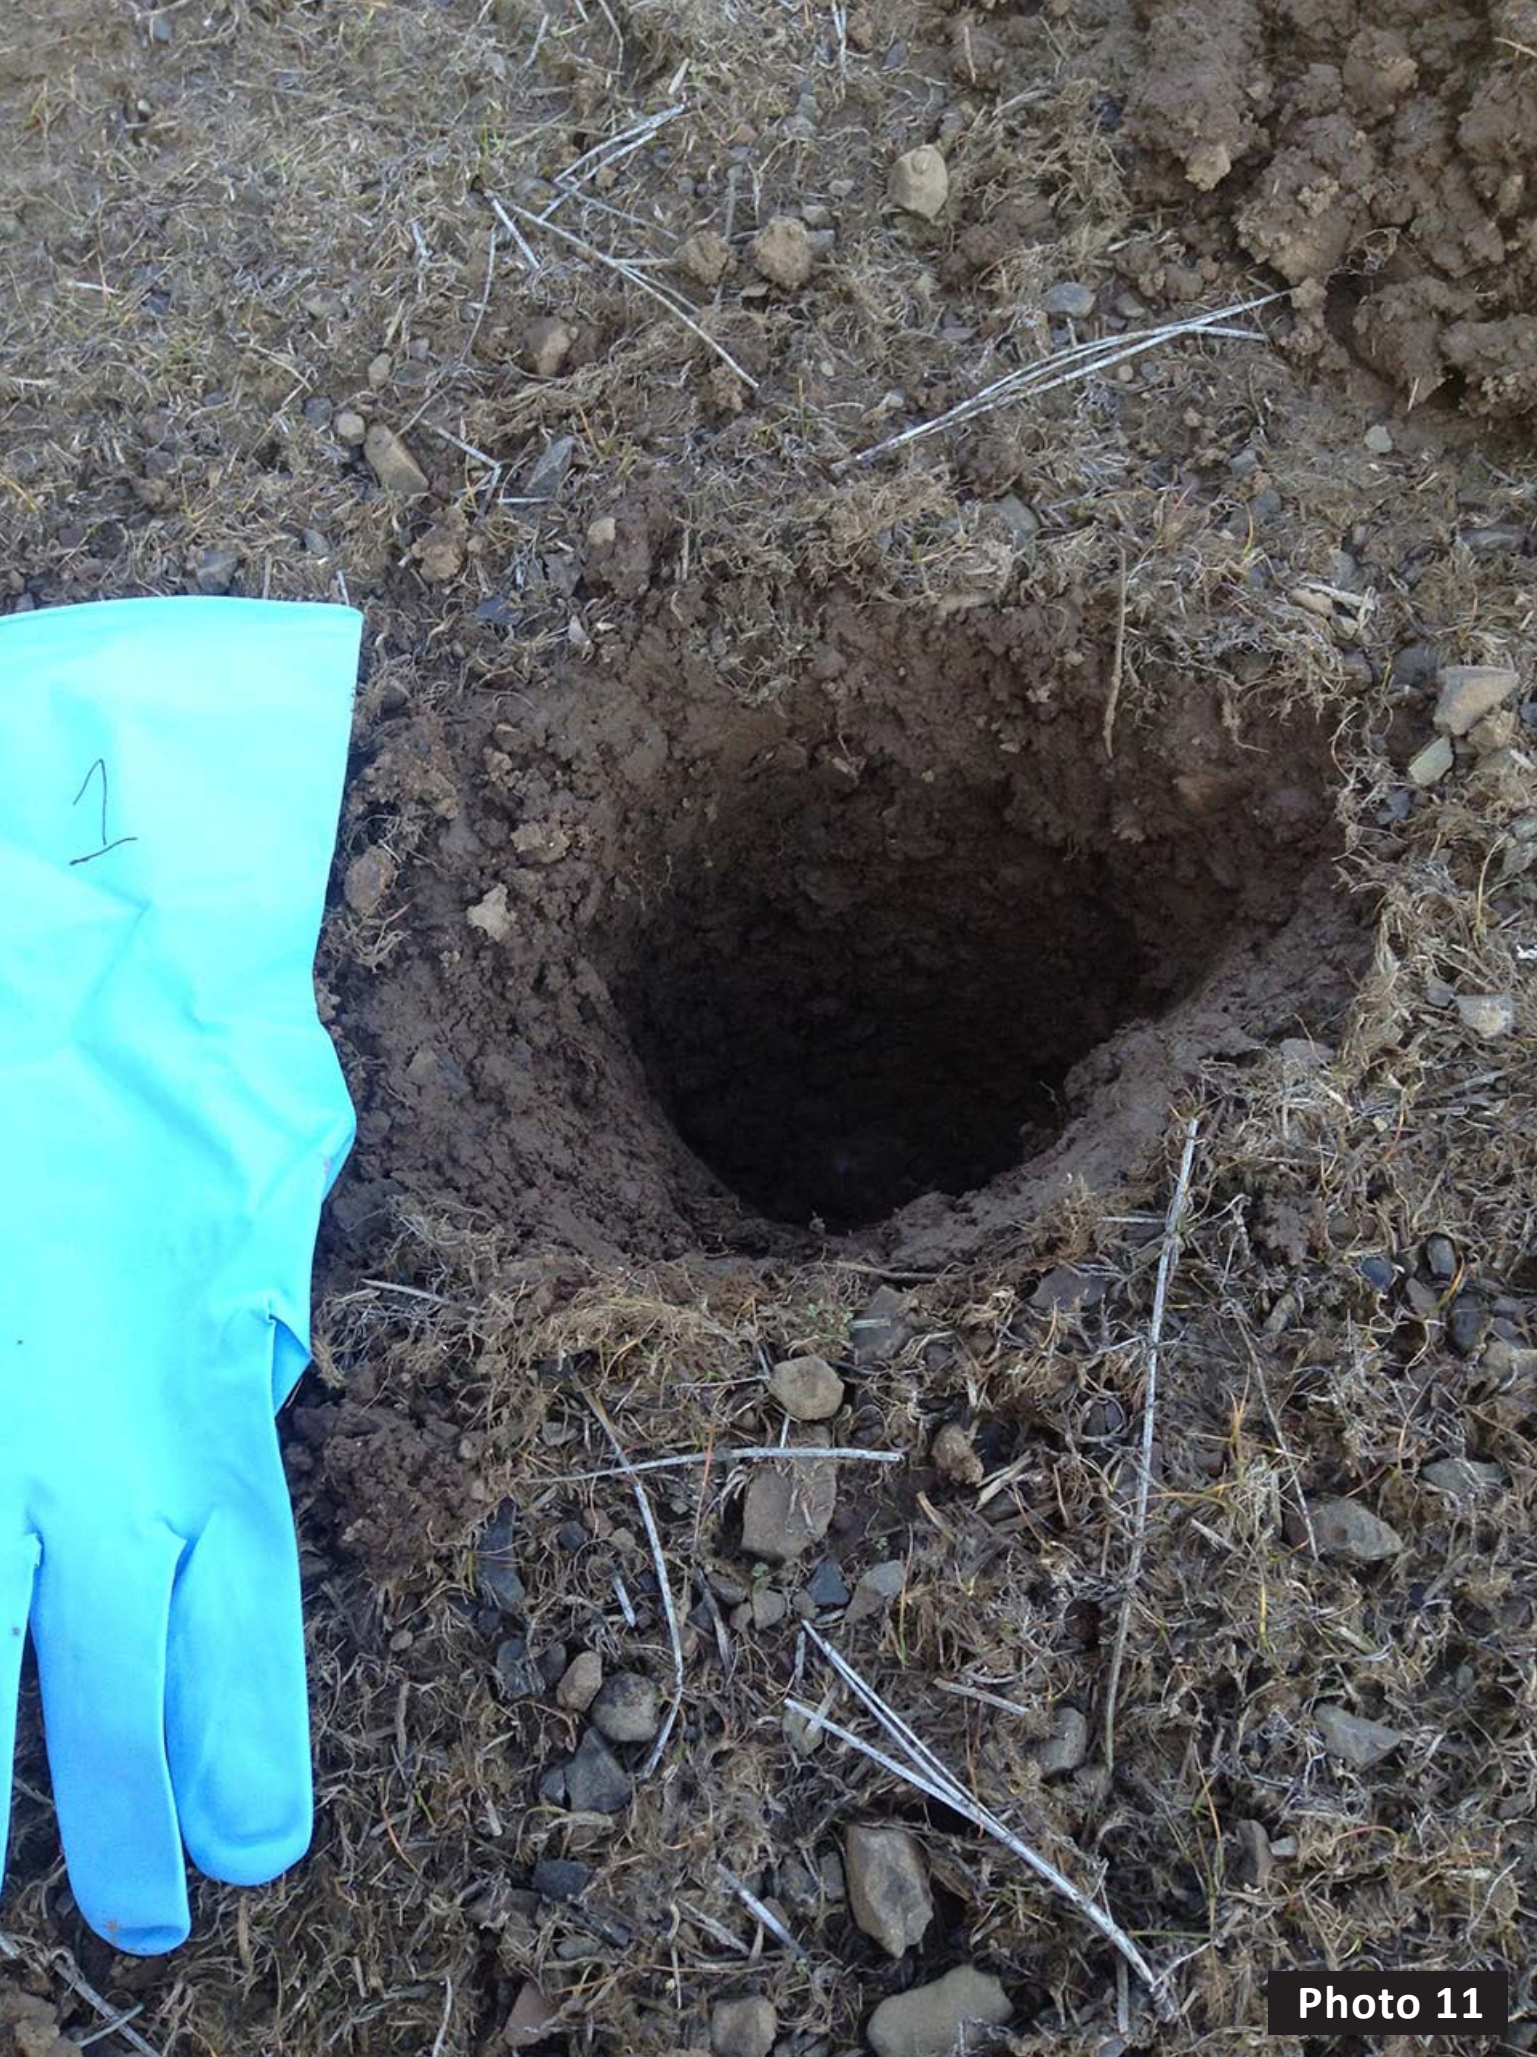
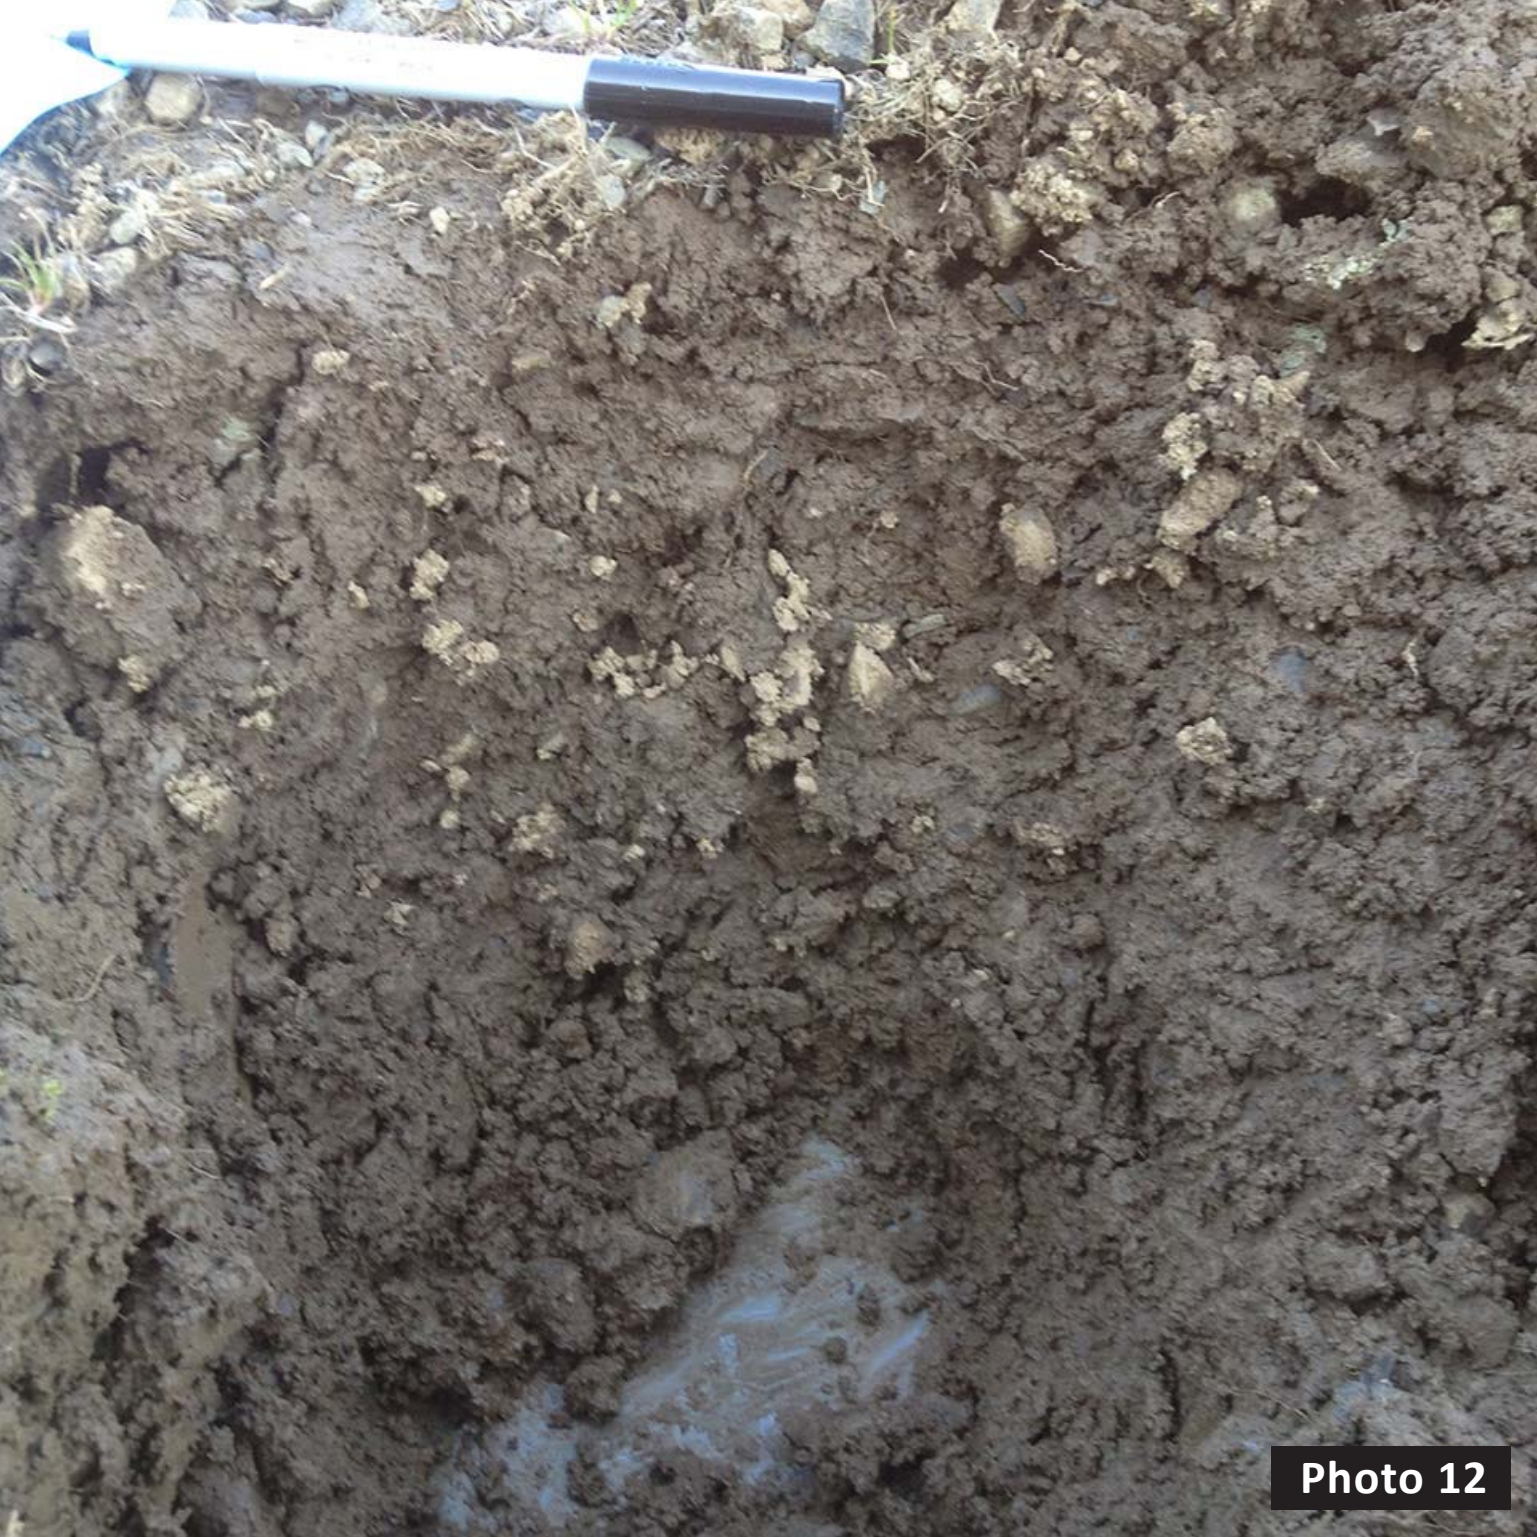
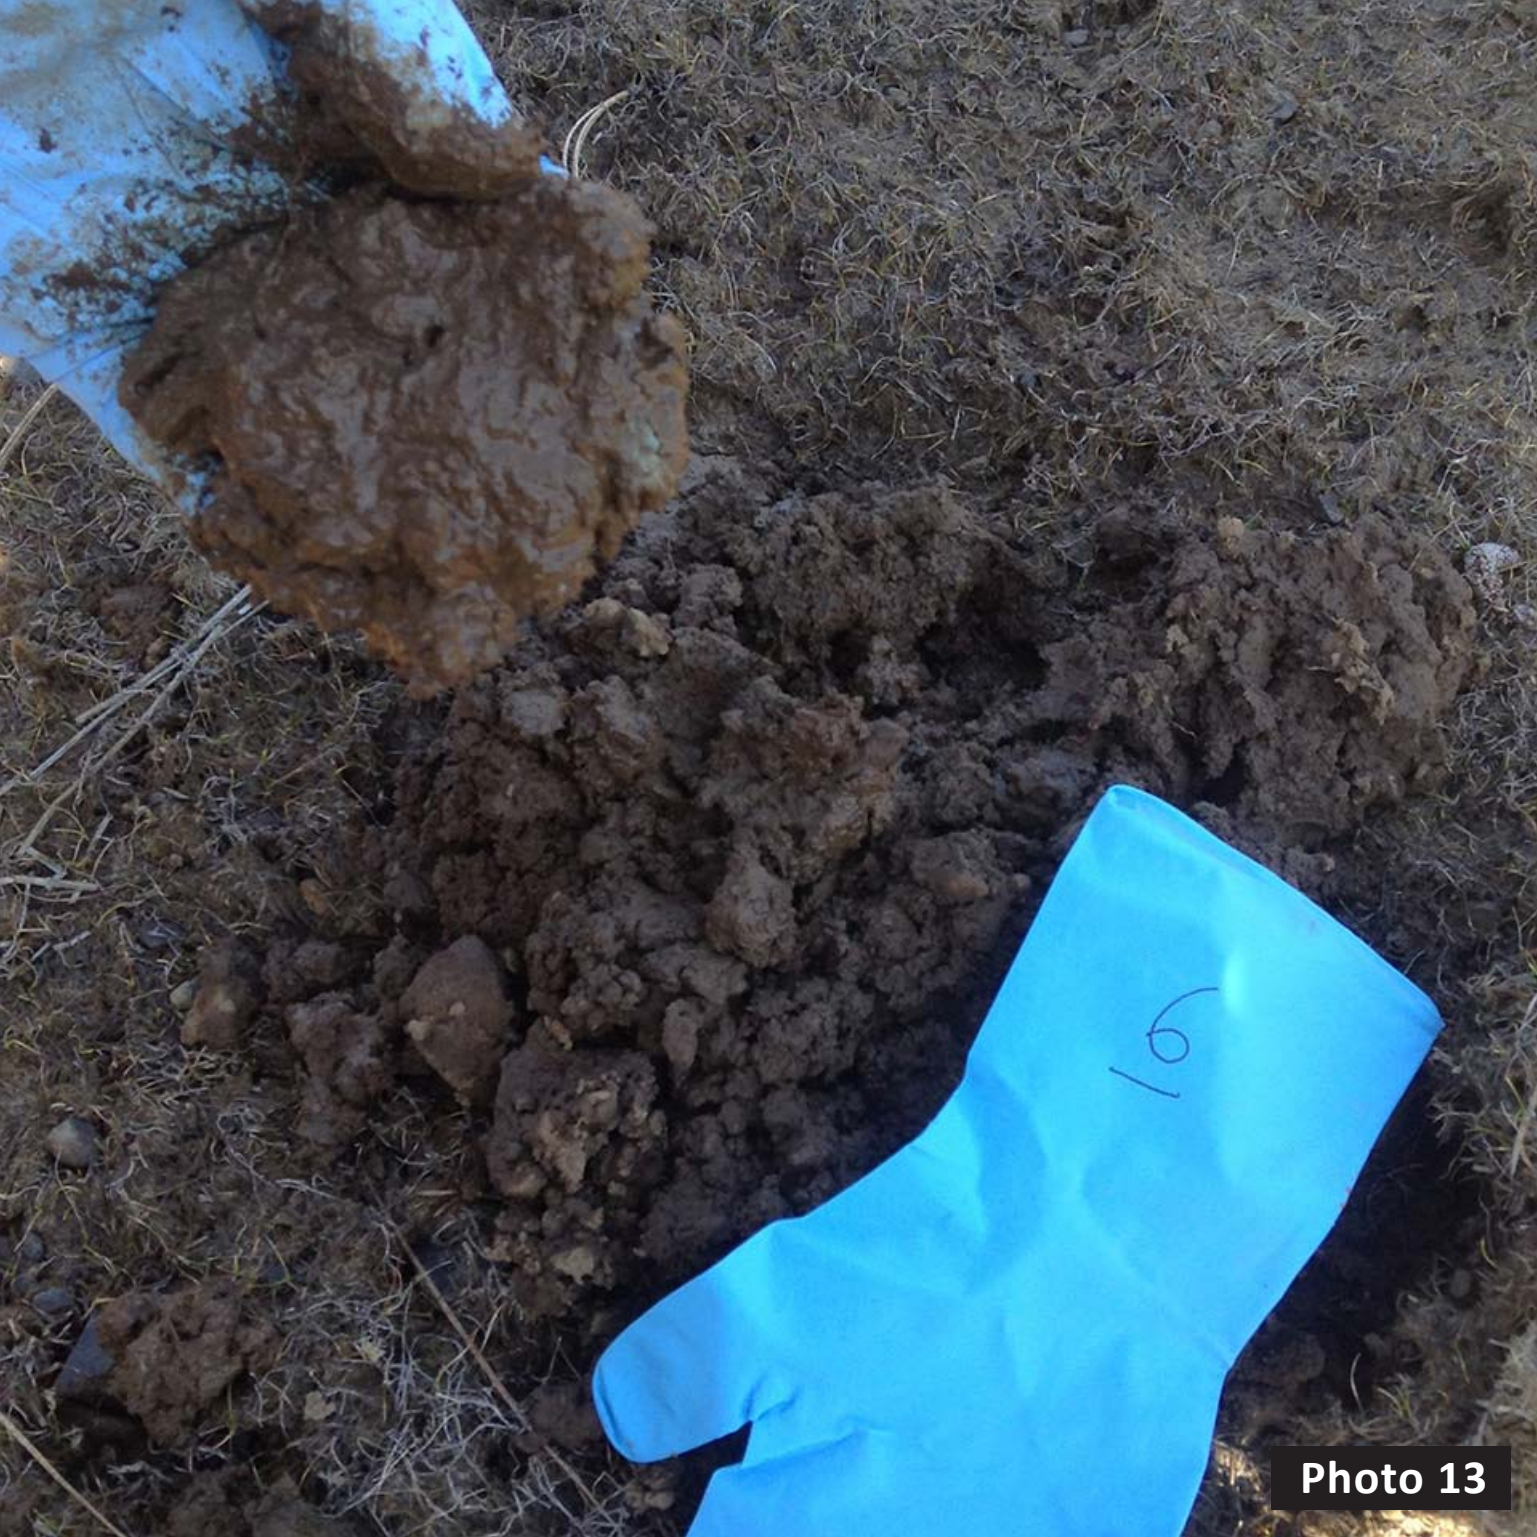
Photo 11

- 1) Gravel with silt/clay and sand, brown, saturated (grid points 1, 5, 6, 7, and 8). The amount of gravel ranged up to an estimated 50 percent. The gravel is angular and ranges up to 1.5 inches across. Due to the saturated conditions, the ability to perform field estimation of the grain size distribution (i.e., soil texture by feel method) was very limited. The distribution of grain sizes of the sand was difficult to assess in the field because of the large proportion of fines, both visually and by feel. See Photos 11, 12, and 13.

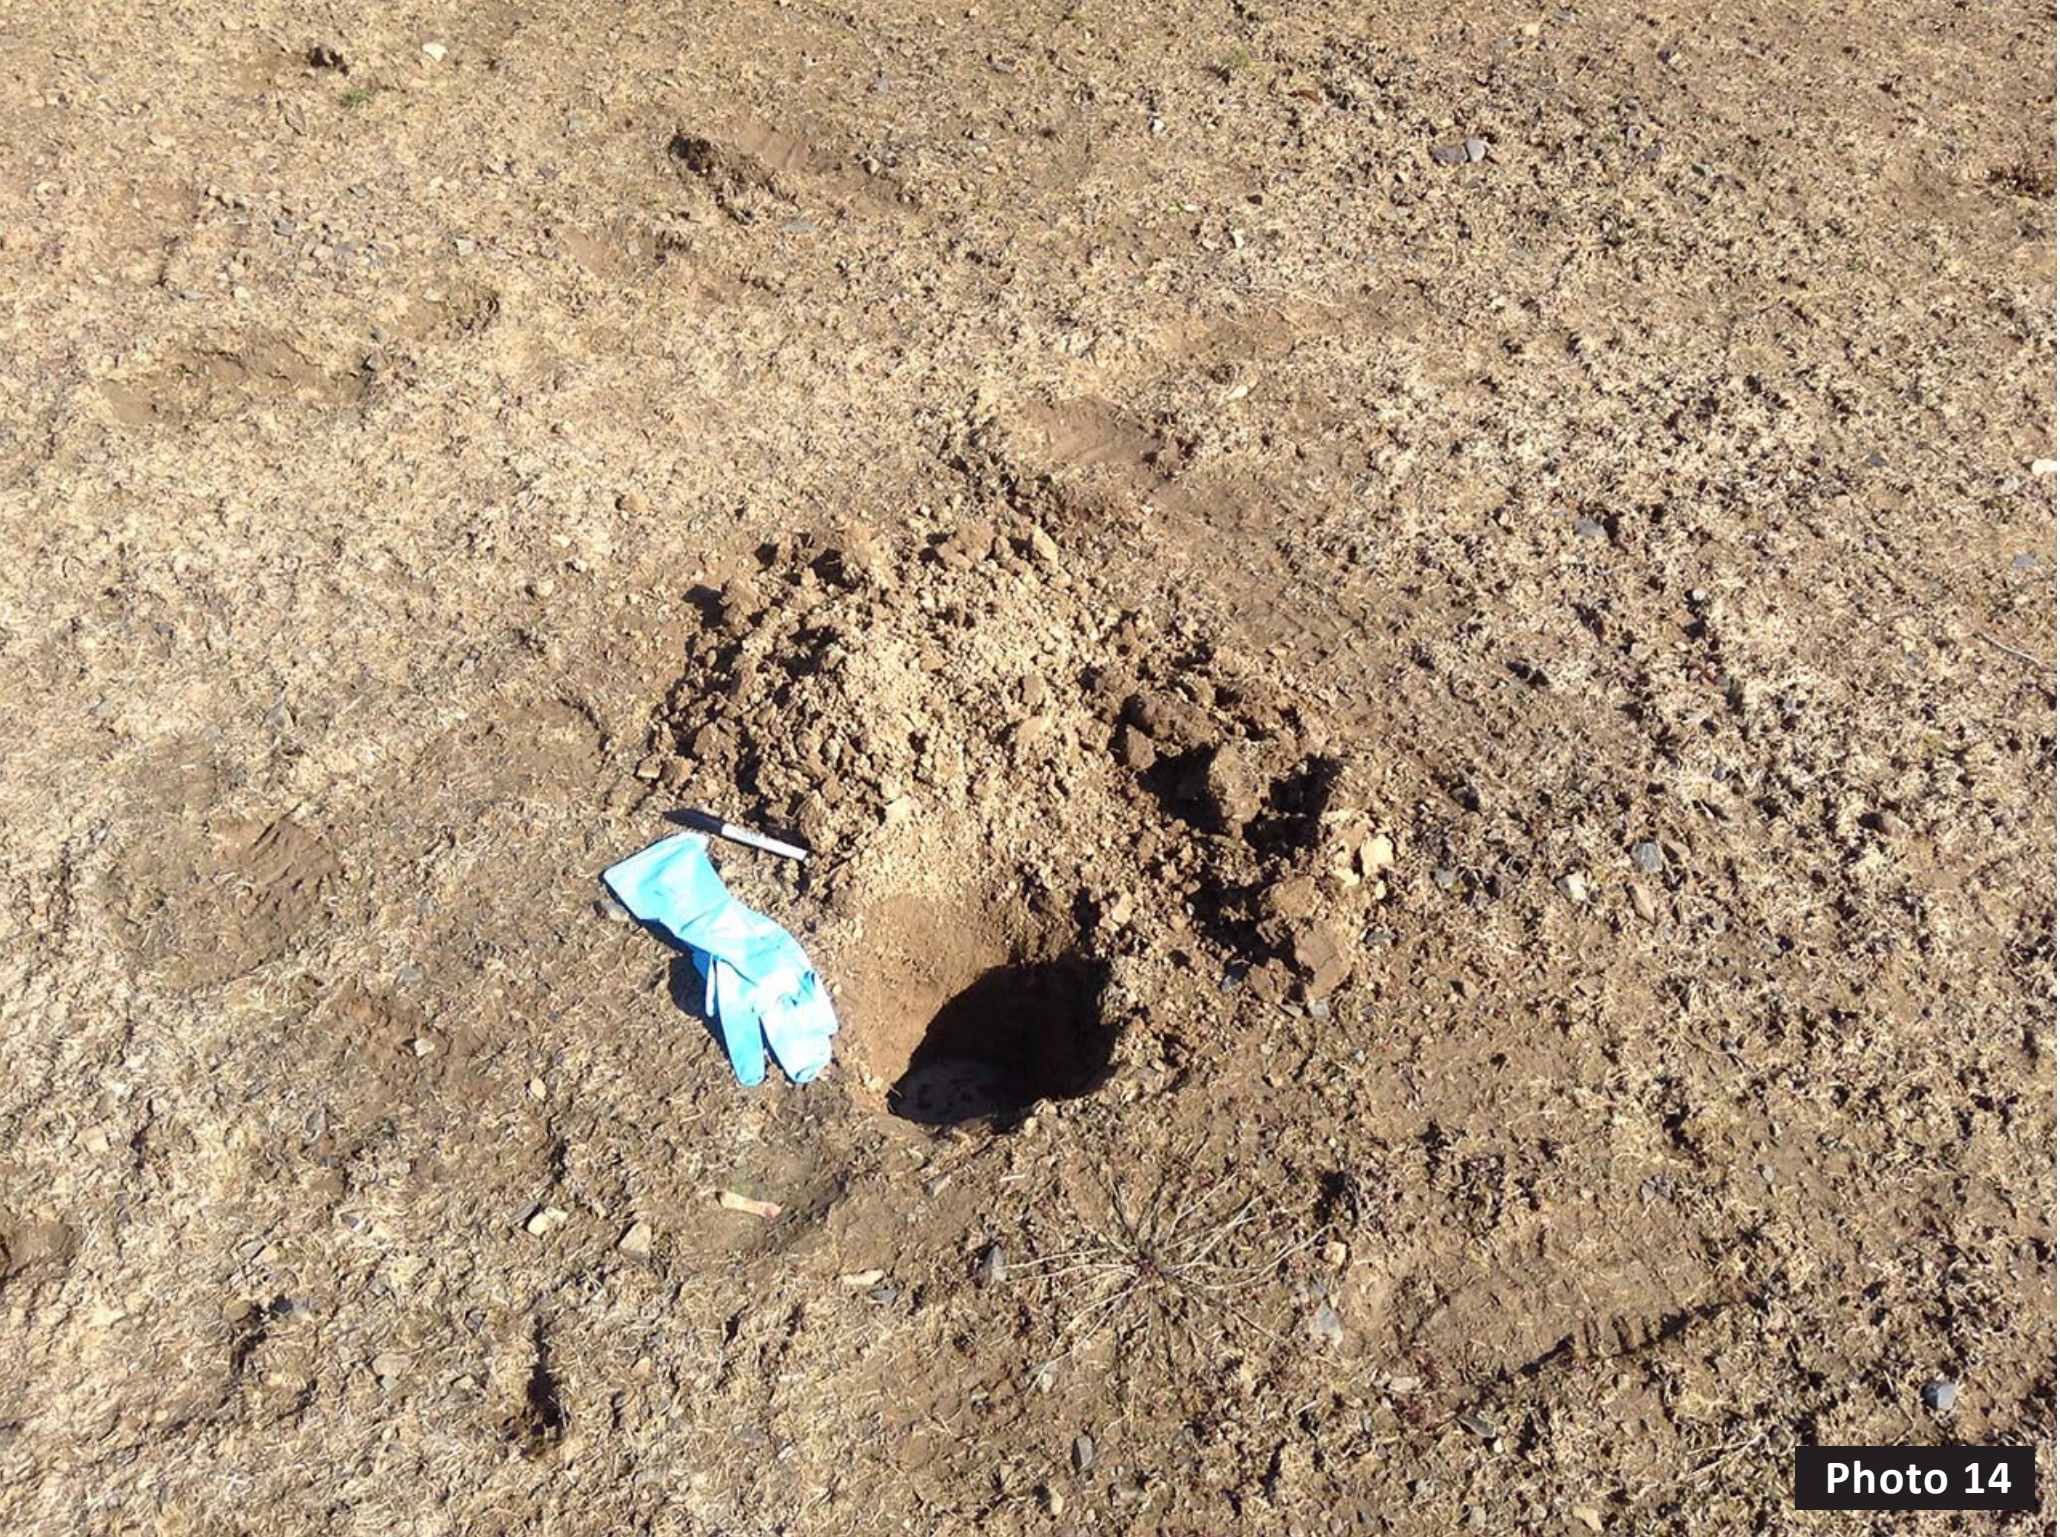
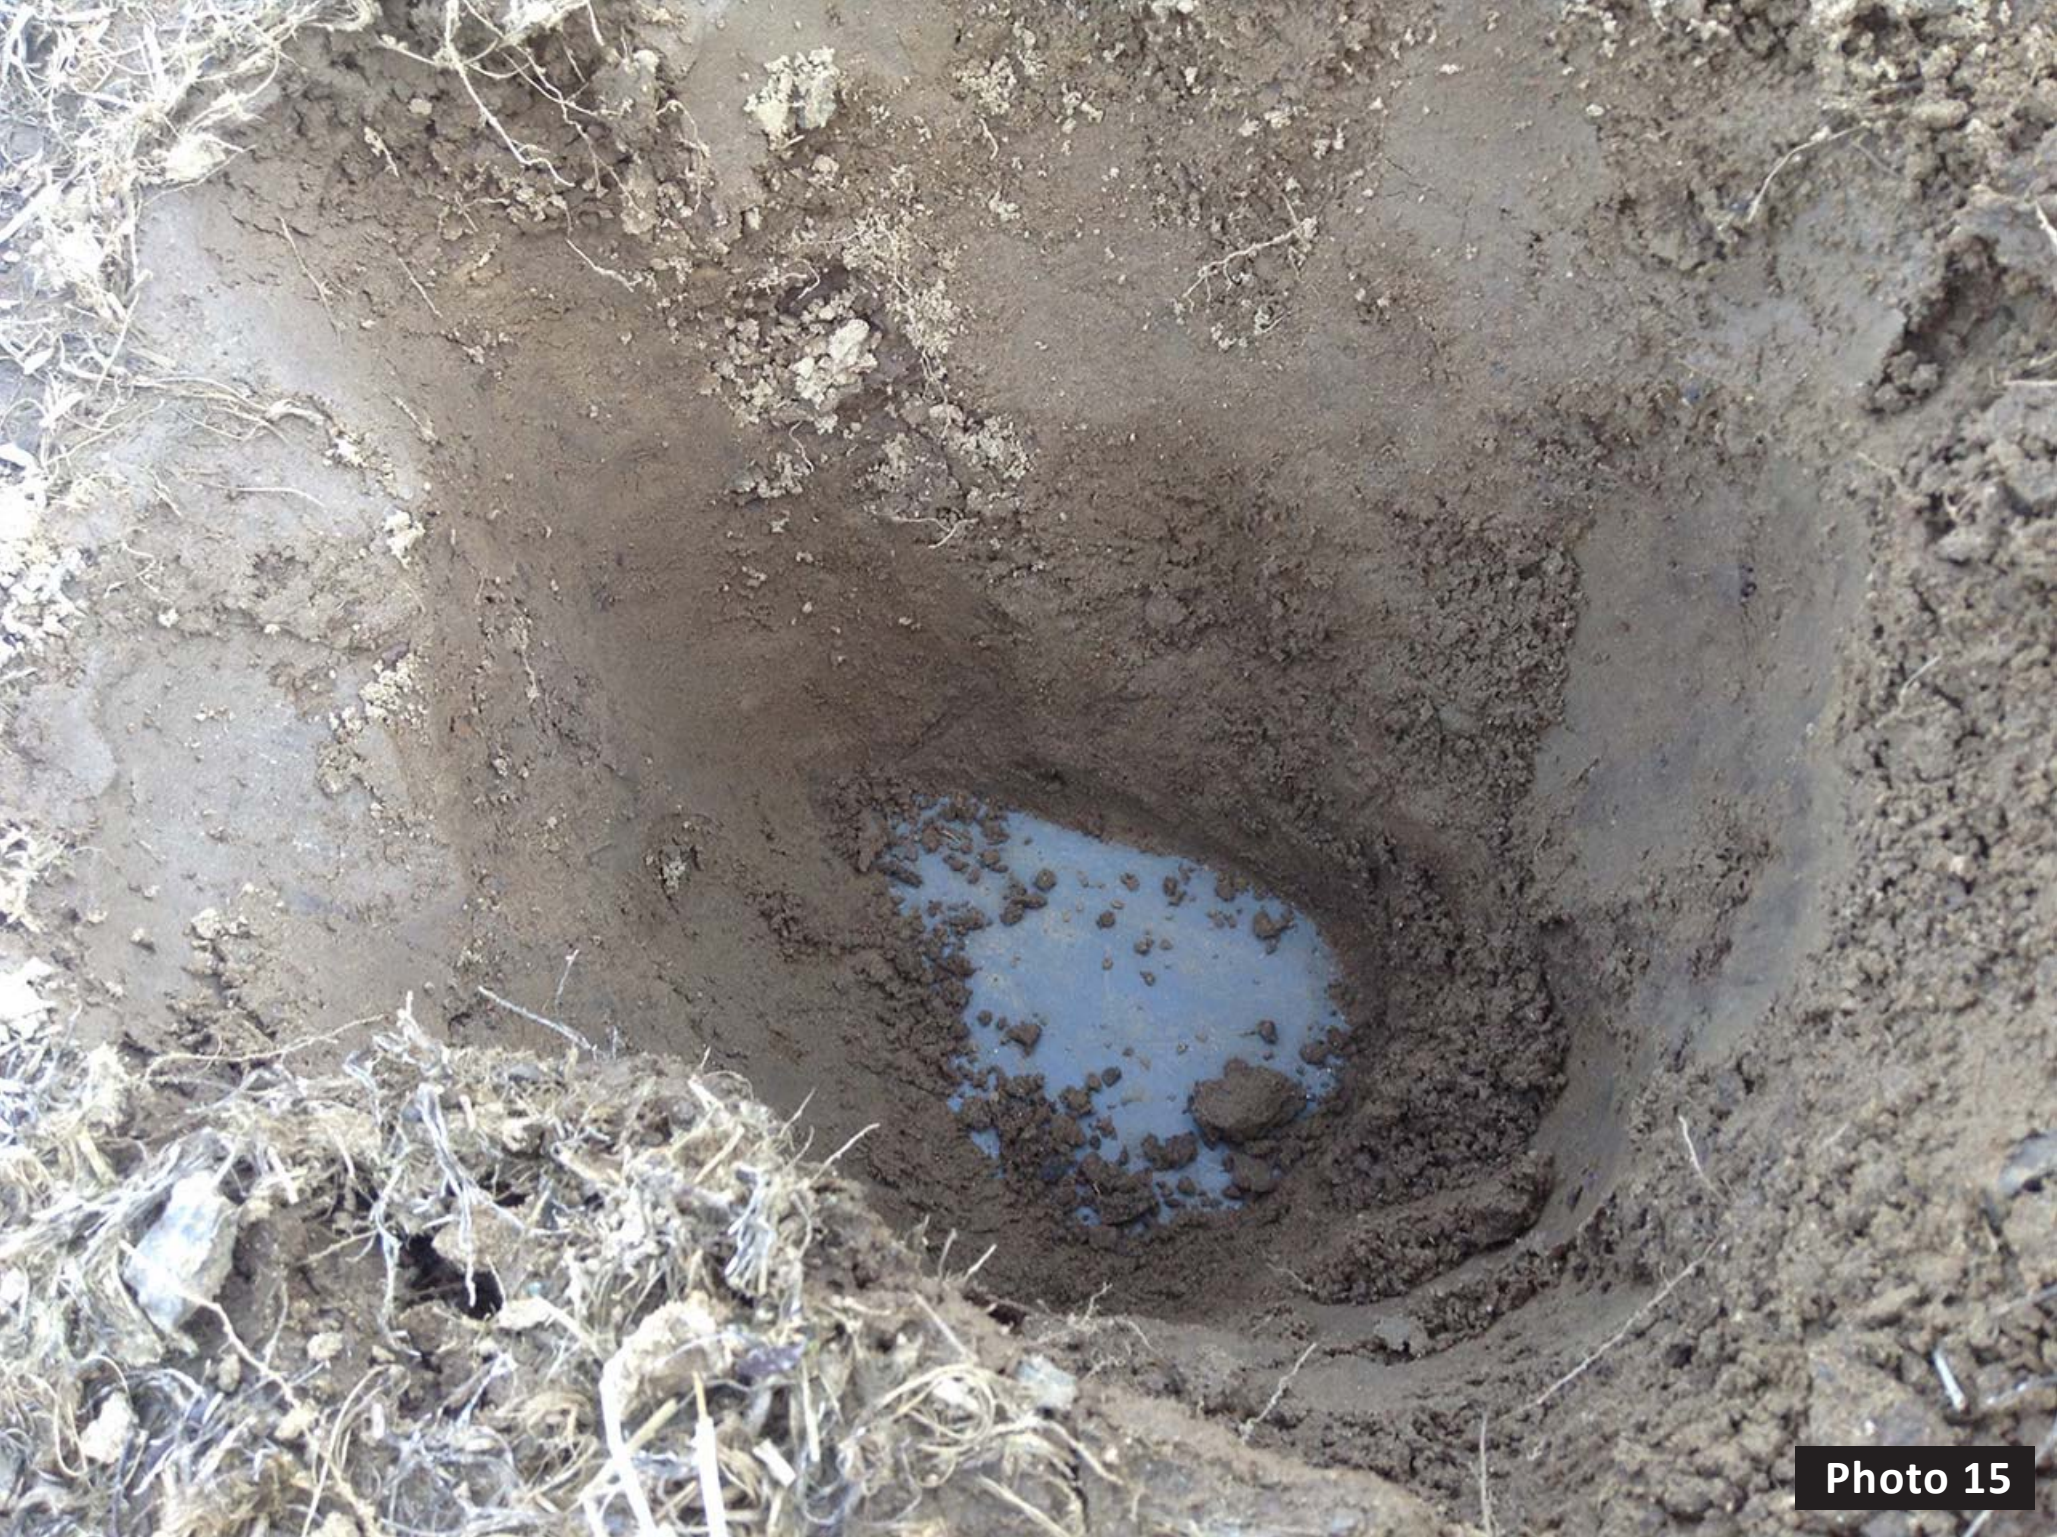
Photo 14

- 2) Sand with silt/clay and gravel, brown, moist (grid points 3, 4, and 9). The sand appeared to be poorly graded, with grain size predominantly fine and very fine. The amount of gravel was minor, except at the surface. See Photos 14 and 15.
