Draft Technical Memorandum

Orofino Asbestos Site

Vegetative Cover Performance Evaluation

April 14, 2014

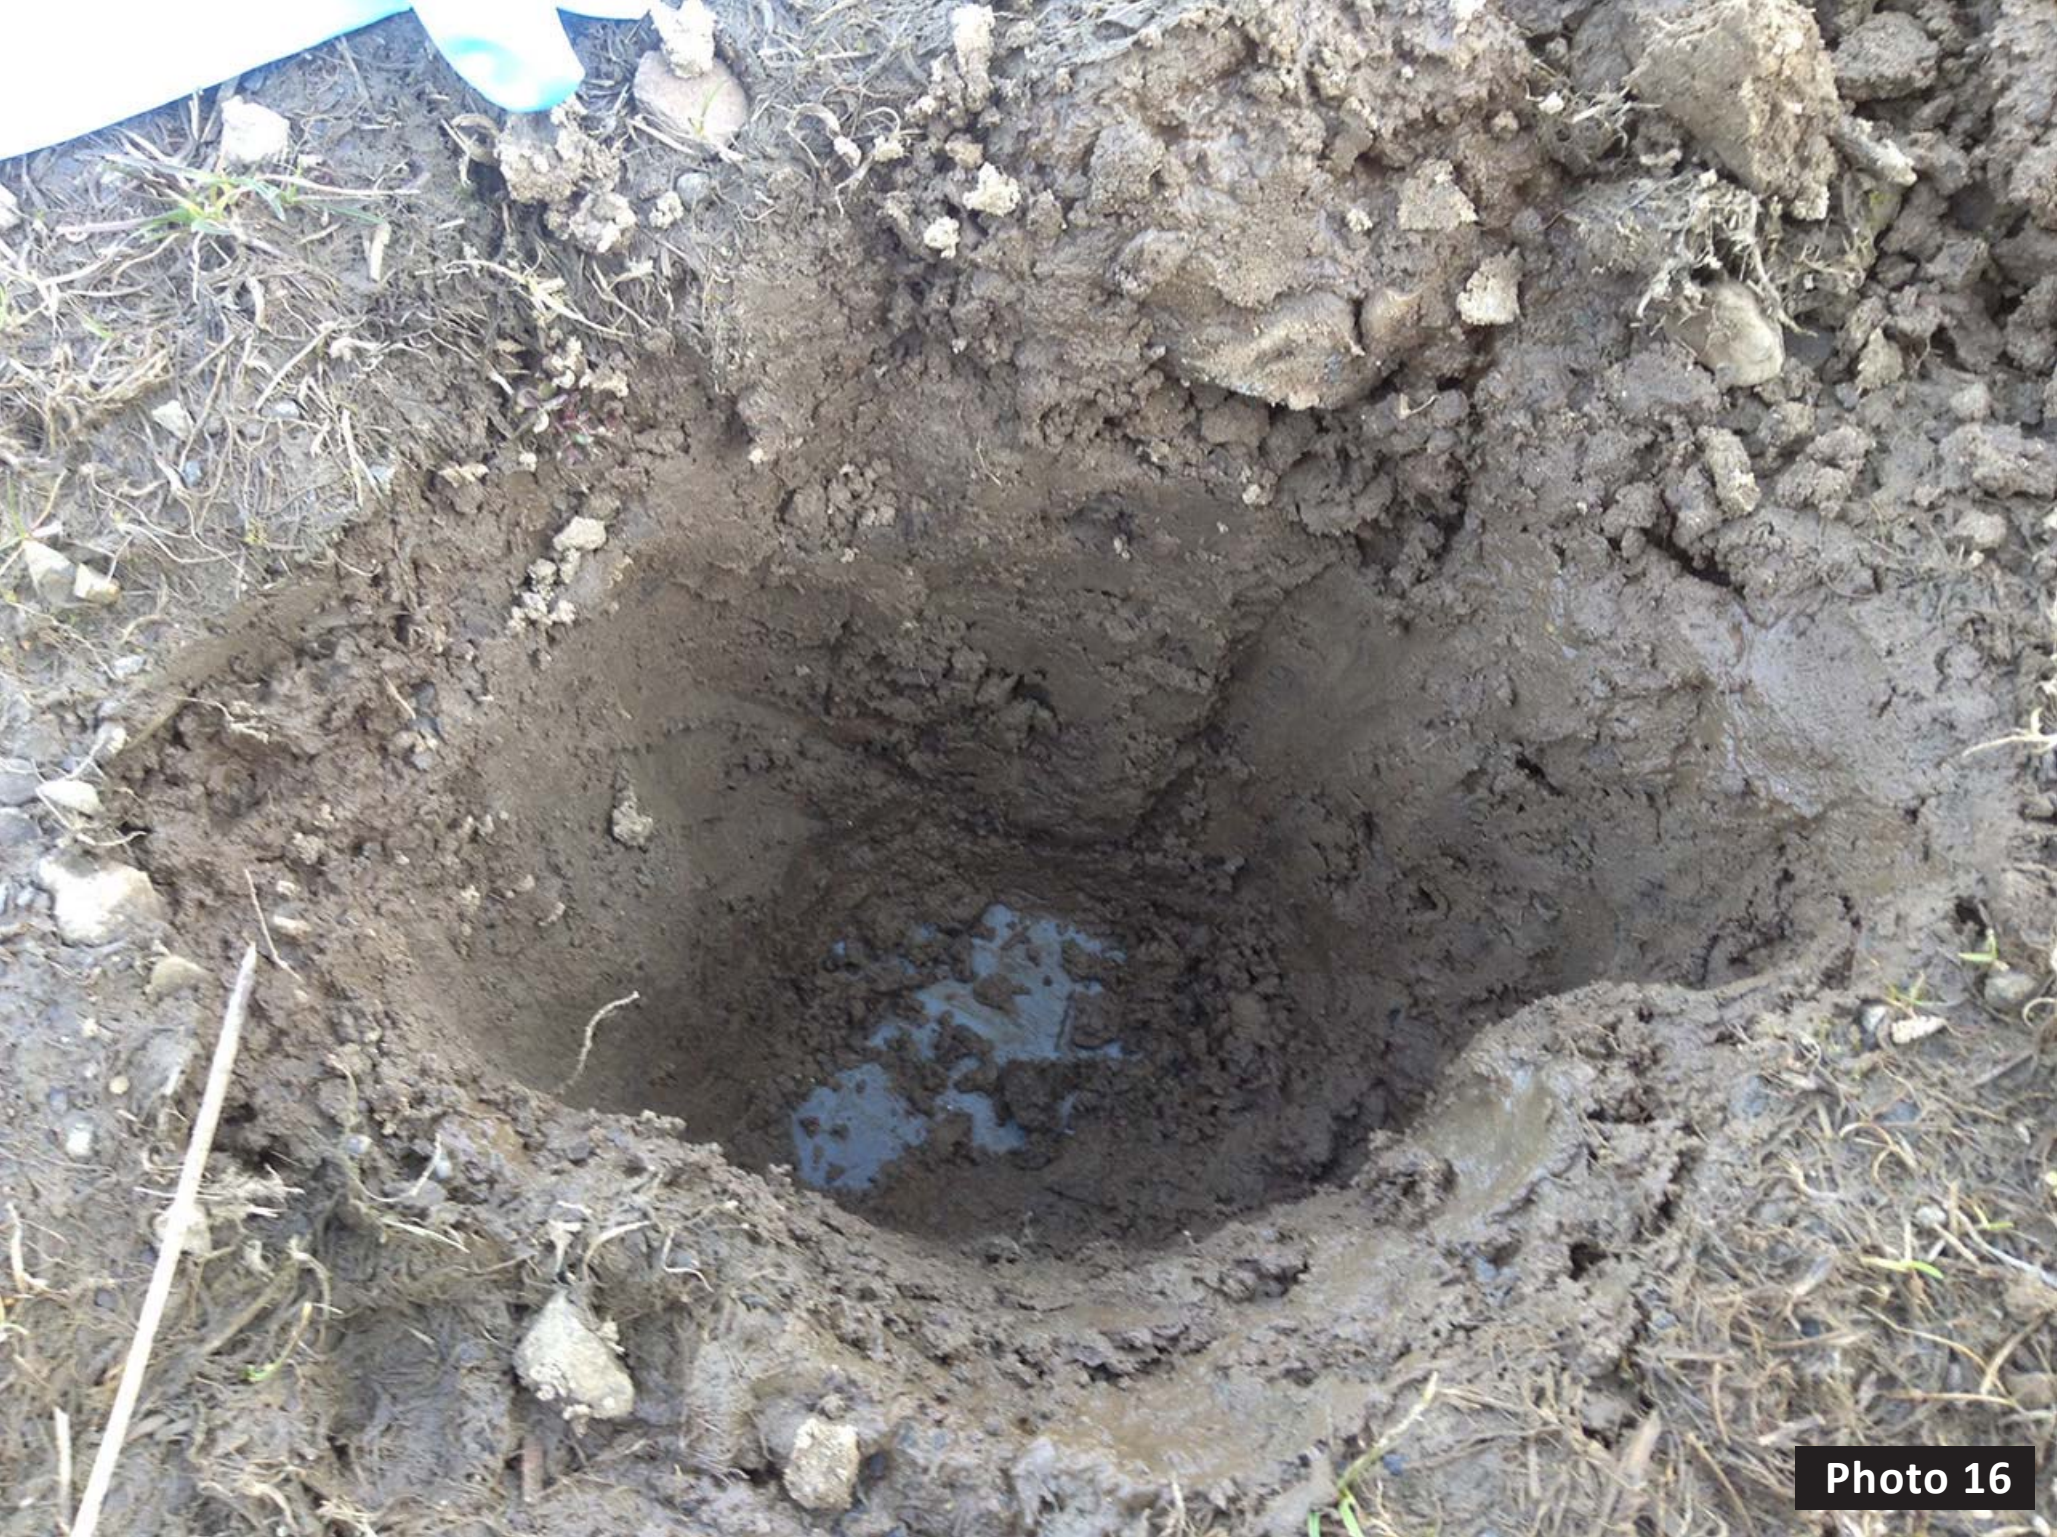
Photo 16

- 3) Silt/clay and sand and gravel, brown, saturated (grid point 2). The soil was saturated at grid point 2 at least in part because it is located in a low area between the dry well and the asphalt parking lot. See Photo 16.
