ARGONAUT MINE TAILINGS STORAGE SITE

EARTH TAILINGS DAM AND  
CONCRETE MULTI-ARCH DAM (ARGONAUT DAM)

GEOTECHNICAL REPORT

U. S. ARMY CORPS OF ENGINEERS  
SACRAMENTO DISTRICT  
FEBRUARY 2015

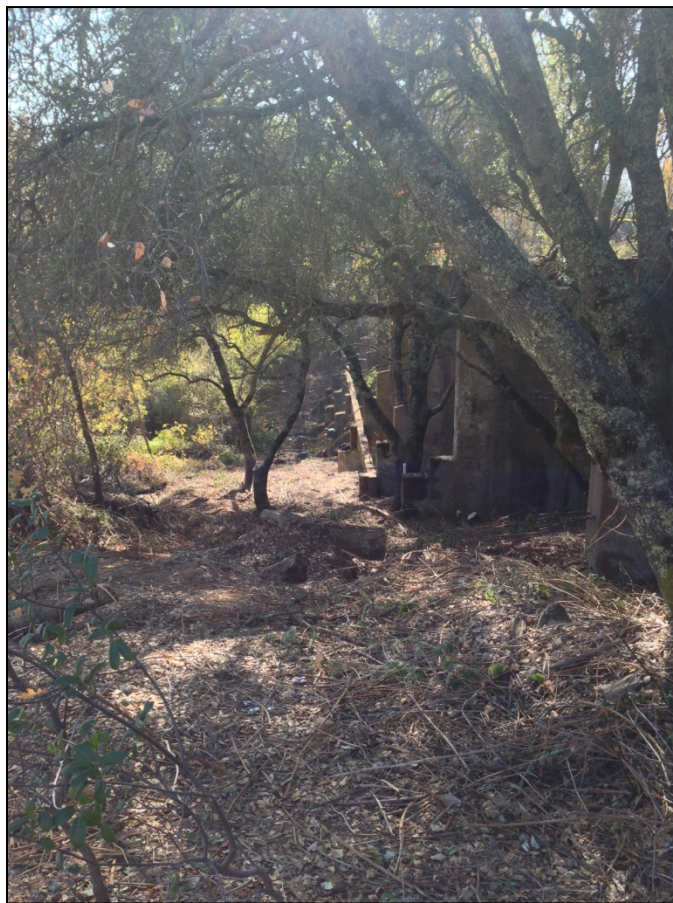
Photo 1-2. Argonaut CMA Tailings Storage Dam - Nov 2013

A more recent photograph of the dam from November 2013 is shown in Photo 1-2. This photo is also taken from the left abutment on the downstream side, and it can be seen how heavy the vegetation growth has become (even after a lot of it was recently cleared).

USACE visual inspections of the CMA dam were first conducted in July 2013, where it was found to be very difficult to inspect the dam due to the overgrowth of tress and other vegetation. The results of the inspections can be found in the USACE references of 2013 (USACE, 23 Jul 2013) (USACE, 30 Jul 2013).

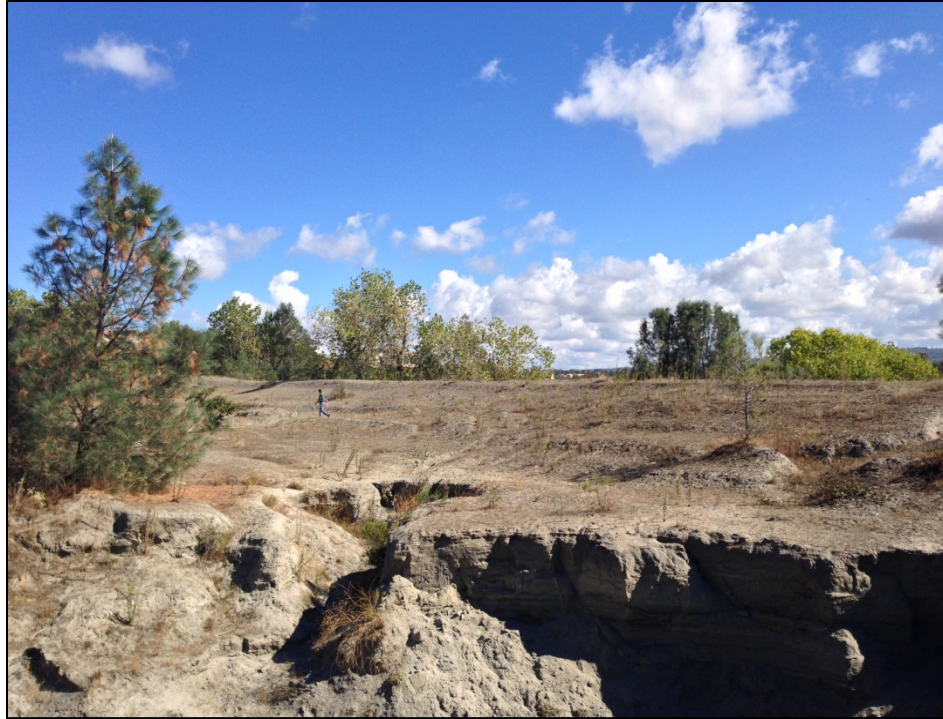
There are some small ponds and sinkholes on the upstream side of the dam that have most likely developed as the result of settlement and erosion over time. If the groundwater levels are high and the tailings are saturated and the dam does fail, some of the tailings could flow down slope to the CMA dam and increase the loads on that structure, or possibly overtop the dam. A view from the upstream side of the dam, looking Northeast, can be seen in Photo 6-1. This photo shows a sinkhole and the erosion scarp and channel that leads to the breach at the right abutment of the dam. A view of the breach at the right abutment of the earth tailings dam is shown in Photo 6.2.

**Photo 6-1. Earth Tailings Dam from Upstream Side - Looking Northeast (25 Sep 2013)**

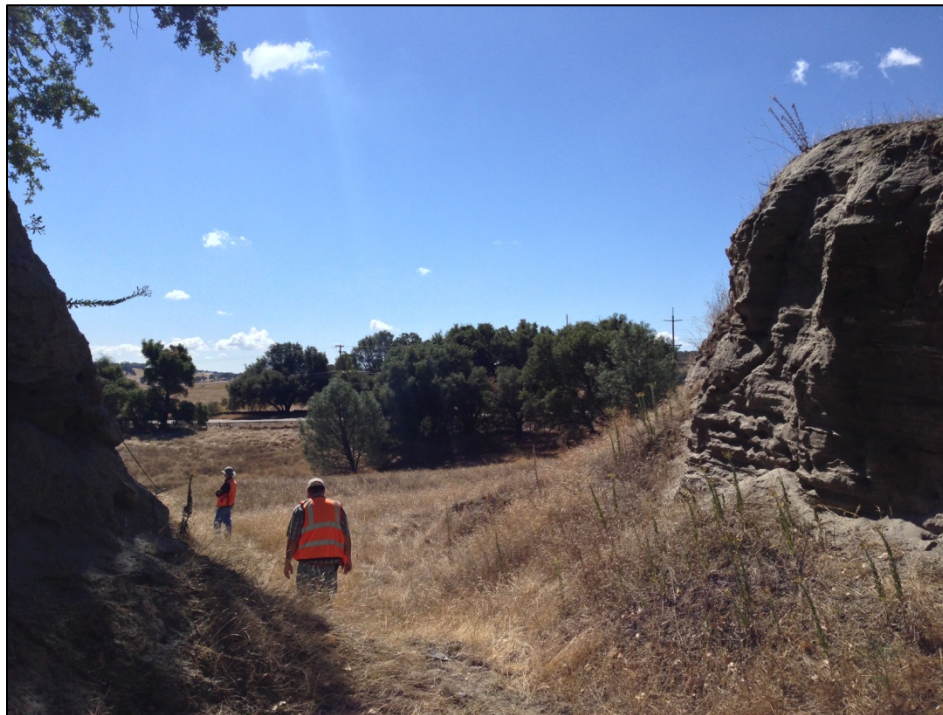
The LETS dam has already been breached on the right side (looking downstream) down to approximate elevation 1415 feet (NAVD88). The cause of the breach is unknown but could have been created to release surface water from the tailings and most likely has further eroded over time. The tailings behind the dam, being highly erodible and subject to internal erosion (piping), could develop significant piping potential through the dam and foundation. However, since the dam is unable to store water and develop large hydraulic gradients across the structure, it is less prone to significant failure and damaging consequences.

**Photo 6-2. Breach at Right Abutment - Looking Downstream or Southeast (25 Sep 13)**

The lower earth tailings storage (LETS) dam was found to be marginally stable with regards to slope stability. The LETS dam has been breached at the right abutment and fortunately does not store water. The materials that comprise the LETS dam were found to be coarser and stronger with regards to shear strength than the tailings behind the dam. There are several small ponds and sinkholes behind the LETS dam, and it would be beneficial to re-grade and drain these towards the right abutment breach to reduce the chance that the stored water in the ponds could cause erosion and possible internal instability of the dam. The ponds and sinkholes could also be backfilled as long as the area is graded so that water drains towards the right abutment breach. These materials will not flow very far if water tables are kept low, and this will reduce the chance that these materials will flow downhill and impact the concrete multi-arch (CMA) dam.

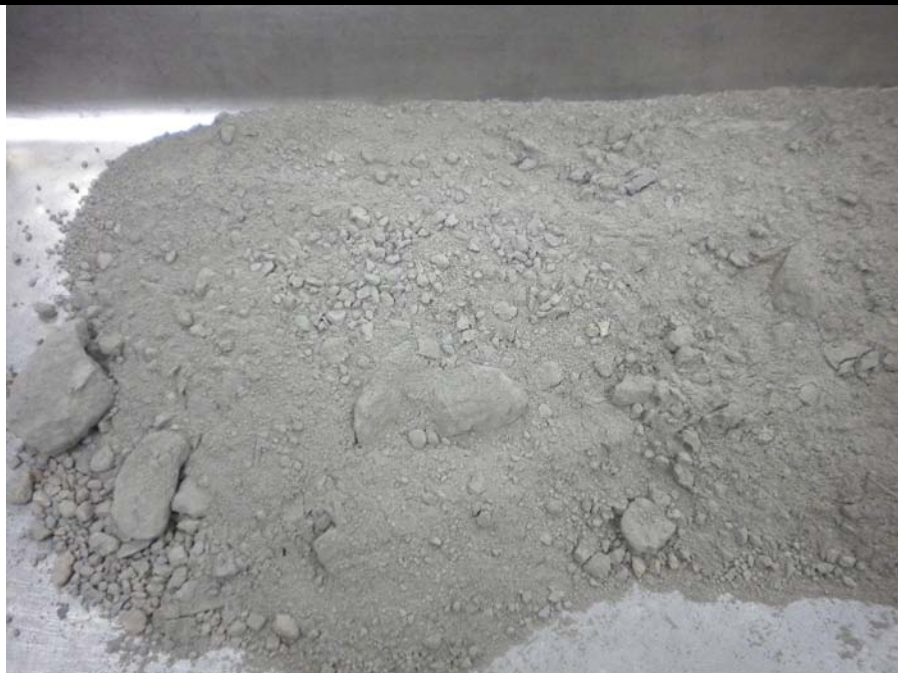
<b>Date</b>	11/14/14			
<b>Location</b>				
<b>Direction</b>				
<b>Comments:</b> 2f-1-39-ST Fine Silt with Gravel				
<b>Photograph ID</b>	2

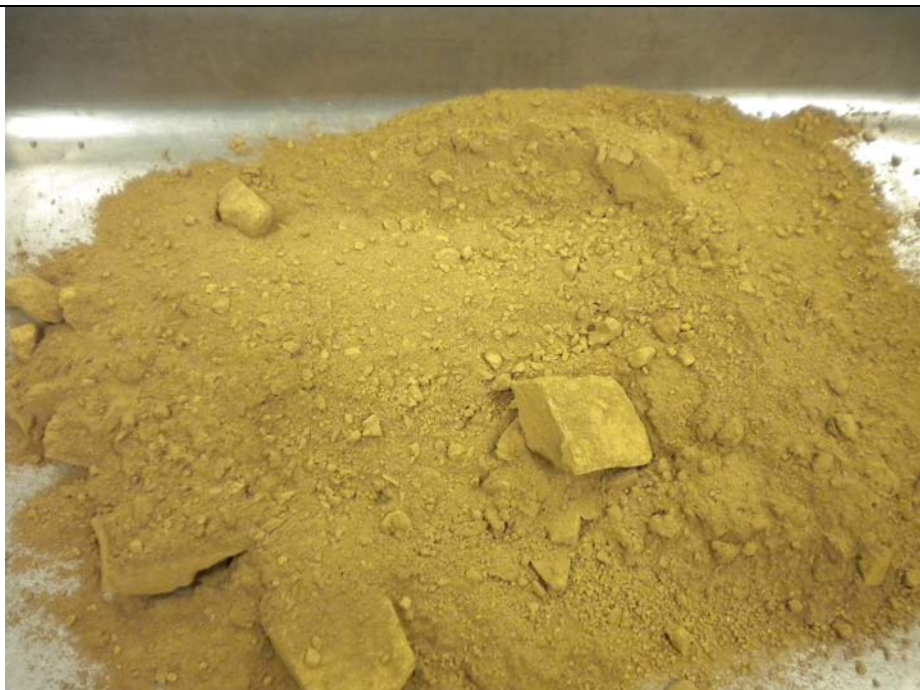
<b>Date</b>	11/14/14			
<b>Location</b>				
<b>Direction</b>				
<b>Comments:</b> <del>2f-1-57.5-ST</del> Brown silt with Gravel  2F-14-03 at 57.5 Depth

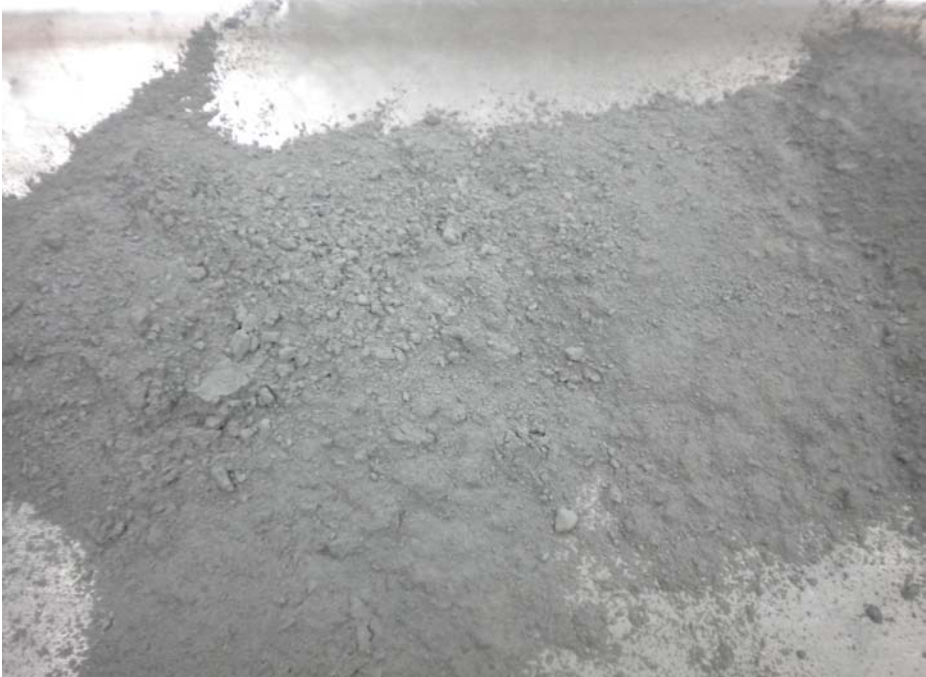
<b>Date</b>	11/14/14			
<b>Location</b>				
<b>Direction</b>				
<b>Comments:</b> <del>2F-1-58-ST</del> Black Fine Silt  2F-14-04 at 58' Depth				
<b>Photograph ID</b>	4			
<b>Date</b>				
<b>Location</b>				
<b>Direction</b>				
<b>Comments:</b>
