**Subject: Final Removal Assessment Report
Wrigley Charcoal
Lyles, Hickman County, Tennessee
Contract Number (No.) EP-S4-14-03
TDD No. TT-02-004**

EXECUTIVE SUMMARY

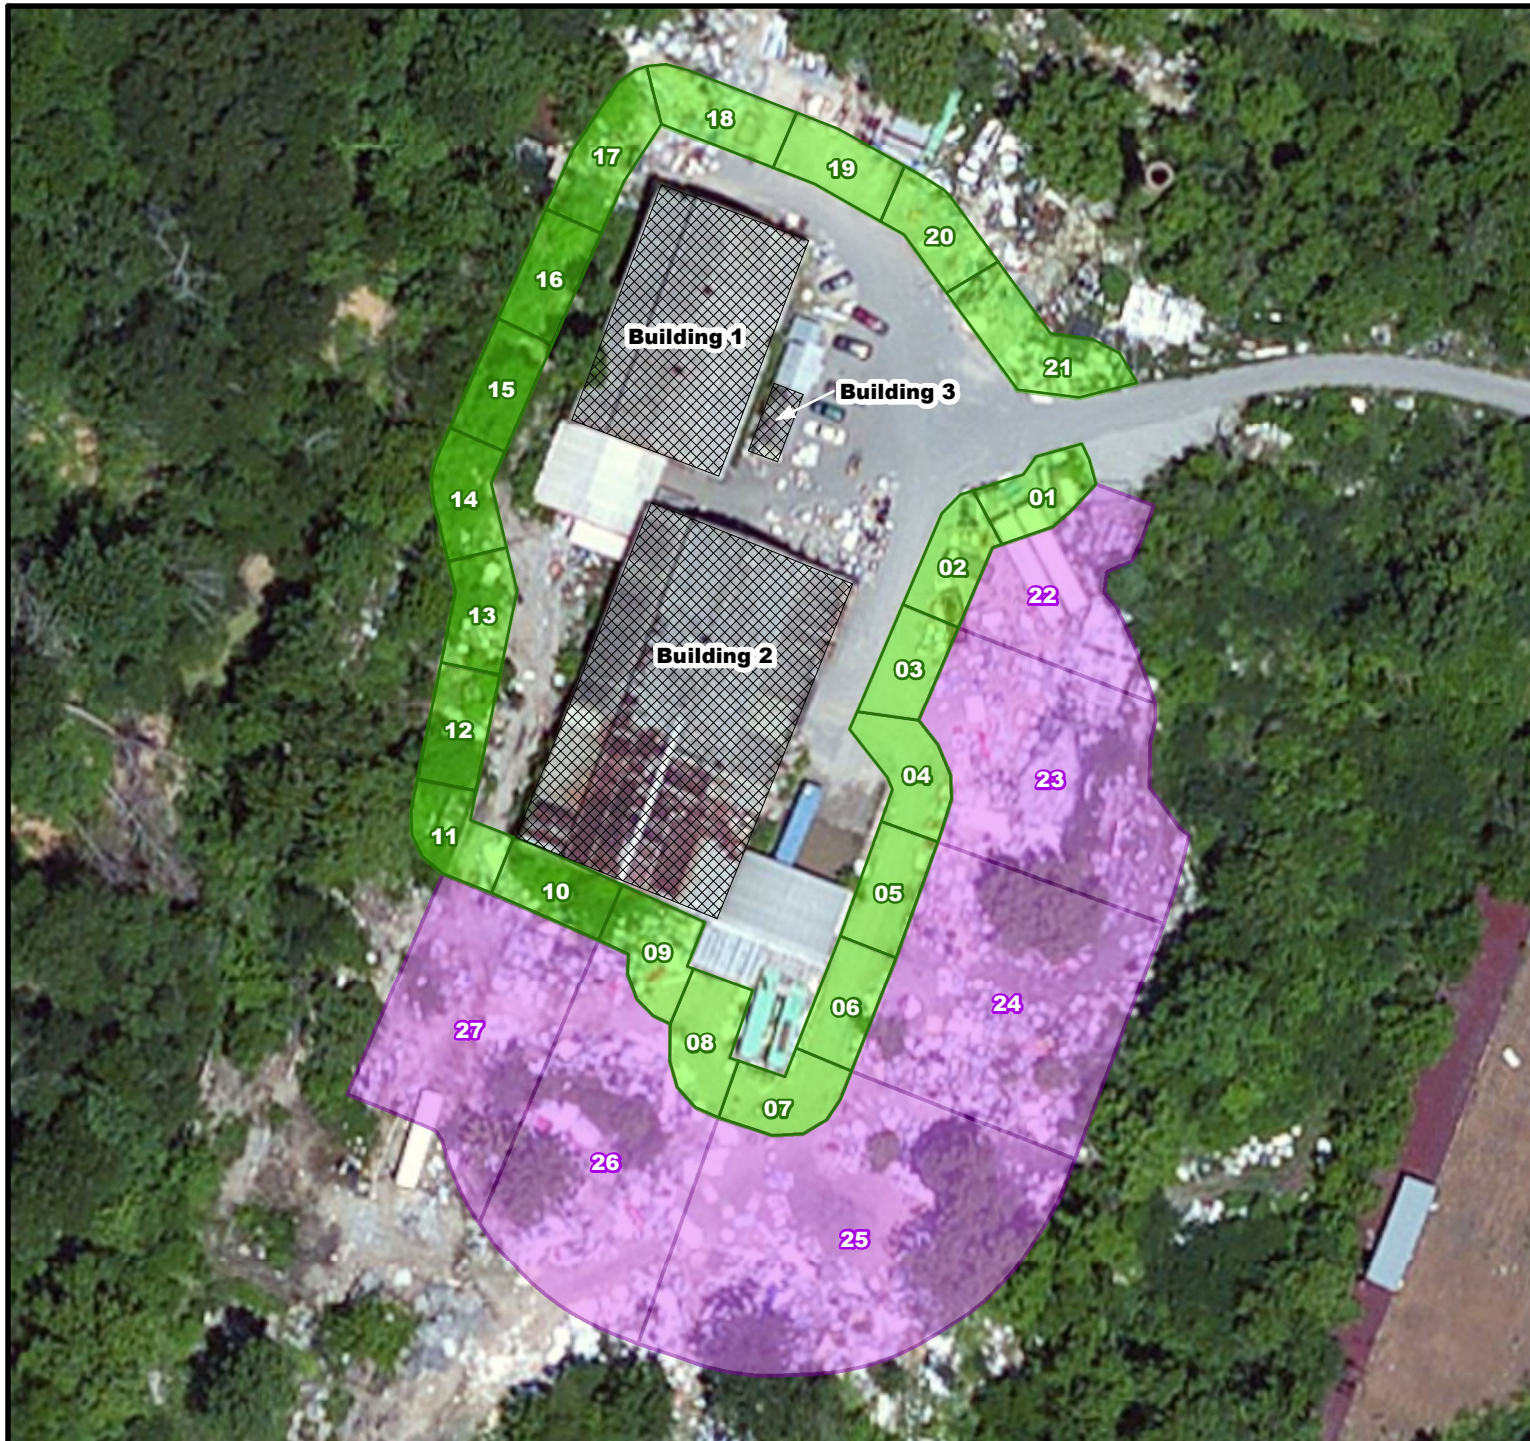
FIGURE 2

Site Layout with
Sampling Areas

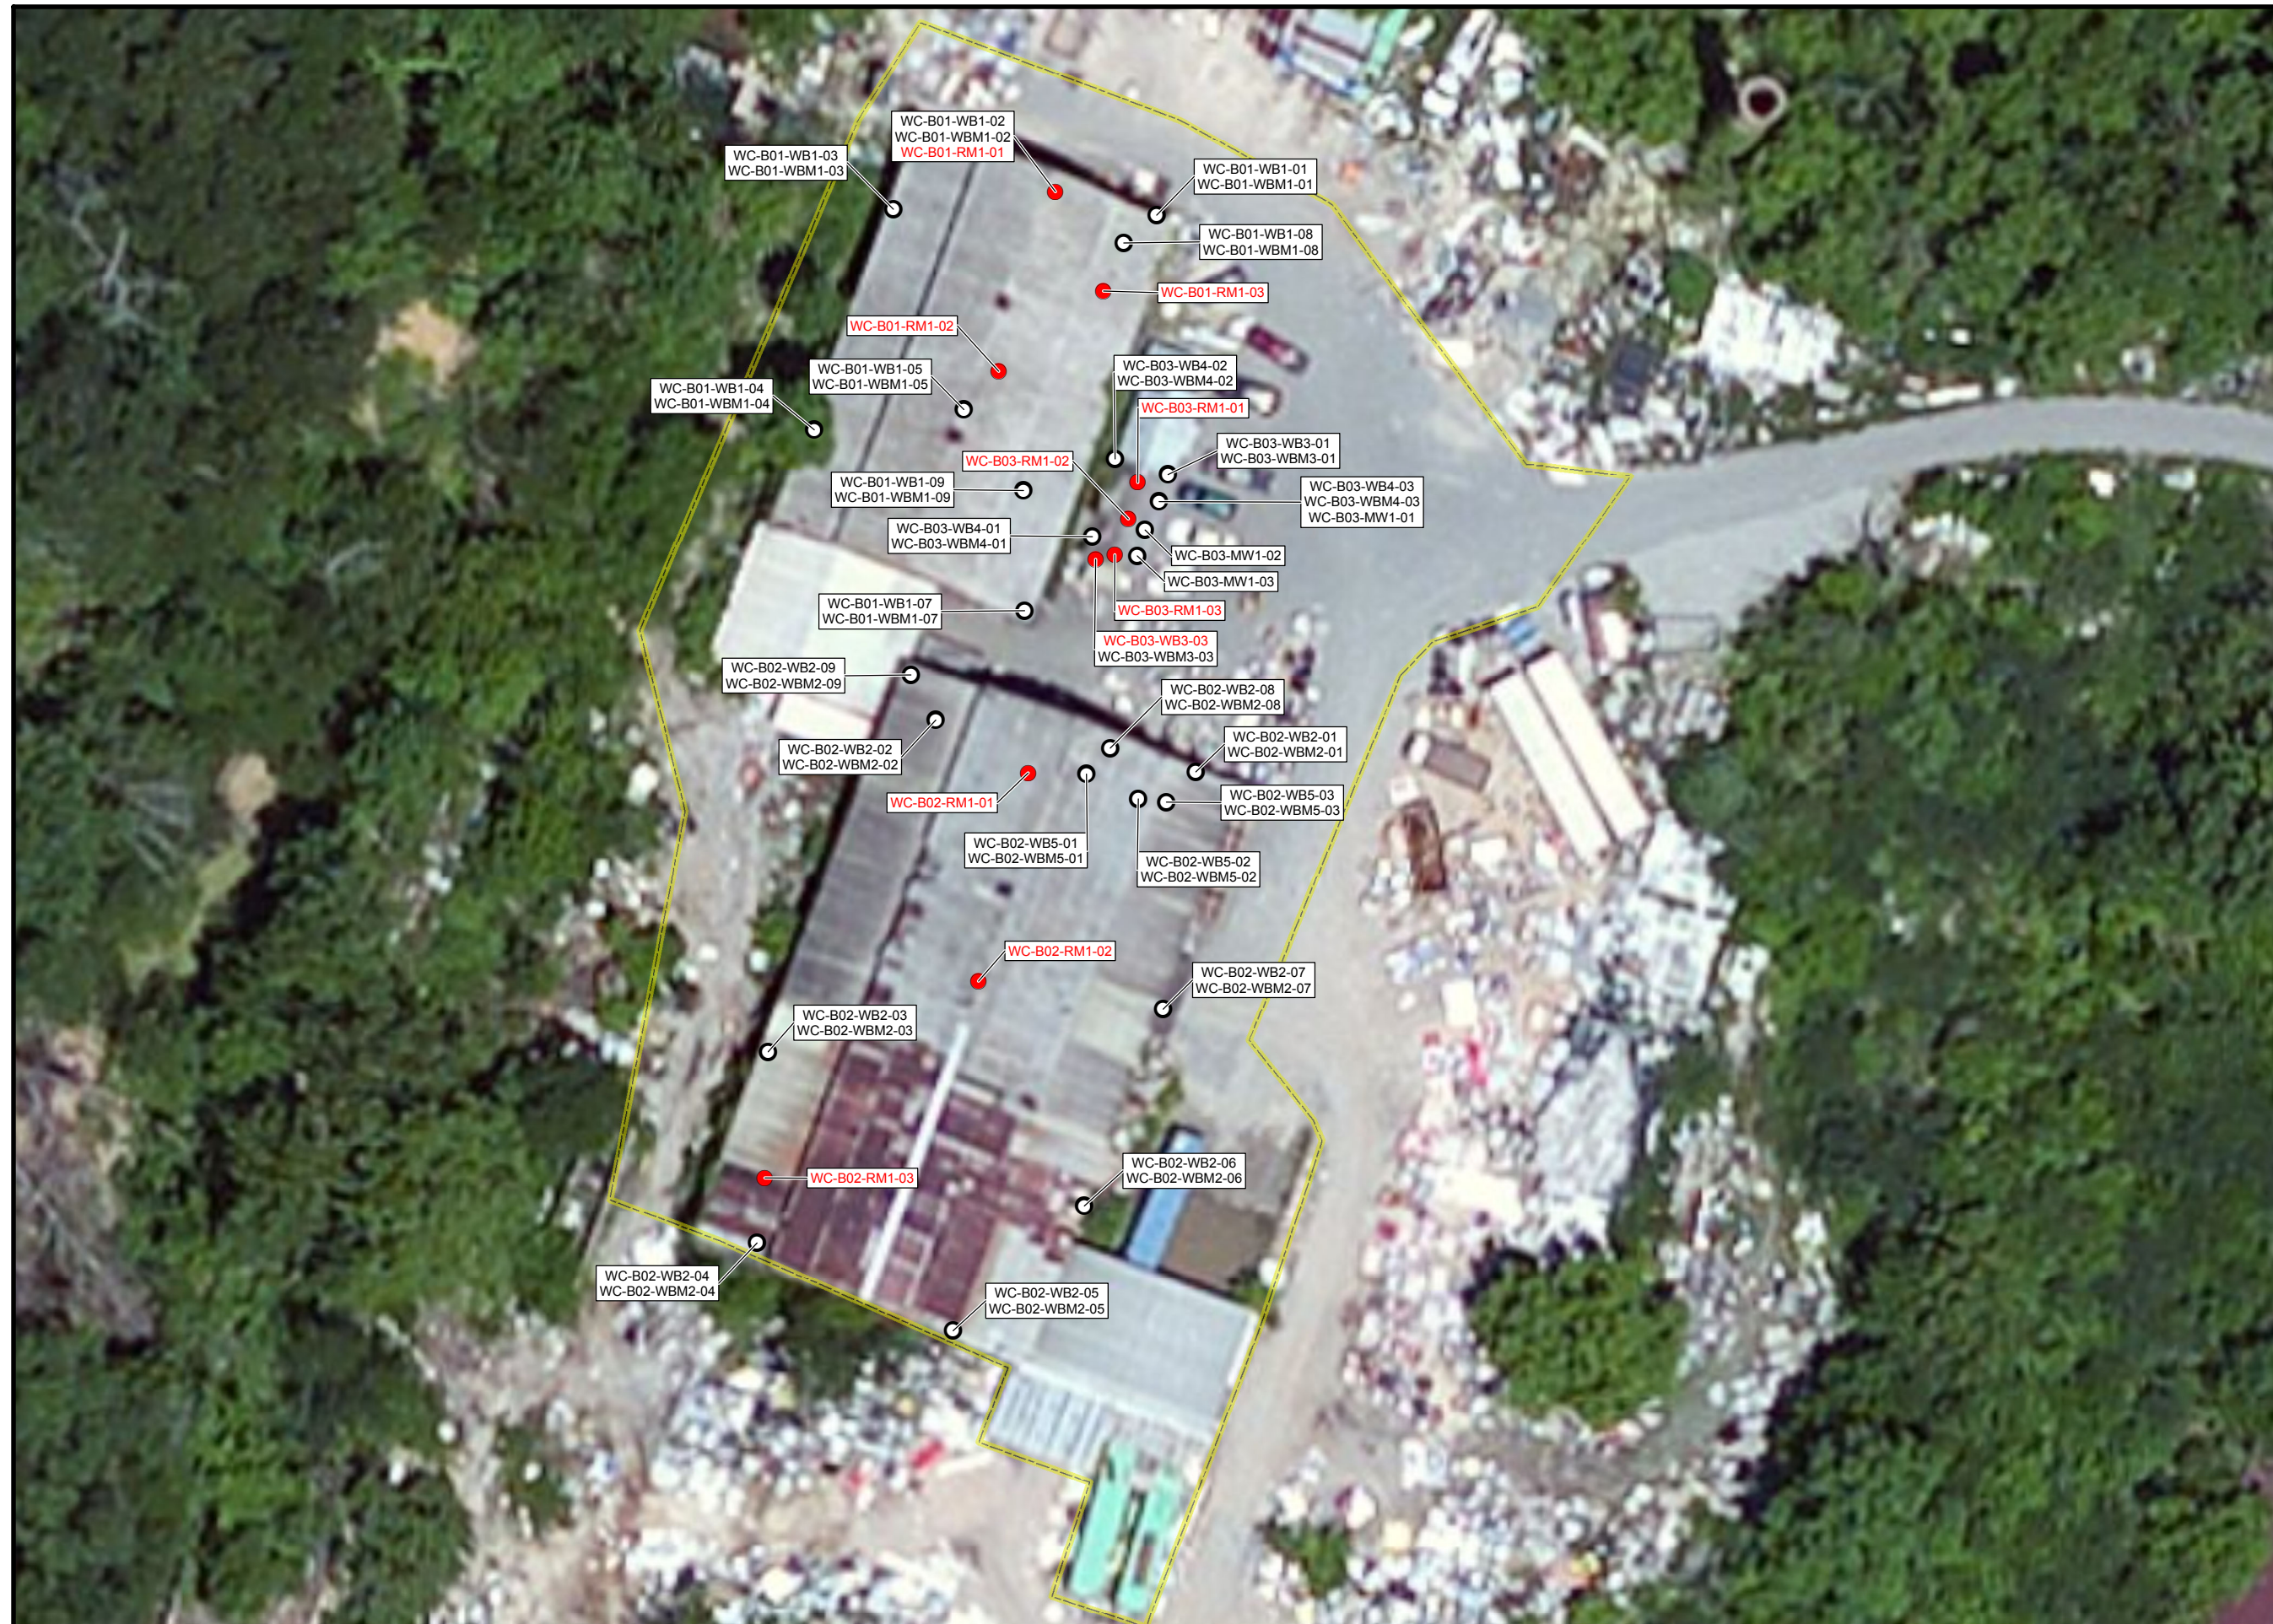
FIGURE 3
 Asbestos Bulk Sampling Locations and Results

For a specific list of analytical results for bulk samples collected from each building, see Table 1 in Enclosure 2. Sample locations are identified on Figure 3 in Enclosure 1. Photographic documentation of the materials sampled are located in Enclosure 3.

A total of 66 bulk samples were collected from the identified suspect ACM. The results of the bulk sampling and analysis indicated that 10 samples contained asbestos concentrations greater than one percent and could be categorized as ACM. The materials in the table below are classified as ACM.

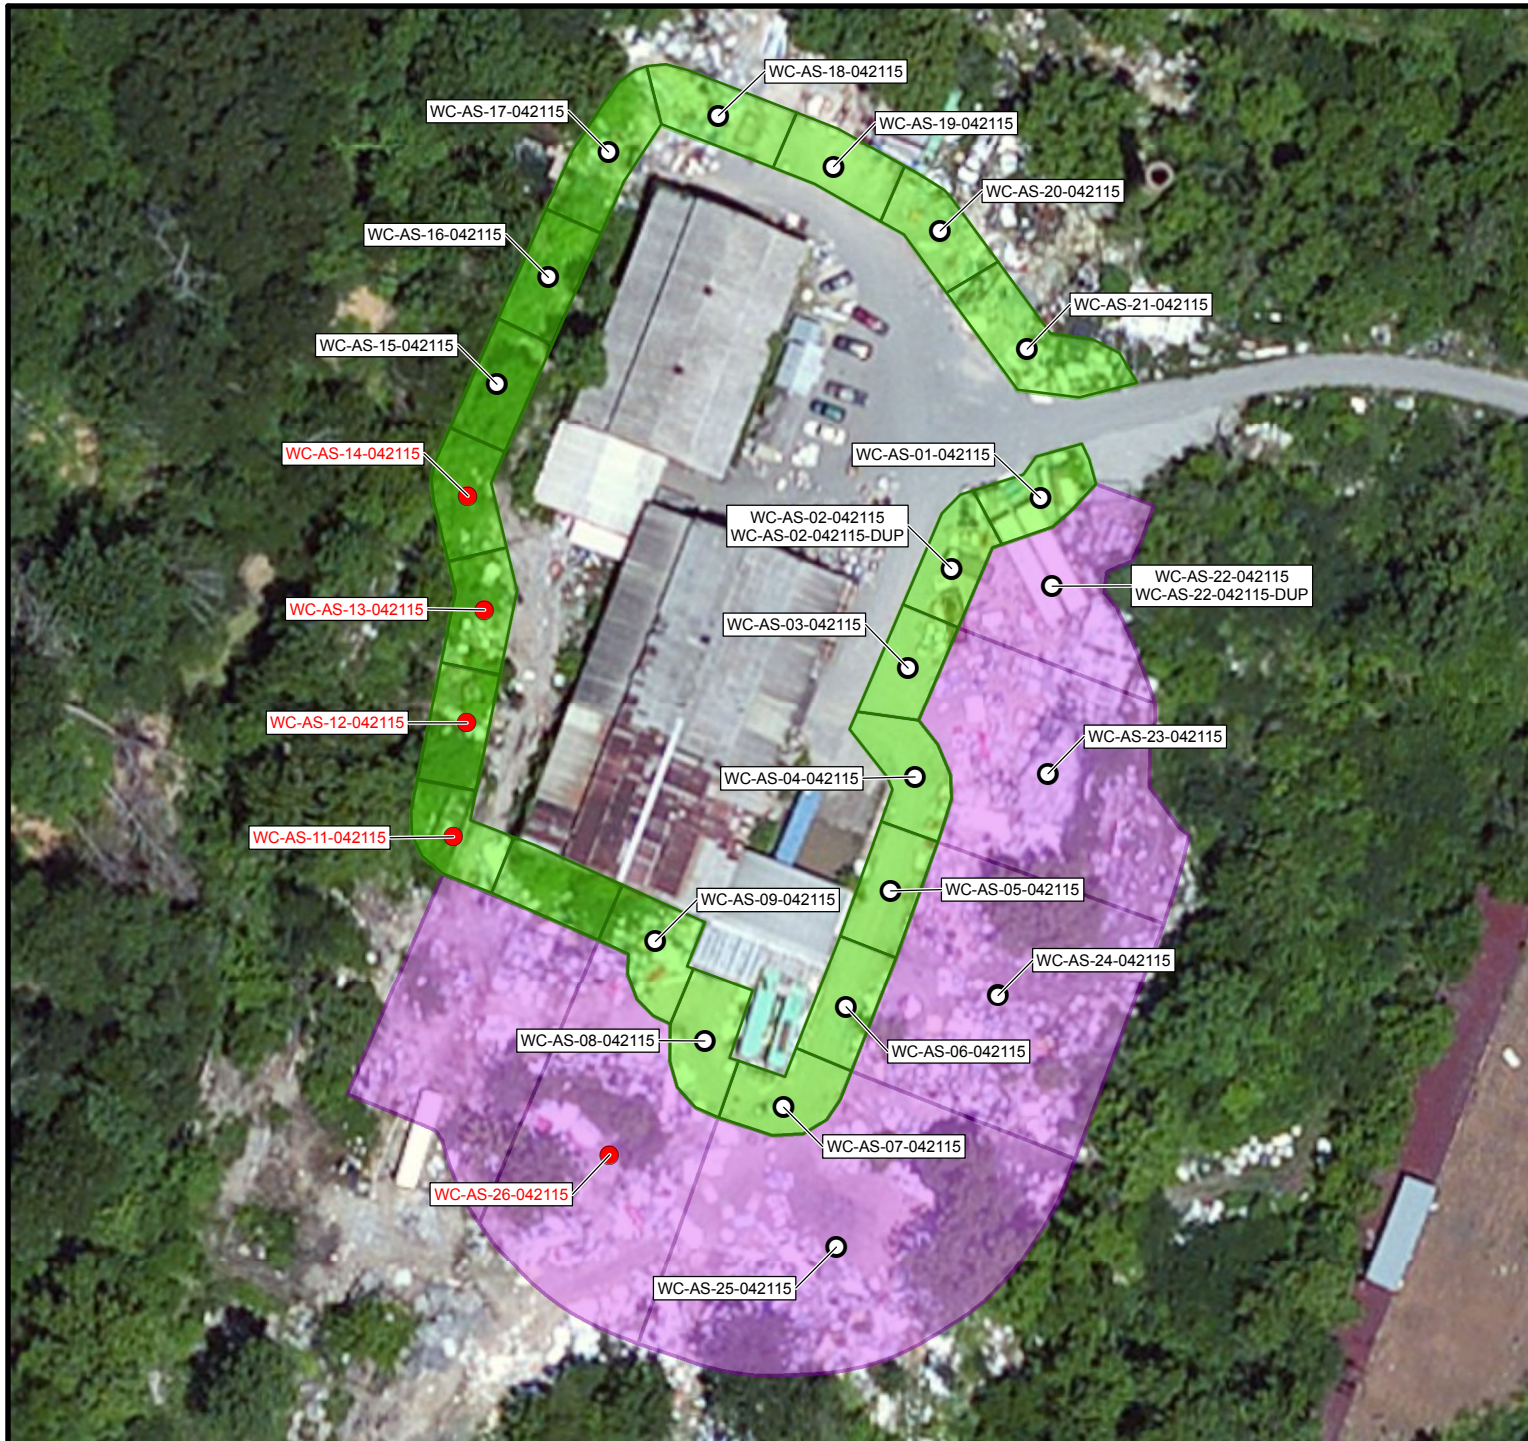
Asbestos Soil Sampling Locations and Results

- Area 11 – Sample WC-AS-11-042115 had an asbestos concentration of 0.30 percent.
- Area 12 – Sample WC-AS-12-042115 had an asbestos concentration of 0.60 percent.
- Area 13 – Sample WC-AS-13-042115 had an asbestos concentration of 0.50 percent.
- Area 14 – Sample WC-AS-14-042115 had an asbestos concentration of 0.40 percent.
- Area 26 – Sample WC-AS-26-042115 had an asbestos concentration of 0.30 percent.

For a specific list of analytical results for the soil samples collected around the designated removal area, see Table 2 in Enclosure 2. Sample locations are identified on Figure 4 in Enclosure 1.

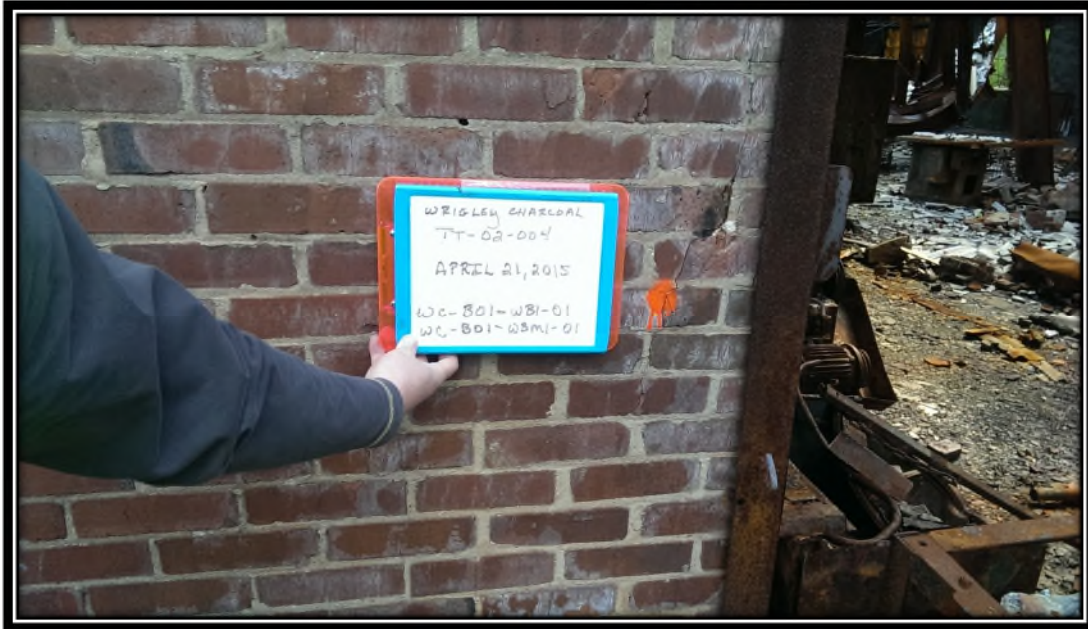
OFFICIAL PHOTOGRAPH NO. 2
U.S. ENVIRONMENTAL PROTECTION AGENCY

Subject: The red brick wall and associated mortar sampled from Building 1. Sampling results indicated there was no asbestos detected from either building material.

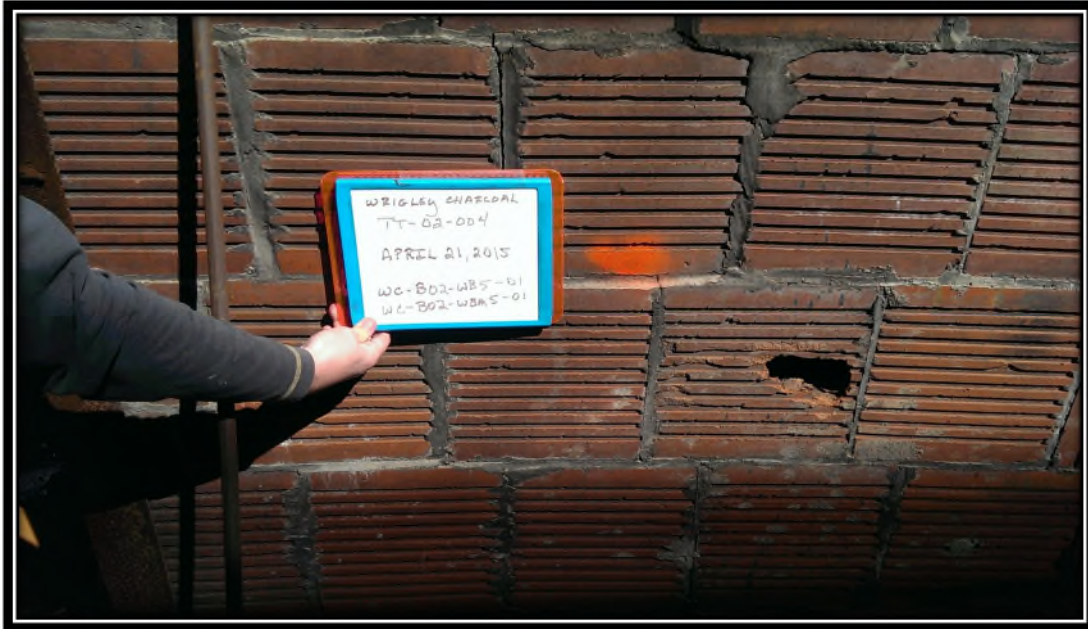
OFFICIAL PHOTOGRAPH NO. 5
U.S. ENVIRONMENTAL PROTECTION AGENCY

Subject: The red rectangular brick wall and associated mortar sampled from Building 2. Sampling results indicated there was no asbestos detected from either building material.

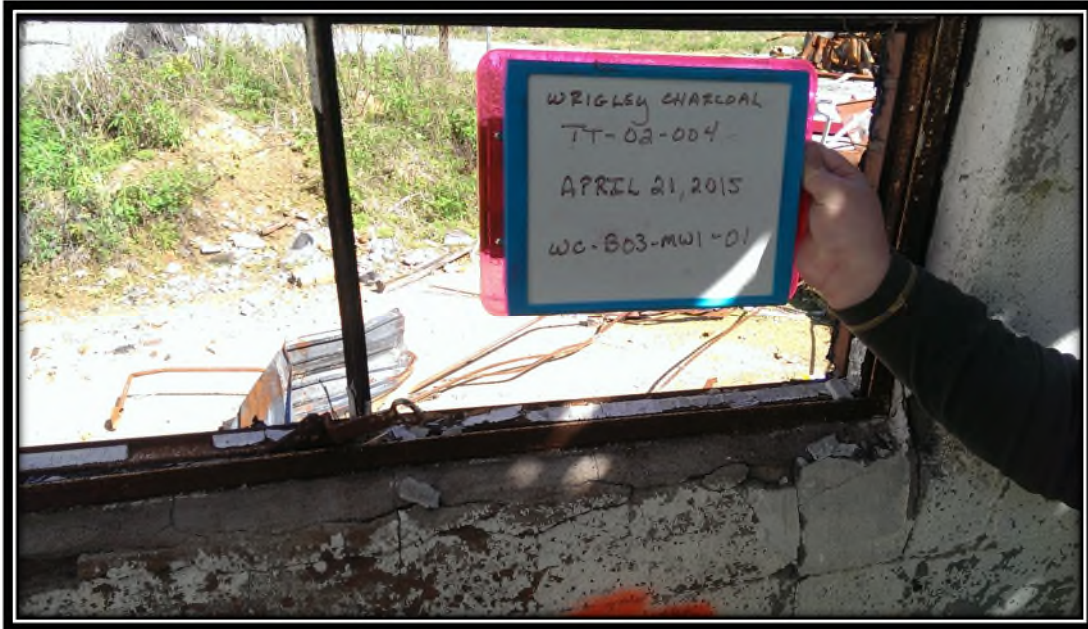
OFFICIAL PHOTOGRAPH NO. 6
U.S. ENVIRONMENTAL PROTECTION AGENCY

Subject: The window glazing sampled from Building 3. Sampling results indicated there was no asbestos detected.

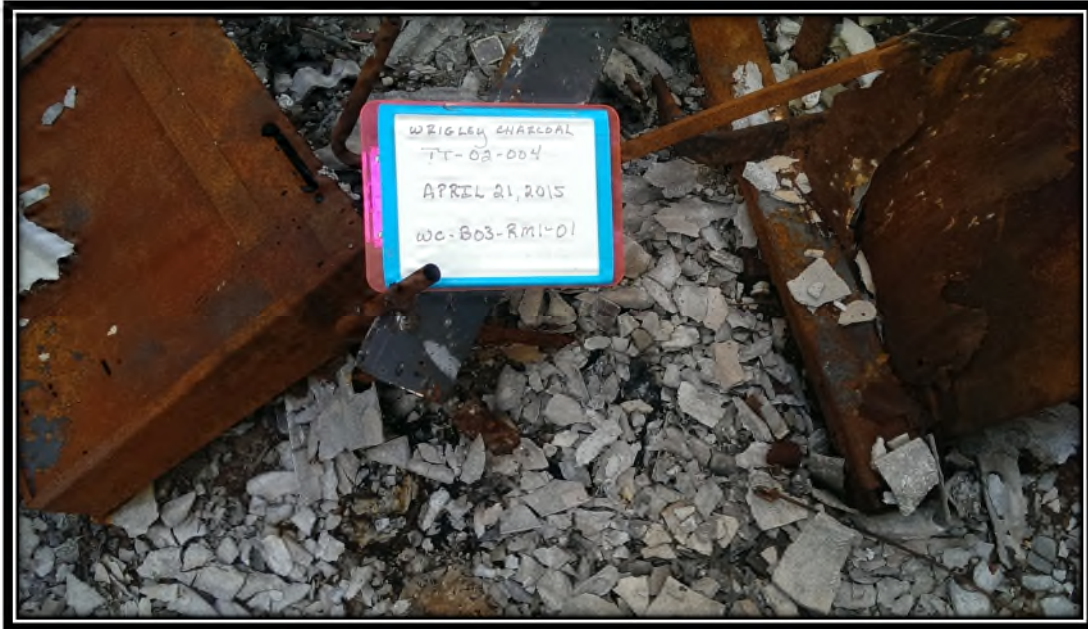
OFFICIAL PHOTOGRAPH NO. 7
U.S. ENVIRONMENTAL PROTECTION AGENCY

During previous emergency response activities, the cementitious roof material was extensively damaged in each building and in some cases been rendered friable classifying the material as regulated asbestos-

Subject: The cementitious roof material sampled from Building 3. Sampling results indicated chrysotile asbestos concentrations ranged from 10 to 15 percent.

These materials usually become RACM and removal is required by a state of Tennessee licensed asbestos abatement contractor before renovation or demolition affect the materials and disposal must be managed as ACM.

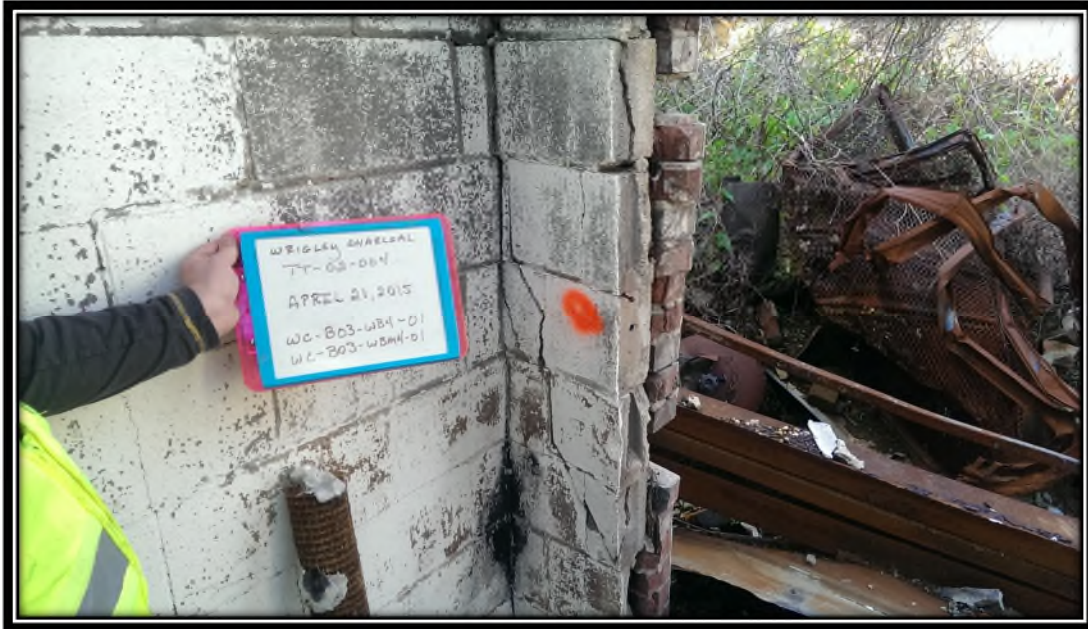
OFFICIAL PHOTOGRAPH NO. 9
U.S. ENVIRONMENTAL PROTECTION AGENCY

Subject: The concrete brick wall and associated mortar sampled from Building 3. Sampling results indicated there was no asbestos detected from either building material.
