SITE INSPECTION ANALYTICAL RESULTS REPORT

BULLY BOY MILL

Piute County, Utah

UT0009114384

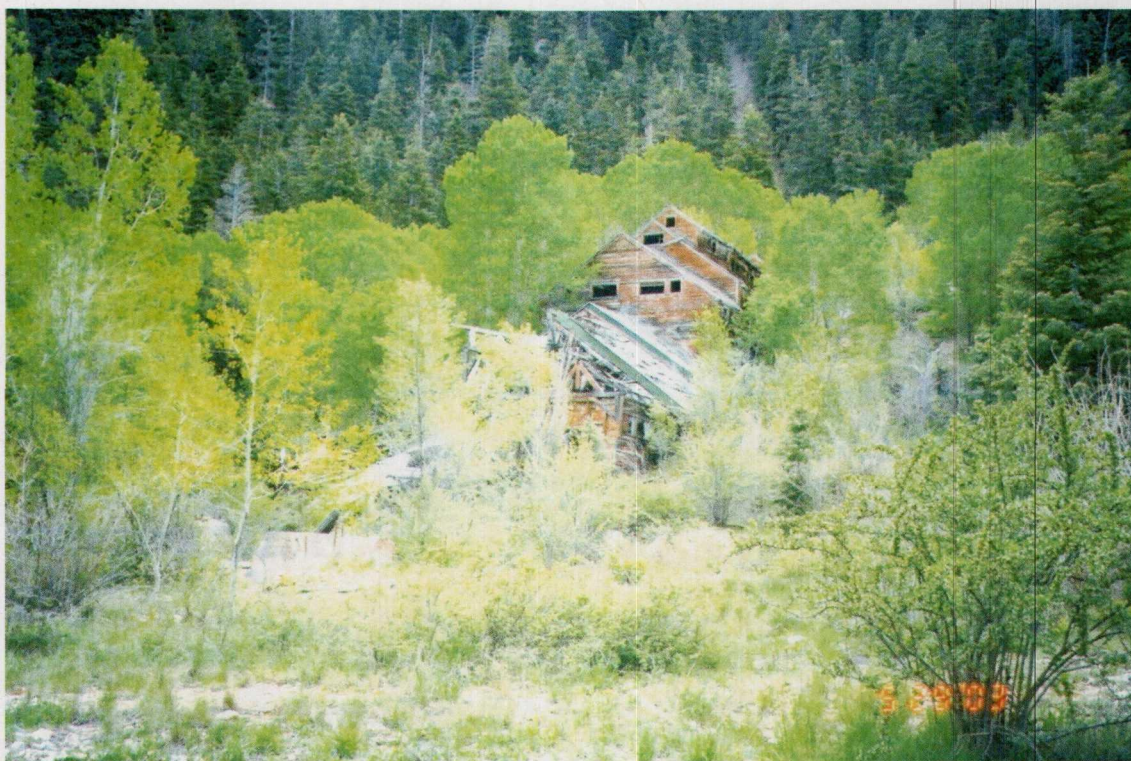
Location: Bully Boy Mill
The Bully Boy Mill.

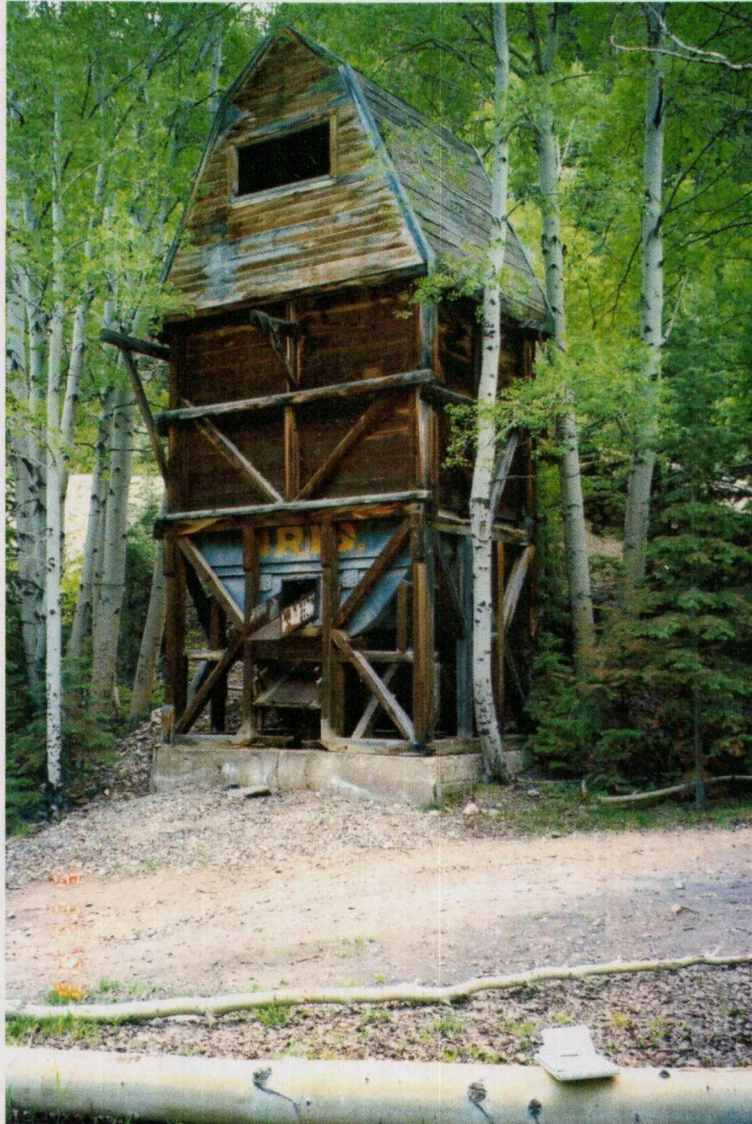
Location: Bully Boy Mill View: South
The Iris Ore Chute near the Bully Boy Mill..

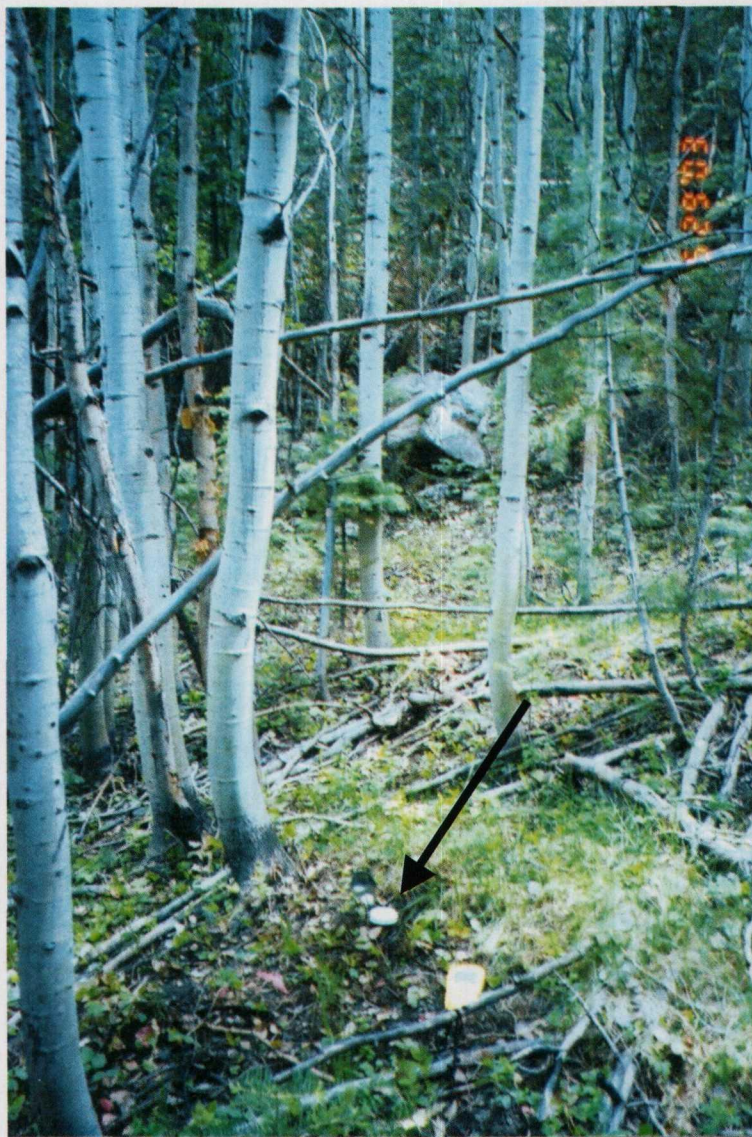
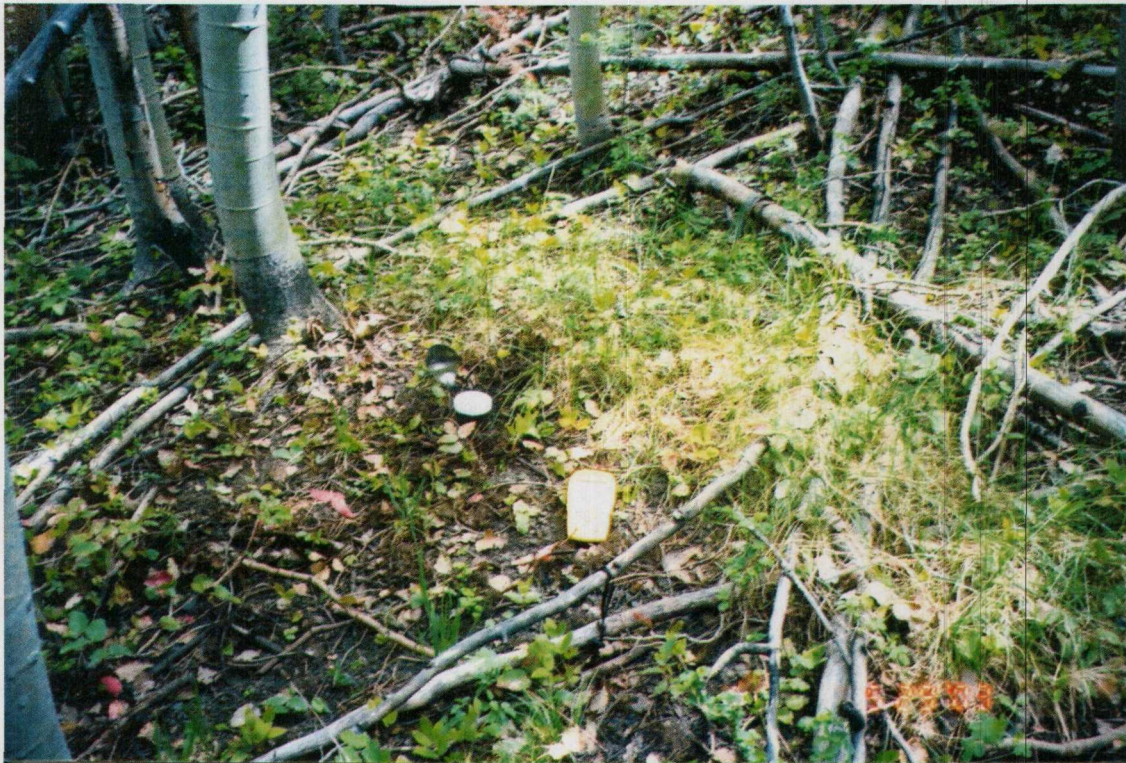
Location: Bully Boy Mill View: South Date: 5/29/2003
Location of Sample BB-SF-09.

Location: Bully Boy Mill
Sample BB-SF-09.

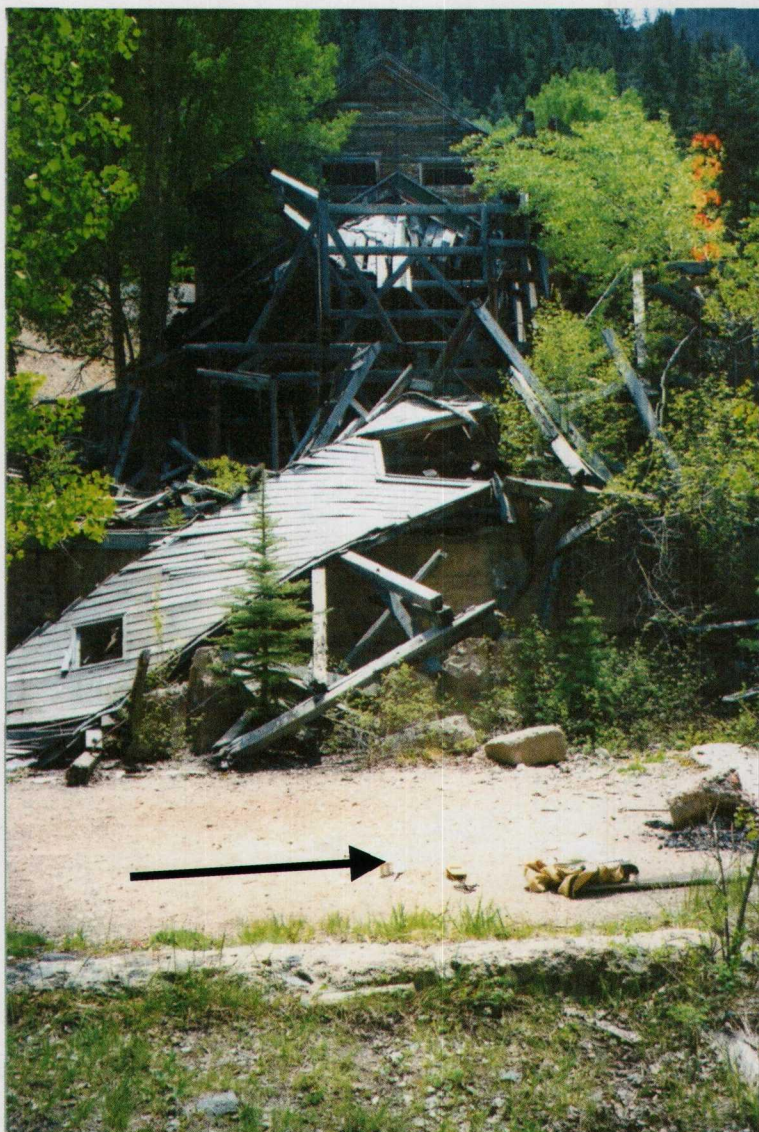
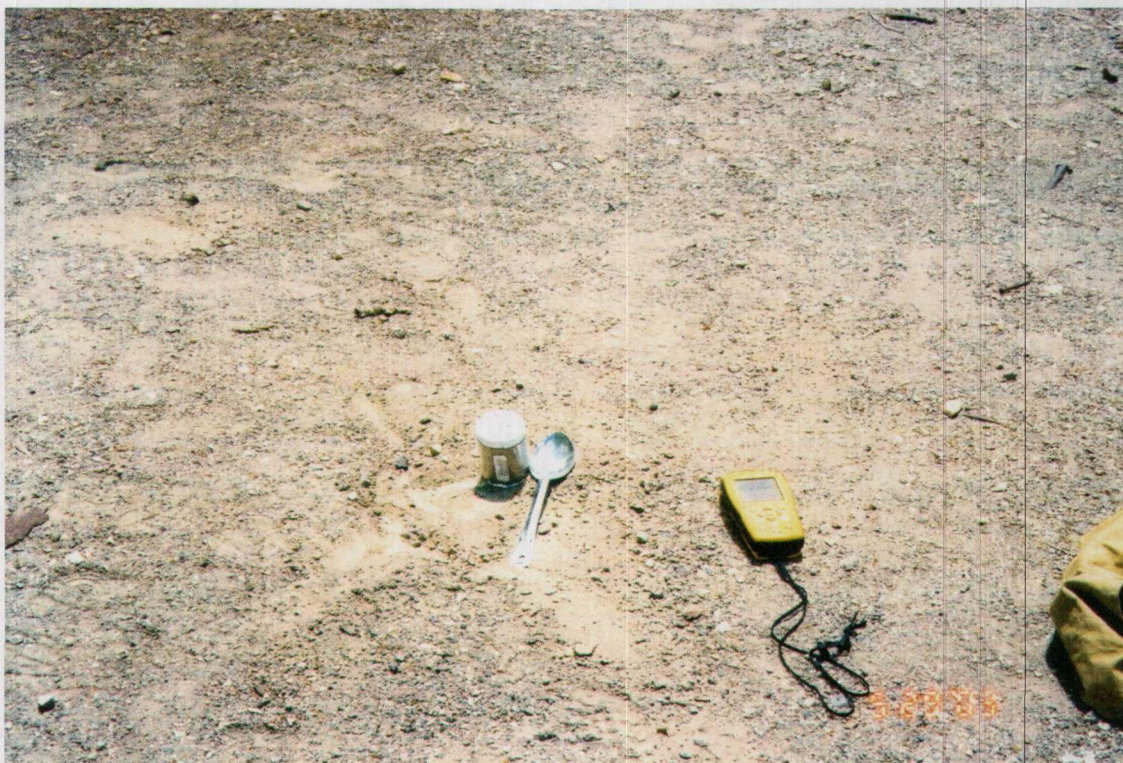
The mercury concentration of sample BB-SF-13 (background) is 0.14 mg/kg. There were 5 observed releases of mercury. These observed releases ranged from 0.44 mg/kg (in sample BB-SF-15) to 2.5 mg/kg (in sample BB-SF-10). All of the sample results for mercury were below the SCDM Screening for Non-Cancer Toxicological Responses benchmark for mercury of 23 mg/kg.

Location: Bully Boy Mill View: South
Location of Sample BB-SF-10.

Location: Bully Boy Mill
Sample BB-SF-10.

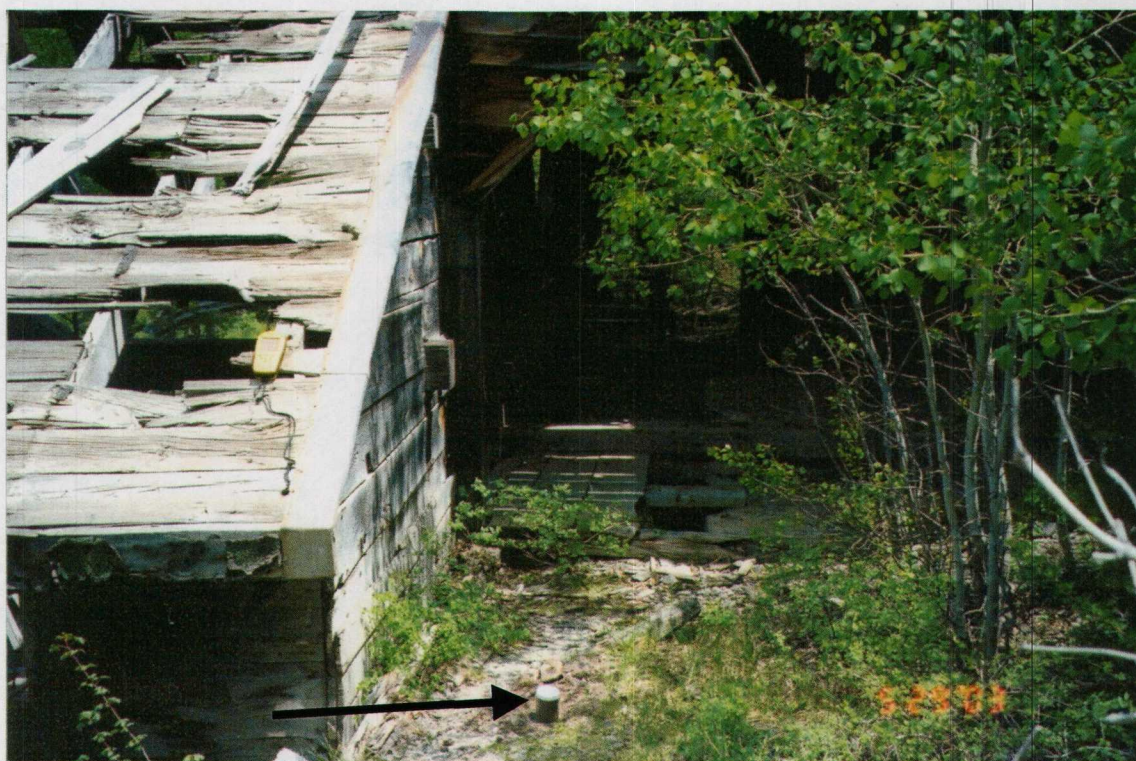
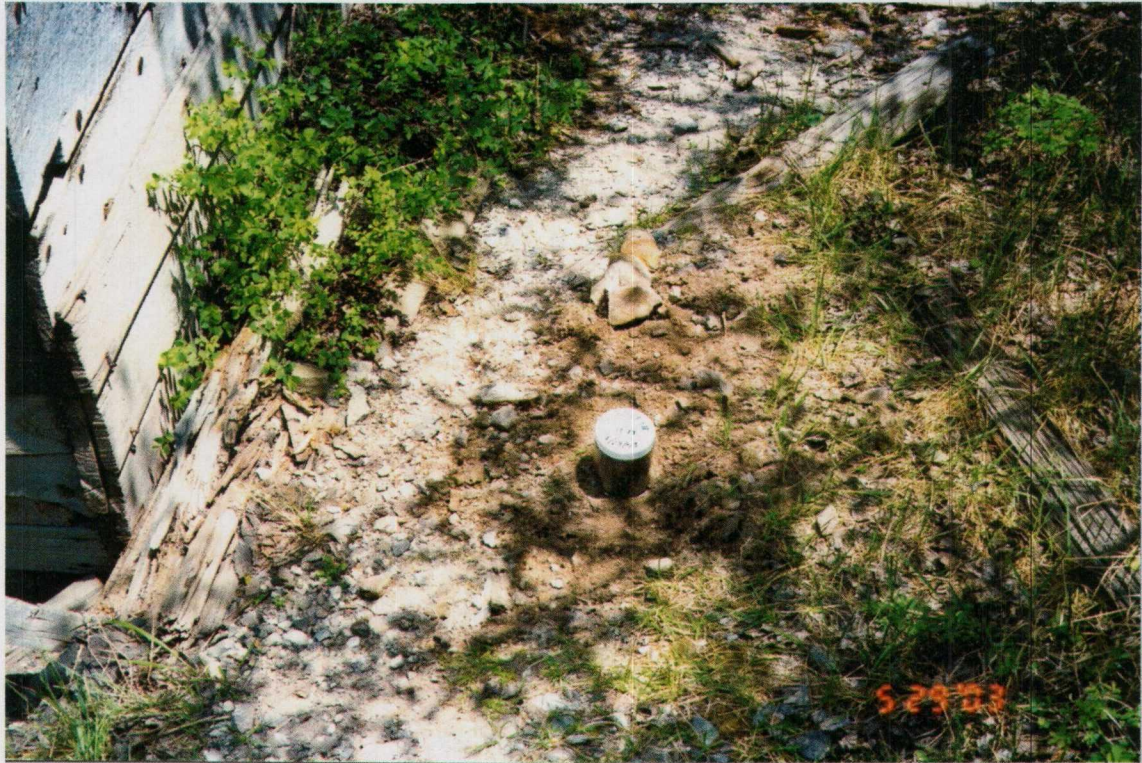
Soil samples BB-SF-11 and BB-SF-13 had few observed releases when compared to the other 7 samples (the background sample, BB-SF-09, excluded). These 2 samples were collected from areas that were likely not impacted by mining activities (BB-SF-11 from the side of the mill and BB-SF-13 from the entrance to Miner's Park).

Additionally, sample BB-SF-11 had observed releases of lead and calcium, but calcium is not considered hazardous. Sample BB-SF-13 had an observed release of potassium, which is not considered hazardous.

Location: Bully Boy Mill
Location of Sample BB-SF-11.

Location: Bully Boy Mill
Sample BB-SF-11.

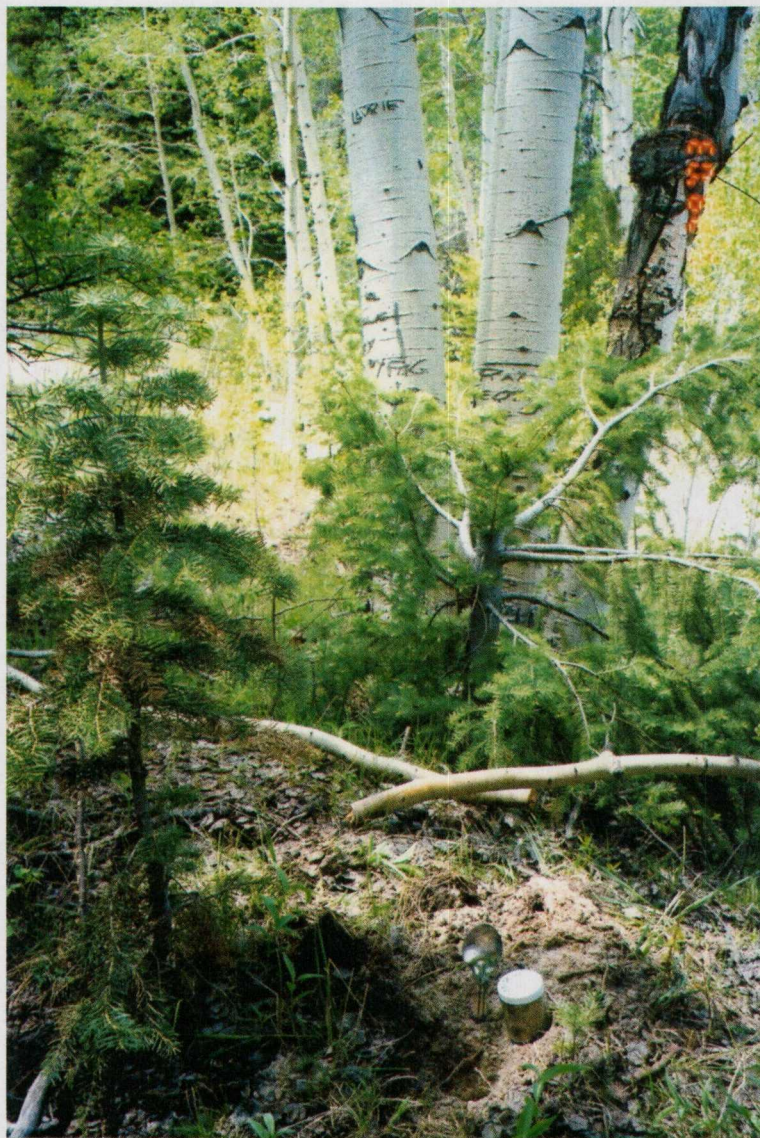
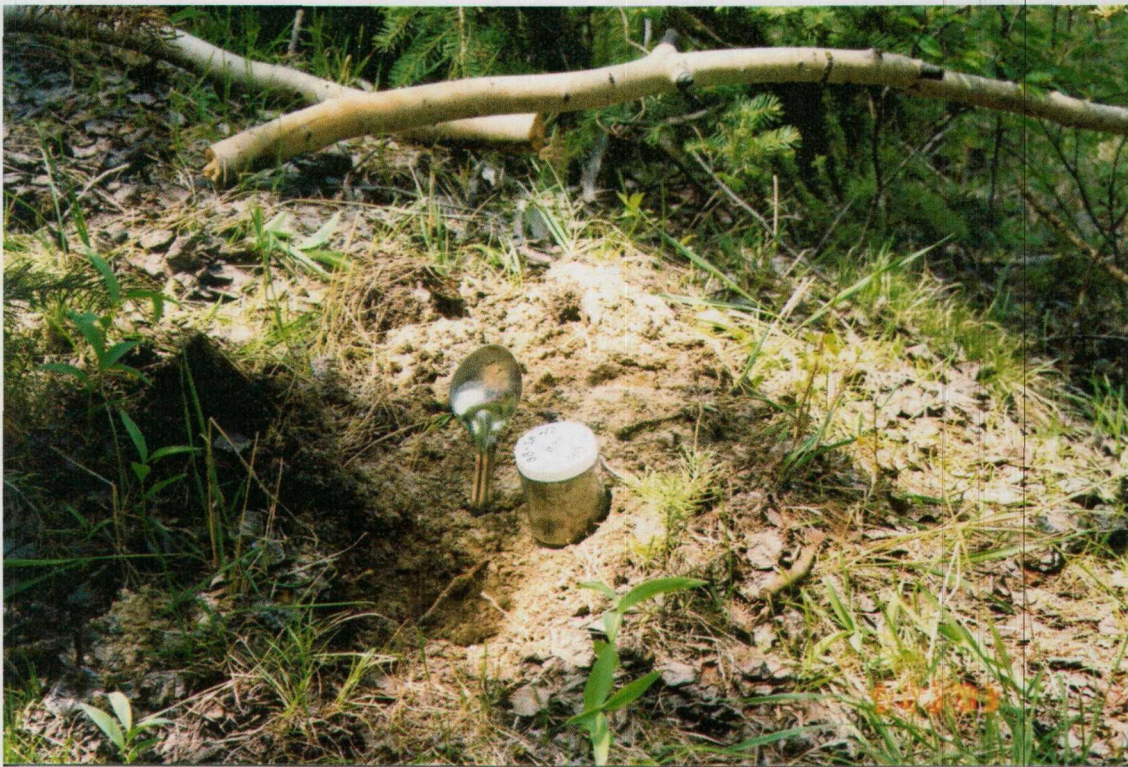
- The background concentration of manganese was 663 mg/kg. Sample BB-SF-12 had a concentration of 2,020 mg/kg. This constitutes 1 observed release of manganese. The SCDM Screening for Non-Cancer Toxicological Responses benchmark for manganese is 11,000 mg/kg.

Location: Bully Boy Mill View: Northwest
Location of Sample BB-SF-12.

Location: Bully Boy Mill
Sample BB-SF-12.

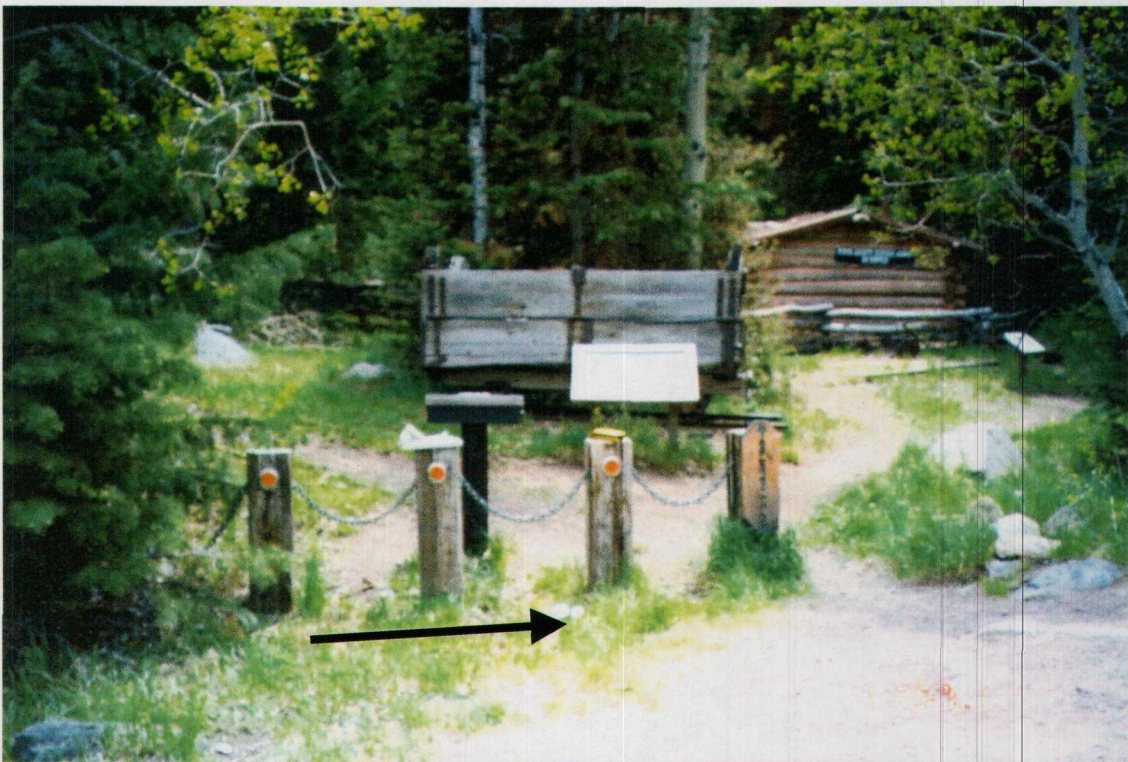
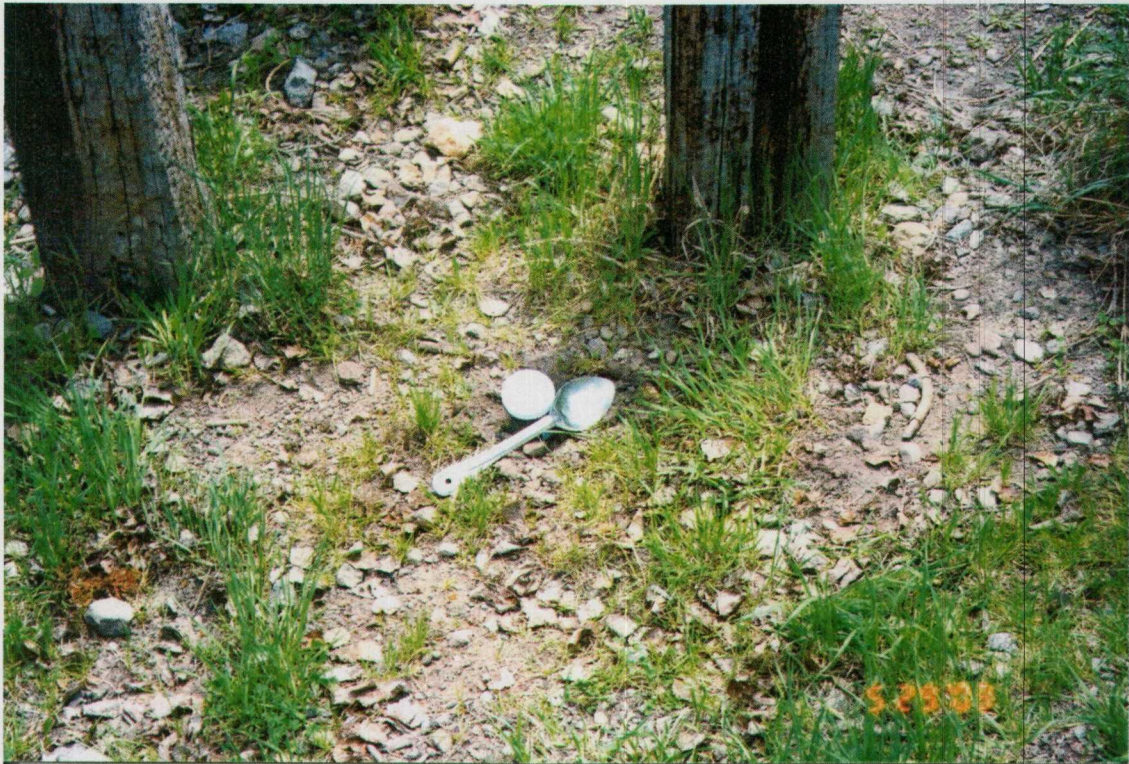
Location: Bully Boy Mill
Location of Sample BB-SF-13.

Location: Bully Boy Mill
Sample BB-SF-13.

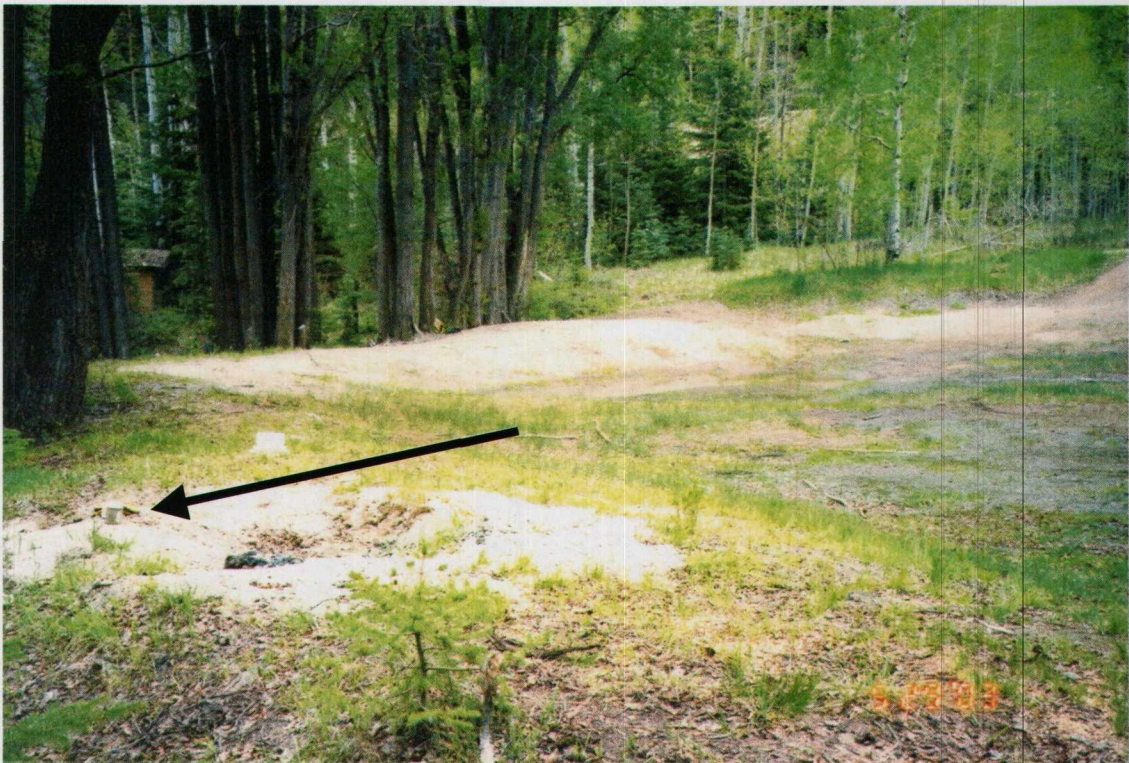
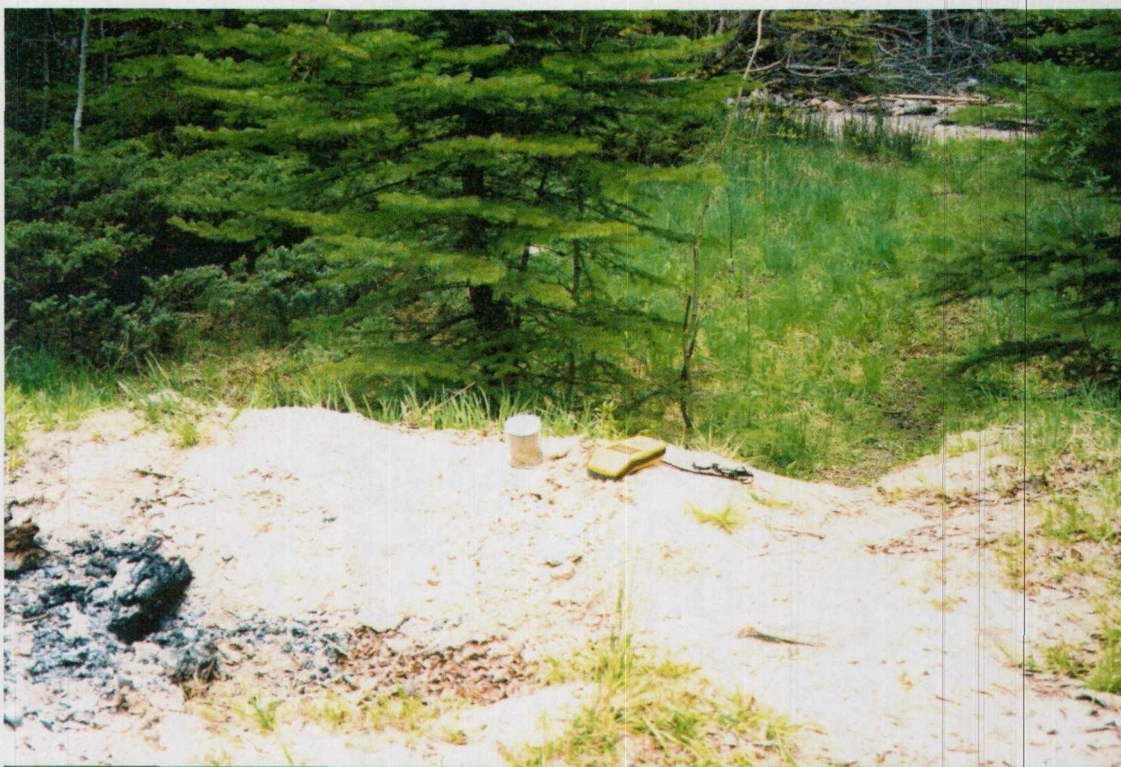
Location: Bully Boy Mill
Location of Sample BB-SF-14.

Location: Bully Boy Mill
Sample BB-SF-14.

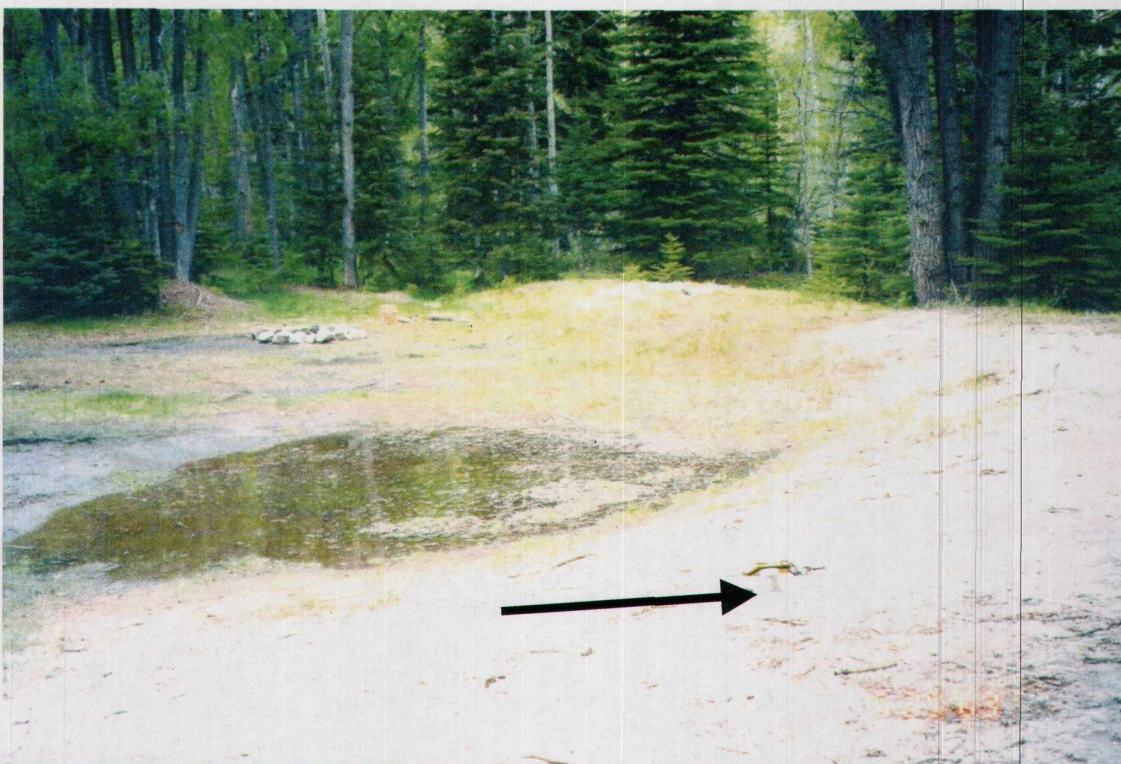
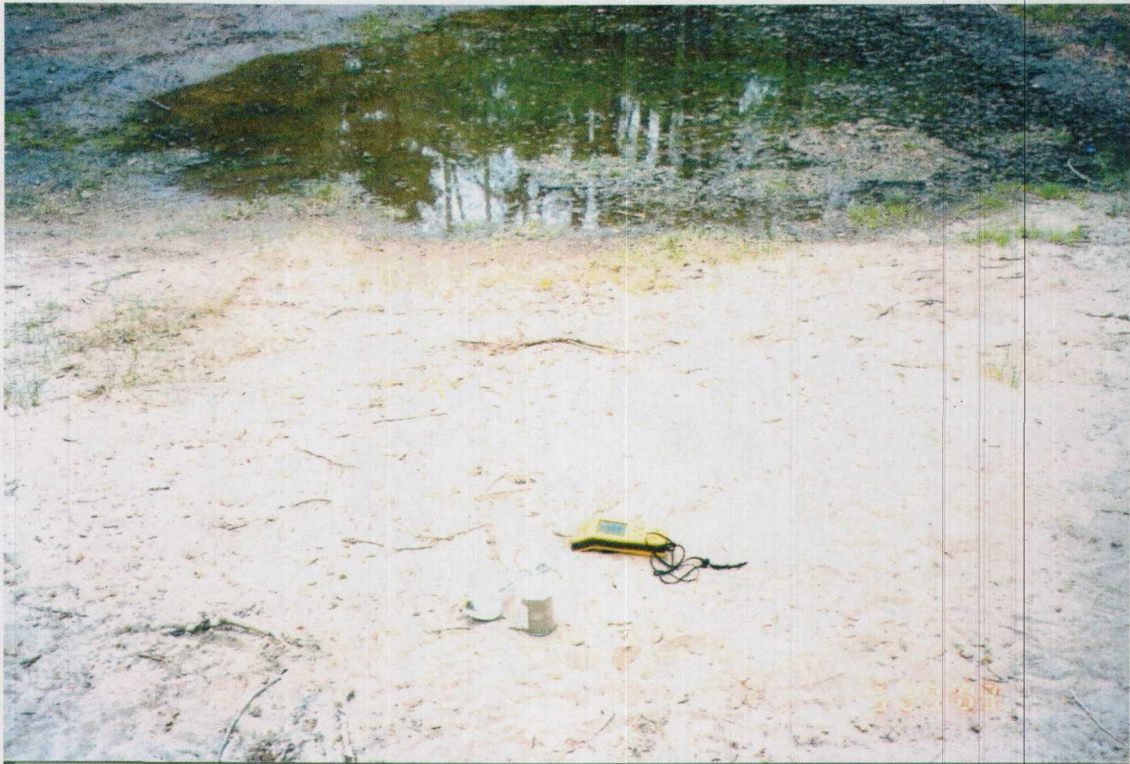
Location: Bully Boy Mill
Location of Sample BB-SF-15.

Location: Bully Boy Mill
Sample BB-SF-15.

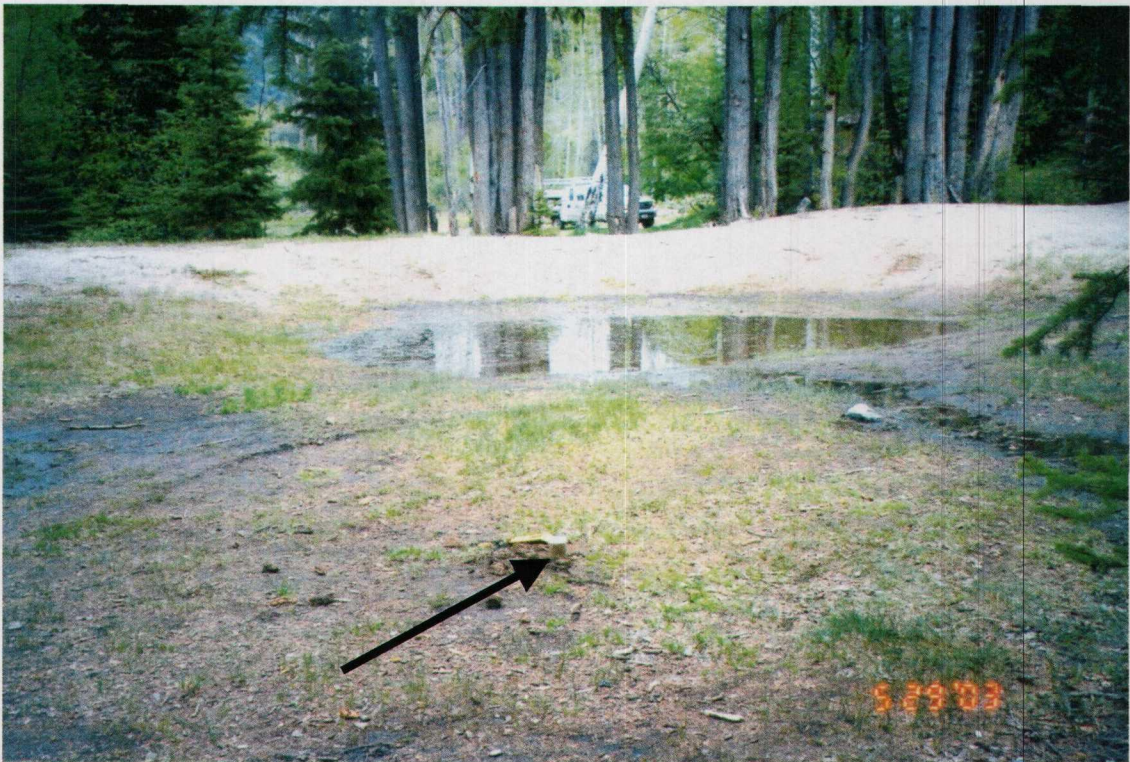
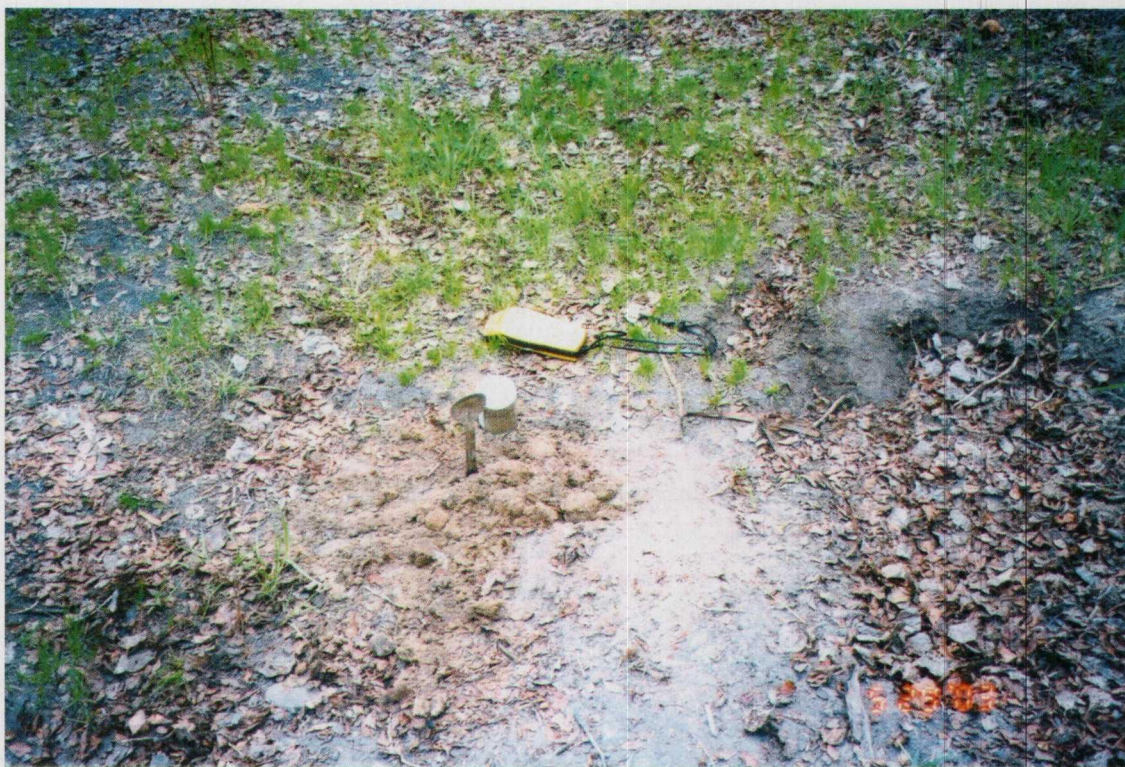
Location: Bully Boy Mill
Location of Sample BB-SF-16.

Location: Bully Boy Mill View: West
Sample BB-SF-16.

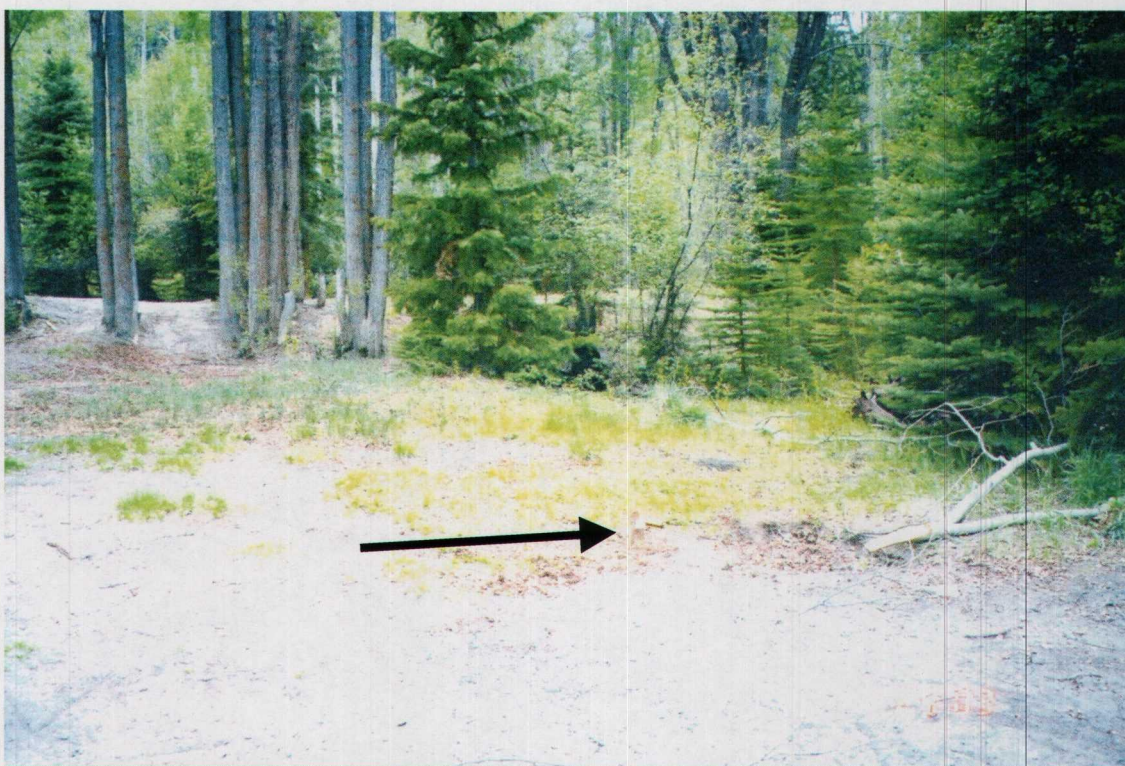
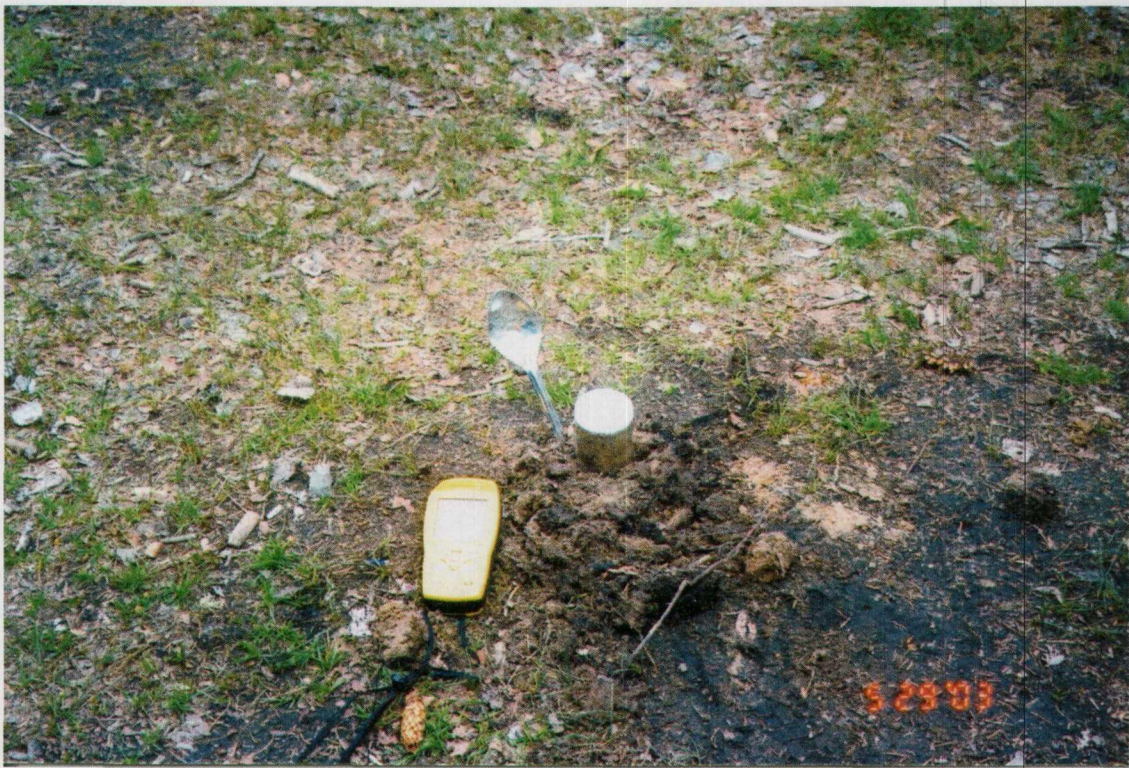
- The background concentration for selenium was 1.0 mg/kg. Concentrations of selenium ranged from 8.2 mg/kg (in sample BB-SF-17) to 23.5 mg/kg (in sample BB-SF-18), constituting 6 observed releases. Of the remaining 7 samples, only sample BB-SF-10 with a concentration of 2.8 mg/kg did not have an observed release. The SCDM Screening for Non-Cancer Toxicological Responses benchmark for selenium is 390 mg/kg.

Location: Bully Boy Mill View: West
Location of Sample BB-SF-17.

Location: Bully Boy Mill View: West
Sample BB-SF-17.

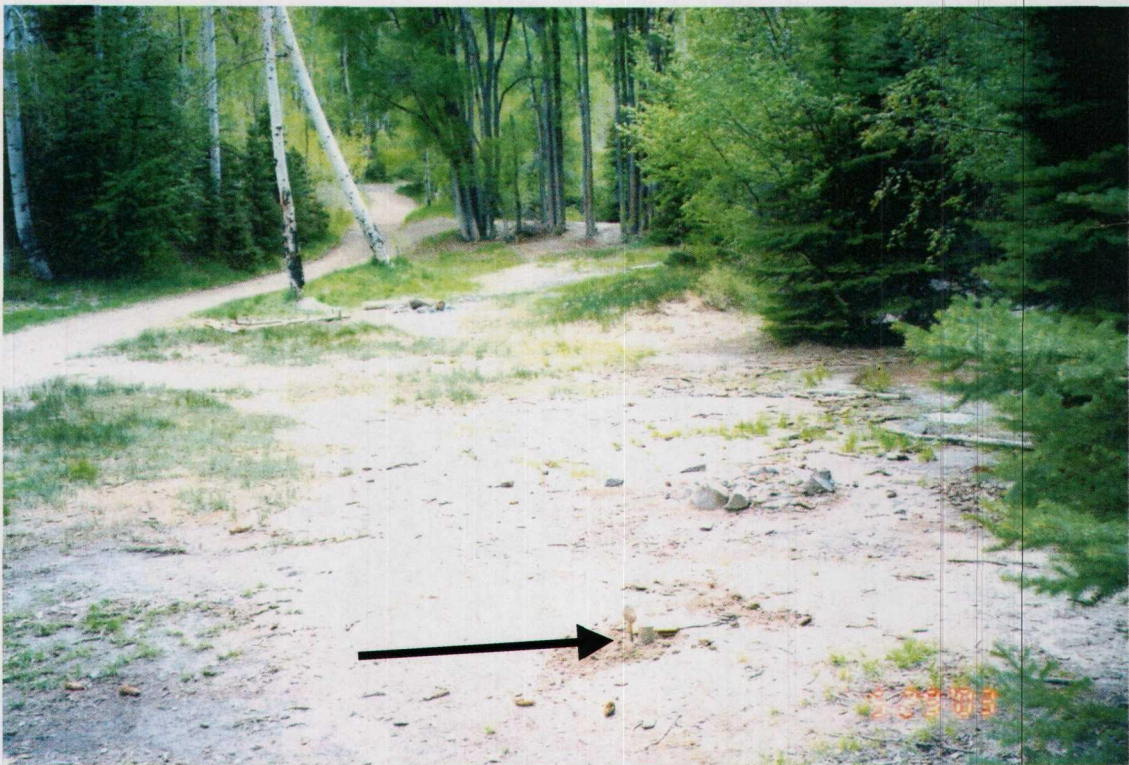
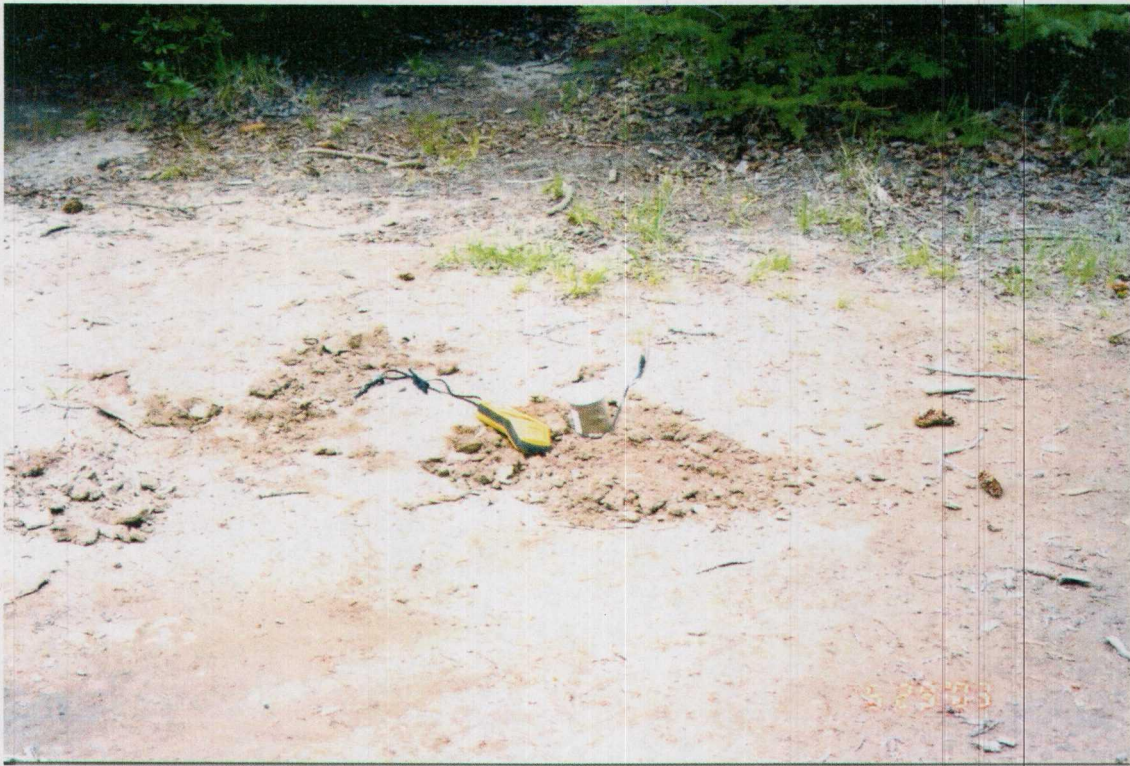
- The background concentration for lead was 90.4 mg/kg. Concentrations of lead ranged from 1,620 mg/kg (in sample BB-SF-10) to 19,600 mg/kg (in sample BB-SF-18), constituting 8 observed releases (as mentioned previously, sample BB-SF-11 had an observed release as well as the remaining 7 samples). There is no SCDM benchmark for lead in soil.

Location: Bully Boy Mill View: West
Location of Sample BB-SF-18.

Location: Bully Boy Mill View: West
Sample BB-SF-18.

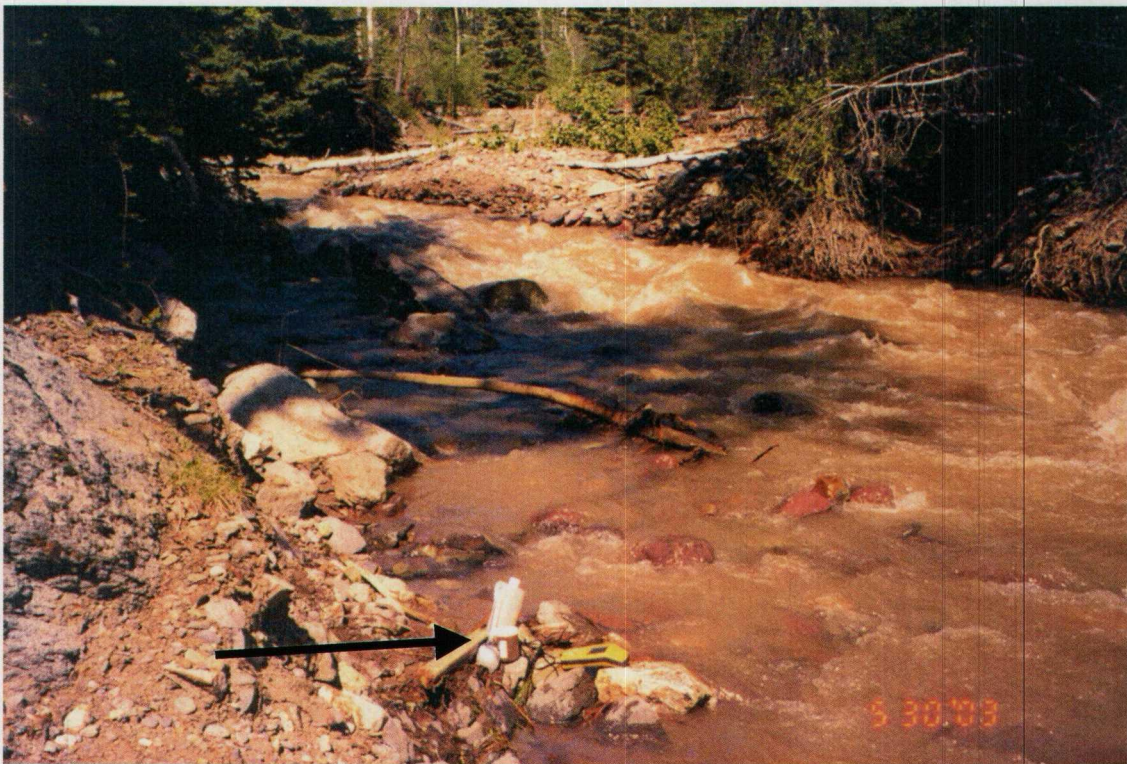
Location: Bully Boy Mill View: North
Location of Samples BB-SW-01 and BB-SD-06.

Location: Bully Boy Mill View: West
Samples BB-SW-01 and BB-SD-06.

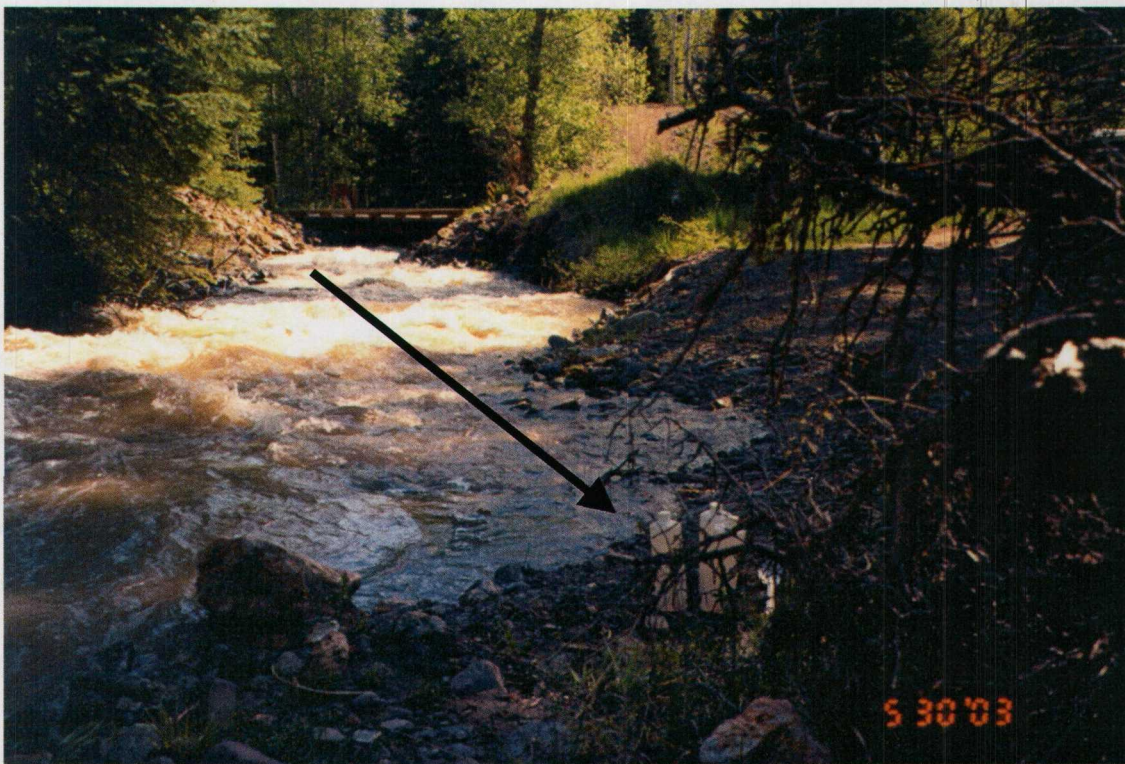
There was one observed release in surface water that was collected from Pine Creek. This occurred in the downgradient sample (BB-SW-02) for cobalt, however this sample was duplicated and the duplicate sample (BB-SW-03) did not have an observed release. Also this observed release was exactly 3 times the concentration observed in the background sample (BB-SW-01). Cobalt has no SCDM values for surface water.

Location: Bully Boy Mill View: North
Location of Samples BB-SW-02, BB-SW-03, and BB-SD-07.

Location: Bully Boy Mill View: East
Samples BB-SW-02, BB-SW-03, and BB-SD-07.
