SITE INSPECTION ANALYTICAL RESULTS REPORT

BULLY BOY MILL

Piute County, Utah

UT0009114384

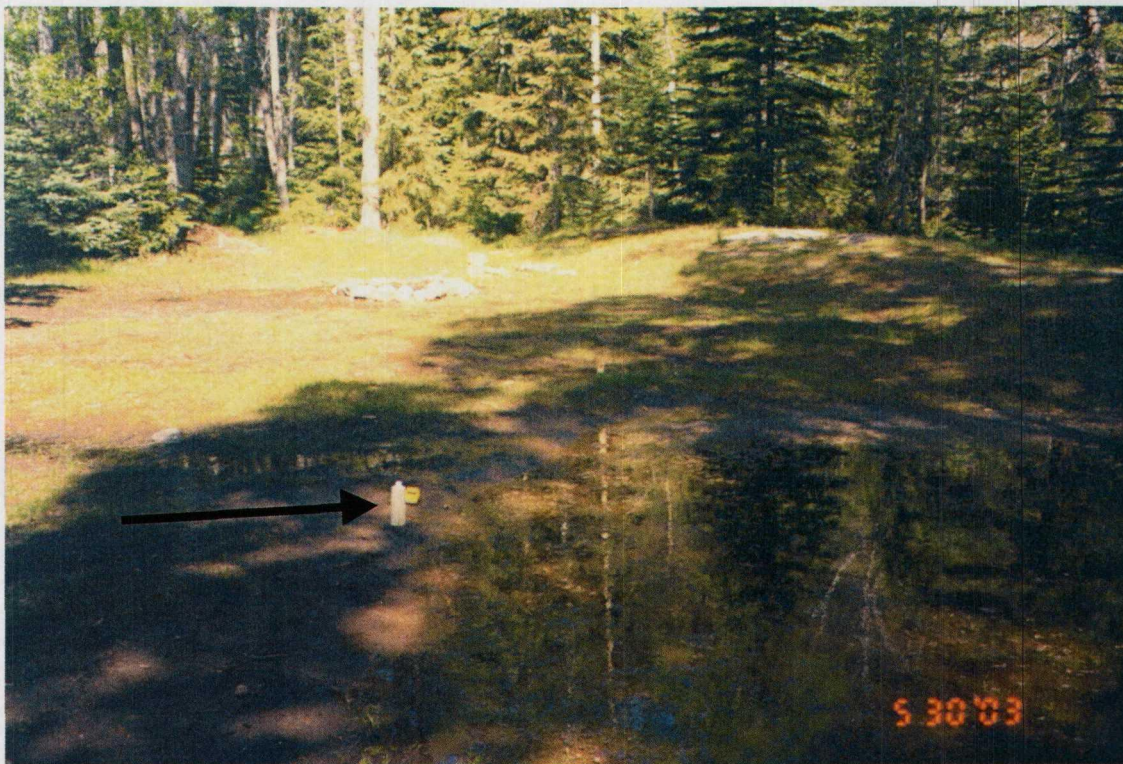
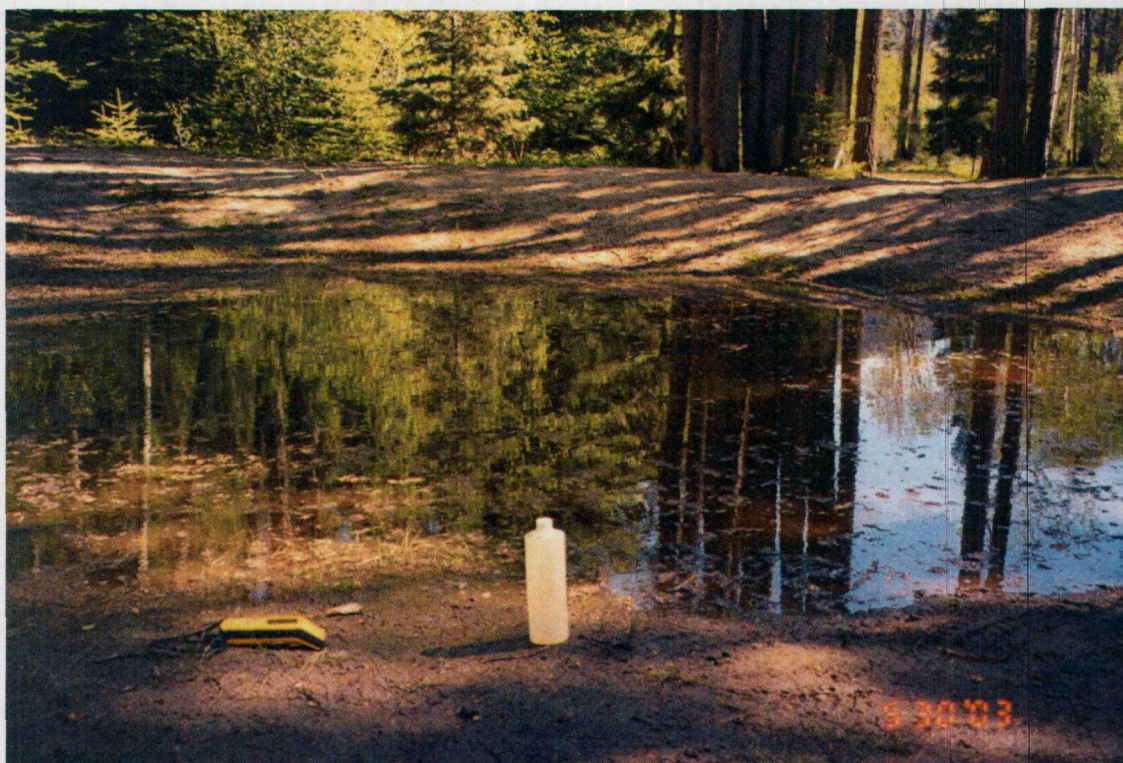
the concentrations for antimony, cadmium, copper, lead, silver, and zinc were all high enough to constitute observed releases. The concentrations of cadmium, copper, lead and zinc also exceeded SCDM environmental benchmarks.

The opportunity sample (BB-SW-04) had concentrations that were significantly greater than the other samples. When this opportunity sample is compared to the background surface-water sample taken from Pine Creek, BB-SW-01, the concentrations for antimony, cadmium, copper, lead, silver, and zinc were all high enough to constitute observed releases. The concentrations of cadmium, copper, lead and zinc also exceeded their respective SCDM environmental benchmarks. The opportunity sample was collected from an ephemeral pond in the area where

Location: Bully Boy Mill View: North
Location of Sample BB-SW-04.

Location: Bully Boy Mill View: West
Sample BB-SW-04.
