**Photographic Documentation Log**  
**Old Saratoga Hospital Site**  
**Providence Township, Saratoga County, New York**  
**August 4 and September 16 and 17, 2015**

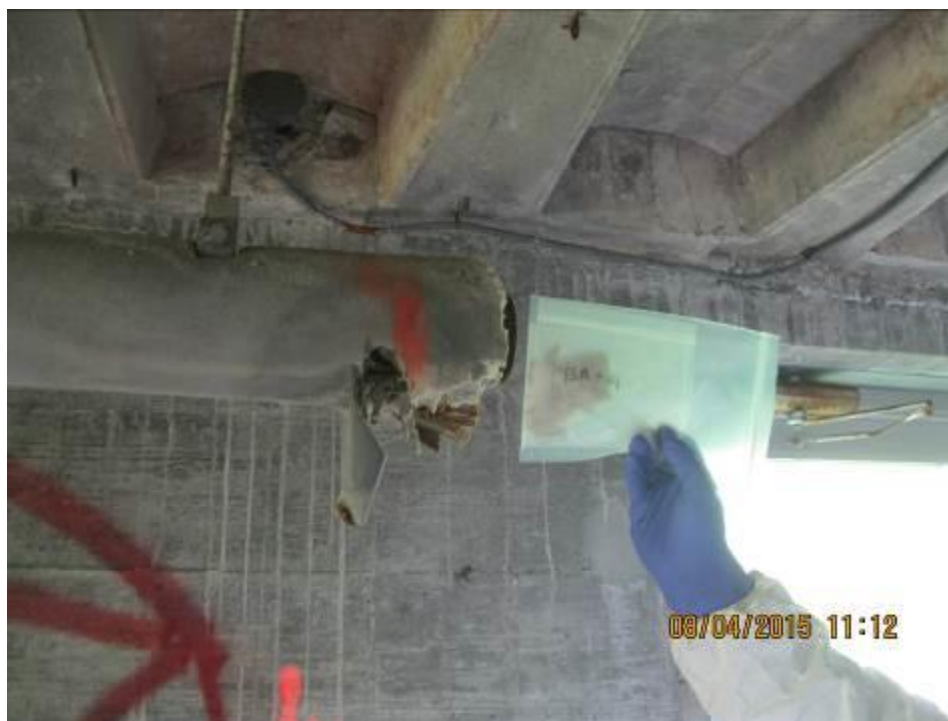
**Photograph 1:** Location P001-BA-001 in the west wing basement. The sample was collected from pipe insulation. Analytical results indicate that the sample contains 44.40% chrysotile asbestos.

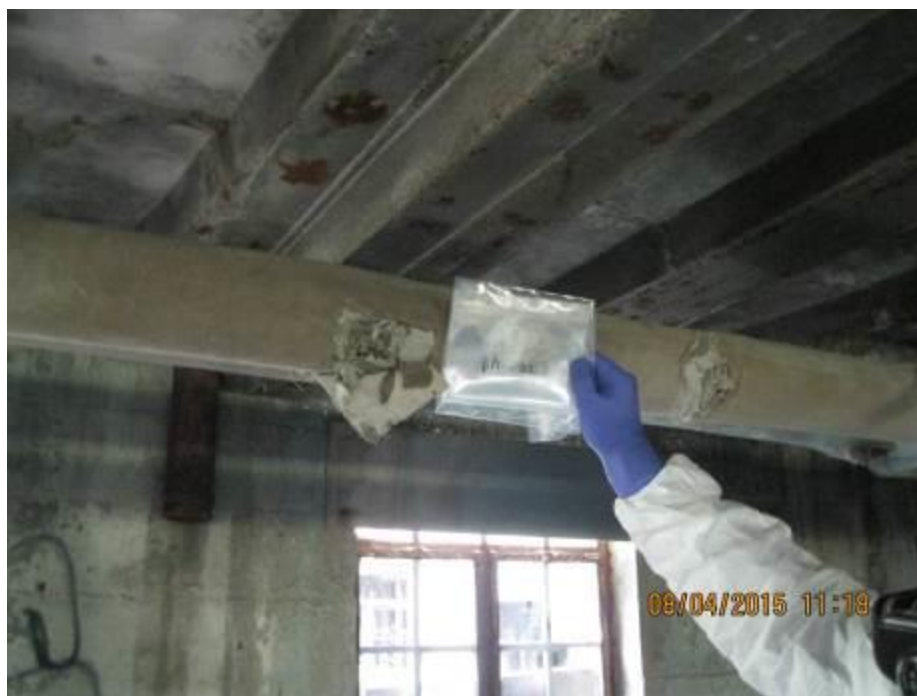
**Photograph 2:** Location P001-BA-002 in the west wing basement. The sample was collected from pipe insulation. Analytical results indicate that the sample contains 57.10% chrysotile asbestos.

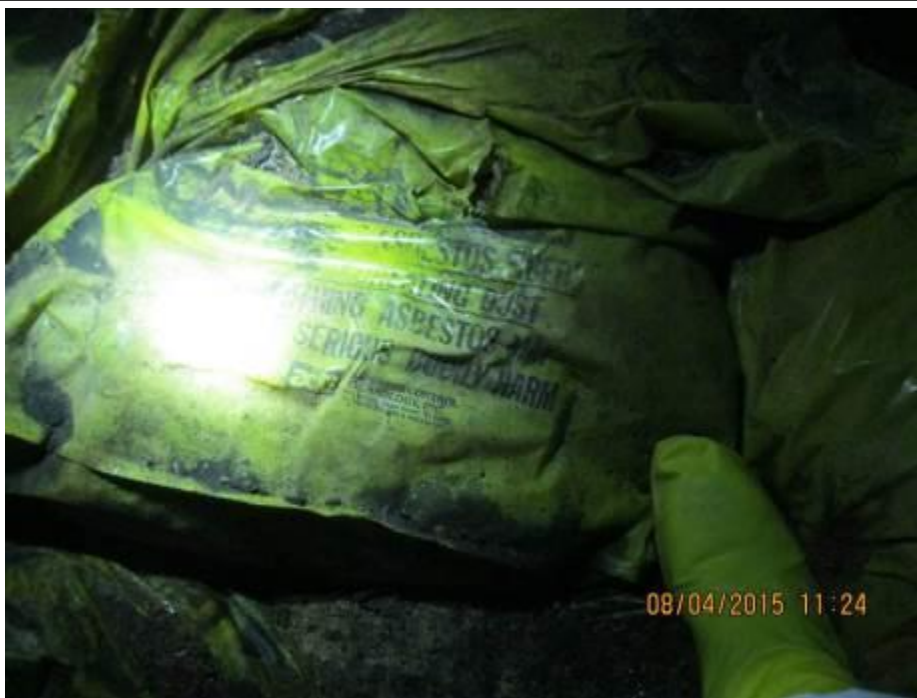
**Photograph 3:** Location P001-BA-003 in the west wing basement. The sample was collected from material outside of “Asbestos” labeled bags. Analytical results indicate that the sample contains 33.30% chrysotile asbestos.

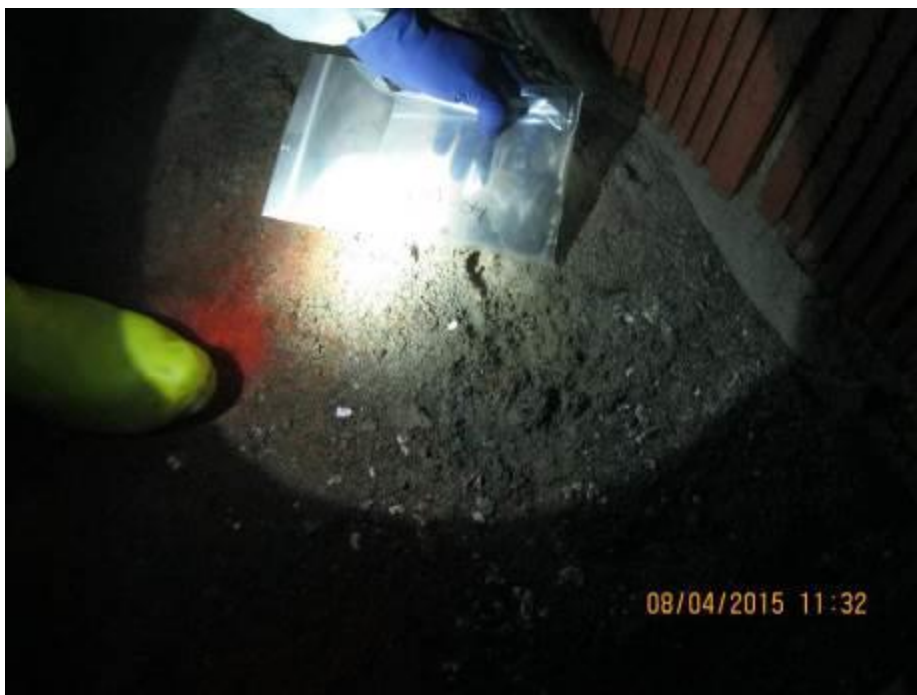
**Photograph 4:** Location P001-BA-004 in west wing basement. The sample was collected from a debris pile on the floor. Analytical results indicate that the sample was non-detect for asbestos.

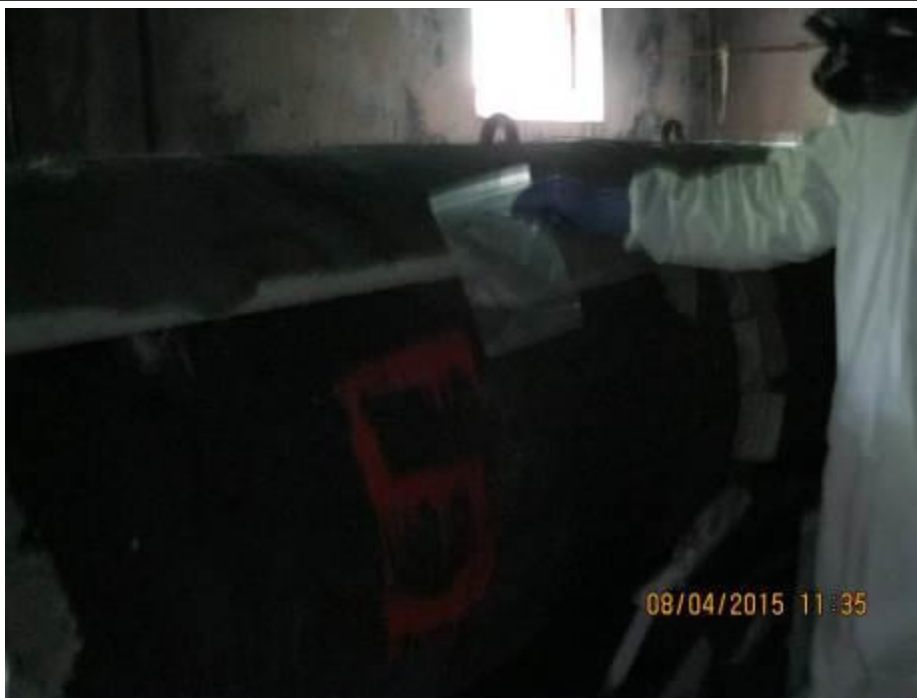
**Photograph 5:** Location P001-BA-005 in west wing basement. The sample was collected from insulation around a suspect boiler tank. Analytical results indicate that the sample contains 15.80% amosite and 5.26% chrysotile asbestos.

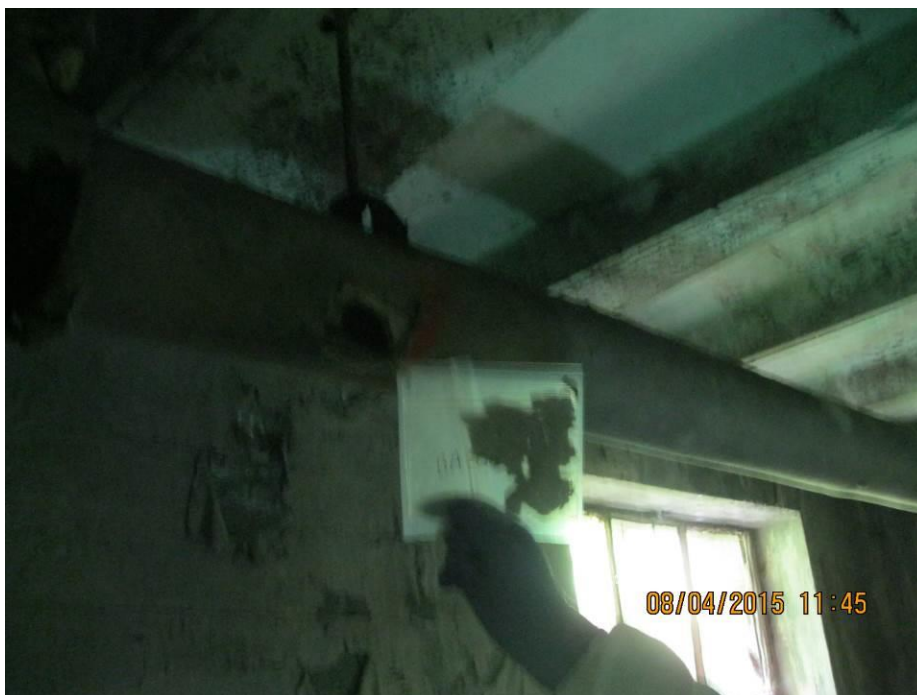
**Photograph 6:** Location P001-BA-006 in the west wing basement. The sample was collected from pipe insulation. Analytical results indicate that the sample contains 26.70% chrysotile asbestos.

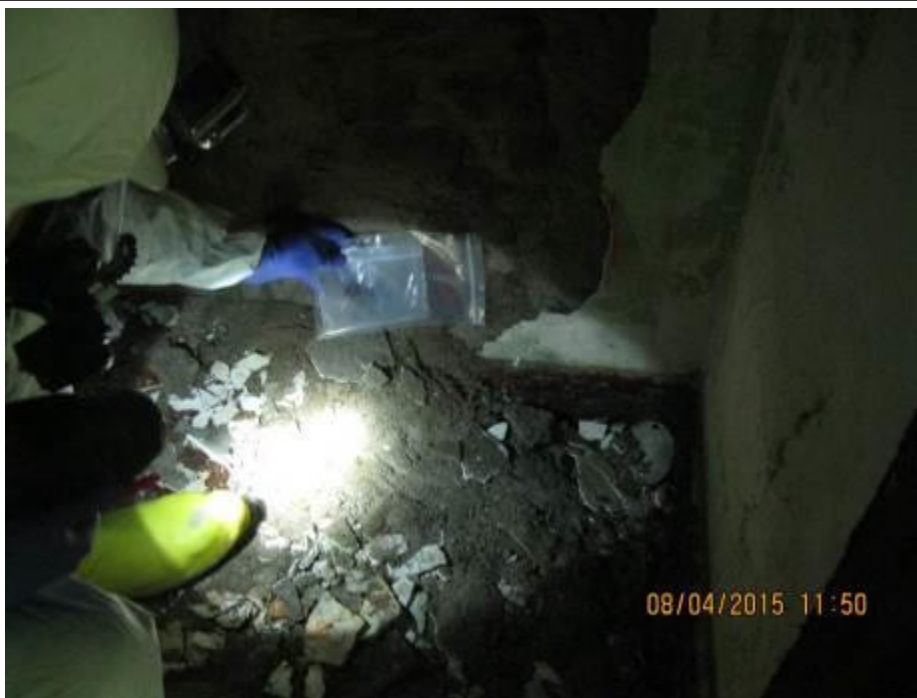
**Photograph 7:** Location P001-BA-007 in west wing basement. The sample was collected from a debris pile on the floor. Analytical results indicate that the sample was non-detect for asbestos.

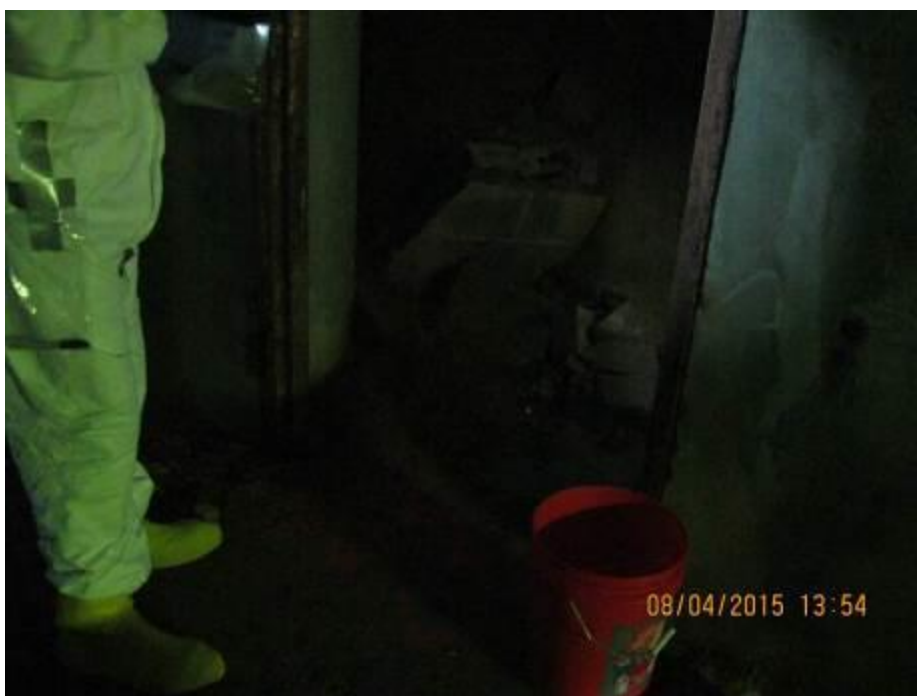
**Photograph 8:** Location P001-BA-008 in west wing basement. The sample was collected from a debris pile on floor. Analytical results indicate that the sample contains 4.82% chrysotile asbestos.

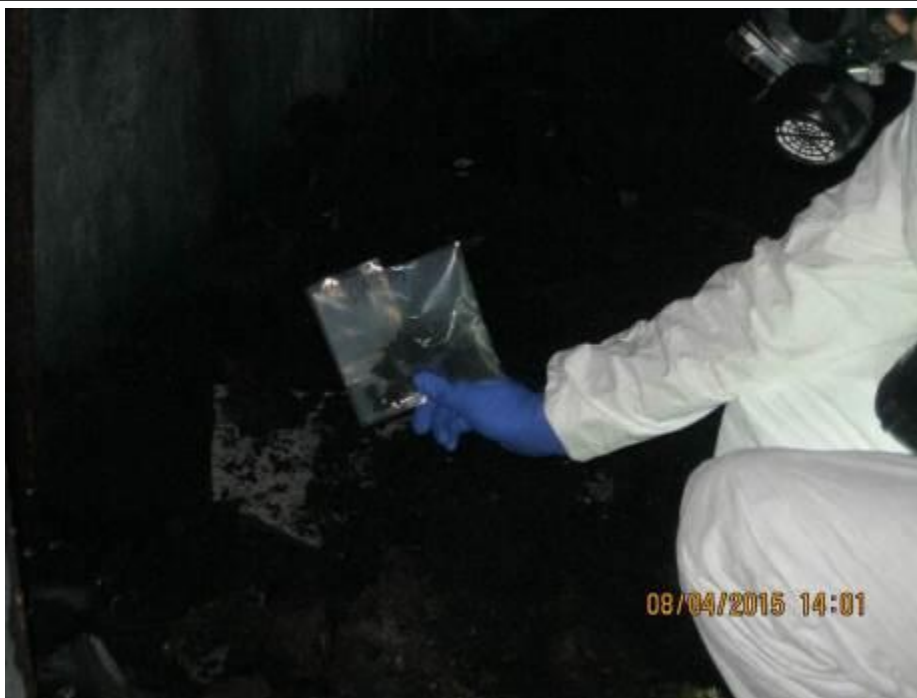
**Photograph 9:** Location P001-BA-009 in west wing basement. The sample was collected from a debris pile on floor. Analytical results indicate that the sample was non-detect for asbestos.

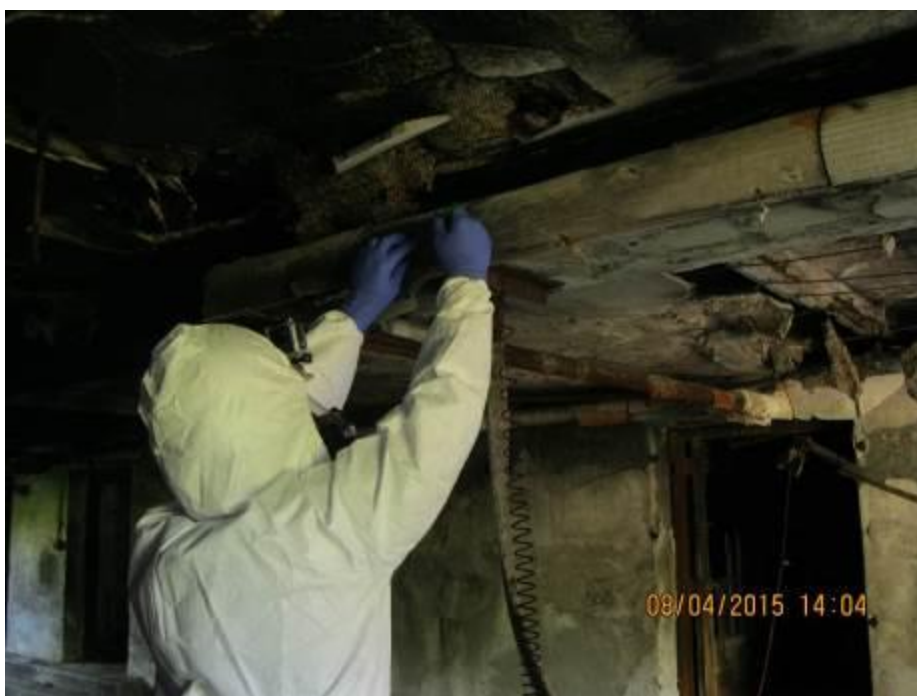
**Photograph 10:** Location P001-BA-010 in the west wing basement. The sample was collected from pipe insulation. Analytical results indicate that the sample contains 21.10% chrysotile asbestos.

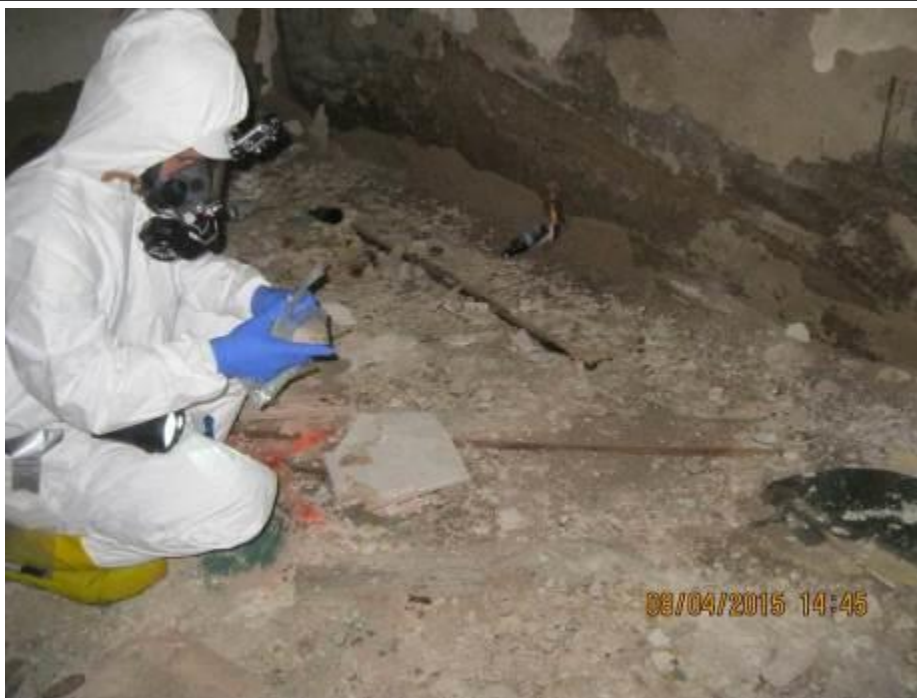
**Photograph 11:** Location P001-BA-011 in east wing basement. The sample was collected from floor tile. Analytical results indicate that the sample was non-detect for asbestos.

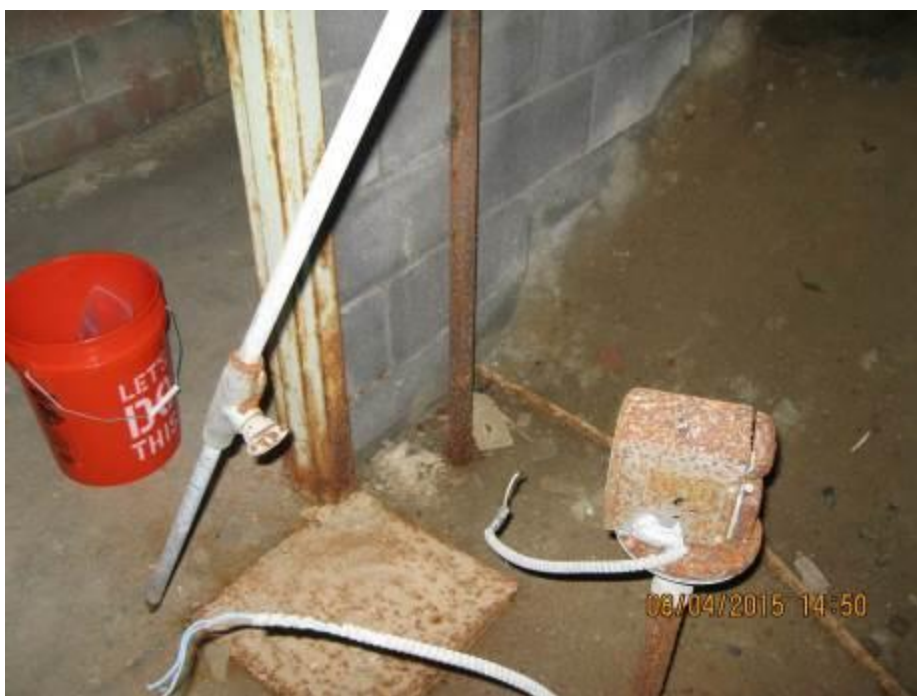
**Photograph 12:** Location P001-BA-012 in east wing basement. The sample was collected from a debris pile. Analytical results indicate that the sample was non-detect for asbestos.

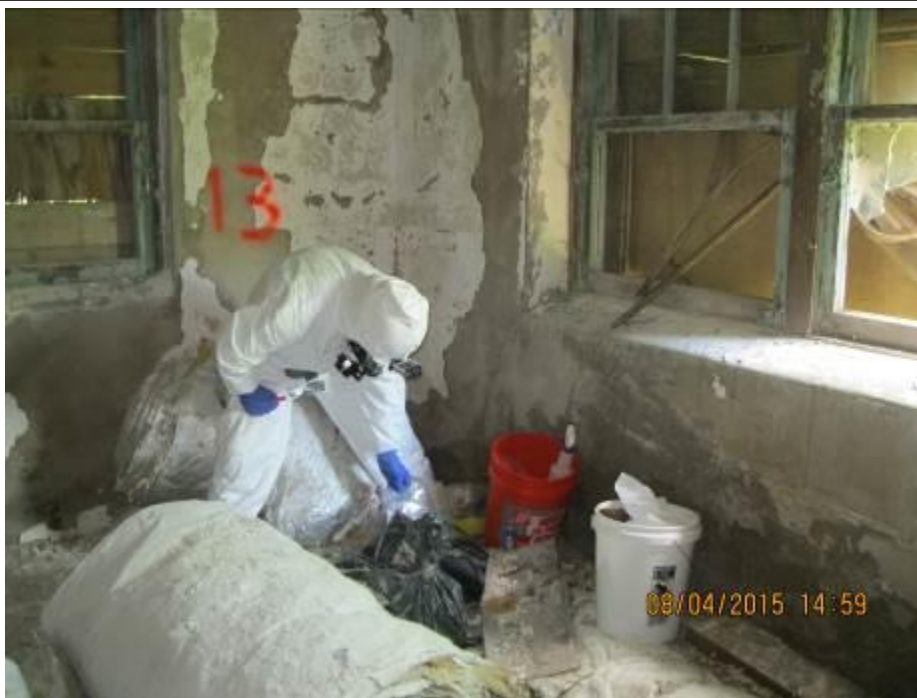
**Photograph 13:** Location P001-BA-013 in east wing basement. The sample was collected from “Asbestos” labeled poly trash bag. Analytical results indicate that the sample contains 19.10% chrysotile asbestos.

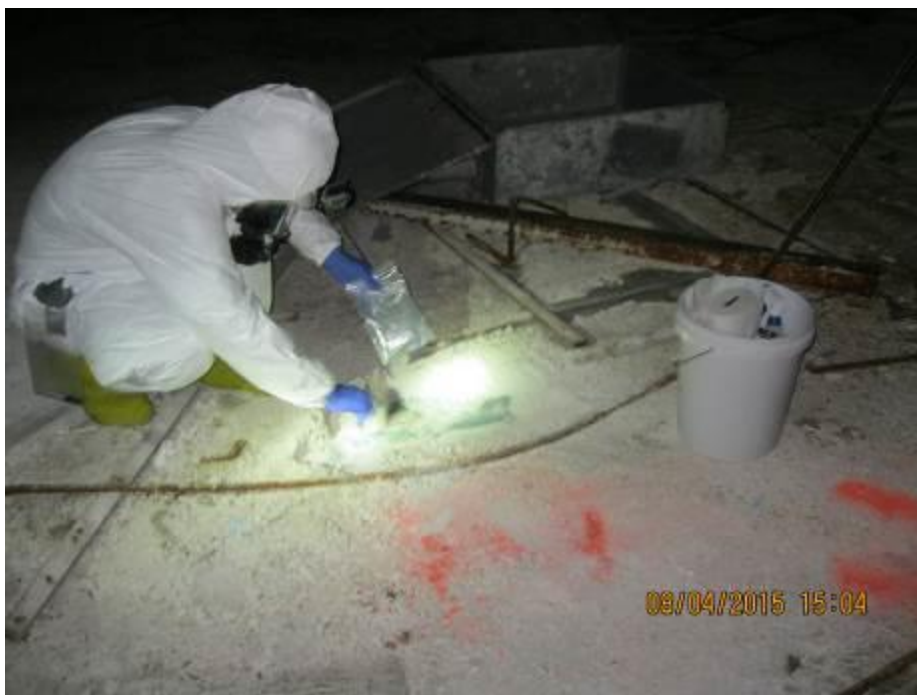
**Photograph 14:** Location P001-BA-014 in east wing basement. The sample was collected from a debris pile on floor. Analytical results indicate that the sample contains 5.40% chrysotile asbestos.

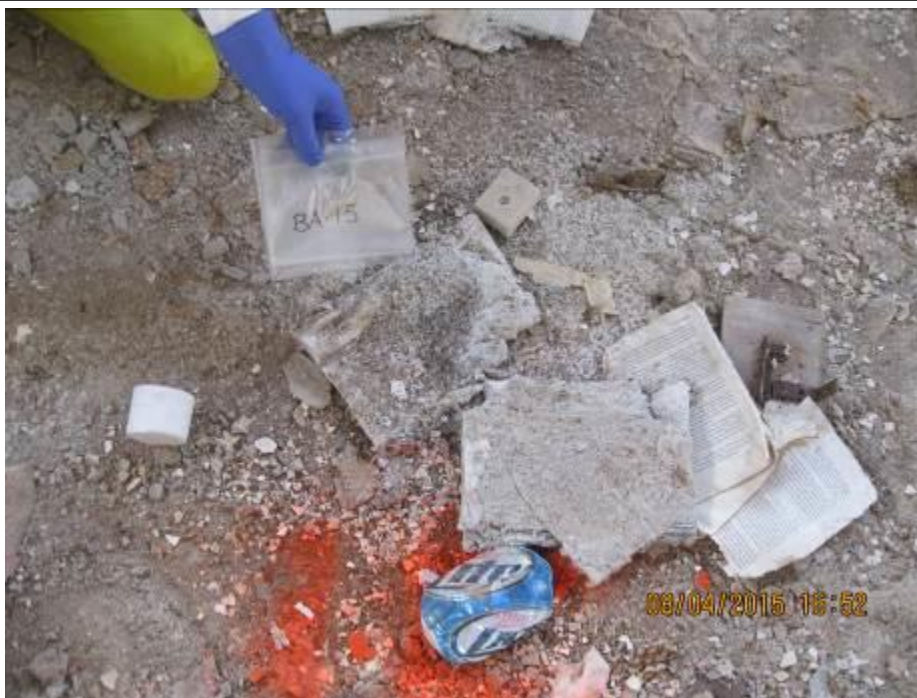
**Photograph 15:** Location P001-BA-015 in west wing first floor. The sample was collected from ceiling tile that had fallen to the floor. Analytical results indicate that the sample was non-detect for asbestos.

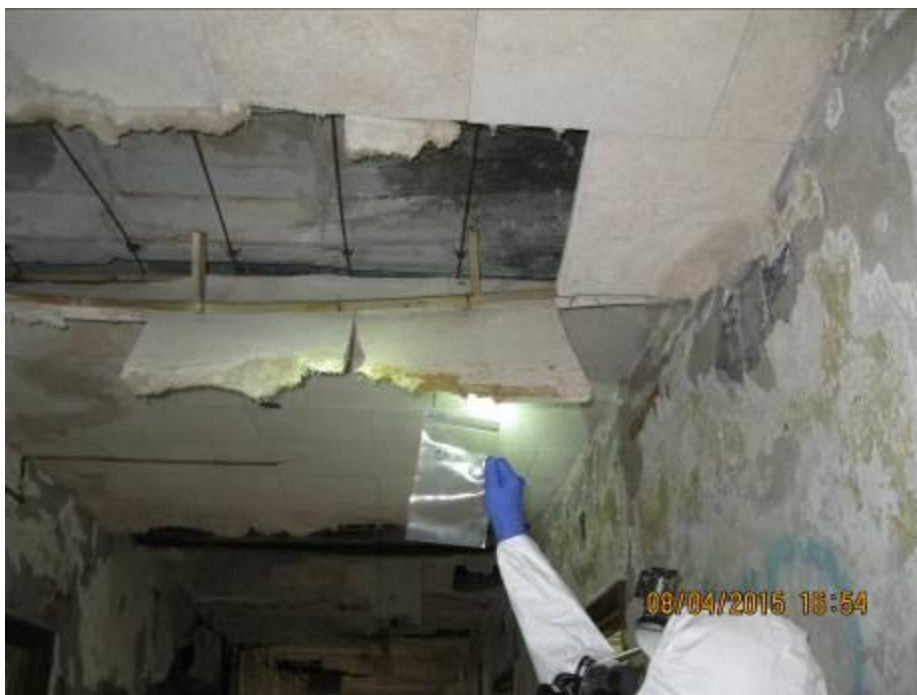
**Photograph 16:** Location P001-BA-016 in west wing first floor. The sample was collected from ceiling tile. Analytical results indicate that the sample was non-detect for asbestos.

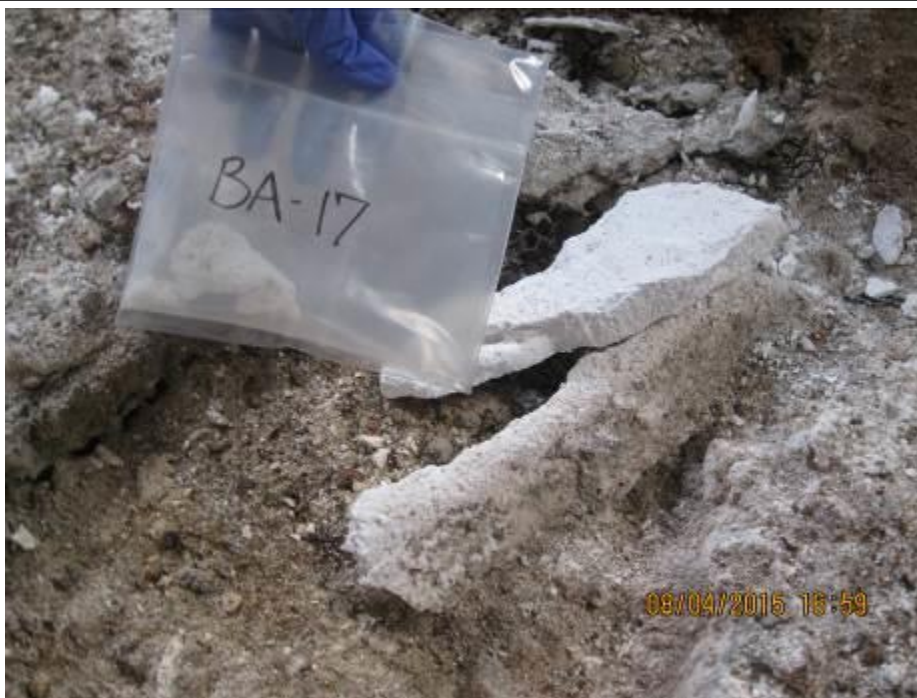
**Photograph 17:** Location P001-BA-017 in west wing first floor. The sample was collected from degrading ceiling tile. Analytical results indicate that the sample was non-detect for asbestos.

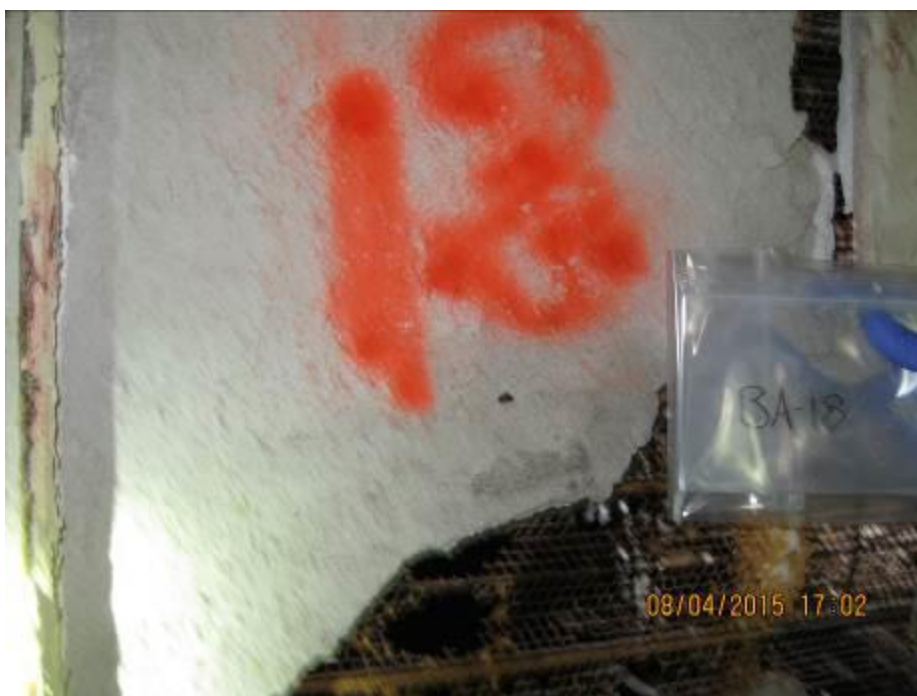
**Photograph 18:** Location P001-BA-018 in west wing first floor. The sample was collected from degrading drywall. Analytical results indicate that the sample was non-detect for asbestos.

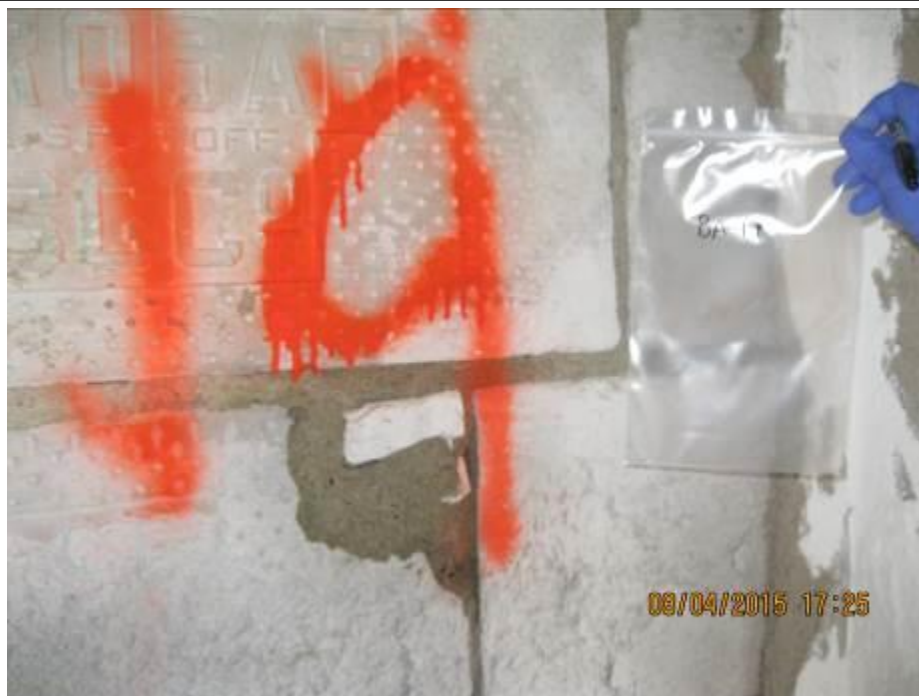
**Photograph 19:** Location P001-BA-019 in east wing first floor. The sample was collected from pyrobar/mortar material. Analytical results indicate that the sample was non-detect for asbestos.

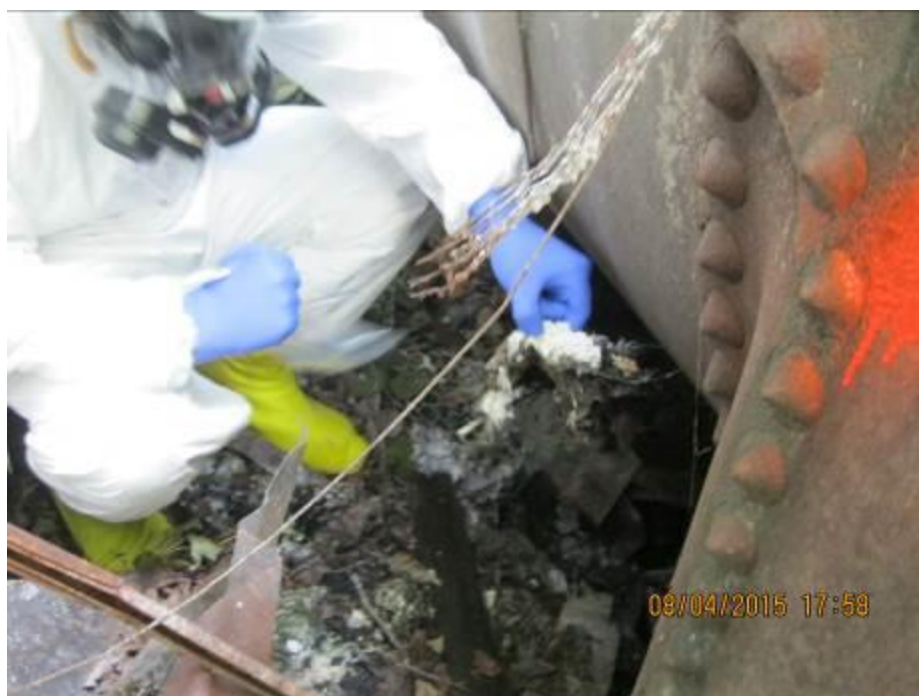
**Photograph 20:** Location P001-BA-020 outside of the building, approximately 15 feet to the north in a pit. The sample was collected from insulation on a suspect tank. Analytical results indicate that the sample contains 36.40% chrysotile asbestos.

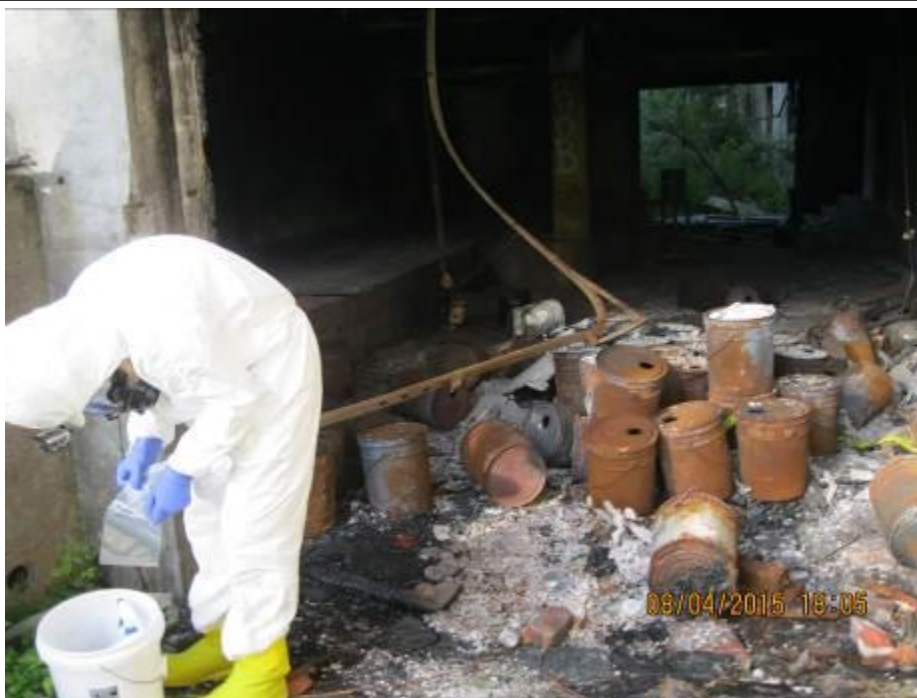
**Photograph 21:** Location P001-BA-021 outside the northwest entrance to the building, adjacent to sample location P001-BA010. The sample was collected from a debris pile. Analytical results indicate that the sample contains 36.40% chrysotile asbestos.

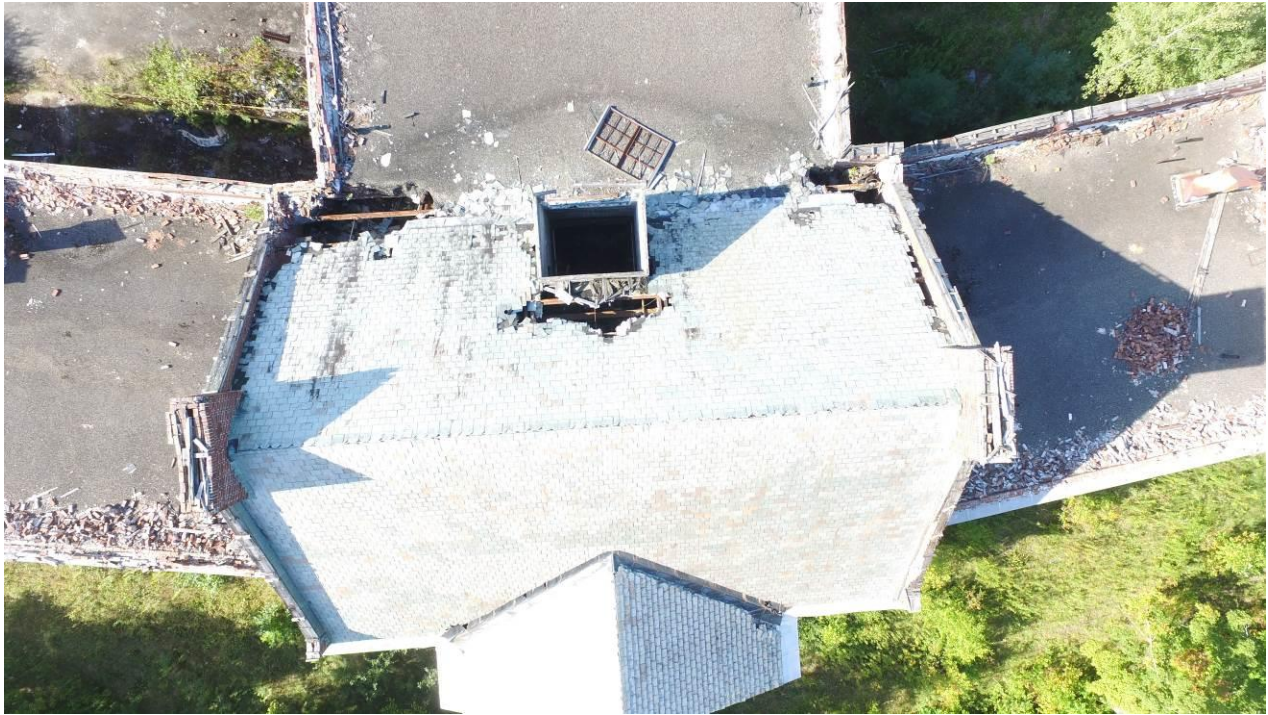
**Photograph 23:** Roof over main entrance to facility. Photograph taken with the camera on the drone.

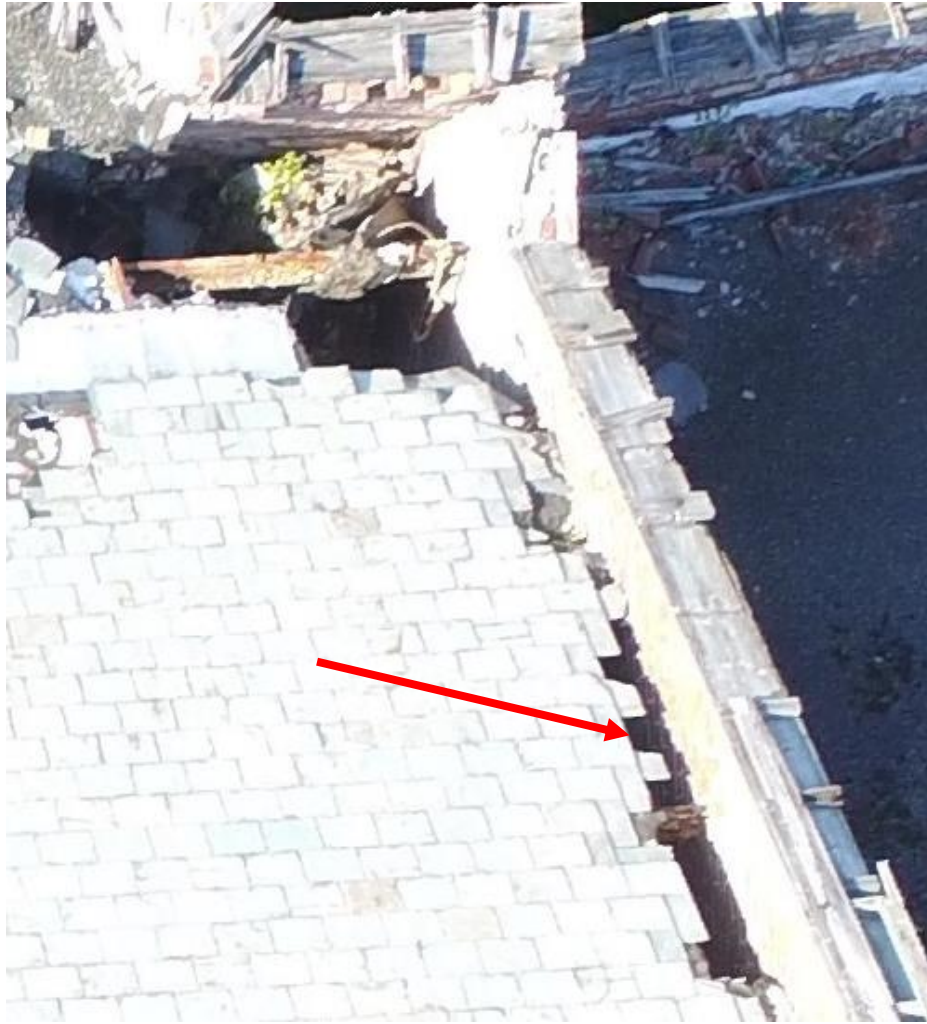
**Photograph 25:** Close-up of Photograph 24 showing possible parting of roof from east wall.

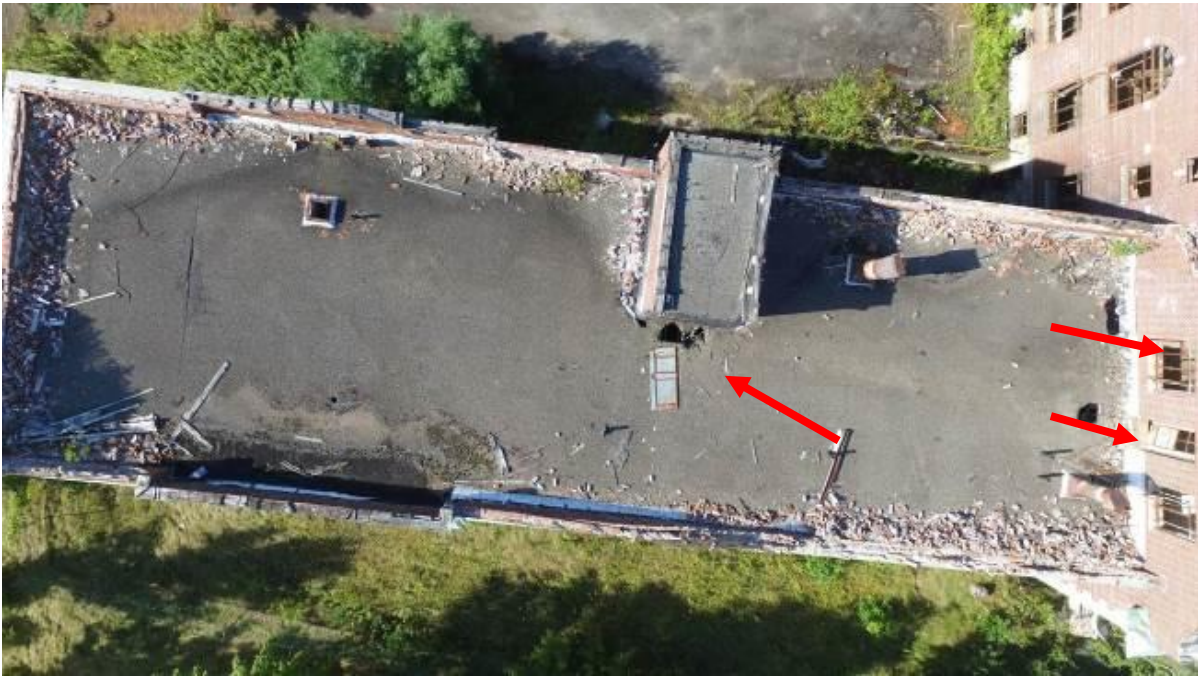
**Photograph 27:** Panoramic photograph of roof west of central entrance showing additional holes in roof.

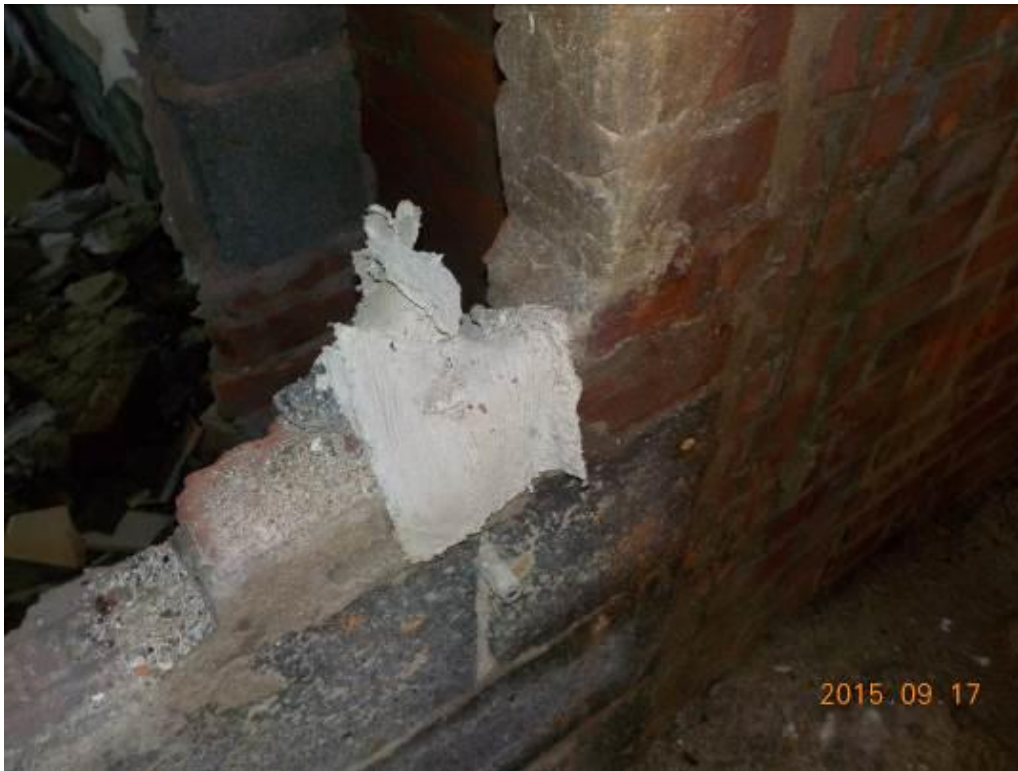
**Photograph 28:** Location P001-BA-022. The sample was collected from pipe wrap fallen onto partially collapsed wall. Analytical results indicate that the sample contains 50.00% chrysotile asbestos.

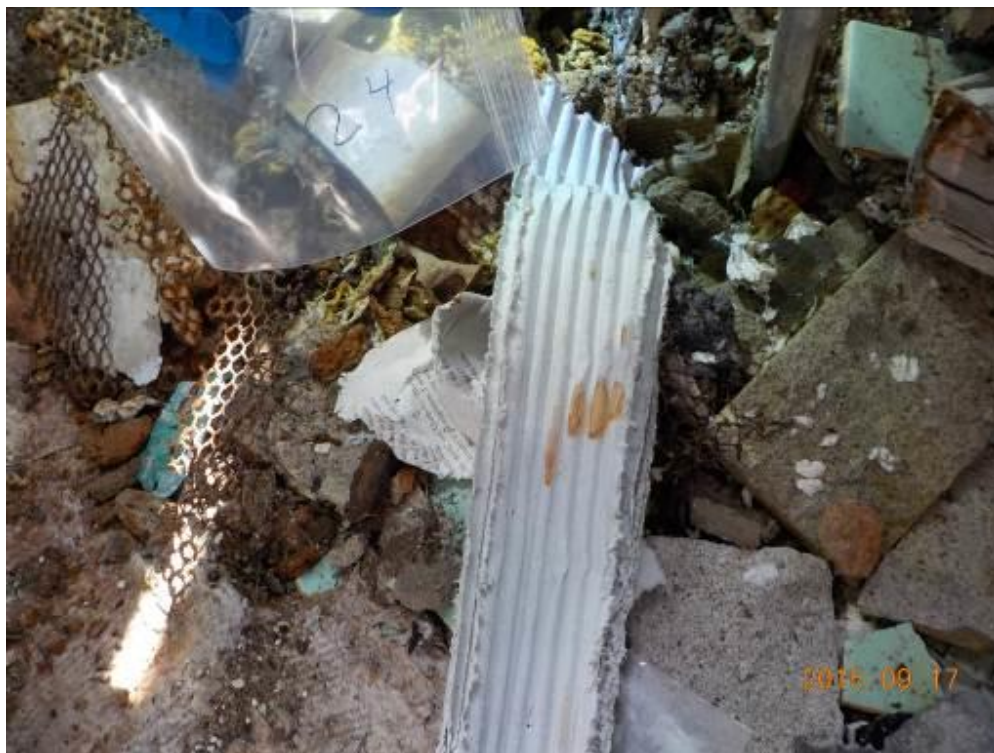
**Photograph 29:** Location P001-BA-024. The sample was collected from pipe wrap fallen onto floor. Analytical results indicate that the sample contains 57.10% chrysotile asbestos.

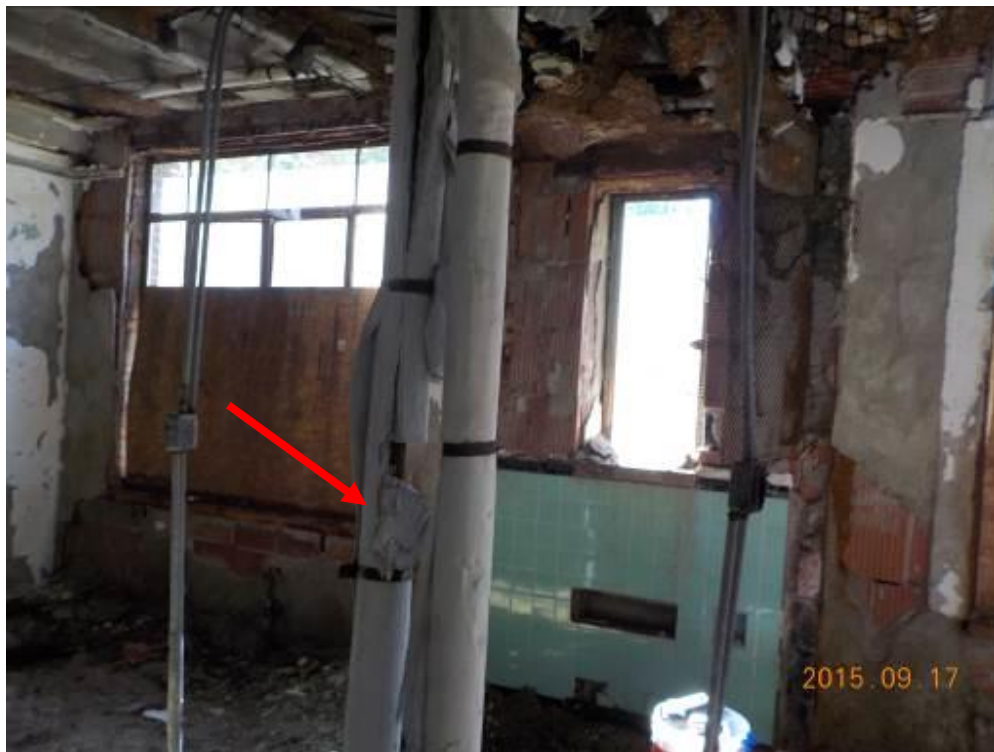
**Photograph 30:** Location P001-BA-025. The sample was collected from deteriorated pipe wrap on vertical pipe. Analytical results indicate that the sample contains 57.10% chrysotile asbestos.

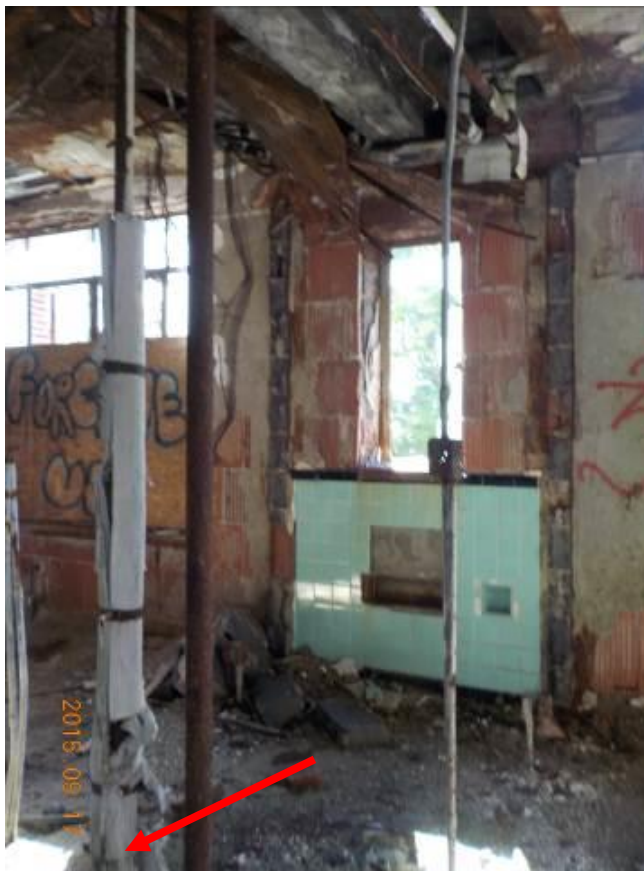
**Photograph 31:** Location P001-BA-026. The sample was collected from deteriorated pipe wrap on vertical pipe. Broken, opened window in background. Analytical results indicate that the sample contains 66.70% chrysotile asbestos.

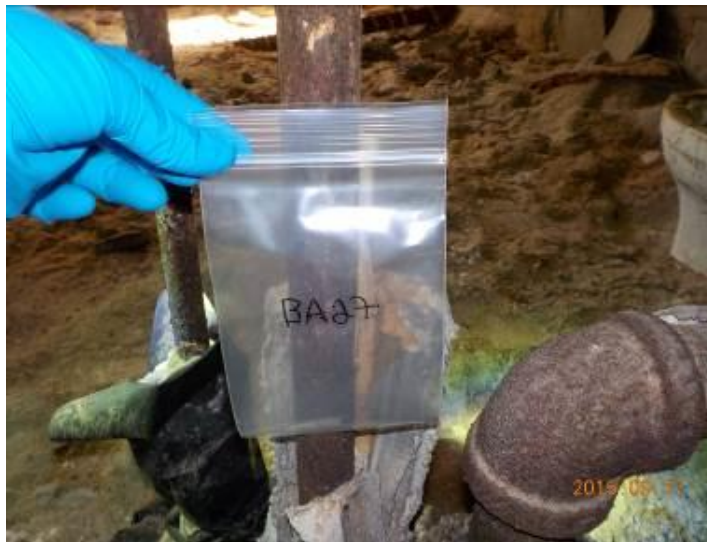
**Photograph 32:** Location P001-BA-027. The sample was collected from deteriorated pipe wrap at the base of a vertical pipe. Analytical results indicate that the sample contains 44.40% chrysotile asbestos.

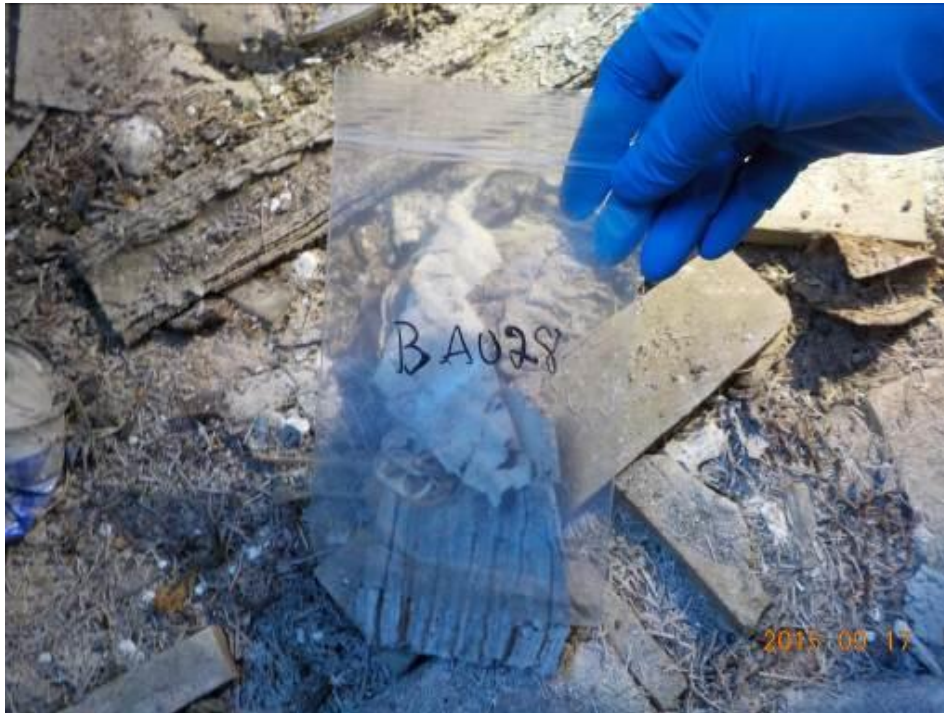
**Photograph 33:** Location P001-BA-028. The sample was collected from pipe wrap on floor. Analytical results indicate that the sample contains 57.10% chrysotile asbestos.

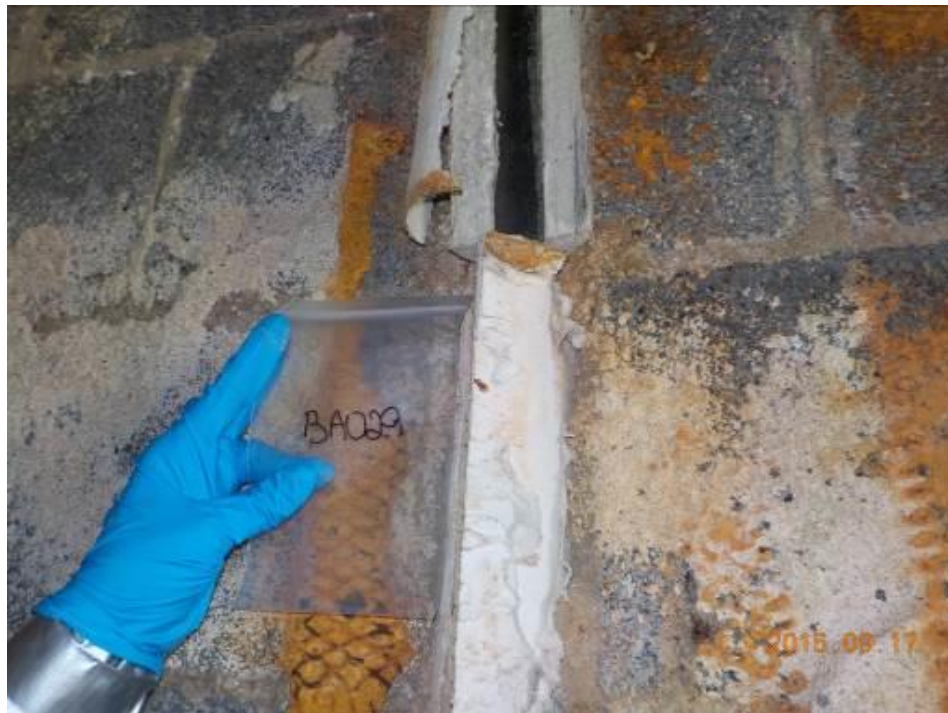
**Photograph 34:** Location P001-BA-029. The sample was collected from pipe wrap protruding from wall. The pipe is partially embedded in the wall. There is an adjacent pipe and pipe wrap similar to this. Several broken/open windows are located in the room. Analytical results indicate that the sample contains 30.80% chrysotile asbestos.

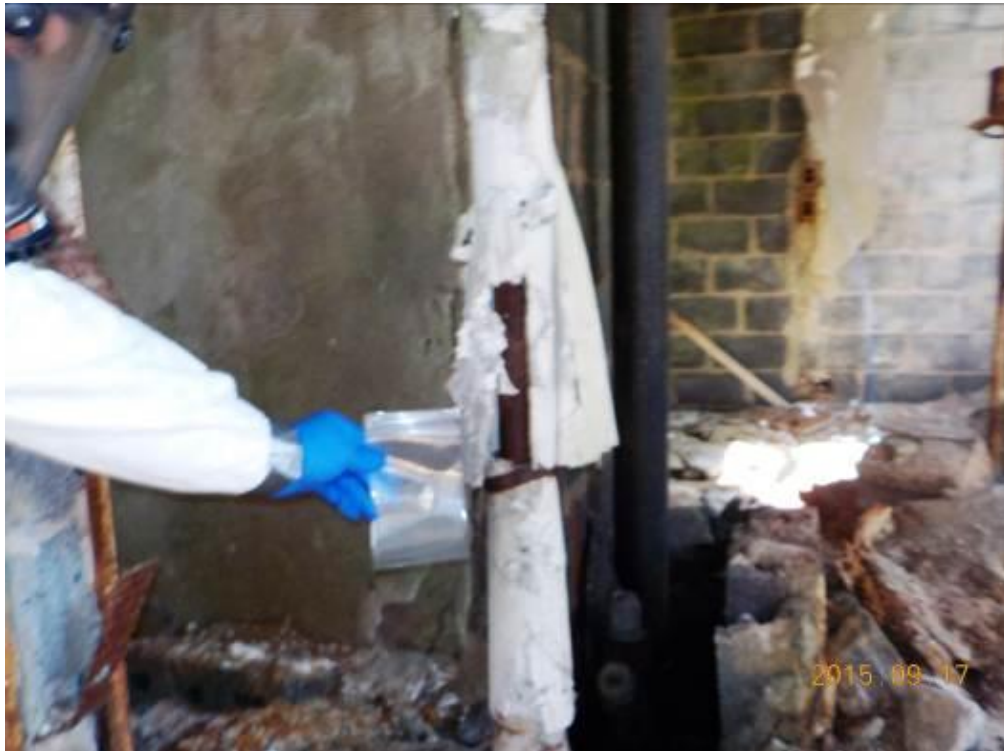
**Photograph 35:** Location P001-BA-030. The sample was collected from deteriorated pipe wrap on vertical pipe. Analytical results indicate that the sample contains 50.00% chrysotile asbestos.
