**Photographic Documentation Log**  
**Old Saratoga Hospital Site**  
**Providence Township, Saratoga County, New York**  
**August 4 and September 16 and 17, 2015**

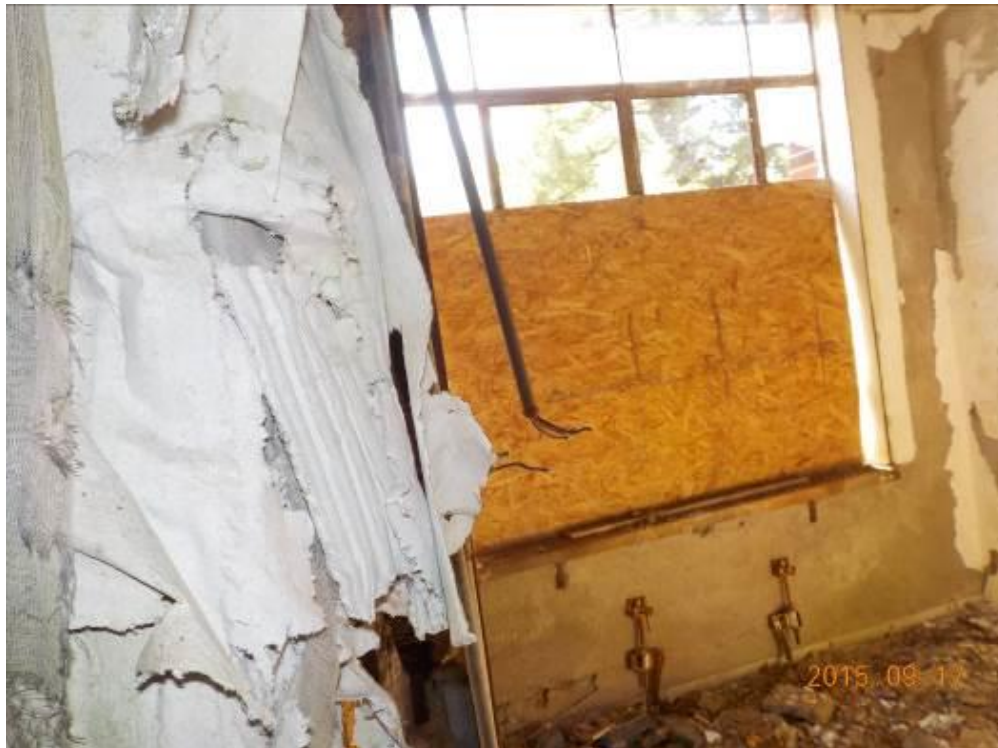
**Photograph 36:** The same room where sample P001-BA-030 was collected. There is an abundant amount of deteriorated pipe wrap in the room and a partially boarded up window.

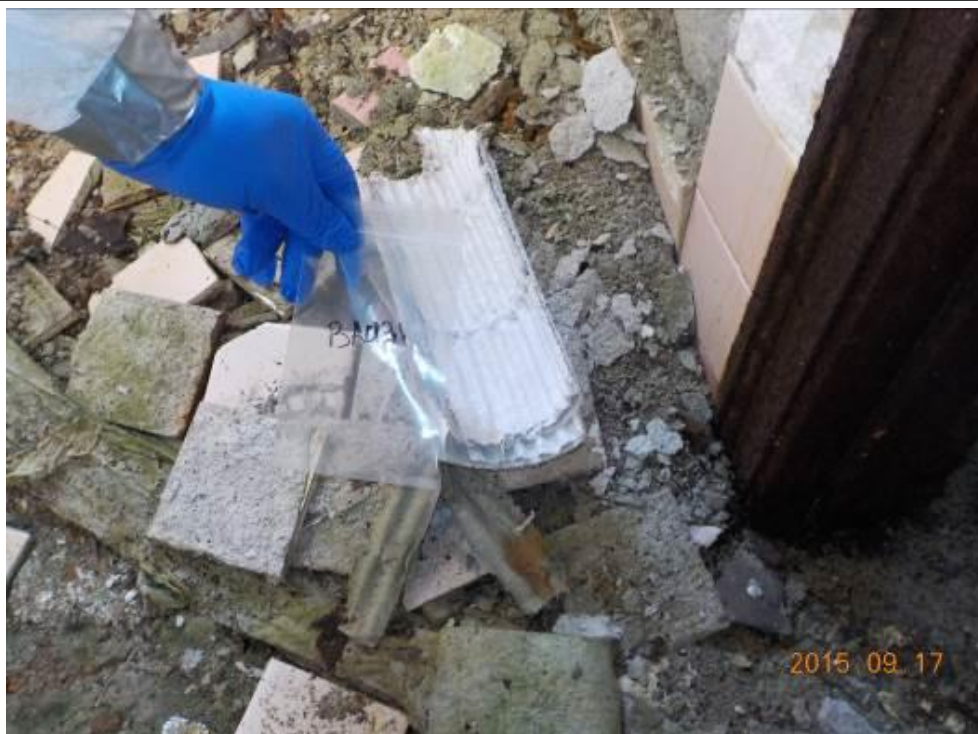
**Photograph 37:** Location P001-BA-031. The sample was collected from pipe wrap fallen onto floor from overhead pipe. Analytical results indicate that the sample contains 57.10% chrysotile asbestos.

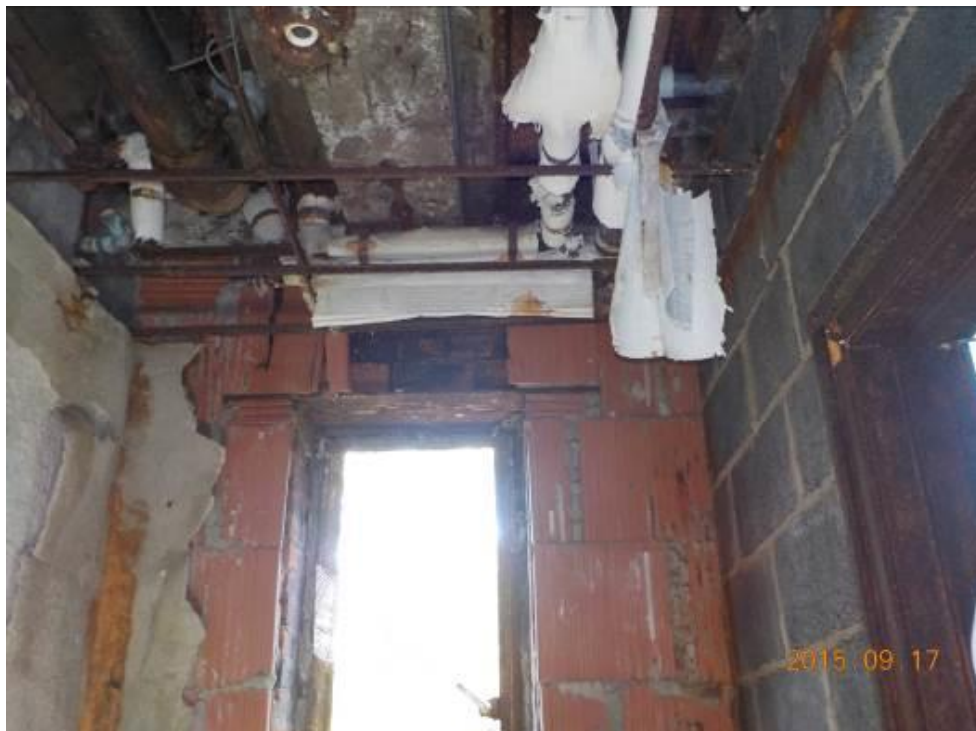
**Photograph 38:** The same room where sample P001-BA-031 was collected. There is an abundant amount of deteriorated pipe wrap in the room.

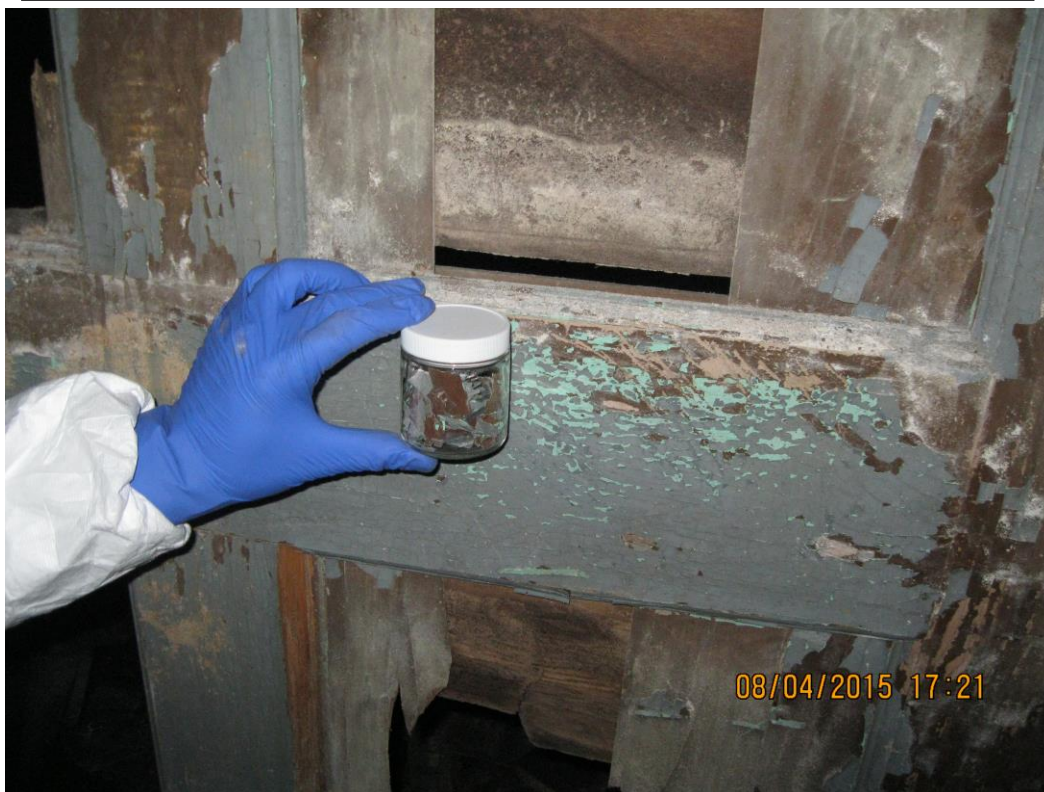
**Photograph 39:** Location P001-PC-001. The paint chip sample was collected in basement and analyzed for toxicity characteristic leaching procedure (TCLP) metal analysis (barium, cadmium, and lead only). The results were 127 J micrograms per liter ( $\mu\text{g/L}$ ) for barium, 26.6 J  $\mu\text{g/L}$  for cadmium, and 41,100  $\mu\text{g/L}$  for lead.
