**ENCLOSURE 3**  
**PHOTOGRAPHIC LOG**  
(32 Pages)

**Location:** Wrigley Charcoal Removal Action

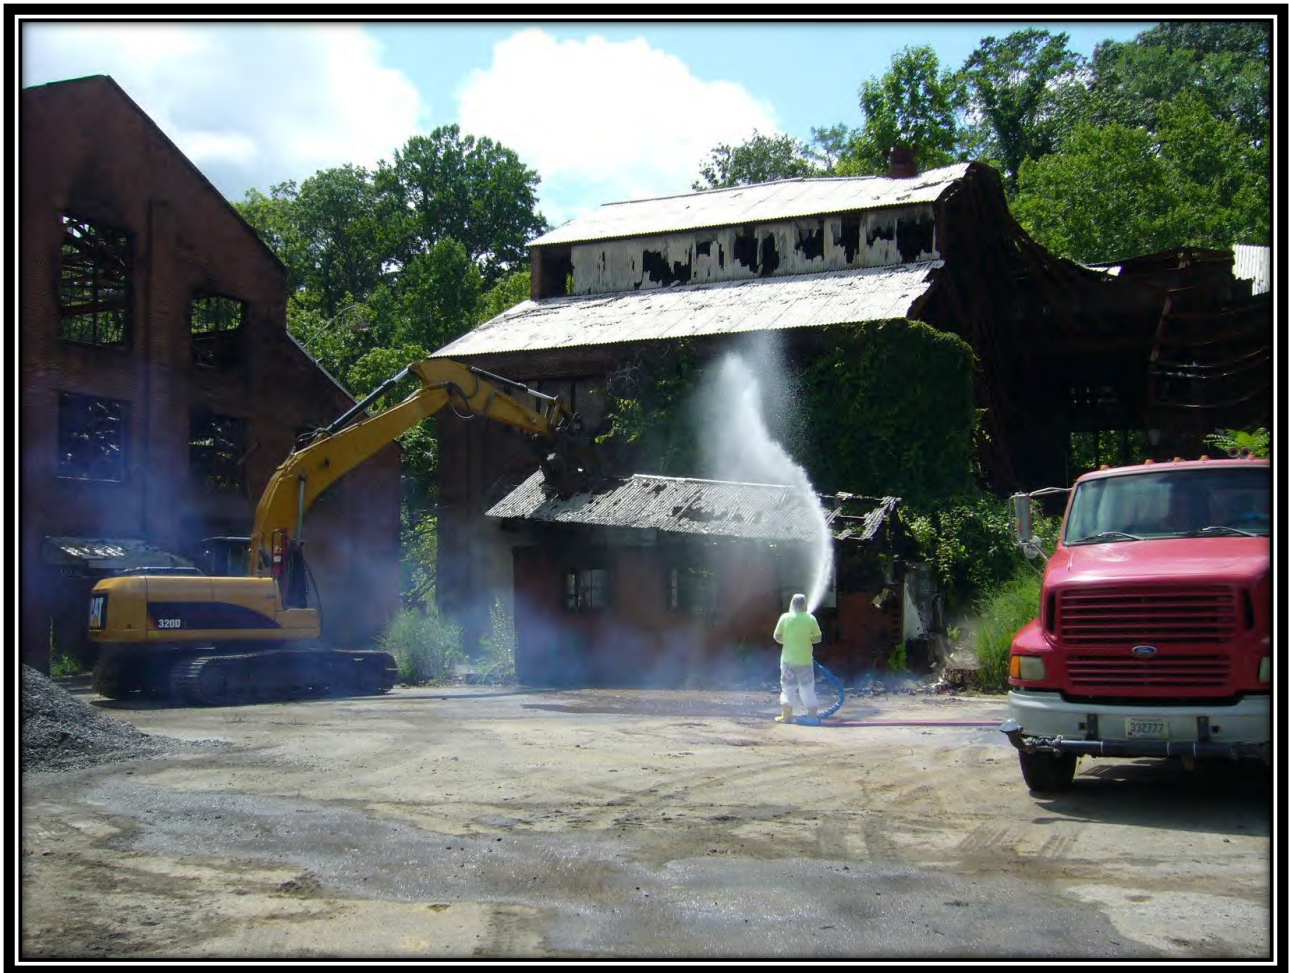
**OFFICIAL PHOTOGRAPH NO. 1**  
**U.S. ENVIRONMENTAL PROTECTION AGENCY**

**Subject:** CMC, Inc. (CMC), the U.S. Environmental Protection Agency (EPA) Emergency and Rapid Response Services (ERRS) contractor, used tracked excavators with shear and grapples attachments to demolish the small office building located southeast of the north building. CMC used water from the water truck to minimize the generation of airborne dust during demolition activities.

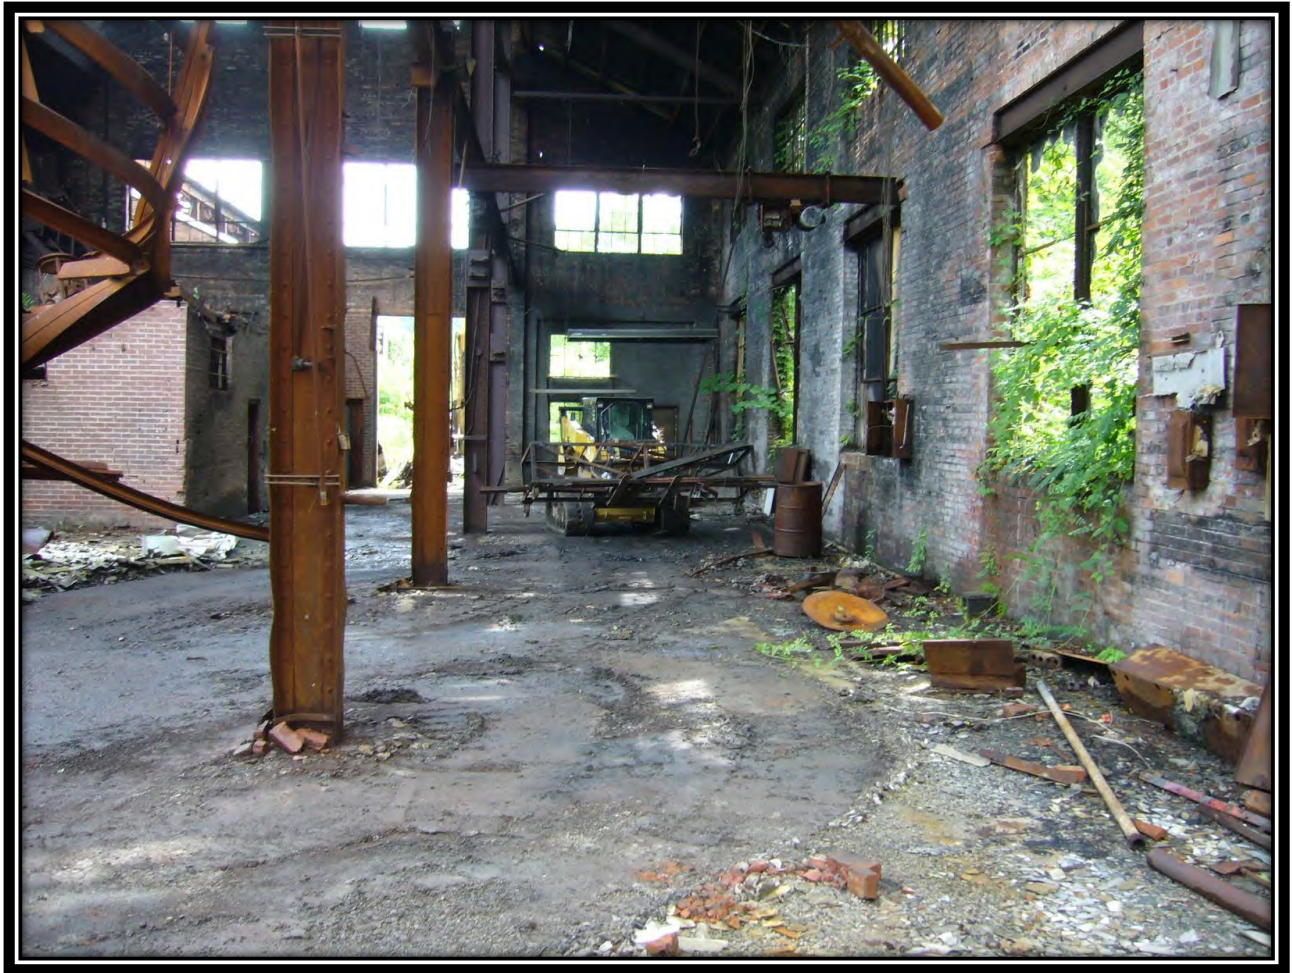
**OFFICIAL PHOTOGRAPH NO. 2**  
**U.S. ENVIRONMENTAL PROTECTION AGENCY**

**Subject:** CMC used a skid steer to remove asbestos-containing materials (ACM), asbestos-contaminated debris, and scrap metal from inside and outside of the north building prior to demolition.

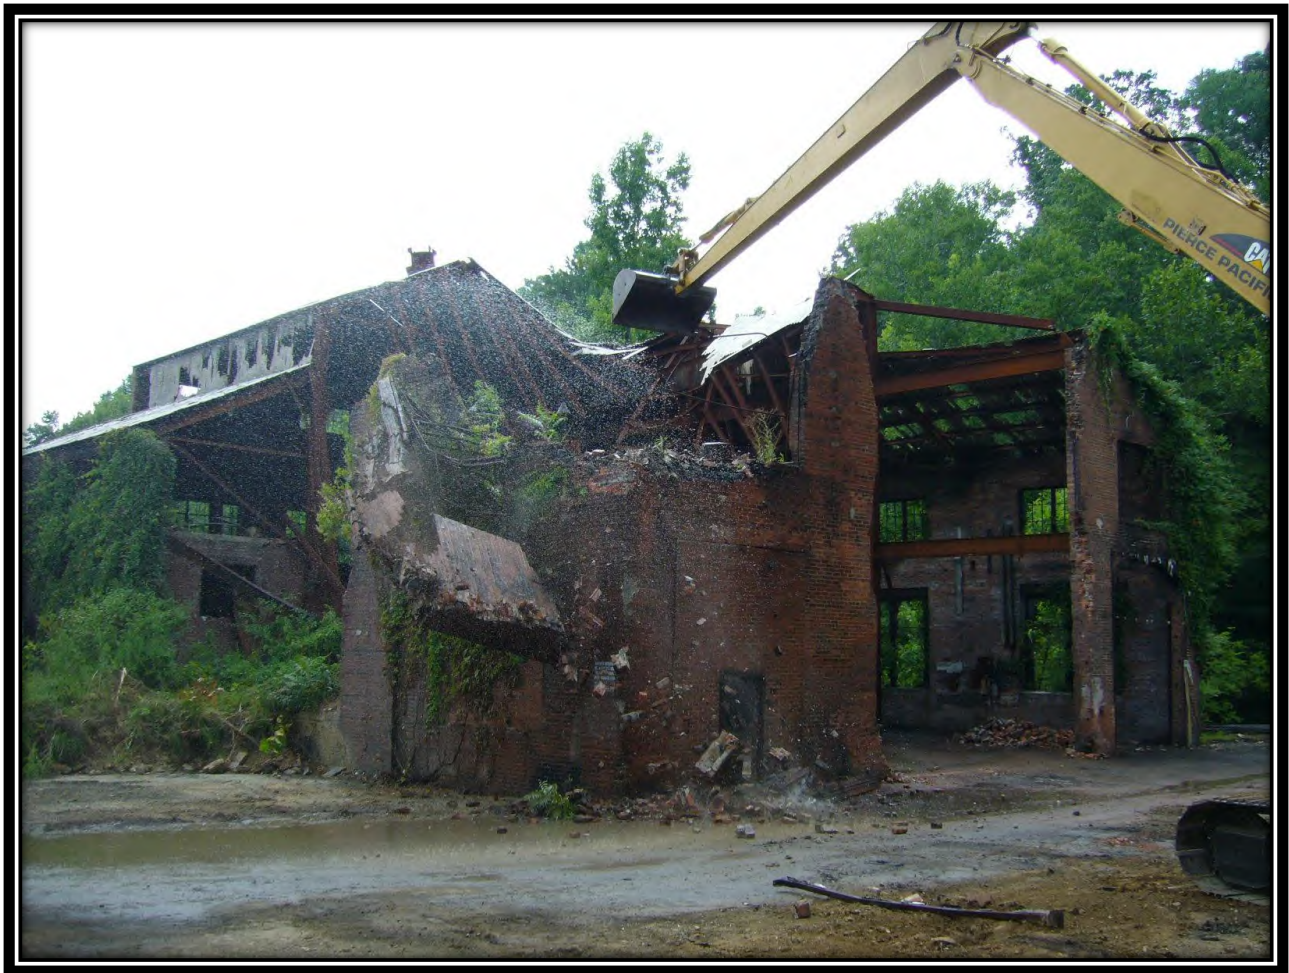
**OFFICIAL PHOTOGRAPH NO. 3**  
**U.S. ENVIRONMENTAL PROTECTION AGENCY**

**Subject:** CMC used a tracked excavator with a bucket attachment to demolish the northern wall of the north building. CMC used water from the water truck to minimize the generation of airborne dust during demolition activities.

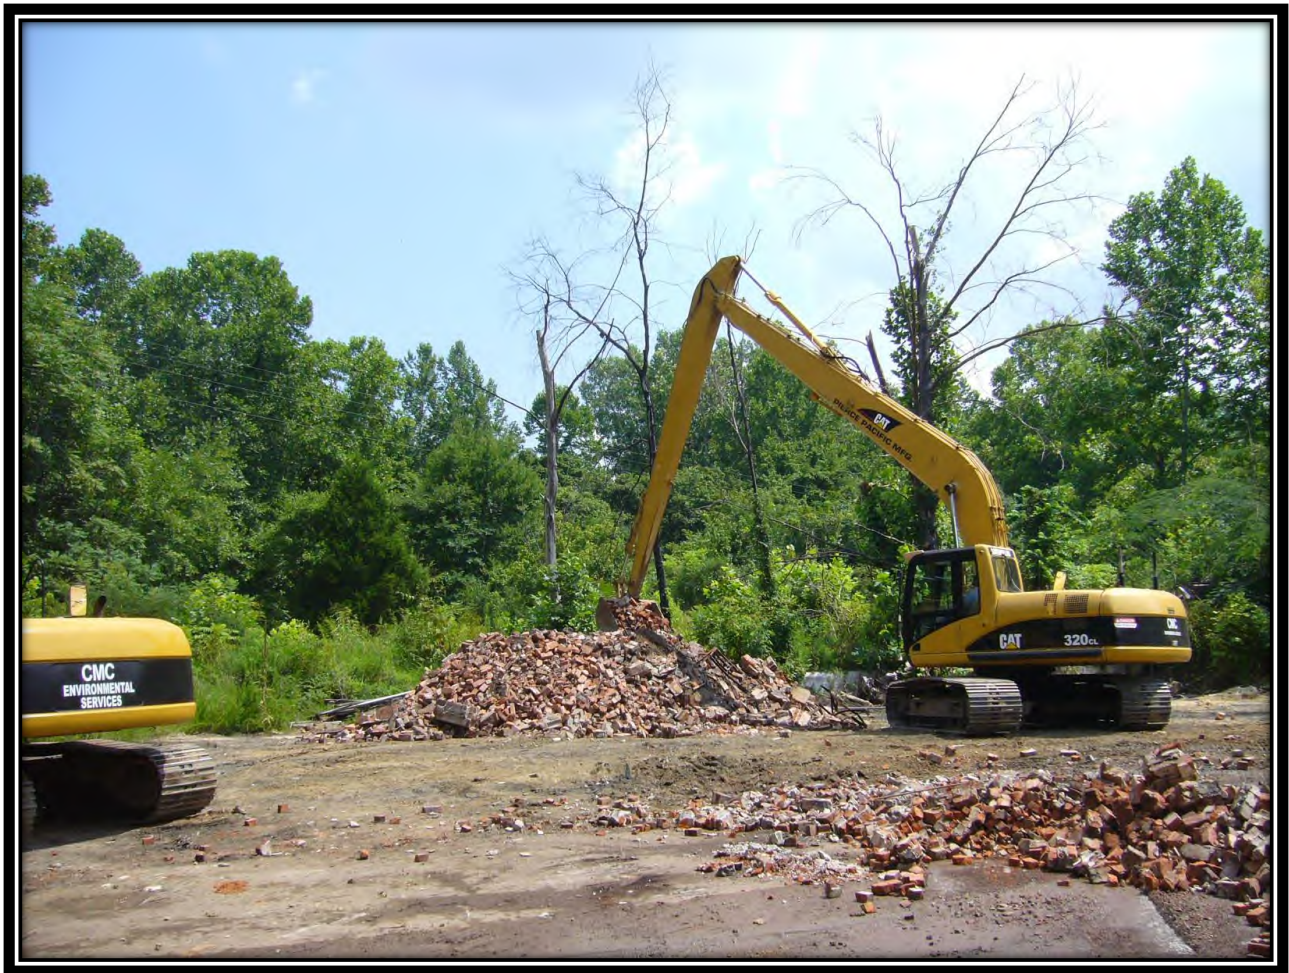
**OFFICIAL PHOTOGRAPH NO. 4  
U.S. ENVIRONMENTAL PROTECTION AGENCY**

**Subject:** A Tetra Tech START, State of Tennessee-accredited asbestos inspector and project monitor visually inspected the building debris associated with demolition activities. Demolition debris that Tetra Tech START did not observe to be mixed with ACM was placed in the north staging area.

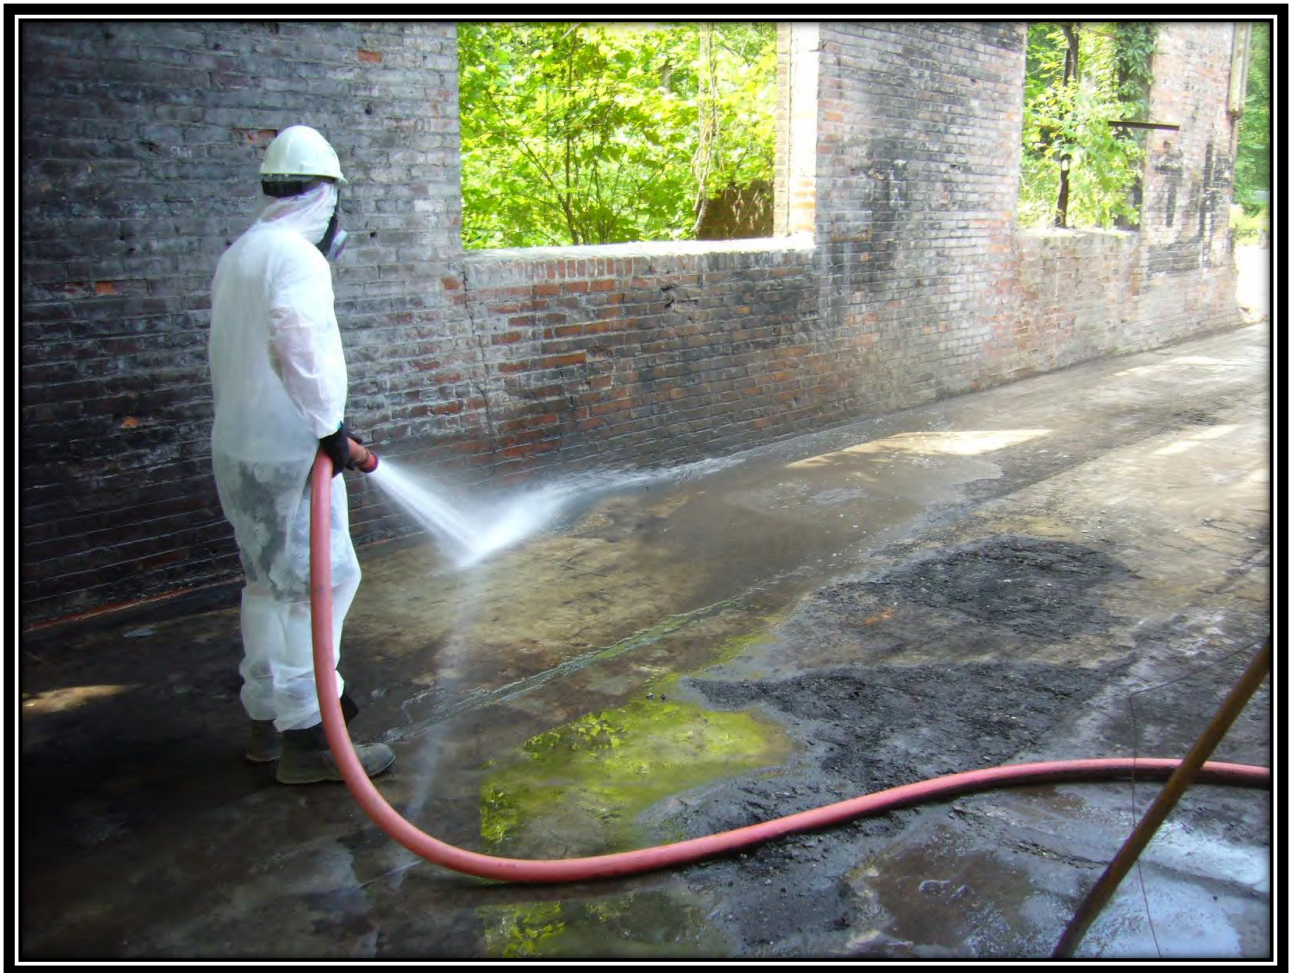
**OFFICIAL PHOTOGRAPH NO. 6**  
**U.S. ENVIRONMENTAL PROTECTION AGENCY**

**Subject:** CMC used water from the water truck to remove residual asbestos-contaminated debris from the building footprint prior to demolition.

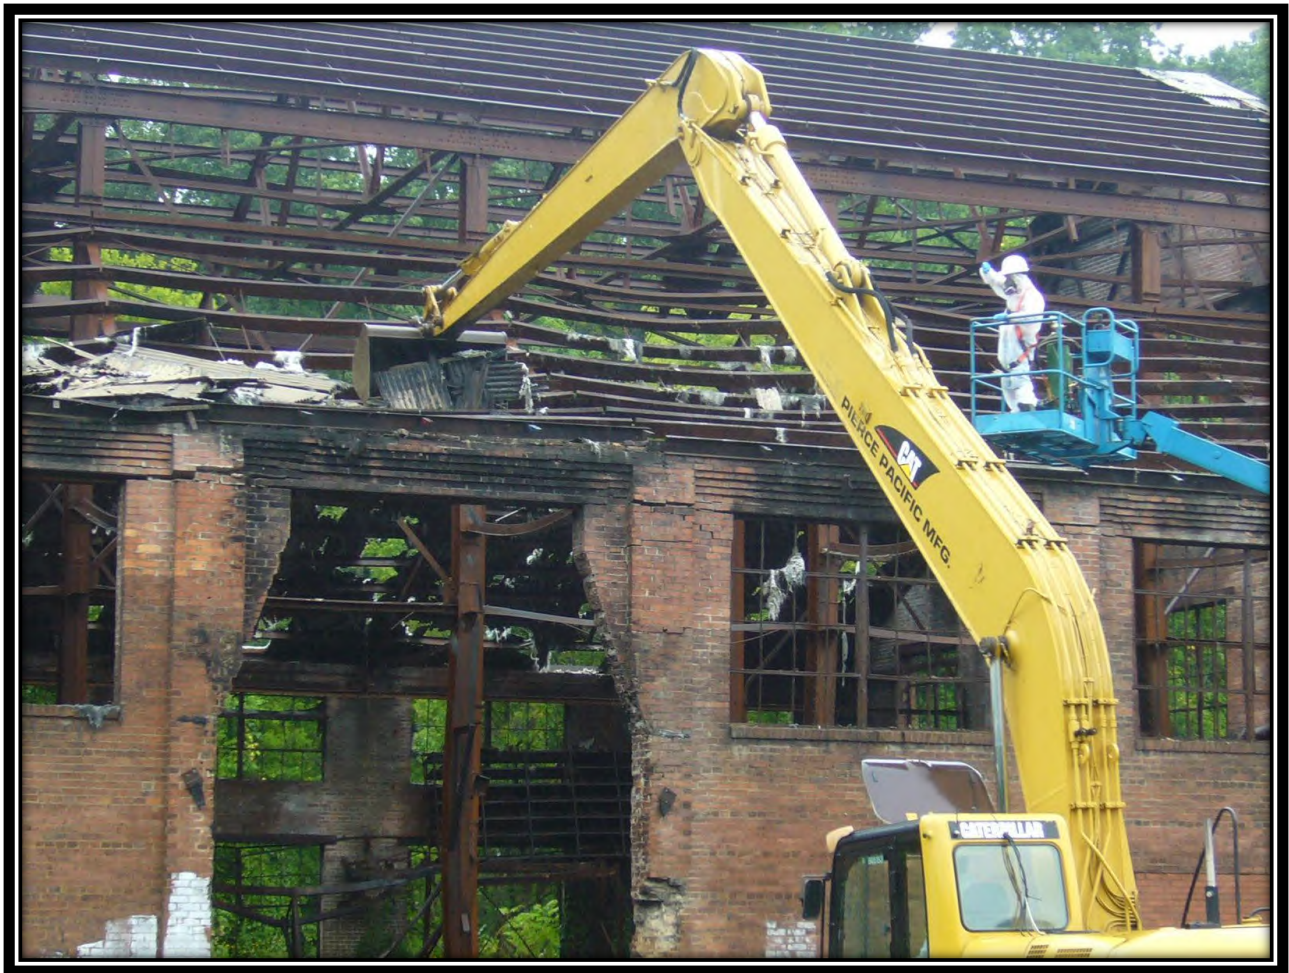
**OFFICIAL PHOTOGRAPH NO. 8**  
**U.S. ENVIRONMENTAL PROTECTION AGENCY**

**Subject:** CMC used a tracked excavator with a bucket attachment and manual scrapers to remove asbestos-containing roofing material from the eastern side of the south building.

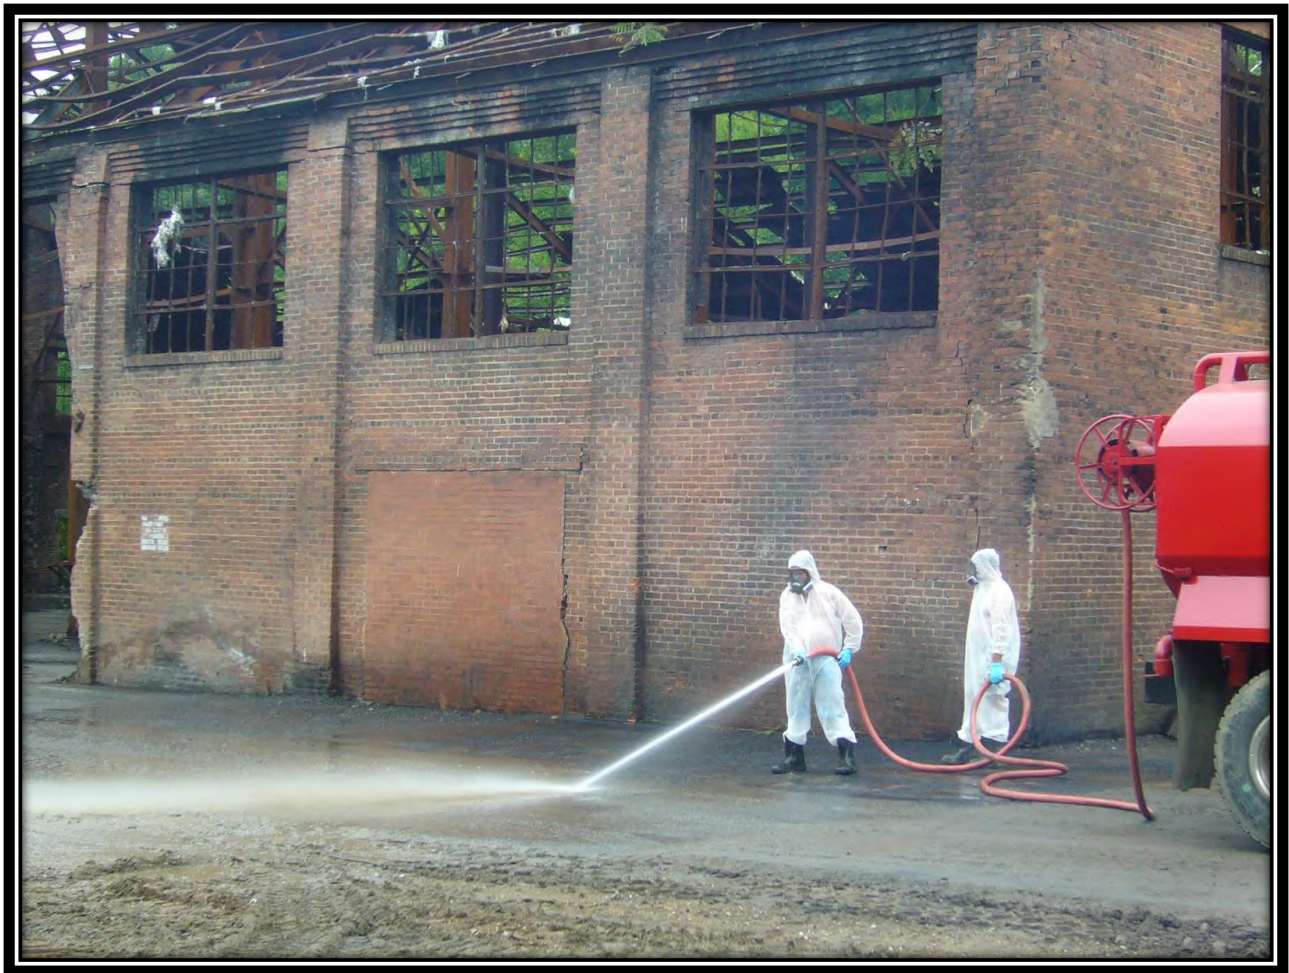
**OFFICIAL PHOTOGRAPH NO. 9**  
**U.S. ENVIRONMENTAL PROTECTION AGENCY**

**Subject:** CMC used water from the water truck to remove residual asbestos-contaminated debris from the roadways around the northern and eastern sides of the south building prior to demolition.

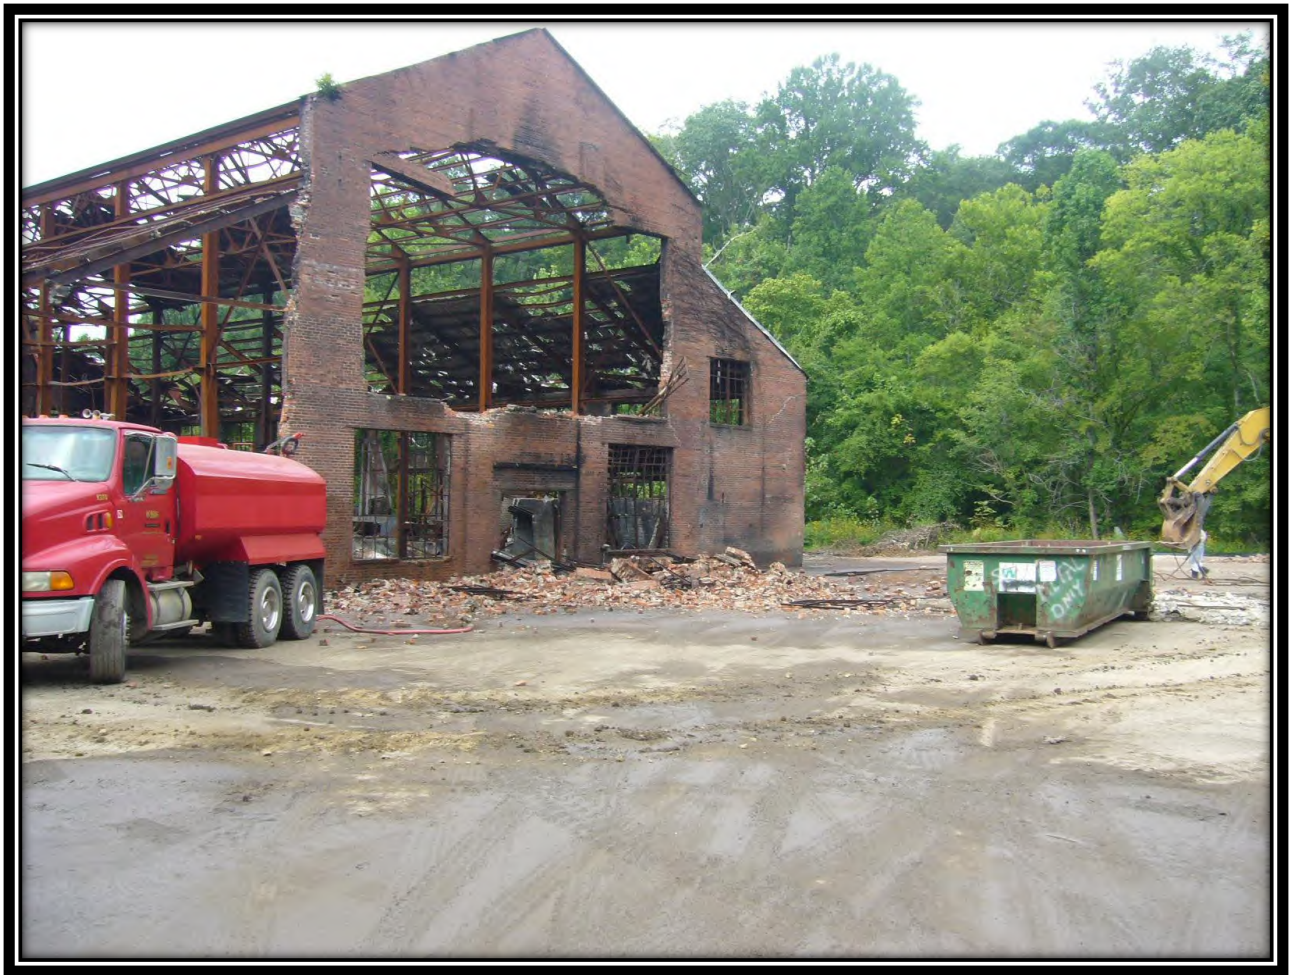
**OFFICIAL PHOTOGRAPH NO. 10**  
**U.S. ENVIRONMENTAL PROTECTION AGENCY**

**Subject:** CMC used tracked excavators with attached cables to demolish the northern wall of the south building.

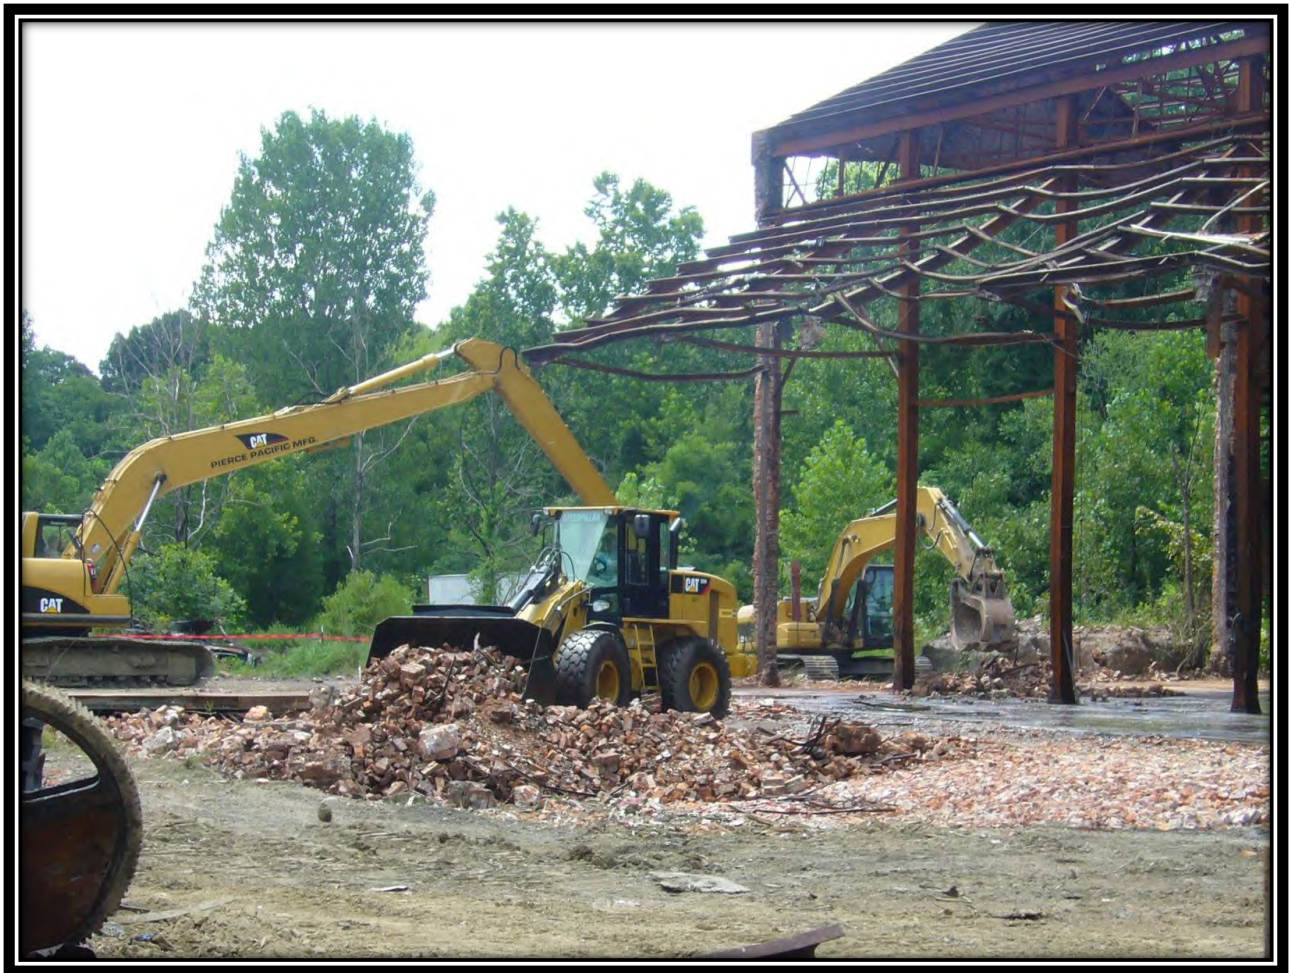
**OFFICIAL PHOTOGRAPH NO. 11  
U.S. ENVIRONMENTAL PROTECTION AGENCY**

**Subject:** A Tetra Tech START, State of Tennessee-accredited asbestos inspector and project monitor visually inspected building debris associated with demolition activities. Brick from demolition activities that Tetra Tech START did not observe to be mixed with ACM was placed in the depressed area located southeast of the south building, next to the loading dock.

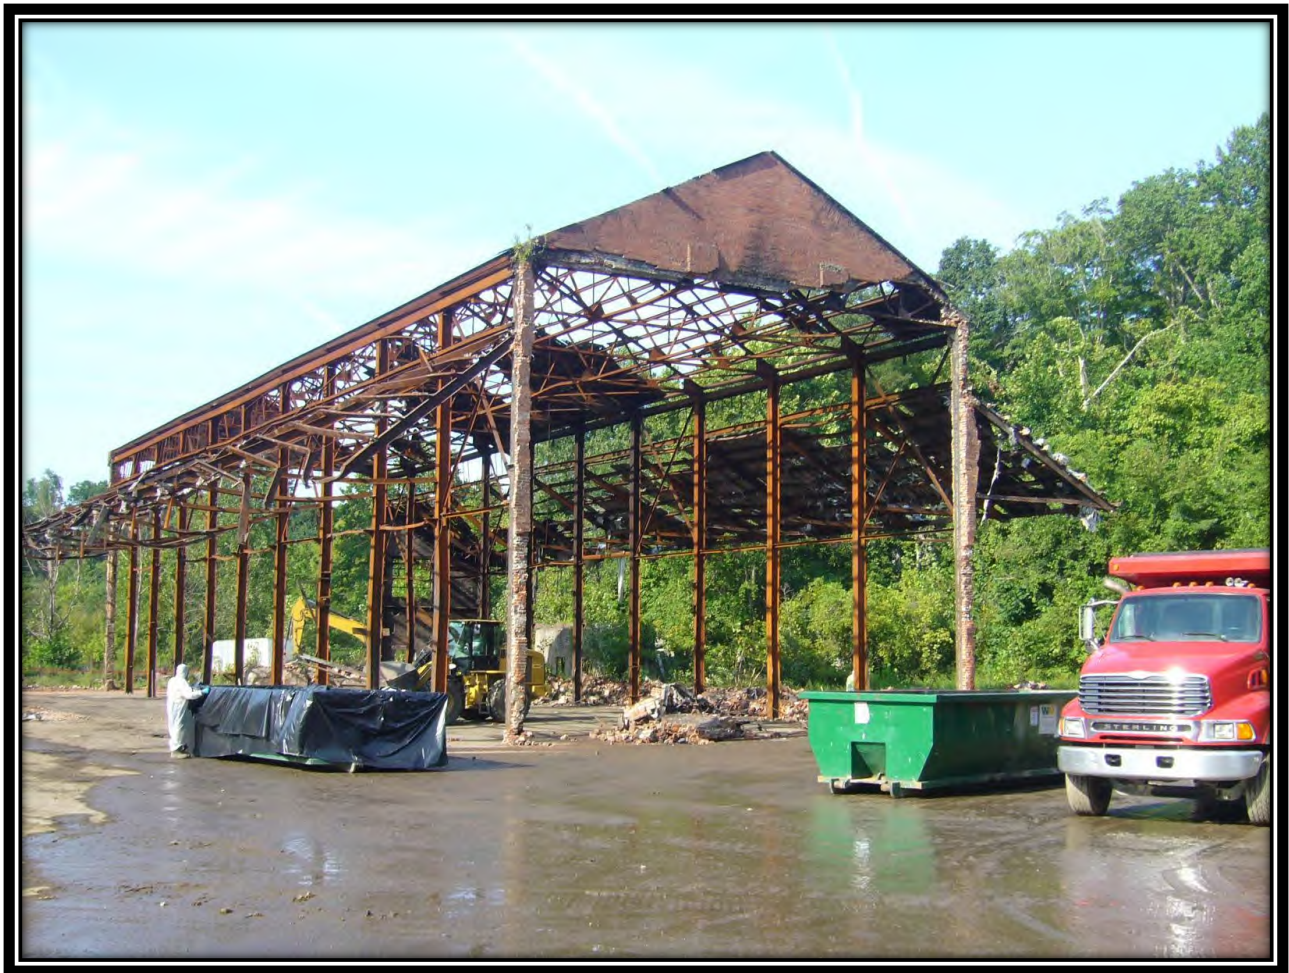
**OFFICIAL PHOTOGRAPH NO. 12  
U.S. ENVIRONMENTAL PROTECTION AGENCY**

**Subject:** Demolition debris observed mixed with ACM was placed in rolloff containers lined with two layers of six-mil plastic sheeting for transport to and disposal at a State of Tennessee-approved asbestos landfill.

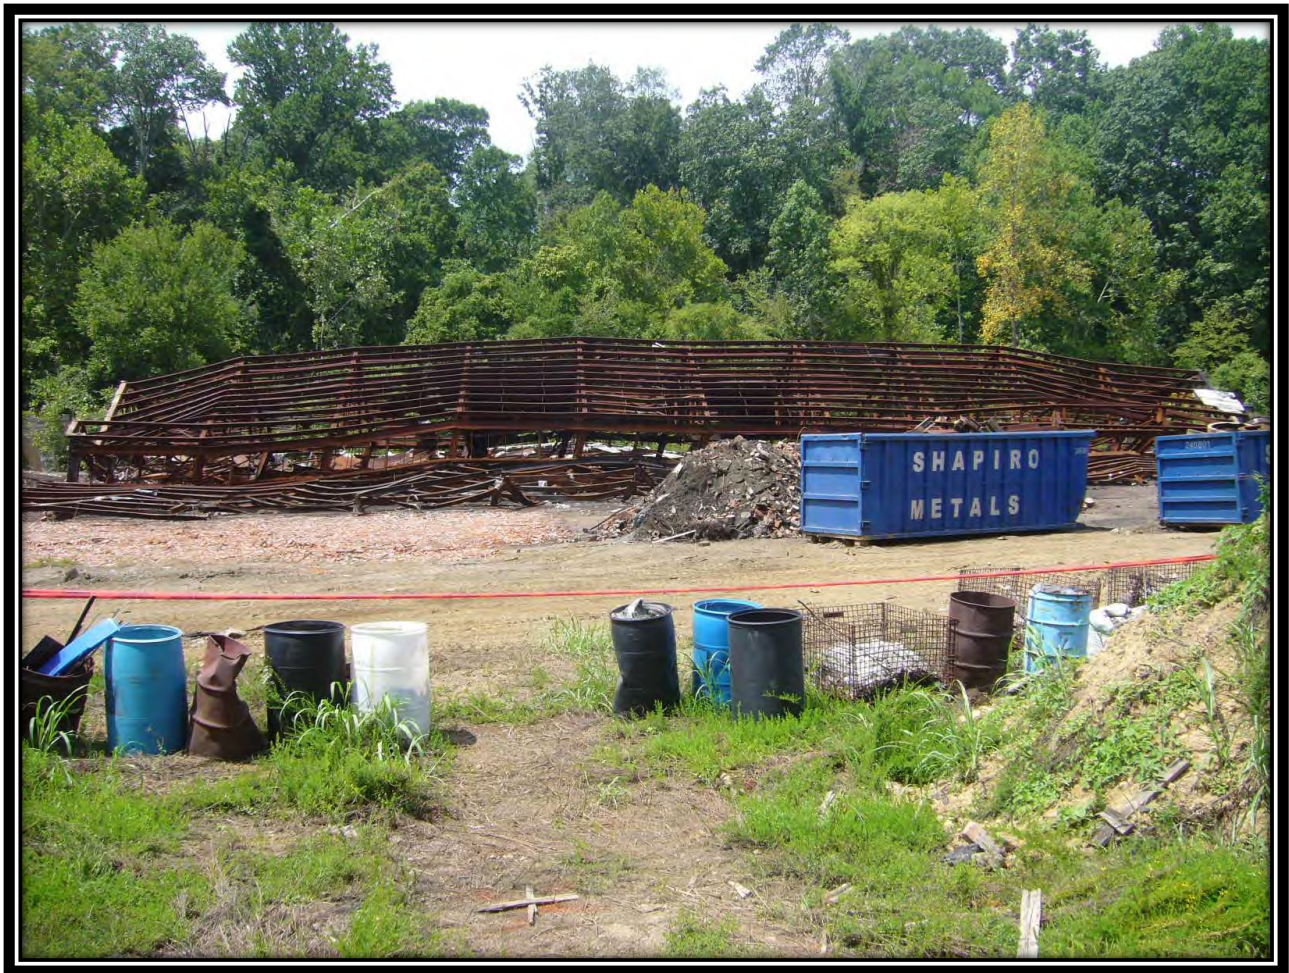
**OFFICIAL PHOTOGRAPH NO. 13**  
**U.S. ENVIRONMENTAL PROTECTION AGENCY**

**Subject:** The structural steel was torch cut and tracked excavators with cables attached to the northern wall were used to pull down the structural framework of the south building.

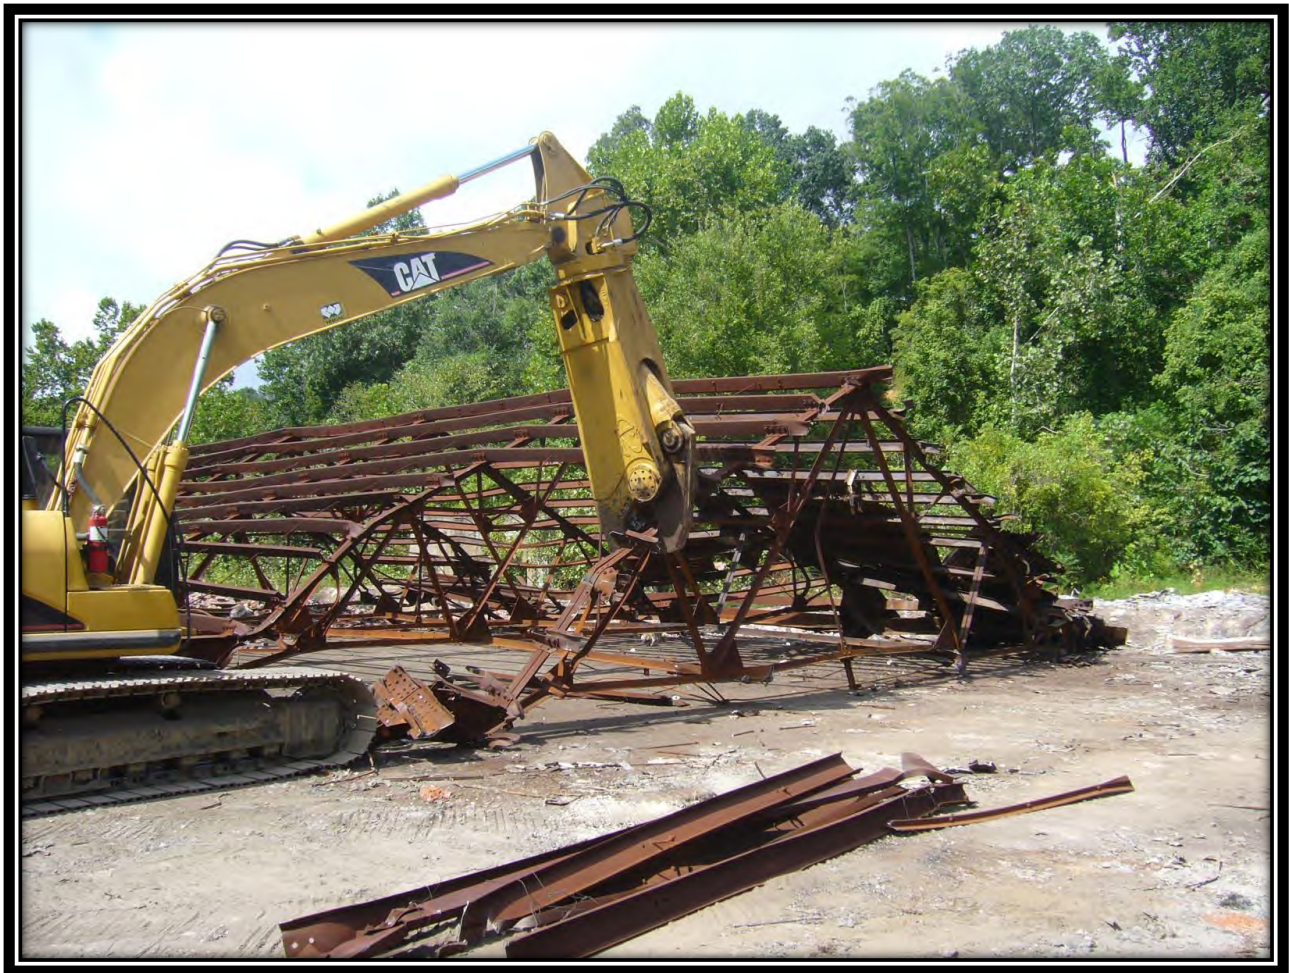
**OFFICIAL PHOTOGRAPH NO. 14  
U.S. ENVIRONMENTAL PROTECTION AGENCY**

**Subject:** CMC used a tracked excavator with a shear attachment to dismantle the structural framework of the south building. The structural steel was staged, decontaminated, loaded, and transported off site for recycling.

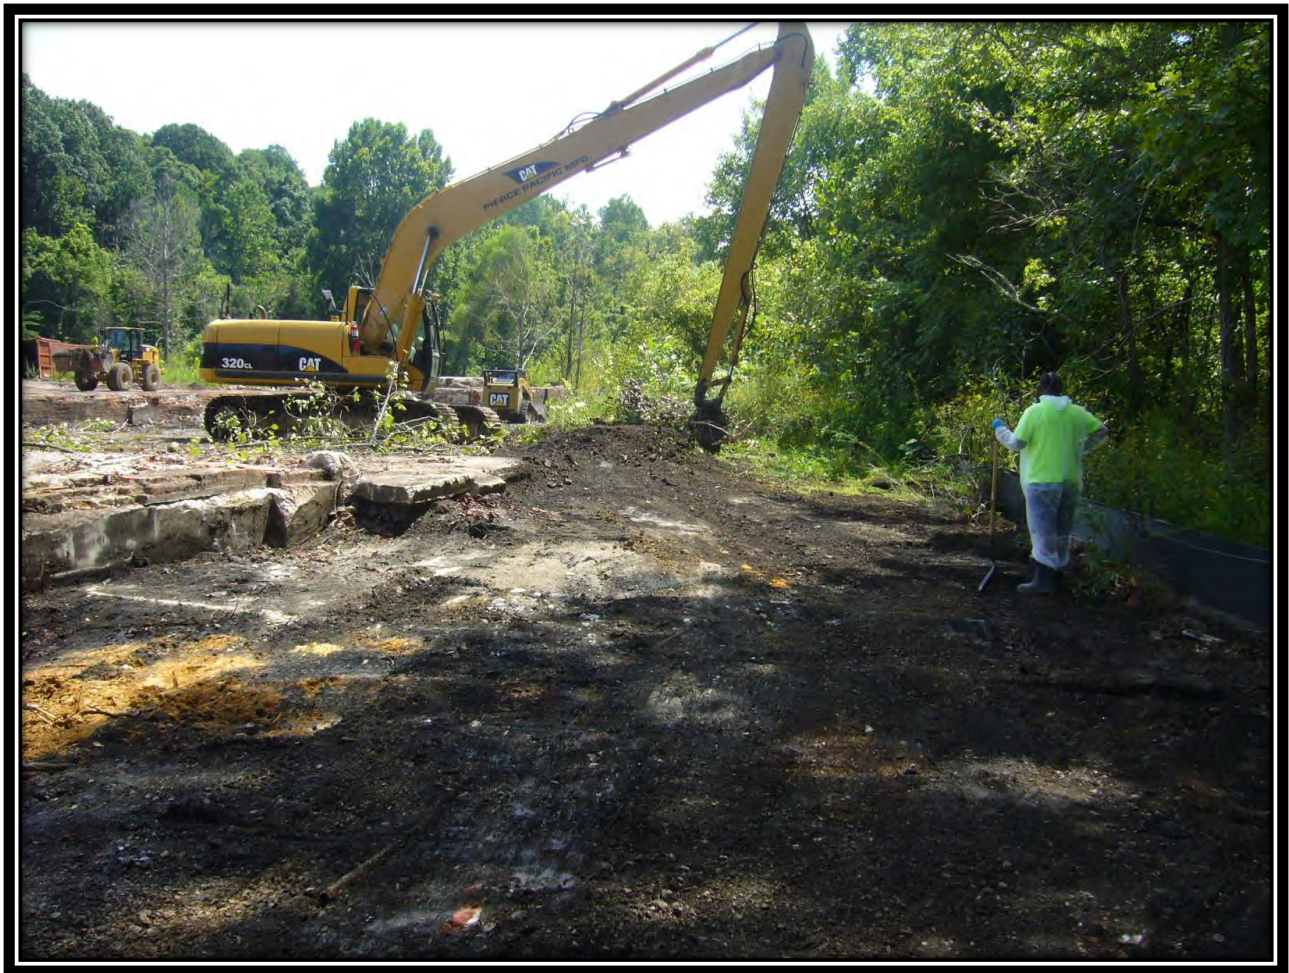
**OFFICIAL PHOTOGRAPH NO. 15**  
**U.S. ENVIRONMENTAL PROTECTION AGENCY**

**Subject:** CMC used a tracked excavator with a bucket attachment to remove asbestos-contaminated soil from the western side of the site.

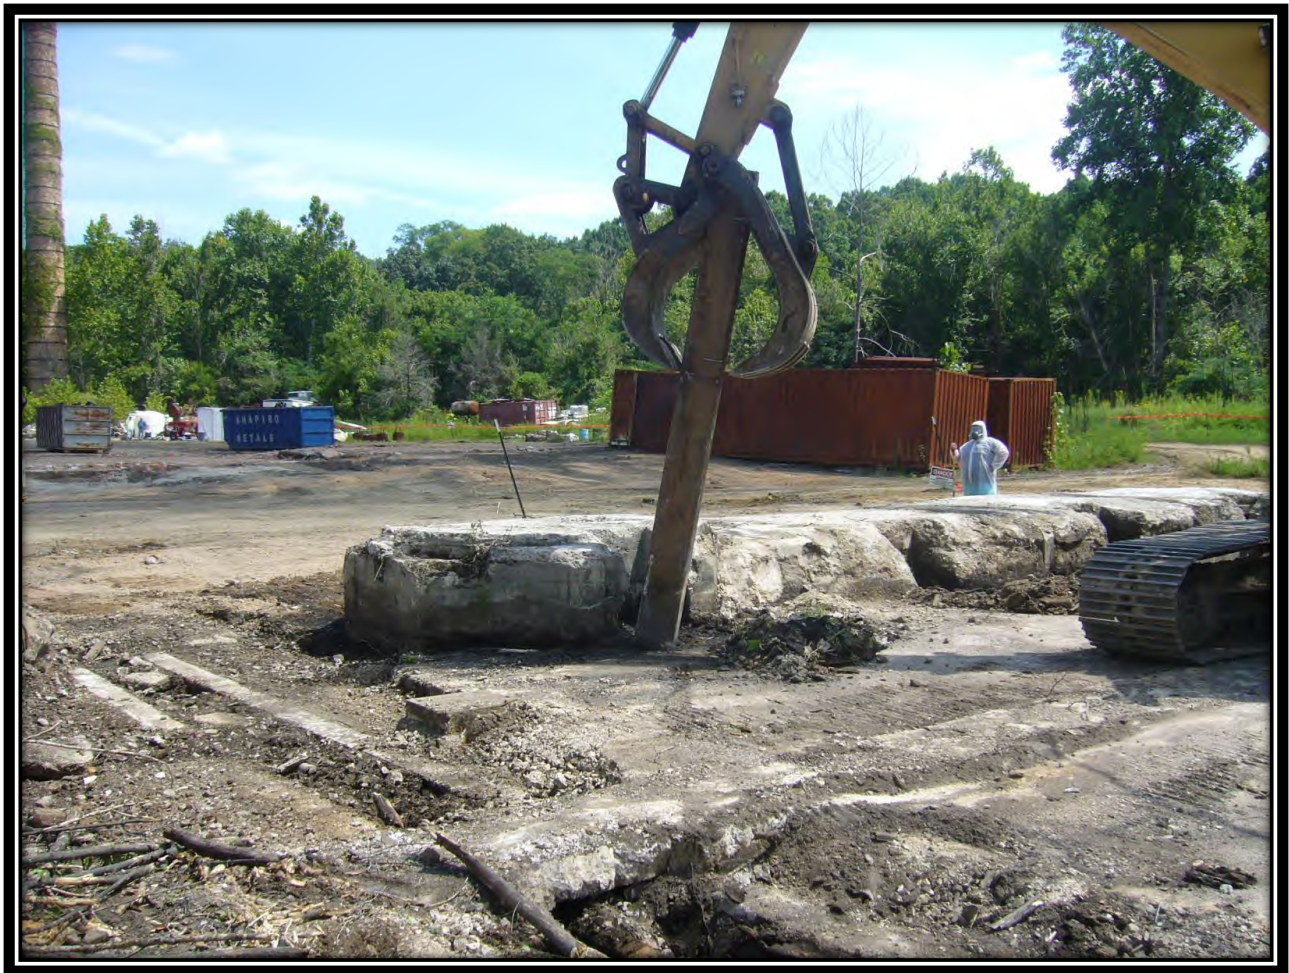
**OFFICIAL PHOTOGRAPH NO. 16  
U.S. ENVIRONMENTAL PROTECTION AGENCY**

**Subject:** CMC used a tracked excavator with a bucket attachment to remove asbestos-contaminated soil from the southern end of the site. CMC discovered a former building footprint and a trench in Grids 26 and 27 during excavation activities.

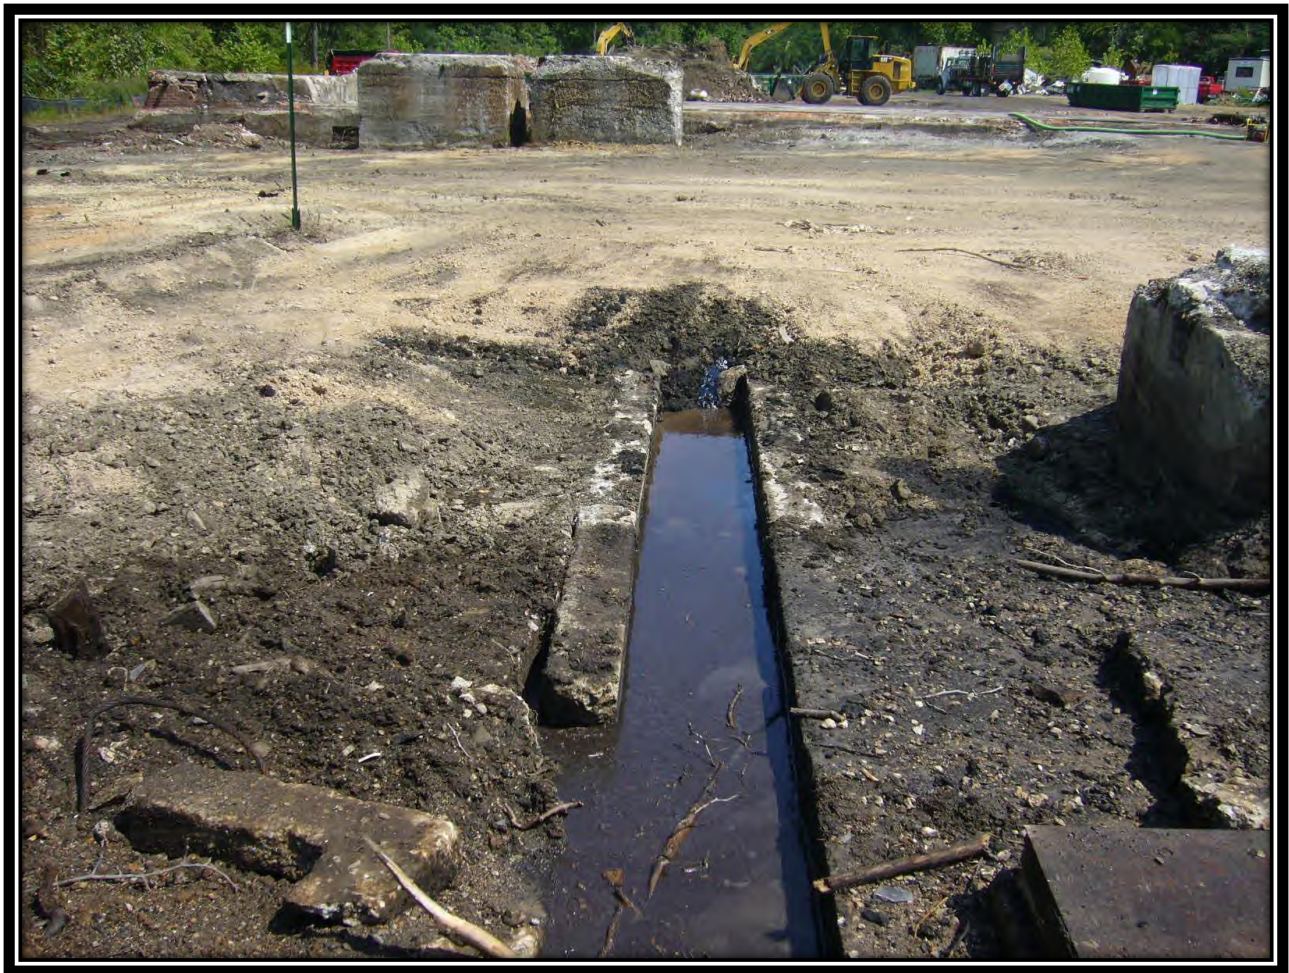
**OFFICIAL PHOTOGRAPH NO. 17**  
**U.S. ENVIRONMENTAL PROTECTION AGENCY**

**Subject:** CMC observed a black, tar-like sludge at the northern end of the trench during excavation activities. CMC ceased excavation of the trench and notified the EPA On-Scene Coordinator (OSC) of the discovery.

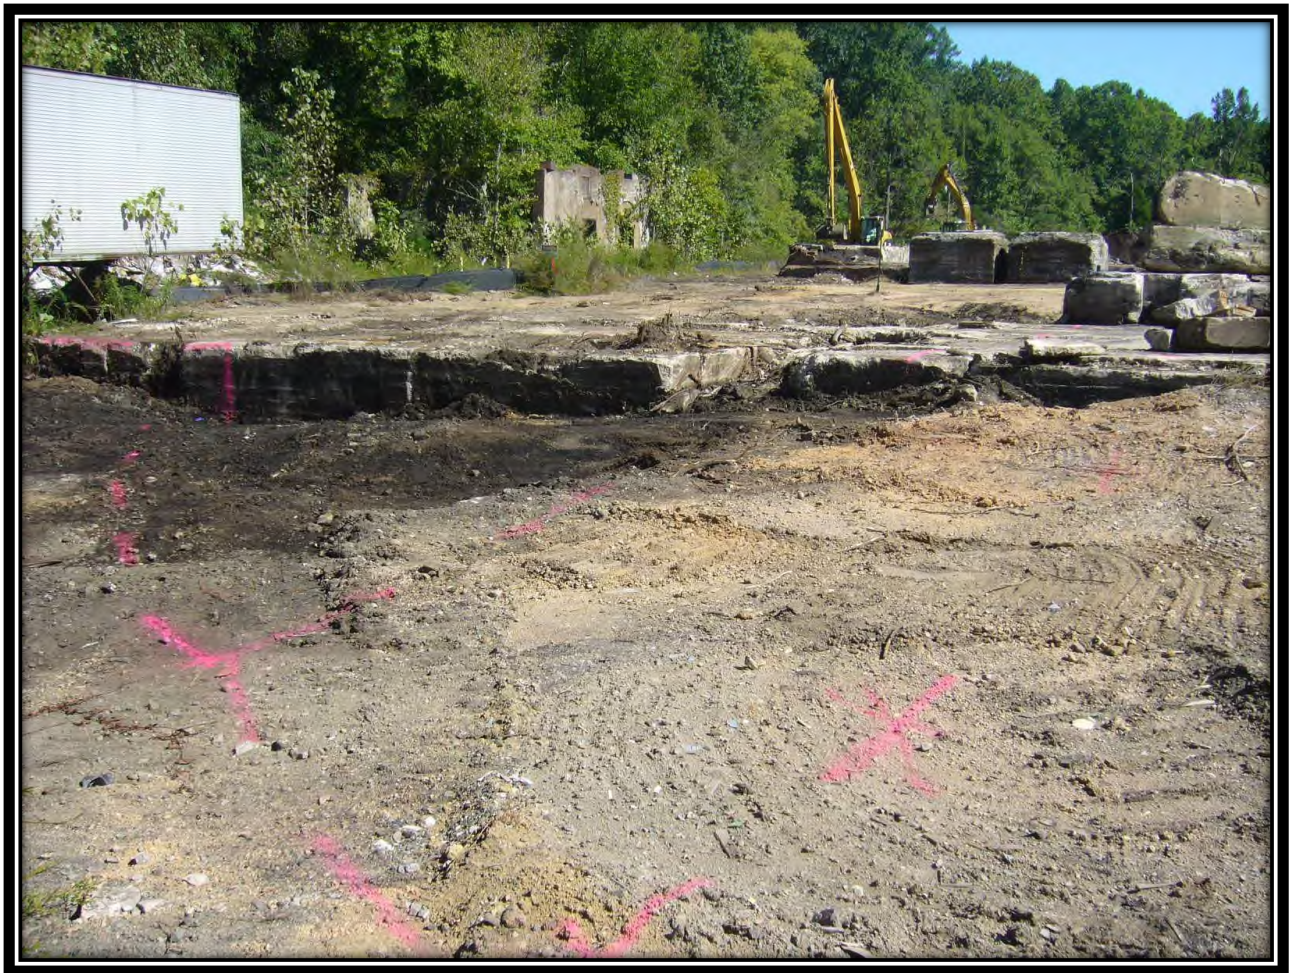
**OFFICIAL PHOTOGRAPH NO. 18  
U.S. ENVIRONMENTAL PROTECTION AGENCY**

**Subject:** CMC excavated asbestos-contaminated soil, identified from a previous assessment or during removal activities, from areas located at the southern and western sides of the site. A Tetra Tech START, State of Tennessee-accredited asbestos inspector and project monitor delineated each grid with marking paint and conducted visual inspections of the areas. If Tetra Tech START observed ACM during a visual inspection, CMC conducted additional soil excavation in each identified area. Asbestos-contaminated soil was placed in lined rolloff containers for transport and disposal off site.

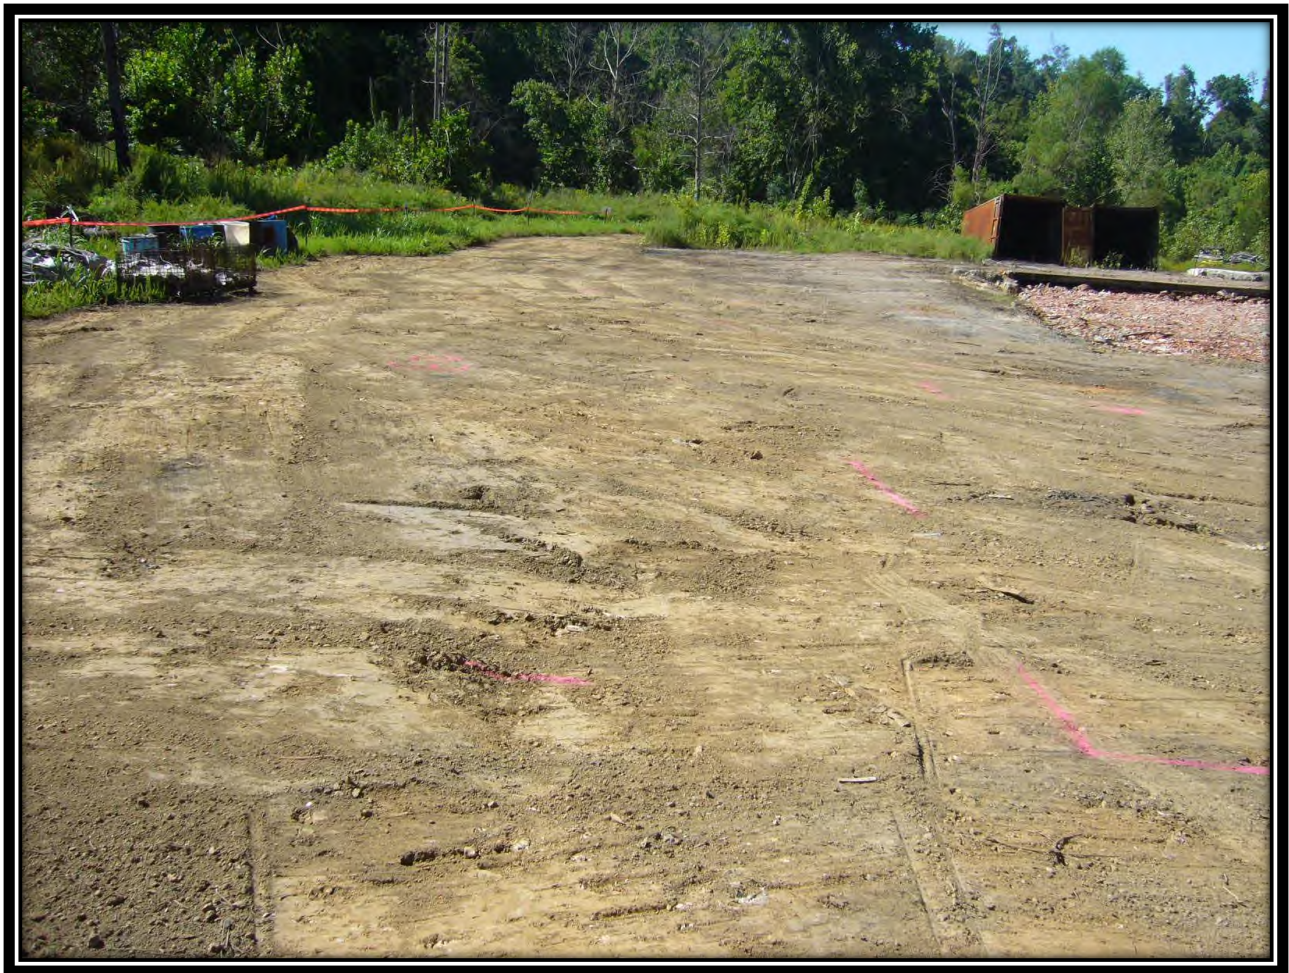
**OFFICIAL PHOTOGRAPH NO. 19  
U.S. ENVIRONMENTAL PROTECTION AGENCY**

**Subject:** CMC excavated soil from areas used for staging or traveled by site equipment located at the northern and eastern sides of the site, respectively. Soil from these areas was placed in lined rolloff containers for transport and disposal off site. A Tetra Tech START, State of Tennessee-accredited asbestos inspector and project monitor delineated each grid with marking paint and conducted visual inspections of the areas. Tetra Tech START did not observe ACM during the visual inspection of these areas and additional soil excavation was not required.
