**ENCLOSURE 3**  
**PHOTOGRAPHIC LOG**  
(32 Pages)

**Location:** Wrigley Charcoal Removal Action

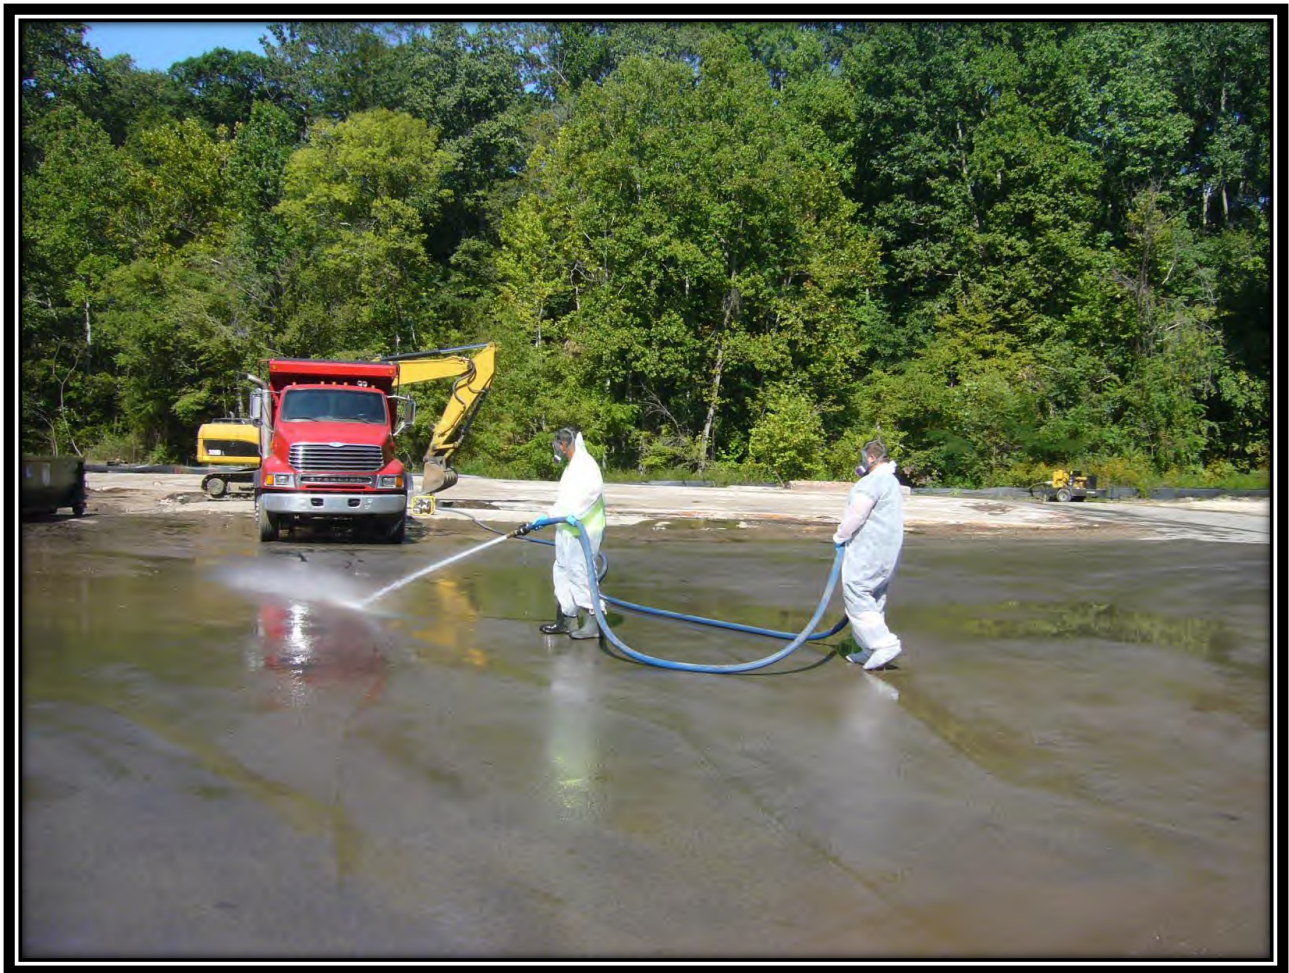
**OFFICIAL PHOTOGRAPH NO. 20  
U.S. ENVIRONMENTAL PROTECTION AGENCY**

**Subject:** CMC used water from the water truck to remove residual asbestos-containing debris from the roadways and building footprints. Pooled residual asbestos-contaminated debris was removed and placed in lined rolloff containers for transport and disposal off site.

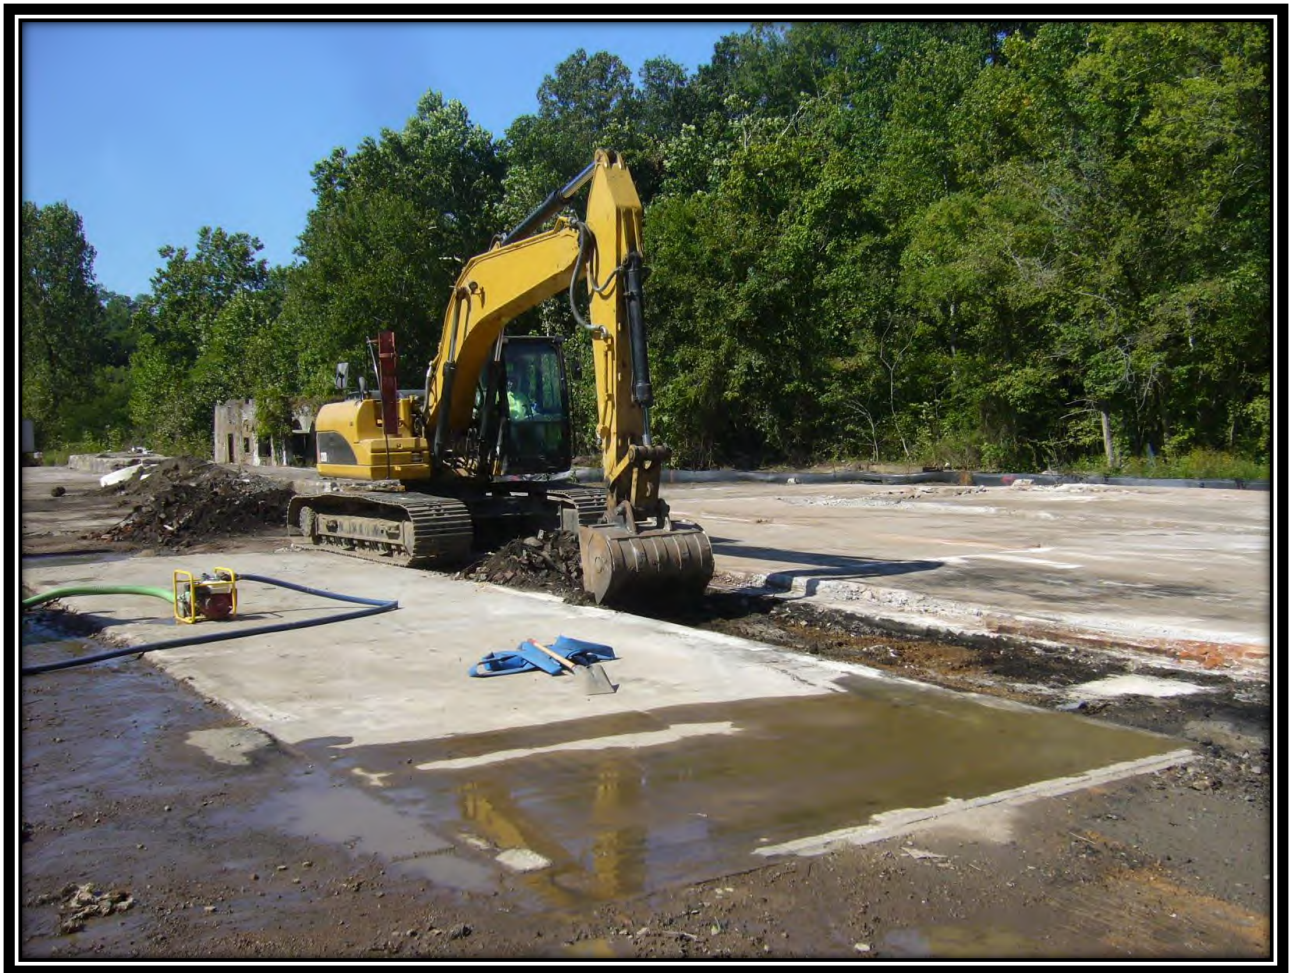
**OFFICIAL PHOTOGRAPH NO. 21  
U.S. ENVIRONMENTAL PROTECTION AGENCY**

**Subject:** A Tetra Tech START, State of Tennessee-accredited asbestos inspector and project monitor visually inspected excavated areas located between the building footprints. If Tetra Tech START observed ACM during the visual inspection, CMC conducted additional soil excavation in each identified area. Asbestos-contaminated soil was placed in lined rolloff containers for transport and disposal off site.

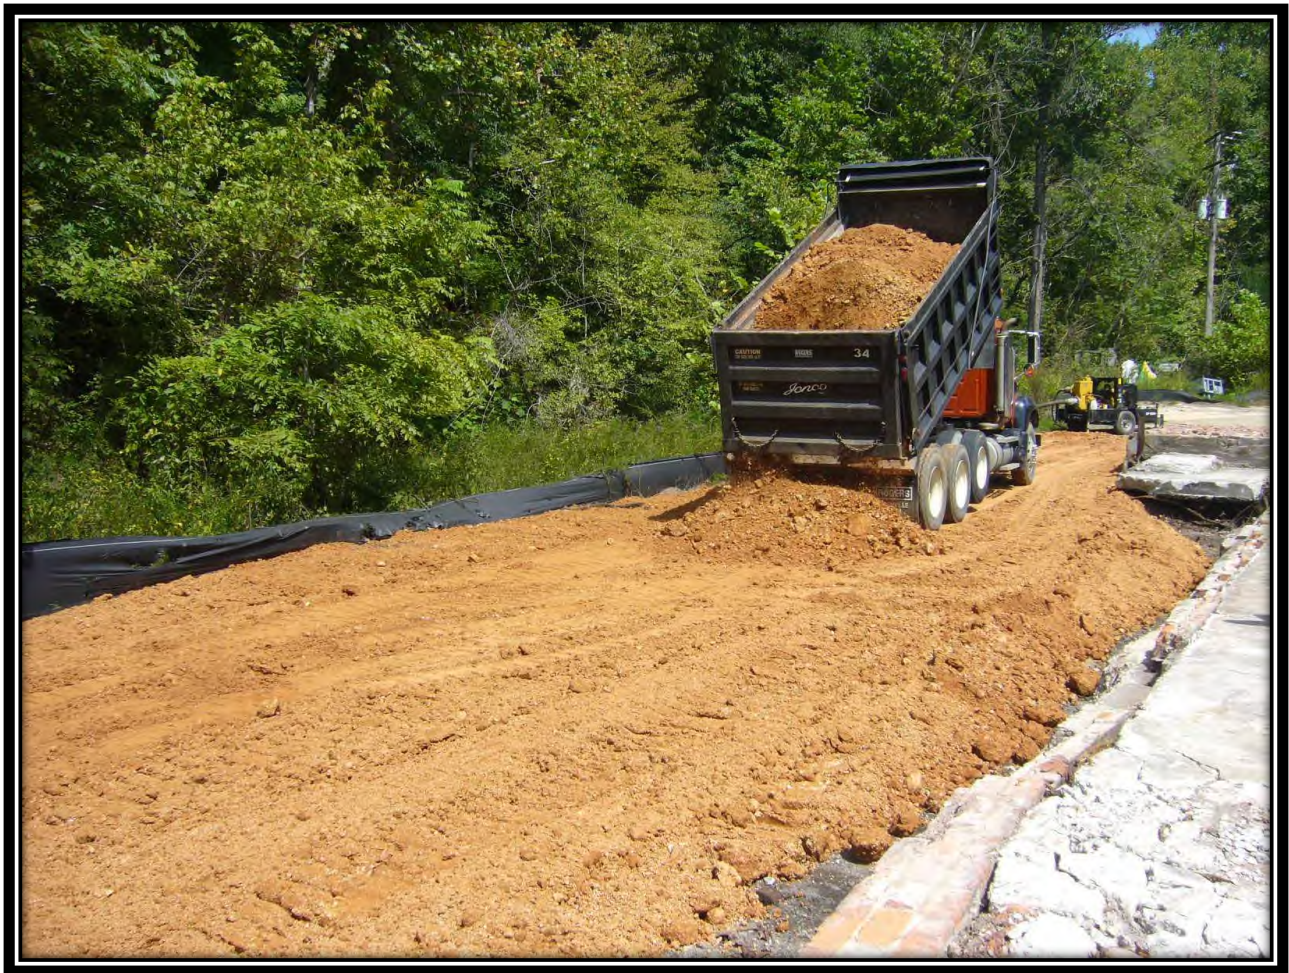
**OFFICIAL PHOTOGRAPH NO. 22**  
**U.S. ENVIRONMENTAL PROTECTION AGENCY**

**Subject:** Composite soil sampling results indicated the presence of asbestos in the excavated removal areas, identified from a previous assessment and during removal activities, located around the perimeter of the site. CMC covered these excavated areas with six inches of backfill soil. Sixty-nine truckloads of backfill soil were provided by Jenco Construction, Inc., located in Bon Aqua, Tennessee.

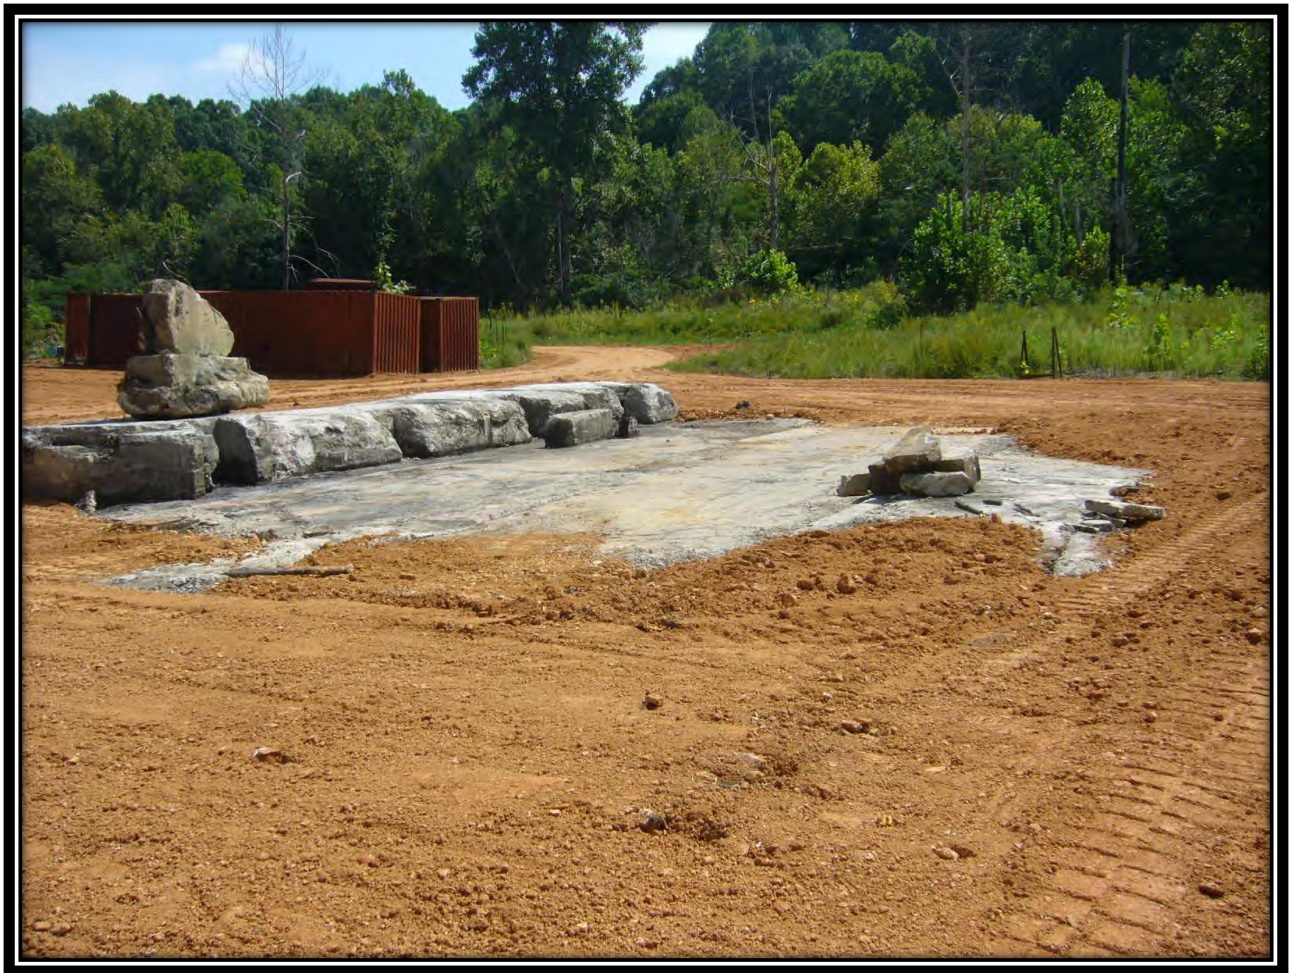
**OFFICIAL PHOTOGRAPH NO. 23**  
**U.S. ENVIRONMENTAL PROTECTION AGENCY**

**Subject:** The trench and those areas located at the southern end of the site requiring additional excavation were backfilled with additional soil and graded to the original elevation.

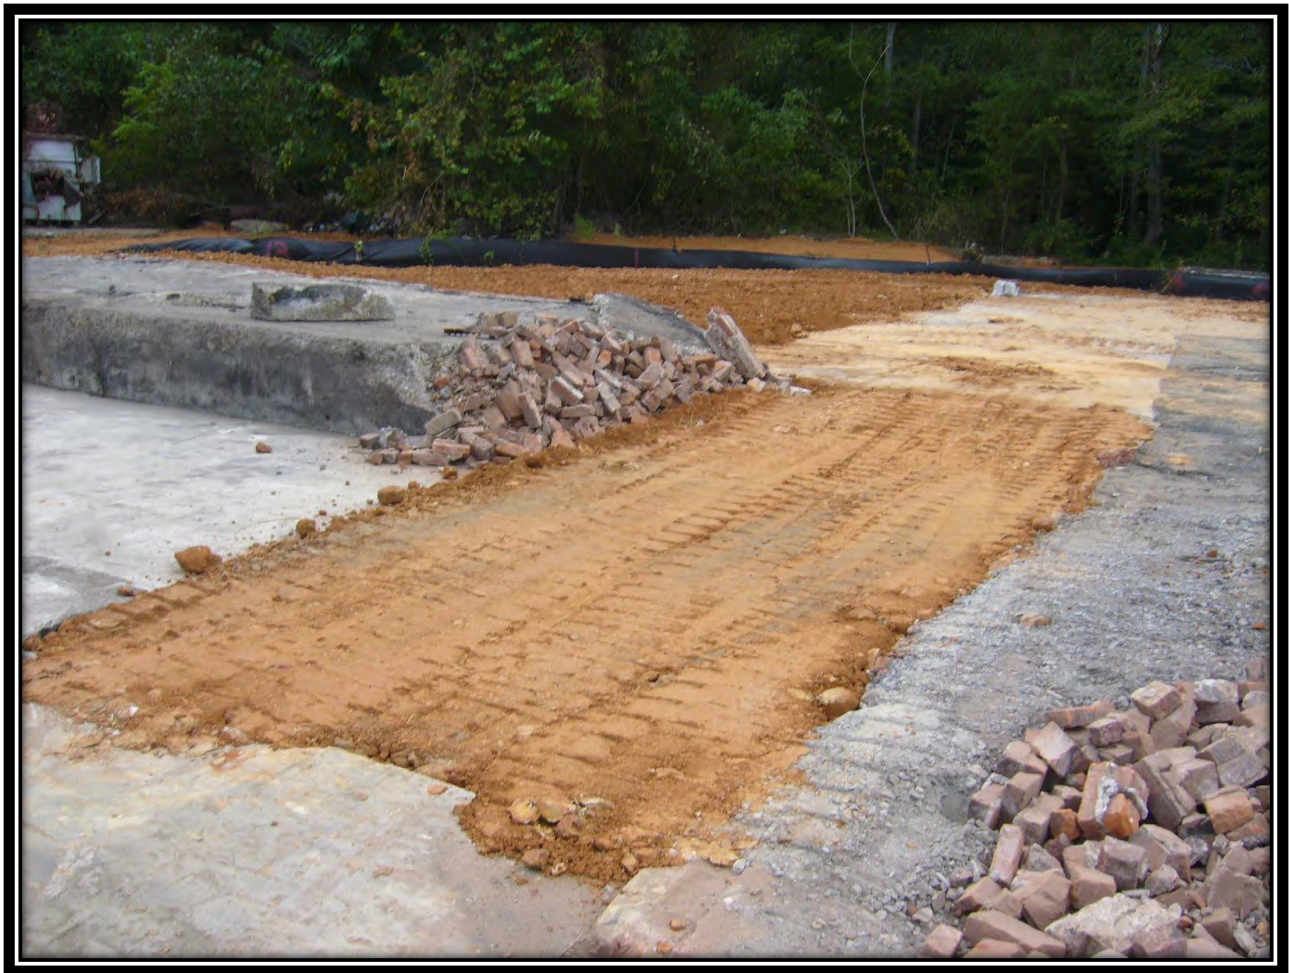
**OFFICIAL PHOTOGRAPH NO. 24  
U.S. ENVIRONMENTAL PROTECTION AGENCY**

**Subject:** CMC restored excavated areas between the building footprints by placing approximately six inches of backfill soil on top of those areas. Occasionally, brick from the north staging area was used to fill in holes in the roadway or cover portions of the exposed building footprint prone to erosion.

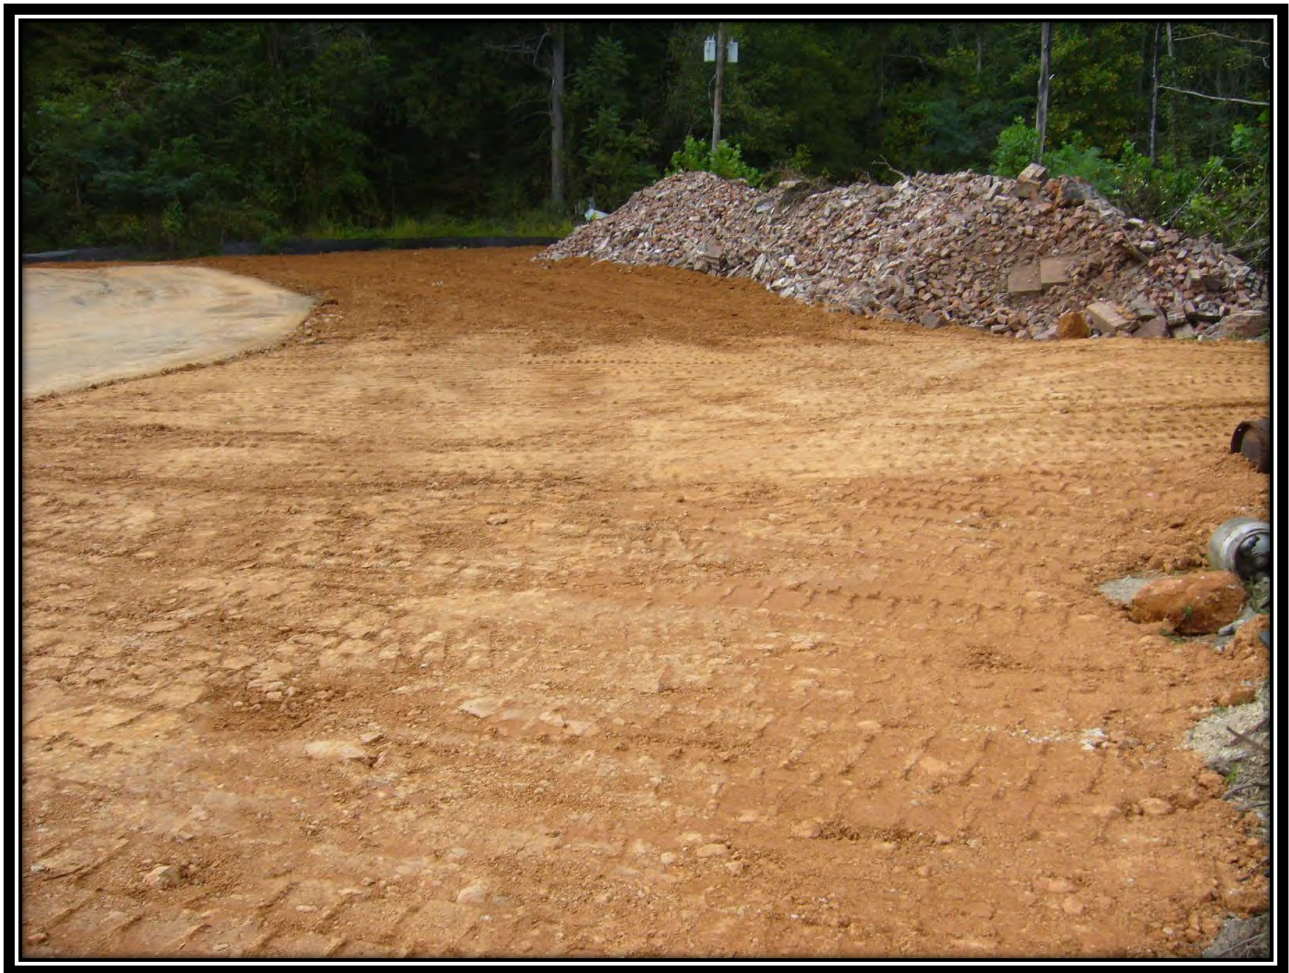
**OFFICIAL PHOTOGRAPH NO. 25**  
**U.S. ENVIRONMENTAL PROTECTION AGENCY**

**Subject:** Composite soil sampling results indicated the presence of asbestos in the excavated areas located in the north staging area and the eastern area traveled by site equipment during removal activities. CMC covered these excavated areas with approximately six inches of backfill soil.

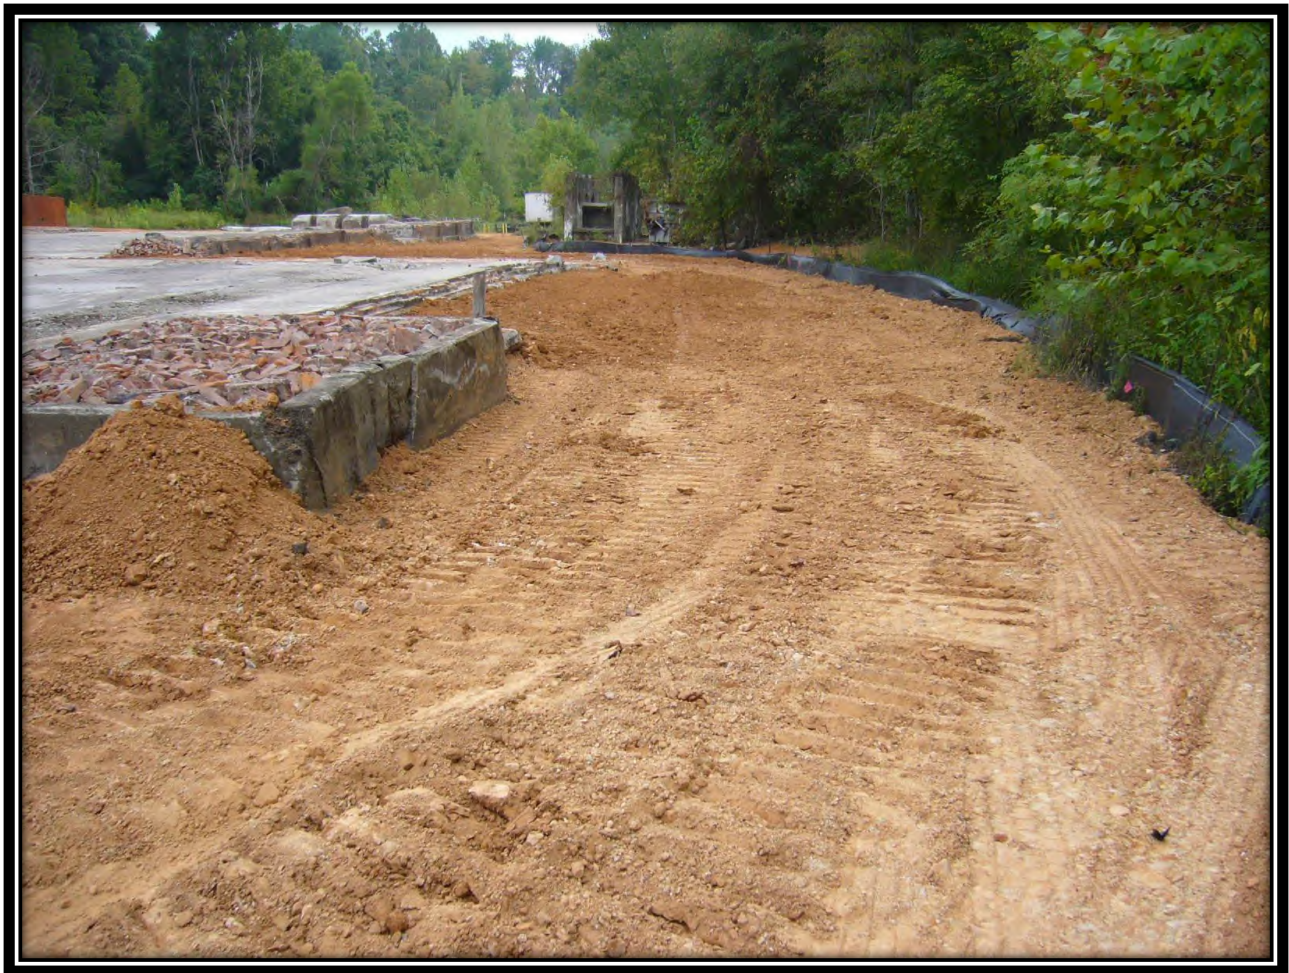
**OFFICIAL PHOTOGRAPH NO. 26  
U.S. ENVIRONMENTAL PROTECTION AGENCY**

**Subject:** Composite soil sampling results indicated the presence of asbestos in the excavated removal areas, identified from a previous assessment and during removal activities, located at the southern and eastern sides of the site. CMC covered these excavated areas with approximately six inches of backfill soil.

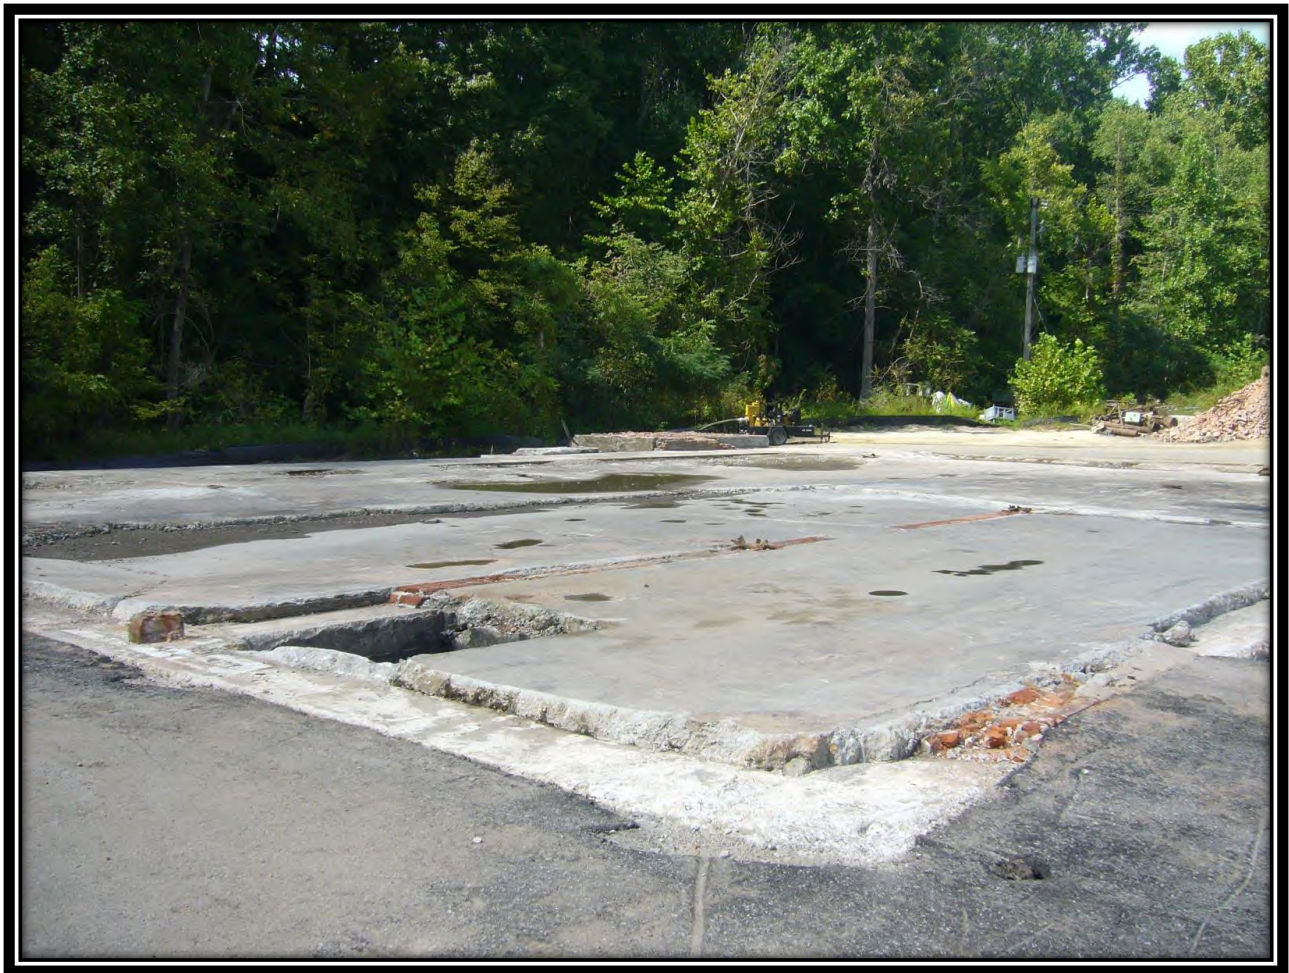
**OFFICIAL PHOTOGRAPH NO. 27**  
**U.S. ENVIRONMENTAL PROTECTION AGENCY**

**Subject:** The remaining north building footprint after the completion of demolition and removal.

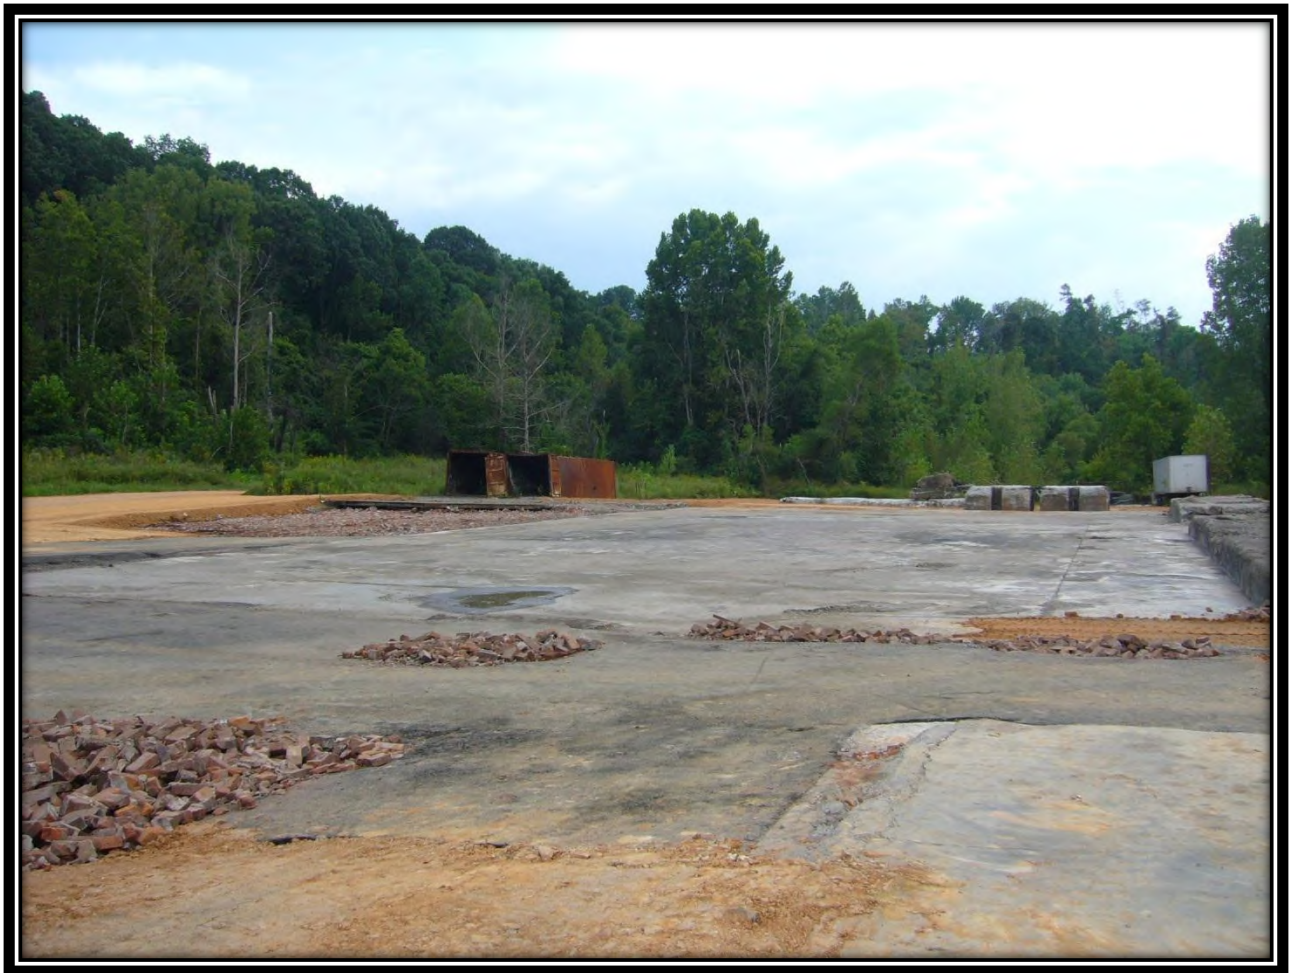
**OFFICIAL PHOTOGRAPH NO. 28**  
**U.S. ENVIRONMENTAL PROTECTION AGENCY**

**Subject:** The remaining south building footprint after the completion of demolition and removal.

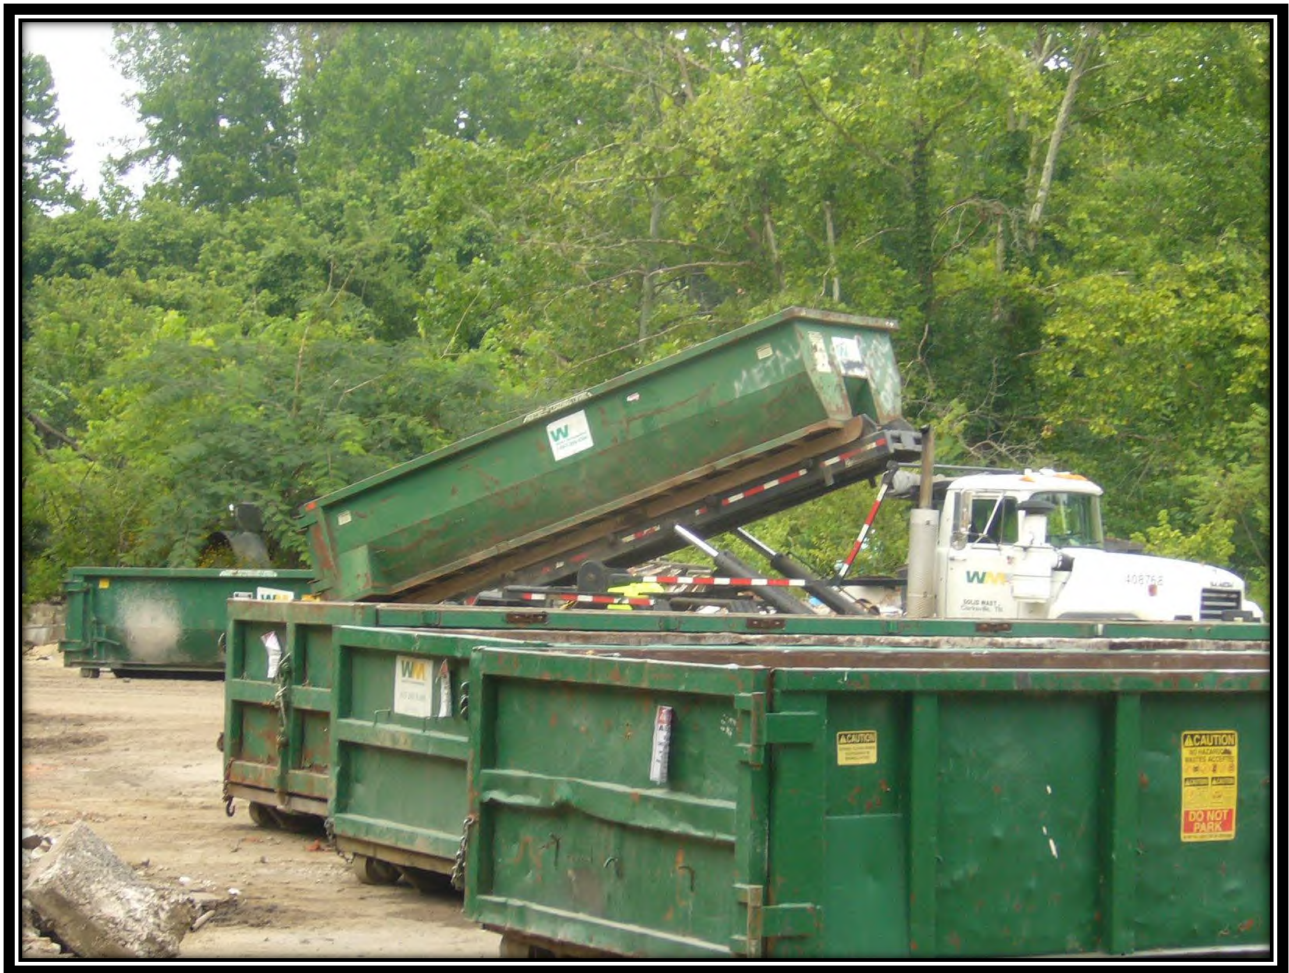
**OFFICIAL PHOTOGRAPH NO. 30  
U.S. ENVIRONMENTAL PROTECTION AGENCY**

**Subject:** Approximately 2,860 cubic yards, in a total of 143, 20-cubic yard rolloff containers, were picked up by Waste Management, Inc. and transported to West Camden Sanitary Landfill, located in Camden, Tennessee, a State of Tennessee-approved asbestos landfill.

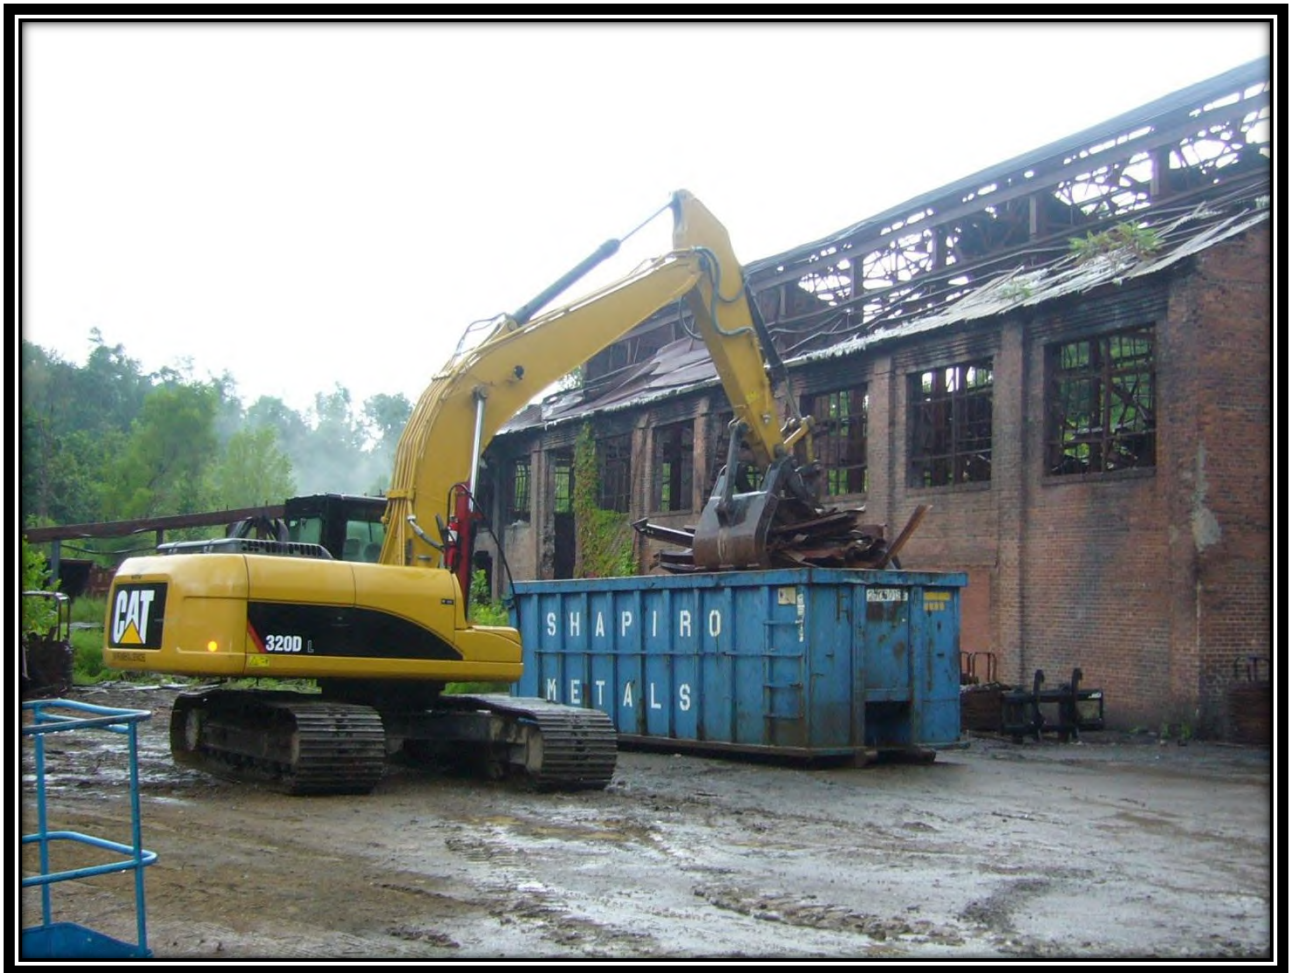
**OFFICIAL PHOTOGRAPH NO. 31  
U.S. ENVIRONMENTAL PROTECTION AGENCY**

**Subject:** Approximately 336 tons of recyclable metal in a total of 31 rolloff containers were picked up by and transported to Shapiro Metals located in Dickson, Tennessee, for recycling.

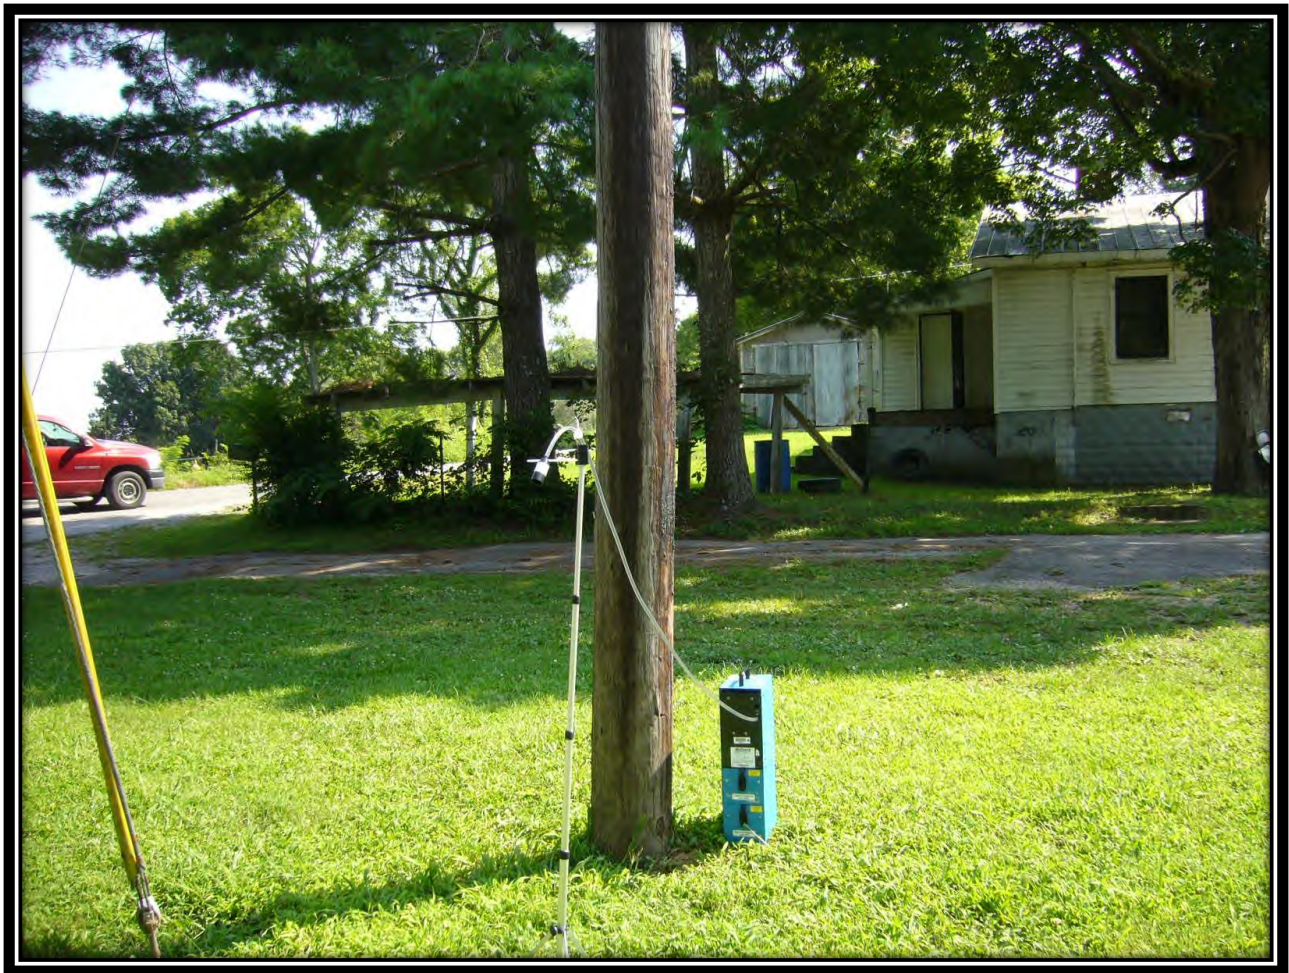
**OFFICIAL PHOTOGRAPH NO. 32**  
**U.S. ENVIRONMENTAL PROTECTION AGENCY**

**Subject:** Tetra Tech START conducted initial background and daily perimeter area air sampling at one on-site location and three residential locations.
