**Subject: Removal Action Report  
Wrigley Charcoal  
Lyles, Hickman County, Tennessee  
EPA Contract Number (No.) EP-S4-14-03  
Technical Direction Document (TDD) No. TT-01-026**

## **EXECUTIVE SUMMARY**

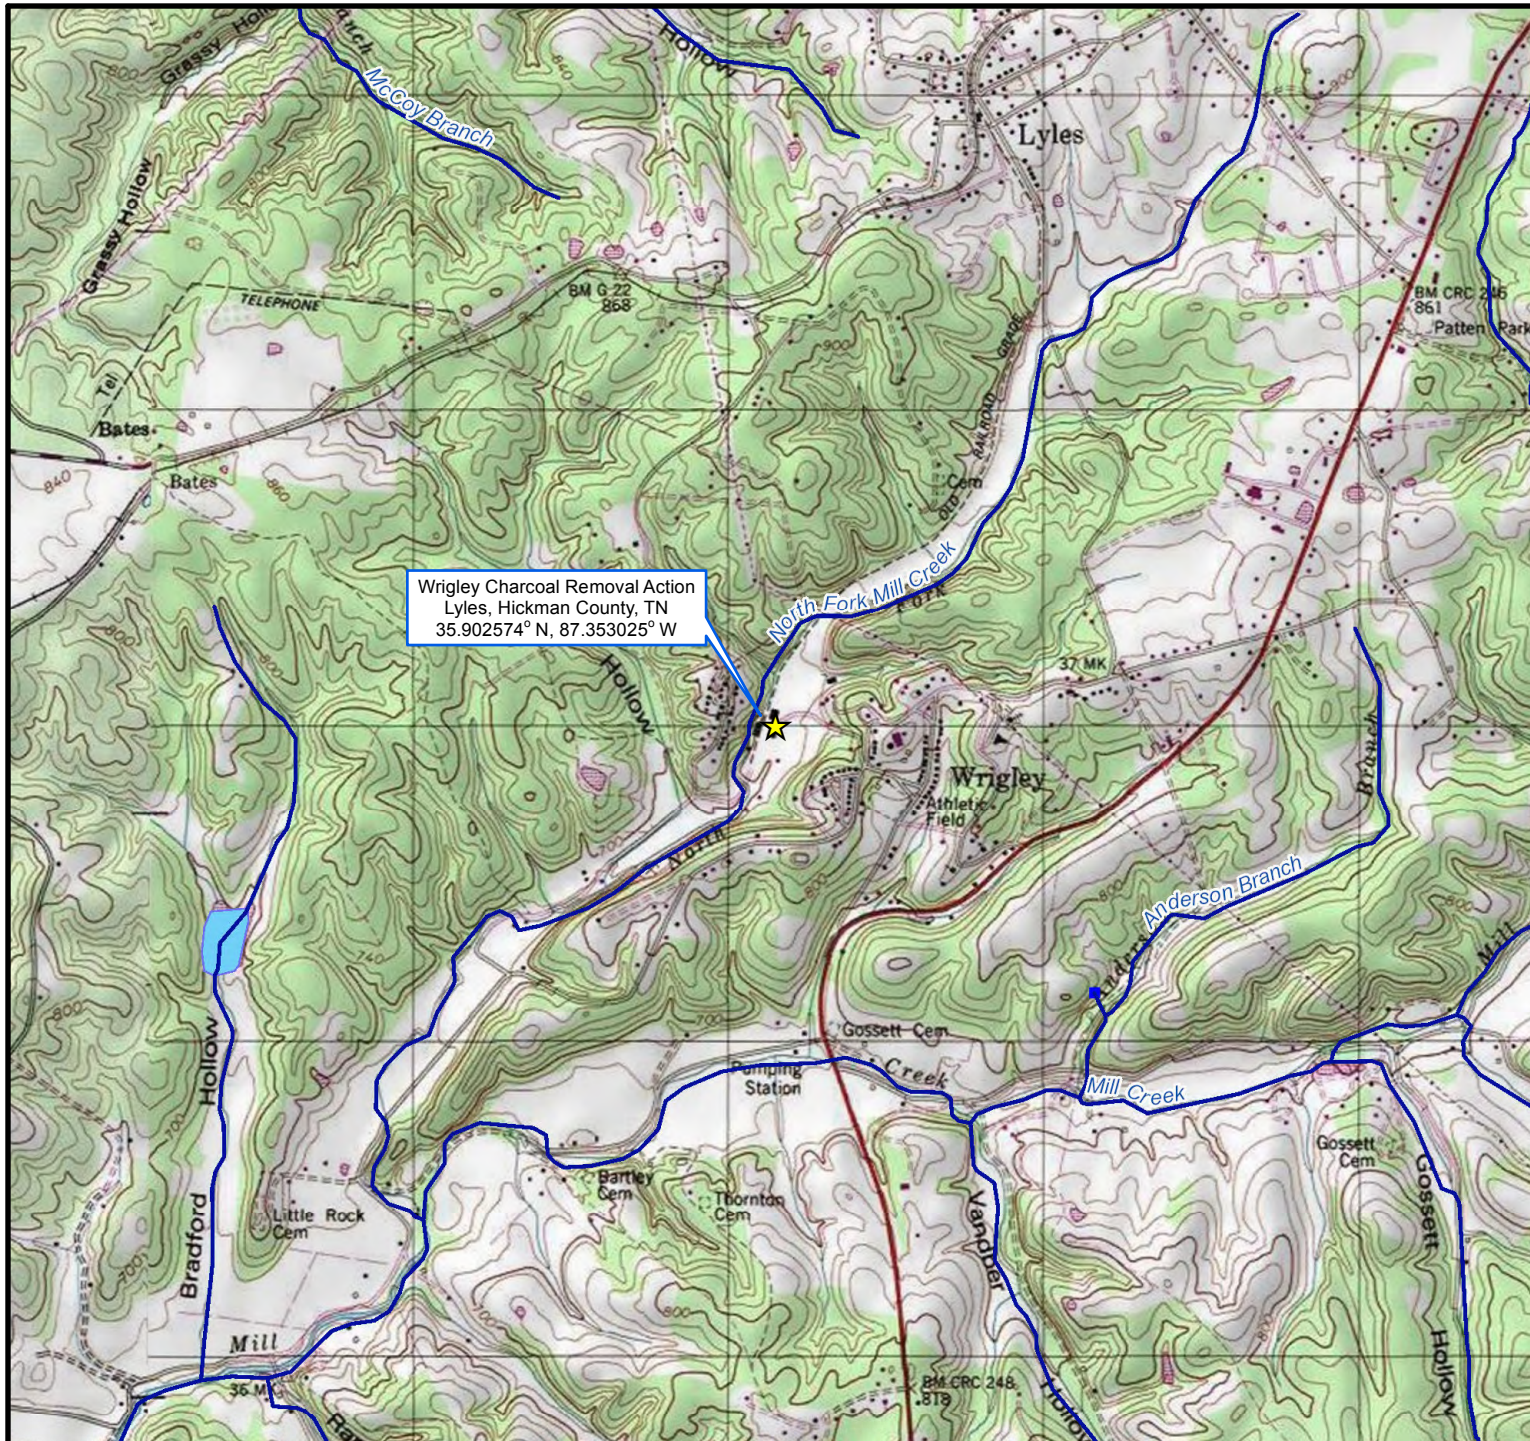
**FIGURE 1**

**Site Location**

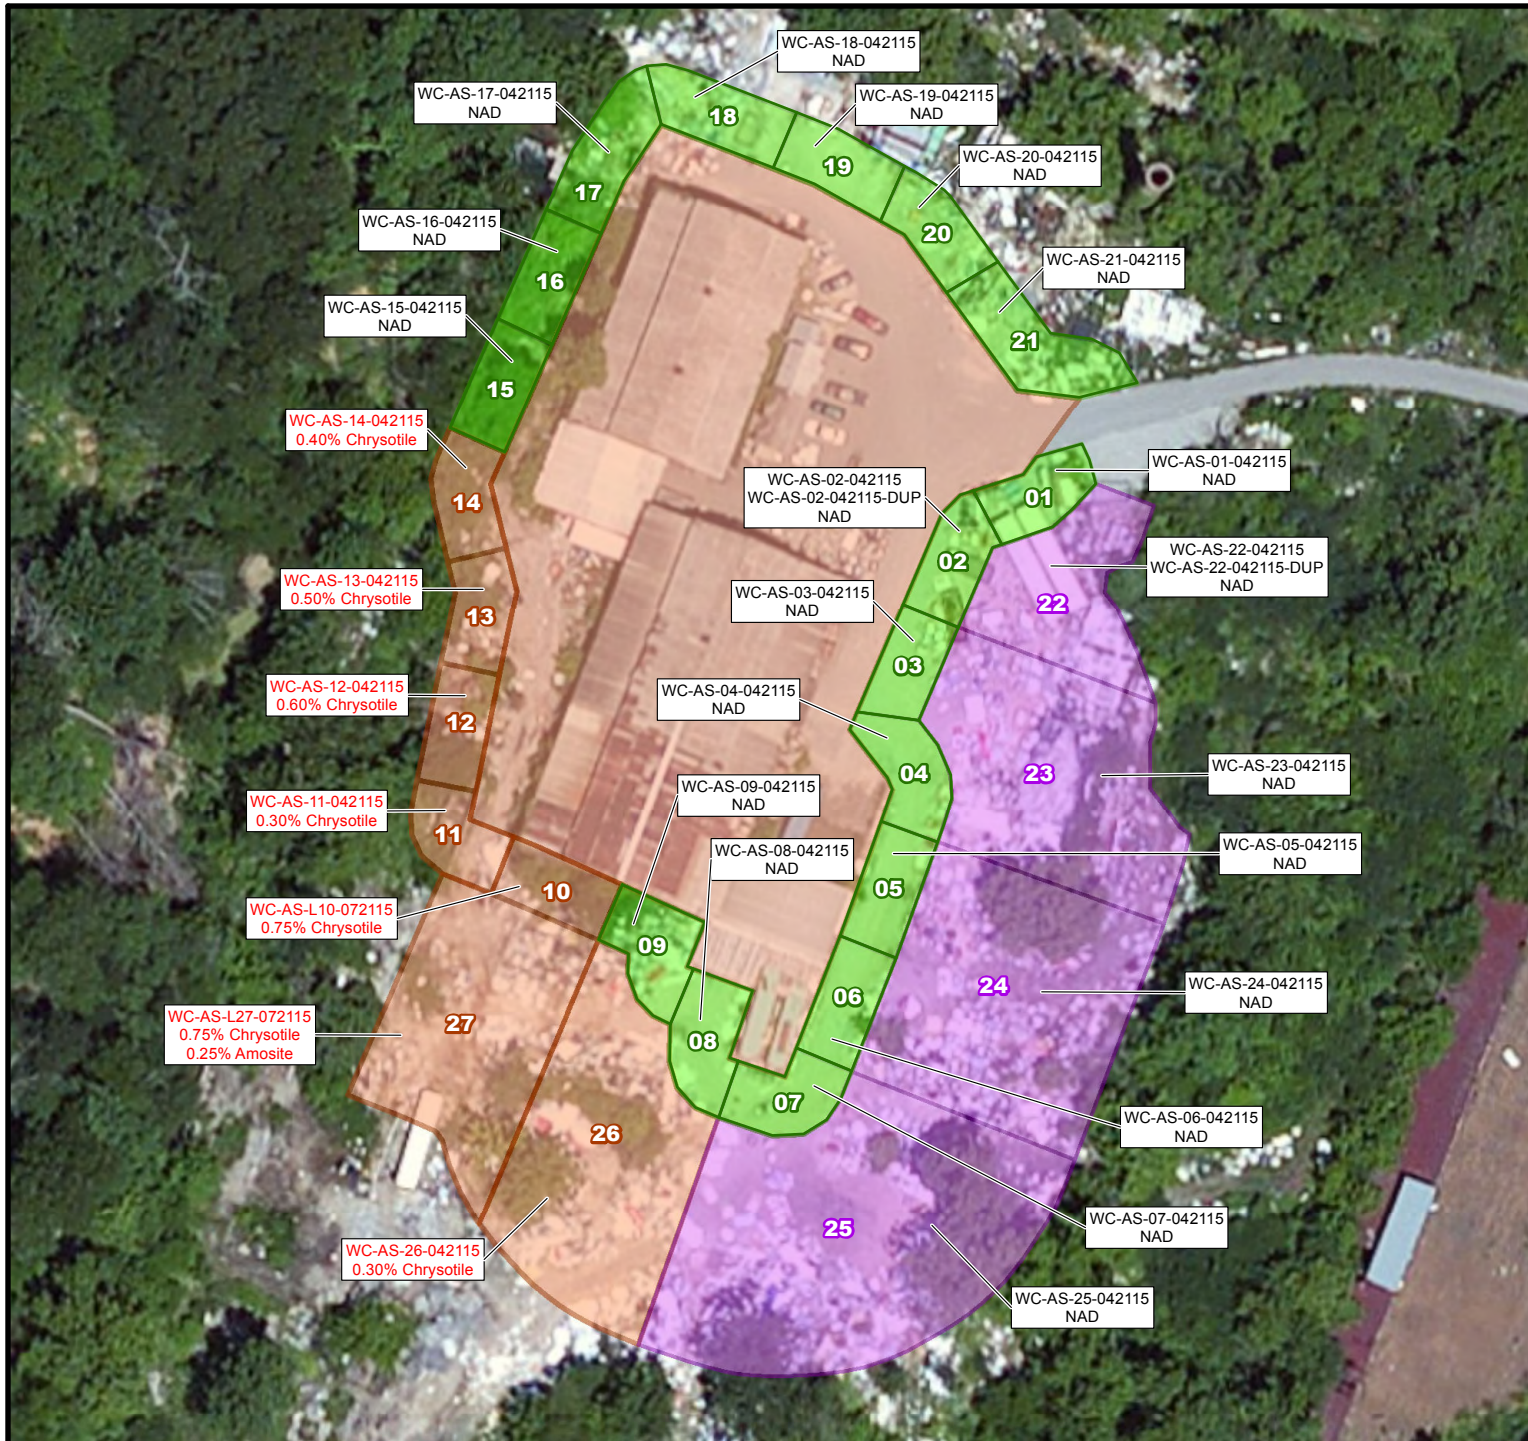
- Legend**
- Soil Sampling Area, No Asbestos Detected (grids approx. 50' x 25')
  - Additional Soil Sampling Area, No Asbestos Detected (grids approx. 100' x 100')
  - Identified Removal Area

On July 21, 2015, Tetra Tech START collected two surface composite soil samples from Grids 10 and 27. The samples were submitted to MAS for analysis via CARB Method 435. Sampling results indicated Grid 10 contained 0.75 percent asbestos and Grid 27 contained 0.75 percent chrysotile asbestos and 0.25 percent amosite asbestos (see Table 5 in Enclosure 2). These grids were identified for soil removal.

From August 20 through 26, 2015, Tetra Tech START collected 15 surface composite soil samples, including one duplicate sample, from excavated areas throughout the site. The samples were submitted to MAS for analysis via CARB Method 435. Sampling results indicated that the percentage of asbestos ranged 0.5 to 5.25 percent chrysotile asbestos (see Table 5 in Enclosure 2). Additional soil removal was not conducted and the excavated areas were capped using backfill soil.

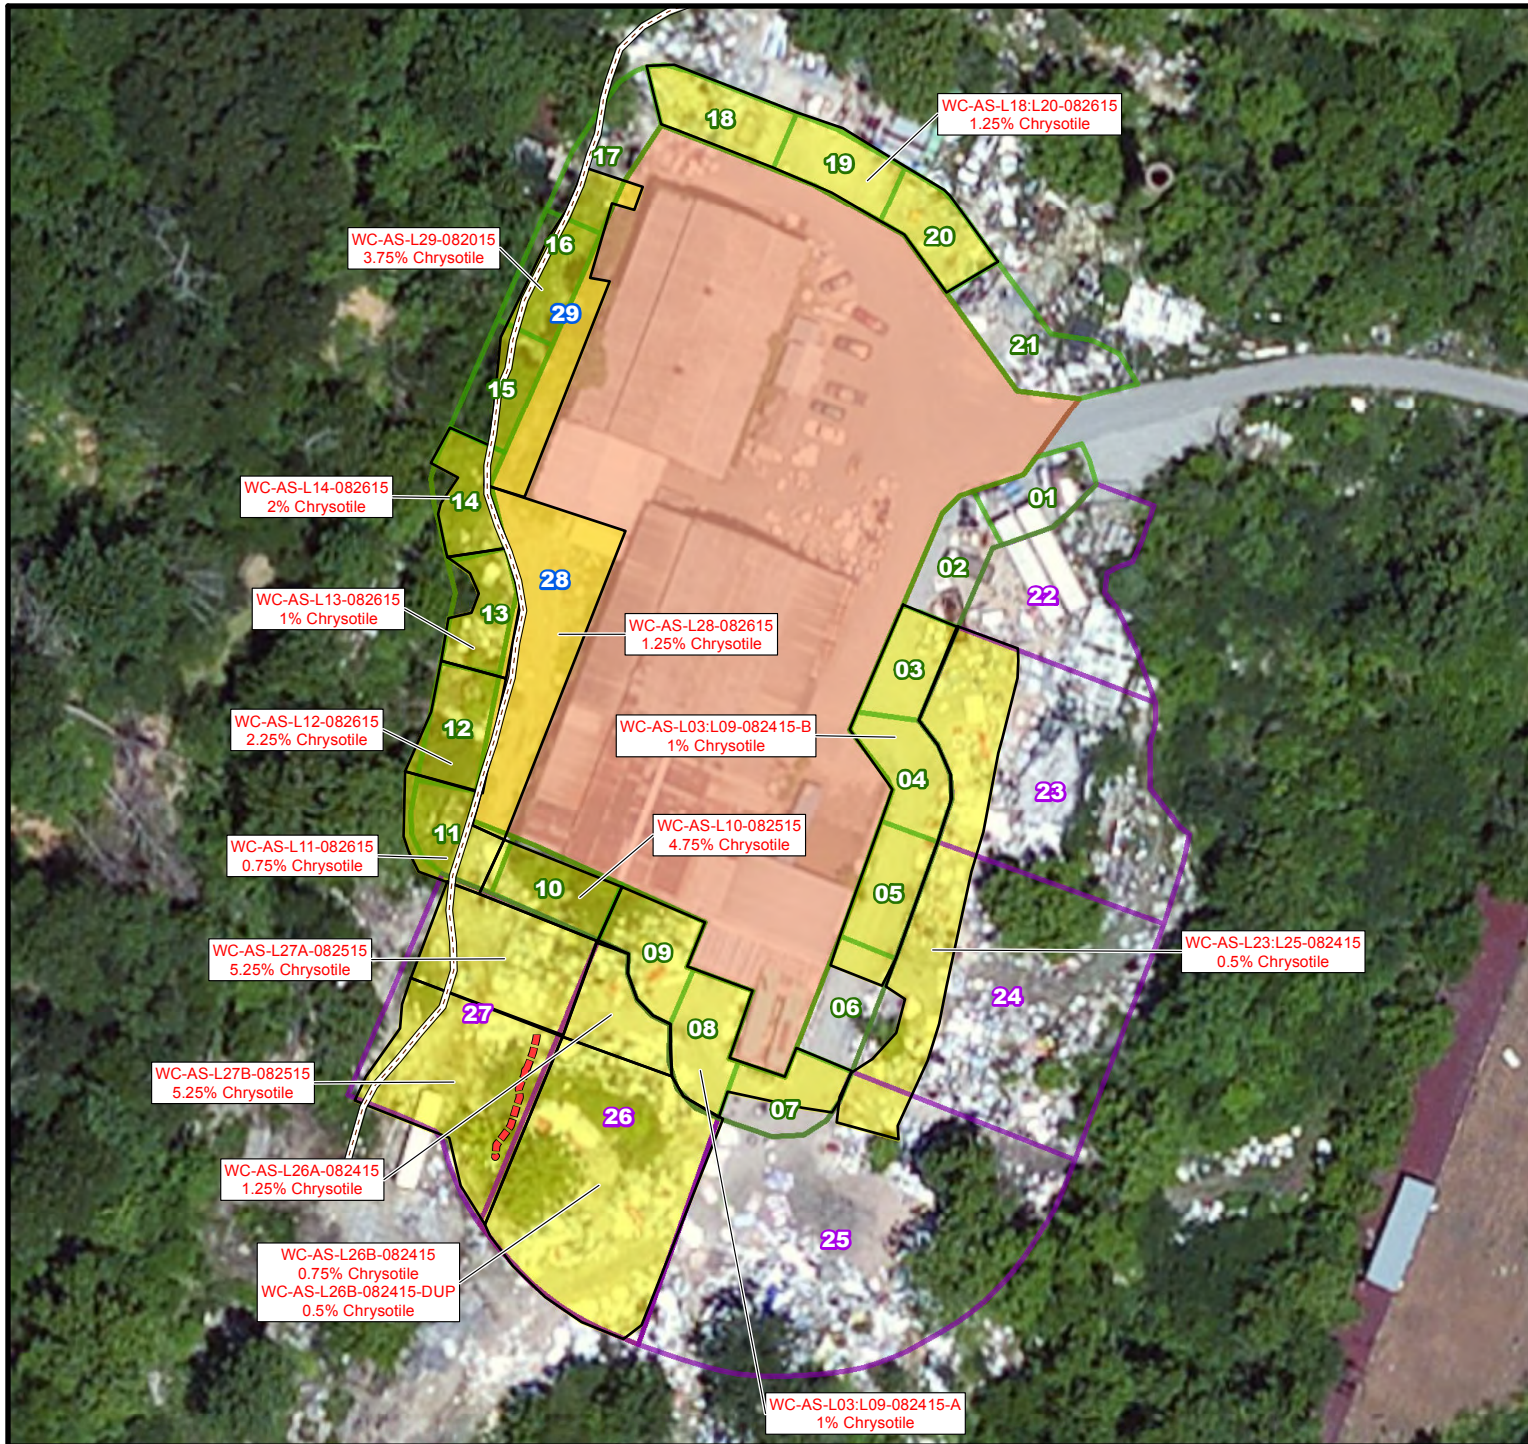
- South Trench
- Silt Fence
- Soil Removal/Post Removal Sampling Areas with Asbestos Detected
- April 2015 Assessment Area (grids approx. 50' x 25')
- April 2015 Assessment Area (grids approx. 100' x 100')
- Site Building Removal Area

After the site buildings demolition was completed, CMC removed surface soil from areas identified during removal and previous assessment sampling activities. These removal areas were located on the southern and western sides of the site and included grids 10 through 14 and 26 through 29 (see Figures 4 and 5 in Enclosure 1). CMC removed approximately two to four inches of asbestos-contaminated soil from these areas using a tracked excavator with a bucket attachment. During removal activities in grids 26 and 27, CMC discovered a former building footprint and a trench (see Figure 6 in Enclosure 1). As CMC was excavating soil from the trench, a black, tar-like sludge appeared from the northern end of the south trench. CMC ceased excavation and notified EPA OSC Spurlin. No further excavation was conducted in the trench area. After excavation was completed, a visual inspection of each area was conducted by Tetra

Soil was also removed from the access road along the eastern side of the site (grids 3 through 9 and 23 through 25), the north staging area (grids 18 through 20), and small areas located between the building footprints to remove possible contamination from the regulated area. CMC removed approximately one to two inches of soil from these areas using a tracked excavator with a bucket attachment. After excavation was completed, a visual inspection of each area was conducted by Tetra Tech START. Once there was no visible ACM observed on the ground, removals were concluded.

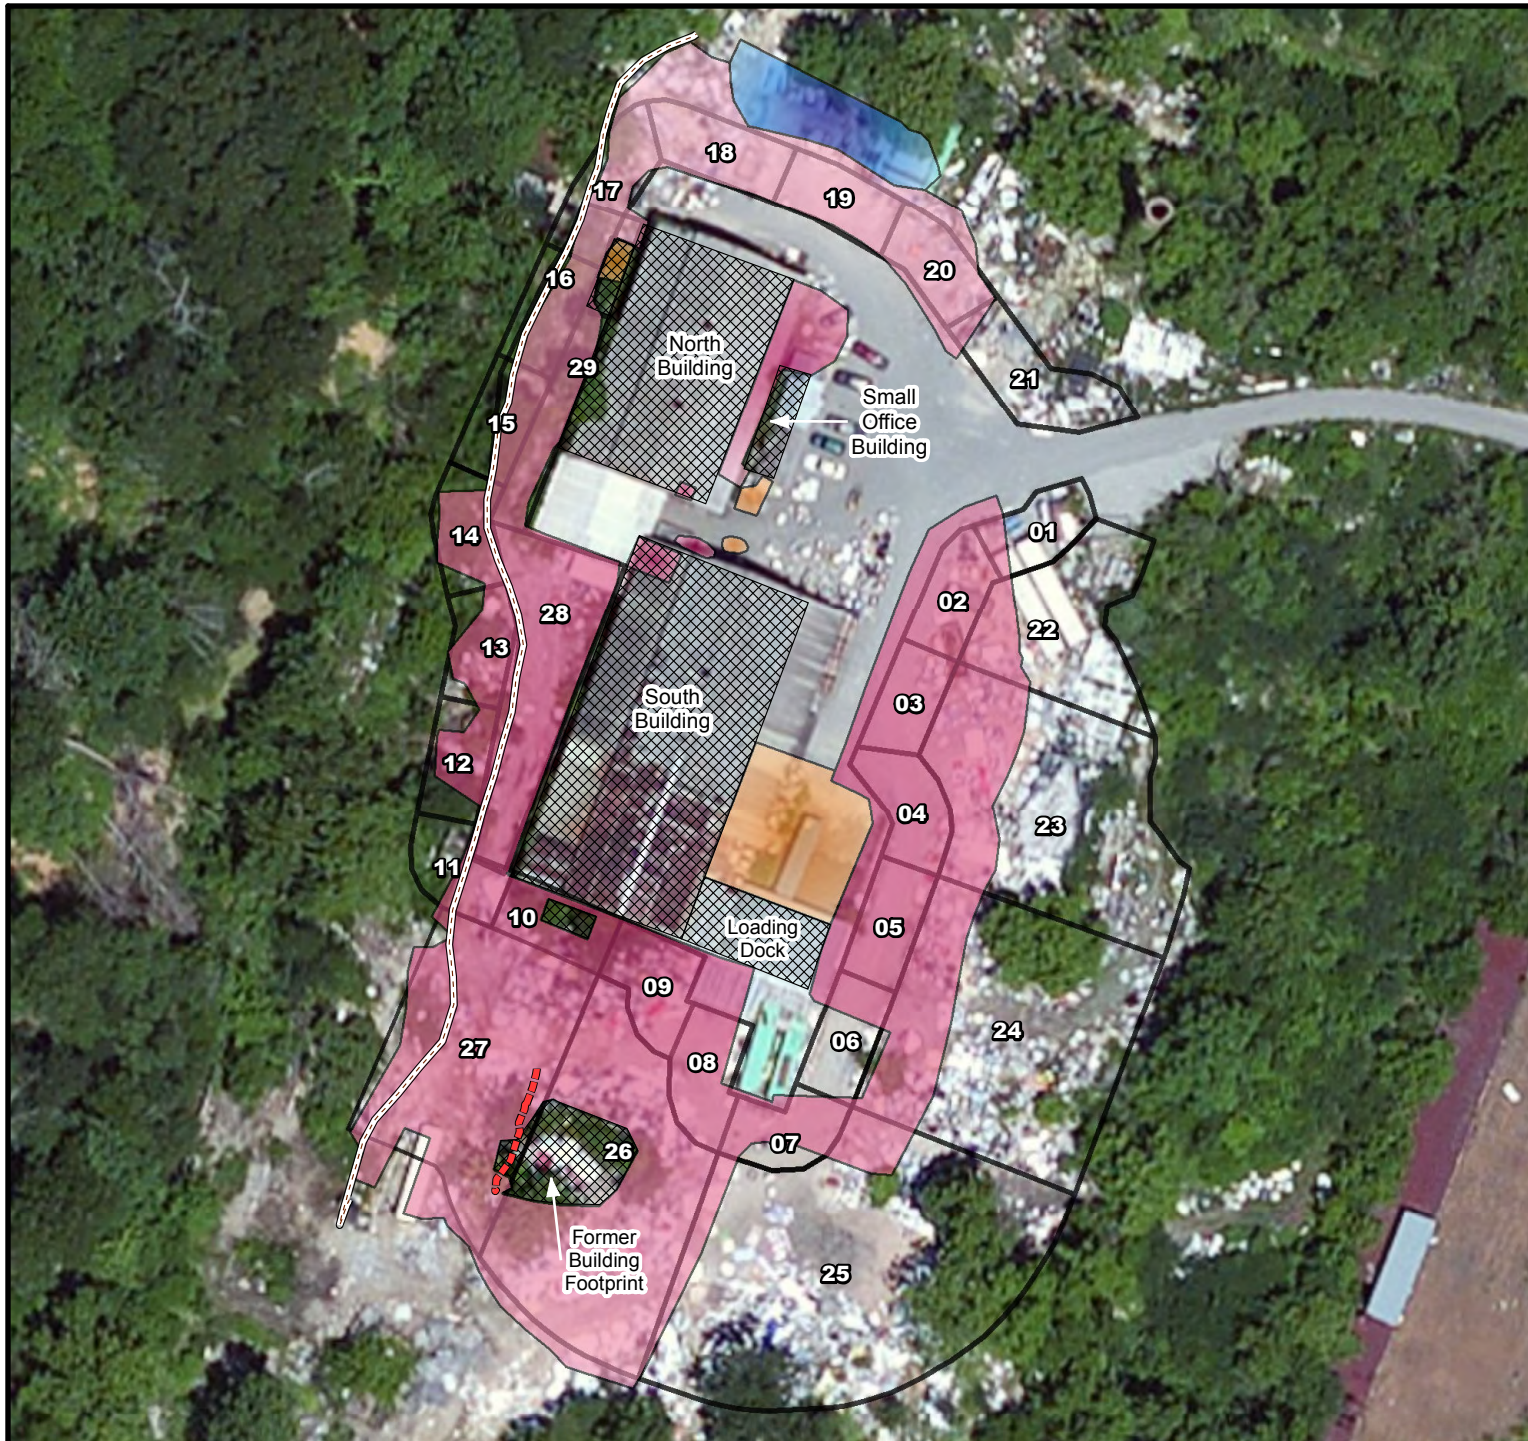
- - - - South Trench
- Silt Fence
- Former Structure Outline
- Brick Backfilled Area
- Brick Staging
- Soil Backfill Covered Area
- Soil Assessment Areas

Excavated areas were backfilled by placing approximately six inches of clean soil in the grid locations, as well as between the small office and north and south buildings (see Figure 6 in Enclosure 1). Sixty-nine truckloads of soil were provided by Jenco Construction, Inc., located in Bon Aqua, Tennessee. Other small surface depressions located between the buildings were filled with brick from the north staging area (see Figure 6 in Enclosure 1).
