200 North Post Road Project Summary

SITE NAME	Post Road Drum Site
Property Owner	Alaska Railroad Corporation; leased to SAN LLC; rented to Precision Pavement Marking, Inc.
Business Information	Operated by Precision Pavement Marking, Inc. Business Owner: William Duran Vizzerra Jr. POC: Bruce Chambers, 907-565-5661
SSID#	10ZZ
Location	200 North Post Road, Anchorage , Alaska 99501
Latitude	61.223464°
Longitude	- 149.861306°

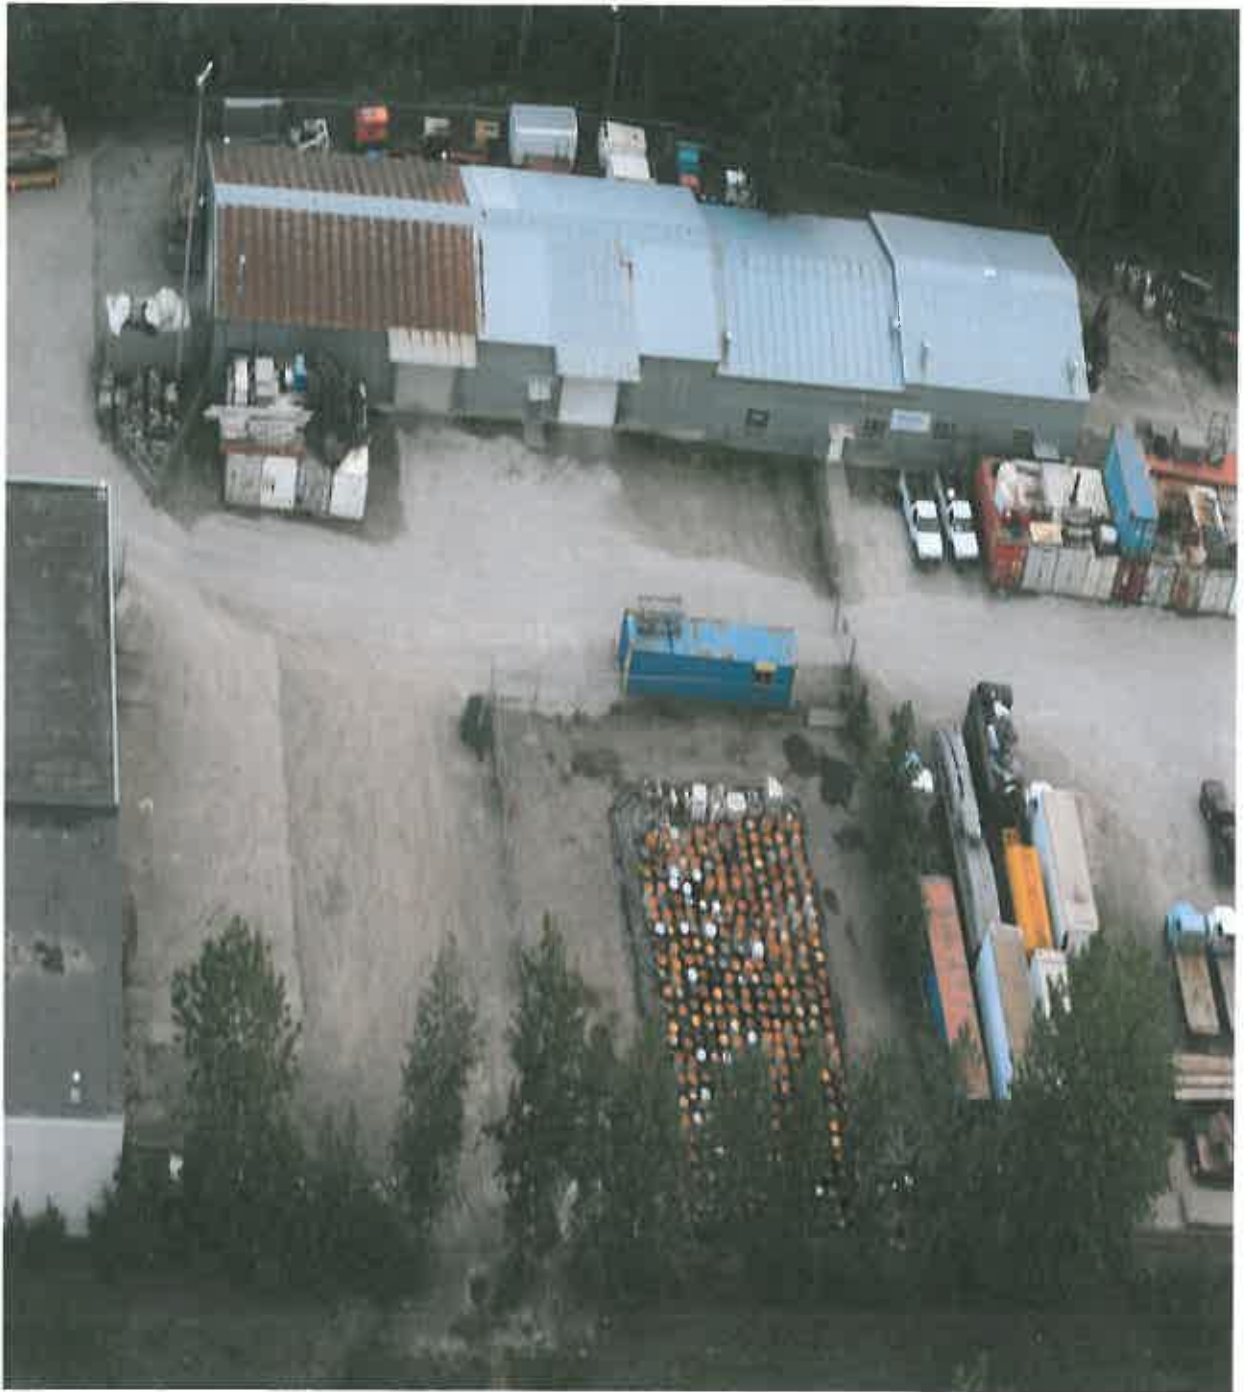
(Pic .1)

Aerial view of site Prior to Clean Up Activities @ 200 Post Road, Anchorage, Alaska

The property is located at 200 North Post Road Anchorage, Alaska. The drum site is located west of Post Road behind a warehouse structure which faces Post Road. The site is an outdoor fenced area that is used for storage. In 2005, Precision Pavement Marking Inc. (PPMI) started moving paint materials and equipment from 1702 Ship Avenue to 200 North Post Road. It was believed that the materials stored at the site were all usable products and the site was being utilized as a storage area only. (Attachment 2, Pic.1)

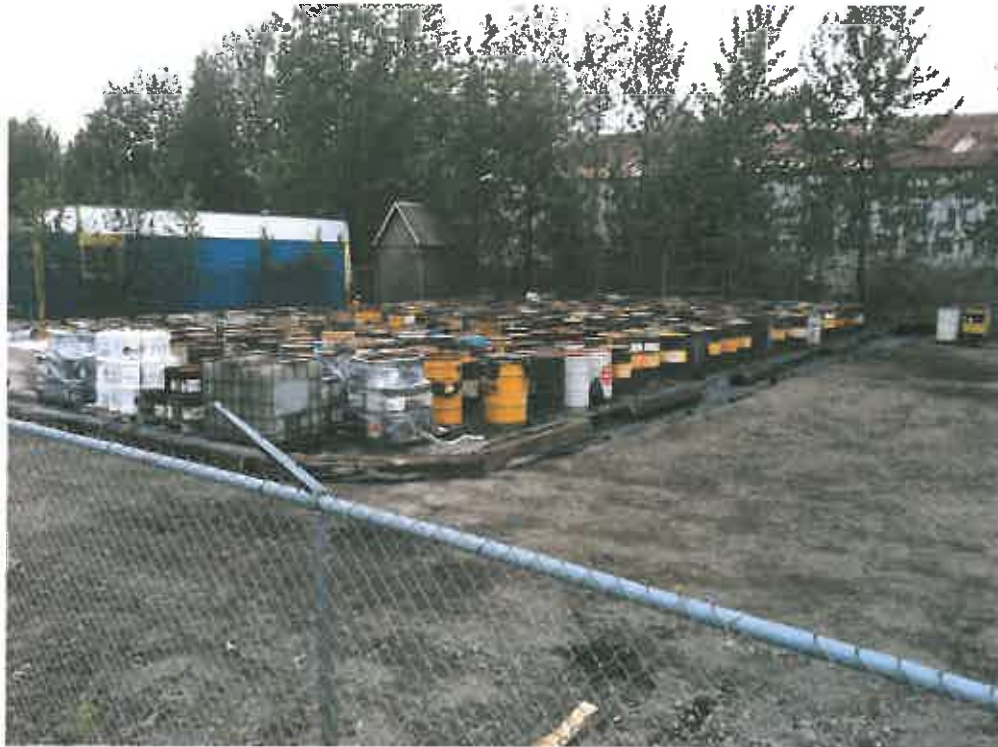
Site View NE (Pic. 2)

The site is located within a 90-foot by 100-foot chain-link fenced yard. The yard is a flat, unpaved surface. There are no established pathways or engineered drainage systems in the yard that contained the drums, 5-gallon pails and 250-gallon bulk containers. The containment area was made with heavy plastic sheets and railroad ties. (Attachment 2, Pic.2 and Pic.3)

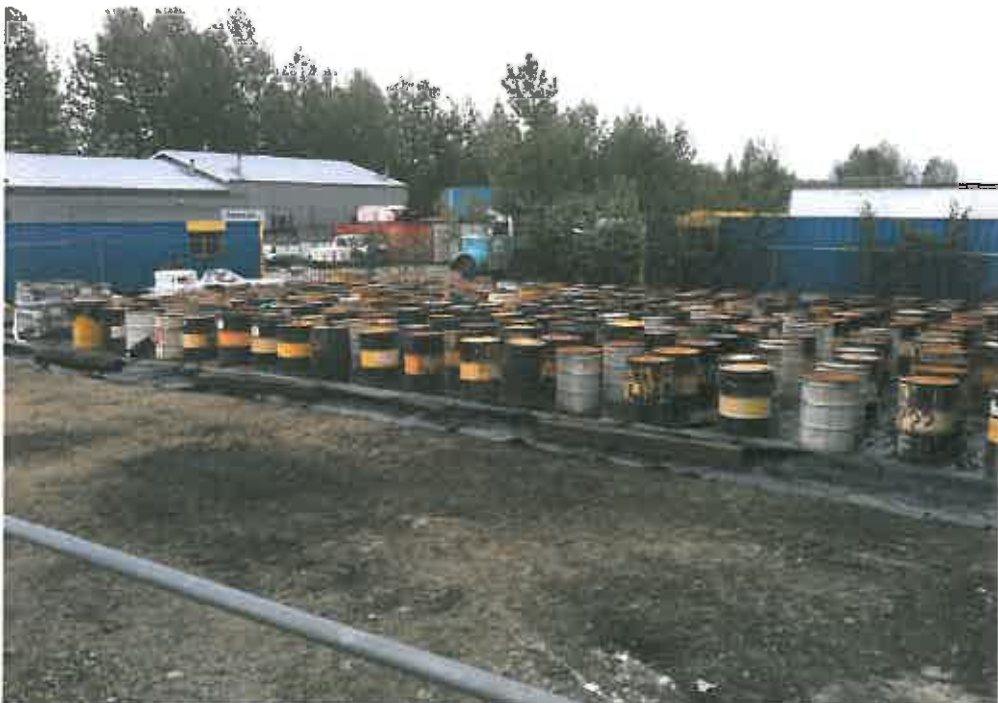
Site View SE (Pic.3)

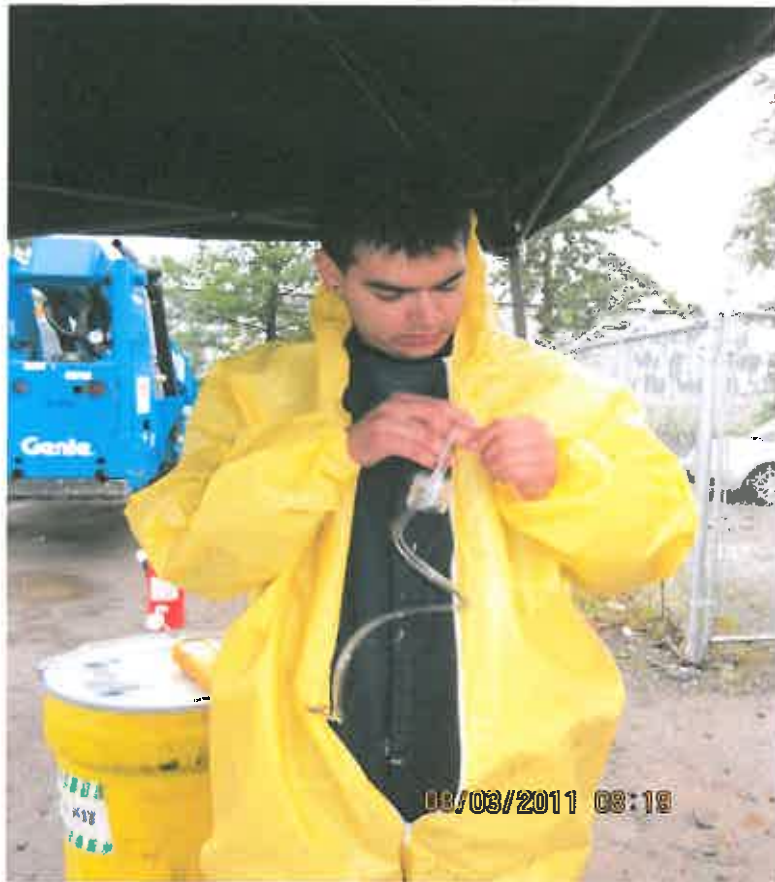
Donning the Air Monitoring Equipment
(Pic.4)

To verify that exposures stayed within the PEL at all times, continuous air and personal exposure monitoring was performed while sampling work was completed by EAI personnel. EAI monitored for the following hazardous chemicals while performing sampling/characterization work at the Post Road site:

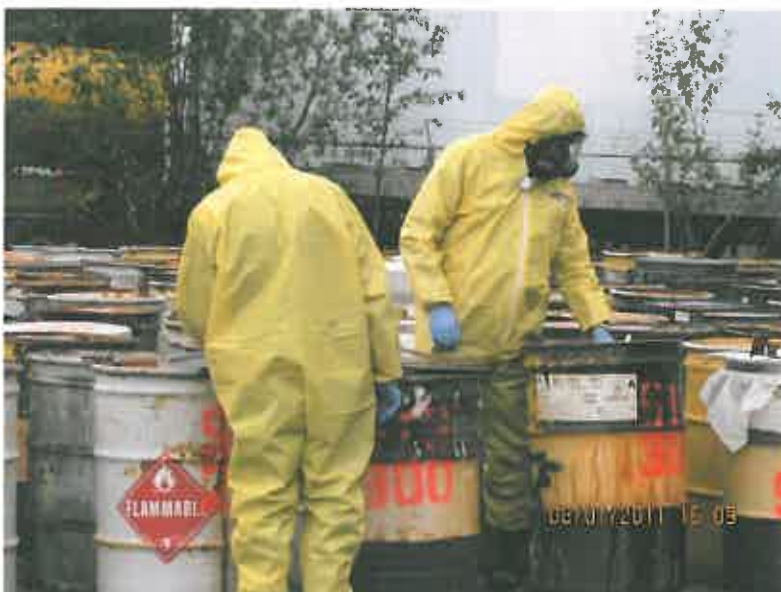
Sampling the Containers (Pic.5)

All containers needed to be characterized and approved for disposal before any movement of them could be initiated and on August 1, 2011, the site team started the process. The first task was to open all the drums, identify the contents, sample as needed, and determine the condition of each container for transportation. This activity was completed on August 5, 2011. (Attachment 2, Pic.5)

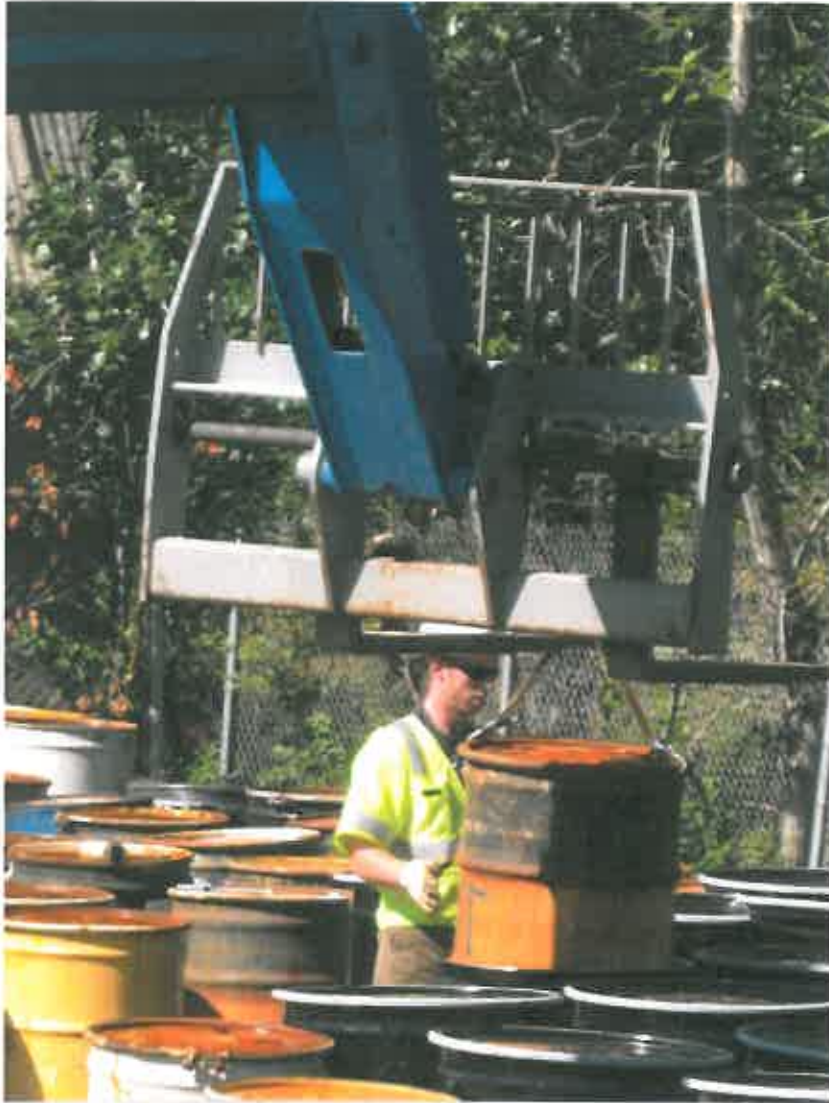
(Pic.6)

Over Packing of Drums

During August 10th-12th and September 13th-14th, 280 each 55-gallon drums were packaged into 85-gallon open top steel drums and nine each 85-gallon drums were over packed into 110-gallon open top steel drums. (Attachment 2, Pic.6,7,8)

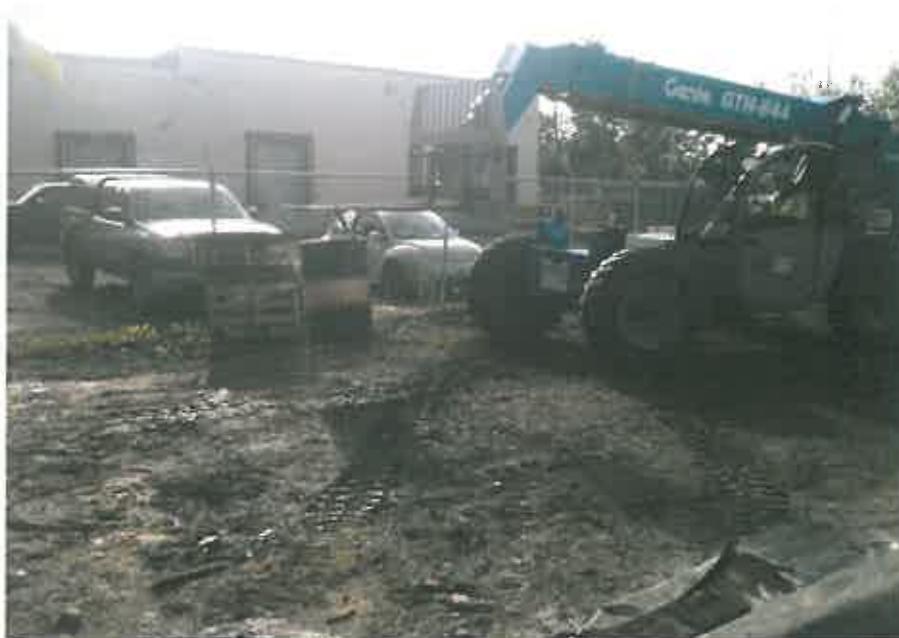
(Pic.7)

Over Packing Activities

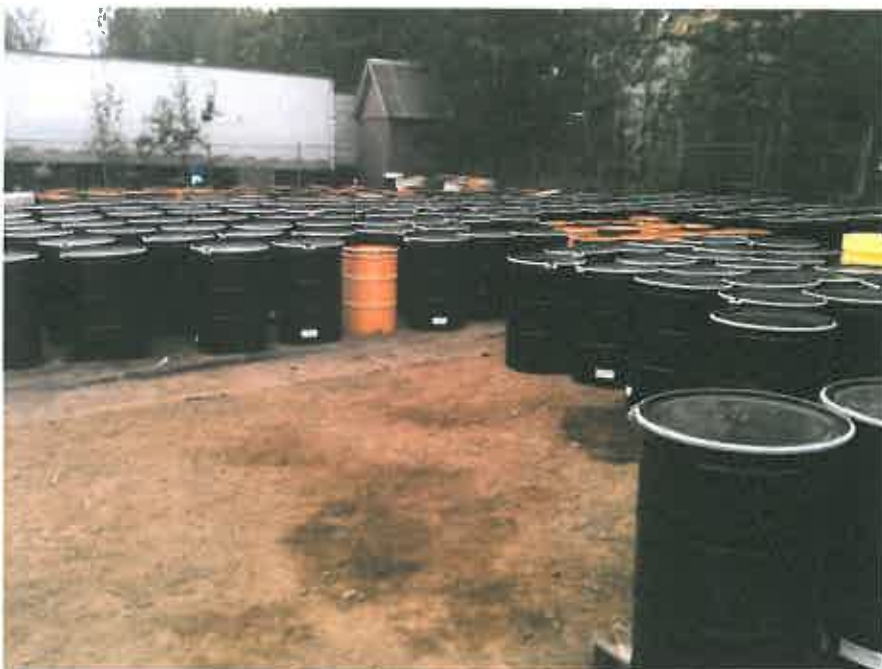
Over Packed Drums (Pic.8)

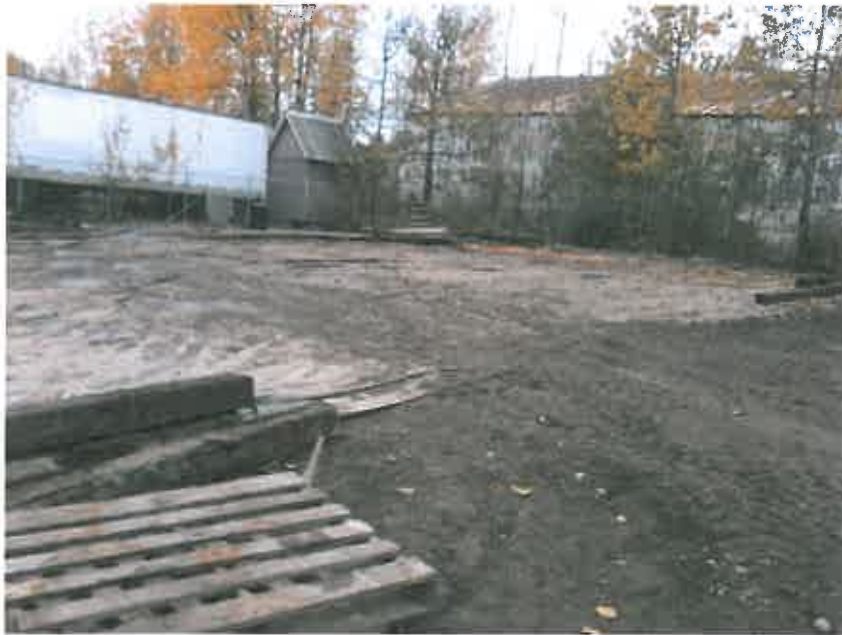
Ground Cover Removal (Pic.9)

EPA OSC, Bob Whittier, inspected the site for any spills or leaks that may have occurred from the containers while they were stored on the property. No spills or leakage of any waste on the ground surface was observed, and therefore no multi-incremental soil sampling was determined to be necessary at the site. (Attachment 2, Pic.9)

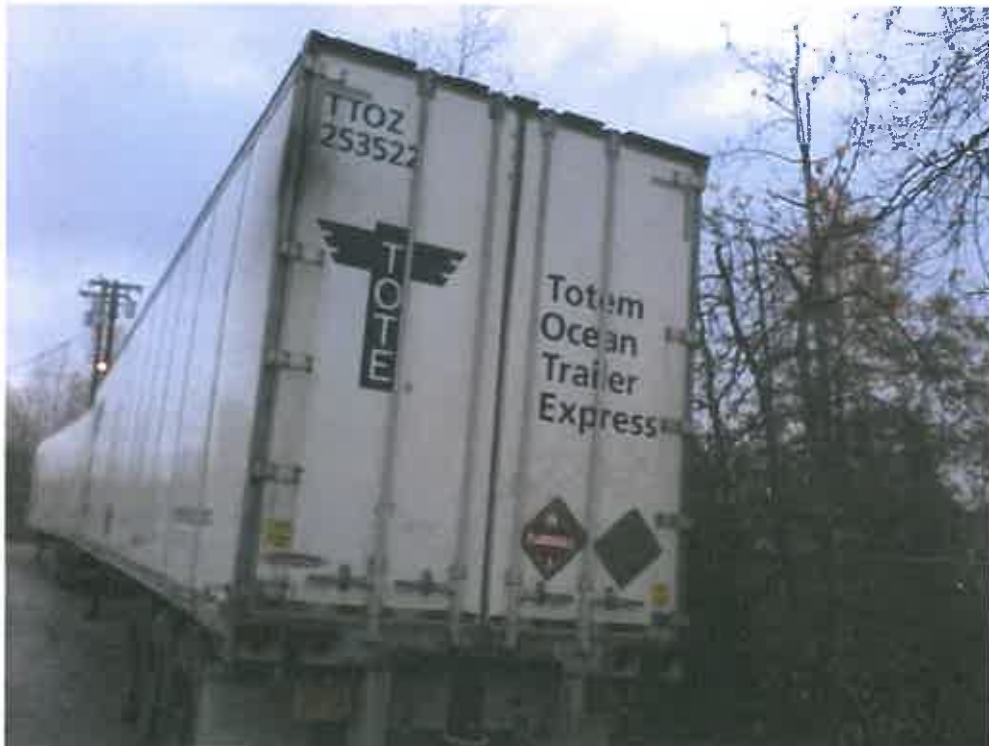
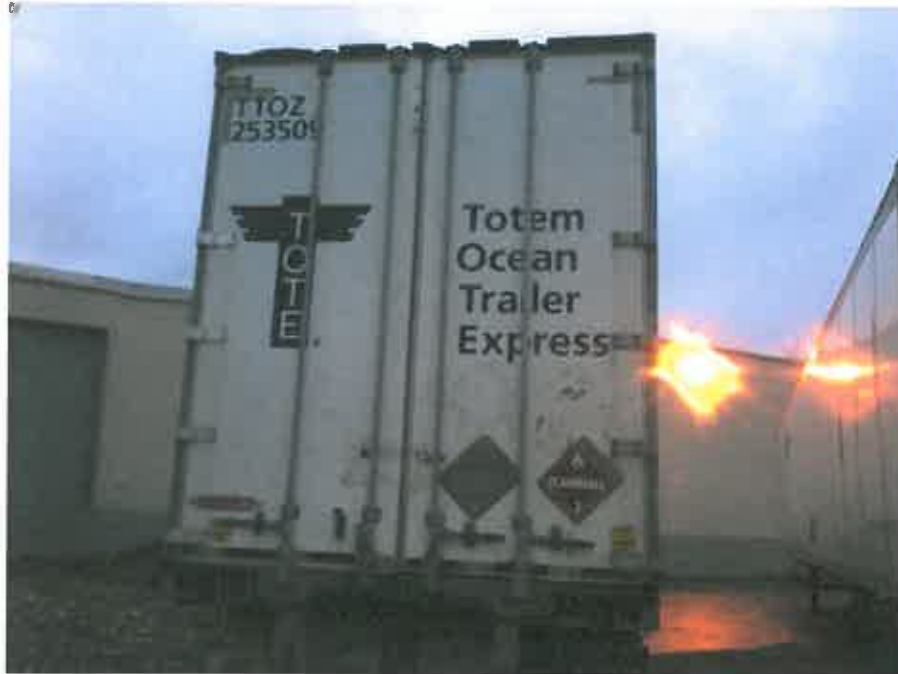
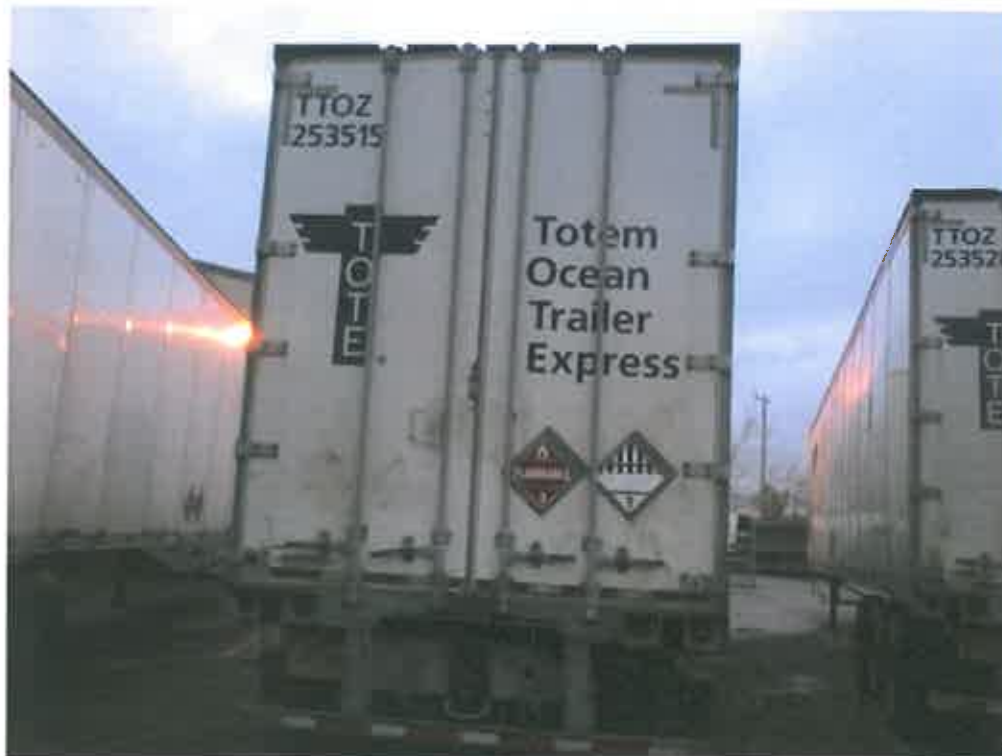
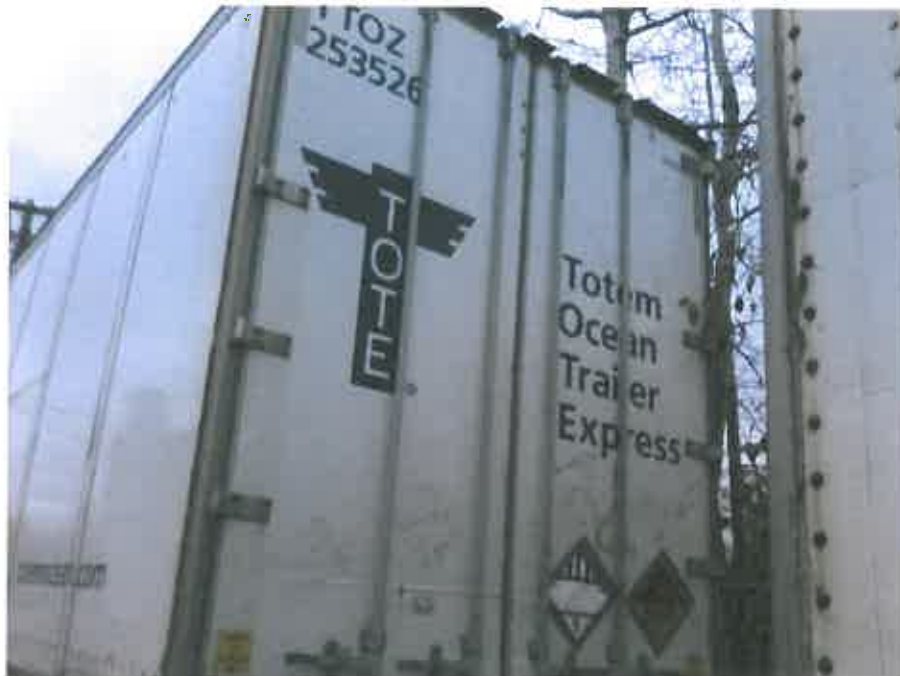
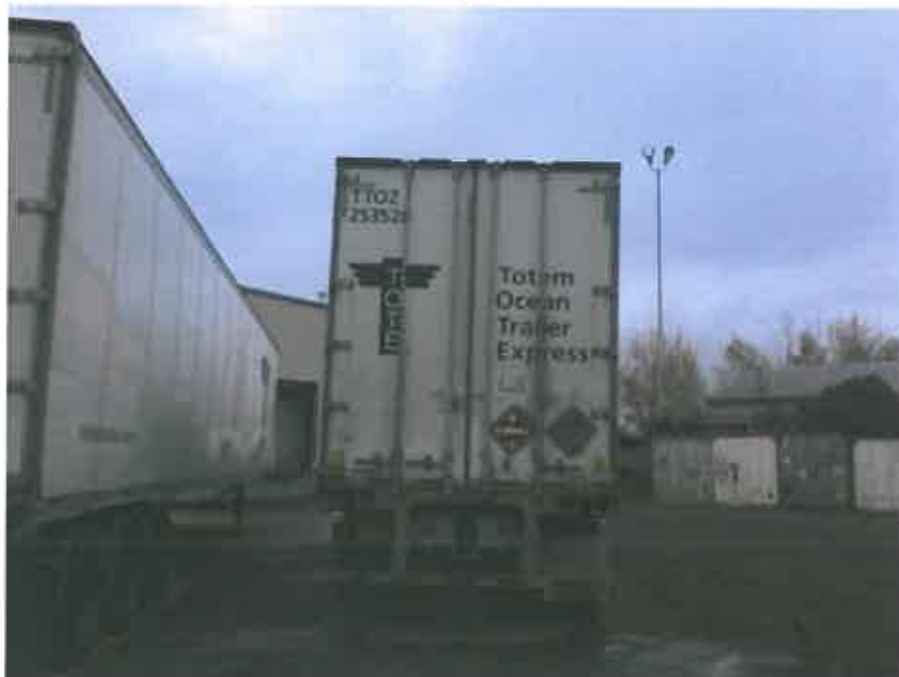
Placarded Trailer #1

Placarded trailer #2

Placarded trailer #3

Placarded Trailer #4

Placarded Trailer #5

Drums were marked and labeled on September 15, 2011 in preparation for trailer loading which would begin on September 19th. Five each 53-foot trailers were staged throughout the week to be loaded with the last drum being loaded on September 23rd, 2011. None of the placarded trailers left the site area until disposal facilities' final approvals were obtained. (Attachment 2, Pic.10,11,12,13,14)

All waste containers and transport vehicles were packaged, marked, labeled, and placarded in accordance with Federal Regulations. (Attachment 2, Pic.10, 11, 12, 13, 14)

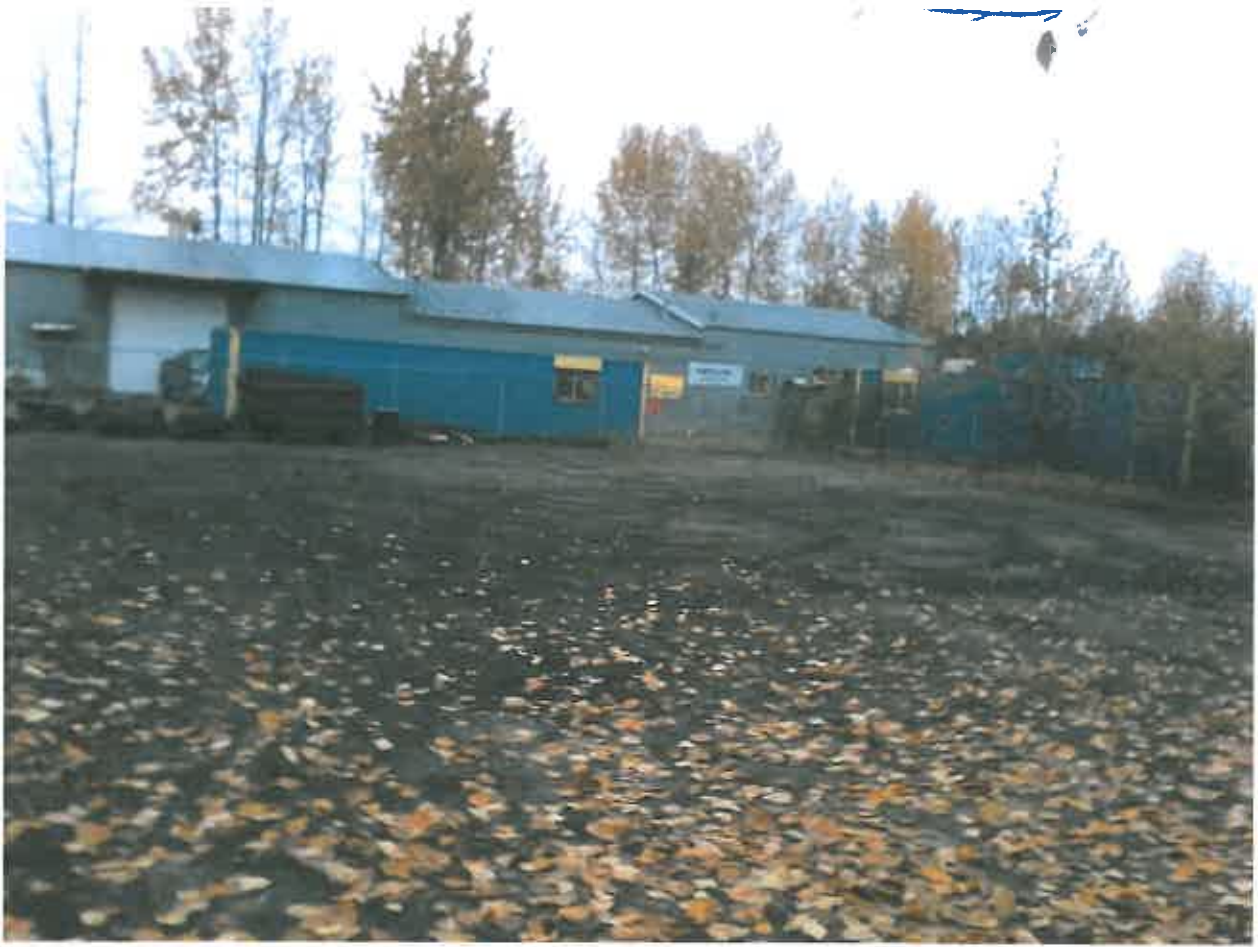
(Pic.15)

Finished Site @200 Post Road, Anchorage , Alaska

The overall objective of having no waste containers left onsite was accomplished. All containers identified within the TCRAP were removed from the site and transported to EPA approved disposal facilities. EPA OSC, Bob Whittier, confirmed the goal was accomplished during the final walk-through on September 29, 2011. (Attachment 1, Pic.15)
