Re: Contract Number EP-S7-06-02, Technical Direction Document Number 10-09-0008  
2011 Removal Action Report, Orofino Asbestos Site, Orofino, Clearwater County, Idaho

# REMOVAL ACTION REPORT

**Orofino Asbestos Site**  
**Orofino, Clearwater County, Idaho**  
**TDD: 10-09-0008**

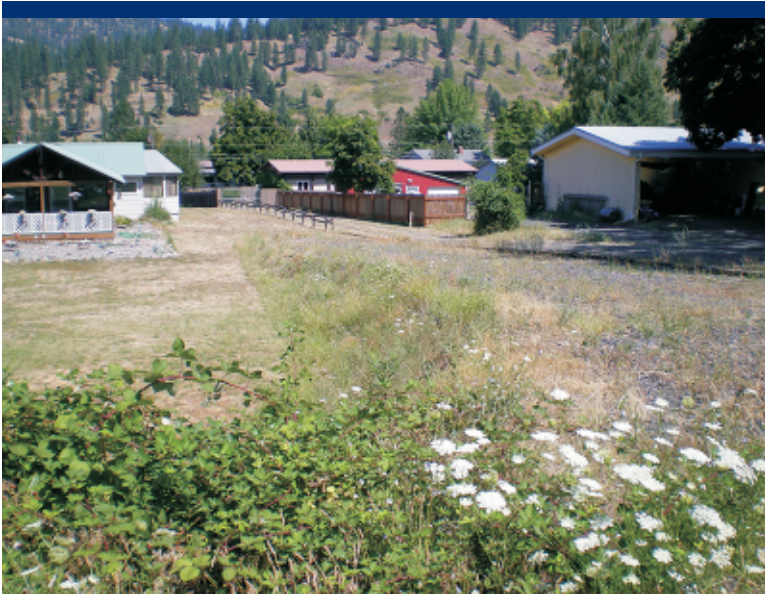
Photo 1 Pre-removal of asbestos-contaminated soil at 12719 Hartford Avenue.

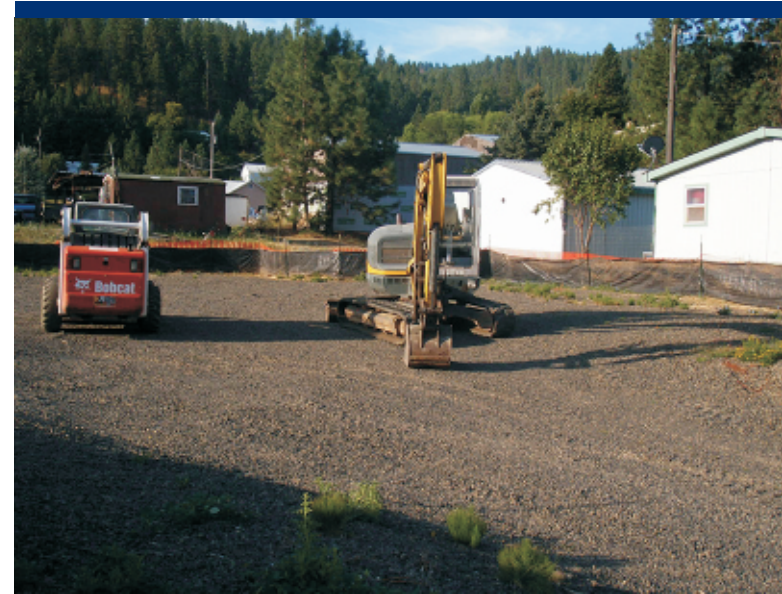
Photo 2 Pre-removal of asbestos-contaminated soil at 12140 Hartford Avenue.

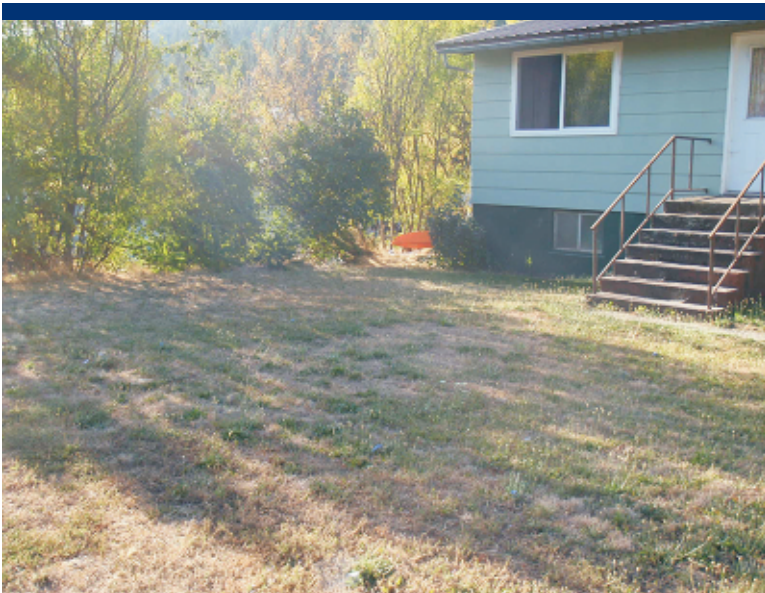
Photo 3 Pre-removal of asbestos-contaminated soil at 12170 Hartford Avenue.

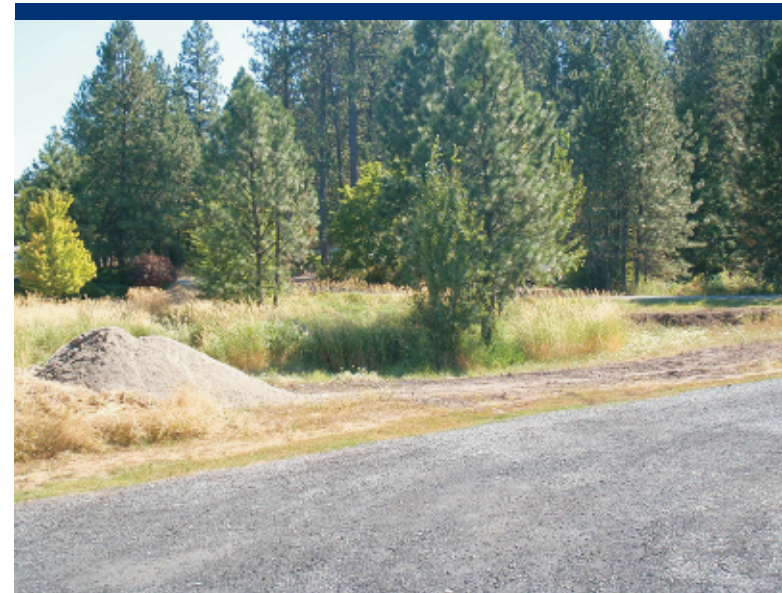
Photo 4 Post-removal of asbestos-contaminated soil from 12453 Hartford Avenue.

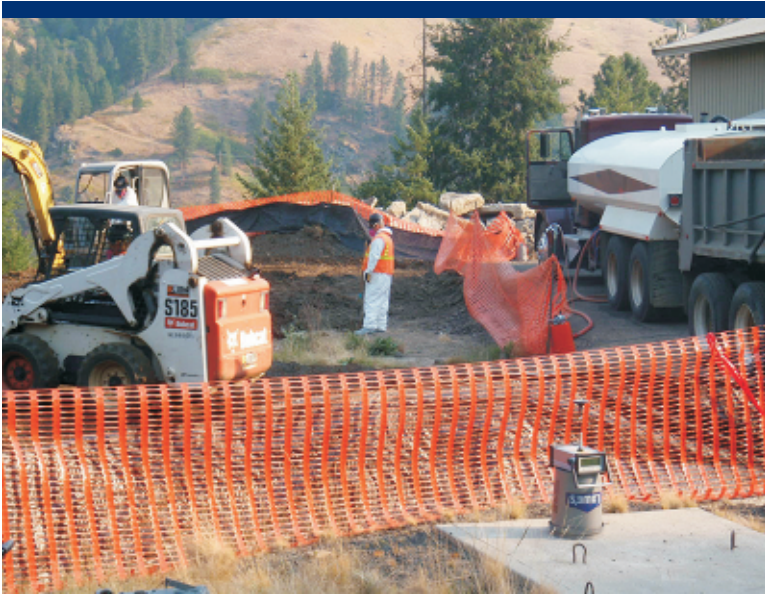
Photo 5 Excavation of asbestos-contaminated soil from 4753 Transfer Station Road.

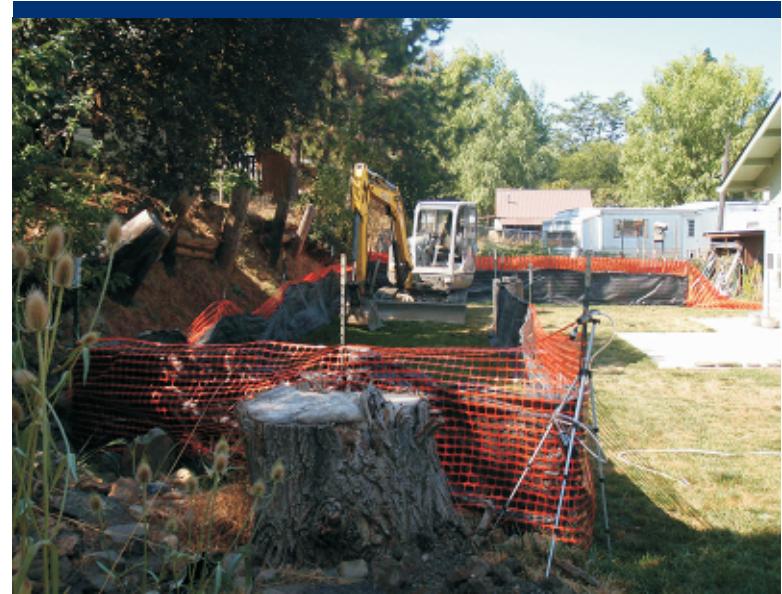
Photo 6 Pre-removal of asbestos-contaminated soil at 12742 Hartford Avenue.

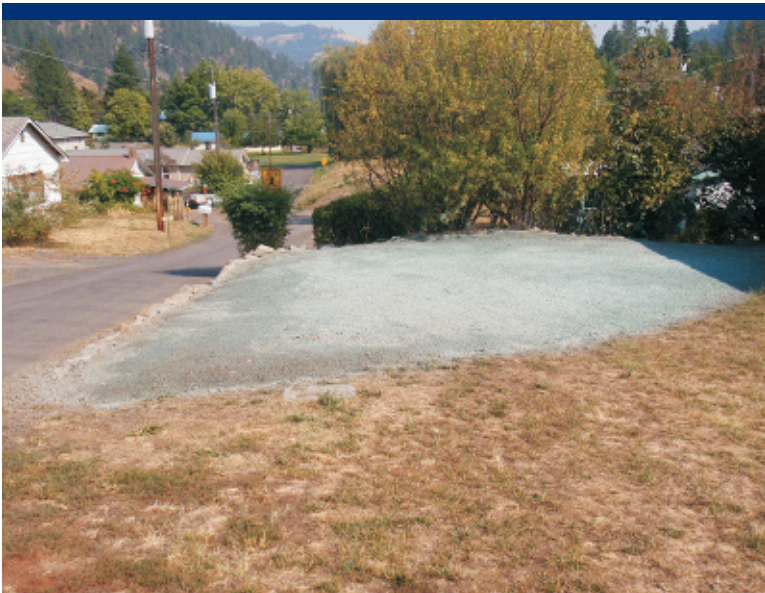
Photo 7 12170 Hartford Avenue backfill and hydro-seeding completed.

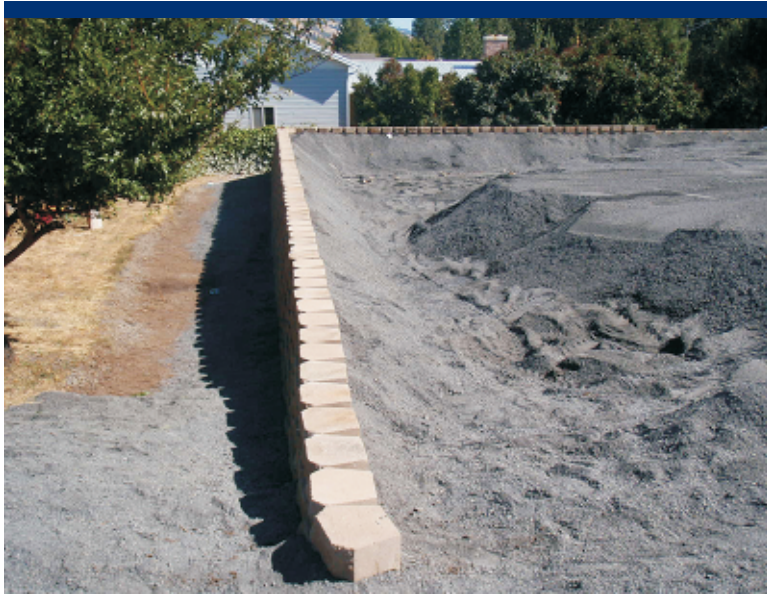
Photo 9 Small retaining wall completed at 12517 Hartford Avenue.

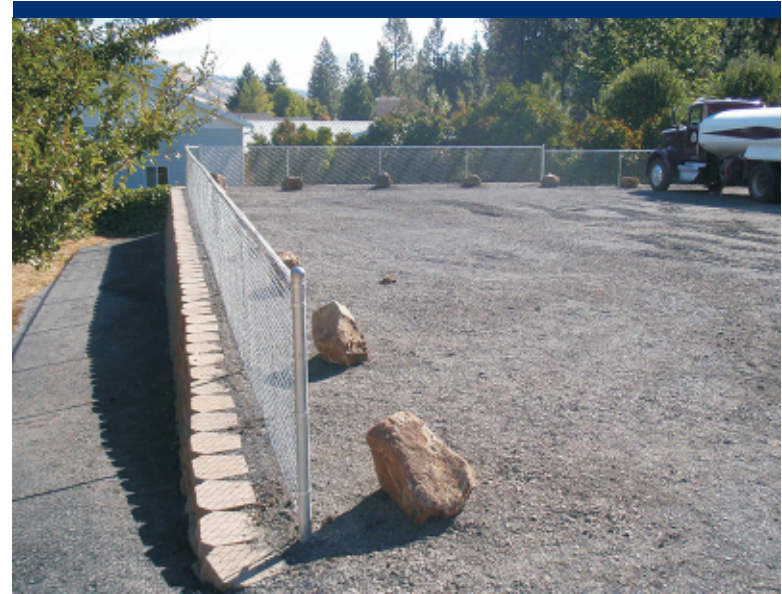
Photo 10 12517 Hartford Avenue backfill and fence completed.

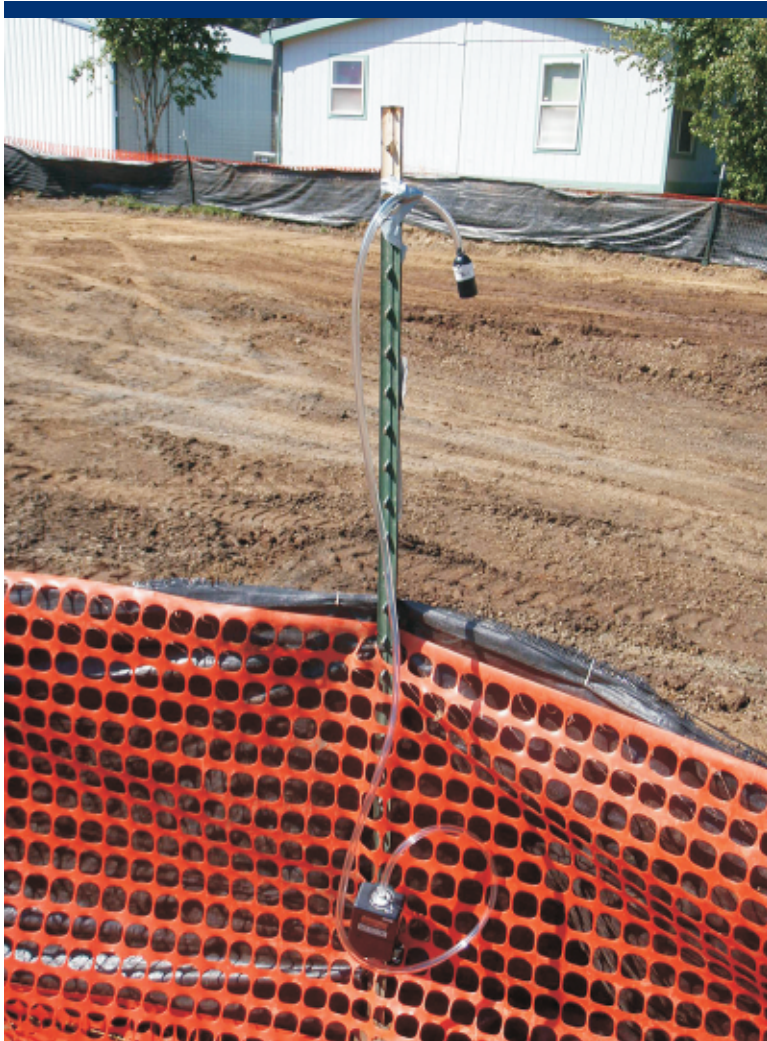
Photo 11 Example of air sampling pump and cassette.

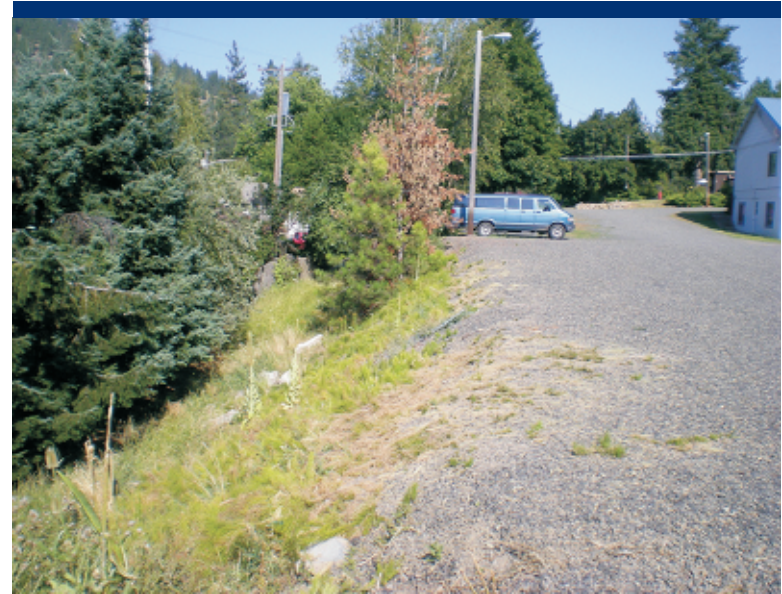
Photo 12 Church parking lot at 291 118th St. before construction of the wall.

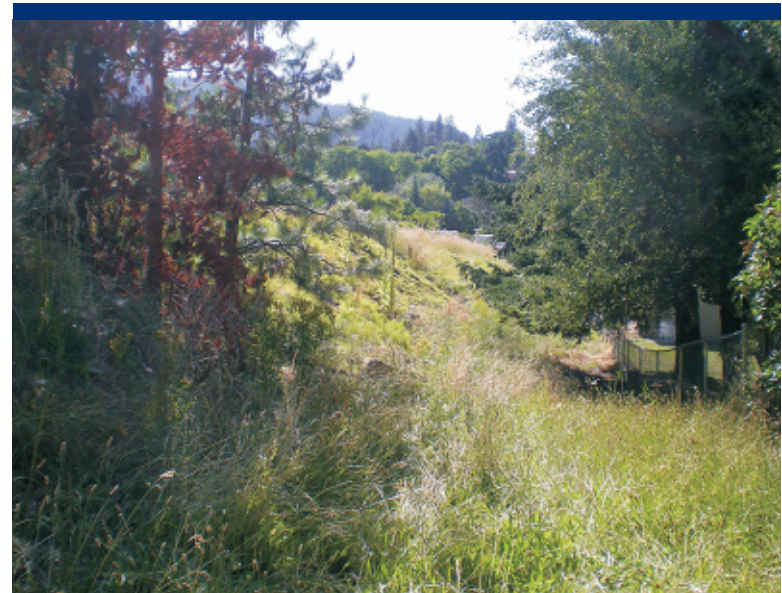
Photo 13 Lower view of the north slope of church parking lot where wall will be constructed.

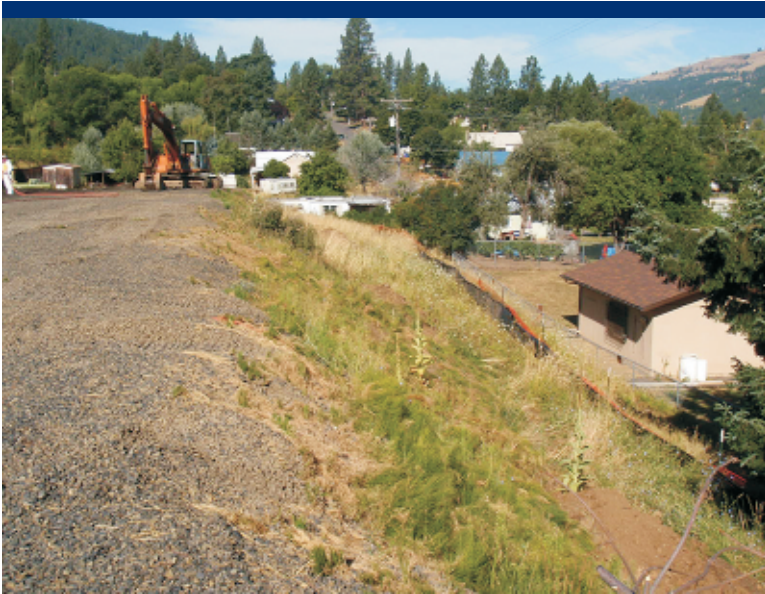
Photo 14 Upper view of the north slope of church parking lot where wall will be constructed.

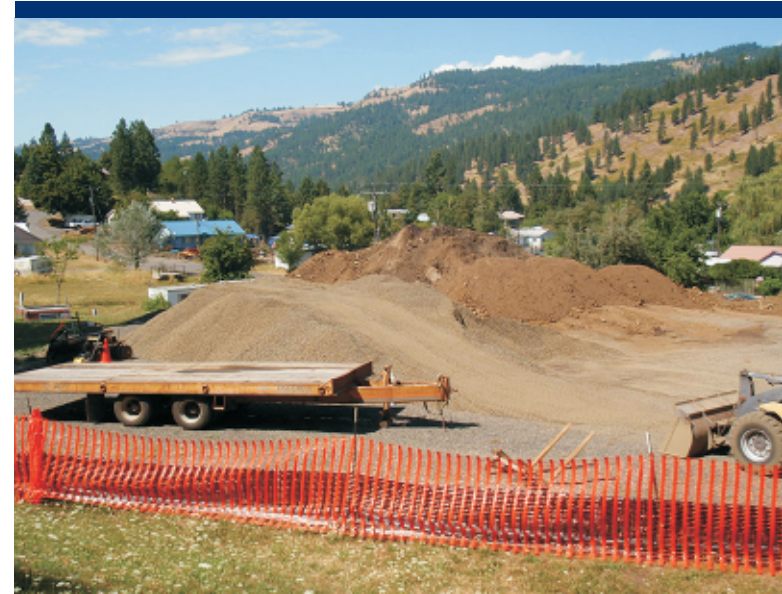
Photo 15 Stockpiles of asbestos-contaminated soil from remote properties at 291 118th St.

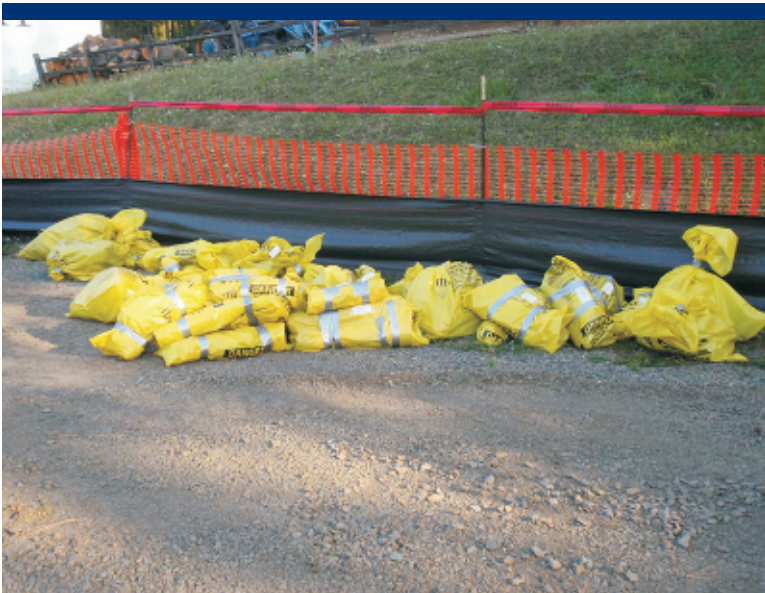
Photo 16 Bagged asbestos-cement pipe (ACP) staged at 291 118th St.

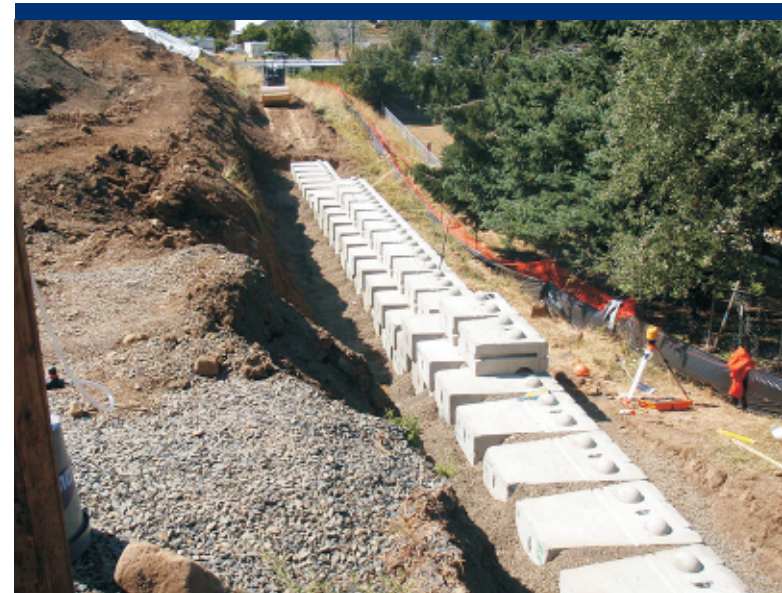
Photo 17 Base blocks of the wall for the north side of the parking lot retaining wall.

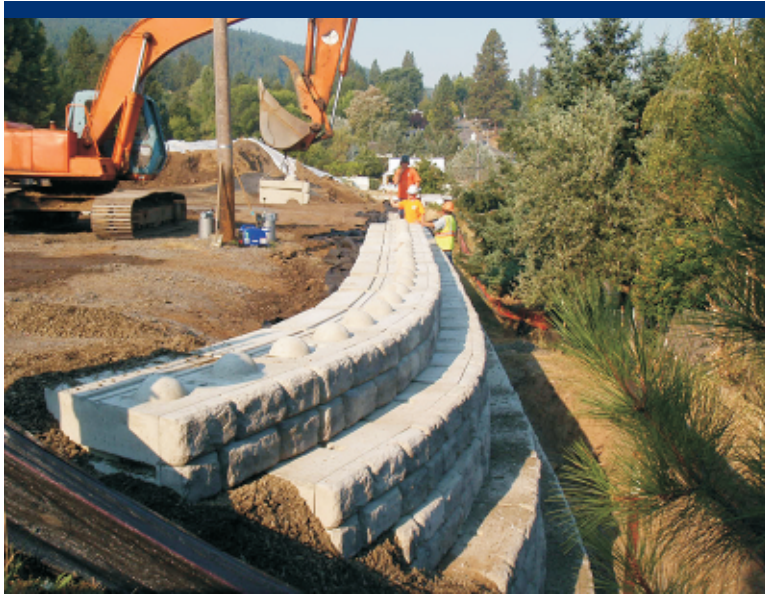
Photo 18 East end of the north side of the retaining wall.

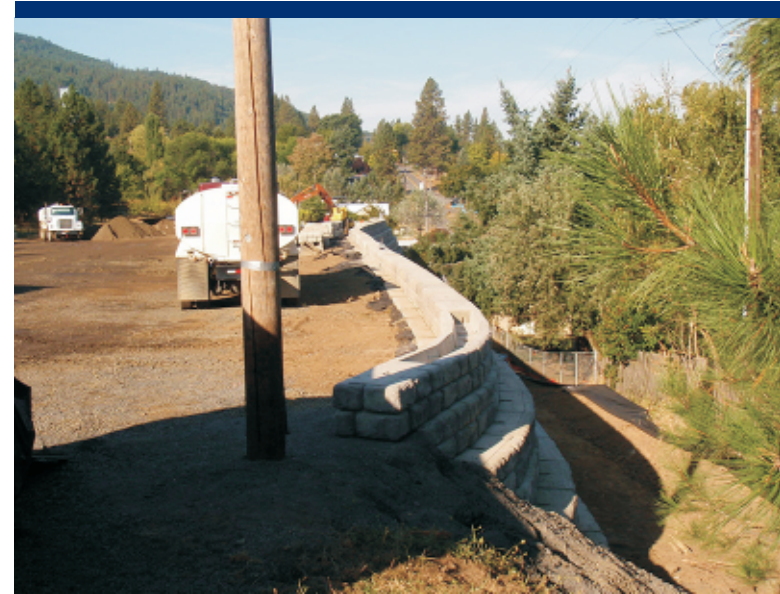
Photo 19 View of the completed north side retaining wall.

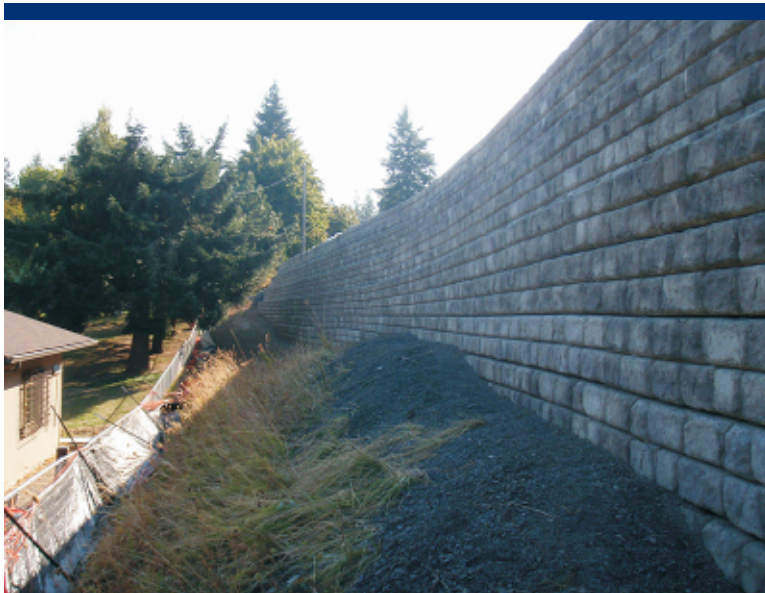
Photo 20 View of north retaining wall from the down hill side.

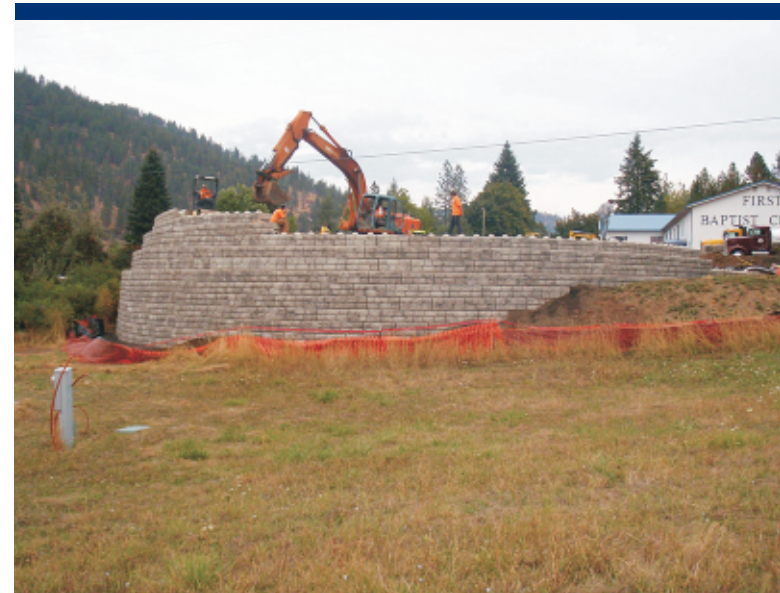
Photo 21 View of the west side of the retaining wall.

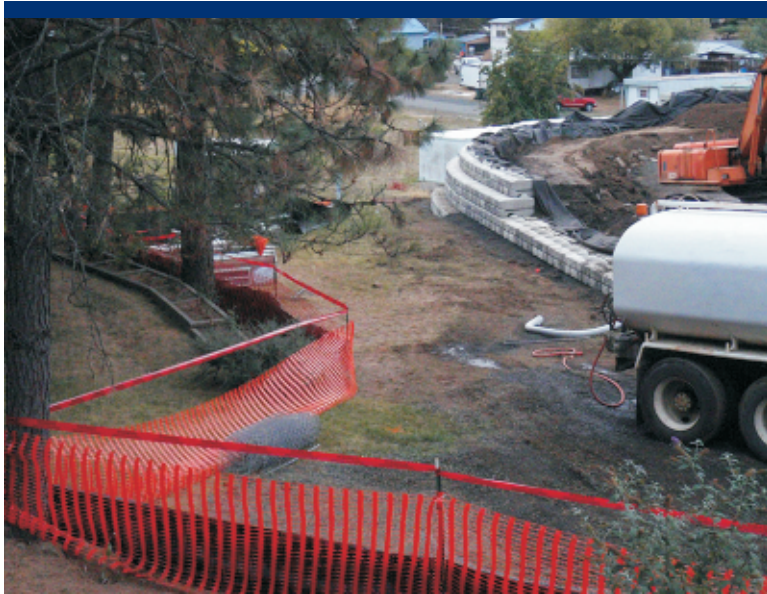
Photo 22 South terminal end of the retaining wall under construction.

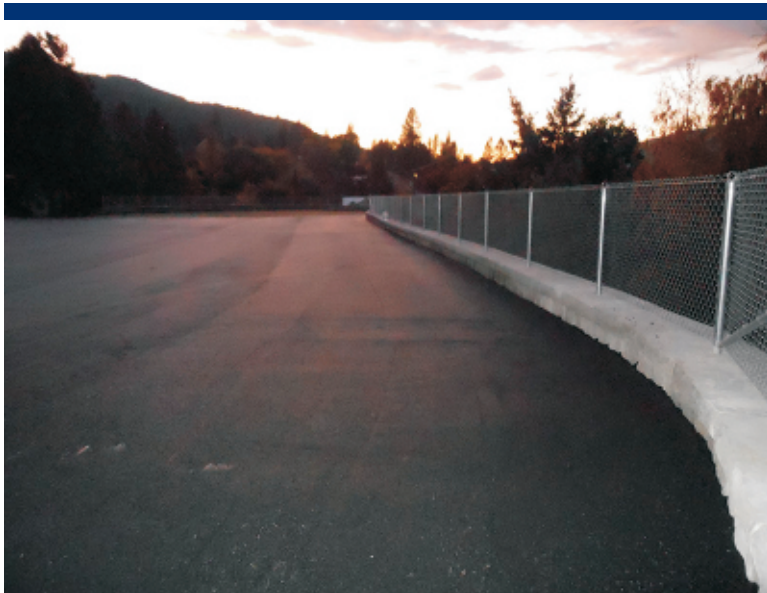
Photo 24 Completed asphalt cover and fence.

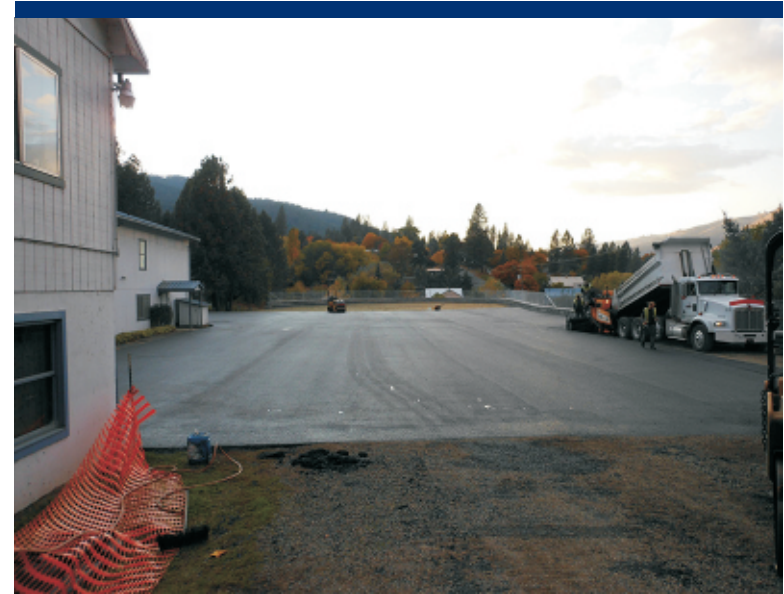
Photo 23 Asphalt subcontractor completes the parking lot.

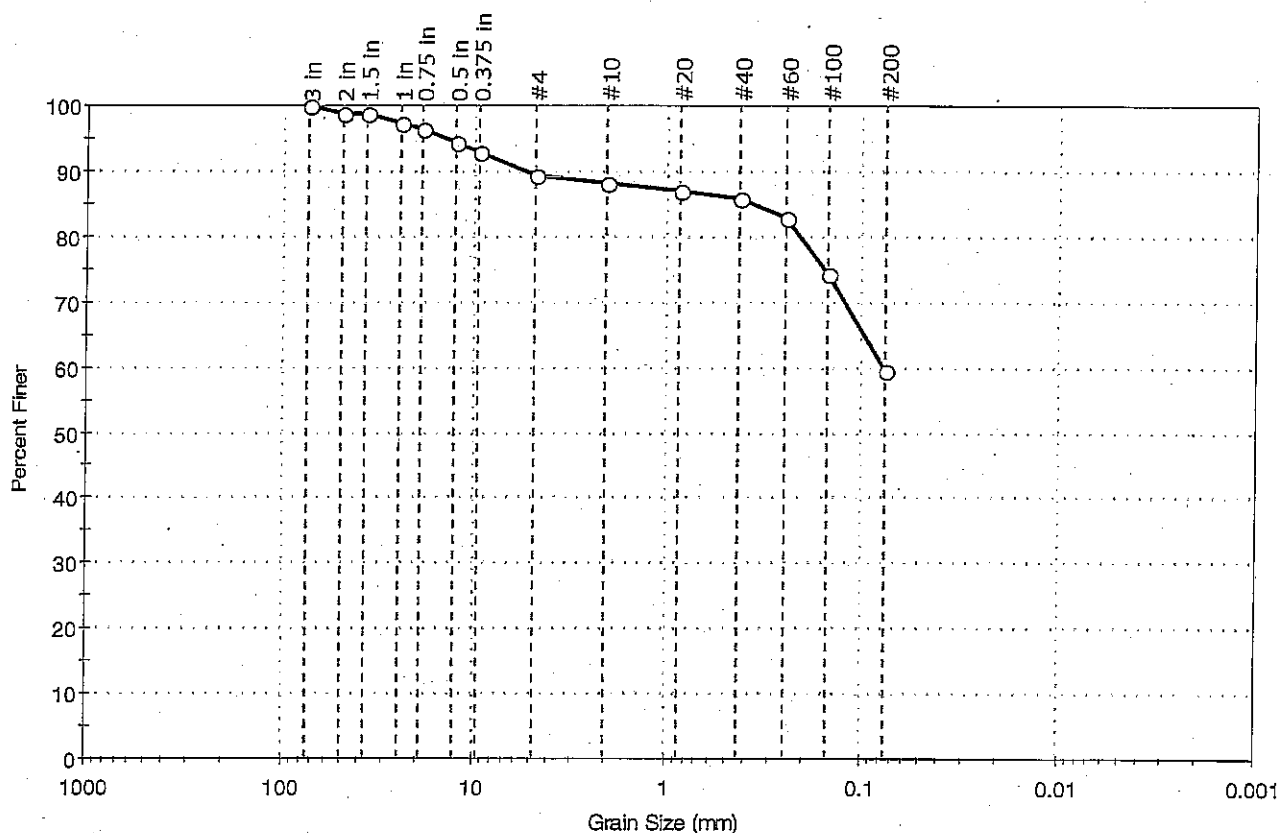
## Particle Size Analysis - ASTM D 422-63 (reapproved 2002)

% Cobble	% Gravel	% Sand	% Silt & Clay Size
—	10.6	29.7	59.7

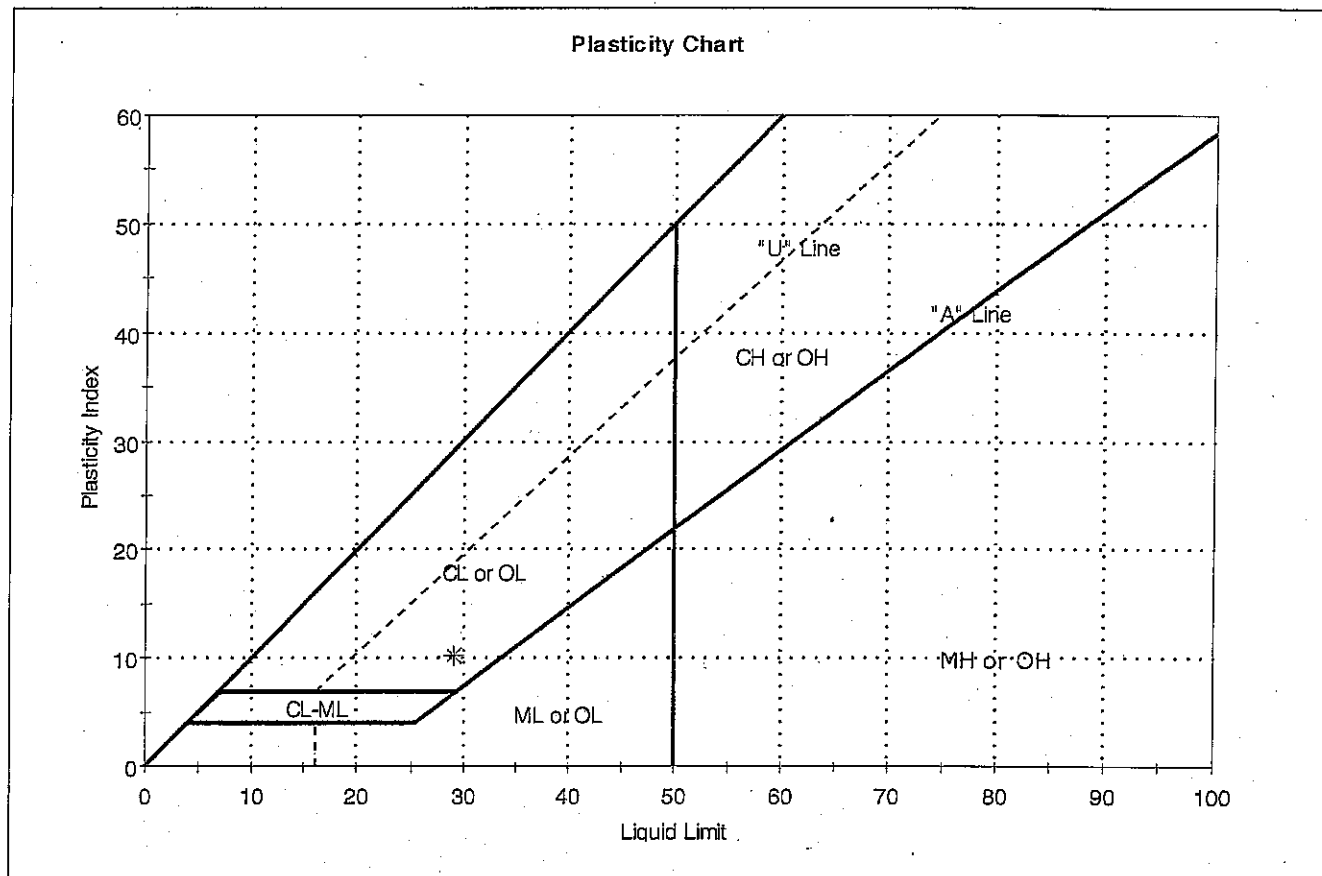
## Atterberg Limits - ASTM D 4318-05

Symbol	Sample ID	Boring	Depth	Natural Moisture Content, %	Liquid Limit	Plastic Limit	Plasticity Index	Liquidity Index	Soil Classification
*	11082201	---	---	14	29	19	10	0	Sandy lean clay (CL)

Sample Prepared using the WET method  
 14% Retained on #40 Sieve  
 Dry Strength: LOW  
 Dilatancy: SLOW  
 Toughness: MEDIUM

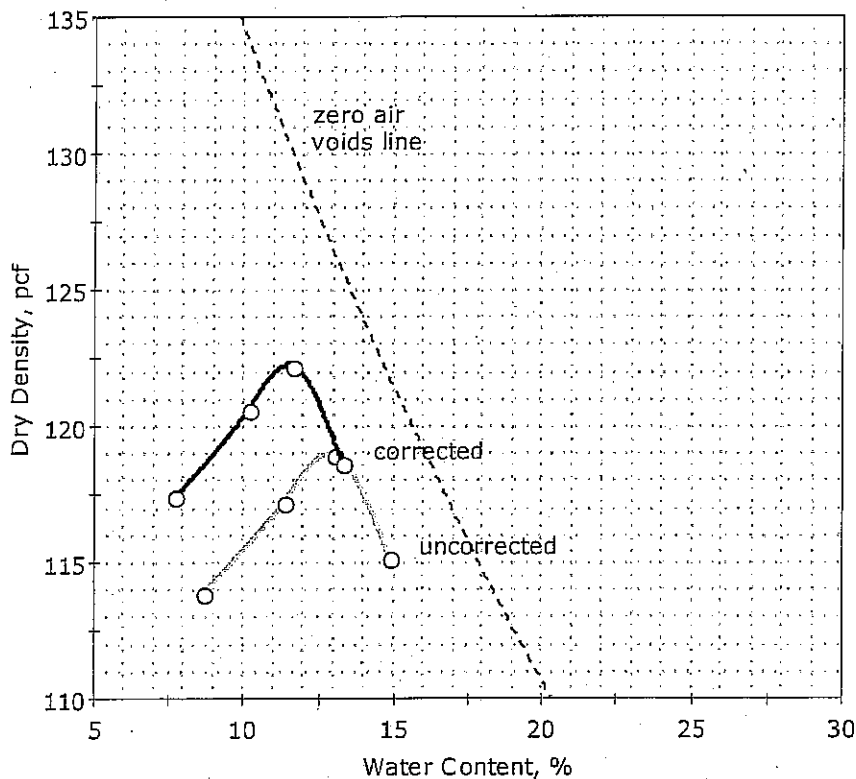
## Compaction Report - ASTM D 1557

Data Points	Point 1	Point 2	Point 3	Point 4
Dry density, pcf	113.9	117.2	118.9	115.2
Moisture Content, %	8.6	11.4	13.0	14.9

Optimum Moisture= 13.0 %

Corrected Optimum Moisture= 11.5 %
