MEMORANDUM

SUBJECT: Approval for a Time-Critical Removal Action at the Otsego Township Dam Area of the Allied Paper, Inc./Portage Creek/Kalamazoo River Superfund Site, Allegan County, Michigan (EPA ID MID006007306)

Allied Paper, Inc./Portage Creek/Kalamazoo River Superfund Site –
Otsego Township Dam Area

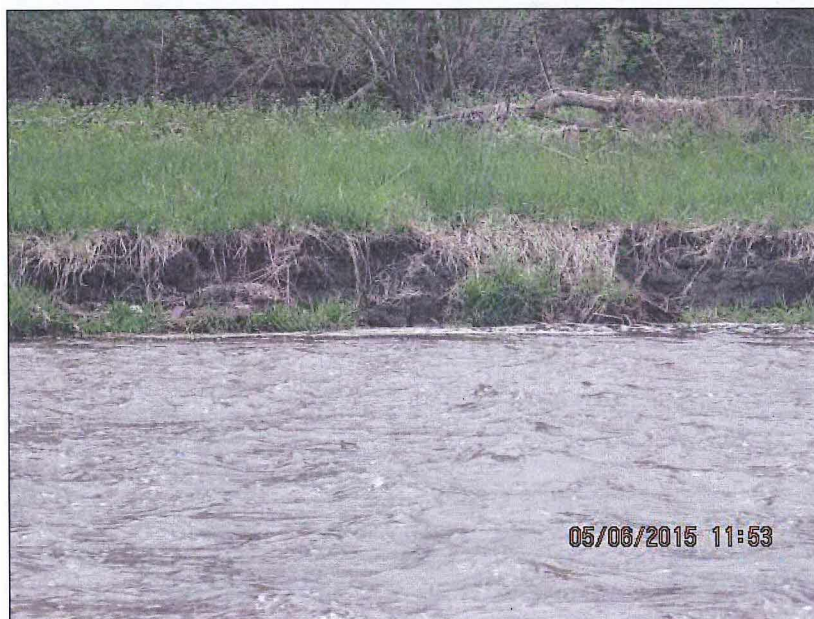
Photograph No.: 1

Photograph 1. Riverbank erosion of contaminated soils on south bank (May 2015)

Subject: Riverbank erosion of contaminated soils into Kalamazoo River on north bank.

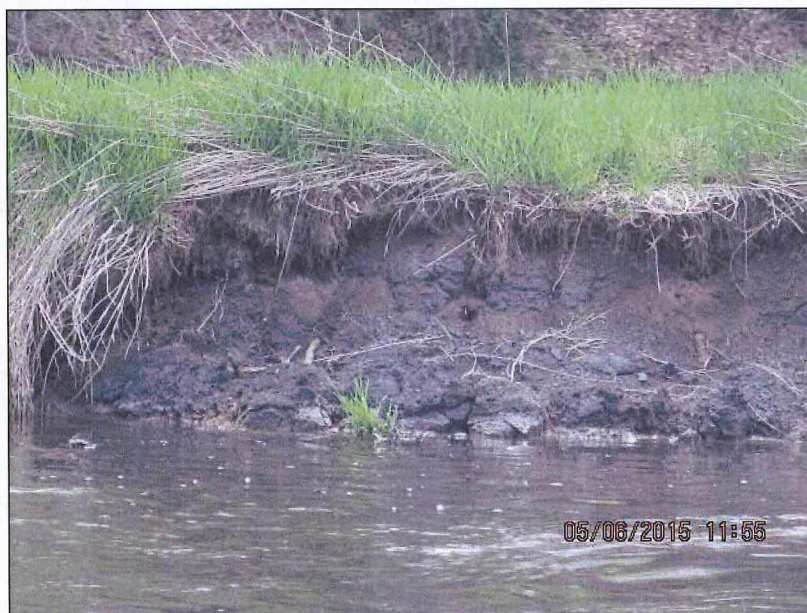
Photograph No.: 2

Photograph 2. Riverbank erosion of contaminated soils on south bank (May 2015)

Subject: Riverbank erosion of contaminated soils into Kalamazoo River on south bank.

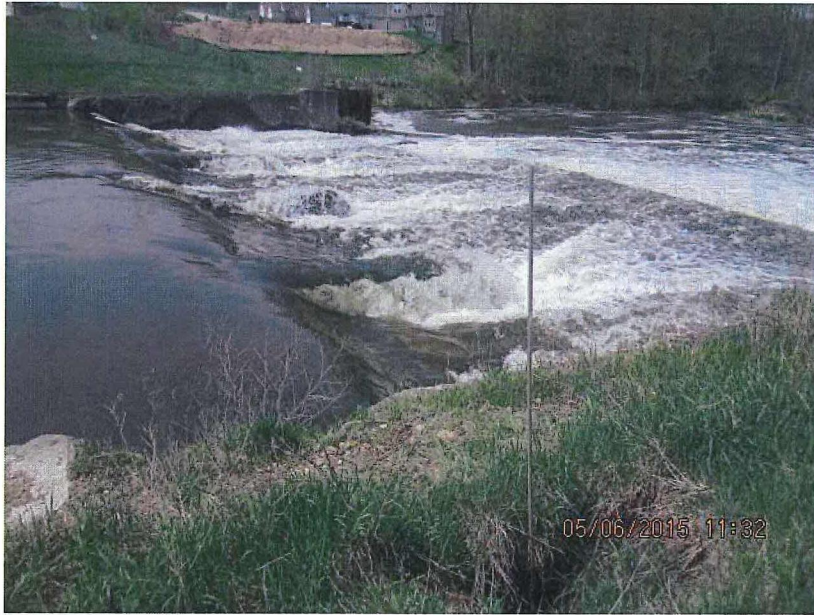
Photograph No.: 3

Photograph 3. Deterioration of concrete spillway structure and sinkhole (May 2015)

Subject: Deterioration of concrete spillway structure and sinkhole (foreground), replaced by a temporary water control structure in 2016.

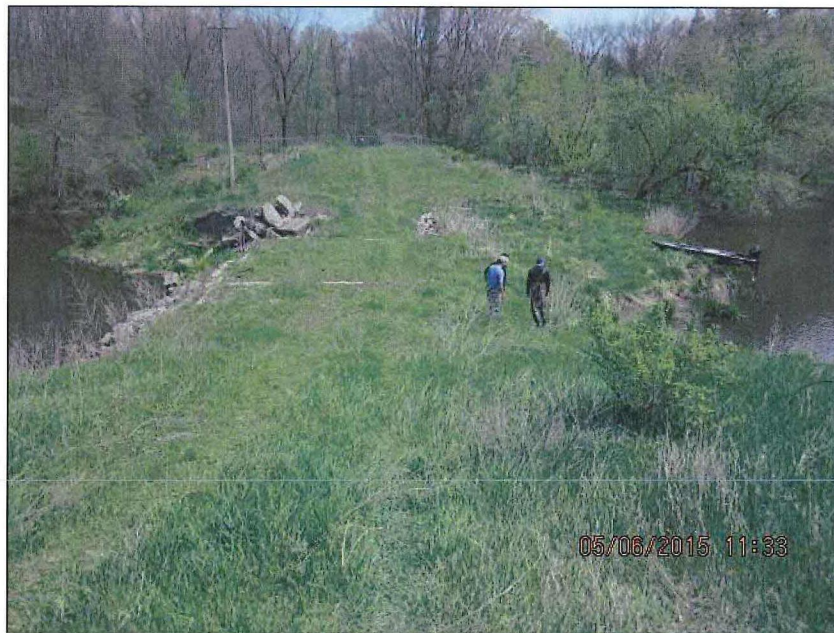
Photograph No.: 4

Photograph 4. Deterioration of earthen/concrete portion of dam (May 2015)

Subject: Deterioration of earthen/concrete portion of Otsego Township Dam, replaced by a temporary water control structure in 2016.

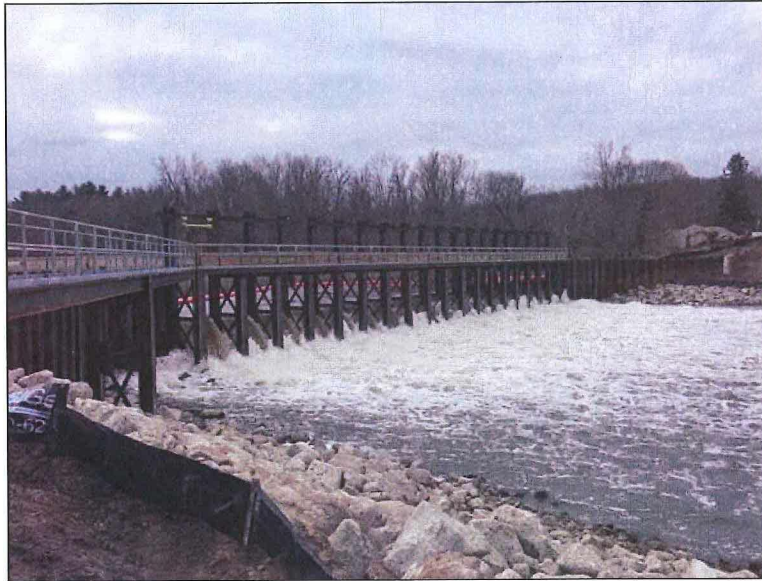
Photograph No.: 5

Photograph 5. Temporary water control structure in operation (March 2016)
