**Re: Buried Linear Feature Survey
Hal. H. Clark Park's Delaware Canal Footer Drain and vicinity
Centerbridge Facility
Bucks County, Solebury Township, Pennsylvania**

RETTEW Field Services
Photo Documentation

PROJECT NAME: Center Bridge

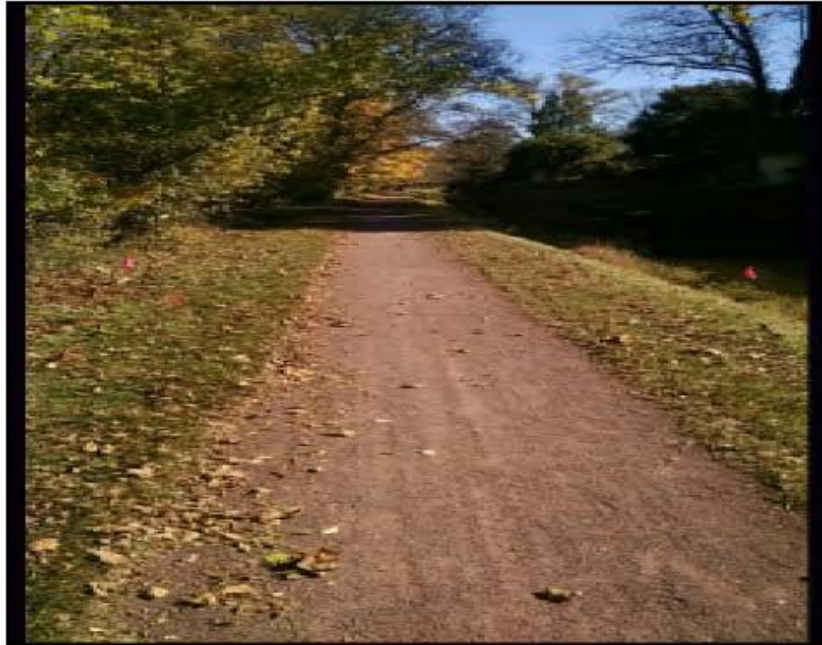
PHOTO 1

View of the towpath
facing southeast.

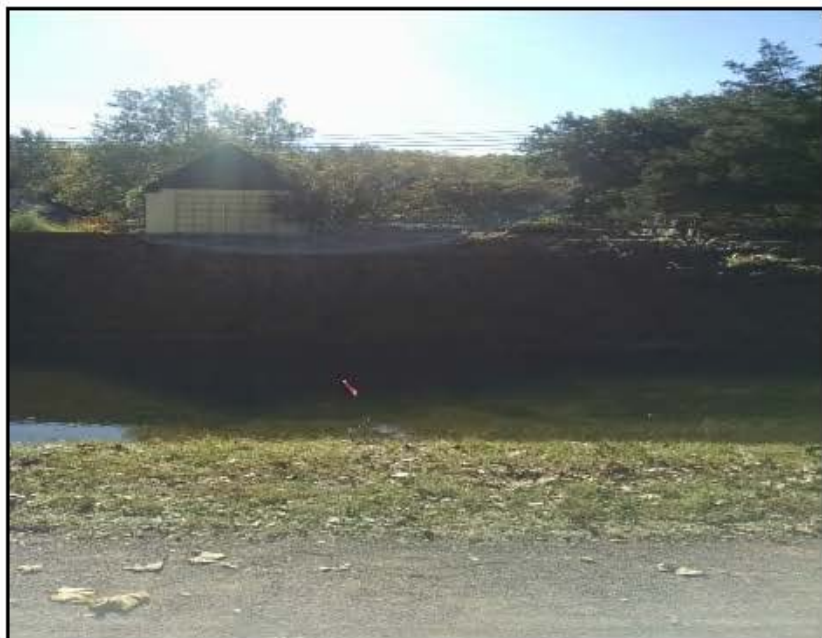
PHOTO 2

View of the path of the
exposed steel pipeline
facing Dr. Hill's property.

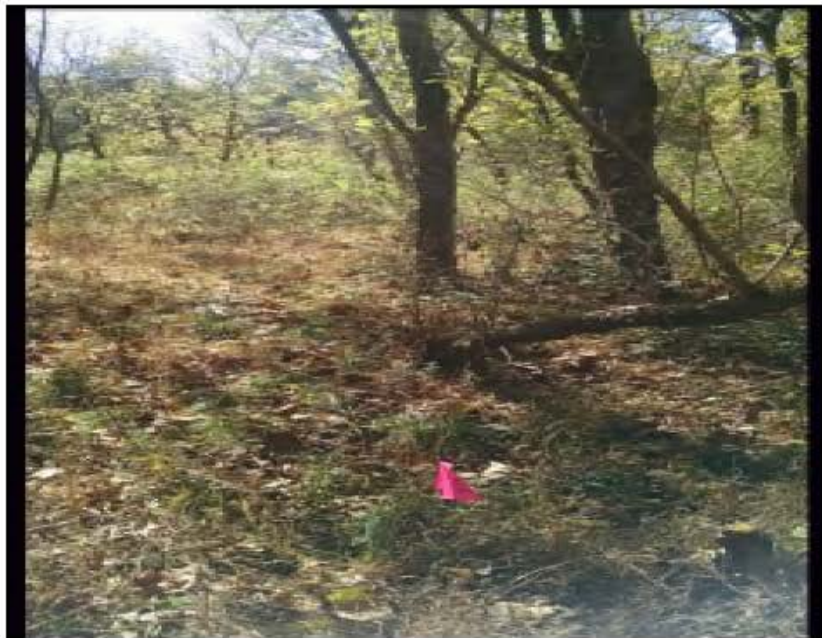
PHOTO 4

View of the area where a
potential line was traced
near the property line of
41-28-57 and 41-18-130
(Attachment C).

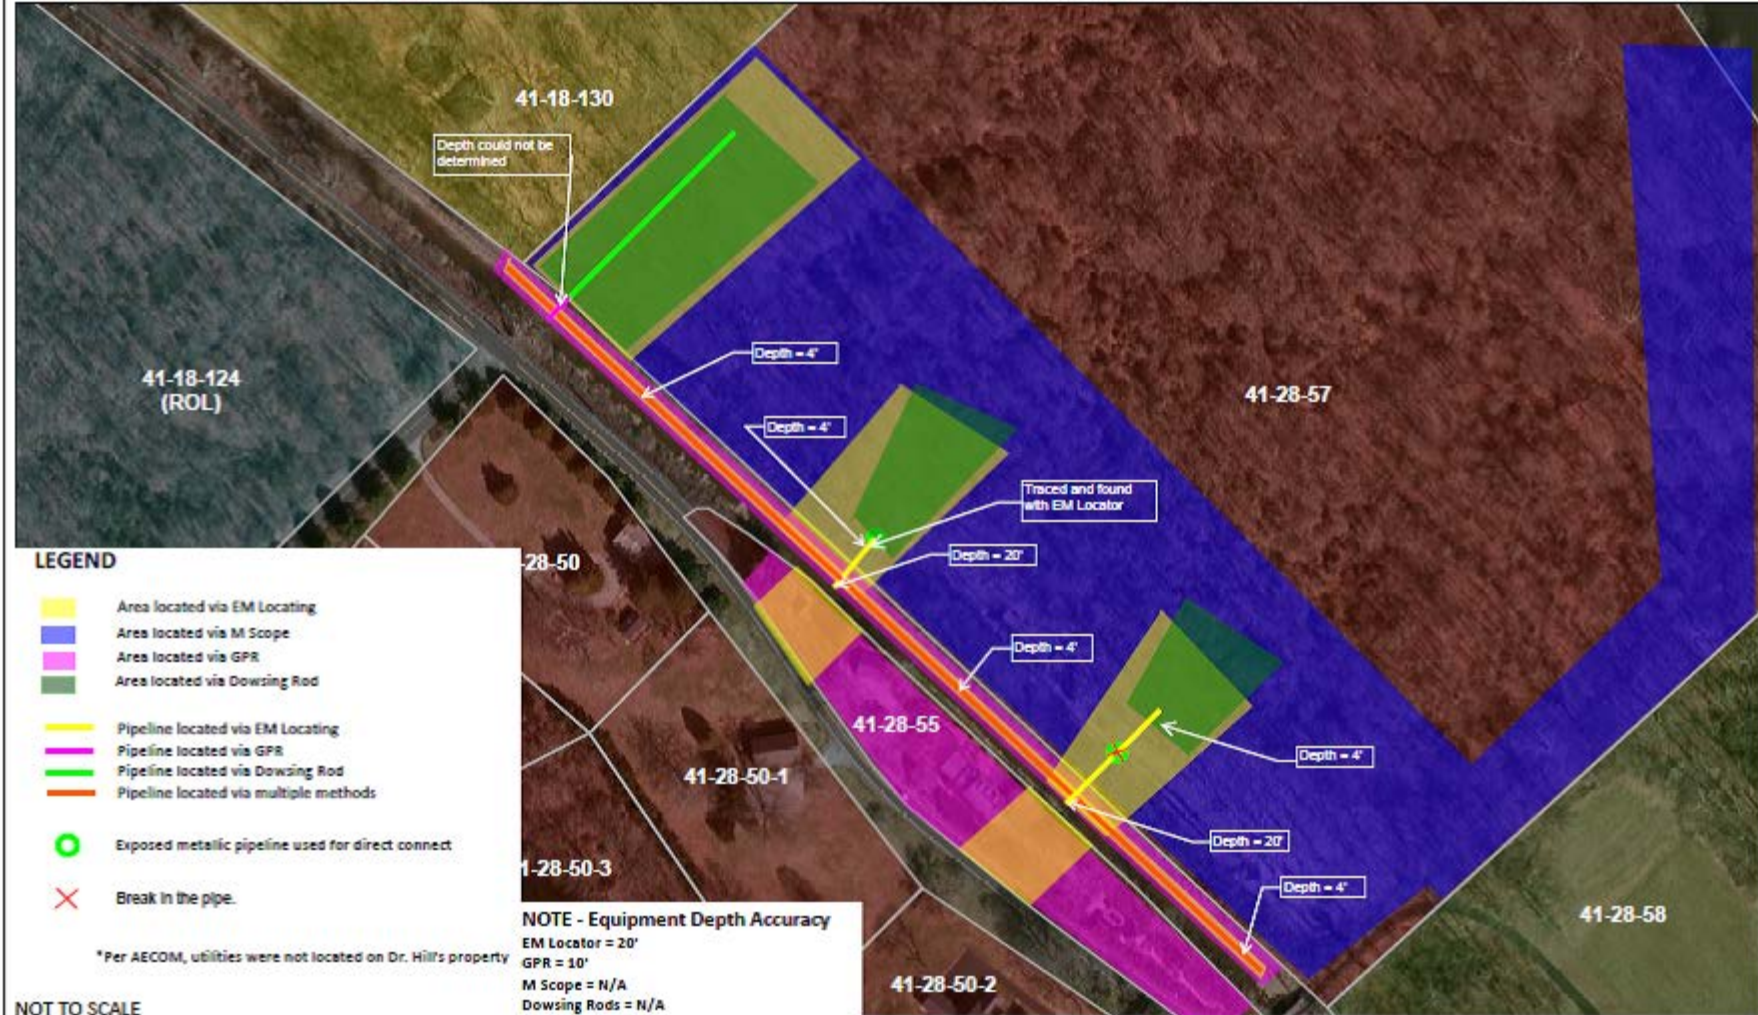
FIGURE 1

A summary of Rettew's findings is provided in the attached memorandum, including a figure illustrating potential locations of buried linear features. Please note that the memorandum text and figure indicate "pipelines" were identified. It should not be assumed that these are petroleum pipelines. While buried pipe or related cavities may have been detected, it is possible that these features are associated with the canal, footer drain system, or historic or current utilities. Excavation and visual observation of the buried linear features were not performed, and their purpose and usage have not been determined.

Utility Map
